Project Completion Report

LAKE CHAPEAU SEDIMENT INPUT AND HYDROLOGIC RESTORATION TERREBONNE PARISH, LOUISIANA TE-0026

Project Name: Lake Chapeau Sediment Input and Hydrologic Restoration Project
CPRA/State Project No.: TE-0026
Report Date: October 1, 2018
By: Delta Coast Consultants

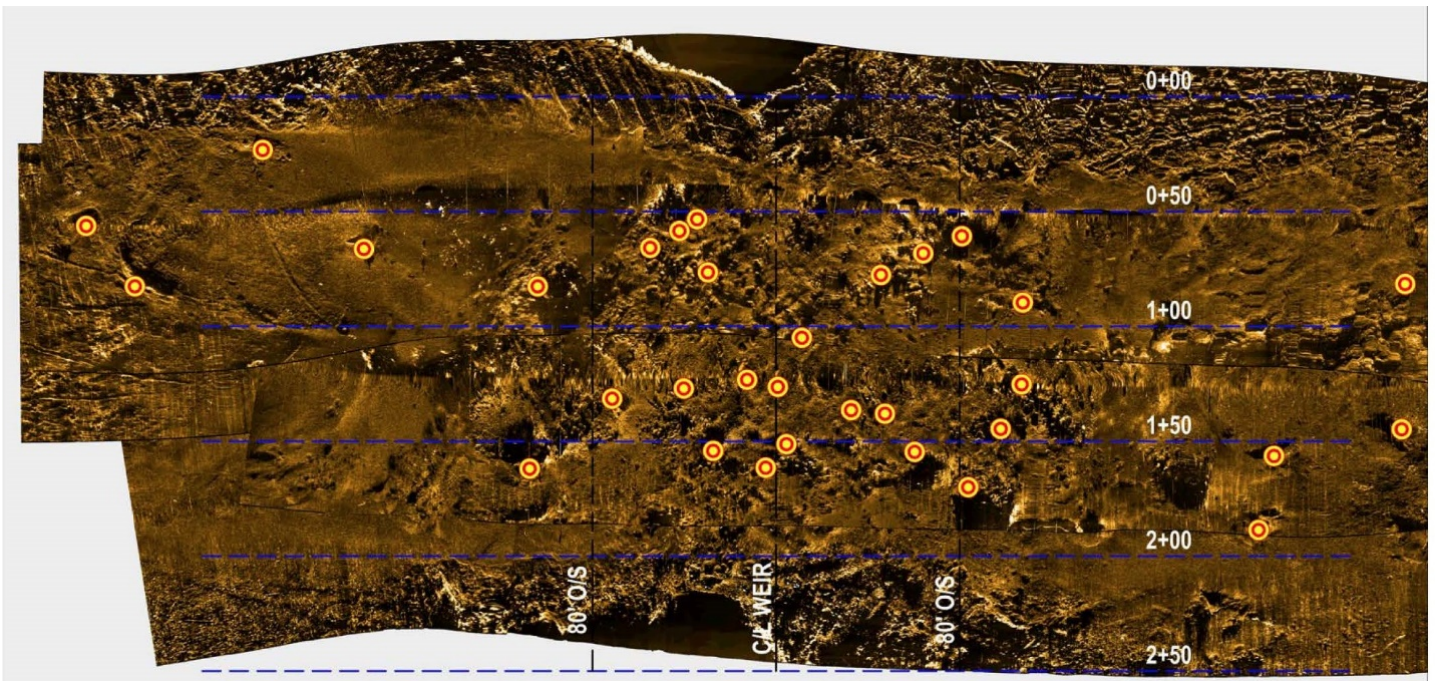
Side Scan Sonar Image of Removed Weir #4

The image below represents the water bottom of weir No. 4 after construction was completed on the degradation of the rock weir. The side-scan sonar survey was performed on September 11, 2018 and was conducted with a Klein 3900 (445kHz, 900kHz Side-scan Sonar interfaced with RTK GPS and Hypack v2017. The data was post processed in Chesapeake Sonar Wiz v6.

The targets on the image represent undulations of the water bottom that are higher in elevation than the adjacent bottom. However, none of these targets appear to be at an elevation that is above the plan design elevation of -8.0. Therefore, based on the as-built survey data that the contractor submitted to us for review and on this side-scan sonar survey, the project has been completed in accordance with the design grades for this project.

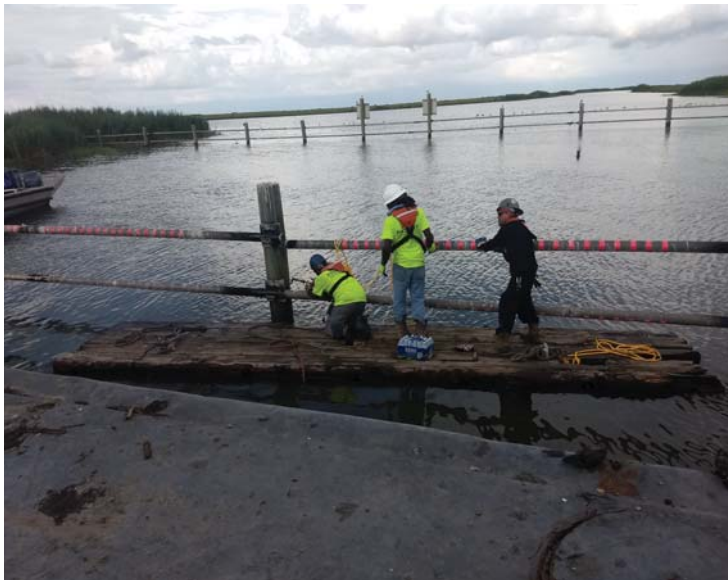
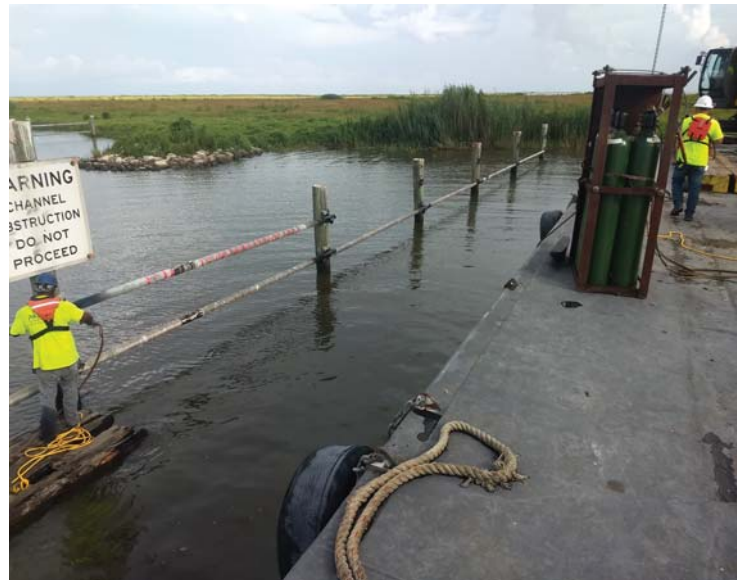
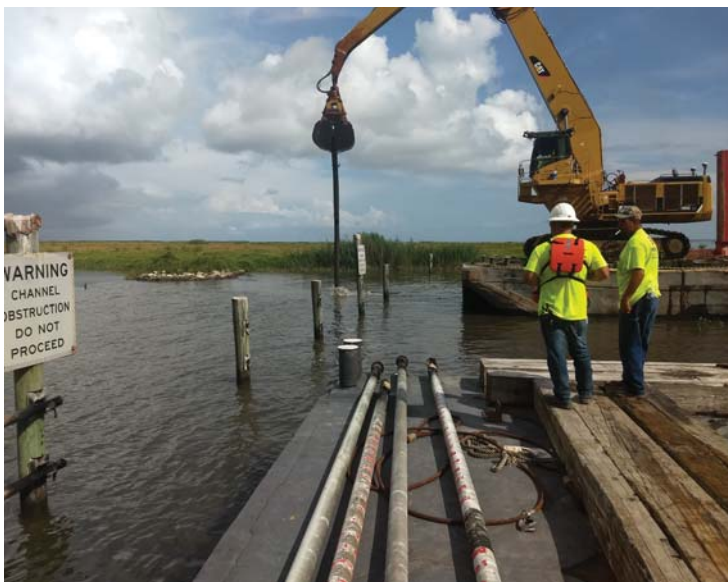
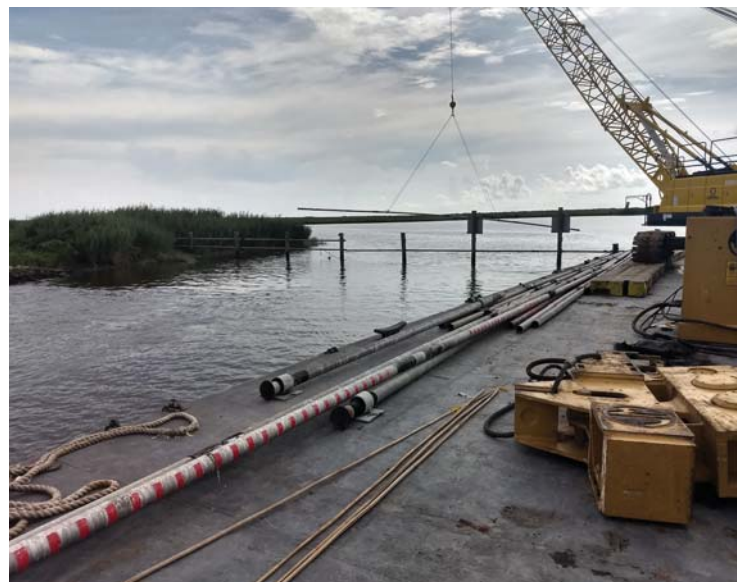
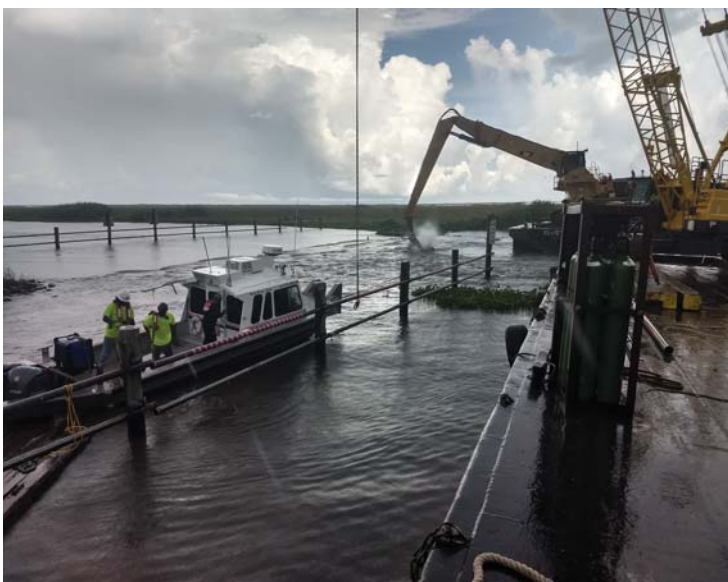
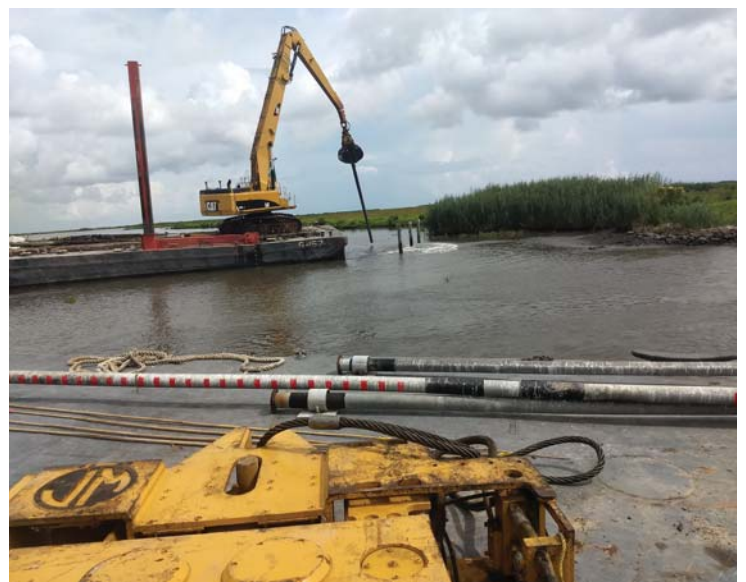
Cut and removed metal pipes.

Pulled wooden piles. One pile brock 2' below mudline in center of channel.

Moved Northern portion of Rip-Rap in channel to create access for barge.

Two Piles on north side left in place and two piles on southwest side left in place.

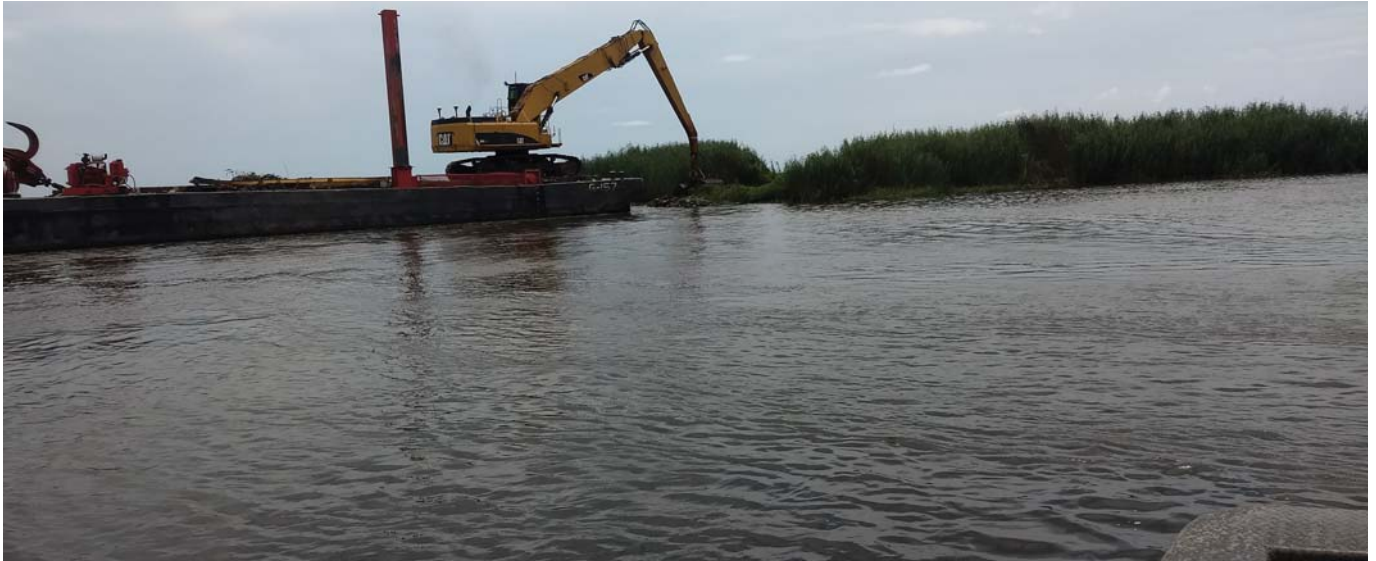
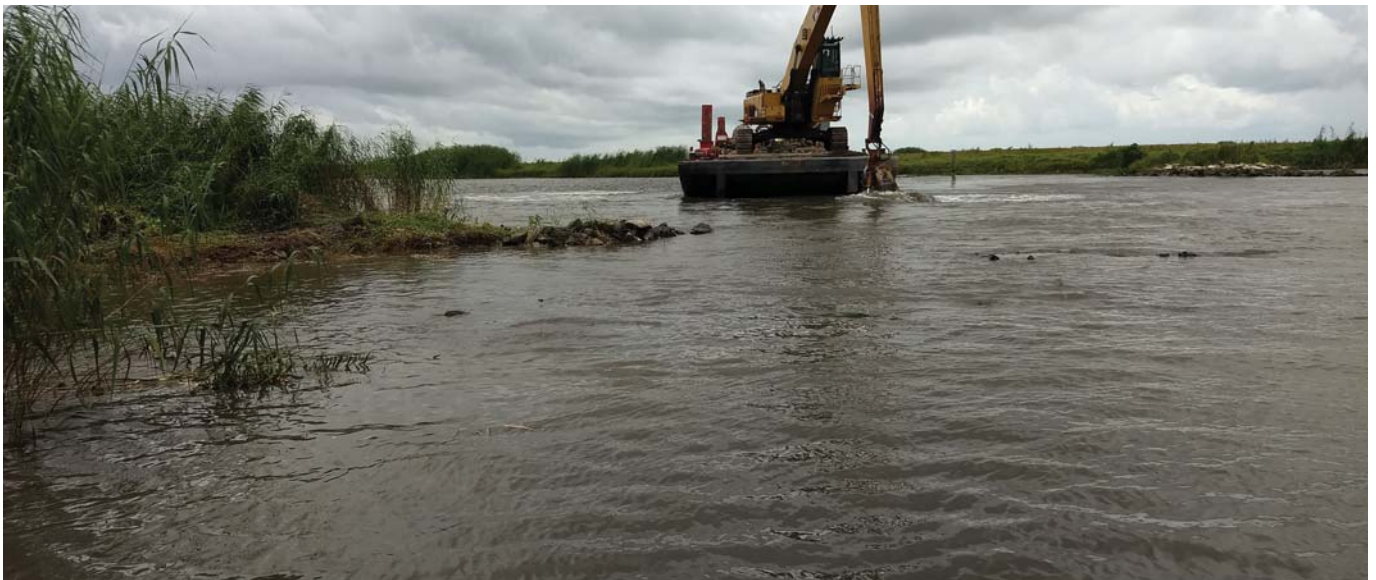
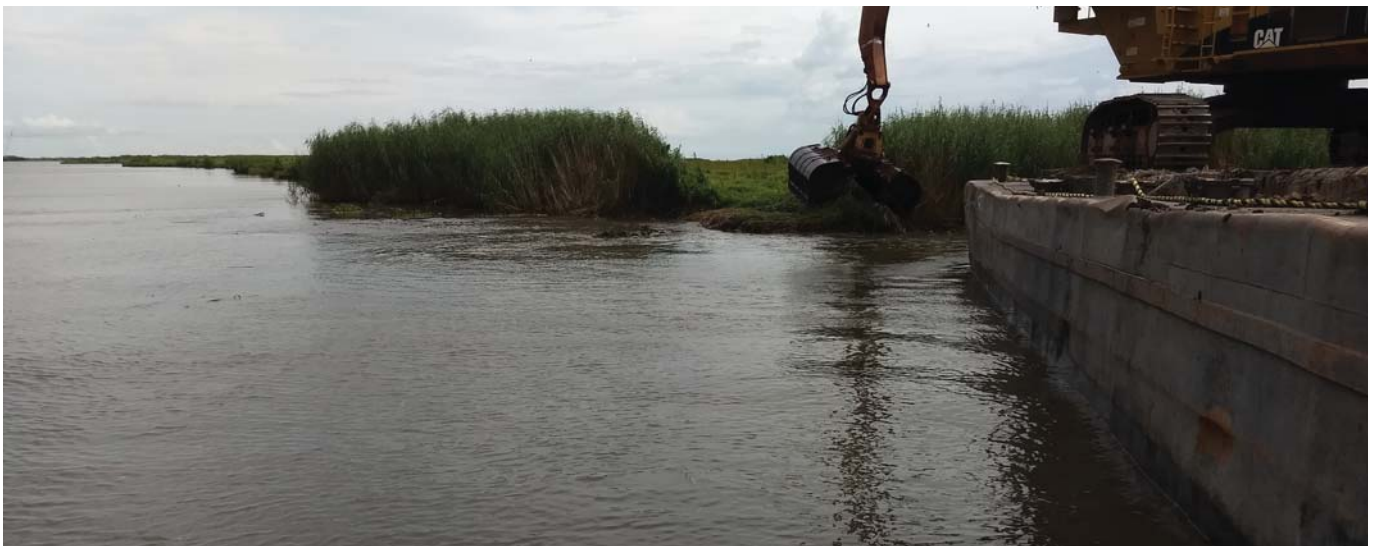
Moved Rip-Rap into channel.

disposing liner on barge

Retrieving liner on water and disposed on barge.

Two Piles on north side left in place and two piles on southwest side left in place.

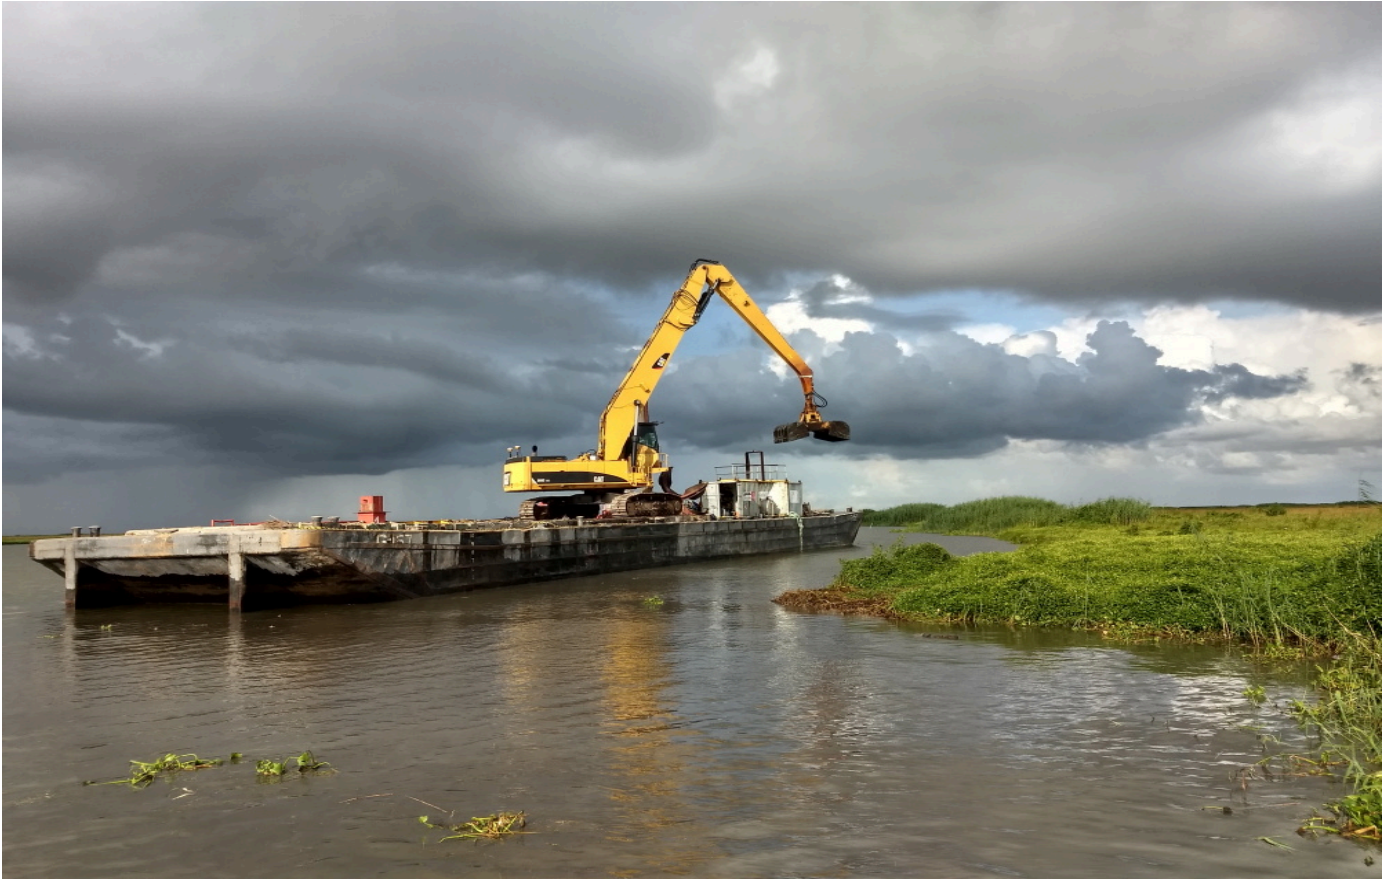
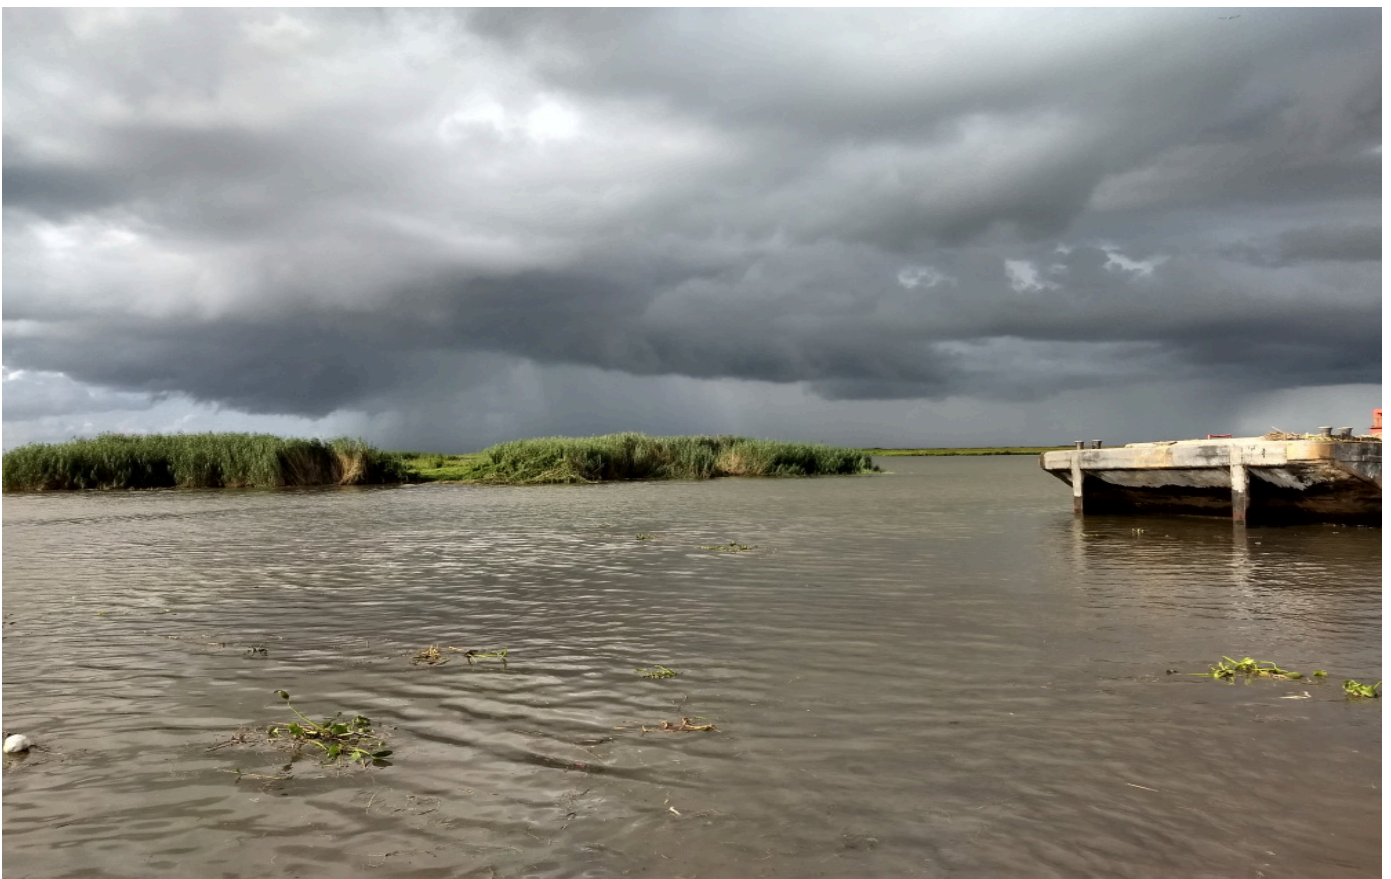
Moved Rip-Rap into channel.

Removed last 4 Piles.

Poled area for proper depth.

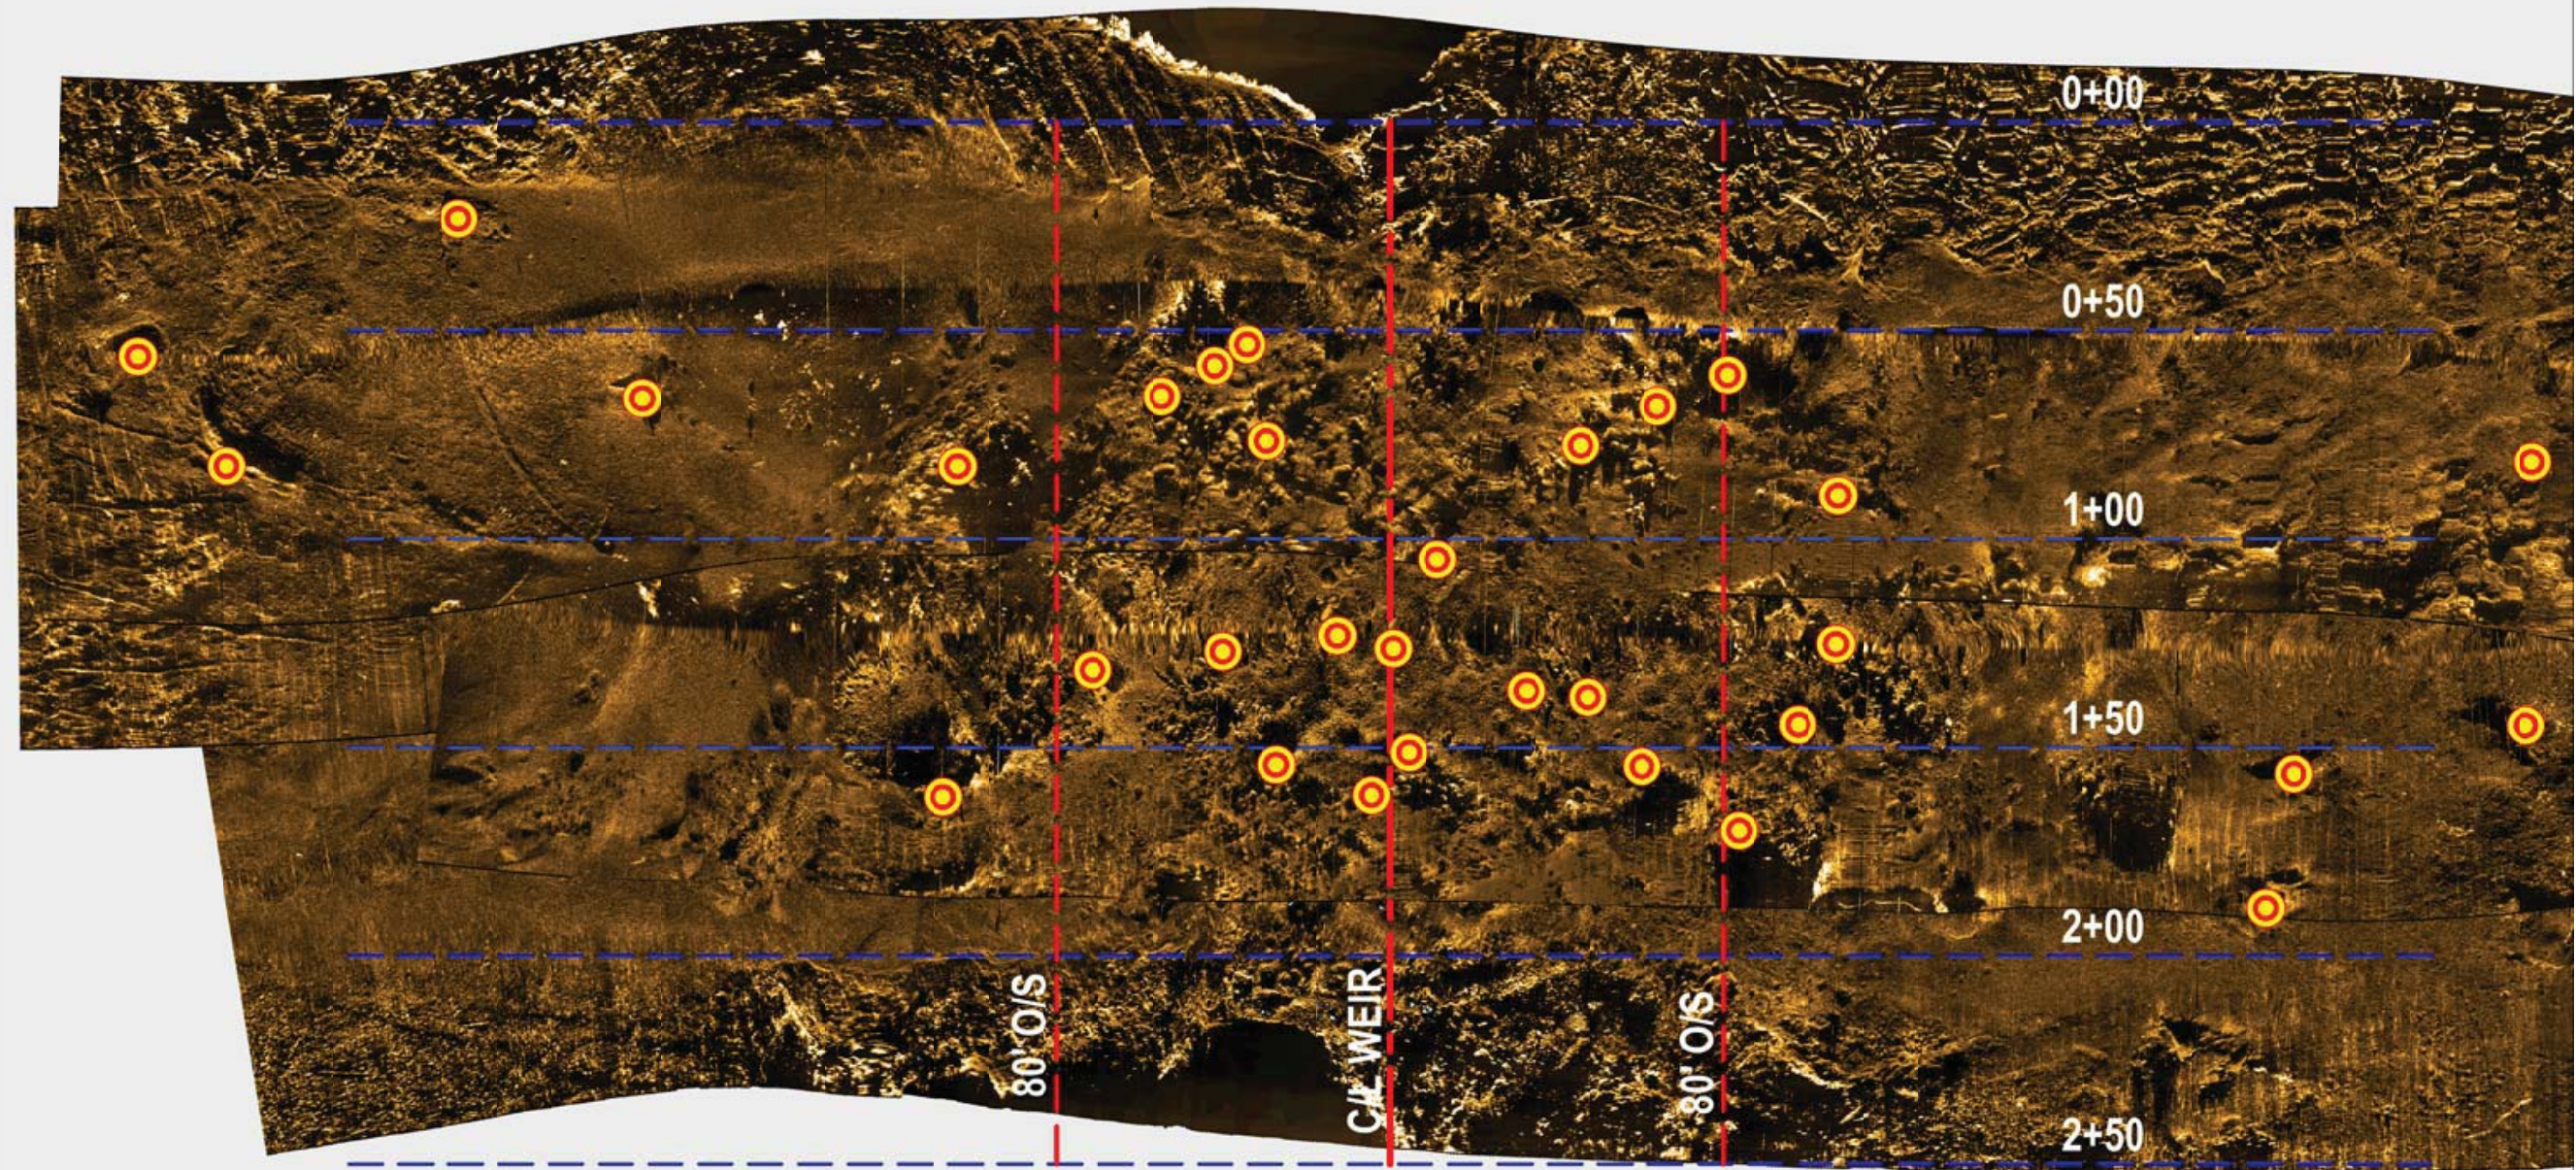
Side Scan Sonar Image of Removed Weir No. 4

The targets on the image represent undulations of the water bottom that are higher in elevation than the adjacent bottom. However, none of these targets appear to be at an elevation that is above the plan design elevation of -8.0.
