**State of Louisiana  
Coastal Protection and Restoration  
Authority of Louisiana (CPRA)**

**2019 Operations, Maintenance,  
and Monitoring Report**

**Humble Canal Hydrologic  
Restoration (ME-11)**

November 2019  
Cameron Parish

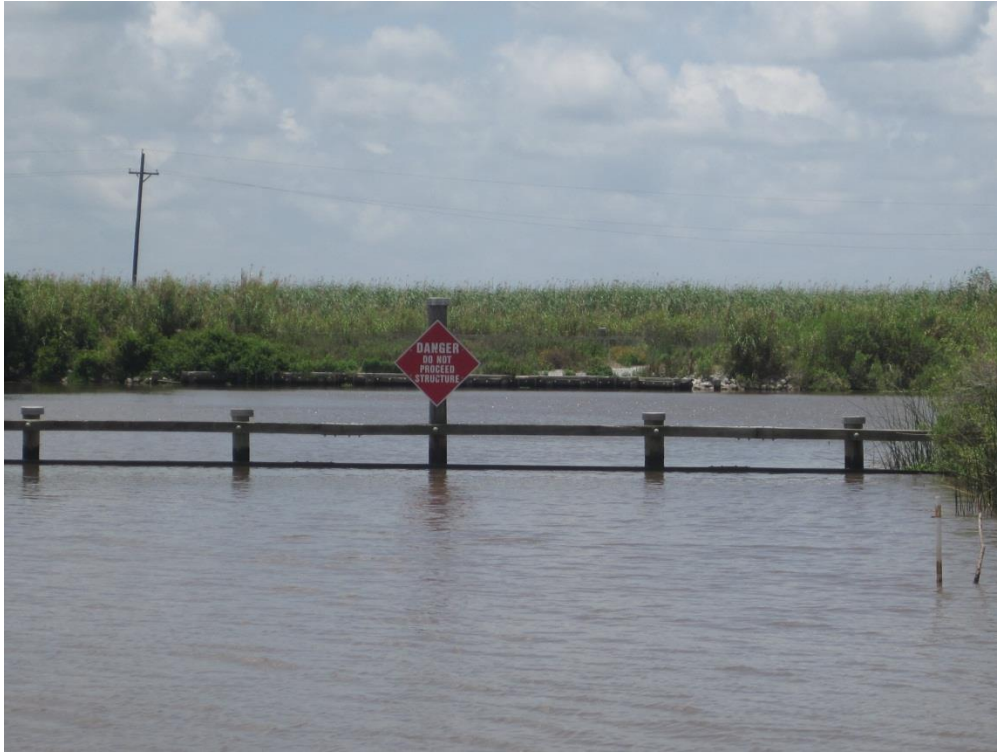
The structure is in excellent condition and the warning signs were intact. (Photos: Appendix A, Photo 1)

**Photo No. 1, Marine barrier with signage. (2013)**

Item	Condition	Physical Damage	Corrosion	Photo #	Observations and Remarks
Timber Bulkhead / Caps	N/A				
Steel Grating	N/A				
Stop Logs	N/A				
Hardware	good				
Timber Piles	good				
Timber Wales	good				
Galv. Pile Caps	good				
Cables	N/A				
Signage / Supports	good			1	
Rip Rap (fill)	N/A				
Eathern Embankment	N/A

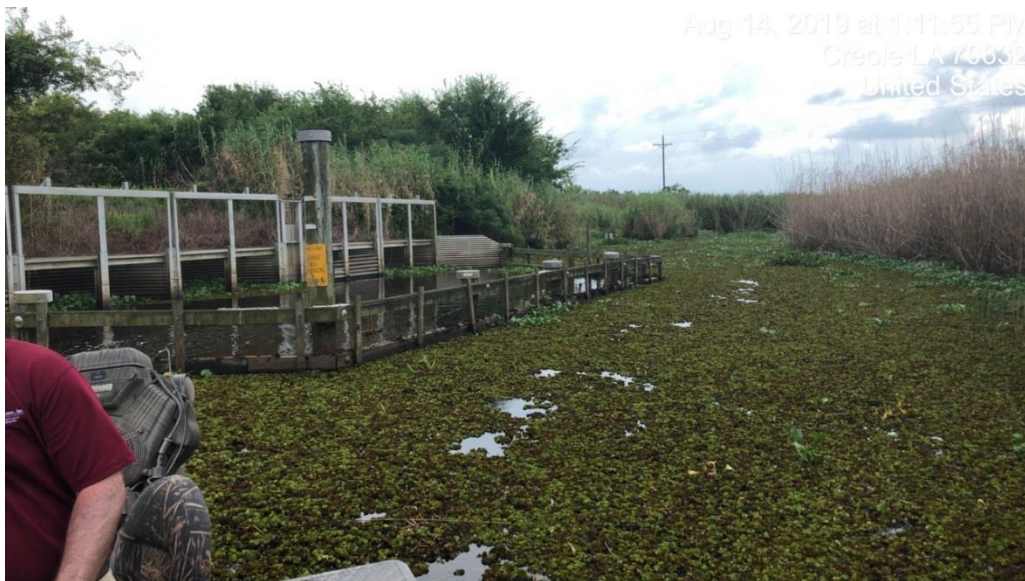
This feature is in good condition, but needs some minor repairs. A portion of the wire fence material has degraded and broken off just above the water line. The wooden pilings and bracing are intact. (Photos: Appendix A, Photo 2 & 3)

The structure is in good condition. The stoplogs and screw gate appear to be functioning as intended. One flapgate appears to be missing. Some grating on the outlet side needs to be replaced. The wingwall rock armor on the inlet and outlet side of the structure and the crushed stone aggregate on the top of the structure are intact. (Photos: Appendix A, Photos 2 & 4)

**Photo No. 2, Inlet side of structure**

Item	Condition	Physical Damage	Corrosion	Photo #	Observations and Remarks
Timber Bulkhead / Caps	N/A				
Steel Grating	N/A				
Stop Logs	N/A				
Hardware Wire Fence	Fair			2&3	The wire fencing needs to be replaced in areas where broken. But overall still keeping hyacinths away from the structure.
Timber Piles	good			2&3	
Timber Walers	good			2&3	
Galv. Pile Caps	good				
Cables	N/A				
Signage /Supports	N/A				
Rip Rap (fill)	N/A				
Earthen Embankment	N/A

Before the end of life, the grating, hyacinth fence, and one flapgate is in need of repair. Landrights agreement have expired and will need to be extended to perform this work.

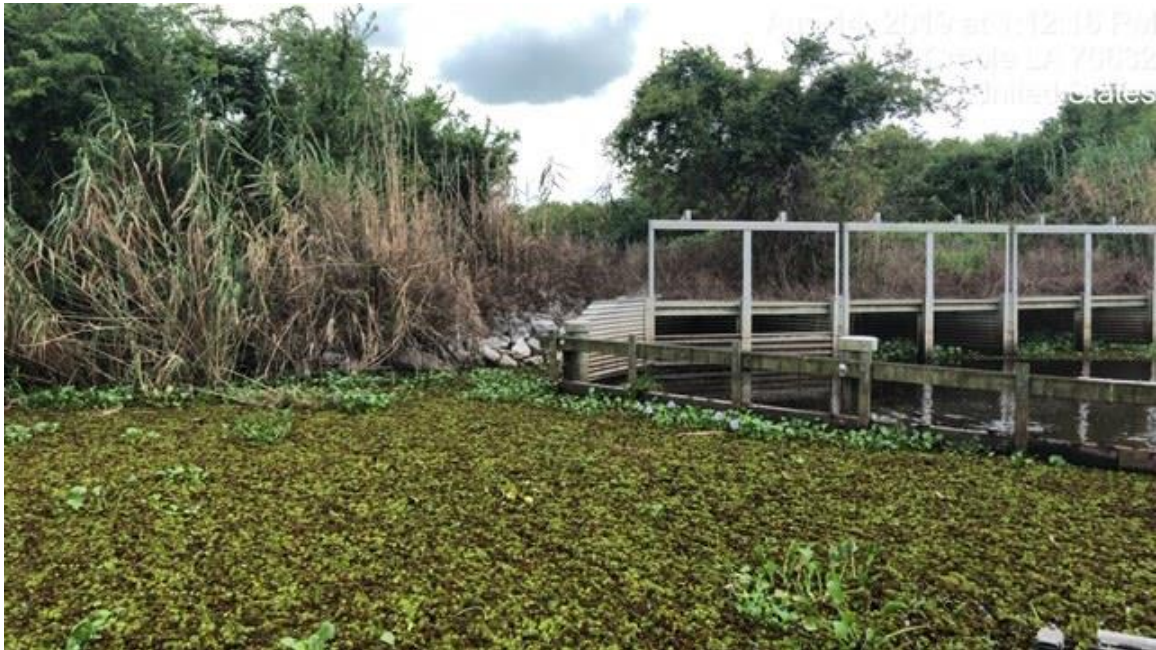
**Photo No. 3, Inlet side of structure**

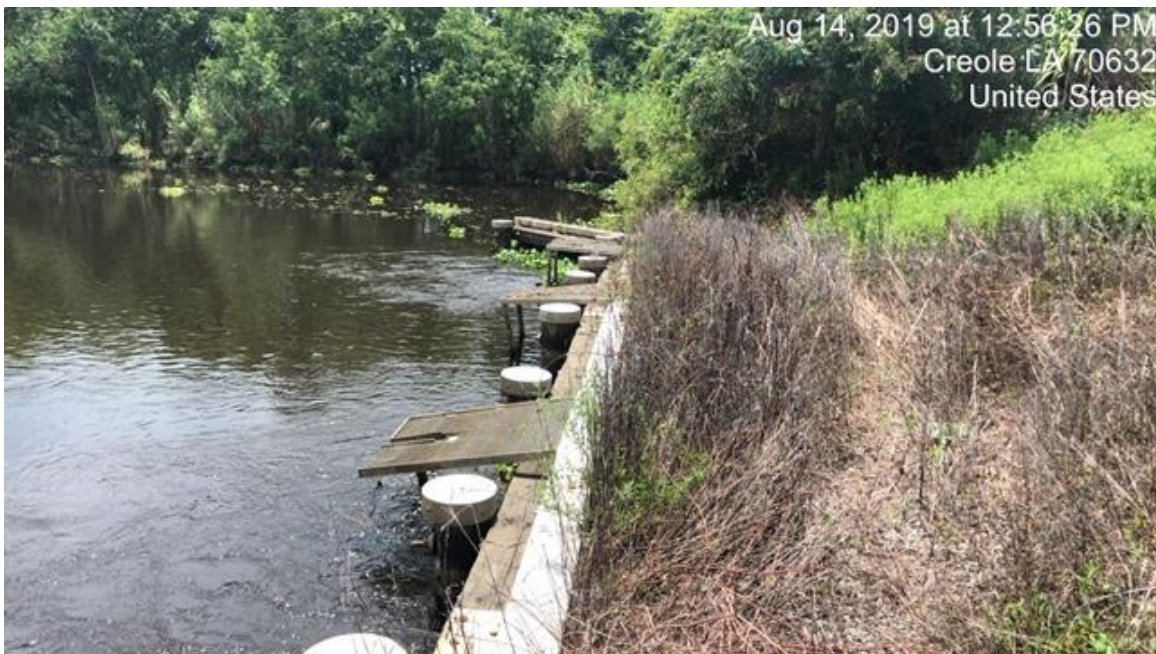
**Photo No. 4, Outlet side of structure**

Item	Condition	Physical Damage	Corrosion	Photo #	Observations and Remarks
Timber Bulkhead / Caps	good				
Steel Grating Flapgates	Fair			4	Some grating needs to be replaced. One flapgate is missing and needs to be replaced.
Stop Logs	good				
Storage Box	good				
Hardware	good			2	
Timber Piles	good			2&4	
Timber Wales	good				
Galv. Pile Caps	good			2&4	
Lifting device	good				
Signage /Supports	N/A				
Rip Rap (fill)	good				
Structure Embankment (Crushed Stone)	good			1,2&4	
Eathern Embankment Inlet Channel	good			1&4

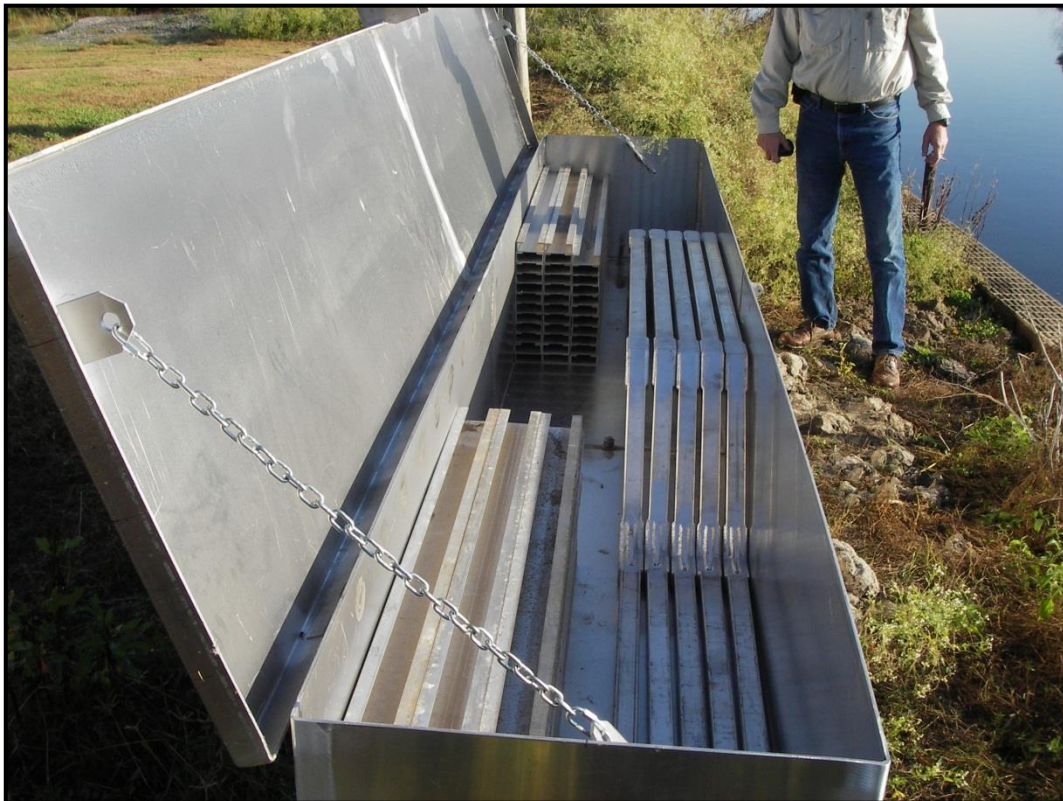
**Photo No. 5,** Storage box for locking arms and stop logs (2013)
