**Coastal Protection and Restoration
Authority of Louisiana (CPRA)**

**2014/2015 Annual Inspection
Report**

**PECAN ISLAND TERRACING
PROJECT
(ME-14)**

June 30, 2015
Vermilion Parish

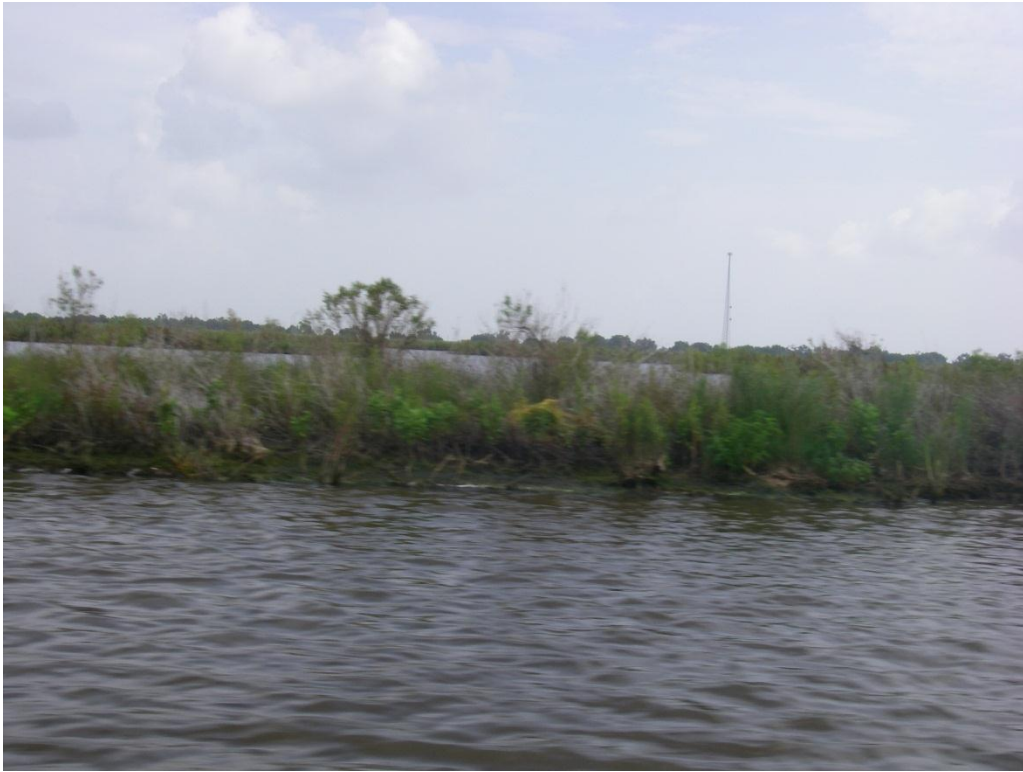
Photo No. 1, Southern Earthen Terraces

The majority of the earthen terraces are in good condition. There is some erosion taking place on the north side of the individual terraces. Previously noted erosion on the southernmost sacrificial terraces has worsened. On the west side of the terrace field, the first two rows of the southernmost sacrificial terraces are no longer visible above the water surface. The third row is also beginning to show signs of degradation. In addition, a portion of the first row of the east southernmost terraces is no longer visible above the water surface. (Photos: Appendix B, Photo 1)

Overall, the Pecan Island Terracing Project (ME-14) is functioning as designed and in good condition. The erosion of the southern sacrificial terraces will continue to be monitored. NOAA and CPRA have agreed to investigate land rights and possible erosion solutions for these sacrificial terraces.

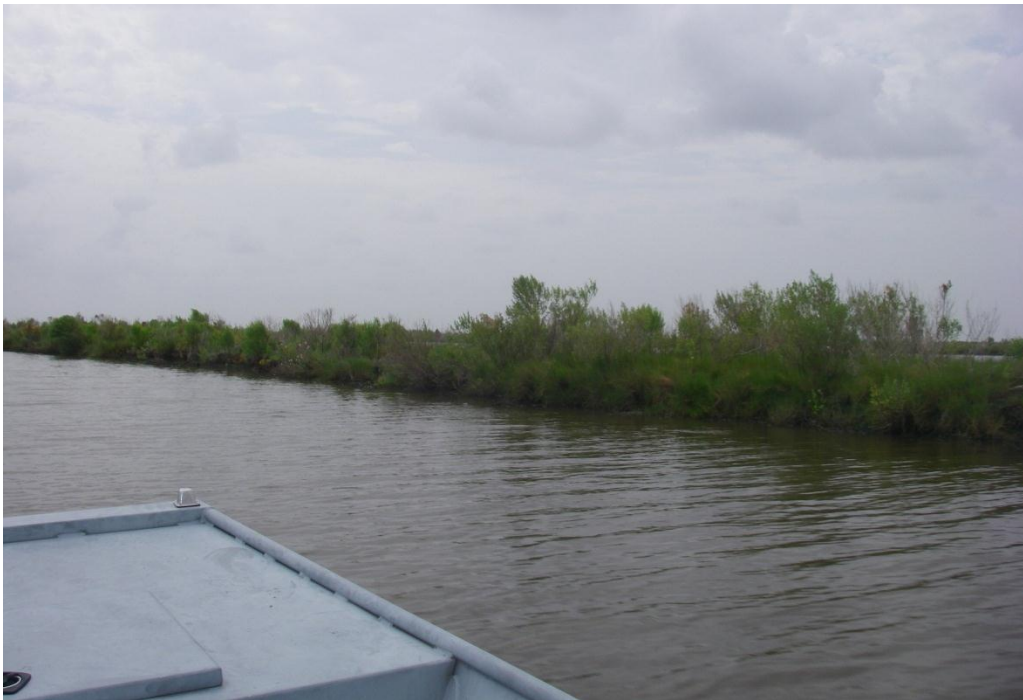
Photo No. 2, Typical Terrace

The tops of the terraces are covered with vegetation. Species noted include *Spartina alterniflora*, *Baccharis*, and *Spartina patens*. (Photos: Appendix B, Photo 2)
