**Coastal Protection and Restoration
Authority (CPRA)**

**2015 Operations,
Maintenance,
and Monitoring Report**

**Freshwater Introduction South of
Highway 82**

State Project Number ME-16
Priority Project List 9

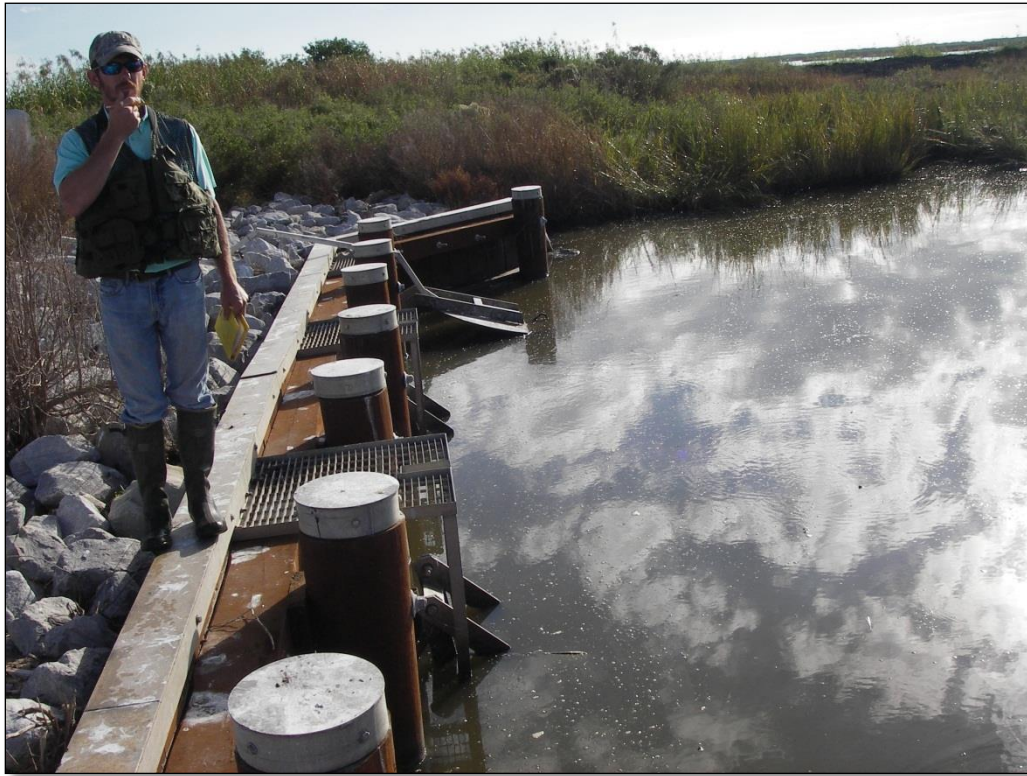
Photo No. 1, New Cop-Cop Structure, outlet side of structure.

The structure is in good condition. Rock revetment looks good. (Photos: Appendix A, Photos 1 & 2)

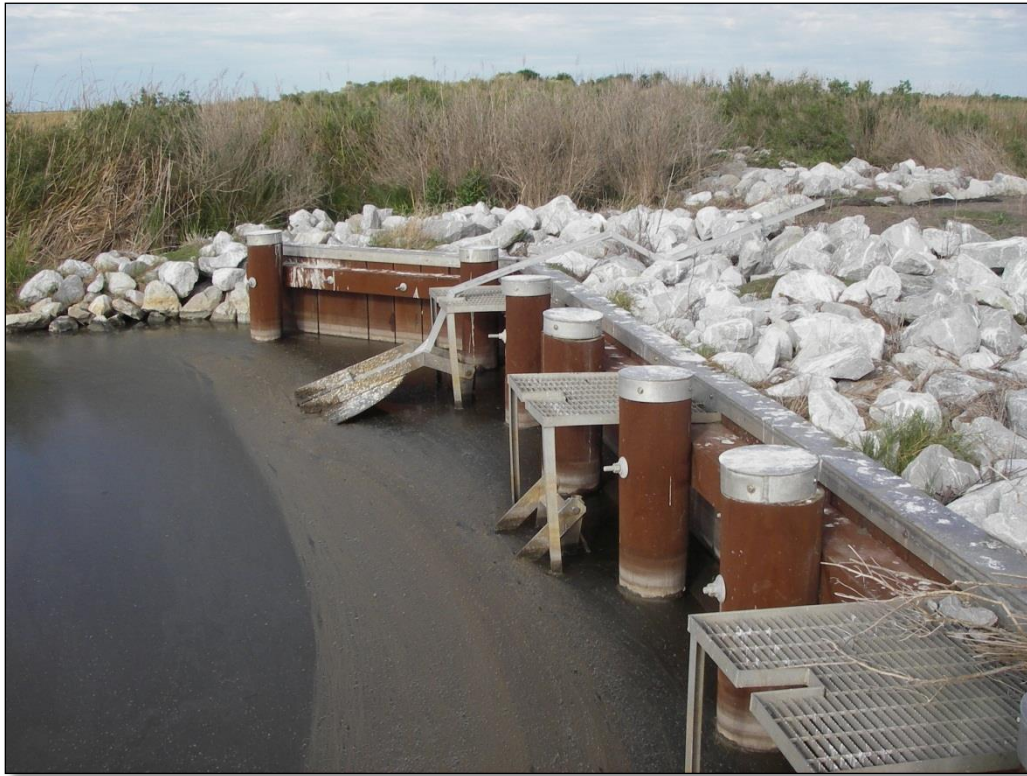
Photo No. 3, Perry Bayou Structure, outlet side of structure.

Overall this structure is in good condition. Rock revetment looks good. (Photos: Appendix A, Photo 3 & 4)

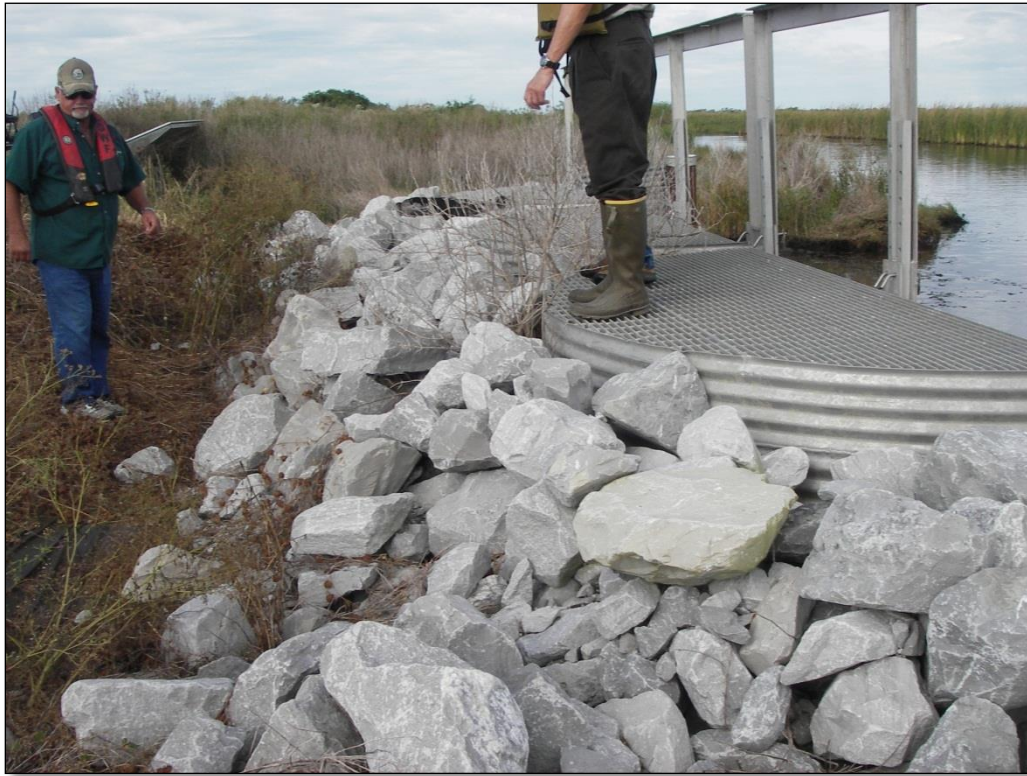
Photo No. 5, McNeese Bayou Structure, inlet side of structure.

Overall this structure is in good condition. Rock revetment looks good. (Photos: Appendix A, Photo 5 & 6)

- Lifting chains should be provided on the flapgates at the Hess' Cut (formerly New Dyson), New Cop Cop, and Structure No. 10.
- Rock rip rap should be filled in closer to the structure at Structure No. 10.
- Concrete on the Little Constance Structure which was damaged by the rock placement during the maintenance event needs repair.
- Structural operations should return to the original operations plan.

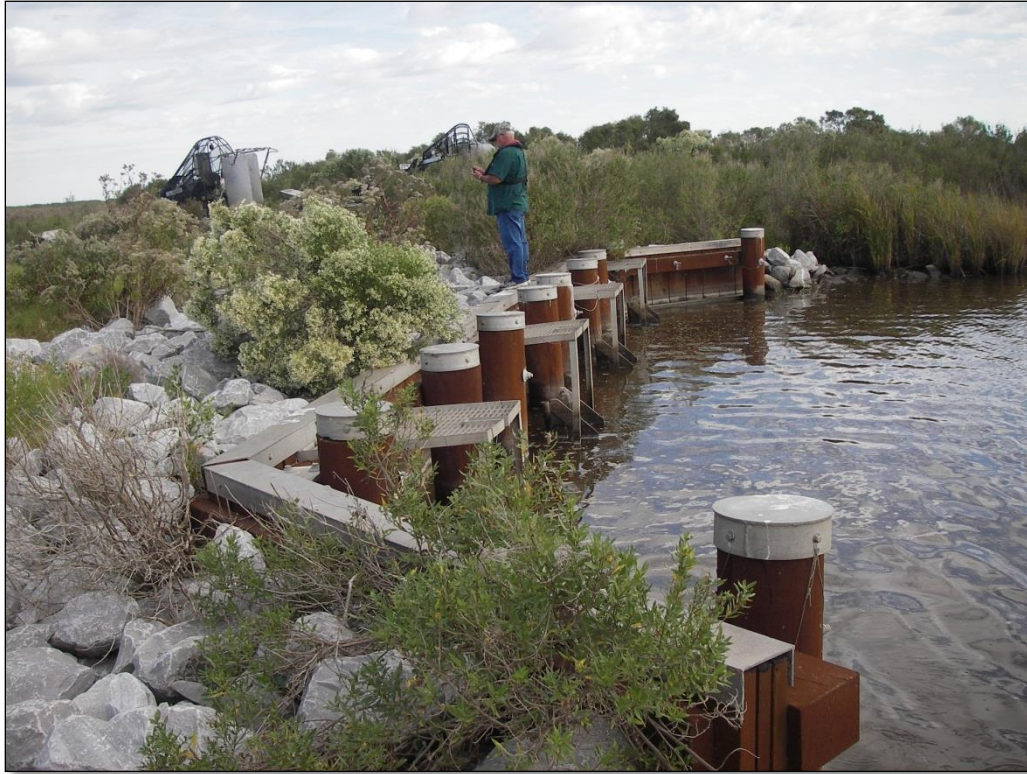
Photo No. 7, Hess' Cut Structure, outlet side of structure.

Overall this structure is in good condition. Rock revetment looks good. (Photos: Appendix A, Photo 7 & 8)

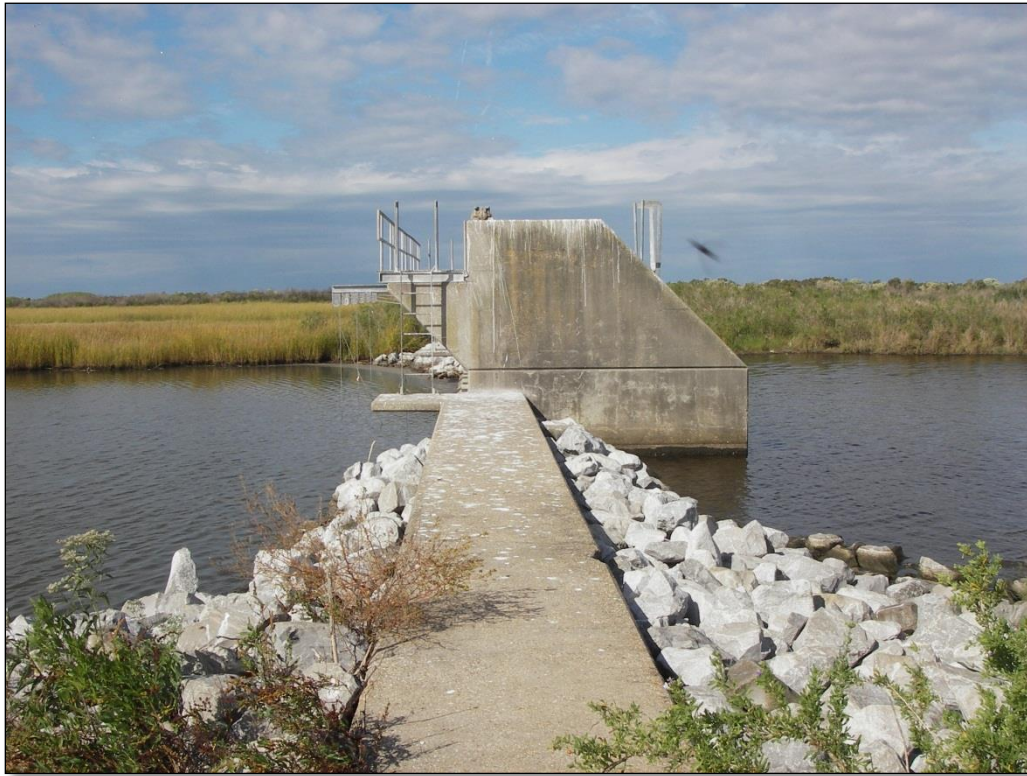
Photo No. 9, Little Constance Structure, east side of structure.

Overall this structure is in good condition. Rock revetment looks good. (Photos: Appendix A, Photo 9 & 10)

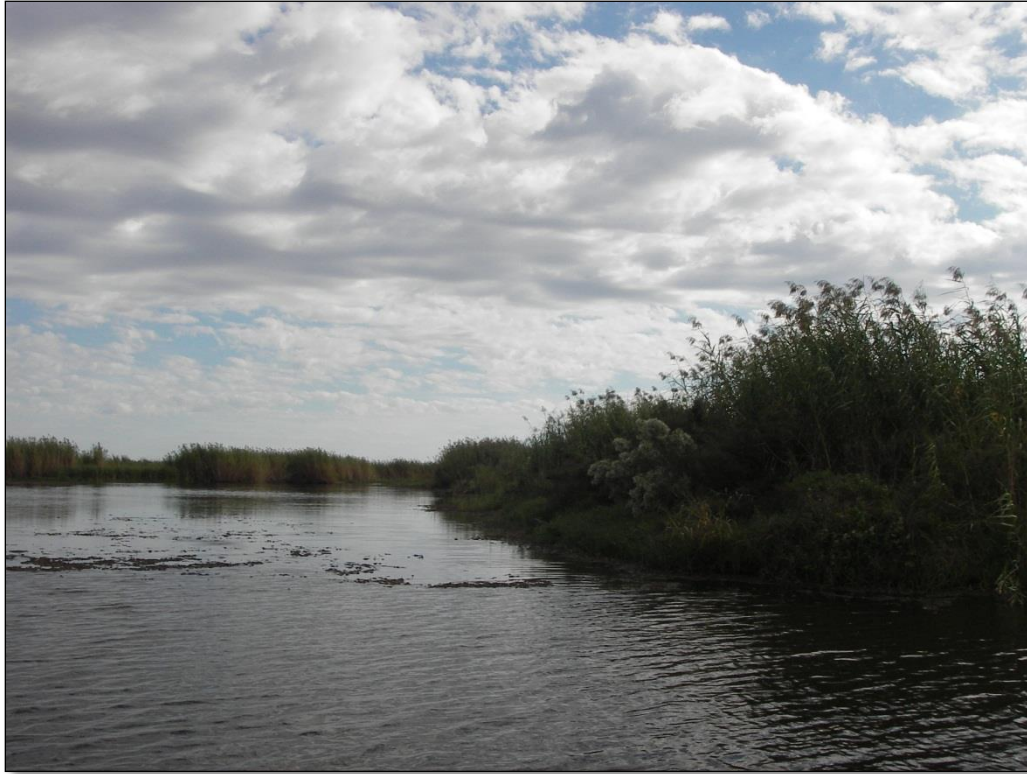
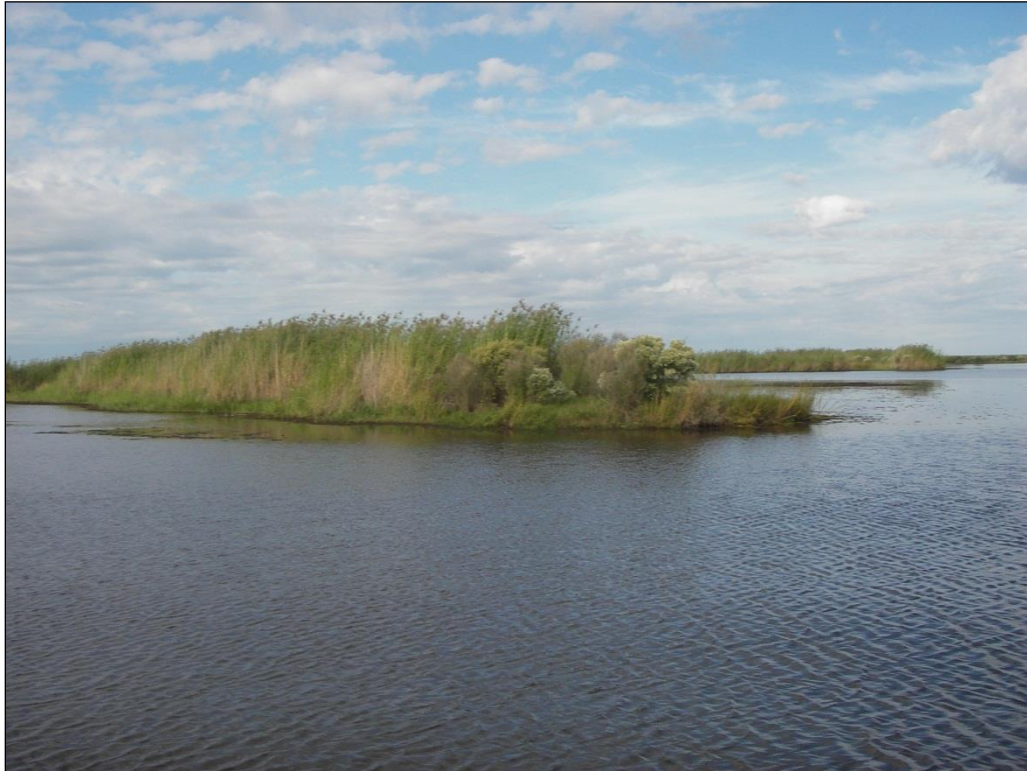
The terrace field is in very good condition. The vegetation is healthy and there appears to be little erosion. (Photos: Appendix A, Photo 11 & 12)
