2015 Operations, Maintenance, and Monitoring Report

**Grand-White Lake Land Bridge
Protection**

State Project Number ME-19
Priority Project List 10

May 2015
Cameron Parish

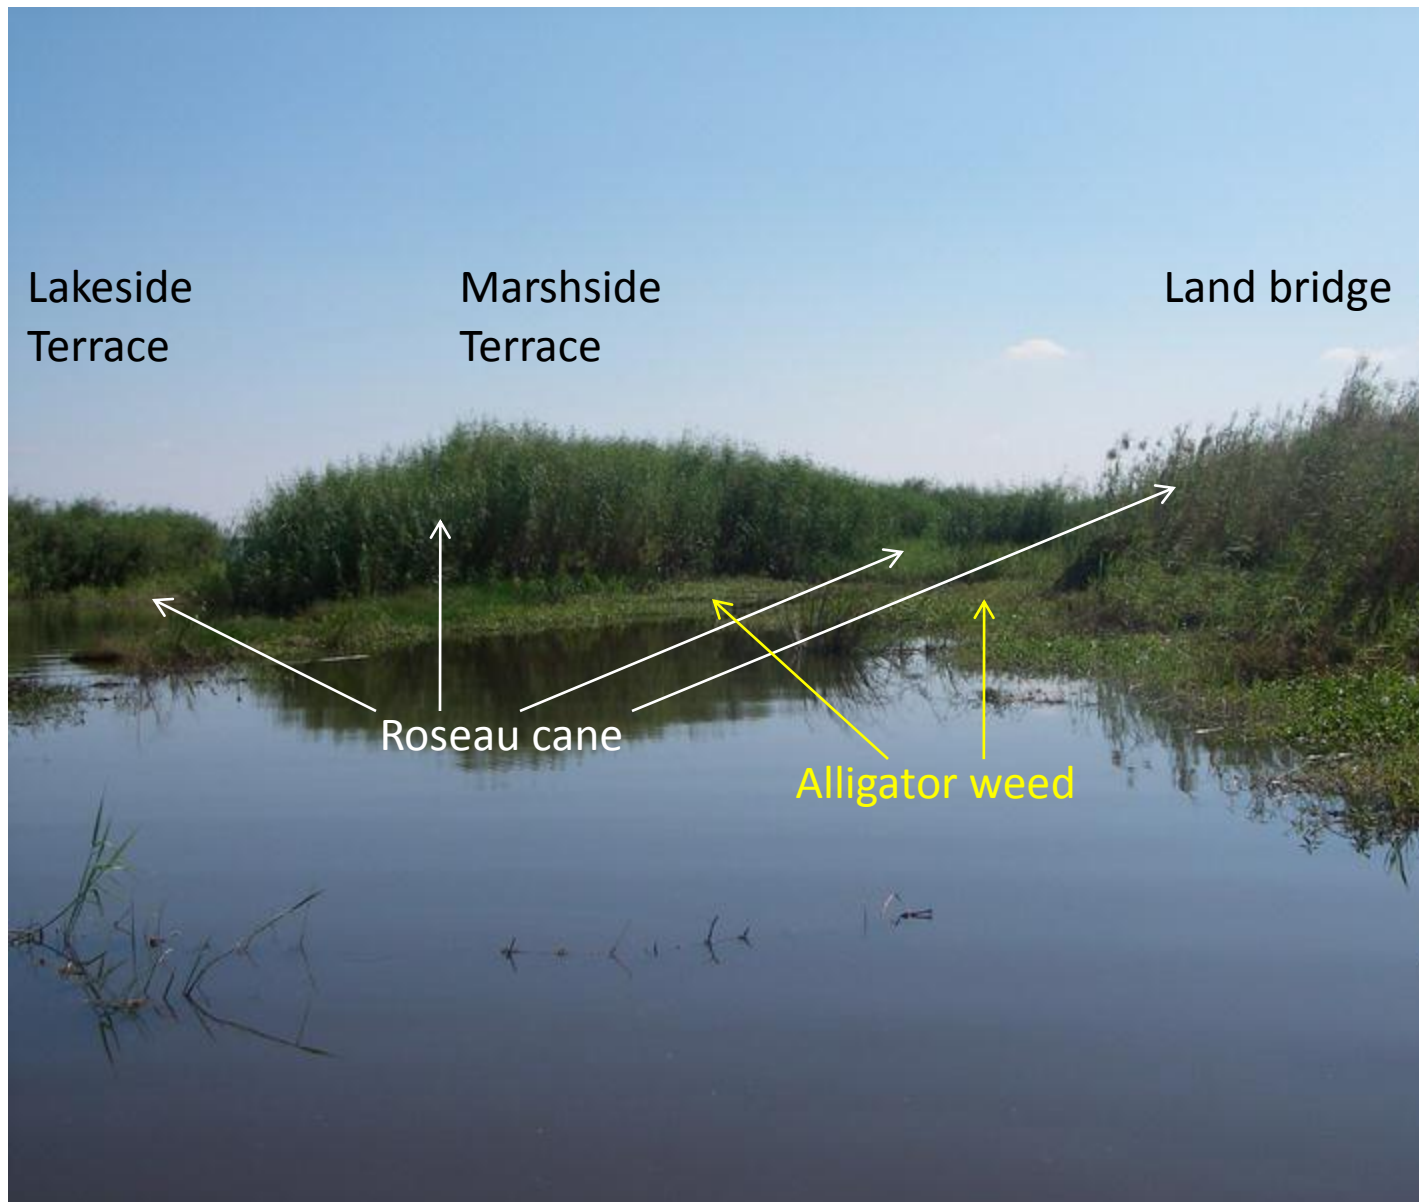
Figure 7. Vegetation along Collicon Lake expands as terrace and land-bridge vegetation merge. At the time of this photograph (October 21, 2008) the vegetation between the land-bridge and terrace was floating; therefore, the vegetative expansion was not included in the shoreline change analysis. If the merging vegetation anchors into the soil below, then it will be considered emergent and define the vegetated shoreline of the land bridge.

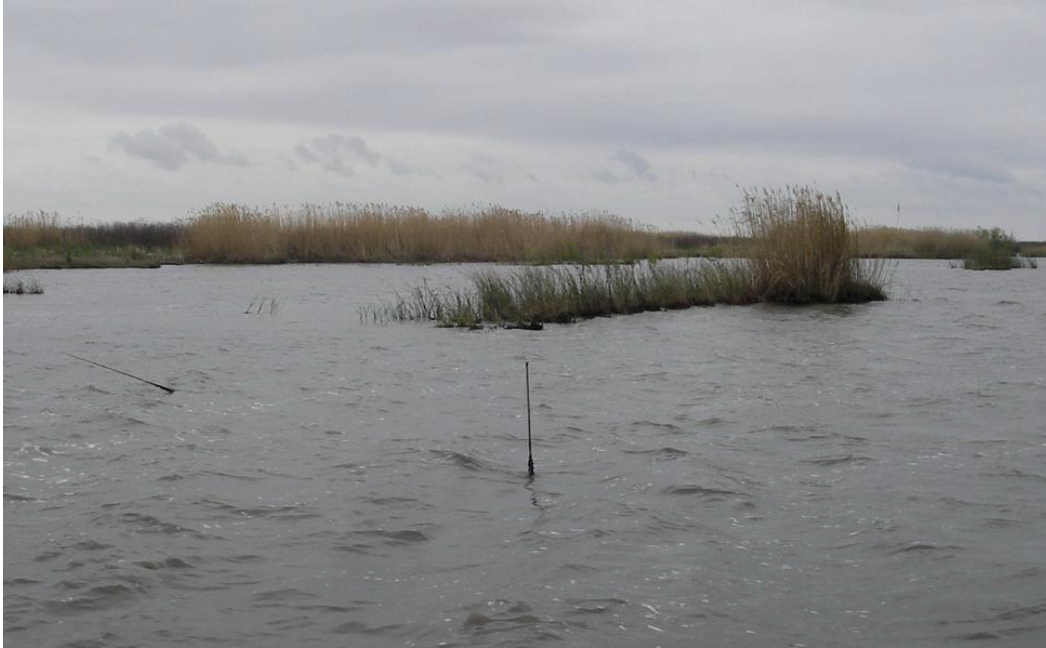
Figure 10. Many terraces have eroded since construction, especially the lakeside terraces (e.g. LS42) which were intended to be sacrificial and buffer the marsh side terraces. Note the cane poles that mark the original corners of the terrace. Picture was taken on March 24, 2010.

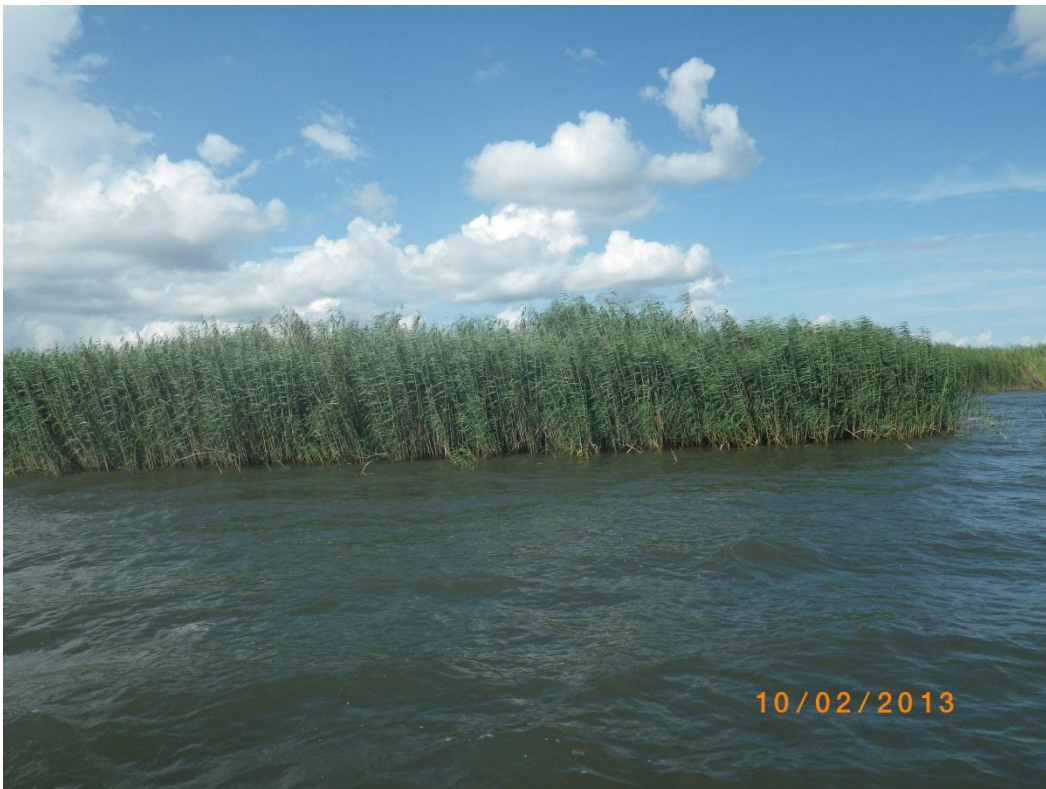
Figure 11. October 2, 2013 photograph of LS42 (shown above in 2010), a lakeside terrace, depicting vegetation growth. Note the expansion of Roseau cane since the 2010 photography.

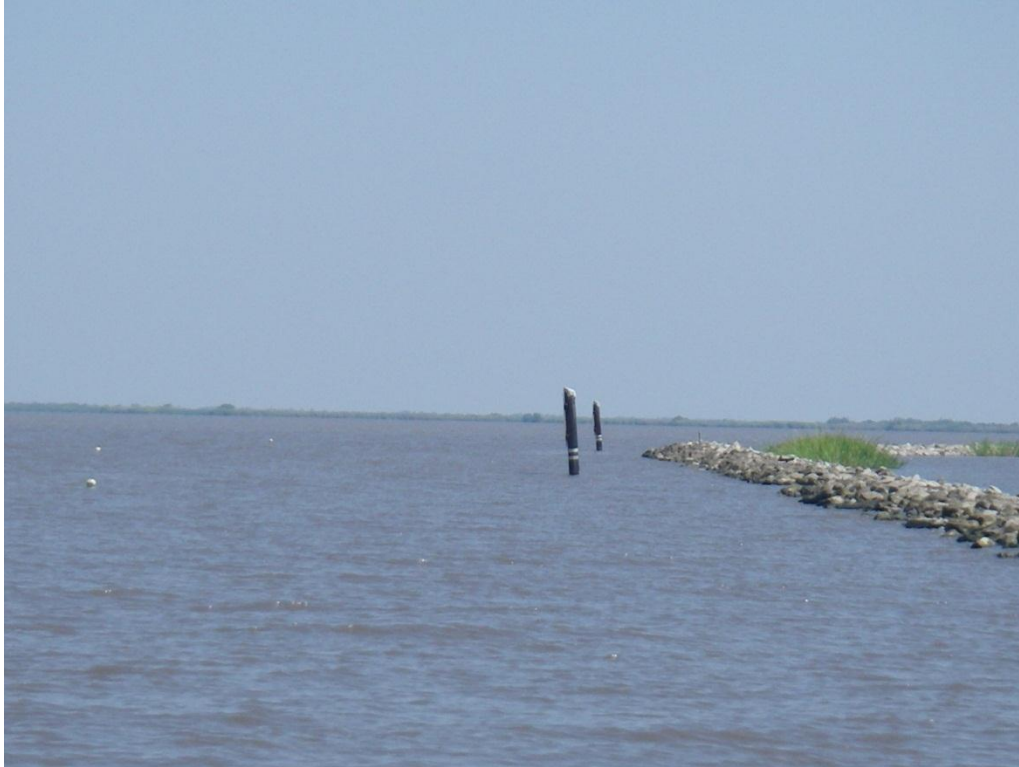
The foreshore rock dike feature is in excellent condition. Warning signs are present. There is vegetation behind the rock dike over the majority of length of dike. No maintenance is required at this time (Photos: Appendix A, Photo 1-3).

Photo No. 1, Rock Dike and Signs on East Shoreline of Grand Lake

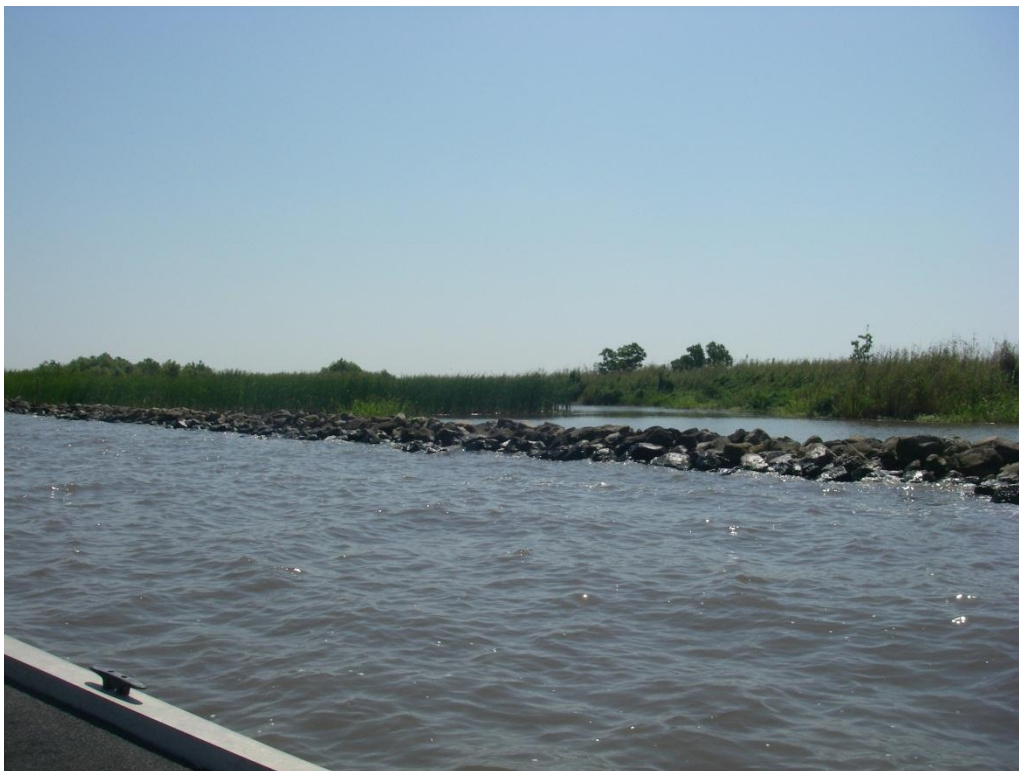
Photo No. 2, Vegetation and Rock Dike on East Shoreline of Grand Lake

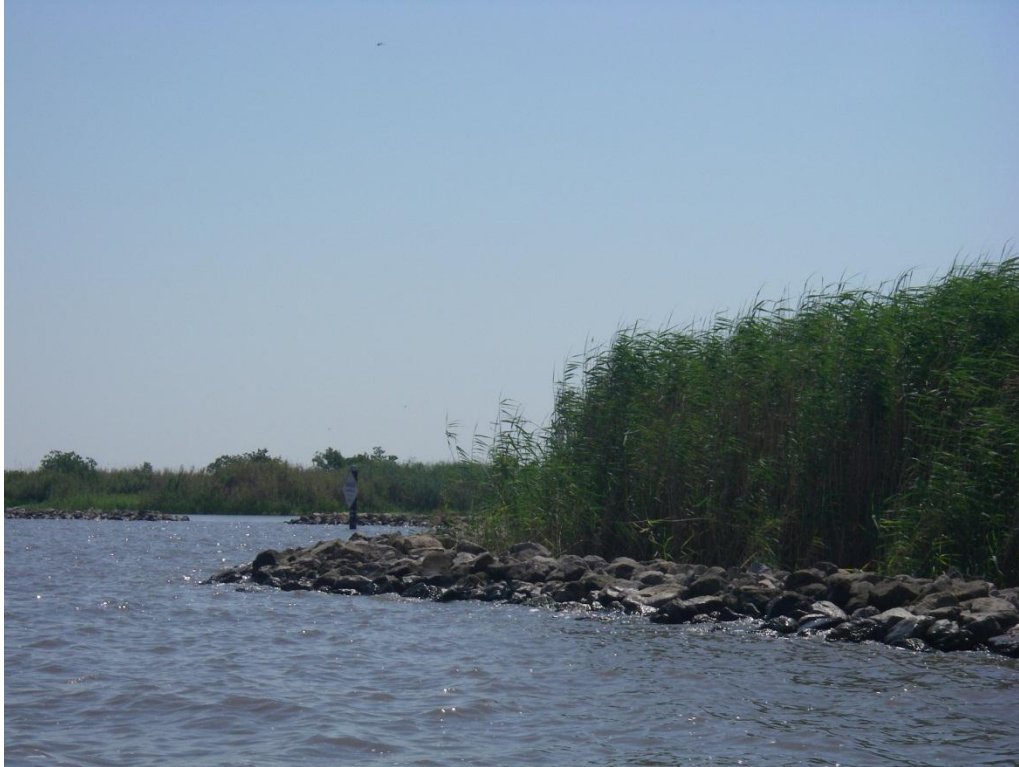
Photo No. 3, Rock Dike on East Shoreline of Grand Lake

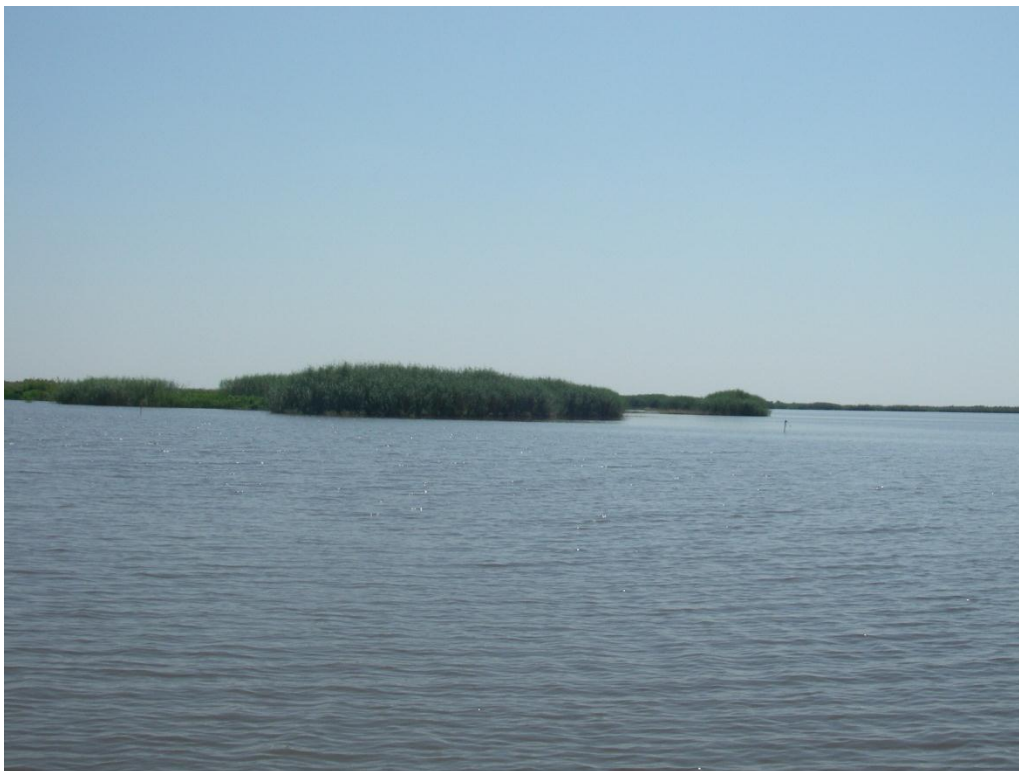
are flourishing with Roseau Cane; however, it was difficult to distinguish by boat whether two rows of terraces remain (Photos: Appendix A, Photo 4 &6).

Photo No. 4, Earthen Terraces on North End of Collicon Lake

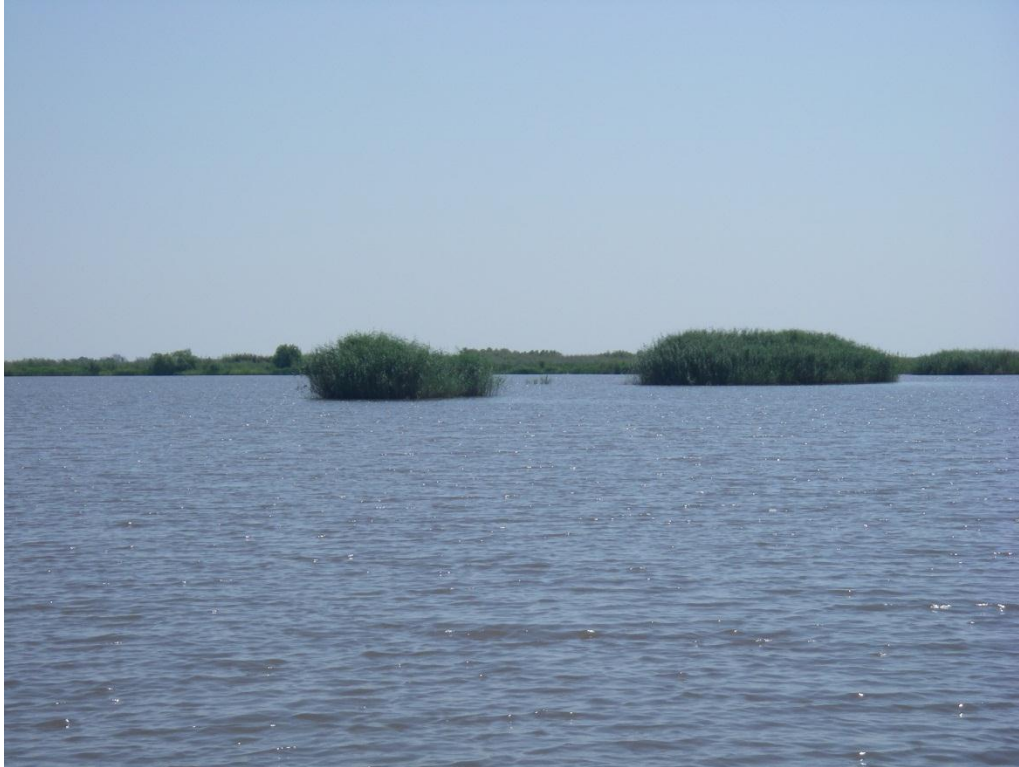
Marsh side and lake side earthen terraces along Collicon Lake continue to experience erosion. Several terraces along the northwest and west shoreline of Collicon Lake are no longer visible. (Photos: Appendix A, Photo 5) The northern and southern most sections of terraces

Photo No. 5, Earthen Terraces on Northwest and West Sides of Collicon Lake

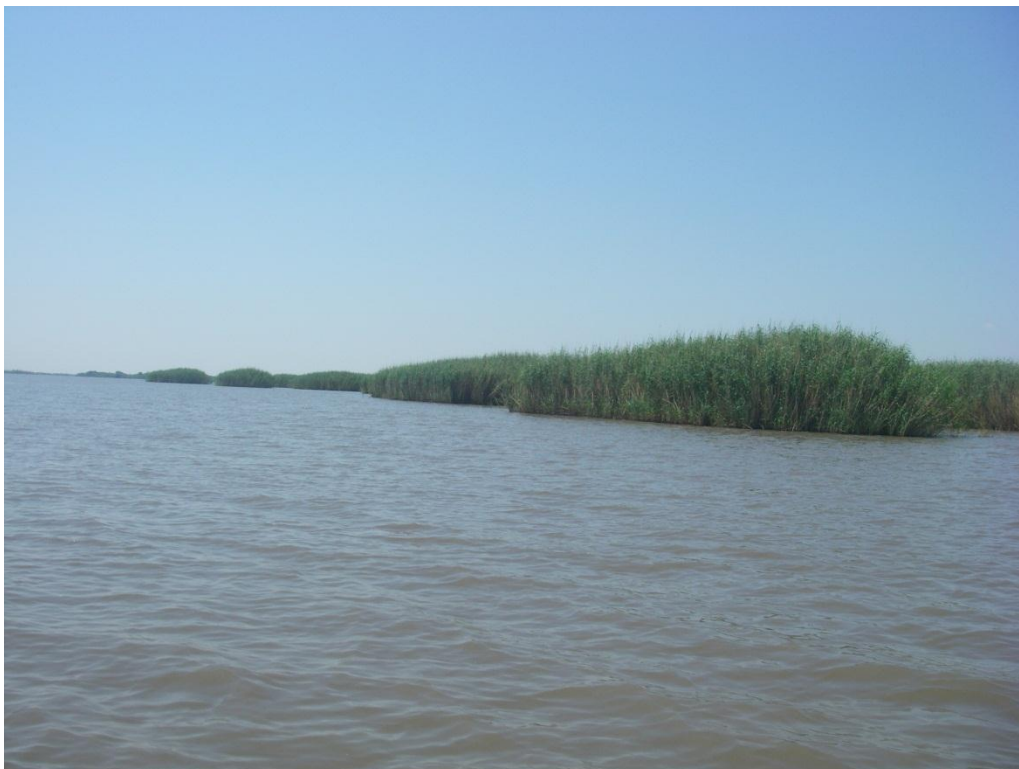
Photo No. 6, Earthen Terraces on Southwest End of Collicon Lake
