## **2022 Operations, Maintenance, and Monitoring Report**

### **Freshwater Bayou Canal Wetland Protection and Freshwater Bayou Bank Stabilization**

State Project Number ME-04 and ME-13  
Priority Project List 2 and Priority Project List 5

June 2022  
Vermilion Parish

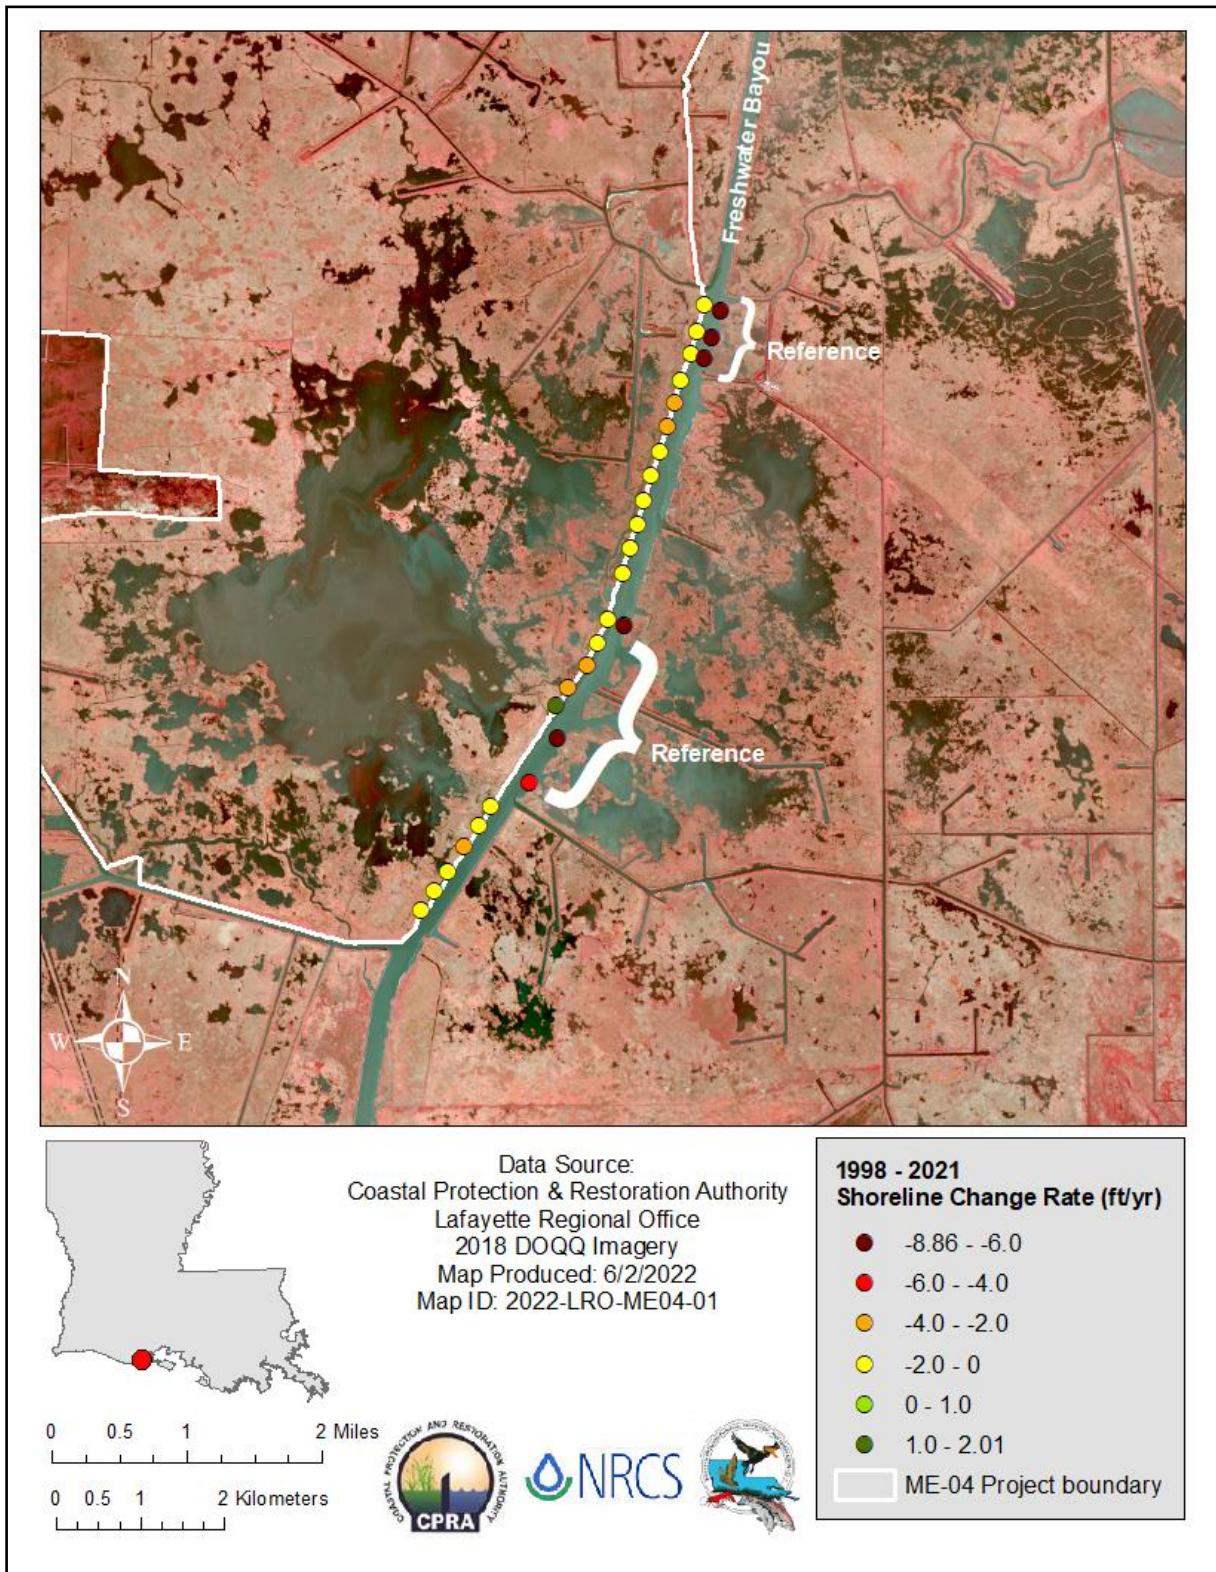
**Figure 9.** ME-04 shoreline change rates (ft/yr) from 1998 to 2021 within the Freshwater Bayou Wetland Protection project and reference areas. The project rock dike has reduced shoreline erosion while the reference shoreline has expanded as it connects to interior waterways increasing tidal exchange and scouring.

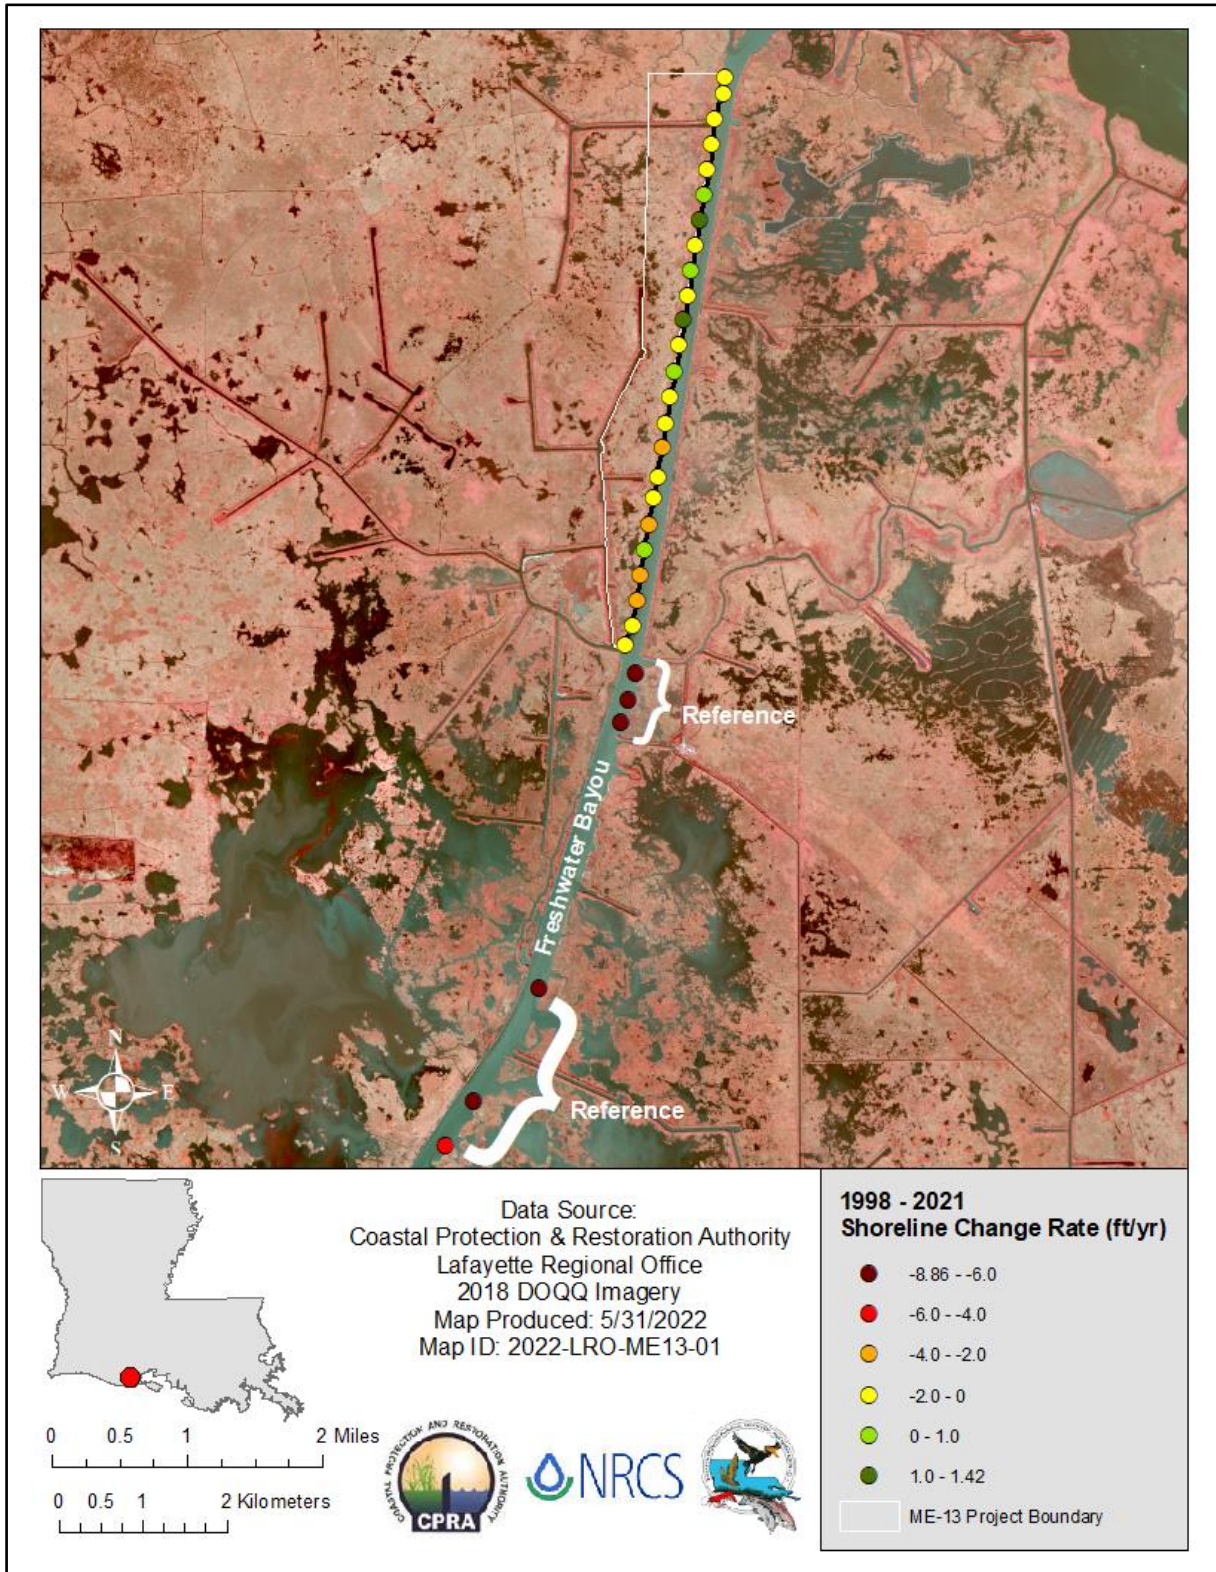
**Figure 10.** ME-13 shoreline change rates (ft/yr) from 1998 to 2021 within the Freshwater Bayou Wetland Protection project and reference area. The project rock dike has reduced shoreline erosion while the reference shoreline has expanded as it connects to interior waterways increasing tidal exchange and scouring.

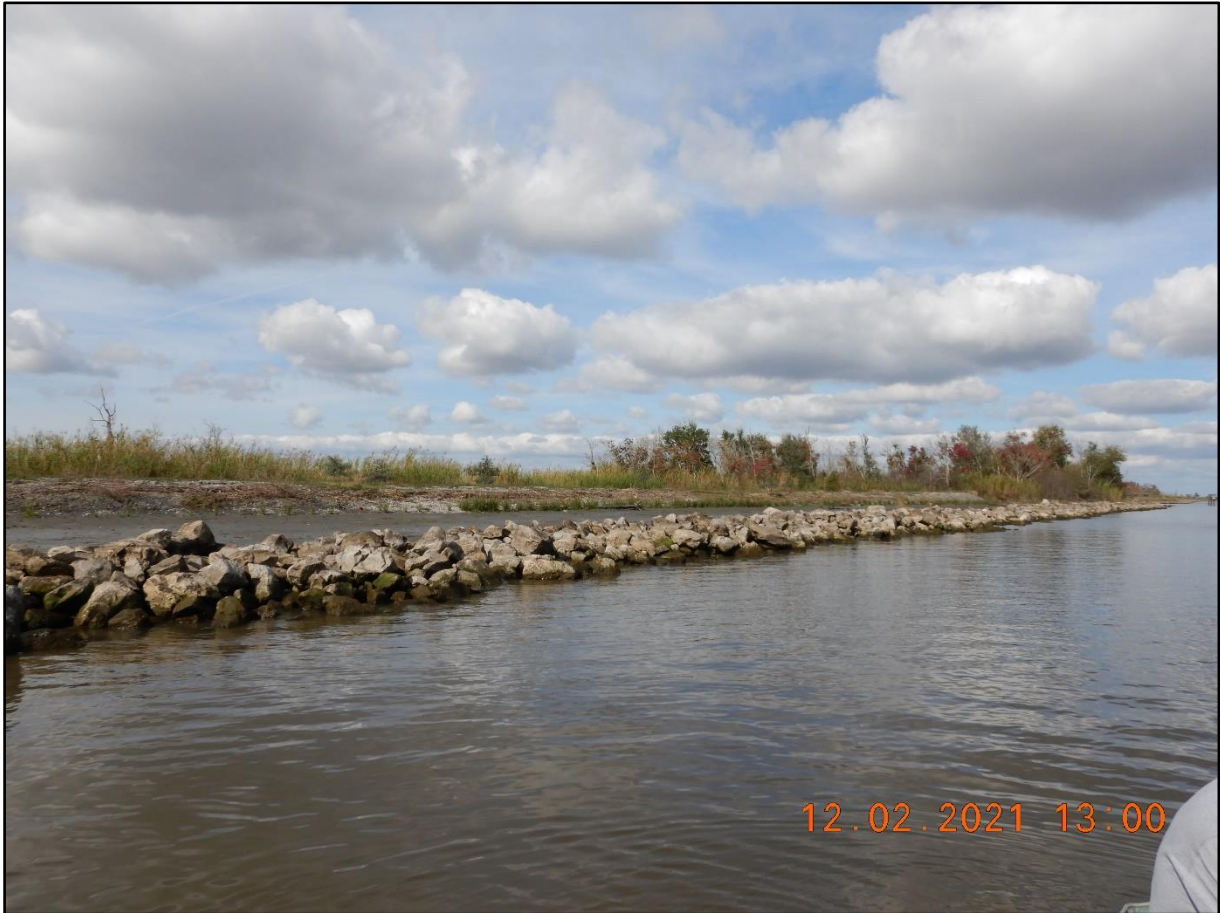
The ME-04 rock dike has been repaired multiple times. Rock was added in 2002 and 2005 but material quantity was limited so only certain stretches were repaired. ME-13 also had a partial repair in 2005 but both shoreline dikes were repaired in their entirety in 2016. No breaches were observed during the 2021 data collection effort (Figure 13).

**Figure 13.** A photograph representing the rock dock condition along the ME-04 and ME-13 shorelines during the most recent data collection effort in 2021.

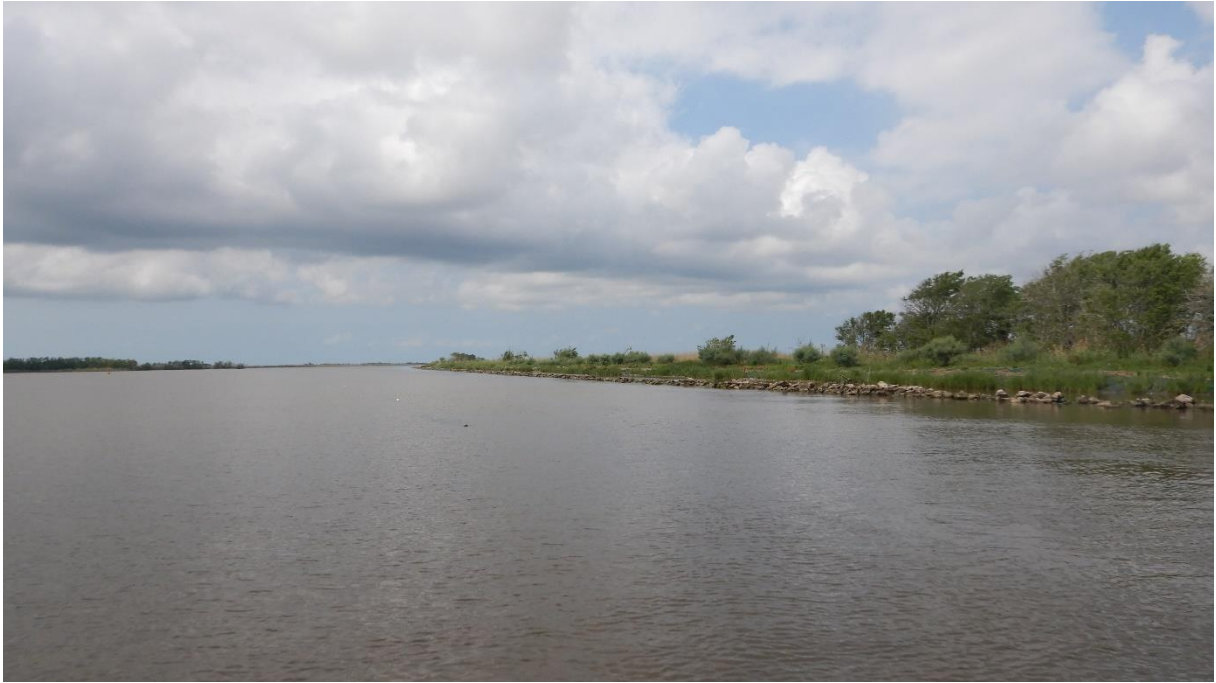
**Photo No. 1, Typical Rock Dike ME-04**

**ME-04:** The inspection revealed the entire 28,000 linear feet of foreshore rock dike is in good condition (Appendix B, Photos 1-3). Minimal maintenance should be required during the next 20 years of life extension. In addition, the 300 foot section of rock dike originally gapped when the project was constructed has now been filled in by the Vermilion Parish Police Jury using Interim Emergency Board funds. This work was completed prior to the last maintenance event in 2015.

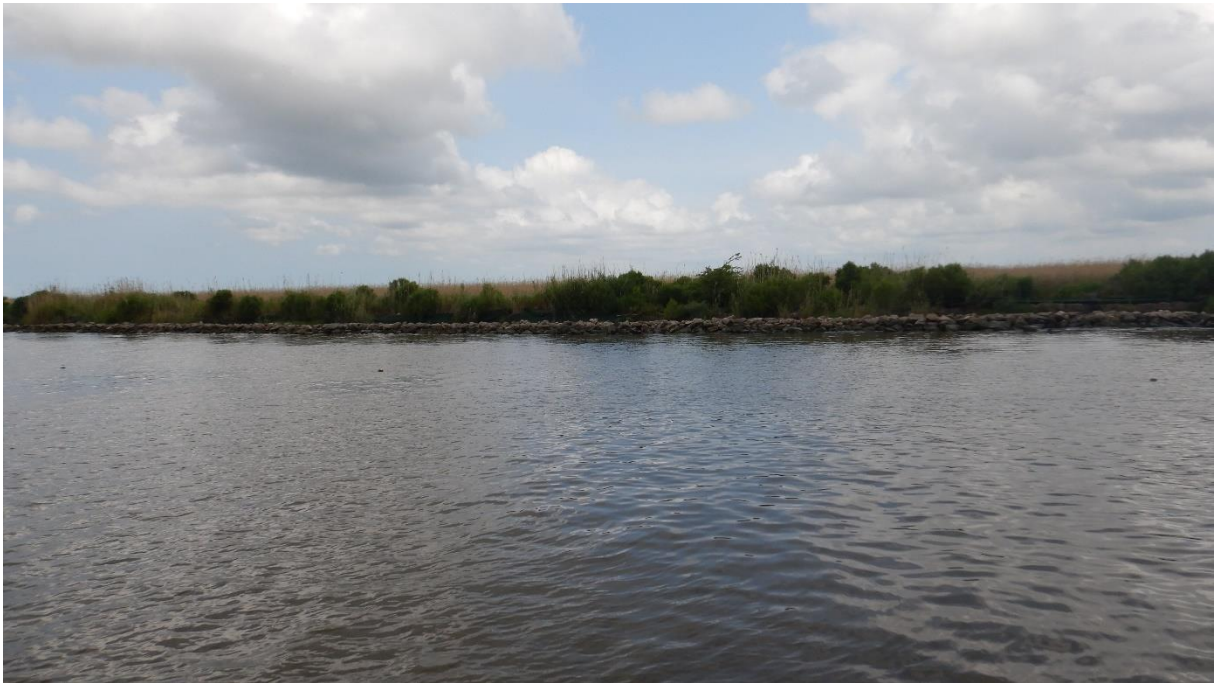
**Photo No. 2, Typical Rock Dike ME-13**

**ME-13:** The inspection revealed the entire 23,193 linear feet of foreshore rock is in good condition (Appendix B, Photos 4-6). Minimal maintenance should be required during the next 20 years of life extension.
