**2015/2016 Annual Inspection  
Report**

**FRESHWATER BAYOU CANAL  
BANK STABILIZATION  
PROJECT (ME-13)**

State Project Number ME-13  
Priority Project List 5

March 4, 2016  
Vermilion Parish

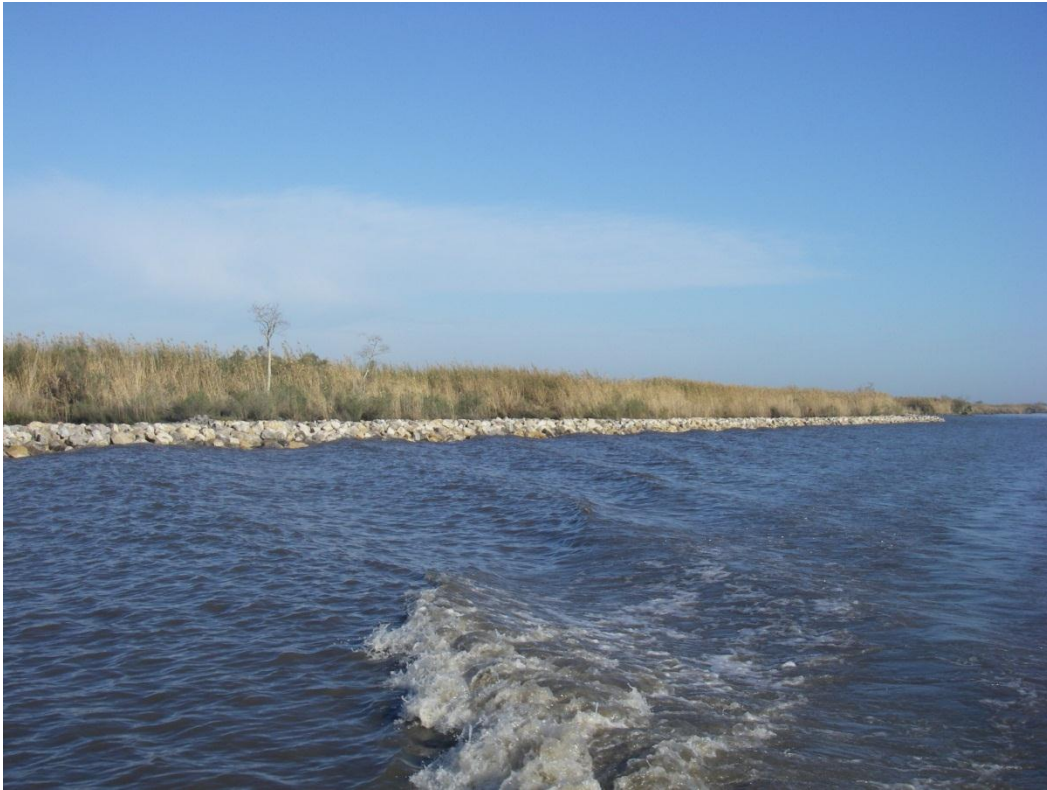
**Photo No. 1, Typical Rock Dike**

The inspection revealed the entire 23,193 linear feet of foreshore rock dike repaired in the recent 2015 maintenance project is in excellent condition. (Appendix B, Photos 1-3) This project is ready to move into the next 20 year life extension as approved by the CWPPRA Task Force.

Item	Condition	Physical Damage	Corrosion	Photo #	Observations and Remarks
Steel Bulkhead / Caps	N/A				
Steel Grating	N/A				
Stop Logs	N/A				
Hardware	N/A				
Timber Piles	N/A				
Timber Wales	N/A				
Galv. Pile Caps	N/A				
Cables	N/A				
Signage /Supports	N/A				
Rip Rap (fill) (foreshore dike)	Excellent			1,2,3	Maintenance work to restore dike to constructed elevation in excellent condition. Vegetation growth was noted.
Earthen Embankment	N/A
