2021 Operations, Maintenance, and Monitoring Report

Pecan Island Terracing (ME-14)

State Project Number ME-14
Priority Project List 7

March 2022
Vermilion Parish

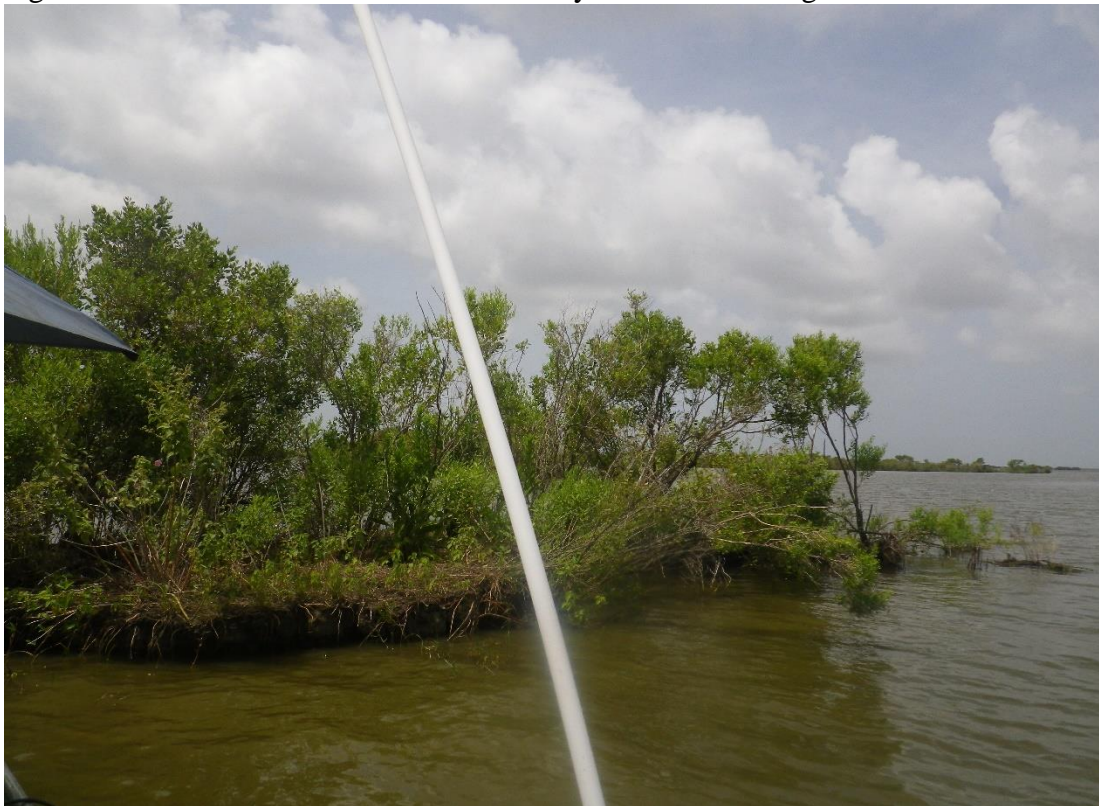
Figure 13. Pecan Island Terracing (ME-14) photo from 7-8-2020 of emergent vegetation cover on a thinned and cut bank terrace with a heavy shrub presence. This was a typical terrace.

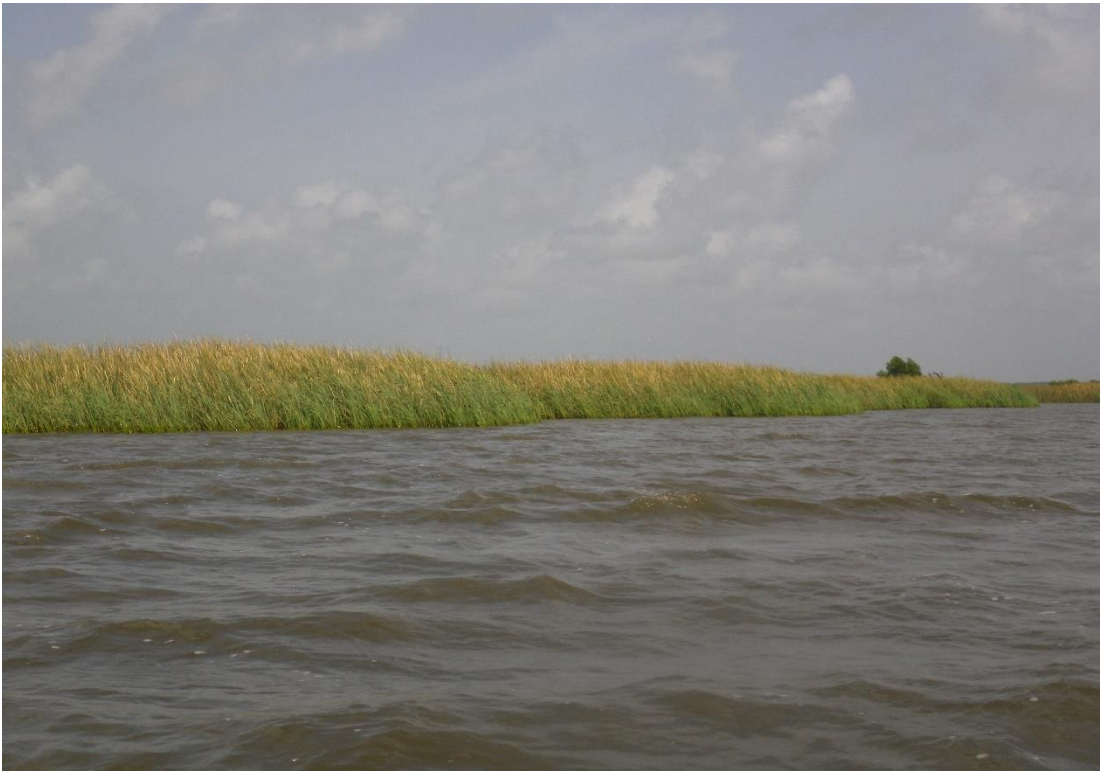
Figure 14. Pecan Island Terracing (ME-14) Photo from 7-8-2020 of emergent vegetation cover spreading out from a terrace in 2020. This was a rare occurrence.

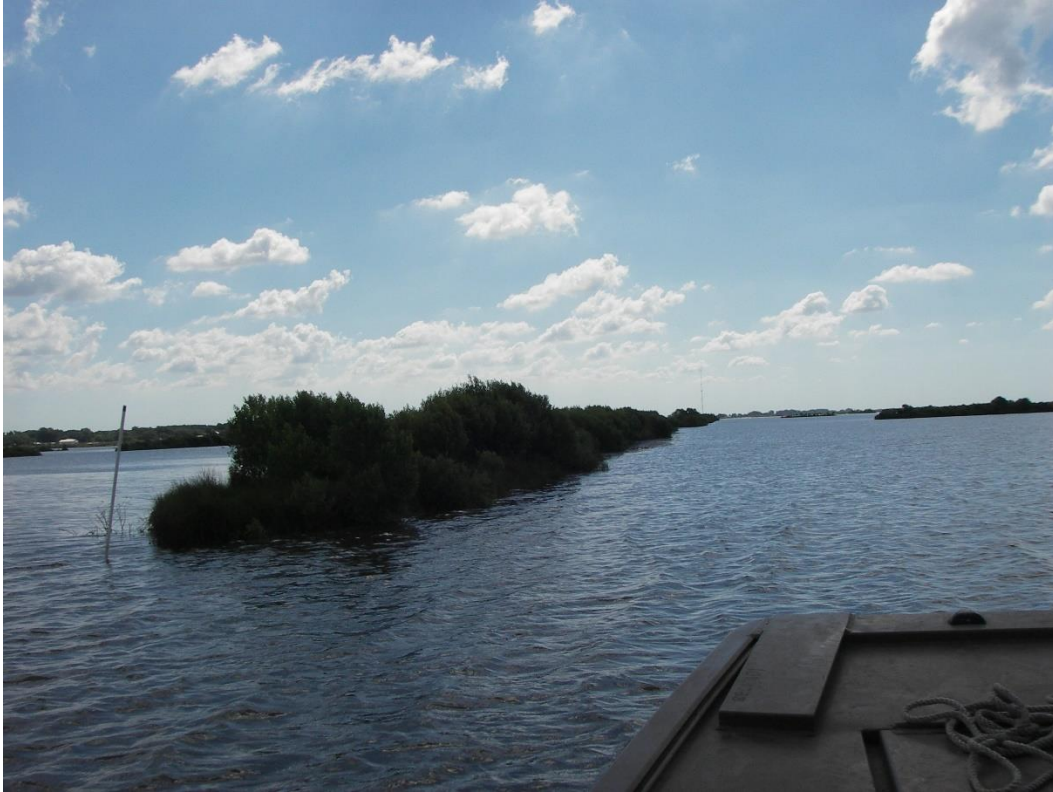
The majority of the earthen terraces are in good condition. There is some erosion taking place on the north side of the individual terraces. Previously noted erosion on the southernmost sacrificial terraces has worsened. On the west side of the terrace field, the first two rows of the southernmost sacrificial terraces are no longer visible above the water surface. The third row is also beginning to show signs of degradation. In addition, a portion of the first row of the east southernmost terraces is no longer visible above the water surface. (Photos: Appendix A, Photo 1-4)

Photo No. 1, Typical intact terrace with health vegetation. (2015)

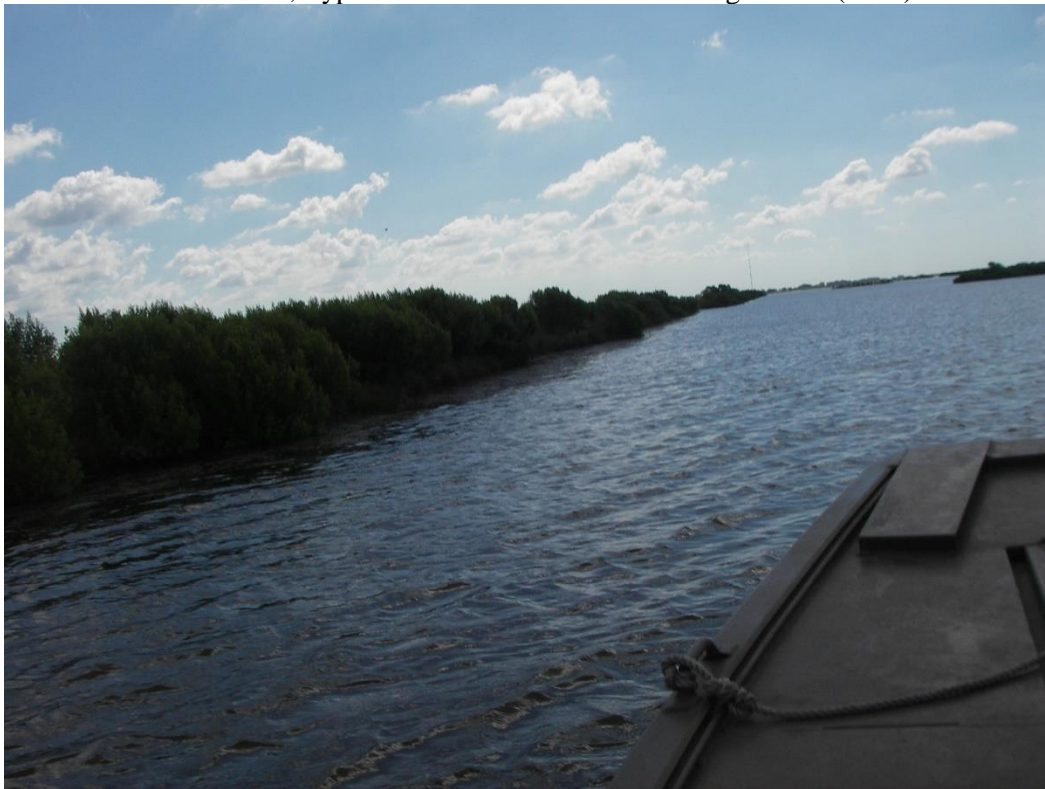
Photo No. 2, Typical intact terrace with health vegetation. (2015)

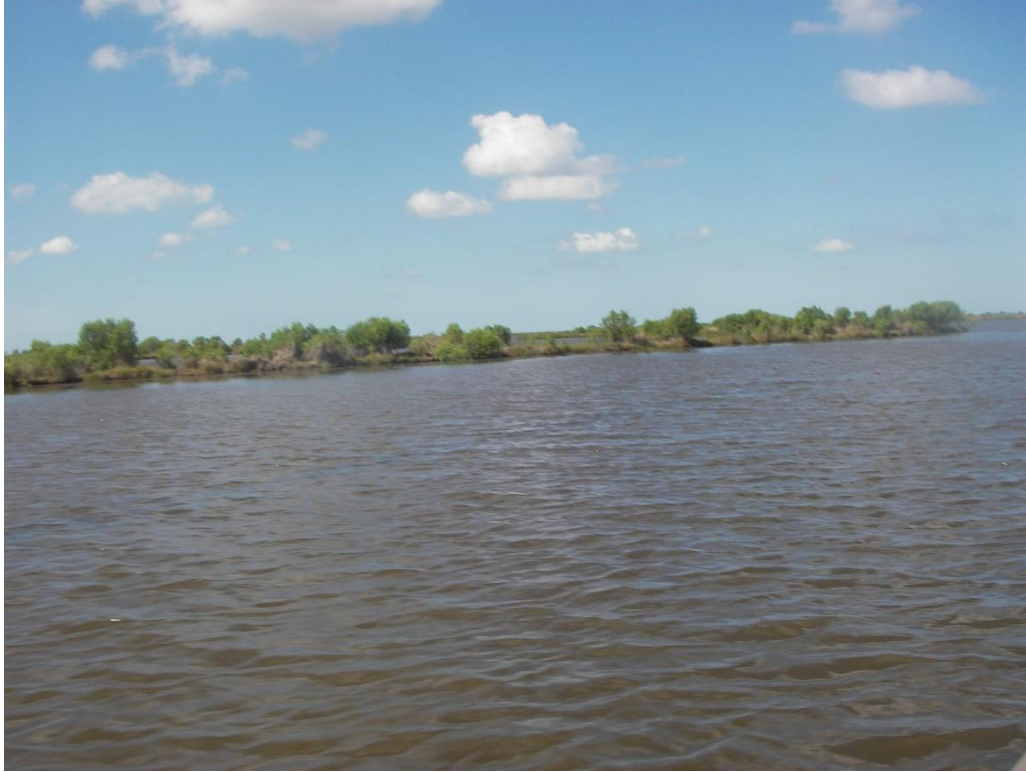
Photo No. 3, Typical thinning eroding terrace with health vegetation. (2015)

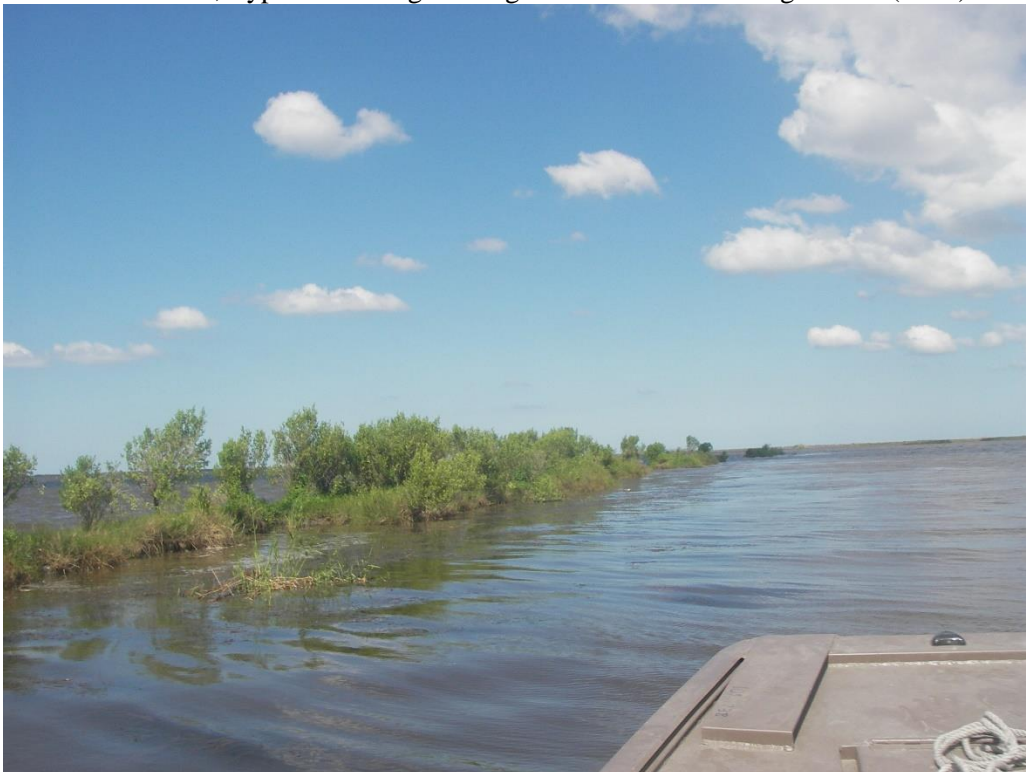
Photo No. 4, Typical thinning eroding terrace with health vegetation. (2015)

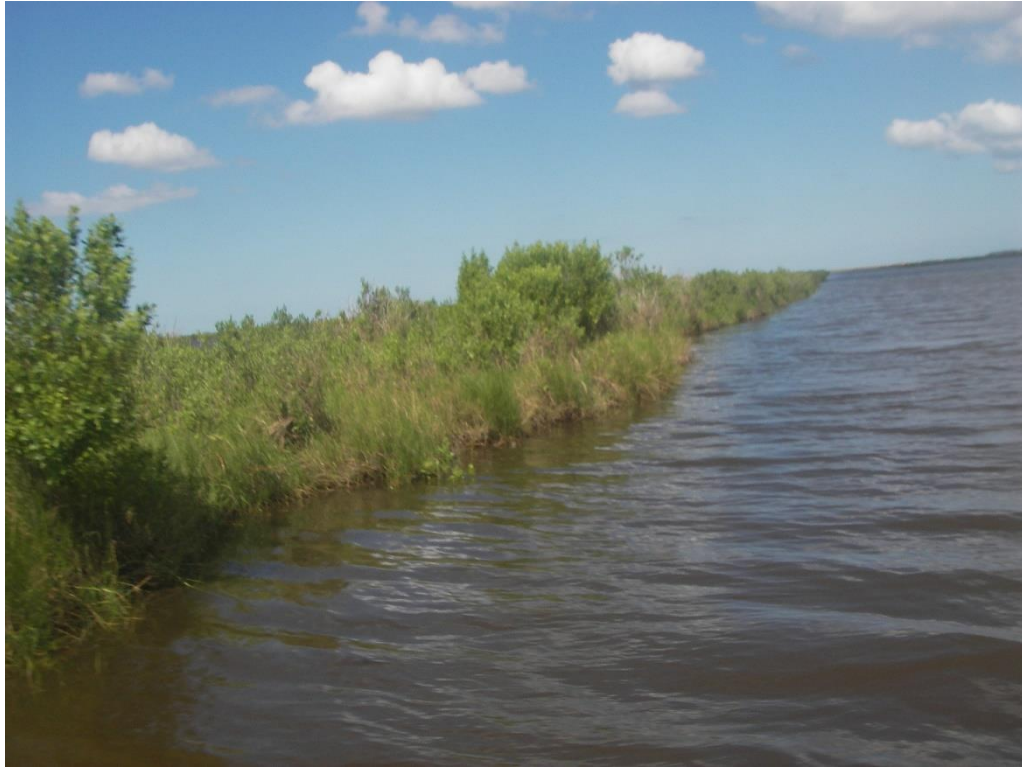
The tops of the terraces are approximately 50 percent covered with vegetation. Species noted include *Spartina alterniflora*, *Juncus*, *Baccharis*, and *Spartina patens*. (Photos: Appendix A, Photo 5-7).

Photo No. 5, Typical intact terrace with health vegetation. (2015)

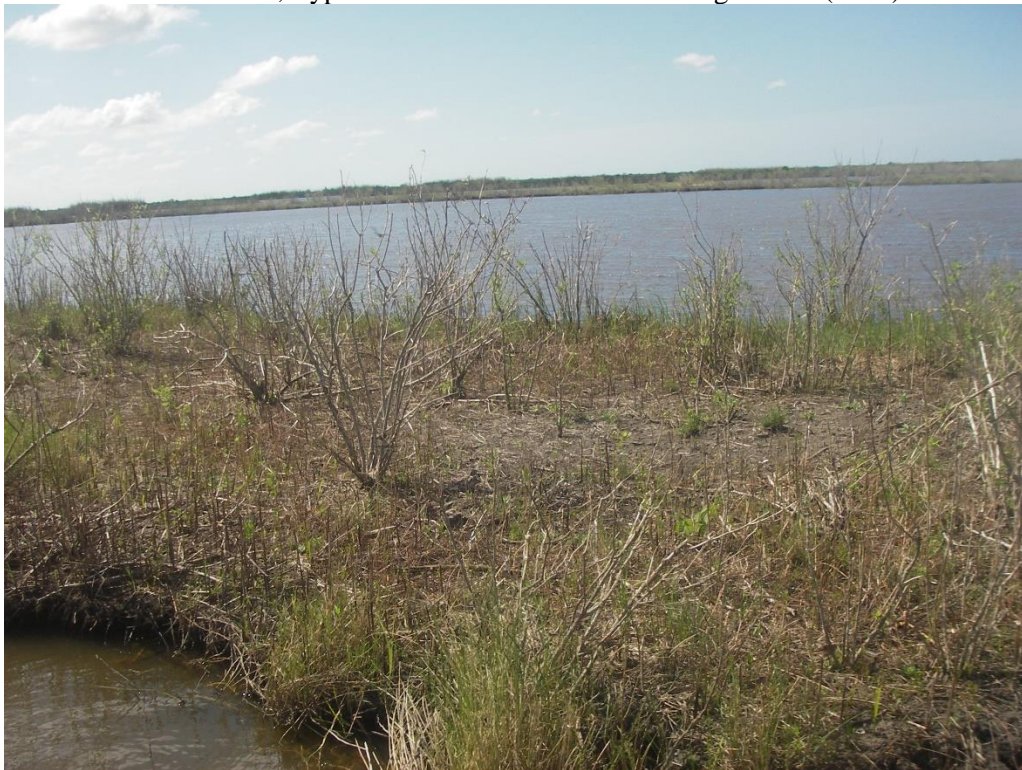
Photo No. 6, Typical intact terrace with stressed vegetation. (2015)

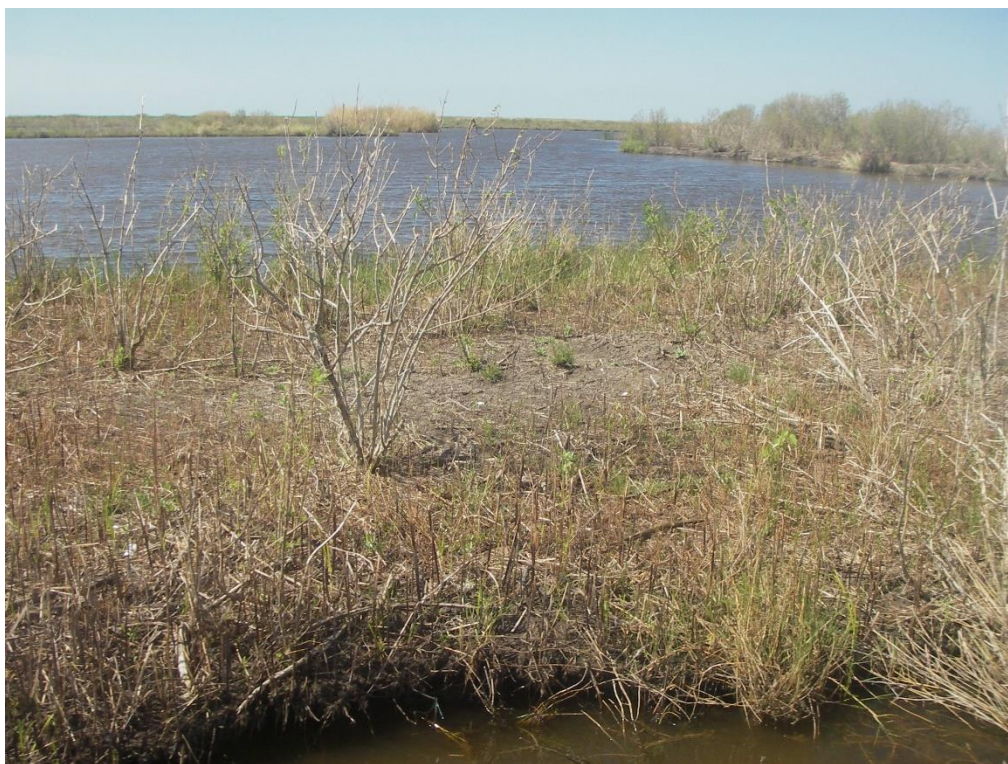
Photo No. 7, Typical intact terrace with stressed vegetation. (2015)
