**Coastal Protection and Restoration
Authority (CPRA)**

2020 Operations, Maintenance, and Monitoring Report

Freshwater Introduction South of Highway 82

State Project Number ME-16
Priority Project List 9

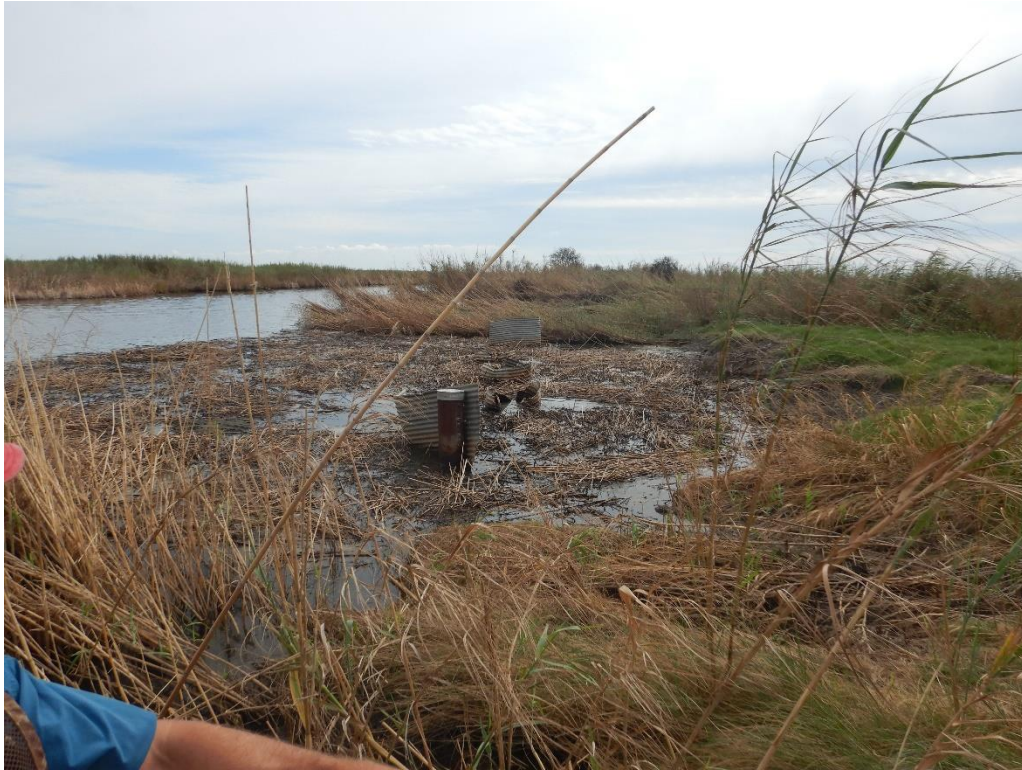
The inlet side of the structure received considerable damage. The corrugated aluminum wing walls and all four (4) half-round aluminum risers, along with the variable crest weir inlet and framing hardware were damaged beyond repair. Approximately 20 percent of the soil and rock armoring between the structure inlet and outlet sides has been washed away.

With water levels elevated, it was not possible to assess damage below the water line.

The outlet side of the structure (aluminum backflow gates and timber bulkhead) appeared to be in working order as water could be seen flowing out. The backflow gates were not manually operated to determine condition or operability. (Photos: Appendix A, Photo 1)

Photo No. 1, New Cop Cop Structure - Risers and wing wall destroyed. Portion of Levee and armament washed away.

All flashboard risers have been damaged beyond repair. All 48 inch corrugated aluminum culverts, timber piles and outlet side of structure are believed to be intact and functional. Until further assessment, the LRO assumes repair will consist of new fabricated flashboard risers with variable crest weir inlet and framing hardware attached to the existing culverts, inlet wing walls replacement, soil fill replacement above and adjacent to structures, rock armament placed above soil fill and adjacent to structures.

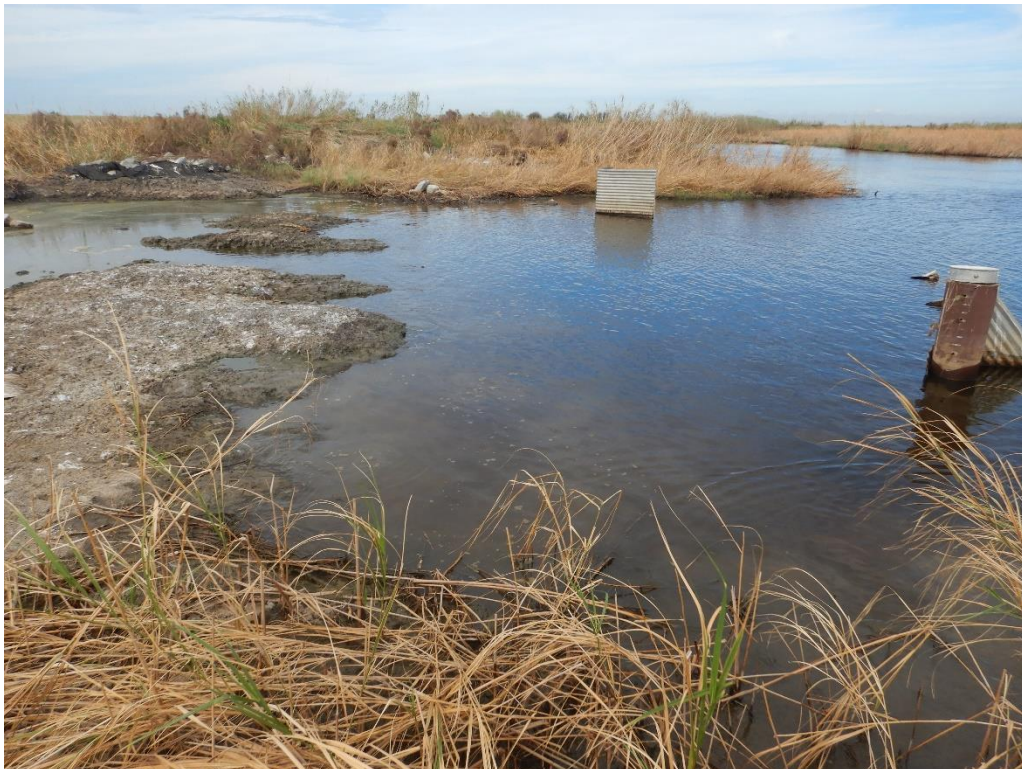
The inlet side of the structure received considerable damage. The corrugated aluminum wing walls and all three (3) half-round aluminum risers, along with the variable crest weir inlet were damaged beyond repair. Approximately 80 percent of the soil and rock armament above the structure has been washed away.

With water levels elevated, it was not possible to assess damage below the water line.

The outlet side of the structure (aluminum backflow gates and timber bulkhead) appeared to be in working order as water could be seen flowing out. The backflow gates were not manually operated to determine condition or operability. (Photos: Appendix A, Photo 2)

Photo No. 2, Perry Bayou Structure - Risers and wing wall destroyed. Portion of Levee and armament washed away.

Item	Condition	Physical Damage	Corrosion	Photo #	Observations and Remarks
Steel Bulkhead / Caps	N/A				
Steel Grating	Good				
Stop Logs	Gone				
Hardware	Good				
Timber Piles	Good				
Timber Wales	Good				
Galv. Pile Caps	Good				
Culverts	Gone			2	All riser inlets are destroyed.
Signage /Supports Staff Gages	N/A				
Rip Rap (fill)	Gone			2	All rip rap on the inlet side of the structure has washed away.
Earthen Embankment	Bad			2	Approximately 80% of the earthen embankment on the inlet side of the structure has washed away.
What are the conditions of the existing levees?					
Are there any noticeable breaches?					
Settlement of rock plugs and rock weirs?					
Position of stoplogs at the time of the inspection?					
Are there any signs of vandalism?

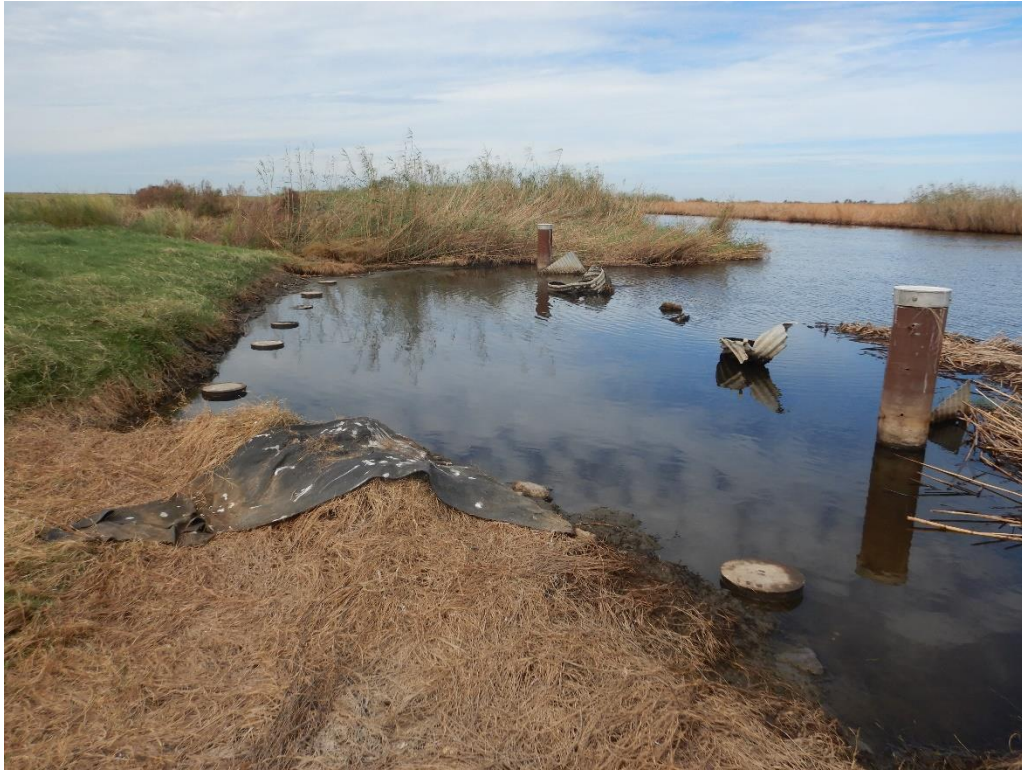
The inlet side of the structure received considerable damage. The corrugated aluminum wing walls and all three (3) half-round aluminum risers, along with the variable crest weir inlet and framing hardware were damaged beyond repair. Approximately 30 percent of the soil and rock armament above the structure has been washed away. There was further erosion of the levee directly adjacent to the structure.

With water levels elevated, it was not possible to assess damage below the water line. The first set of timber piles back from inlet were visible above the water line and appear to be sound and plumb.

The outlet side of the structure (aluminum backflow gates and timber bulkhead) appeared to be in working order as water could be seen flowing out. The backflow gates were not manually operated to determine condition or operability. (Photos: Appendix A, Photo 3)

Photo No. 3, McNeece Bayou Structure - Risers and wing wall destroyed. Portion of Levee and armament washed away.

Item	Condition	Physical Damage	Corrosion	Photo #	Observations and Remarks
Flapgates	Good				
Steel Grating	Good				
Stop Logs	Good				
Hardware	Good				
Timber Piles	Good				
Timber Walkway					
Timber Wales	Good				
Galv. Pile Caps	Good				
Culverts	Gone			3	All riser inlets have been destroyed.
Signage /Supports Staff Gages	N/A				
Rip Rap (fill)	Gone			3	All rip rap on the inlet side of the structure has washed away.
Earthen Embankment	Bad			3	Approximately 30% of the earthen embankment on the inlet side of the structure has been washed away.
What are the conditions of the existing levees?					
Are there any noticeable breaches?					
Settlement of rock plugs and rock weirs?					
Position of stoplogs at the time of the inspection?					
Are there any signs of vandalism?

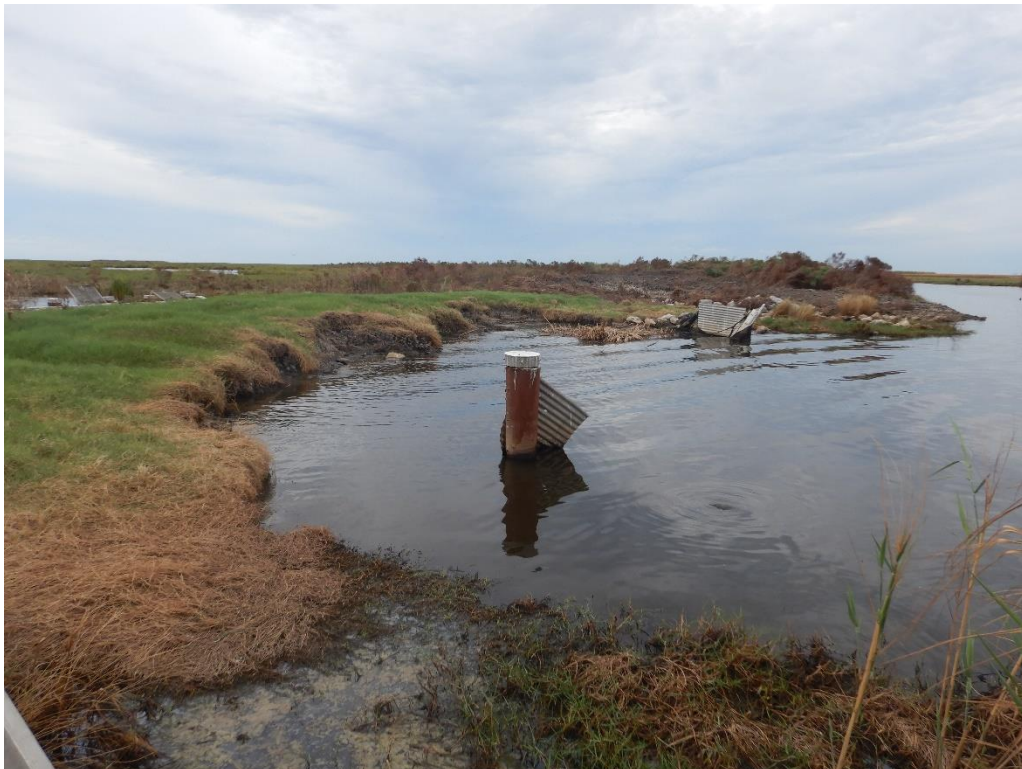
The inlet side of the structure received considerable damage. The corrugated aluminum wing walls and all four (4) half-round aluminum risers, along with the variable crest weir inlet and framing hardware were damaged beyond repair. Approximately 30 percent of the soil and rock armament above the structure has been washed away.

With water levels elevated, it was not possible to assess damage below the water line. The first set of timber piles back from inlet were visible just below the water line and appear to be sound and plumb.

The outlet side of the structure received some minor damage. Three (3) aluminum grating platforms are detached from the outlets and are lifted. One (1) aluminum grating platform has broken free of the bulkhead. Water could be seen flowing out of the backflow gates. The backflow gates were not manually operated to determine condition or operability. (Photos: Appendix A, Photo 4)

Photo No. 4, Hess Structure - Risers and wing wall destroyed. Portion of Levee and armament washed away.

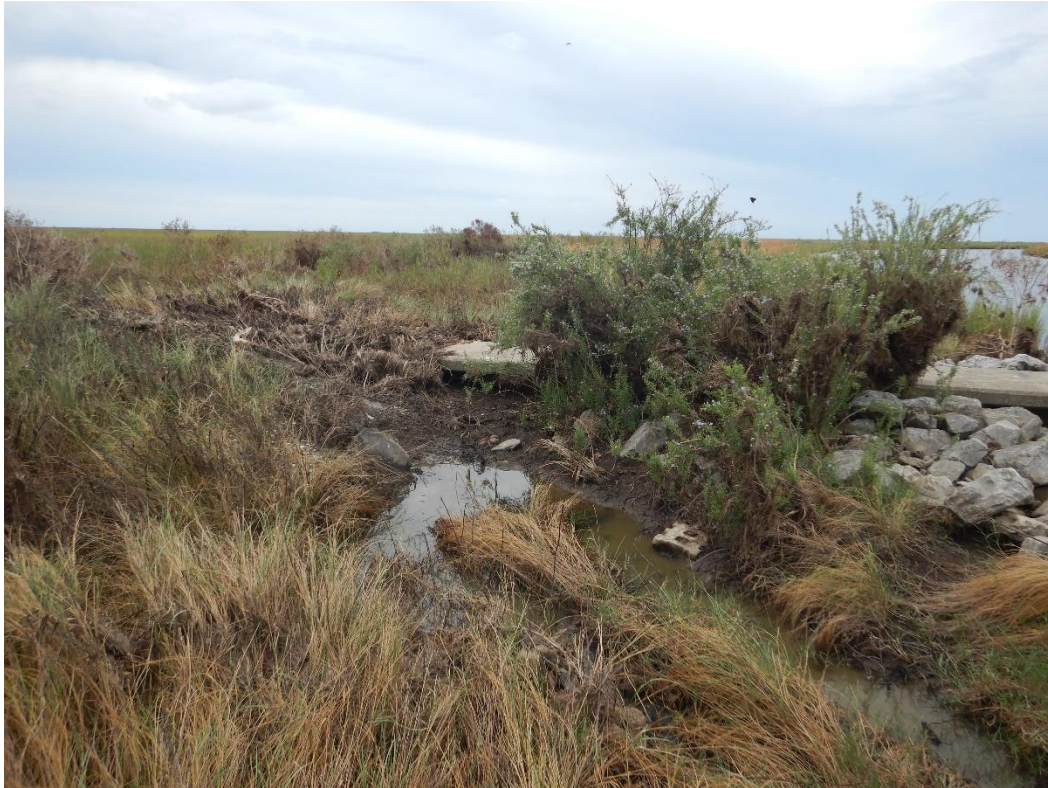
Some minor damage to structure and erosion of embankment adjacent to the structure. Minor damage to the structure included detached ladders and spalling of concrete. Spalling of the concrete is most likely a long term aging of the structure and not due to the storm. Some concrete appeared to be broken off due to force and could be storm related. Some rock armament and soil have been washed away on embankment around the structure.

Weir inlets are below water line and were unable to be assessed. Backflow gates appeared to be in the fully closed position below the water line. Therefore, backflow gates could not be assessed. The backflow gate lifting mechanism was not operated, therefore it is unknown if there are any damages to the lifting system. (Photos: Appendix A, Photo 5 & 6)

Photo No. 5, Little Constance Structure – Erosion and scour around end of structure.

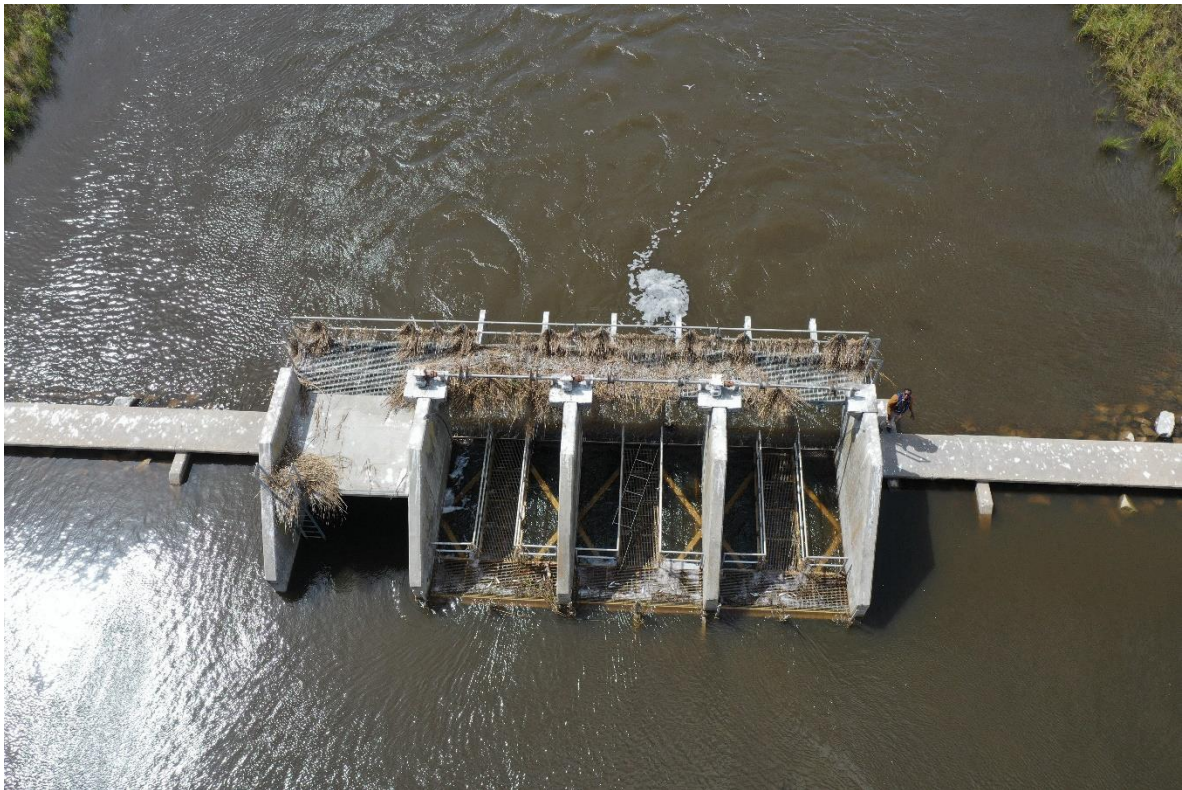
Photo No. 6, Little Constance Structure – Vegetative rack on structure.

Item	Condition	Physical Damage	Corrosion	Photo #	Observations and Remarks
Concrete Control Structure	Good			6	Vegetative rack on structure, but generally faired well. Ladders detached.
Flap Gates	Good				
Stop Logs	Good				
Hardware	Good				
Timber Piles	N/A				
Timber Walkway					
Timber Wales	N/A				
Galv. Pile Caps	N/A				
Cables	Good				
Signage / Supports	N/A				
Staff Gages					
Rip Rap (fill)	Good			5	Some scour around structure. Some light soil and rock placement needed.
Earthen Embankment	N/A				
What are the conditions of the existing levees?					
Are there any noticeable breaches?					
Settlement of rock plugs and rock weirs?					
Position of stoplogs at the time of the inspection?					
Are there any signs of vandalism?

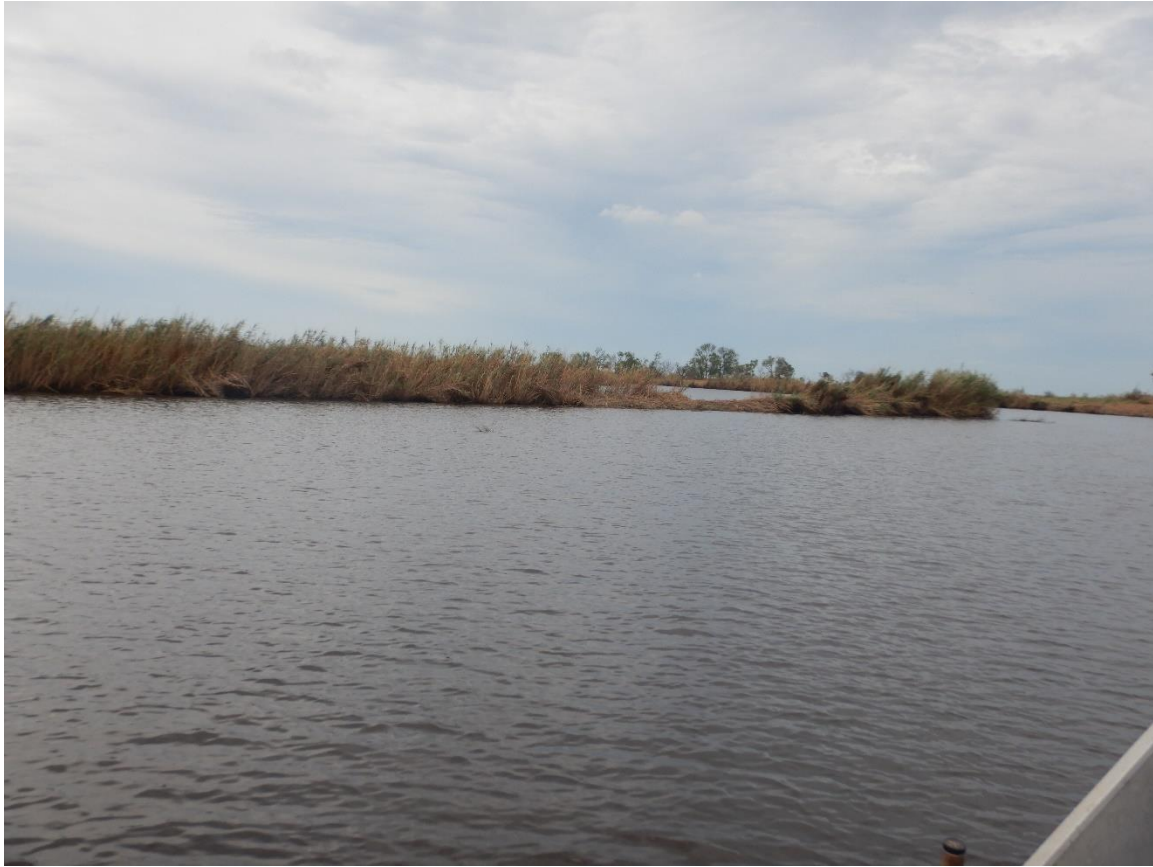
One segment of terrace in the southernmost area of the terrace field experienced some erosion. Generally, the terrace field is in good condition. (Photos: Appendix A, Photo 7)

Photo No. 7, Earthen terrace.
