2025 Operations, Maintenance, and Monitoring Report

Freshwater Introduction South of Highway 82

State Project Number ME-16
Priority Project List 9

December 2025
Calcasieu Parish

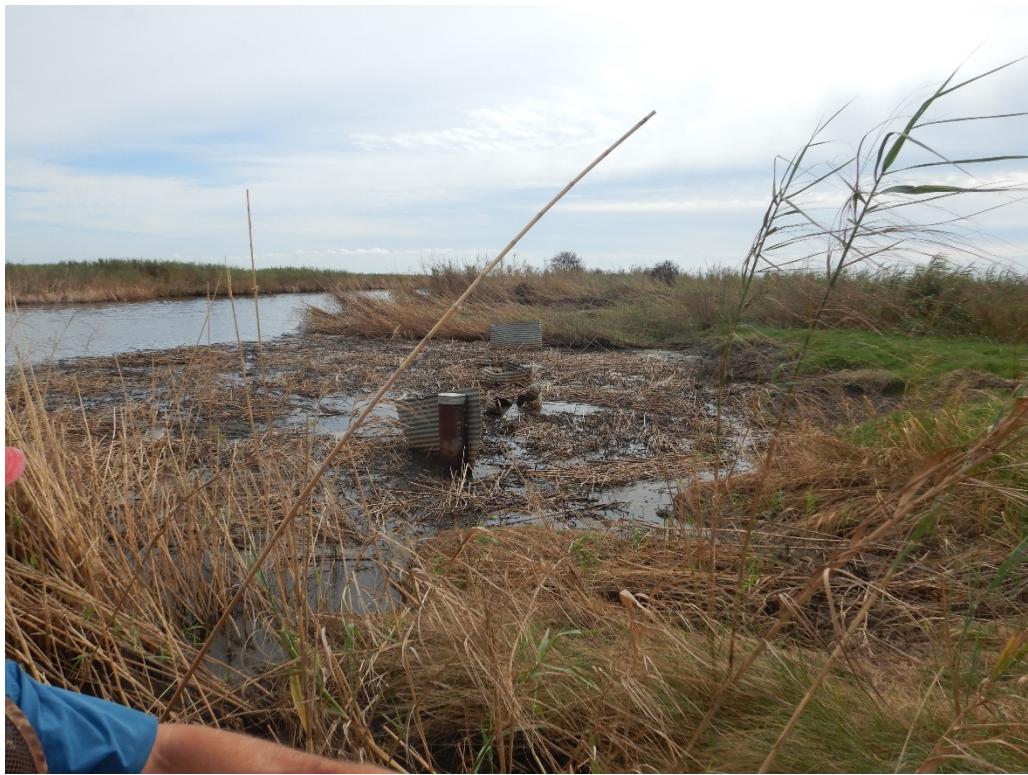
The inlet side of the structure received considerable damage. The corrugated aluminum wing walls and all four (4) half-round aluminum risers, along with the variable crest weir inlet and framing hardware were damaged beyond repair. Approximately 20 percent of the soil and rock armoring between the structure inlet and outlet sides has been washed away.

With water levels elevated, it was not possible to assess damage below the water line.

The outlet side of the structure (aluminum backflow gates and timber bulkhead) appeared to be in working order as water could be seen flowing out. The backflow gates were not manually operated to determine condition or operability. (Photos: Appendix A, Photo 1)

Photo No. 1, New Cop Cop Structure - Risers and wing wall destroyed. Portion of Levee and armament washed away.

All flashboard risers have been damaged beyond repair. All 48 inch corrugated aluminum culverts, timber piles and outlet side of structure are believed to be partially intact and functional.

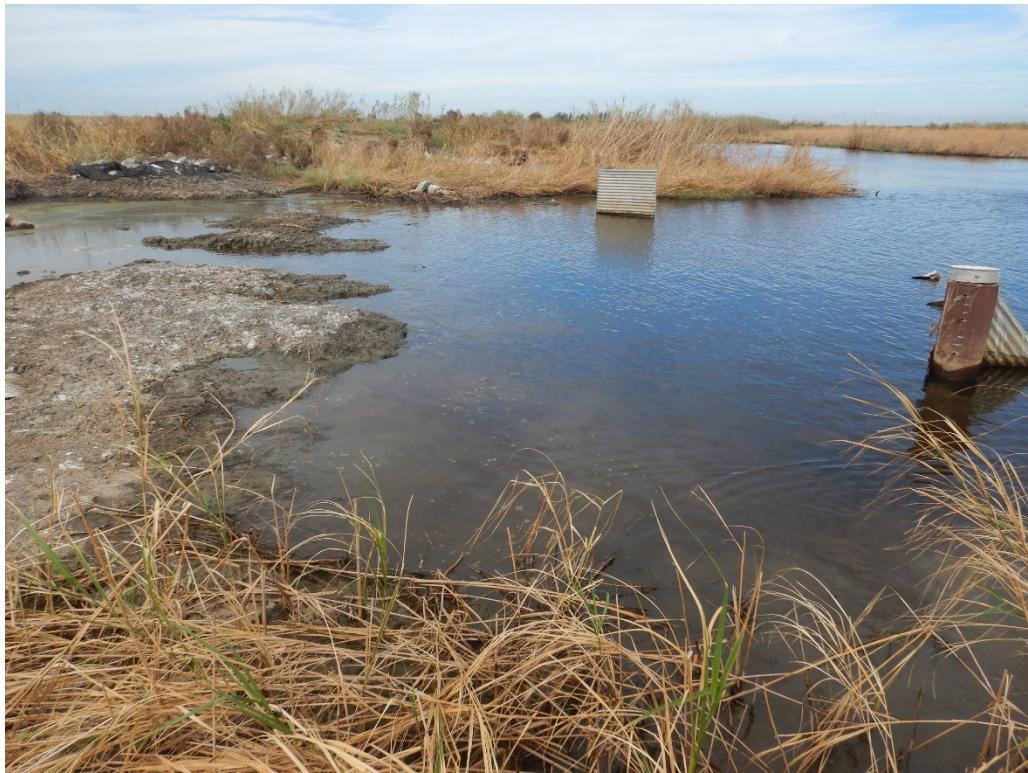
The inlet side of the structure received considerable damage. The corrugated aluminum wing walls and all three (3) half-round aluminum risers, along with the variable crest weir inlet were damaged beyond repair. Approximately 80 percent of the soil and rock armament above the structure has been washed away.

With water levels elevated, it was not possible to assess damage below the water line.

The outlet side of the structure (aluminum backflow gates and timber bulkhead) appeared to be in working order as water could be seen flowing out. The backflow gates were not manually operated to determine condition or operability. (Photos: Appendix A, Photo 2)

Photo No. 2, Perry Bayou Structure - Risers and wing wall destroyed. Portion of Levee and armament washed away.

Item	Condition	Physical Damage	Corrosion	Photo #	Observations and Remarks
Steel Bulkhead / Caps	N/A				
Steel Grating	Good				
Stop Logs	Gone				
Hardware	Good				
Timber Piles	Good				
Timber Wales	Good				
Galv. Pile Caps	Good				
Culverts	Gone			2	All riser inlets are destroyed.
Signage /Supports Staff Gages	N/A				
Rip Rap (fill)	Gone			2	All rip rap on the inlet side of the structure has washed away.
Earthen Embankment	Bad			2	Approximately 80% of the earthen embankment on the inlet side of the structure has washed away.
What are the conditions of the existing levees?					
Are there any noticeable breaches?					
Settlement of rock plugs and rock weirs?					
Position of stoplogs at the time of the inspection?					
Are there any signs of vandalism?

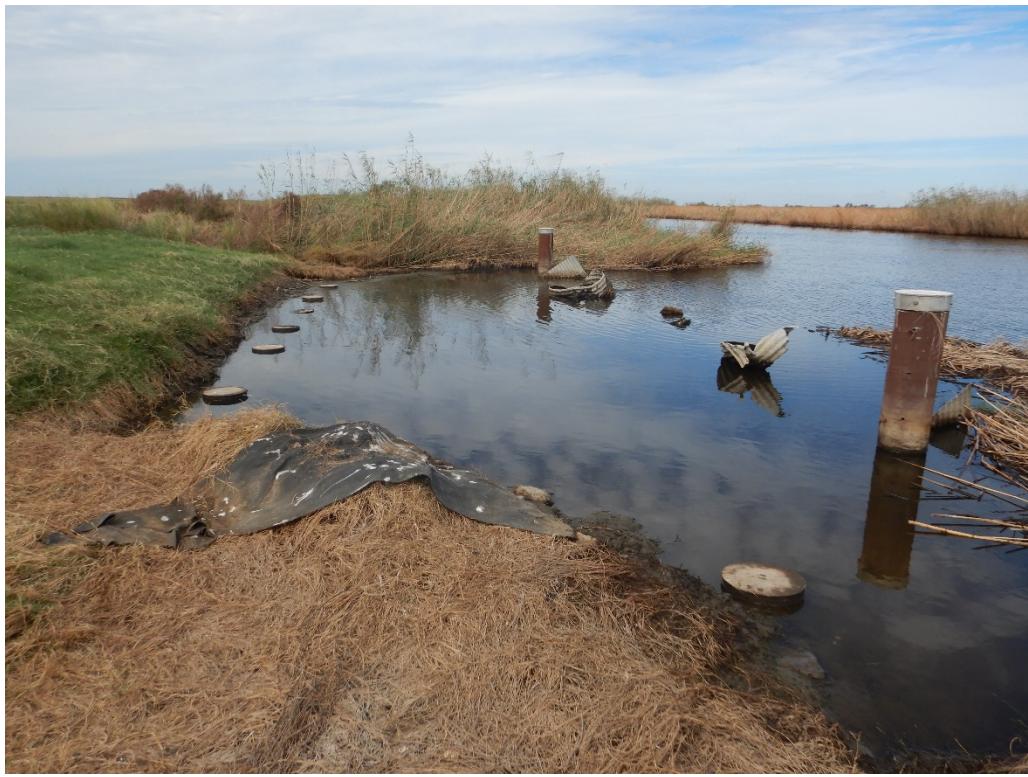
The inlet side of the structure received considerable damage. The corrugated aluminum wing walls and all three (3) half-round aluminum risers, along with the variable crest weir inlet and

framing hardware were damaged beyond repair. Approximately 30 percent of the soil and rock armament above the structure has been washed away. There was further erosion of the levee directly adjacent to the structure.

With water levels elevated, it was not possible to assess damage below the water line. The first set of timber piles back from inlet were visible above the water line and appear to be sound and plumb.

The outlet side of the structure (aluminum backflow gates and timber bulkhead) appeared to be in working order as water could be seen flowing out. The backflow gates were not manually operated to determine condition or operability. (Photos: Appendix A, Photo 3)

Photo No. 3, McNeese Bayou Structure - Risers and wing wall destroyed.
Portion of Levee and armament washed away.

Item	Condition	Physical Damage	Corrosion	Photo #	Observations and Remarks
Flapgates	Good				
Steel Grating	Good				
Stop Logs	Good				
Hardware	Good				
Timber Piles	Good				
Timber Walkway					
Timber Wales	Good				
Galv. Pile Caps	Good				
Culverts	Gone			3	All riser inlets have been destroyed.
Signage /Supports	N/A				
Staff Gages					
Rip Rap (fill)	Gone			3	All rip rap on the inlet side of the structure has washed away.
Earthen Embankment	Bad			3	Approximately 30% of the earthen embankment on the inlet side of the structure has been washed away.
What are the conditions of the existing levees?					
Are there any noticeable breaches?					
Settlement of rock plugs and rock weirs?					
Position of stoplogs at the time of the inspection?					
Are there any signs of vandalism?

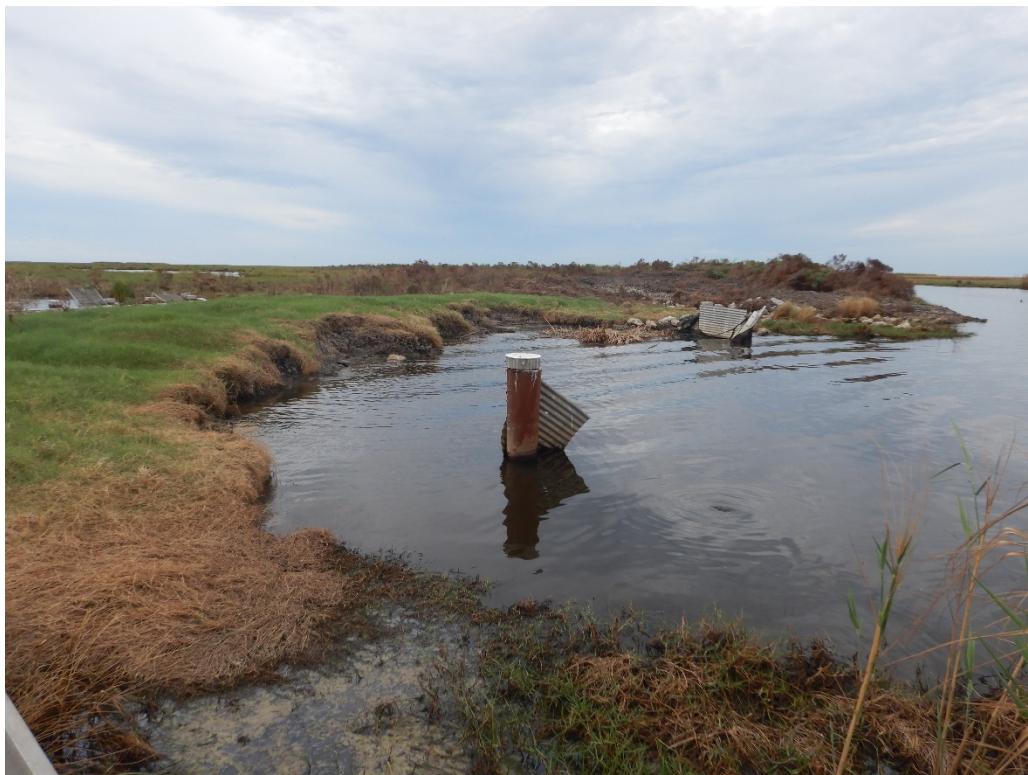
The inlet side of the structure received considerable damage. The corrugated aluminum wing walls and all four (4) half-round aluminum risers, along with the variable crest weir inlet and framing hardware were damaged beyond repair. Approximately 30 percent of the soil and rock armament above the structure has been washed away.

With water levels elevated, it was not possible to assess damage below the water line. The first set of timber piles back from inlet were visible just below the water line and appear to be sound and plumb.

The outlet side of the structure received some minor damage. Three (3) aluminum grating platforms are detached from the outlets and are lifted. One (1) aluminum grating platform has broken free of the bulkhead. Water could be seen flowing out of the backflow gates. The backflow gates were not manually operated to determine condition or operability. (Photos: Appendix A, Photo 4)

Photo No. 4, Hess Structure - Risers and wing wall destroyed. Portion of Levee and armament washed away.

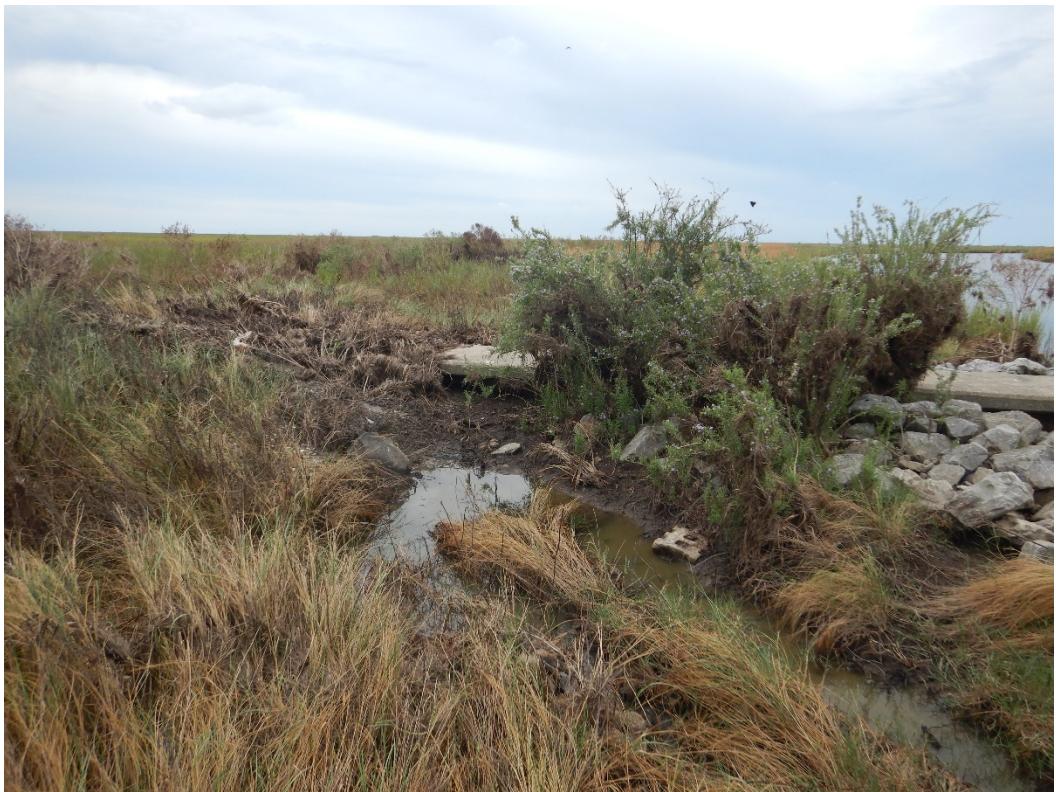
Some minor damage to structure and erosion of embankment adjacent to the structure. Minor damage to the structure included detached ladders and spalling of concrete. Spalling of the concrete is most likely a long term aging of the structure and not due to the storm. Some concrete appeared to be broken off due to force and could be storm related. Some rock armament and soil have been washed away on embankment around the structure.

Weir inlets are below water line and were unable to be assessed. Backflow gates appeared to be in the fully closed position below the water line. Therefore, backflow gates could not be assessed. The backflow gate lifting mechanism was not operated, therefore it is unknown if there are any damages to the lifting system. (Photos: Appendix A, Photo 5 & 6)

Photo No. 5, Little Constance Structure – Erosion and scour around end of structure.

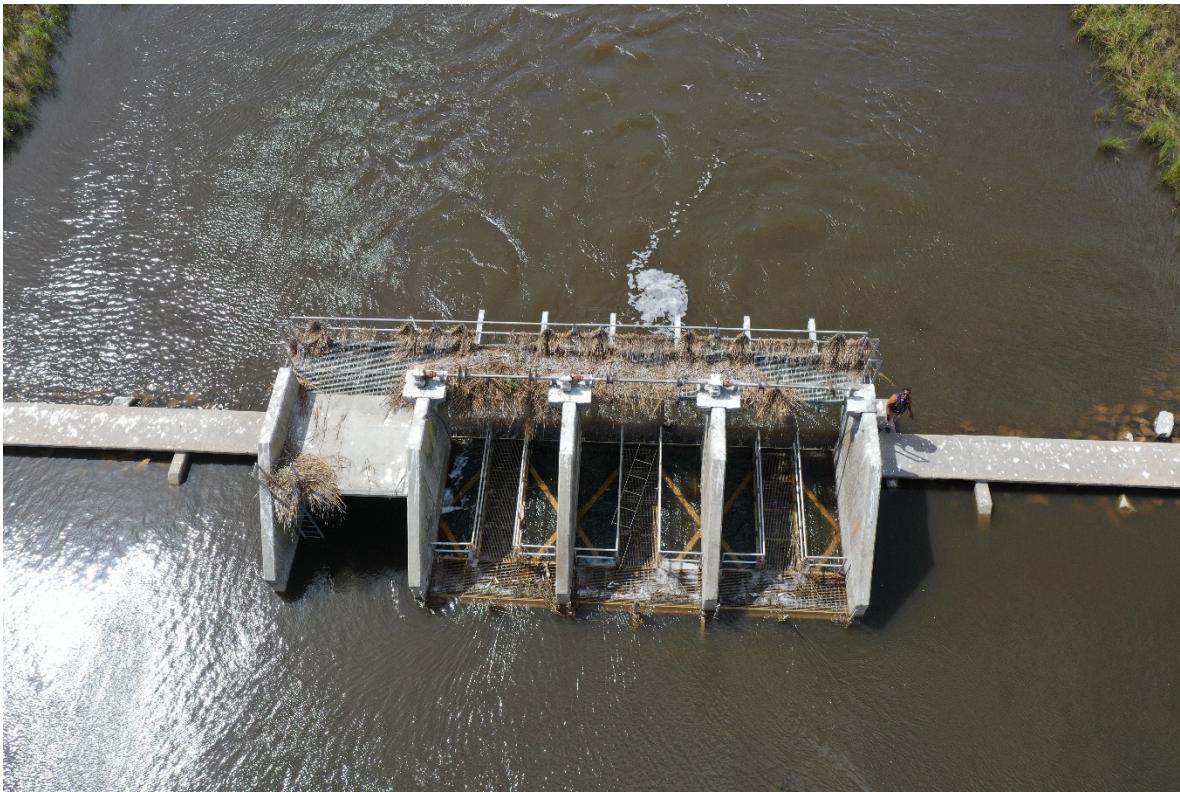
Photo No. 6, Little Constance Structure – Vegetative wrack on structure.

Item	Condition	Physical Damage	Corrosion	Photo #	Observations and Remarks
Concrete Control Structure	Good			6	Vegetative rack on structure, but generally faired well. Ladders detached.
Flap Gates	Good				
Stop Logs	Good				
Hardware	Good				
Timber Piles	N/A				
Timber Walkway					
Timber Wales	N/A				
Galv. Pile Caps	N/A				
Cables	Good				
Signage /Supports Staff Gages	N/A				
Rip Rap (fill)	Good			5	Some scour around structure. Some light soil and rock placement needed.
Earthen Embankment	N/A				
What are the conditions of the existing levees?					
Are there any noticeable breaches?					
Settlement of rock plugs and rock weirs?					
Position of stoplogs at the time of the inspection?					
Are there any signs of vandalism?

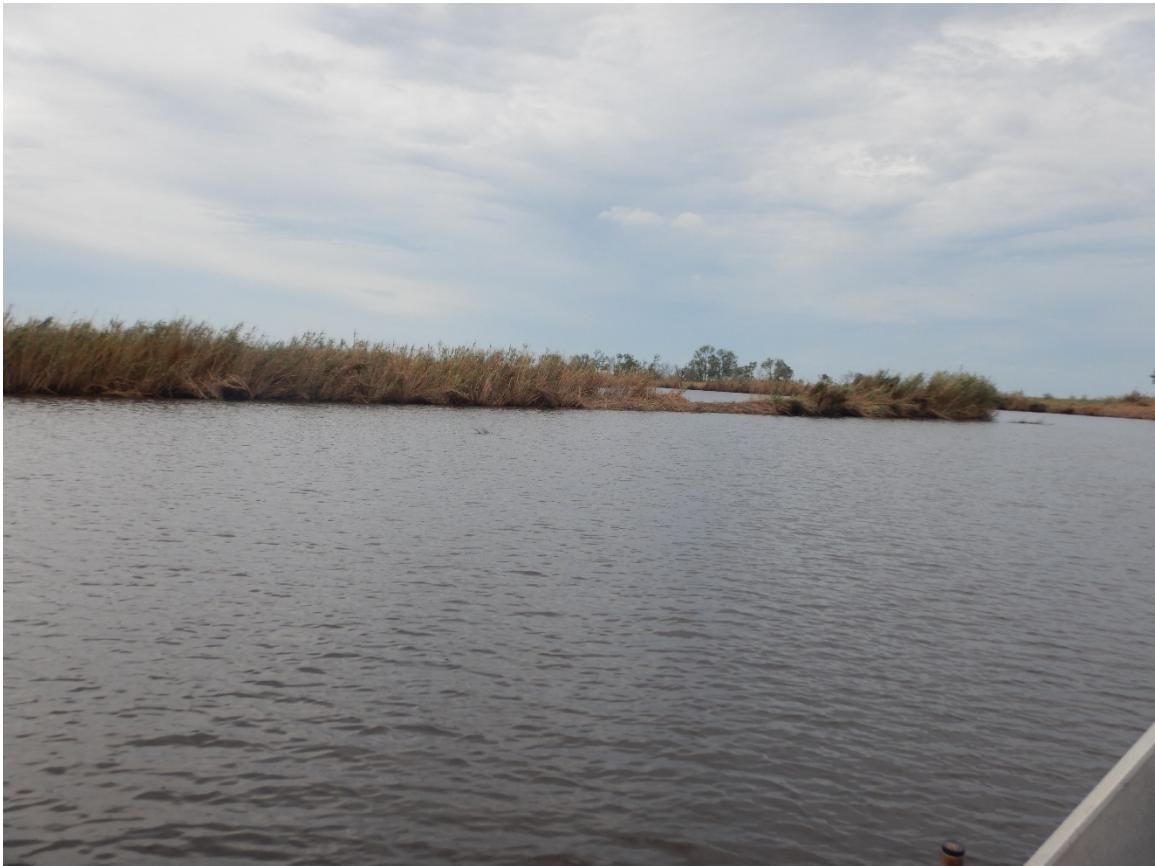
One segment of terrace in the southernmost area of the terrace field experienced some erosion. Generally, the terrace field is in good condition. (Photos: Appendix A, Photo 7)

Photo No. 7, Earthen terrace.
