### 2022 Operations, Maintenance, and Monitoring Report

### Grand-White Lake Land Bridge Protection

State Project Number ME-19  
Priority Project List 10

September 2022  
Cameron Parish

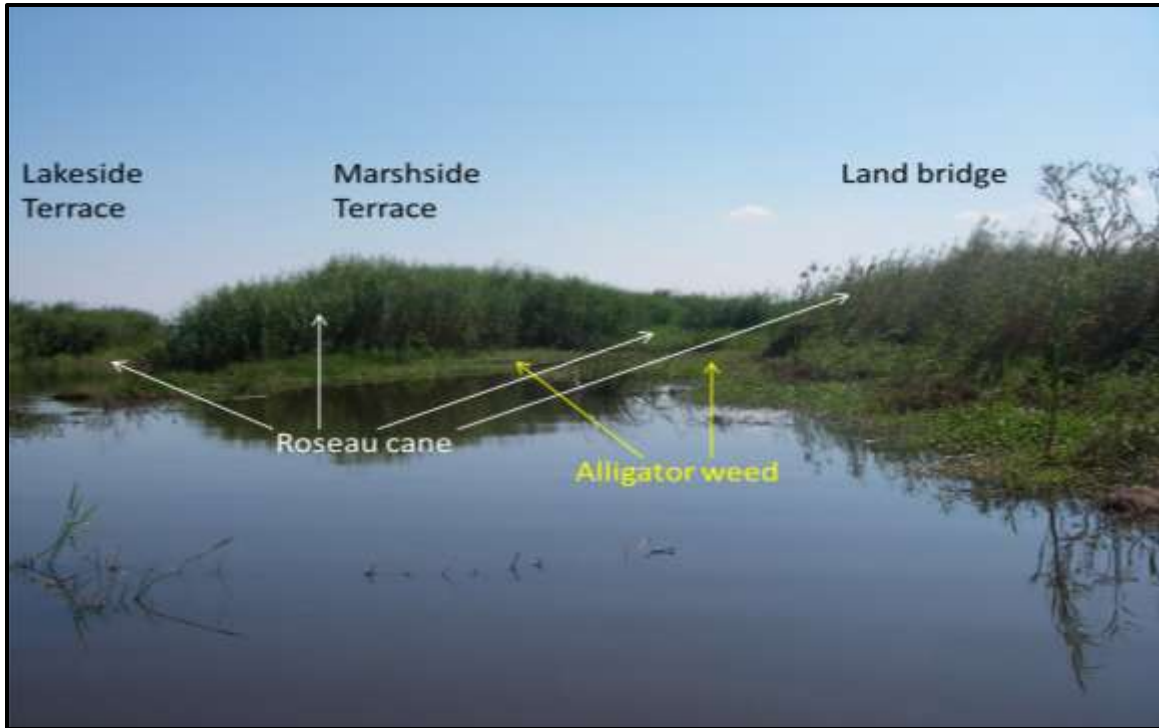
**Figure 10.** Vegetation along Collicon Lake expands as terrace and land bridge vegetation merge. At the time of this photograph (October 21, 2008) the vegetation between the land bridge and terrace was floating; therefore, the vegetative expansion was not included in the shoreline change analysis. If the merging vegetation anchors into the soil below, then it will be considered emergent and define the vegetated shoreline of the land bridge.

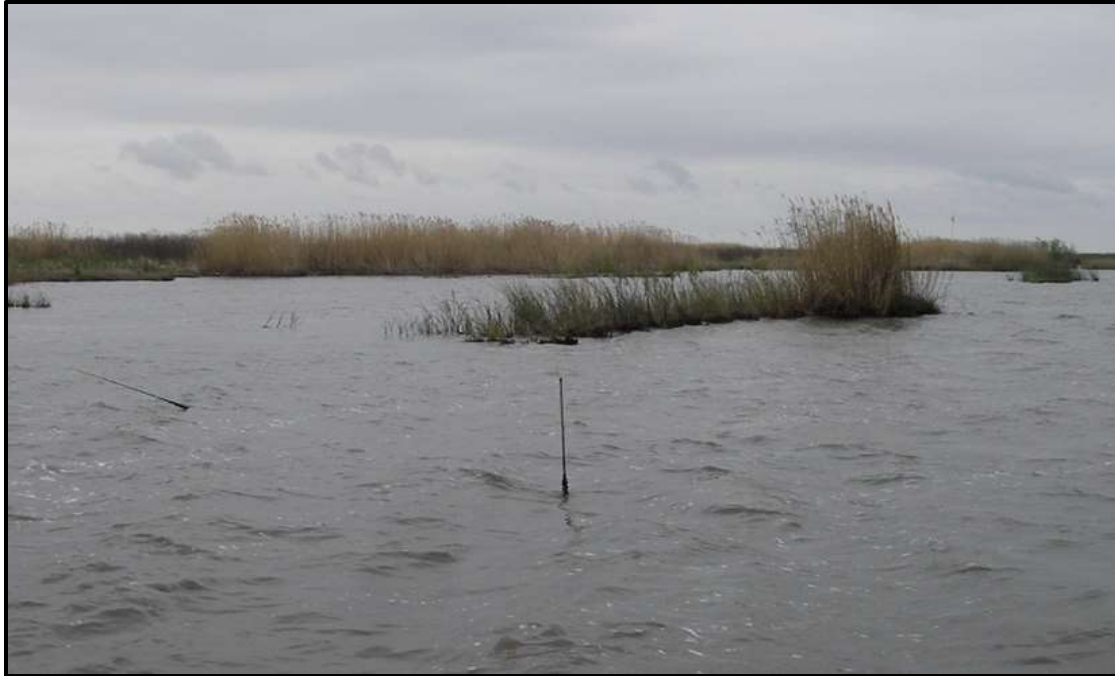
**Figure 13.** Many terraces have eroded since construction, especially the lakeside terraces (e.g. LS42) which were intended to be sacrificial and buffer the marsh side terraces. Note the cane poles that mark the original corners of the terrace. Picture was taken on March 24, 2010.

Armoring the lakeside slope of terraces along Collicon Lake should be considered to prevent future shoreline erosion.

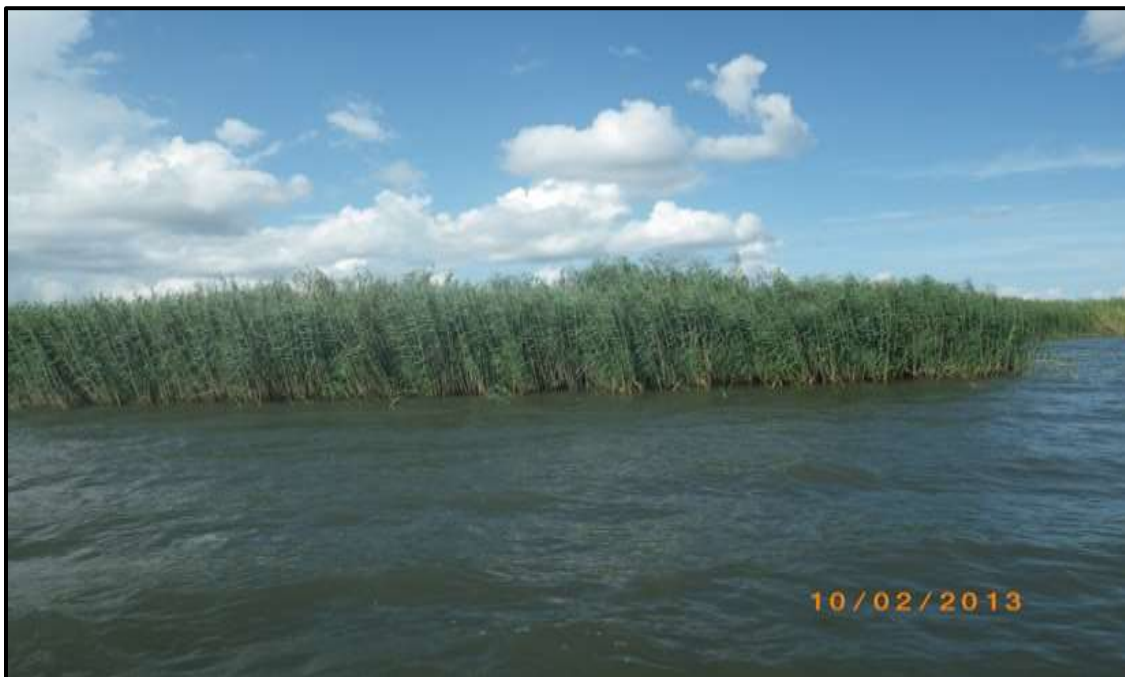
**Figure 14.** October 2, 2013 photograph of LS42 a lakeside terrace, depicting vegetation growth. Note the expansion of Roseau cane since the 2010 photography in comparison to Figure 12 above.

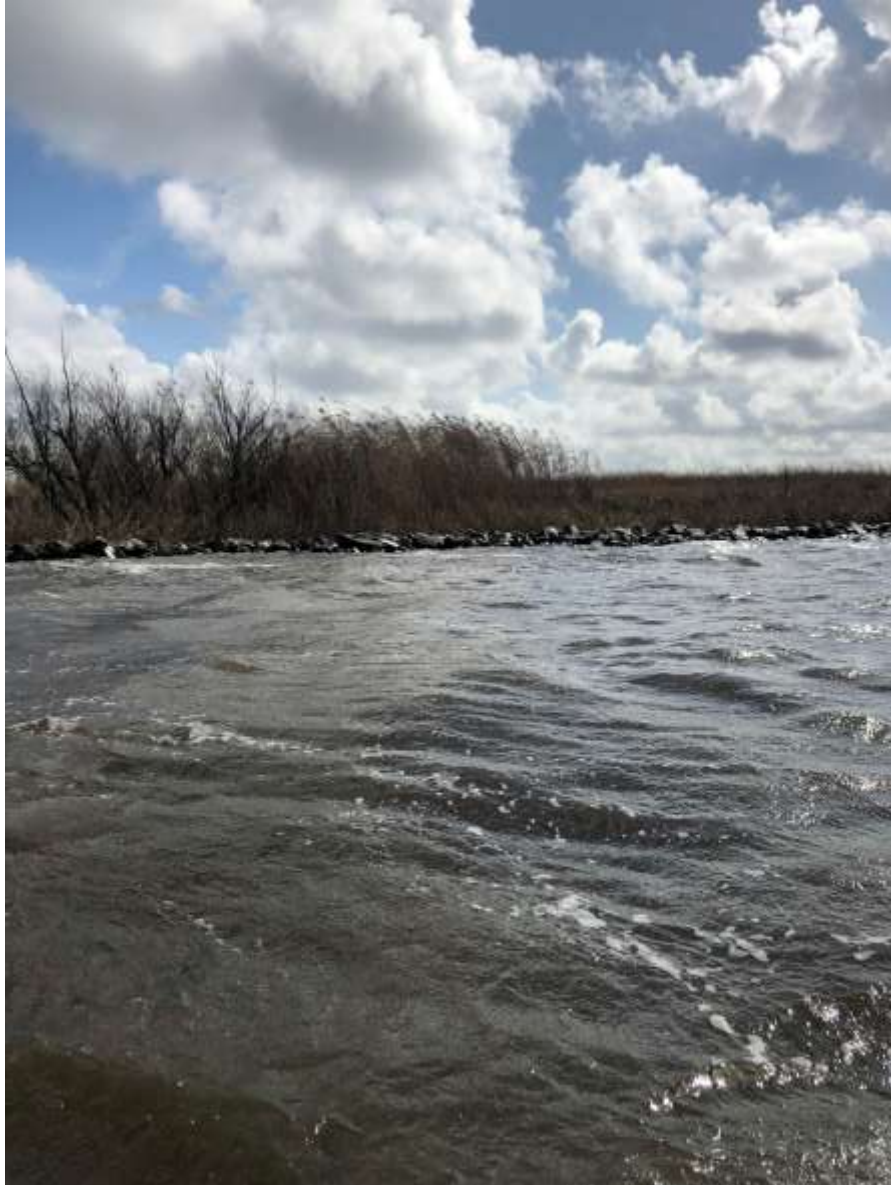
The foreshore rock dike feature is in good condition. Warning signs are present. There is vegetation behind the rock dike over the majority of length of dike. The south end of the rock dike needs to be extended approximately three hundred (300) linear feet to the existing shoreline to reduce erosion of the southern tie-in of the project.

Foreshore Rock Dike 2023 O&M Inspection

A Task Order is being developed for engineering design of a proposed three hundred (300') linear foot extension of the rock dike on the southern end of the project. Also the entire linear footage of the rock dike will be surveyed to identify any reaches which may need to be lifted. The proposed extension of the rock dike

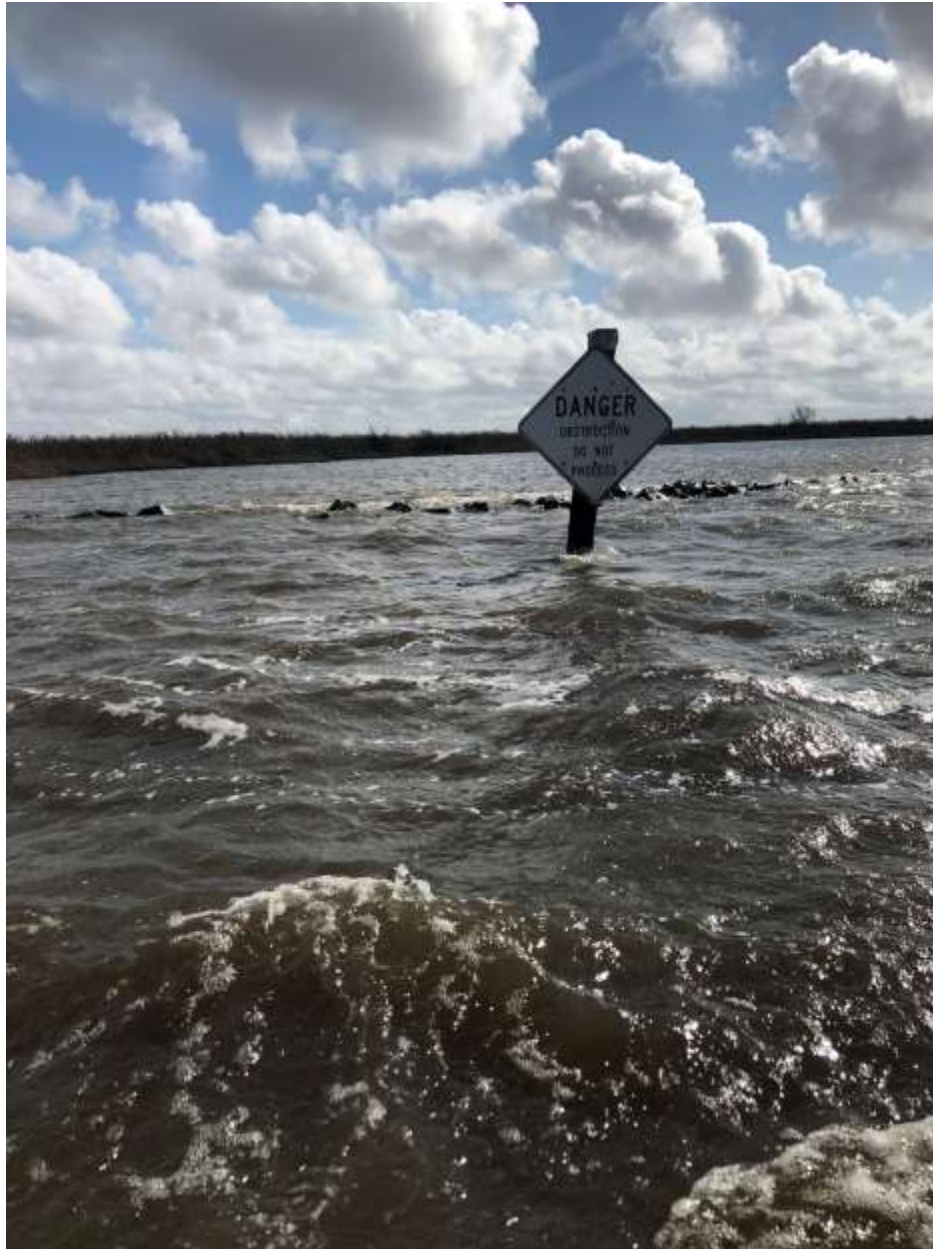
Foreshore Rock Dike and Warning Sign 2023 O&M Inspection

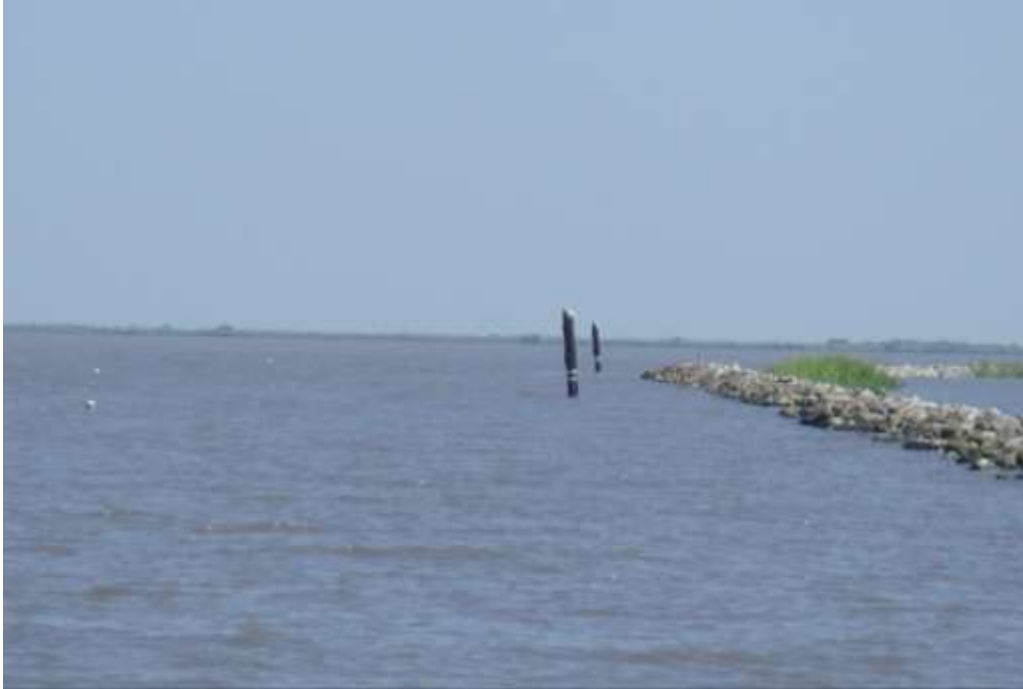
**Photo No. 1,** Rock Dike and Signs on East Shoreline of Grand Lake (2012)

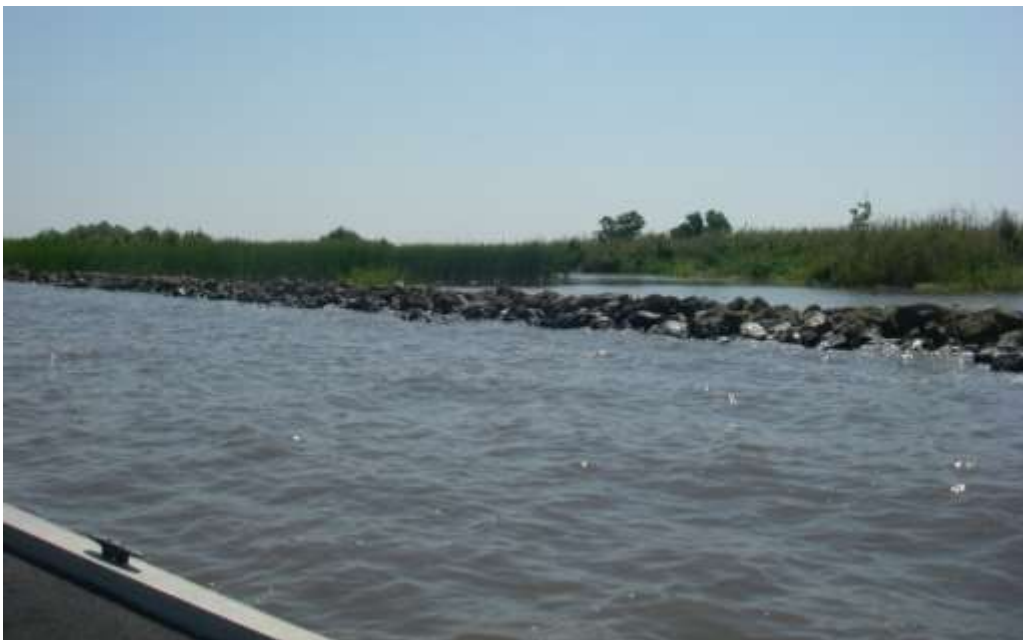
**Photo No. 2,** Vegetation and Rock Dike on East Shoreline of Grand Lake (2012)

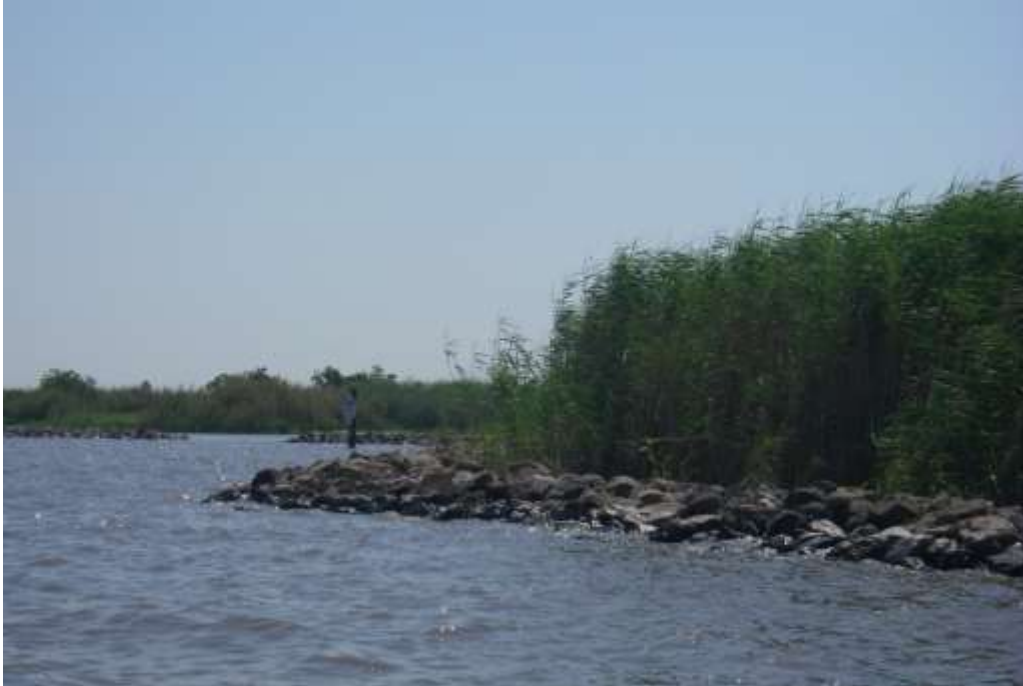
**Photo No. 3,** Rock Dike on East Shoreline of Grand Lake (2012)

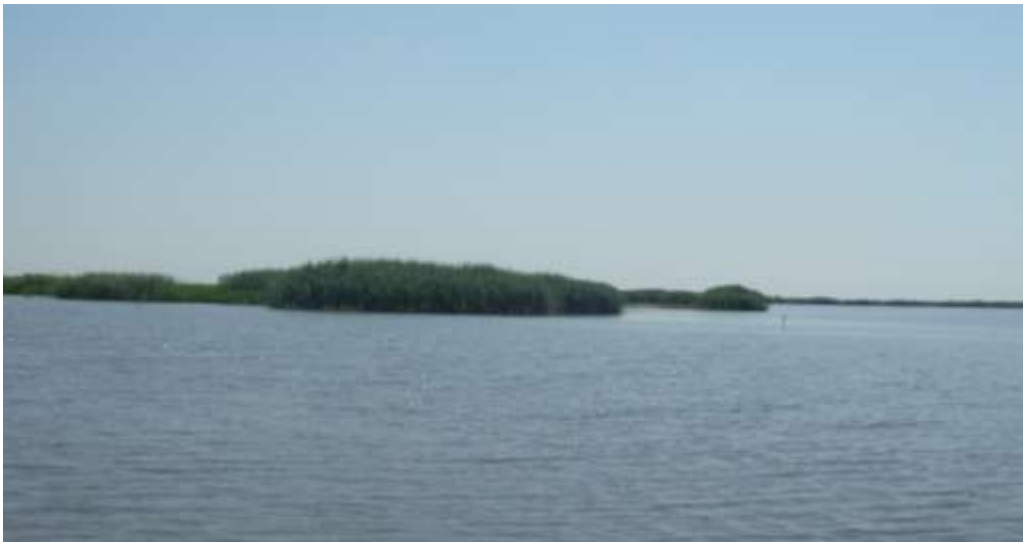
**Photo No. 4,** Earthen Terraces on North End of Collicon Lake (2012)

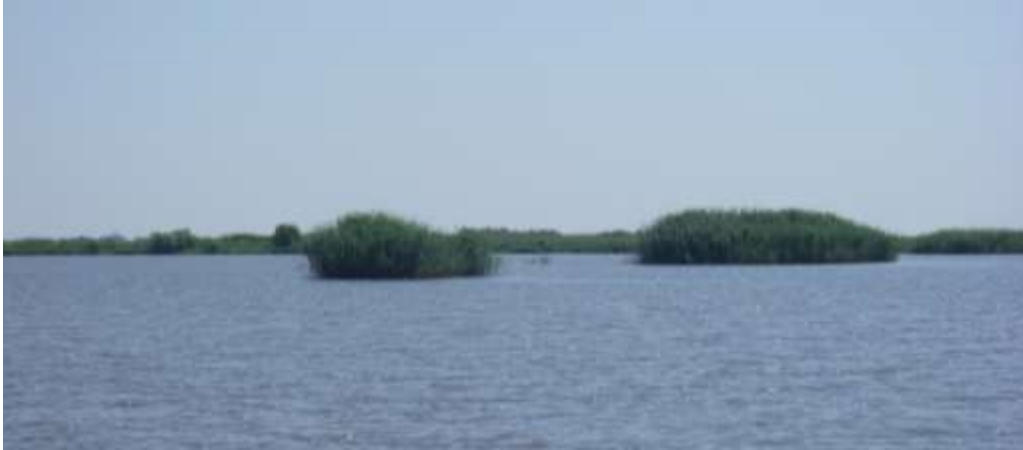
**Photo No. 5,** Earthen Terraces on Northwest and West Sides of Collicon Lake (2012)

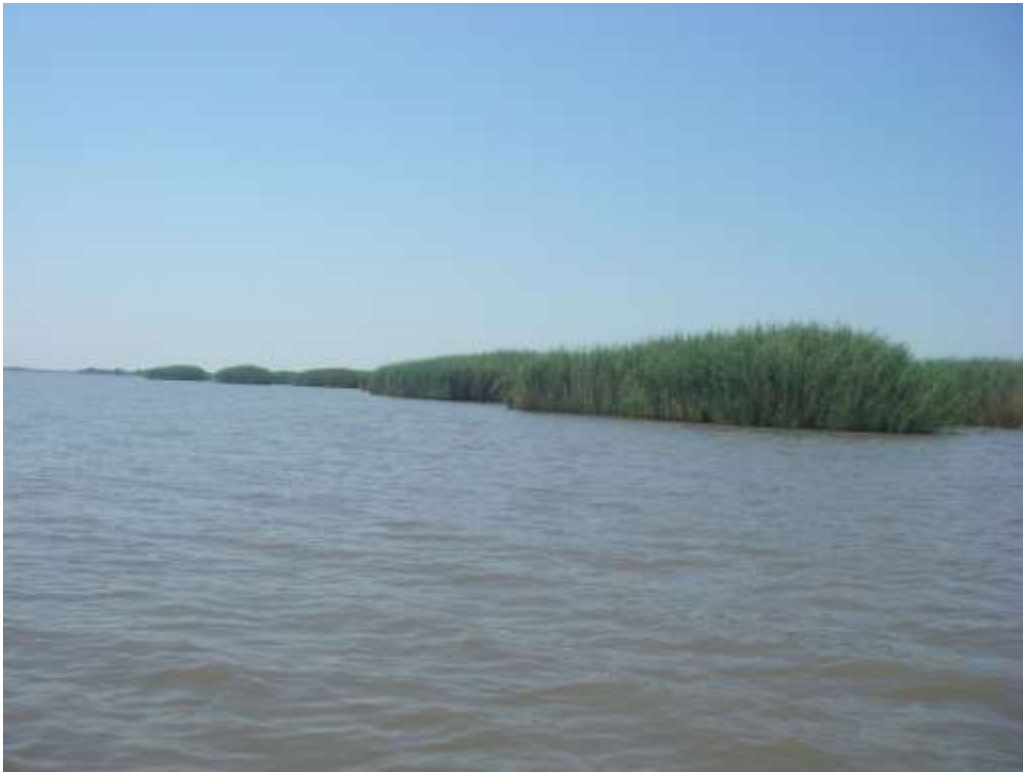
**Photo No. 6,** Earthen Terraces on Southwest End of Collicon Lake (2012)

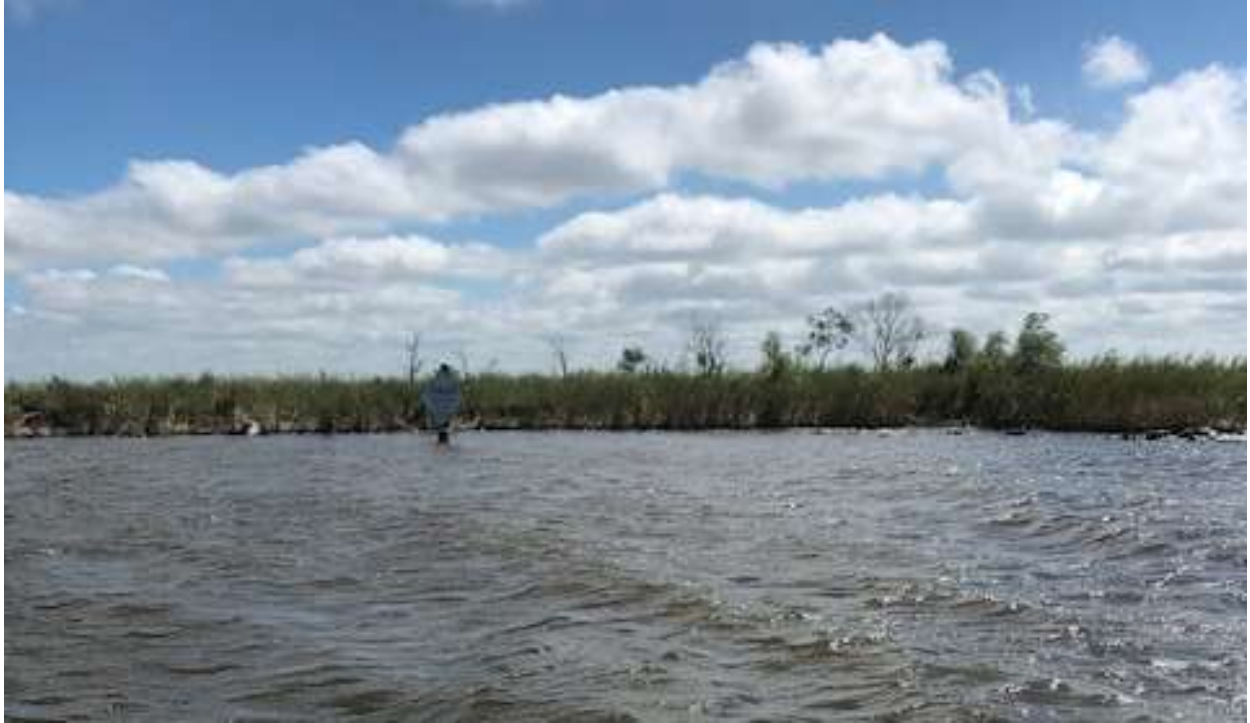
Photo No. 7. Post Hurricane Laura -Typical rock dike (2020)

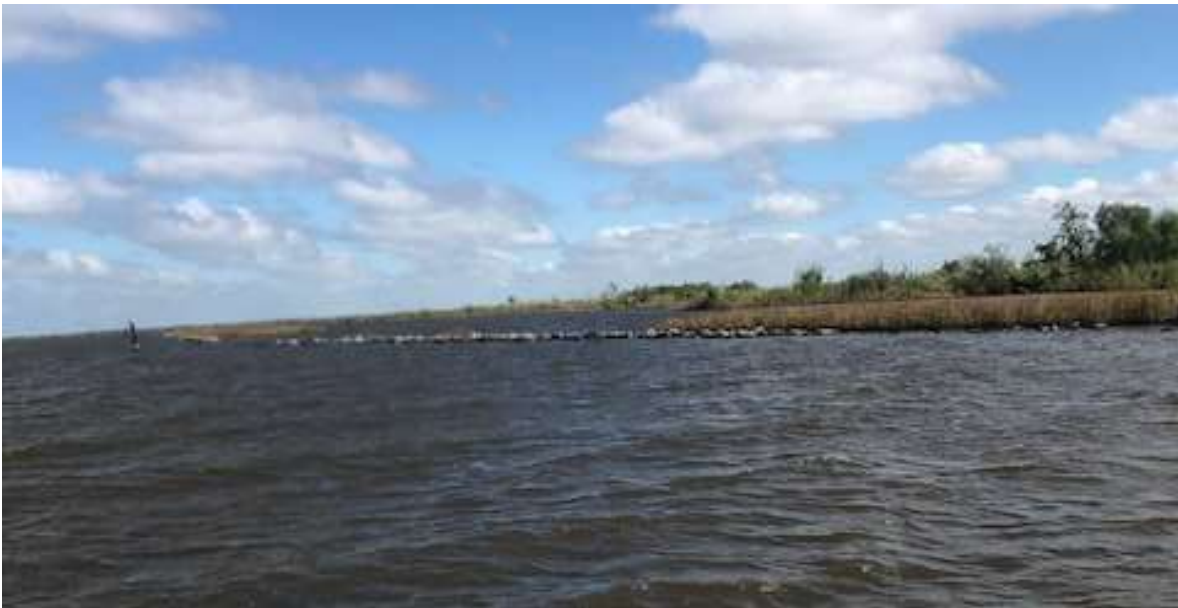
Photo No. 8. Post Hurricane Laura -Typical rock dike (2020)
