2024 Operations, Maintenance, and Monitoring Report

Grand-White Lake Land Bridge Protection

State Project Number ME-19
Priority Project List 10

February 2024
Cameron Parish

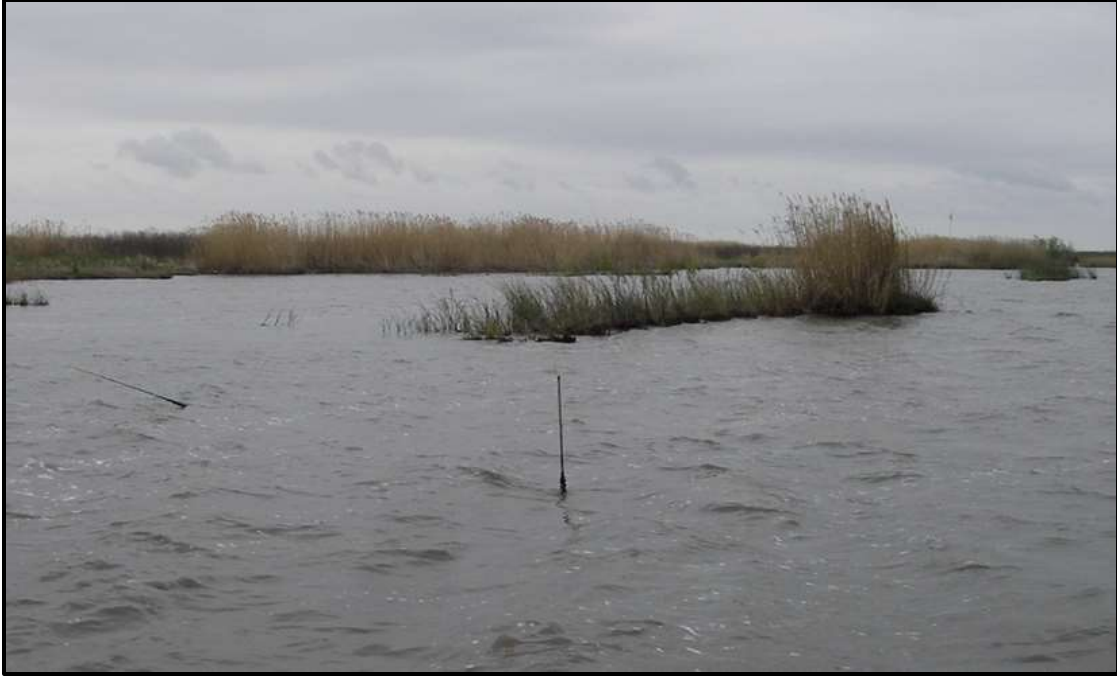
Figure 13. Many terraces have eroded since construction, especially the lakeside terraces (e.g. LS42) which were intended to be sacrificial and buffer the marsh side terraces. Note the cane poles that mark the original corners of the terrace. Picture was taken on March 24, 2010.

Armoring the lakeside slope of terraces along Collicon Lake should be considered to prevent future shoreline erosion.

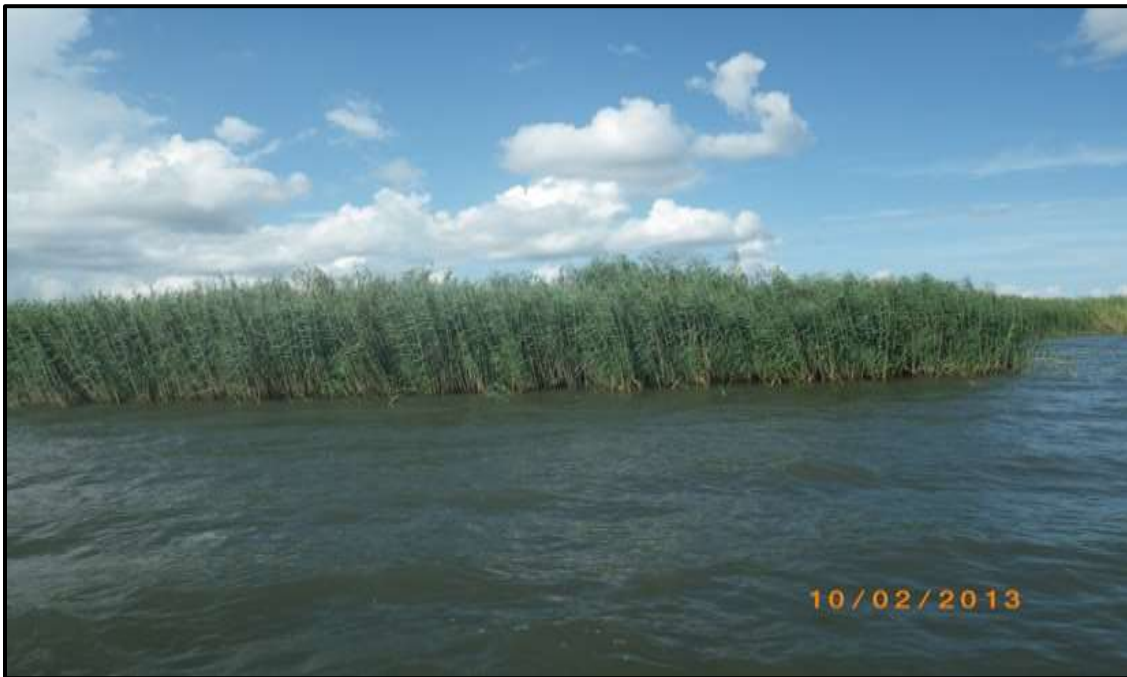
Figure 14. October 2, 2013 photograph of LS42 a lakeside terrace, depicting vegetation growth. Note the expansion of Roseau cane since the 2010 photography in comparison to Figure 12 above.

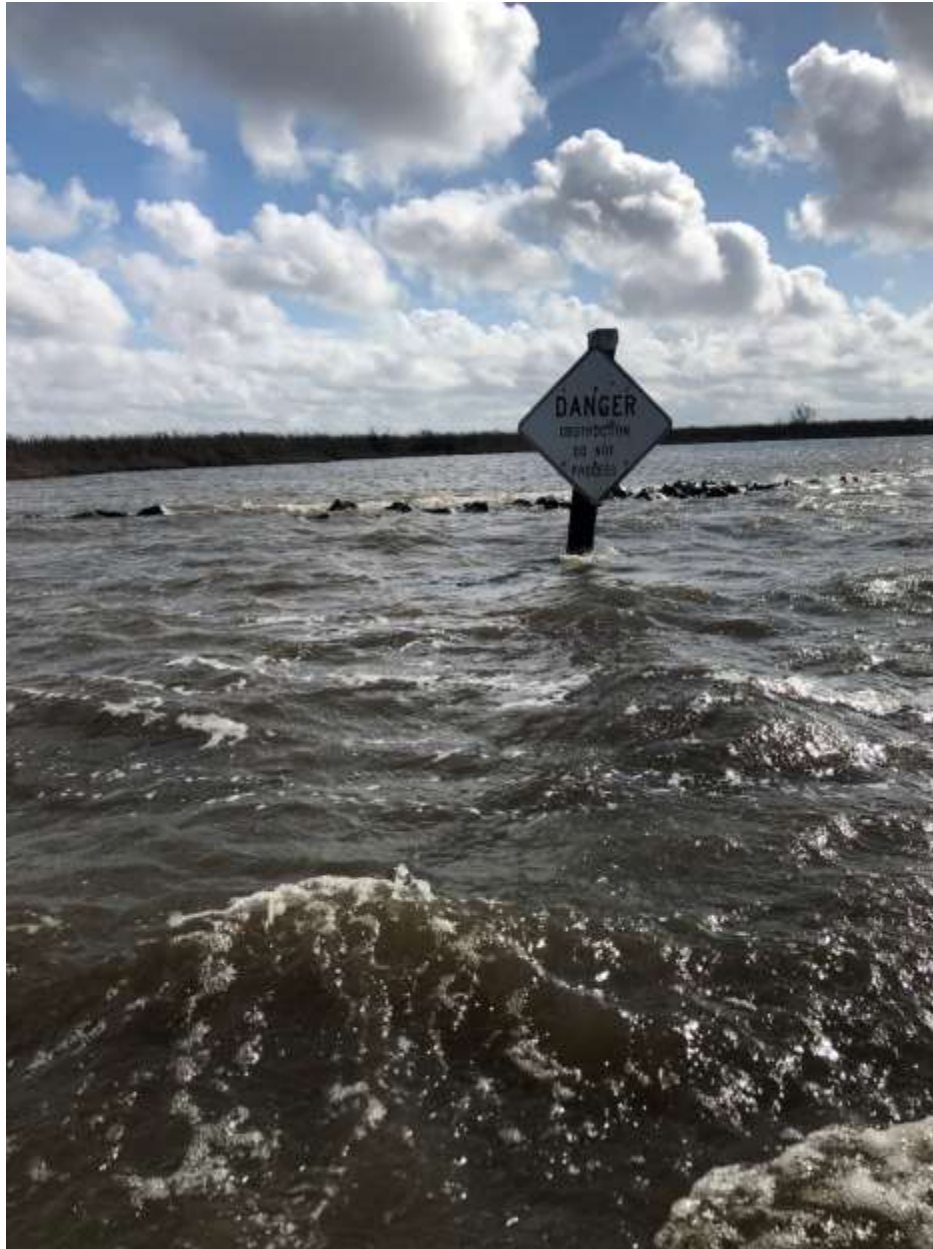
Foreshore Rock Dike and Warning Sign 2023 O&M Inspection
