**Coastal Protection and Restoration
Authority of Louisiana (CPRA)**

2024/2025 Annual Inspection Report

SOUTH WHITE LAKE SHORELINE PROTECTION

State Project Number ME-0022
Priority Project List #12

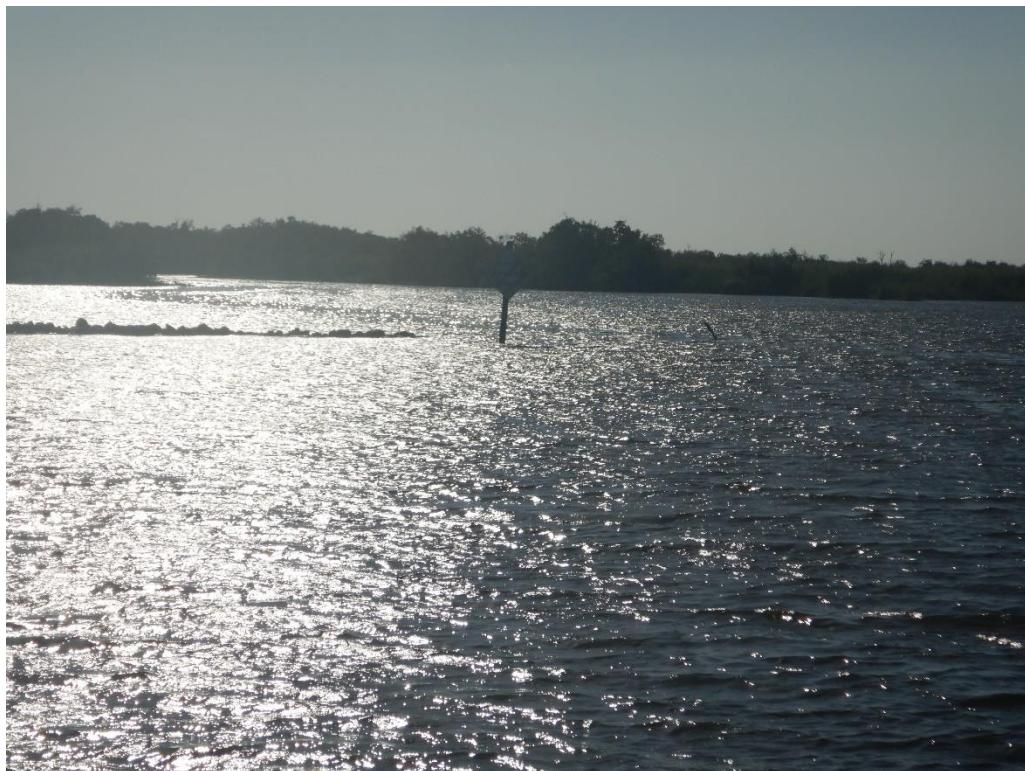
The rock breakwater feature appears to be functioning properly. During the inspection, only a small portion of the breakwater was encountered that appeared to indicate differential settlement, which occurred near fisheries access gaps. These areas appeared indicative of the natural slope down to lower fish access gap elevation, and could be analyzed more closely during future O&M if necessary. Most, if not all, signs were shown to indicate UV damage and

Photo 6: View of Possible Differential Settlement Near Warning Sign and Fisheries Access Gap, Possible Warning Sign Maintenance Needed, Facing West

As end-of-life approaches, a final O&M event is recommended which should incorporate signage maintenance as a focal point.

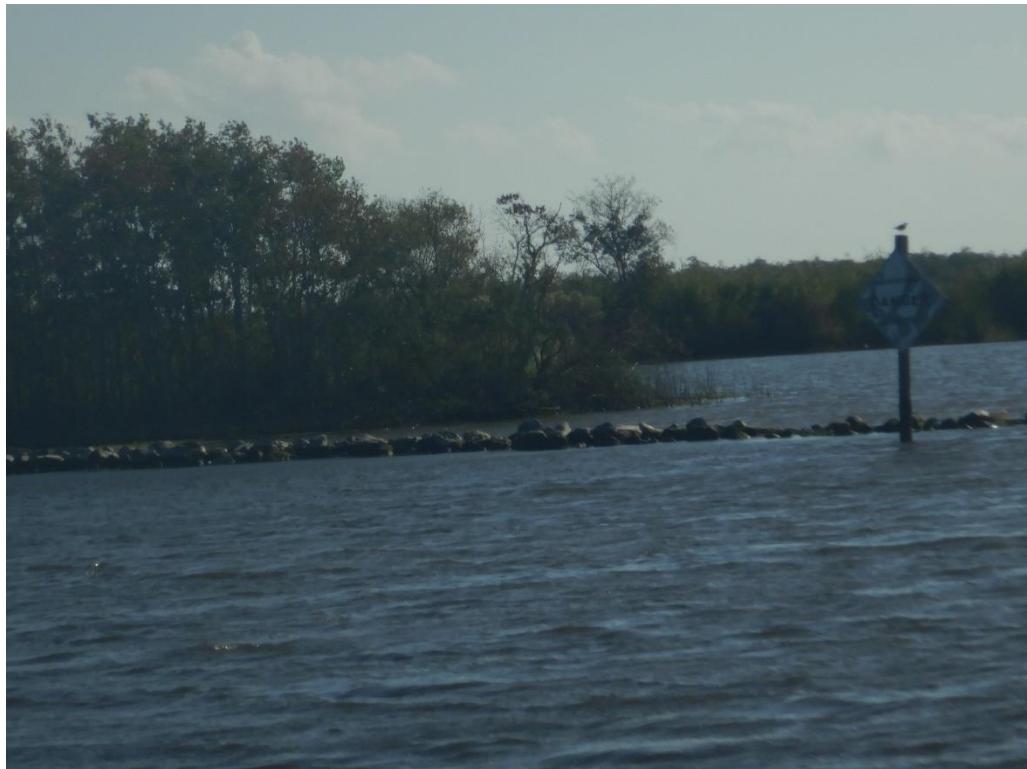
Photo 7: Photograph of Warning Sign, Warning Sign Maintenance Needed

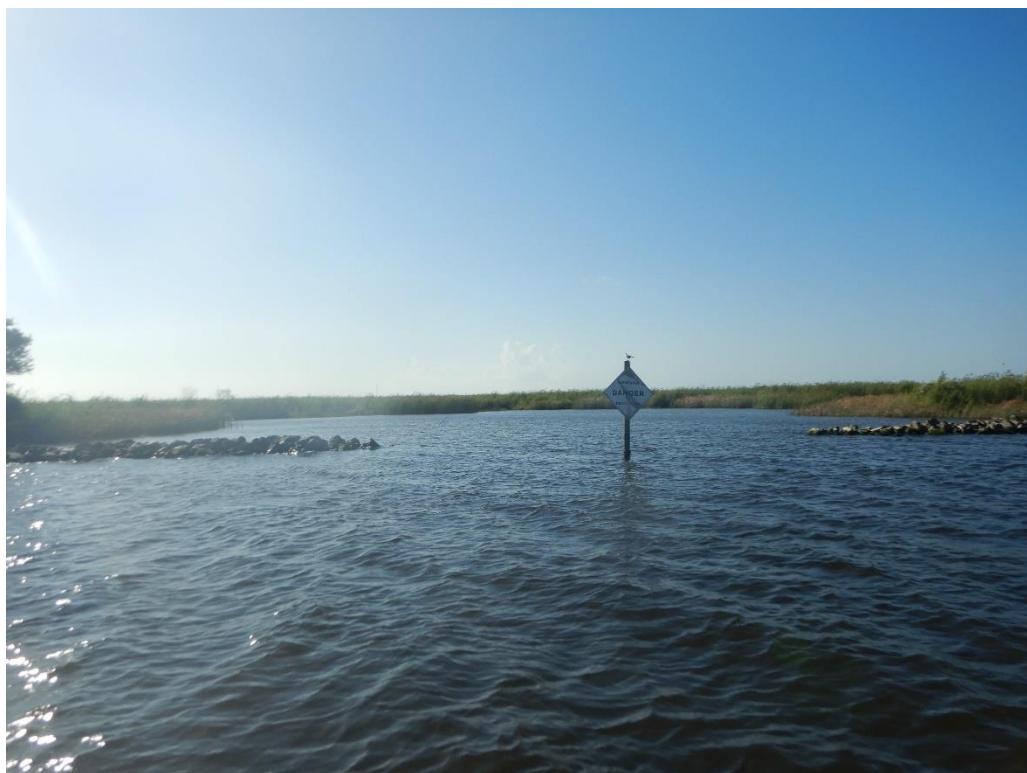
Photo 8: Photograph of ME-22 Rock Rip Rap Shoreline Protection Feature, Pictured Near Central Portion of Project Footprint, Warning Sign and Fisheries Access Gap Shown, Warning Sign Maintenance Needed, Facing South

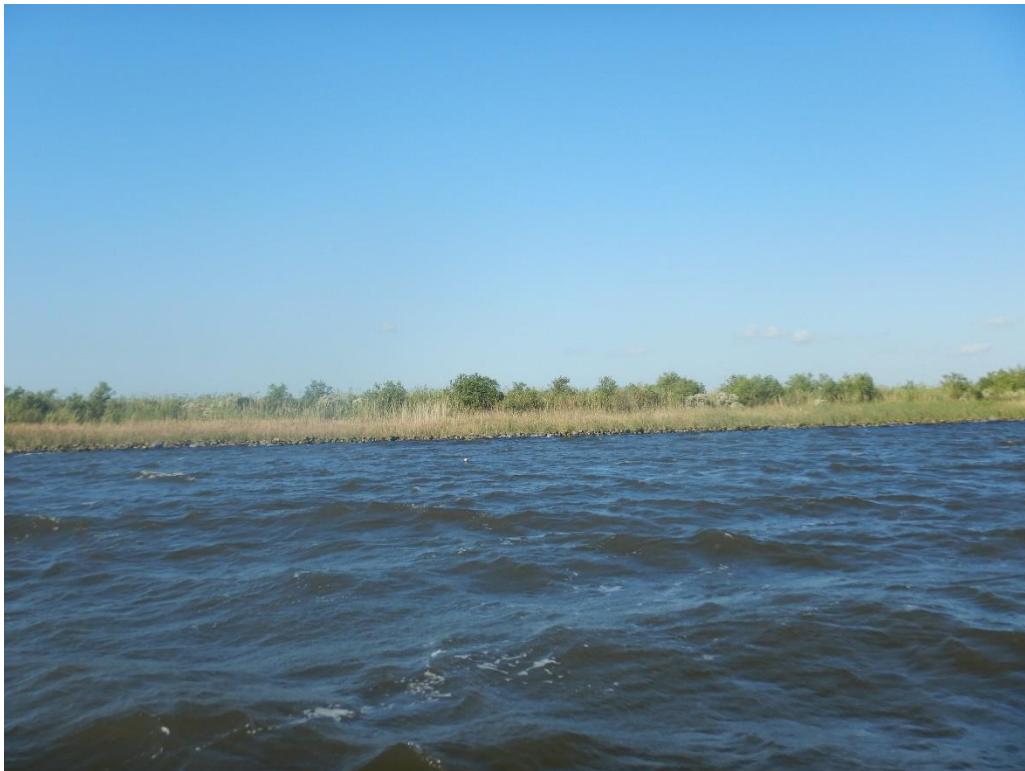
Photo 11: View of ME-22 Rock Rip Rap Shoreline Protection Feature, Emphasizing Marsh Environment Behind and Likely Indicative of Accretionary Processes, Facing South

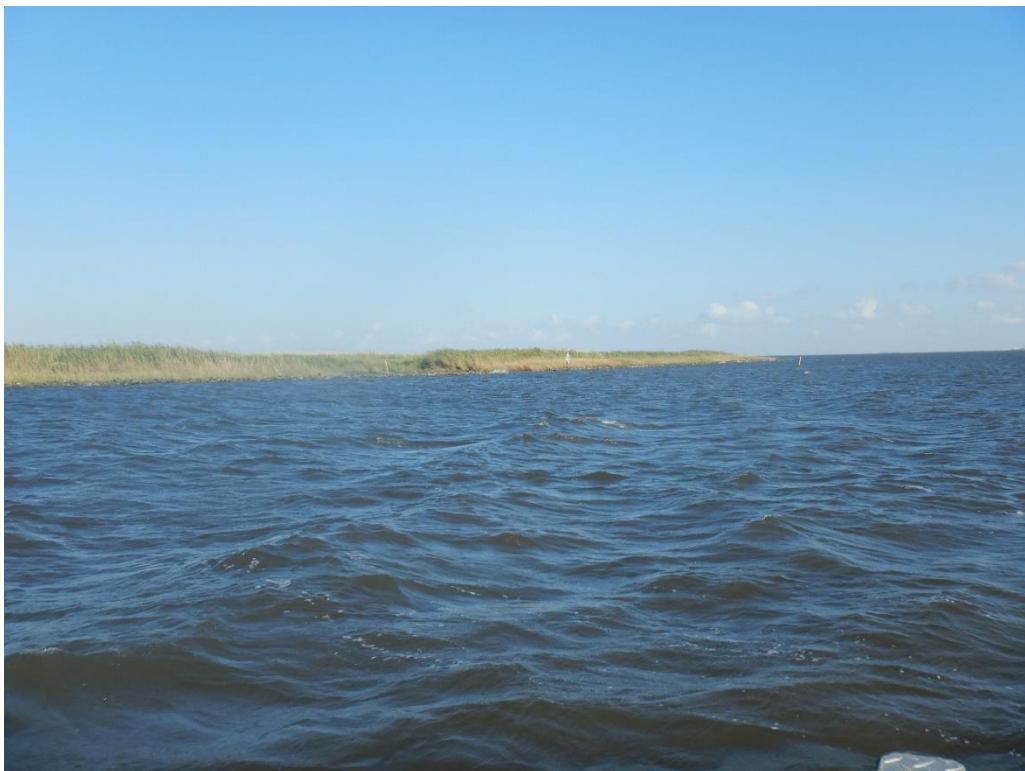
Photo 12: View of ME-22 Rock Rip Rap Shoreline Protection Feature, Emphasizing Marsh Environment Behind and Likely Indicative of Accretionary Processes, Facing Southwest

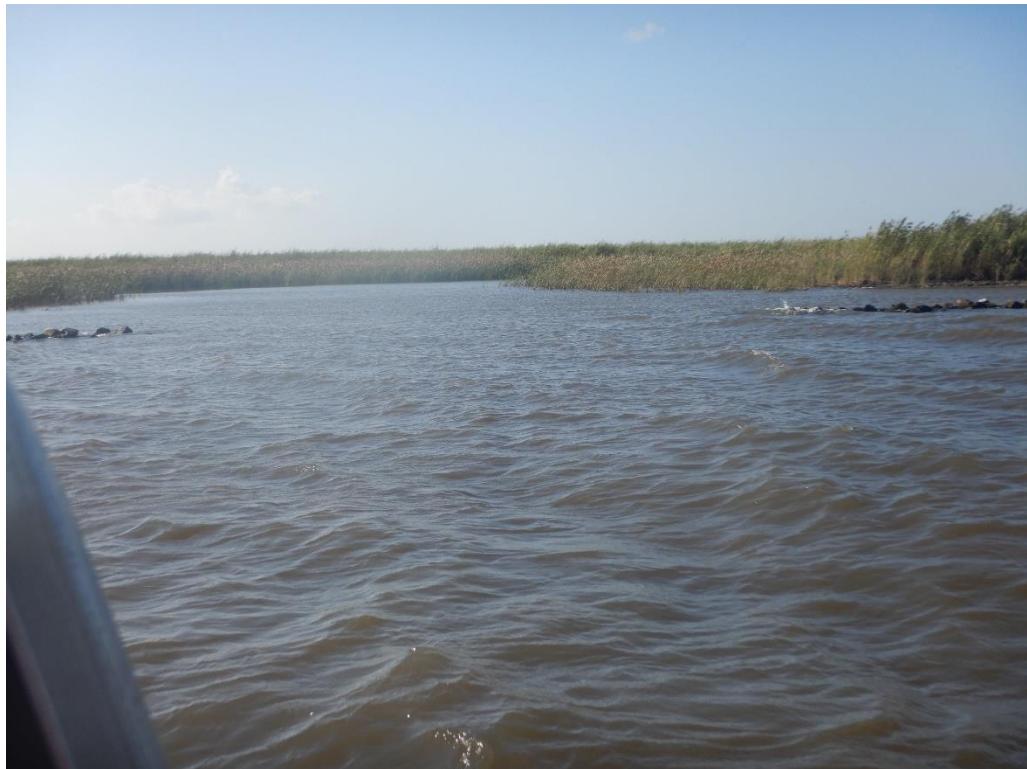
are recommended for replacement. There were six noted locations where signs and piles were missing entirely, possibly indicative of the piling having been snapped at the mudline or otherwise broken. Signage is recommended to be addressed in a final O&M event. **APPENDIX B** shows photographs, with some photographs emphasizing observed differential settlement. **APPENDIX D** contains a figure showing the locations of missing signage issues at ME-0022.

Photo 13: View of Possible Differential Settlement Near Warning Sign and Fisheries Access Gap, Warning Sign Missing with Warning Sign Maintenance Needed, Facing Southeast

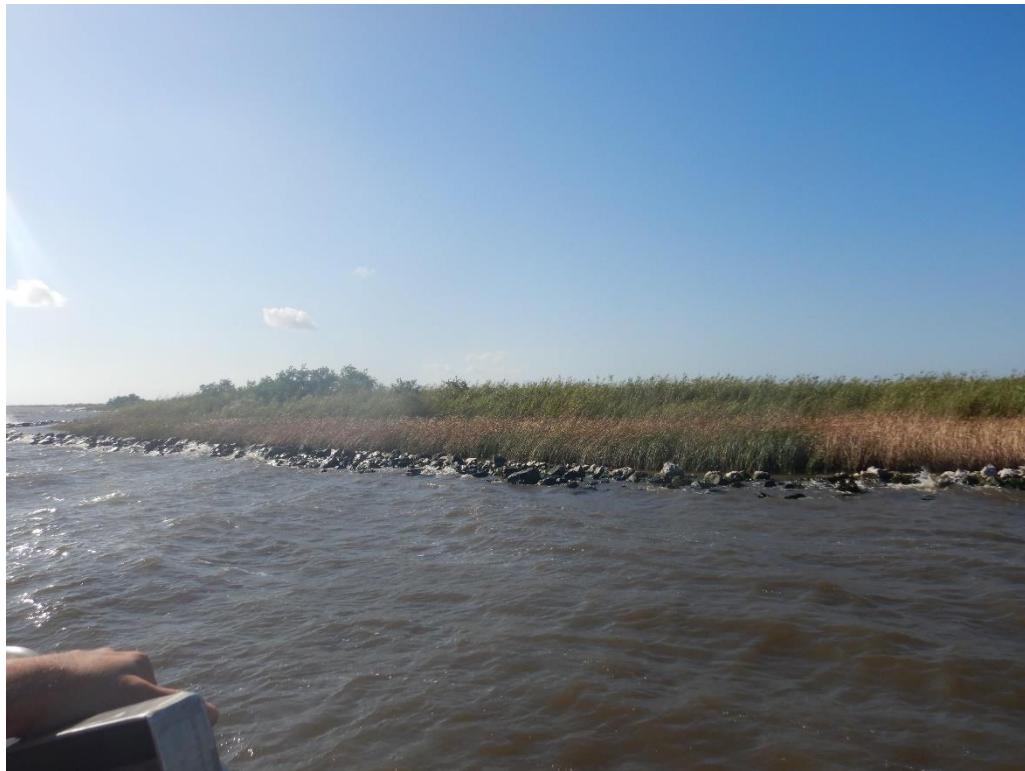
Photo 15: View of ME-22 Rock Rip Rap Shoreline Protection Feature, Emphasizing Marsh Environment Behind and Likely Indicative of Accretionary Processes, Facing South
