**State of Louisiana
Coastal Protection and Restoration
Authority**

2018 Operations, Maintenance, and Monitoring Report

Delta Wide Crevasses (MR-09)

State Project Number MR-09
Priority Project List 6

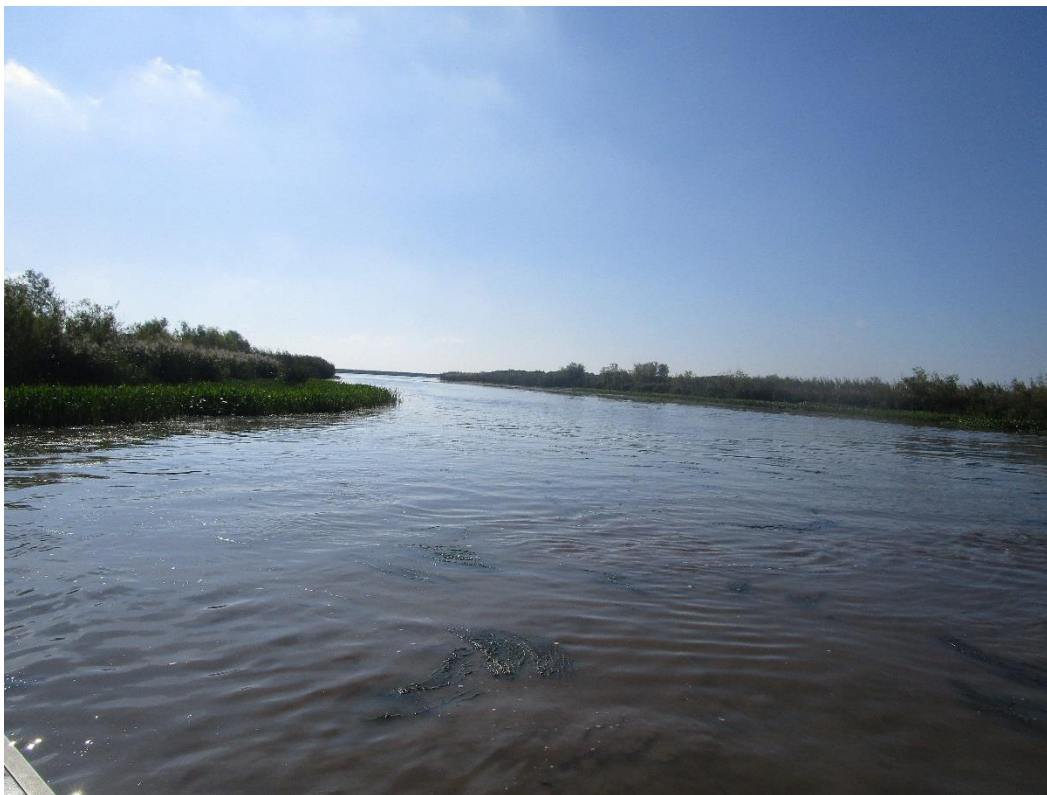
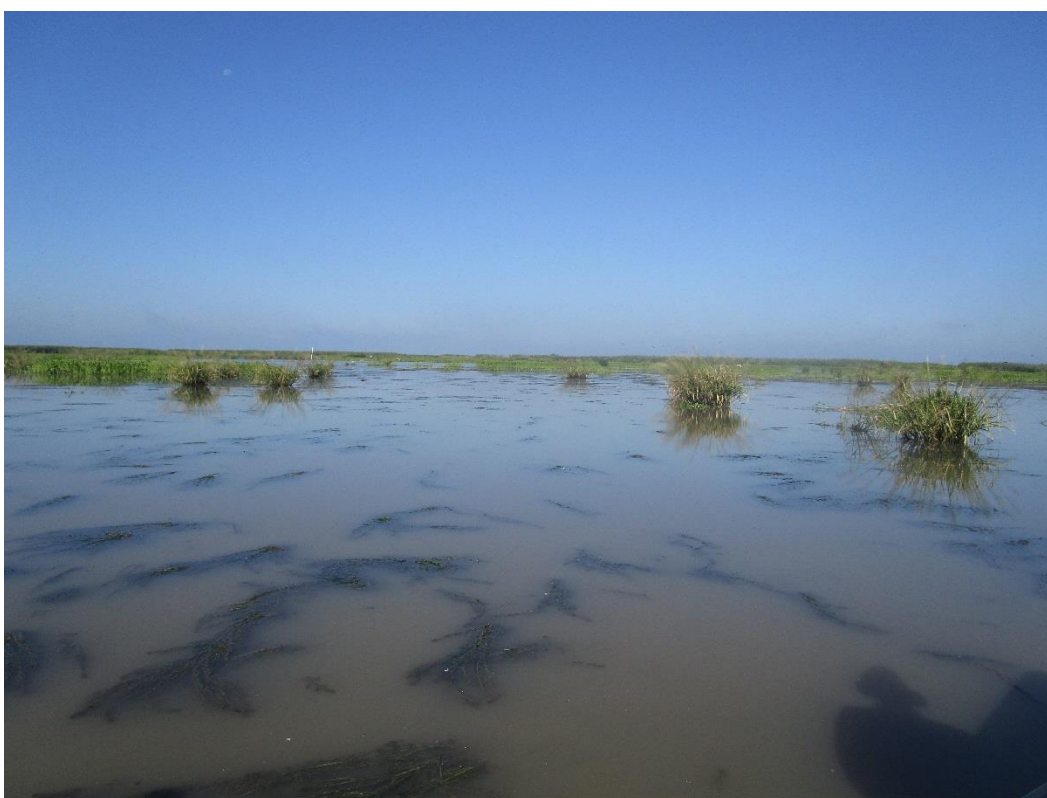
- Crevasse MP-1 (dredged): (1,000 ft. X 100 ft. X -10.0 ft. NAVD 88 as constructed) This crevasse is located on Main Pass at N29 deg 15 min 40.9 sec; W089 deg 13 min 52.5 sec. The spoil areas on each bank were well vegetated. The channel, based on spot-checked sounding of 4' appeared to retain some of its originally dredged depth and was adequate to continue carrying sediment to the receiving area.
- Crevasse MP-3 (dredged): (1,000 ft. X 100 ft. X -10.0 ft. NAVD 88 as constructed) This crevasse is located on Main Pass at N29 deg 14 min 29.8 sec;

Crevasse MP-1 (View 1)

Crevasse MP-1 (View 2)

As a result of the inspection, the team concluded that all project features are functioning and should continue to do so without any immediate maintenance.

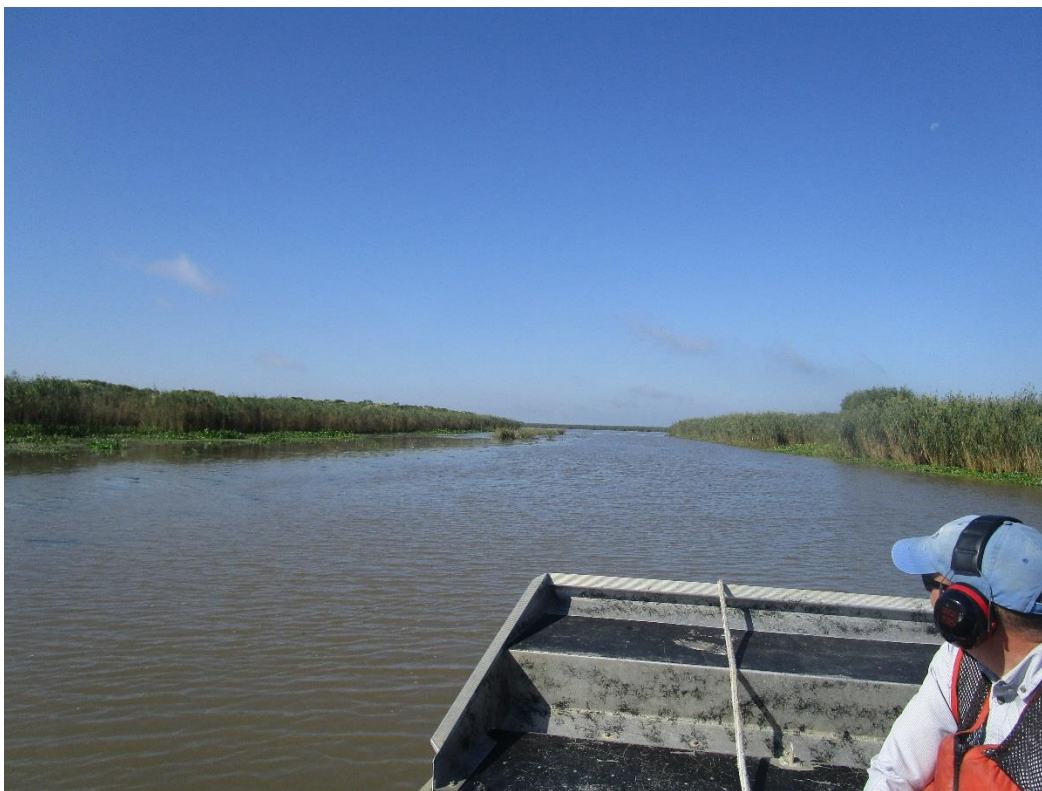
Crevasse MP-3

W089 deg 14 min 19.6 sec. The spoil areas on each bank were well vegetated. The channel, based on spot-checked soundings of 6' to 7' near the mouth and 4' thereafter, appeared to retain most of its originally dredged depth and was adequate to carry sediment to the receiving area.

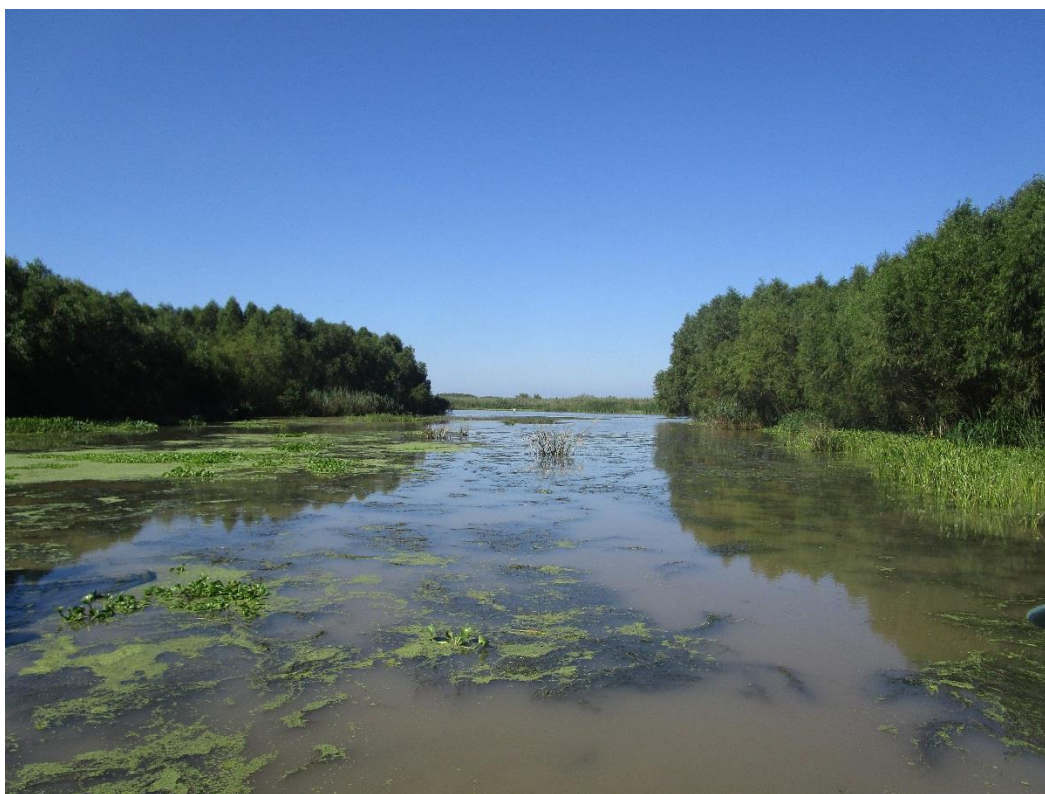
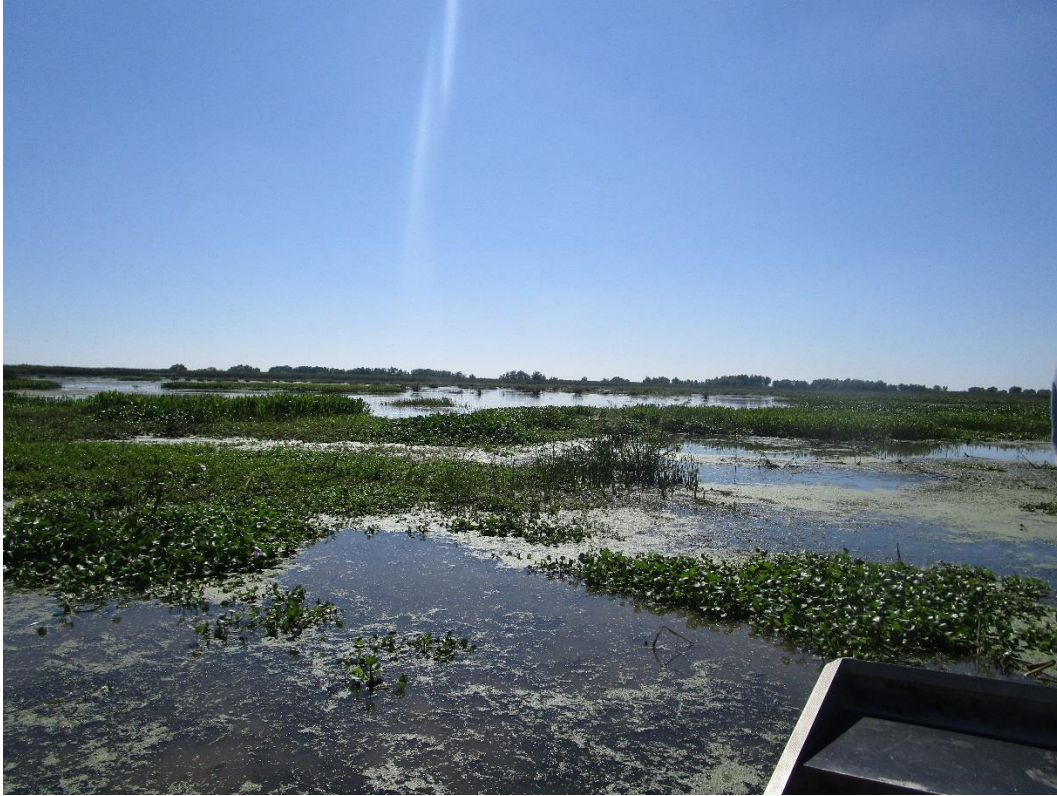
- iii. Crevasse OP-4 (dredged): (400 ft. X 100 ft. X -8.0 ft. NAVD 88 as constructed) This crevasse is located on Octave Pass at N29 deg 12 min 18.7 sec; W089 deg 14 min 0.3 sec. The spoil areas on each bank were well vegetated. The channel, based on spot-checked soundings of 4', appeared to retain some of its originally dredged depth and was adequate to continue carrying sediment to the receiving area.

Crevasse OP-4 (View 1)

Crevasse OP-4 (View 2)

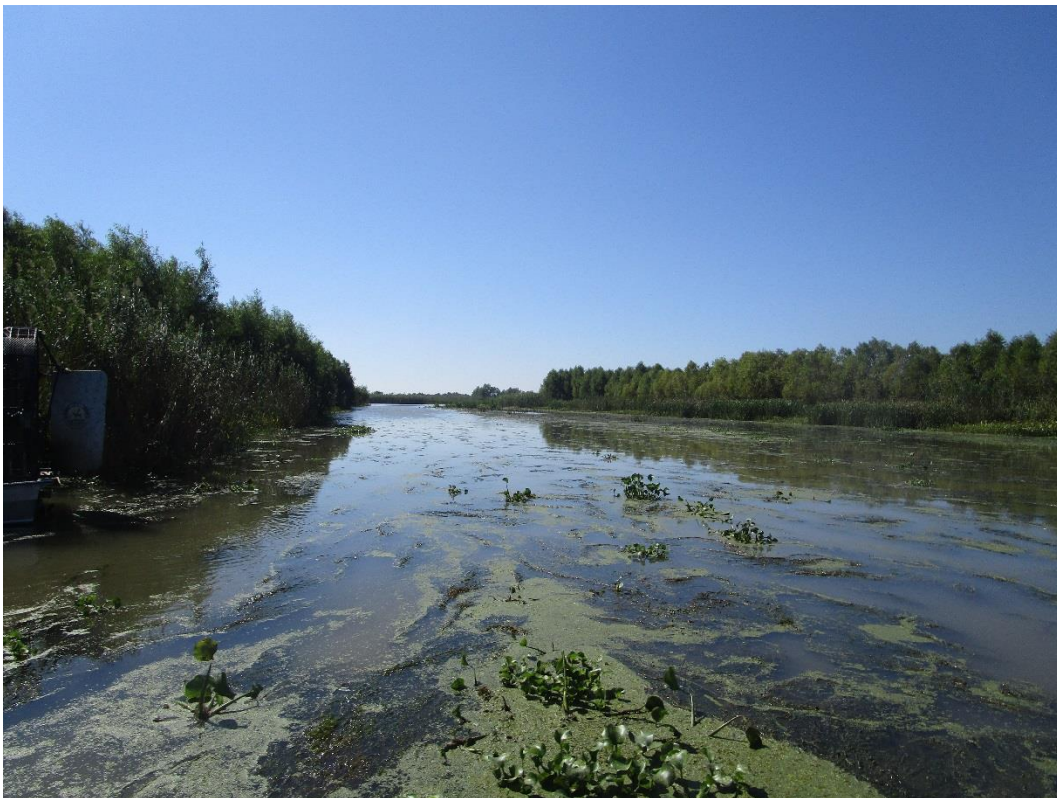
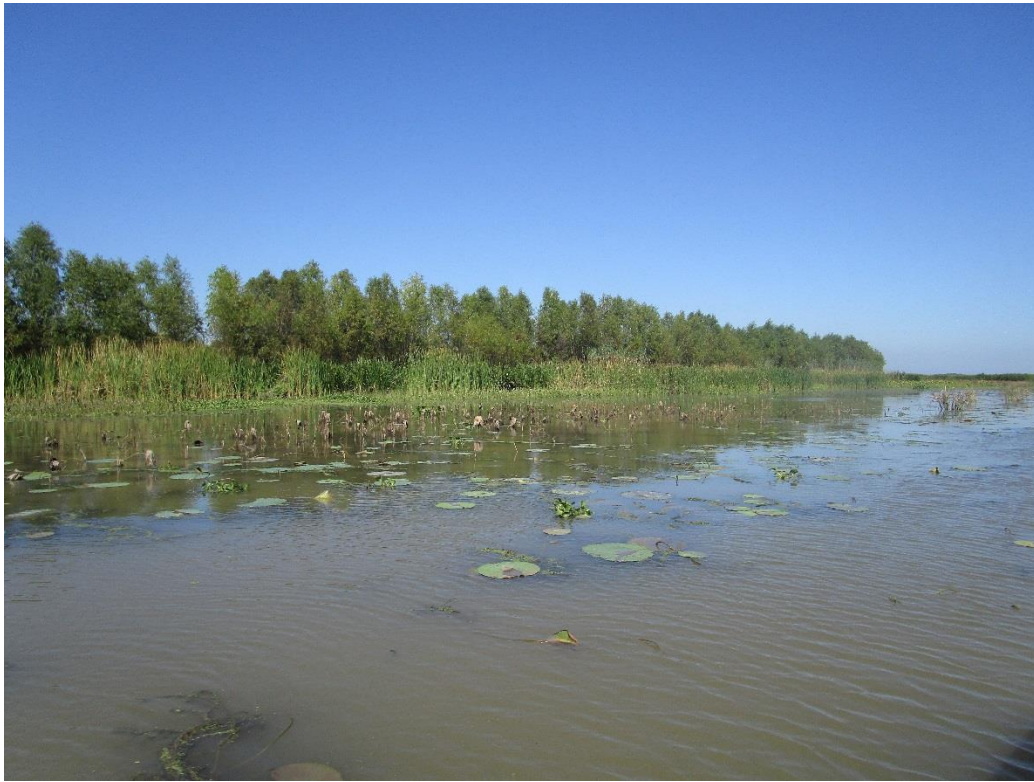
- iv. Crevasse OP-5 (dredged): (840 ft. X 100 ft. X -8.0 ft. NAVD 88 as constructed) This crevasse is located on Octave Pass at N29 deg 12 min 4.4 sec; W089 deg 15 min 2.5 sec. The spoil areas on each bank were well vegetated. The channel, although not sounded, appeared to retain most of its originally dredged depth and was adequate to carry sediment to the receiving area.

Crevasse OP-5 (View 1)

Crevasse OP-5 (View 2)

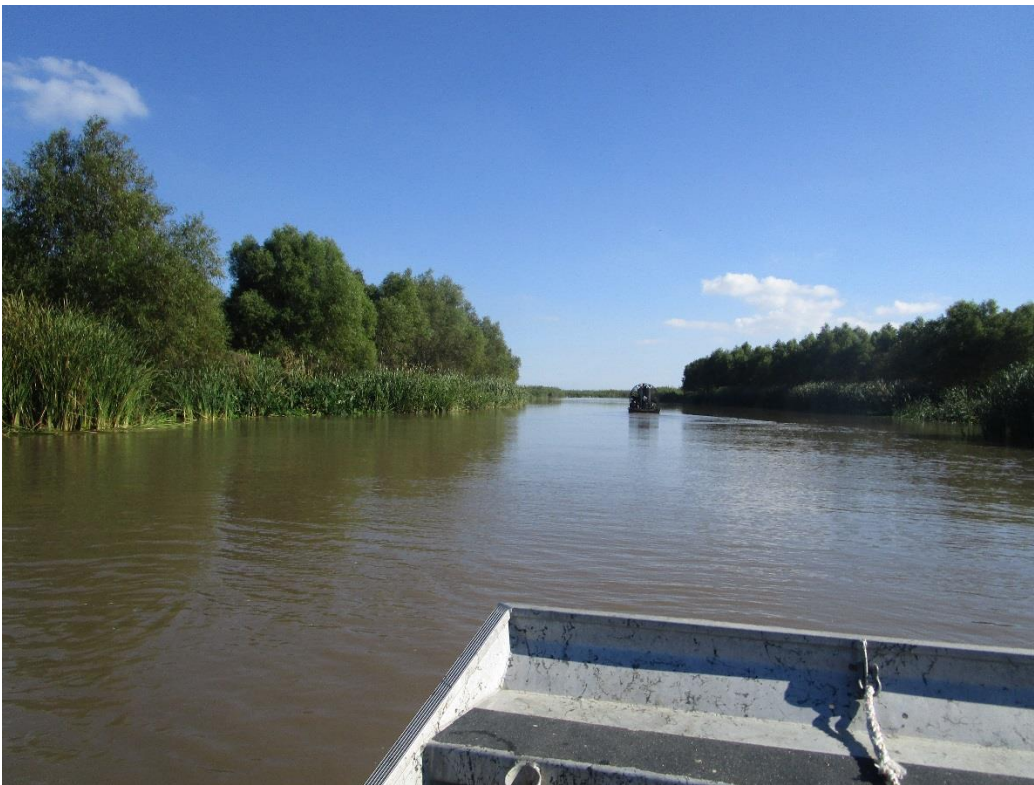
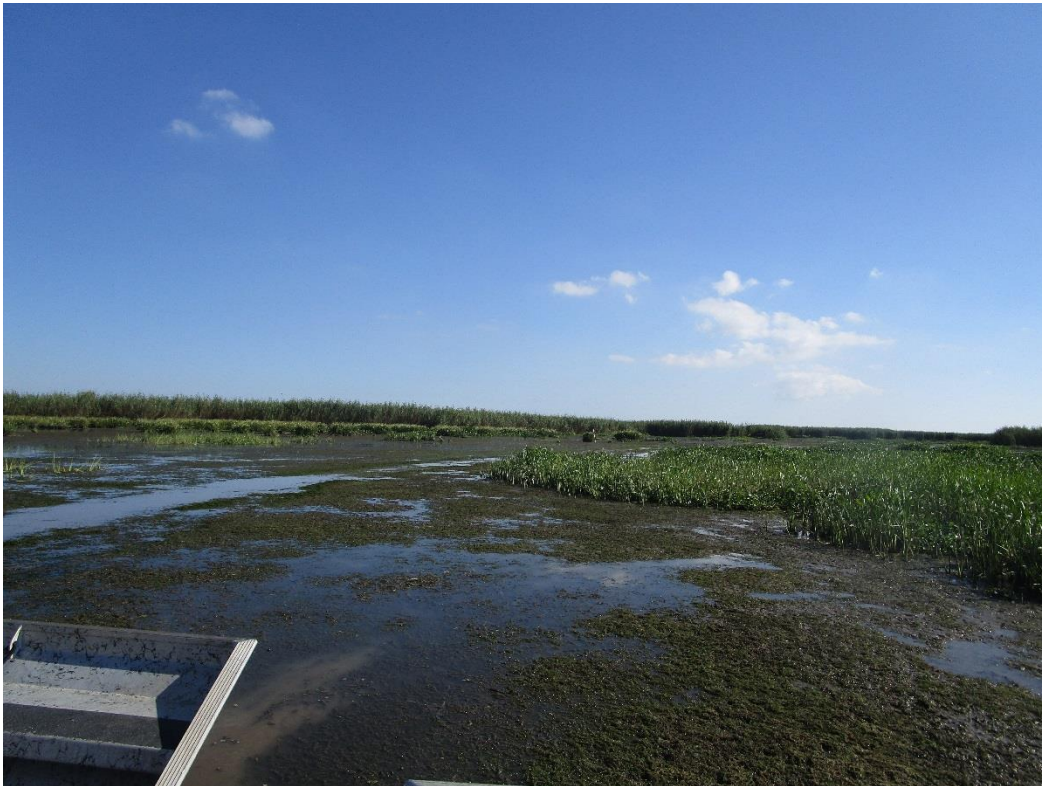
- v. Johnson Pass Crevasse (Maintenance Dredged): (1,200 ft. X 75 ft. X -8.0 ft. NAVD 88 as constructed) This existing crevasse is located on Johnson Pass at N29 deg 7 min 36.3 sec; W089 deg 12 min 30.1 sec. The spoil areas on each bank were well vegetated. The channel, based on spot-checked soundings of 8', appeared to retain most of its originally dredged depth and was adequate to carry sediment to the receiving area.

Johnson Pass Crevasse (View 1)

Johnson Pass Crevasse (View 2)

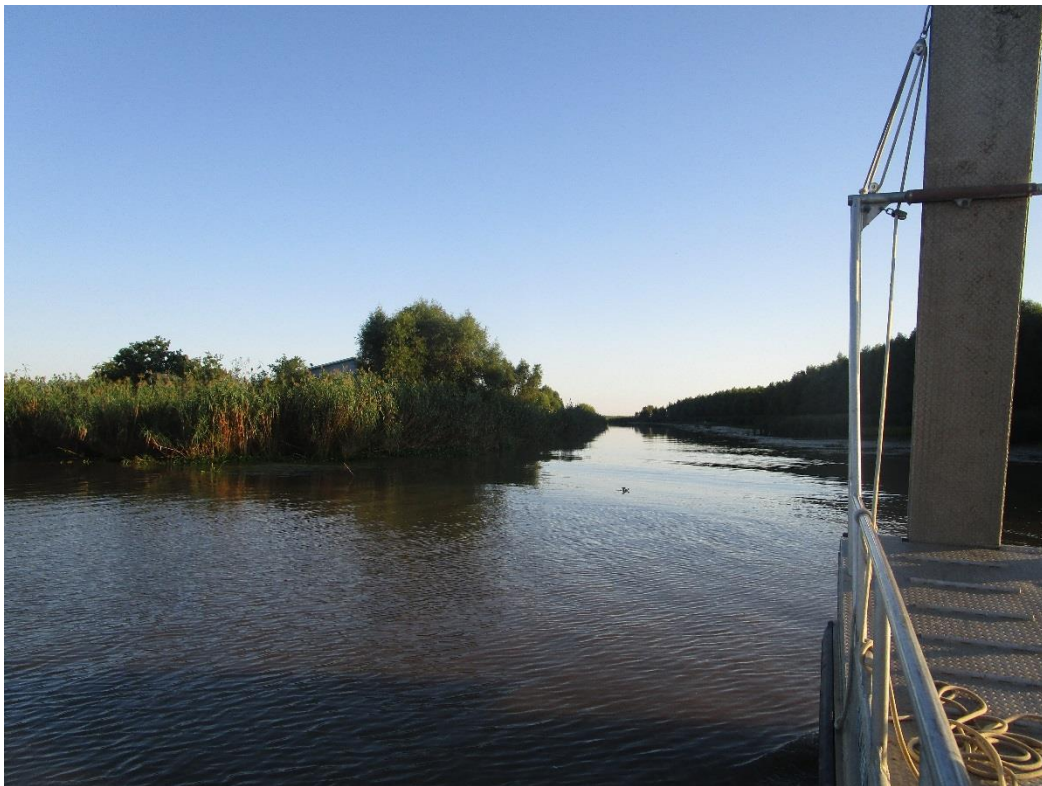
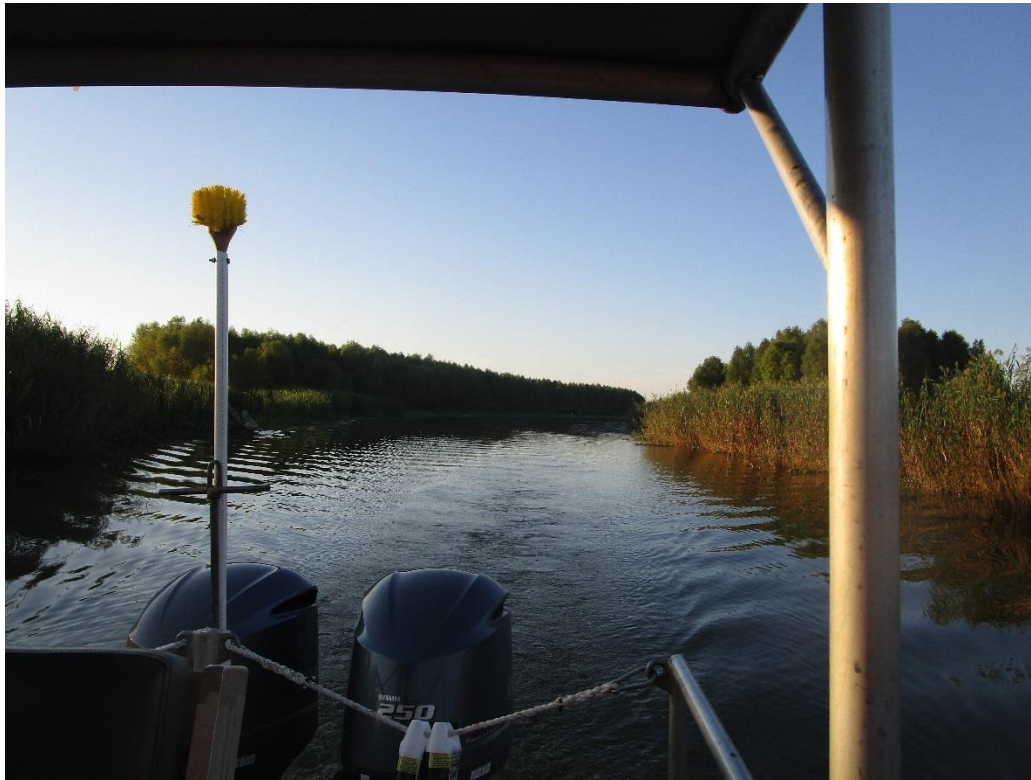
- vi. Sawdust Bend Crevasse (i.e. Crevasse 6; Maintenance Dredged): (1,550 ft. X 75 ft. X -8.0 ft. NAVD 88 as constructed) This existing crevasse is located on Sawdust Bend at N29 deg 8 min 17.8 sec; W089 deg 13 min 33.3 sec. The spoil areas on each bank were well vegetated. The channel, based on spot-checked soundings of 5' near the mouth and 6' to 7' thereafter, appeared to retain most of its originally dredged depth and was adequate to carry sediment to the receiving area.

Sawdust Bend Crevasse (View 1)

Sawdust Bend Crevasse (View 2)

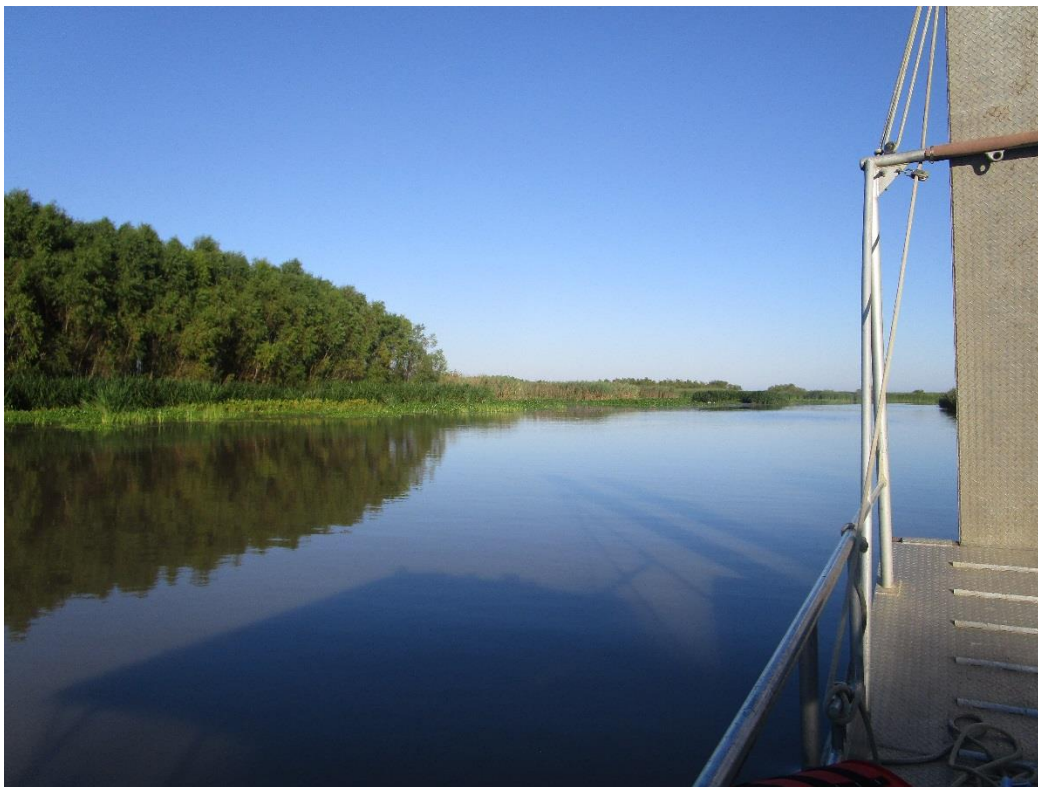
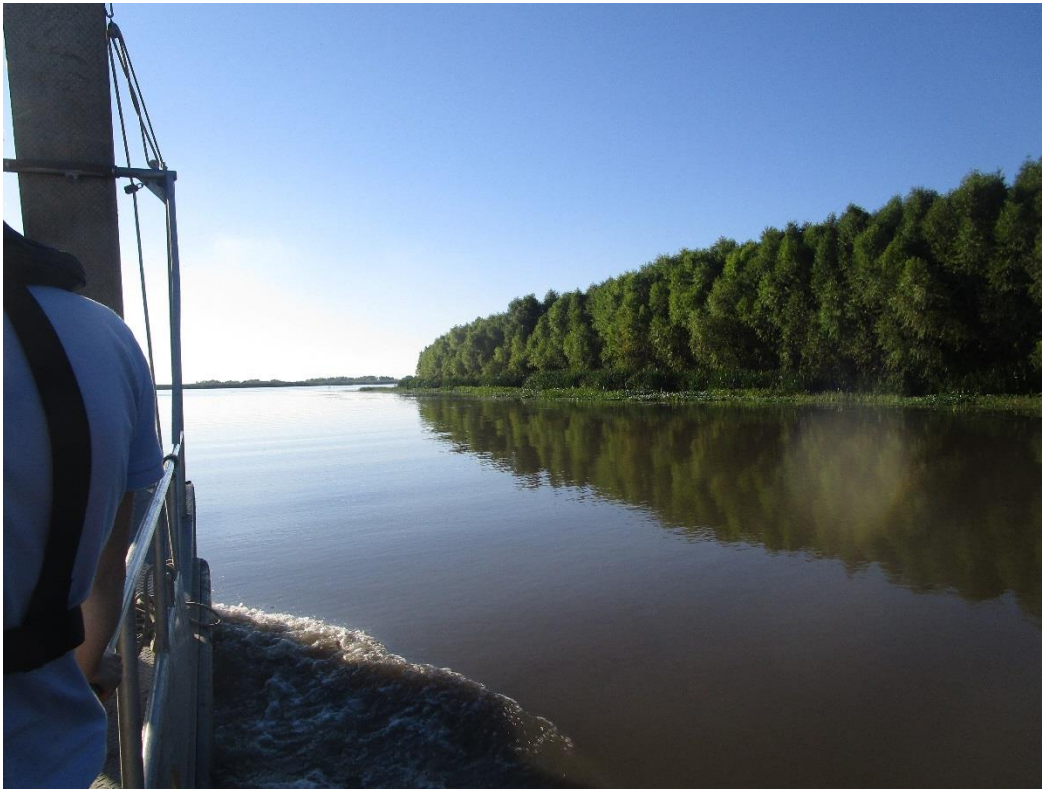
- vii. South Pass Crevasse (Maintenance Dredged): (1,000 ft. X 100 ft. X -8.0 ft. NAVD 88 as constructed) This existing crevasse is located on South Pass at N29 deg 6 min 20.2 sec; W089 deg 14 min 5.9 sec. The spoil areas on each bank were well vegetated. The channel, based on spot-checked soundings of 5' to 7' near the mouth and 6' to 7' thereafter, appeared to retain most of its originally dredged depth and was adequate to carry sediment to the receiving area.

South Pass Crevasse (View 1)

South Pass Crevasse (View 2)
