**State of Louisiana
Coastal Protection and Restoration Authority**

2018 Annual Inspection Report

**DELTA WIDE CREVASSES
(MR-09)**

State Project Number MR-09
Priority Project List 6

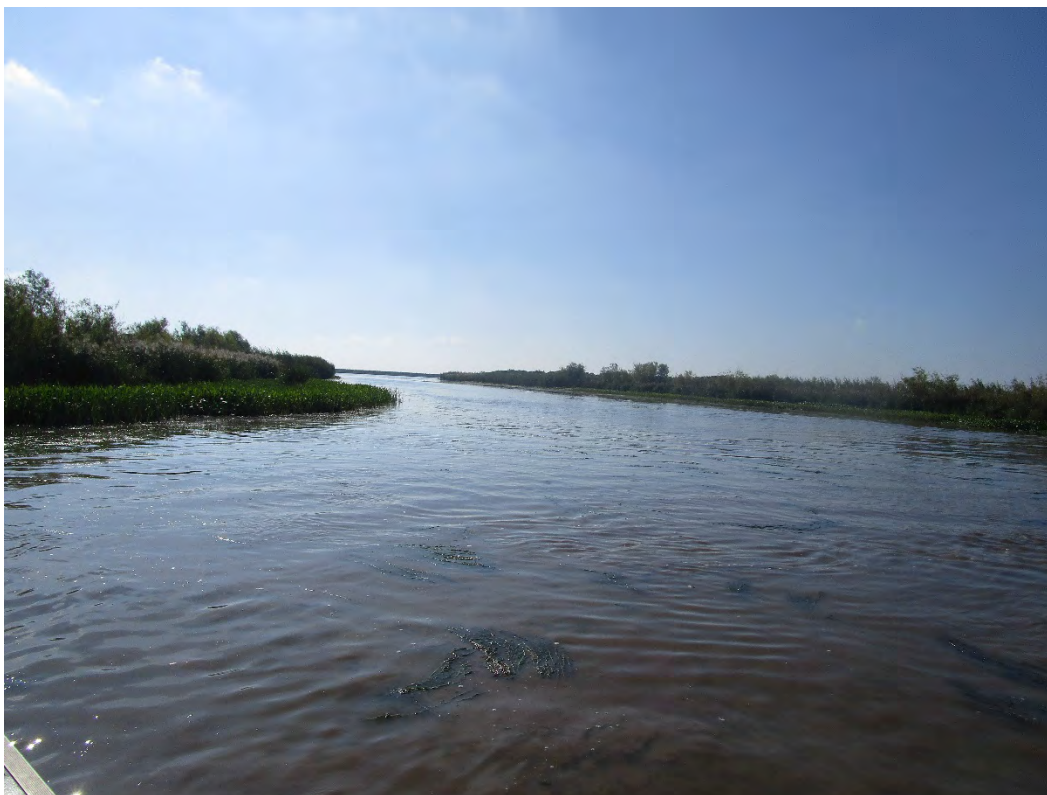
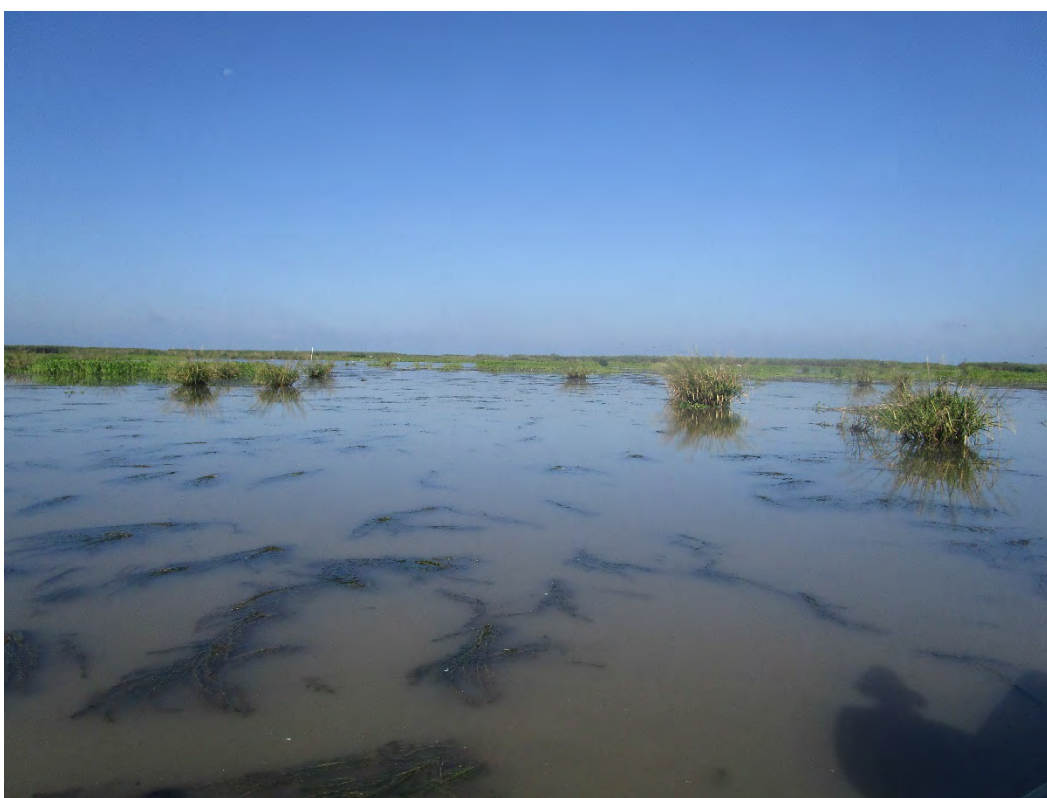
Crevasse No. MP-1 (View 1)

- A. Crevasse No. MP-1 (dredged): (1,000 ft. X 100 ft. X -10.0 ft. NAVD 88 as constructed) This crevasse is located on Main Pass at N29 deg 15 min 40.9 sec; W 089deg 13 sec 52.5 min. The spoil areas on each bank were well vegetated. The depth, based on spot-checked sounding of 4’ appeared to retain some of its originally dredged depth and was adequate to continue carrying sediment to the receiving area.

Item	Condition	Physical Damage	Dimensions	Photo	Observations and Remarks
Crevasse # MP-1	Good	None	1,000 ft X 100 ft by -10.0' NAVD 88	Appendix B	This crevasse is located on Main Pass at N29 deg 15 min 40.9 sec; W 089deg 13 sec 52.5 min. The spoil areas on each bank were well vegetated. The depth, based on spot-checked sounding of 4' appeared to retain some of its originally dredged depth and was adequate to carry sediment to the receiving area.
Crevasse # MP-3	Good	None	1,000 ft X 100 ft by -10.0' NAVD 88	Appendix B	This crevasse is located on Main Pass at N29 deg 14 min 29.8 sec; W 089 deg 14 sec 19.6 min. The spoil areas on each bank were well vegetated. The depth, based on spot-checked soundings of 6' to 7' near the mouth and 4' thereafter, appeared to retain most of its originally dredged depth and was adequate to carry sediment to the receiving area.
Crevasse # OP-4	Good	None	400 ft X 100 ft by -8.0' NAVD 88	Appendix B	This crevasse is located on Octave Pass at N29 deg 12 min 18.7 sec; W 089 deg 14 sec 0.3 min. The spoil areas on each bank were well vegetated. The depth, based on spot-checked soundings of 4', appeared to retain some of its originally dredged depth and was adequate to carry sediment to the receiving area.

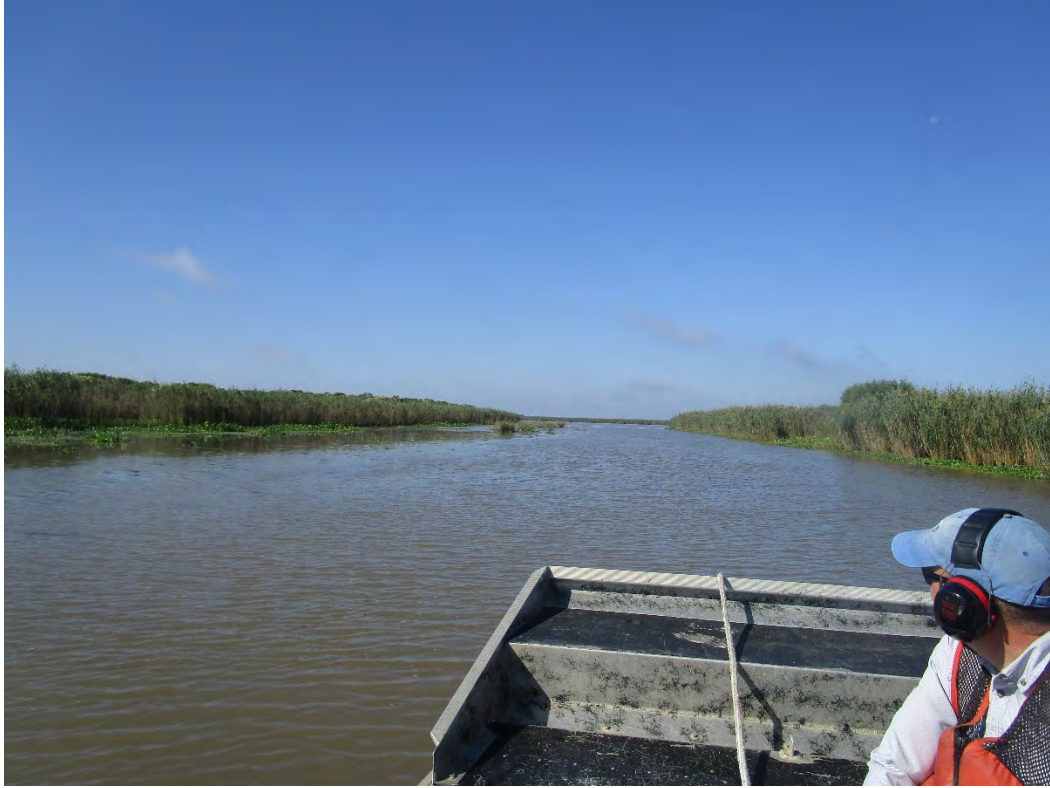
- B. Crevasse No. MP-3 (dredged): (1,000 ft. X 100 ft. X -10.0 ft. NAVD 88 as constructed) This crevasse is located on Main Pass at N29 deg 14 min 29.8 sec; W 089 deg 14 sec 19.6 min. The spoil areas on each bank were well vegetated. The depth, based on spot-checked soundings of 6’ to 7’ near the mouth and 4’ thereafter, appeared to retain most of its originally dredged depth and was adequate to carry sediment to the receiving area.

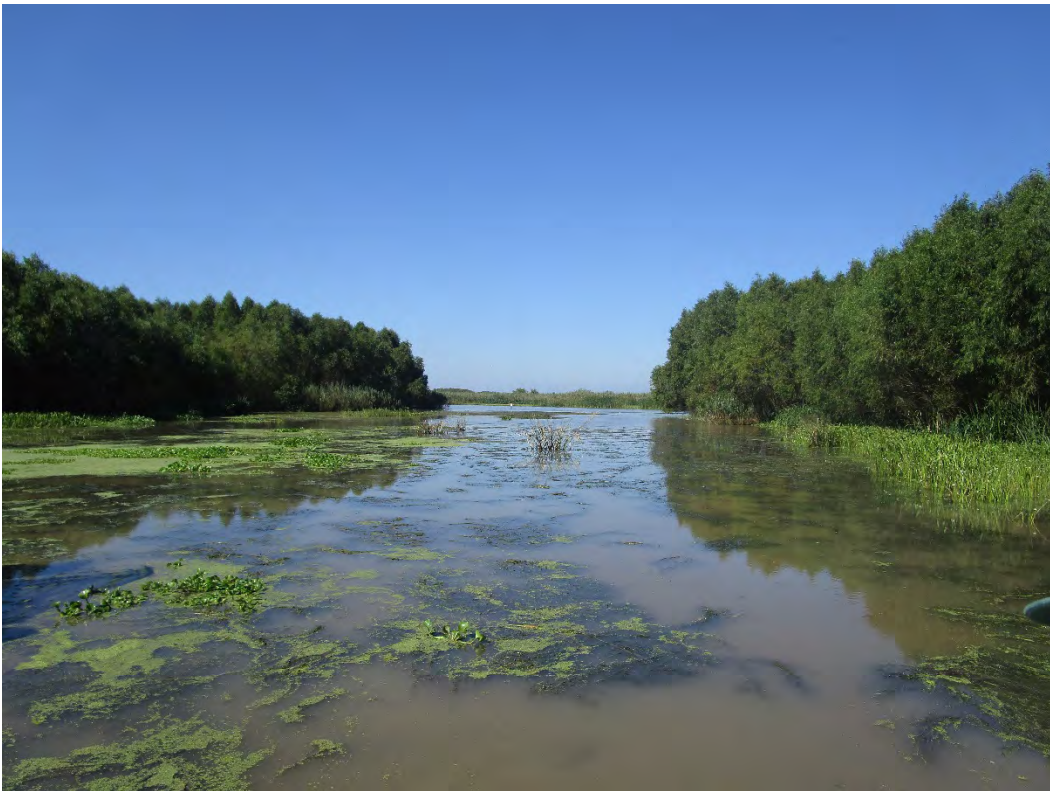
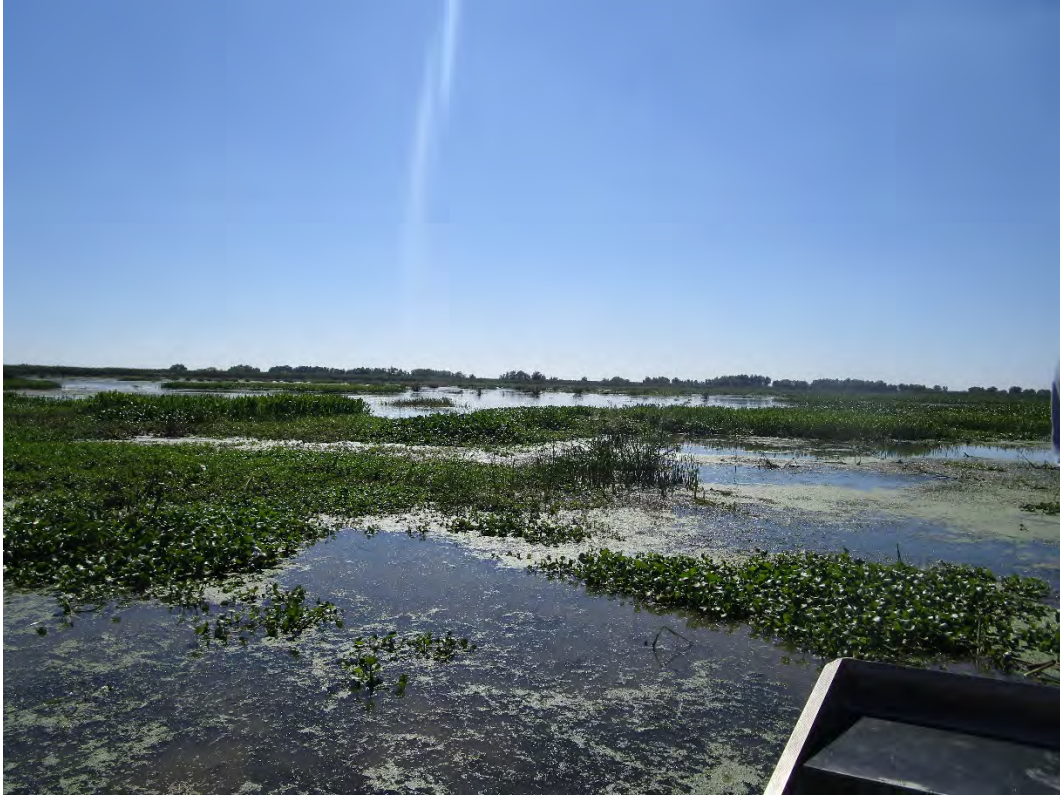
Crevasse No. OP-4 (View 1)

- C. Crevasse OP-4 (dredged): (400 ft. X 100 ft. X -8.0 ft. NAVD 88 as constructed) This crevasse is located on Octave Pass at N29 deg 12 min 18.7 sec; W 089 deg 14 sec 0.3 min. The spoil areas on each bank were well vegetated. The depth, based on spot-checked soundings of 4’, appeared to retain some of its originally dredged depth and was adequate to continue carrying sediment to the receiving area.

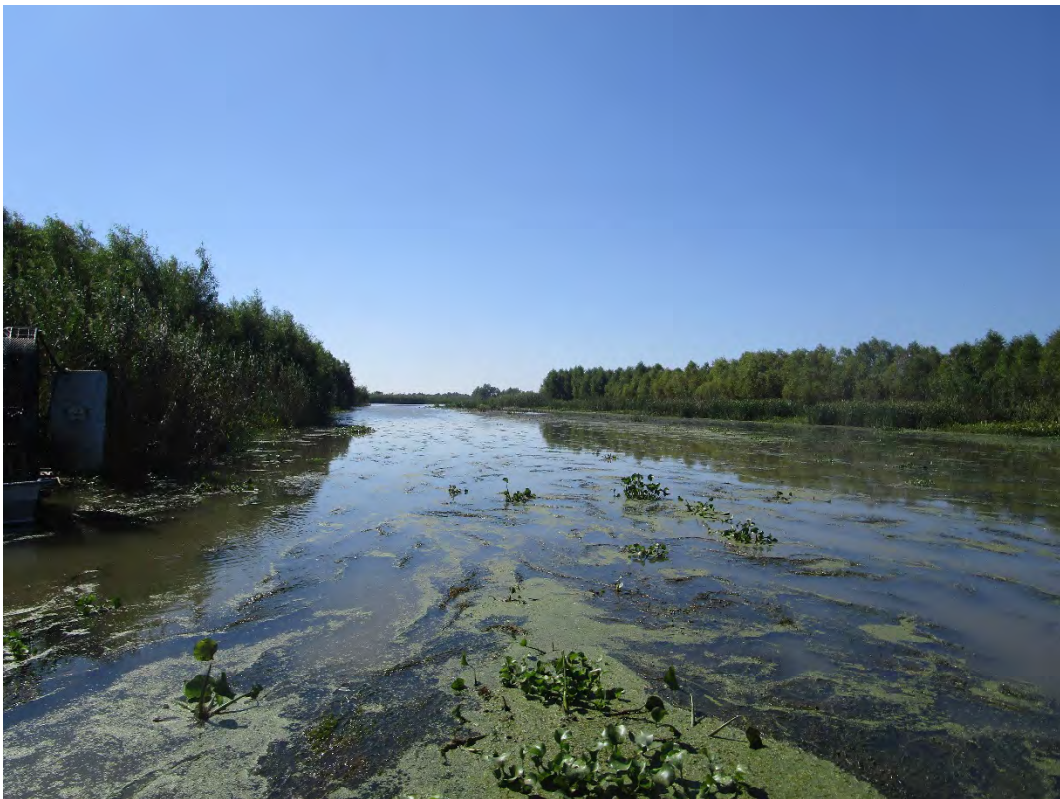
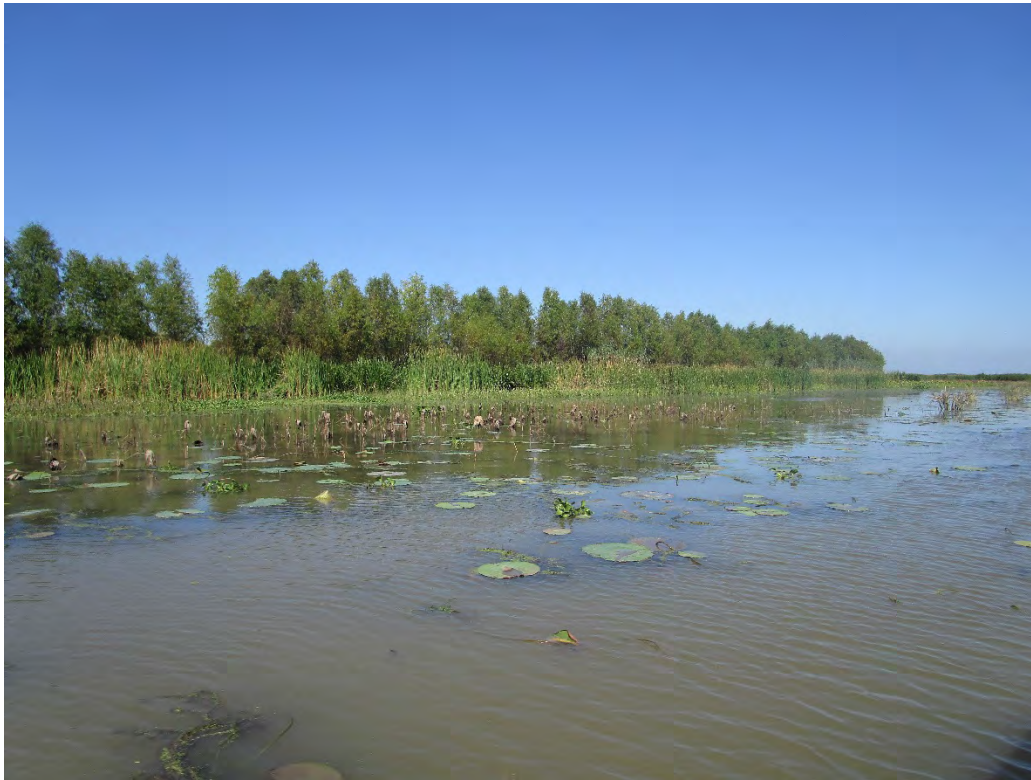
Crevasse No. OP-5 (View 1)

- D. Crevasse OP-5 (dredged): (840 ft. X 100 ft. X -8.0 ft. NAVD 88 as constructed) This crevasse is located on Octave Pass at N29 deg 12 min 4.4 sec; W 089 deg 15 sec 2.5 min. The spoil areas on each bank were well vegetated. The depth, although not sounded, appeared to retain most of its originally dredged depth and was adequate to carry sediment to the receiving area.

Crevasse # OP-5	Good	None	840 ft X 100 ft by -8.0' NAVD 88	Appendix B	This crevasse is located on Octave Pass at N29 deg 12 min 4.4 sec; W 089 deg 15 sec 2.5 min. The spoil areas on each bank were well vegetated. The depth, although not sounded, appeared to retain most of its originally dredged depth and was adequate to carry sediment to the receiving area.
Johnson Pass Crevasse	Good	None	1,200 ft X 75 ft by -8.0' NAVD 88	Appendix B	This existing crevasse is located on Johnson Pass at N29 deg 7 min 36.3 sec; W 089 deg 12 sec 30.1 min. The spoil areas on each bank were well vegetated. The depth, based on spot-checked soundings of 8', appeared to retain most of its originally dredged depth and was adequate to carry sediment to the receiving area.
Sawdust Bend Crevasse	Good	None	1,550 ft X 75 ft by -8.0' NAVD 88	Appendix B	This existing crevasse is located on Sawdust Bend at N29 deg 8 min 17.8 sec; W 089 deg 13 sec 33.3 min. The spoil areas on each bank were well vegetated. The depth, based on spot-checked soundings of 5' near the mouth and 6' to 7' thereafter, appeared to retain most of its originally dredged depth and was adequate to carry sediment to the receiving area.

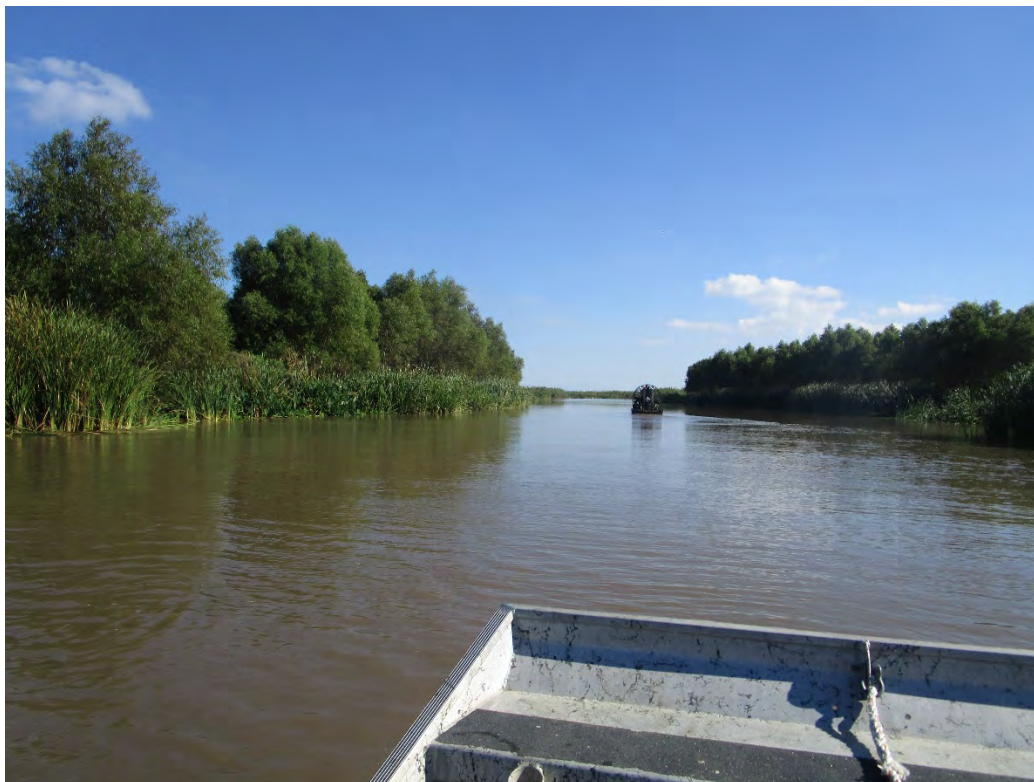
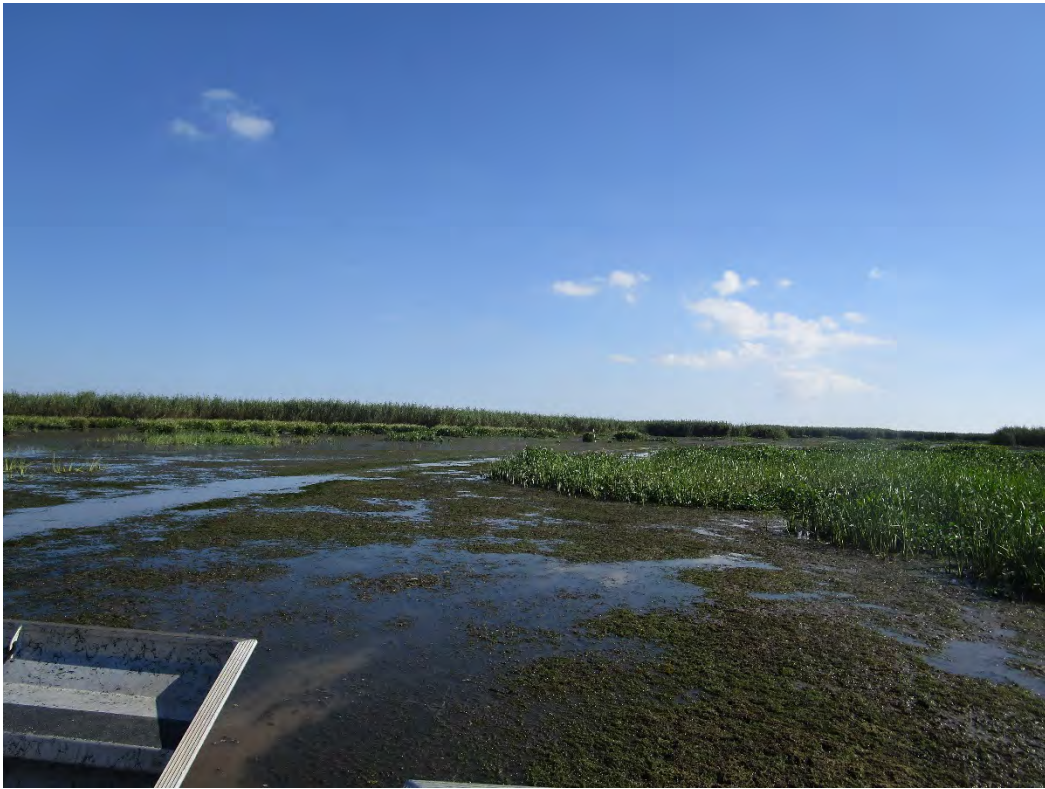
Johnson Pass Crevasse (View 1)

- E. Johnson Pass Crevasse (Maintenance Dredged): (1,200 ft. X 75 ft. X -8.0 ft. NAVD 88 as constructed) This existing crevasse is located on Johnson Pass at N29 deg 7 min 36.3 sec; W 089 deg 12 sec 30.1 min. The spoil areas on each bank were well vegetated. The depth, based on spot-checked soundings of 8’, appeared to retain most of its originally dredged depth and was adequate to carry sediment to the receiving area.

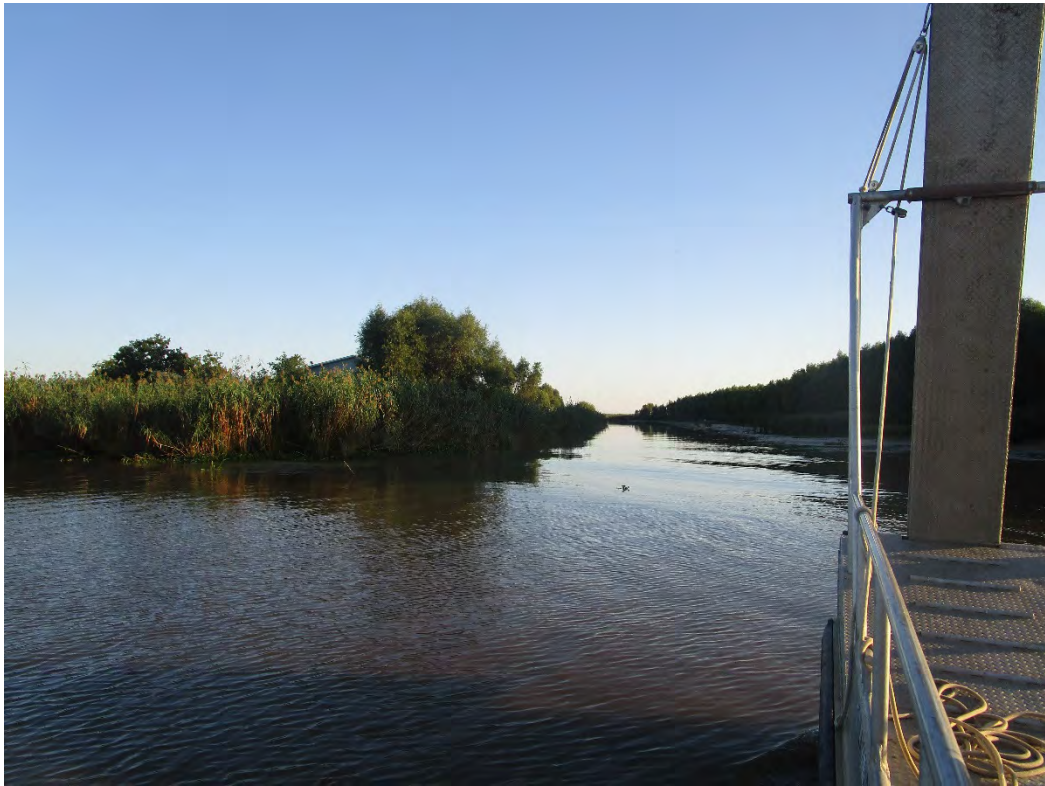
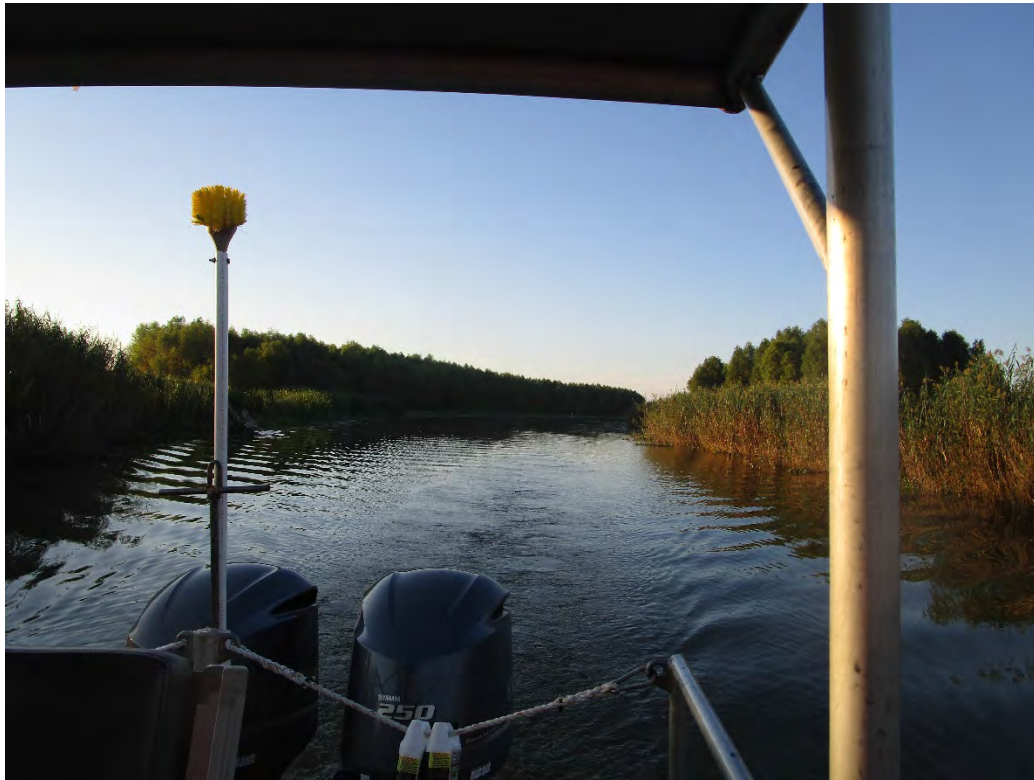
Sawdust Bend Crevasse (View 1)

- F. Sawdust Bend Crevasse (Maintenance Dredged): (1,550 ft. X 75 ft. X -8.0 ft. NAVD 88 as constructed) This existing crevasse is located on Sawdust Bend at N29 deg 8 min 17.8 sec; W 089 deg 13 sec 33.3 min. The spoil areas on each bank were well vegetated. The depth, based on spot-checked soundings of 5’ near the mouth and 6’ to 7’ thereafter, appeared to retain most of its originally dredged depth and was adequate to carry sediment to the receiving area.

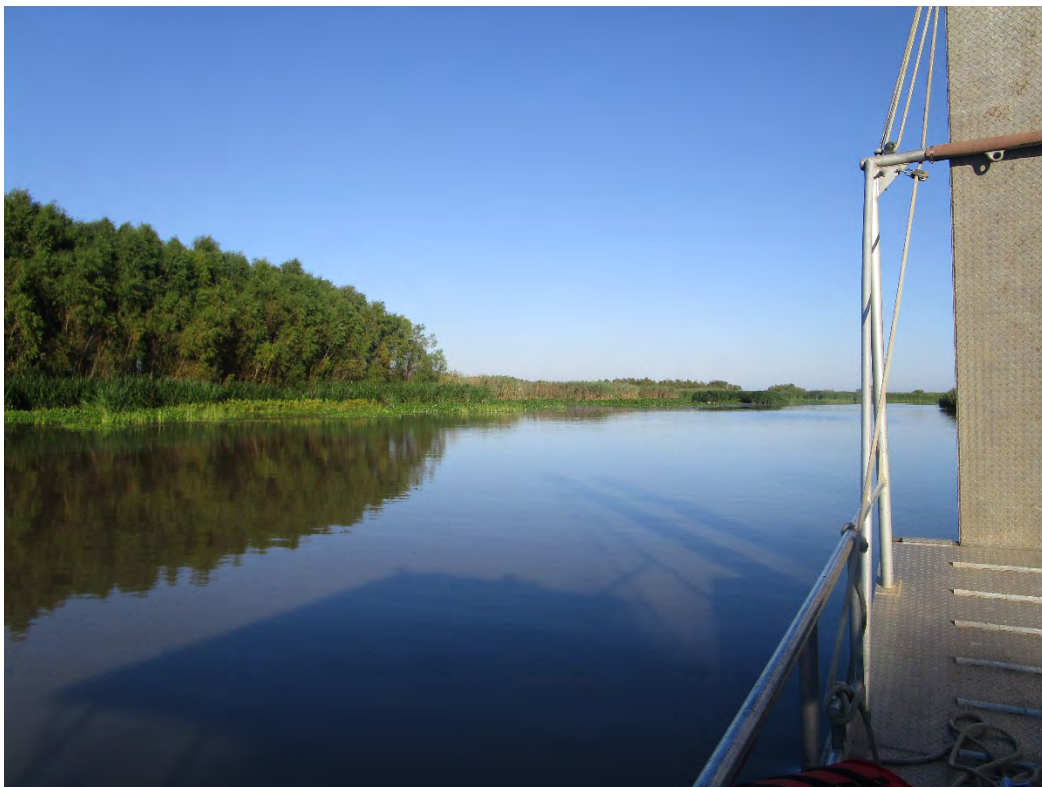
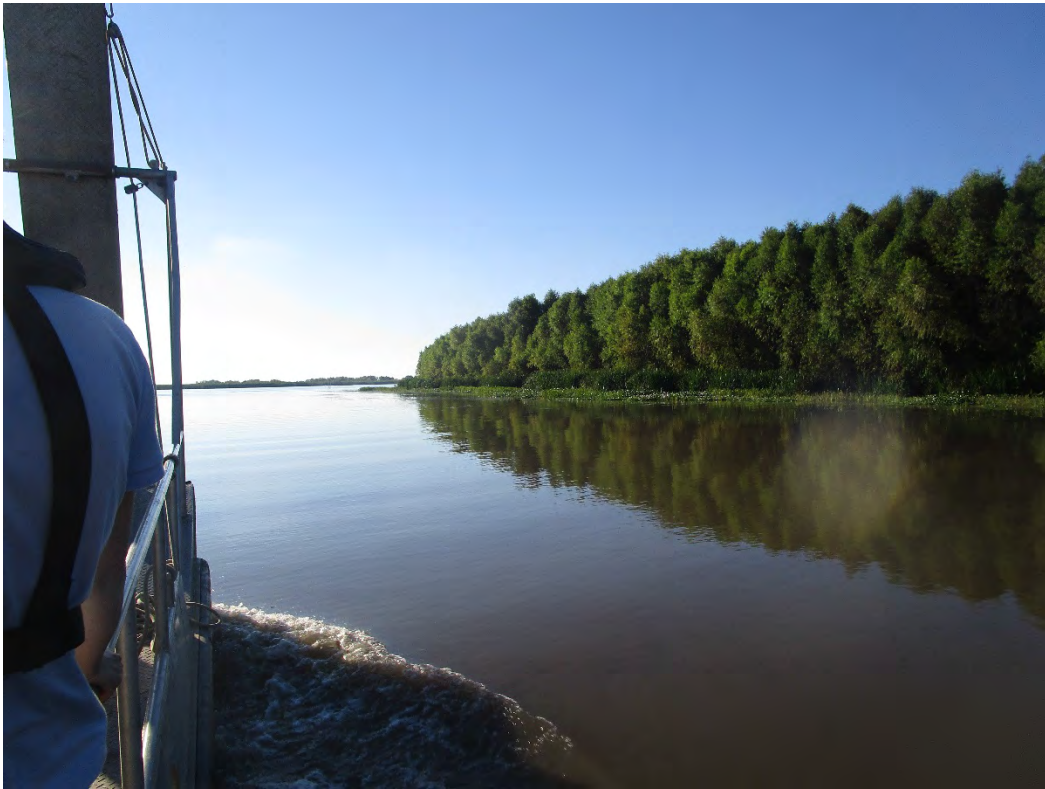
South Pass Crevasse (View 1)

- G. South Pass Crevasse (Maintenance Dredged): (1,000 ft. X 100 ft. X -8.0 ft. NAVD 88 as constructed) This existing crevasse is located on South Pass at N29 deg 6 min 20.2 sec; W 089 deg 14 sec 5.9 min. The spoil areas on each bank were well vegetated. The depth, based on spot-checked soundings of 5’ to 7’ near the mouth and 6’ to 7’ thereafter, appeared to retain most of its originally dredged depth and was adequate to carry sediment to the receiving area.

South Pass Crevasse	Good	None	1,000 ft X 100 ft by -8.0' NAVD 88	Appendix B	This existing crevasse is located on South Pass at N29 deg 6 min 20.2 sec; W 089 deg 14 sec 5.9 min. The spoil areas on each bank were well vegetated. The depth, based on spot-checked soundings of 5' to 7' near the mouth and 6' to 7' thereafter, appeared to retain most of its originally dredged depth and was adequate to carry sediment to the receiving area.
