## **State of Louisiana Coastal Protection and Restoration Authority**

# **2024 Operations, Maintenance, and Monitoring Report**

## **Bayou Chevee Shoreline Protection** (PO-22)

State Project Number PO-22 Priority Project List 5

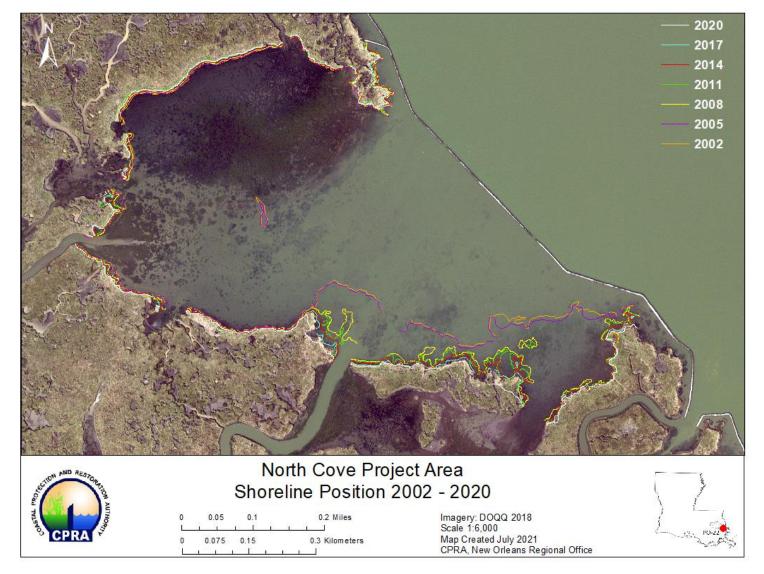
All areas have experienced some shoreline retreat since the previous survey in 2017. For the period of time from 2017 to 2020 the North Cove project area experienced an average rate of shoreline retreat of 3.3 ft/yr (Table 1) and an average net shoreline loss of 10.5 ft (Table 2). Similar to the trend observed in previous surveys, the majority of the shoreline retreat in the North Cove project area occurred on the north facing bank along the southeastern shoreline (Figure 3).

A comparison of the two reference areas along the Lake Pontchartrain shoreline reveals distinct differences. In the North Cove reference area, the Lake Pontchartrain shoreline segment retreated at an average 3.6 ft/yr (Table 1) for a net shoreline change of -68.6 ft. (Table 2) over the entire monitoring period. In contrast, the South Cove reference area retreated at an average of 47.3 ft/yr for a net shoreline change of -890.3 ft. for the same period. The South Cove reference area shoreline retreated at a 13 times greater rate than the North. A likely explanation for the different result is the spatial orientation of the shoreline in the reference areas. In the South Cove, the majority of the shoreline is northfacing. In the North Cove reference area, the Lake Pontchartrain shoreline faces eastnortheast. A north-facing shoreline in an area with high fetch such as the South Cove is vulnerable to wind generated waves from the north, such as those associated with the passage of winter cold fronts. The east-northeast facing shoreline of the North Cove reference area is less affected by north winds. This area also has less fetch from this direction as a result of a protrusion of land to the north near Irish Bayou at the western end of the Interstate 10 bridge. This phenomenon would also explain the pattern of shoreline retreat within the North Cove project area, where most of the shoreline retreat was concentrated in a section of north-facing shoreline in the southeast portion of the cove (Figure 3).

Figure 3. Results of 7 shoreline position surveys from 2002 – 2020 for the North Cove project area of the Bayou Chevee Shoreline Protection (PO-22) project.

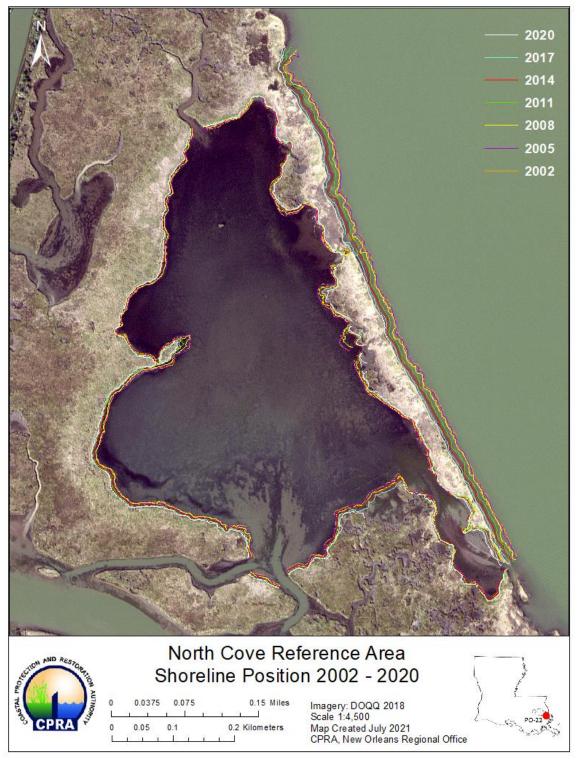
The North Cove reference area is divided into 2 sub-areas: 1.) an interior pond protected by a narrow strip of marsh from the wave action of Lake Pontchartrain, and 2.) a northeast-facing segment of Lake Pontchartrain shoreline (Figure 4). For the 2017 – 2020 time period the pond portion of the North Cove reference area experienced an average rate of shoreline retreat of 0.9 ft/yr (Table 1). The Lake Pontchartrain shoreline portion of the North Cove reference area experienced an average rate of shoreline retreat of 3.3 ft/yr (Table 1), and an average net shoreline loss of 10.7 ft (Table 2). The shoreline has retreated along the entire surveyed length of the Lake Pontchartrain shoreline at a fairly uniform rate. At some point between the 2008 and 2011 surveys, the narrow strip of marsh separating the interior pond from the lake breached at the southern end, just below southern extent of the surveyed area, creating a connection between the two. This breach has expanded since then, and an additional breach has formed just to the north. Additionally, there are several other locations north of these breaches where the strip of marsh separating the interior pond from Lake Pontchartrain is approximately 40-ft wide and in danger of breaching in the near future (Figure 4).

**Figure 4.** Results of 7 shoreline position surveys from 2002 - 2020 for the North Cove reference area of the Bayou Chevee Shoreline Protection (PO-22) project.

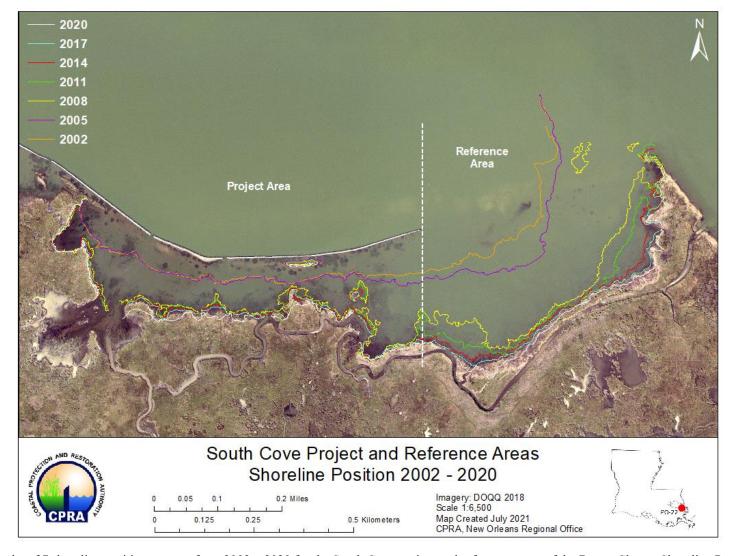
Cove reference area, this area continues to experience high rates of shoreline retreat. Although shoreline retreat has occurred along the entire length of South Cove reference area shoreline, much of the retreat has occurred along the eastern and western ends of the shoreline reach (Figure 5). The section of shoreline in the center of the South Cove reference area has retreated to the natural levee created by a bayou that parallels the shoreline here. The marsh in this area is likely more resilient and resistant to erosion than the surrounding marsh, thus accounting for the slightly lower rate of shoreline retreat here.

Figure 5. Results of 7 shoreline position surveys from 2002 – 2020 for the South Cove project and reference areas of the Bayou Chevee Shoreline Protection (PO-22) project. The dashed line indicates the boundary between project and reference areas.

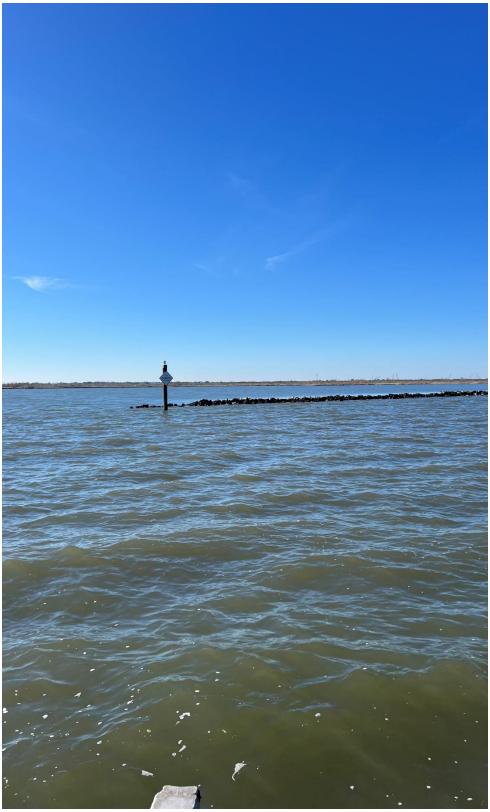
Photo #1 – Terminus of Southern Reach.

Item	Condition	Pysical Damage	Corrosion	Photo #	Observations and Remarks					
Foreshore										
Rock Dike	Fair	Settling	None	3, 4	North end looking good. South end	settling below accepta	ıble grade.			
North Cove						<u>.</u>				
Foreshore										
Rock Dike	Poor	Settling	None	1, 2	Settling below acceptable grade.					
South Cove										
USFWS Dike										
Segment	Poor	Settling	None		Settled below acceptable grade.					
Exposed Shore		Inundated/								
South of Dike	Poor	Washed Away	N/A		Needs protection.					
Nav Aids	Excelent	None	None	2	Recently installed.

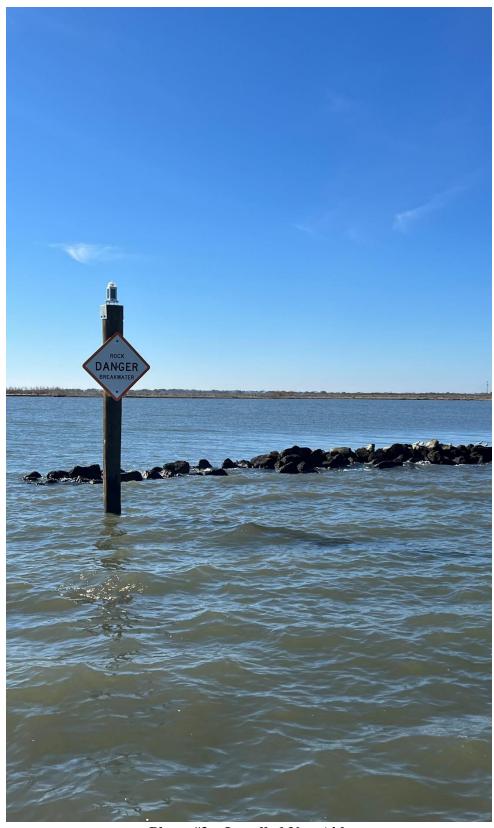
Photo #2 – Installed Nav Aid.

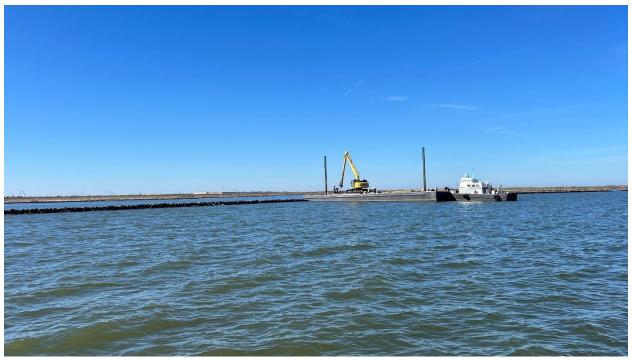
Photo #3 – Northern Reach (Nav Aid Installation).

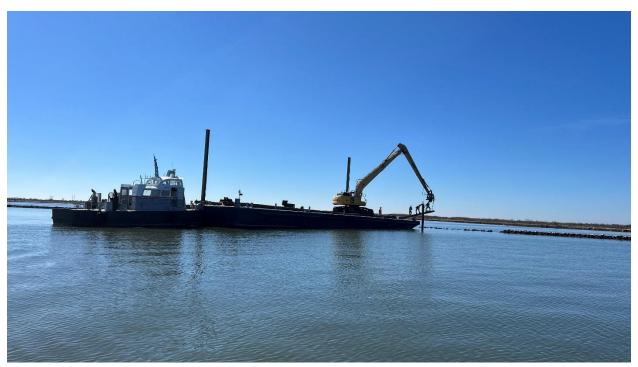
Photo #4 - Terminus of Northern Reach.
