## 2014 Operations, Maintenance, and Monitoring Report

### Goose Point / Point Platte Marsh Creation (PO-33)

State Project Number PO-33  
Priority Project List 13

July 23, 2014  
St. Tammany Parish

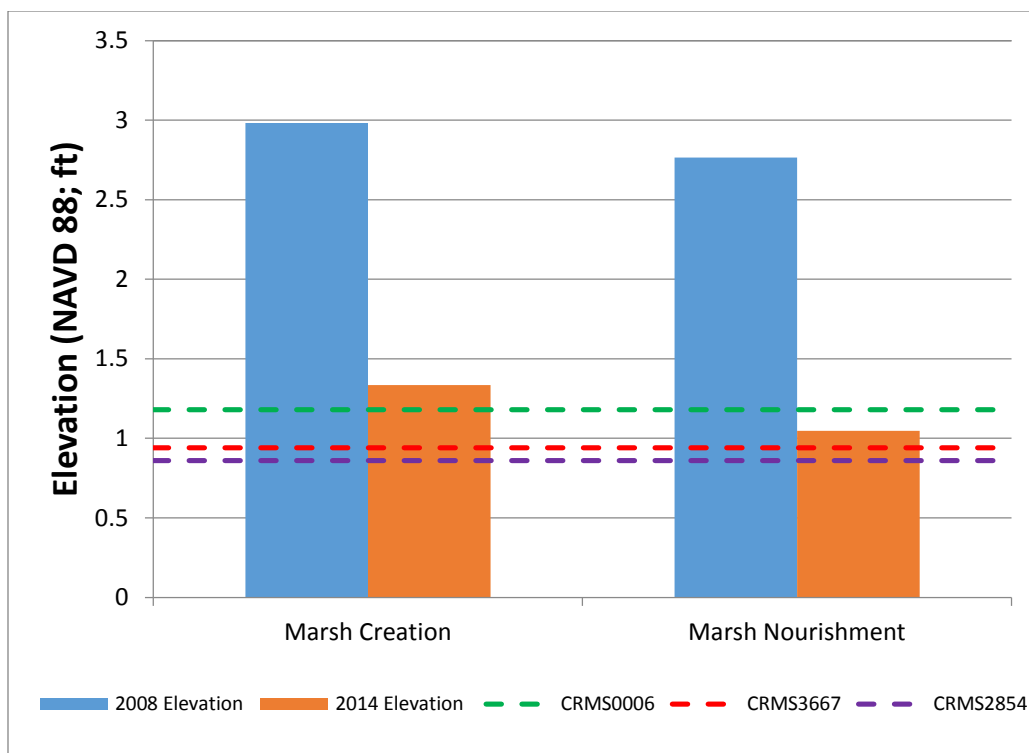
**Figure 2.** Average elevation of PO-33 marsh creation areas and marsh nourishment areas in 2008 and 2014.

Average elevation in the marsh creation areas was 2.98 ft in the 2008 as-built survey (NAVD88, Figure 2) and 1.34 ft in 2014, a decline of 1.64 ft over the 5.5-yr period between surveys. Likewise, average elevation in the marsh nourishment areas changed from 2.77 ft in 2008 to 1.05 ft in 2014, a decline of 1.72 ft. Within the marsh creation areas, elevation change ranged from -1.07 ft (Area C) to -2.29 ft (Area B; Figure 3).

Based on pre-construction settlement calculations, it was expected that the marsh creation areas built to an initial elevation of 2.5 ft NAVD88 would settle to an elevation of 1.08 ft NAVD88 at year 3, with most of the settlement occurring in the first 2 years. The average 2014 survey elevation for the marsh creation areas (1.34 ft) slightly exceeds the pre-construction target. Average elevation at the marsh creation areas also exceeded marsh elevations at the 3 CRMS sites in the vicinity of the project. Average elevation within the marsh nourishment areas (1.05 ft NAVD88) is equivalent to the pre-construction target elevation for the project and higher than 2 of the 3 CRMS sites in the vicinity. The marsh elevation at CRMS0006 is slightly higher than those at CRMS2854 and CRMS3667. This is likely due to the proximity of this site to the Lake Pontchartrain shoreline.

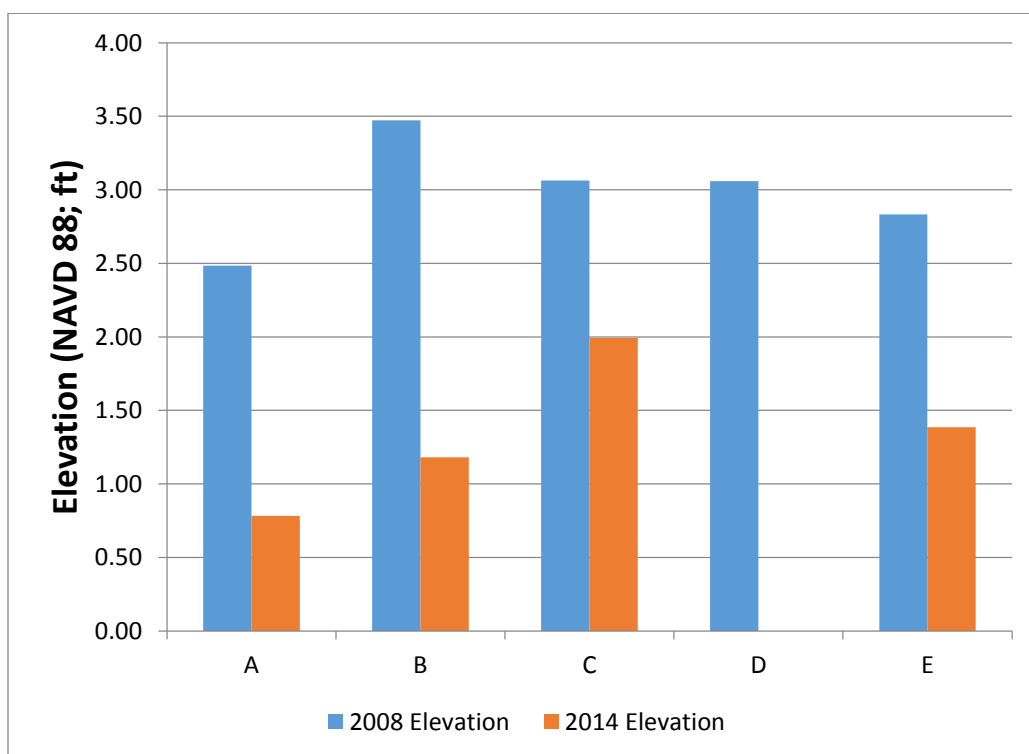
**Figure 3.** Average elevation of PO-33 marsh creation areas in 2008 and 2014.

Marsh Creation Area C had the highest average elevation in 2014 (1.99 ft NAVD88) while Area A had the lowest (0.78 ft NAVD88). The lower elevation at Area A may be attributable to several factors. In addition to having a lower as-built elevation, this area was identified through pre-construction soil borings as having native soil conditions that could result in high rates of foundation settlement (Simoneaux 2006).

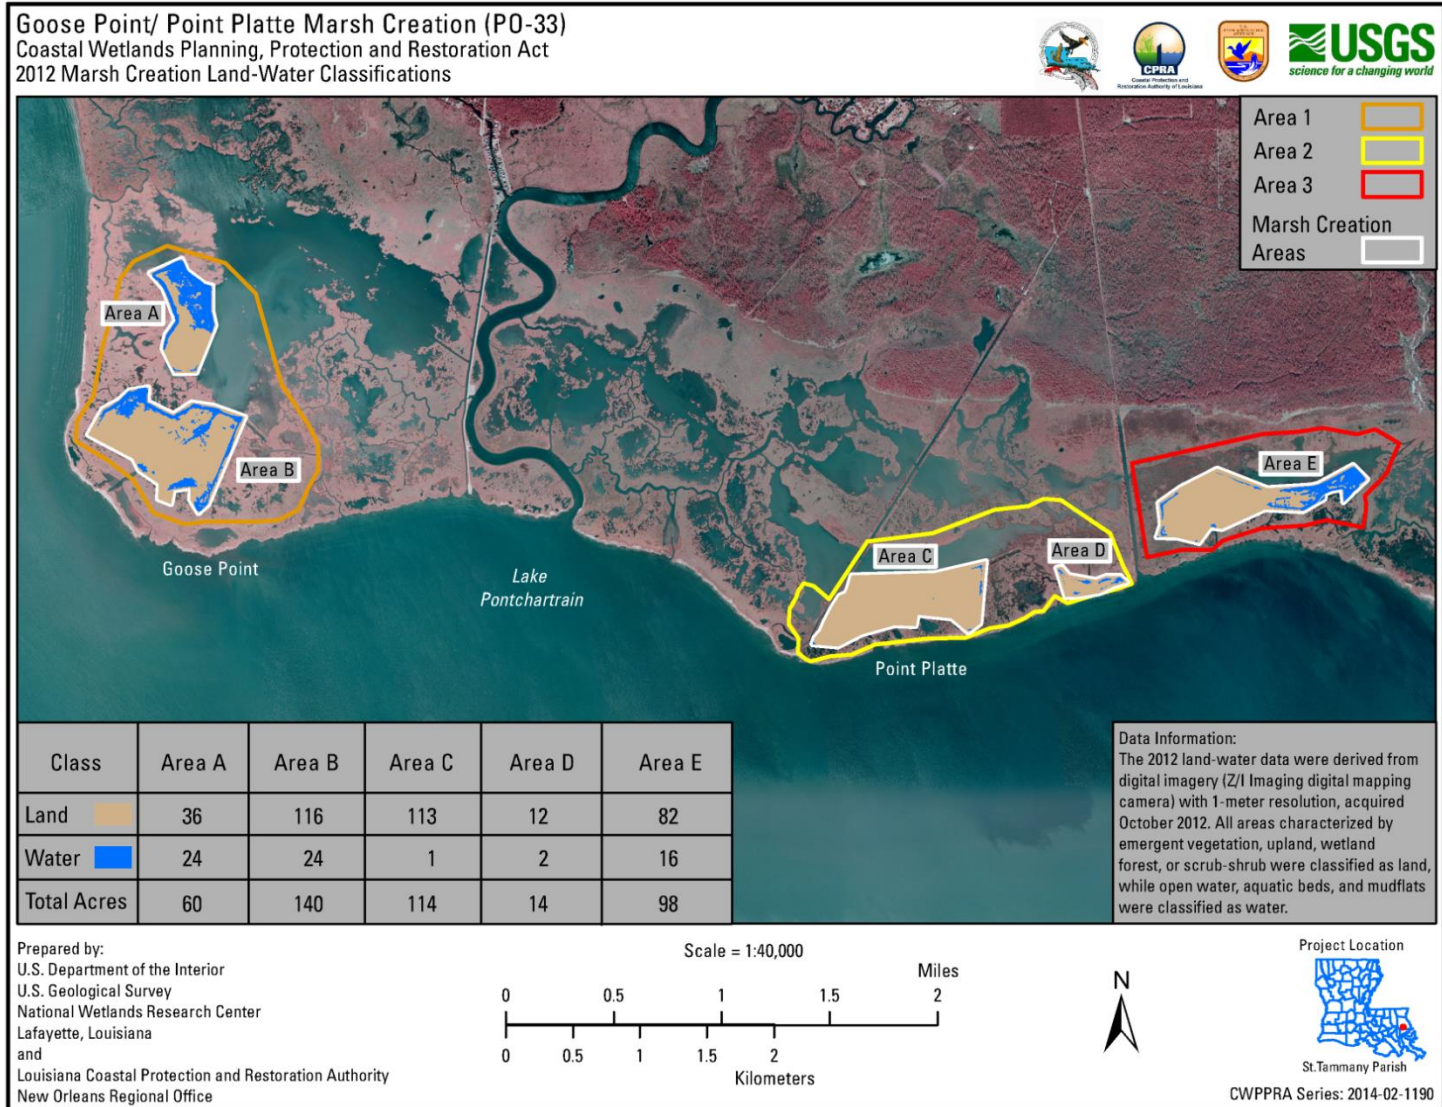
**Figure 5.** Land-water analysis of the 5 Marsh Creation Areas within the PO-33 project area.

Within the marsh creation areas, the 2012 land-water analysis indicates that there are 359 ac of land (84.3%) and 67 ac of water (15.7%). At an individual level, Areas C and D had the highest percentages of land at 99.1% and 85.7%, respectively (Figure 5). Area A had the lowest percentage of land with 60%. Within several of the marsh creation areas, particularly areas A, B, and E, shallow, narrow canals have formed just inside the containment dikes where sediment for the creation of the dikes was excavated during construction. This phenomenon is not entirely unexpected and has been observed in other marsh creation projects where fill material for containment dikes was excavated from within the marsh creation footprint (e.g. BA-36 Dedicated Dredging on the Barataria Basin Landbridge; BA-37 Little Lake Shoreline Protection/Dedicated Dredging Near Round Lake).

There are several large, un-vegetated mudflats within the marsh creation areas, most notably an approximately 17-ac area in the northeastern part of Area A, an approximately 11-ac area on the eastern end of Area E, and several smaller mudflats within Area B (Fig. 5). The methodology used for land-water analysis classifies mudflats as water, therefore accounting for the larger percentages of water within Areas A, B, and E. These areas were targeted with a planting of *Spartina alterniflora* in the spring of 2014. The conditions within the planting areas are conducive for vegetative growth and it is anticipated that these areas will vegetate rapidly within the coming years.

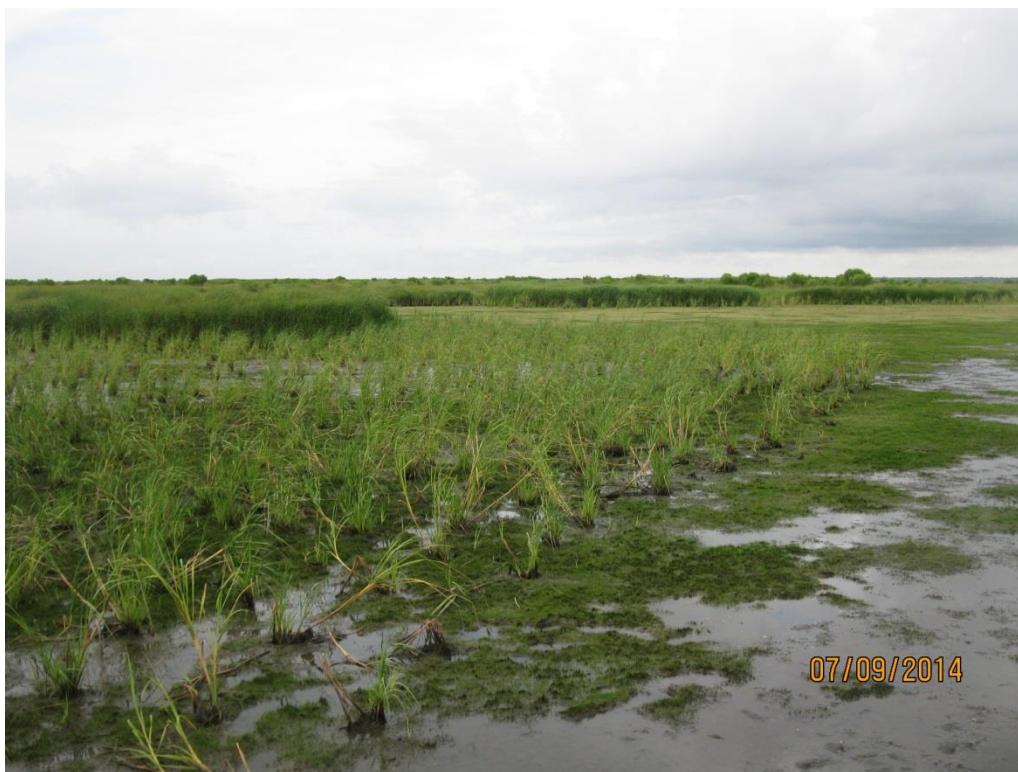
Fill Area A - Much of the interior containment borrow area has subsided below the water surface elevation; this condition was anticipated prior to construction, and results in a more diverse marsh habitat. Grass plantings performed in the spring of 2014 looked good generally, although some plantings on the north end of the fill cell failed to root and were overturned.

Area A – *Spartina alterniflora* plantings with vegetated fill area beyond

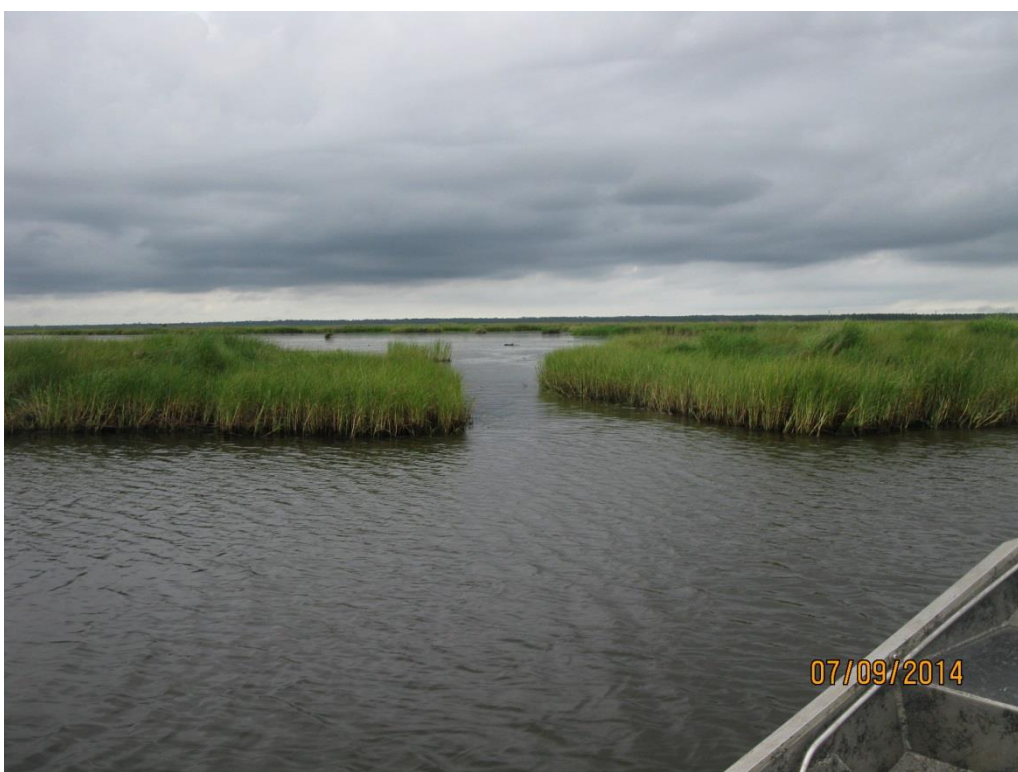
Area A – Containment degraded for tidal exchange at north end of fill area

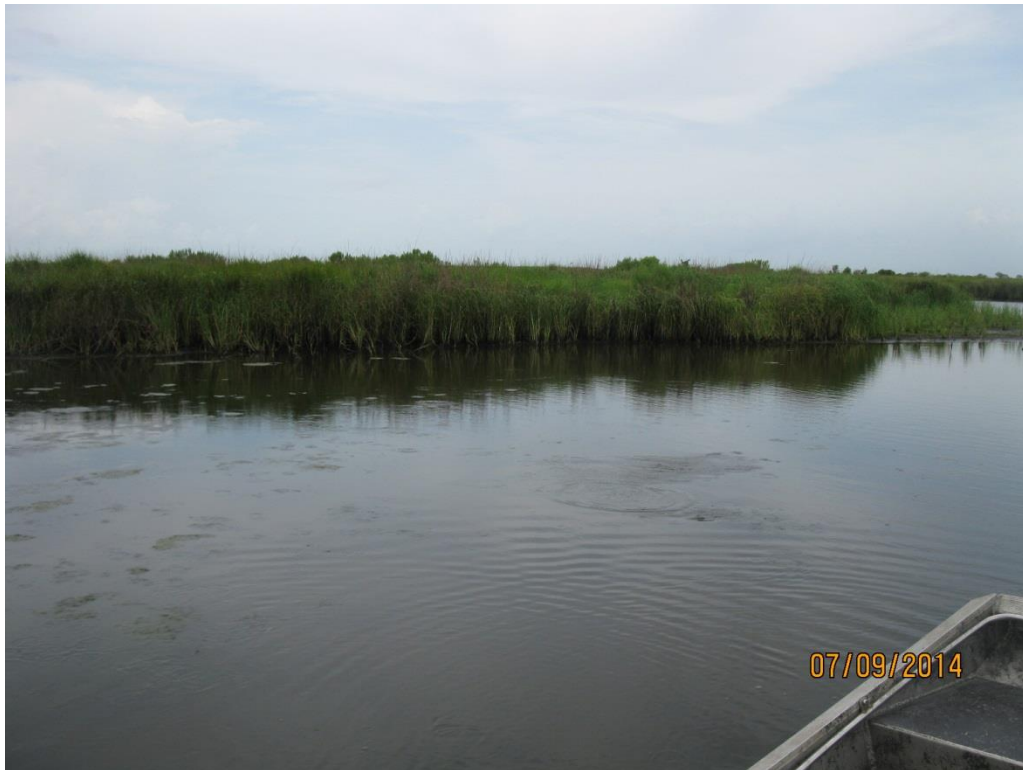
Fill Area B - Some of the interior containment borrow area has subsided below the water surface elevation; this condition was anticipated prior to construction and was deemed acceptable. Marsh plantings performed in the spring of 2014 appeared vigorous and showed healthy new growth.

**Area B** – Shallow water in containment borrow area with fill area beyond

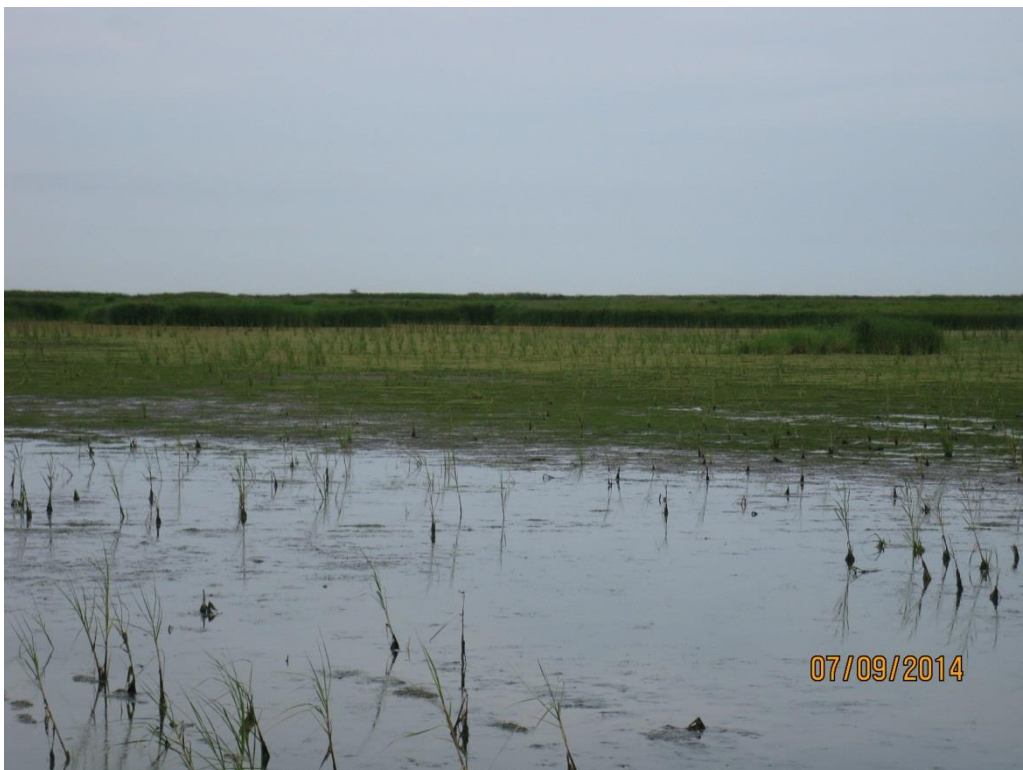
**Area B** – Recent *Spartina alterniflora* plantings with marsh nourishment area in background

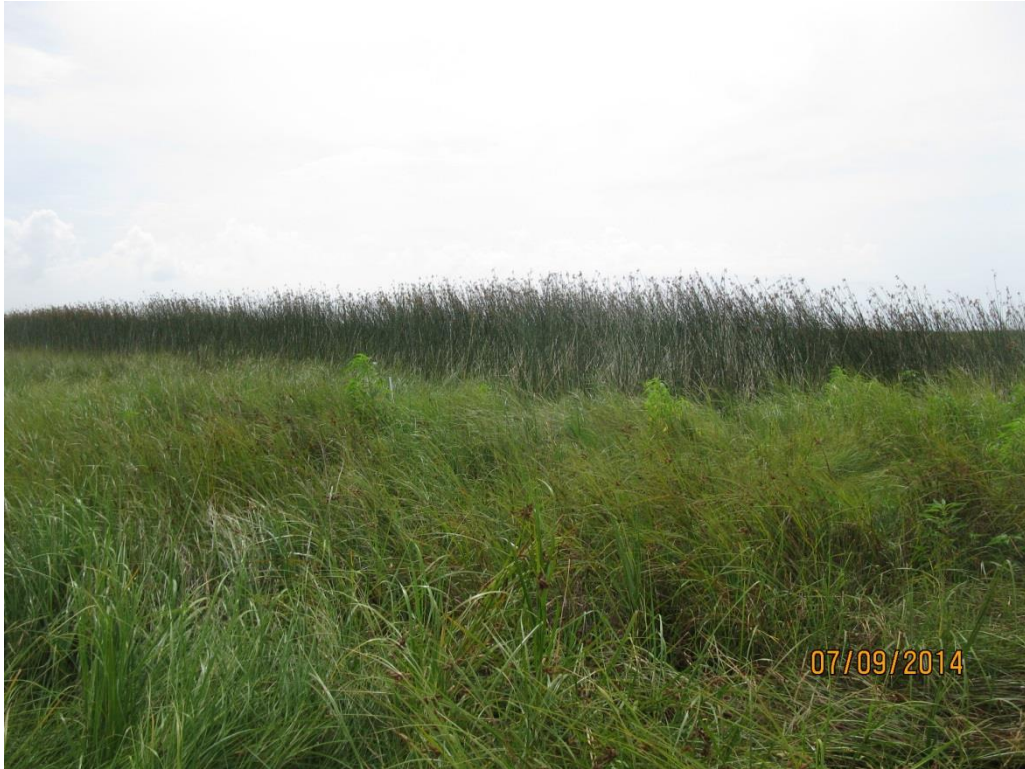
Fill Area C - This area has vegetated very well. The perimeter containment borrow area has subsided, but no open water areas were visible. This marsh creation area and the containment berms were nearly 100% vegetated.

**Area C – North containment berm with marsh creation in background**

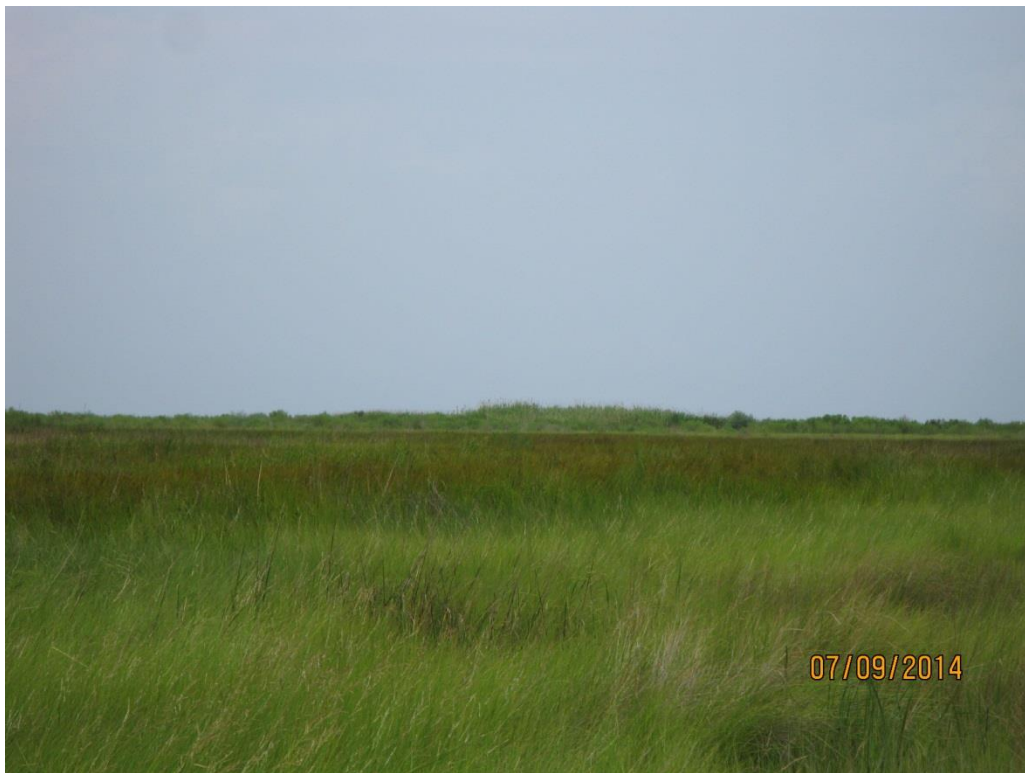
**Area C – Interior marsh viewed from north containment rim**

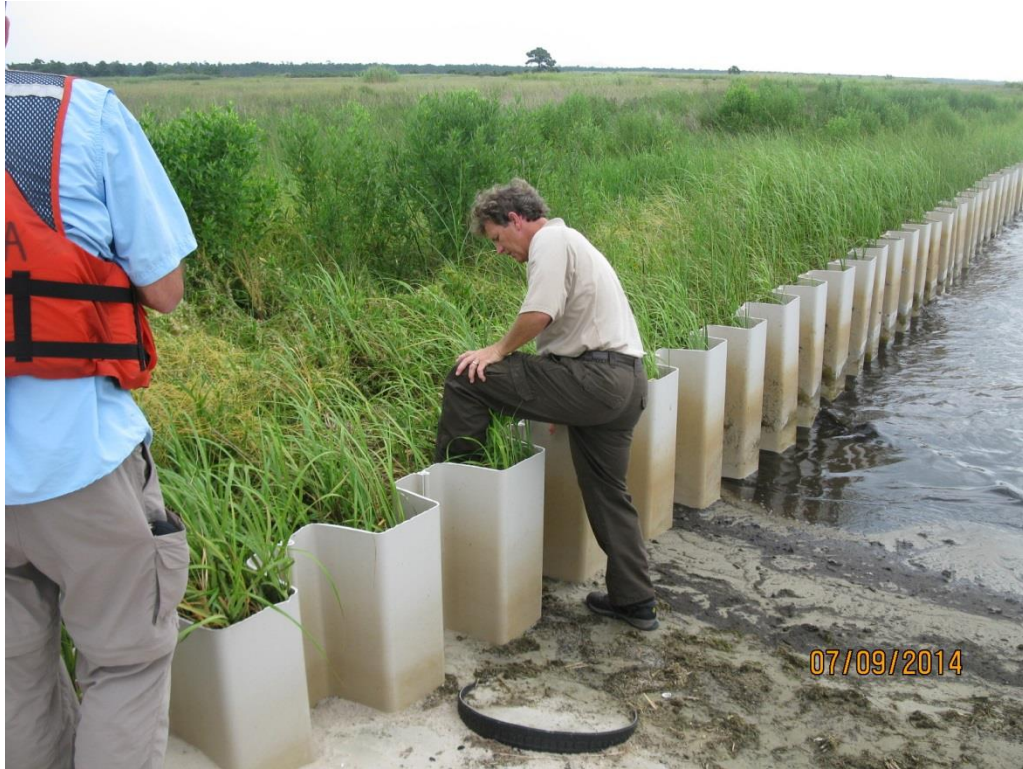
**Area D – Marsh infill behind vinyl sheet pile wall**

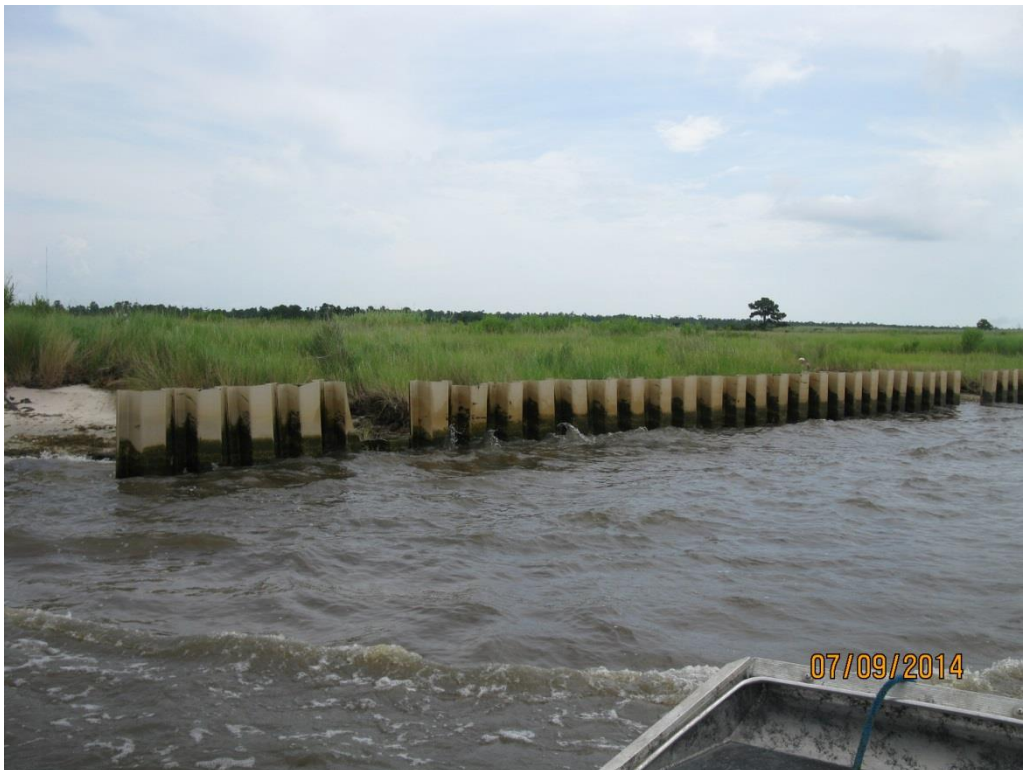
Fill Area D - Some of the vinyl sheet piles along the lake shore showed signs of damage, probably vandalism from hunters attempting to access the marsh creation areas. Marsh conditions behind the sheet pile wall appeared to be healthy, but some scour was visible behind the damaged wall sections.

**Area D – Apparent vandalism; sheet piles appear to have been cut**

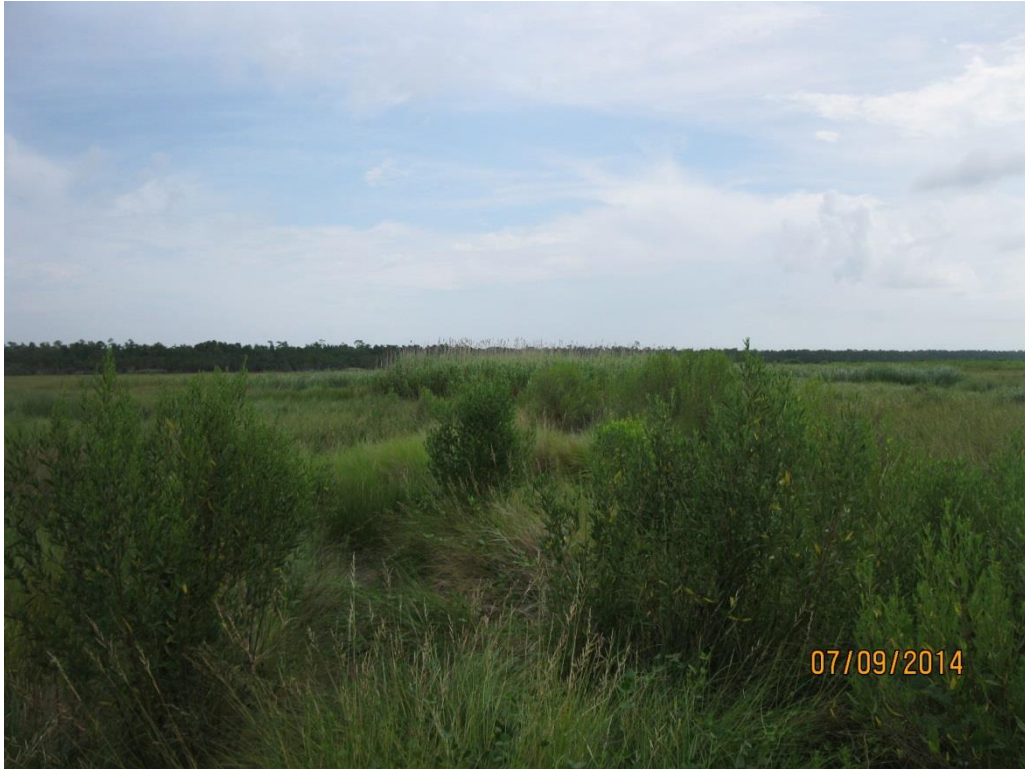
Fill Area E - Low water conditions at the time of inspection prevented a thorough evaluation of this fill cell; however, the marsh creation area as viewed from the northwest containment berm looked healthy. The containment area was almost 100% vegetated.

**Area E – Vegetated containment berm at northwest end of fill cell**

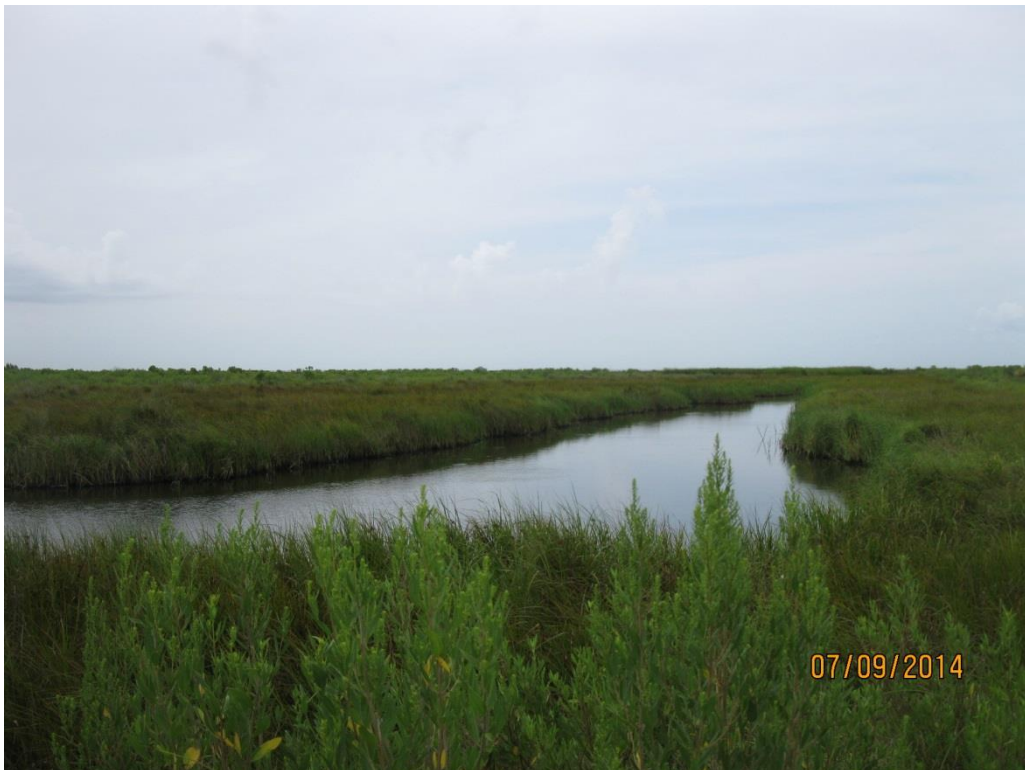
**Area E – Shallow water in containment borrow area with marsh fill beyond**
