**State of Louisiana
Coastal Protection and Restoration Authority**

2019 Annual Inspection Report

Bayou Bonfouca Marsh Creation Project

State Project Number PO-0104
Priority Project List 20

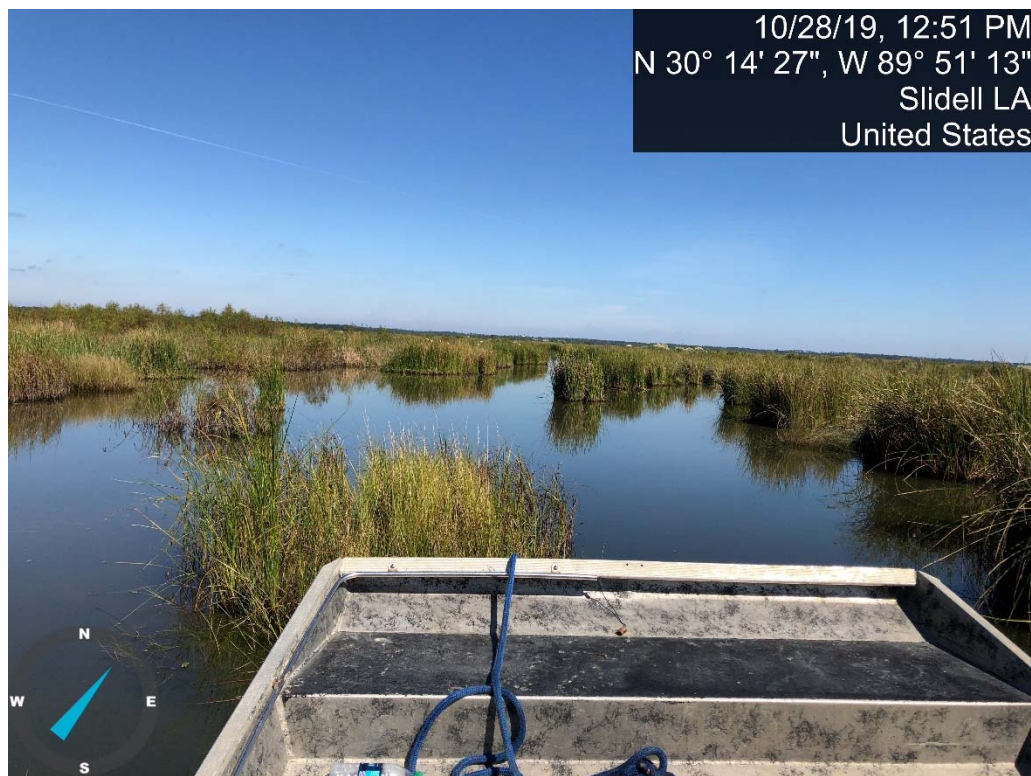
Photo 1: Marsh Creation Area 1

Location of proposed tidal creek on southern end of MCA 1(near Pond B)

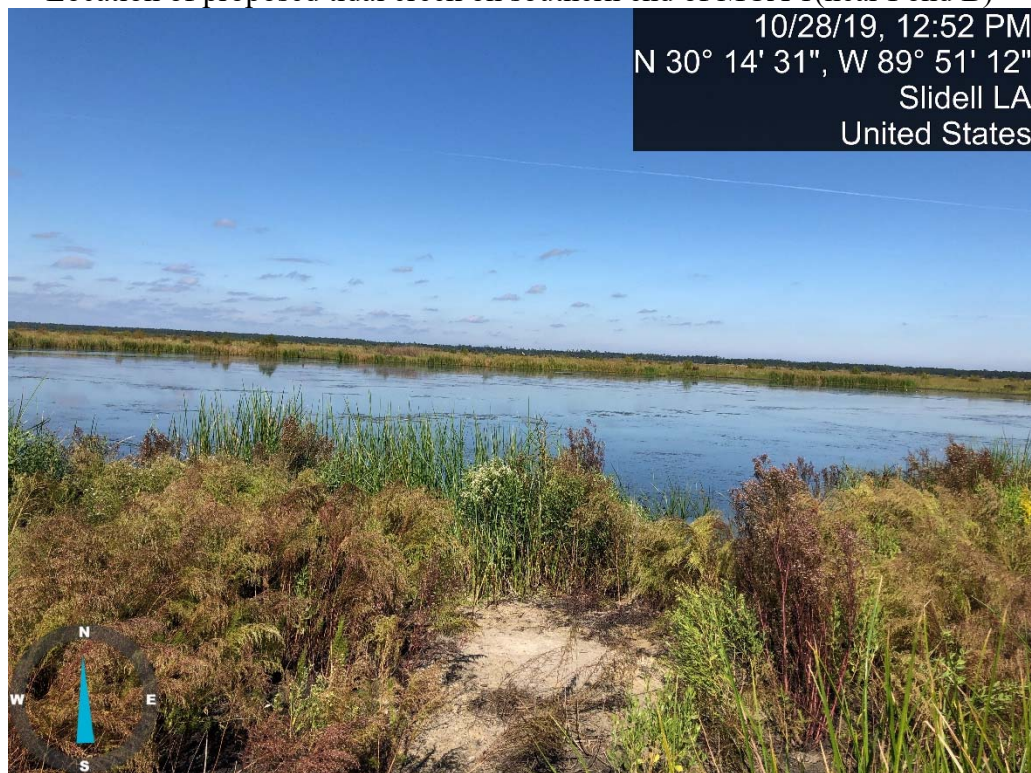
Photo 2: Marsh Creation Area 1

Pond B viewed from the pond containment dike.

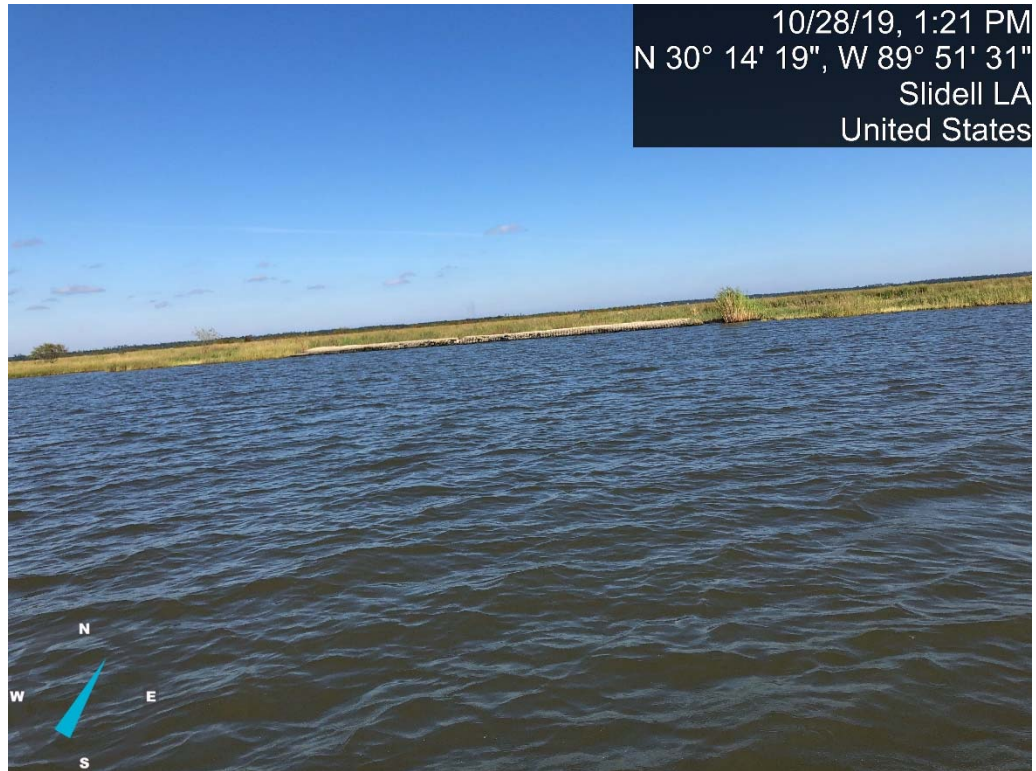
Photo 3: Marsh Creation Area 1

Articulated concrete mats at the intersection of the MCA 1 containment dike and Lake Pontchartrain

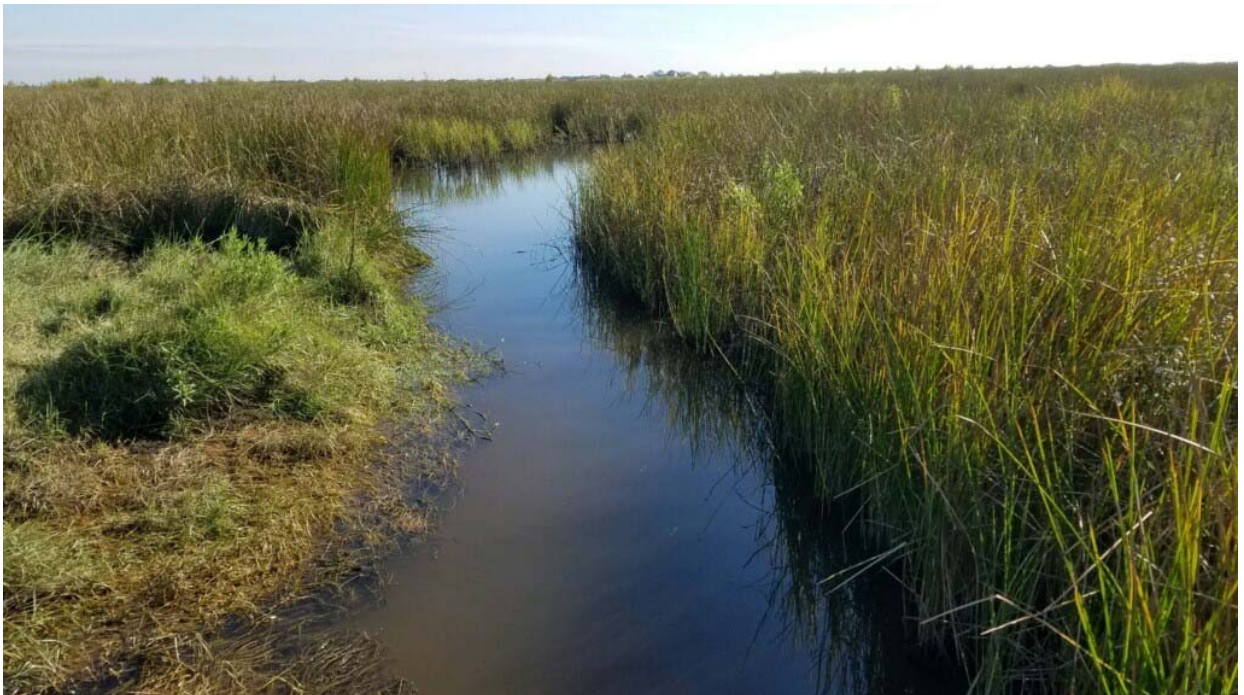
Photo 4: Marsh Creation Area 1

Existing gap on western side of northern earthen containment dike.

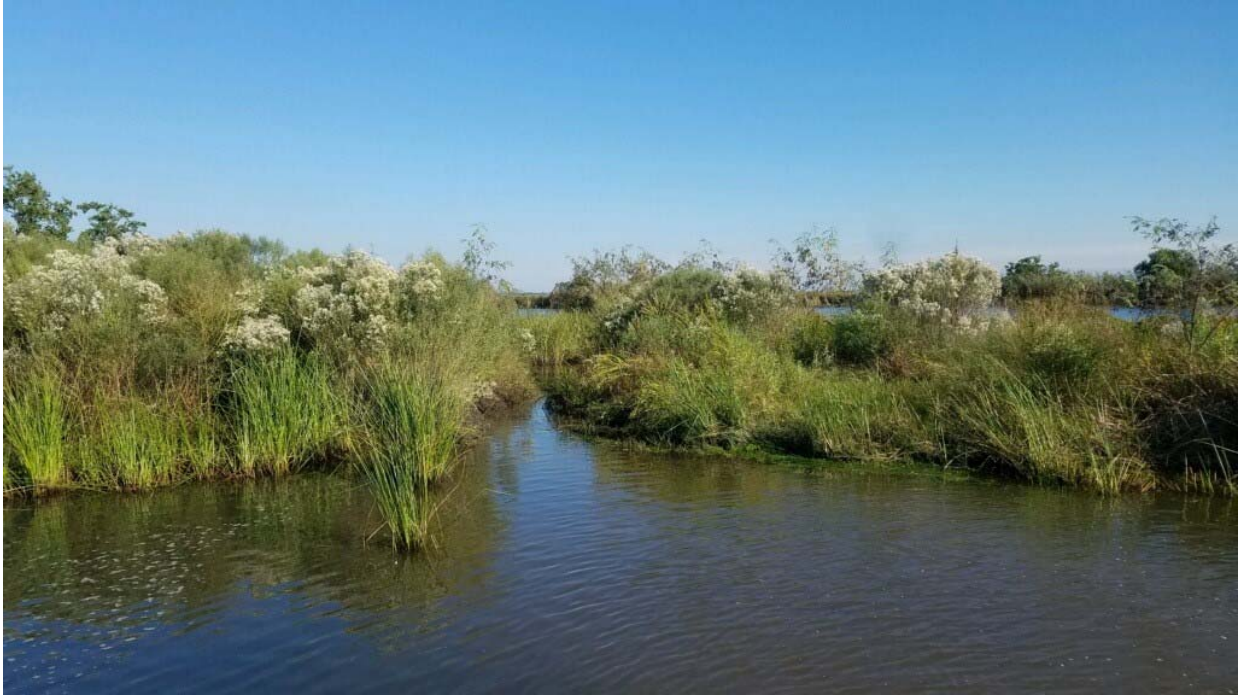
Photo 5: Marsh Creation Area 1
Northwestern corner of MCA 1

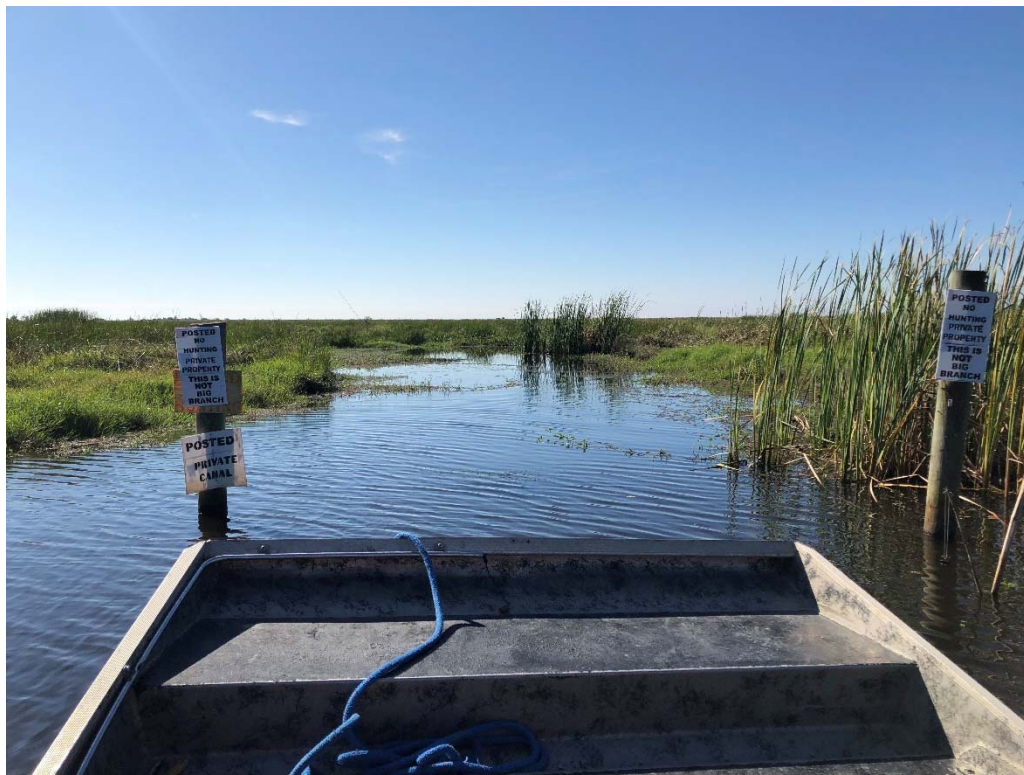
Photo 6: Tidal Creek NE of Marsh Creation Area 2
Pilings at the intersection of the proposed tidal creek and the Bayou Liberty Marina

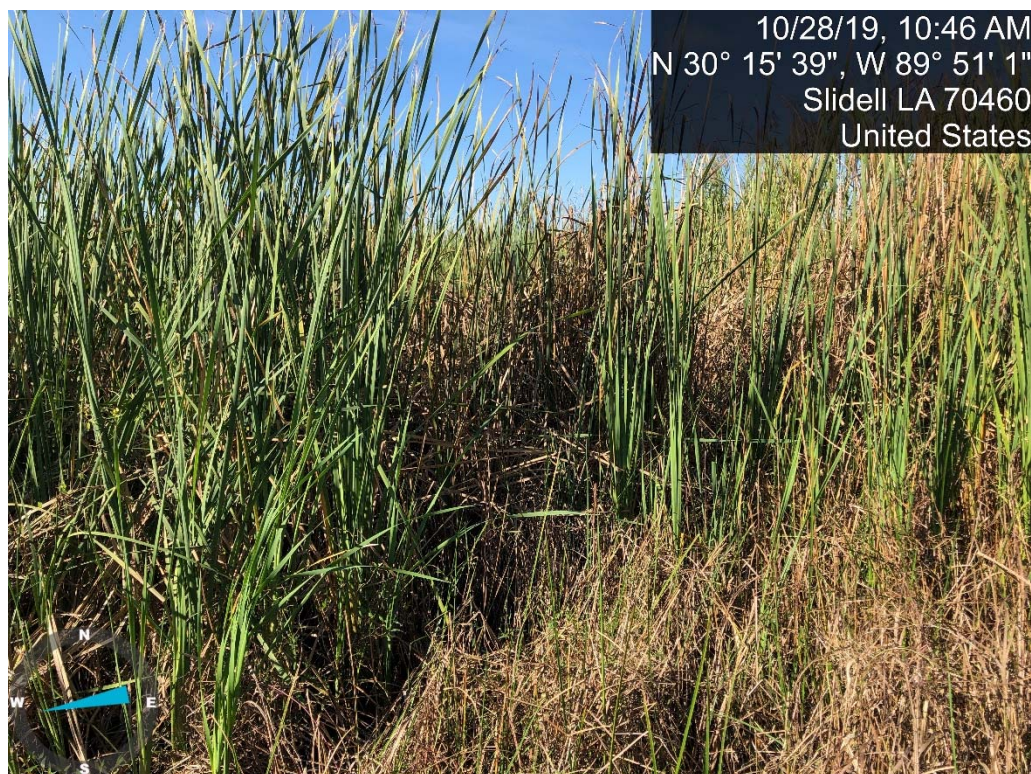
Photo 7: Marsh Creation Area 2

Northeastern corner viewed from earthen containment dike

MCA 2	Very Good	None	6-7, 9-10	We observed a silted in gap on the southern dike, west of the proposed dike gap location. Dike gaps will be added to planned maintenance event where proposed creeks meet pond dikes. Southernmost proposed creek will be revised to follow interior borrow canal.
MCA 3	Very Good	None	11-12	Much of MCA 3 is a shallow area about 6" deep. USFWS (D. Breaux) said that prior to construction, the area was about 2.5' deep. With the tide at +1.9 feet NAVD 88 at the time of the inspection, MCA 3 is at an approximate elevation of +1.4 feet NAVD 88, which is higher than the target elevation of +1.1 feet NAVD 88. Both previously proposed gaps for this marsh creation area will be removed from the plans because tidal exchange is already occurring at these locations. USFWS (D. Breaux) noted that the eastern gap was previously existing, but when they chose to put a gap there, it was much smaller. Now it allows for sufficient tidal exchange.

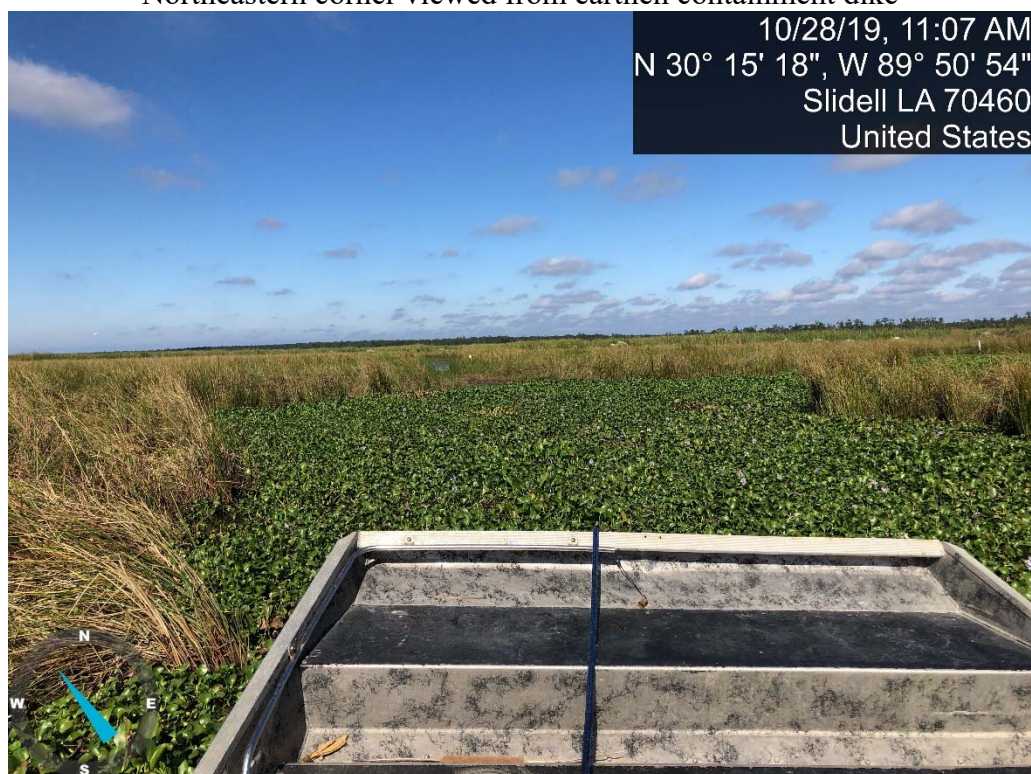
Photo 8: Access Route South of Marsh Creation Area 2

Southern access to Marsh Creation Area 2 for upcoming maintenance event. This is within the marsh nourishment area.

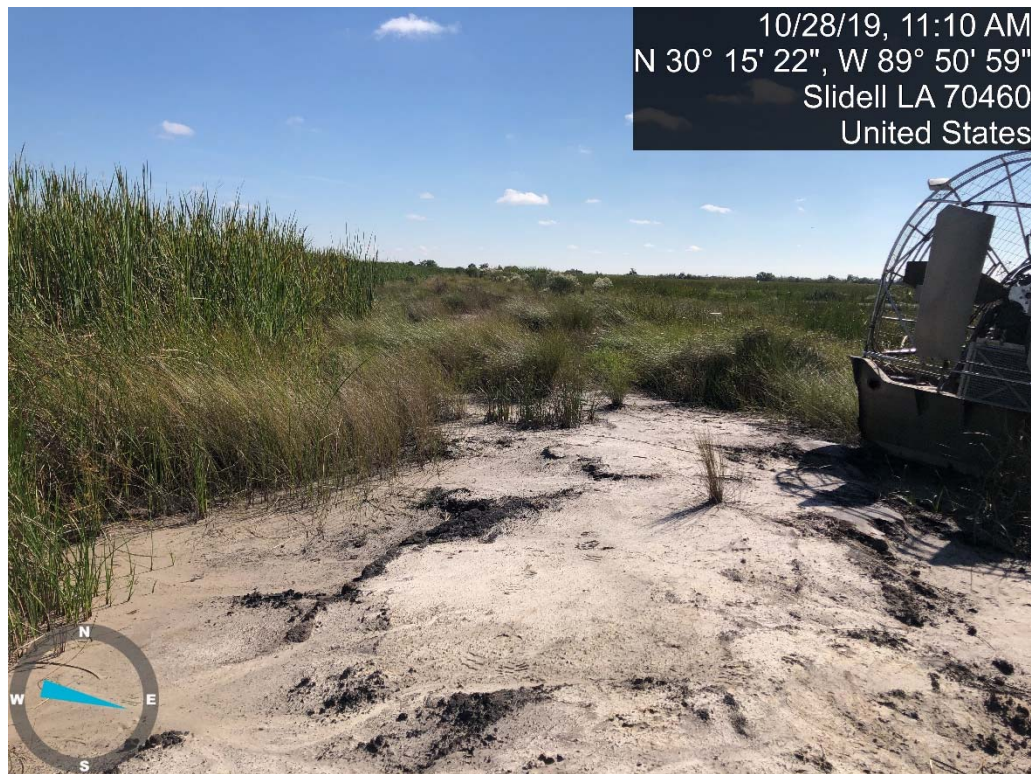
Photo 9: Marsh Creation Area 2

High point along southern earthen containment dike

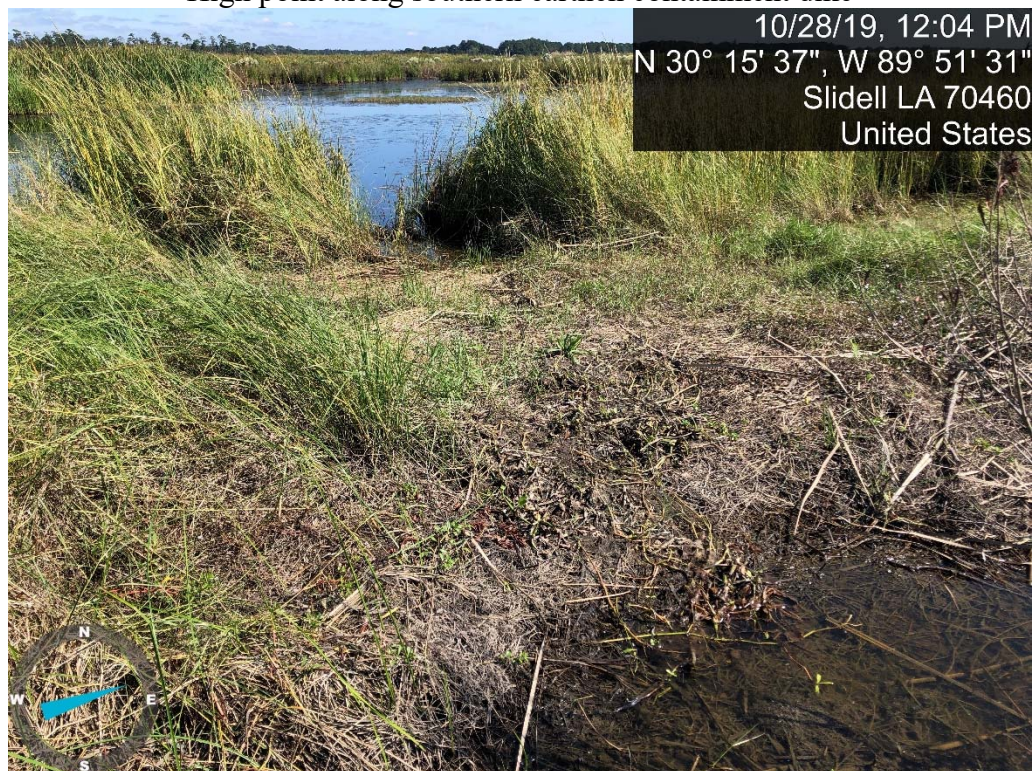
Photo 10: Marsh Creation Area 2

Earthen containment dike at the proposed gap location on the west end of MCA 2

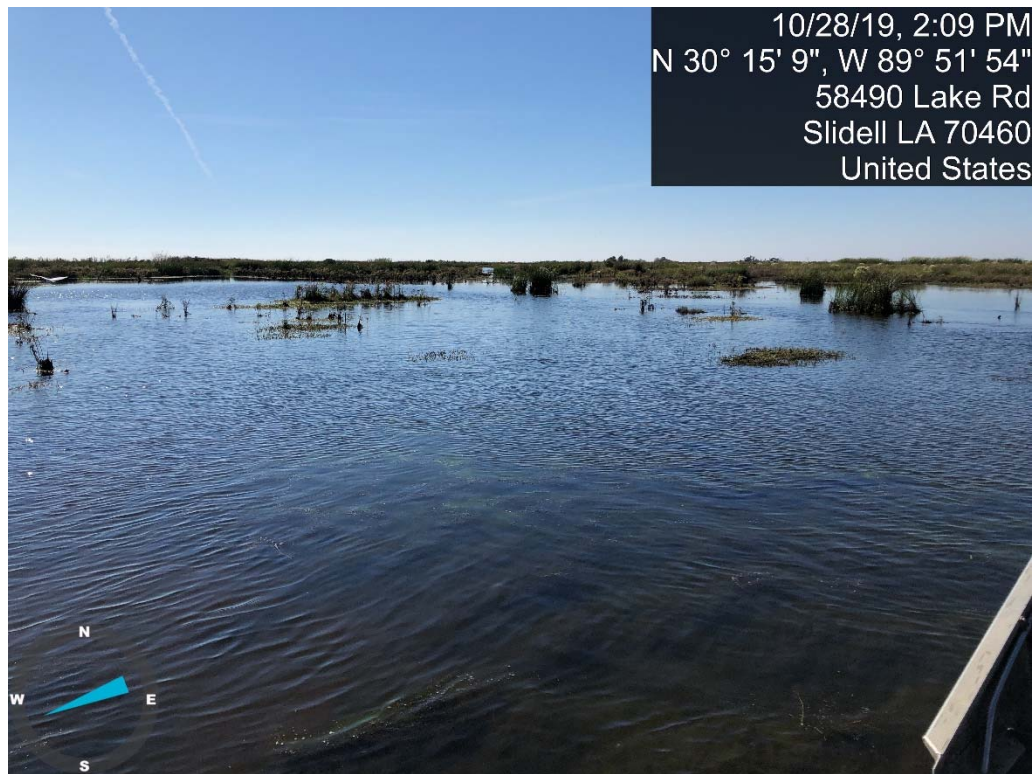
Photo 11: Marsh Creation Area 3

From visual observation, this area appeared to be about 6" deep. With the tide reading of +1.9 feet NAVD 88, the elevation here may be approximately +1.4 feet NAVD 88.

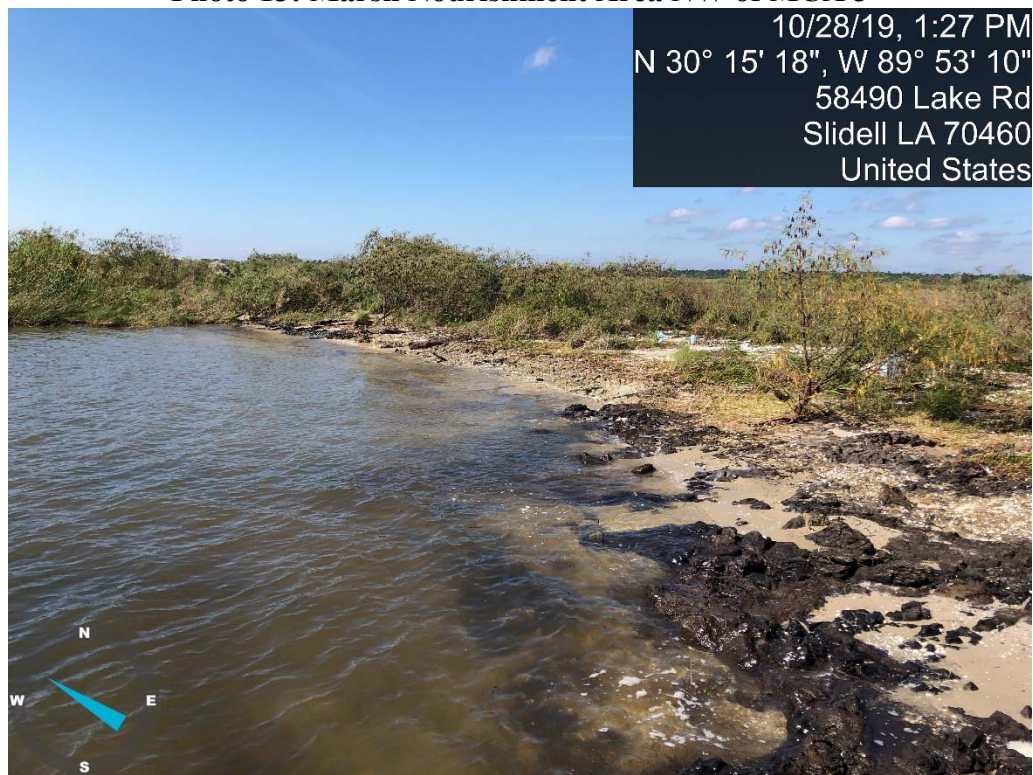
Photo 14: Marsh Creation Area 4

Fragile earthen containment dike location adjacent to Lake Pontchartrain. A breach has previously occurred here.

MCA 4	Very Good	None	14-17	End of dike degradation on western side appears to be slightly different than the location marked on the as-builts. It appears that the dike continues a couple hundred feet further than marked on the as-builts. End of dike degradation on the eastern side appears to match what is reflected in the as-builts. Previously proposed gap will be removed from plans. Per as-builts, this part of the dike has been degraded. We were not able to access the exact location because the water got too deep to continue on foot, so tidal exchange is already occurring in that area.
Uncontained Marsh Creation (SE of MCA 1)	Very Good	None	N/A	USFWS would like to plan a tidal creek in this area in the future, not as a part of the upcoming maintenance event.
Marsh Nourishment	Very Good	None	8, 13, 18	Appears to be in good condition. We observed the plantings from February which appear to be surviving.

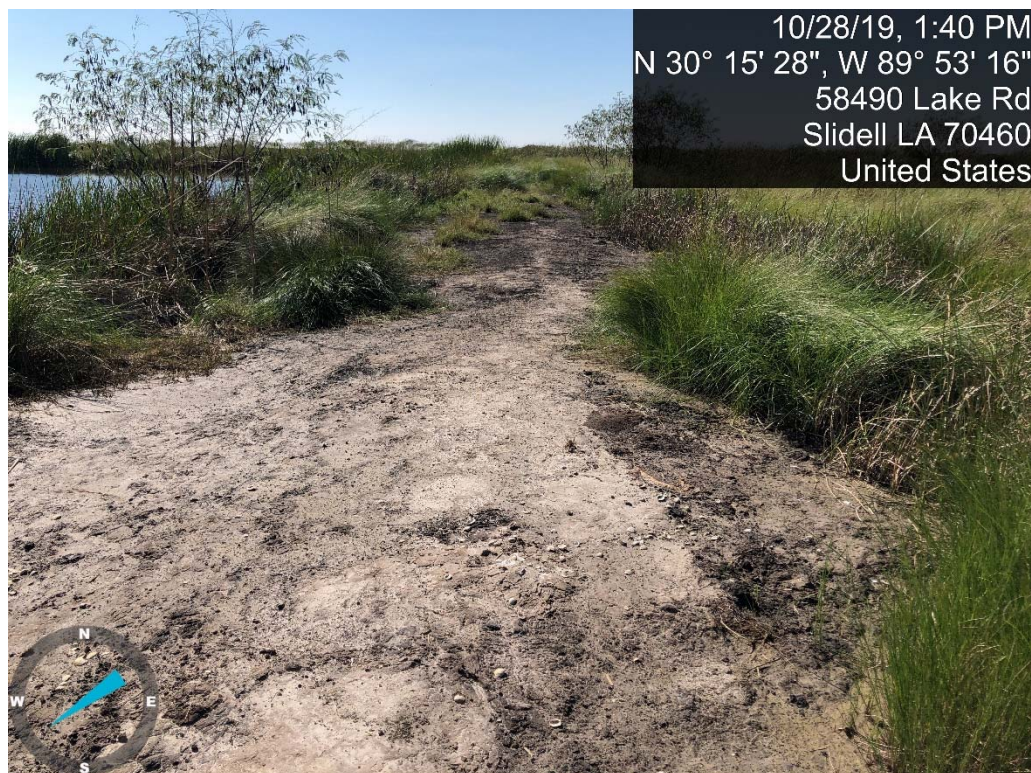
Photo 15: Marsh Creation Area 4
Earthen containment dike

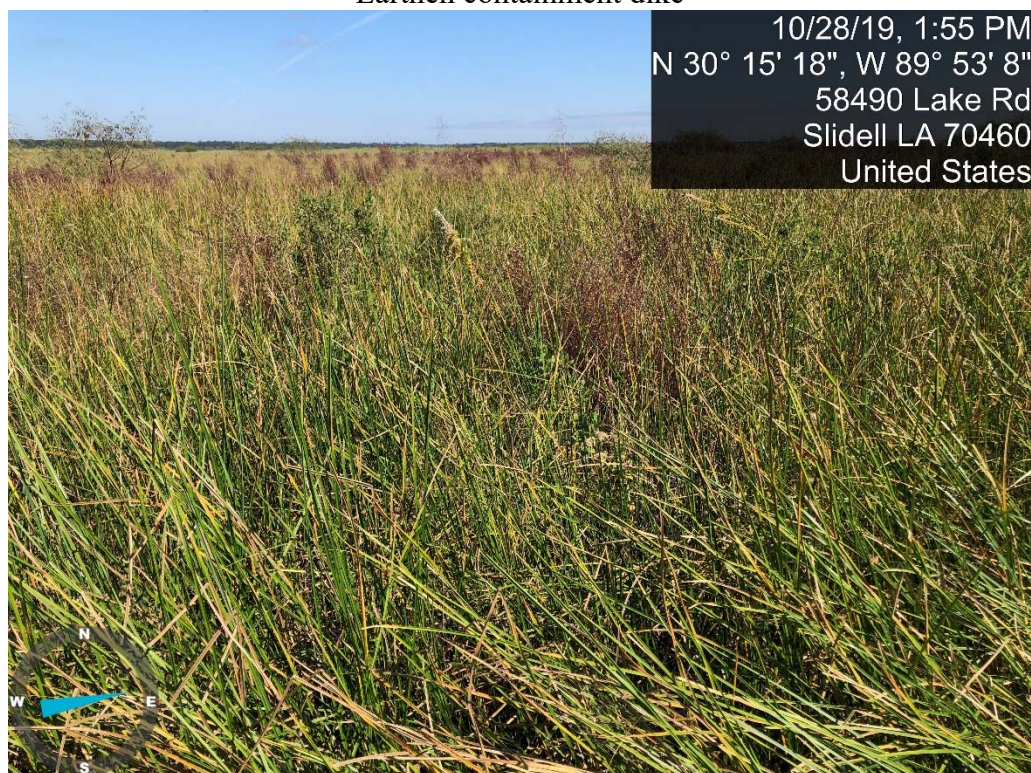
Photo 16: Marsh Creation Area 4
Healthy marsh viewed from earthen containment dike

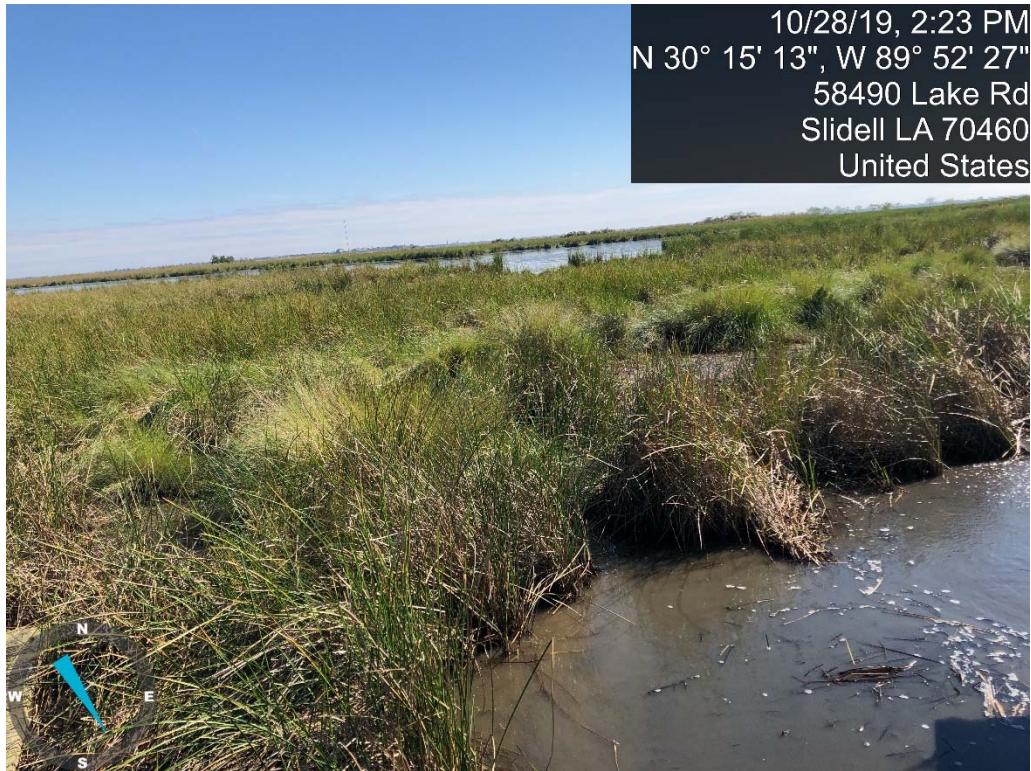
Photo 17: Marsh Creation Area 4
Earthen containment dike at the NE corner of MCA 4

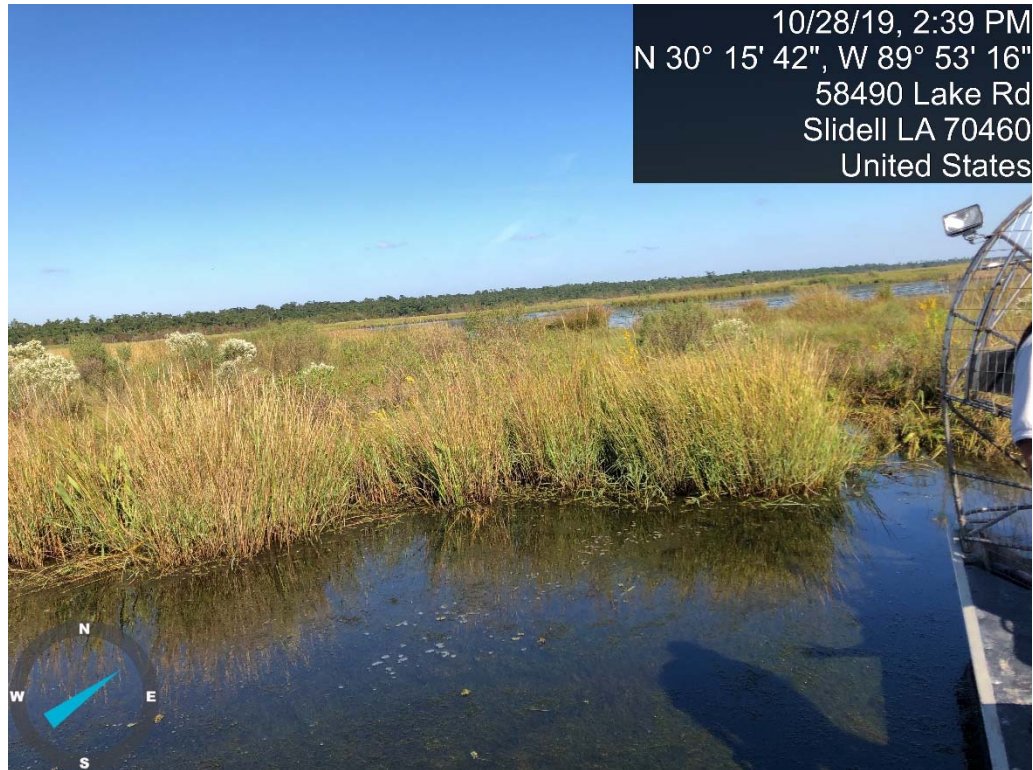
Photo 19: Goose Point / Point Platte Cell E

Location of proposed earthen containment dike gap at NE corner of cell

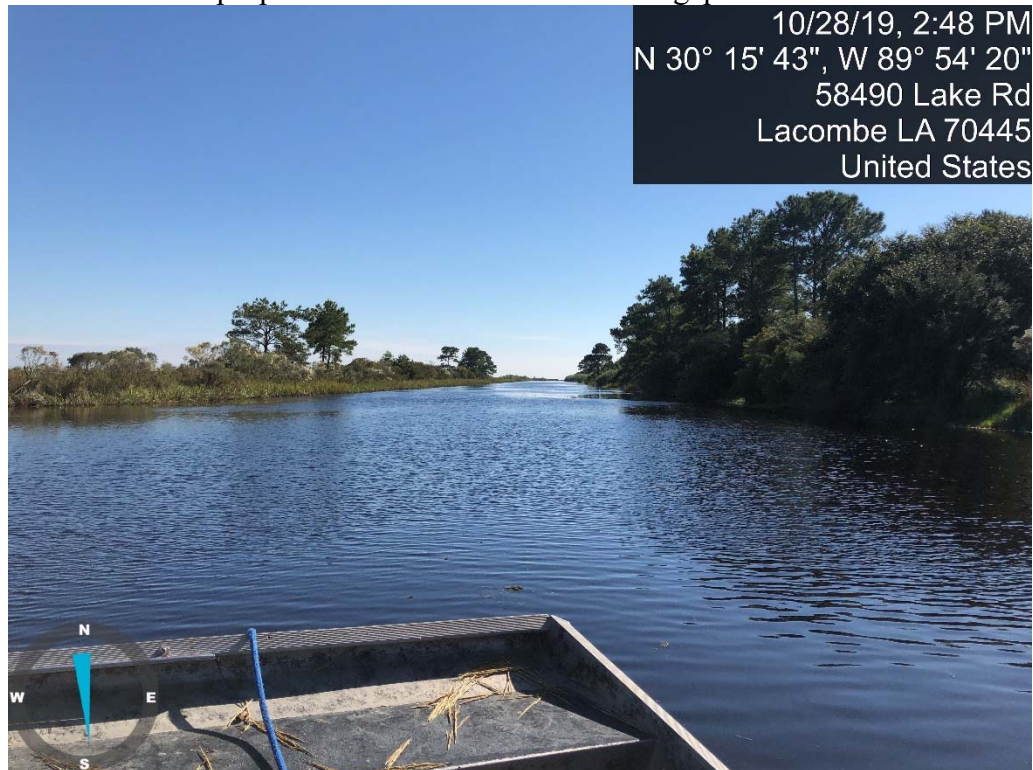
Photo 20: Southern Natural Gas Pipeline Canal

Canal is wide and deep. Equipment for the upcoming maintenance event can likely be floated across the canal with permission from pipeline operator.
