**State of Louisiana
Coastal Protection and Restoration Authority**

2019 Annual Inspection Report

Hopedale Hydrologic Restoration

State Project Number PO-0024
Priority Project List 8

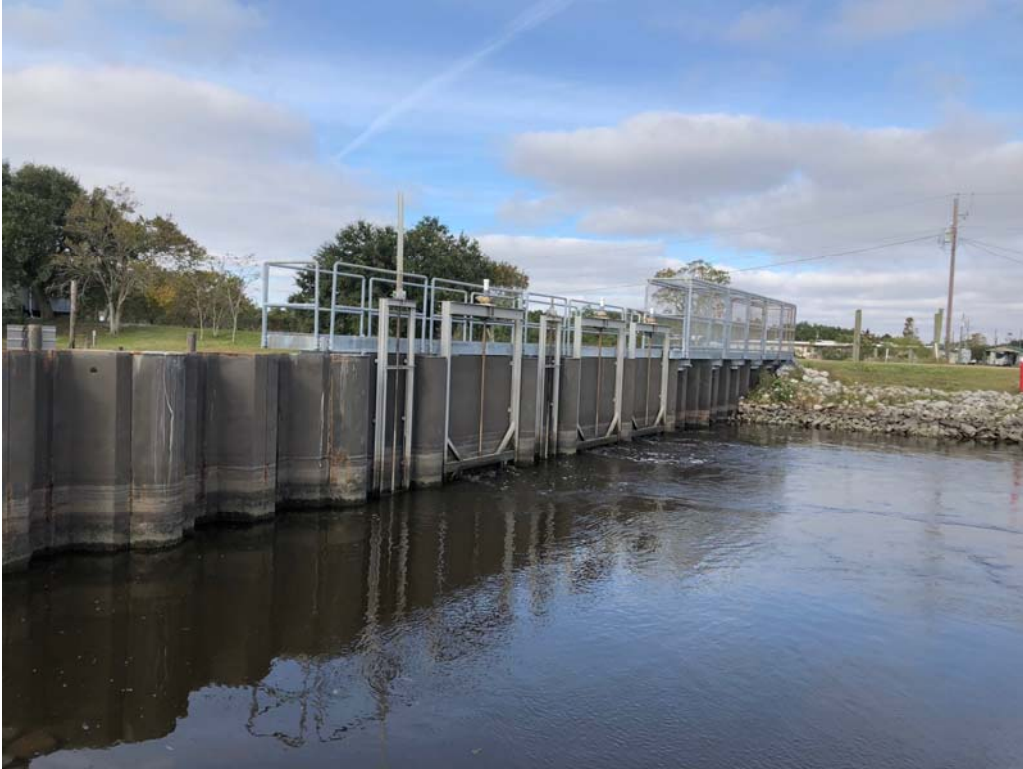
Photo 1: Structure viewed from project exterior (downstream) on southern bank

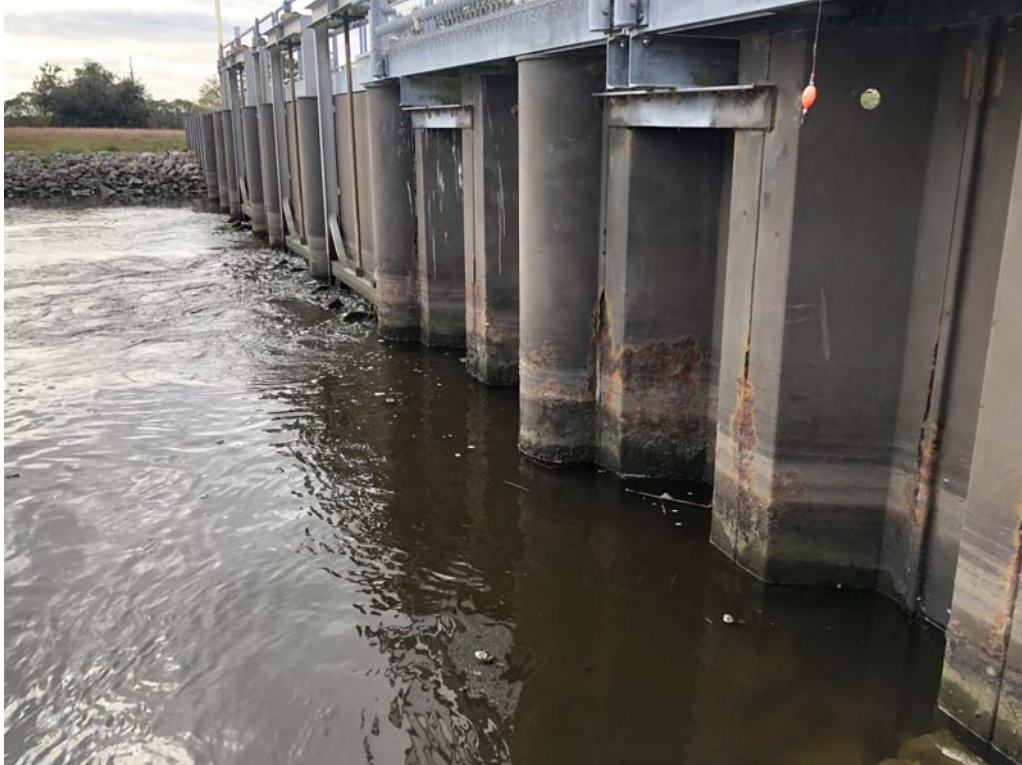
Photo 2: Structure viewed from project exterior (downstream) on northern bank

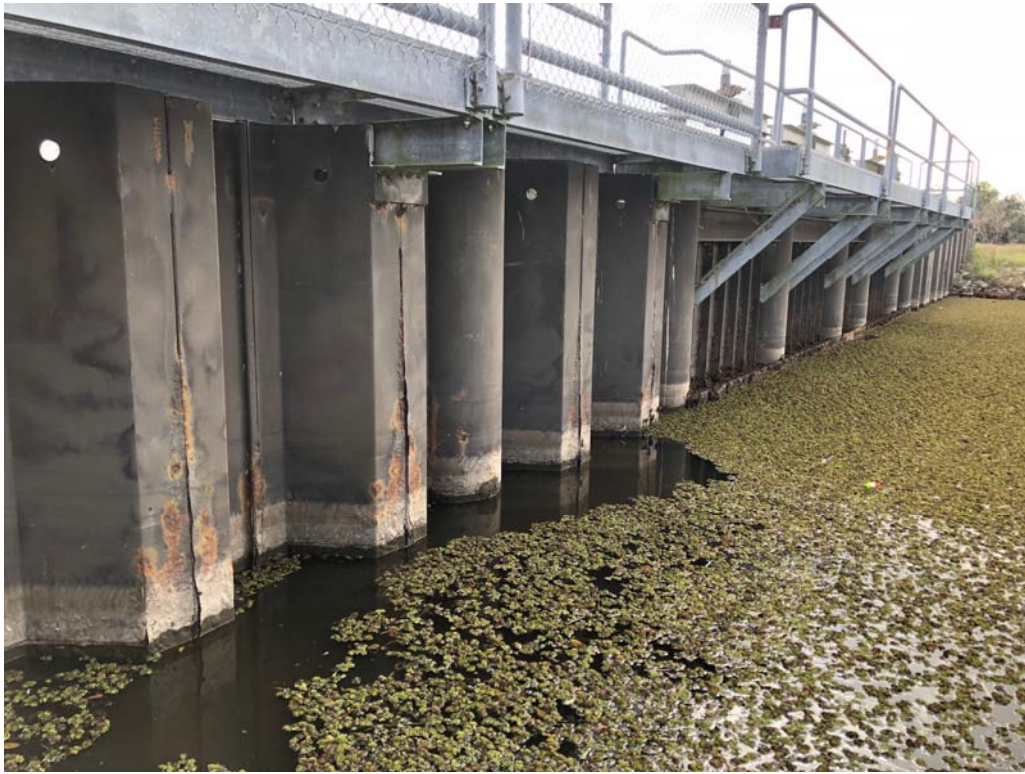
Photo 3: Structure viewed from project interior (upstream) northern bank

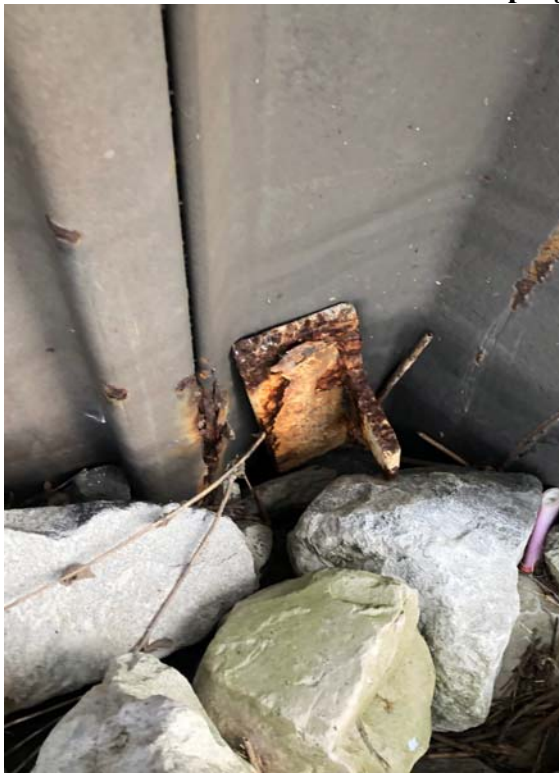
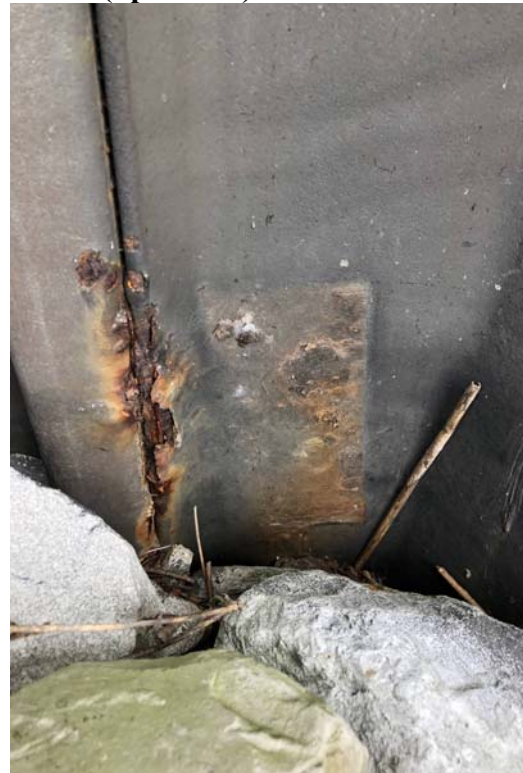
Photos 4 & 5: Fabricated metal piece was loosely attached to the sheetpile and fell off when touched. This photo is from downstream northeast bank. An identical piece was found at roughly the same location on the upstream northeast bank.
