**2020 Annual Inspection Report**

**Lake Borgne Shoreline Protection  
Project**

State Project Number PO-30  
Priority Project List 10

December 2021  
St. Bernard Parish

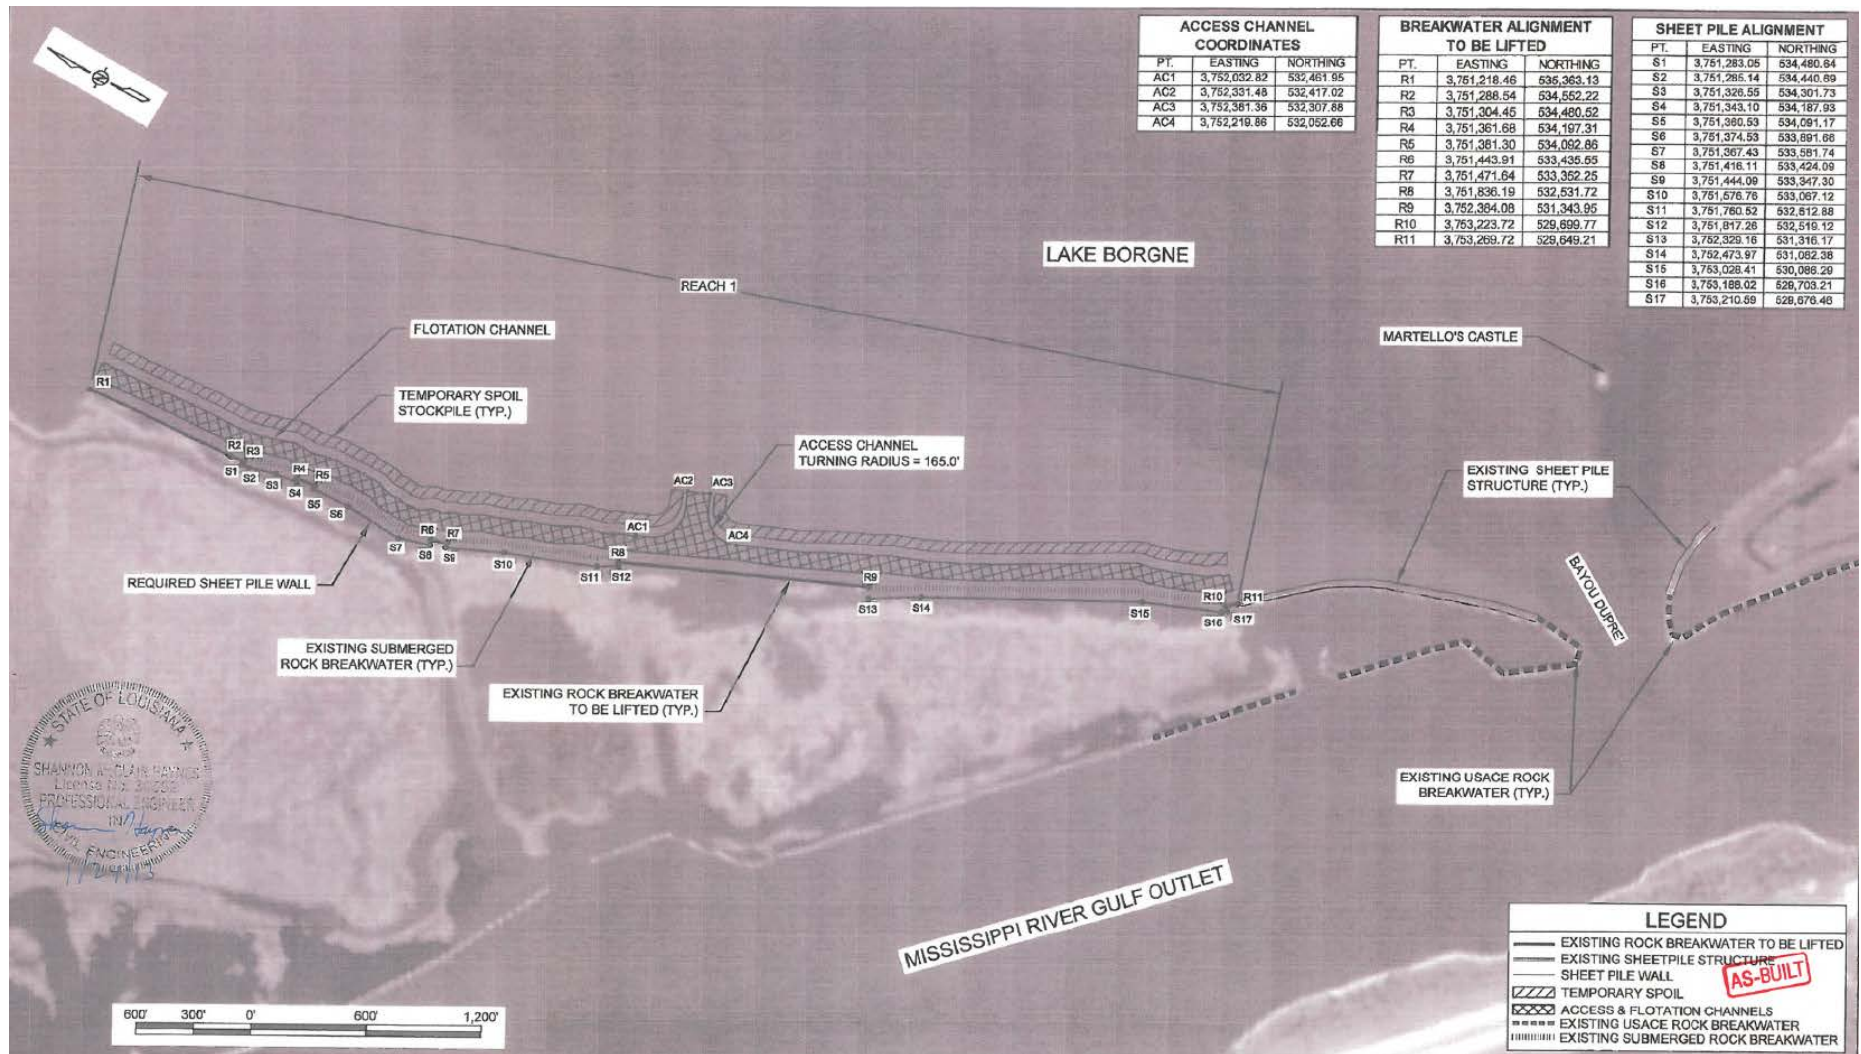
Figure 1: 2013 Maintenance Event As Built for Reach 1

- A. Breakwater Reach 1 (North of Bayou Dupre)** – There is significant deterioration of this feature, as described below from north to south. See Figure 1 for point coordinates.

Start Point	End Point	Length (LF)	Type	Condition
R1	R3	890	Rock	Good
R3	R4	290	Sheet pile	Good. Some sheets appear to be detaching from the structure. The performance of the feature does not appear to be affected.
R4	R5	110	Rock	Good
R5	R6	660	Sheet pile	This entire section is badly deteriorated. None of this section appears to be salvageable aside from the piles. A maintenance event is being planned to rehabilitate this segment.
R6	R7	90	Rock	Good
R7	R8	905	Sheet pile	Approximately 9% of the length of this segment will be able to remain, and approximately 91% of the length of this segment will need to be rehabilitated, with only the piles to remain. From north to south, the first 305 feet will need to be rehabilitated, followed by 80 feet that can remain, and the remainder of approximately 525 feet will need to be rehabilitated. A maintenance event is being planned to repair this segment.
R8	R9	1310	Rock	This segment has experienced some settlement.

R9	R10	1850	Sheet pile	Approximately 40% of the length of this segment will be able to remain, and approximately 60% of the length of this segment will need to be rehabilitated, with only the piles to remain. From north to south, the first 110 feet can remain, followed by 180 feet that will need to be rehabilitated, followed by 310 feet that can remain, followed by 330 feet that will need to be rehabilitated, followed by 200 feet that can remain, followed by 180 feet that will need to be rehabilitated, followed by 110 feet that can remain, and the remainder of the approximately 420 feet will need to be rehabilitated. A maintenance event is being planned to rehabilitate this segment.

CPRA is currently planning a maintenance event to rehabilitate segments along the sheet pile wall in Reach 1, replace the failed tie rod on the double sheet pile wall breakwater, and enhance the remaining intact waler splices by replacing hardware with more durable alternatives.

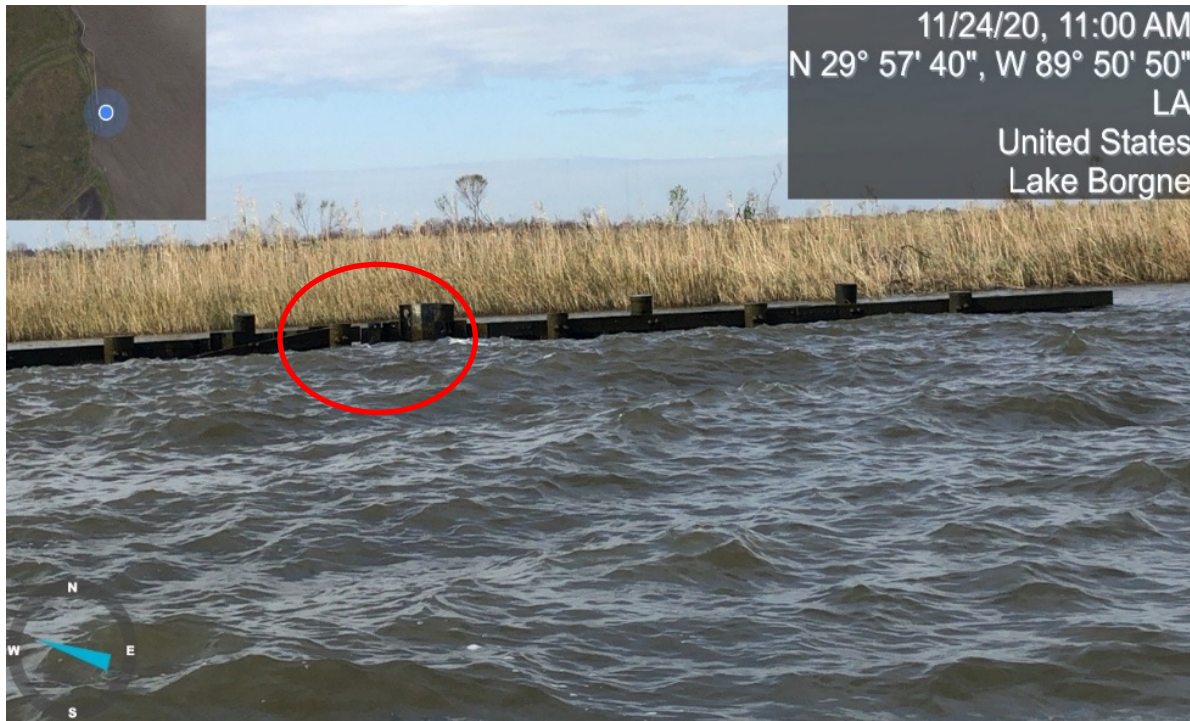
**Photo 1**

Example of Vinyl sheet pile wall that is still pinned at its bottom edge but detached at its top edge. This photo was taken near the most northwestern extent of PO-30 Reach 1.

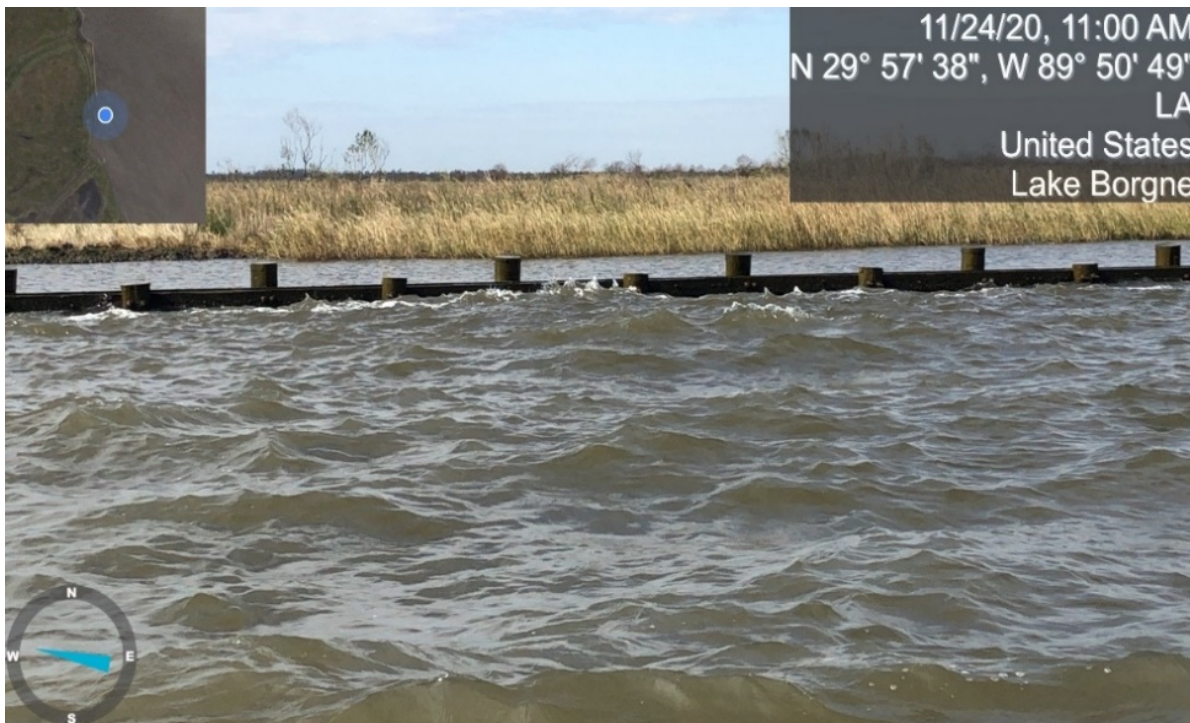
**Photo 2**

Example of a section of sheet pile wall that is fully intact

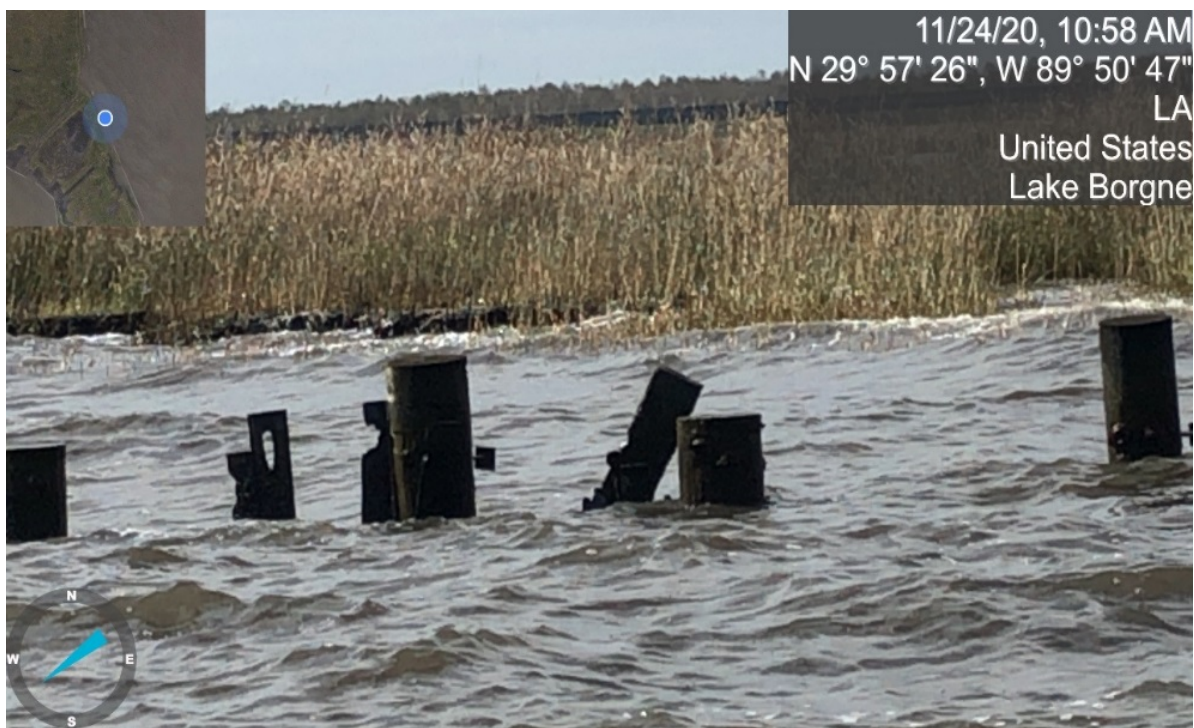
**Photo 3**

Battered section of PO-30 with displaced water depicted as well as a clear depiction of a degraded vinyl sheet pile.

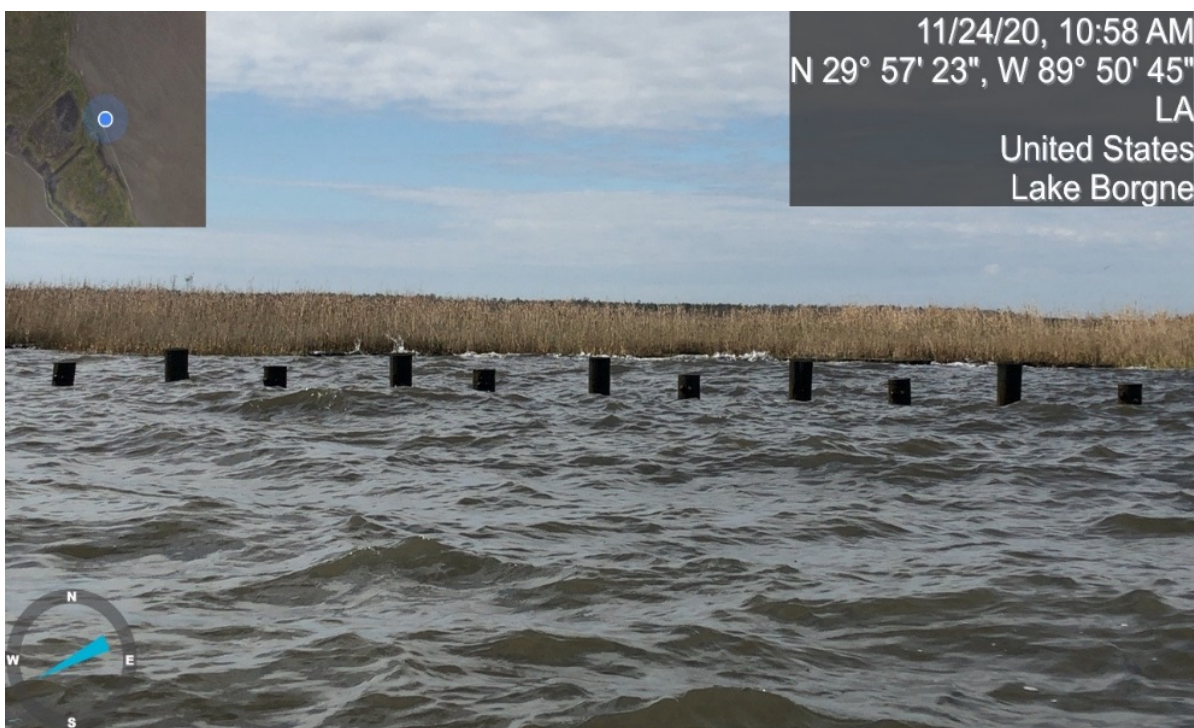
**Photo 4**

Section of sheet pile wall where only the timber piles remain standing

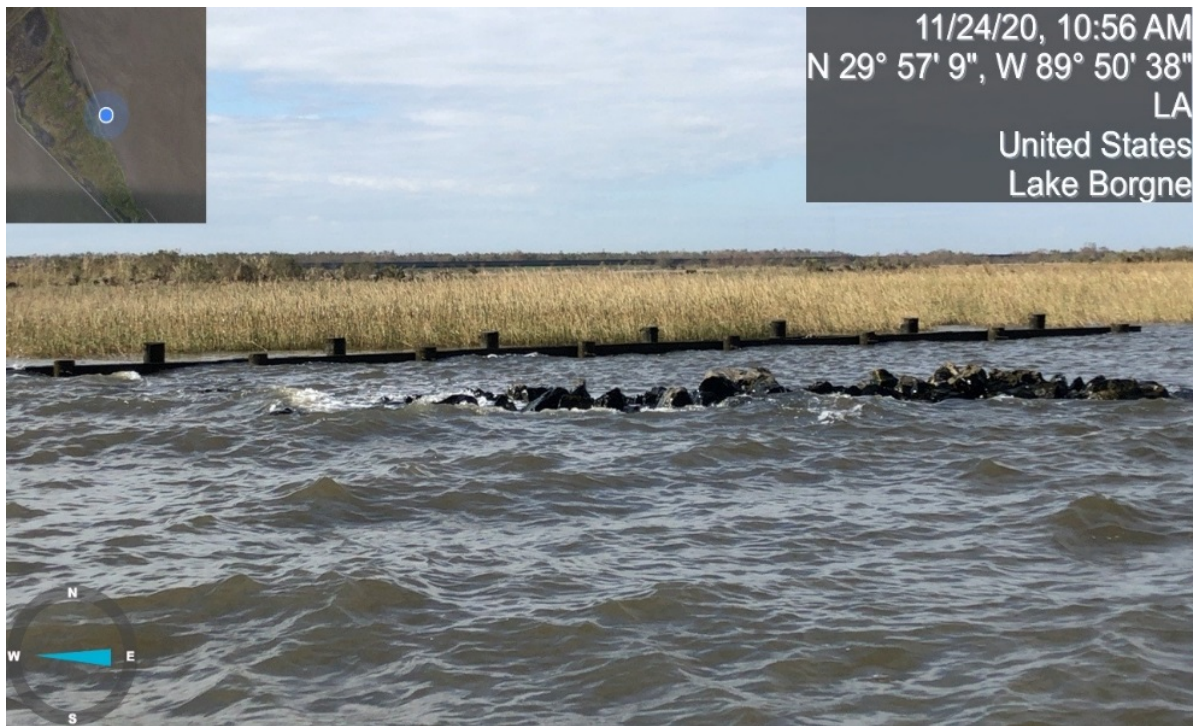
**Photo 5**

Another section of intact sheet pile wall occurring behind a section of existing rock shoreline protection.

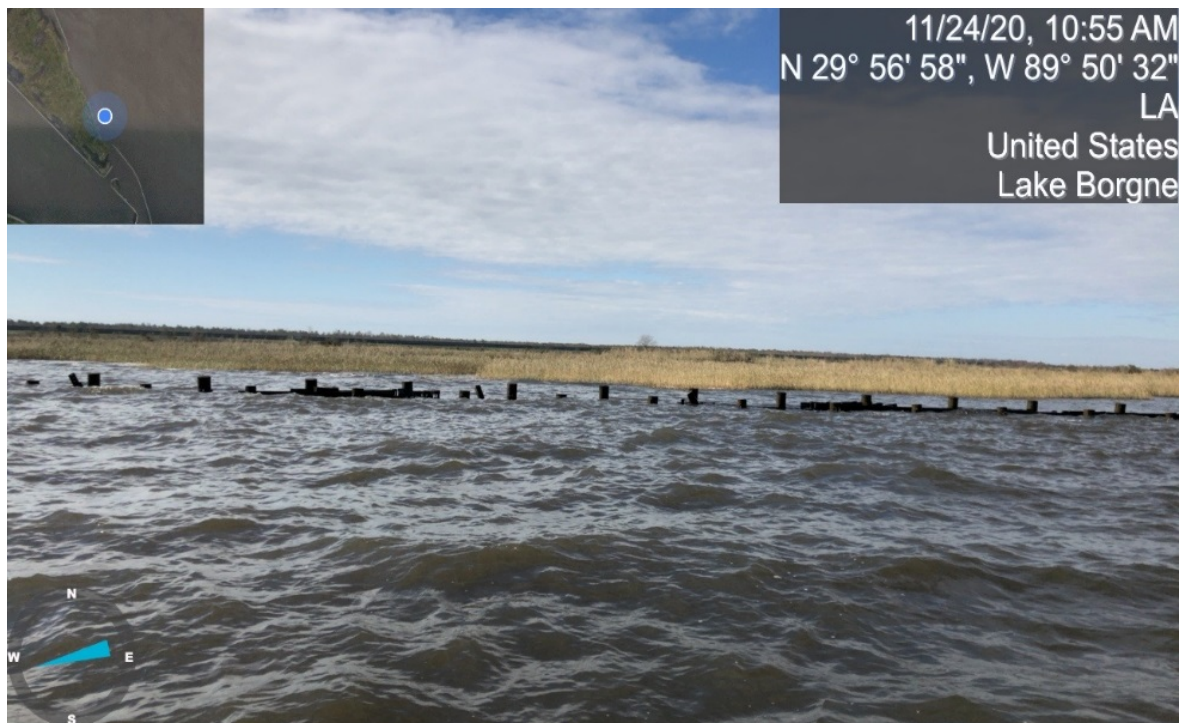
**Photo 6**

This depicts a portion of the section of sheet pile wall that suffered additional damage due to Hurricane Zeta.

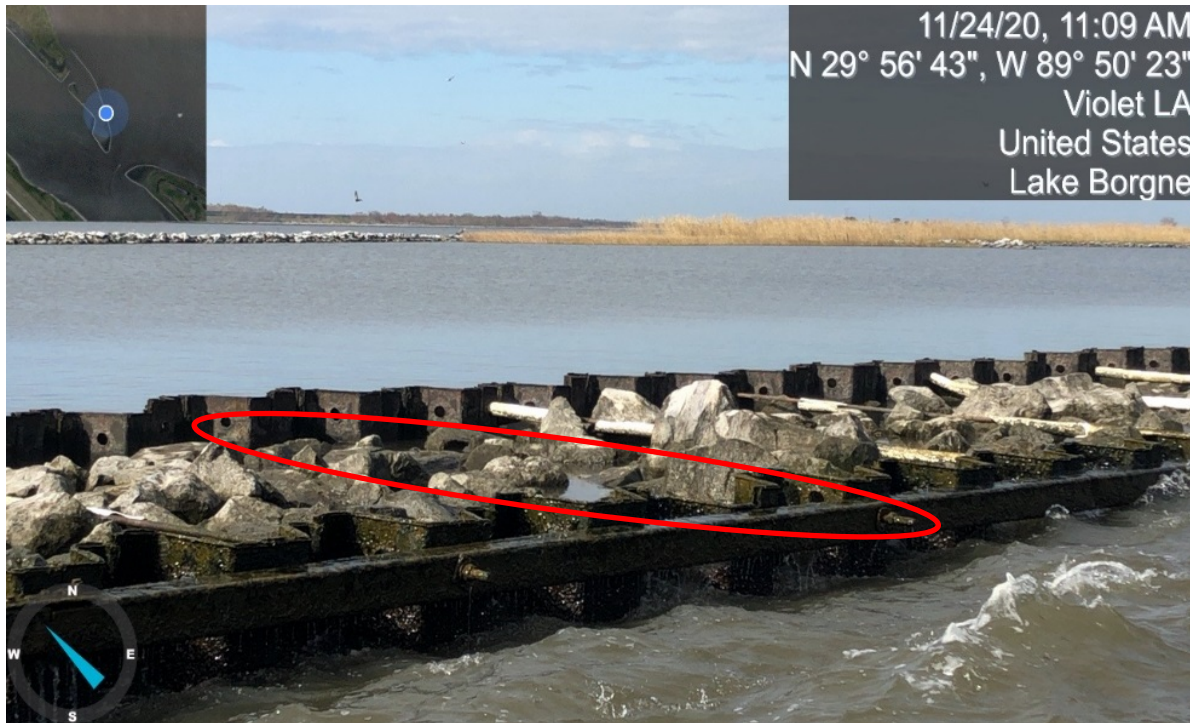
**Photo 7**

This photo depicts the double sheet pile wall aspect of PO-30. It can be seen that there is a missing tie-rod that was used for lateral support between the horizontal walers.

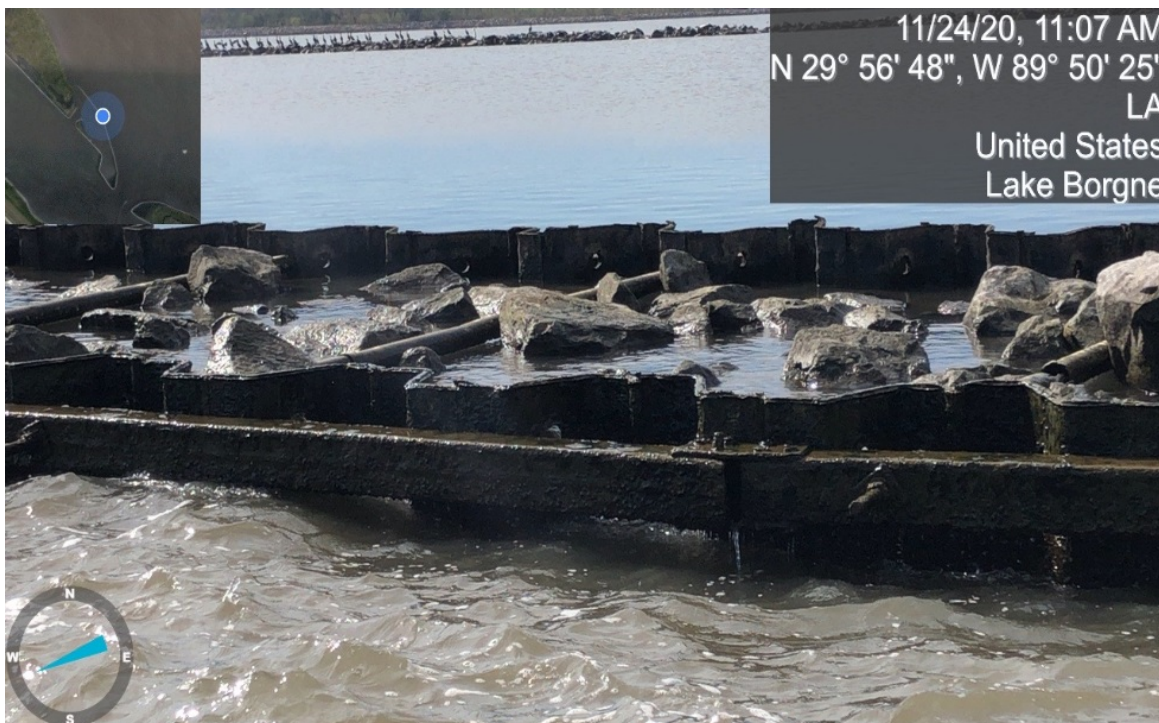
**Photo 8**

Zoomed view of the double sheet pile wall consisting of two steel sheet pile walls braced on their respective outside faces by horizontal walers. The walers are then tied together by tie-rods sheathed in PVC pipe. Rock was then placed within the walls after the structure was constructed.

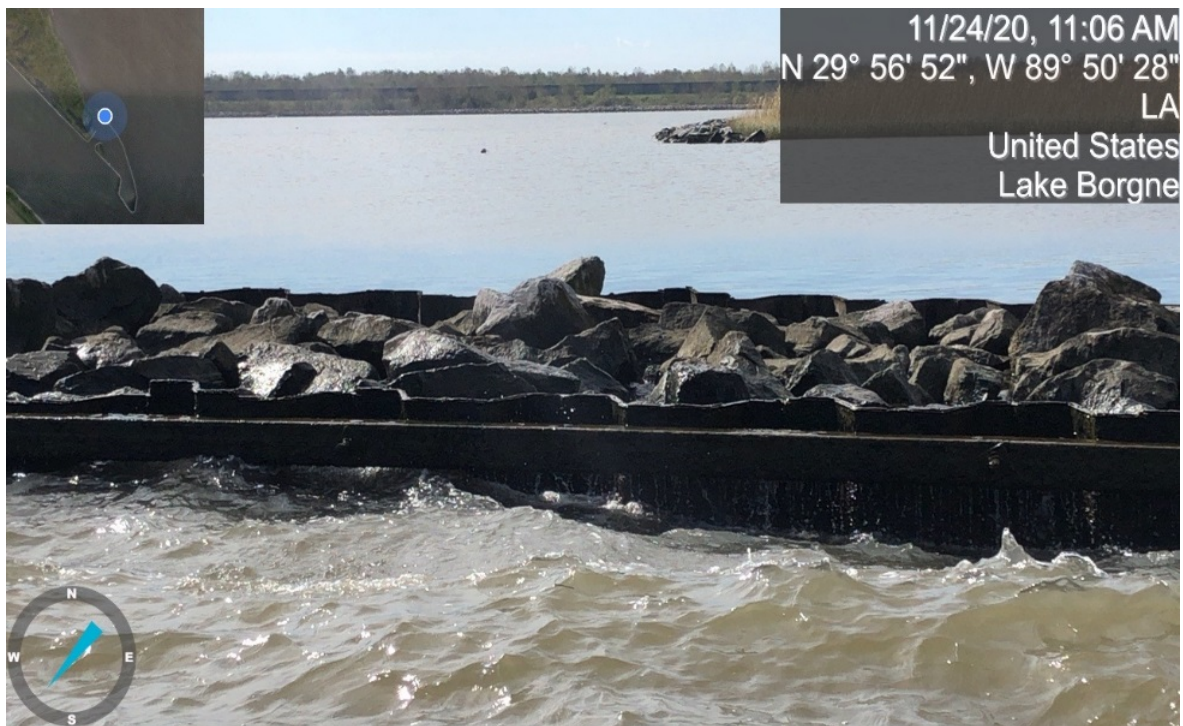
**Photo 9**

Section of double sheet pile wall where the tie-rods are completely covered by rock, making it difficult to locate damaged or missing tie rods.
