**State of Louisiana  
Coastal Protection and Restoration Authority**

**2021 Annual Inspection Report**

**Lake Borgne Shoreline Protection  
Project**

State Project Number PO-30  
Priority Project List 10

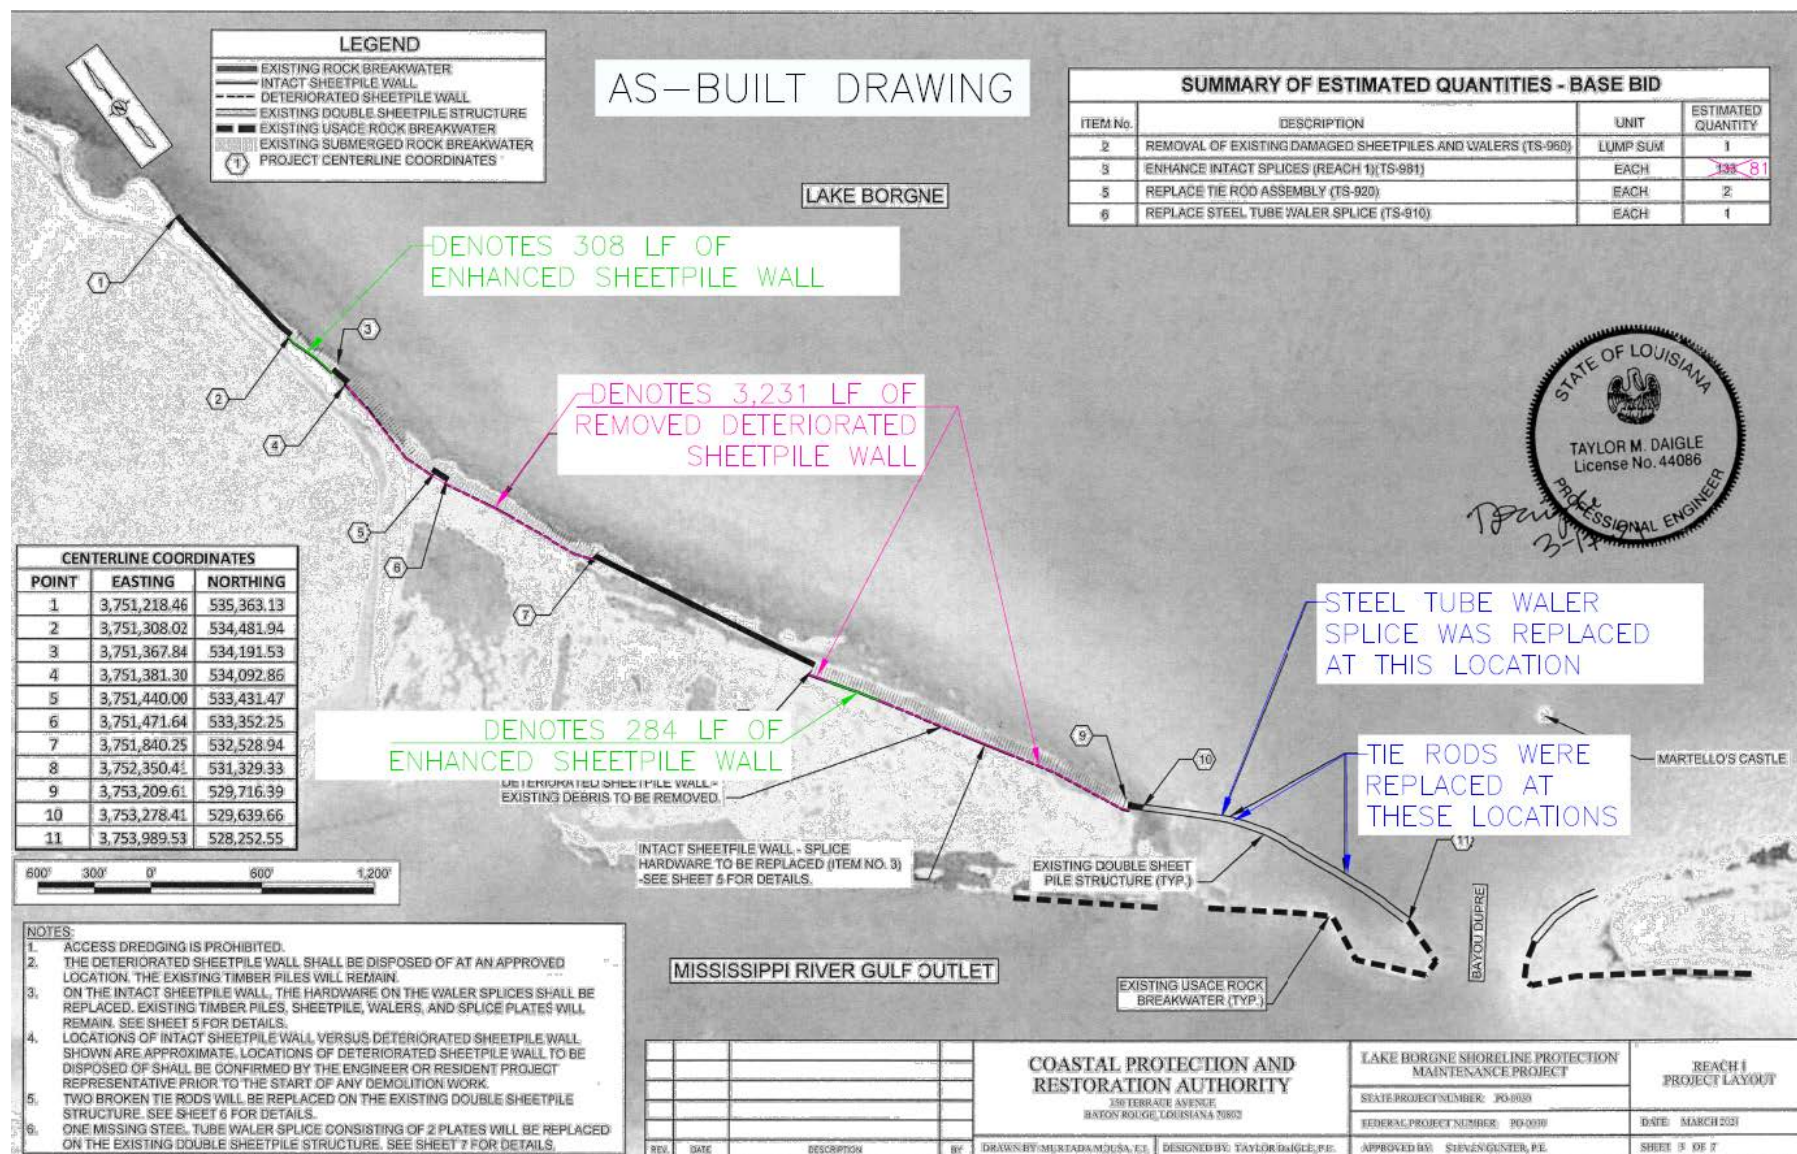
Figure 1: 2021 Maintenance Event As Built for Reach 1

The composite sheet pile wall that was installed during the 2014 maintenance event was first noted to have damage during the 2016 annual inspection. Over the next five years, the composite sheet pile wall continued to deteriorate, creating the need for a maintenance event. Due to budget limitations that prevented the project team from replacing the damaged wall, the scope of the maintenance event included the removal of the damaged wall (all components except for the timber piles which may be used to reinstall shoreline protection if funding becomes available), enhancing the splice hardware on the intact wall, replacing two tie rods on the double steel sheet pile structure, and replacing one steel tube waler splice on the double steel sheet pile structure. The as-built drawing for Reach 1 is included in Figure 1. The maintenance project was accepted on October 12, 2021.

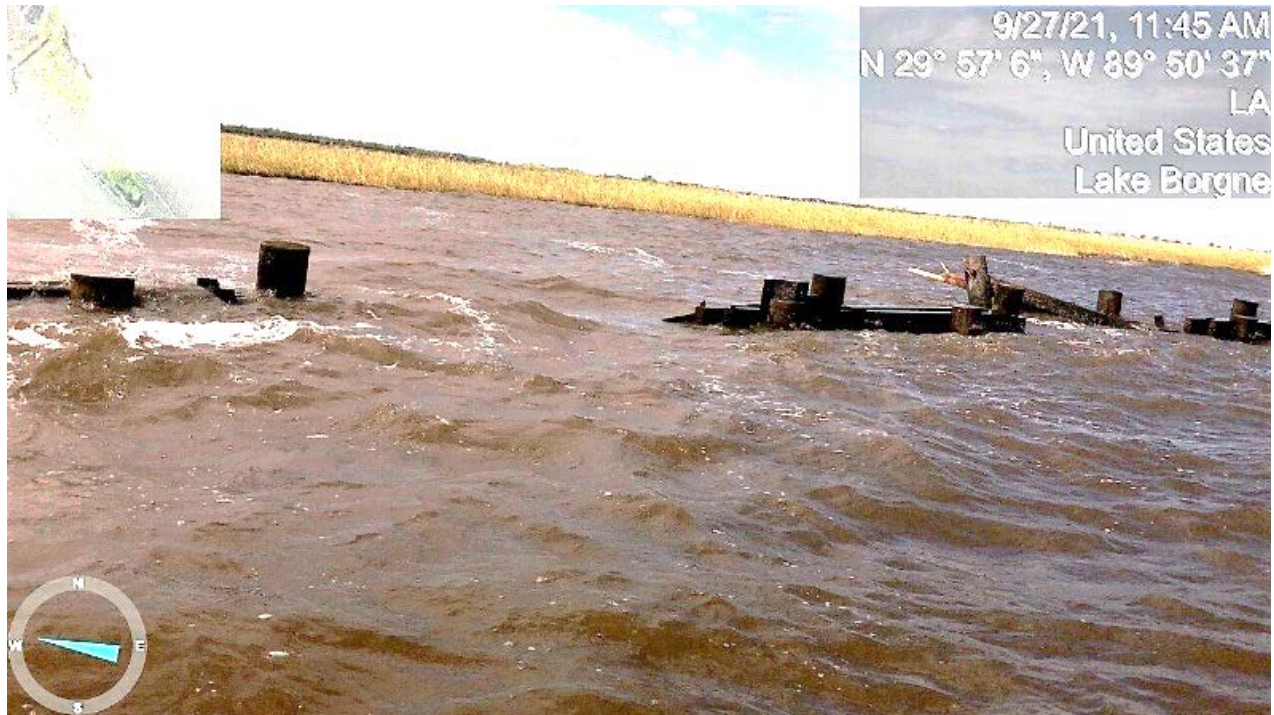
**Photo 1: Reach 1**

- A. Breakwater Reach 1 (North of Bayou Dupre)** – Localized damage was noted in three (3) locations as a result of Hurricane Ida (August 2021). It appears that a vessel or debris struck the composite sheet pile wall at these locations. Aside from those three locations, the recently enhanced composite sheet pile wall appears to be in good condition. The areas that were removed during the maintenance event are no longer functioning as a breakwater. The rock breakwater has experienced some settlement but is in generally good condition.

Damage Location#1 – 40' long at 29°57'6", -89°50'37" – During Hurricane Ida, something appears to have struck the structure here. Approximately 40' of the structure should be removed at this location (measured from the last good pile on the left side of the photo to the second to last pile on the right side of the photo – this includes a stretch of about 15' in between the two gaps caused by the collision).

No immediate repairs are planned. The locations damaged during Hurricane Ida will be considered for repair later in the project life based on recommendations from CPRA and concurrence from EPA.

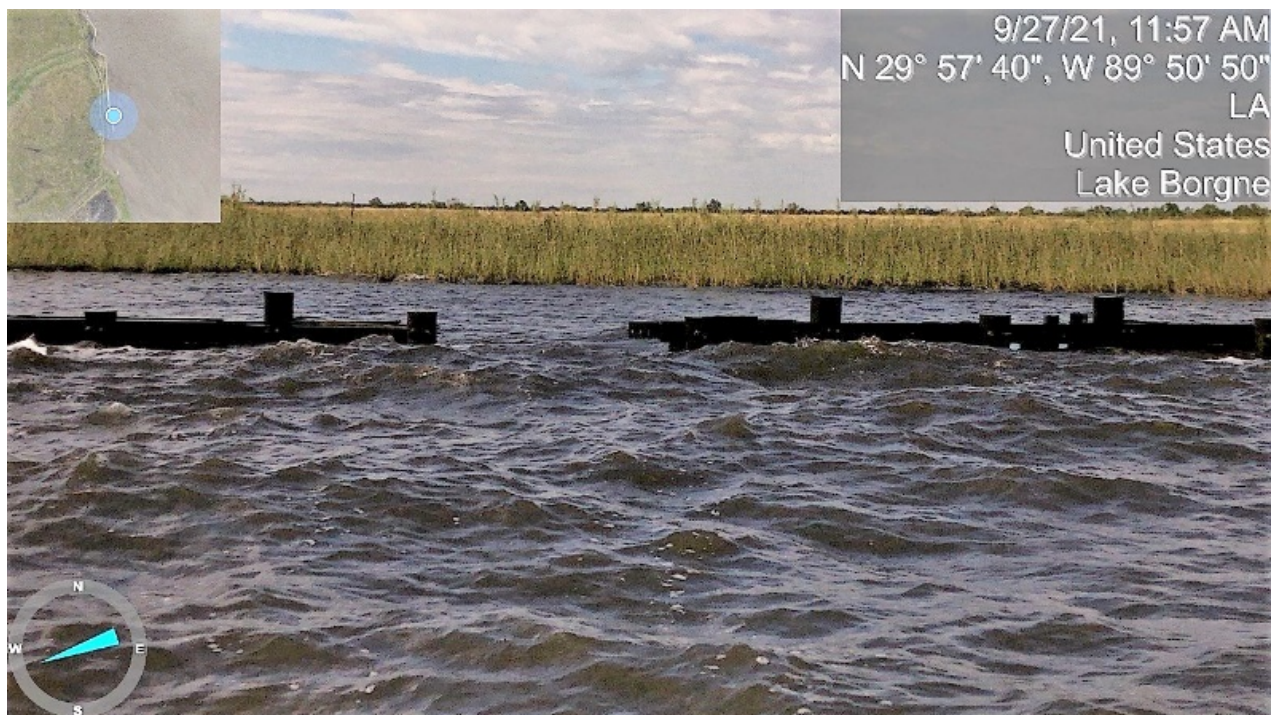
**Photo 2: Reach 1**

Damage Location #2 – 10' long at 29°57'40", -89°50'50" – During Hurricane Ida, something appears to have struck the structure here. Approximately 10' of the structure should eventually be removed at this location (measured as the gap between the two portions of the structure in good condition).

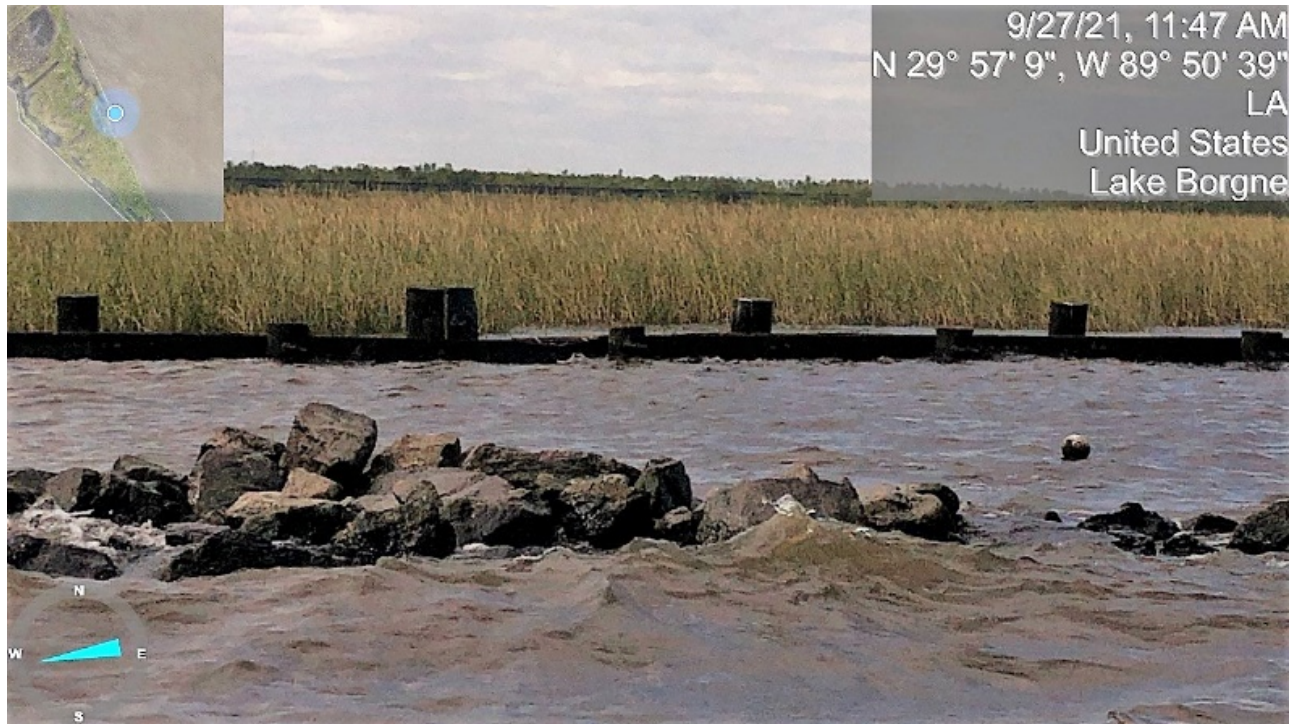
**Photo 3: Reach 1**

Damage Location #3 – 29°57'9", -89°50'39" – Some more minor damage was noted at this location. It is difficult to see in this photo, but the damaged location is near the center/left of this photo. A repair is feasible here rather than removal of the structure.

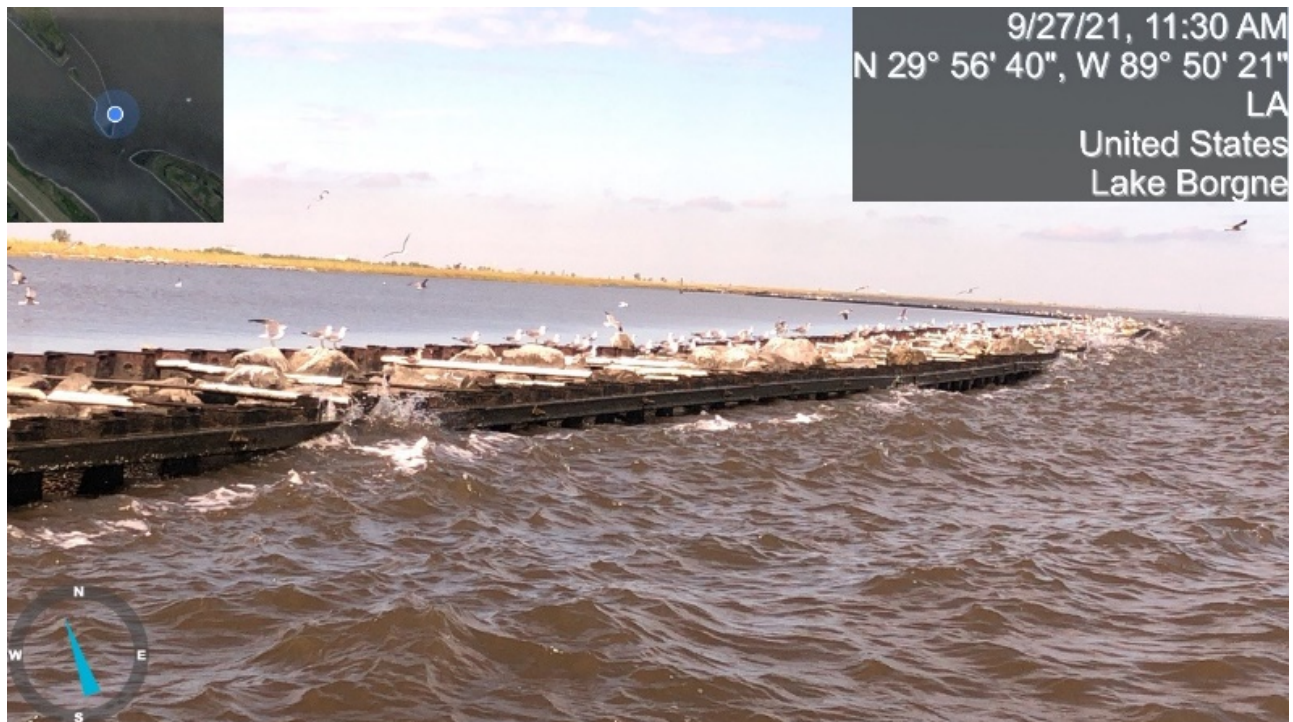
**Photo 4: Reach 1**

Double steel sheet pile structure appears to be in good condition.

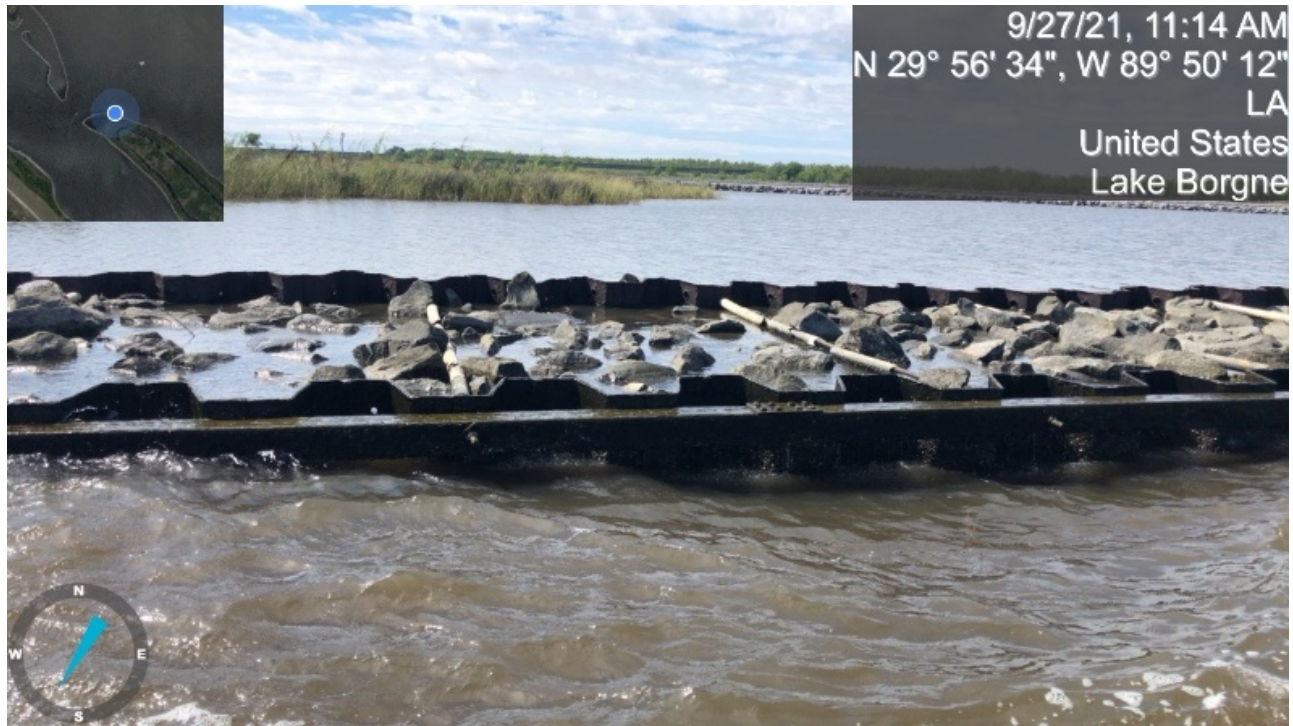
**Photo 5: Reach 2**

Double steel sheet pile structure appears to be in good condition.

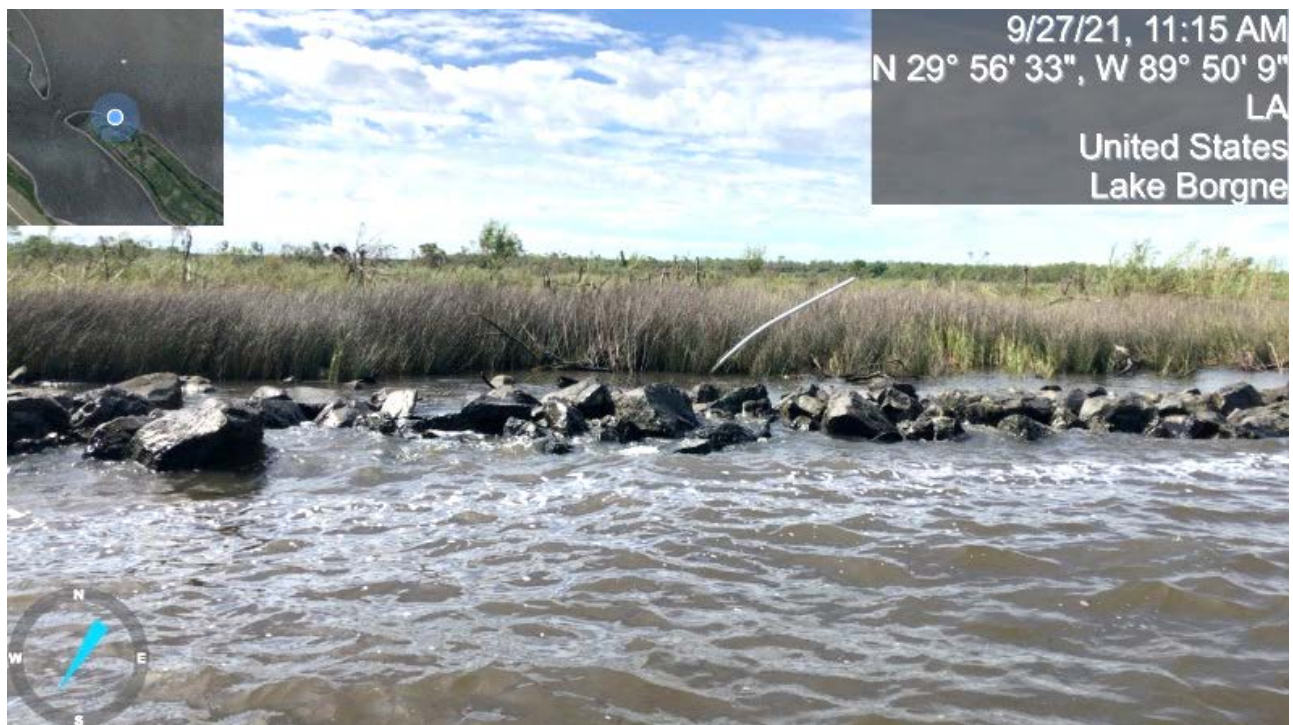
**Photo 6: Reach 2**

Rocks appear to be in generally good condition.

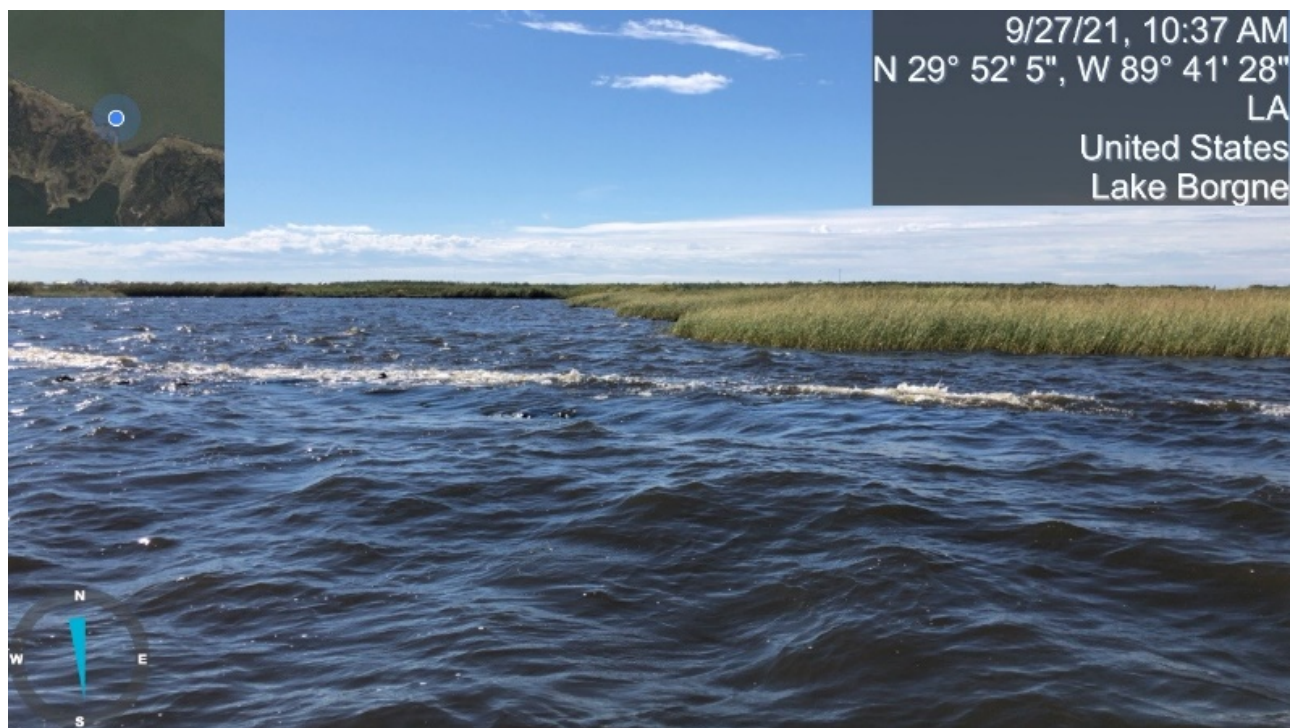
**Photo 7: Reach 3**

Some rocks are low (as shown in this photo), but generally the rocks in Reach 3 appear to be in good condition.

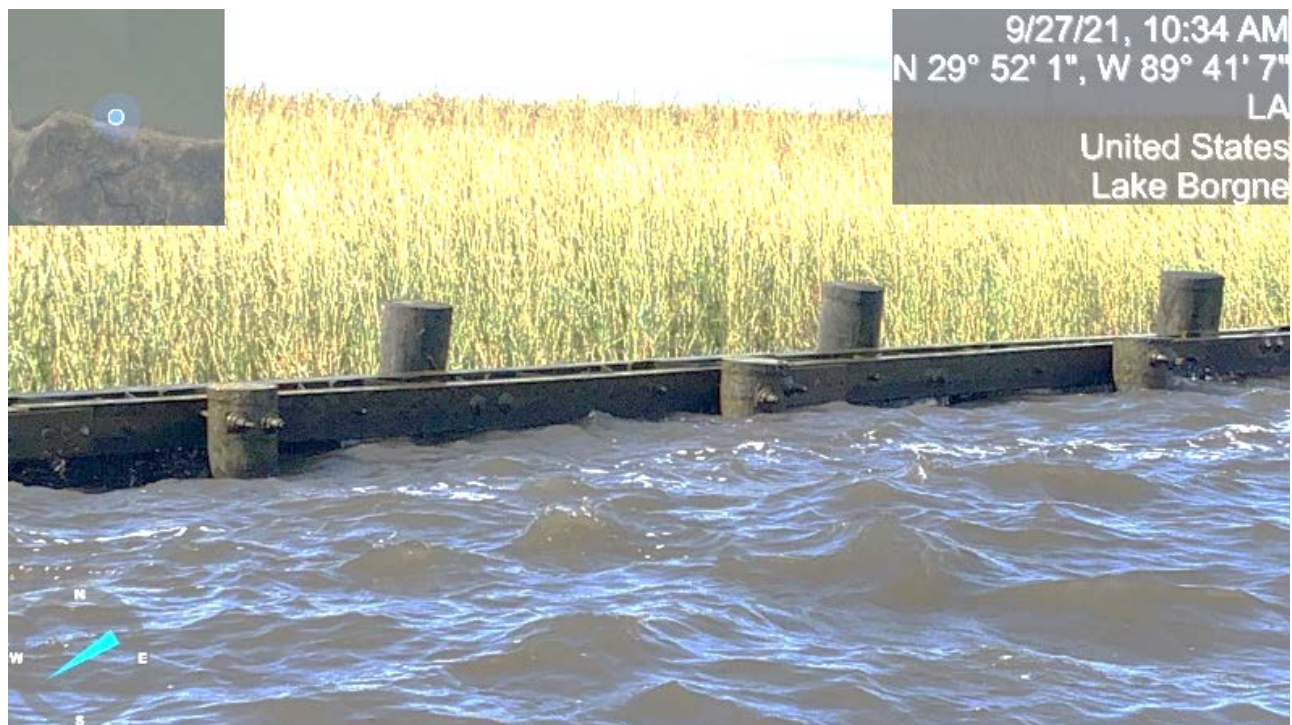
**Photo 8: Reach 3**

Composite sheet pile wall appears to be in generally good condition.

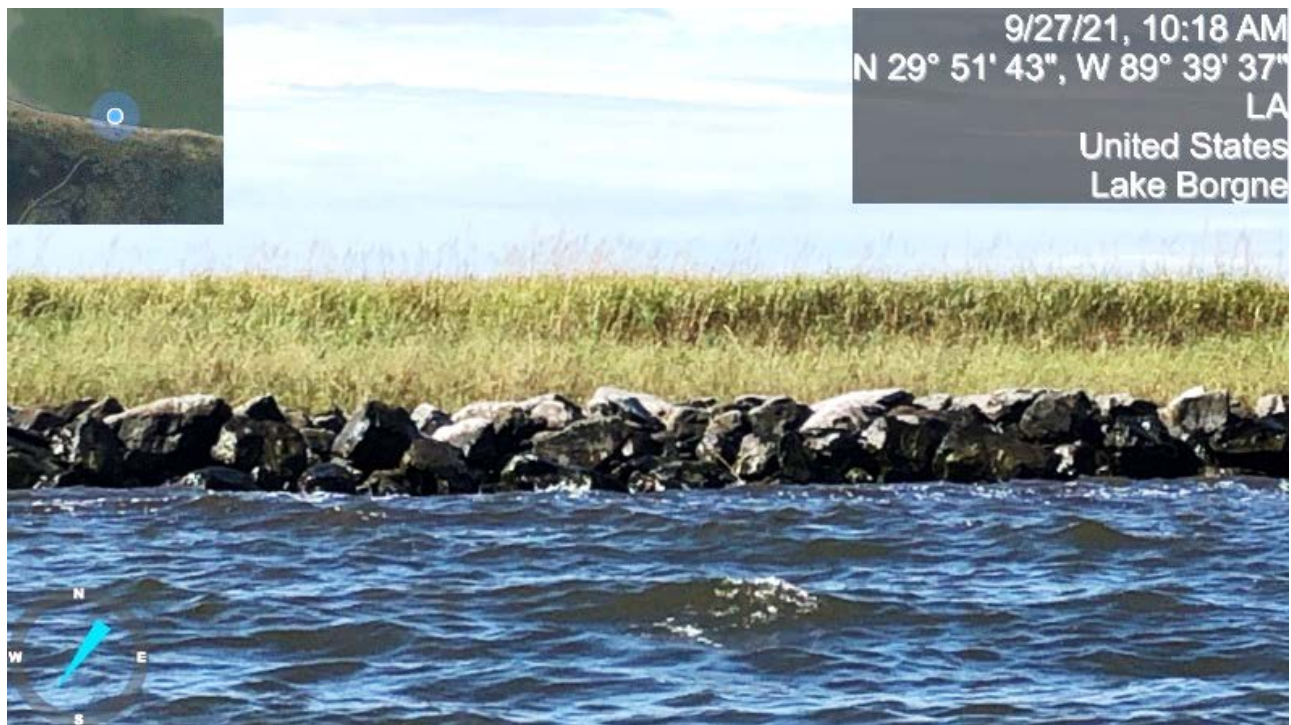
**Photo 9: Reach 4**  
Rocks appear to be in generally good condition.
