**State of Louisiana
Coastal Protection and Restoration Authority**

2022 Annual Inspection Report

**Lake Borgne Shoreline Protection
Project**

State Project Number PO-30
Priority Project List 10

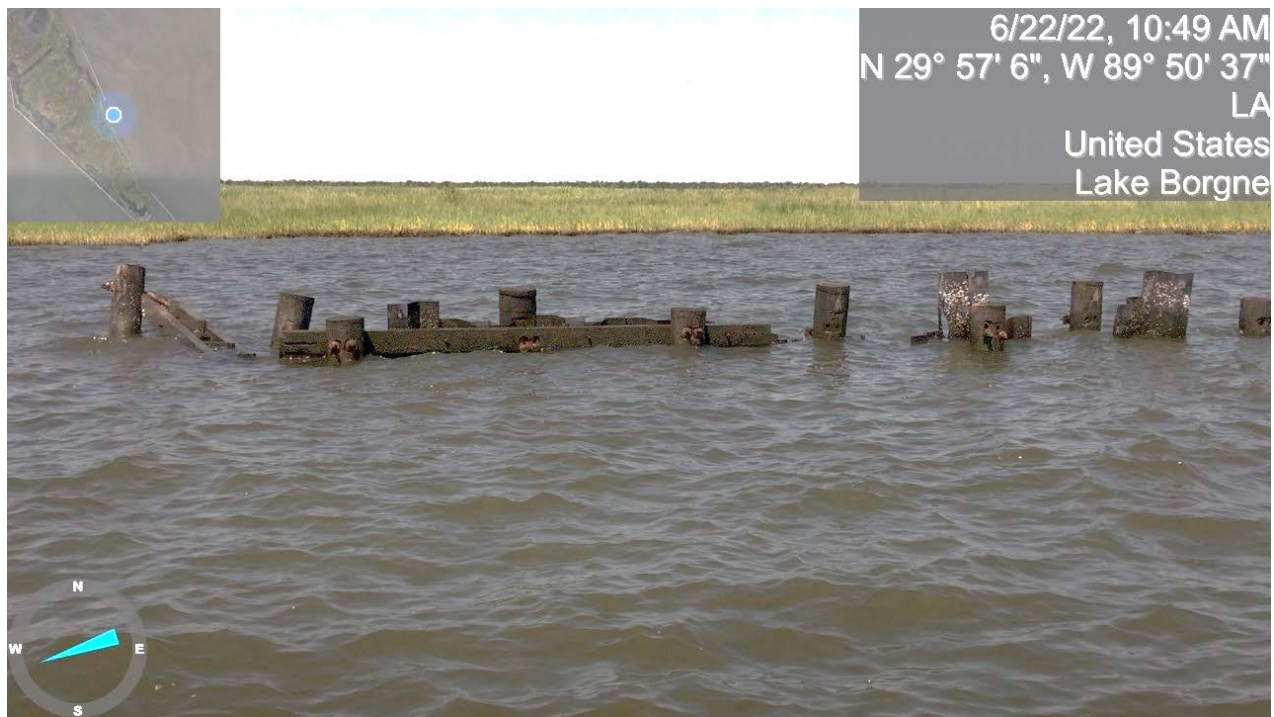
Photo 1: Reach 1

- A. Breakwater Reach 1 (North of Bayou Dupre)** – Along the composite sheetpile alignment, localized damage was noted in three (3) locations as a result of Hurricane Ida (August 2021). It appears that a vessel or debris struck the composite sheet pile wall at these locations. Since the 2021 inspection, two of the three damaged locations from Hurricane Ida have experienced further deterioration. In addition, one splice plate was observed to be non-functional (missing all 3 bolts on one side), and damage was noted at the northern extent of the sheetpile. In all other locations, the recently enhanced composite sheet pile wall is functioning. The areas that were removed during the maintenance event are no longer functioning as a breakwater. The rock breakwater has experienced some settlement but is in generally good condition.

Northern side of Damage Location #1 – 29°57'6", -89°50'37" – During Hurricane Ida, something appears to have struck the structure here. This location has experienced further damage since the 2021 post-Ida inspection.

CPRA recommends an end-of-life maintenance event to include the removal of all remaining components of the composite sheetpile wall, a rock lift in selected low areas, and addressing the corrosion on the steel double sheet pile wall breakwater. A budget increase would likely be required for this final maintenance event.

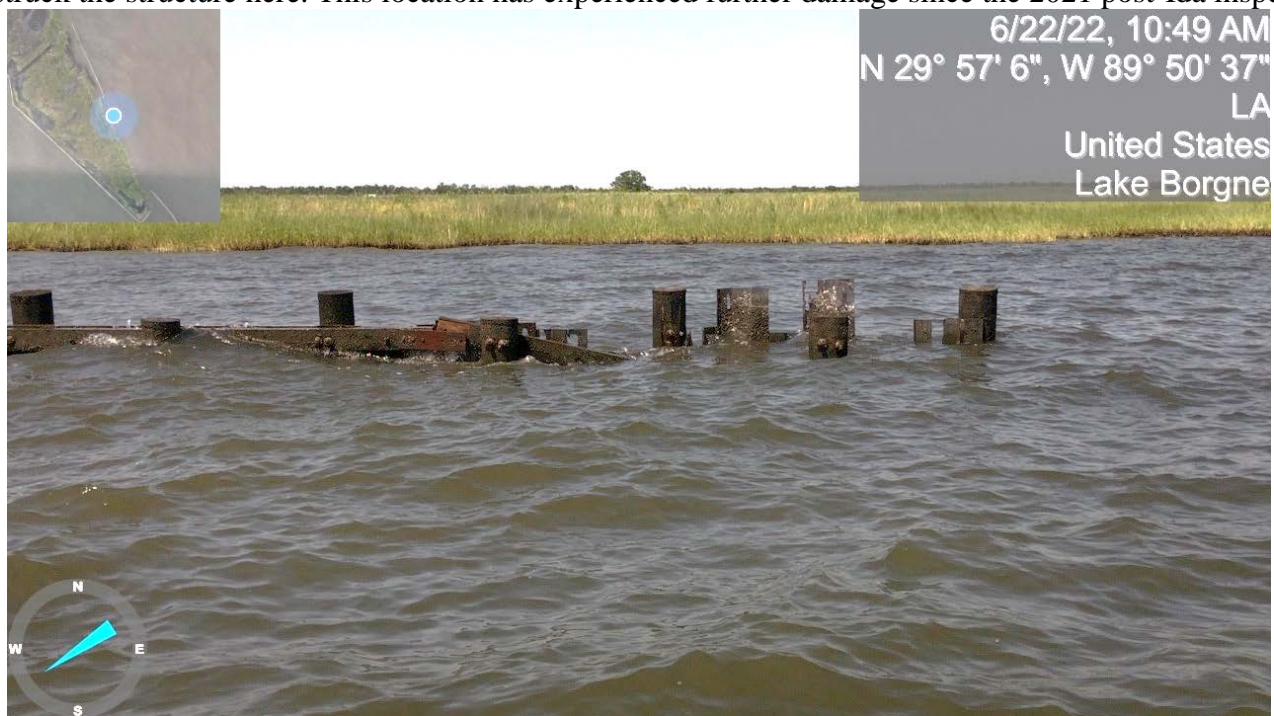
Photo 2: Reach 1

Southern side of Damage Location #1

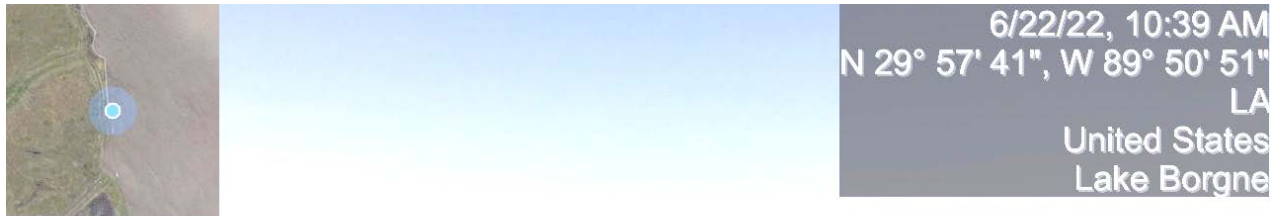
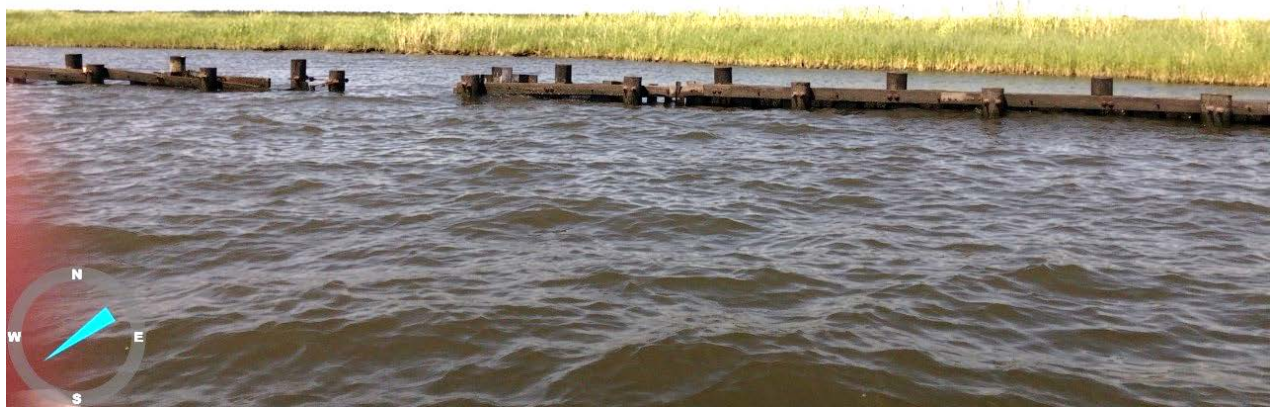
Photo 3: Reach 1

Damage Location #2 – 29°57'40", -89°50'50" – During Hurricane Ida, something appears to have struck the structure here. This location has experienced further damage since the 2021 post-Ida inspection.

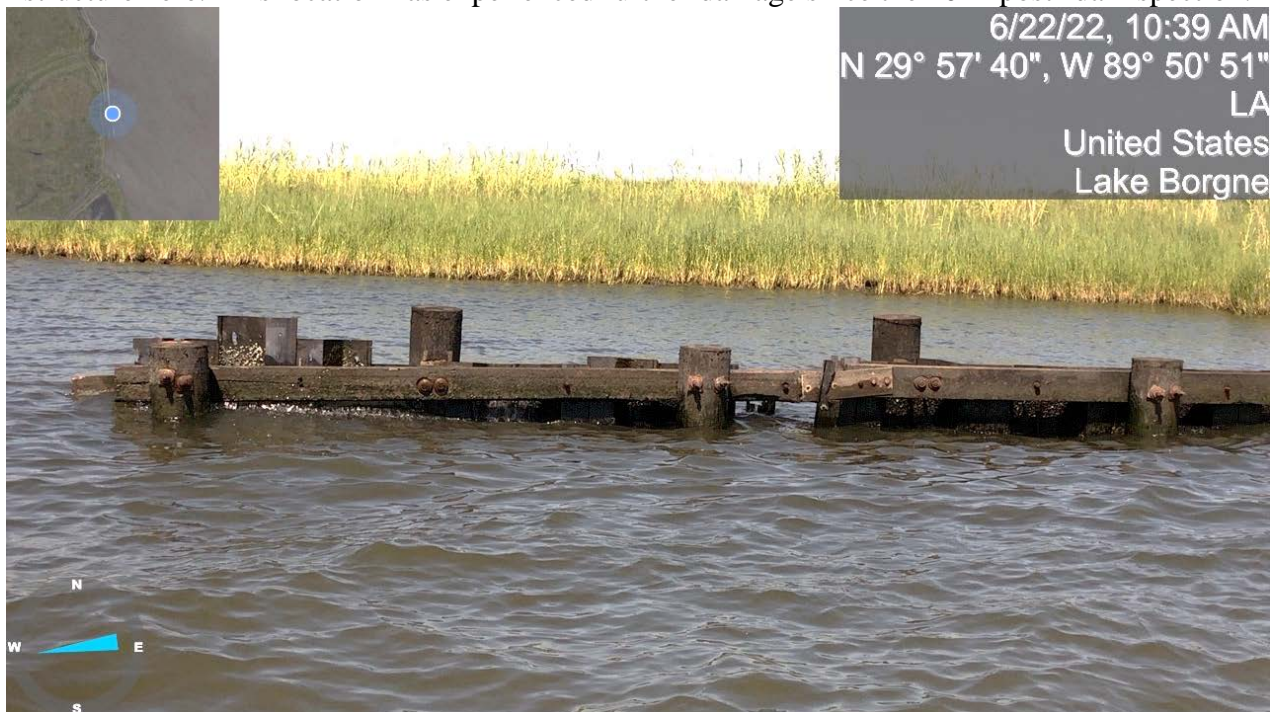
Photo 4: Reach 1

Damage Location #2 – Closer view of northern side of damaged area.

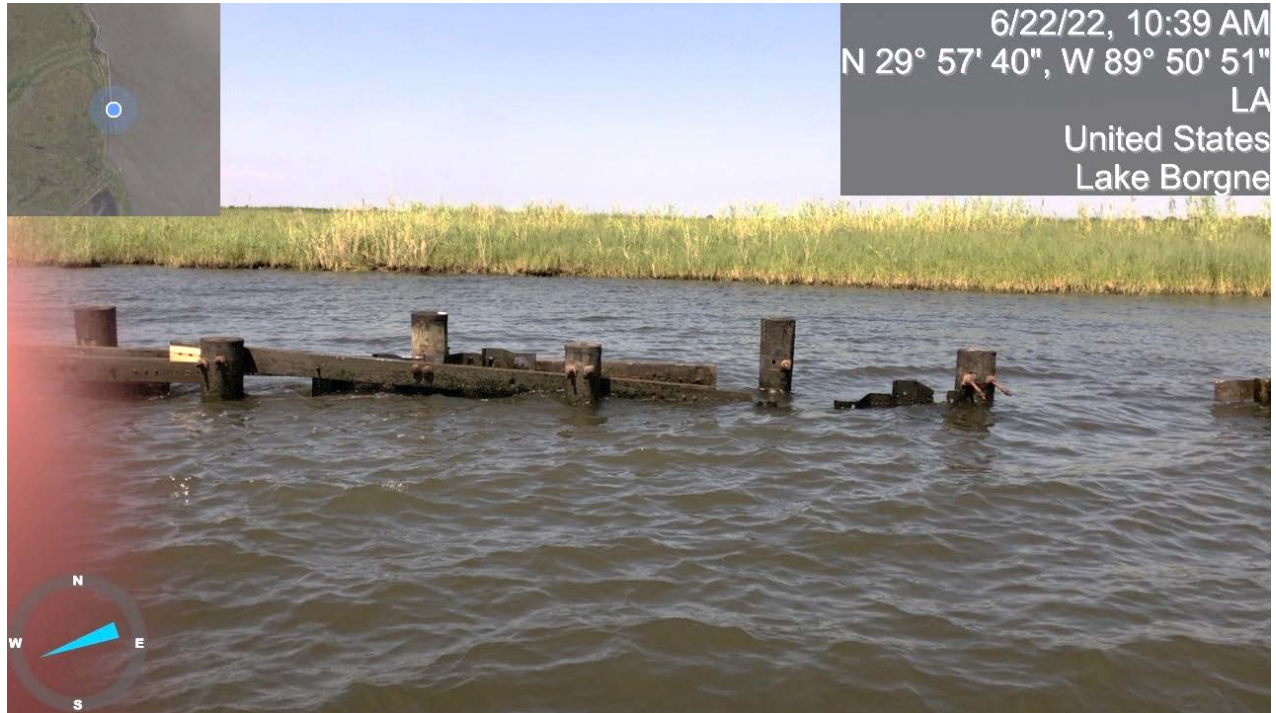
Photo 5: Reach 1

Damage Location #2 – Closer view of southern side of damaged area.

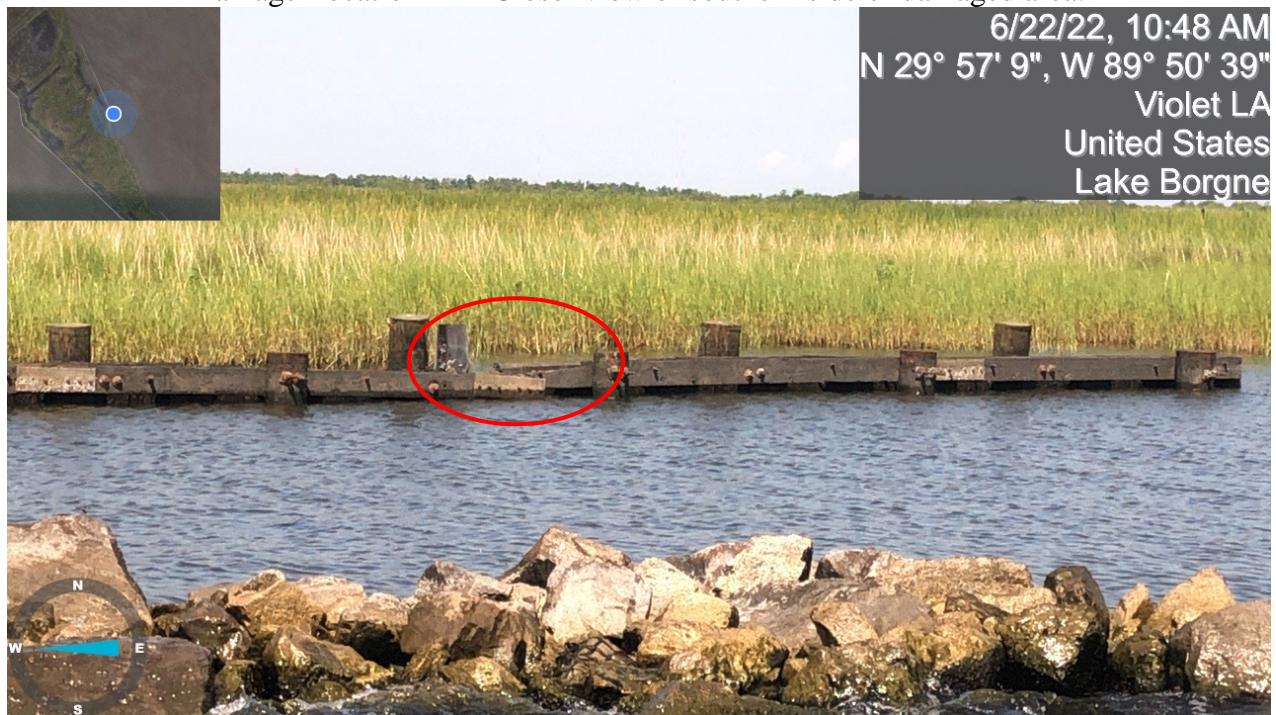
Photo 6: Reach 1

Damage Location #3 – 29°57'9", -89°50'39" – Some more minor damage was noted at this location. It is difficult to see in this photo, but the damaged location is near the center/left of this photo. No further damage was noted at this location since the time of the 2021 post-Ida inspection.

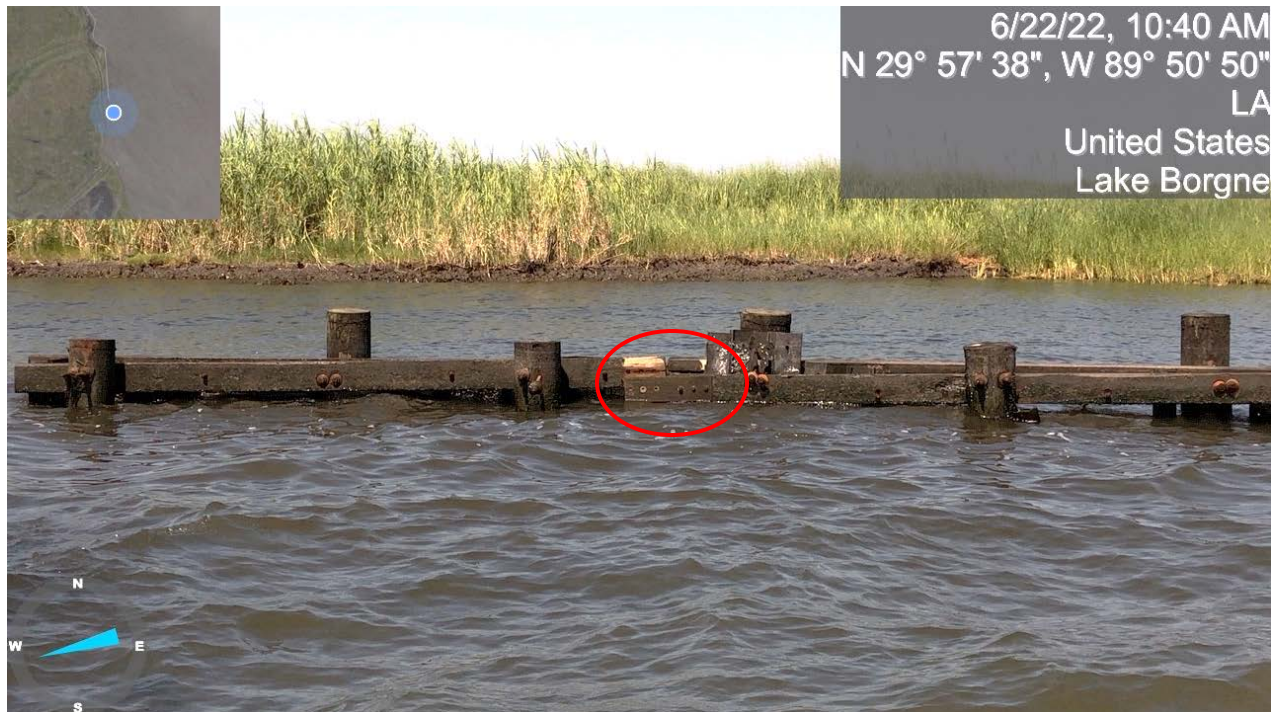
Photo 7: Reach 1

Splice non-functional as it is missing all 3 bolts on one side.

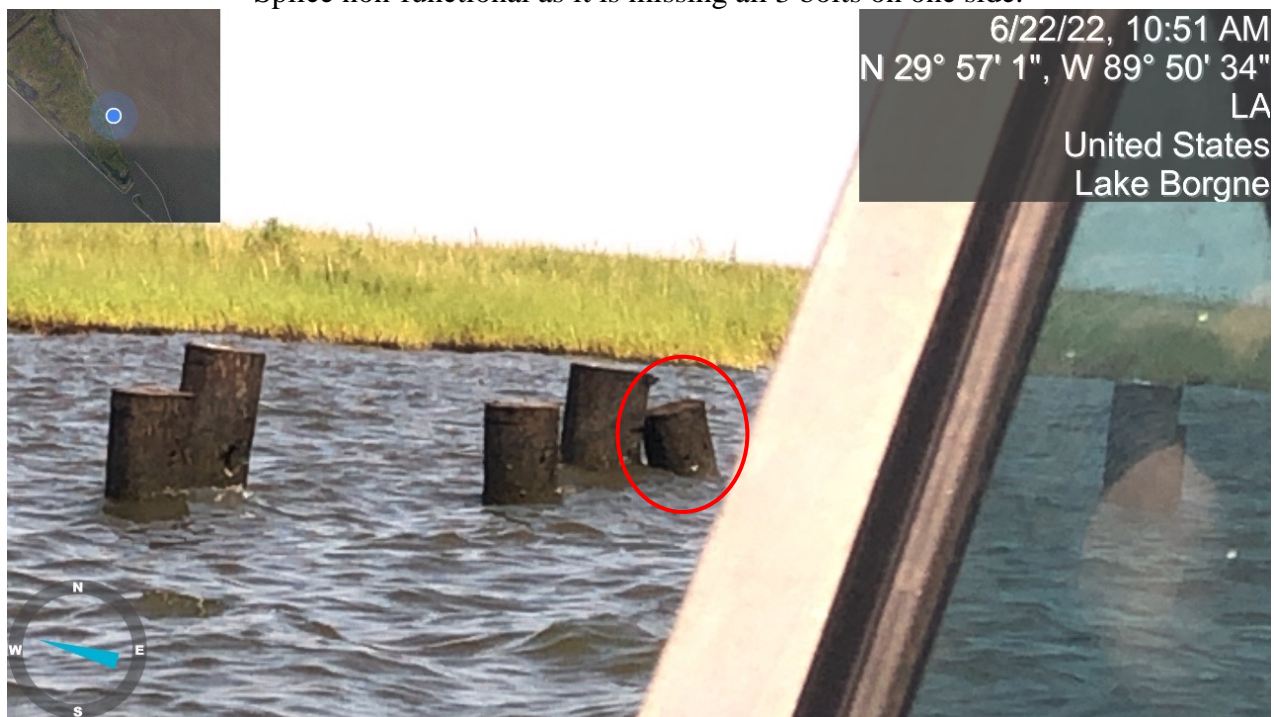
Photo 8: Reach 1

Timber pile noted out of alignment

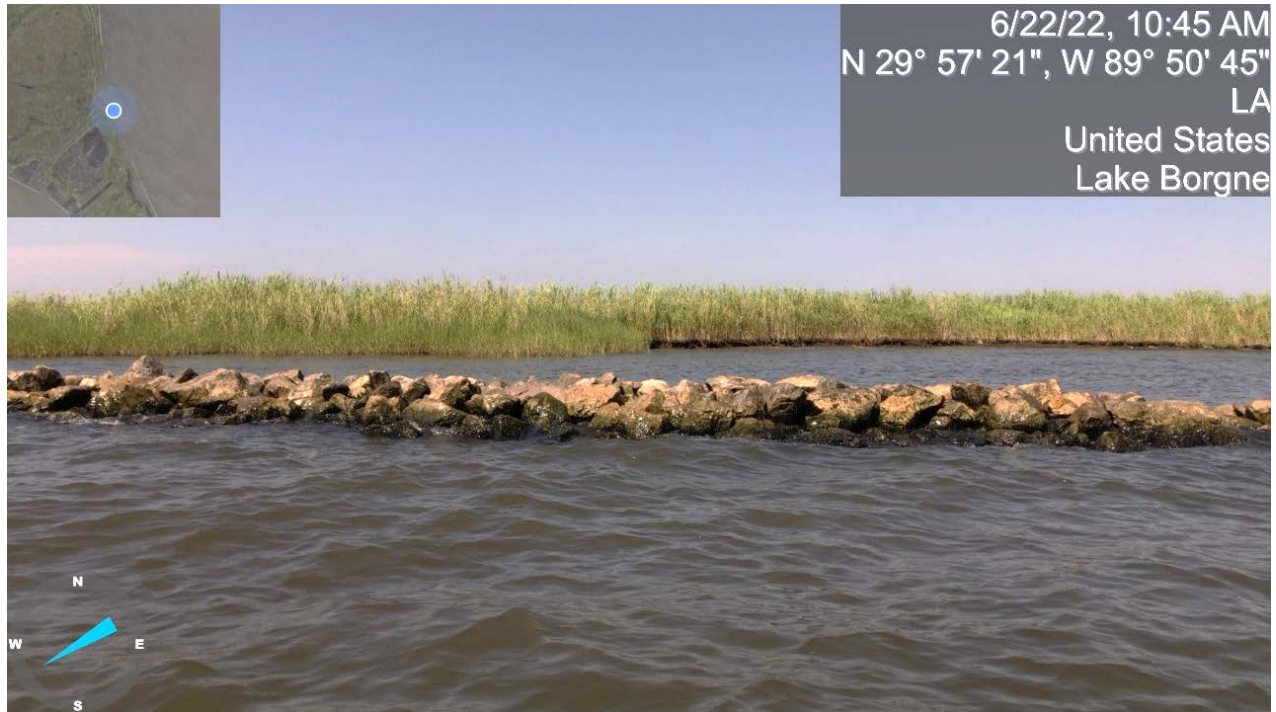
Photo 9: Reach 1
Rock breakwater in generally good condition

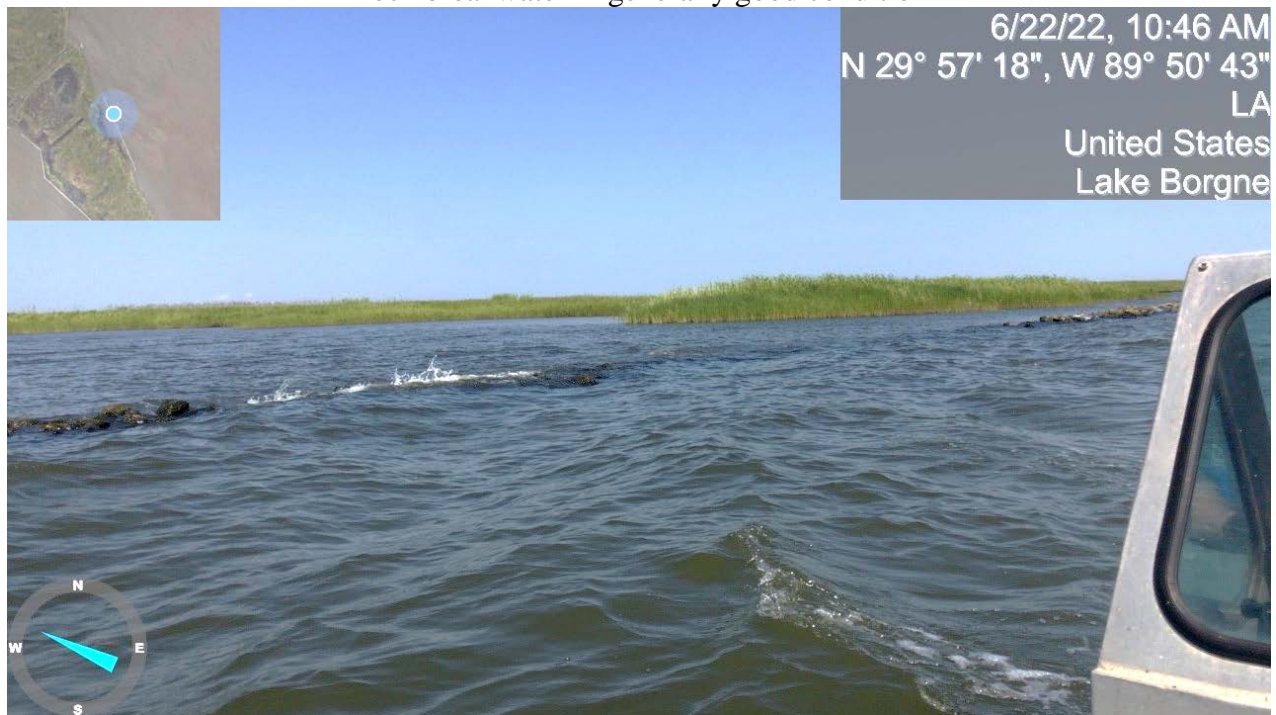
Photo 10: Reach 1
This area of the rock breakwater has experienced significant settlement.

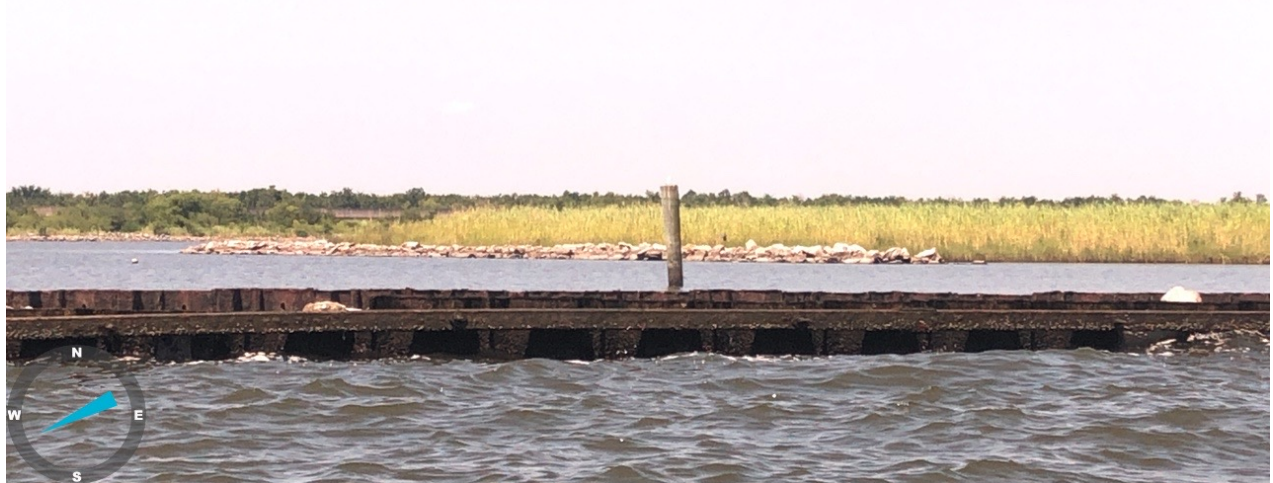
Photo 11: Reach 1

- G. Warning Signs –**
- a. Warning Sign (WS) 10 – Located in Reach 1 between the PO-30 structure and the MRGO – Pile is in place, but sign is missing.
 - b. WS 11 – Located in Reach 1 on the Lake Borgne side of the PO-30 structure – Pile and sign are in place, but sign is in poor condition.

WS 10 – Pile is in place, but sign is missing.

Immediate repairs include the replacement of the warning signs near the mouth of Bayou Dupre. CPRA is currently assembling contract documents for this work.

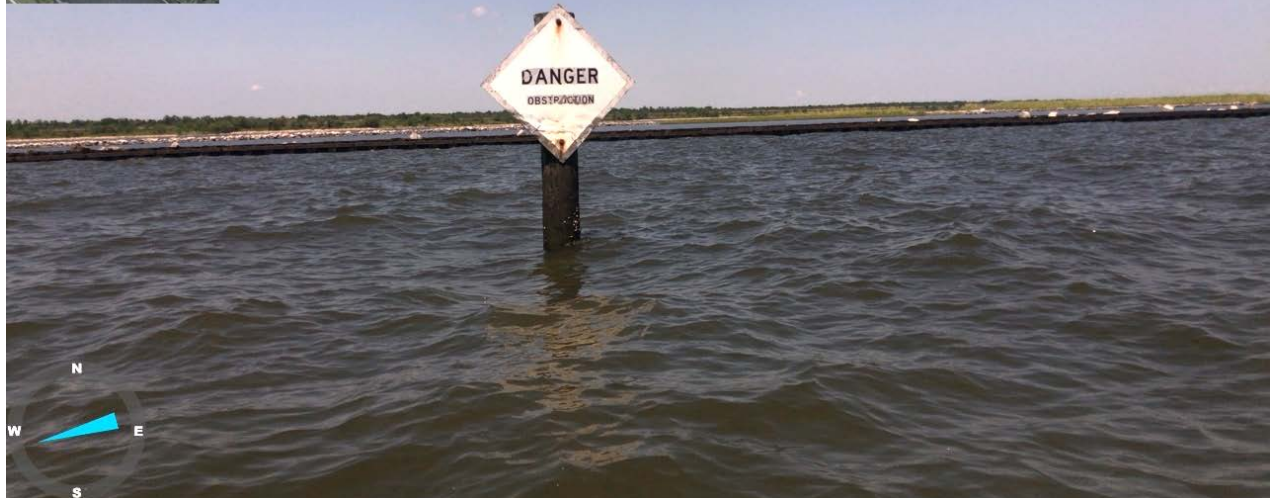
Photo 12: Reach 1

WS 11 – Pile and sign are in place, but sign is in poor condition.

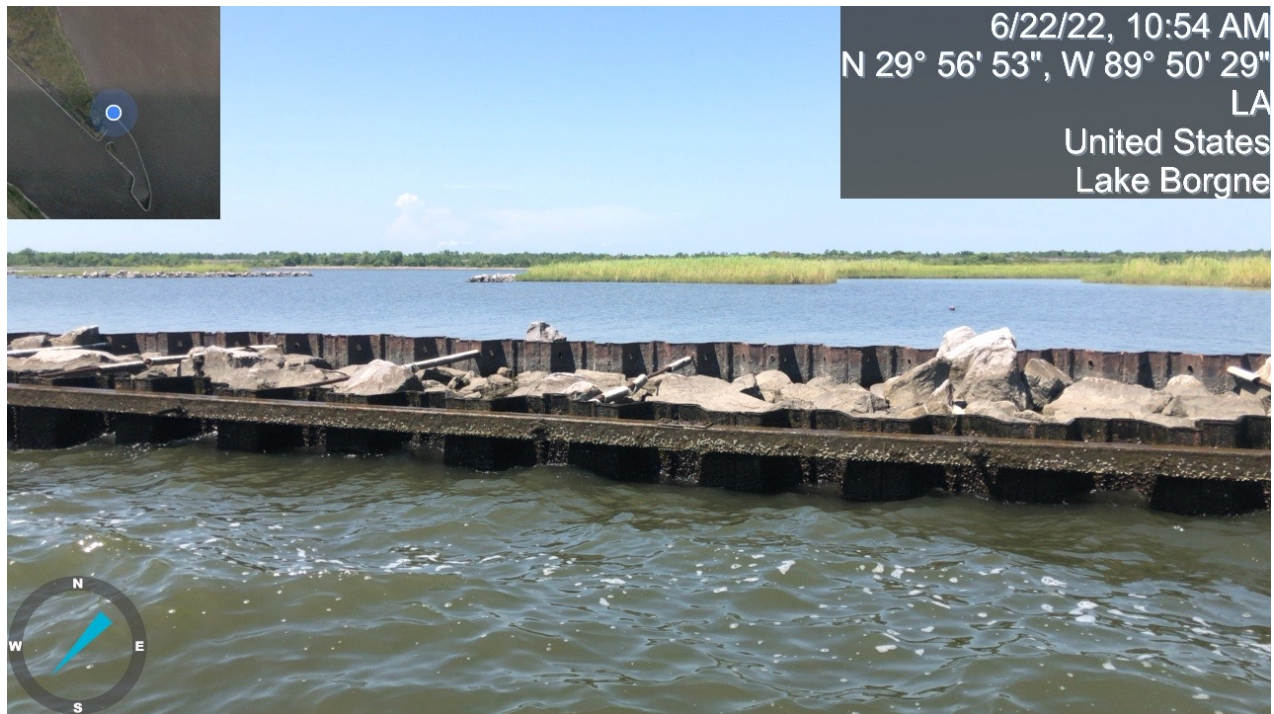
Photo 13: Reach 1

- E. Breakwater Reach 4 (East of Bayou Yscloskey)** – The rock breakwater has experienced some settlement but is in generally good condition.
- F. Double Sheet pile Wall Breakwater at the mouth of Bayou Dupre** – The double sheet pile wall breakwater appears to be performing well, although significant corrosion of all features of the steel sheet pile structure is noted. The interior rock has experienced minor settlement, but this does not appear to be impacting project performance.

Double steel sheet pile structure appears to be functioning well, although significant corrosion was noted.

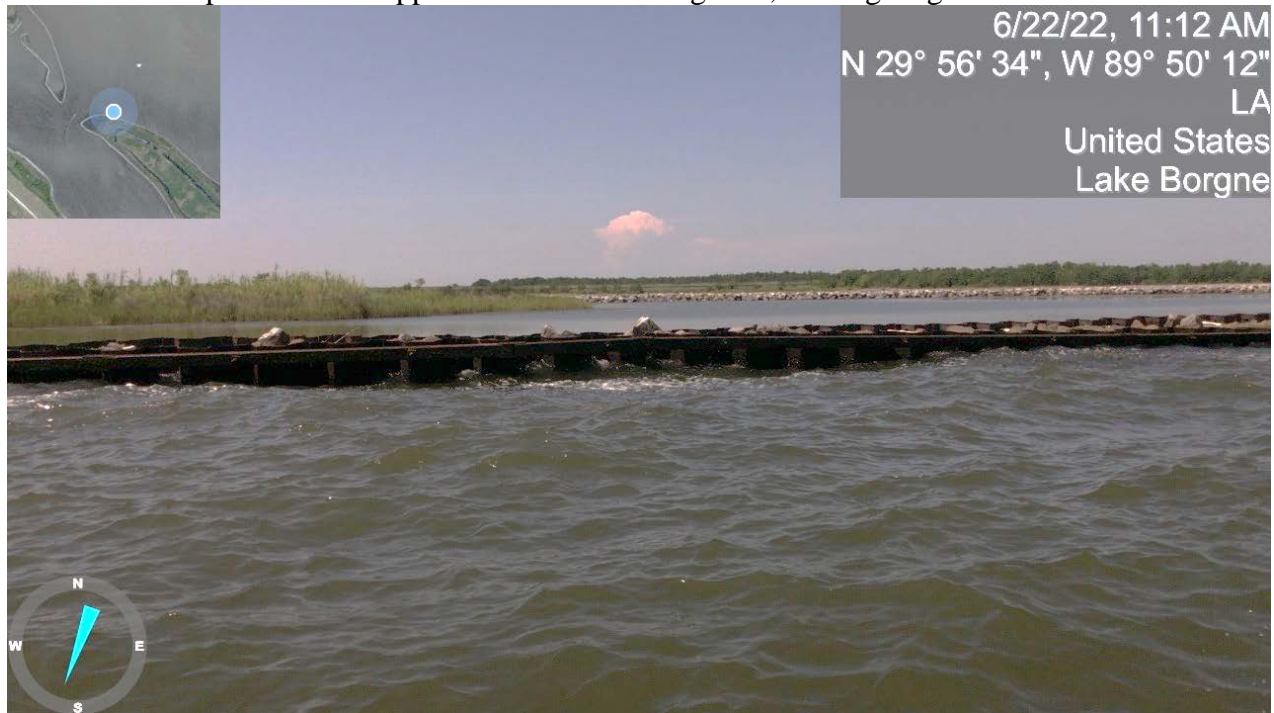
Photo 14: Reach 2

Double steel sheet pile structure appears to be functioning well, although significant corrosion was noted.

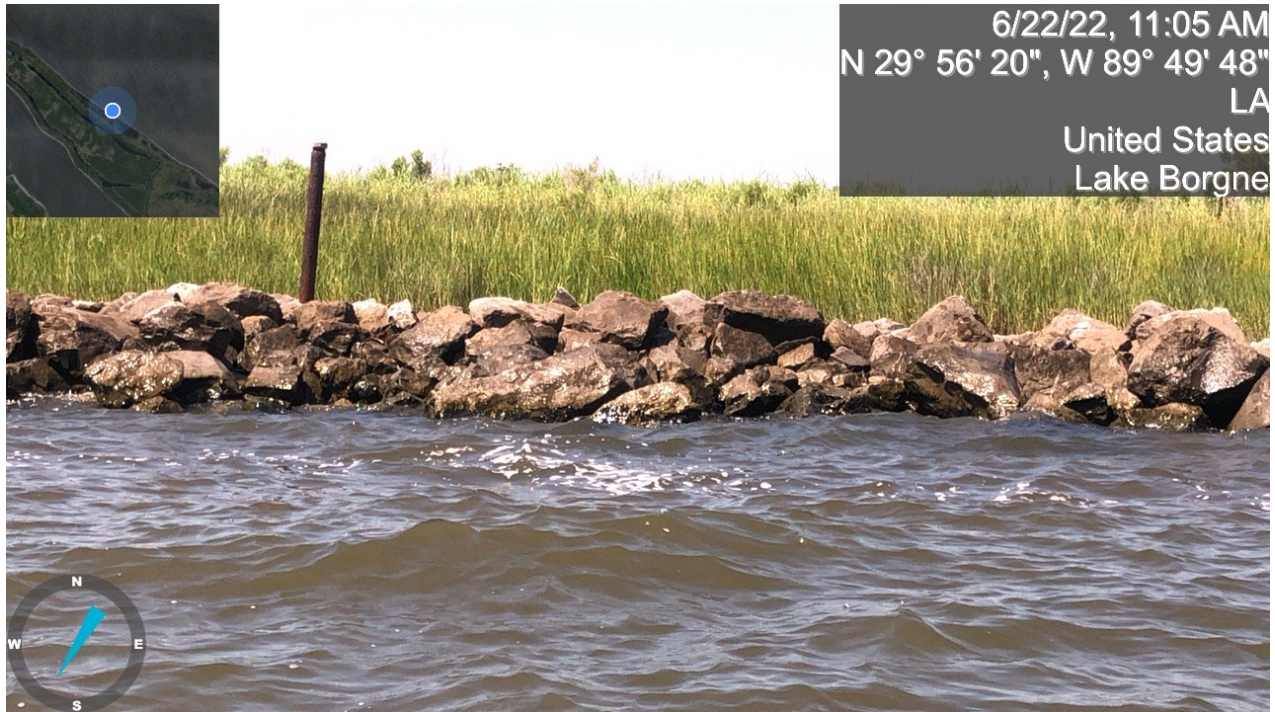
Photo 15: Reach 2

Rock breakwater in generally good condition

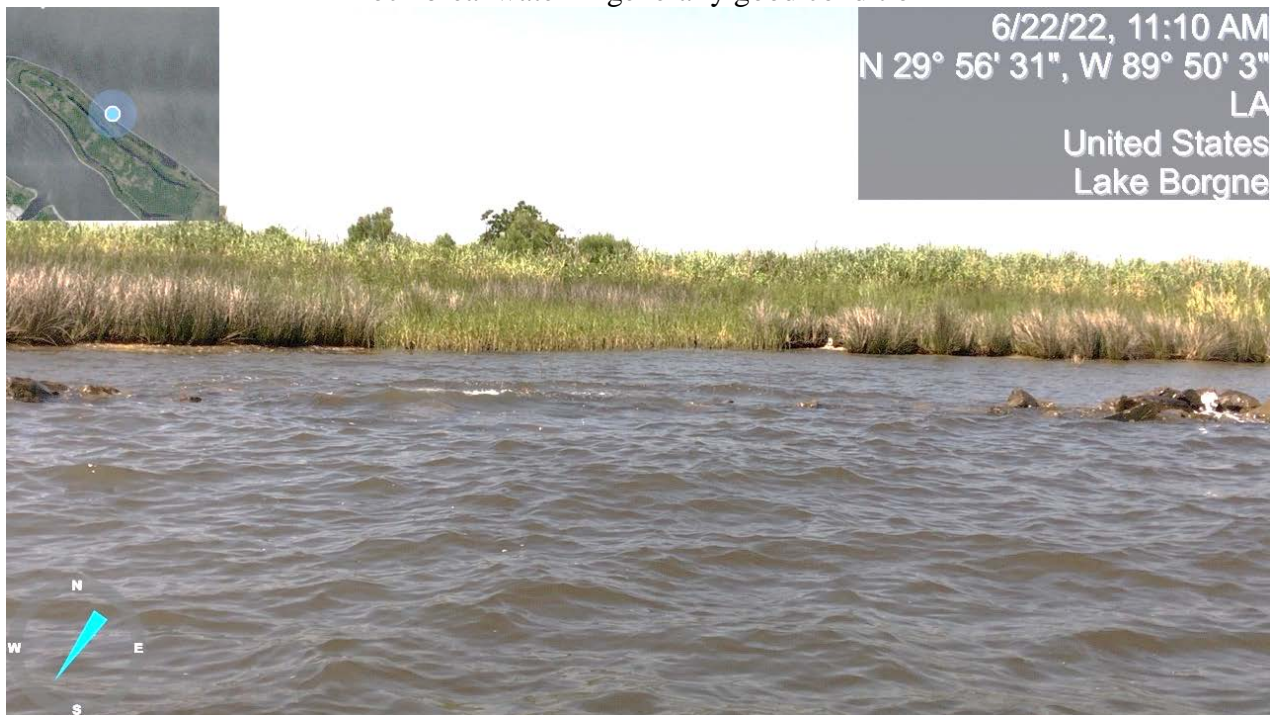
Photo 16: Reach 2

This area of the rock breakwater has experienced significant settlement with associated shoreline retreat visible.

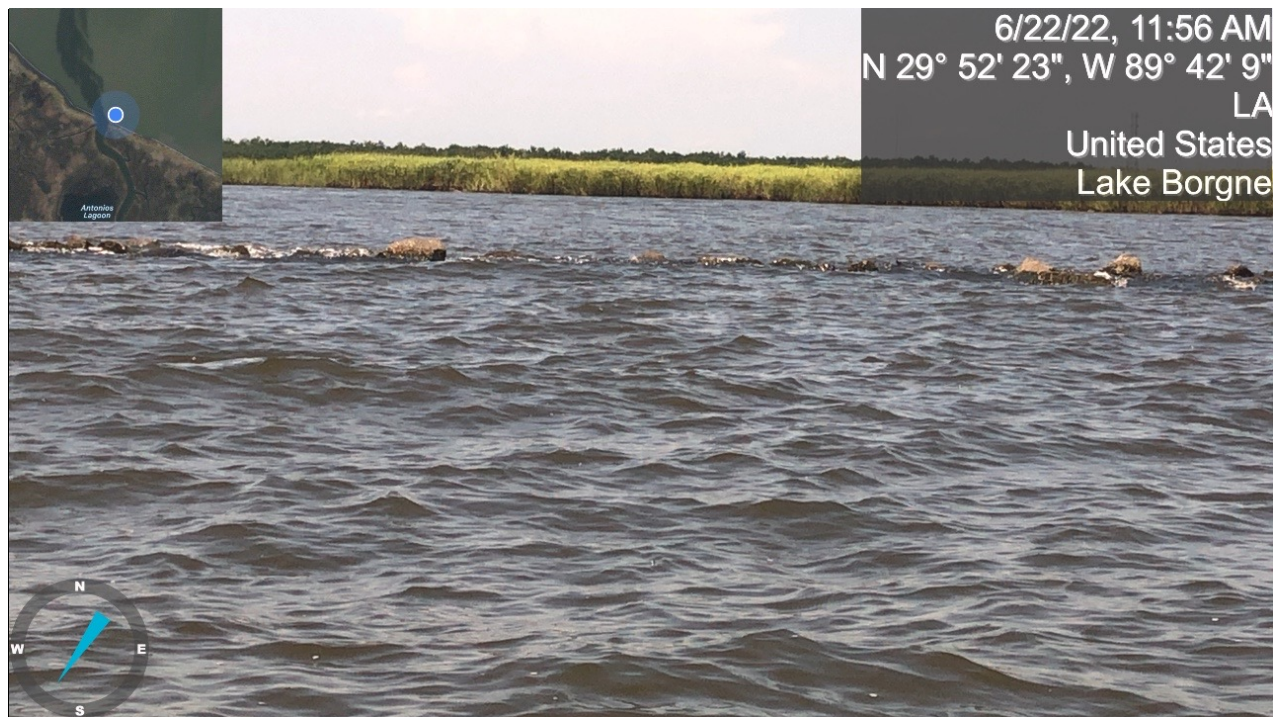
Photo 17: Reach 3

- B. Breakwater Reach 2 (South of Bayou Dupre)** – The rock breakwater has experienced some settlement but is in generally good condition.
- C. Breakwater Reach 3 Strong (West of Tennessee Gas Pipeline)** – The rock breakwater has numerous low spots with marsh retreat observed behind those locations. Other areas are performing well.

This area of the rock breakwater has experienced significant settlement with associated shoreline retreat visible.

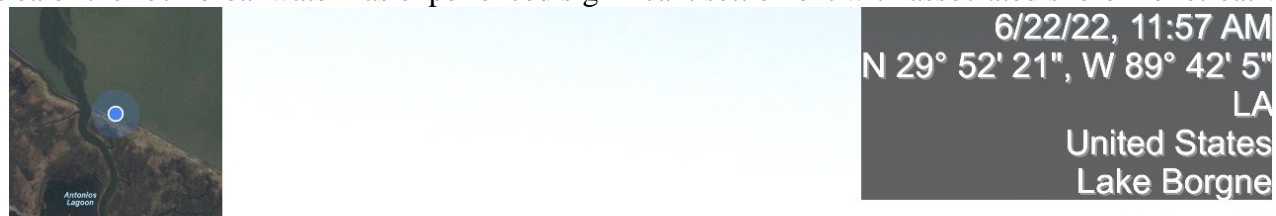
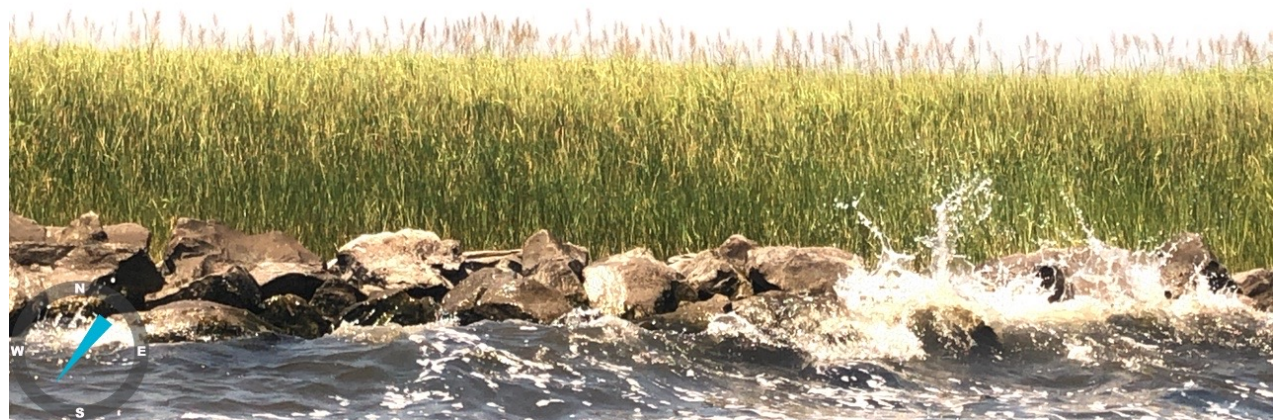
Photo 18: Reach 3

Rock breakwater in generally good condition

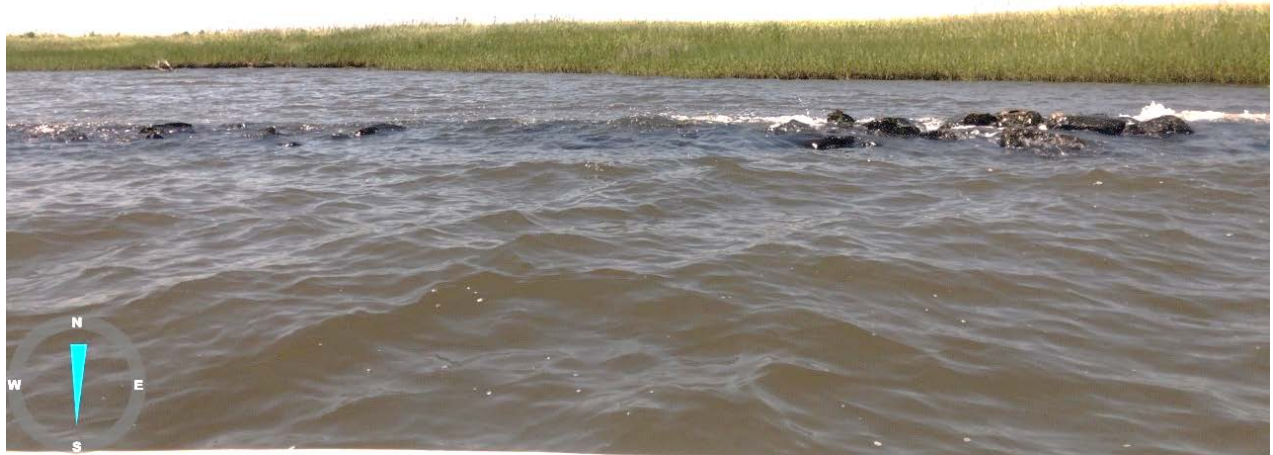
Photo 19: Reach 3

This area of the rock breakwater has experienced significant settlement with associated shoreline retreat visible.

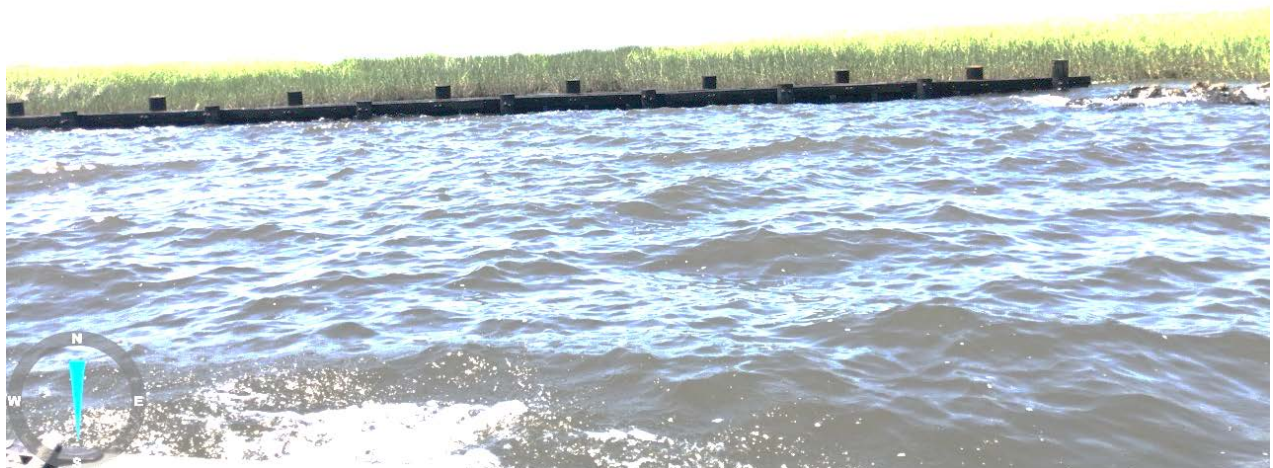
Photo 20: Reach 3

Composite sheet pile wall appears to be in generally good condition.

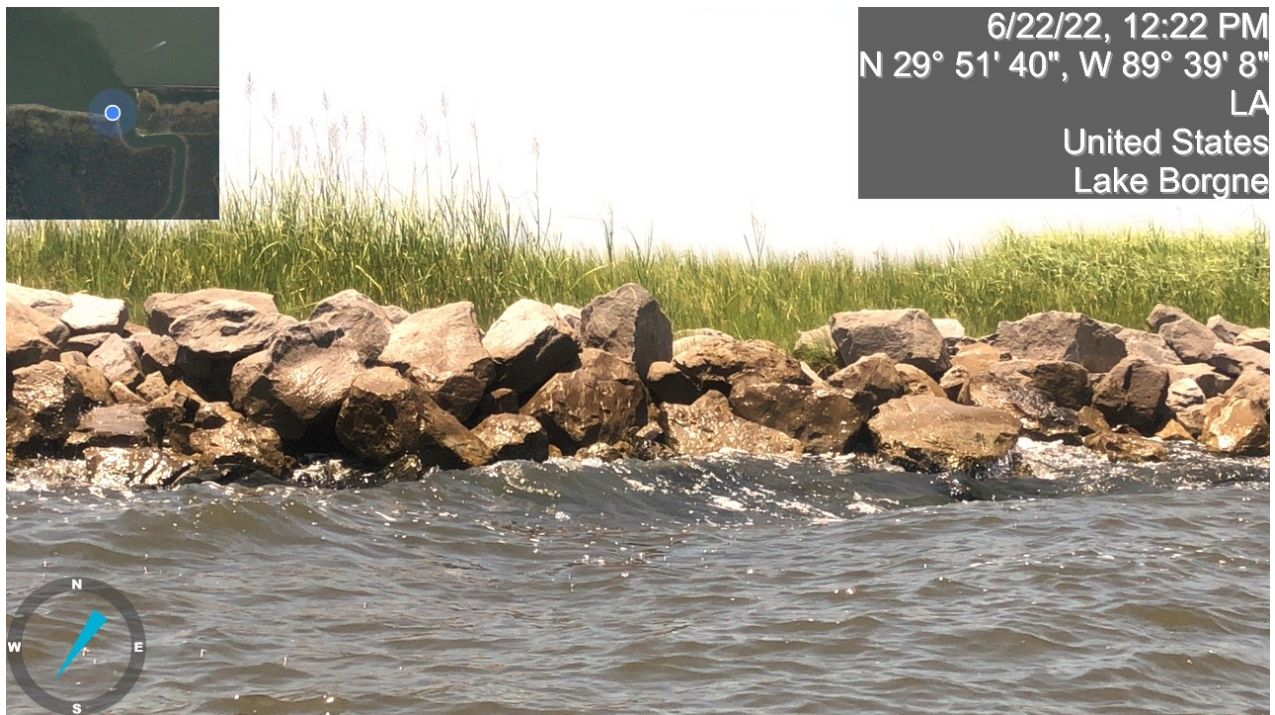
Photo 21: Reach 4
Rocks appear to be in generally good condition.
