**State of Louisiana
Coastal Protection and Restoration Authority**

2024 Annual Inspection Report

**Lake Borgne Shoreline Protection
Project**

State Project Number PO-30
Priority Project List 10

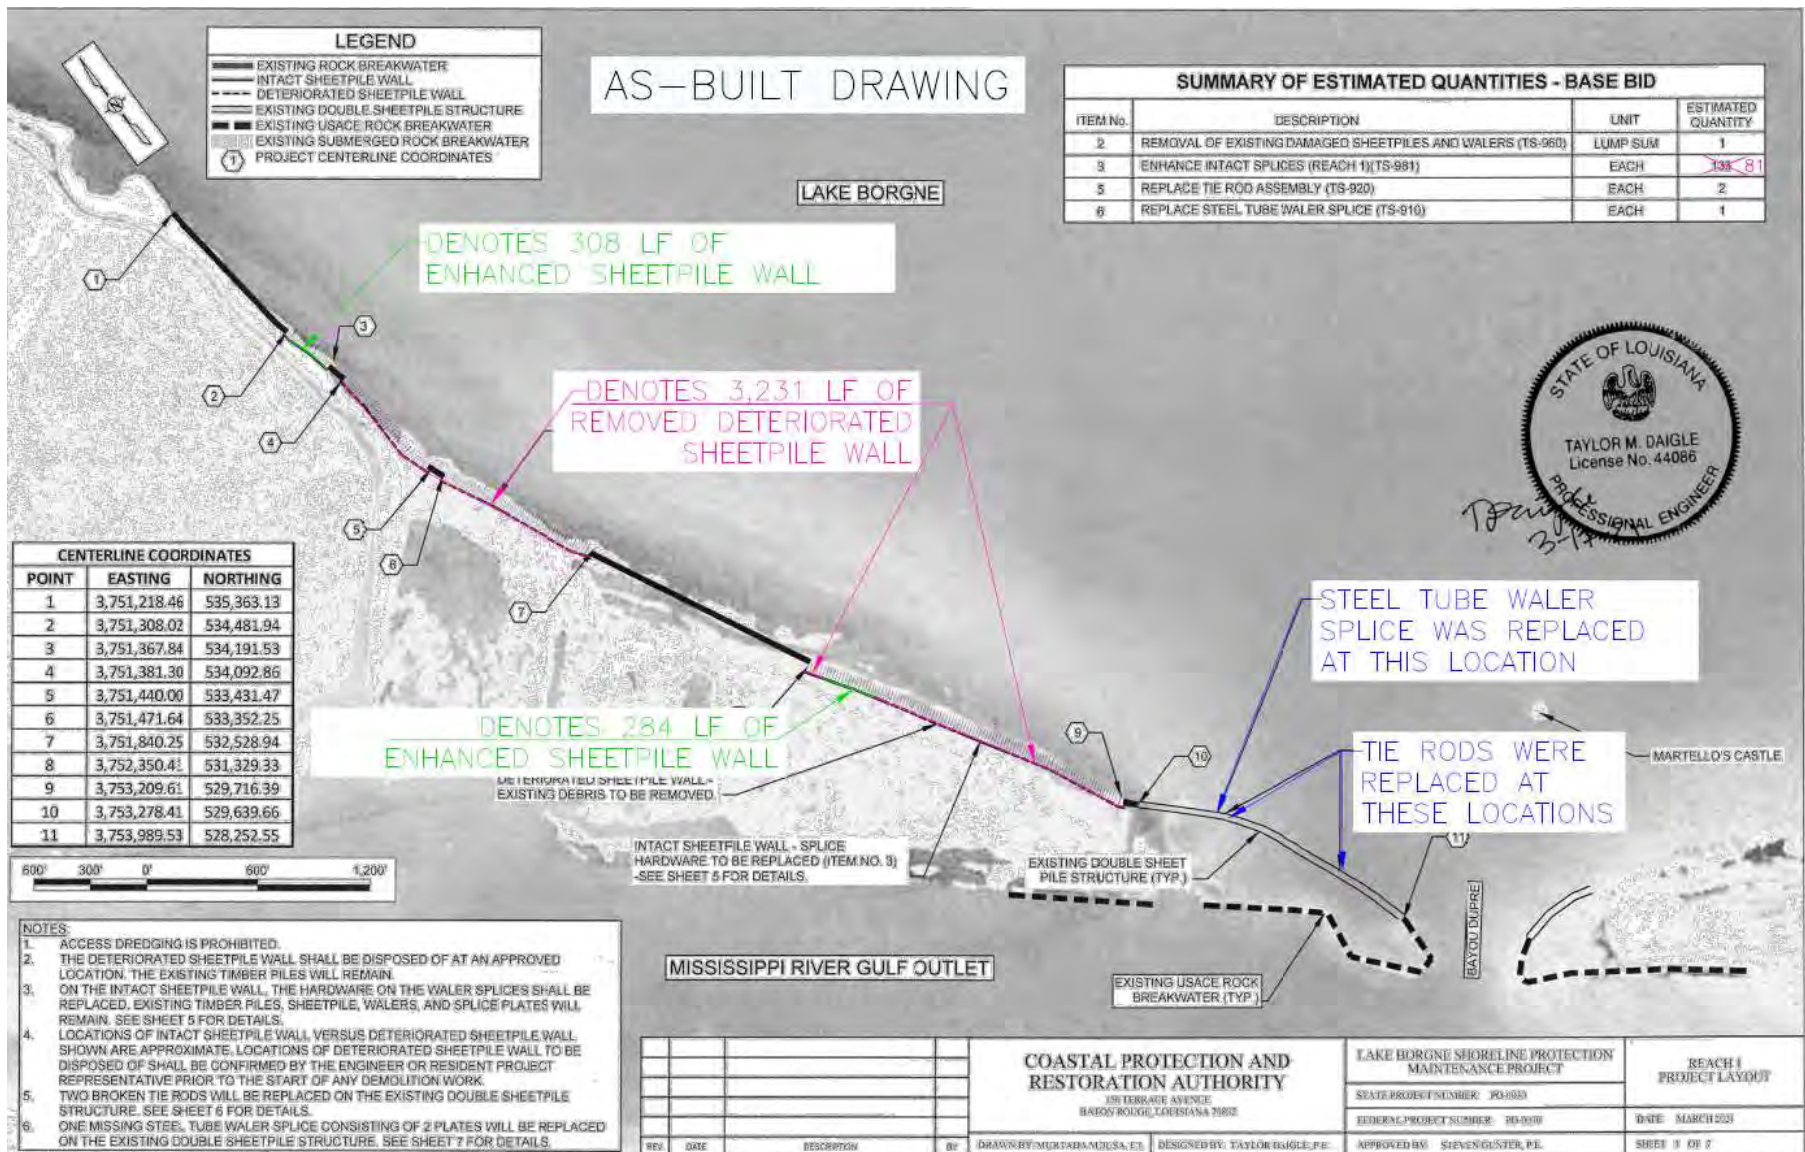
Figure 1: 2021 Maintenance Event As Built for Reach 1

The composite sheet pile wall that was installed during the 2014 maintenance event was first noted to have damage during the 2016 annual inspection. Over the next five years, the composite sheet pile wall continued to deteriorate, creating the need for a maintenance event. Due to budget limitations that prevented the project team from replacing the damaged wall, the scope of the maintenance event included the removal of the damaged wall (all components except for the timber piles which may be used to reinstall shoreline protection if funding becomes available), replacing the splice hardware on the intact wall, replacing two tie rods on the double steel sheet pile structure, and replacing one steel tube waler splice on the double steel sheet pile structure. The as-built drawing for Reach 1 is included in Figure 1. The maintenance project was accepted on October 12, 2021.

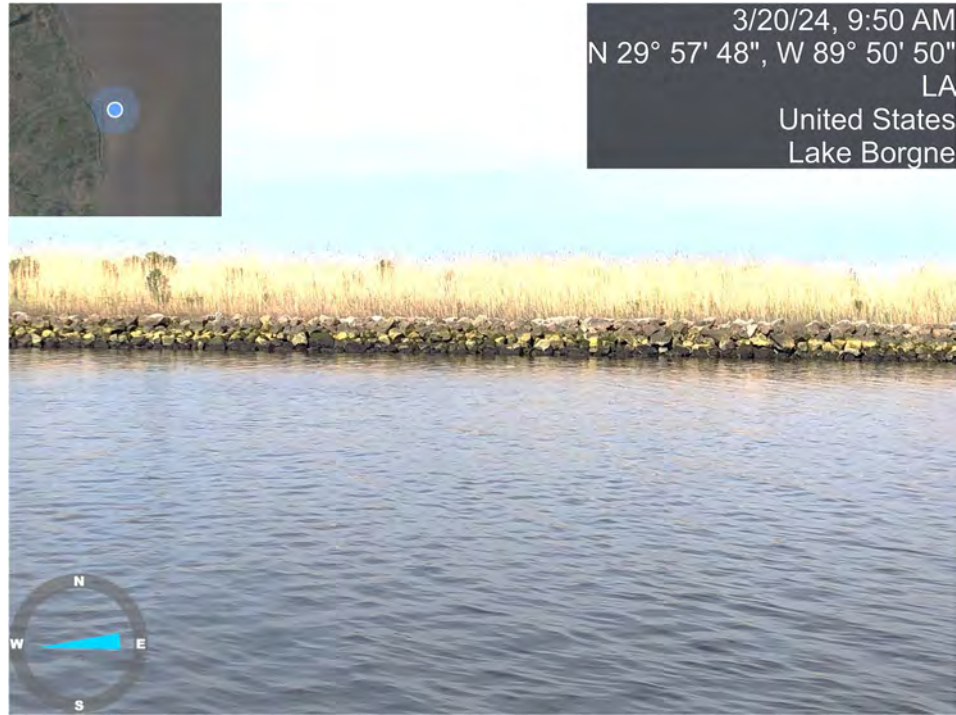
Photo 1: Reach 1

Rock breakwater appears to be in good condition. Note that the tide was low (EL -1.0-ft) at the time of the inspection.

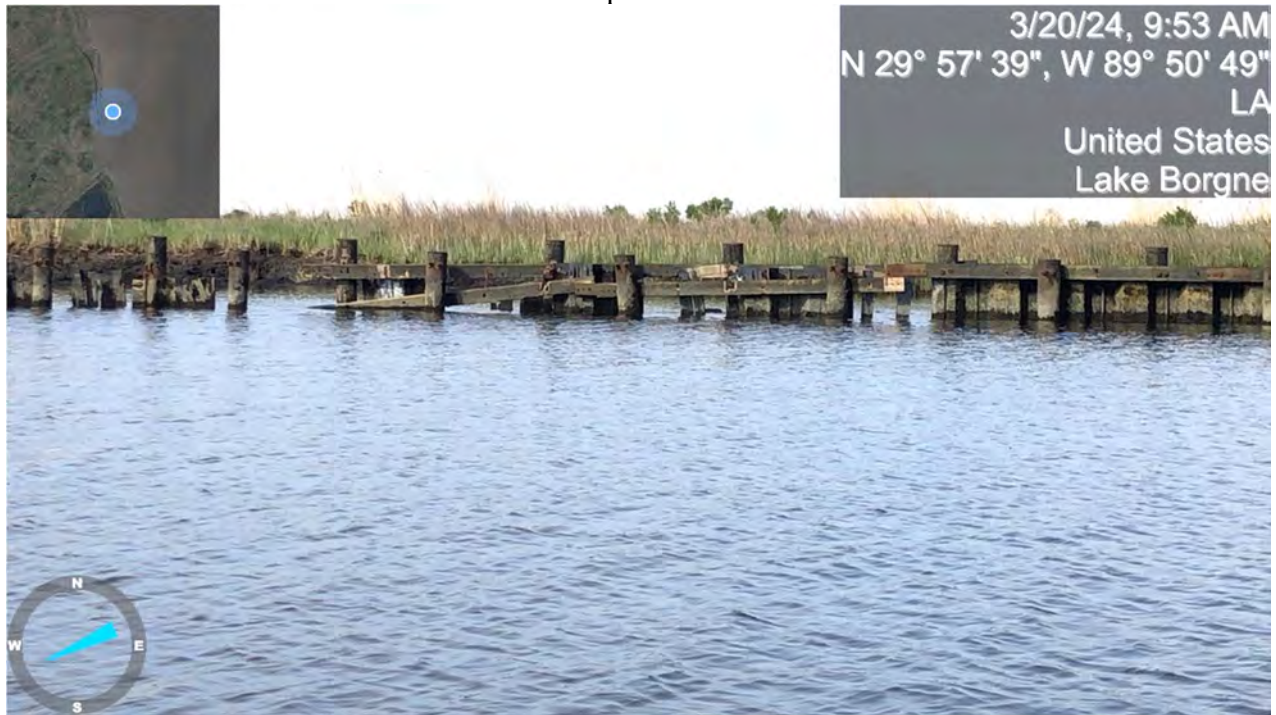
Photo 2: Reach 1

- A. **Breakwater Reach 1 (North of Bayou Dupre)** – Along the composite sheetpile alignment, the majority of the sheetpile that was upgraded with new hardware in 2021 is now damaged, with only a few short segments still intact. The areas where the composite sheetpile were removed during the maintenance event are also no longer functioning as a breakwater (only the timber piles remain). The rock breakwater has experienced some settlement but is in generally good condition.

This damage demonstrates the typical condition of the remaining composite sheet pile wall and walers in Reach

CPRA recommends an end-of-life maintenance event to include the removal of all remaining components of the composite sheetpile wall including the timber piling, the removal of the steel features at the mouth of Bayou Dupre, mechanically lowering the elevation of the remaining rock and sand at the mouth of Bayou Dupre, and a possible rock lift in selected low areas. Immediate actions include a spot elevation survey along the rock alignment to inform the scope of the end-of-life maintenance event.

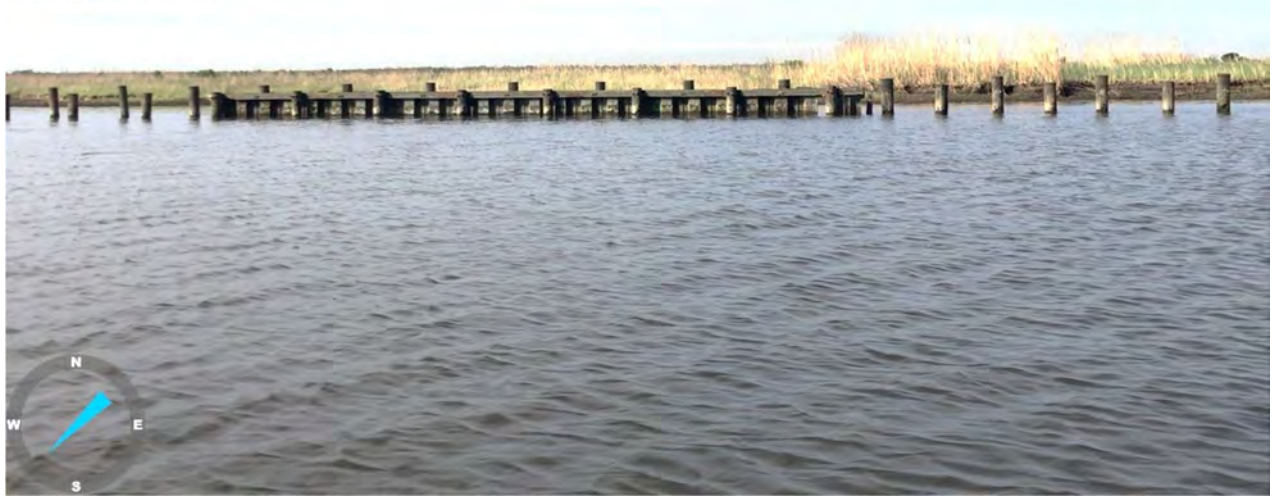
Photo 3: Reach 1

This particular segment of composite sheet pile is in better condition than the rest of the composite sheet pile in Reach 1, with only a few sheets missing on the northern (right) side.

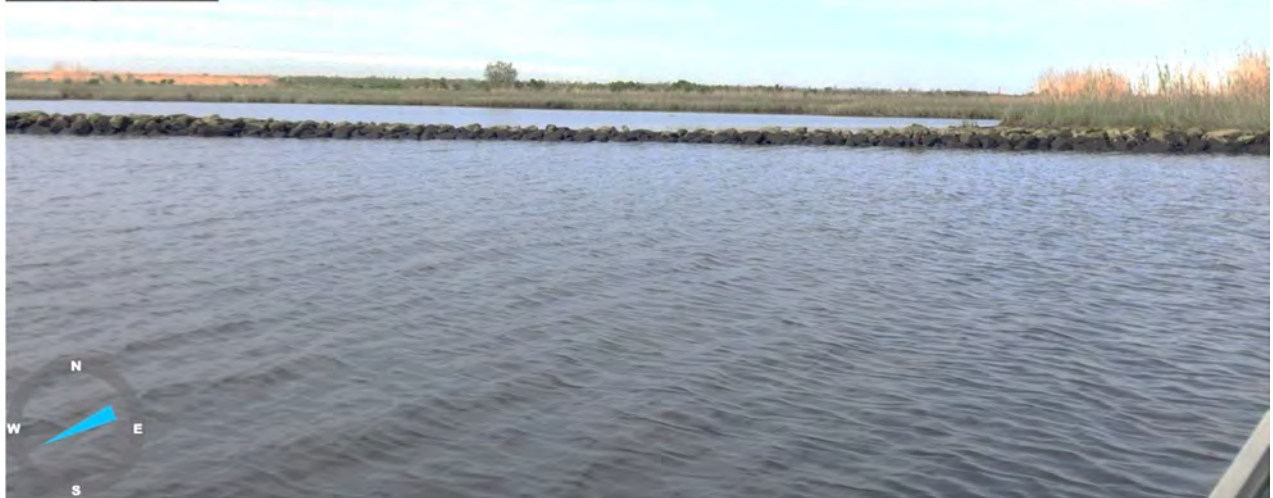
Photo 4: Reach 1

This area of the rock breakwater has experienced significant settlement. At a normal tide, the rocks near the middle of this photo would be overtopped.

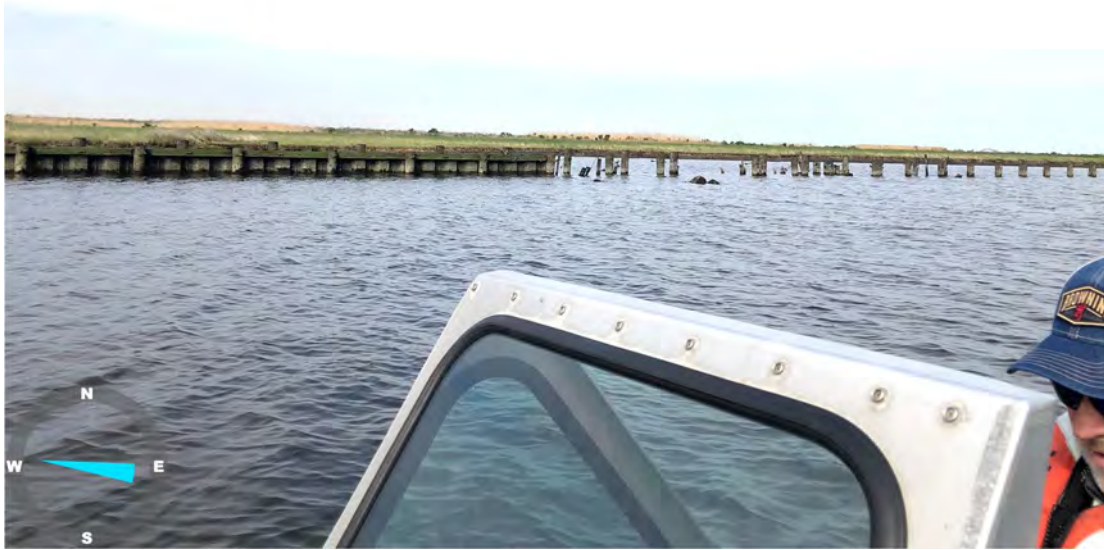
Photo 5: Reach 1

Composite sheetpile segment showing a portion (left side) intact and a portion (middle) damaged – with almost all components missing. The sheetpiling on the right side of the photo had been previously removed in 2021.

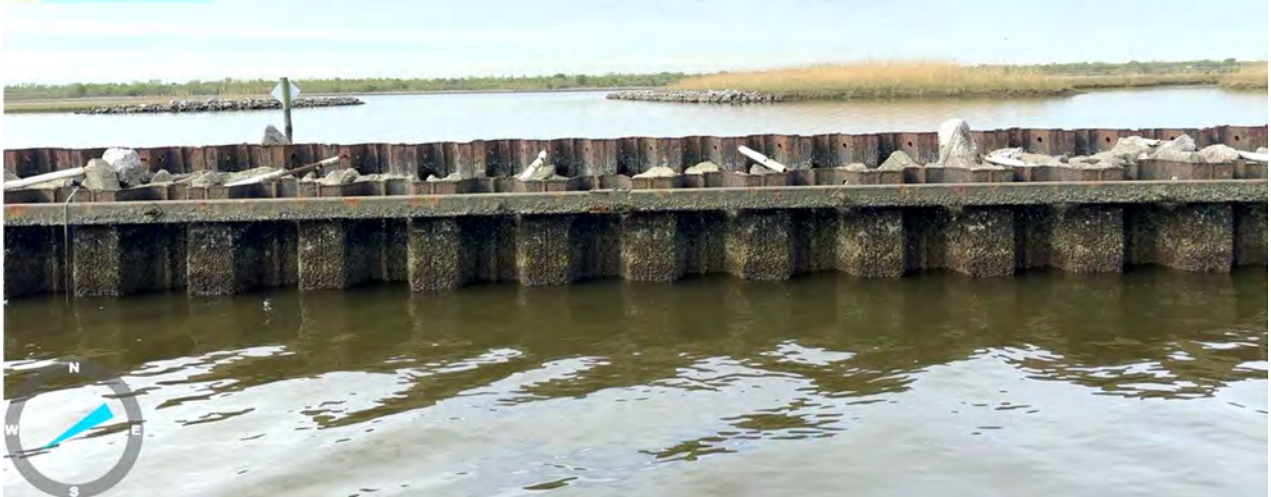
Photo 6: Reach 1

- E. **Breakwater Reach 4 (East of Bayou Yscloskey)** – The rock breakwater has experienced some settlement but is in generally good condition.
- F. **Double Sheet pile Wall Breakwater at the mouth of Bayou Dupre** – The double sheet pile wall breakwater appears to be performing well, although significant corrosion of all features of the steel sheet pile structure is noted. The interior rock has experienced settlement, but this does not appear to be impacting project performance. Most tie rods are still functioning; however, most ties are showing significant areas of reduced cross section due to corrosion.

Typical condition of double sheetpile structure at the mouth of Bayou Dupre

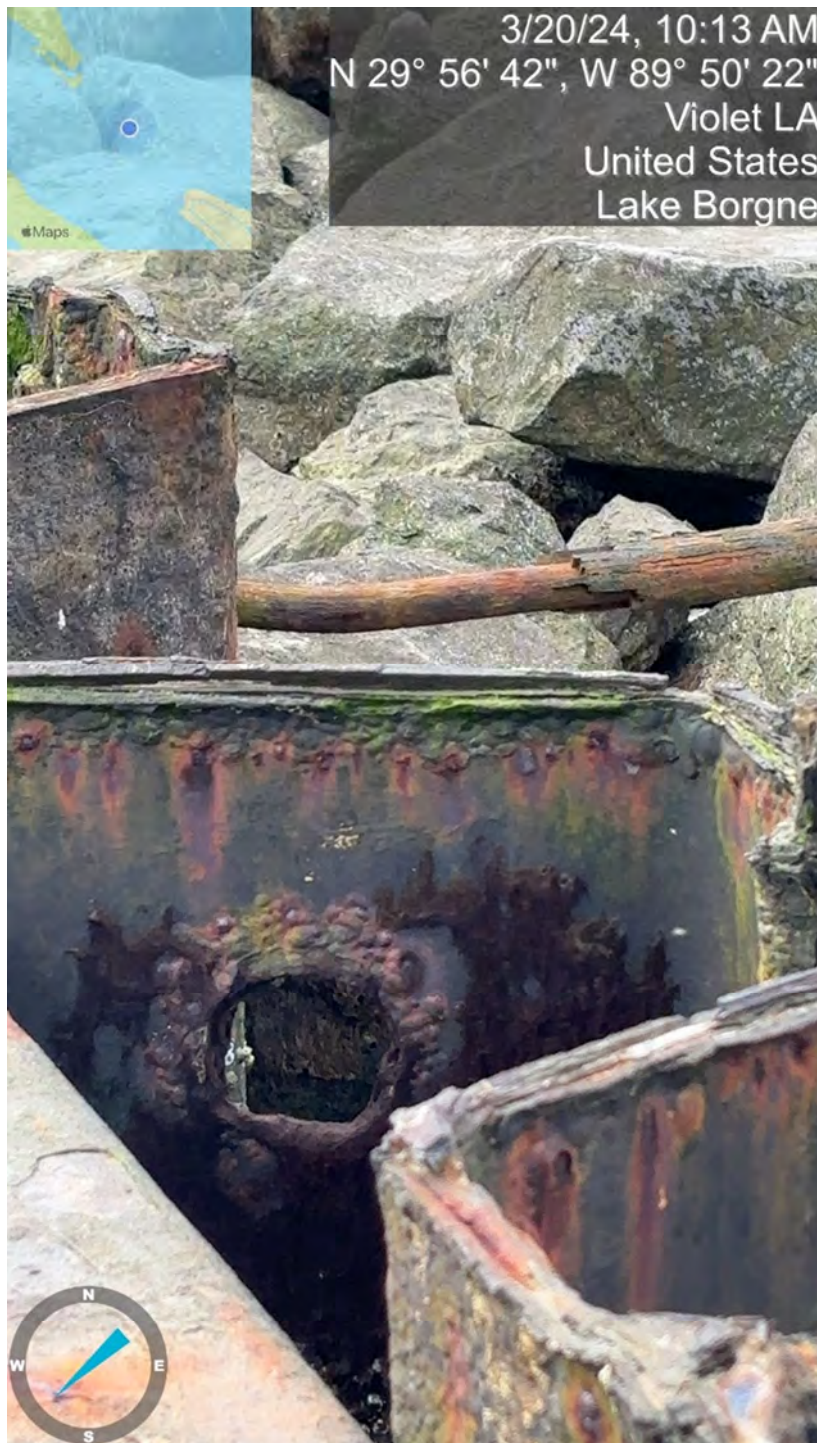
Photo 7: Reach 1

Closer view of corrosion on double sheetpile wall and reduced cross section of the tie rods at the mouth of Bayou Dupre

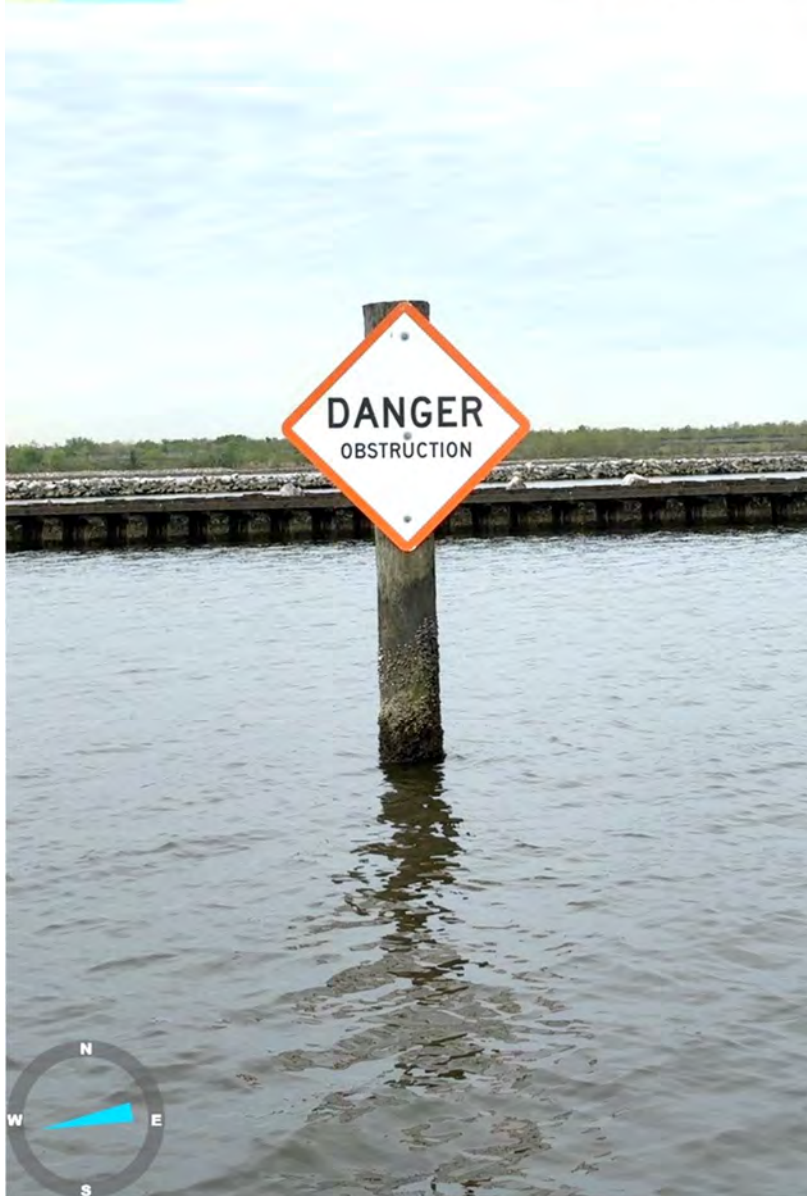
Photo 8: Reach 1

WS 11 – Pile and new sign appear to be in good condition.

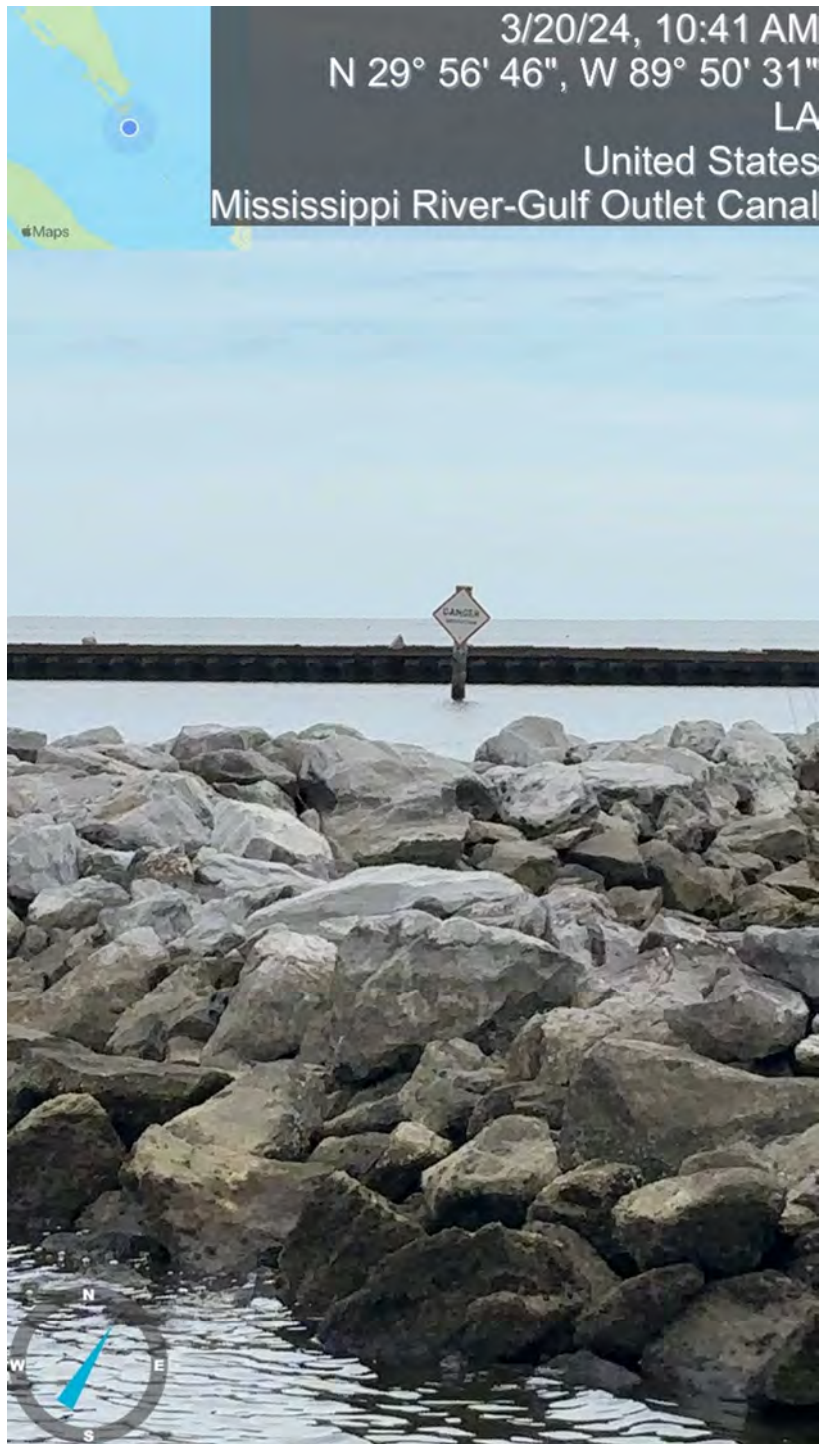
Photo 9: Reach 1

WS 10 – Pile and new sign appear to be in good condition.

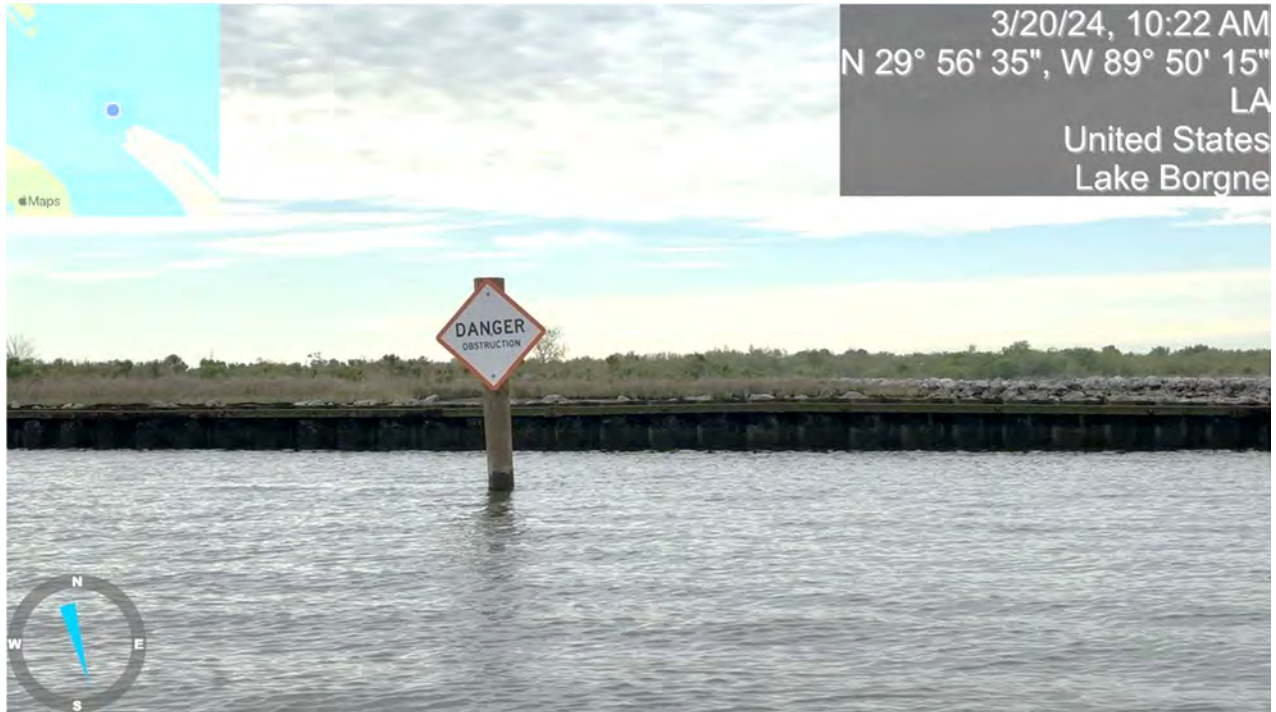
Photo 10: Reach 2

WS 12 – New pile and new sign appear to be in good condition.

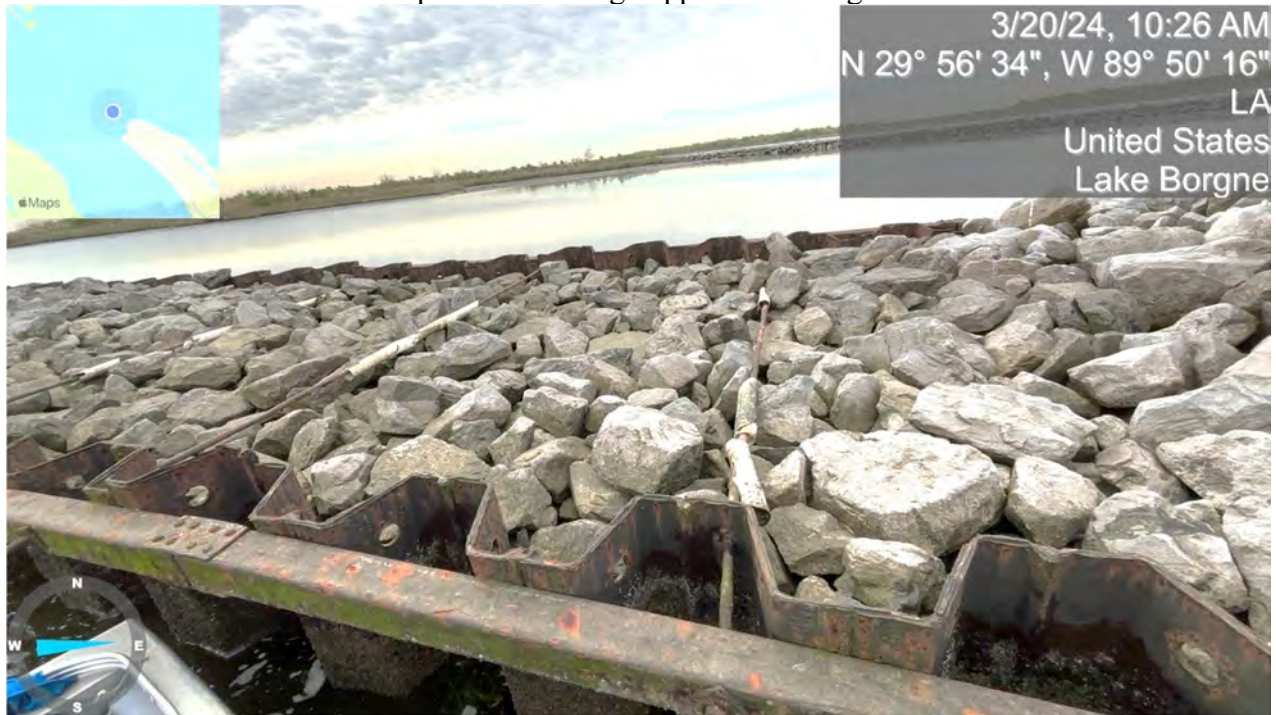
Photo 11: Reach 2

Typical condition of double sheetpile structure at the mouth of Bayou Dupre

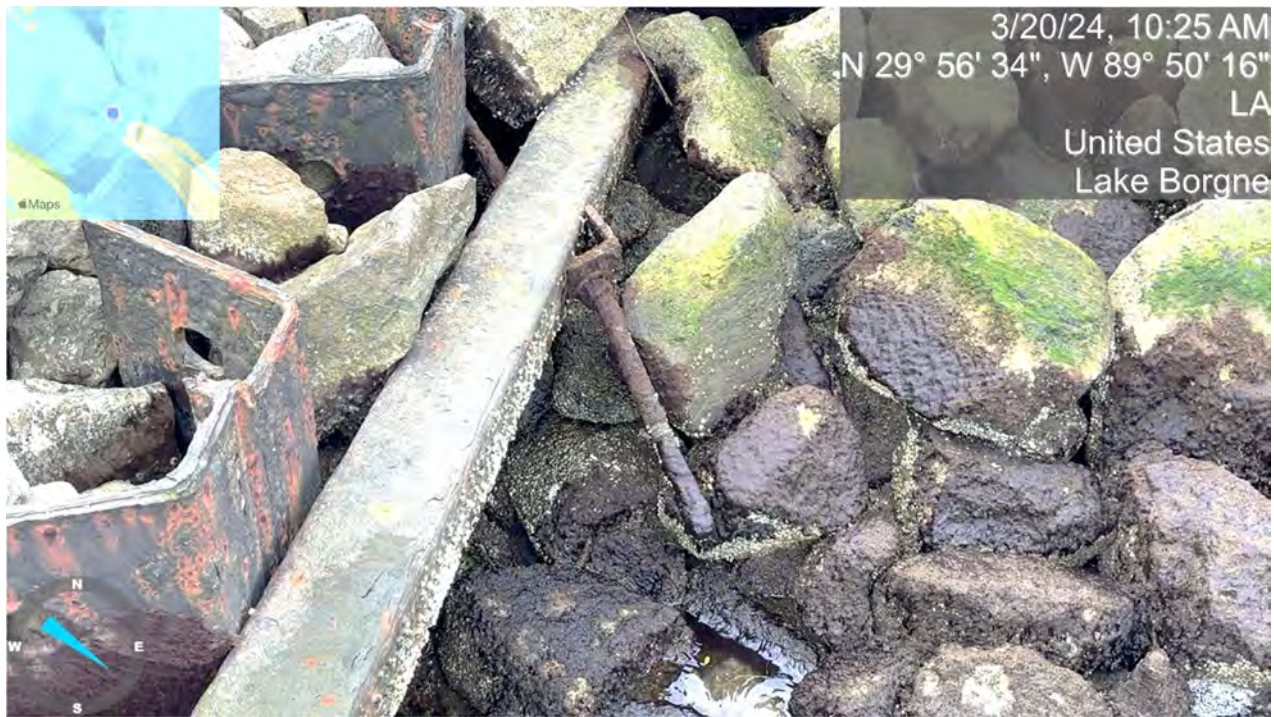
Photo 12: Reach 2

Damaged tie rod on the double sheetpile structure at the mouth of Bayou Dupre, near the tie in to the USACE rocks.

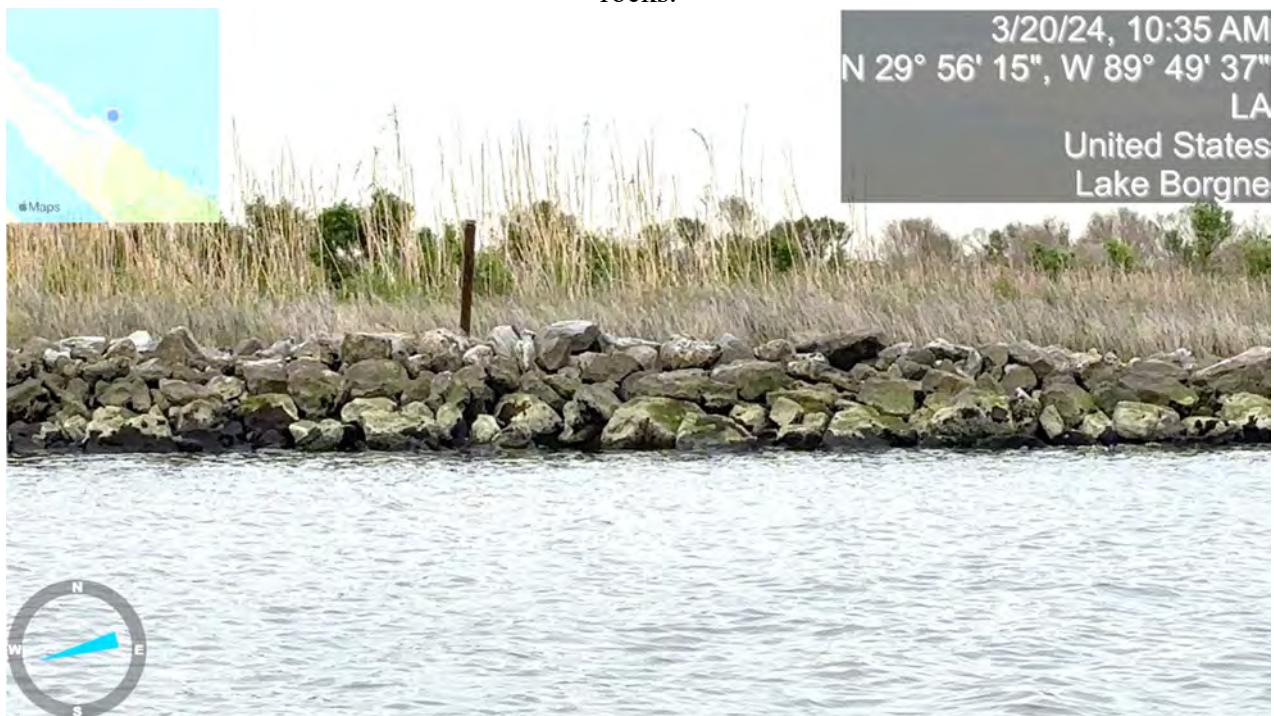
Photo 13: Reach 2

Rock breakwater in generally good condition

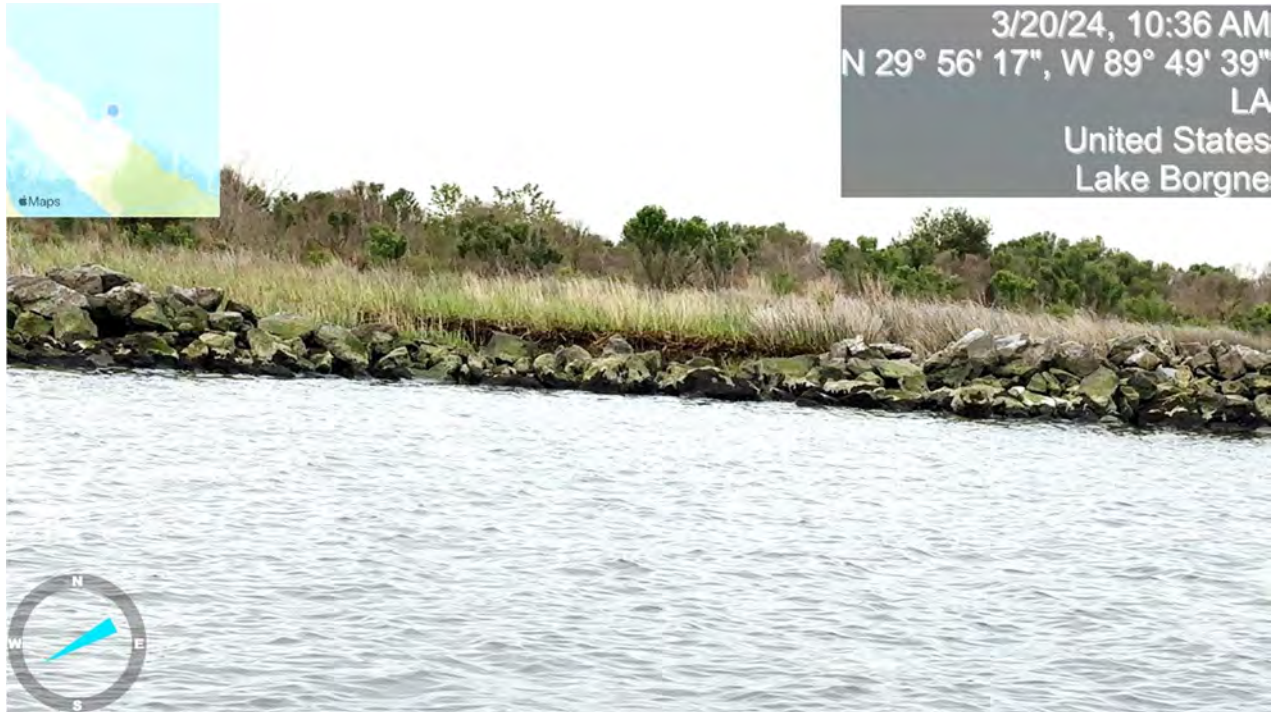
Photo 14: Reach 2

This short segment of the rock breakwater has experienced visible differential settlement.

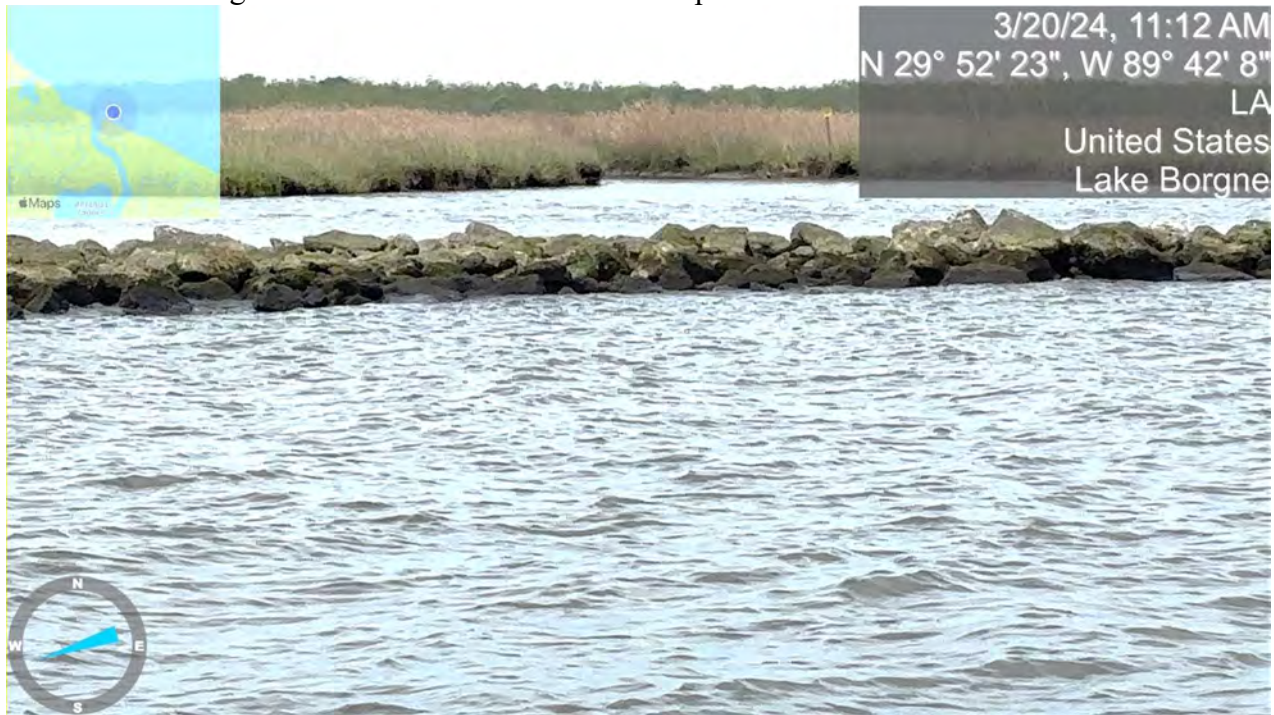
Photo 15: Reach 3

- B. **Breakwater Reach 2 (South of Bayou Dupre)** – The rock breakwater has experienced some settlement but is in generally good condition.
- C. **Breakwater Reach 3 Strong (West of Tennessee Gas Pipeline)** – The rock breakwater has numerous low spots with marsh retreat observed behind those locations. Other areas are performing well.

This area of the rock breakwater has experienced significant settlement with associated shoreline retreat visible.

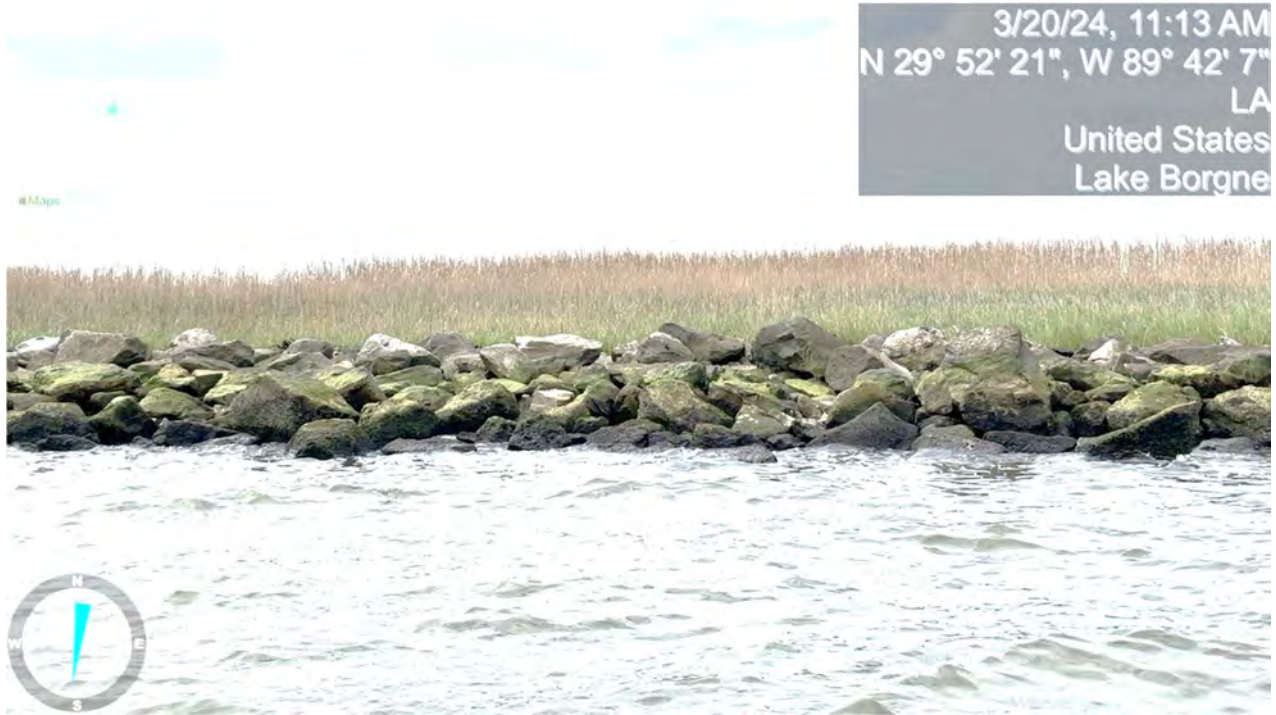
Photo 16: Reach 3
Rock breakwater in generally good condition

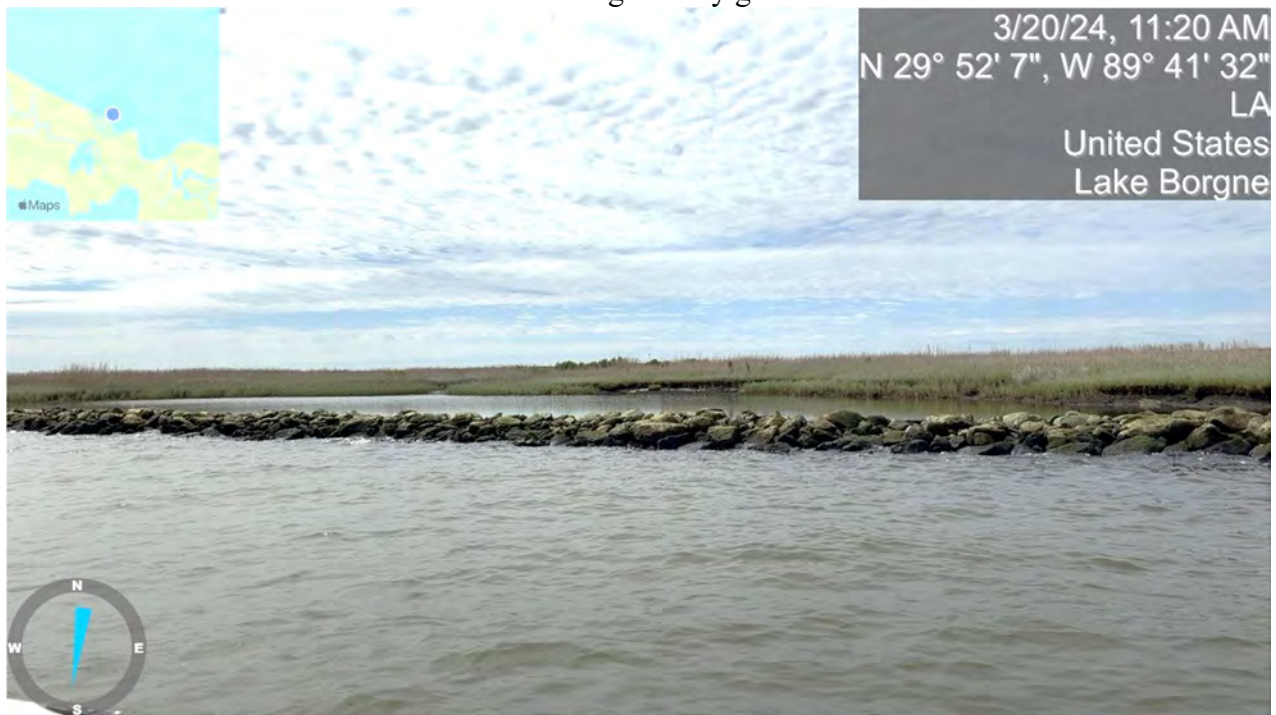
Photo 17: Reach 3

This area of the rock breakwater has experienced significant settlement with associated shoreline retreat visible. At a normal tide, these rocks would be overtopped.

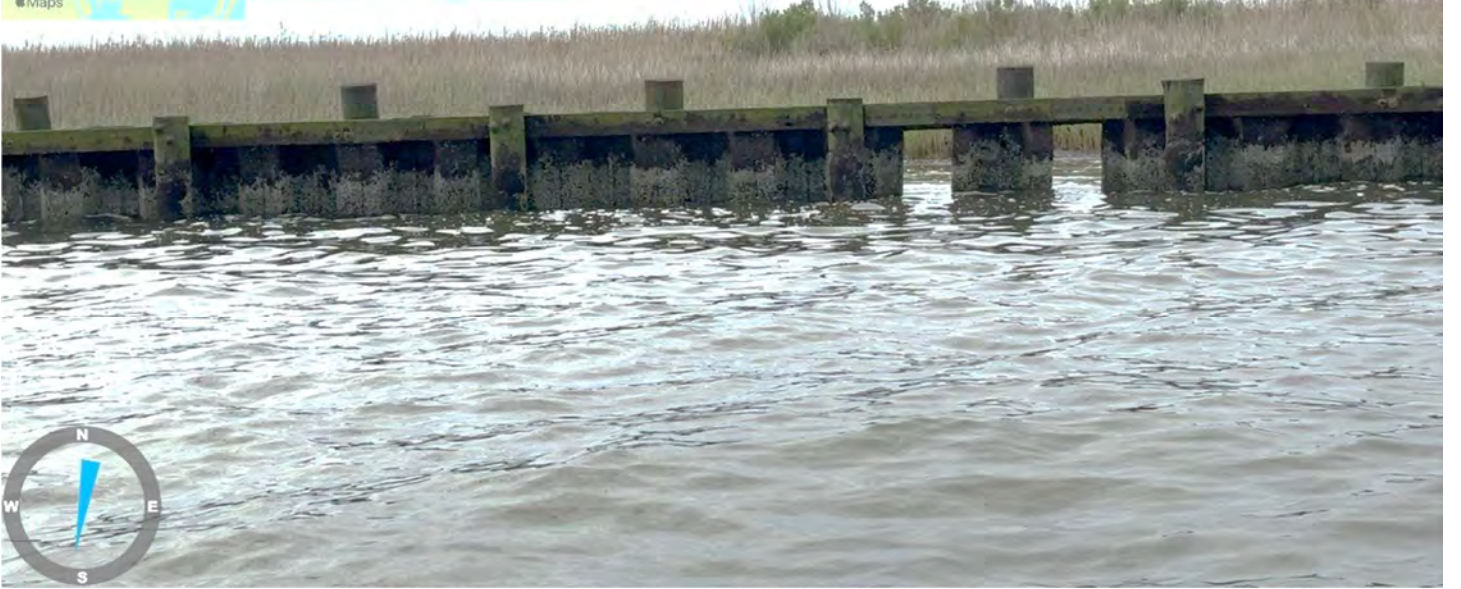
Photo 18: Reach 3

Composite sheet pile wall appears to be in generally good condition, although two missing panels are noted.

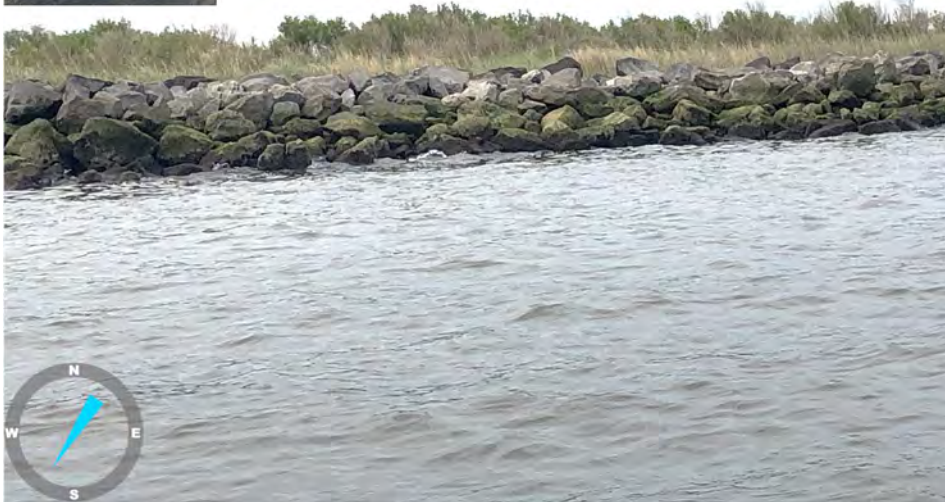
Photo 19: Reach 4

Rocks appear to be in generally good condition.
