**State of Louisiana  
Coastal Protection and Restoration Authority**

**2020 Annual Inspection Report**

**Goose Point / Point Platte Marsh  
Creation Project**

State Project Number PO-33  
Priority Project List PPL-13

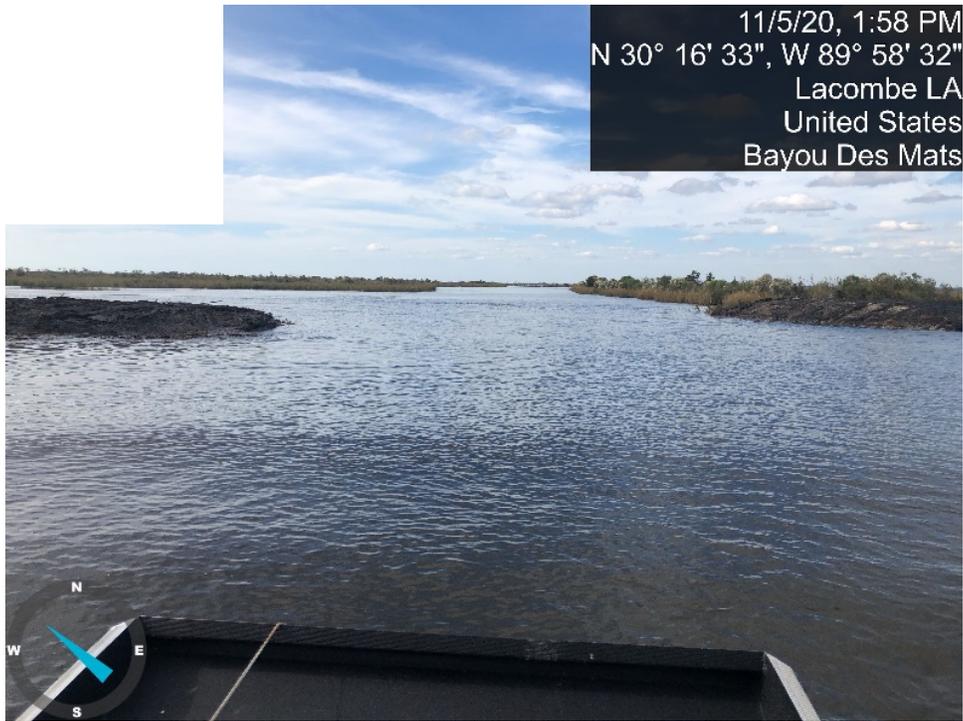
**Photo 1: Cell A**  
Recently constructed northern gap

Project Feature	Condition	Physical Damage	Photo #	Observations and Remarks
<u>Cell A</u>	Good	None	1-4	Some large areas are noticeably lower than the surrounding marsh. The surrounding marsh appears to be healthy.
<u>Cell B</u>	Very Good	None	5-11	The marsh appears to be healthy.
<u>Cell C</u>	Very Good	None	12-14	The marsh appears to be healthy.
<u>Cell D</u> Vinyl Sheet Pile	Very Good	None	15-16	The marsh appears to be healthy. The vinyl sheet pile was not visited as a part of this annual inspection.
<u>Cell E</u> Vinyl Sheet Pile	Very Good	None	17-20	The marsh appears to be healthy. The vinyl sheet pile was not visited as a part of this annual inspection.

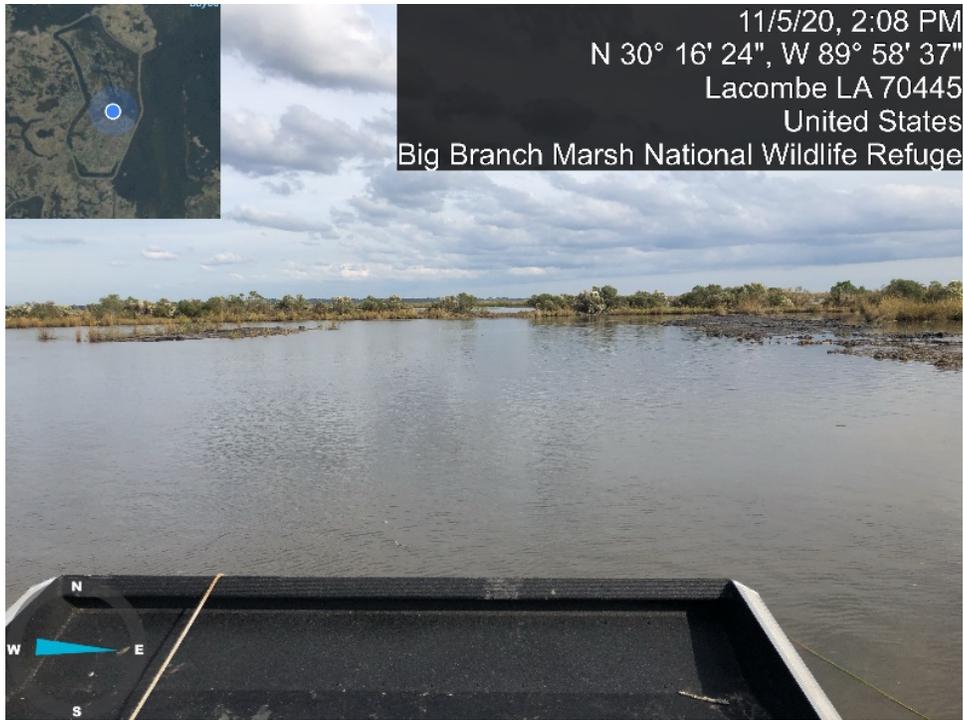
**Photo 2: Cell A**  
Recently constructed northern creek, facing the eastern containment dike. This area is lower than the surrounding marsh.

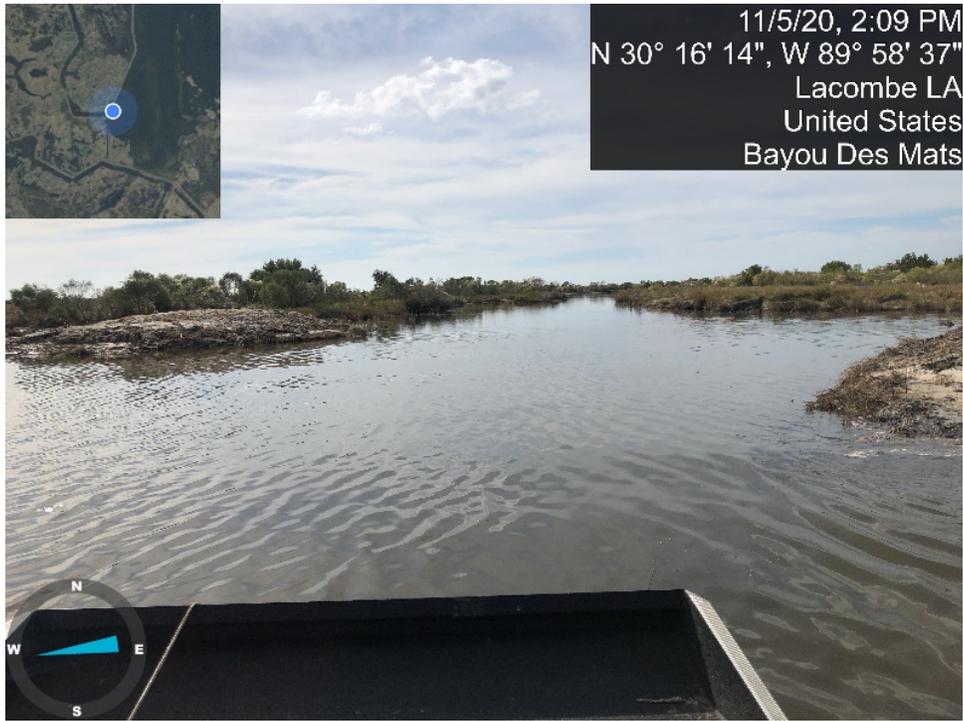
**Photo 3: Cell A**  
Recently constructed southern gap

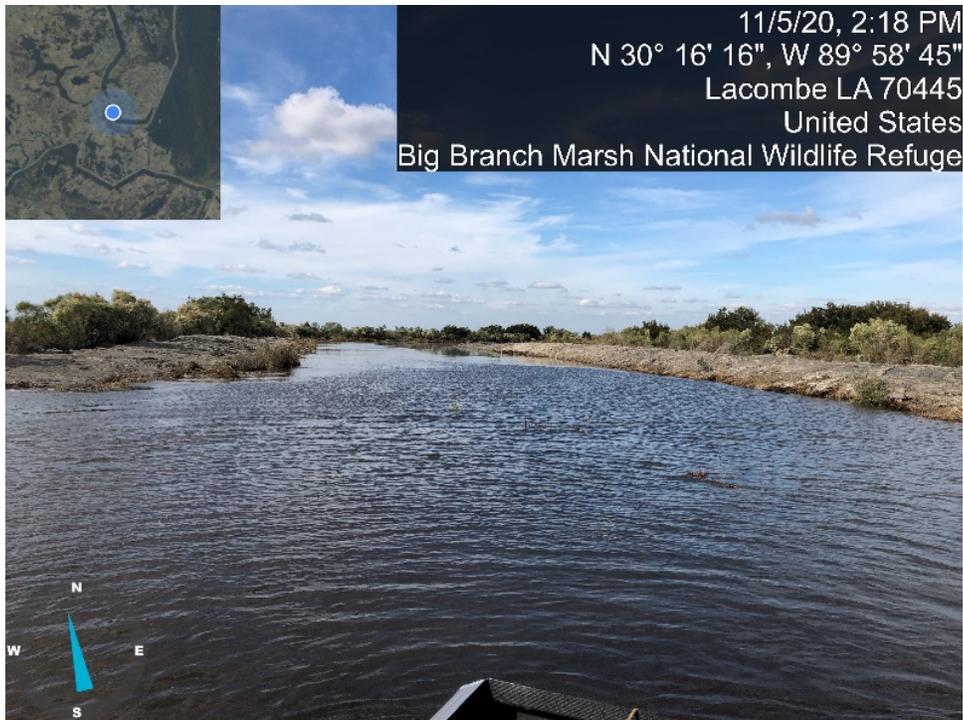
**Photo 4: Cell A**  
Recently constructed southern creek

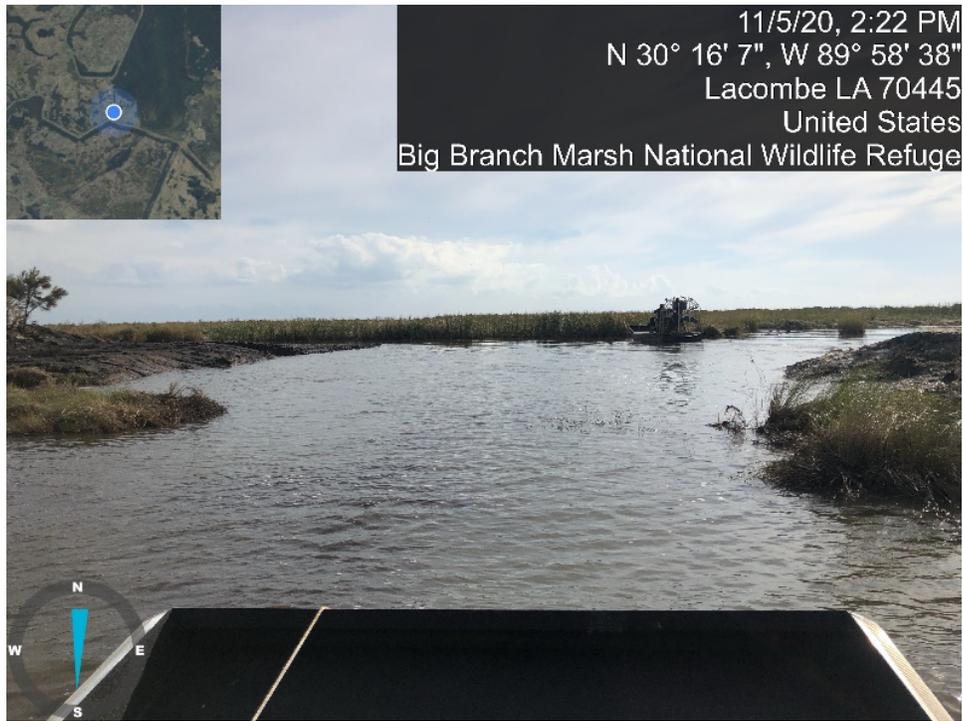
**Photo 5: Cell B**  
Recently constructed northwestern gap

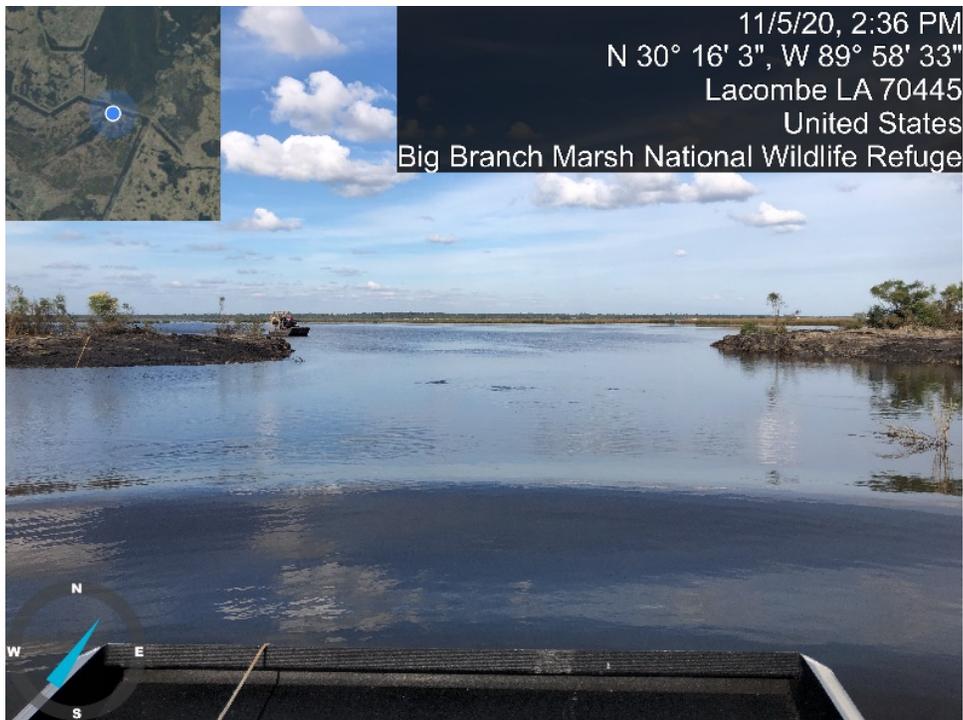
**Photo 6: Cell B**  
Recently constructed north/middle gap

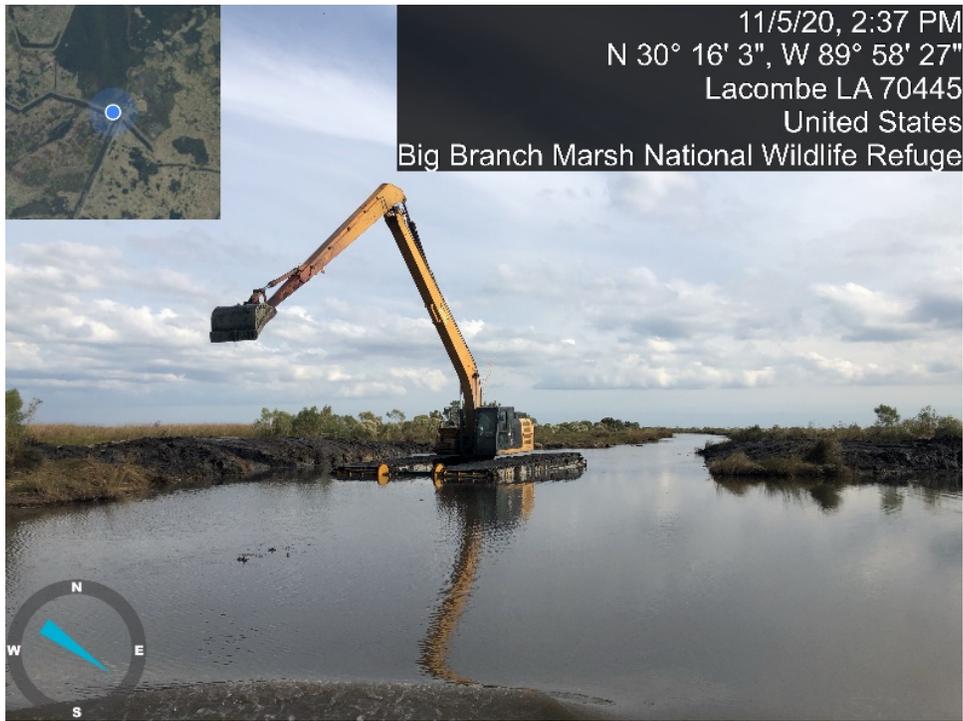
**Photo 7: Cell B**

Northeastern gap – Contractor was working on this gap at the time of the inspection.

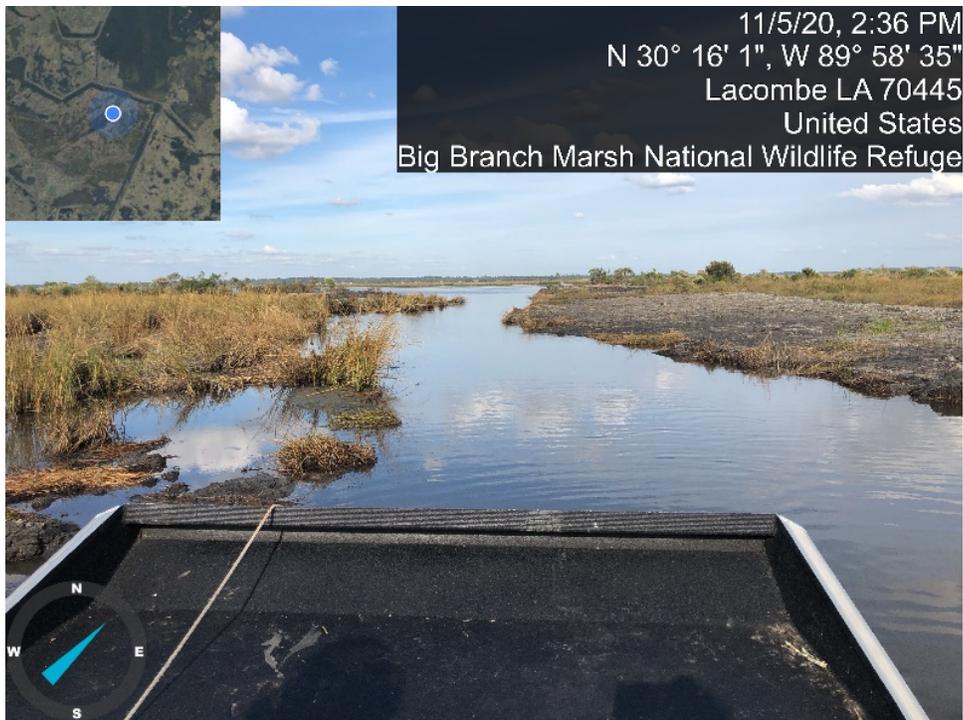
**Photo 8: Cell B**

Recently constructed northern creek

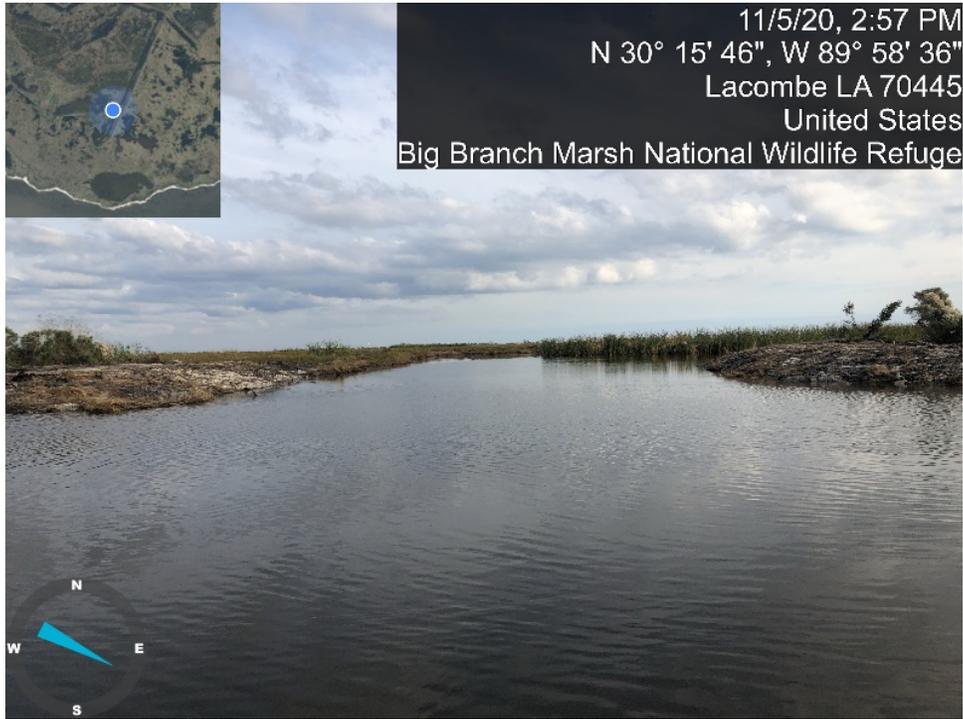
**Photo 9: Cell B**  
Recently constructed southeastern gap

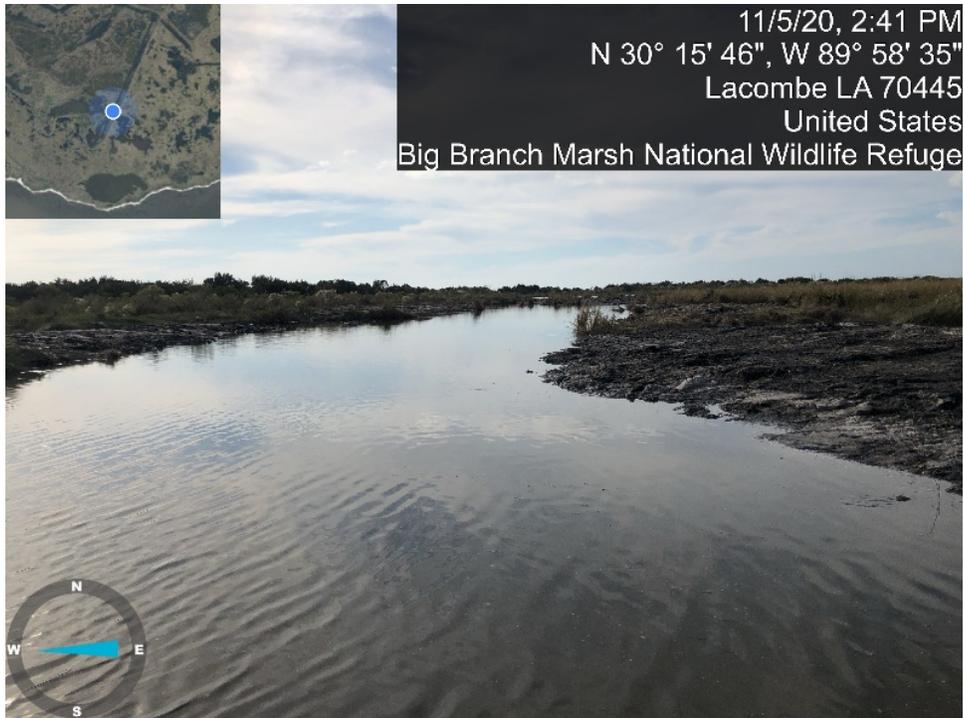
**Photo 10: Cell B**  
Recently constructed southern creek

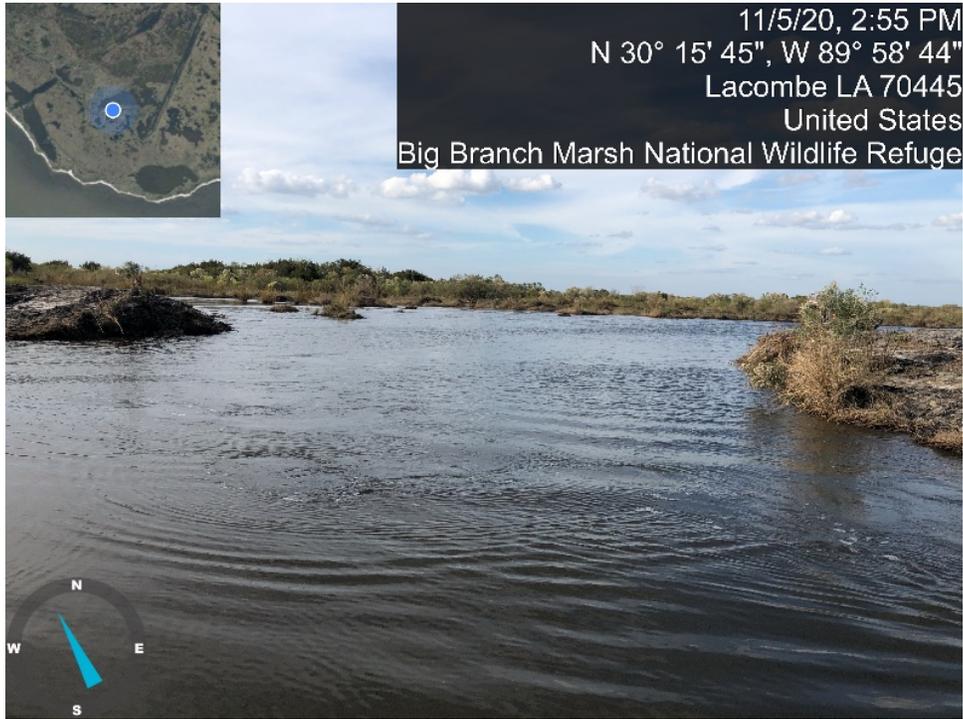
**Photo 11: Cell B**  
Recently constructed southwestern gap

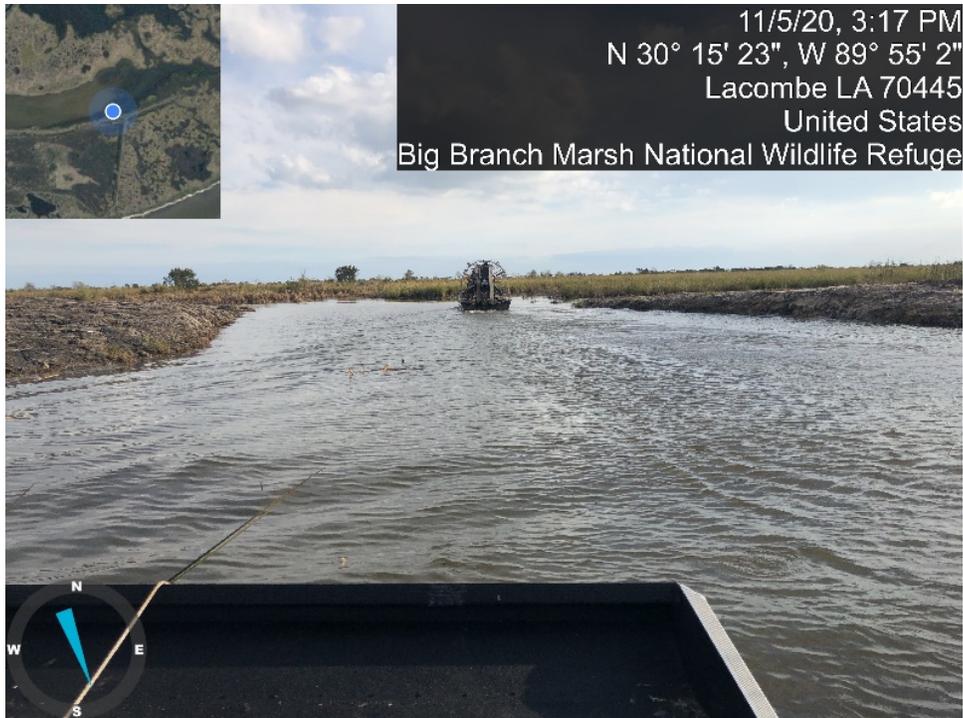
**Photo 12: Cell C**  
Recently constructed western gap

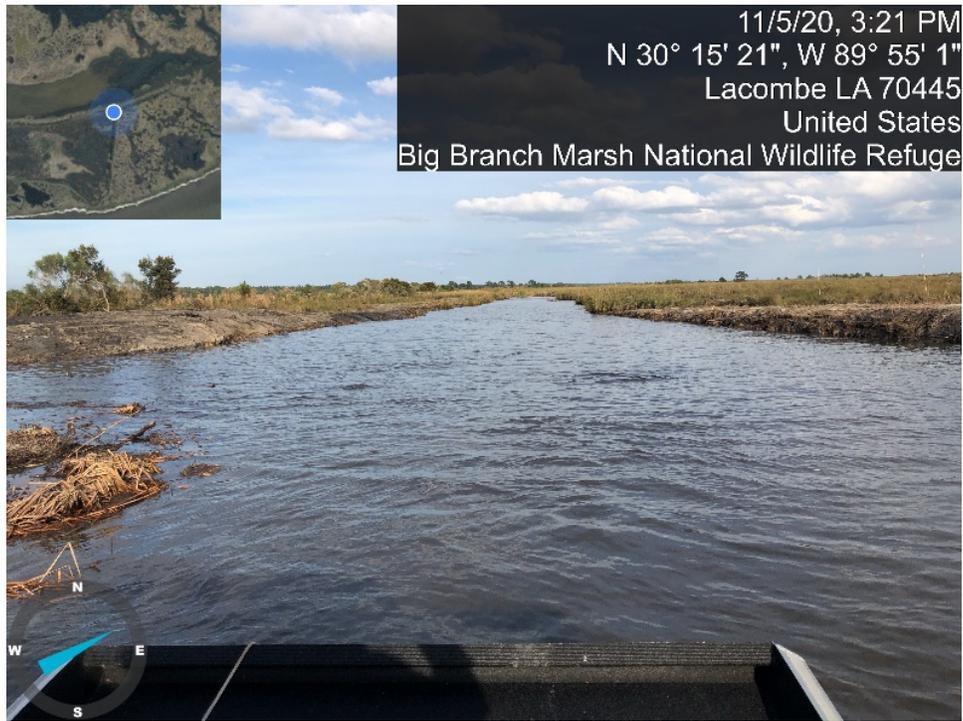
**Photo 13: Cell C**  
Recently constructed eastern gap looking into creek

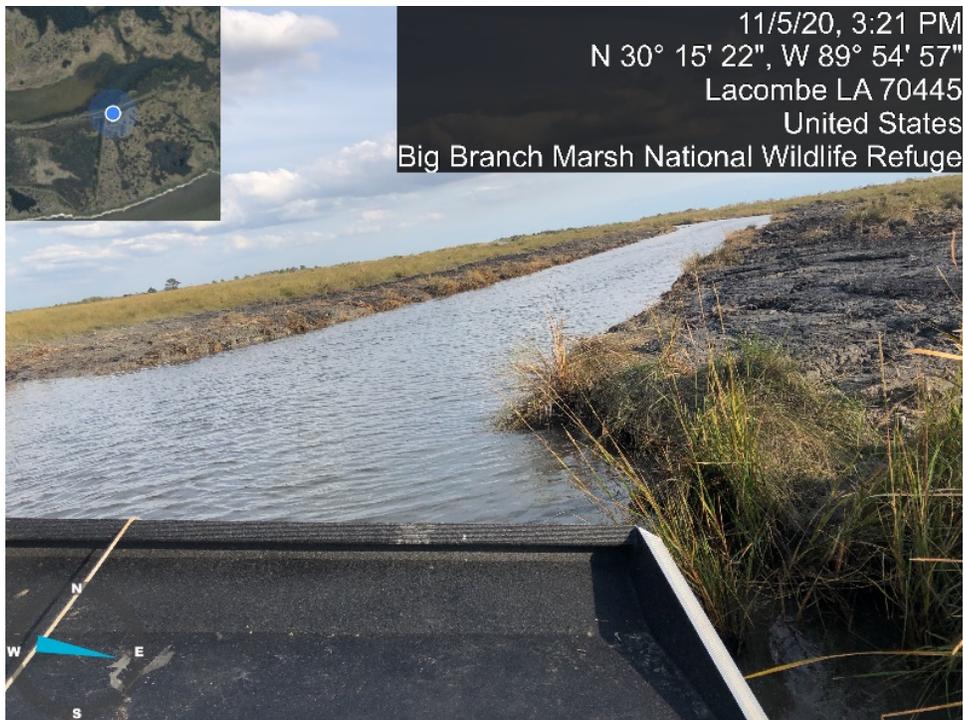
**Photo 14: Cell C**  
Recently constructed creek

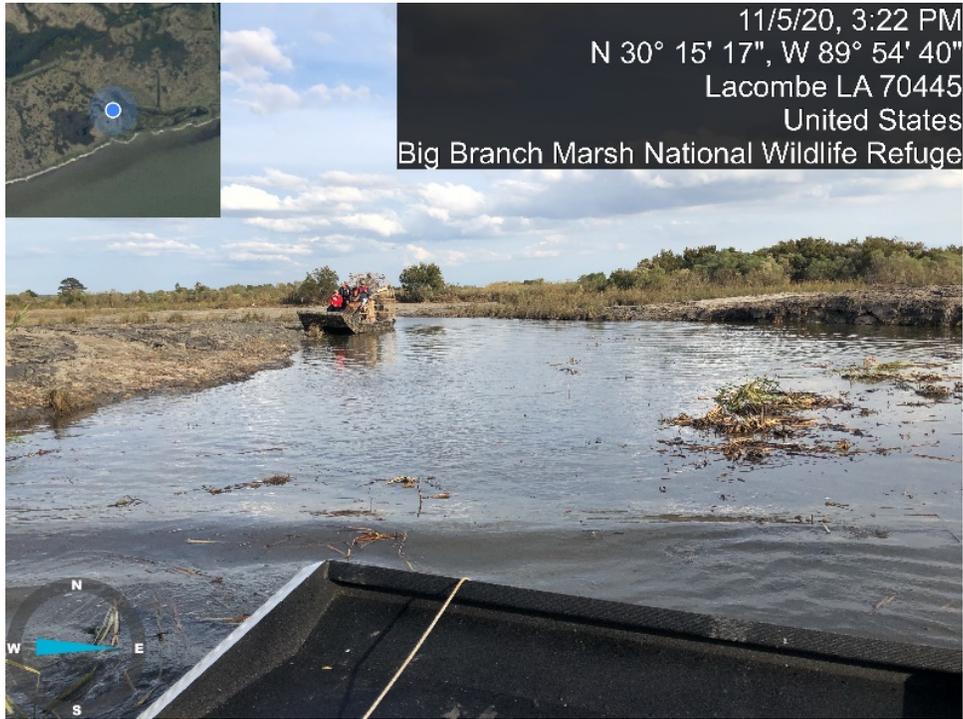
**Photo 15: Cell D**  
Recently constructed gap

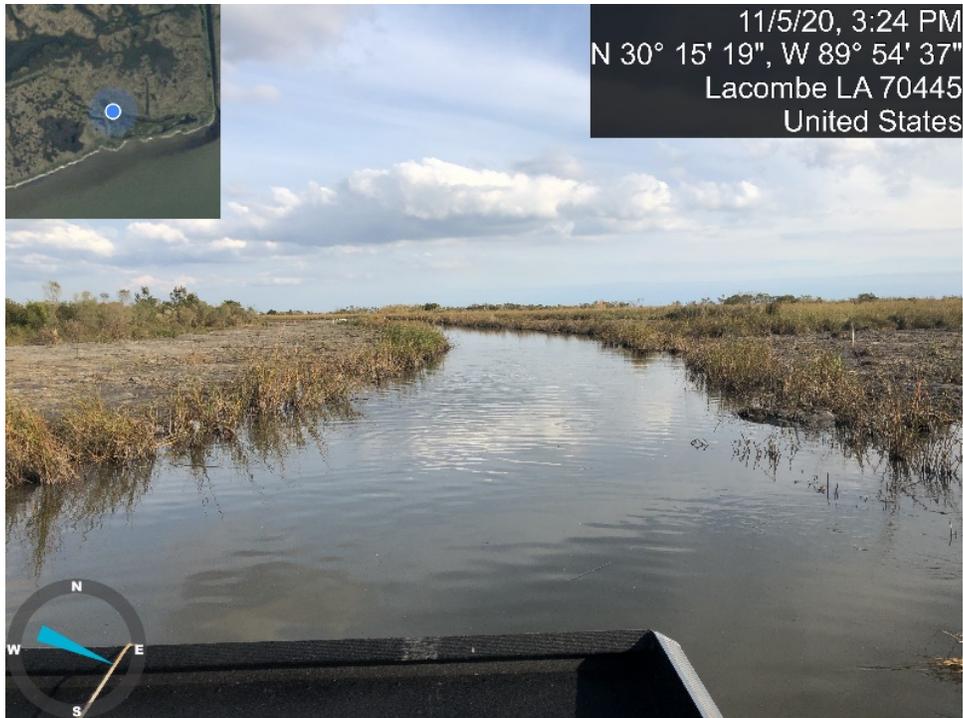
**Photo 16: Cell D**  
Recently constructed creek

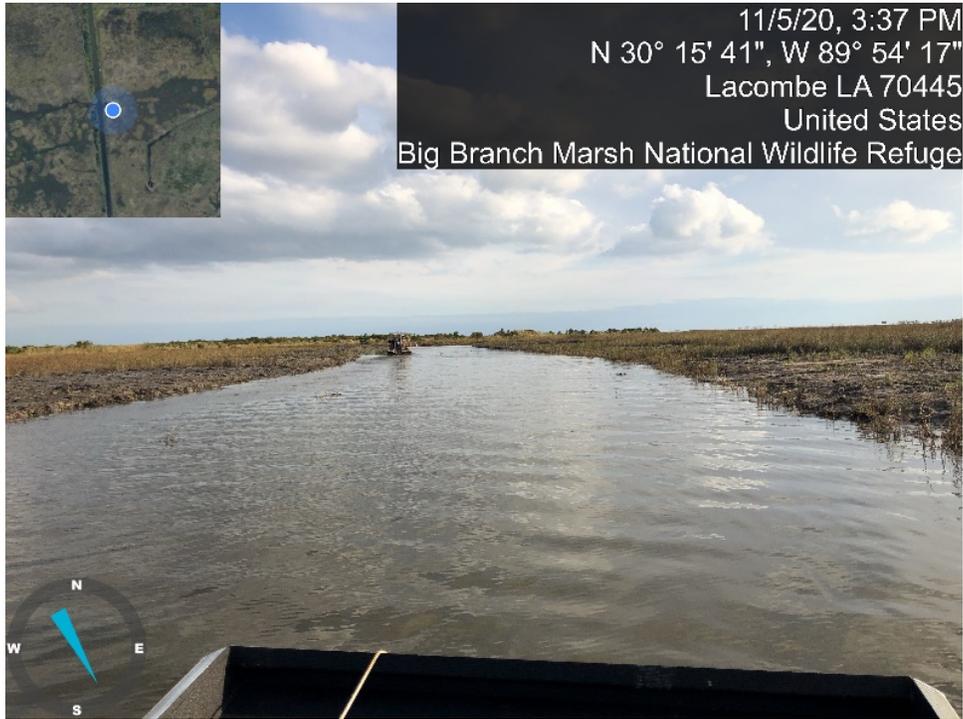
**Photo 17: Cell E**  
Recently constructed creek

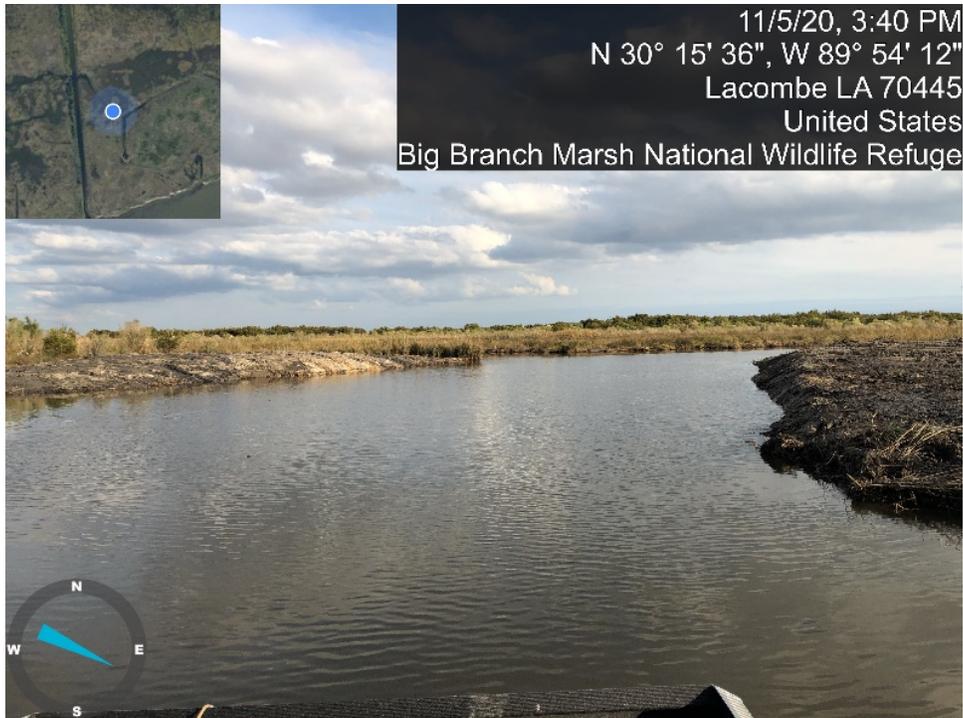
**Photo 18: Cell E**  
Recently constructed western gap

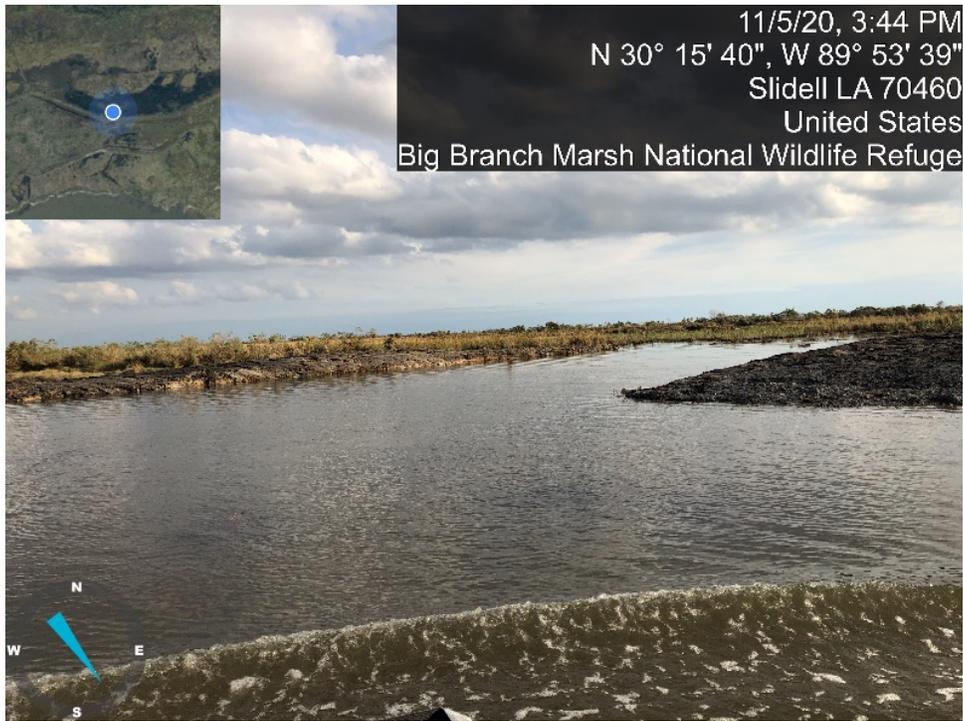
**Photo 19: Cell E**  
Recently constructed middle gap

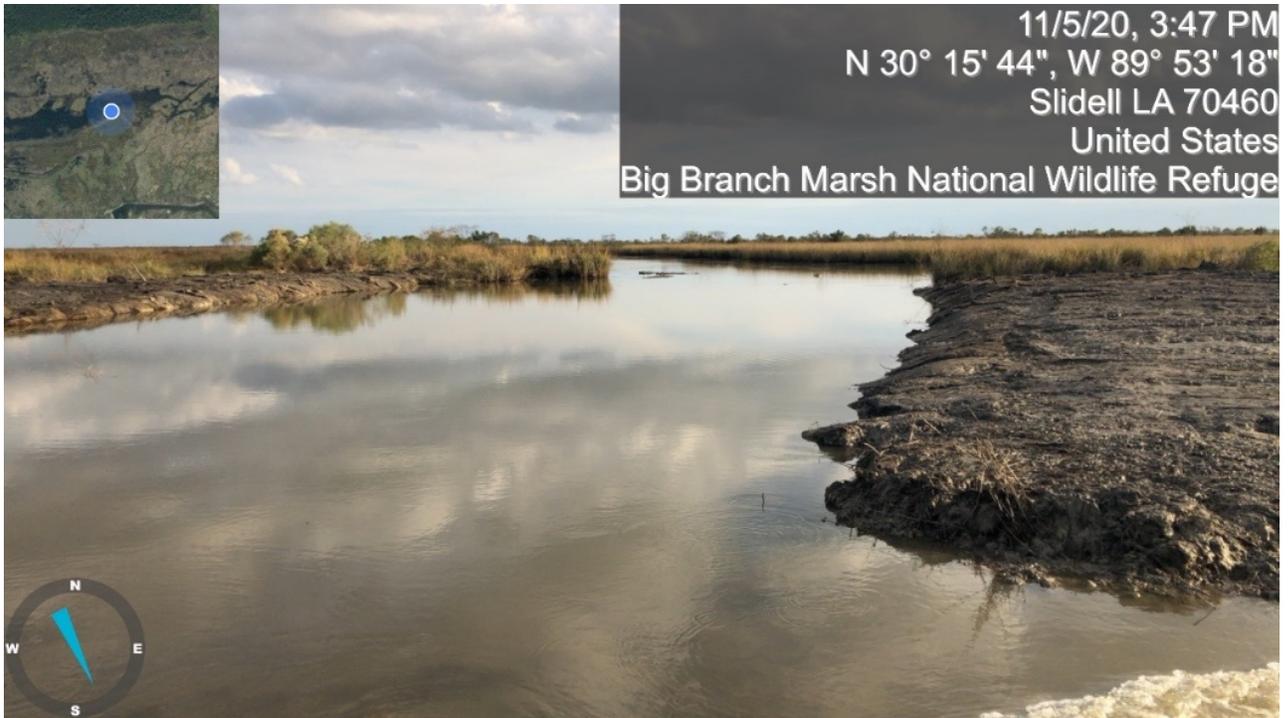
**Photo 20: Cell E**  
Recently constructed eastern gap
