**2022 Annual Inspection Report**

**Goose Point / Point Platte Marsh  
Creation Project**

State Project Number PO-33  
Priority Project List PPL-13

July 2022  
St. Tammany Parish

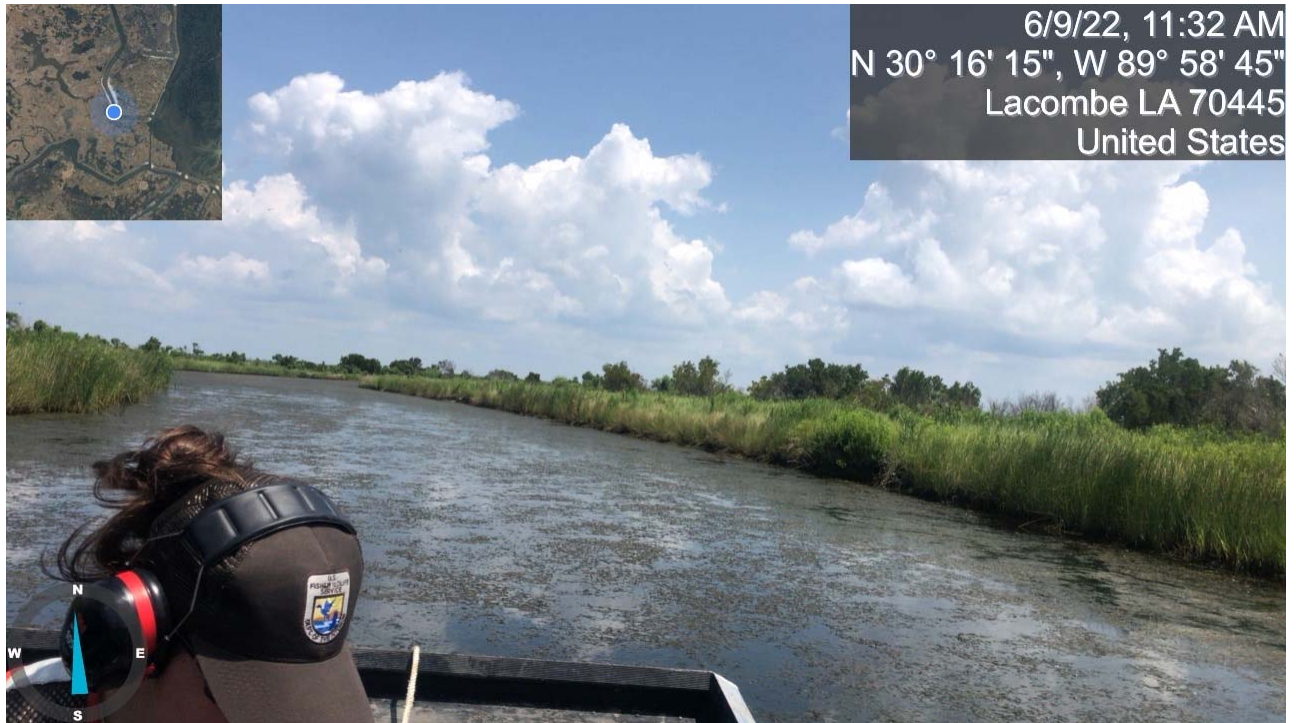
**Photo 1: Cell A**

Marsh area (on right side of photo) viewed from southern tidal creek

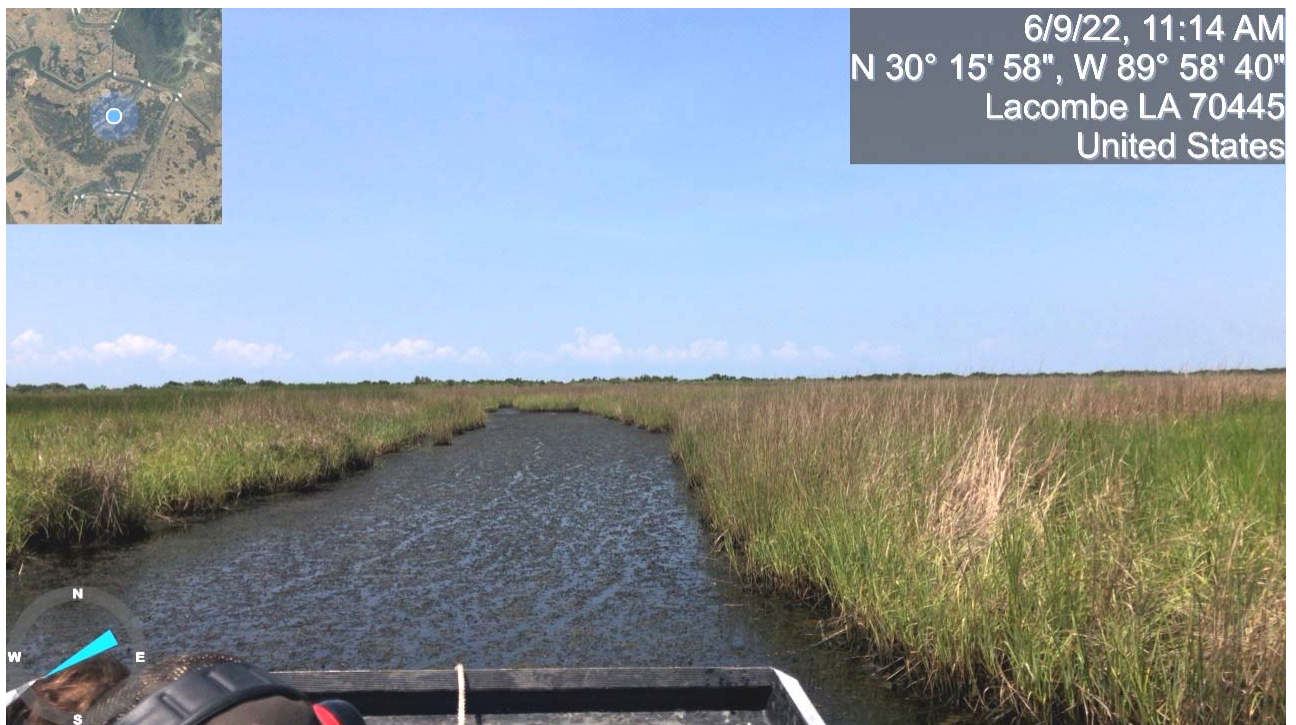
**Photo 2: Cell B**

Marsh creation area viewed from northern tidal creek

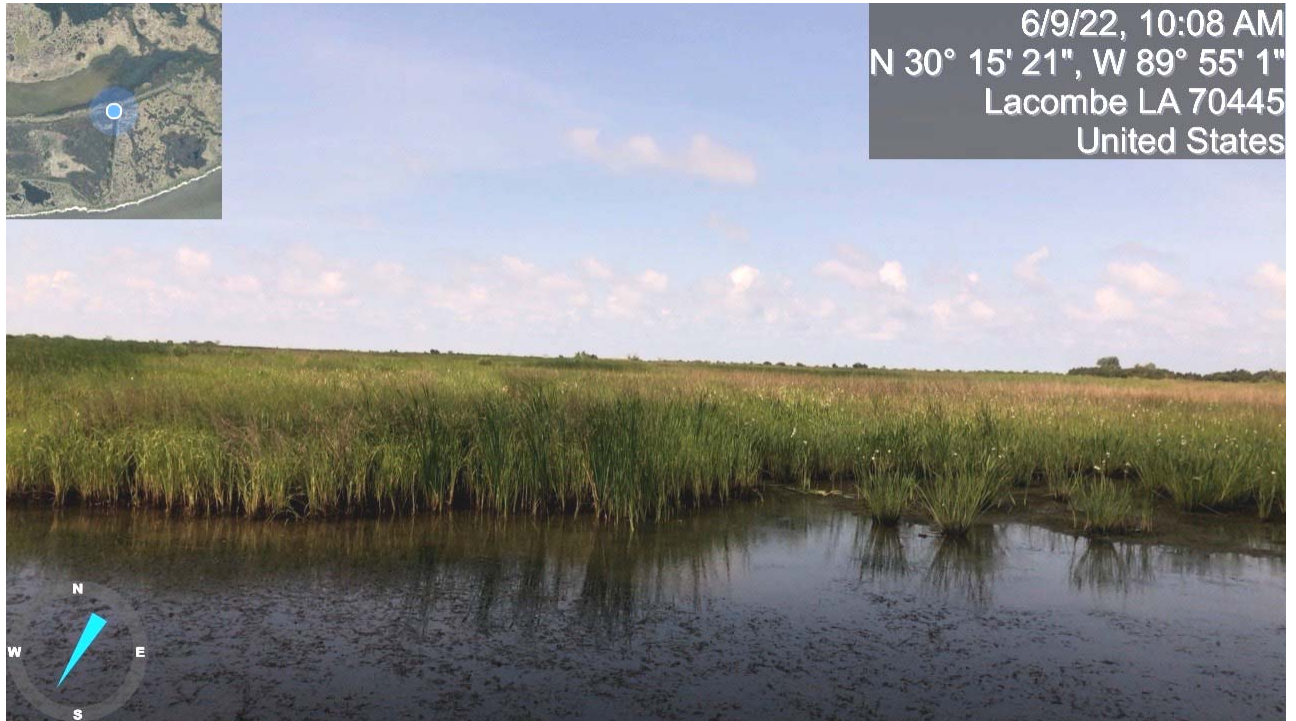
**Photo 3: Cell C**  
Healthy marsh in Cell C

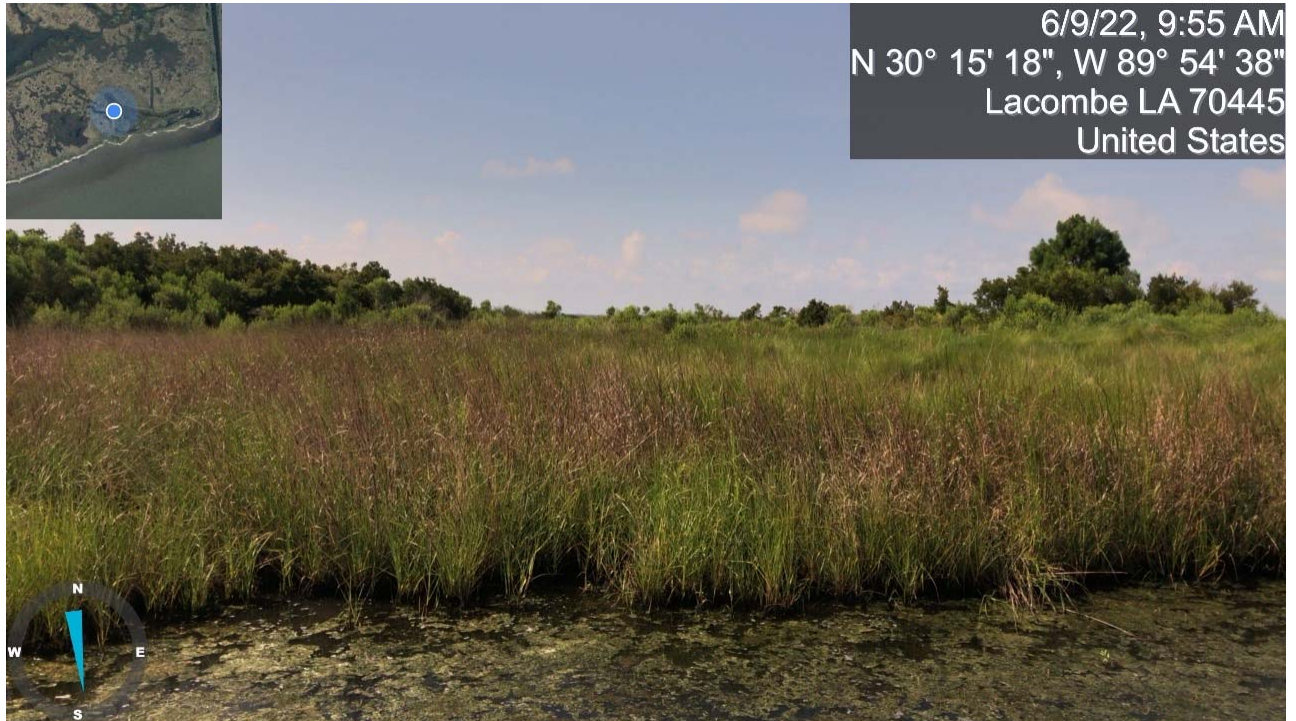
**Photo 4: Cell D**  
Healthy marsh in Cell D with earthen containment dike (ECD) in background

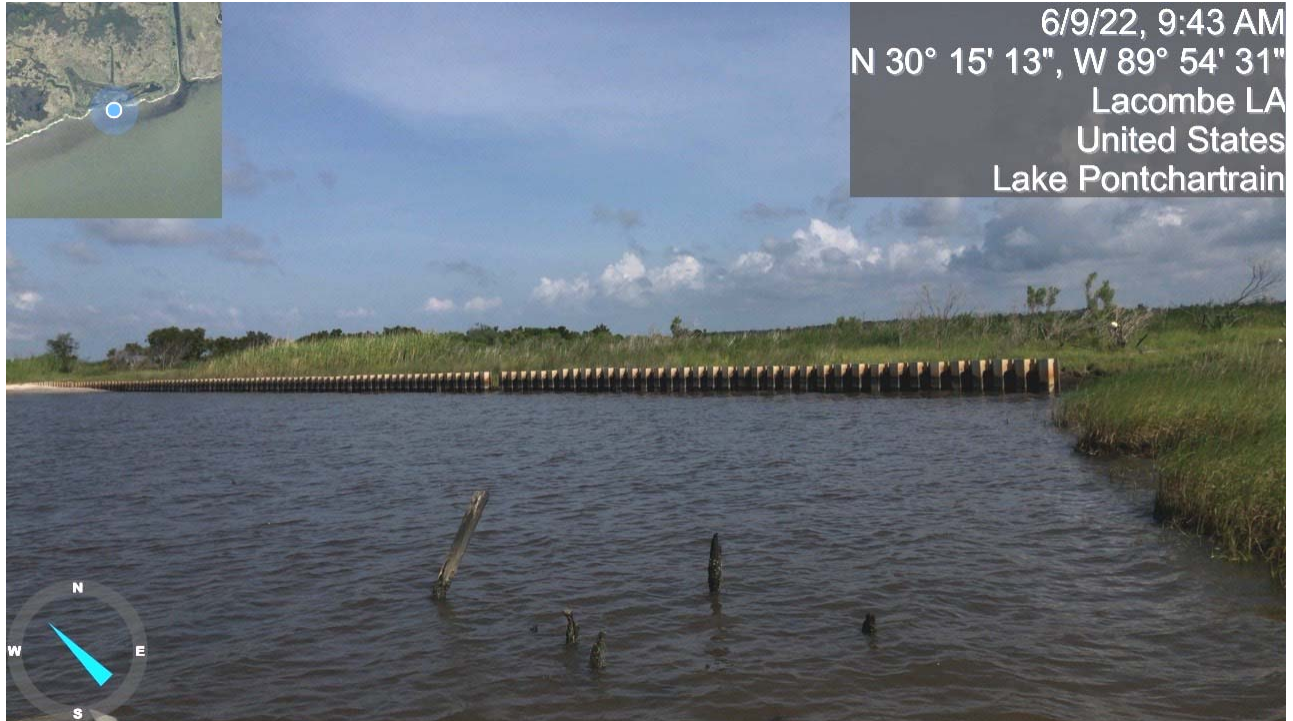
**Photo 5: Cell D**

Western segment of Cell D composite sheet pile on lake rim. One sheet is missing near the middle of the segment. The shoreline is eroding at the eastern extent of the sheet pile (right side of photo) but appears to be solid on the western extent of the sheet pile (left side of photo).

Project Feature	Condition	Physical Damage	Photo #	Observations and Remarks
<u>Cell A</u>	Good	None	1	The marsh appears to be healthy.
<u>Cell B</u>	Very Good	None	2	The marsh appears to be healthy.
<u>Cell C</u>	Very Good	None	3	The marsh appears to be healthy.
<u>Cell D</u> Vinyl Sheet Pile	Very Good	Minor	4-7	The marsh appears to be healthy. There is some minor damage to the sheet pile. At the extents of some of the sheet pile segments, the shoreline is eroding.
<u>Cell E</u> Vinyl Sheet Pile	Very Good	Minor	8-9	The marsh appears to be healthy. There is some minor damage to the sheet pile. At the extents of sheet pile segments, the shoreline is eroding.

USFWS is interested in removing the composite sheet pile along the lake rim at Cells D & E in an effort to stop further erosion at the ends of the sheet pile segments. However, the current project budget does not support this. This may be considered at the project end of life.

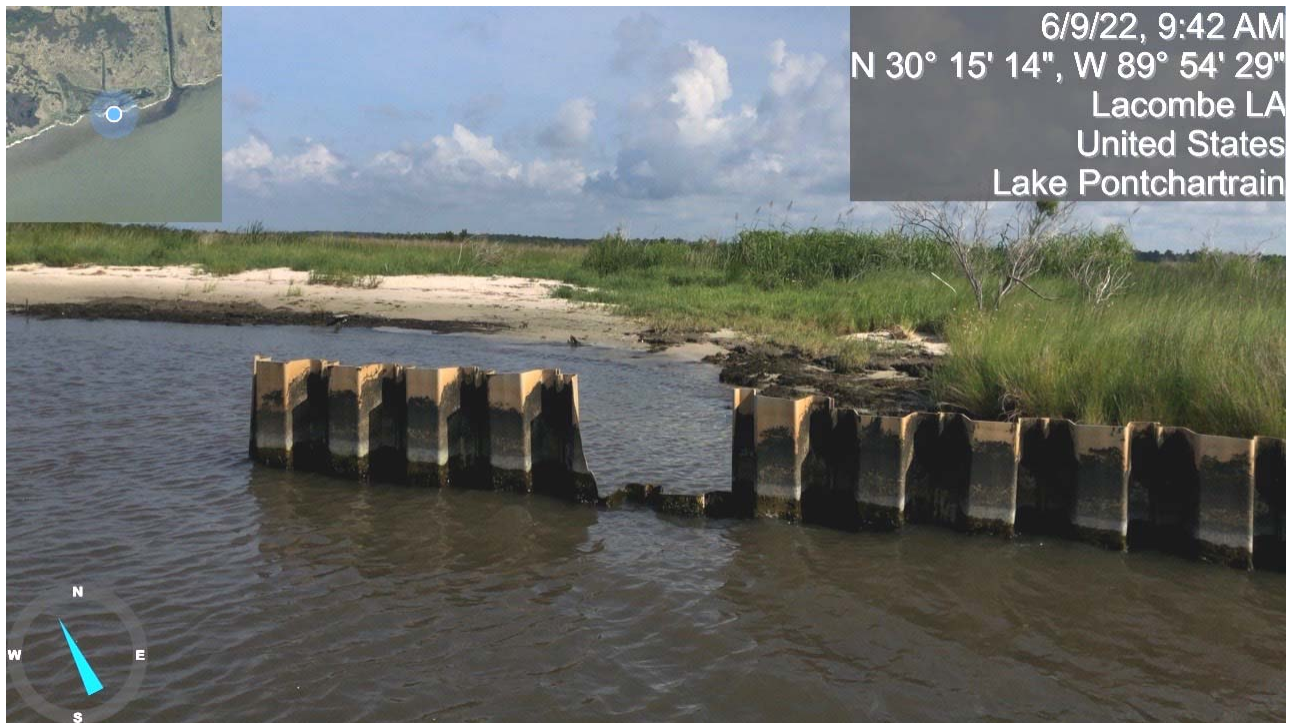
**Photo 6: Cell D**

Eastern segment of Cell D composite sheet pile on lake rim. Some damage and erosion is noted here at the western extent of the sheet pile segment.

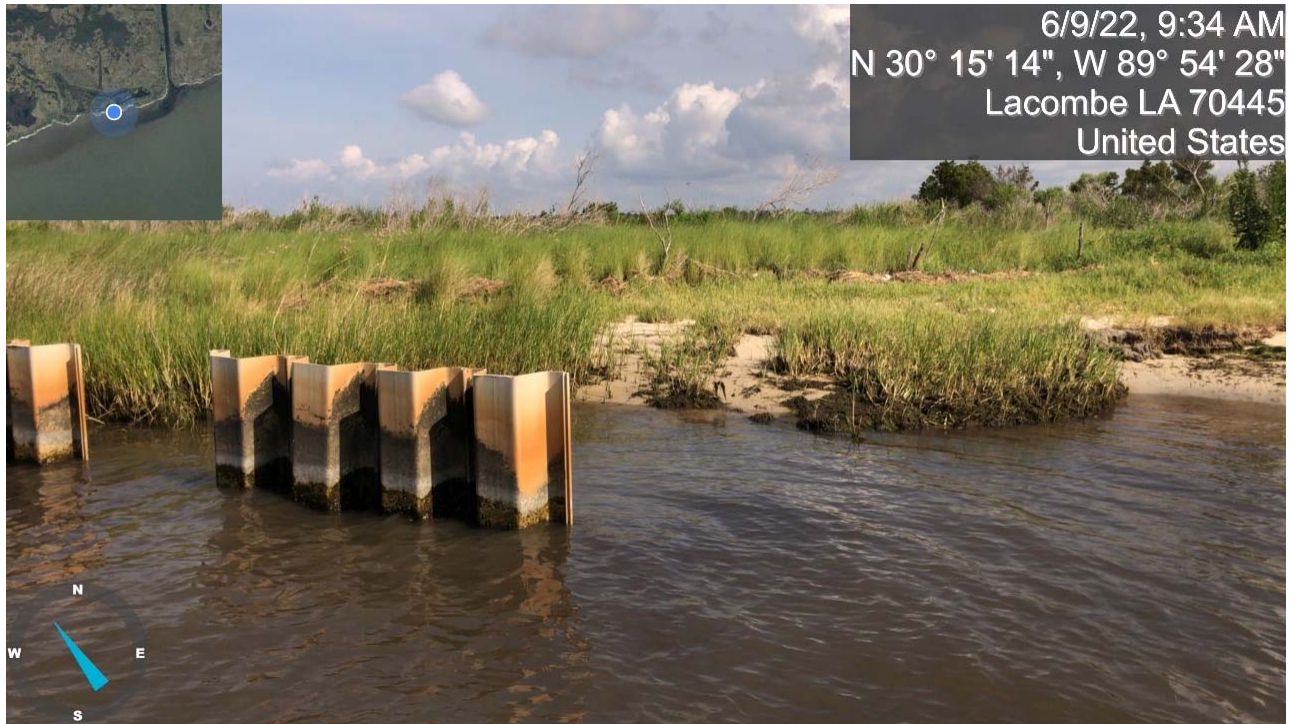
**Photo 7: Cell D**

Eastern segment of Cell D composite sheet pile on lake rim. Some damage and erosion is noted here at the eastern extent of the sheet pile segment.

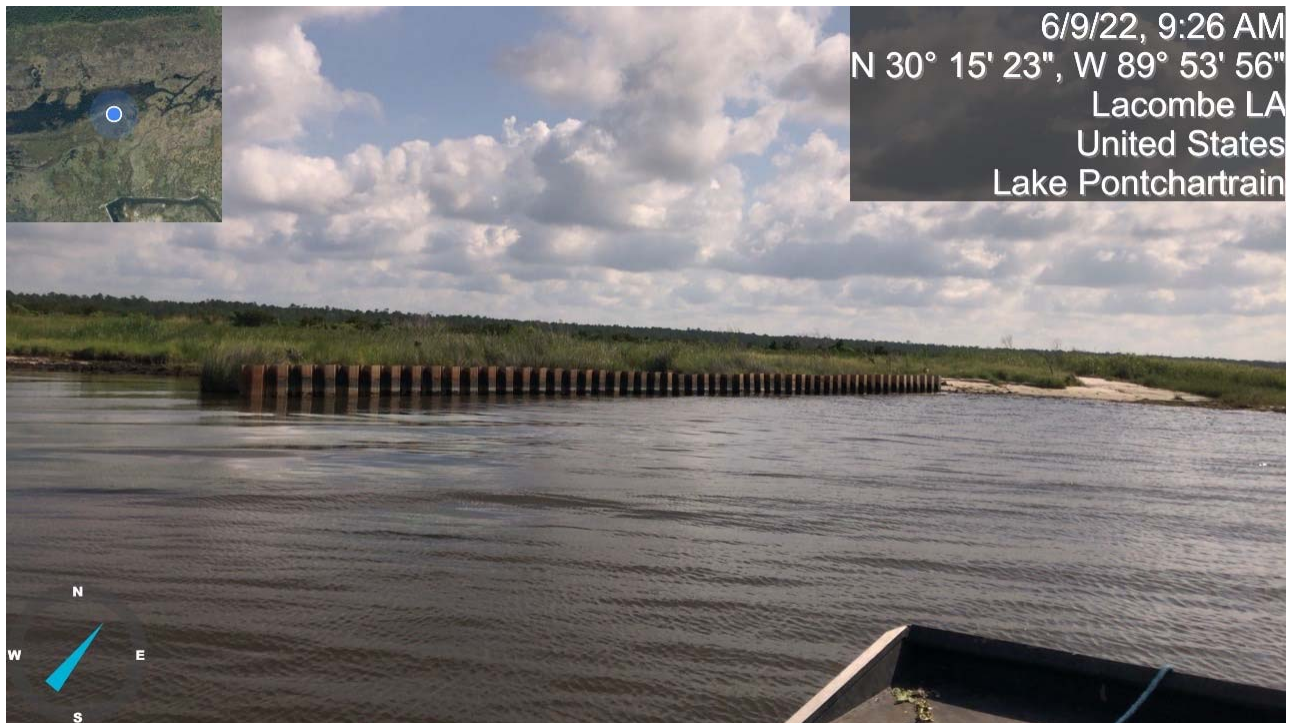
**Photo 8: Cell E**

Cell E composite sheet pile on lake rim. The shoreline is erosion at the eastern extents of the sheet pile.

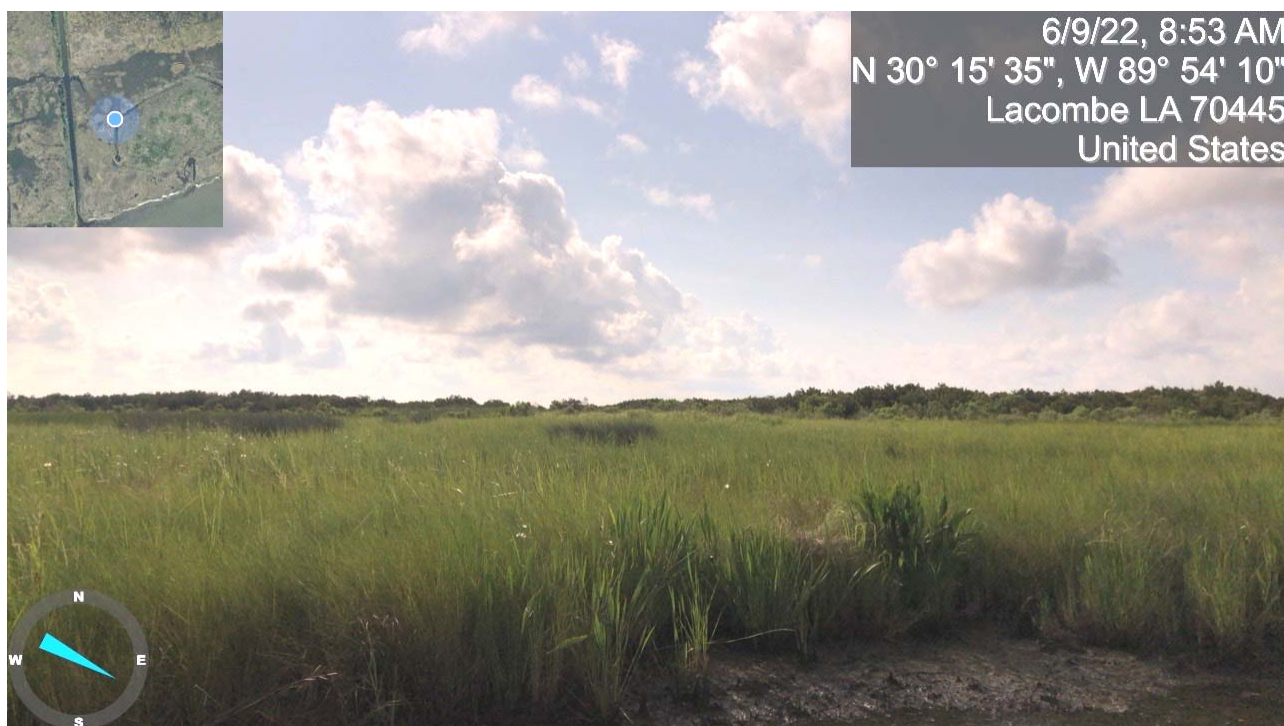
**Photo 9: Cell E**  
Healthy marsh in Cell E
