**State of Louisiana
Coastal Protection and Restoration
Authority**

2015 Annual Inspection Report

**POINT AU FER ISLAND
HYDROLOGIC RESTORATION**

State Project Number TE-22
Priority Project List 2

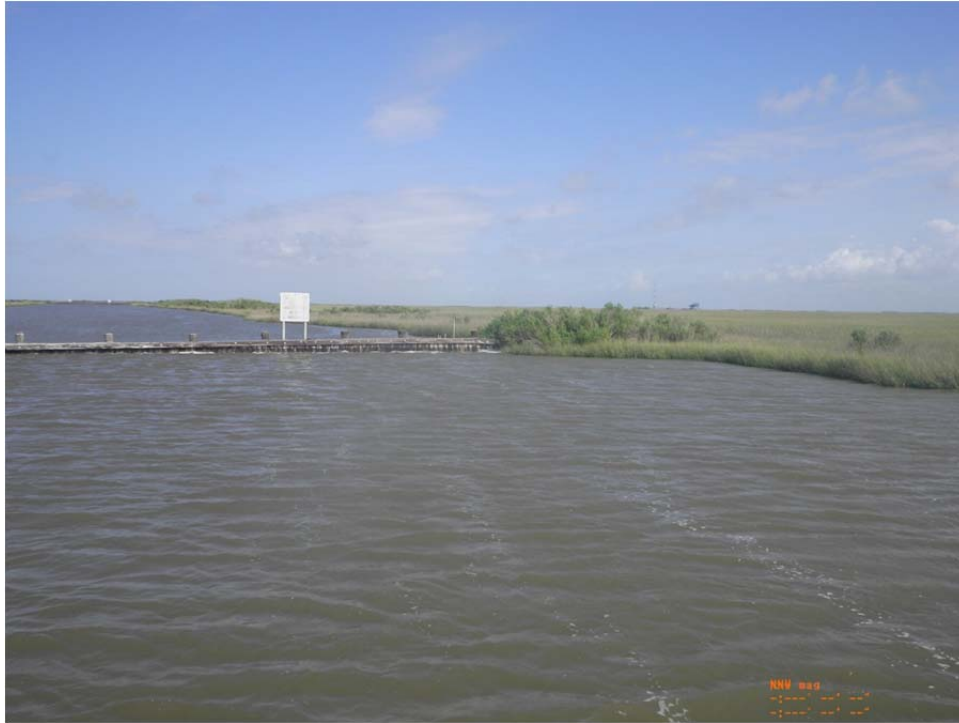
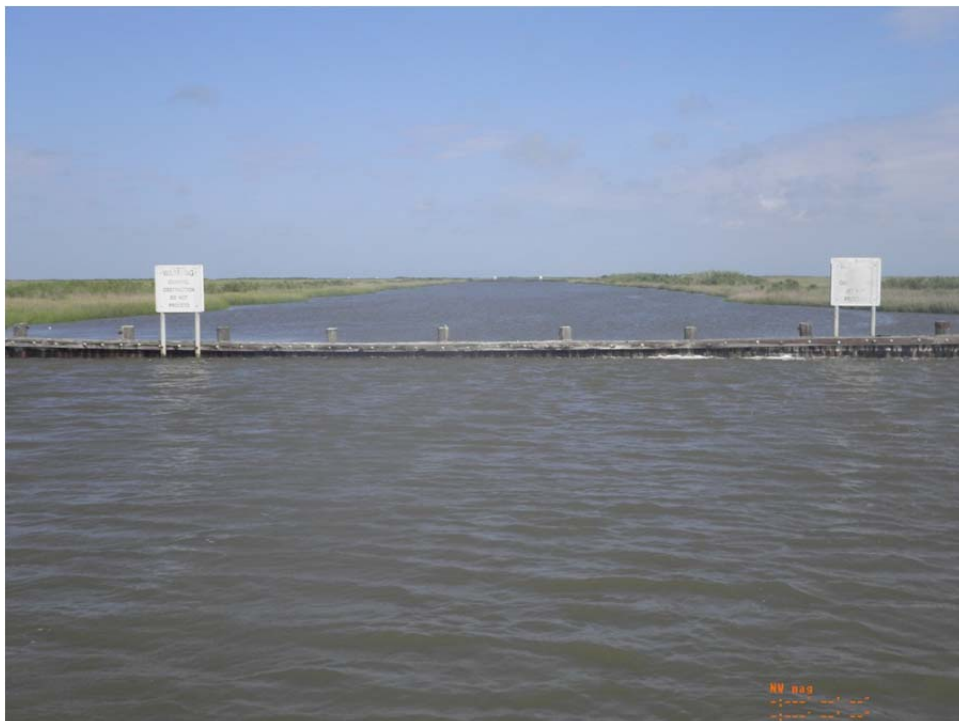
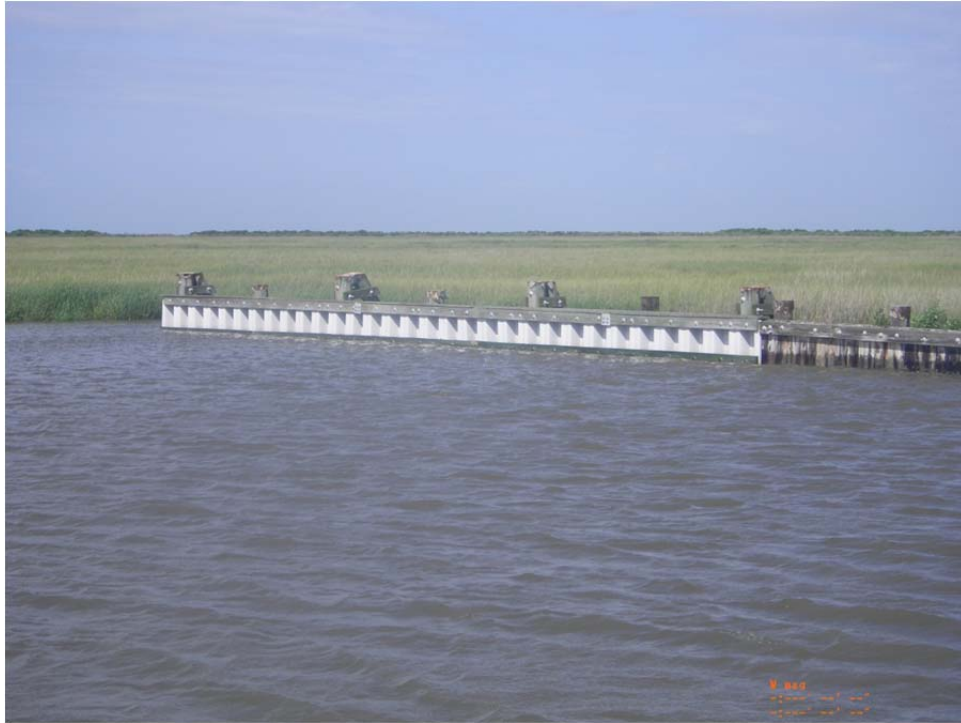
The timber bulkhead plug located on the east end of Hester Canal near Bay Castaguier appeared to be weathered but remains in fair condition. The warning signs attached to the structure are in fair to poor condition. The letters and reflective material on the sign have faded over time and may be difficult to see at night. There is also a large breach around the vinyl bulkhead and Sub-Mar mats on the south side of the structure allowing water to flow around the plug. The embankment tie-in on the north side of the structure has no signs of erosion or breaching. Since the project is close to the 20 year project life, we are not recommending any maintenance to the structure itself. However, we are recommending that the warning signs be replaced prior to closing the project out. (Appendix B; Photos 1 through 3)

Photo 1: Timber sheetpile plug and tie-in to marsh on north side of Structure No.8 along Hester Canal.

Photo 2: Timber sheetpile plug and warning signs at the center of Hester Canal at Structure No.8.

Photo 3: Vinyl sheetpile plug extension installed along Hester Canal on the south side of Structure No.8 in 2003.

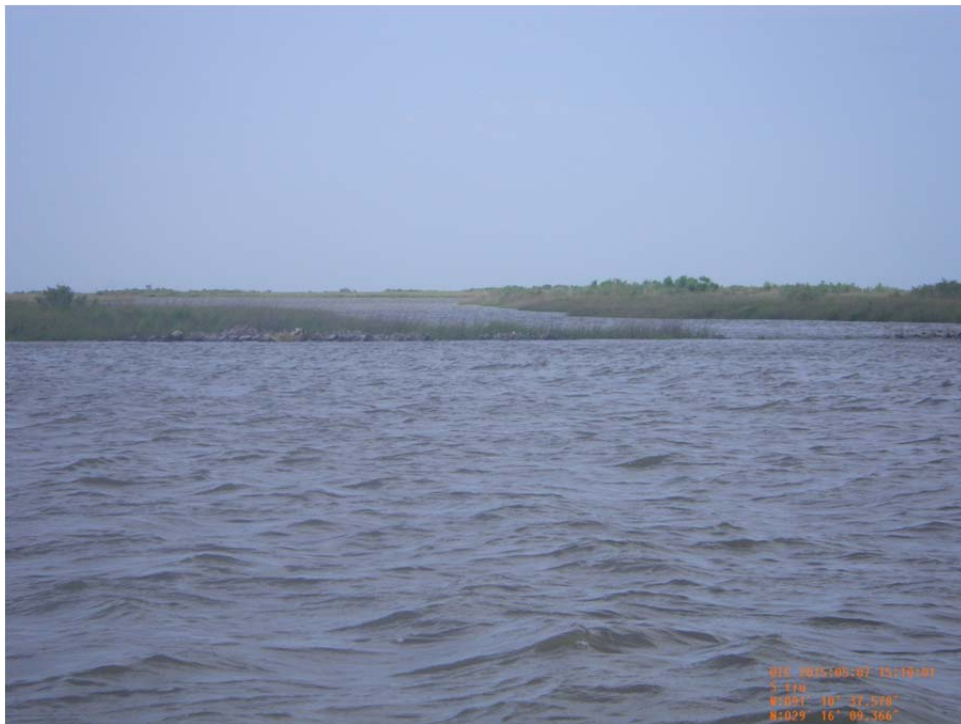
Photo 4: Remnants of rock plug on the east side of Structure No.3 between Mosquito Bay and Four League Bay at the head of Transco Canal.

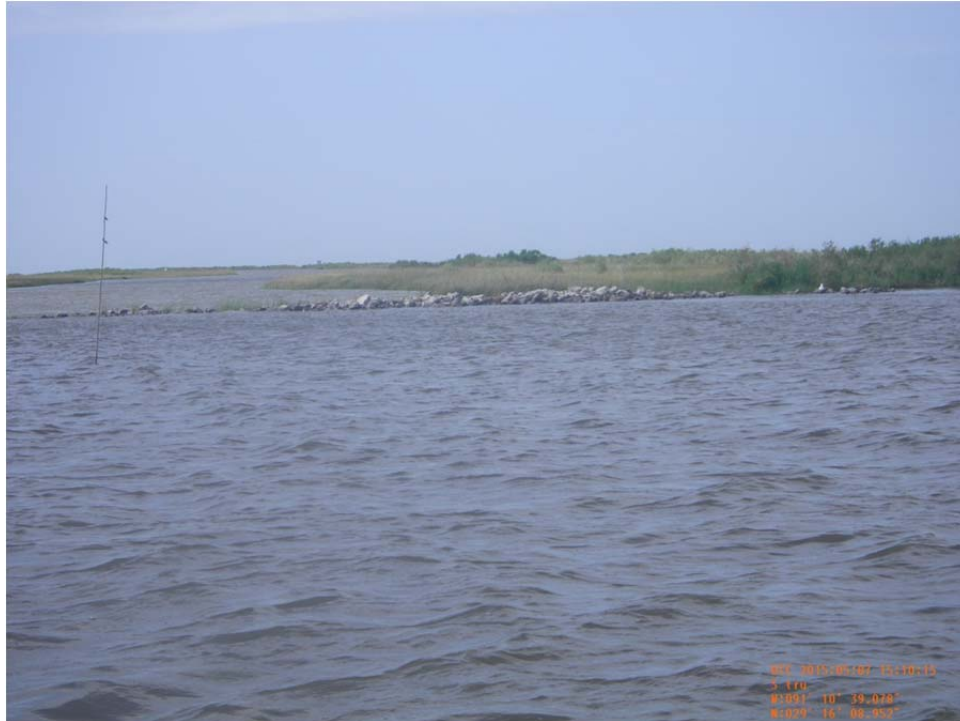
Photo 5: West side of rock plug at Structure No.3 between Mosquito Bay and Four League Bay at the head of Transco Canal.

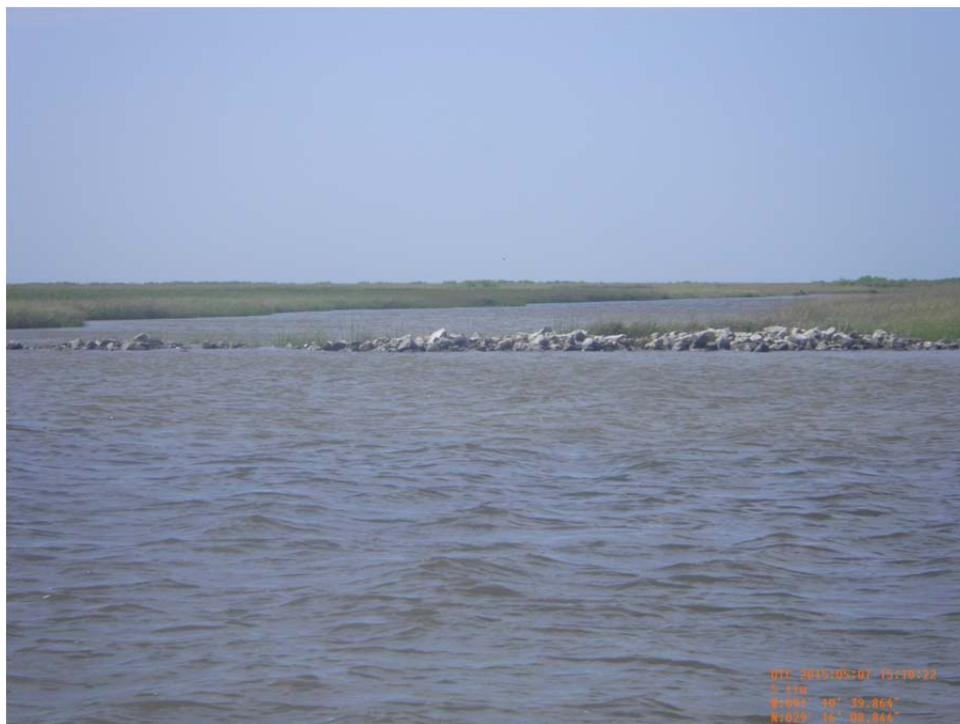
Photo 6: East side of rock plug at Structure No.3 between Mosquito Bay and Four League Bay at the head of Transco Canal.

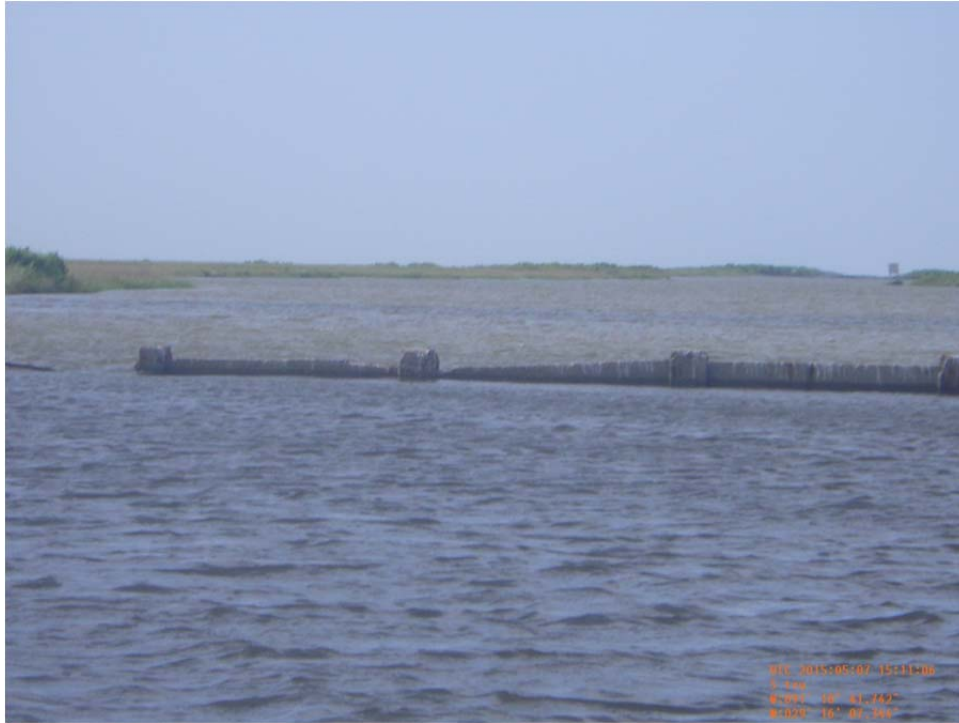
Photo 7: Original oil field concrete bulkhead between the rock plug of Structure No.3 at the head of Transco Canal.

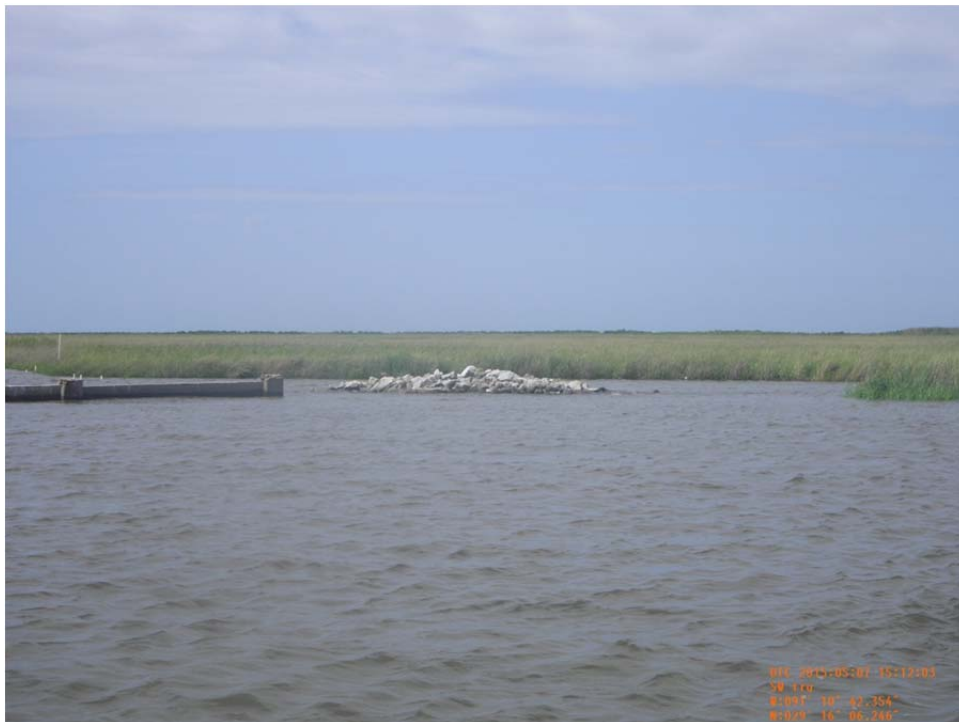
Photo 8: Concrete bulkhead and rock plug on the west side of Structure No.3 at the head of Transco Canal.

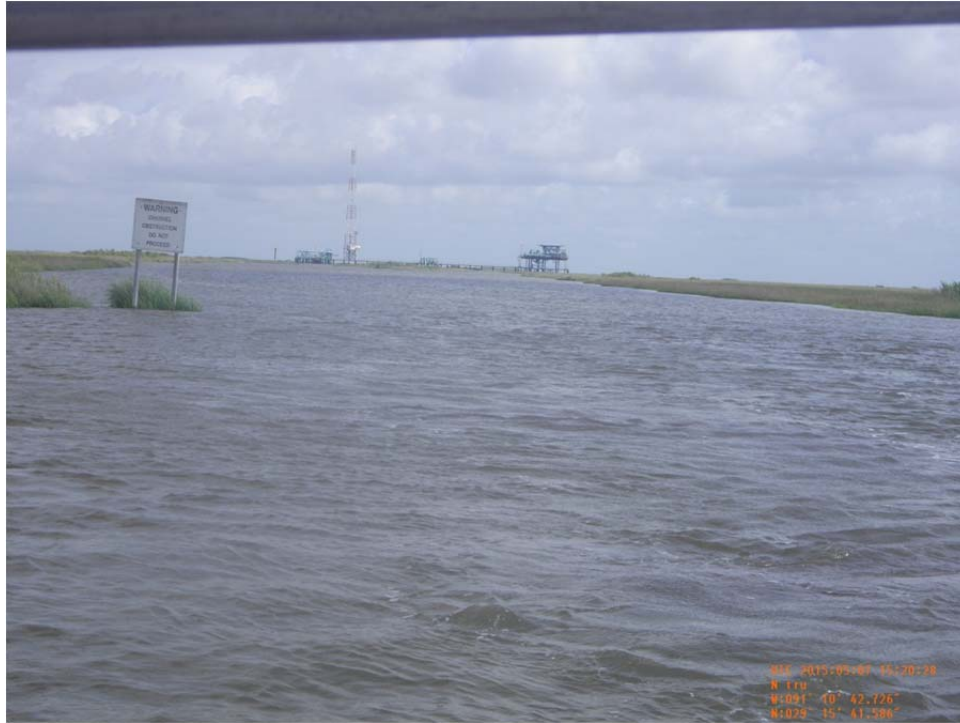
The shell Plug No. 3A located in Transco Canal just north of Hester Canal is in poor condition. As previously reported, the shell plug has eroded in the center of the structure leaving the plug crest below the water line allowing water to pass over the structure. According to the as-built drawings and construction plans, the shell plug was constructed to elevation +4.0 NGVD. The embankment tie-ins are still intact and have no signs of erosion or breaching around the ends. The warning sign and supports on the west side are in good condition, but the sign on the east side is missing. At this time repairing the shell plug is not recommended due to construction access constraints; however, this plug should continue to be monitored on future site visits. (Appendix B; Photo 9)

Photo 9: View of submerged rock plug and warning sign at Structure No.3A along Transco Canal.

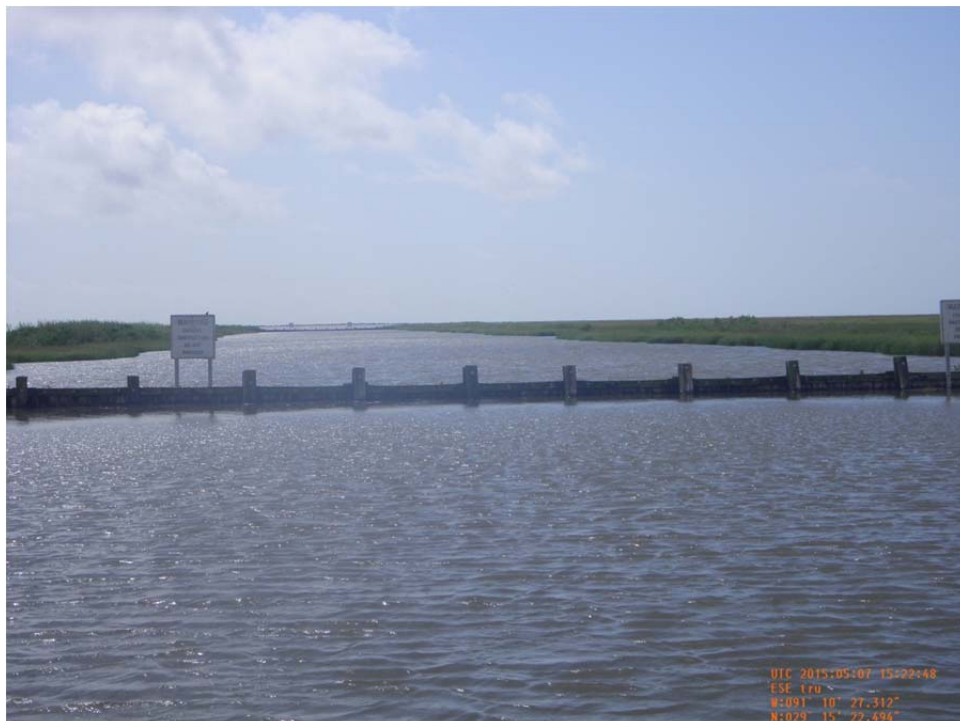
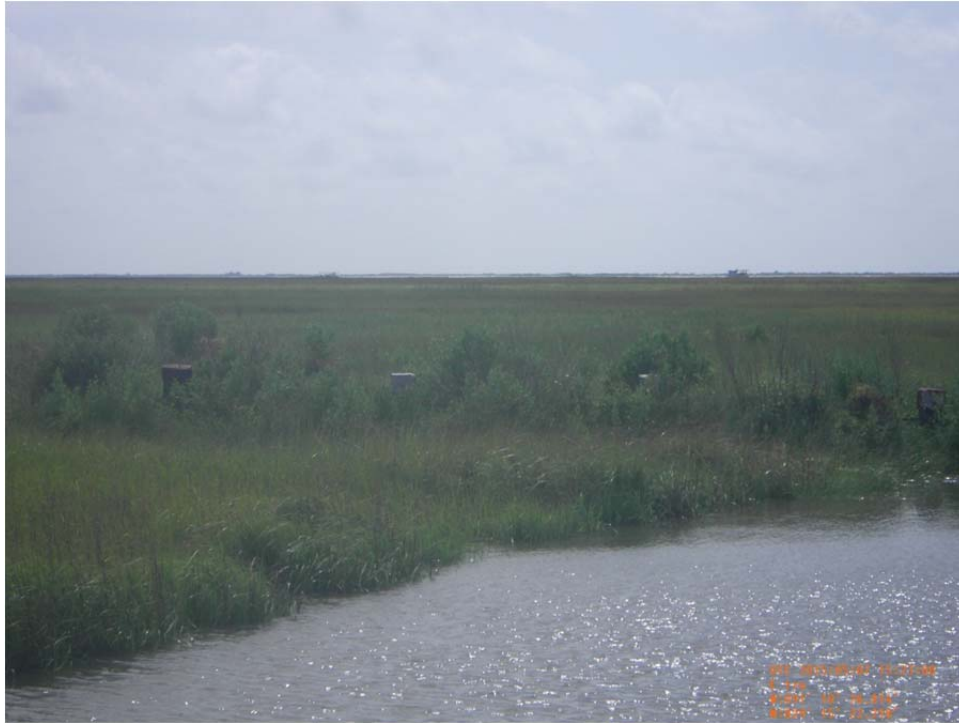
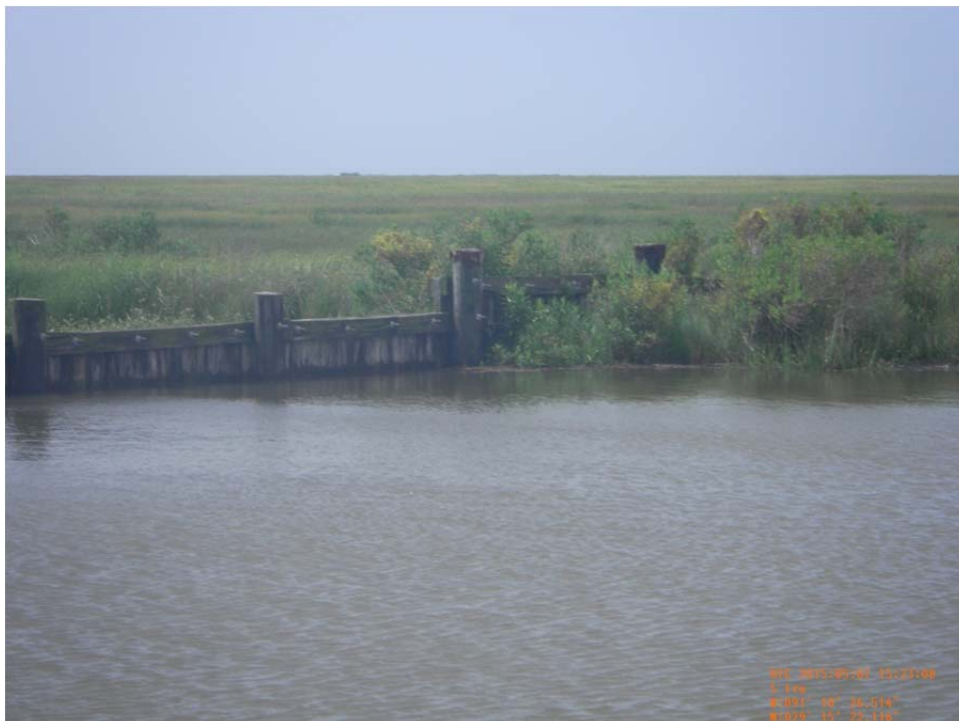
The timber bulkhead Plug No. 7 located on the east end of Hester Canal just west of Plug No. 8 appeared to be weathered but still in good condition. All of the structural components are intact with no visible signs of damage. There is a small hole in one of the boards in the timber bulkhead which allows water to transfer through the structure. Due to the size of the hole and the small amount of water that is able to flow through, we are not recommending corrective actions at this time. The embankment tie-ins have no signs of erosion or breaching. The warning signs and supports are faded and the letters and reflective material barely visible. We are not recommending any maintenance of Plug No.7 except replacement of the aluminum warning signs prior to project close-out. (Appendix B; Photos 10 through 12)

Photo 10: View of timer bulkhead plug at Structure No.7 along the east reach of Hester Canal.

Photo 11: Timber sheetpile plug tie-in at marsh on the north side of Structure No.7 along Hester Canal.

Photo 12: Timber sheetpile plug tie-in at marsh on the south side of Structure No.7 along Hester Canal.

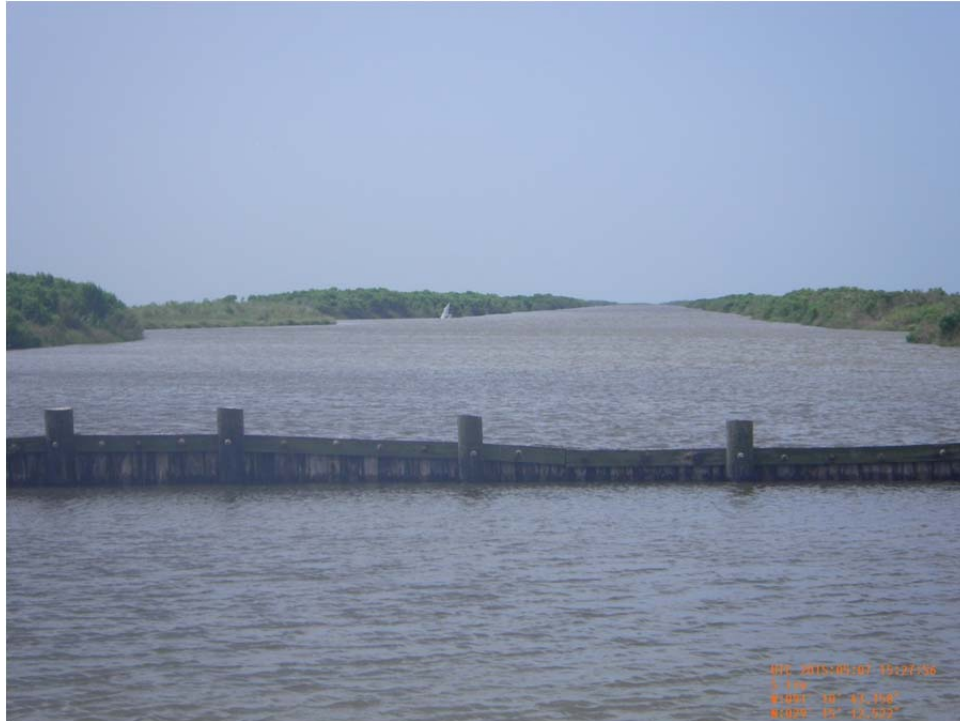
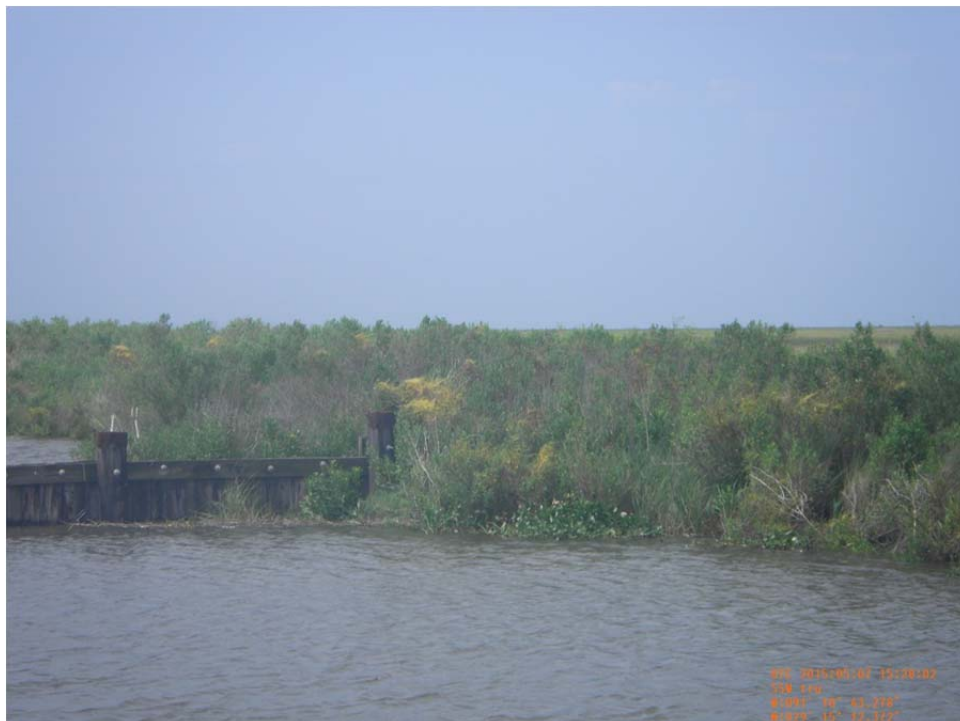
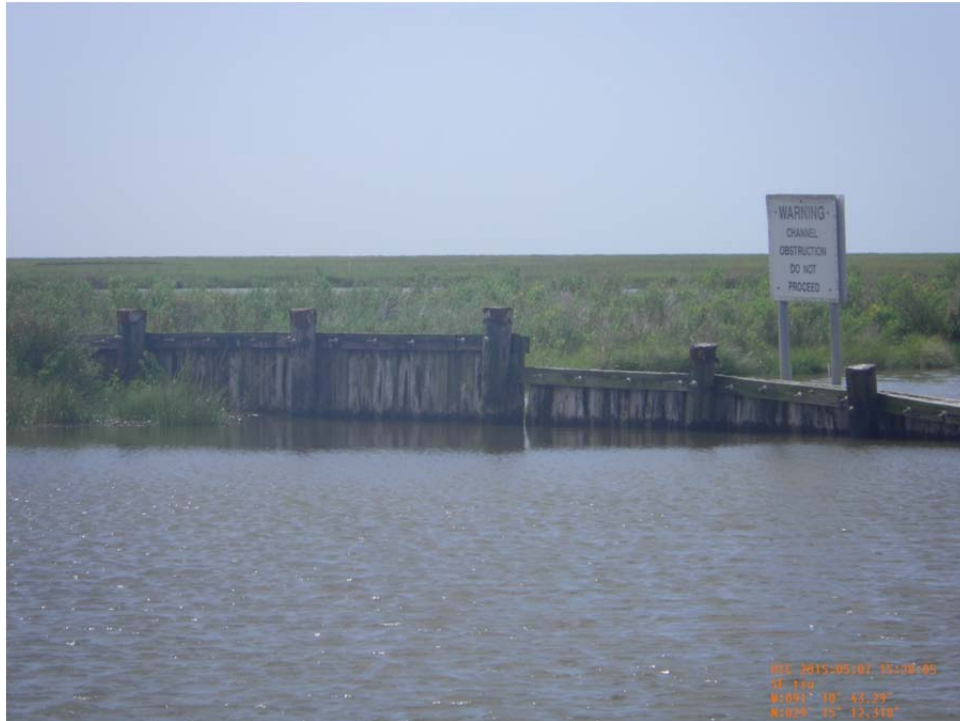
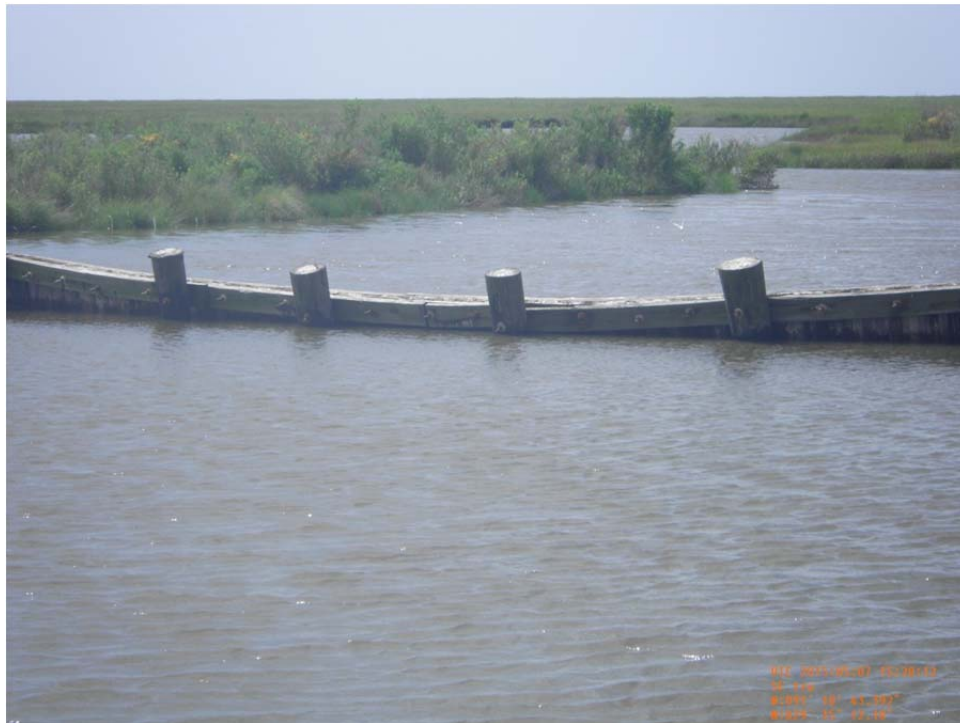
The Plug No. 6 timber bulkhead showed signs of deflection (wavy pattern across canal) shortly after construction. The deflection is now more apparent during the annual inspection than what was observed during construction. Also, there is a separation of the bulkhead (or missing board) near the embankment tie-in on the east side of the structure. This separation is allowing small amounts of water to pass through the bulkhead. The warning signs and supports appear to be in overall fair condition. The bank tie-ins are in good condition with no signs of erosion or breaching. Since this project is close to the end of its 20 year life, we are not recommending maintenance of the structure other than replacement of the aluminum warning signs prior to close-out. (Appendix B; Photos 13 through 16)

Photo 13: Center section of timber sheetpile plug at Structure No.6 along Transco Canal.

Photo 14: View of timber sheetpile plug and the west bank tie-in at Structure No. 6 along Transco Canal.

Photo 15: View of timber sheetpile plug and the east bank tie-in at Structure No.6 along Transco Canal.

Photo 16: View of large bow in the timber sheetpile Plug No.6 at the center of Transco Canal.

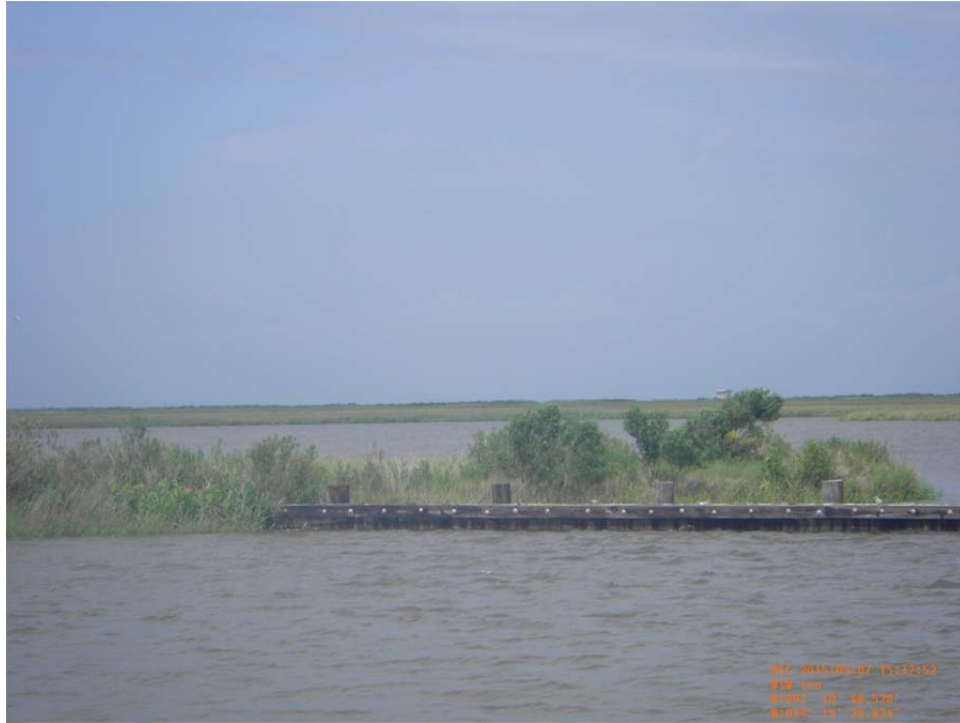
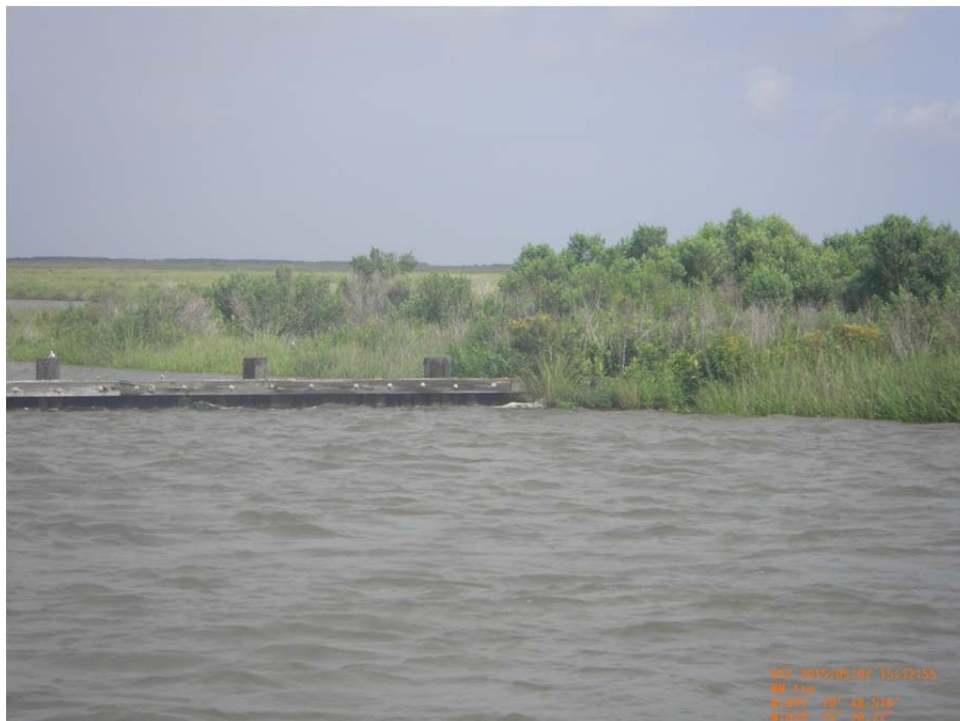
The timber bulkhead Plug No. 2 located just east of Plug No. 1 in Hester Canal appeared to be in good condition. All structural components are intact with no visible signs of damage; however, the timber members did appear to be weathered. The embankment tie-ins are in good condition with no visual signs of erosion. The warning signs and supports were in fair condition. Although the timber bulkhead and its tie-ins have no noticeable defects, the structure is not operating effectively due to a large breach (approximately 70 feet) in the bankline on the south side of the structure which allows tidal flow around Plug No. 2. There are no recommendations for corrective action at this time other than replacement of aluminum warning signs prior to project close-out. (Appendix B; Photos 17 & 18)

Photo 17: View of the timber sheetpile plug and bank tie-in on the south side of Structure No.2.

Photo 18: View of the timber sheetpile plug and bank tie-in on the north side of Structure No.2.

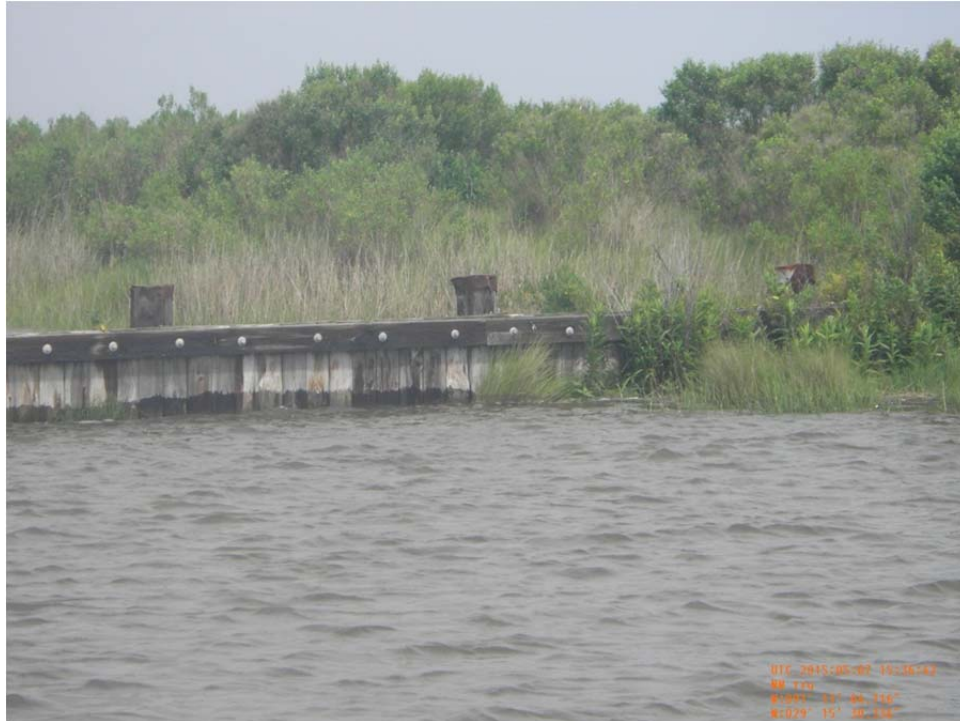
The timber bulkhead Plug No. 1 located on the west end of Hester Canal near Mosquito Bay appears to be in good overall condition. The embankment tie-ins have no signs of breaching or erosion. All structural components are intact with some signs of weathering of the timber members. The warning signs and supports are also in fair condition. There are no recommendations for corrective actions at this time other than replacing the aluminum

Photo 19: View of the timber sheetpile plug and bank tie-in on the north side of Structure No.1.

warning signs prior to project close-out. (Appendix B; Photo 19 – additional photos of Plug No.1 were not useable)

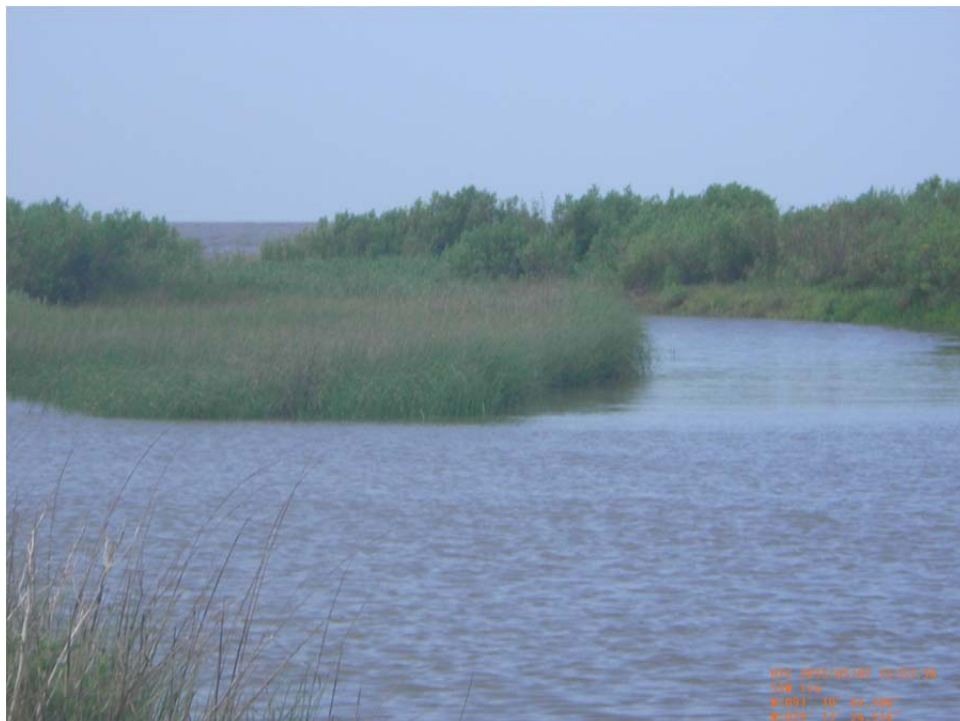
Photo 20: View of the small channel leading to Structure No.4 at the end of Transco Canal along the Gulf of Mexico shoreline.
