**State of Louisiana
Coastal Protection and Restoration
Authority**

2016 Annual Inspection Report

**LAKE CHAPEAU SEDIMENT INPUT
AND HYDROLOGIC RESTORATION
PROJECT**

State Project Number TE-26
Priority Project List 3

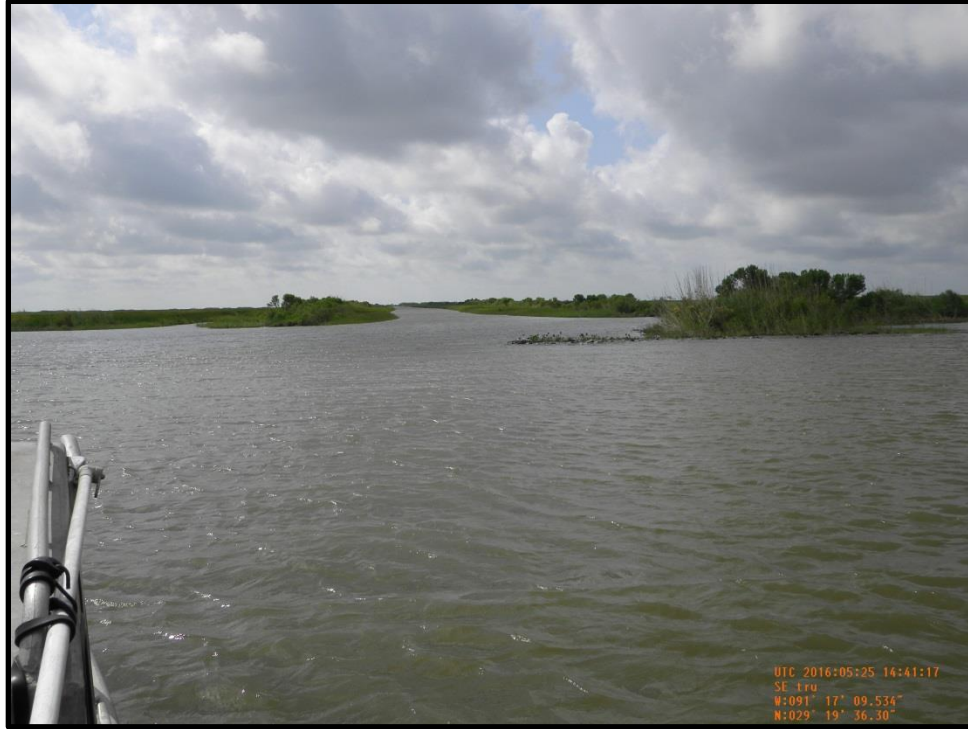
Photo 1: Overall view of north western rock plug

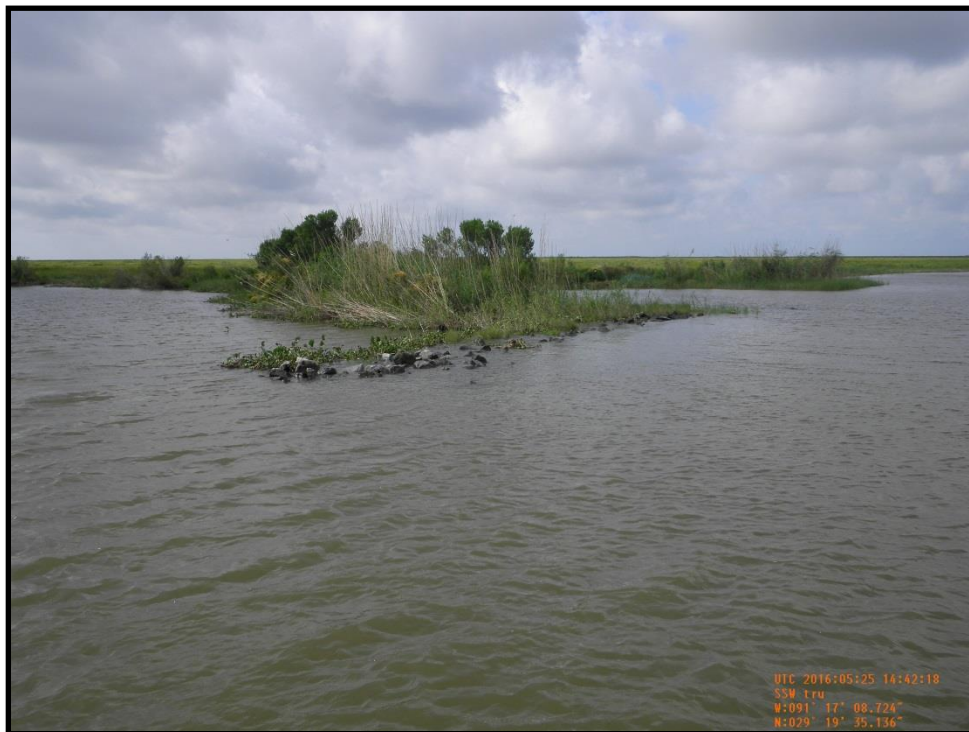
Photo 2: Overall view of north western rock plug

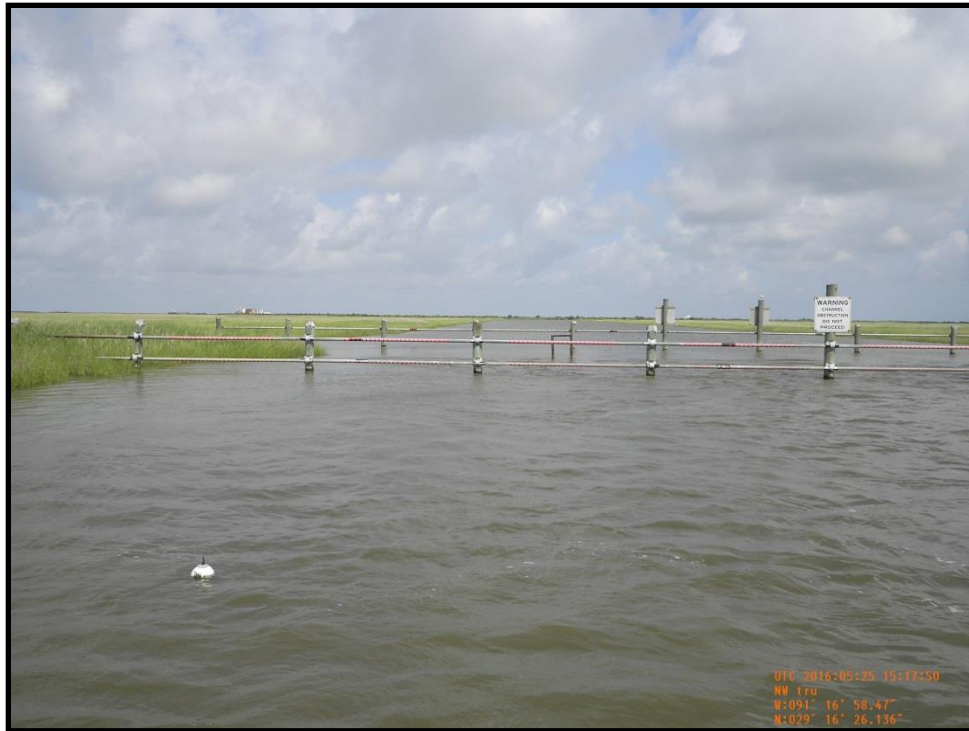
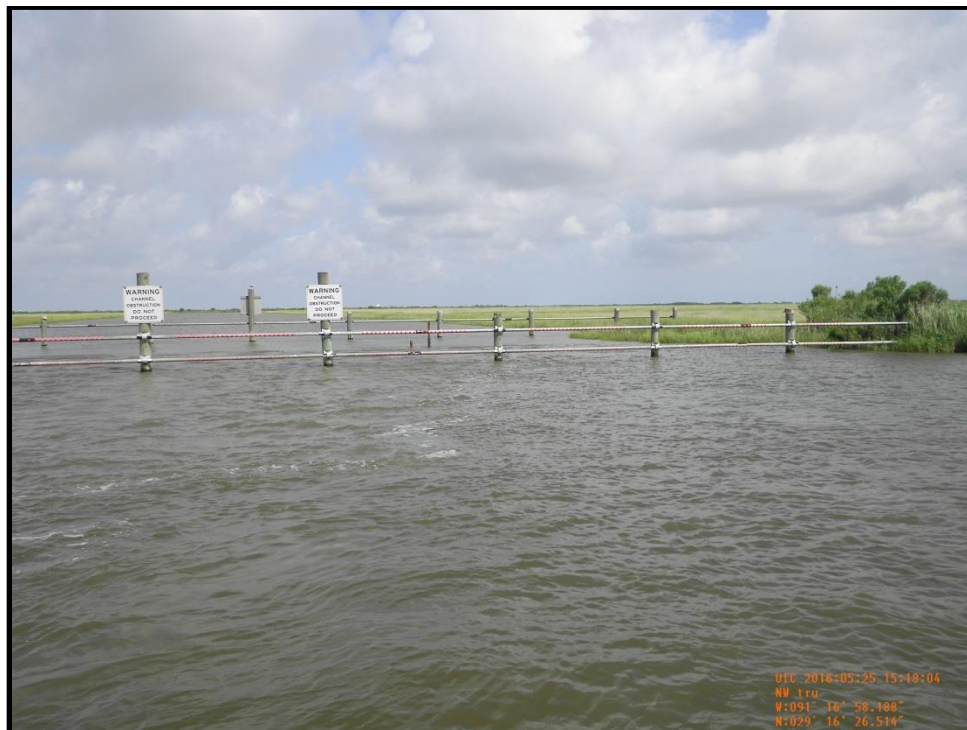
Overall, the rock weir at Site No. 7 is in good condition. There are no obvious signs of breaching or erosion around the embankment tie-ins. The timber barricade is in good condition with moderate corrosion on the timber pile caps. The warning signs and their supports have no apparent damage and appear to be in good condition as well. There are no other recommendations for maintenance at this time. (See Appendix B, Photos 3 & 4)

Photo 3: Rock plug tie-in to marsh on the south bank and timber barricade system at Structure No.7

Photo 4: Rock plug tie-in to marsh on the north bank and timber barricade system at Structure No.7

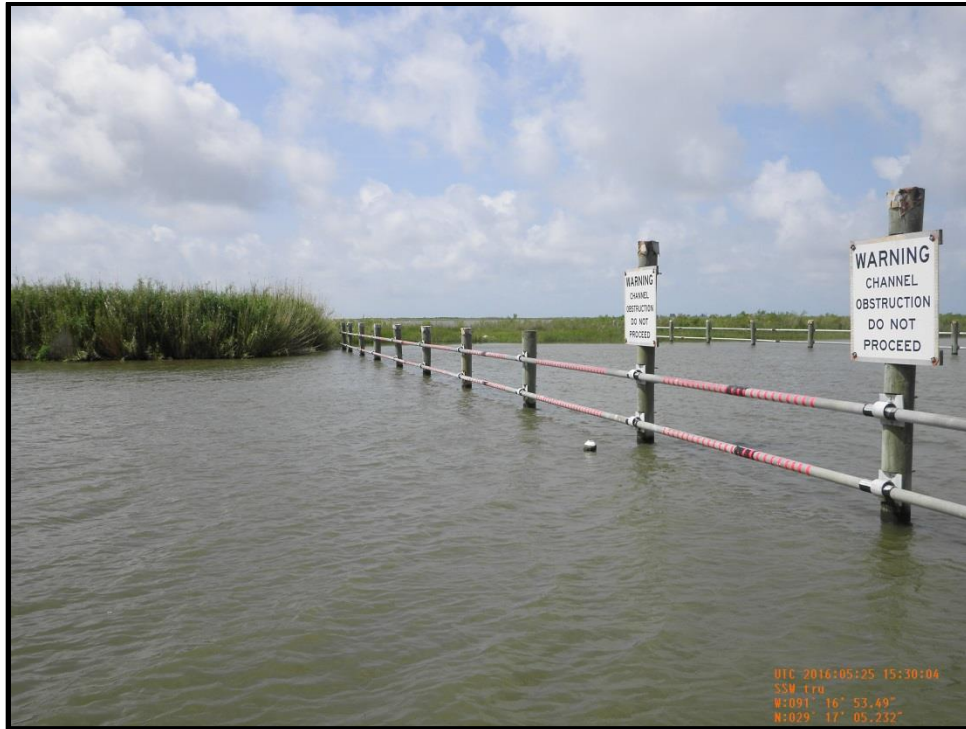
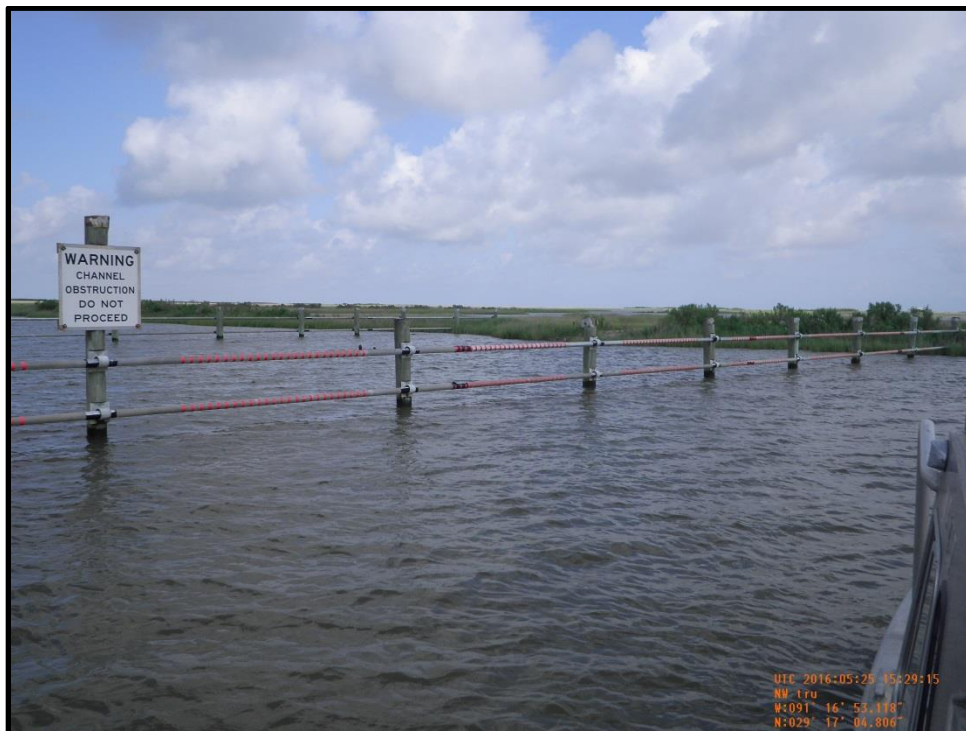
The Site No. 9 rock weir was in good overall condition. There are no visible signs of erosion or breaching around the embankment tie-ins. A few of the galvanized pile caps are missing and several are rusted and corroded. The rest of the timber barricade system appears to be in good condition. The warning signs and supports have no apparent damage and appear to be in good condition. There are no other recommendations for maintenance at this time. (See Appendix B, Photos 5 & 6)

Photo 5: Rock plug tie-in to marsh on the south bank and timber barricade system at Structure No.9

Photo 6: Rock plug tie-in to marsh on the north bank and timber barricade system at Structure No.9

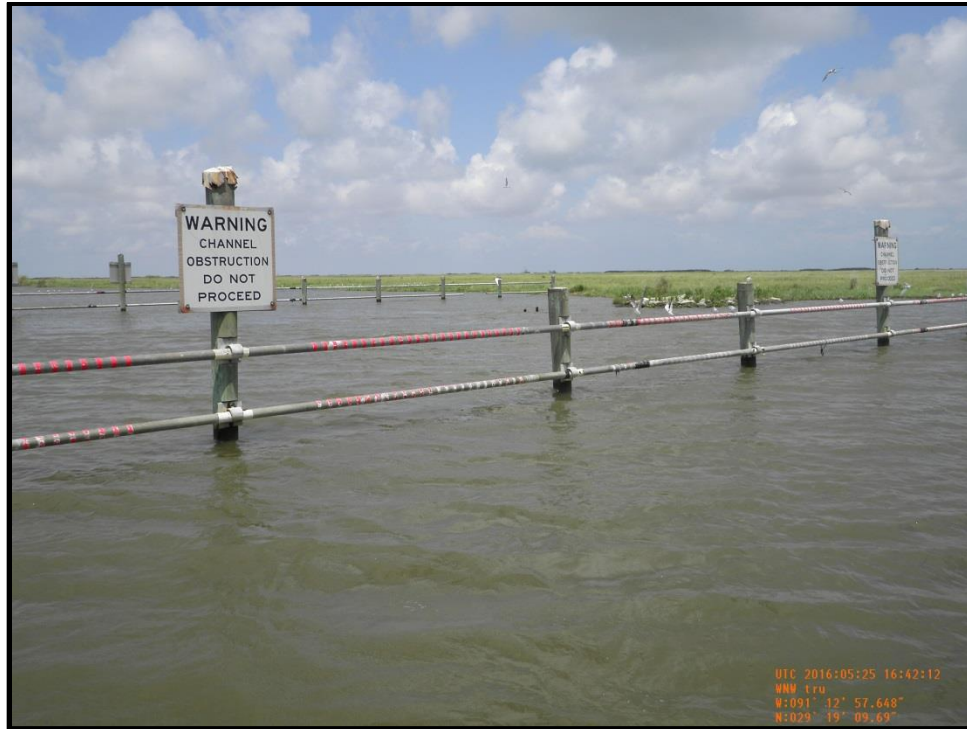
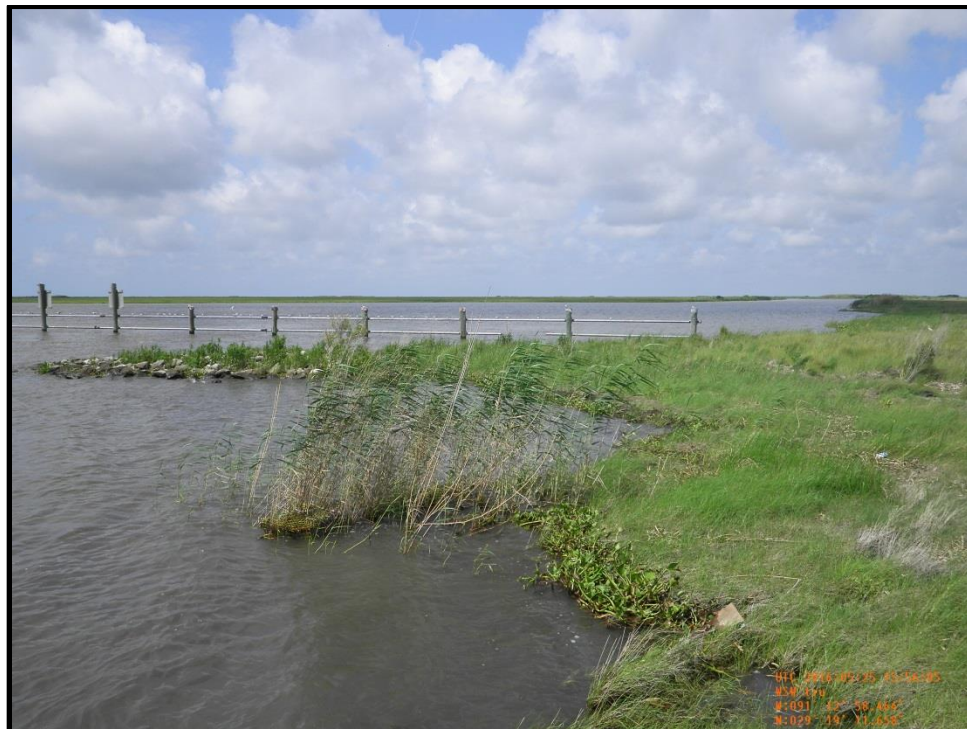
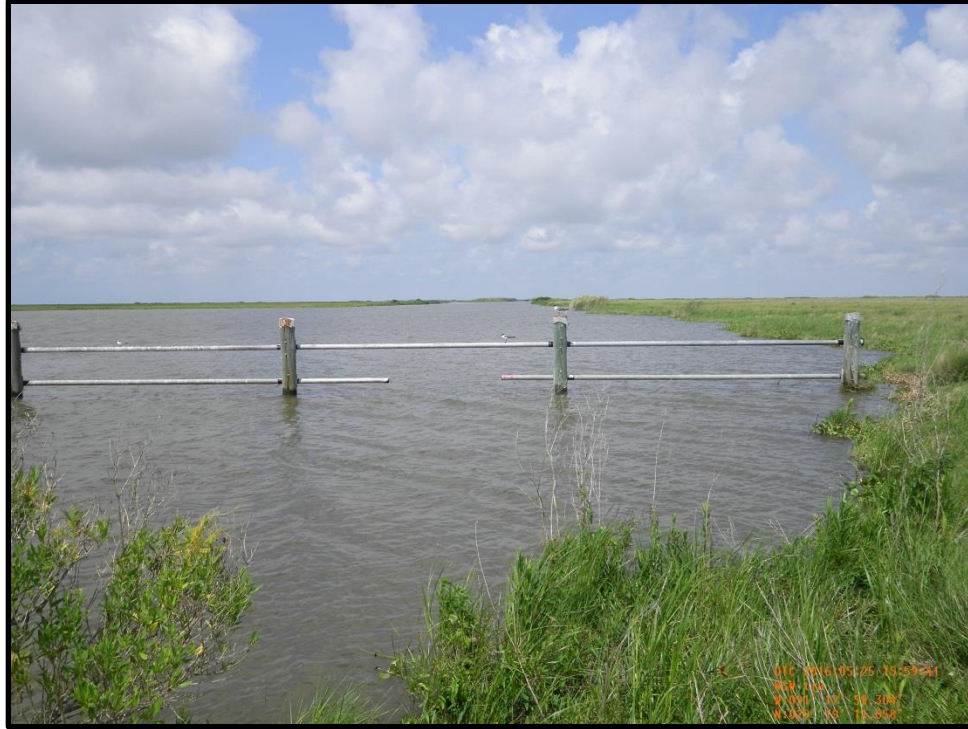
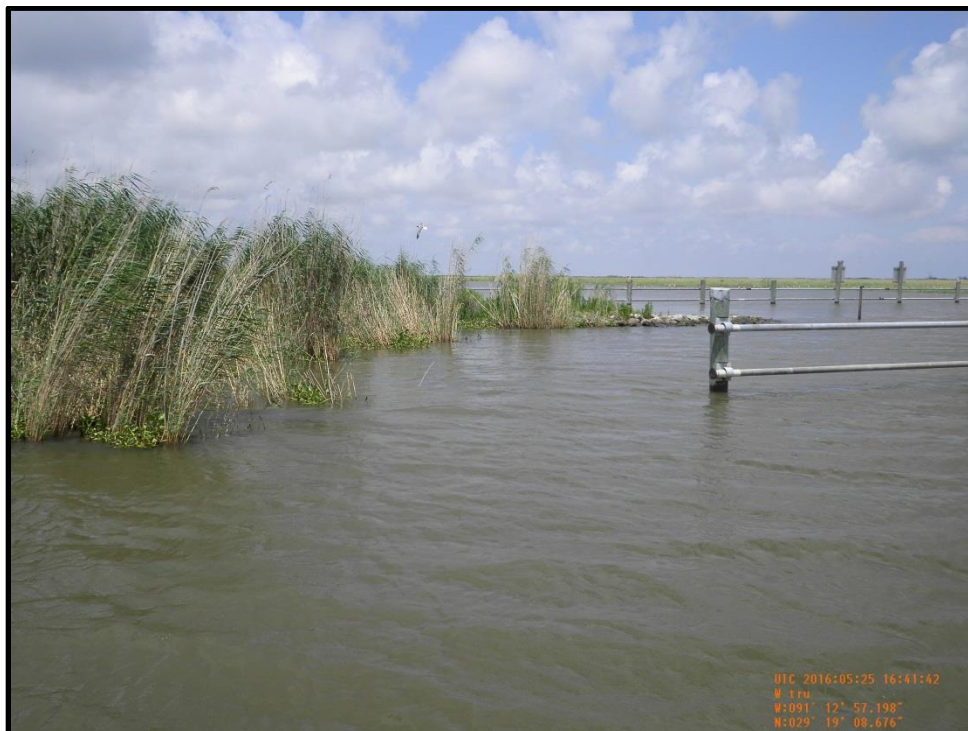
The rock weir appeared to be in fair condition with erosion of the marsh tie-ins on the north side of the structure. As observed on previous inspections, we found that the existing marsh connecting the structure to land on the both sides of the weir was very thin. This has been the condition of the marsh on the southern end of the weir for the last couple of years and it appears that the marsh bank has somewhat stabilized. The marsh on the north side showed signs of being of lower elevation and it appears like water is starting to channel around the structure at that point. CPRA and NMFS agree that at some point the marsh will erode on the south side and the structure will no longer be functional and will become a hazard. It is our plan to remove the timber barricade system and degrade the rock dike structure prior to the

Photo 7: View of rock weir, barricade system, warning signs, and bank tie-in on the north side of Structure No.4.

Photo 8: View of rock weir, barricade system, and bank tie-in on the north side of Structure No.4.

Photo 9: View of damaged interior barrage system on the north side of Structure No.4.

Photo 10: View of rock weir, barrage system, and bank tie-in on the south side of Structure No.4.

close-out of the project in 2019. Other than removing the structure in the future, there are no other maintenance recommendations for Site No.4 (See Appendix B, Photos 7-10)

As mentioned in Section V, the marsh around the tie-ins of the rock dike No. 4 is very thin and is expected to become breached in the near future. CPRA and NMFS have agreed that it would be best to remove the timber piles and barricade system, and degrade the rock dike prior to closing out the project to avoid any hazardous conditions in the future. The permitting and construction plans are currently in production and weir degrading is expected to happen in 2018/2019.

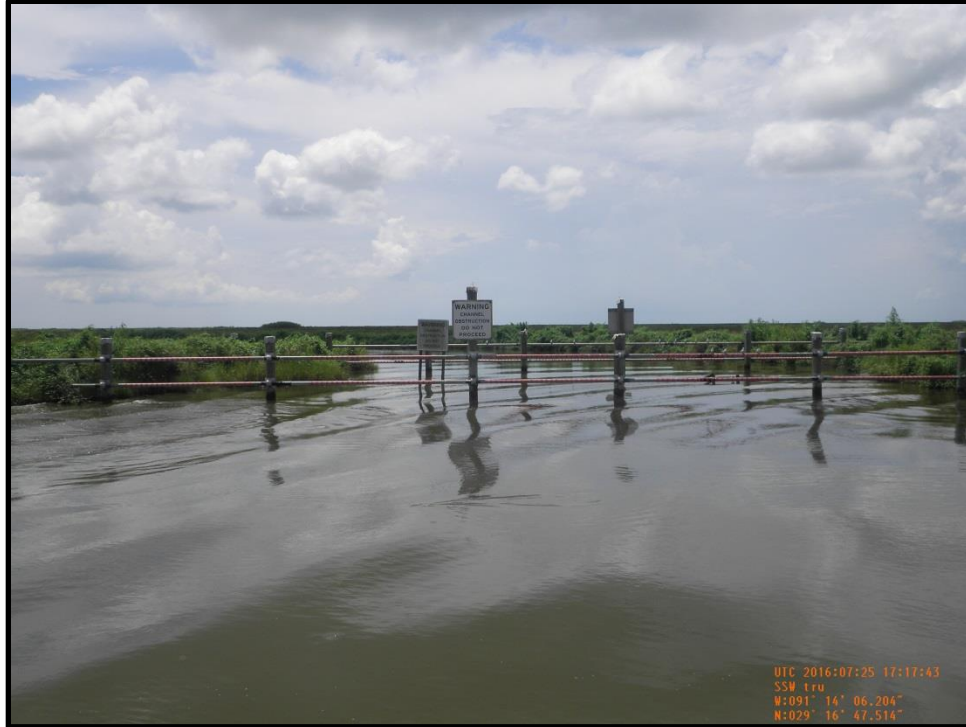
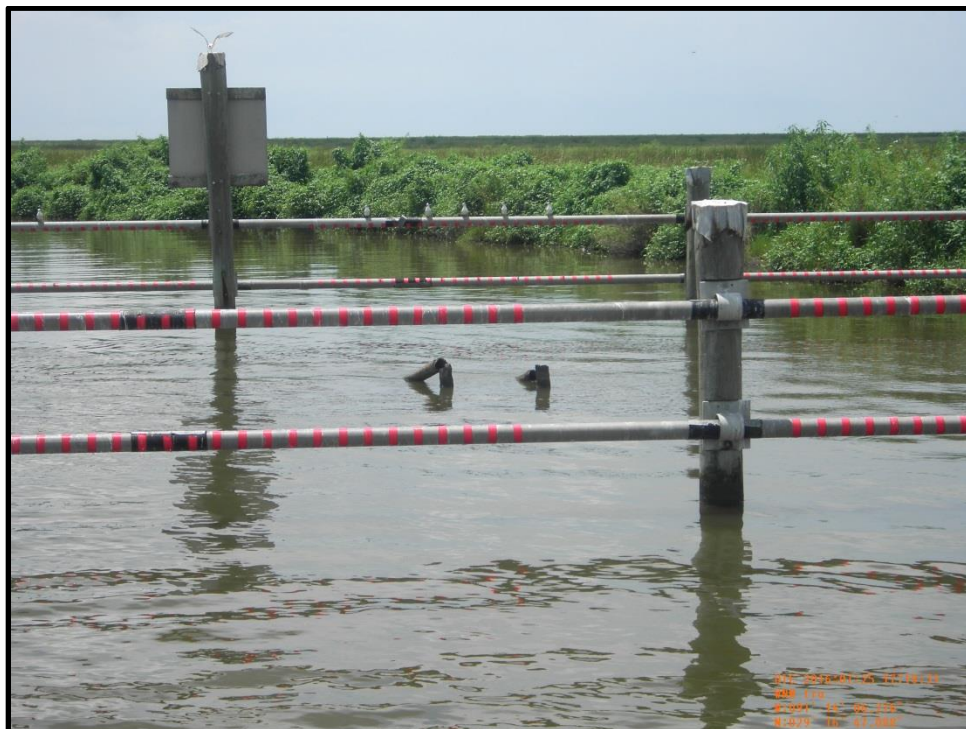
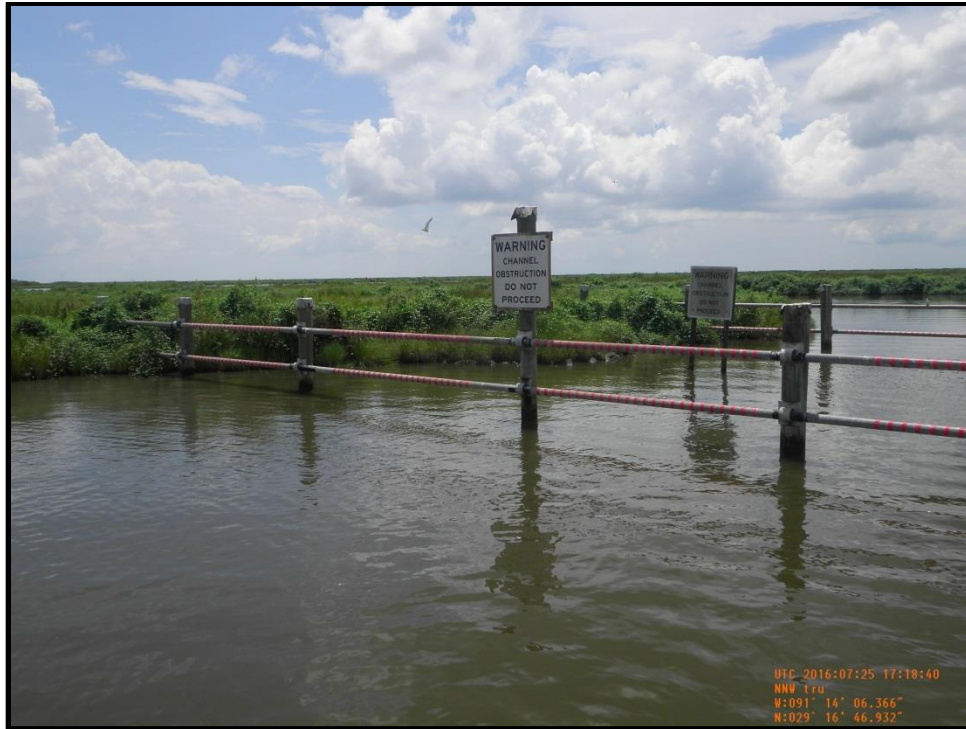
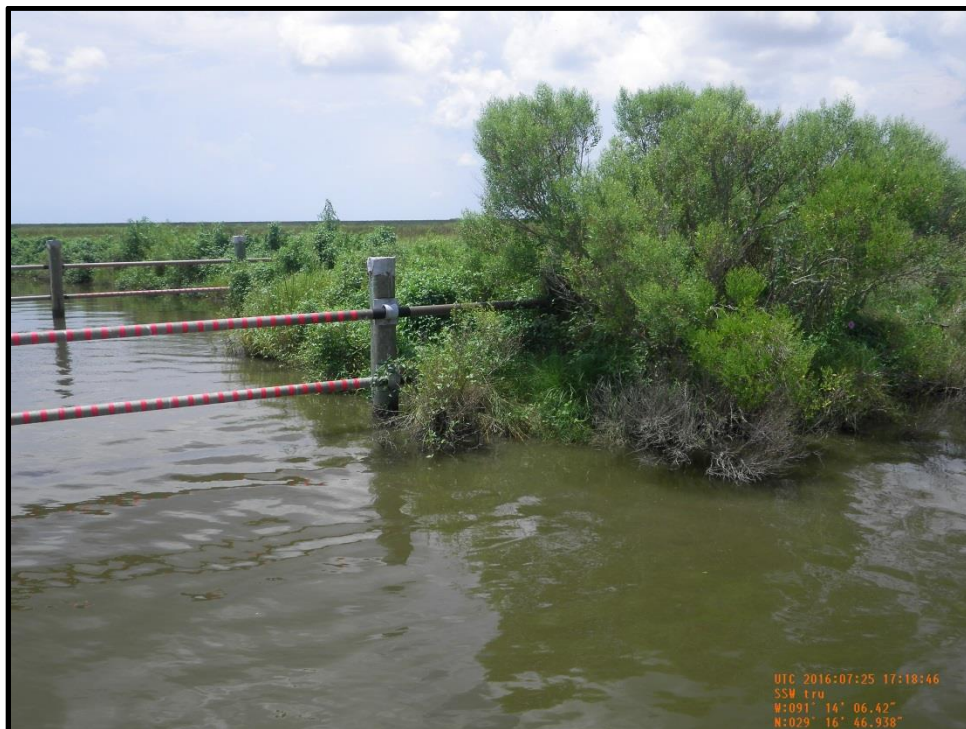
The rock weir was in good overall condition. The marsh tie-ins on both sides of the structure were stable with no obvious erosion or breaching. The barricade system, timber piles and warning signs were in good condition, but one of the three signs was missing. Piling caps and bolts on the bottom half of pipes are beginning to rust. Depth on the north west side of the structure was taken as 2.3' while salinity was measured at 1.8 ppt. There are no plans to perform future maintenance on the rock weir at Site No. 5. (See Appendix B, Photos 11-14)

Photo 11: View of rock weir and barricade system of Structure No.5.

Photo 12: View of damaged/missing sign on Structure No.5.

Photo 13: View of east bank and tie-in of Structure No.5.

Photo 14: View of west bank and tie-in of Structure No.5.

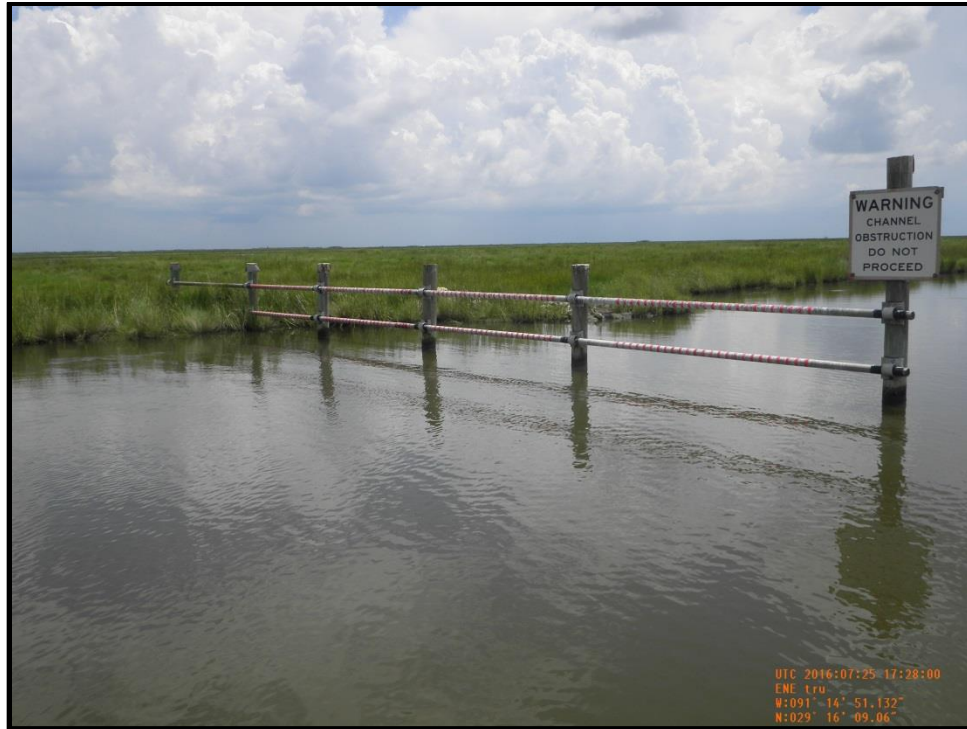
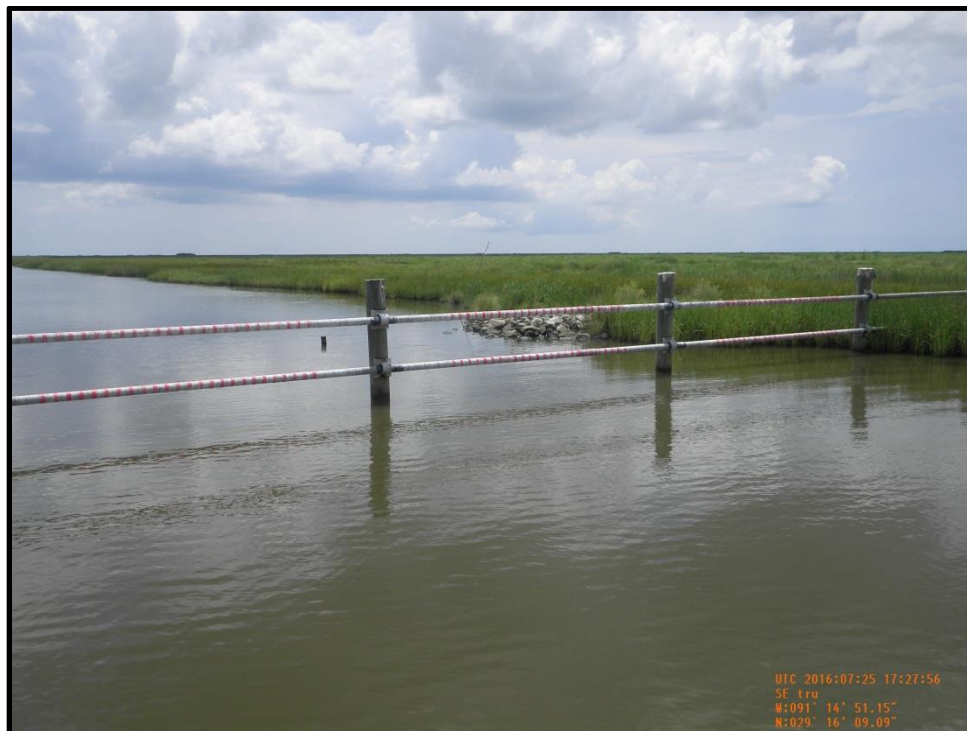
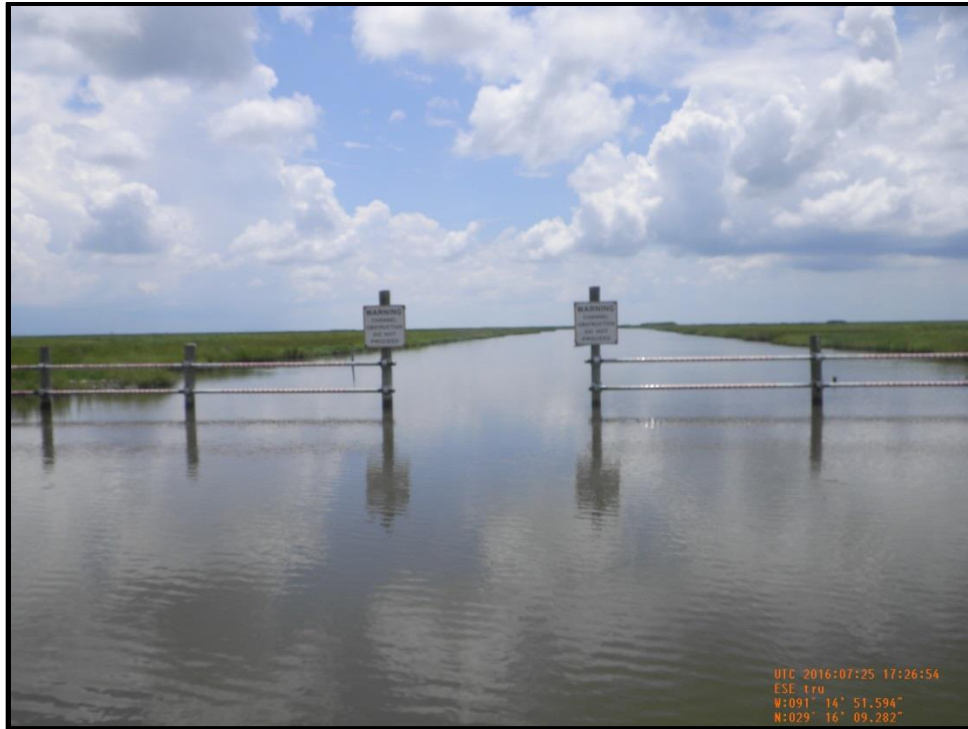
It was discovered during the 2008 Annual Inspection that the timber barricade system in front of the structure had been vandalized. A large section (approximately 10 feet) on both of the center section steel pipe cross members had been cut with a torch and are missing. CPRA and NMFS agree that it is highly likely than any repairs to the steel pile cross member will be vandalized again; therefore, we are not recommending repairs at this time. The barricade of site No. 6 was in good condition with no signs of damage besides the abovementioned vandalism. We did note that several of the sheet metal caps on top of the timber piles were either missing or corroded. The rock weir appeared to be in good overall condition with no signs of erosion or breaching around the embankment tie-ins. The warning signs and supports were also in very good condition. The depth in front of the structure was 3.5 feet and the salinity was measured at 3.4 ppt. There are no other recommendations for maintenance at this time. (See Appendix B, Photos 15-17)

Photo 15: View of north bank, barricade, and tie-in of Structure No.6.

Photo 16: View of south bank, barricade, and tie-in of Structure No.6.

Photo 17: View timber barricade of Structure No.6.
