**State of Louisiana
Coastal Protection and Restoration
Authority**

2015 Annual Inspection Report

**LAKE CHAPEAU SEDIMENT INPUT
AND HYDROLOGIC RESTORATION
PROJECT**

State Project Number TE-26
Priority Project List 3

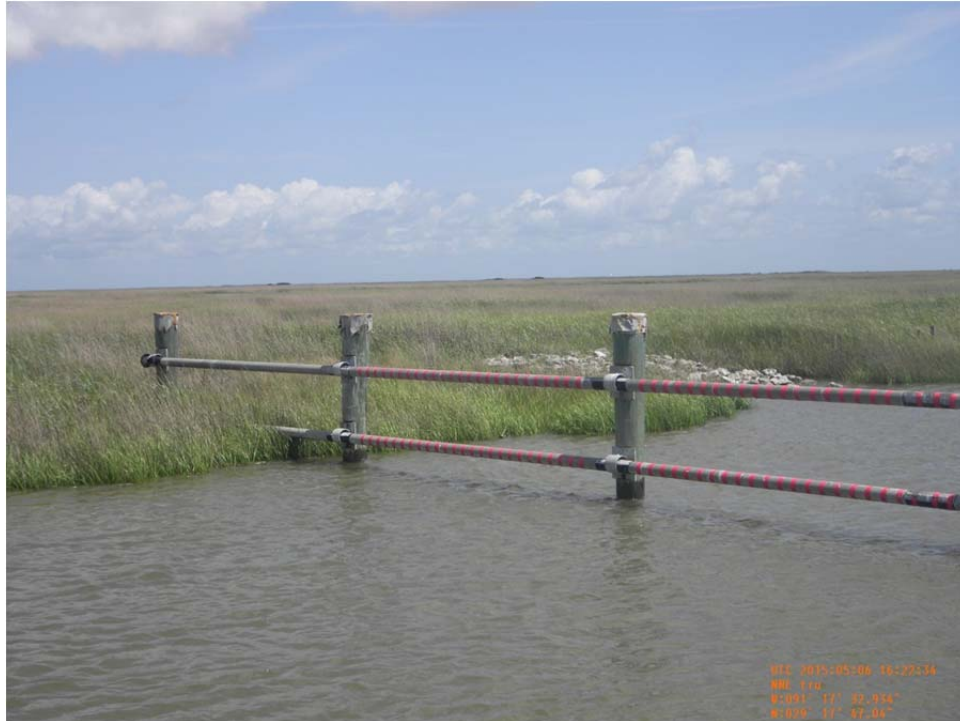
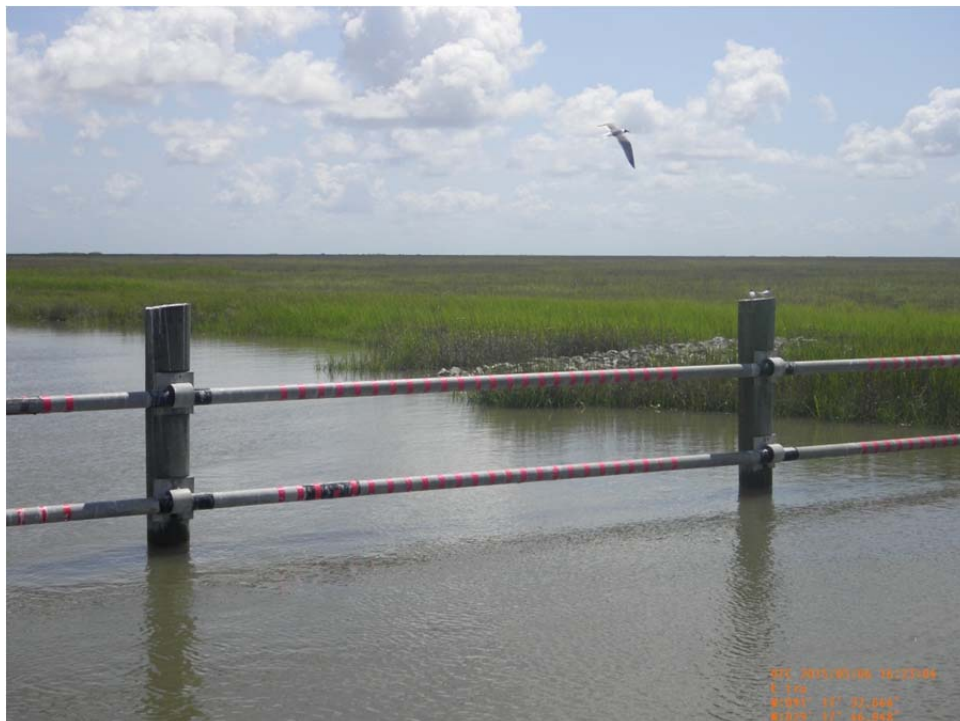
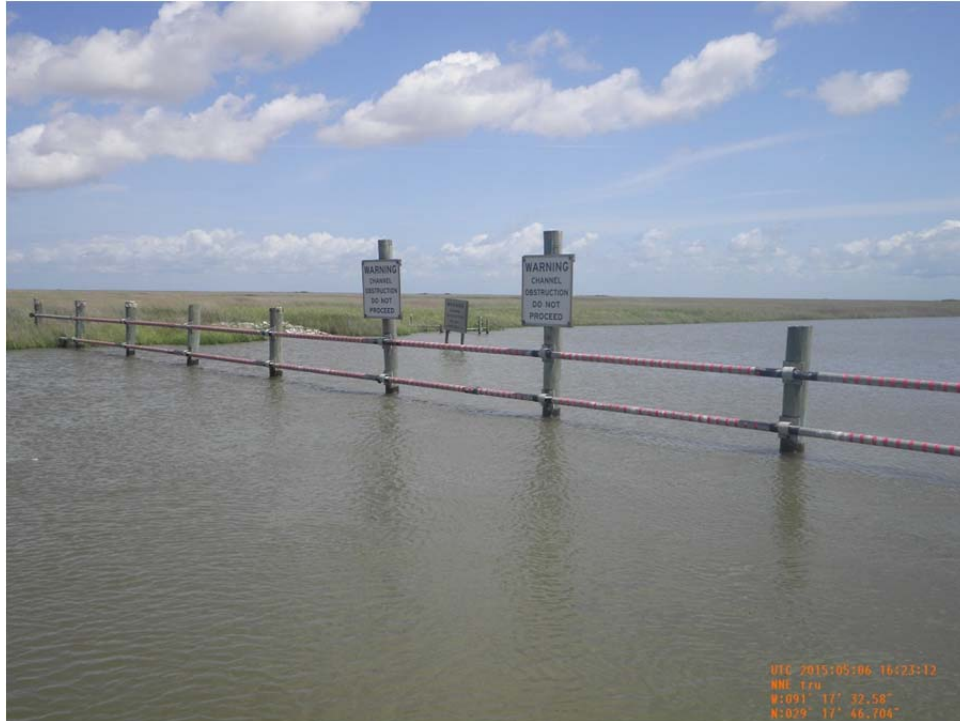
Site No. 1 – Rock Weir

Site No.1 appears to be in good condition with no breaching or erosion around the rock apron over the marsh on both ends of the structure. The signs and timber barricade system was also in good condition. We did note that several of the sheet metal caps on the timber piles were missing and others corroded. We are not recommending any maintenance at this site other than to replace the sheet metal caps prior to closing out the project in 2019. (See Appendix B, Photos 1 through 3)

Photo 1: View of rock weir, timber barricades, and signs, and northwest bank tie-in on Structure No.1

Photo 2: View of rock weir, timber barricades, and signs, and southeast bank tie-in on Structure No.1

Photo 3: Overall view of rock plug, timber barricade structure and warning signs on Structure No.1.

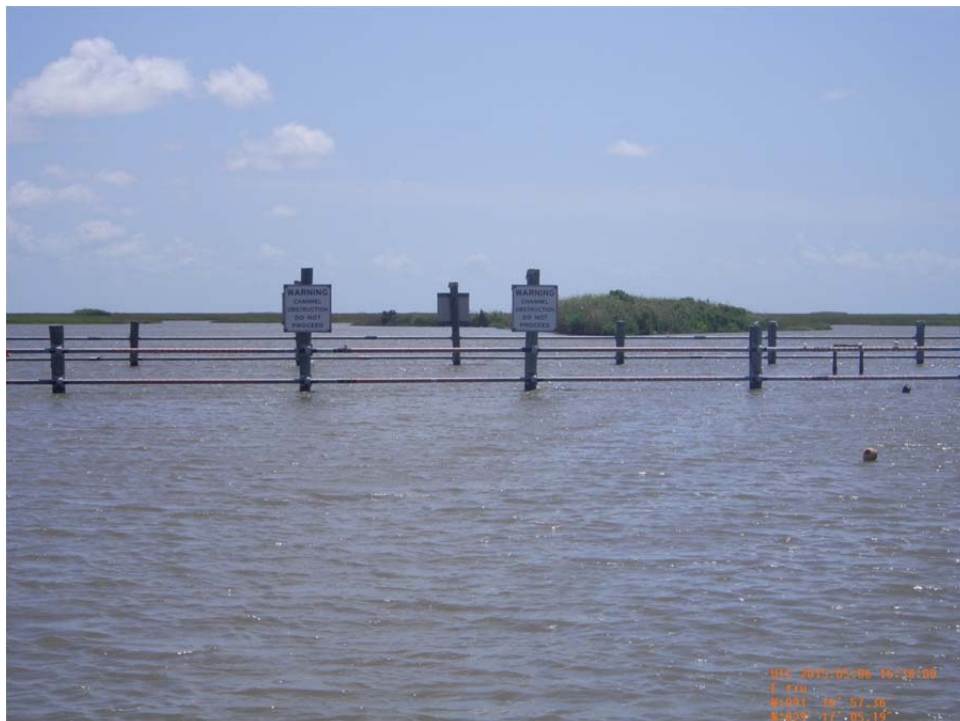
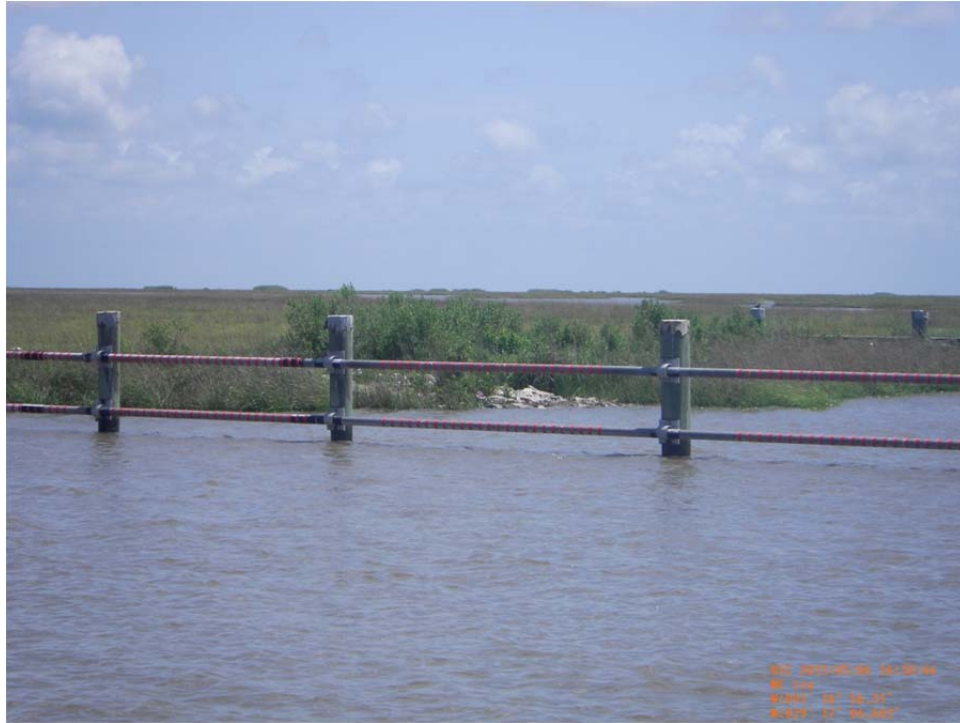
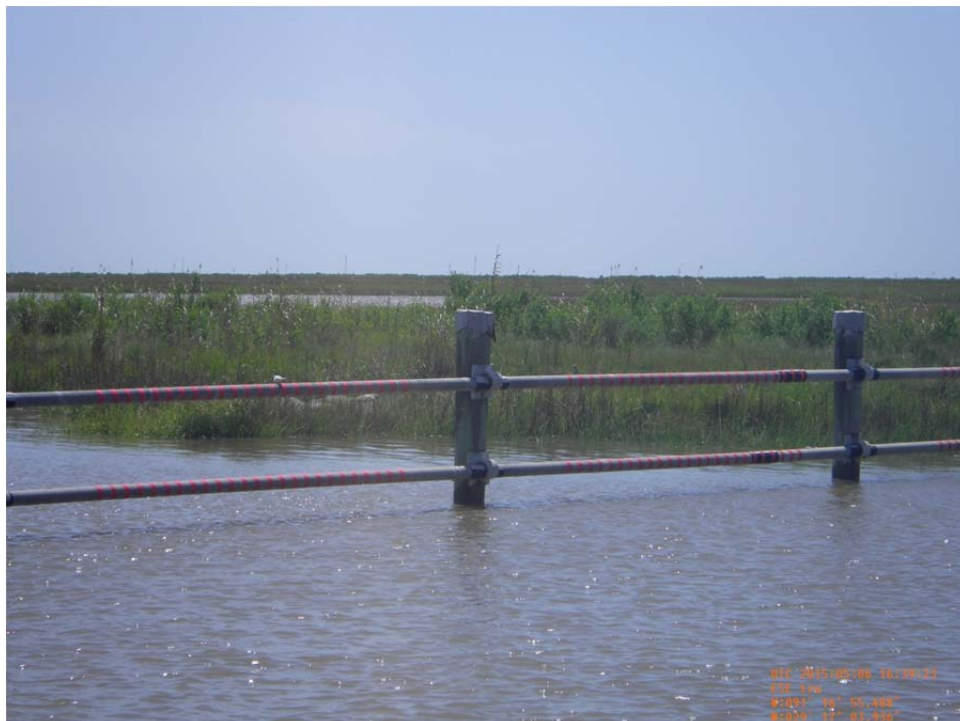
Site No. 9 – Rock Weir

The Site No. 9 rock weir was in good overall condition. There are no visible signs of erosion or breaching around the embankment tie-ins. A few of the galvanized pile caps are missing and several are rusted and corroded. The rest of the timber barricade system appears to be in good condition. The warning signs and supports have no apparent damage and appear to be in good condition. We recommend that the all of the sheet metal caps be replaced prior to closing out the project in 2019. There are no other recommendations for maintenance at this time. (See Appendix B, Photos 4 through 6)

Photo 4: View of rock plug, timber barricade and signage of Structure No.9.

Photo 5: Rock plug tie-in to marsh on the north bank and timber barricade system at Structure No.9.

Photo 6: Rock plug tie-in to marsh on the south bank and timber barricade system at Structure No.9

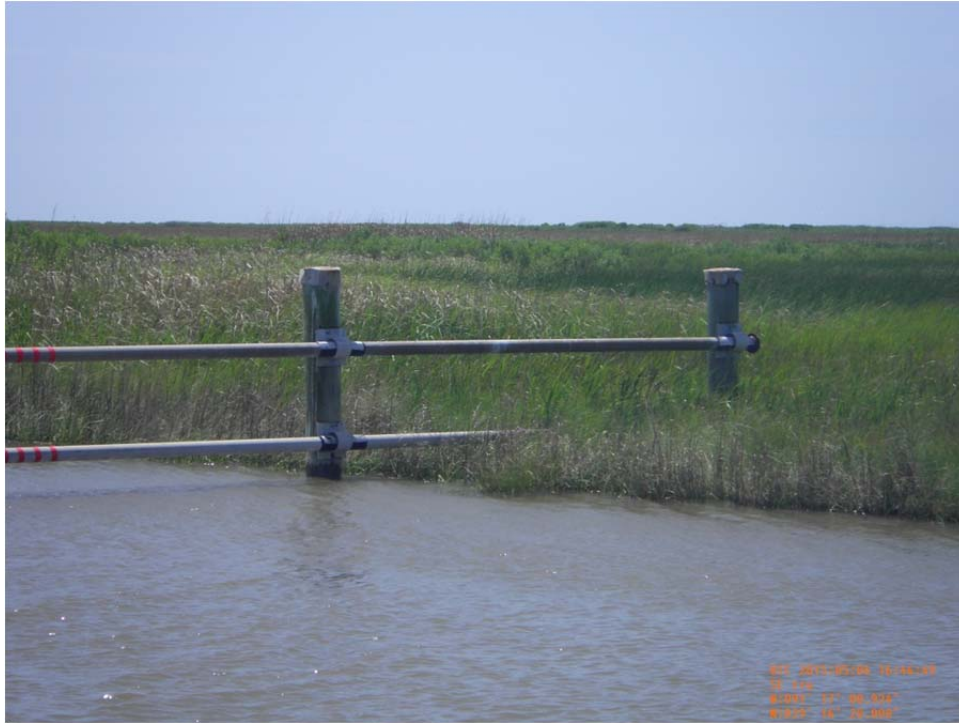
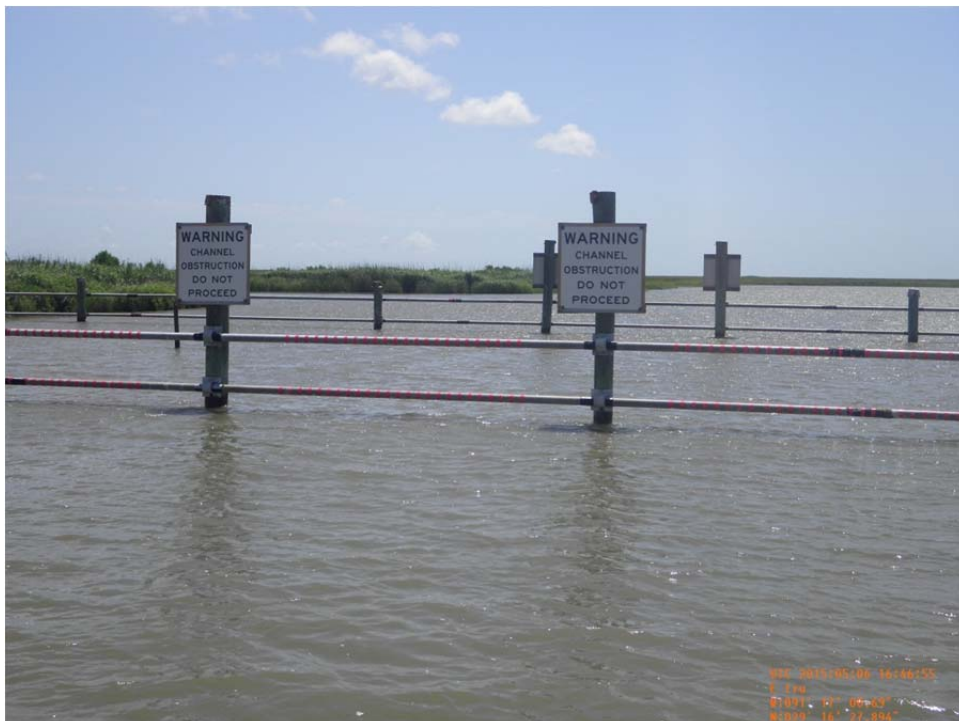
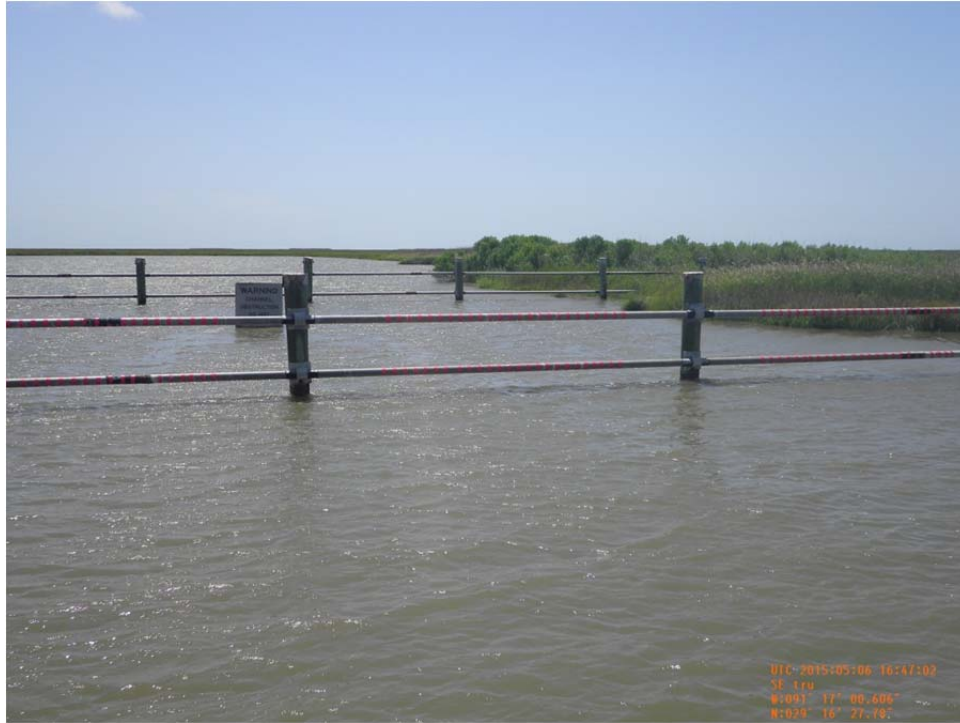
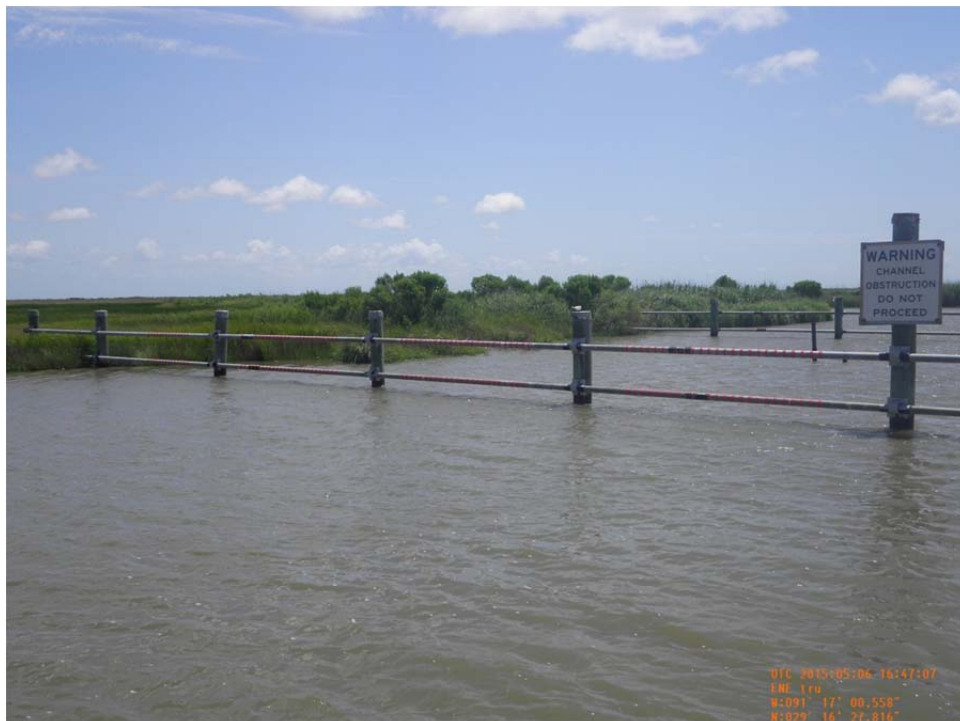
Site No. 7 – Rock Weir

Overall, the rock weir at Site No. 7 is in good condition. There are no obvious signs of breaching or erosion around the embankment tie-ins. The timber barricade is in good condition with moderate corrosion on the timber pile caps. The warning signs and their supports have no apparent damage and appear to be in good condition as well. Prior to closing out the project at the 20 year life, we recommend replacing all of the sheet metal caps on the timber piles. There are no other recommendations for maintenance at this time. (See Appendix B, Photos 7 through 10)

Photo 7: View of timber barricade system along southwest bank of Structure No.7.

Photo 8: View of the rock weir, timber barricade system, and warnings signs along center of channel at Structure No.7.

Photo 9: View of rock weir and timber barricade system along southwest bank of Structure No.7.

Photo 10: View of rock weir, timber barricade system and warnings sign on the northeast bank of Structure No.7.

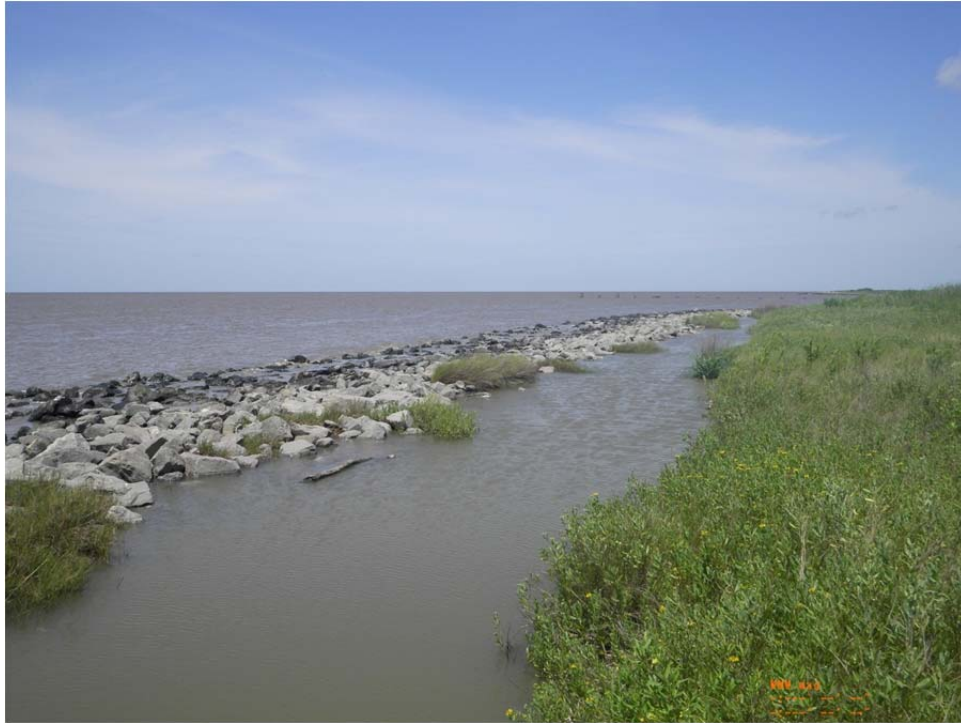
Photo 11: View of rock dike along the Gulf of Mexico adjacent to Mobil Canal looking westward.

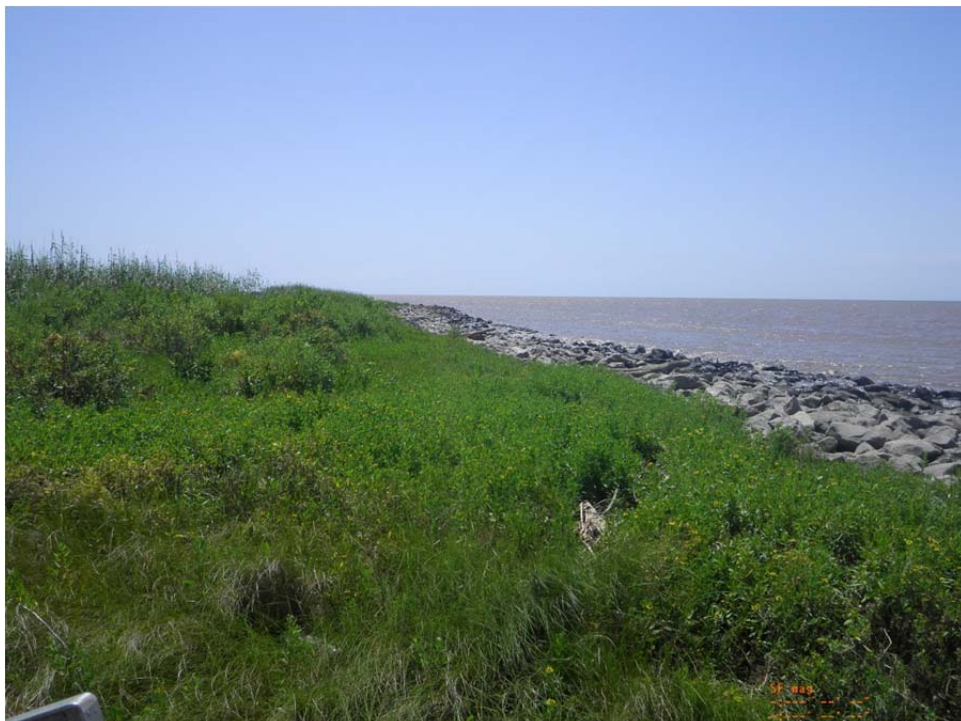
Photo 12: View of rock dike along the Gulf of Mexico adjacent to Mobil Canal looking eastward.

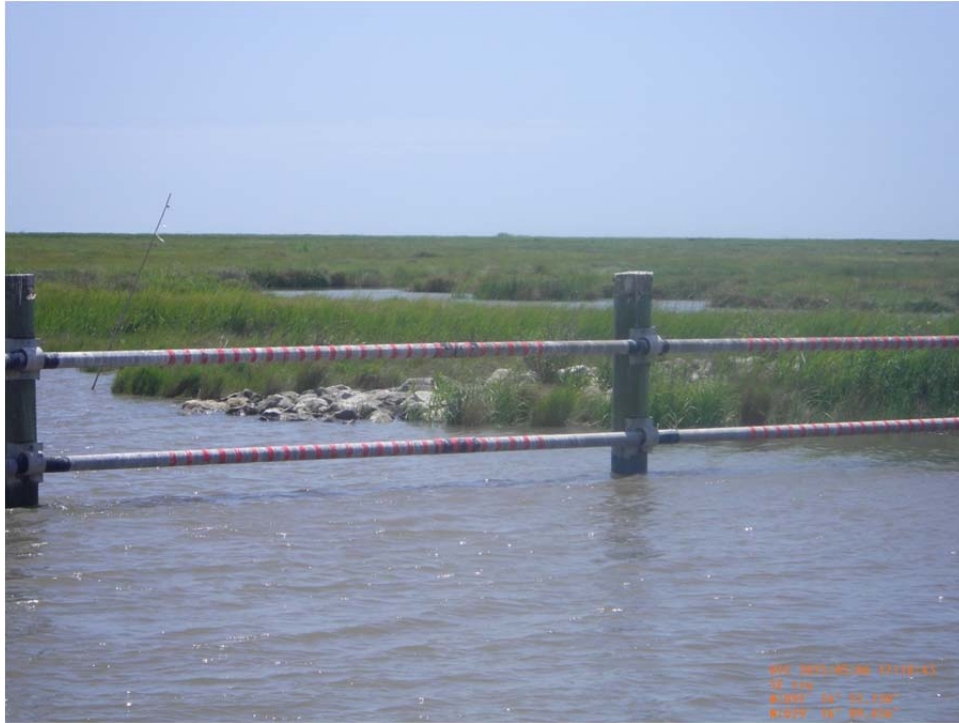
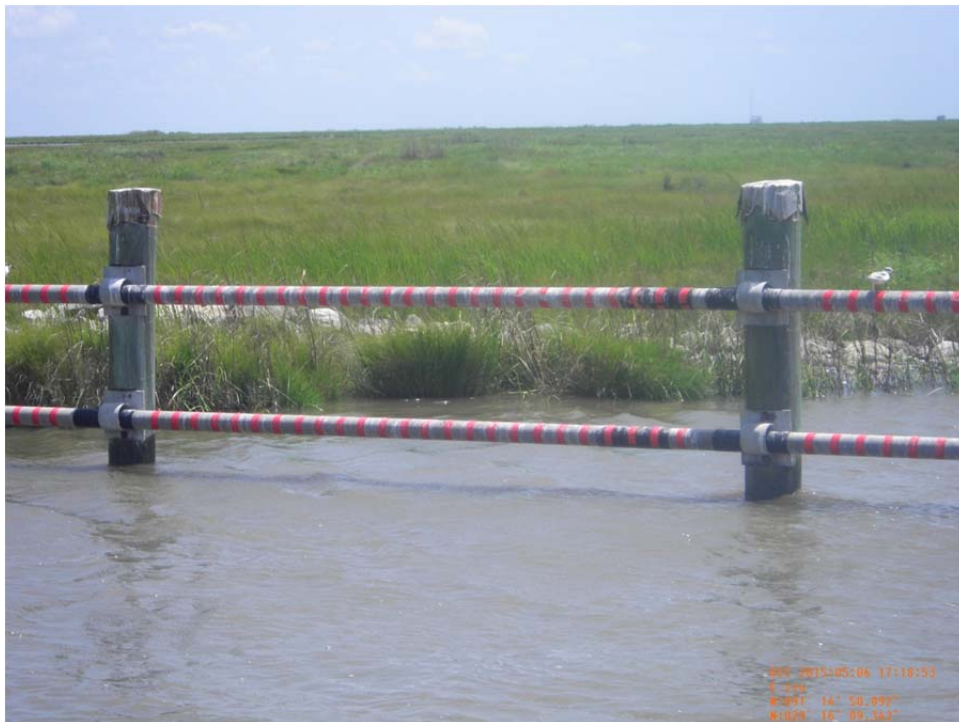
Site No. 6 – Rock Weir

It was discovered during the 2008 Annual Inspection that the timber barricade system in front of the structure had been vandalized. A large section (approximately 10 feet) on both of the center section steel pipe cross members had been cut with a torch and are missing. CPRA and NMFS agree that it is highly likely than any repairs to the steel pile cross member will be vandalized again; therefore, we are not recommending repairs at this time. Other than the vandalized steel pipe cross members, the barricade system is in good condition with no signs of damage. We did note that several of the sheet metal caps on top of the timber piles were either missing or corroded. We recommend replacing all of the sheet metal caps prior to closing out the project in 2019. The rock weir appeared to be in good overall condition with no signs of erosion or breaching around the embankment tie-ins. The warning signs and supports are also in very good condition. There are no other recommendations for maintenance at this time. (See Appendix B, Photos 13 & 14)

Photo 13: View of rock plug tie-in to bank line and timber barricade system on the southwest side of Structure No.6.

Photo 14: View of rock weir tie-in to bank line and timber barricade system on the northeast side of Structure No.6.

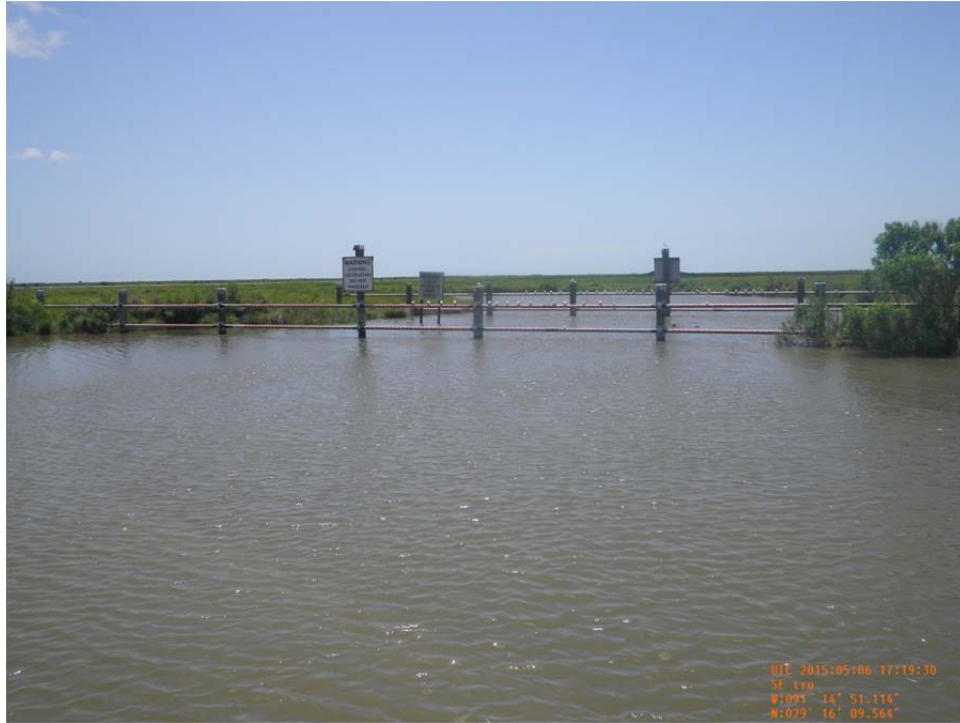
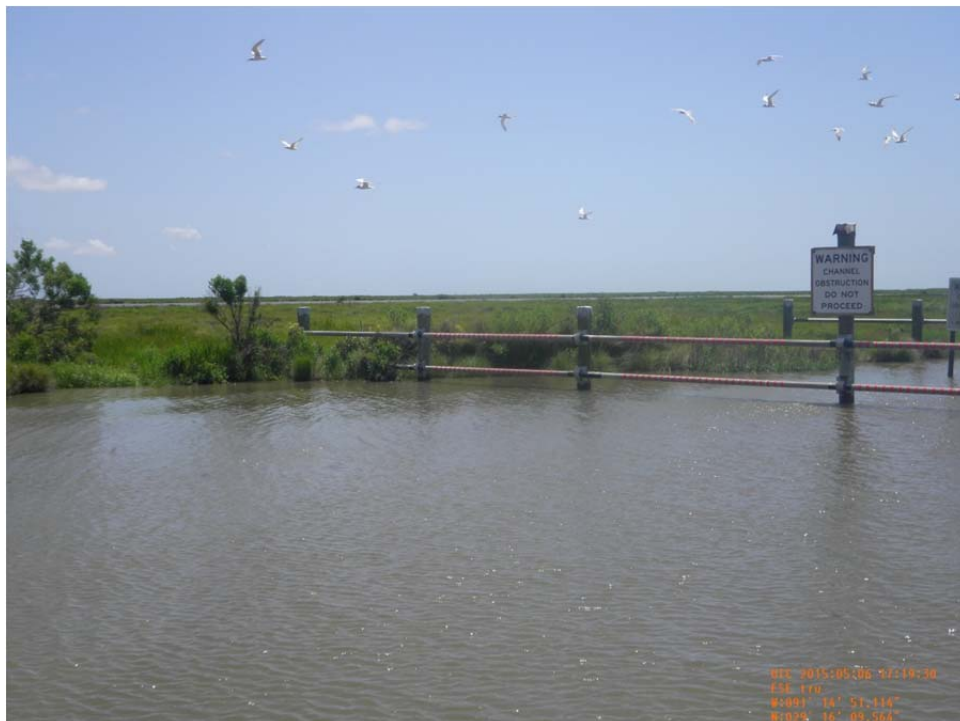
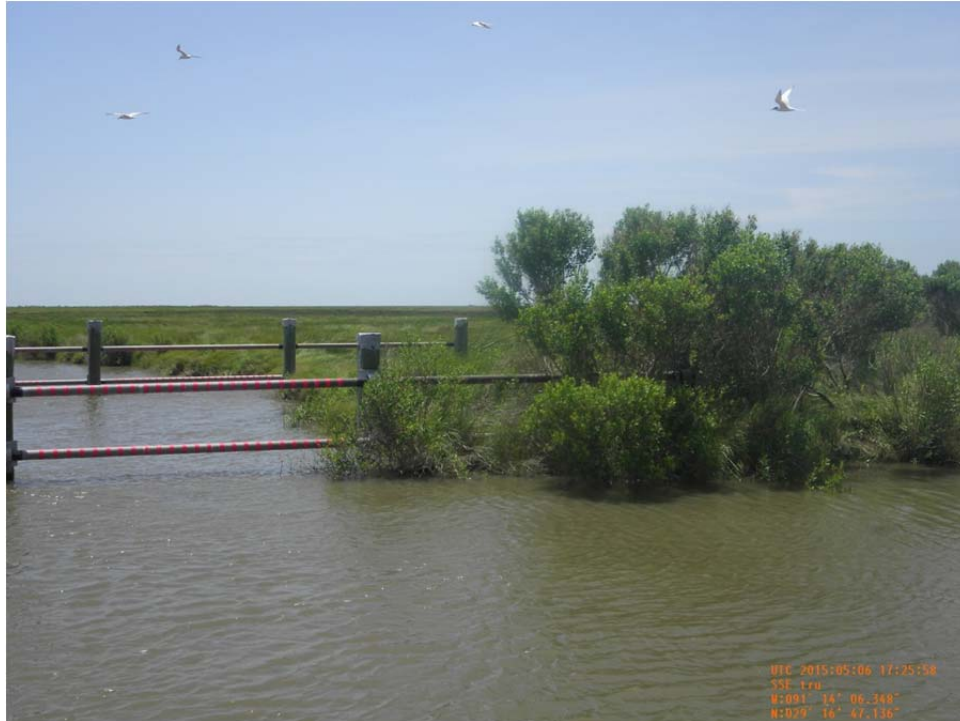
Site No. 5 – Rock Weir

Site No. 5 rock weir is in good overall condition. The marsh tie-ins on both sides of the structure are stable with no obvious erosion or breaching. The barricade system, timber piles and warning signs are in good condition with no visual damage or corrosion. There are no plans to perform future maintenance on the rock weir at Site No. 5. (See Appendix B, Photos 15-17)

Photo 15: View of rock weir, barricade system and warning signs at Structure No.5.

Photo 16: View of rock weir, barricade system and warning sign on the northeast bank at Structure No.5.

Photo 17: View of rock weir, barricade system and warning sign on the southwest bank at Structure No.5.

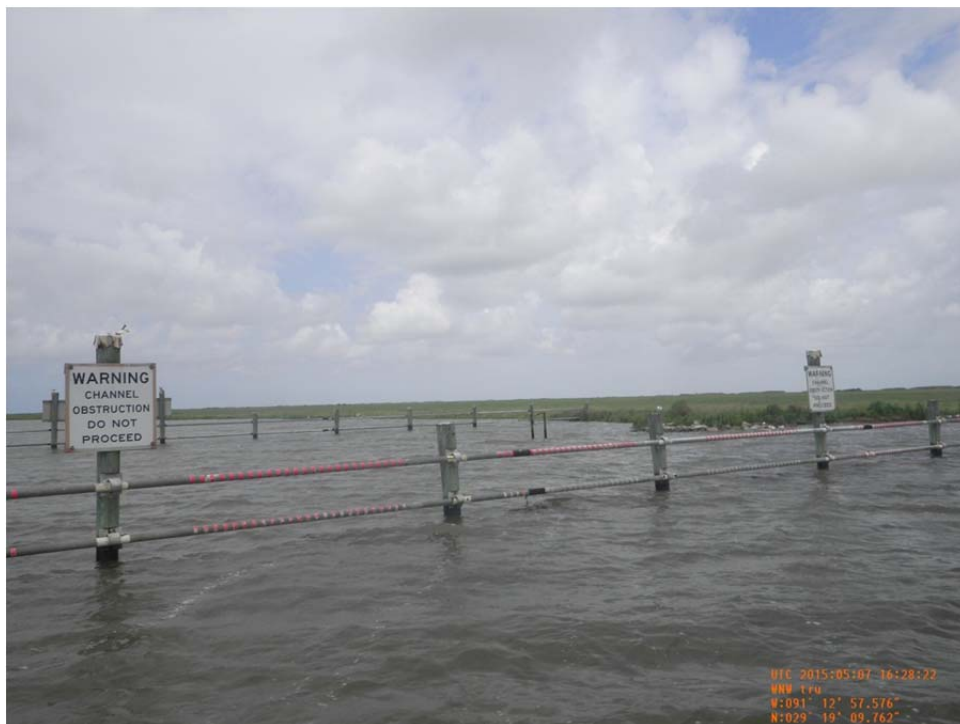
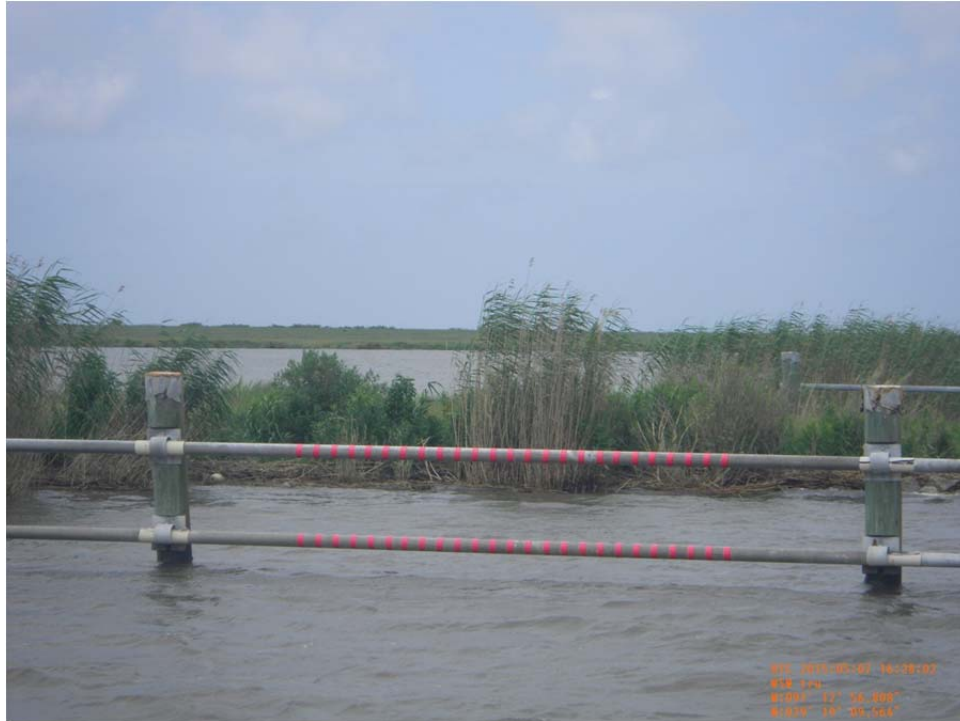
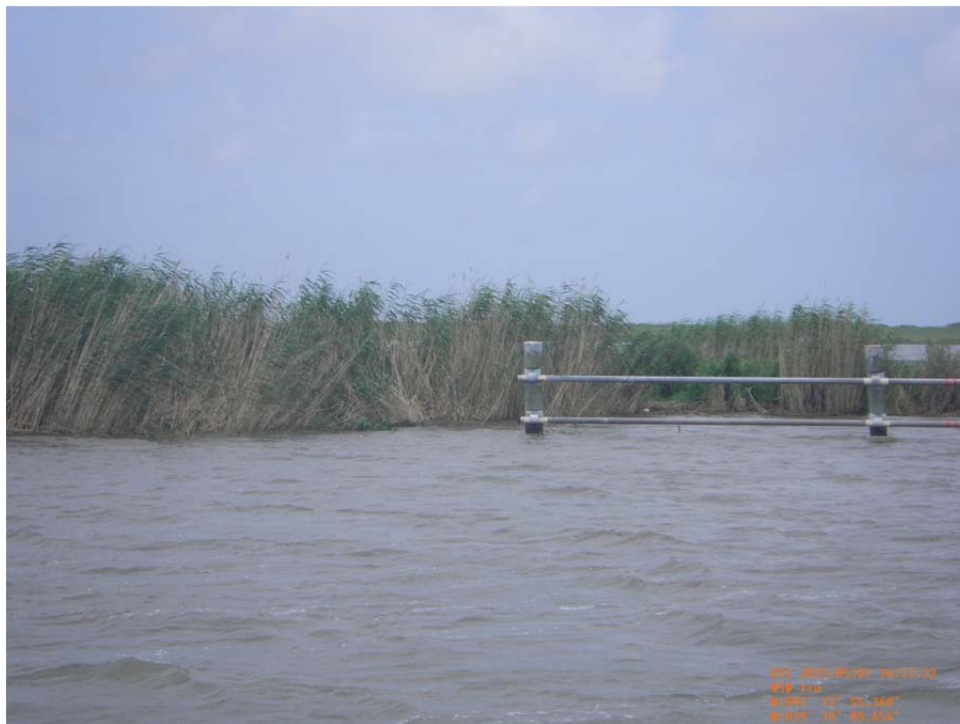
Site No. 4 – Rock Weir

The rock weir appeared to be in fair condition with minor erosion of the marsh tie-ins on the north side of the structure. As observed on previous inspections, we found that the existing marsh connecting the structure to land on the south side of the weir was very thin. This has been the condition of the marsh on the southern end of the weir for the last couple of years and it appears that the marsh bank has somewhat stabilized. CPRA and NMFS agree that at some point the marsh will erode on the south side and the structure will no longer be functional and will become a hazard. It is our plan to remove the timber barricade system and degrade the rock dike structure prior to the close-out of the project in 2019. Other than

removing the structure in the future, there are no other maintenance recommendations for Site No.4 (See Appendix B, Photos 18-20)

Photo 18: View of rock weir, barricade system, warning signs and bank tie-in on the north side of Structure No.4.

Photo 19: View of rock weir, barricade system and bank tie-in on the south side of Structure No.4.

Photo 20: View of rock weir, barricade system and bank tie-in on the south side of Structure No.4.

As mentioned in Section V, the marsh on the southern end of the rock dike tie-in is very thin and is expected to become breached in the near future. CPRA and NMFS has agreed that it would be best to remove the timber piles and barricade system, and degrade the rock dike prior to closing out the project to avoid any hazardous conditions in the future.
