**State of Louisiana
Coastal Protection and Restoration
Authority**

2013 Annual Inspection Report

**BRADY CANAL HYDROLOGIC
RESTORATION PROJECT (TE-28)**

May 6, 2013
Terrebonne Parish

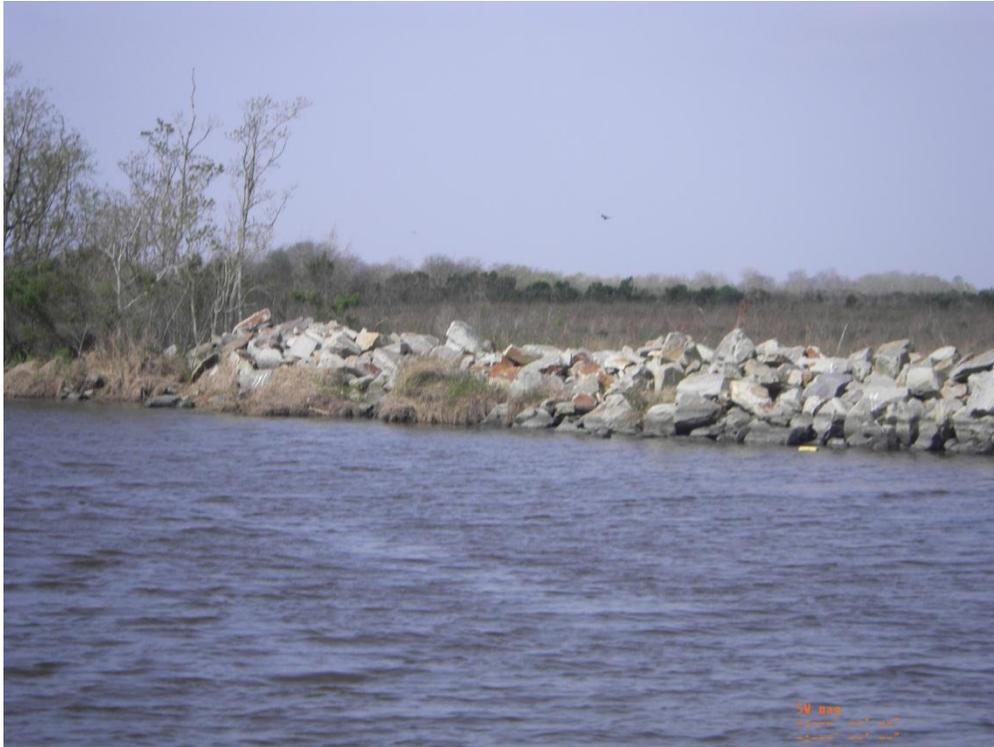
Breach 7 located along the oil field access canal connecting to Superior canal is in good overall condition. There is no observed settlement along the length of the embankment and no erosion or washouts around the embankment tie-ins. There are no recommendations for corrective action at this time, but it will continue to be monitored on future inspections. (See Appendix B, Photos 1 through 3)

Photo 1: Breach 7 located in an oilfield access canal off of Superior Canal. There is no visible settlement or displacement of the rock fill material.

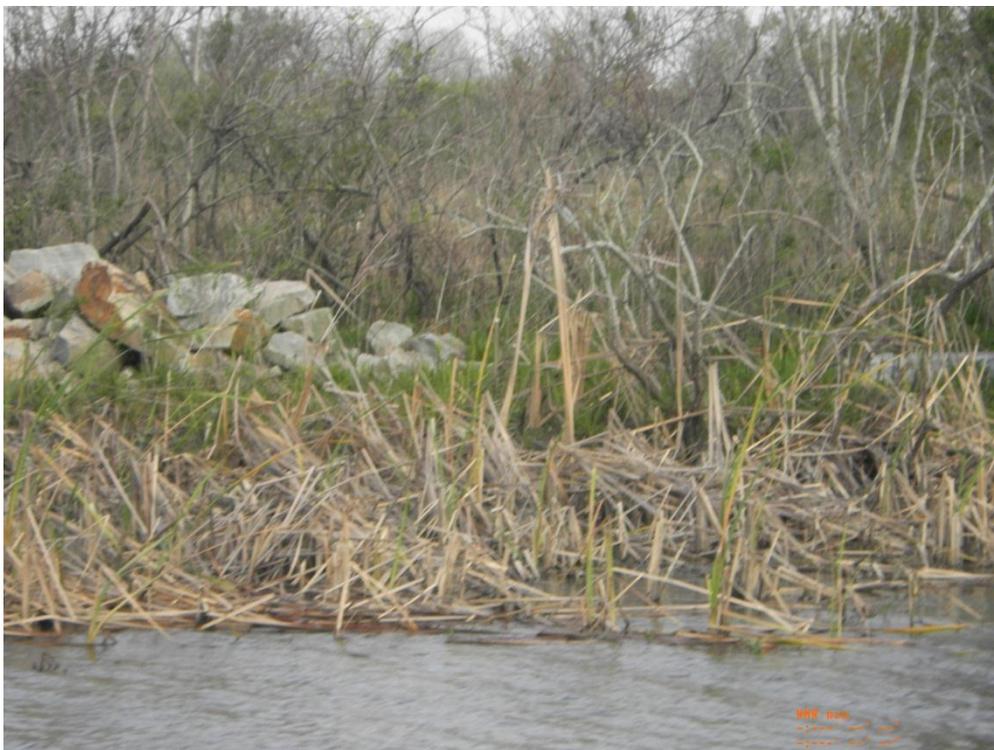
Photo 2: View of the embankment tie-in on the northeast end of Breach 7

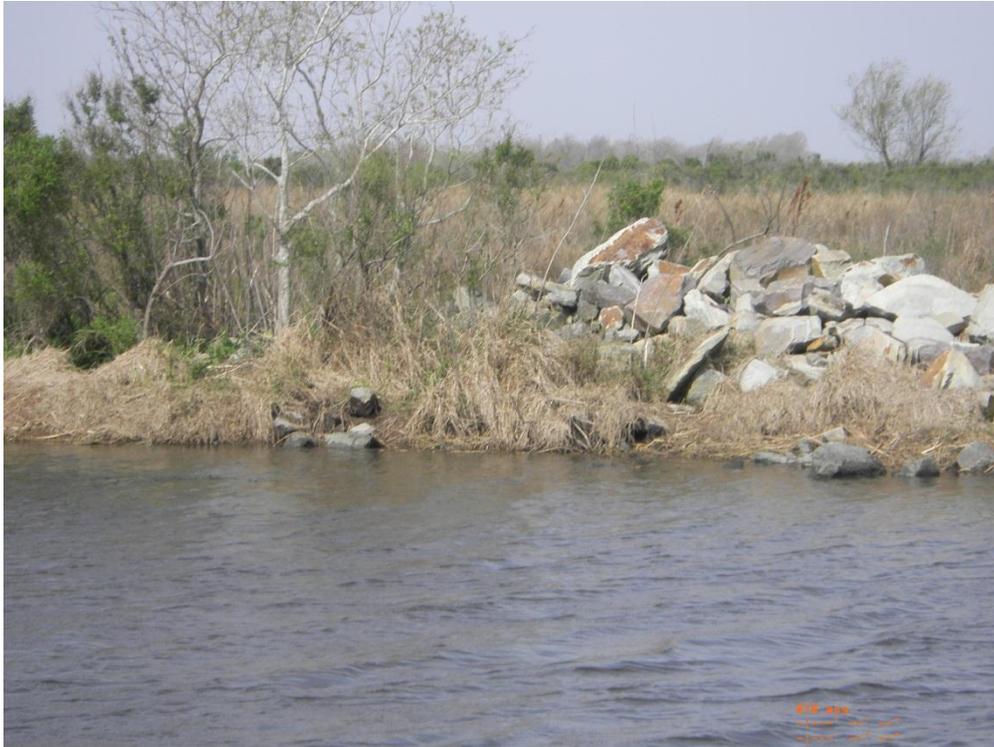
Photo 3: View of the embankment tie-in on the southwest end of Breach 7

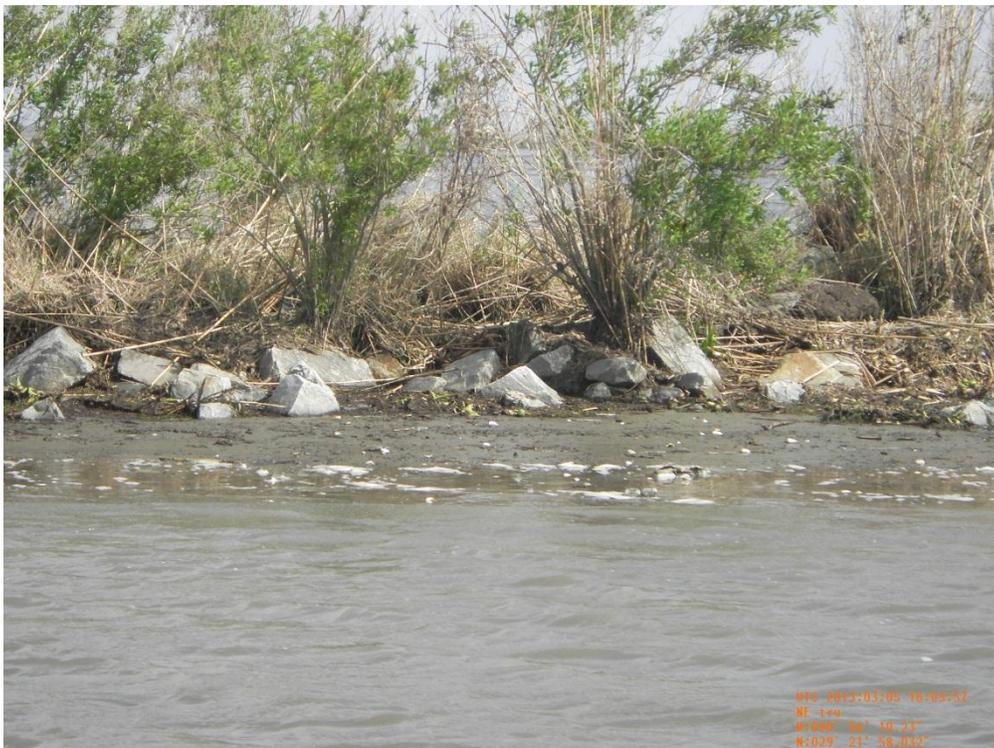
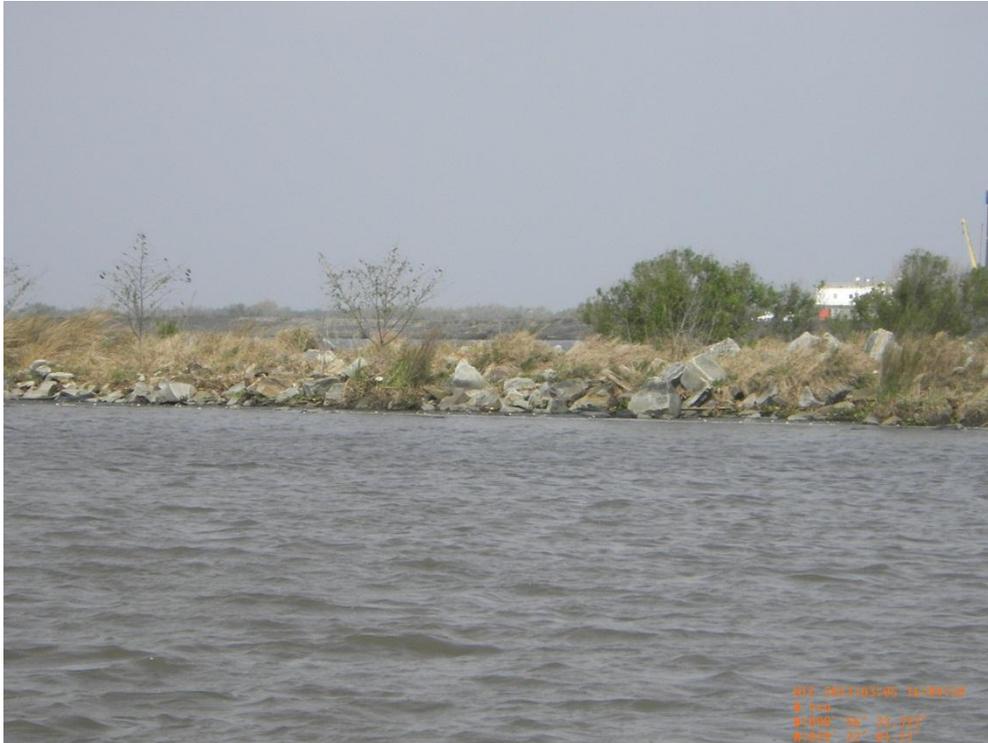
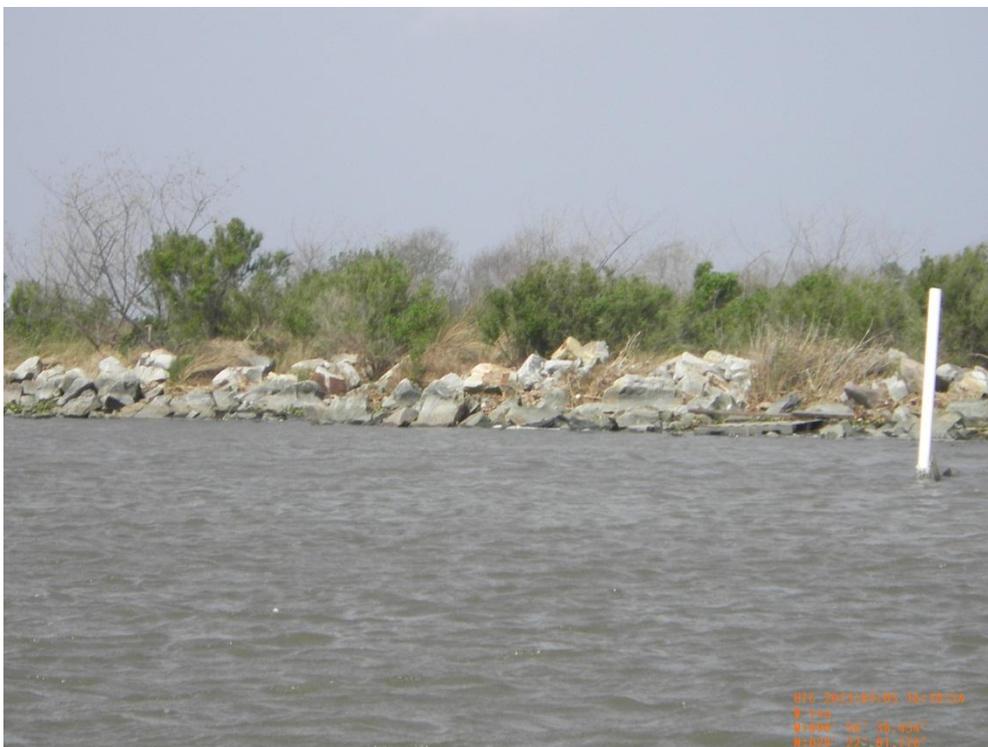
The rock armored embankments and rock dikes found along the north bank of Bayou Decade and Voss Canal are in good condition. The rock dike along Bayou Decade between Jug Lake and Turtle Bayou appears to be in fair condition with isolated low areas and moderate displacement (See Appendix B, Photos 4 through 6). The earthen embankment with rock revetment west of Structure 7 along Bayou Decade appears to be in good condition with no apparent settlement. The earthen embankment with rock revetment beginning at the intersection of Bayou Decade and Voss Canal had some initial settlement after construction but has experienced little change since previous inspections. Despite some minor deficiencies, the structures appear to be operating as intended.

Photo 4: Close up view of the rock armored embankment along the north side of Bayou DeCade between Turtle Bayou and Jug Lake taken from Bayou DeCade

Photo 5: View of the rock armored embankment along the north side of Bayou DeCade between Turtle Bayou and Jug Lake taken from Bayou DeCade

Photo 6: View of the rock armored embankment along the north side of Bayou DeCade between Turtle Bayou and Jug Lake taken from Bayou DeCade

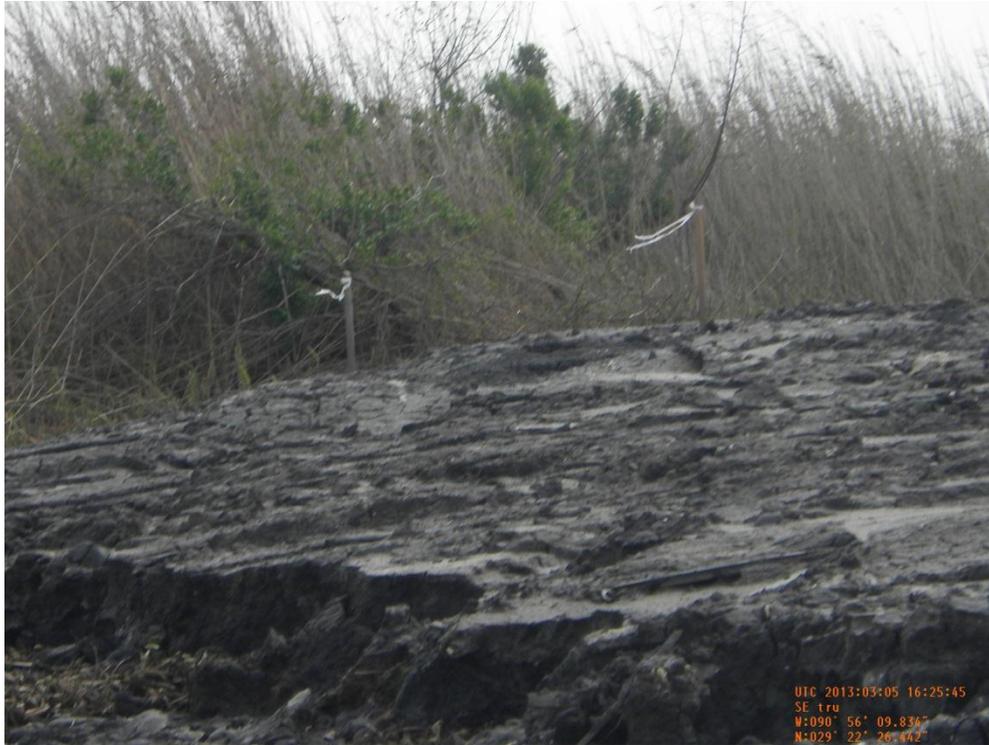
Structure 24 is in good overall condition. There is no visible damage to the steel bulkhead, railings, platform, or the warning signs and their support timbers. As part of the 2012 Maintenance Project, Structure 24 had both of its embankment tie-ins refurbished and then rock armored with 50 linear feet of rip rap to prevent any further erosion around the ends of the structure. Due to this maintenance, the structure is again operating as designed.

As part of the 2012 Maintenance Project, approximately 13,900 linear feet of earthen embankment around the rim of Jug Lake is being refurbished (See Appendix B, Photos 7, 11 through 13, and 17 through 20). The refurbished sections (Appendix D Work Plan) were designated as the most critical areas along the lake rim, some of which were no longer existent due to years of erosion and deterioration. These repairs to the earthen embankment now prevent large amounts of high saline water into an area that is predominantly brackish and allows three (3) water control structures to operate as designed that were previously ineffective. During the annual inspection, it was noted that the earthen embankments had cut banks due to wave action in the lake. These cut banks will be shaped to meet the design template of the maintenance project before the project is completed.

Photo 7: View of the newly refurbished embankment tie-in located on the southern end of Structure 24

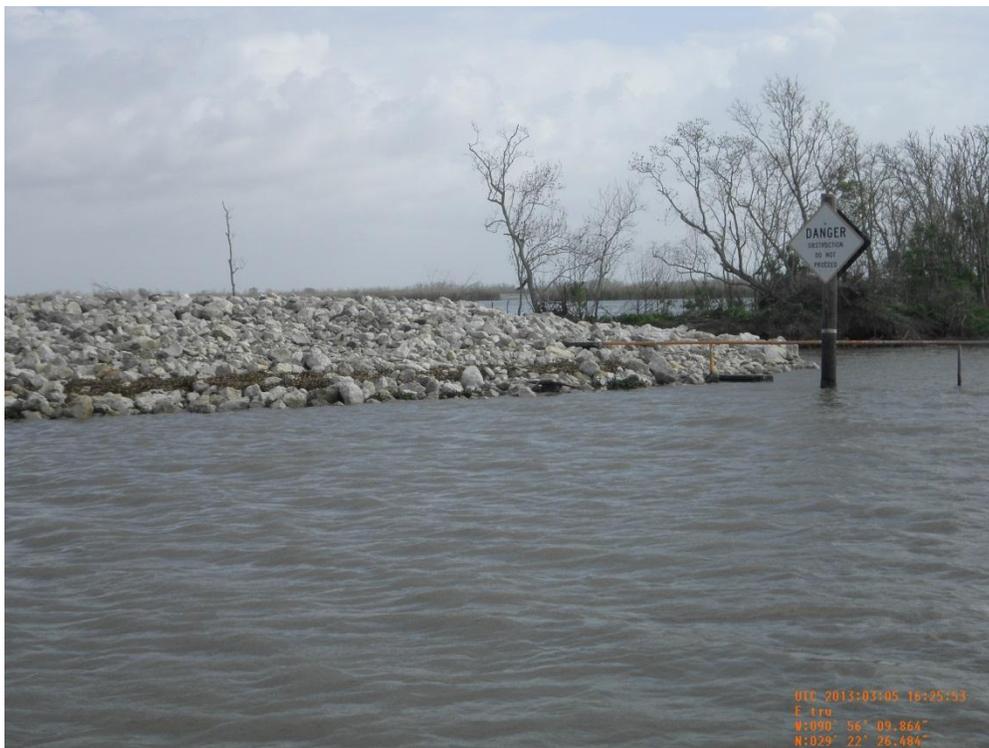
Photo 8: View of the rock armored embankment tie-in on the northern end of Structure 24

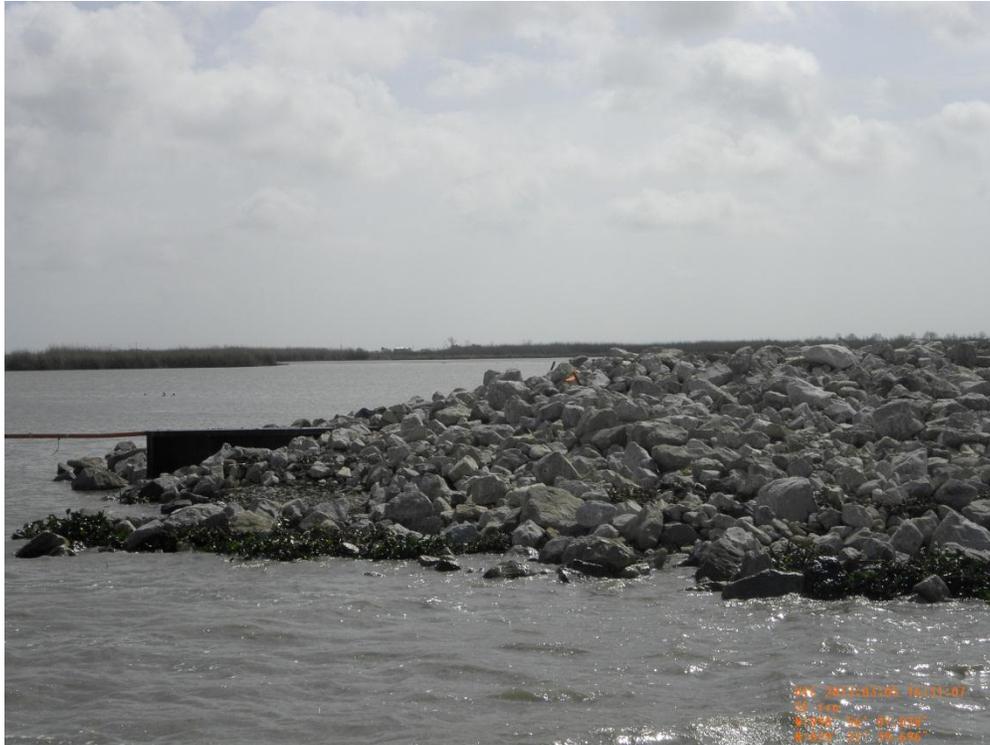
This structure is in good overall condition. There is no visible damage to the steel bulkhead, railings, platform, or the warning signs and their support timbers. As part of the 2012 Maintenance Project, Structure 23 had both of its embankment tie-ins refurbished and then rock armored with rip rap for 50' in each direction to prevent any further erosion around the ends of the structure. Since the refurbishment has closed the breaches around the structure, the structure is now operating as intended. (See Appendix B, Photos 9 through 11)

Photo 9: View of the rock armored embankment on the southern end of Structure 23

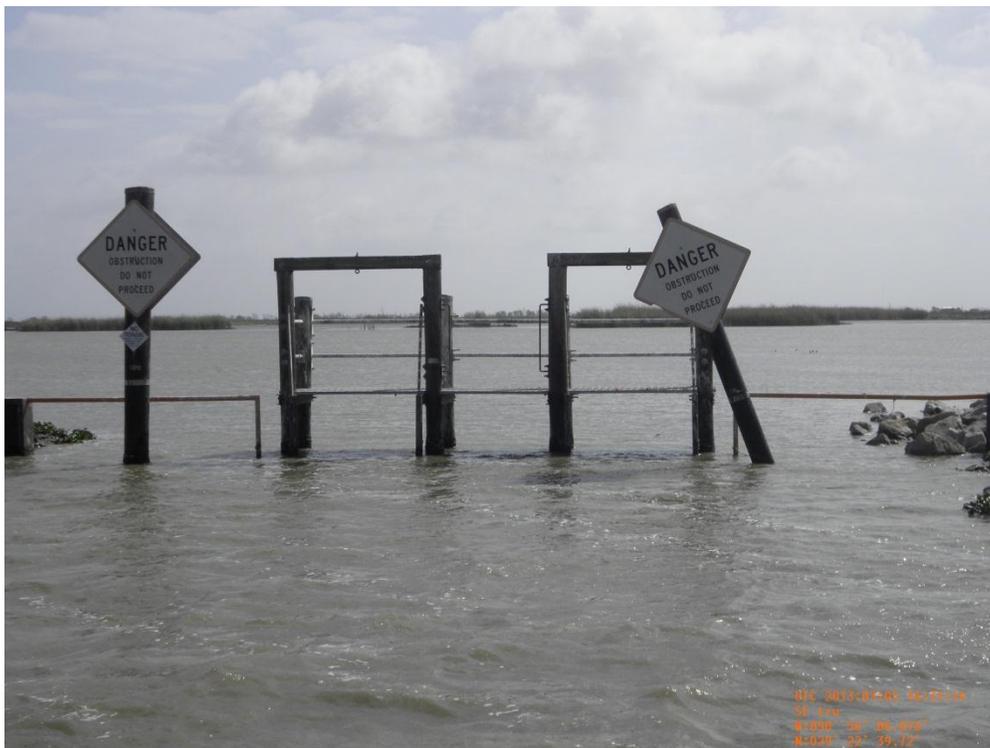
Photo 10: View of Structure 23 variable crest weir timbers, warning signs and steel piping

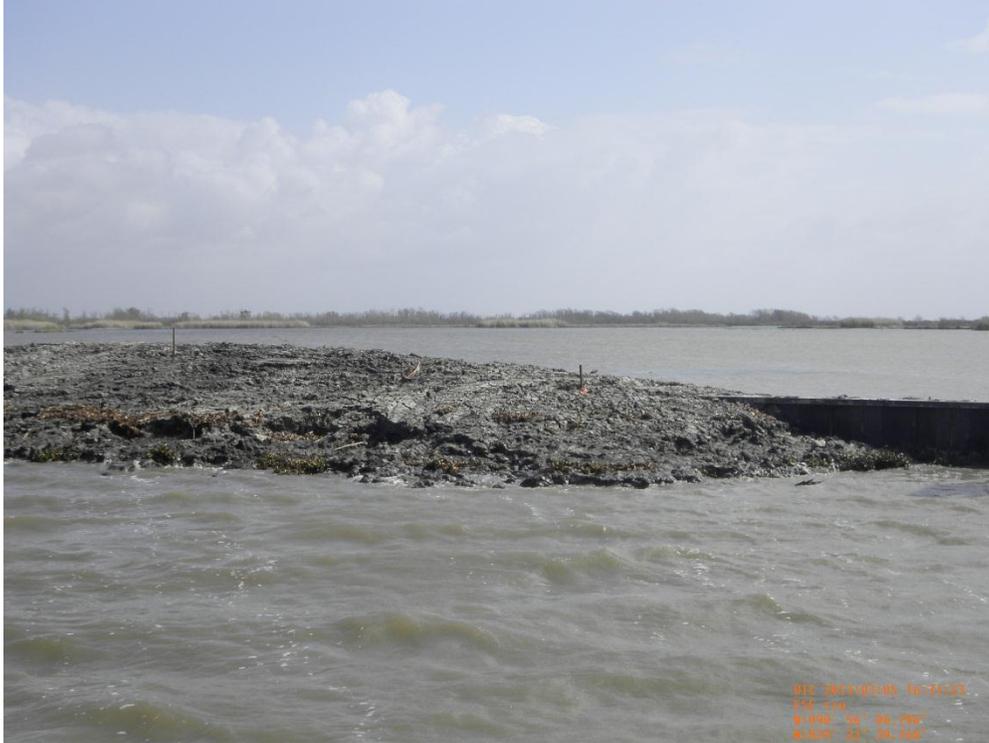
Photo 11: View of the newly refurbished embankment tie-in located on the northern side of Structure 23

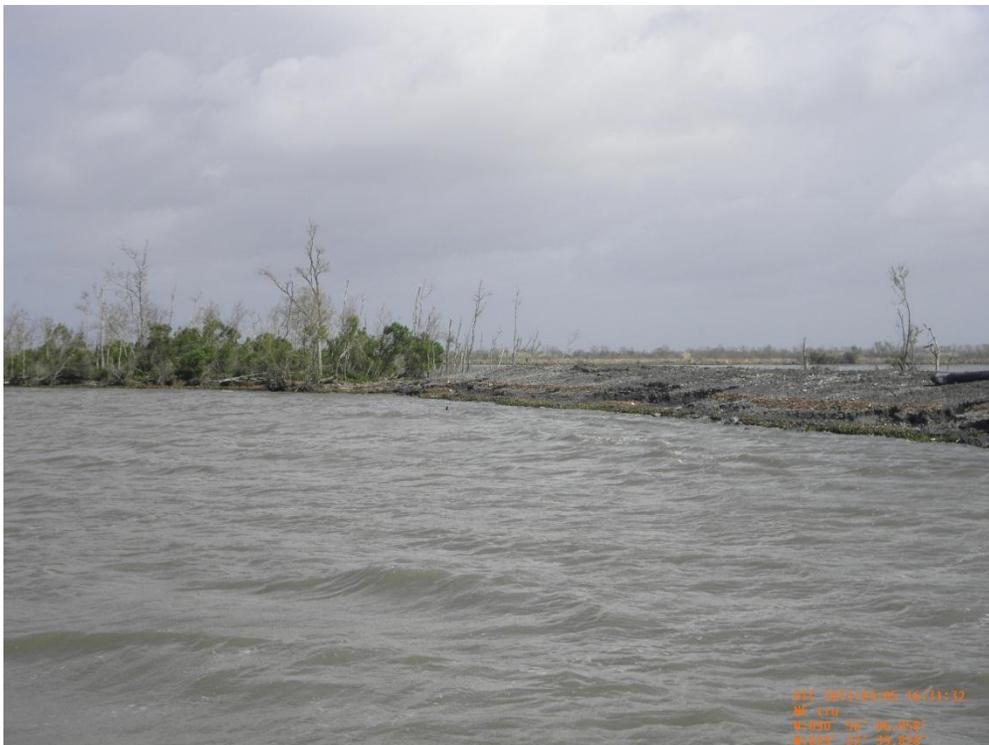
Photo 12: View of the newly refurbished embankment located north of Structure 23 in Jug Lake

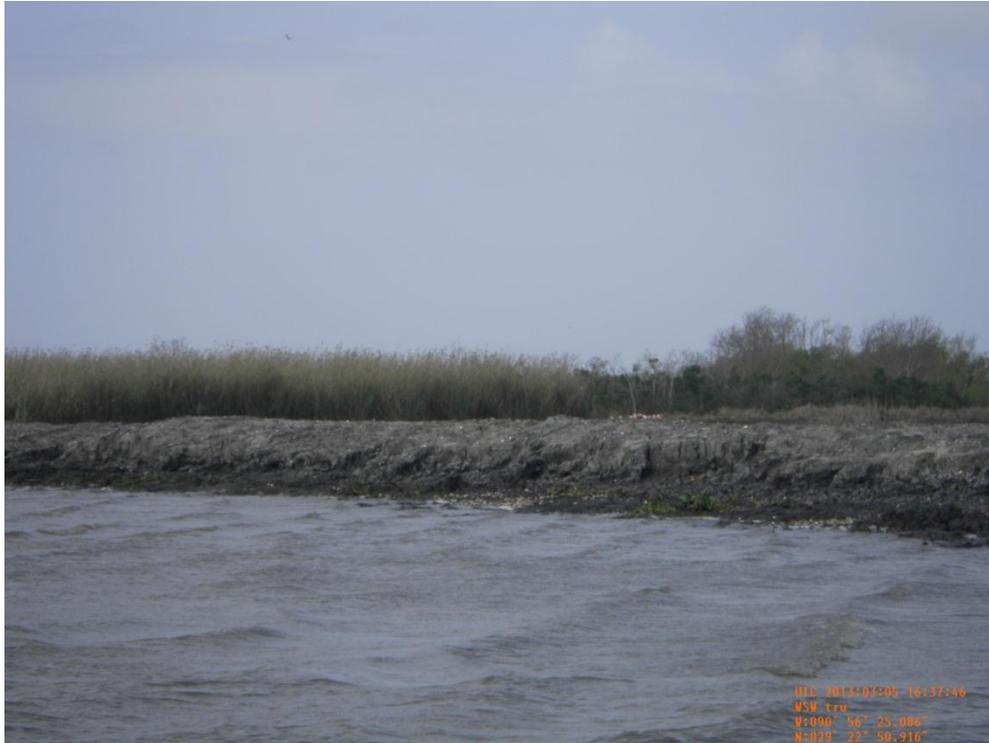
Photo 13: View of the refurbished embankment on the northern bank of Jug Lake

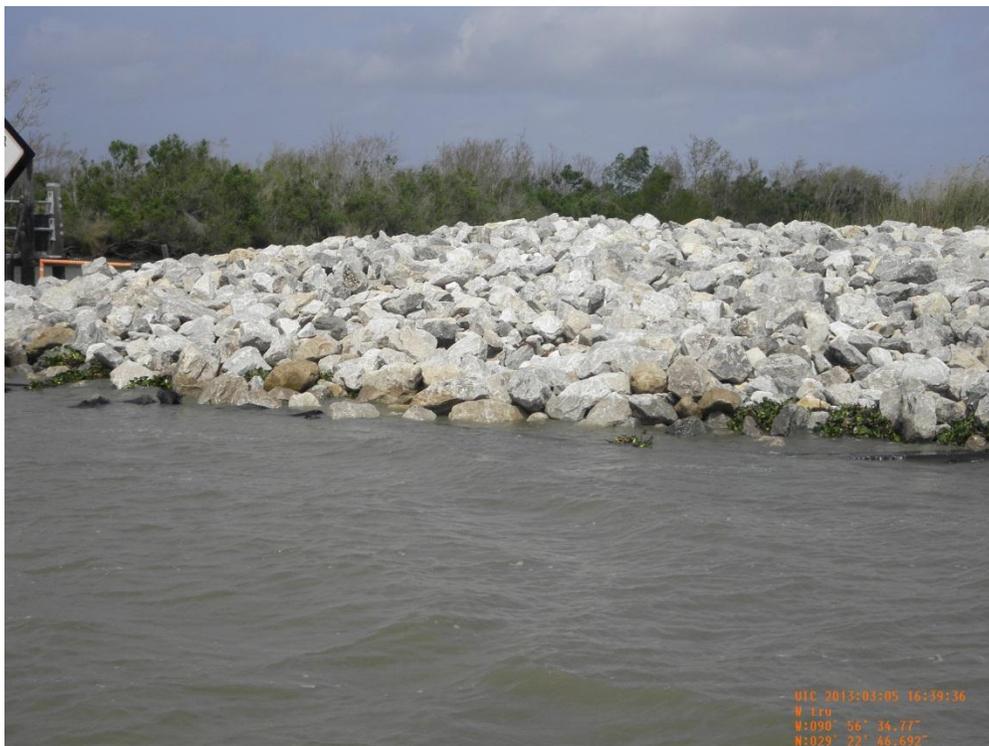
Structure 21 is in good overall condition. There is no visible damage to the steel bulkhead, railings, platform, or the warning signs and their support timbers. As part of the ongoing 2012 Maintenance Project, Structure 21 is in the process of having both of its embankment tie-ins refurbished and then rock armored with 50 linear feet of rip rap to prevent any further erosion around the ends of the structure. Due to this maintenance, the structure is again operating as designed. (See Appendix B, Photos 14 through 16)

Photo 14: View of the rock armored embankment tie-in on the east side of Structure 21

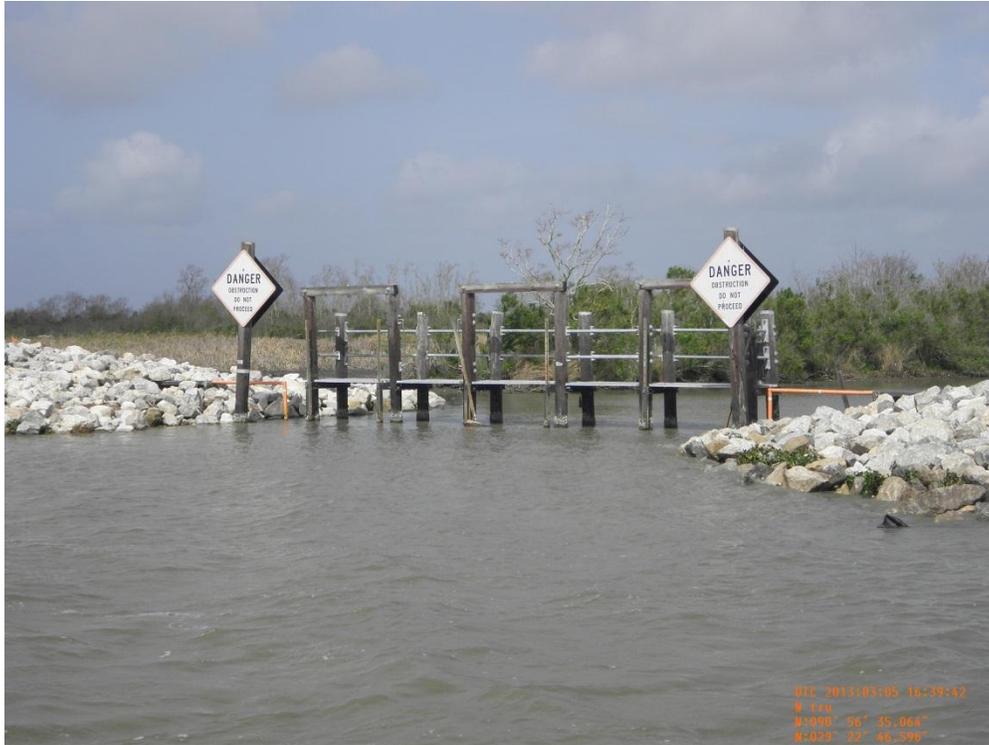
Photo 15: View of Structure 23 variable crest weir timbers, warning signs and steel piping

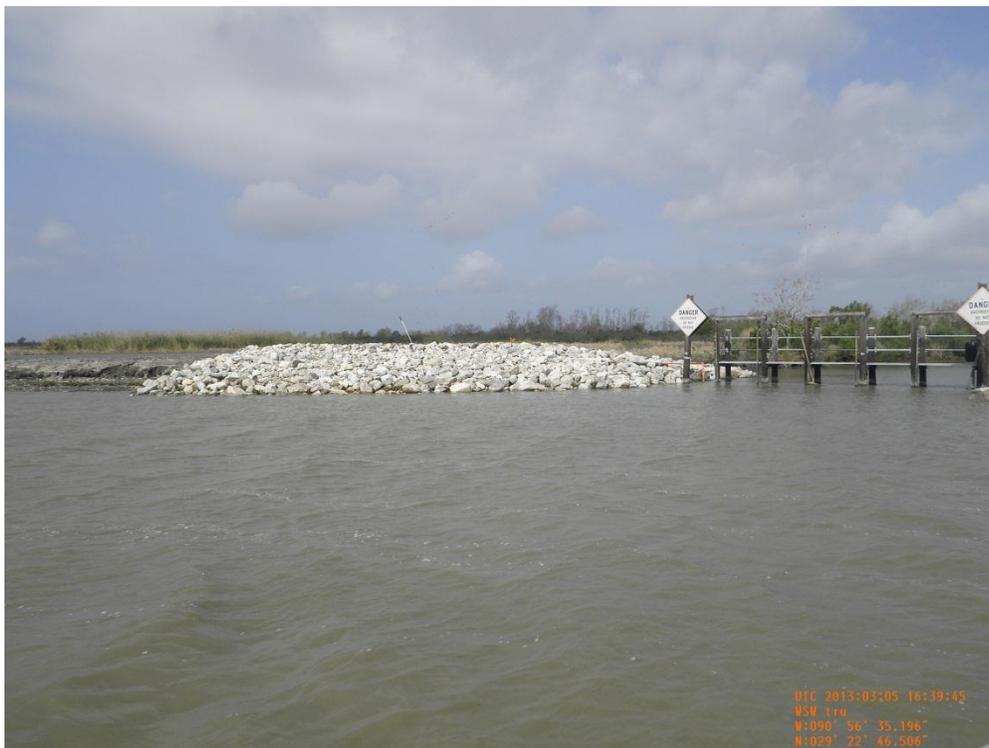
Photo 16: View of the rock armored embankment tie-in on the west side of Structure 21

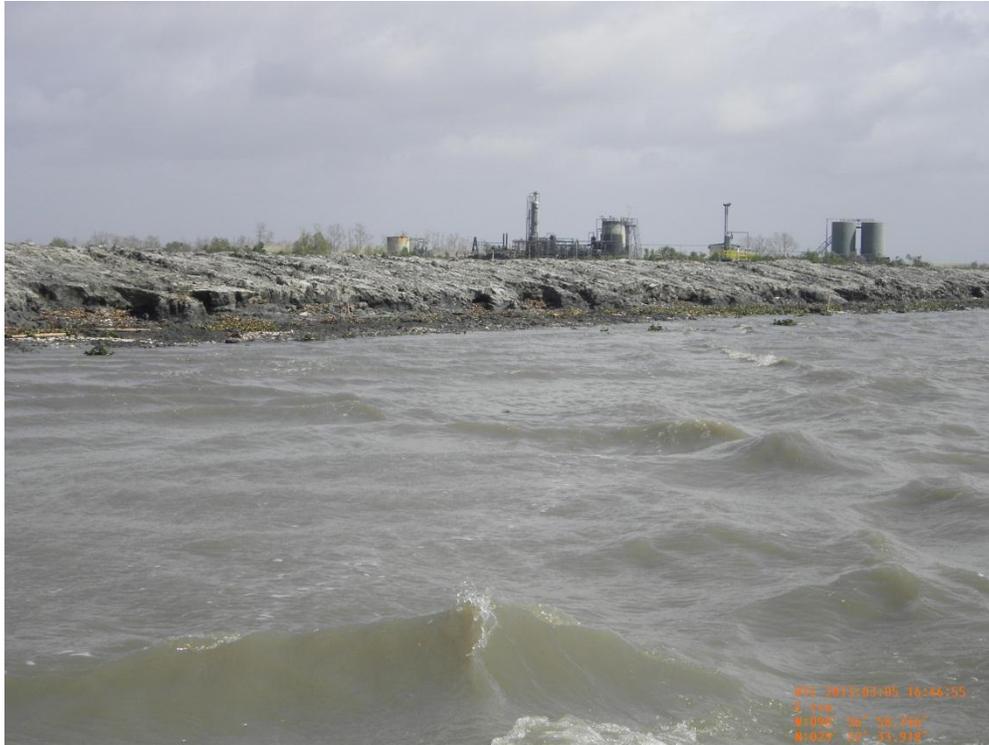
Photo 17: View of the refurbished embankment on the northwest bank of Jug Lake

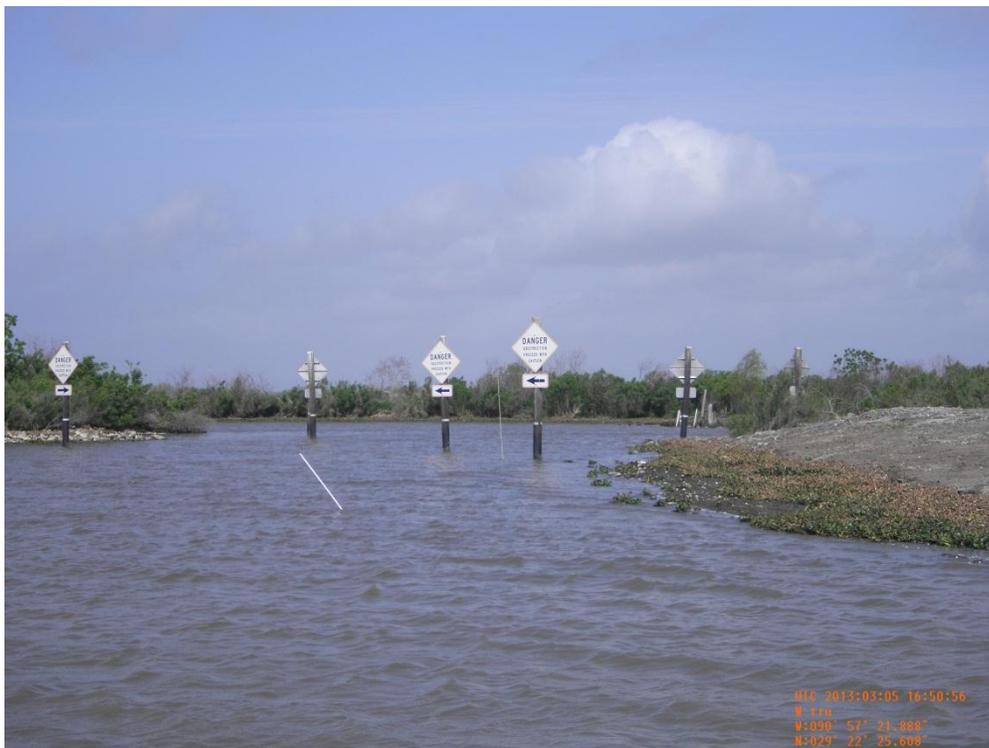
This structure is in good overall condition. There has been some settlement of the rock rip rap on the exposed sides and submerged crest of the structure. In 2012, it was determined the crest of the submerged channel liner has settled to a depth of -5.7 NAVD88, which translates to approximately 1.0' of settlement since construction. All other warning signs and timber supports are in good condition. Structure 21 was excluded from the 2012 Maintenance Project, but the earthen embankment was refurbished up to the structures eastern embankment tie-in. (See Appendix B, Photo 18)

Photo 18: View of Structure 20 rock armored channel liner warning signs

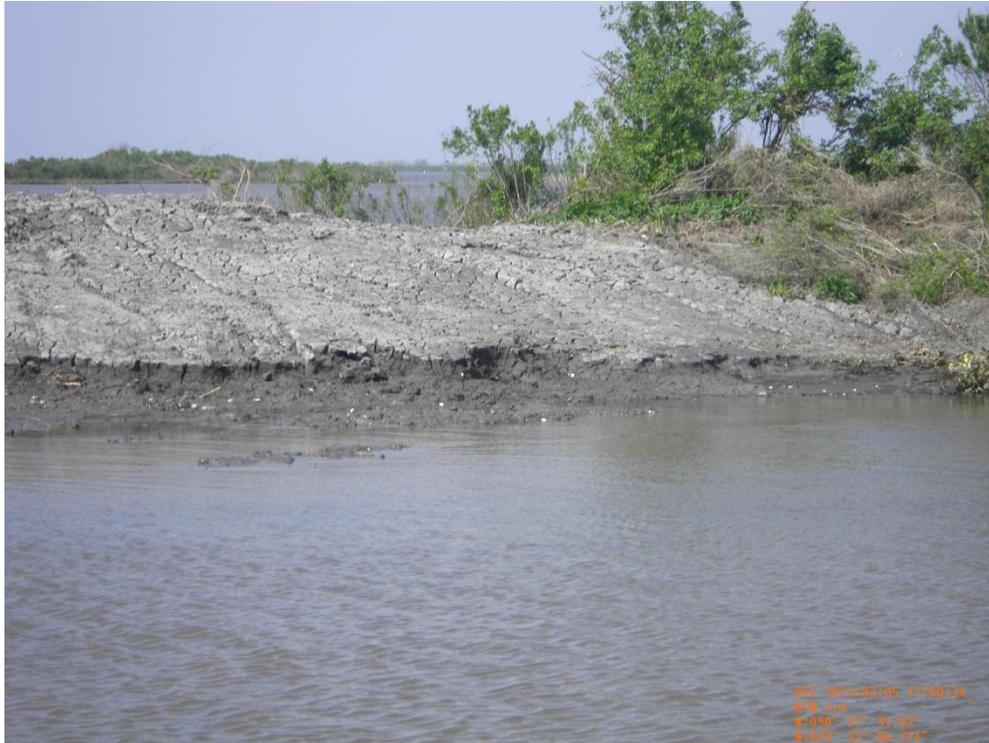
Photo 19: View of the refurbished embankment on the southwest bank of Jug Lake

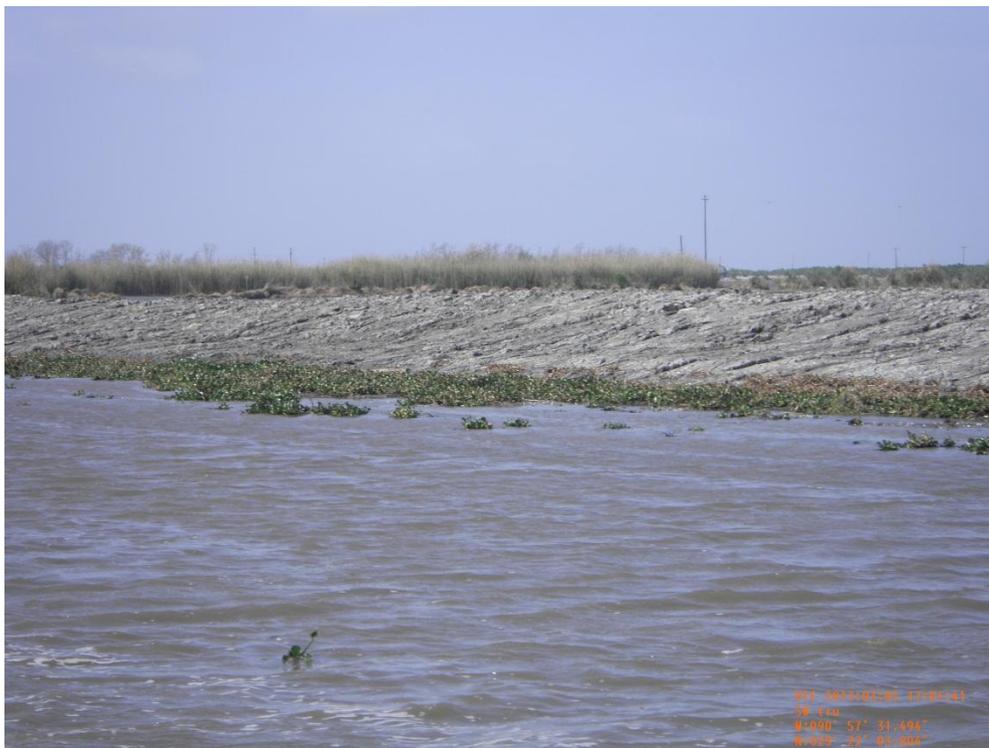
Photo 20: View of the refurbished embankment on the northern bank of Bayou DeCade

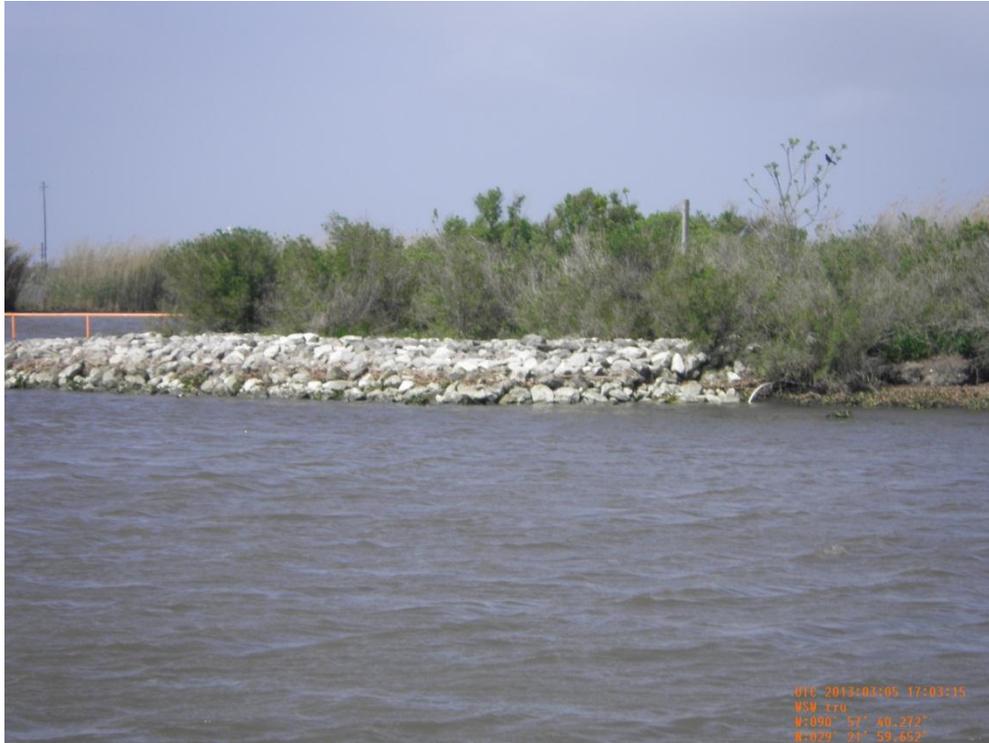
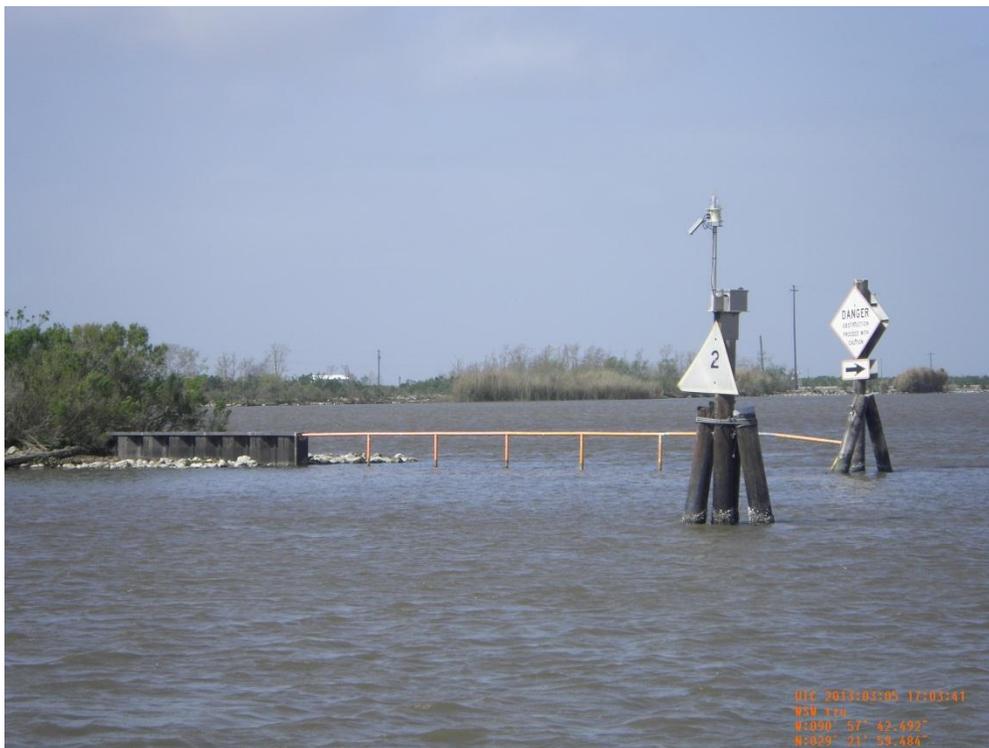
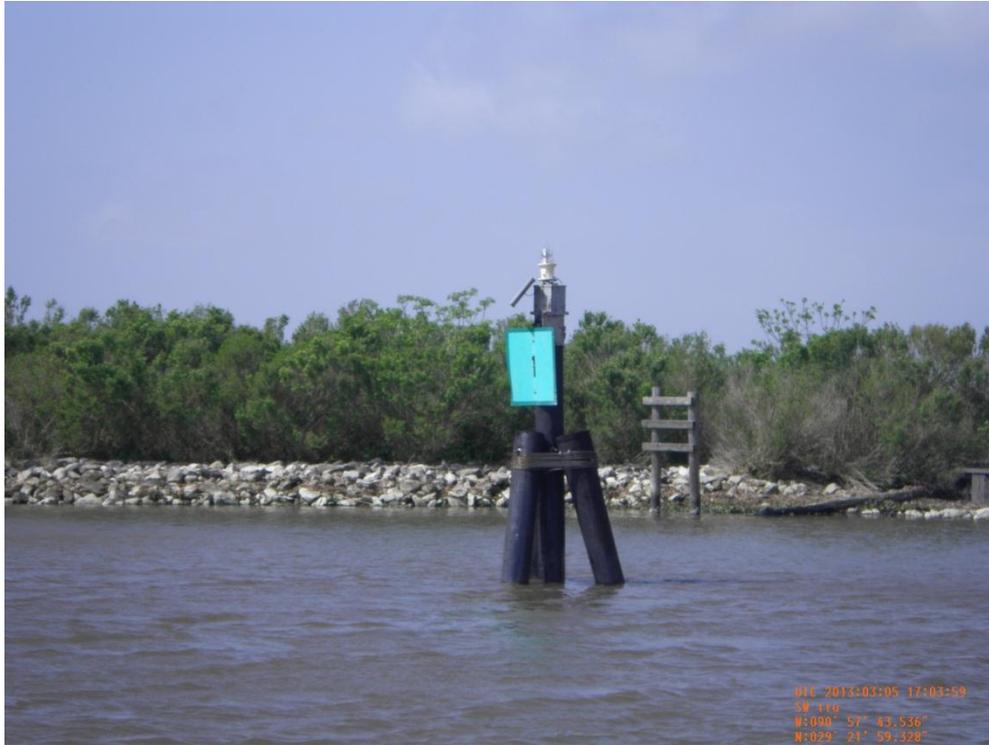
Structure 6 appears to be in good overall condition. There are no signs of erosion or wash-outs around the steel bulkheads and embankment tie-ins. The navigational lights and navigational signs are visible. As part of the 2012 Maintenance Project, two (2) of the timber pile dolphins on the west side of the structure were replaced and fitted with new navigational signs. These timber pile dolphins were believed to be damaged by an oilfield service barge, and the two dolphins with the most damage were chosen for replacement. A water level reading of +0.7' NAVD88 was taken at approximately 10:45am from a project staff gauge near Structure 6. (See Appendix B, Photos 21 through 23)

Photo 21: View of the eastern end of Structure 6 and rock armored embankment

Photo 22: View of the eastern end of Structure 6 and embankment tie-in bulkhead

Photo 23: View of Structure 6 replaced timber pile dolphin included in 2012 Maintenance Project

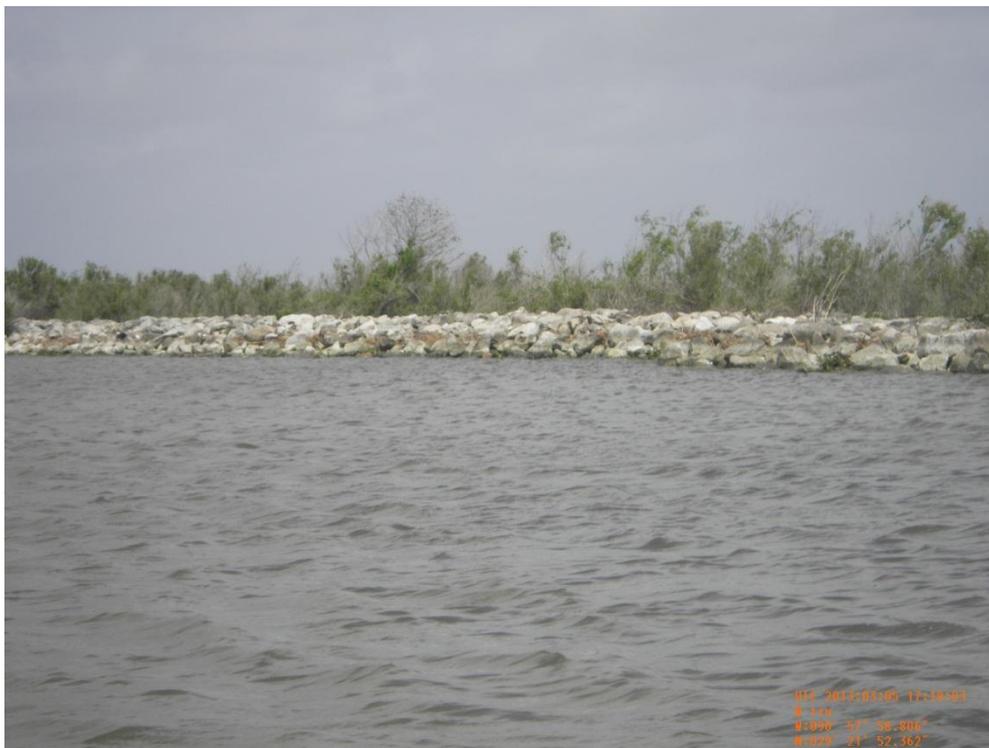
Photo 24: View of rock dike along the north bank of Bayou Decade just west of Structure 6

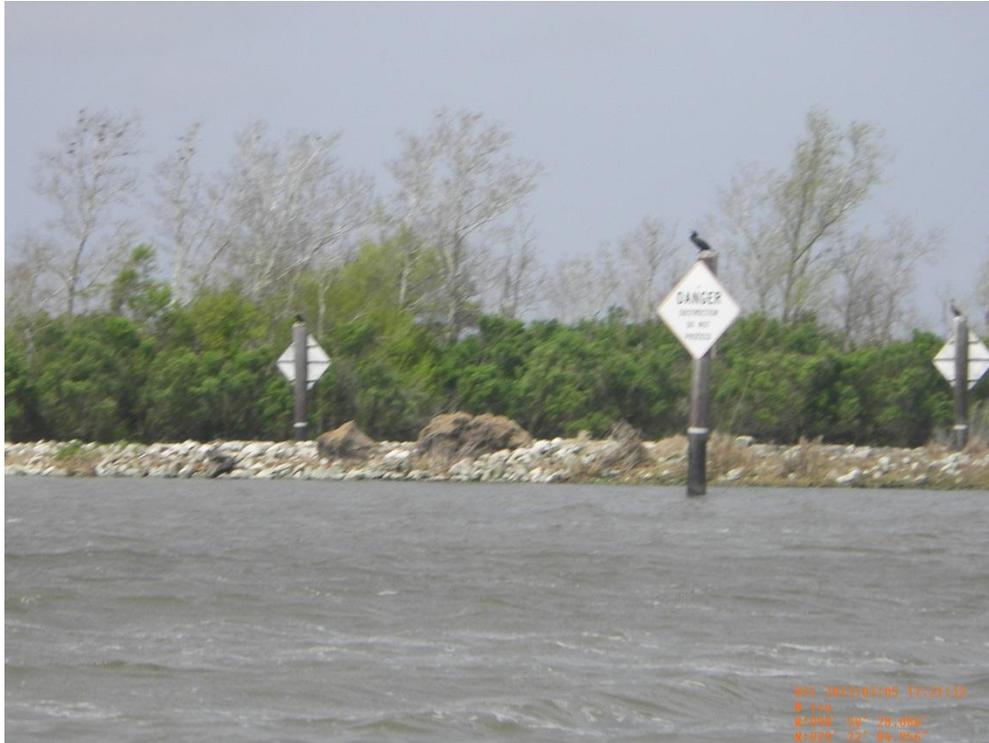
Structure 7 appears to be in good overall condition. There is no observed settlement of the rock plug or signs of erosion around the earthen embankment tie-ins. The warning signs and supports for this structure also appear to be in good condition. This structure does not require maintenance at this time. (See Appendix B, Photo #25)

Photo 25: View of Structure 7 rock plug along the north bank of Bayou Decade

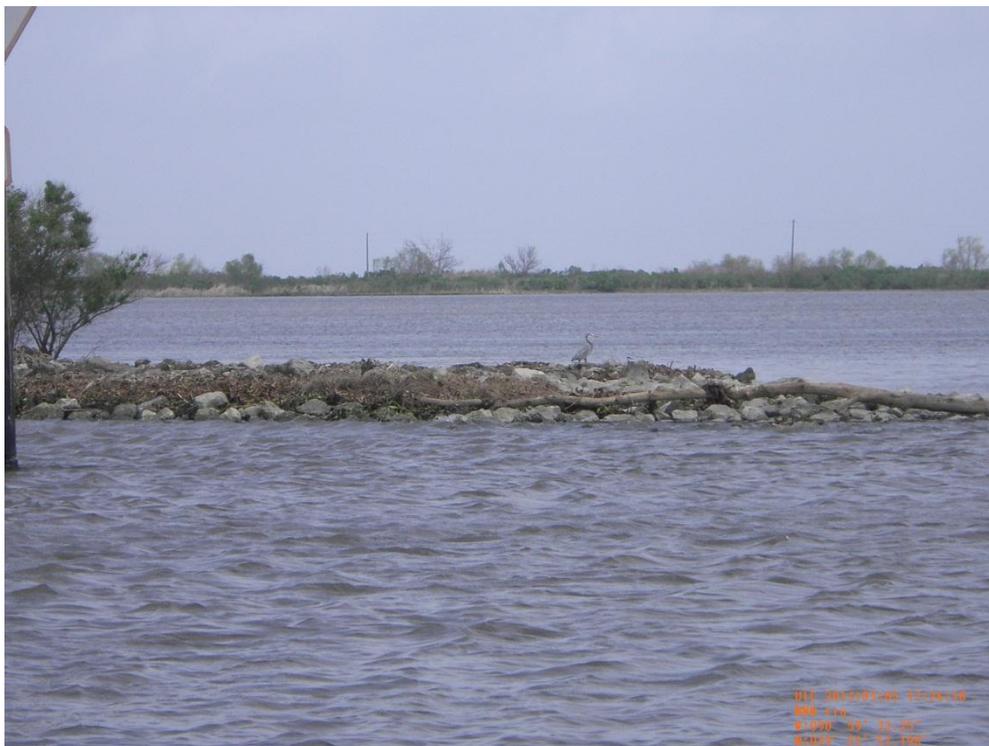
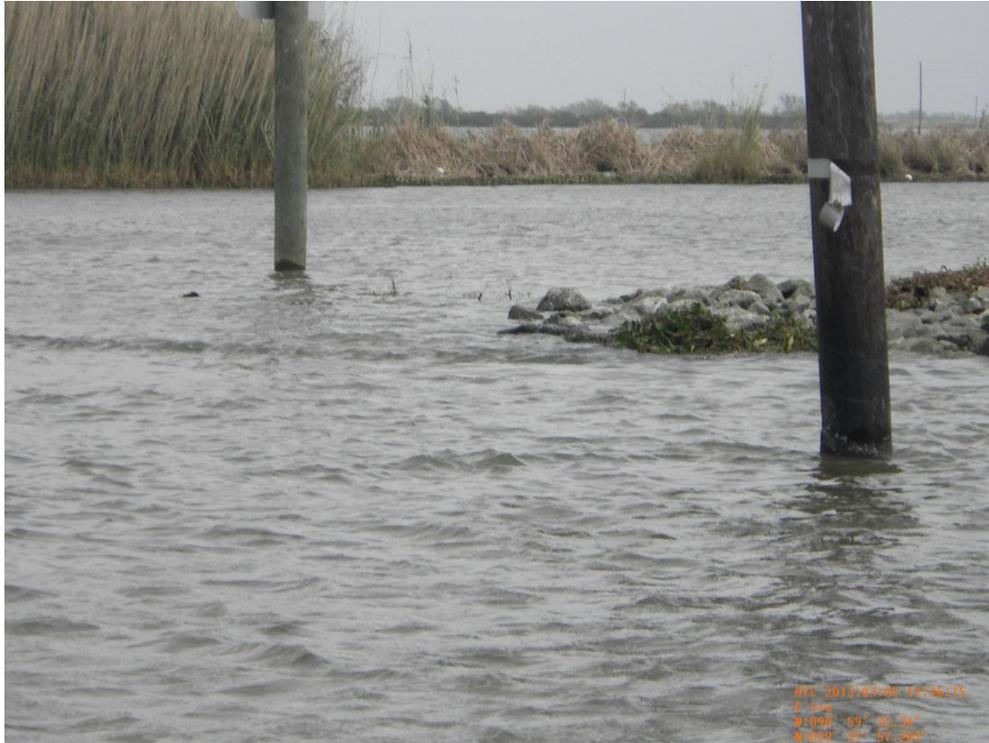
This structure appears to be in good overall condition. There is no additional settlement of the rock observed from previous inspections. From previous inspections, the warning sign timbers on the northeast side of the structure were no longer vertical. As part of the 2012 Maintenance Project, these three (3) of the warning signs and supports were replaced. The remaining warning signs and supports are in good condition. (See Appendix B, Photos 26 through 27)

Photo 26: View of northern end of Structure 10 fixed crest rock weir with barge bay

Photo 27: View of southern end of Structure 10 fixed crest rock weir with barge bay
