**State of Louisiana
Coastal Protection and Restoration
Authority**

2013 Annual Inspection Report

**BRADY CANAL HYDROLOGIC
RESTORATION PROJECT (TE-28)**

May 6, 2013
Terrebonne Parish

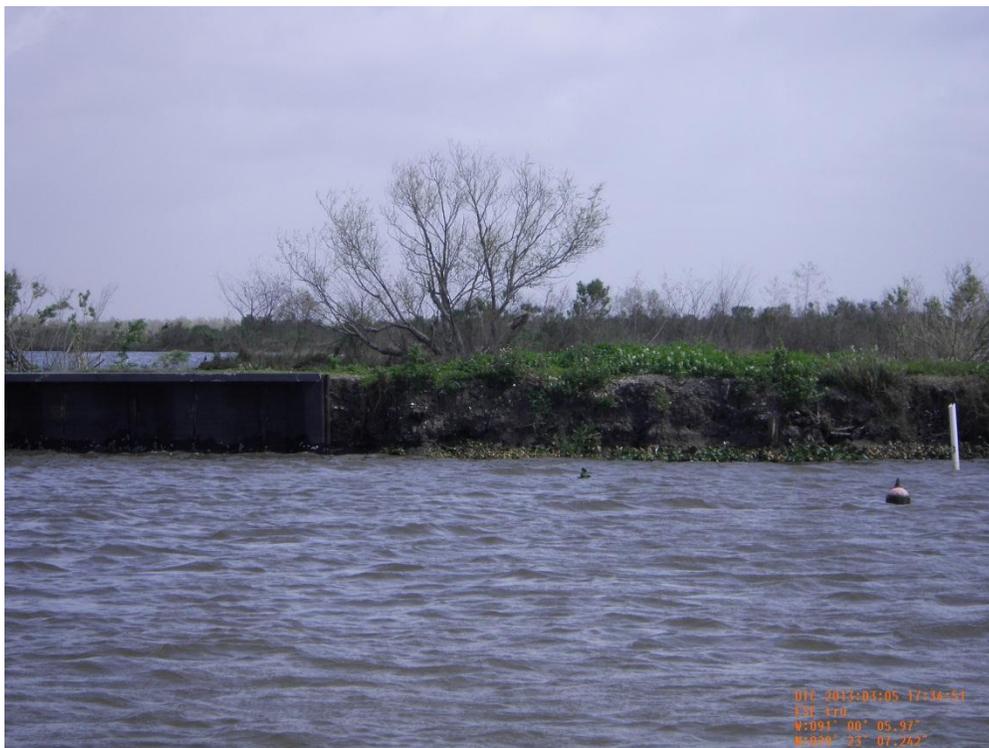
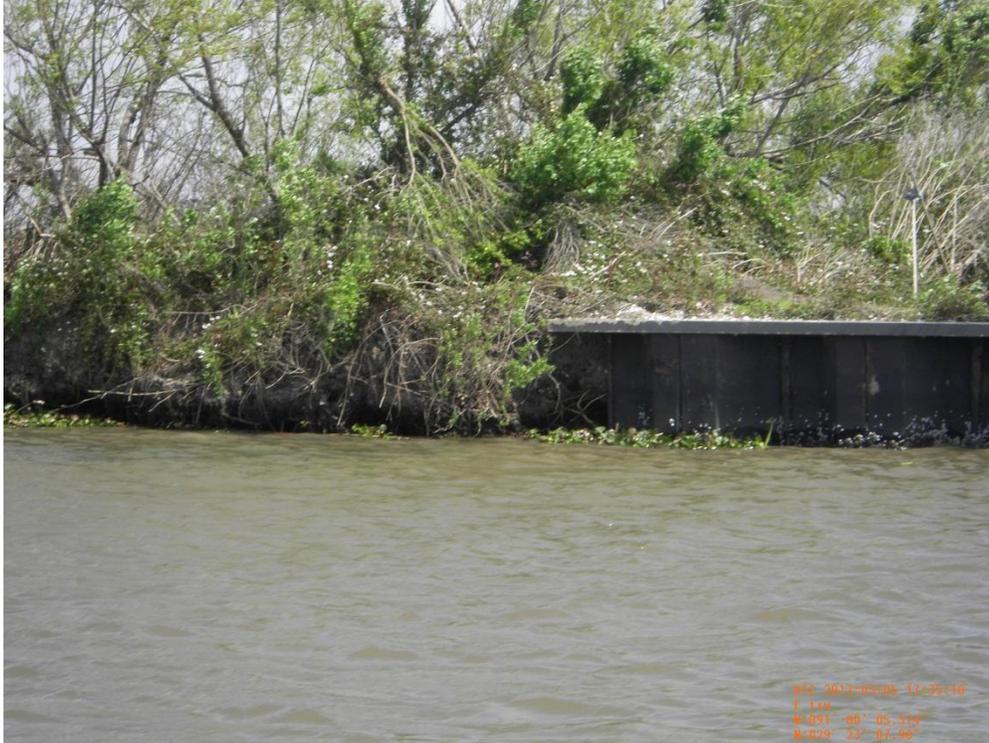
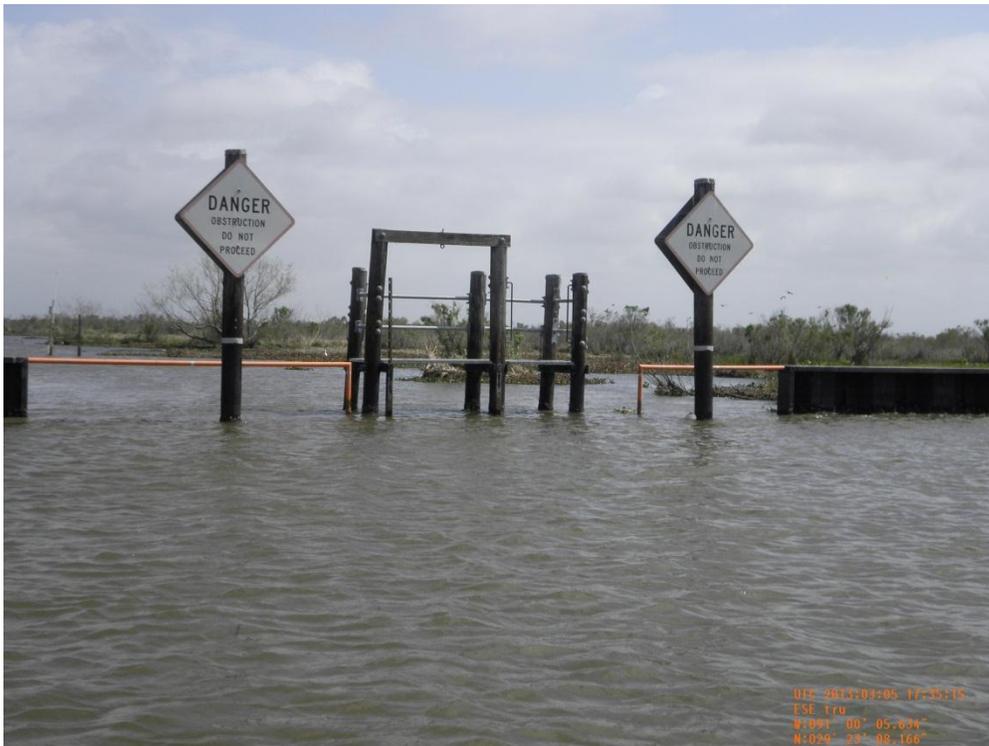
This structure appears to be in good overall condition. There is no visible damage to the railings, platform, steel bulkhead, or warning signs and their timbers. There is some noticeable erosion near the embankment tie-ins. It appears to be caused by boat traffic, as it can only be seen from the Bayou Carencro side of the structure. However, by comparing the pictures of this year to previous annual inspections, it appears this area has stabilized as the erosion has

not been progressing. Without a full breach around the embankment tie-in, this structure is still operating as designed. (See Appendix B, Photos 28 through 30)

Photo 28: View of Structure 14 southern embankment tie-in bulkhead

Photo 29: View of Structure 14 northern embankment tie-in bulkhead

Photo 30: Overall view of Structure 14 variable crest weir timbers, warning signs, and steel piping

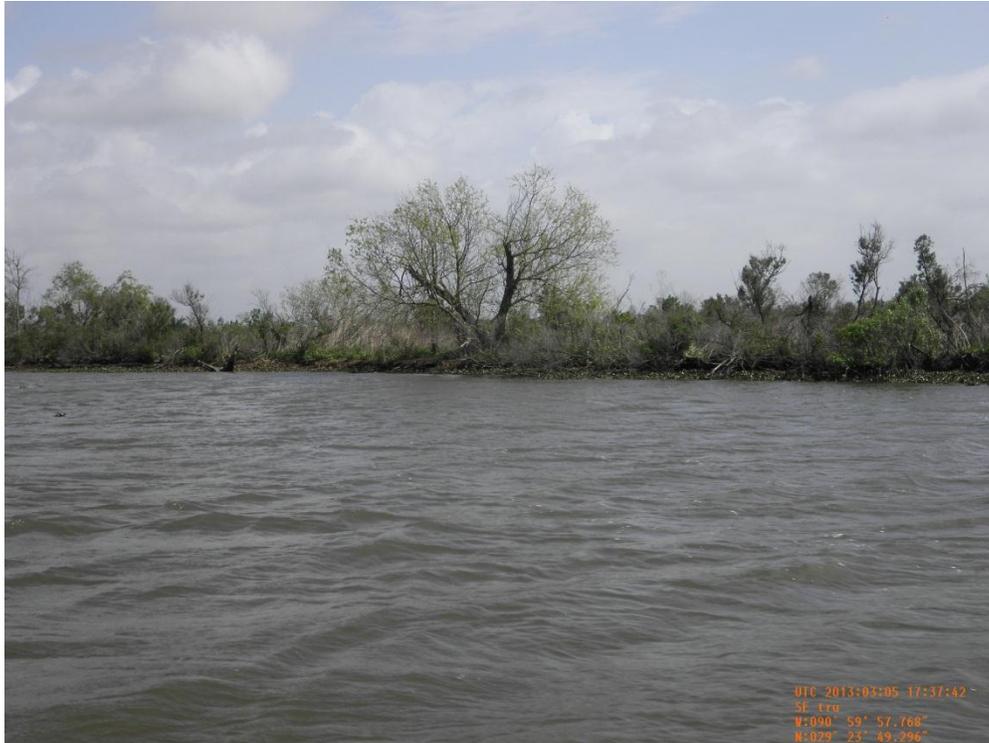
since the previous inspections, there is little threat of these areas breaching. The earthen embankment along Bayou Carencro had some visual low spots identified during this inspection. This section of the project boundary is designated as an overflow bank, so without a full breach, maintenance is not needed at this time (See Appendix B, Photos 31 through 32).

Photo 31: View of the earthen embankment along Bayou Carencro

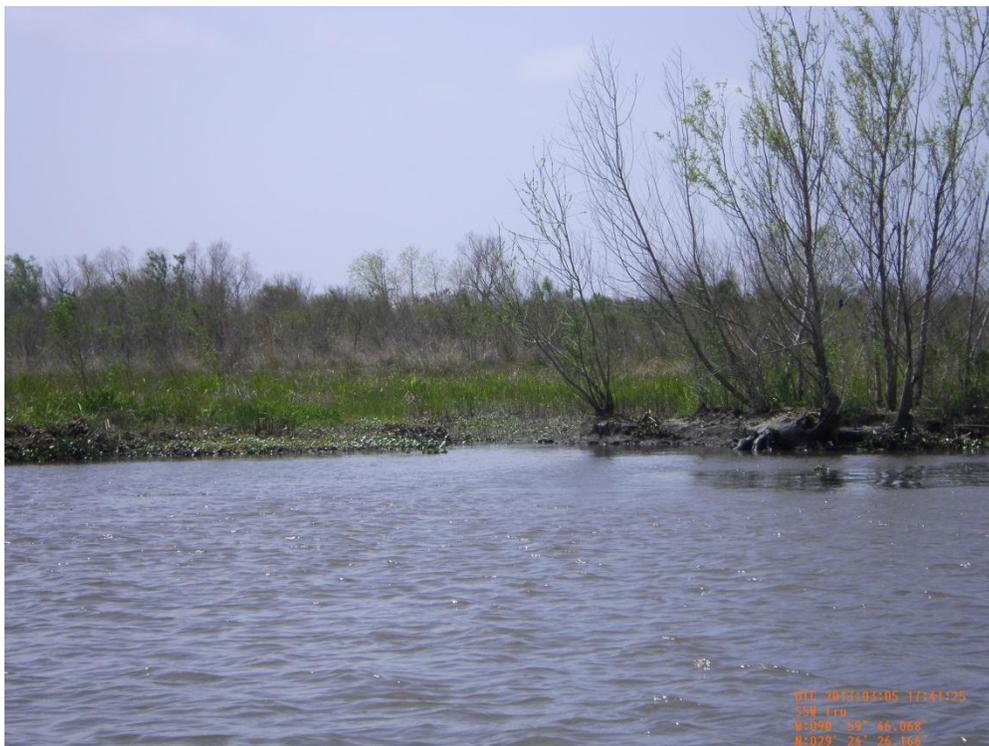
Photo 32: Low spot identified in the earthen embankment along Bayou Carencro. The coordinates are captured in the image.

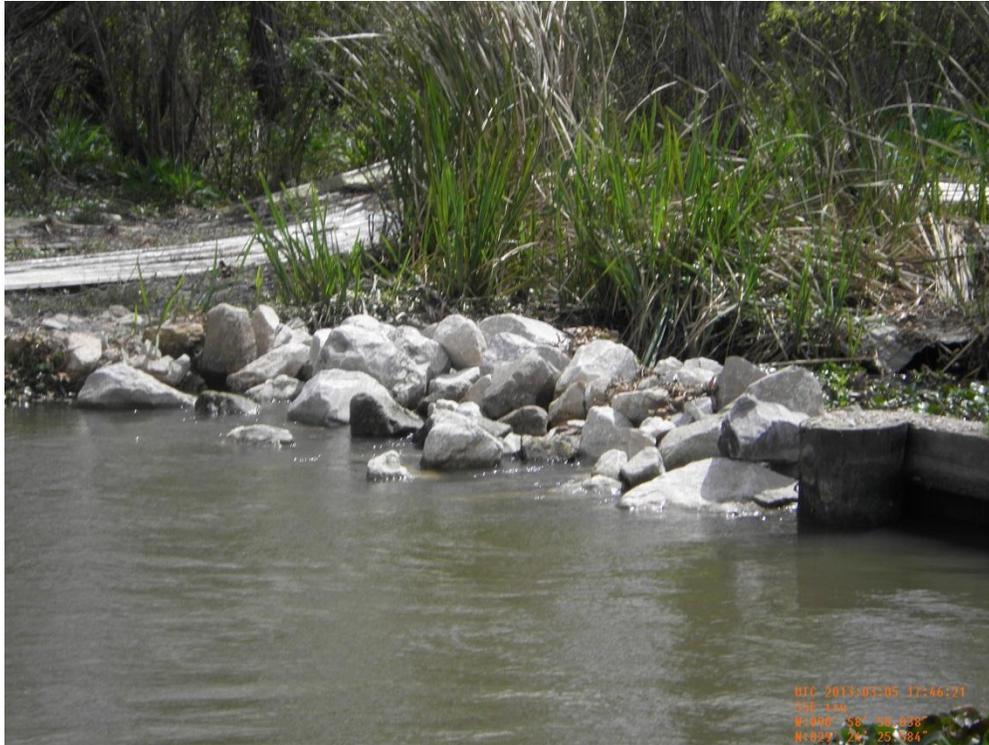
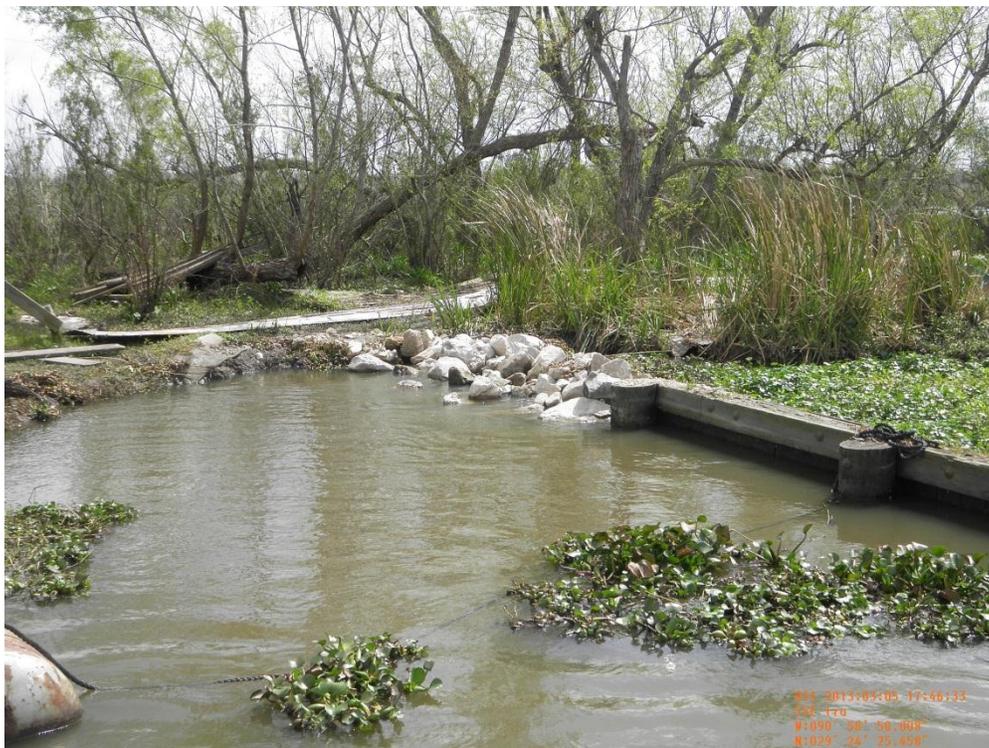
Breach 6 located along Brady Canal adjacent to an existing timber bulkhead (Appendix D Work Plan), was closed as part of the 2012 Maintenance Project. A geotextile fabric was used to line the breach before it was filled with rock rip rap. This area will continue to be monitored on future inspections to determine if any settlement or further breaching has occurred. (See Appendix B, Photos 33 through 34)

Photo 33: Breach Repair 6 located on Brady Canal included in the 2012 Maintenance Project

Photo 34: Breach Repair 6 located on Brady Canal included in the 2012 Maintenance Project
