**2014 Annual Inspection Report**

**BRADY CANAL HYDROLOGIC  
RESTORATION PROJECT (TE-28)**

State Project Number TE-28  
Priority Project List 3

April 28, 2014  
Terrebonne Parish

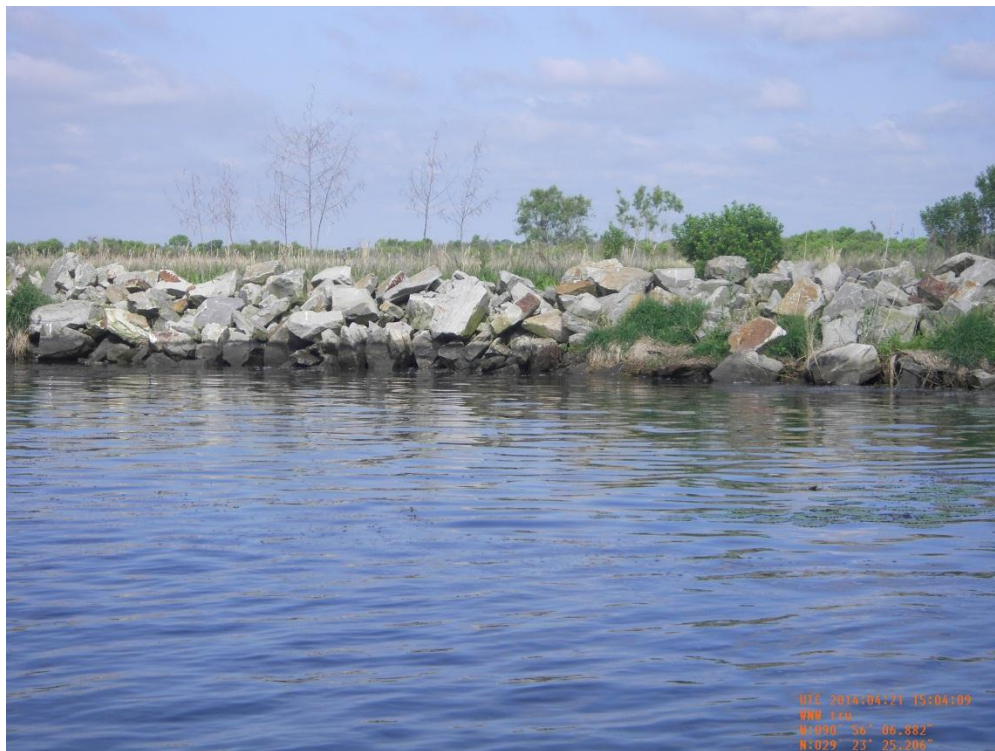
Breach 7 located along the oil field access canal connecting to Superior canal is in good overall condition. There is no observed settlement along the length of the embankment and no erosion or washouts around the embankment tie-ins. There are no recommendations for corrective action at this time, but it will continue to be monitored on future inspections. (See Appendix B, Photos 1 through 3)

Photo 1: Breach 7 located in an oilfield access canal off of Superior Canal. There is no visible settlement or displacement of the rock fill material.

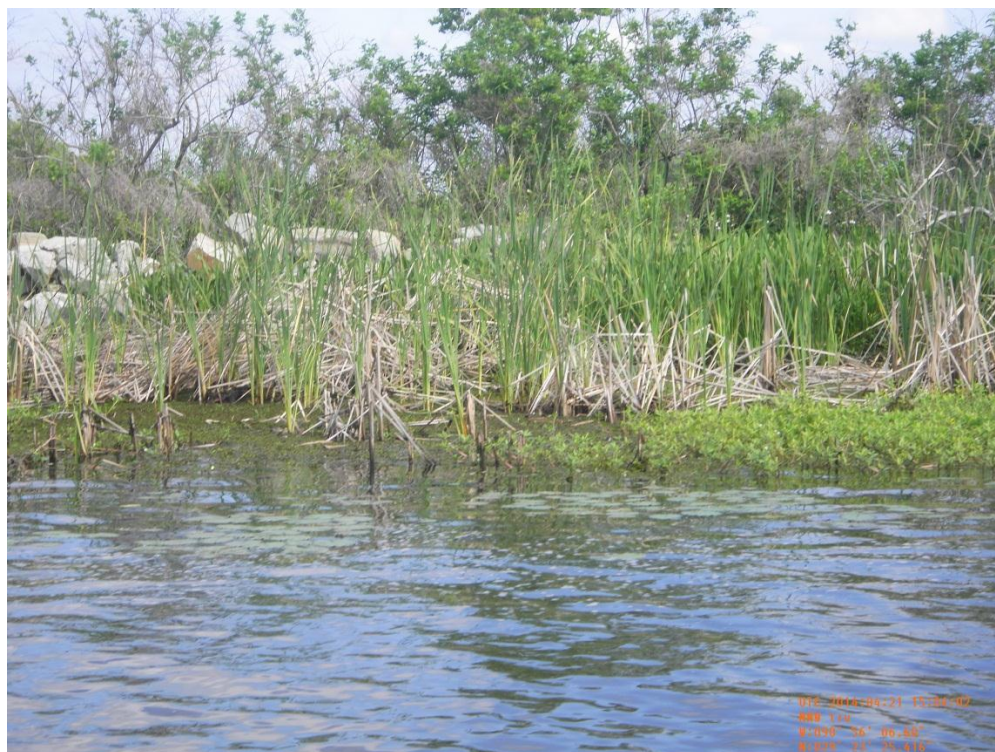
Photo 2: View of the embankment tie-in on the northeast end of Breach 7

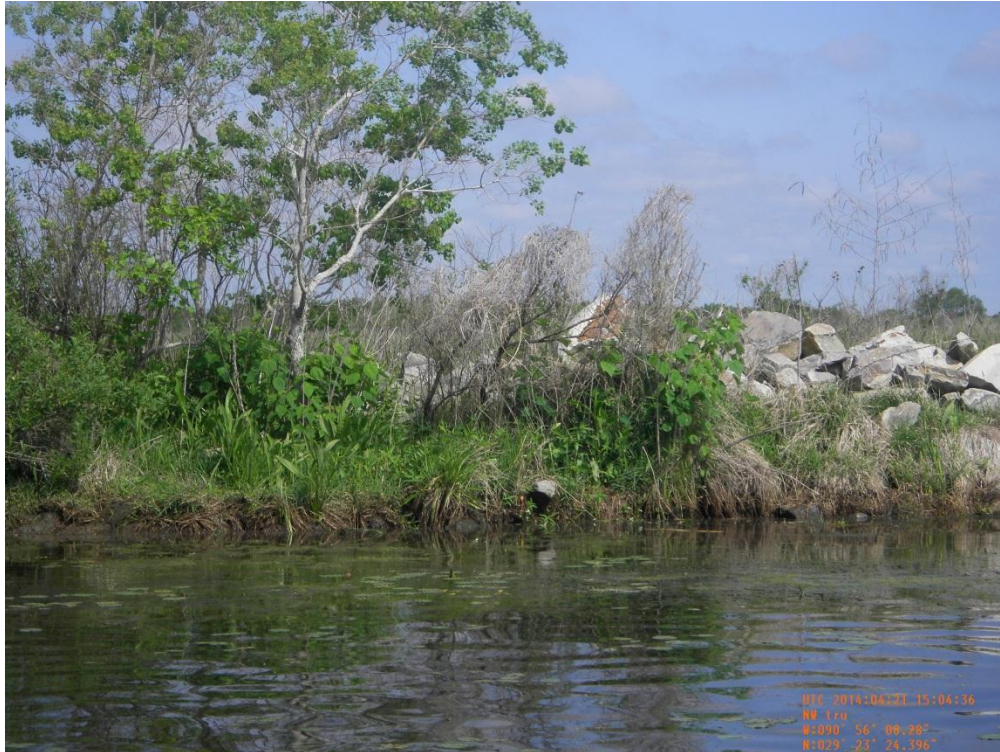
Photo 3: View of the embankment tie-in on the southwest end of Breach 7

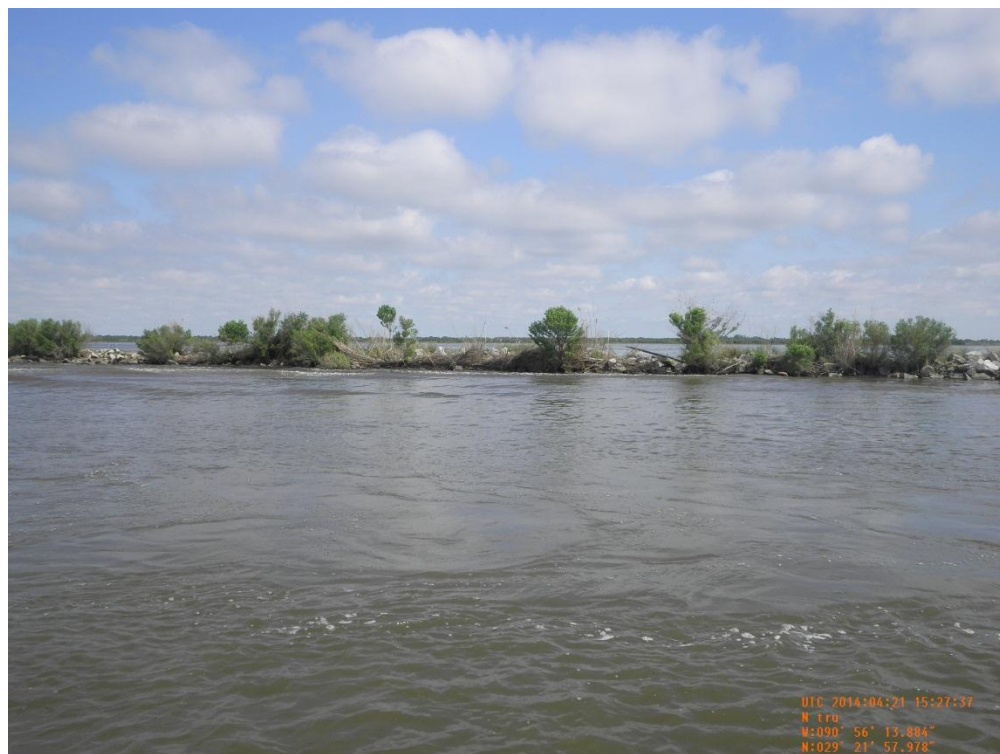
The rock armored embankments and rock dikes found along the north bank of Bayou Decade and Voss Canal are in good condition. The rock dike along Bayou Decade between Jug Lake and Turtle Bayou appears to be in fair condition with isolated low areas and moderate displacement of rock riprap (See Appendix B, Photos 4 through 6). The earthen embankment

Photo 4: Close up view of the rock armored embankment along the north side of Bayou DeCade between Turtle Bayou and Jug Lake taken from Bayou DeCade

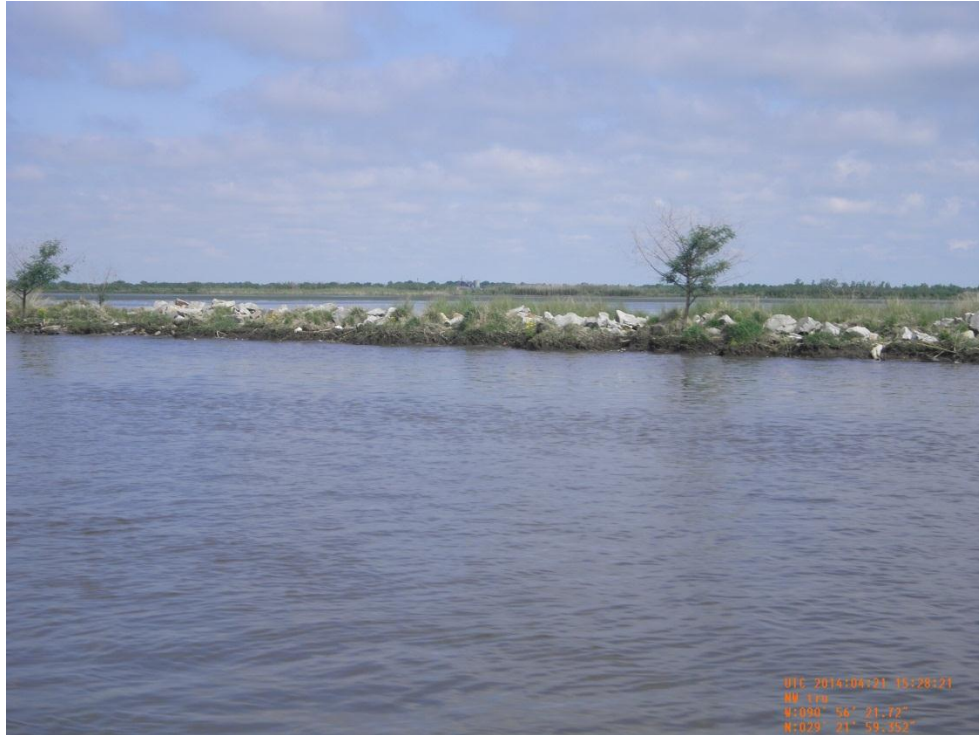
Photo 5: View of the rock armored embankment along the north side of Bayou DeCade between Turtle Bayou and Jug Lake taken from Bayou DeCade

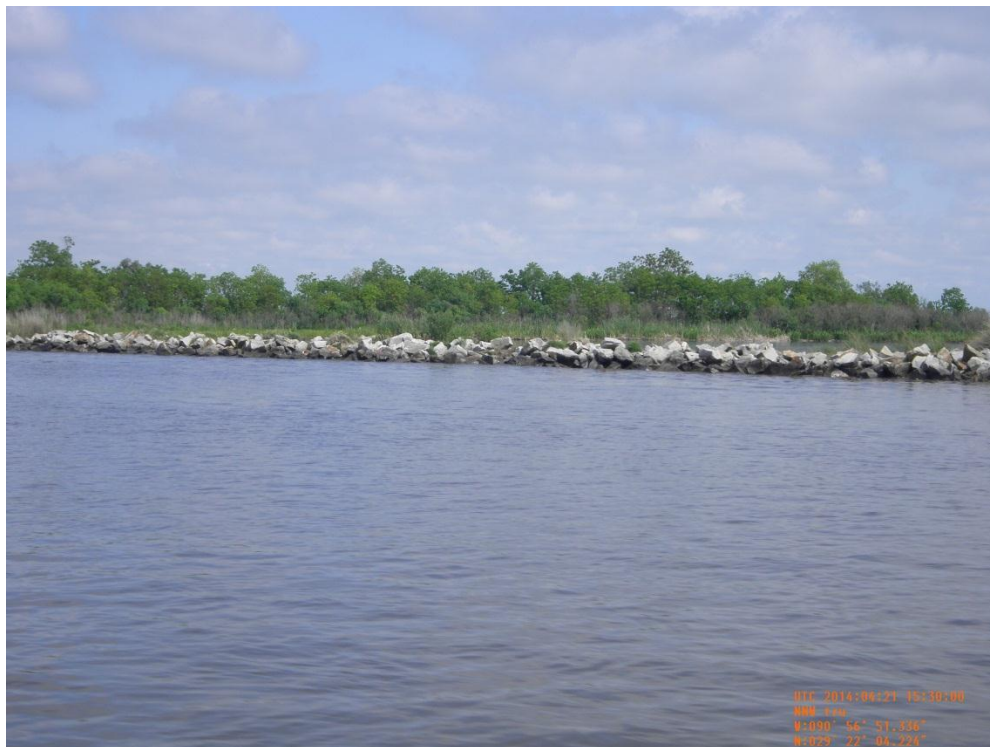
Photo 6: View of the rock armored embankment along the north side of Bayou DeCade between Turtle Bayou and Jug Lake taken from Bayou DeCade

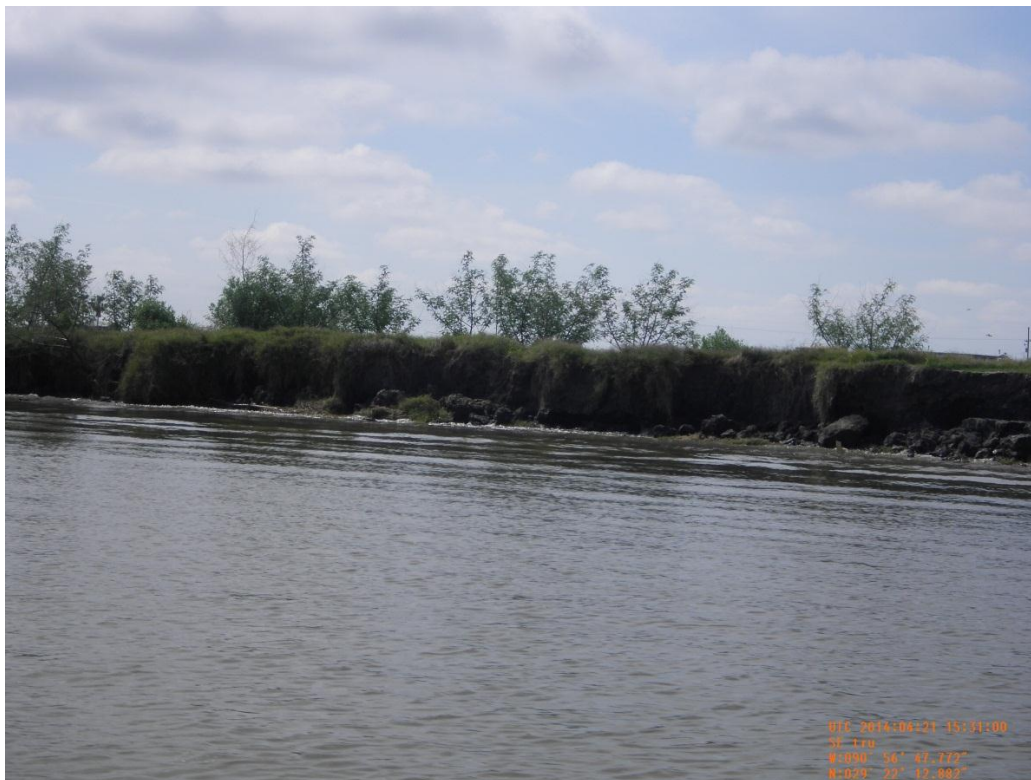
As part of the 2012 Maintenance Project, approximately 13,900 linear feet of earthen embankment around the rim of Jug Lake was refurbished (See Appendix B, Photos 7 through 8). The refurbished sections were designated as the most critical areas along the lake rim, some of which were no longer existent due to years of erosion and deterioration. These repairs to the earthen embankment now prevent large amounts of high saline water into an area that is predominantly brackish and allows three (3) water control structures to operate as designed that were previously ineffective. During the annual inspection, it was noted that the repaired earthen embankments had severe cut banks due to wave action in the lake. However, the cut banks seem to be isolated along the slope on the lake side of the embankment and don't appear to be occurring past the crest of the embankment. The embankment is covered with vegetation and no breaches are present. The erosion of the embankment should slow as this vegetation increases. There are no recommendations for corrective action at this time, but the embankment will need to be monitored on future inspections.

Photo 7: View of the earthen embankment on the southeast bank of Jug Lake

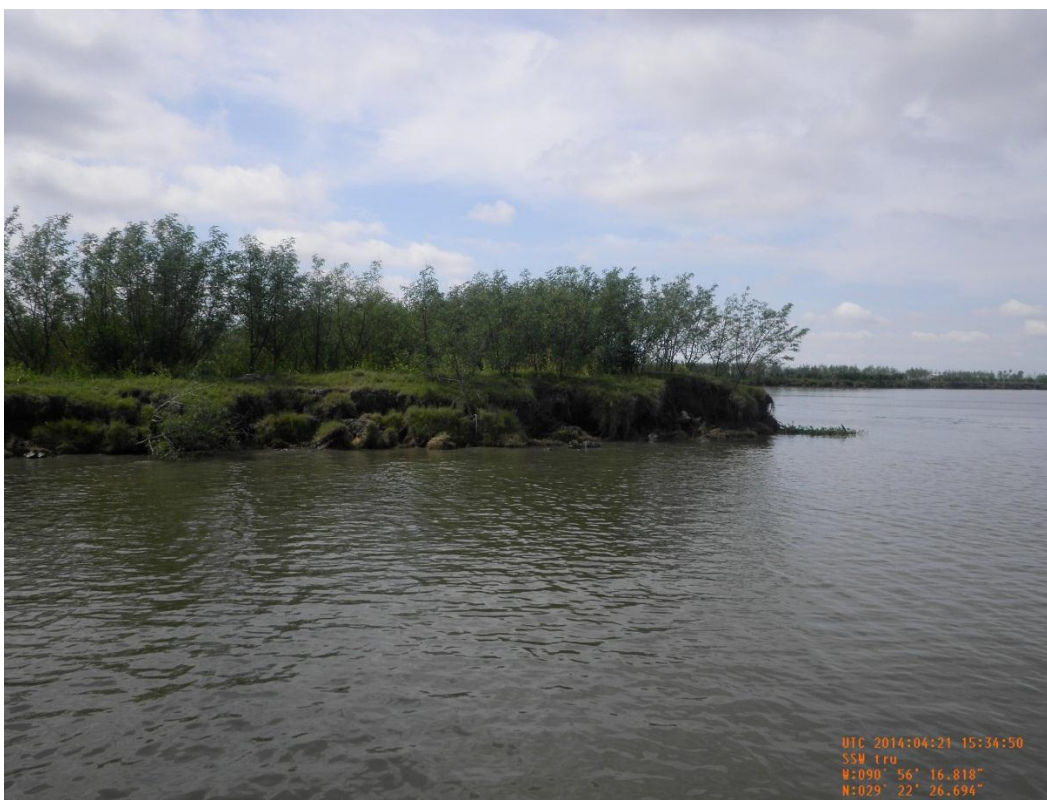
Photo 8: View of the earthen embankment near Structure 24 on the southeast bank of Jug Lake

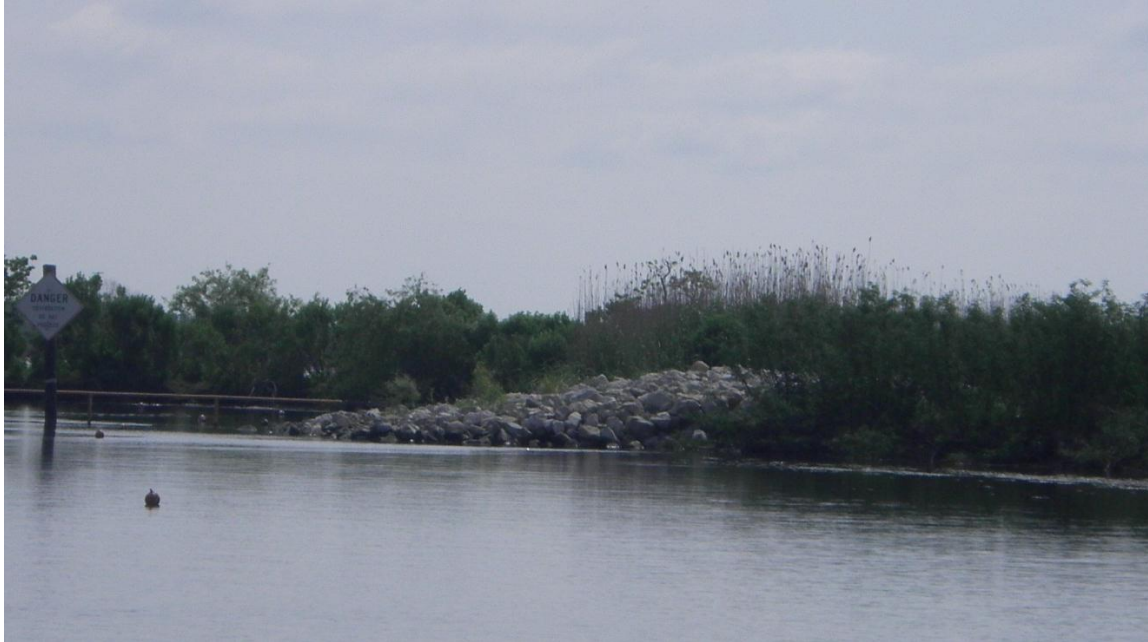
Structure 24 is in good overall condition. There is no visible damage to the steel bulkhead, railings, platform, or the warning signs and their support timbers. As part of the 2012 Maintenance Project, Structure 24 had both of its embankment tie-ins refurbished and then rock armored with 50 linear feet of rip rap to prevent any further erosion around the ends of the structure. There has not been any visual settlement of the rip rap following the completion

of the maintenance project. Due to this maintenance, the structure is again operating as designed. (See Appendix B, Photos 9 through 10)

Photo 9: View of the rock armored embankment tie-in located on the southern end of Structure 24

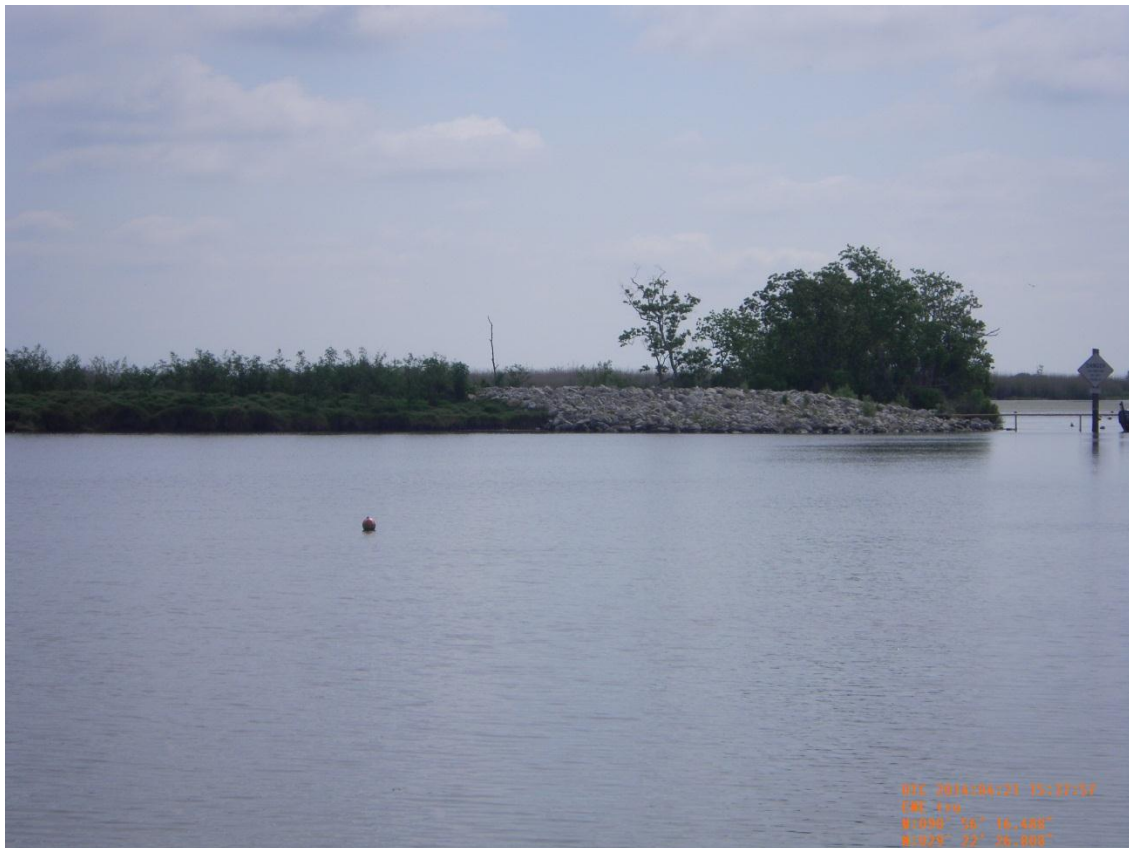
Photo 10: View of the rock armored embankment tie-in on the northern end of Structure 24

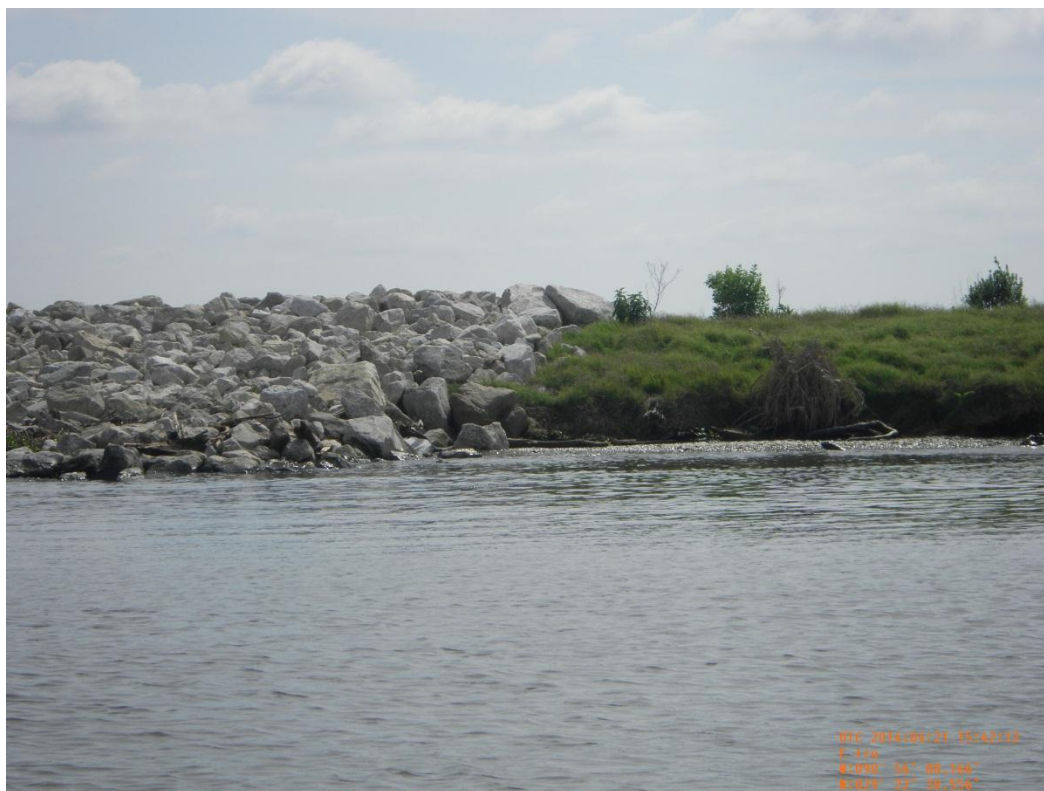
This structure is in good overall condition. There is no visible damage to the steel bulkhead, railings, platform, or the warning signs and their support timbers. As part of the 2012 Maintenance Project, Structure 23 had both of its embankment tie-ins refurbished and then rock armored with rip rap for 50' in each direction to prevent any further erosion around the ends of the structure. There has not been any visual settlement of the rip rap following the completion of the maintenance project. Since the refurbishment has closed the breaches around the structure, the structure is now operating as intended. (See Appendix B, Photos 11 through 14)

Photo 11: View of the rock armored embankment on the southern end of Structure 23

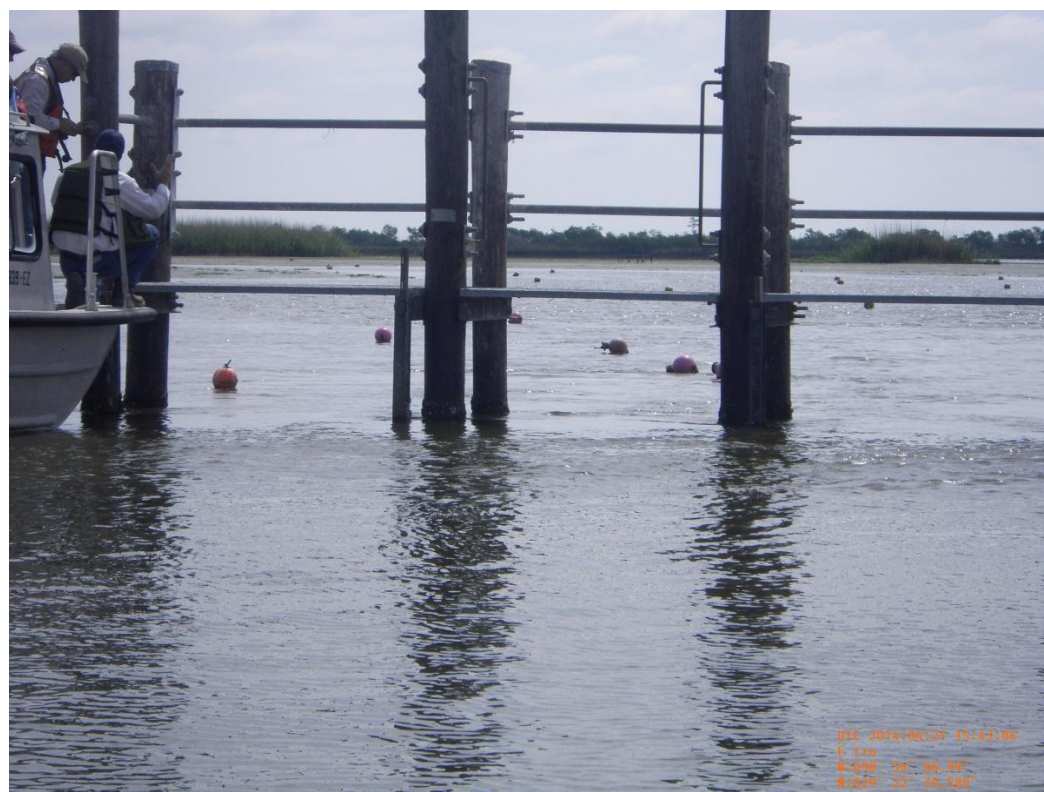
Photo 12: View of Structure 23 variable crest weir timbers, warning signs and steel piping

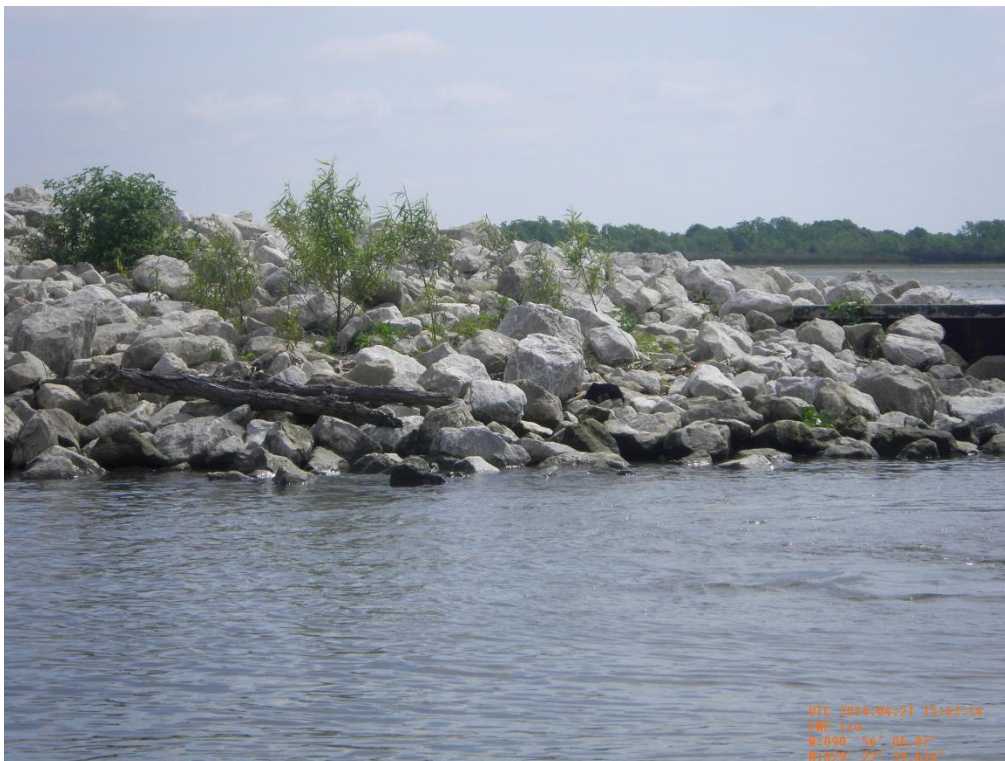
Photo 13: View of the rock armored embankment tie-in located on the northern side of Structure 23

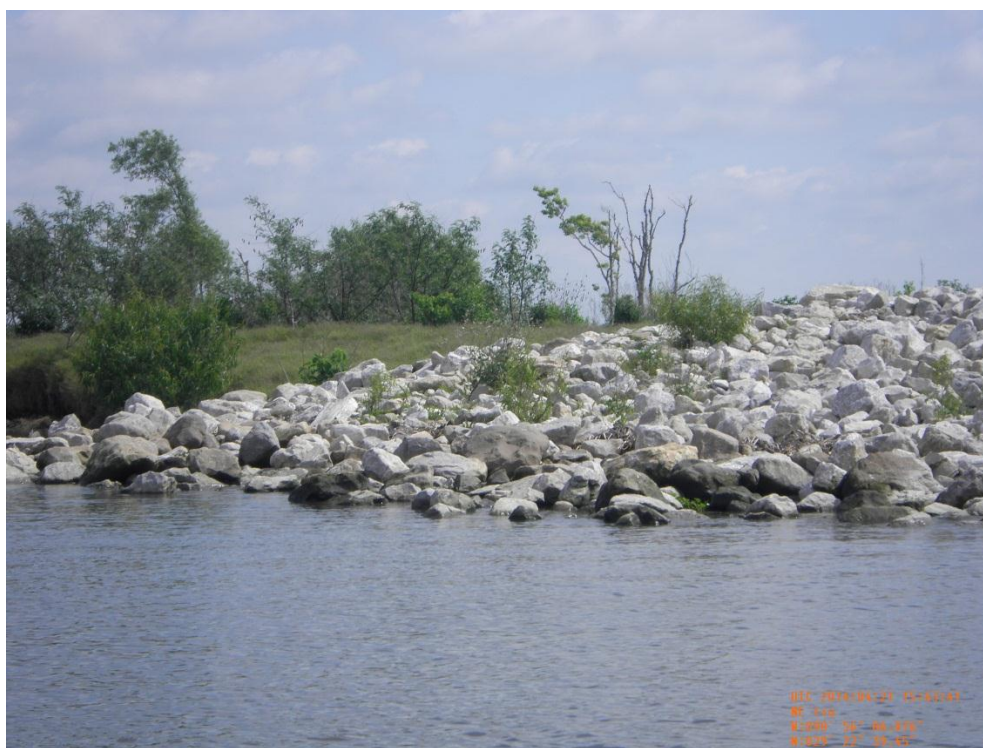
Photo 14: View of the newly refurbished embankment located north of Structure 23 in Jug Lake

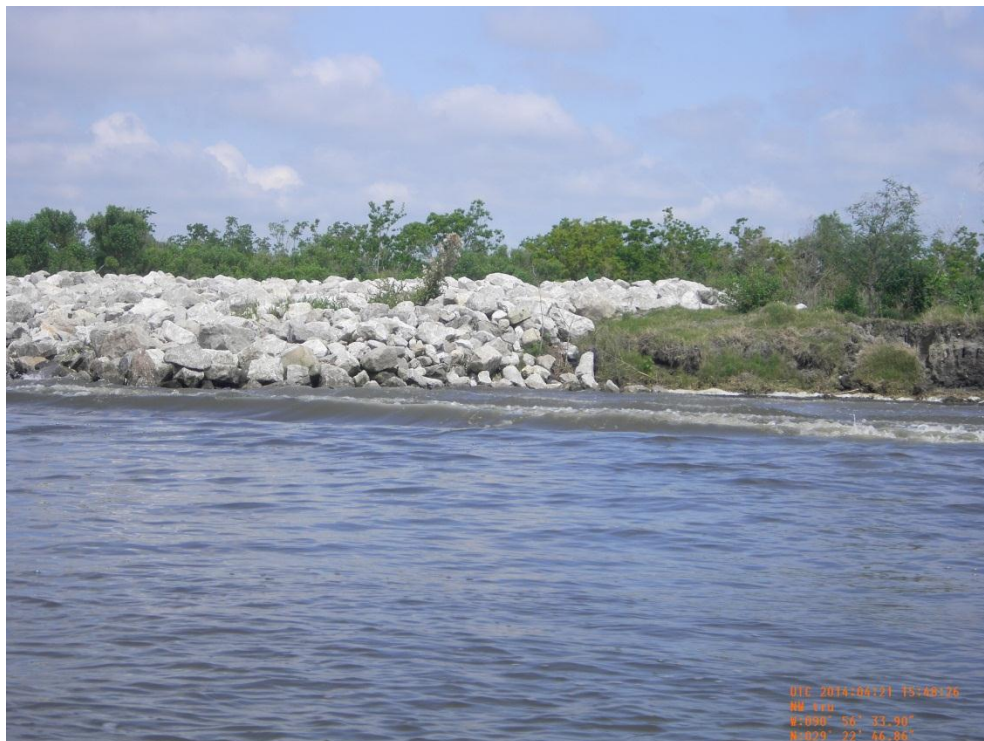
Structure 21 is in good overall condition. There is no visible damage to the steel bulkhead, railings, platform, or the warning signs and their support timbers. As part of the 2012 Maintenance Project, Structure 21 had both of its embankment tie-ins refurbished and then rock armored with 50 linear feet of rip rap to prevent any further erosion around the ends of the structure. There has not been any visual settlement of the rip rap following the completion of the maintenance project. Due to this maintenance, the structure is again operating as designed. (See Appendix B, Photos 16 through 18)

Photo 16: View of the rock armored embankment tie-in on the east side of Structure 21

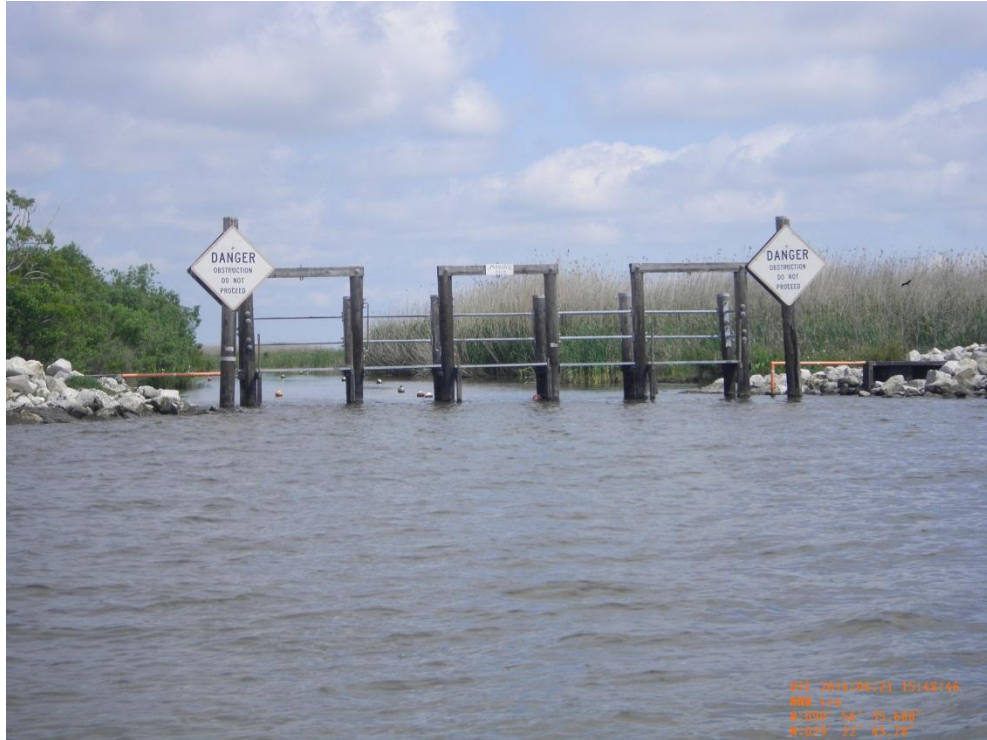
Photo 17: View of Structure 21 variable crest weir timbers, warning signs and steel piping

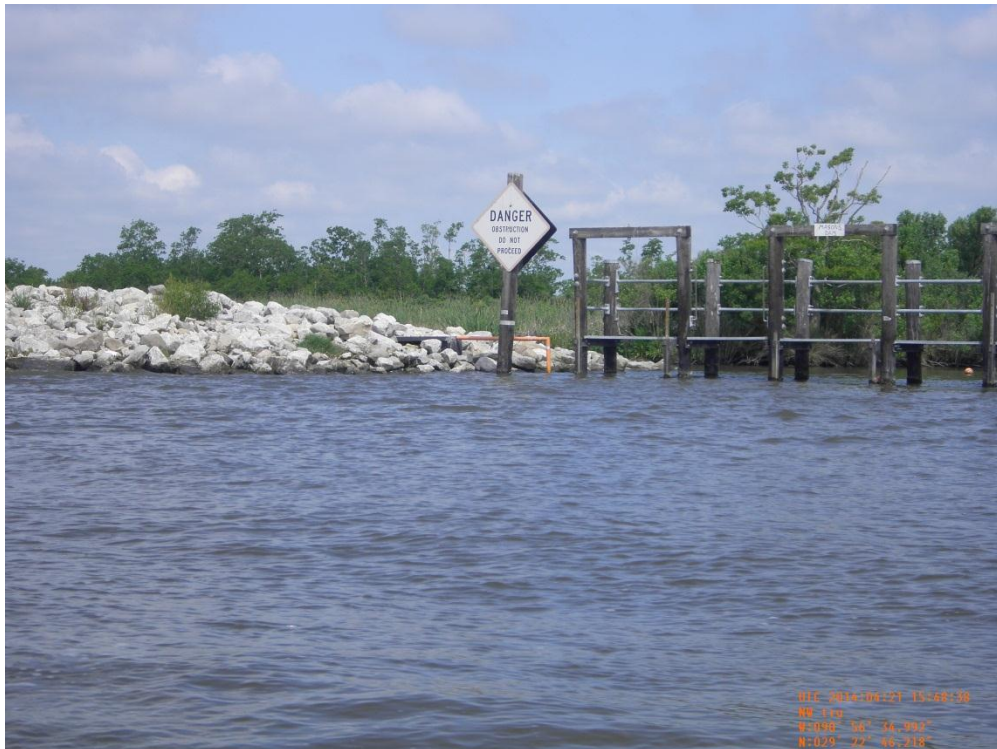
Photo 18: View of the rock armored embankment tie-in on the west side of Structure 21

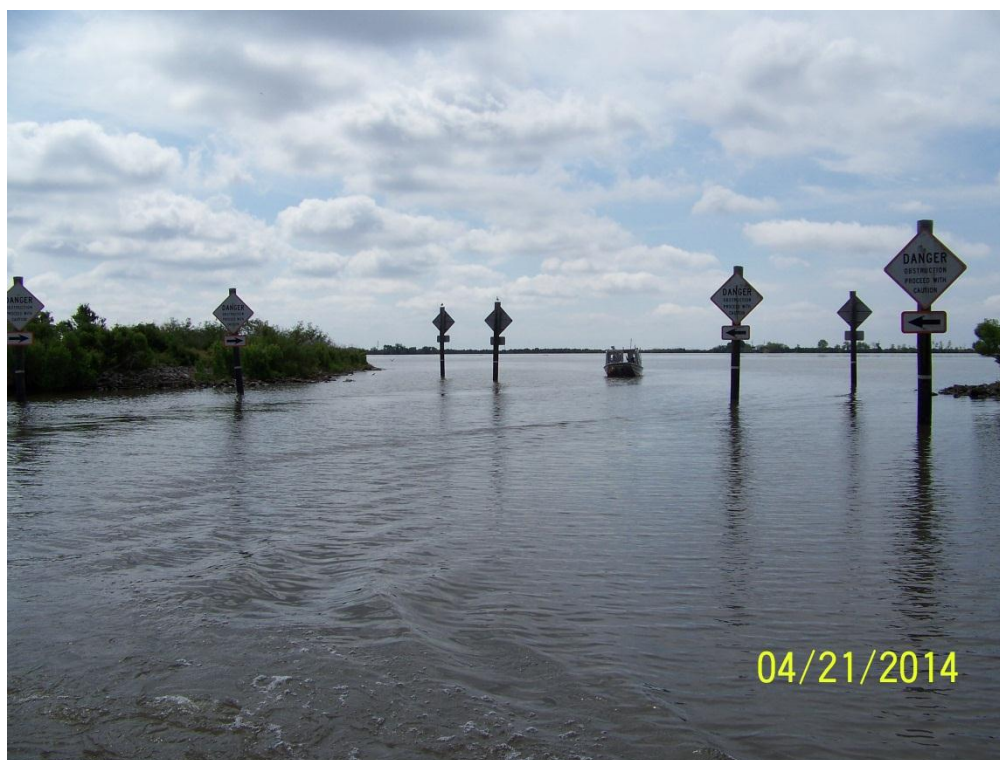
This structure is in good overall condition. As noted in previous annual inspections, there has been some settlement of the rock rip rap on the exposed sides and submerged crest of the structure. In 2012, it was determined the crest of the submerged channel liner has settled to a depth of -5.7 NAVD88, which translates to approximately 1.0' of settlement since construction. All other warning signs and timber supports are in good condition. Structure 20 was excluded from the 2012 Maintenance Project, but the earthen embankment was refurbished up to the structures eastern embankment tie-in. (See Appendix B, Photo 20)

Photo 20: View of Structure 20 rock armored channel liner warning signs

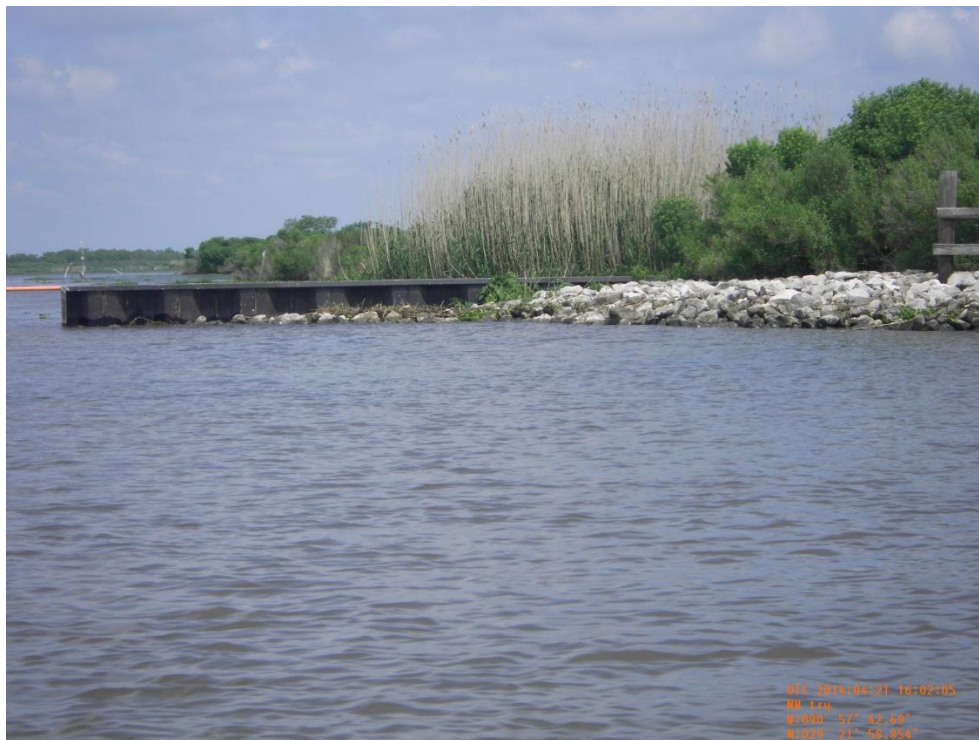
Structure 6 appears to be in good overall condition. There are no signs of erosion or wash-outs around the steel bulkheads and embankment tie-ins. The navigational lights and navigational signs are visible. As part of the 2012 Maintenance Project, two (2) of the timber pile dolphins on the west side of the structure were replaced and fitted with new navigational signs. These timber pile dolphins appear to be in good condition and no maintenance is needed at this time. (See Appendix B, Photos 23 through 25)

Photo 23: View of the eastern end of Structure 6 and rock armored embankment

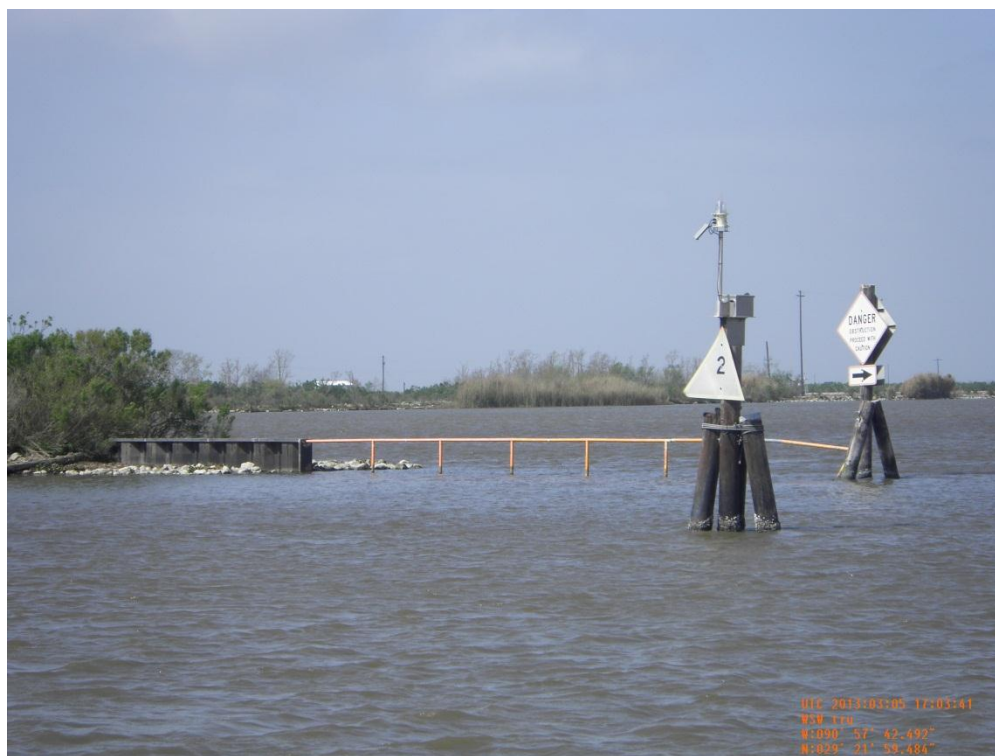
Photo 24: View of the eastern end of Structure 6 and embankment tie-in bulkhead

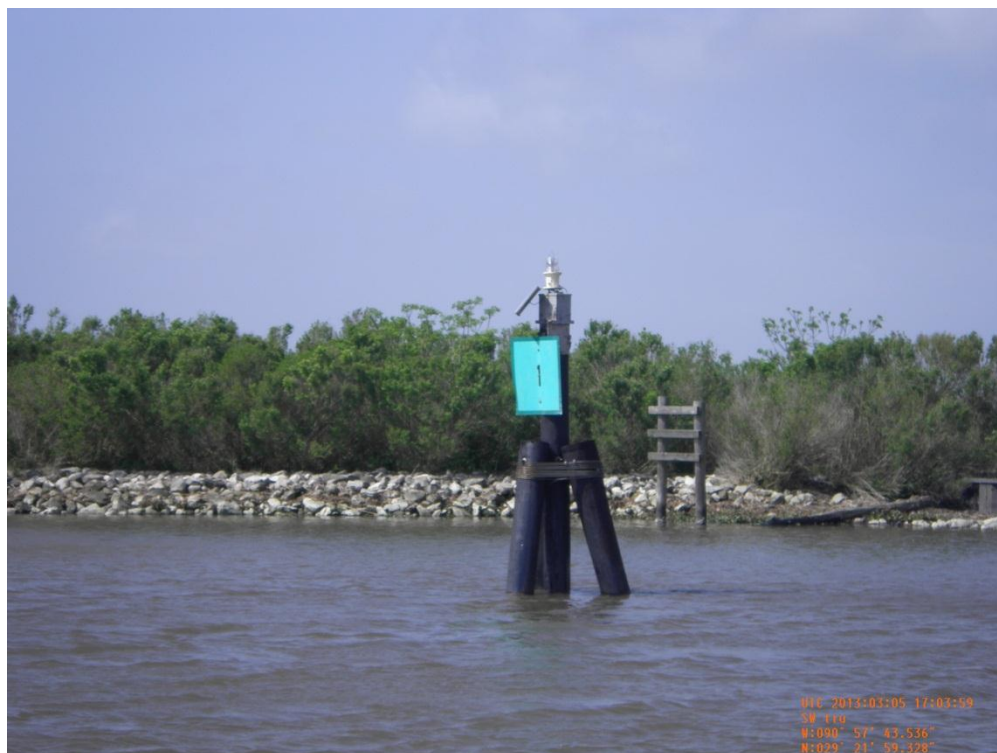
Photo 25: View of Structure 6 replaced timber pile dolphin included in 2012 Maintenance Project

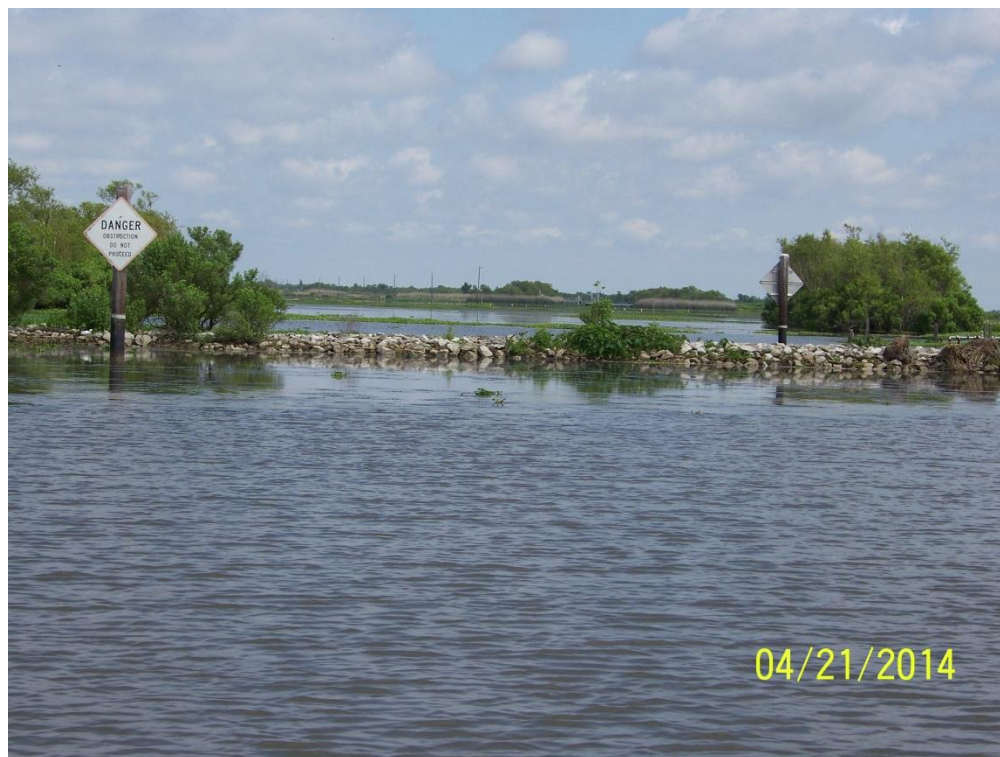
Structure 7 appears to be in good overall condition. There are no signs of extensive settlement of the rock plug or signs of erosion around the earthen embankment tie-ins. The warning signs and supports for this structure also appear to be in good condition. This structure does not require maintenance at this time. (See Appendix B, Photo #27)

Photo 27: View of Structure 7 rock plug along the north bank of Bayou Decade

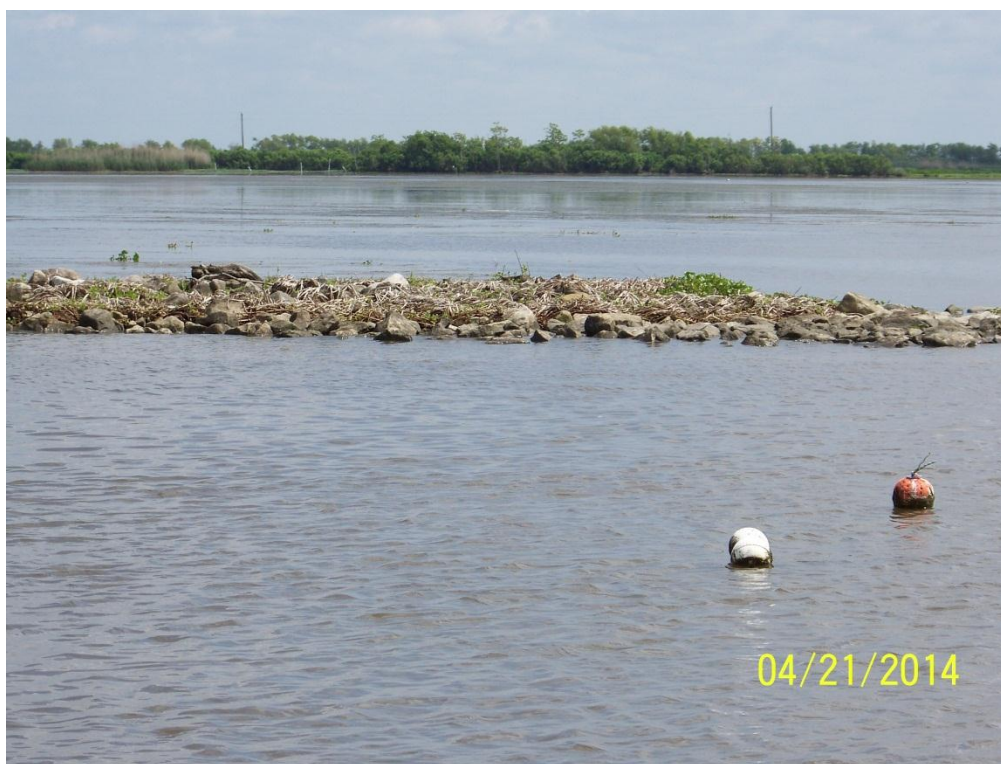
This structure appears to be in good overall condition. There is no additional settlement of the rock observed from previous inspections. From previous inspections, the warning sign timbers on the northeast side of the structure were no longer vertical. As part of the 2012 Maintenance Project, these three (3) warning signs and supports were replaced. The remaining warning signs and supports remain in good condition. (See Appendix B, Photos 28 through 29)

Photo 28: View of northern end of Structure 10 fixed crest rock weir with barge bay

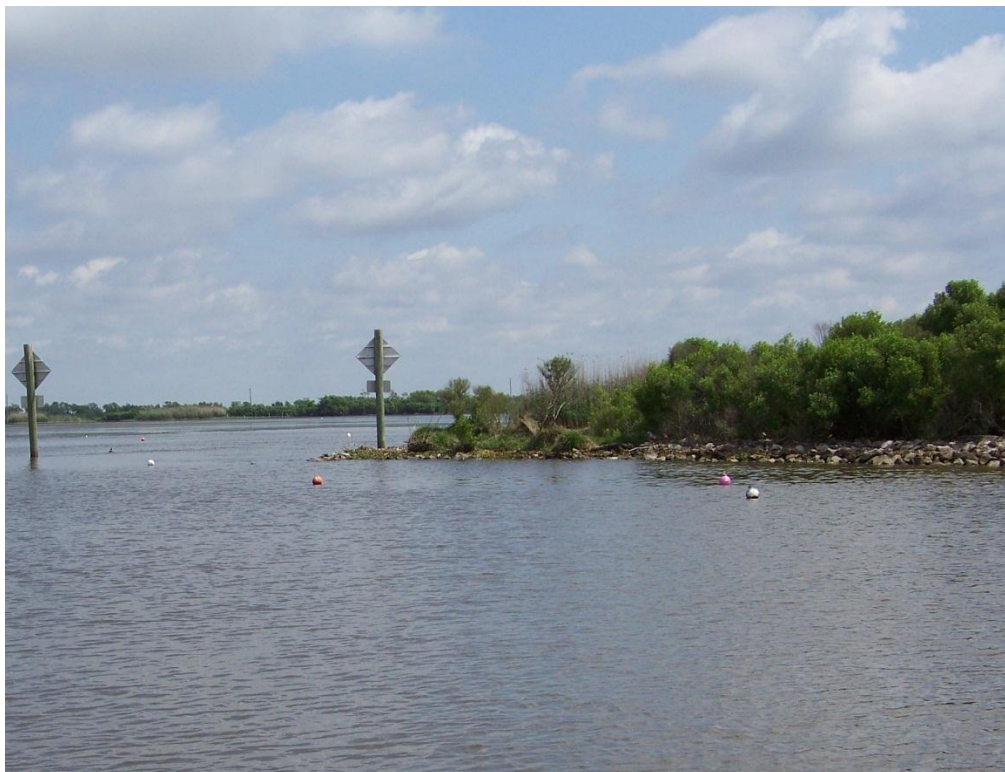
Photo 29: View of southern end of Structure 10 fixed crest rock weir with barge bay

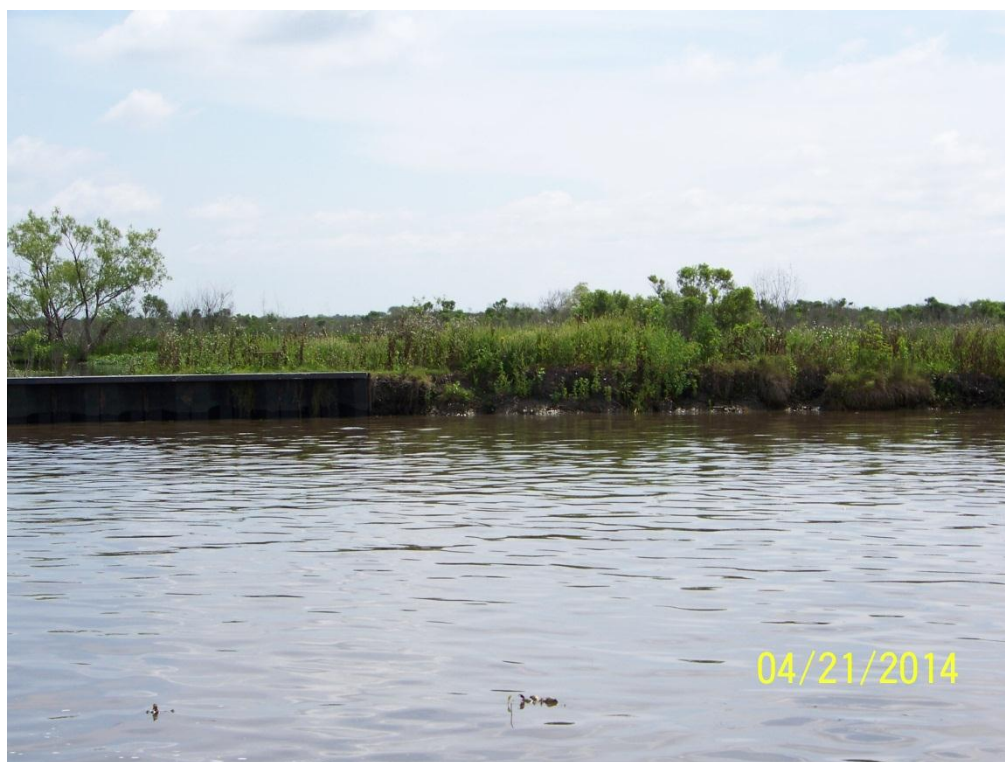
This structure appears to be in good overall condition. There is no visible damage to the railings, platform, steel bulkhead, or warning signs and their timbers. Some noticeable signs of erosion near the embankment tie-ins remain, however, by comparing the pictures of this year to previous annual inspections it appears this area has stabilized as the erosion has not been progressing. Without a full breach around the embankment tie-in, this structure is still operating as designed. (See Appendix B, Photos 30 through 32)

Photo 30: View of Structure 14 southern embankment tie-in bulkhead

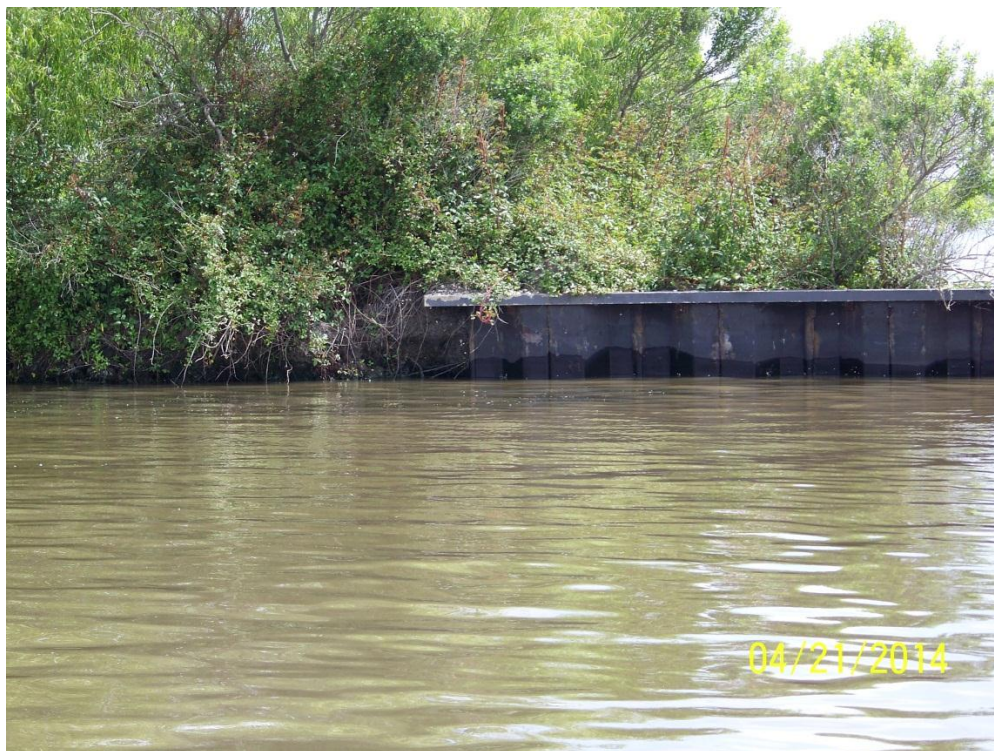
Photo 31: View of Structure 14 northern embankment tie-in bulkhead
