**2014 Annual Inspection Report**

**BRADY CANAL HYDROLOGIC  
RESTORATION PROJECT (TE-28)**

State Project Number TE-28  
Priority Project List 3

April 28, 2014  
Terrebonne Parish

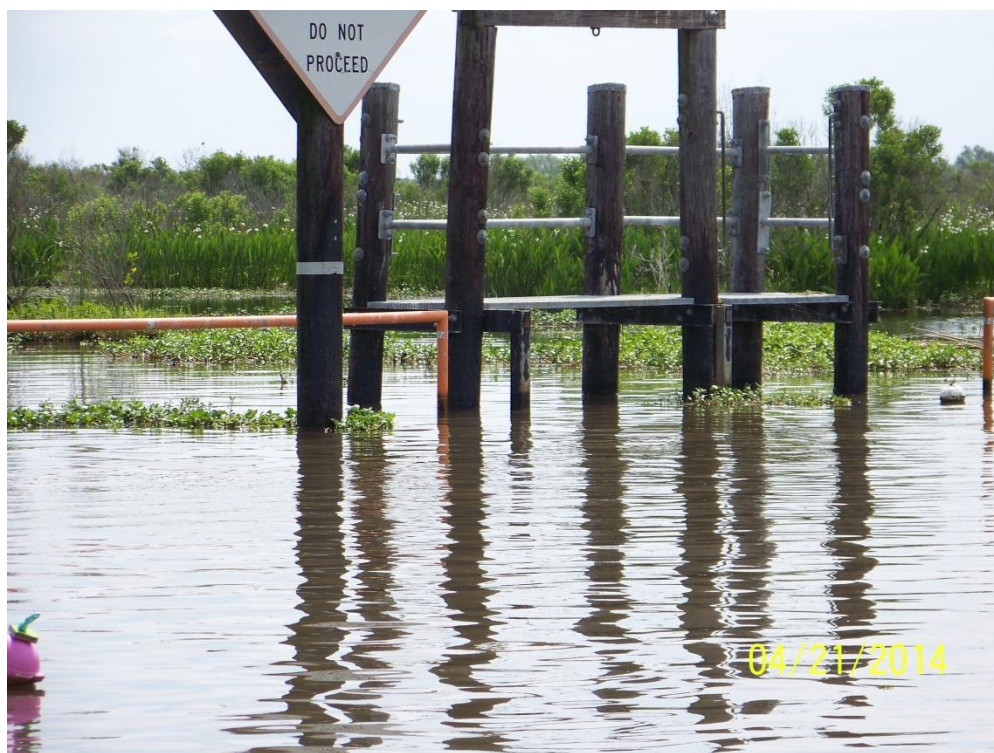
This structure appears to be in good overall condition. There is no visible damage to the railings, platform, steel bulkhead, or warning signs and their timbers. Some noticeable signs of erosion near the embankment tie-ins remain, however, by comparing the pictures of this year to previous annual inspections it appears this area has stabilized as the erosion has not been progressing. Without a full breach around the embankment tie-in, this structure is still operating as designed. (See Appendix B, Photos 30 through 32)

Photo 32: Overall view of Structure 14 variable crest weir timbers, warning signs, and steel piping

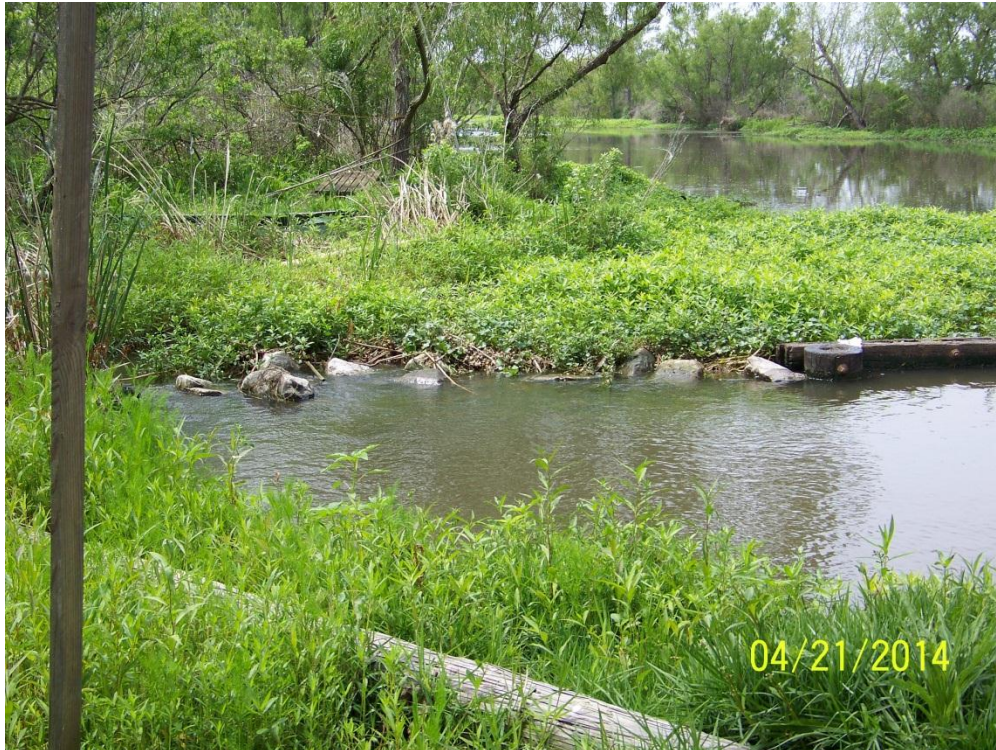
Breach 6 located along Brady Canal adjacent to an existing timber bulkhead, was closed as part of the 2012 Maintenance Project. A geotextile fabric was used to line the breach before it was filled with rock rip rap. There was no visual settlement of the rip rap. (See Appendix B, Photos 33)

Photo 33: Breach Repair 6 located on Brady Canal
