**State of Louisiana
Coastal Protection and Restoration
Authority**

2016 Annual Inspection Report

BRADY CANAL HYDROLOGIC RESTORATION PROJECT (TE-28)

State Project Number TE-28
Priority Project List 3

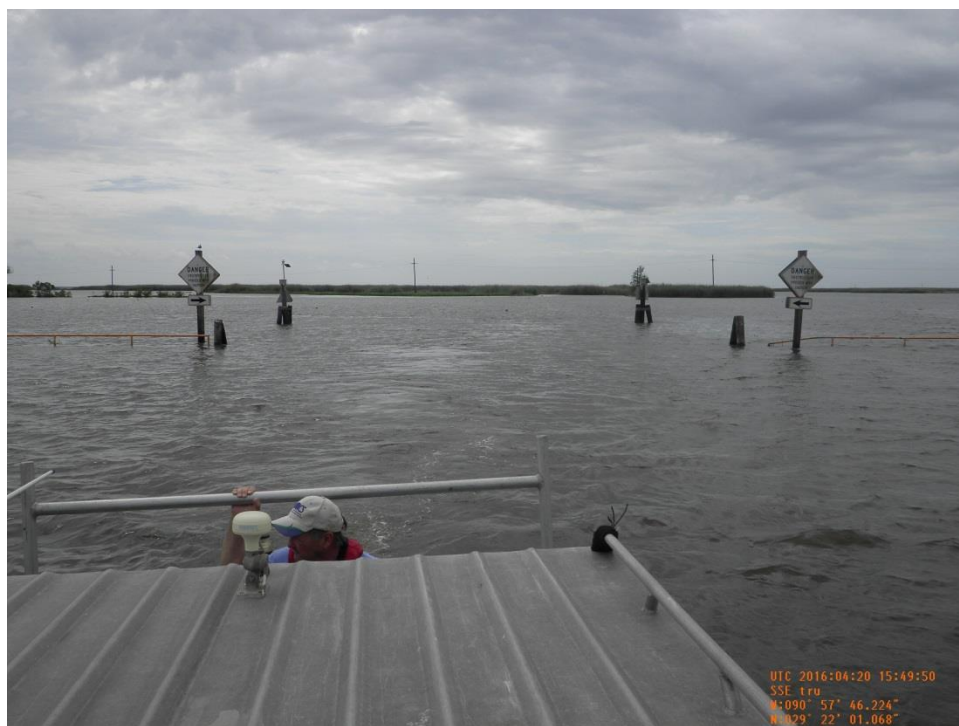
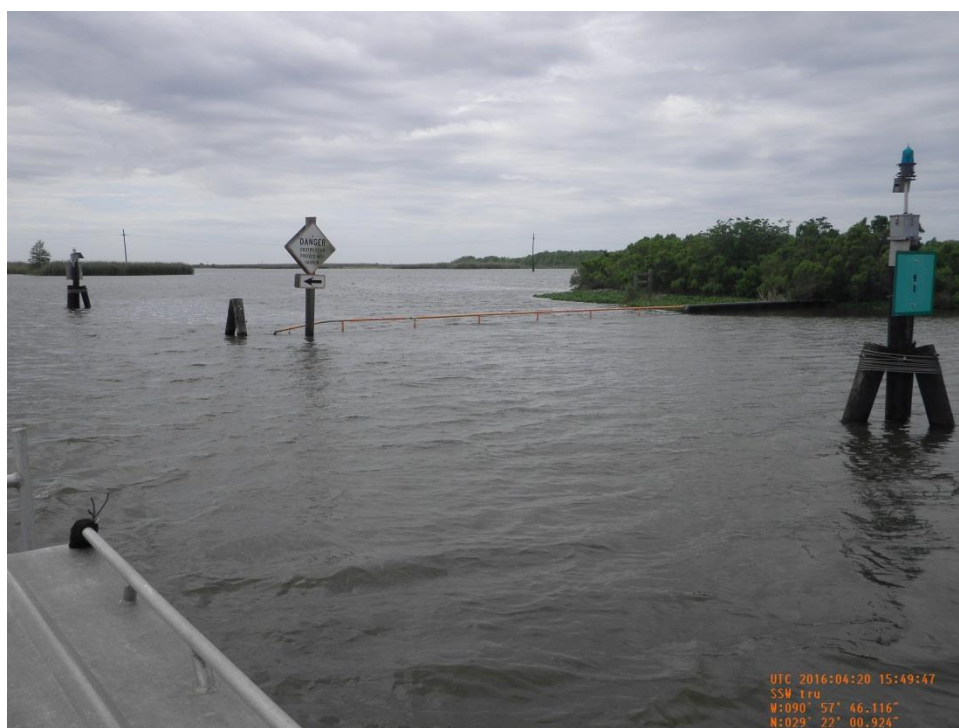
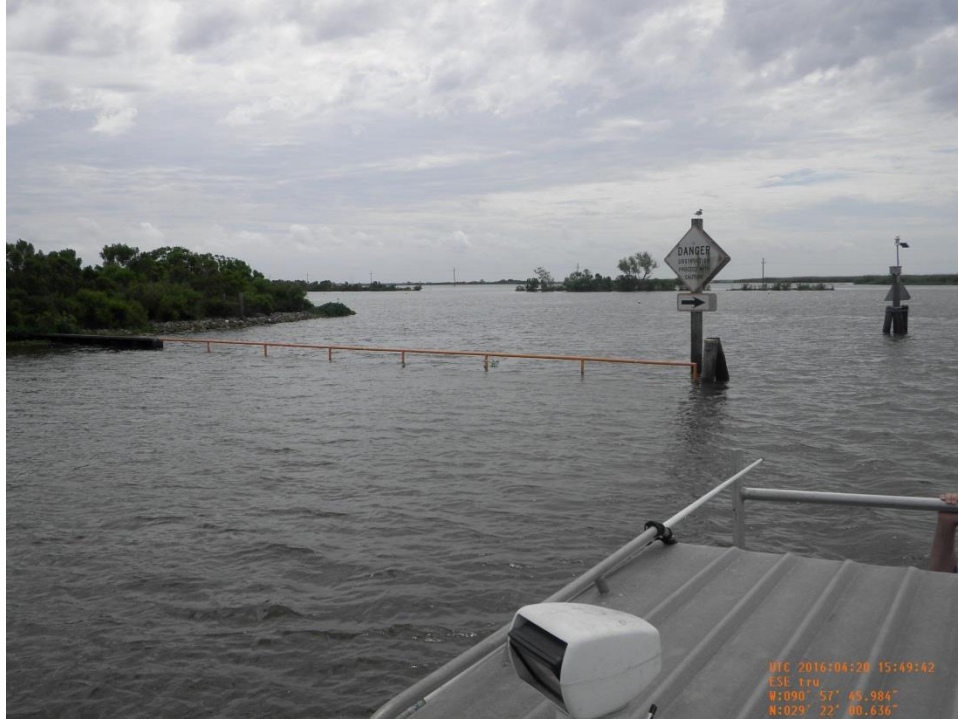
Overall, Structure 6 appears to be in good condition. The bank tie-ins are stable and there are no signs of erosion or breaching around the steel bulkhead or rock tie-ins. The timber navigational aid supports, signs and lights are visible and appear to be in good condition. The navigational aid structures are inspected quarterly through a state-wide contract with Pharo-Marine Automatic Power, Inc. and no major maintenance has been reported. The gauge reading from the CPRA continuous recorder, located just north of Structure No. 6 indicated

that the water elevation was +2.40' NAVD88 at 10:30 a.m. No maintenance will be required at Structure No.6. (See Appendix B, Photos 1 through 3)

Photo 1: view of Structure No.6, a fixed crested weir with barge bay and navigational aids and signage on both sides of the structure.

Photo 2: view of navigational aids and signage at Structure No.6

Photo 3: view of west side navigational aids and signage at Structure No.6

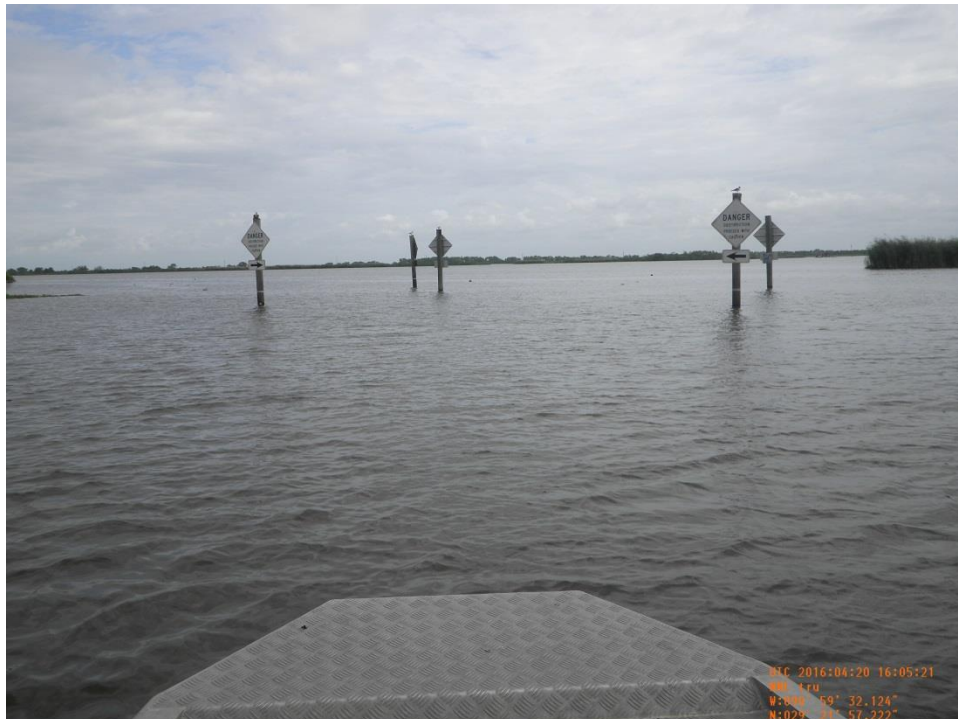
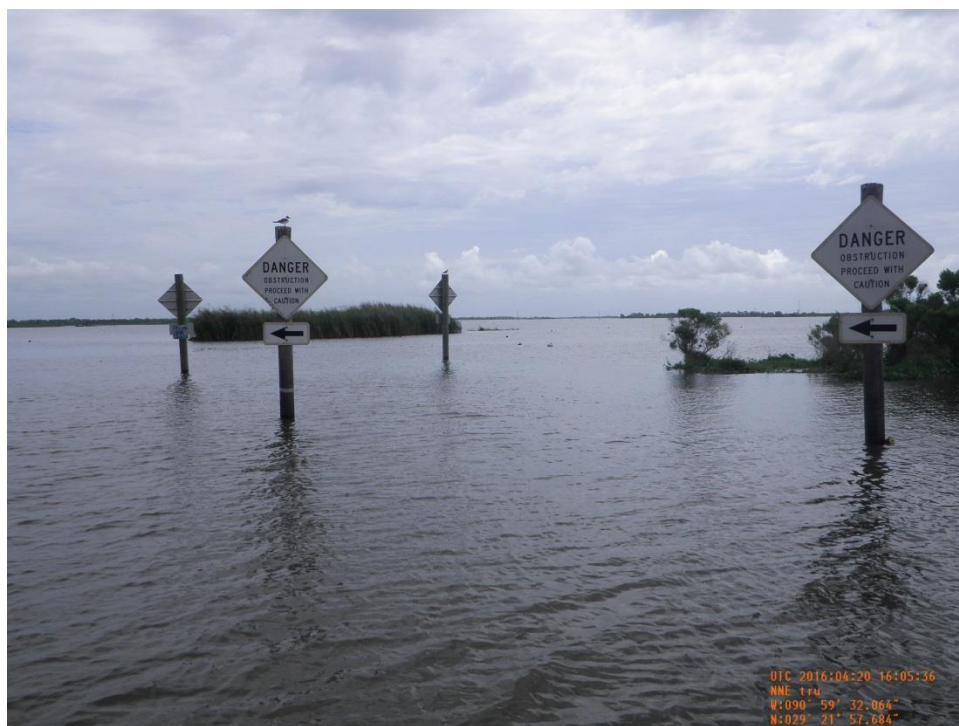
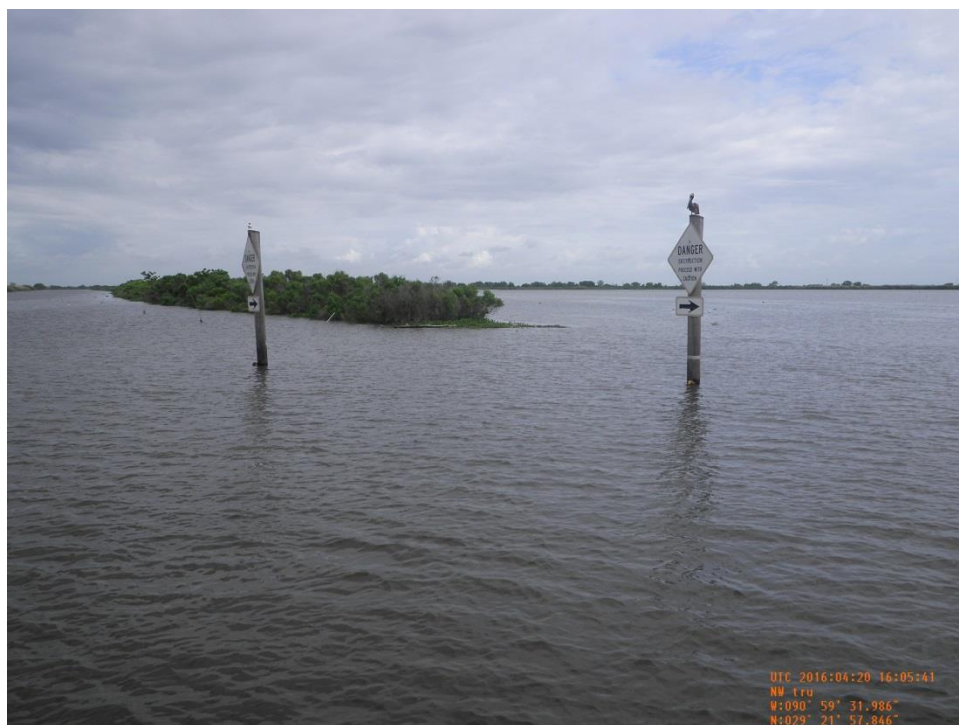
Structure No.10 appears to be in fair to good condition. The rock tie-ins to the bank on both sides of the structure appear to be thin and were mostly submerged which is attributed to settlement and high water during inspection. The center depth of the rock channel liner was approximately 7.0 feet. Based on the gauge reading near Structure No. 6, the elevation of the rock sill would be approximately -5.5' NAVD; these measurements remain unchanged from the previous year. The constructed sill elevation was -4.75', indicating that structure has settled approximately 1 foot. All of the timber piling and warning signs appear to be in good condition (See Appendix B, Photos 4 through 6)

Photo 4: view of warning signs at the entrance of the rock rip rap channel liner (Structure No.10). Several of the warning signs and timber piling were replaced in 2012.

Photo 5: view of south bank of the rock rip rap channel liner (Structure No.10).

Photo 6: view of the north bank of the rock rip rap channel liner (Structure No.10).

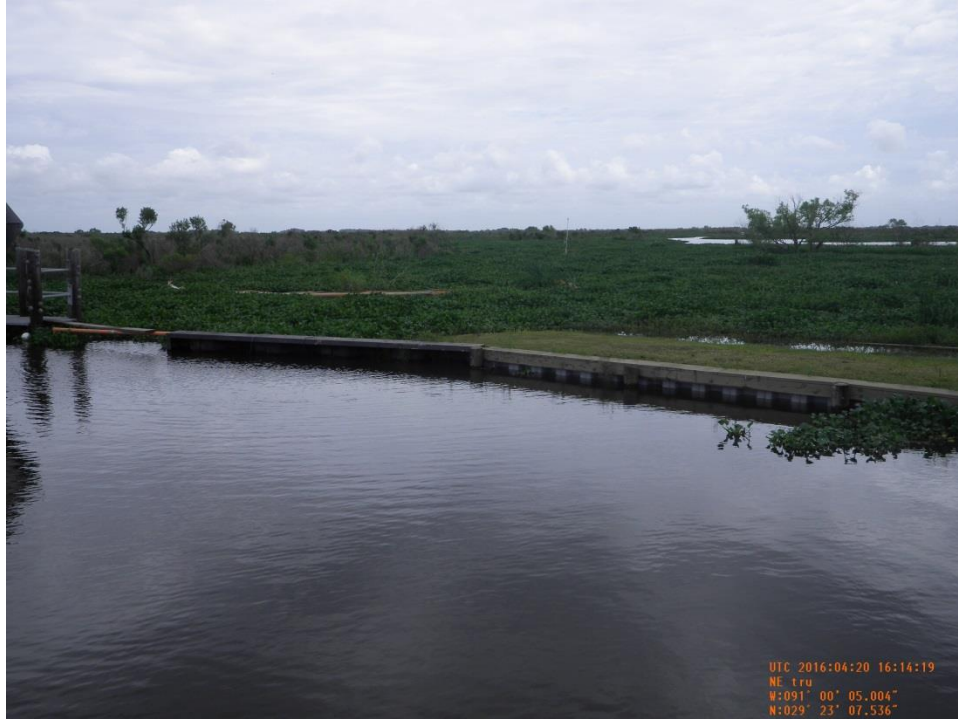
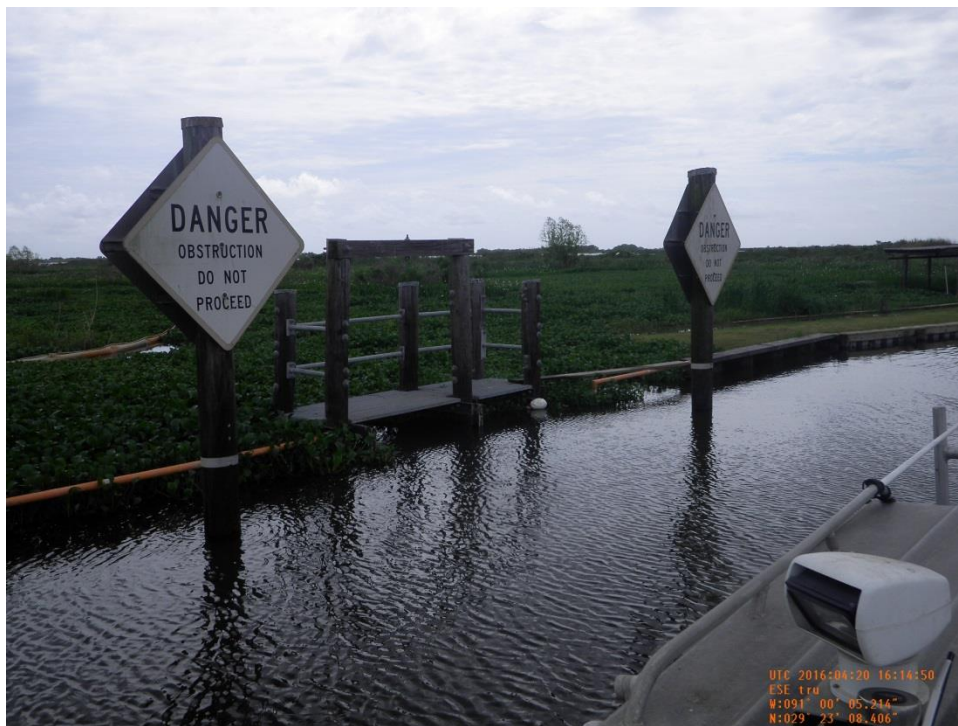
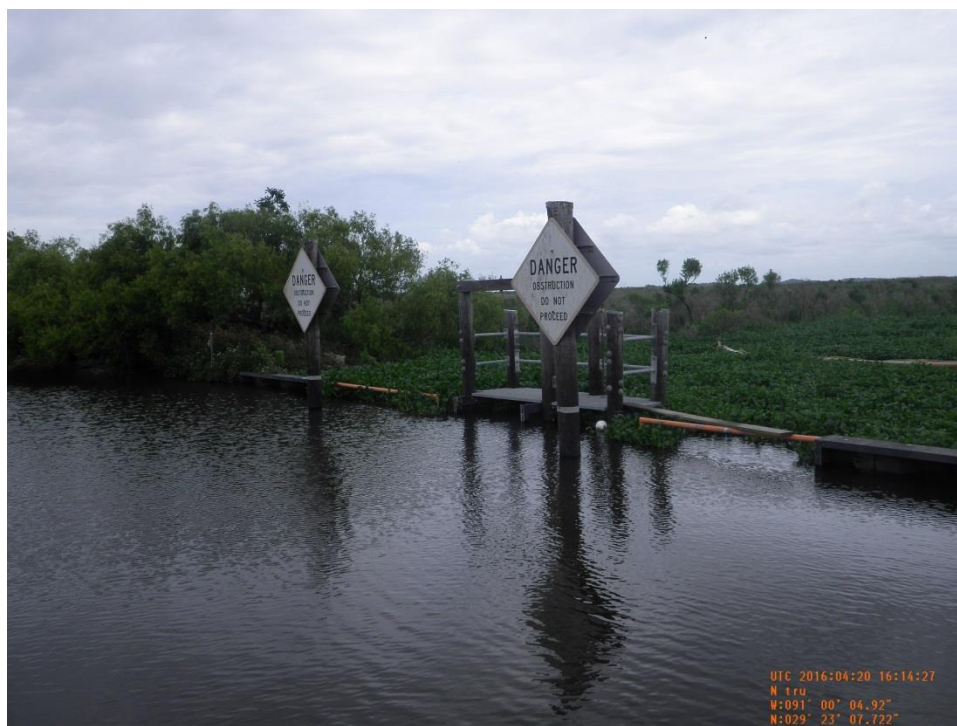
This structure appears to be in fair condition. There was no visible damage to the railings, platform, steel bulkhead or warning signs. As on previous inspections, we did note that the earthen embankment tie-ins on both sides of the structure were experiencing significant erosion with very little, if any, material remaining on the bayou side of the structure. Although there was little landmass on the bayou side of the structure, the marsh side did have enough material to prevent the embankment from breaching. The erosion of the embankment has worsened over the last few years and will require some corrective action within the next couple of years. ConocoPhillips regularly maintains the earthen overflow banks along Carencro Bayou and may be able to dredge material from the bayou to reconstruct the embankment tie-in. It was rumored that ConocoPhillips had performed work to repair the northern tie-in however there are no obvious discrepancies between the 2016 and 2015 sets of pictures. CPRA will coordinate with ConocoPhillips for a possible repair of the tie-ins during their next levee maintenance event. At this time, we will continue to monitor this site for breaches and work with ConocoPhillips on a method of repair. Also, as noted on the previous inspection report, the camp owner just south of Structure 14 had installed a vinyl bulkhead along the front of his camp. The bulkhead extends north and ties into the southern end of the steel bulkhead on the south side of Structure 14, effectively solving the erosion issue on that side of the structure. (See Appendix B, Photos 7 through 9)

Photo 7: view of the south section of the steel sheetpile wall and new constructed vinyl sheetpile installed by the adjacent camp owner.

Photo 8: an overall view of the variable crested weir with stop log bay (Structure No.14)

Photo 9: view of the north section of the steel sheetpile wall and bank tie-in at Structure No.14. The structure is a variable crest weir with a single stop log bay.

Overall, as noted in Section 5 above, the condition of the Brady Canal Hydrologic Restoration (TE-28) project was good with only minor defects such as the eroded bank tie-in on the north side of the steel bulkhead at Structure 14, minor settlement of the rock liners (Structures 10 and 20), cut banks along the face of the earthen embankment along the rim of Jug Lake, and minor settlement and displacement of the rock dike along the north bank of Bayou Decade. The washout on the east side of the submerged weir on Brady canal has been repaired. New overtopping was recorded in two locations each along Turtle Bayou and Jug Lake but may have only been visible during high water; GPS positions have been recorded for future inspection. These noted defects are not considered severe and will not require maintenance at this time. However, we will continue to monitor these areas of concern on future site visits to determine if any changes have occurred.

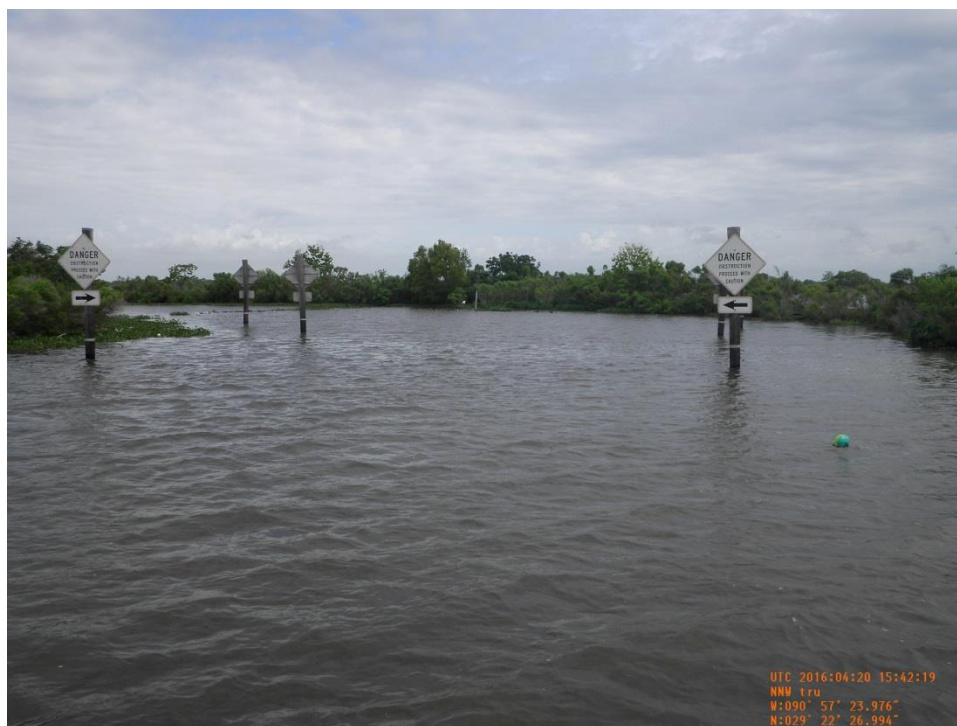
This structure is in good overall condition. As noted in previous annual inspections, there has been some settlement of the rock riprap on the bank tie-ins and submerged crest of the

structure. In 2012, it was determined the crest of the submerged channel liner has settled to a depth of -5.7' NAVD88, which translates to approximately 1.0' of settlement since construction. During the 2016 inspection, the depth of water at the center of the rock channel liner was approximately 8.5', which translates into crest elevation of -6.1' elevation. The water levels at the time of the inspection was +2.4' NAVD. From our calculations, Structure No. 20 has experienced approximately 1.35' settlement since the structure was constructed in 1998. All other warning signs and timber supports are in good condition. The refurbishment of Structure No. 20 was excluded from the 2012 Maintenance Project, but the earthen embankment was capped with riprap up to the structures eastern embankment tie-in. At this time, Structure No. 20 is in good condition and no maintenance will be required. (See Appendix B, Photo 10)

Photo 10: View of Structure No.20, a rock rip rap channel liner, and warning signs located along the north bank of Jug Lake.

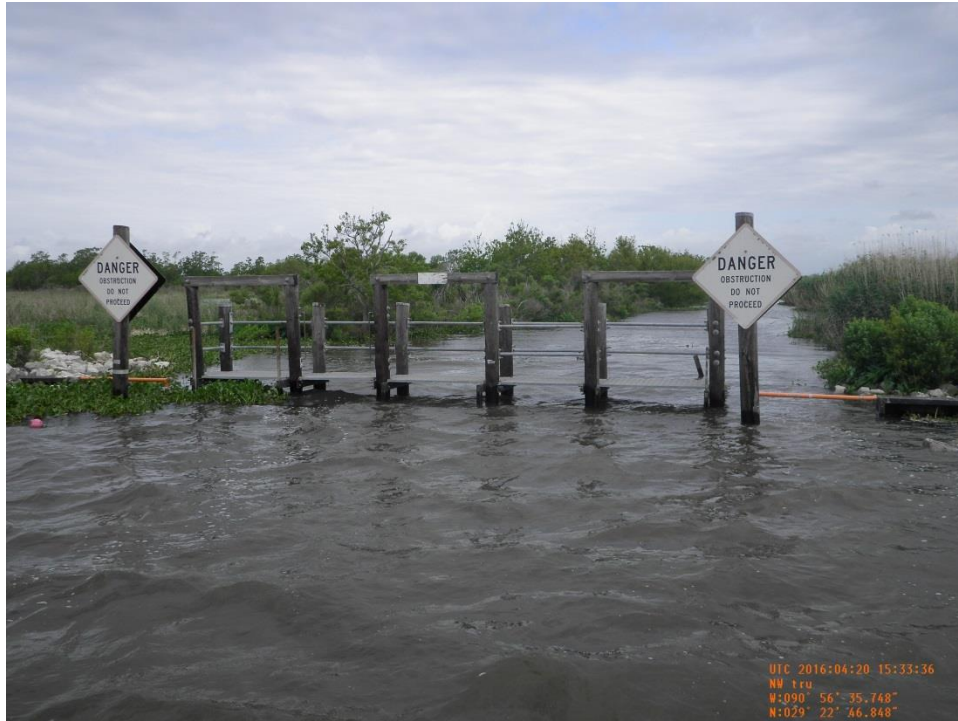
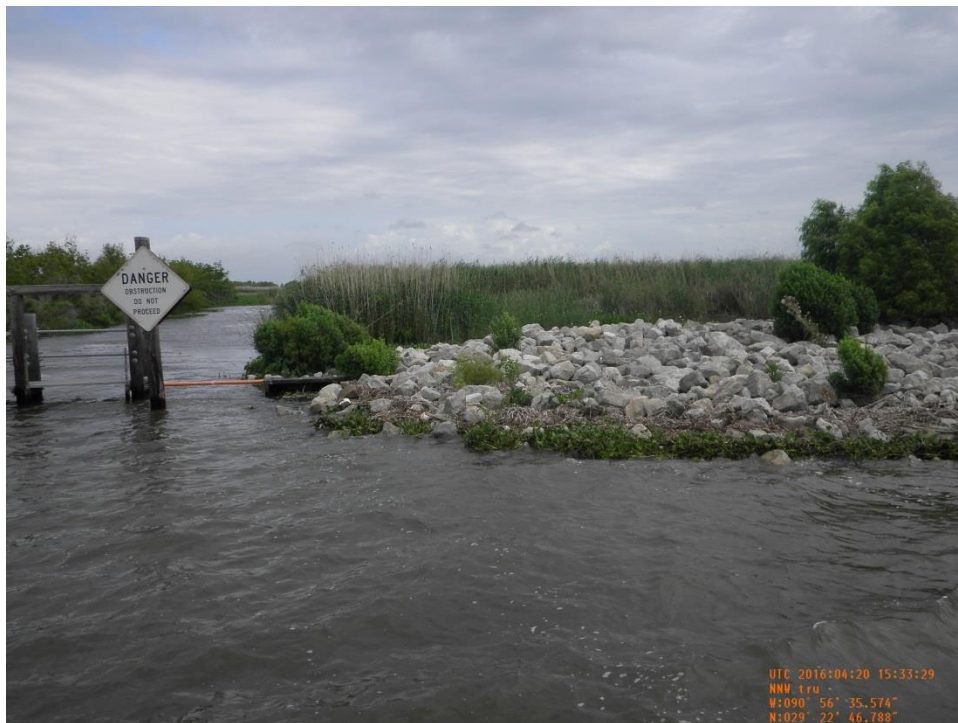
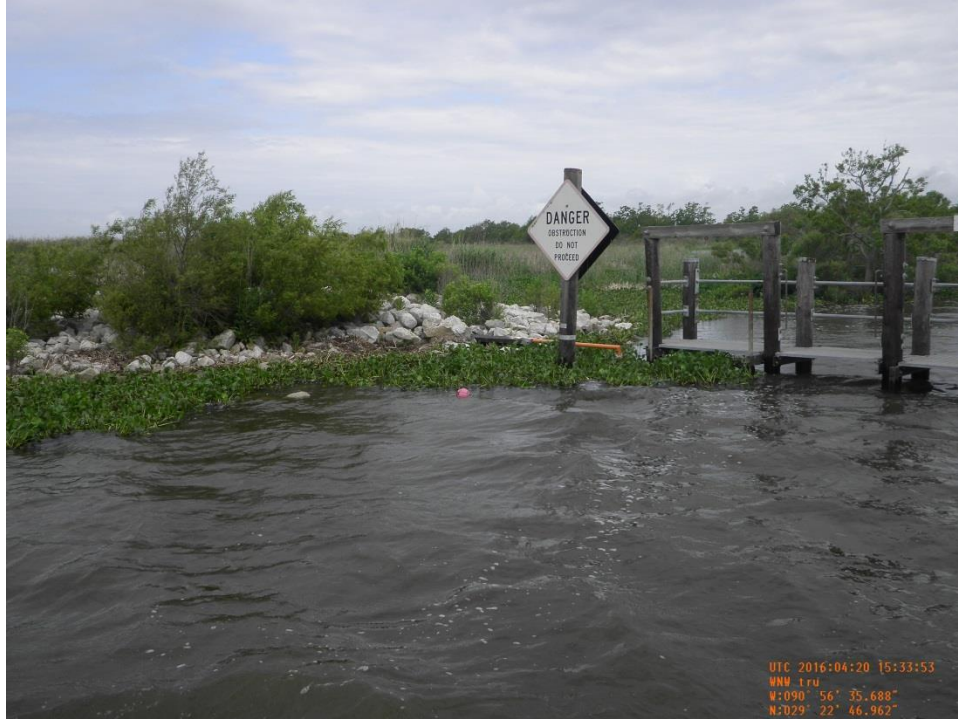
Overall, Structure 21 is in very good condition. There is no visible damage to the steel bulkhead, railings, platform or the warning signs and their timber supports. As part of the 2012 Maintenance Project, Structure 21 had both of its embankment tie-ins refurbished and then armored with 50 linear feet of rock riprap to prevent any further erosion around the ends of the structure. There has not been any visual settlement of the riprap following the completion of the maintenance project. Structure 21 will not require maintenance. (See Appendix B, Photos 11 through 13)

Photo 11: view of rock rip rap revetment on the north side Structure No. 21, a variable crested weir with three (3) stop log bays. The earthen embankment was refurbished and the rock rip rap revetment was installed in 2012.

Photo 12: view of rock rip rap revetment on the north side Structure No. 21.

Photo 13: view of rock rip rap revetment on the south side Structure No. 21.

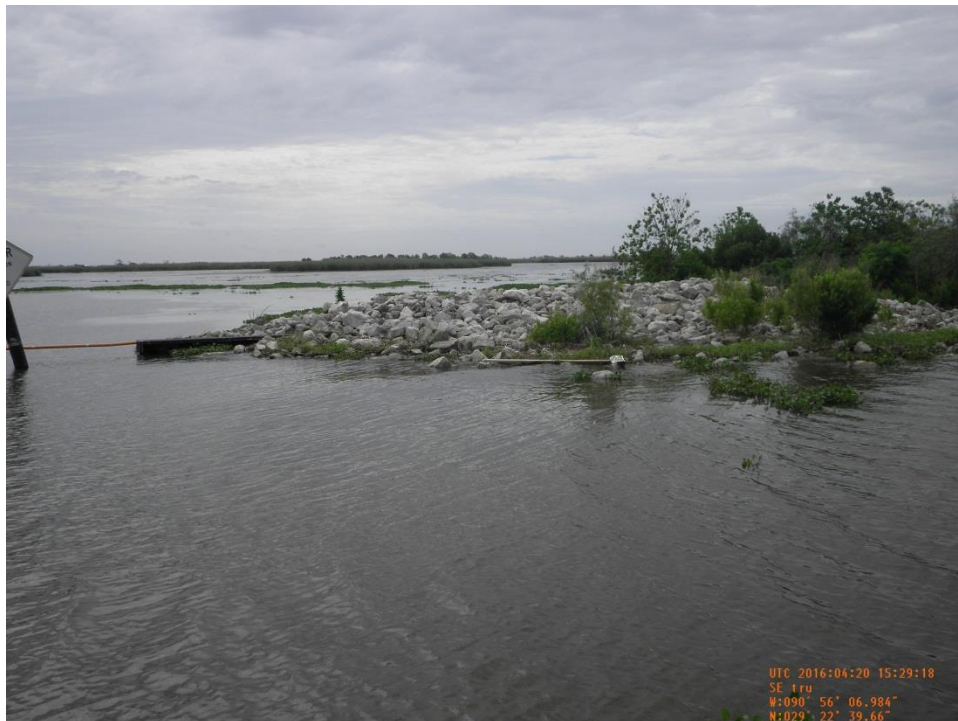
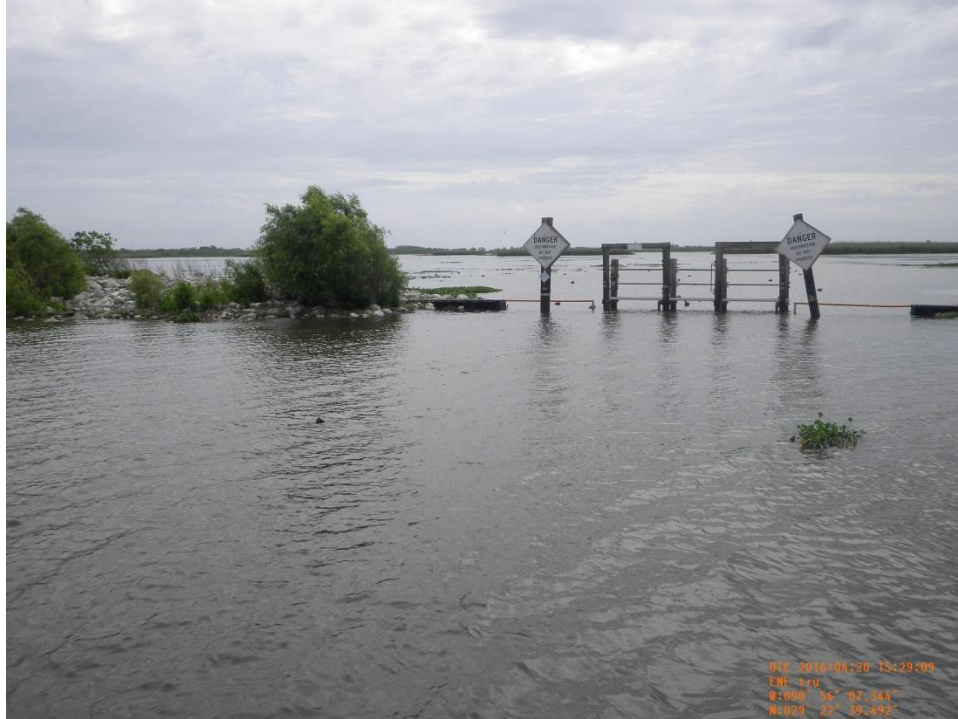
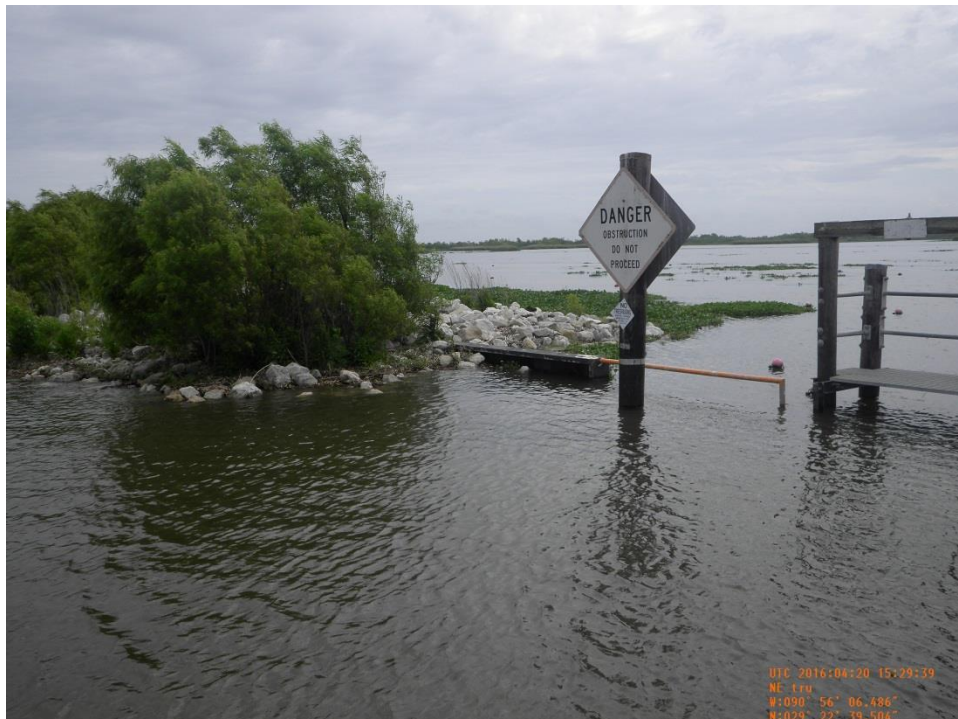
Overall, Structure 23 is in good condition. There is no visible damage to the steel bulkhead, railings, platform, or the warning signs and their timber supports. As part of the 2012 Maintenance Project, Structure 23 had both of its embankment tie-ins refurbished and then armored with 50 linear feet of rock riprap in each direction to prevent any further erosion around the ends of the structure. There has not been any visual settlement of the riprap following the completion of the maintenance project. Structure 23 has been restored to its original constructed condition and will not require maintenance. (See Appendix B, Photos 12 through 14)

Photo 12: View of the rock armament of the earthen embankment on the south side of Structure No.23. The earthen embankment was refurbished and the rock armor installed in 2012.

Photo 13: Overall view of Structure No.23, variable crested weir structure.

Photo 14: View of the rock armament of the earthen embankment on the north side of Structure No.23. The earthen embankment was refurbished and the rock armor installed in 2012.

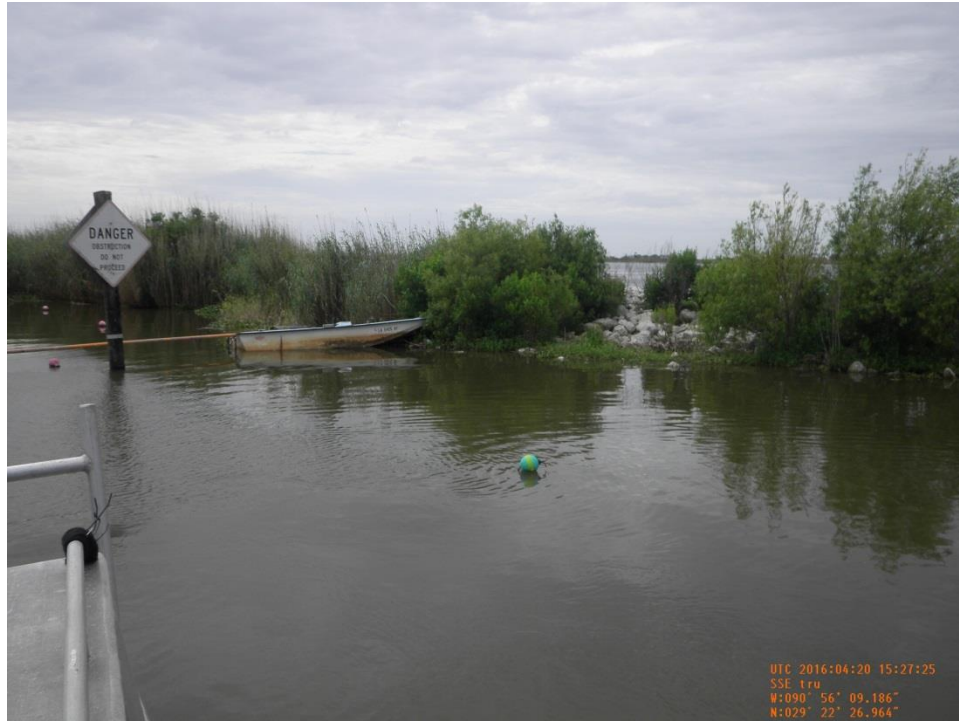
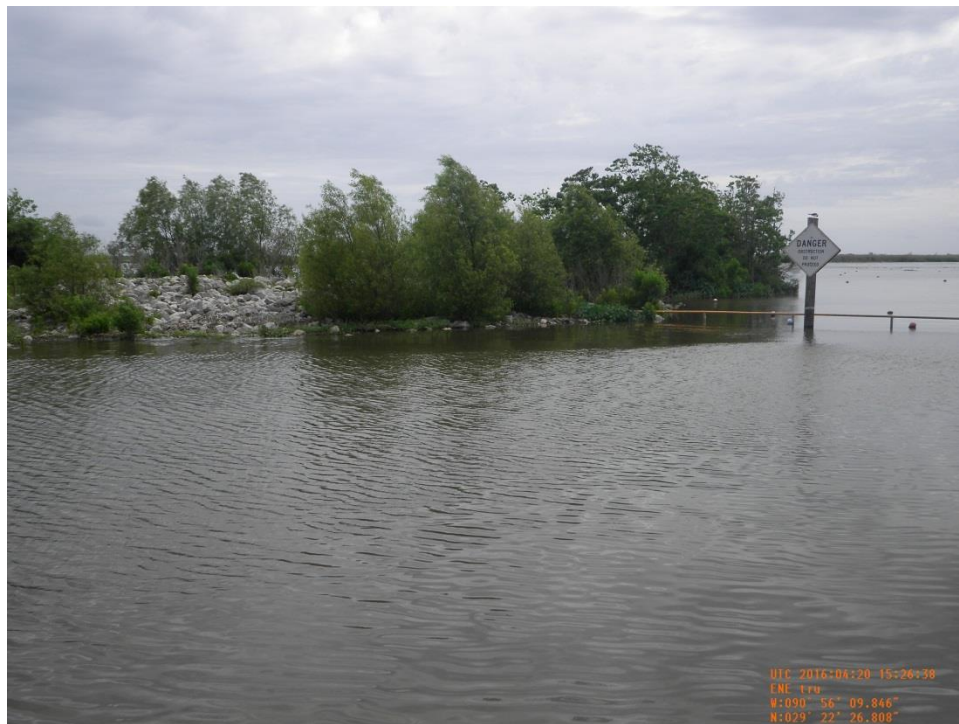
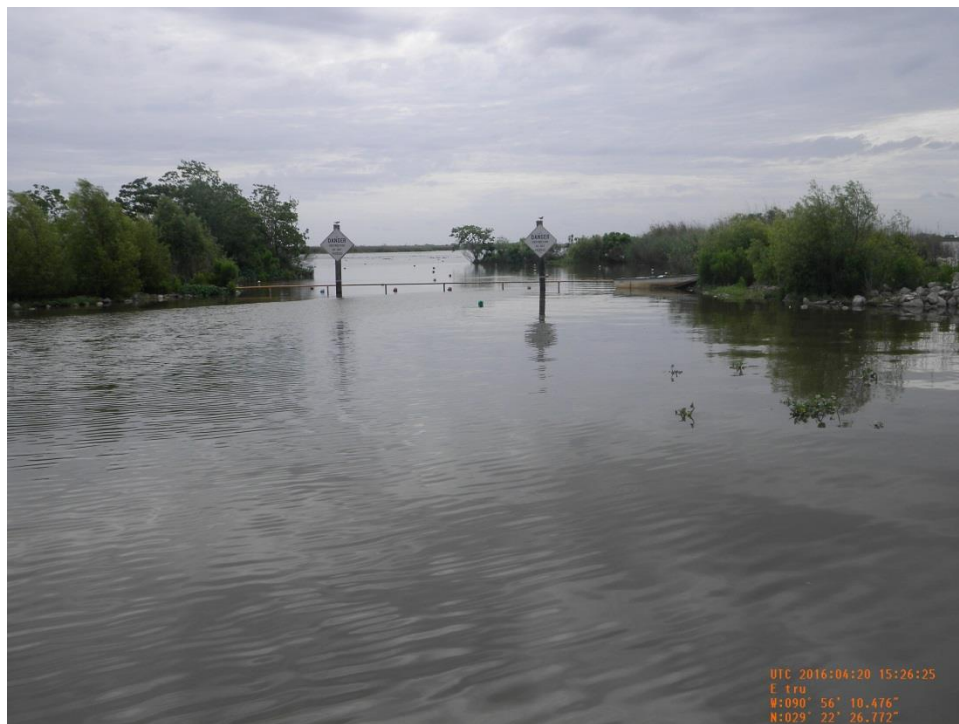
Overall, Structure No. 24 is in good condition. There is no visible damage to the steel bulkhead, railings, platform, or the warning signs and their timber supports. However, the hull of a small recreational fishing vessel is lodged against the structure and may cause damage or access problems in the future. As part of the 2012 Maintenance Project, Structure No. 24 had both of its embankment tie-ins refurbished and armored with rock riprap on both sides to prevent any further erosion around the ends of the structure. There has not been any visual settlement of the riprap following the completion of the maintenance project. Structure No. 24 has been restored to its original constructed condition and will not require maintenance. (See Appendix B, Photos 15 through 17)

Photo 15: View of south bank tie-in of Structure No.24 located along the north bank of Jug Lake. The embankment was refurbished and the rock riprap apron was installed during the 2012 Maintenance Project.

Photo 16: View of north bank tie-in of Structure No.24 located along the north bank of Jug Lake. The embankment was refurbished and rock riprap apron was installed during the 2012 Maintenance Project.

Photo 17: A full view of Structure No.24 located along the north bank of Jug Lake.

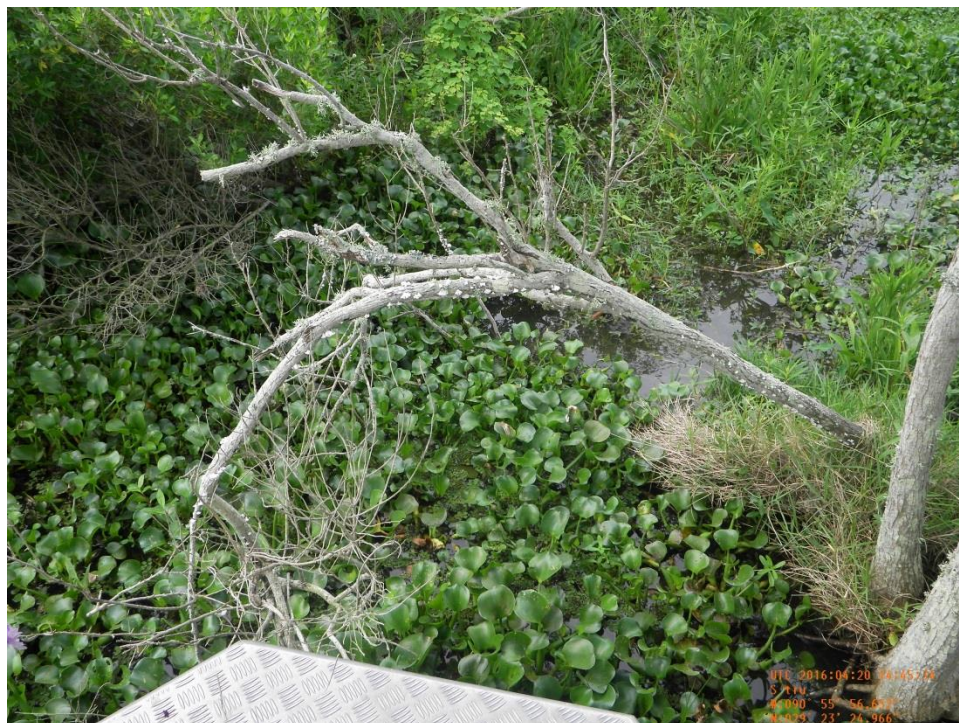
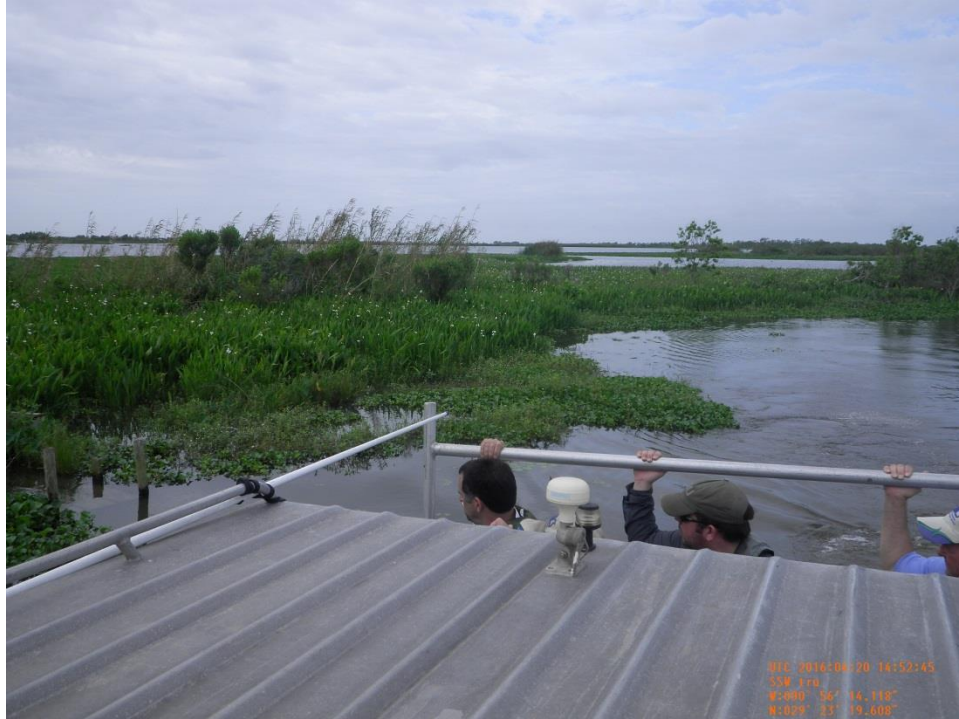
Photo 18: View of high water overtopping in Turtle Bayou

Photo 19: View of high water overtopping in Turtle Bayou

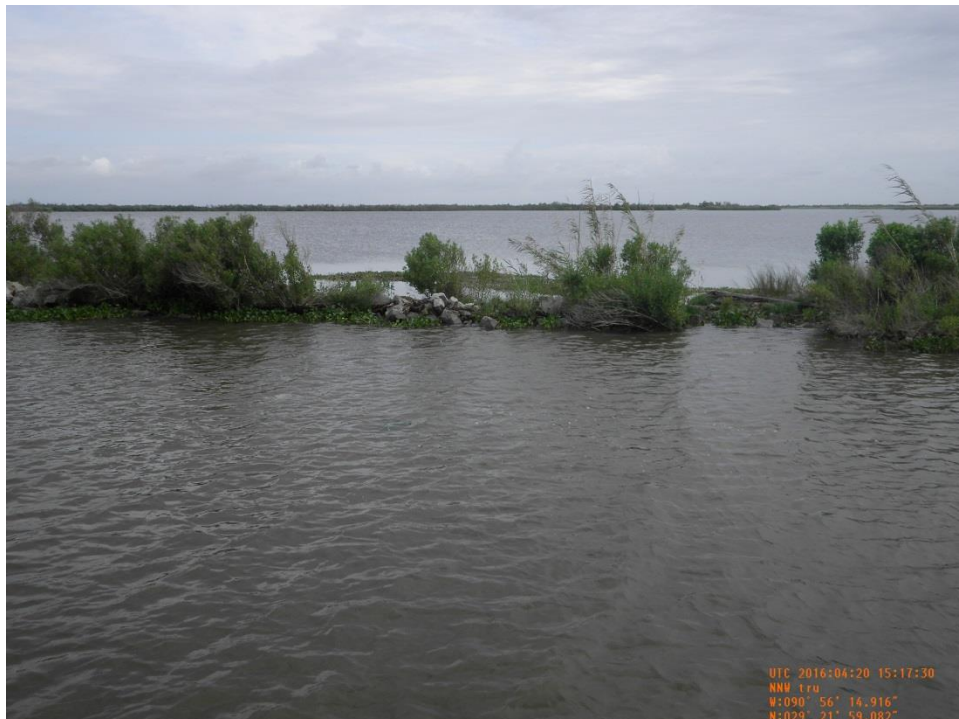
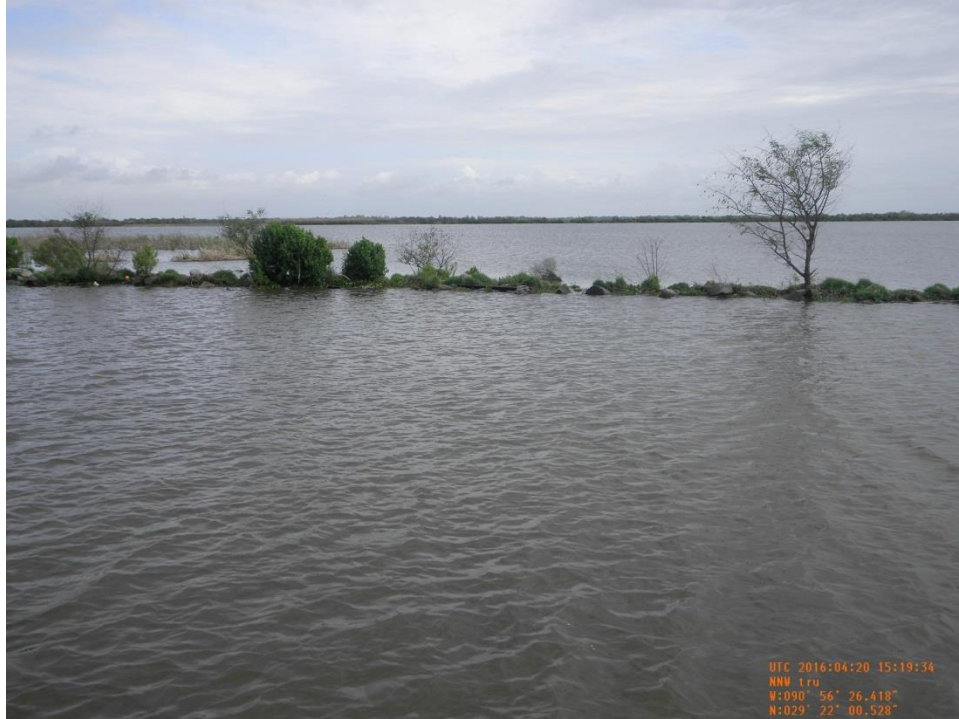
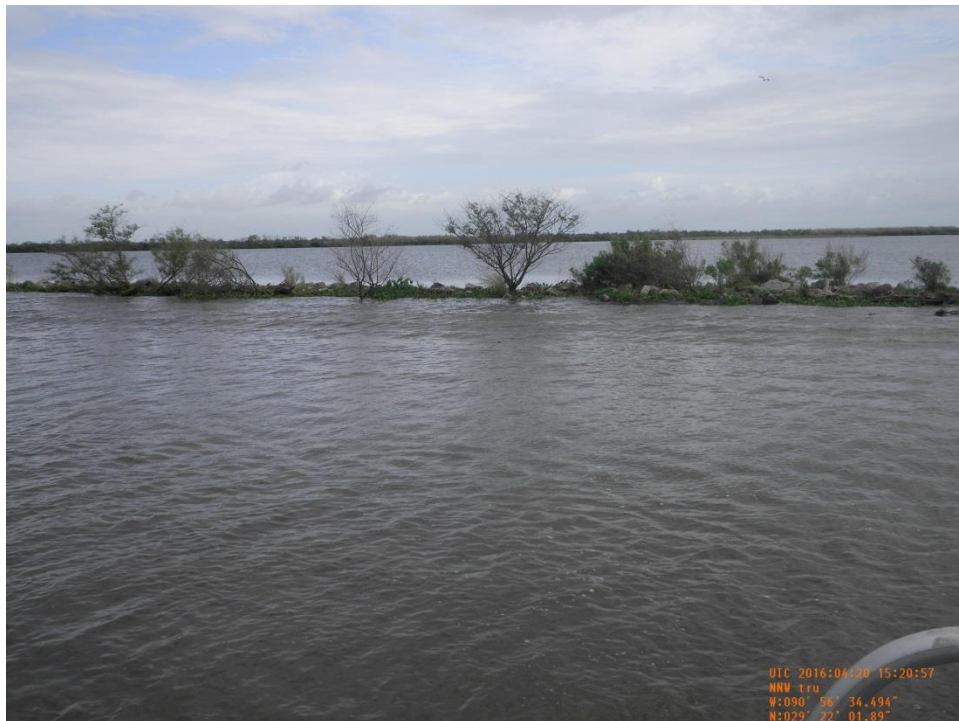
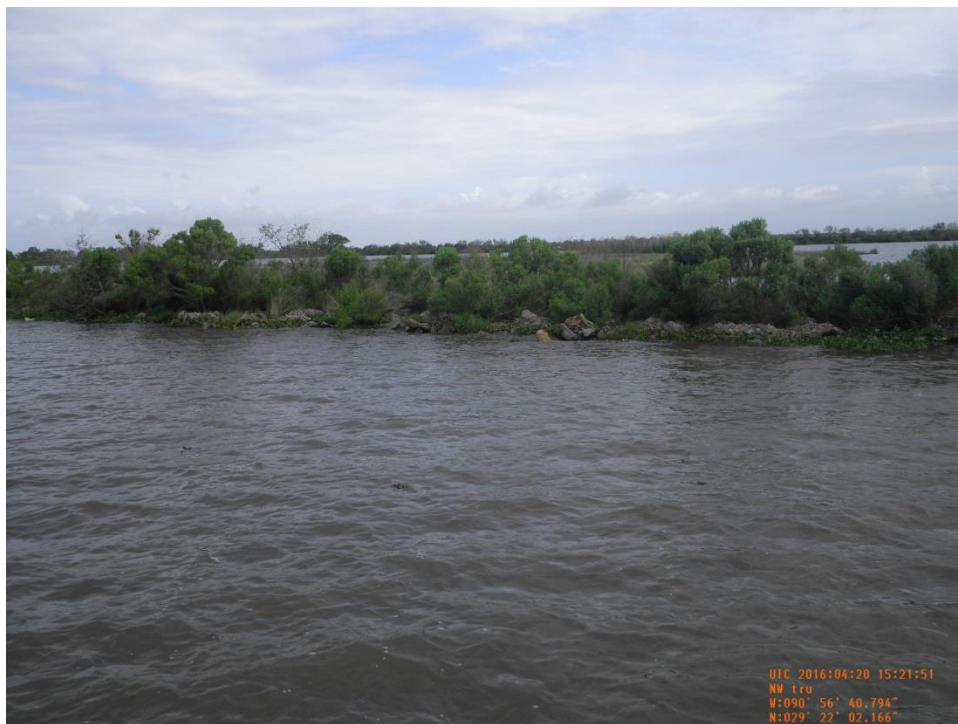
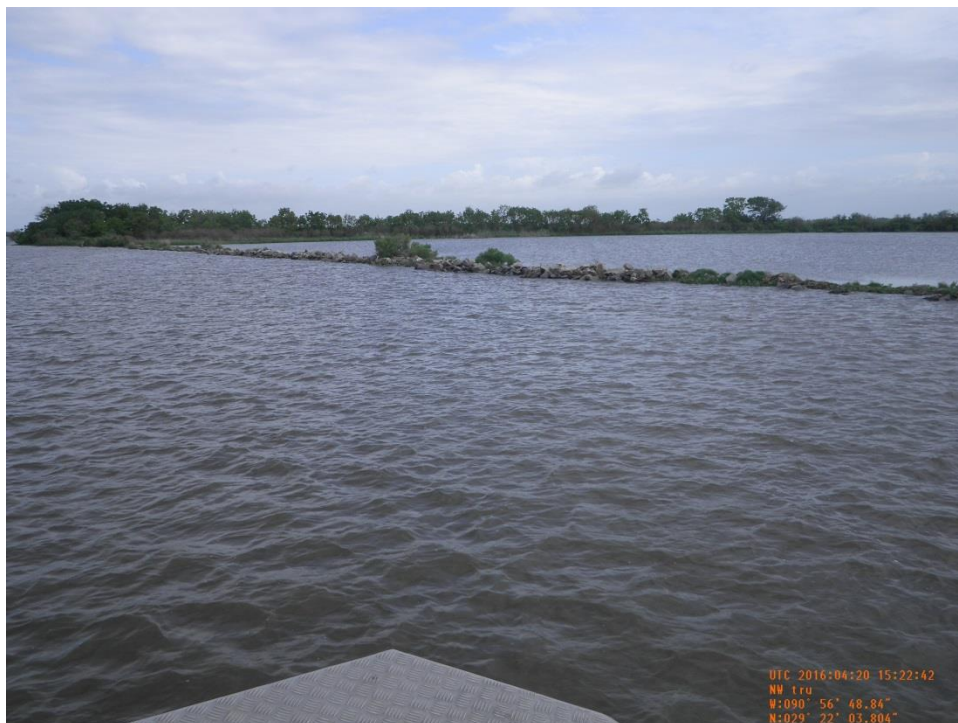
The rock armored embankments and rock dikes along the north bank of Bayou Decade and Voss Canal are in good condition. The rock dike along Bayou Decade between Jug Lake and Turtle Bayou appear to be in fair condition with isolated low areas and moderate settlement of

rock riprap (See Appendix B, Photos 20 through 24). The earthen embankment with rock revetment west of Structure 7 along Bayou Decade appears to be in good condition with no apparent settlement. The earthen embankment with rock revetment beginning at the intersection of Bayou Decade and Voss Canal had some initial settlement after construction but has experienced little change since previous inspections. Despite some minor deficiencies, the rock armored embankments appear to be functioning as intended and no maintenance will be required at this time.

Photo 20: View of the rock armored embankment along the north bank of Bayou Decade near the mouth of Turtle Bayou. The rock armament was installed under the 2003 Maintenance Project. This structure was identified as Breaches 1 through 4.

Photo 21: View of the rock armored embankment along the north bank of Bayou Decade.

Photo 22: View of the rock armored embankment along the north bank of Bayou Decade.

Photo 23: View of the rock armored embankment along the north bank of Bayou Decade.

Photo 24: View of the rock armored embankment along the north bank of Bayou Decade near Jug Lake.

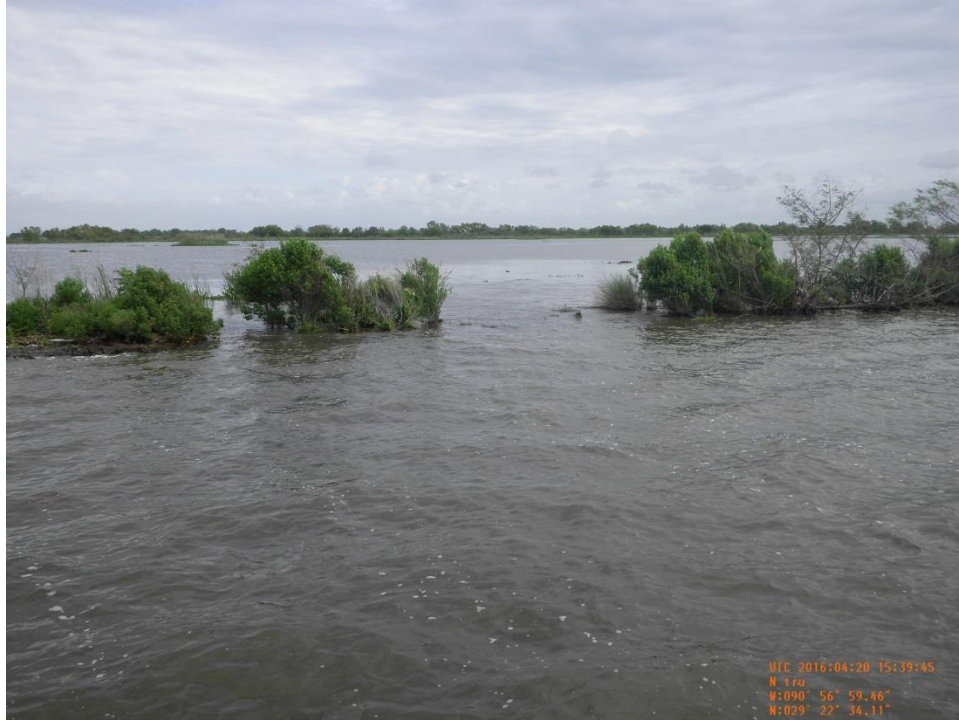
The inspection of the earthen embankments began with the west bank of Turtle Bayou and progressed along Superior Canal, the dead end canal off of Superior Canal, Bayou Decade, Jug Lake, through Voss Canal, Bayou Carencro, and concluded along Brady Canal at the Apache Camp location. The earthen embankments along Turtle Bayou and Superior Canal are in good condition. There are visual variations in the elevation and various vegetative species, but no noticeable breaches in the embankment. However, in one location along Turtle Bayou and the embankment was overtopped approximately 3/10 of a foot (See Appendix B, Photos 18). Overtopping occurred nearby in one other location; across the channel from breach 7, 100 to 200 continuous feet of embankment were submerged (See Appendix B, Photo 19). On the west side of Jug Lake, the high water was observed overtopping a single location approximately 10' wide (See Appendix B, Photo 25). Earthen embankments along Bayou DeCade and Voss Canal are also in good condition. These areas have experienced some erosion, but with little to no change observed since the previous inspections. The sites of overtopping will be monitored closely on future site visits and may require remedial action.

Photo 25: View of the overtopped portion of earthen embankment on the west bank of Jug Lake
