**State of Louisiana
Coastal Protection and Restoration
Authority**

2016 Annual Inspection Report

BRADY CANAL HYDROLOGIC RESTORATION PROJECT (TE-28)

State Project Number TE-28
Priority Project List 3

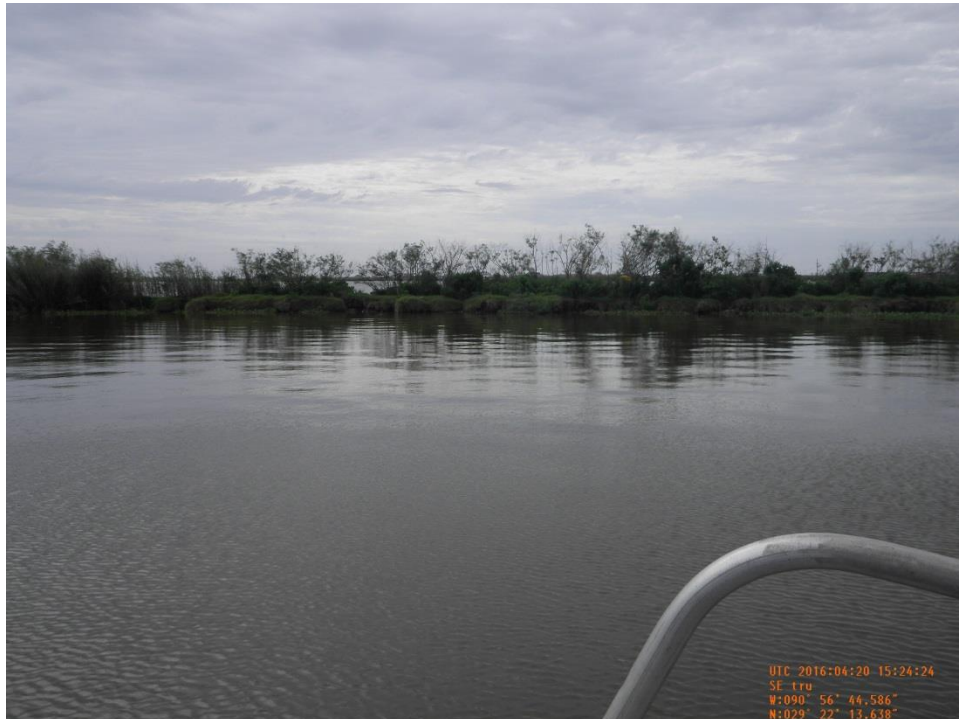
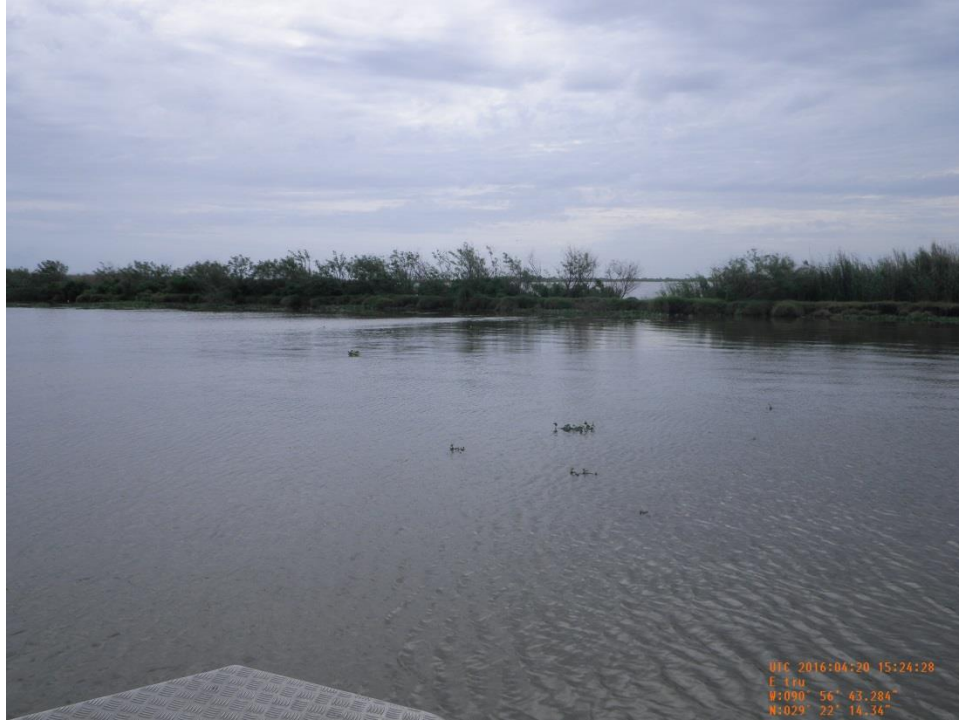
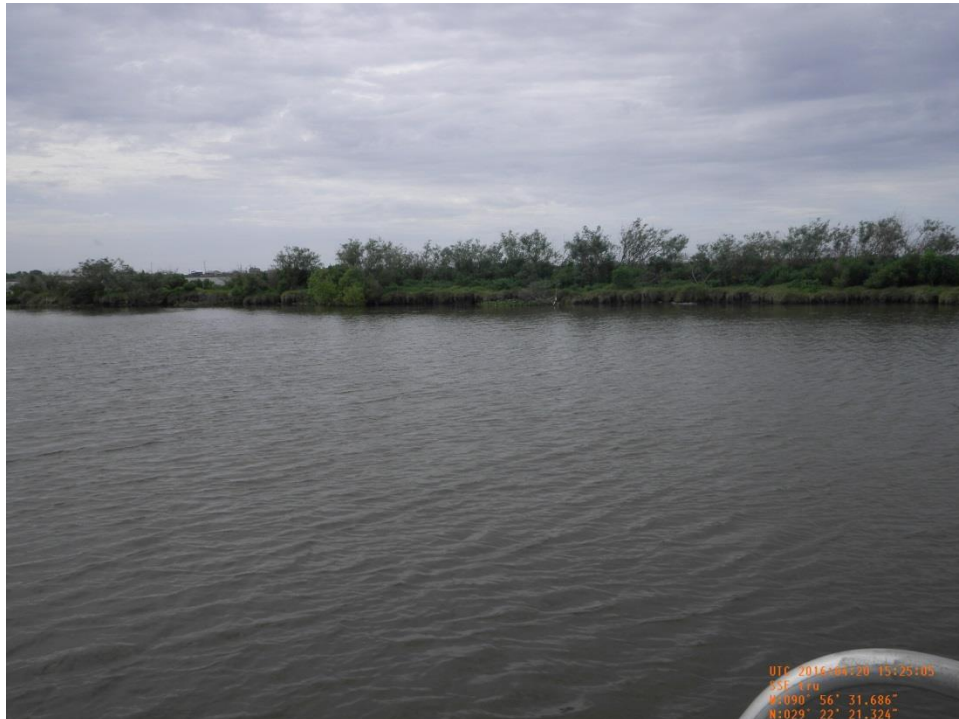
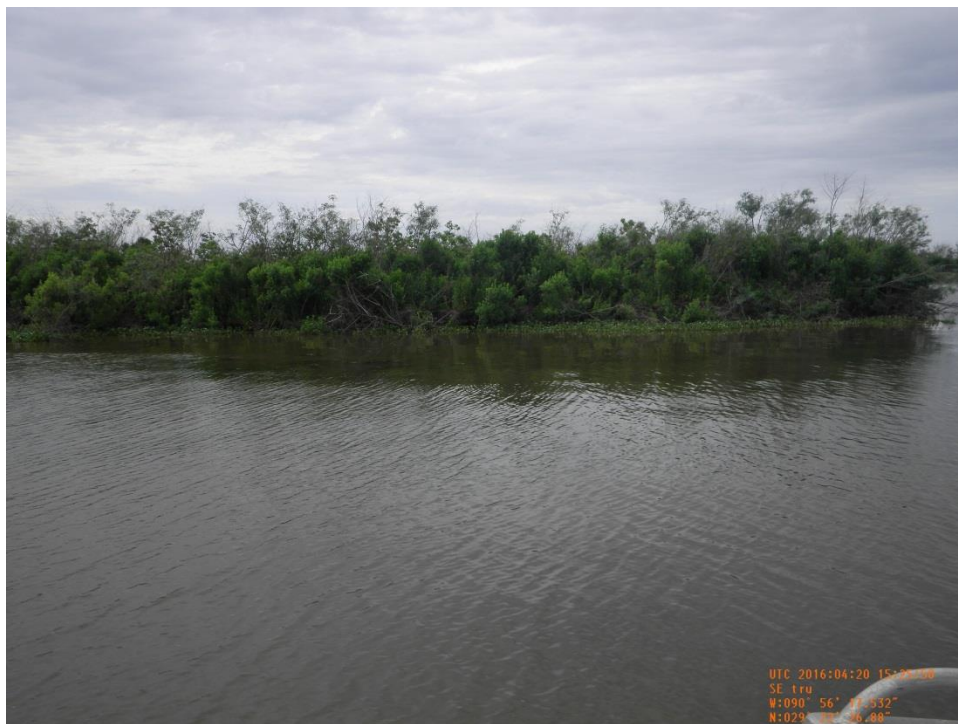
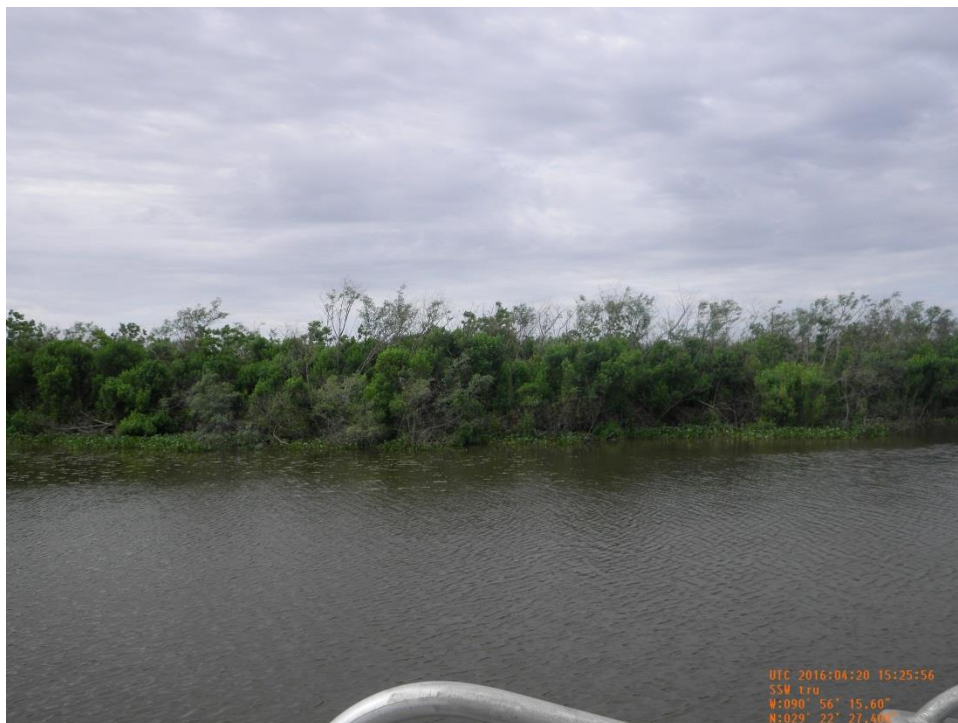
As part of the 2012 Maintenance Project, approximately 13,900 linear feet of earthen embankment around the rim of Jug Lake was refurbished. In previous years, we noted that large cut banks had developed along the face of the newly constructed embankment. Over the past two years, the top of the embankment has vegetated, but there is still a substantial cut bank facing Jug Lake. There are no recommendations for corrective action at this time, but we will continue to monitor on future site visits. (See Appendix B, Photos 26 through 30)

Photo 26: View existing earthen embankment along the south side of Jug Lake. This section of the embankment was refurbished in 2012.

Photo 27: View existing earthen embankment along the south side of Jug Lake.

Photo 28: View existing earthen embankment along the south side of Jug Lake.

Photo 29: View existing earthen embankment along the south side of Jug Lake.

Photo 30: View existing earthen embankment along the south side of Jug Lake.

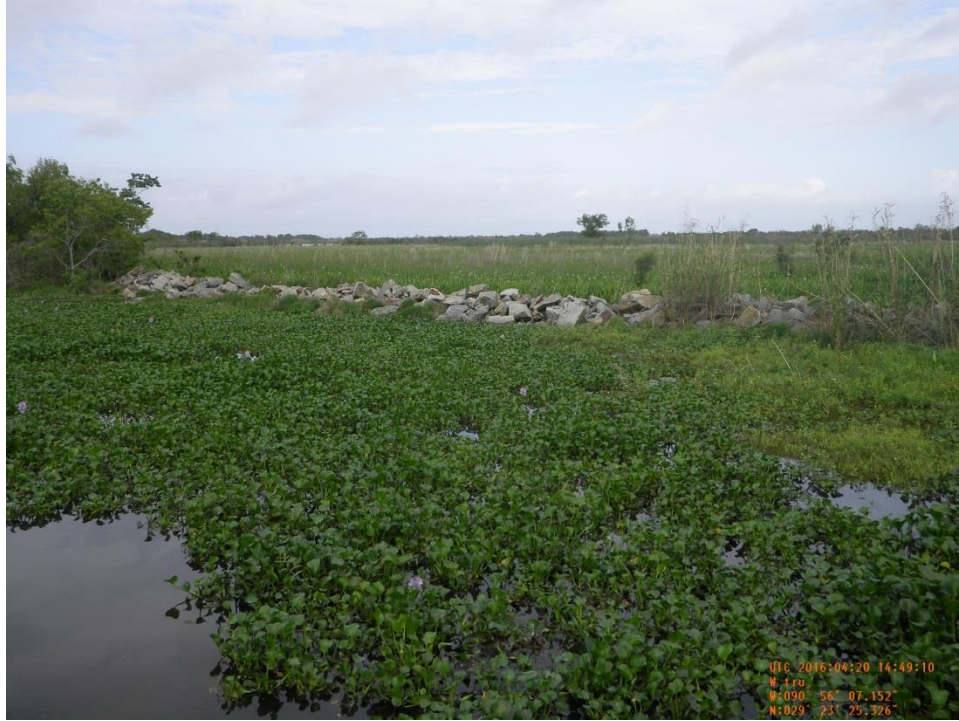
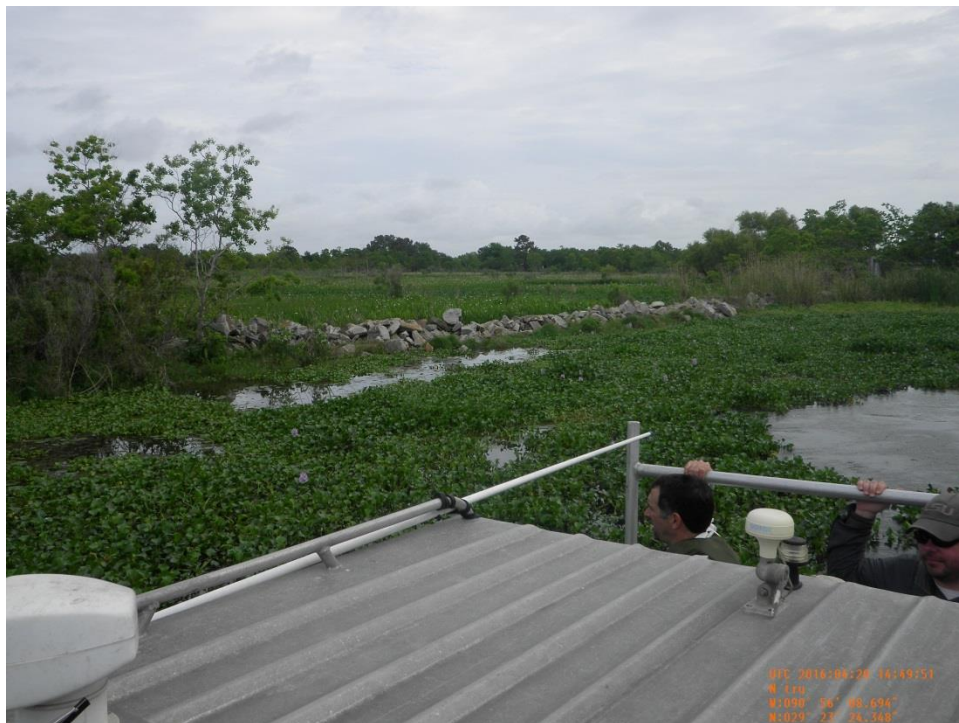
The rock plug known as "Breach 7" is located along an existing oil field access canal connected to Superior canal is in good condition. There was no observed settlement along the length of the embankment and no erosion or washouts around the embankment tie-ins. There are no recommendations for corrective action at this time, but it will continue to be monitored on future inspections. (See Appendix B, Photos 31 and 32)

Photo 31: View of rock plug closure located along an existing location canal west of Superior Canal. This Structure was constructed under the 2003 Maintenance Event, identified as Breach 7

Photo 32: View of rock plug closure located along an existing location canal west of Superior Canal.

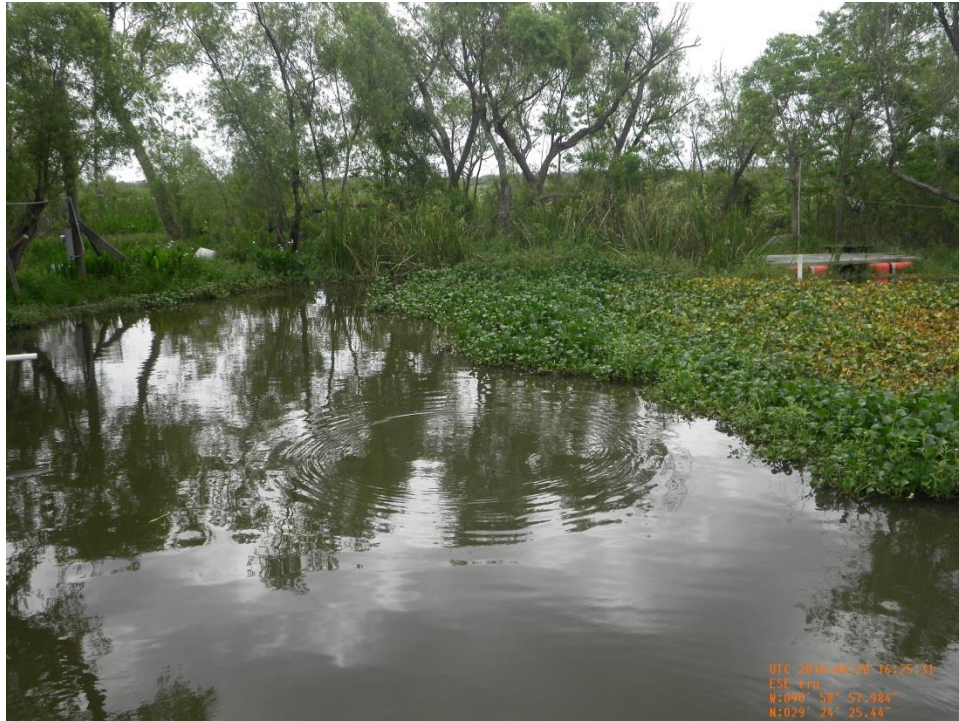
Overall, the structure is in good condition, there is no apparent damage to the submerged bulkhead, it was barely visible. The north eastern tie-in, whose breach had been and recently repaired, looked stable with an abundance of vegetation. There is a mobile camping trailer atop a barge located directly in front of the repaired section and may present navigation problems in the future. (See Appendix B, Photo 33)

Photo 33: view of breach closure adjacent to an existing timber bulkhead at the head of Brady Canal
