**2015 Annual Inspection Report**

**BRADY CANAL HYDROLOGIC  
RESTORATION PROJECT (TE-28)**

State Project Number TE-28  
Priority Project List 3

November 4, 2015  
Terrebonne Parish

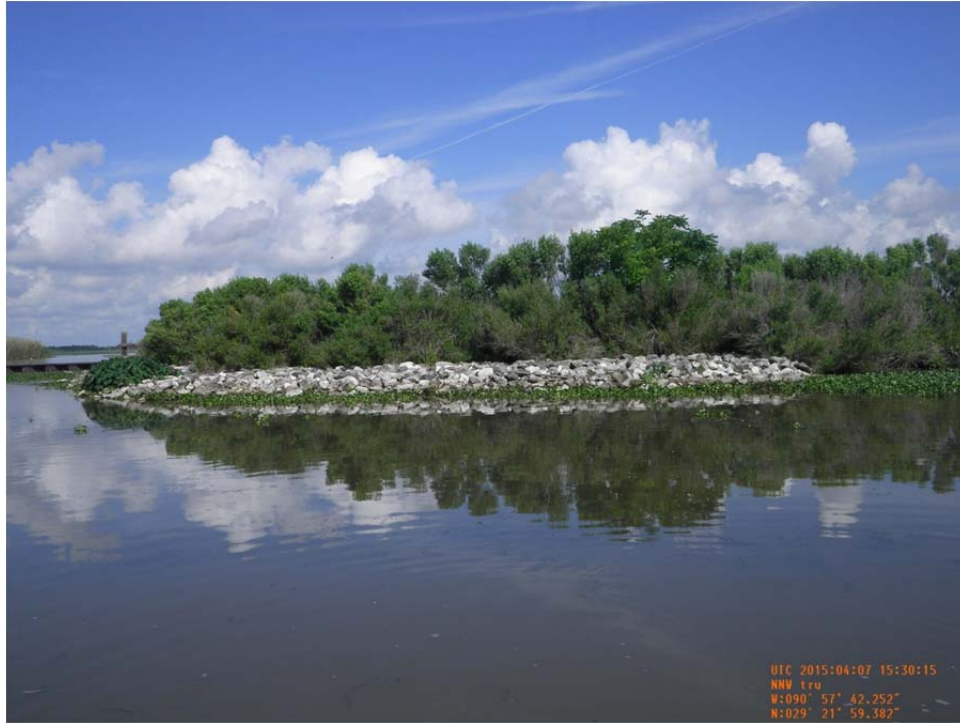
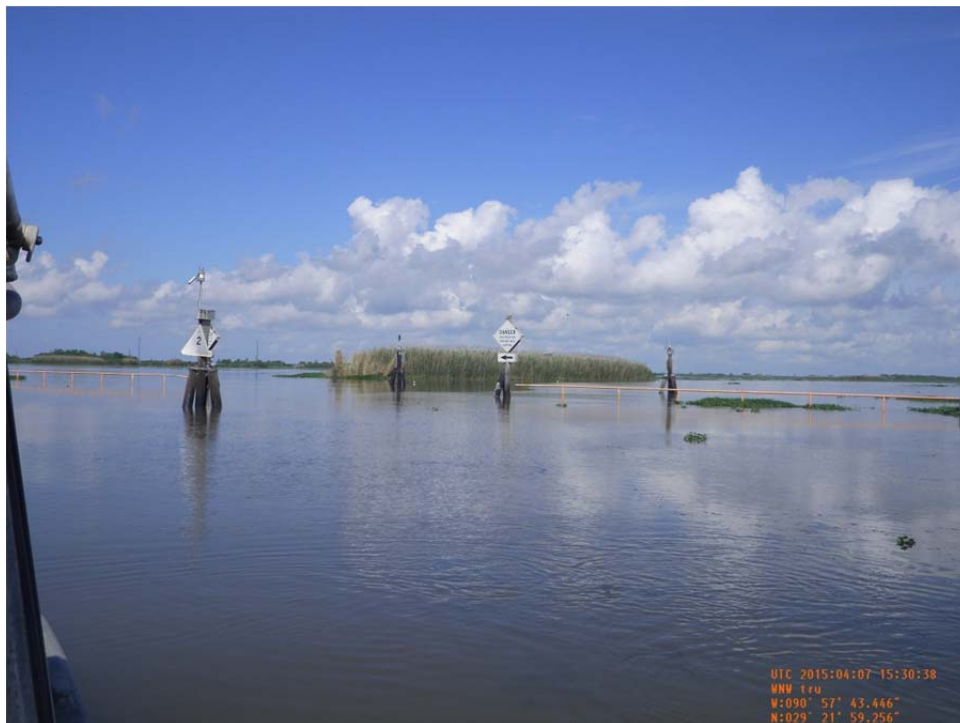
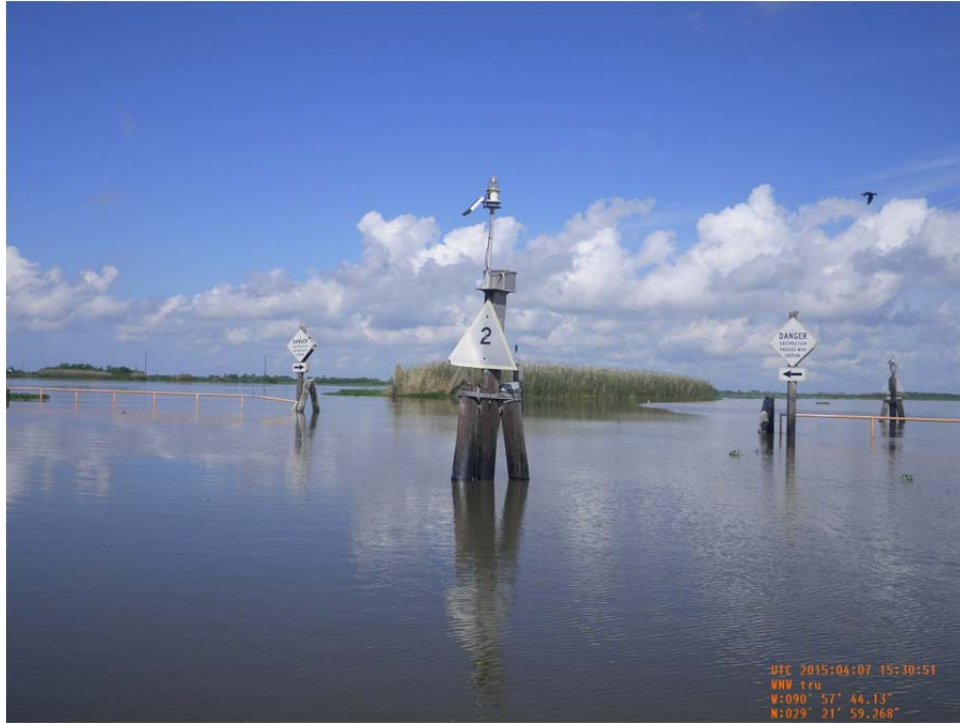
Overall, Structure 6 appears to be in good condition. The bank tie-ins are stable and there are no signs of erosion or breaching around the steel bulkhead or rock tie-ins. The timber navigational aid supports, signs and lights are visible and appear to be in good condition. The navigational aid structures are inspected quarterly through a state-wide contract with Pharo-Marine Automatic Power, Inc. and no major maintenance has been reported. The gauge reading from the CPRA continuous recorder, located just north of Structure No. 6 indicated

that the water elevation was +1.45' NAVD at 10:30 a.m. No maintenance will be required at Structure No.6. (See Appendix B, Photos 1 through 3)

Photo 1: view of rock revetment on the east side of Structure No.6, a fixed crested weir with barge bay, along the north bank of Bayou Decade.

Photo 2: view of Structure No.6, a fixed crested weir with barge bay and navigational aids and signage on both sides of the structure.

Photo 3: view of navigational aids and signage at Structure No.6

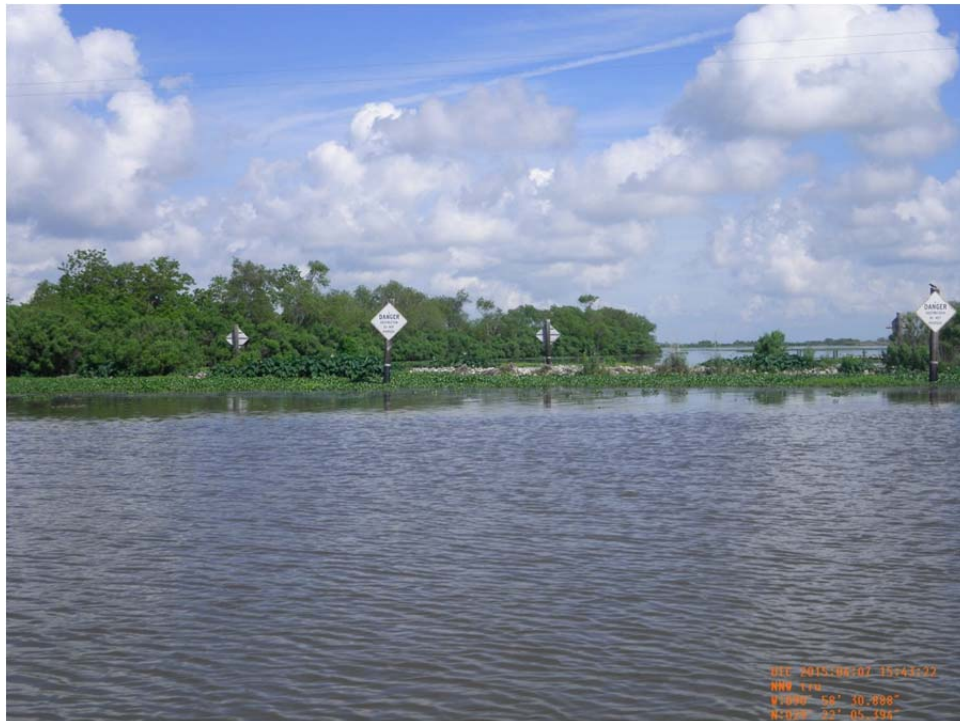
Structure 7 appears to be in good condition with no obvious settlement or defects other than heavy vegetation on and around the rock plug. The warning signs and supports located on both sides of the structure were in good condition. At this time, Structure 7 will not require maintenance. (See Appendix B, Photo #4)

Photo 4: view of rock rip rap plug (Structure No.7) located along the north bank of Bayou Decade between Structure No.6 and Voss Canal.

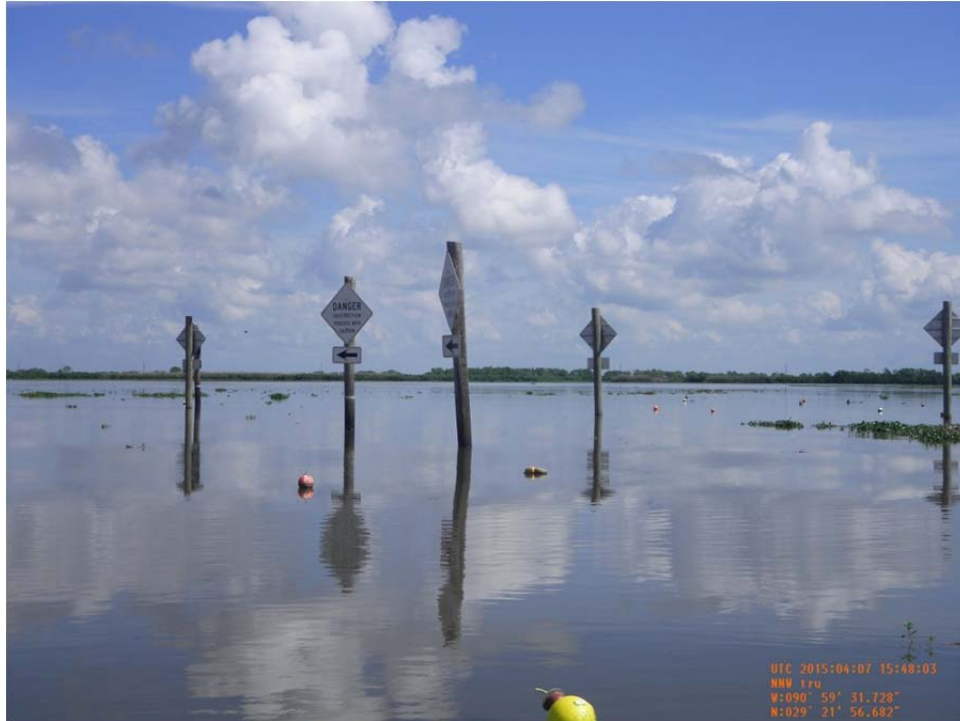
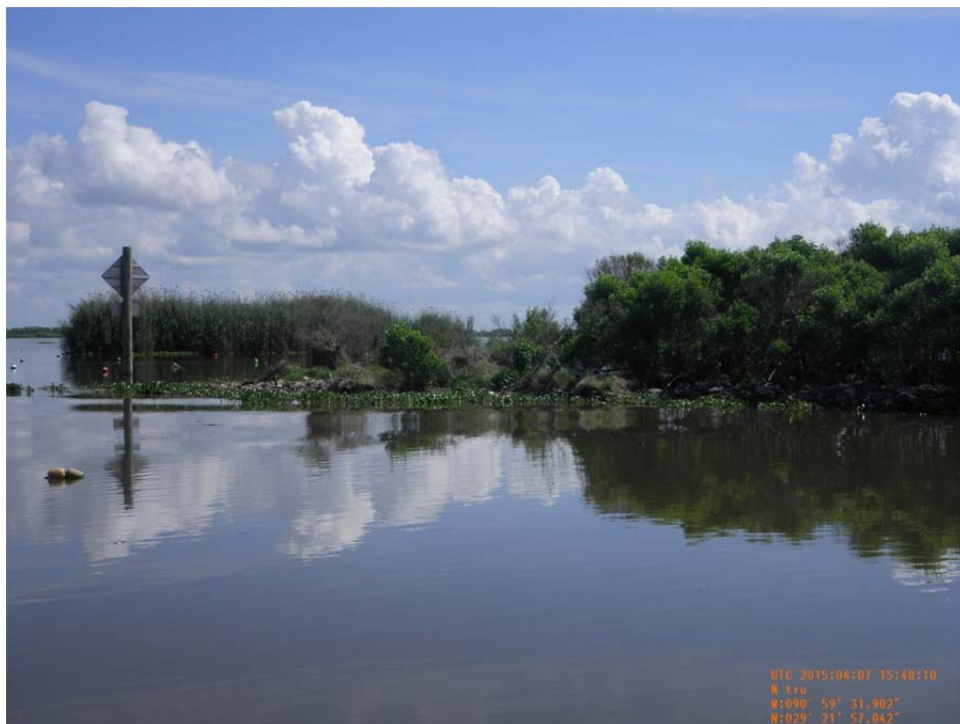
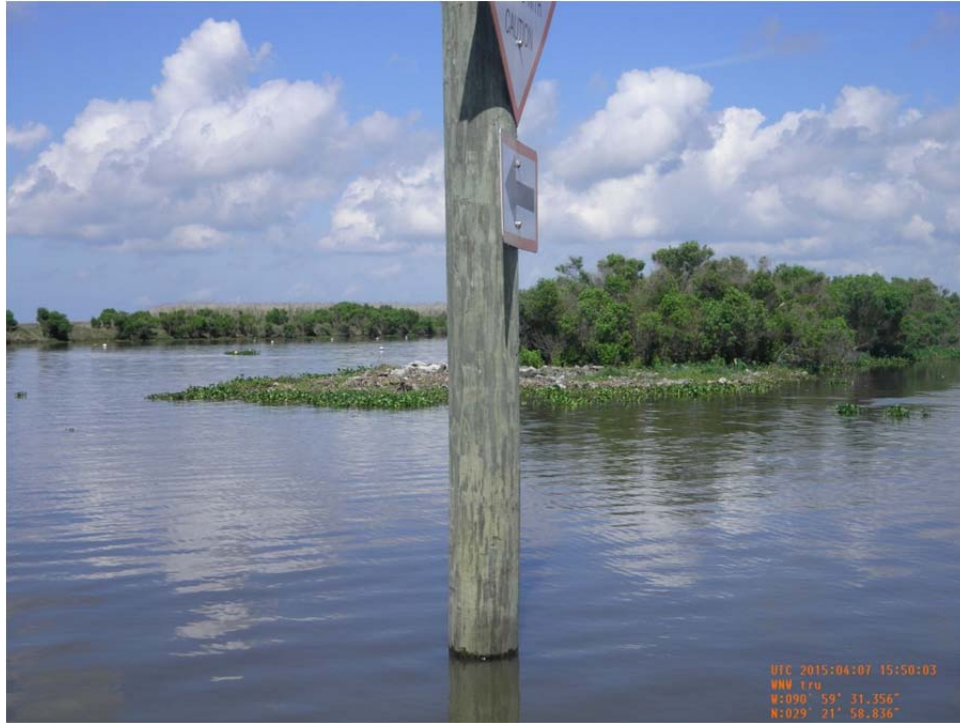
Structure No.10 appears to be in fair to good condition. The rock tie-ins to the bank on both sides of the structure appear to be thin and have settled slightly. The center depth of the rock channel liner was approximately 7.0 feet. Based on the gauge reading near Structure No. 6, the elevation of the rock sill would be approximately -5.5' NAVD. The constructed sill elevation was -4.75', indicating that structure has settled approximately 1 foot. All of the timber piling and warning signs appear to be in good condition (See Appendix B, Photos 5 through 7)

Photo 5: view of warning signs at the entrance of the rock rip rap channel liner (Structure No.10). Several of the warning signs and timber piling were replaced in 2012.

Photo 6: view of south bank of the rock rip rap channel liner (Structure No.10).

Photo 7: view of the north bank of the rock rip rap channel liner (Structure No.10).

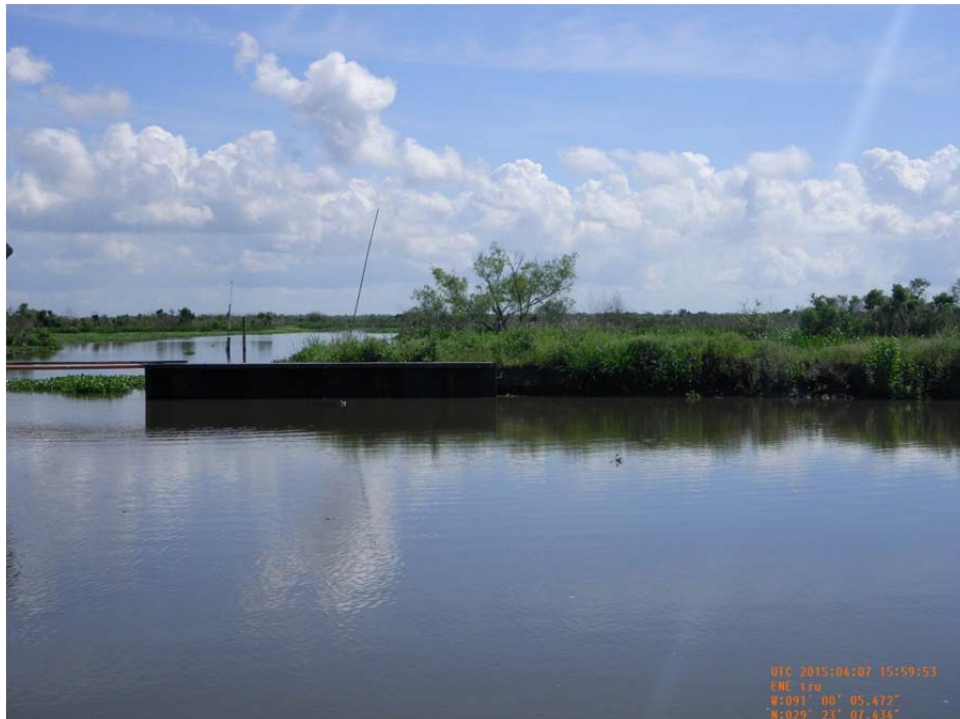
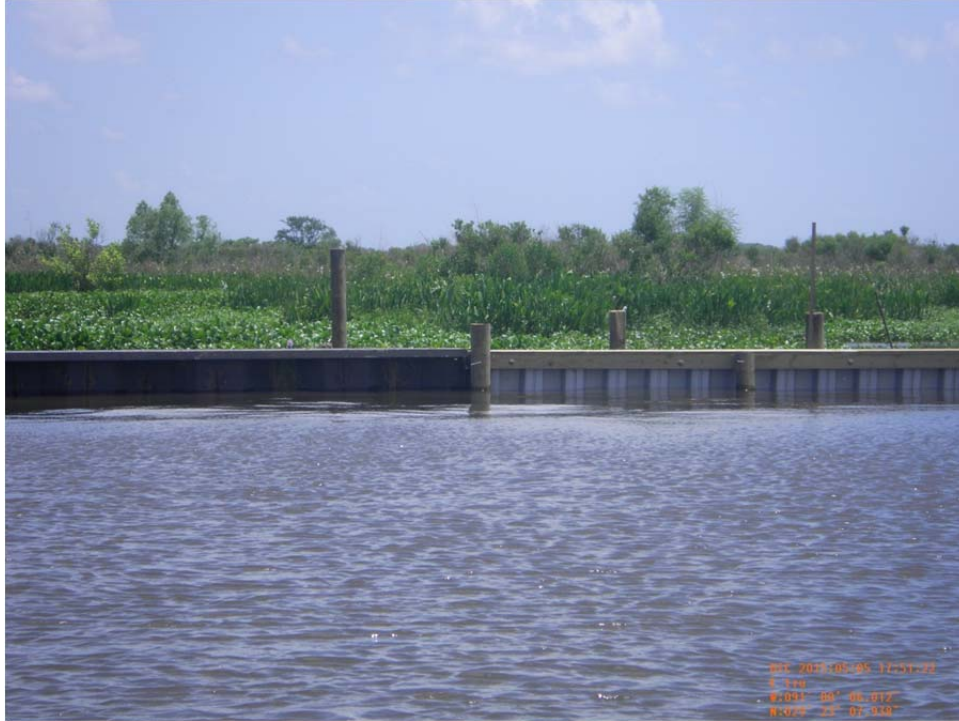
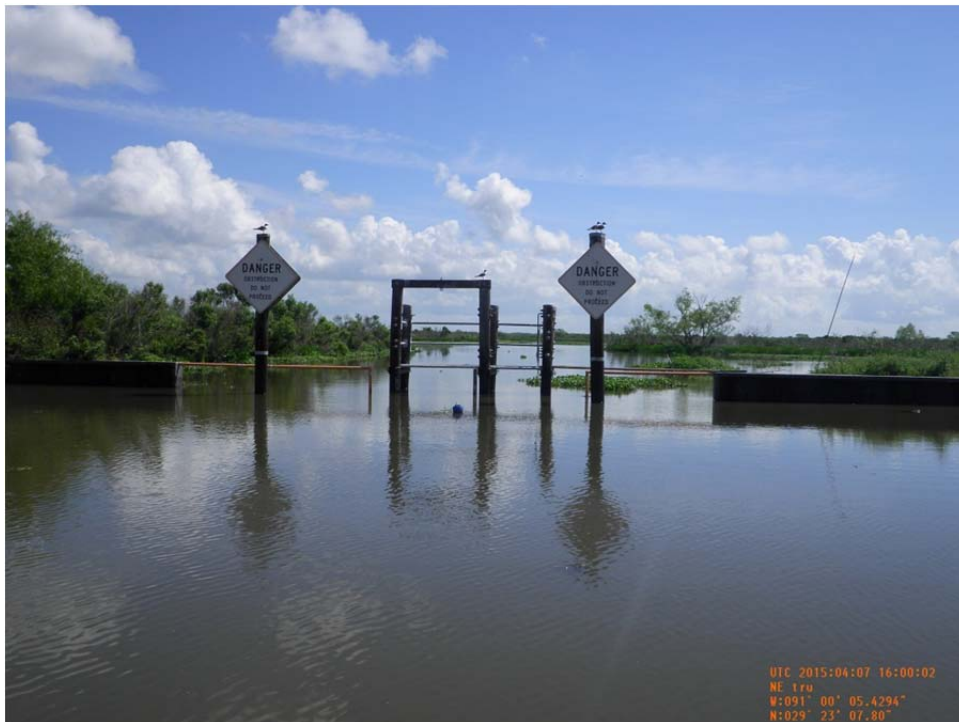
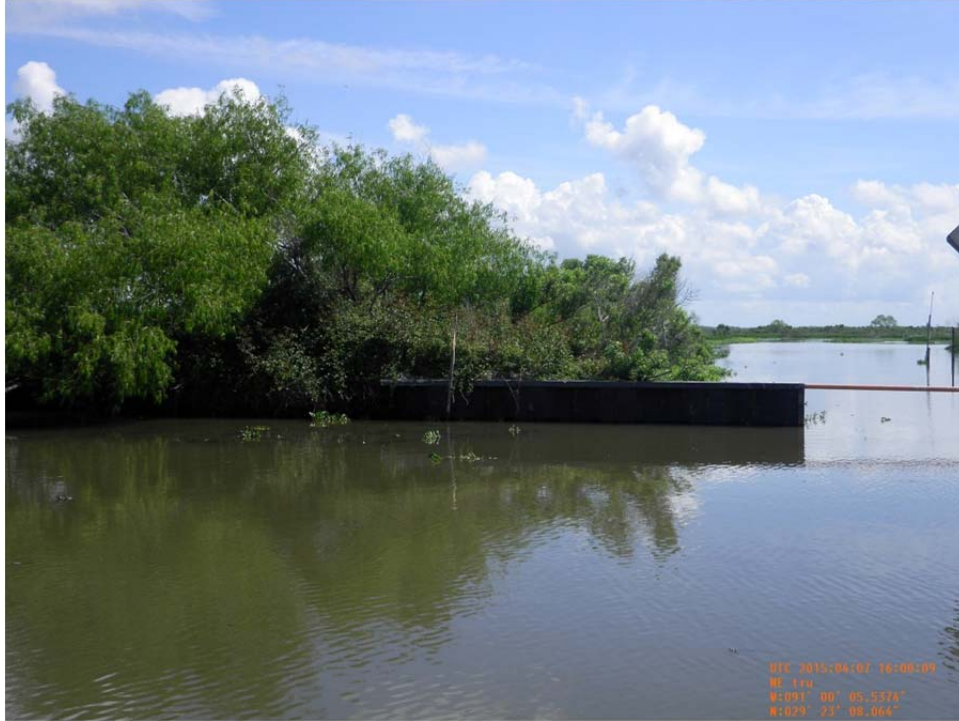
This structure appears to be in fair condition. There was no visible damage to the railings, platform, steel bulkhead or warning signs. As on previous inspections, we did note that the earthen embankment tie-ins on both sides of the structure were experiencing significant erosion with very little, if any, material remaining on the bayou side of the structure. Although there was little landmass on the bayou side of the structure, the marsh side did have enough material to prevent the embankment from breaching. The erosion of the embankment has worsened over the last few years and will require some corrective action within the next couple of years. ConocoPhillips regularly maintains the earthen overflow banks along Carencro Bayou and may be able to dredge material from the bayou to reconstruct the embankment tie-in. CPRA will coordinate with ConocoPhillips for a possible repair of the tie-ins during their next levee maintenance event. At this time, we will continue to monitor this site for breaches and work with ConocoPhillips on a method of repair. **Update: On an unrelated inspection, we noticed that the camp owner just south of Structure 14 had installed a vinyl bulkhead along the front of his camp. The bulkhead extends north and ties into the southern end of the steel bulkhead on the south side of Structure 14, effectively solving the erosion issue on that side of the structure.** (See Appendix B, Photos 8 through 10)

Photo 8: view of the south section of the steel sheetpile wall and bank tie-in at Structure No.14. The structure is a variable crest weir with a single stop log bay.

Photo 8A: view of the south section of the steel sheetpile wall and new constructed vinyl sheetpile installed by the adjacent camp owner.

Photo 9: an overall view of the variable crested weir with stop log bay (Structure No.14)

Photo 10: view of the north section of the steel sheetpile wall and bank tie-in at Structure No.14. The structure is a variable crest weir with a single stop log bay.

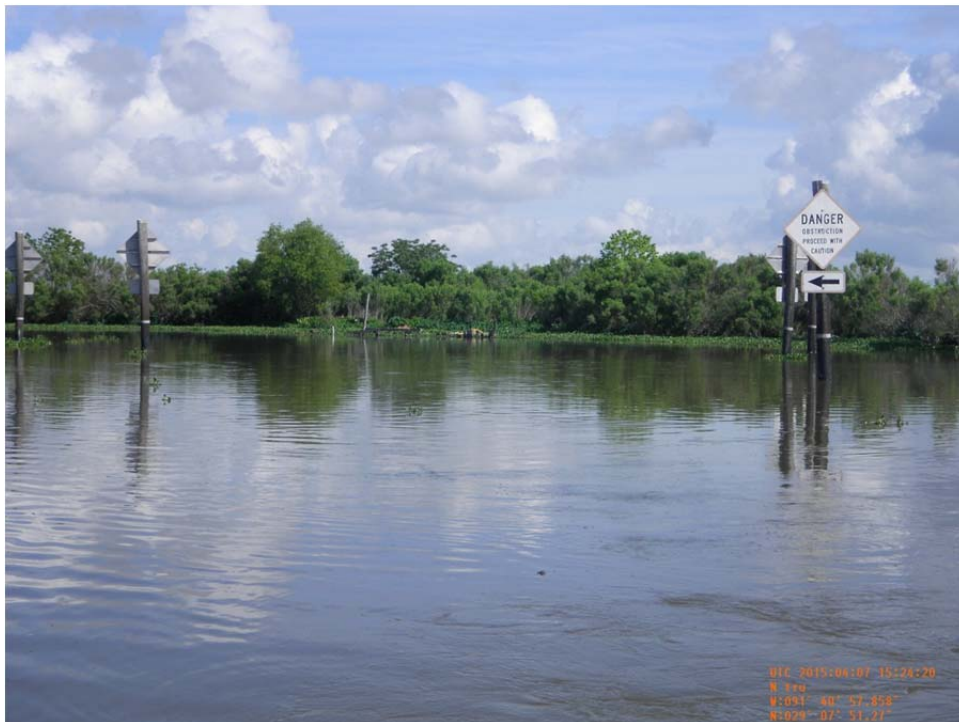
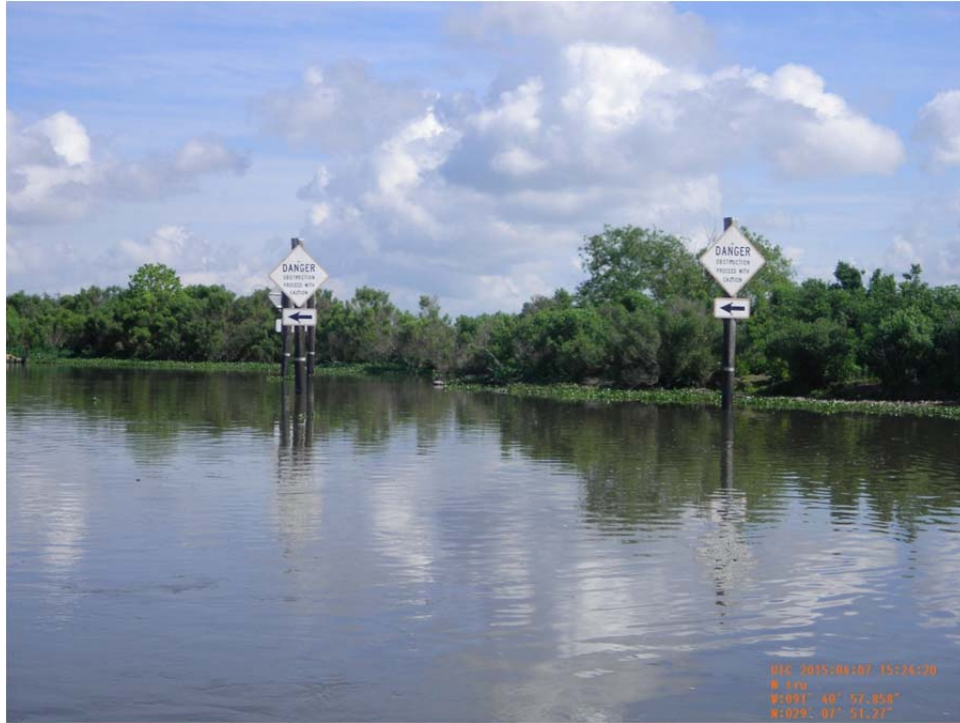
This structure is in good overall condition. As noted in previous annual inspections, there has been some settlement of the rock riprap on the bank tie-ins and submerged crest of the structure. In 2012, it was determined the crest of the submerged channel liner has settled to a depth of -5.7' NAVD88, which translates to approximately 1.0' of settlement since

construction. During the 2015 inspection, the depth of water at the center of the rock channel liner was approximately 7.5', which translates into crest elevation of -6.0' elevation. The water levels at the time of the inspection was +1.45' NAVD. From our calculations, Structure No. 20 has experienced approximately 1.25' settlement since the structure was constructed in 1998. All other warning signs and timber supports are in good condition. The refurbishment of Structure No. 20 was excluded from the 2012 Maintenance Project, but the earthen embankment was capped with riprap up to the structures eastern embankment tie-in. At this time, Structure No. 20 is in good condition and no maintenance will be required. (See Appendix B, Photo 11 and 12)

Photo 11: View of Structure No.20, a rock rip rap channel liner, located along the north bank of Jug Lake.

Photo 12: View of Structure No.20, a rock rip rap channel liner, and warning signs located along the north bank of Jug Lake.

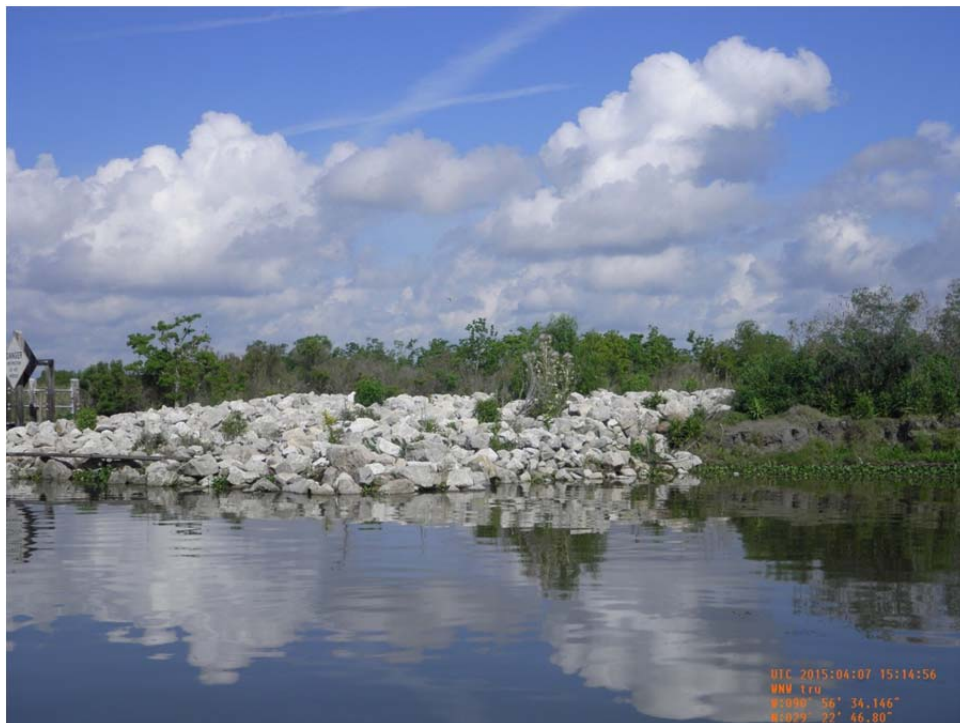
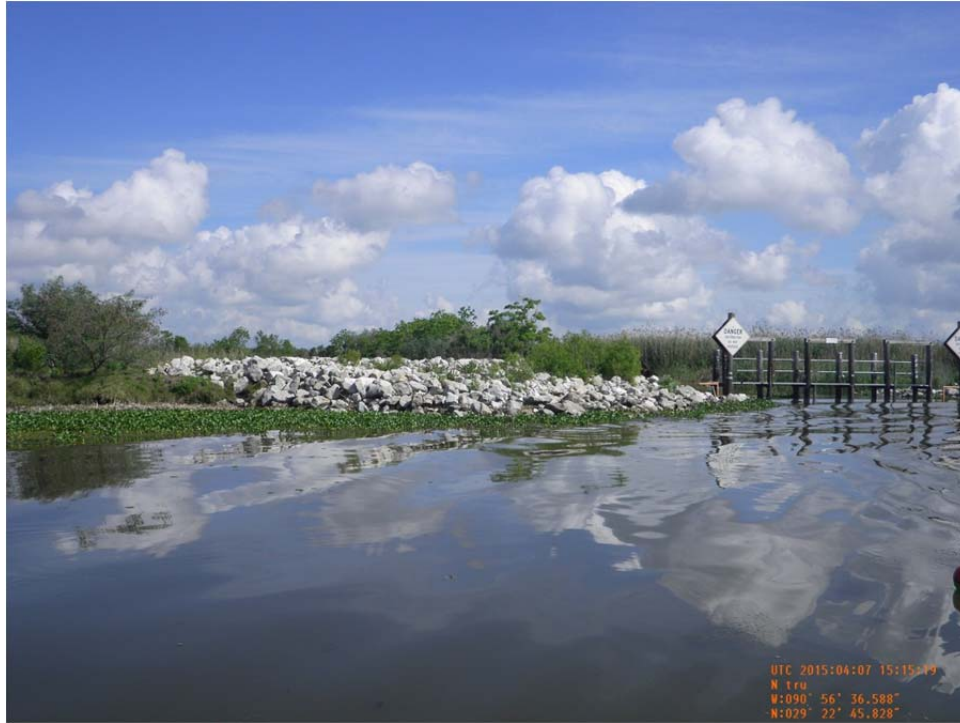
Overall, Structure 21 is in very good condition. There is no visible damage to the steel bulkhead, railings, platform or the warning signs and their timber supports. As part of the 2012 Maintenance Project, Structure 21 had both of its embankment tie-ins refurbished and then armored with 50 linear feet of rock riprap to prevent any further erosion around the ends of the structure. There has not been any visual settlement of the riprap following the completion of the maintenance project. Structure 21 will not require maintenance. (See Appendix B, Photos 13 through 14)

Photo 13: view of rock rip rap revetment on the north side Structure No. 21. The earthen embankment was refurbished and the rock rip rap revetment was installed in 2012.

Photo 14: view of rock rip rap revetment on the south side Structure No. 21, a variable crested weir with three (3) stop log bays. The earthen embankment was refurbished and the rock rip rap revetment was installed in 2012.

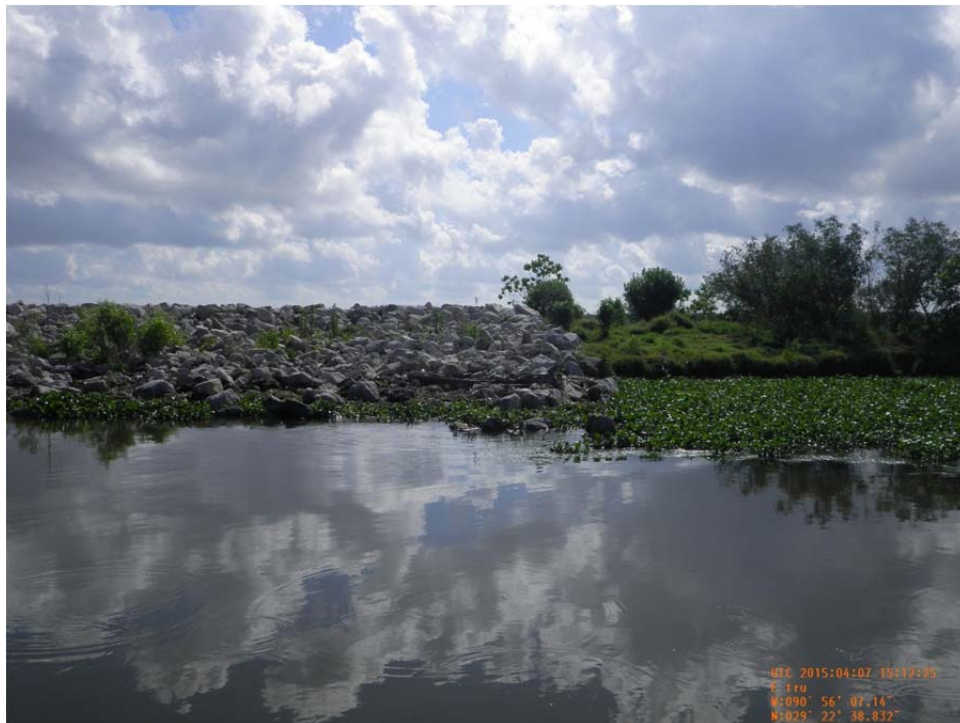
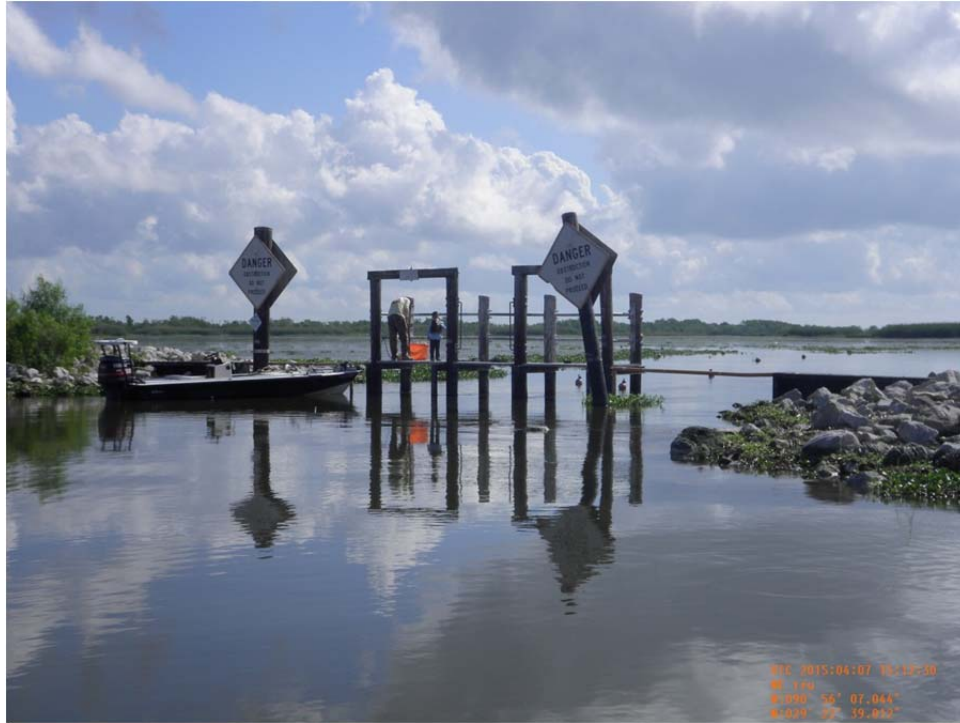
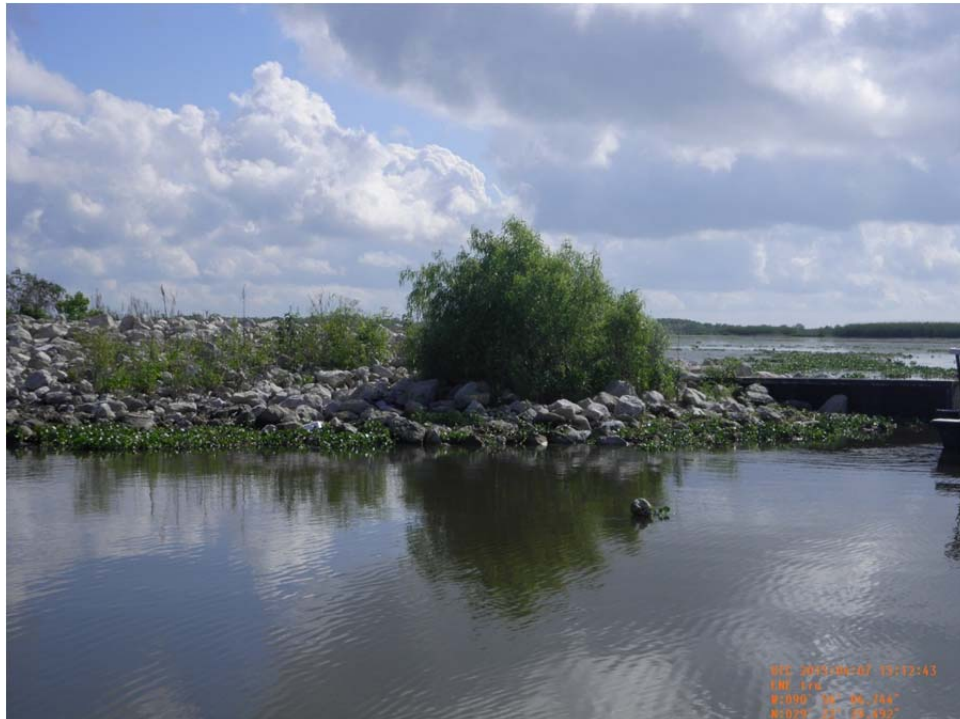
Overall, Structure 23 is in good condition. There is no visible damage to the steel bulkhead, railings, platform, or the warning signs and their timber supports. As part of the 2012 Maintenance Project, Structure 23 had both of its embankment tie-ins refurbished and then armored with 50 linear feet of rock riprap in each direction to prevent any further erosion around the ends of the structure. There has not been any visual settlement of the riprap following the completion of the maintenance project. Structure 23 has been restored to its original constructed condition and will not require maintenance. (See Appendix B, Photos 15 through 17)

Photo 15: View of the rock armament of the earthen embankment on the south side of Structure No.23. The earthen embankment was refurbished and the rock armor installed in 2012.

Photo 16: Overall view of Structure No.23, variable crested weir structure.

Photo 17: View of the rock armament of the earthen embankment on the north side of Structure No.23. The earthen embankment was refurbished and the rock armor installed in 2012.

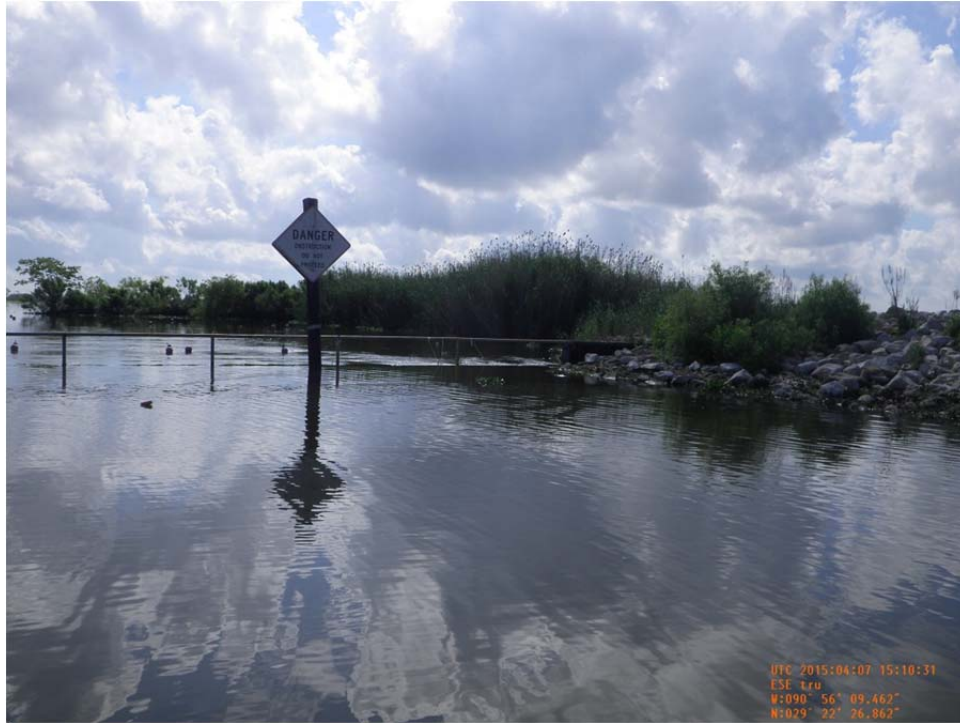
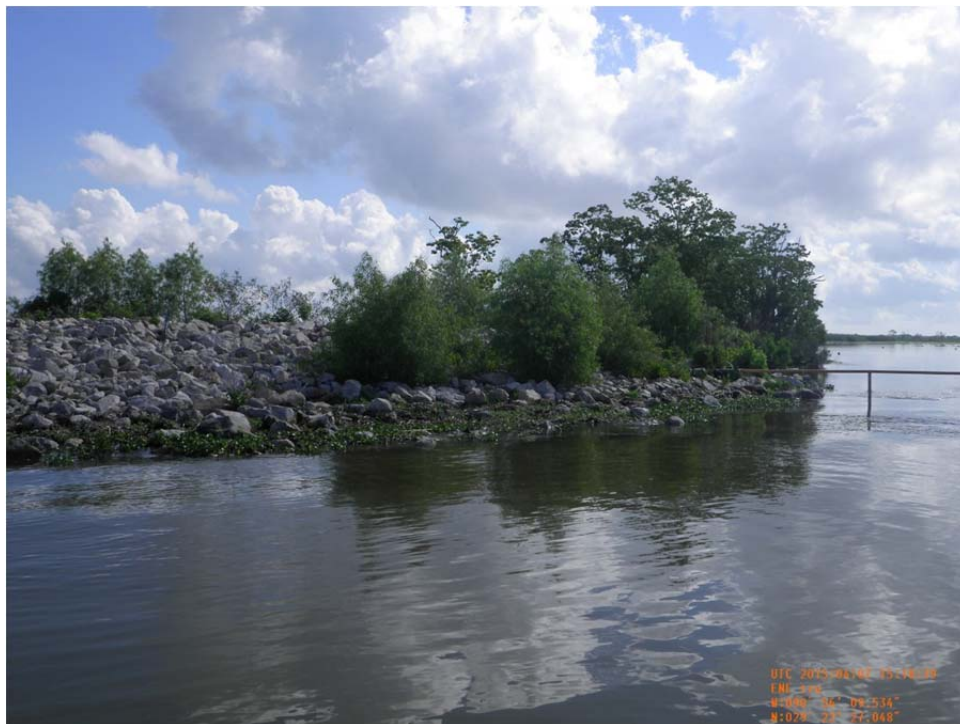
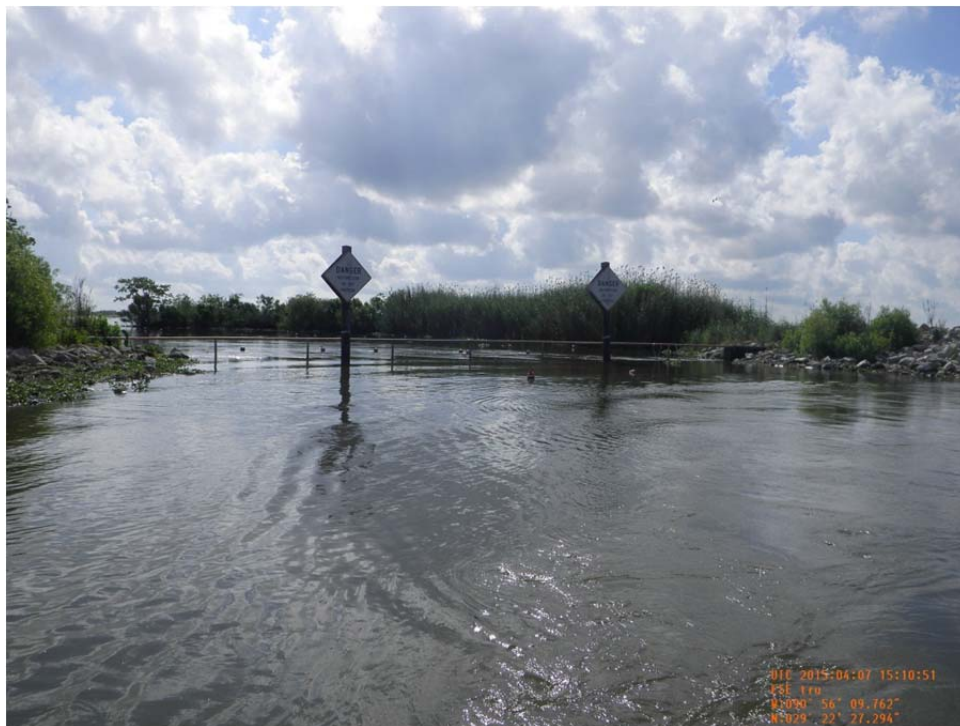
Overall, Structure No. 24 is in good condition. There is no visible damage to the steel bulkhead, railings, platform, or the warning signs and their timber supports. As part of the 2012 Maintenance Project, Structure No. 24 had both of its embankment tie-ins refurbished and armored with rock riprap on both sides to prevent any further erosion around the ends of the structure. There has not been any visual settlement of the riprap following the completion of the maintenance project. Structure No. 24 has been restored to its original constructed condition and will not require maintenance. (See Appendix B, Photos 18 through 20)

Photo 18: View of south bank tie-in of Structure No.24 located along the north bank of Jug Lake. The embankment was refurbished and the rock riprap apron was installed during the 2012 Maintenance Project.

Photo 19: View of north bank tie-in of Structure No.24 located along the north bank of Jug Lake. The embankment was refurbished and rock riprap apron was installed during the 2012 Maintenance Project.

Photo 20: A full view of Structure No.24 located along the north bank of Jug Lake.

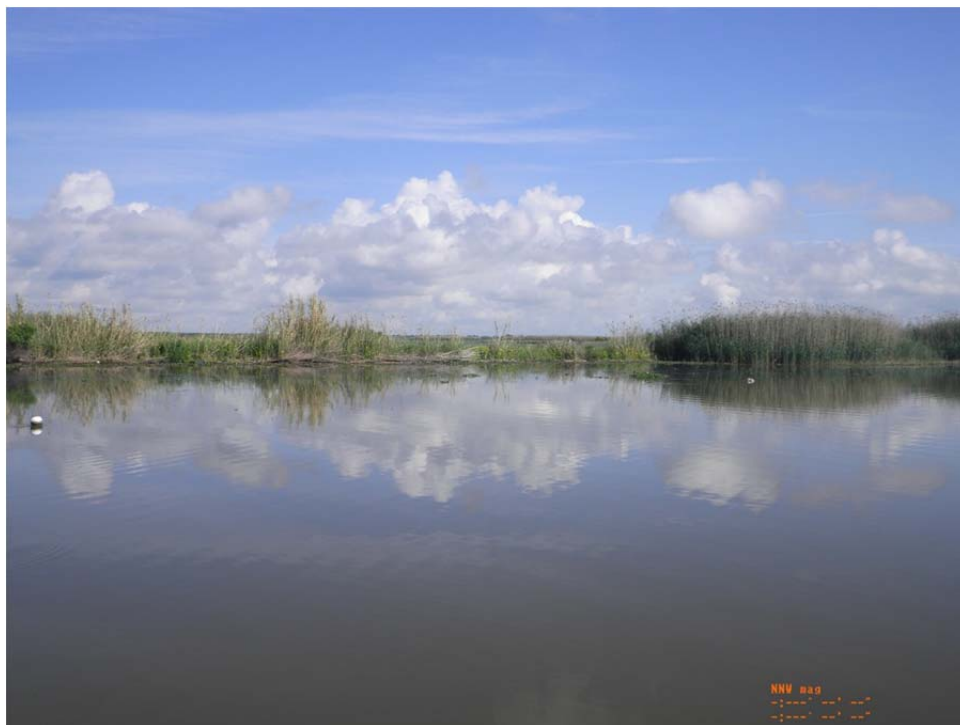
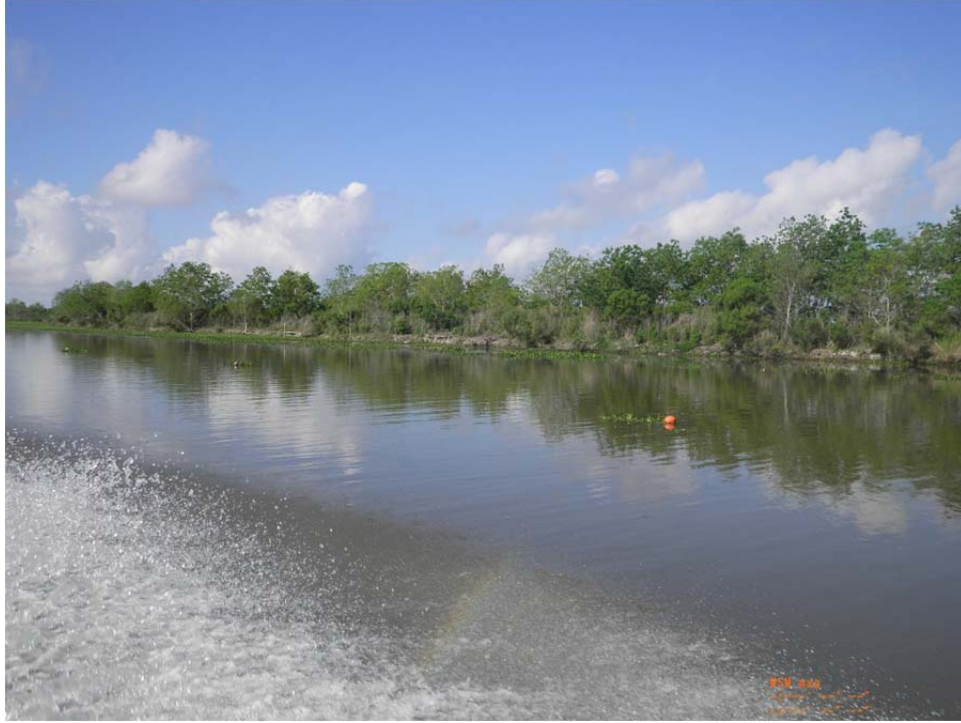
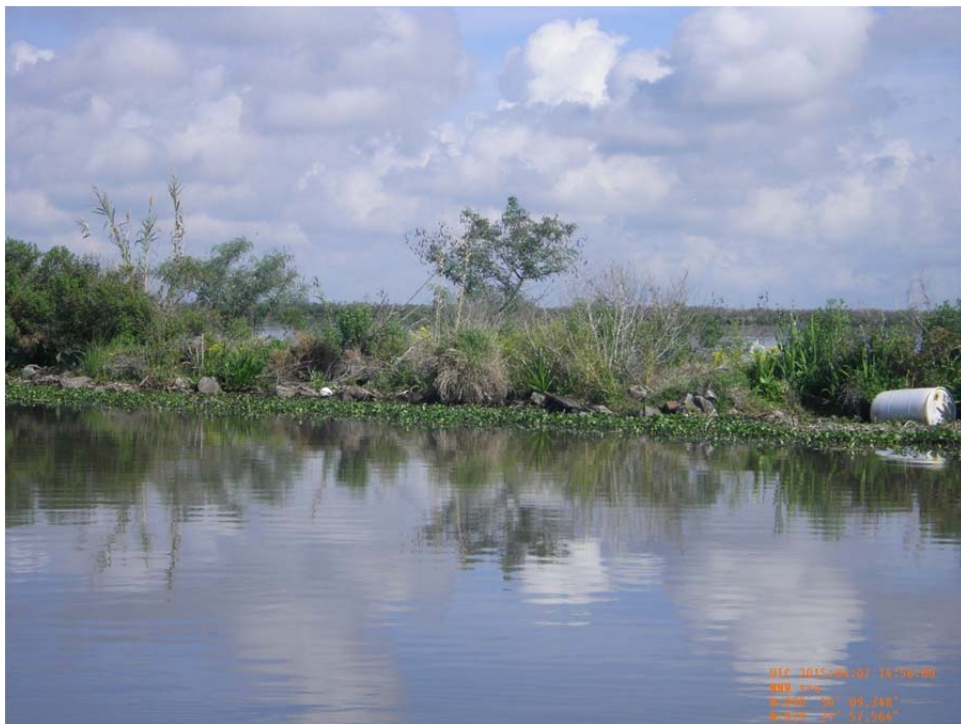
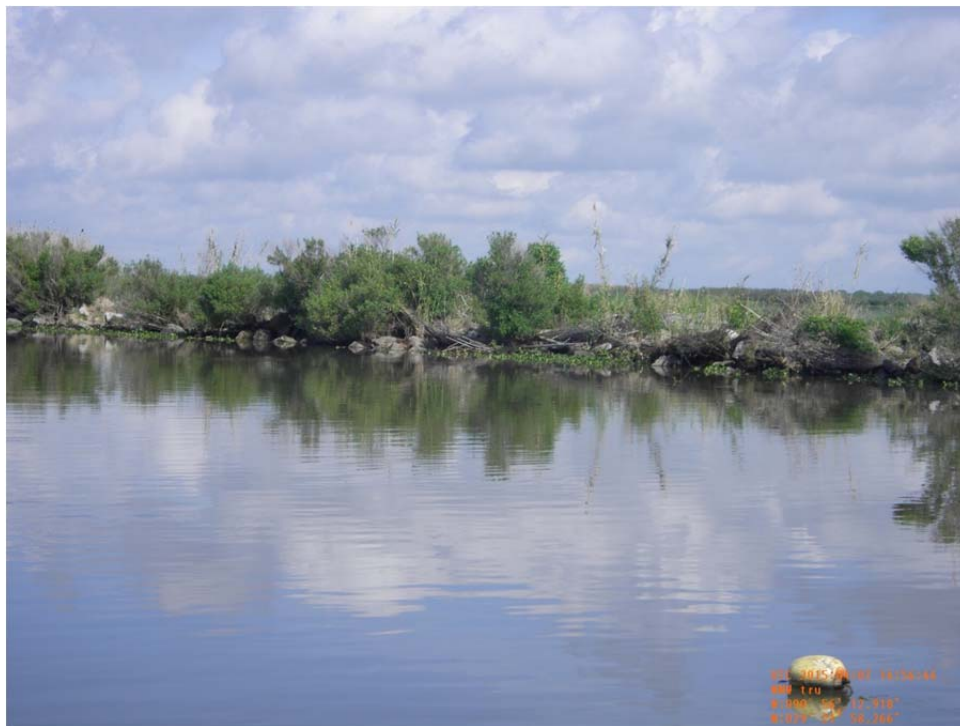
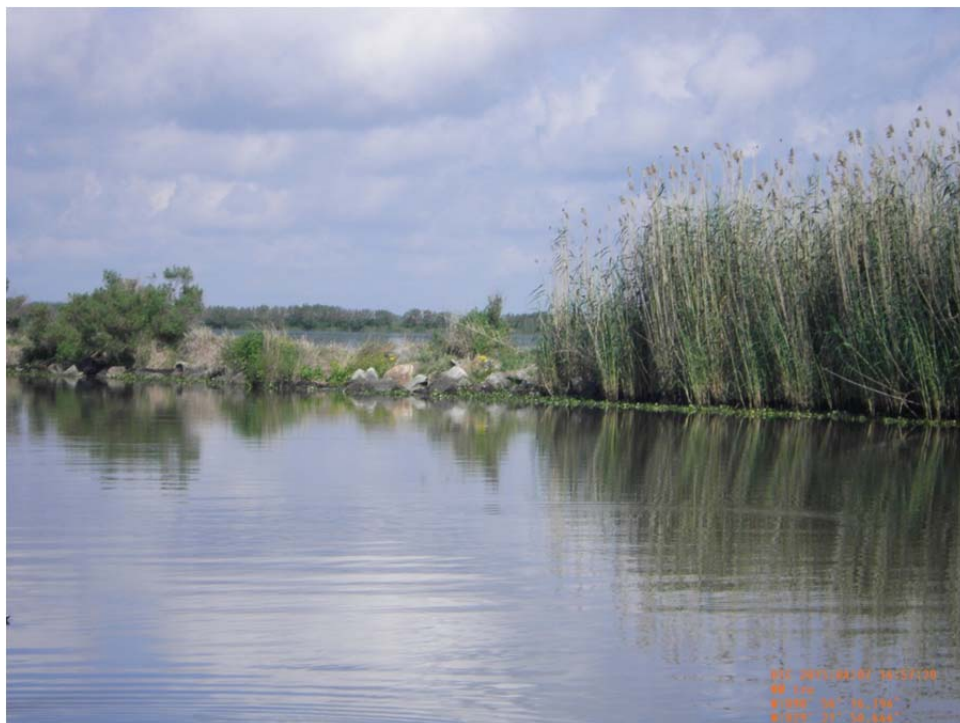
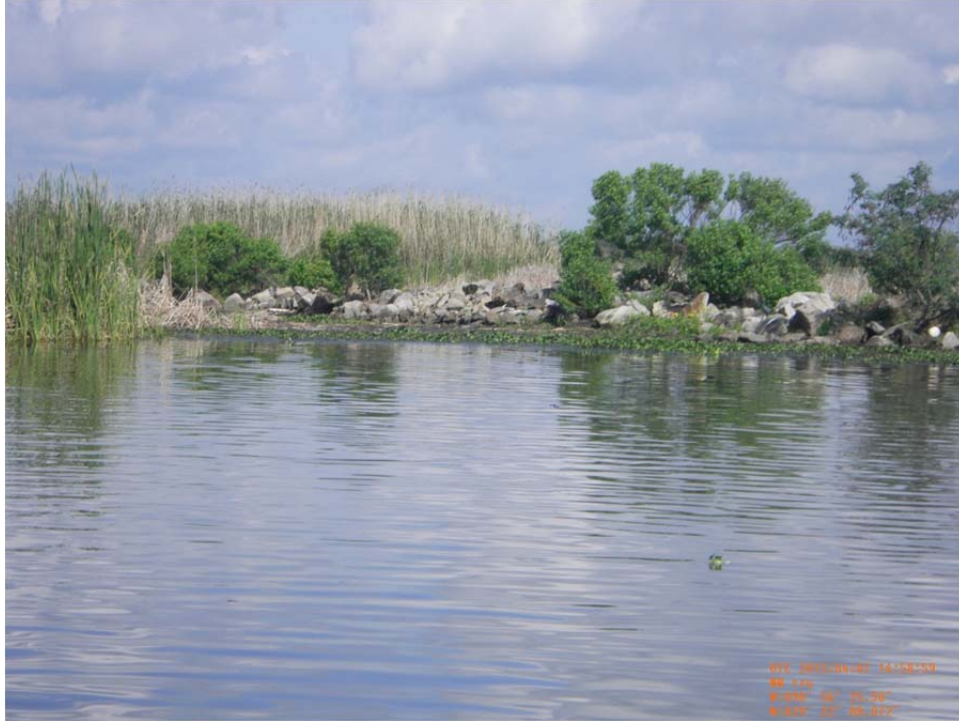
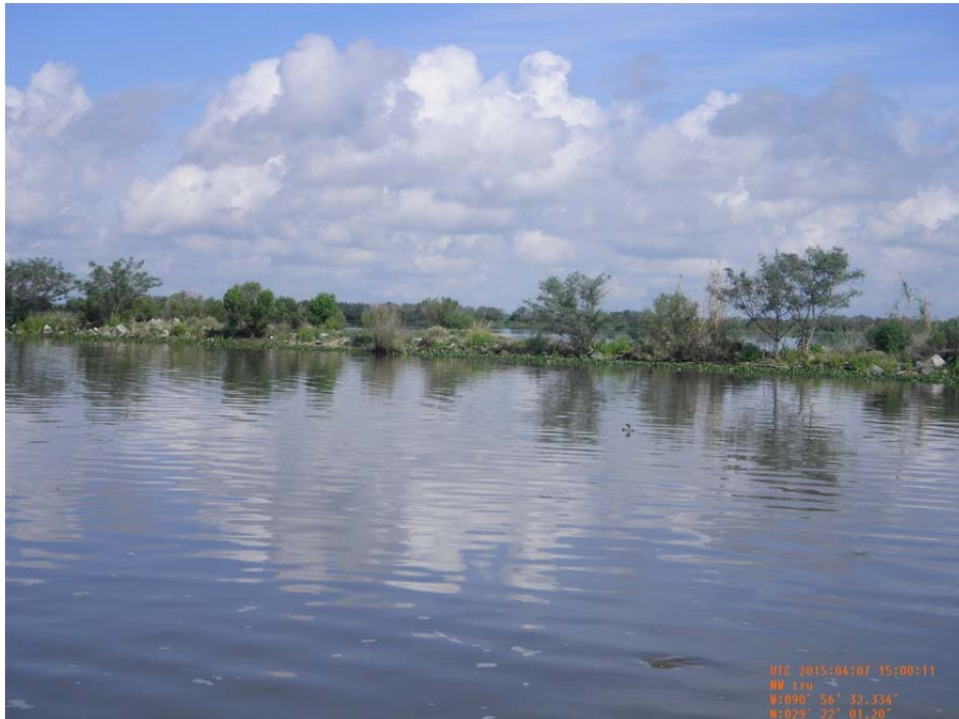
The inspection of the earthen embankments began with the west bank of Turtle Bayou and progressed along Superior Canal, the dead end canal off of Superior Canal, Bayou Decade, Jug Lake, through Voss Canal, Bayou Carencro, and concluded along Brady Canal at the Apache Camp location. The earthen embankments along Turtle Bayou and Superior Canal are in good condition. There are visual variations in the elevation and various vegetative species,

but no noticeable breaches in the embankment. The earthen embankments along Bayou DeCade and Voss Canal are also in good condition. These areas have experienced some erosion, but with little to no change observed since the previous inspections. The earthen embankment along Bayou Carencro had some low spots identified during this inspection. This section of the project boundary is designated as an overflow bank, so without a full breach, maintenance is not needed at this time. (See Appendix B, Photos 21 through 27; 35, 36, 40 through 43)

Photo 21: Photo of existing earthen embankment along the west bank of Turtle Bayou.

Photo 22: Photo of existing earthen embankment along the west bank of Turtle Bayou. This section of bank line was refurbished during the 2003 Maintenance Event.

Photo 23: View of the rock armored embankment along the north bank of Bayou Decade near the mouth of Turtle Bayou. The rock armament was installed under the 2003 Maintenance Project. This structure was identified as Breaches 1 through 4.

Photo 24: View of the rock armored embankment along the north bank of Bayou Decade.

Photo 25: View of the rock armored embankment along the north bank of Bayou Decade.

Photo 26: View of the rock armored embankment along the north bank of Bayou Decade.

Photo 27: View of the rock armored embankment along the north bank of Bayou Decade near Jug Lake.
