**2015 Annual Inspection Report**

**BRADY CANAL HYDROLOGIC  
RESTORATION PROJECT (TE-28)**

State Project Number TE-28  
Priority Project List 3

November 4, 2015  
Terrebonne Parish

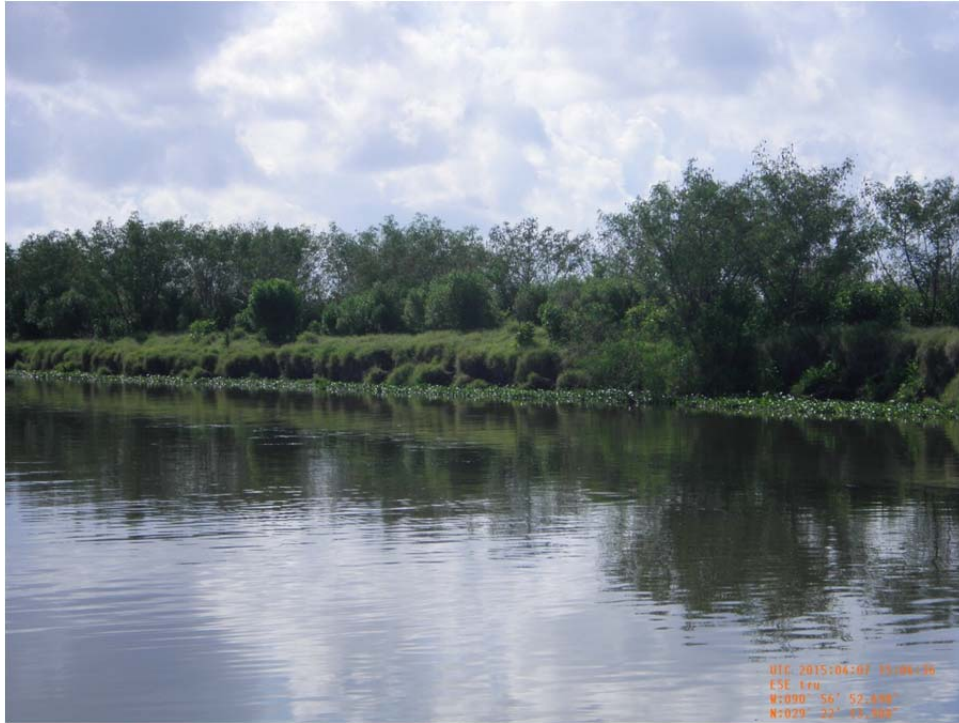
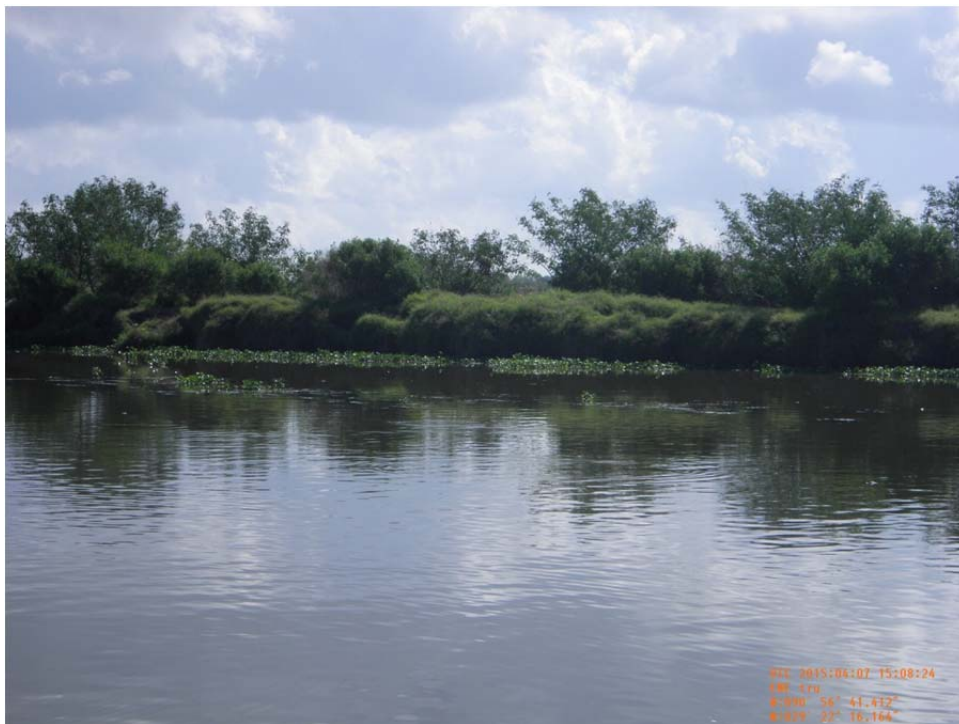
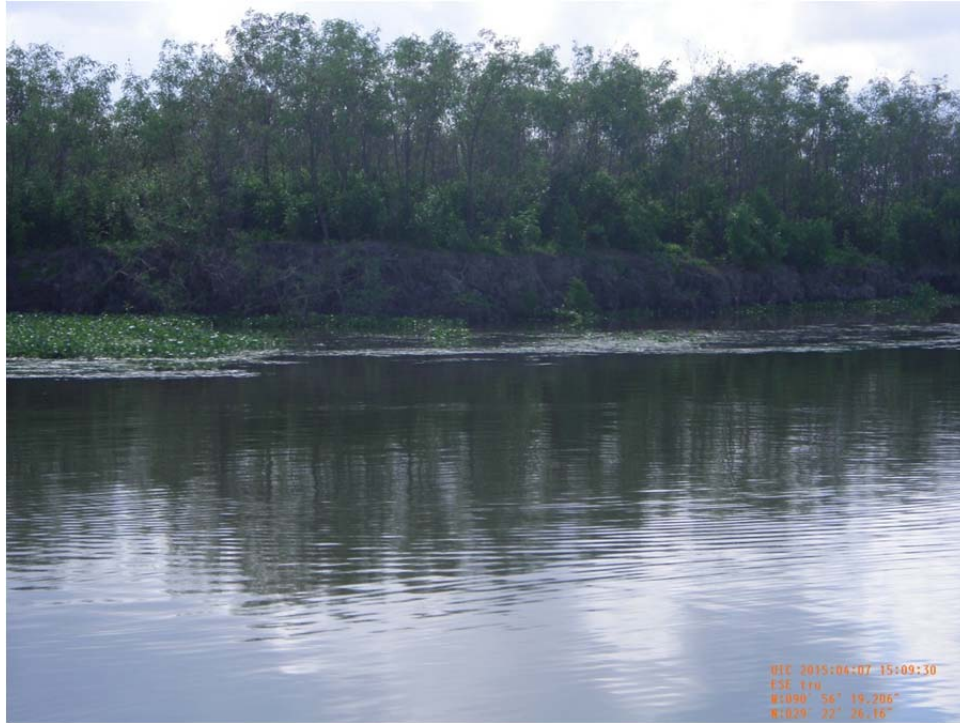
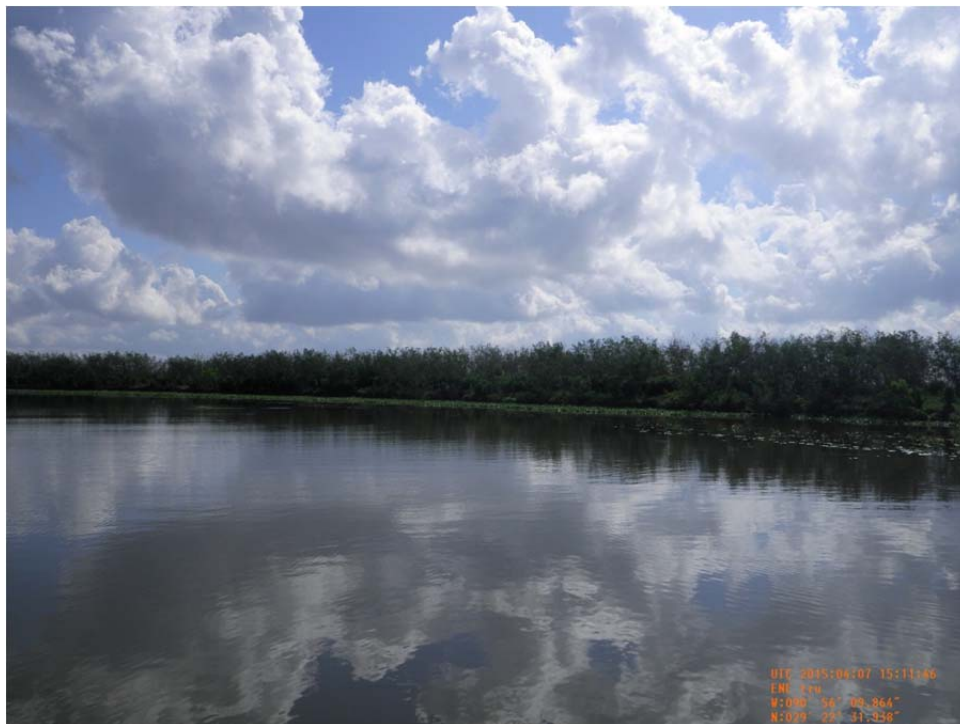
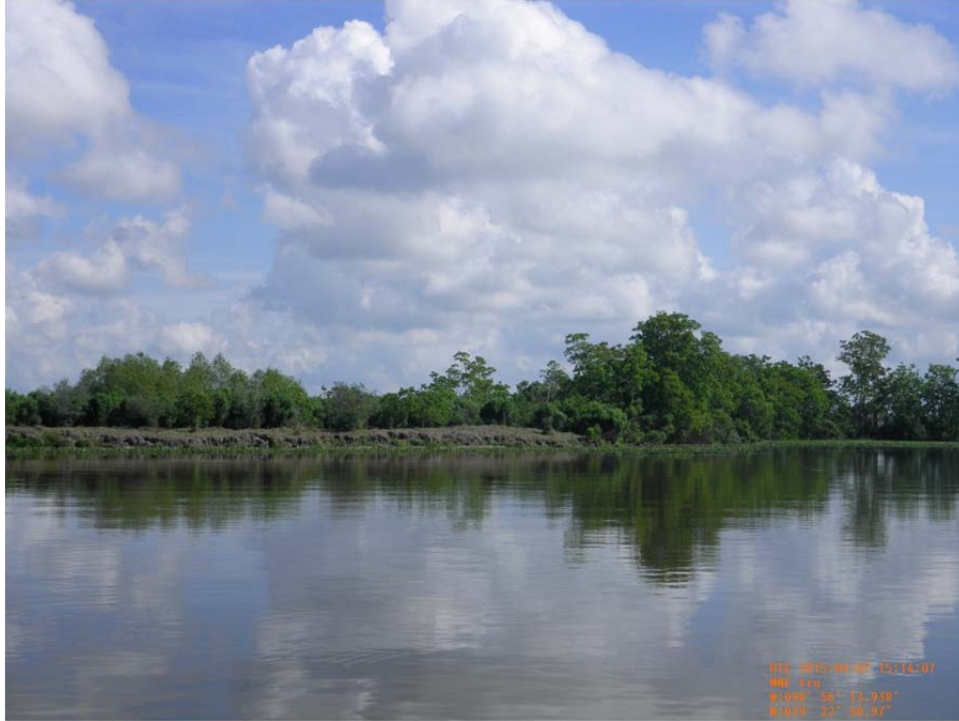
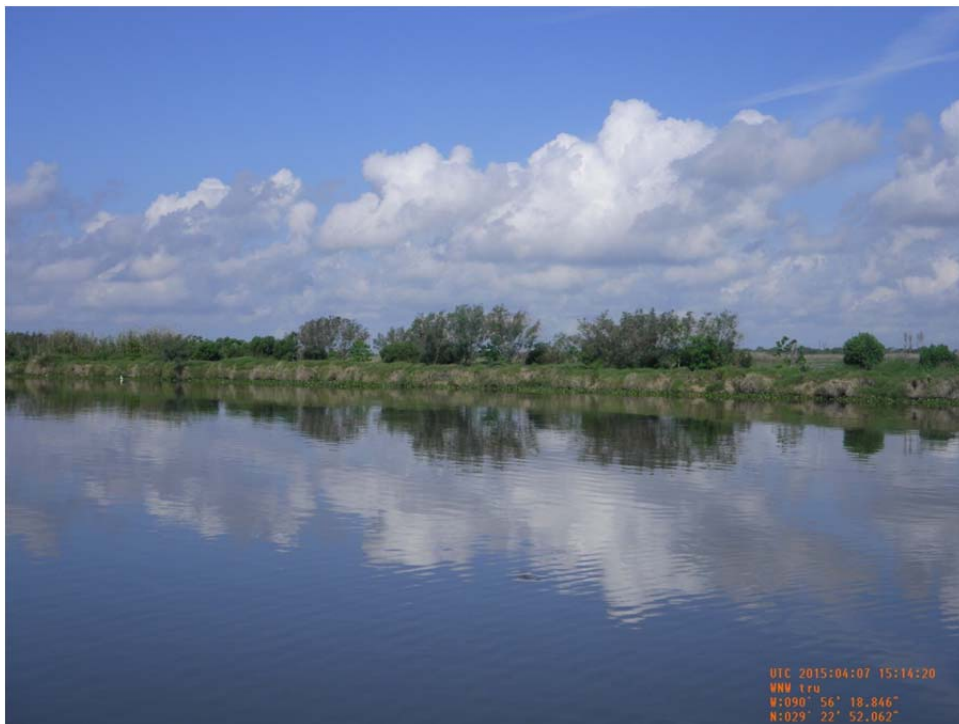
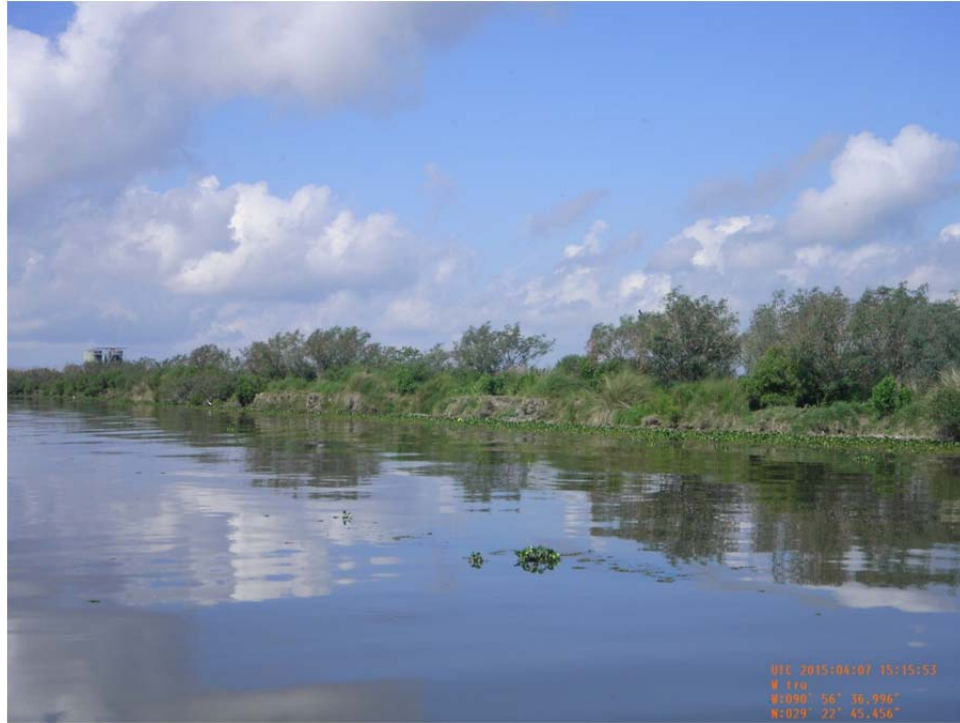
As part of the 2012 Maintenance Project, approximately 13,900 linear feet of earthen embankment around the rim of Jug Lake was refurbished. As of last year, we noted that large cut banks had developed along the face of the newly constructed embankment. This year, the embankment was covered with vegetation and erosion of the face appeared to have stabilized. There are no recommendations for corrective action at this time, but we will continue to monitor on future site visits. (See Appendix B, Photos 28 through 34)

Photo 28: View of the refurbished embankment on the northern bank of Jug Lake. This bank line was refurbished and seeded during the 2012 Maintenance Project.

Photo 29: View of the refurbished embankment on the northern bank of Jug Lake. This bank line was refurbished and seeded during the 2012 Maintenance Project.

Photo 30: View of the refurbished embankment on the northern bank of Jug Lake. This bank line was refurbished and seeded during the 2012 Maintenance Project.

Photo 31: View of the refurbished earthen embankment along the north bank of Jug Lake between Structures 23 and 24. The bank line was refurbished in 2012.

Photo 32: View existing earthen embankment along the south side of Jug Lake. This section of the embankment was refurbished in 2012.

Photo 33: View existing earthen embankment along the south side of Jug Lake. This section of the embankment was also refurbished in 2012.

Photo 34: View existing earthen embankment along the south side of Jug Lake, south of Structure No.21. This section of the embankment was refurbished in 2012.

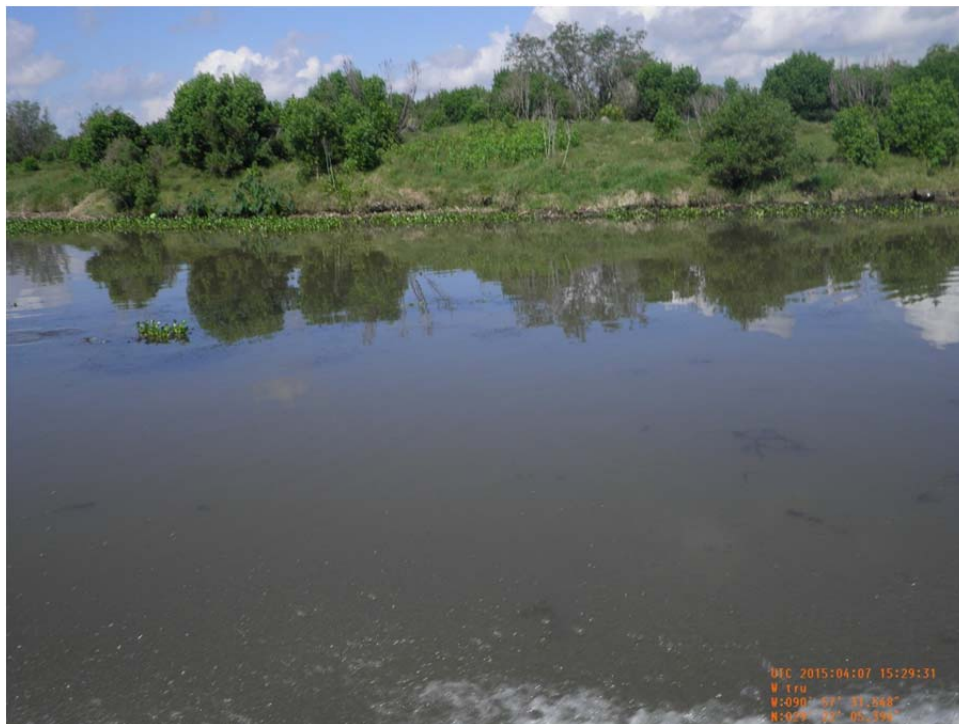
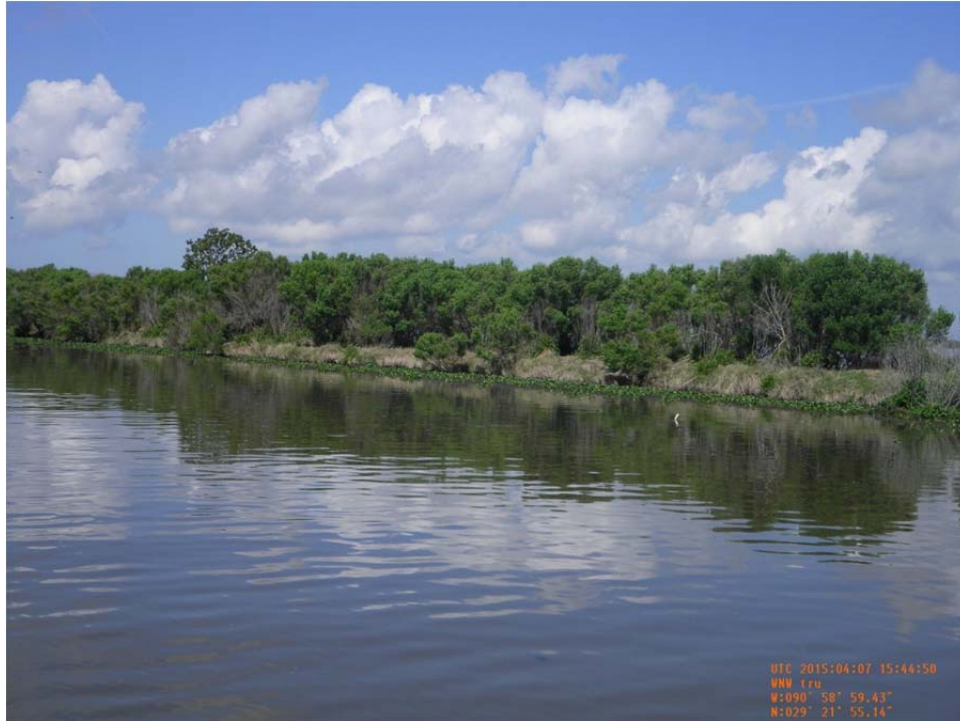
but no noticeable breaches in the embankment. The earthen embankments along Bayou DeCade and Voss Canal are also in good condition. These areas have experienced some erosion, but with little to no change observed since the previous inspections. The earthen embankment along Bayou Carencro had some low spots identified during this inspection. This section of the project boundary is designated as an overflow bank, so without a full breach, maintenance is not needed at this time. (See Appendix B, Photos 21 through 27; 35, 36, 40 through 43)

Photo 35: view of existing earthen embankment long the north bank Bayou Decade at the entrance of Jug Lake on north bank. This section of embankment was refurbished and seeded in 2012.

Photo 36: view of existing earthen embankment along the north bank of Bayou Decade near Voss Canal.

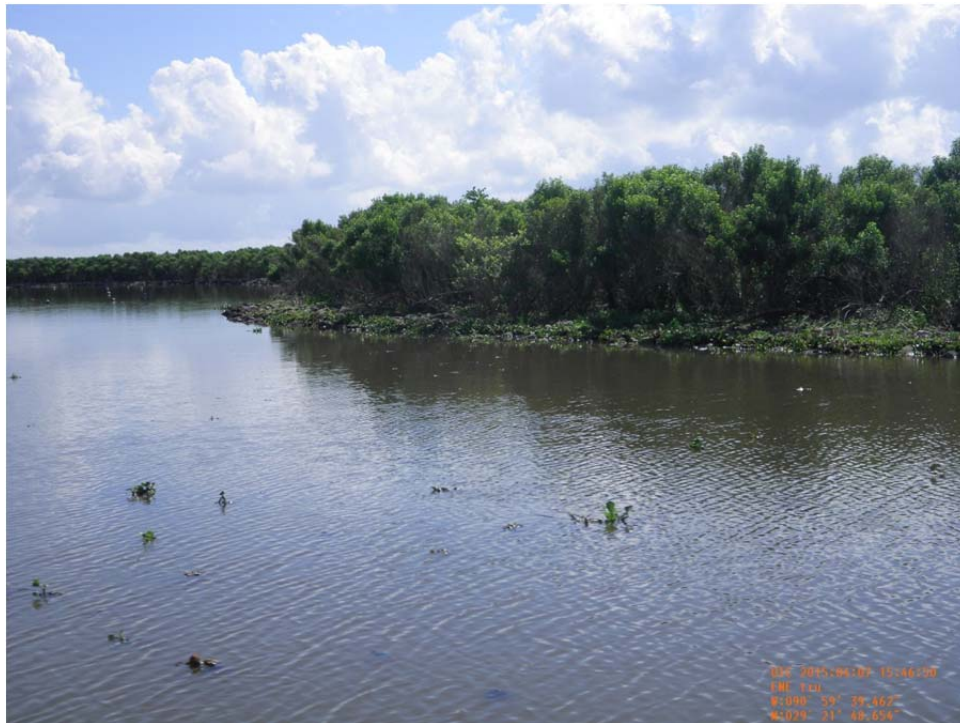
Photo 37: view of low lying rock dike at the entrance of Voss Canal from Bayou Decade.

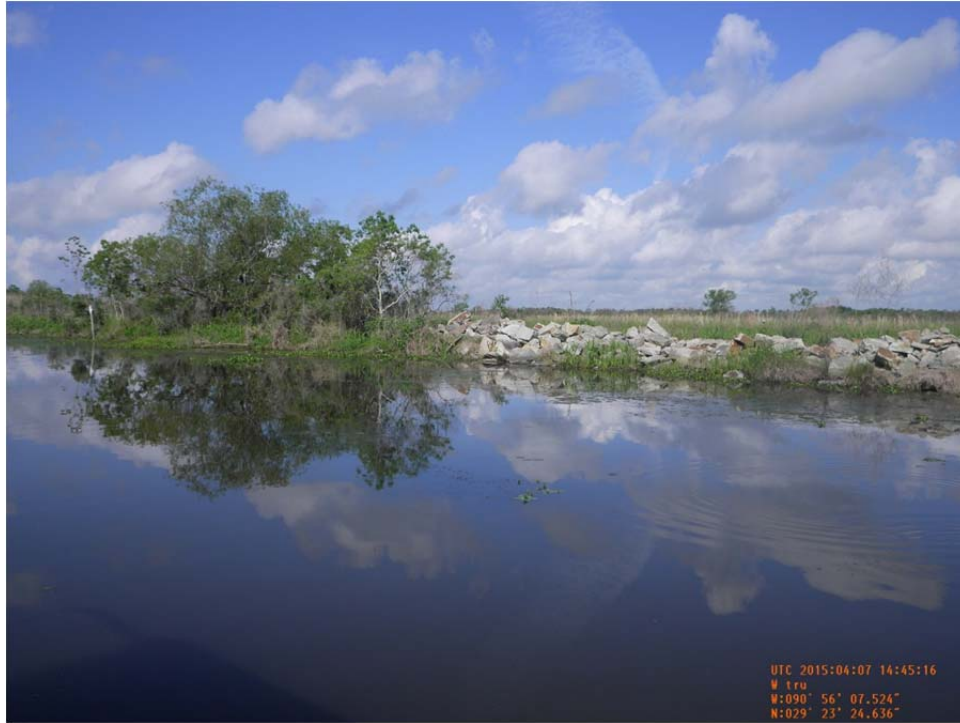
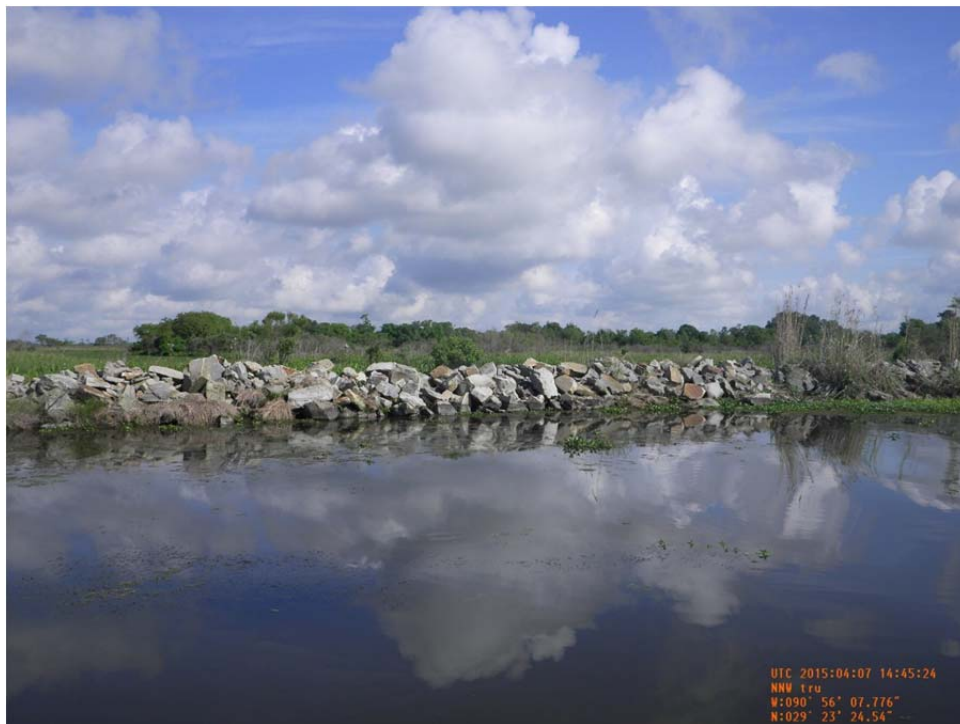
The rock plug known as “Breach 7” is located along an existing oil field access canal connected to Superior canal is in good condition. There was no observed settlement along the length of the embankment and no erosion or washouts around the embankment tie-ins. There are no recommendations for corrective action at this time, but it will continue to be monitored on future inspections. (See Appendix B, Photos 38 and 39)

Photo 38: View of rock plug closure located along an existing location canal west of Superior Canal. This structure was constructed under the 2003 Maintenance Event.

Photo 39: View of rock plug closure located along an existing location canal west of Superior Canal. This structure was constructed under the 2003 Maintenance Event, identified as Breach 7.

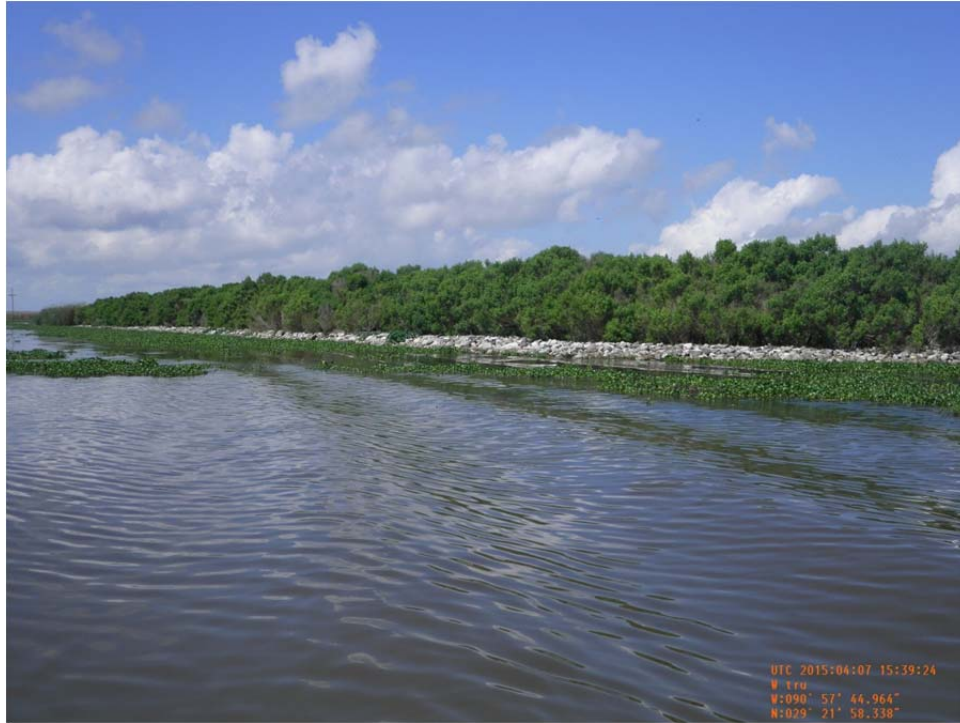
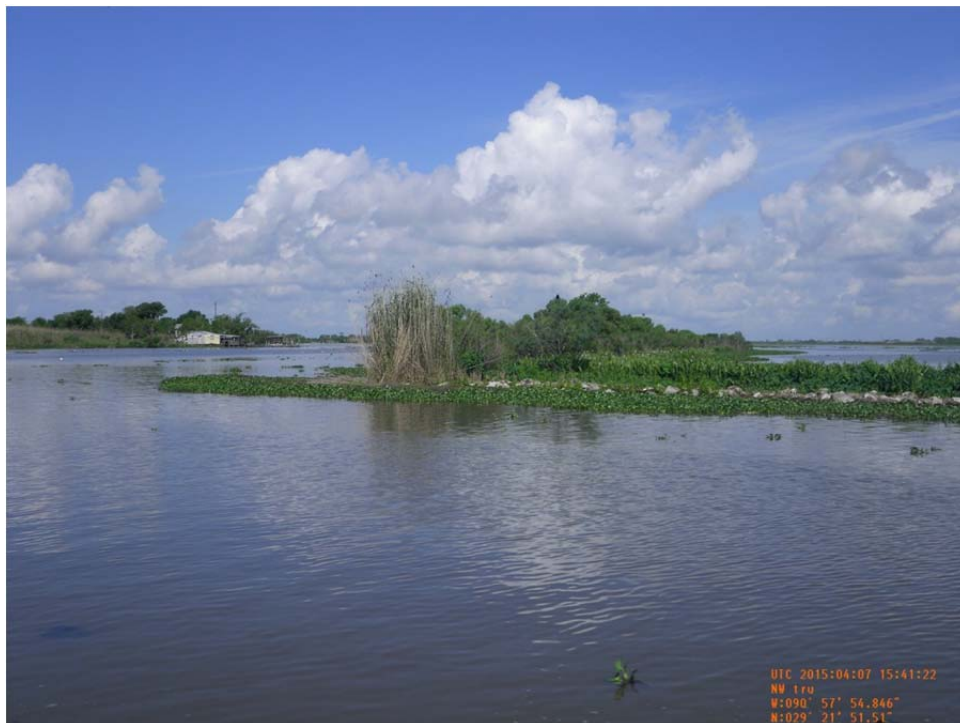
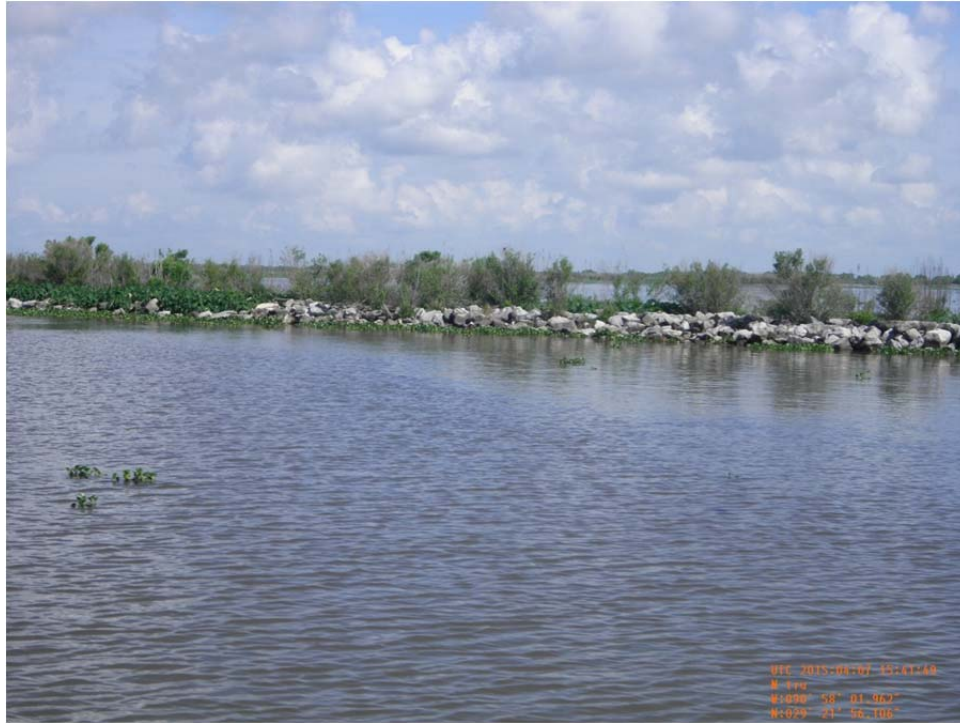
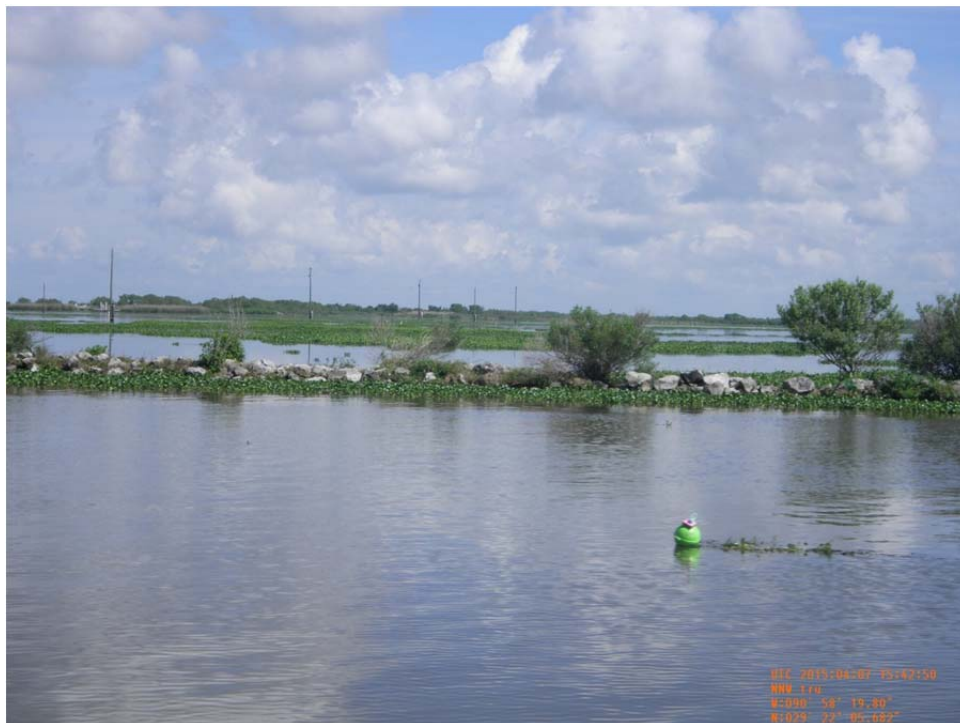
The rock armored embankments and rock dikes along the north bank of Bayou Decade and Voss Canal are in good condition. The rock dike along Bayou Decade between Jug Lake and Turtle Bayou appear to be in fair condition with isolated low areas and moderate displacement of rock riprap. The earthen embankment with rock revetment west of Structure 7 along Bayou Decade appears to be in good condition with no apparent settlement. The earthen embankment with rock revetment beginning at the intersection of Bayou Decade and Voss Canal had some initial settlement after construction but has experienced little change since previous inspections. Despite some minor deficiencies, the rock armored embankments appear to be functioning as intended and no maintenance will be required at this time. (See Appendix B, Photos 41 through 43)

Photo 40: view of earthen embankment with rock rip rap armament along the north bank of Bayou Decade west of Structure No.6

Photo 41: view of rock dike along the north bank of Bayou Decade between Structure No.6 and No.7, a rock rip rap plug.

Photo 42: view of rock dike along the north bank of Bayou Decade between Structure No.6 and No.7, a rock rip rap plug.

Photo 43: view of rock dike along the north bank of Bayou Decade between Structure No.6 and No.7, a rock rip rap plug.

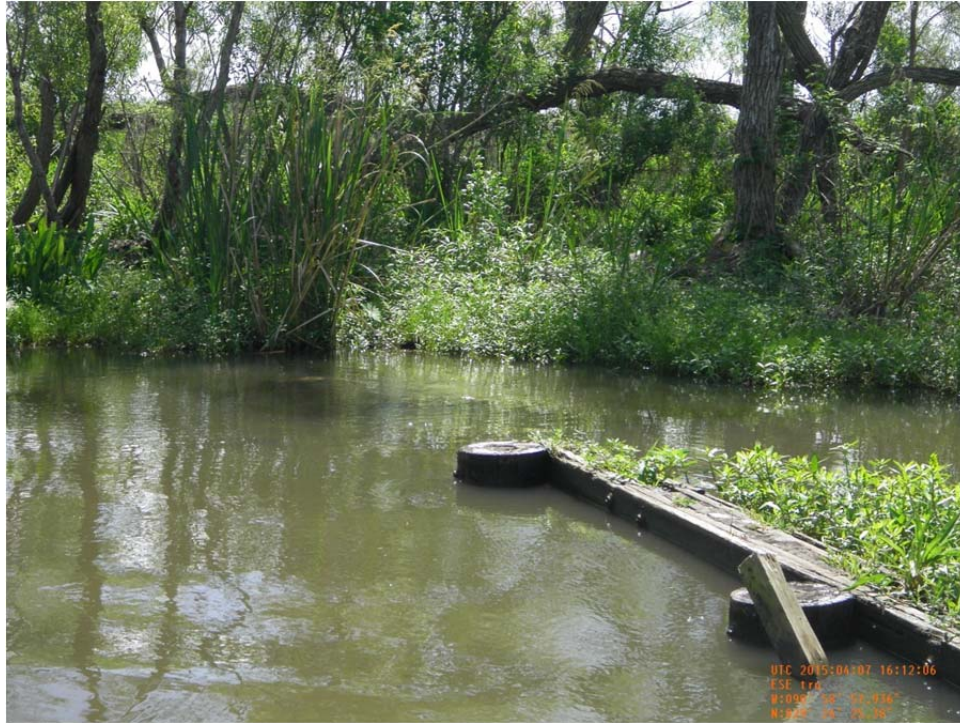
The rock closure adjacent to an existing timber bulkhead at the intersection of Carencro Bayou and Brady Canal identified as Breach 6 was closed as part of the 2012 Maintenance Project. A geotextile fabric was used to line the breach before it was filled with rock riprap. There was no visual settlement of the riprap or erosion of the bank tie-in at the time of the inspection. No maintenance will be required at this location. (See Appendix B, Photos 44)

Photo 44: view of breach closure adjacent to an existing timber bulkhead at the intersection of Carencro Bayou and Brady Canal.
