**2015 Annual Inspection Report**

**Penchant Basin Natural Resource  
Plan, Increment No. 1 (TE-34)**

State Project Number TE-34  
Priority Project List 6

September 21, 2015  
Terrebonne Parish

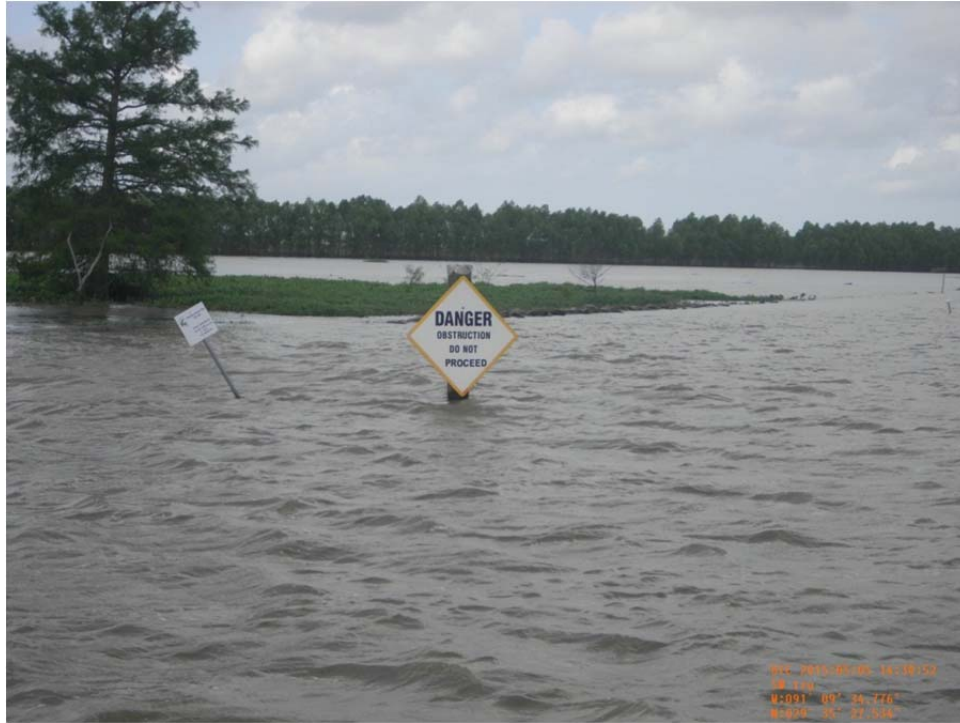
Upon arrival at the marsh creation sites and rock dike on both sides of Bayou Penchant near Bayou Chene, we noticed that the entire rock dike and marsh creation areas were under water due to high river stages. From the existing USGS gauge located in Bayou Penchant, the stage at the time of the inspection was 3.75' at 10:00 a.m. We were unable to visually inspect the rock dike and marsh creation areas, but did note that all of the warning signs were in good condition with no obvious damage. We will attempt to schedule the site visit for next year at a time when the river stages are lower and the features are visible. (Appendix B, Photos 1 through 6)

Photo 1: View of rock containment and fill area on west side of Bayou Penchant at Bayou Chene near Sta. 22+00.

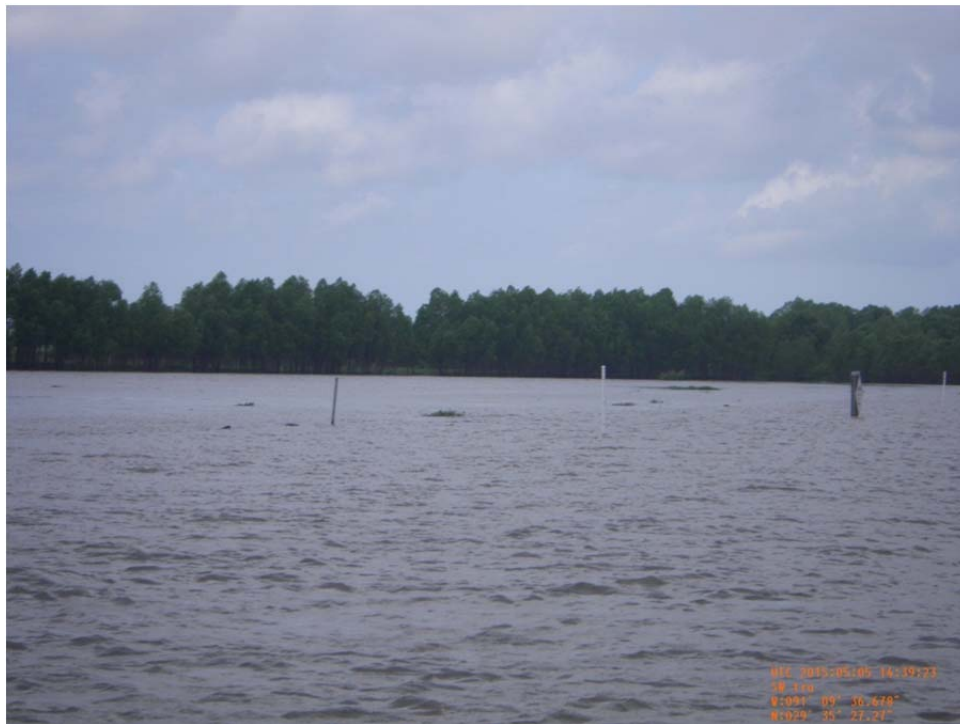
Photo 2: View of the rock containment and fill area on west side of Bayou Penchant at Bayou Chene near Sta. 20+00.

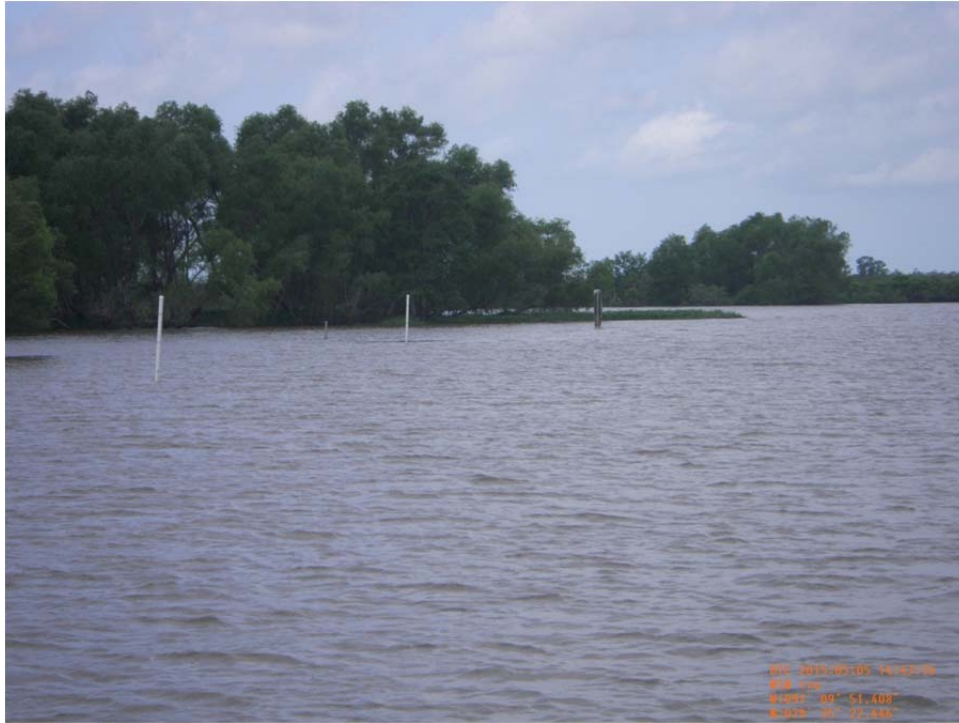
Photo 3: View of rock containment and fill area tie-in on far west end along Bayou Chene near Sta. 5+00.

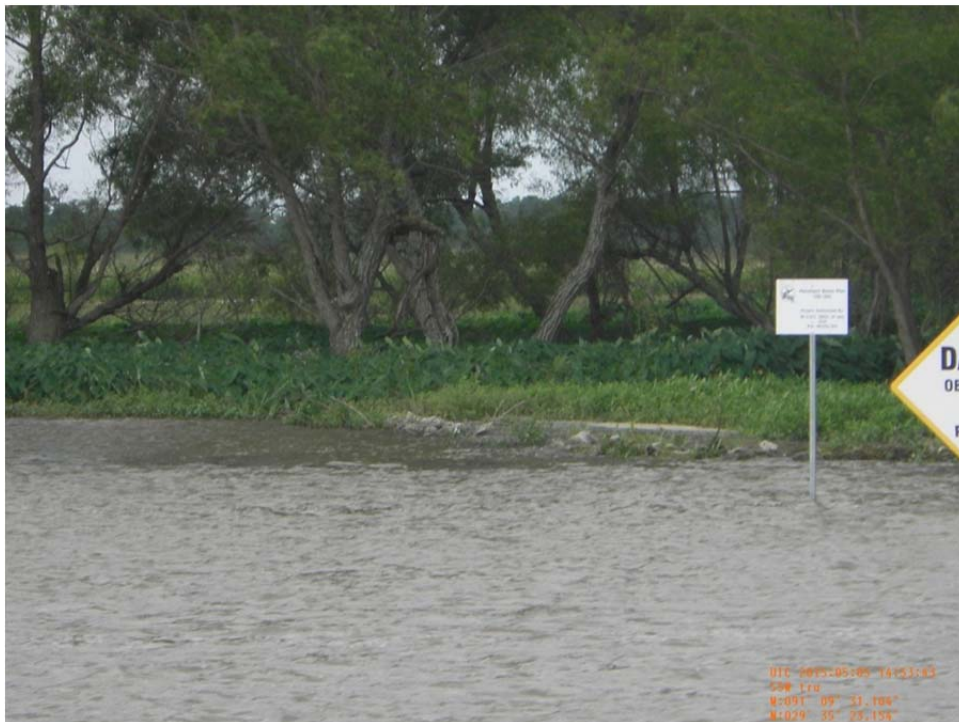
Photo 4: View of rock containment along the west bank at the mouth Bayou Penchant near Sta. 28+00.

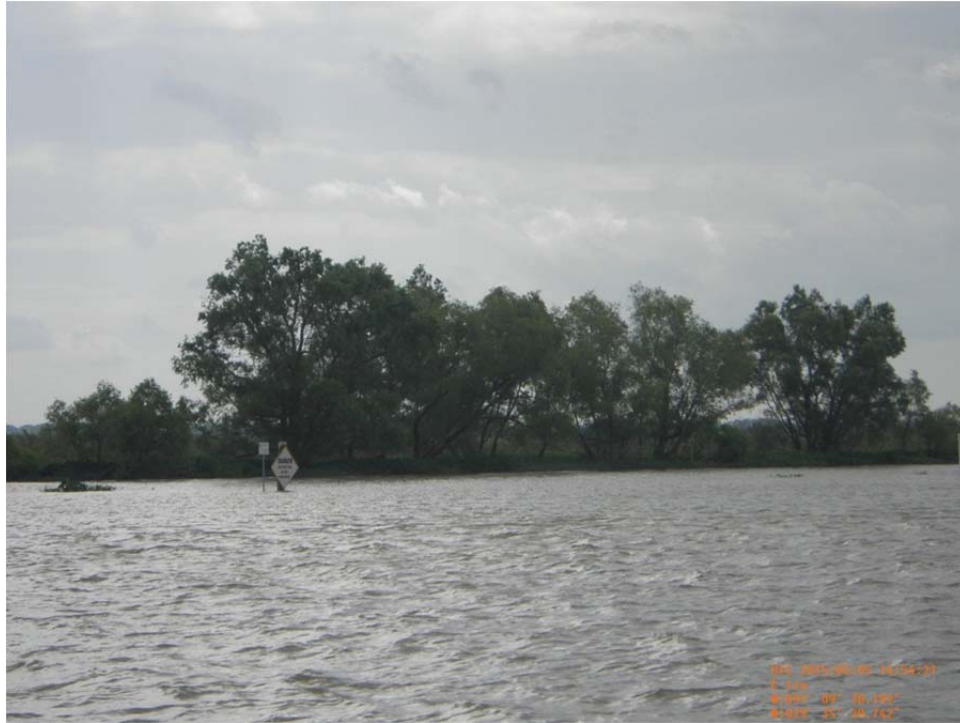
Photo 5: View of rock containment and fill area on the east side at mouth of Bayou Penchant near Sta. 25+00.

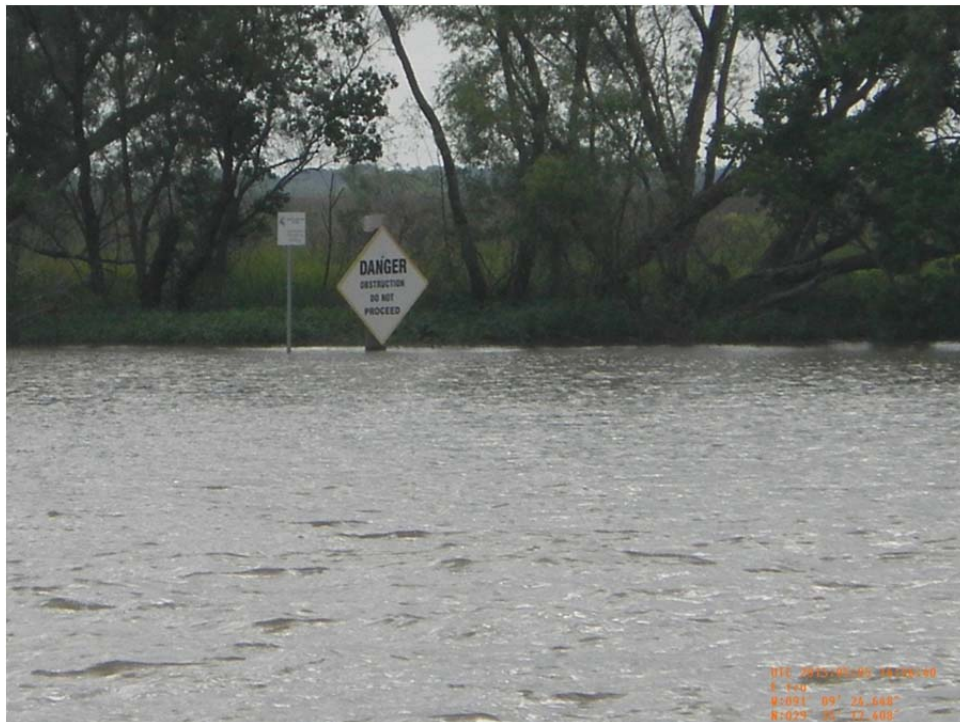
Photo 6: View of rock containment tie-in near Sta. 37+00 along east bank of Bayou Penchant.

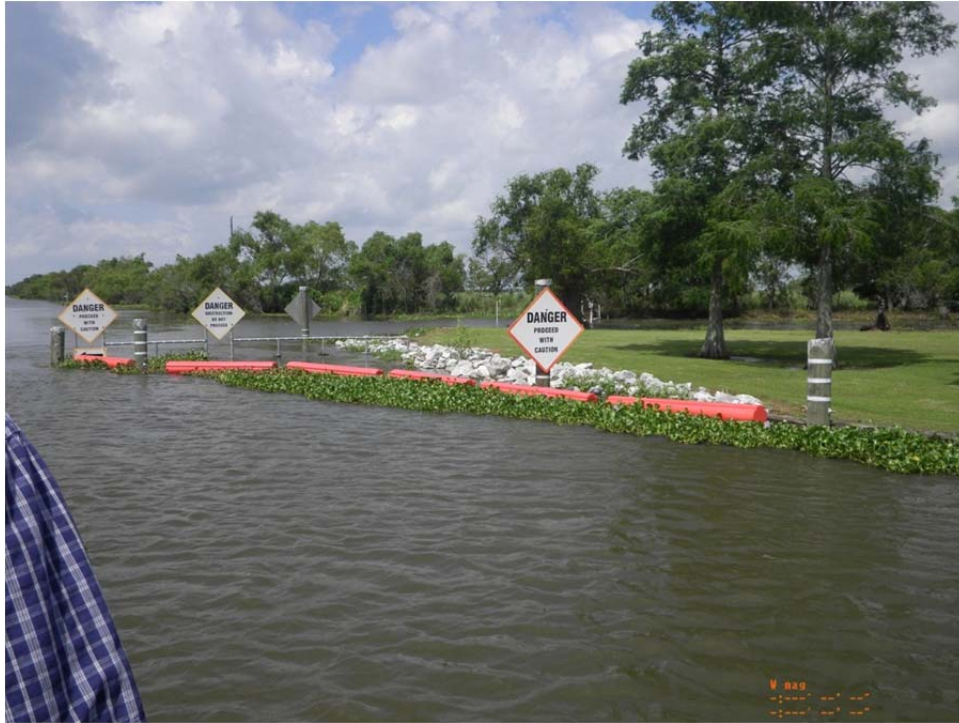
The fixed crest weir with a boat bay and flap-gates at the intersection of Brady Canal and Bayou Penchant was in very good condition with no noticeable defects. The structure was in very good condition and the banks are stable. The recently installed floating debris barriers appear to be functioning well and funneling vegetation and debris through the structure as intended. All signs and supports were in good condition as well. No maintenance will be required at this time. (Appendix B, Photos 7 through 9)

Photo 7: View of steel sheetpile weir with flapgates, rock bank protection and floating debris barrier along the north bank of Brady Canal near the Apache Camp.

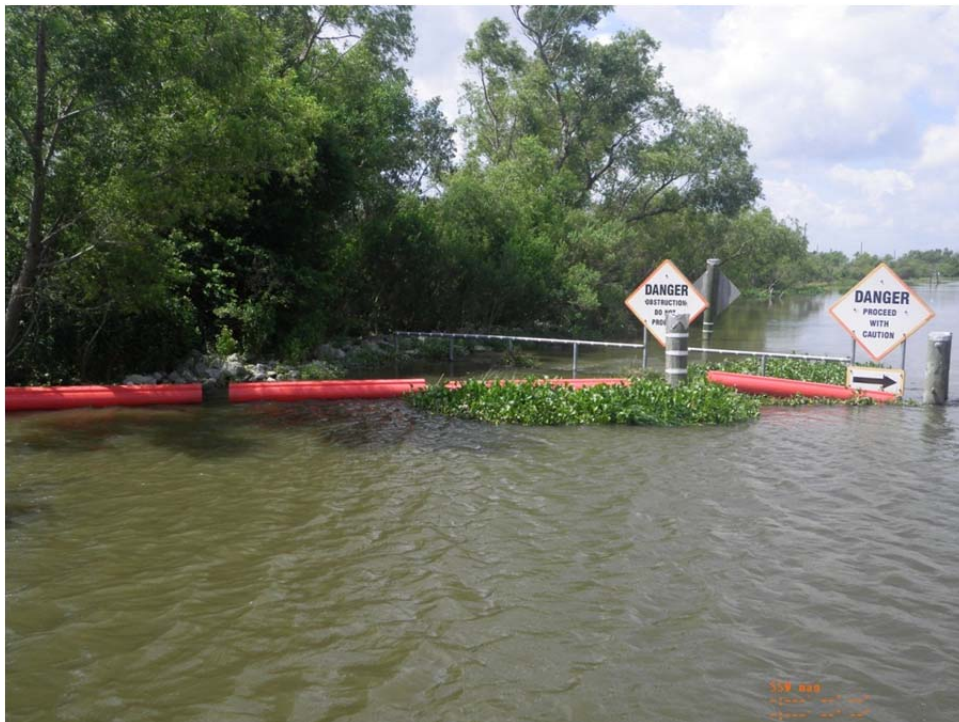
Photo 8: View of steel sheetpile weir with flapgates, rock bank protection and floating debris barrier along the south bank of Brady Canal near the Apache Camp.

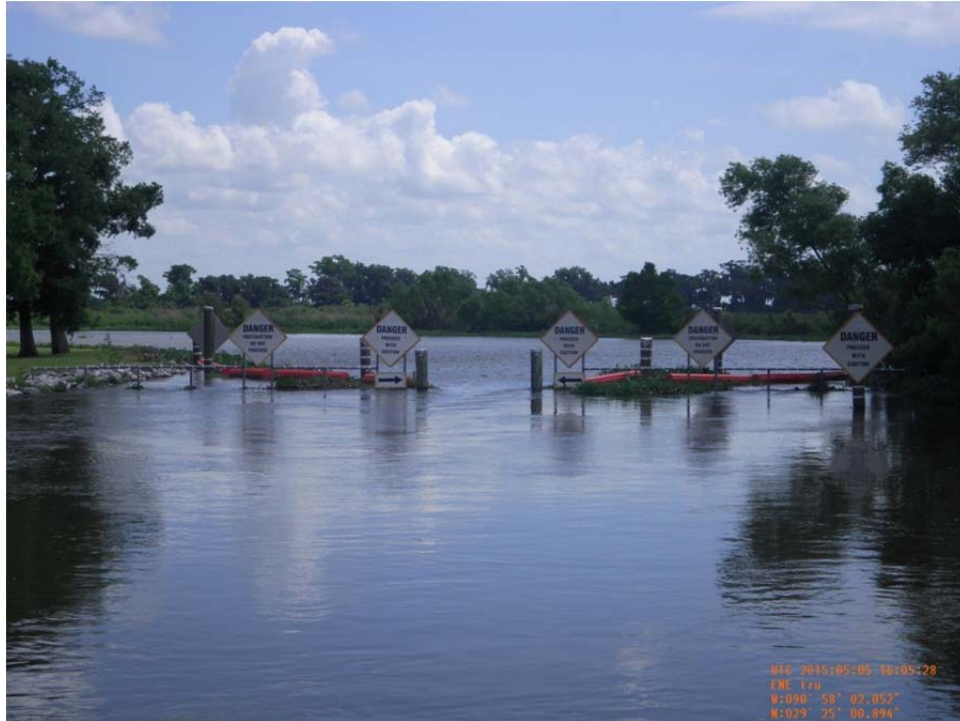
Photo 9: Over all view of the steel sheetpile structure, floating debris barrier, warning signs and rock bank protection across Brady Canal at Bayou Penchant.

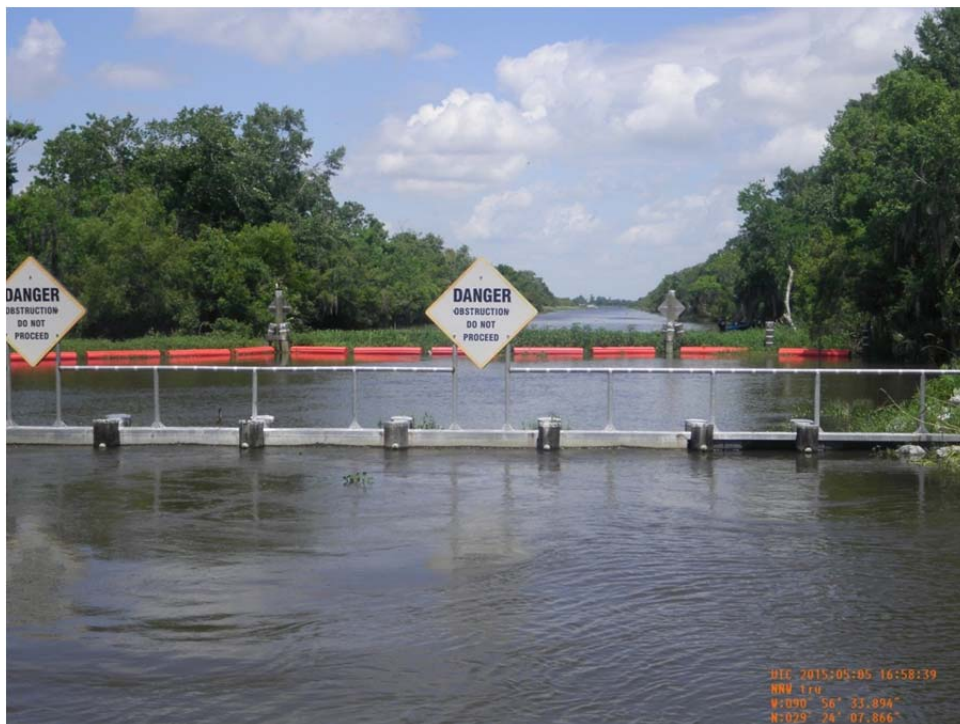
The fixed crest weir with flap-gates along Superior Canal was in good condition with no obvious defects or damage. The bank tie-ins are armored and are in very good condition and the flap gates appear to be operating as designed. The floating debris barrier installed on the north side of the structure was in very good condition and working well. The warning signs were all intact without damage. The structure will not require maintenance at this time. (Appendix B, Photos 10 through 12)

Photo 10: View of steel sheetpile weir with flapgates, floating debris barrier and warning signs across Superior Canal.

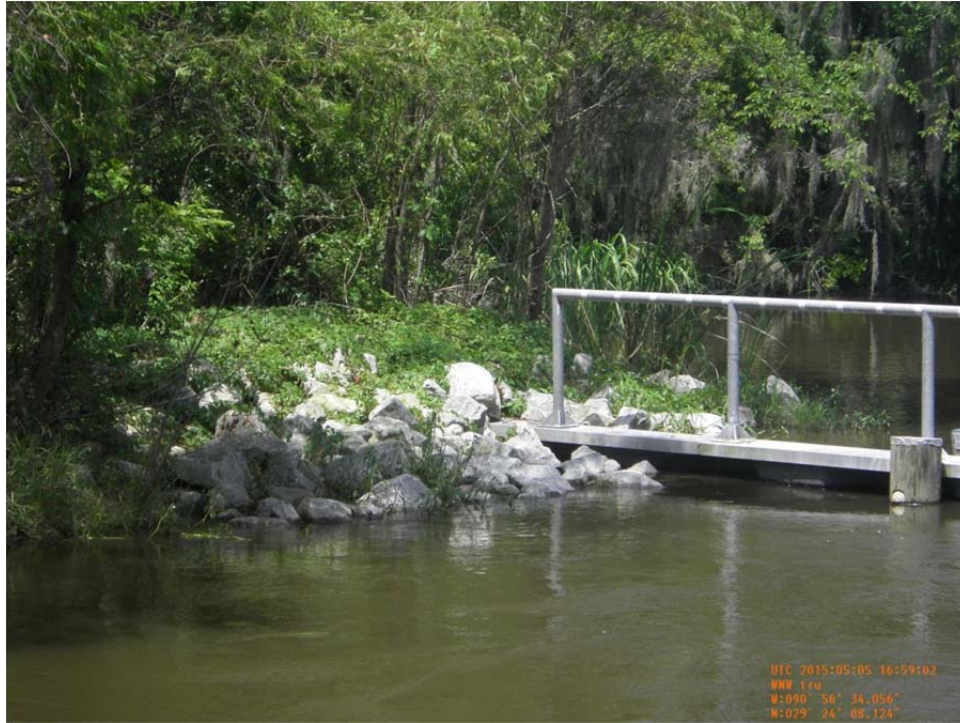
Photo 11: View of steel sheetpile tie-in to bank and rock riprap protection on the south side of the structure.

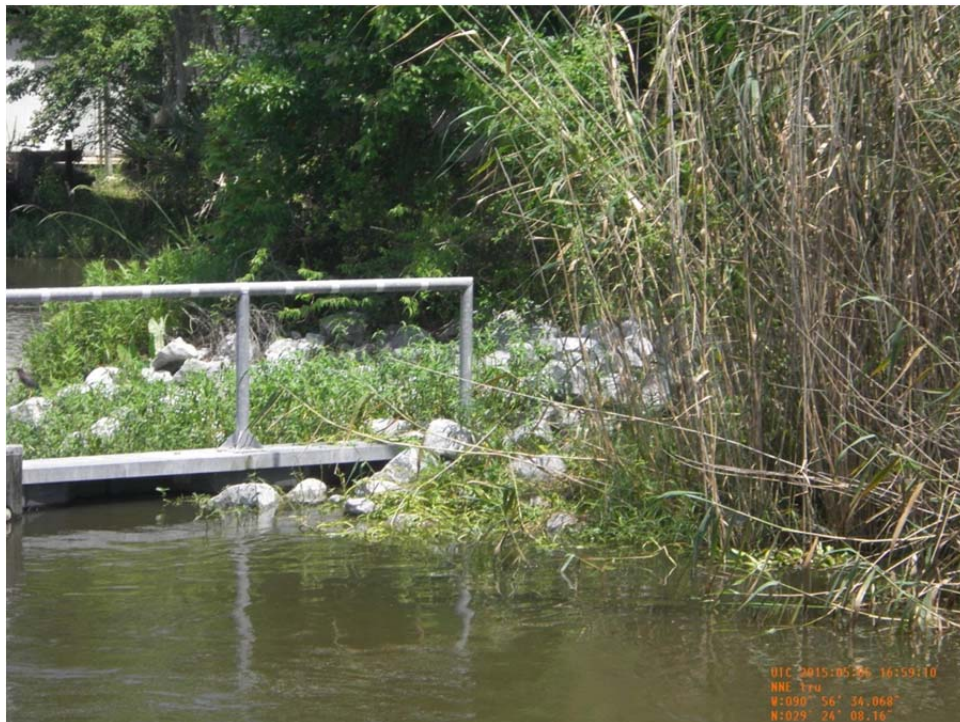
Photo 12: View of steel sheetpile tie-in to bank and rock riprap protection on the north side of the structure.

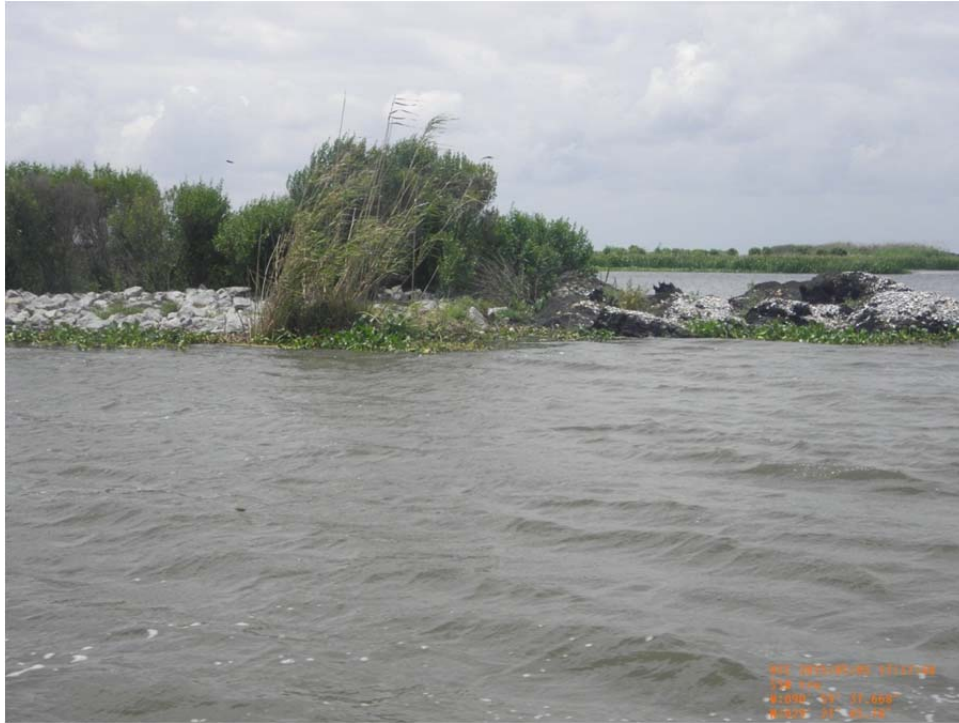
The rock armored embankment along the north bank of Bayou Decade was in good condition with only one obvious flaw at the beginning of Reach 1 near Voss Canal. It appeared that earthen embankment was recently refurbished, but the material was placed without grading and was not uniform (Appendix B, Photo 13). There is no threat of breaching at this time, but we will continue to monitor this in the future. The remaining reaches were in good condition with only minor erosion around the end of Reach 3 near Lost Lake. The earthen embankment itself appears to be well vegetated and stable. No maintenance will be required at this time. (Appendix B, Photos 14 through 16, 20, 23 and 24)

Photo 13: View of rock shoreline revetment at the entrance of Voss Canal along the west bank near Sta. 39+11 of Reach 3.

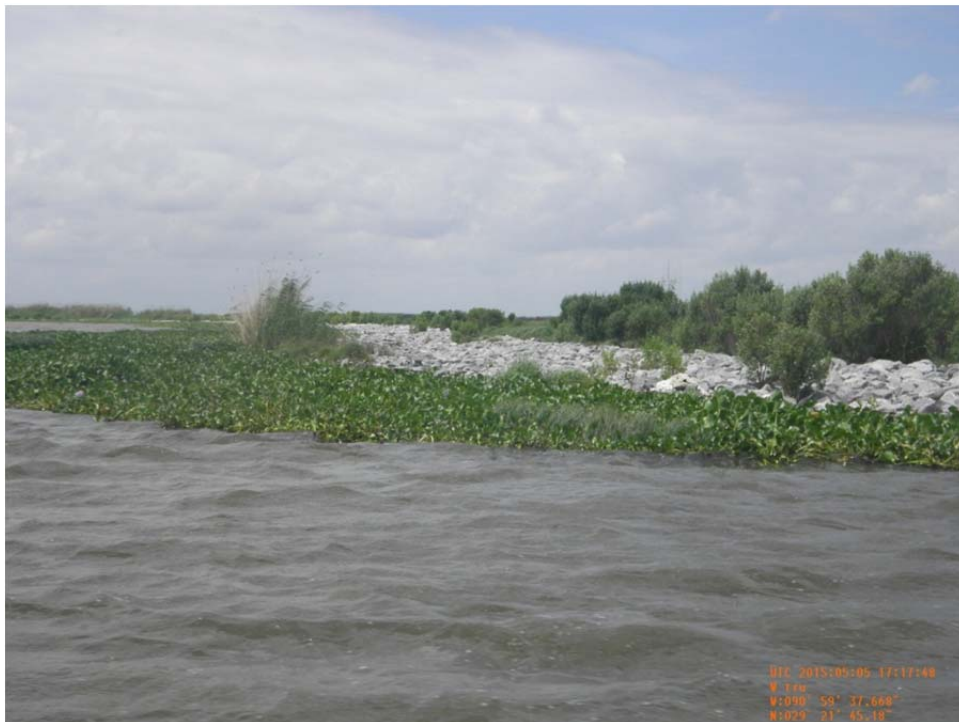
Photo 14: View of rock revetment along the north bank of Bayou Decade near Sta. 35+00 of Reach 3.

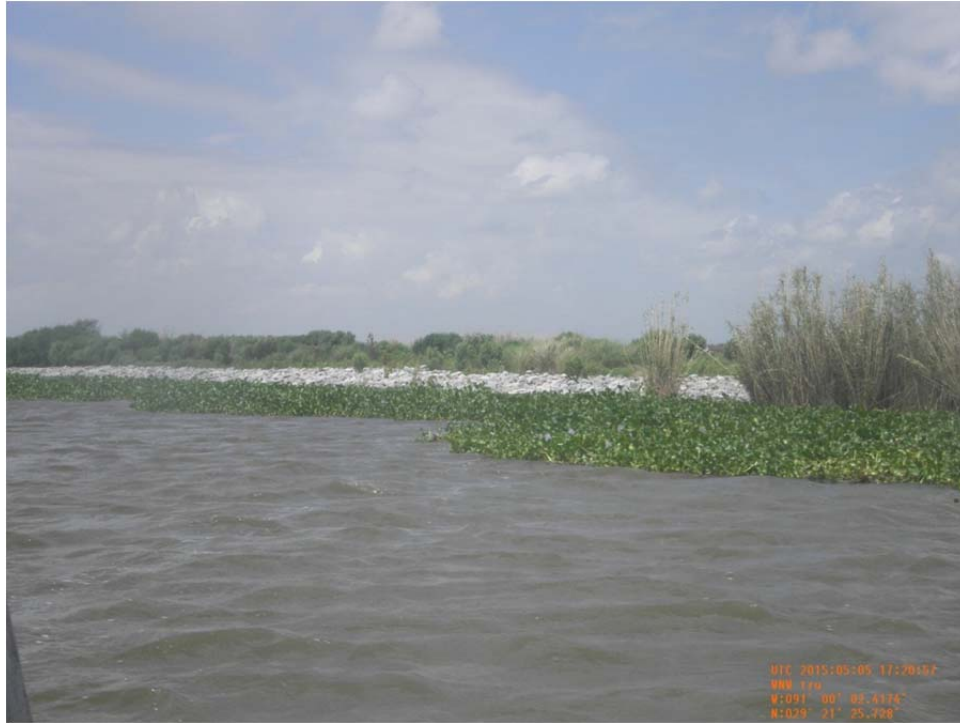
Photo 15: View of rock revetment structure along the north bank of Bayou Decade along Reach 3 near Sta. 10+00.

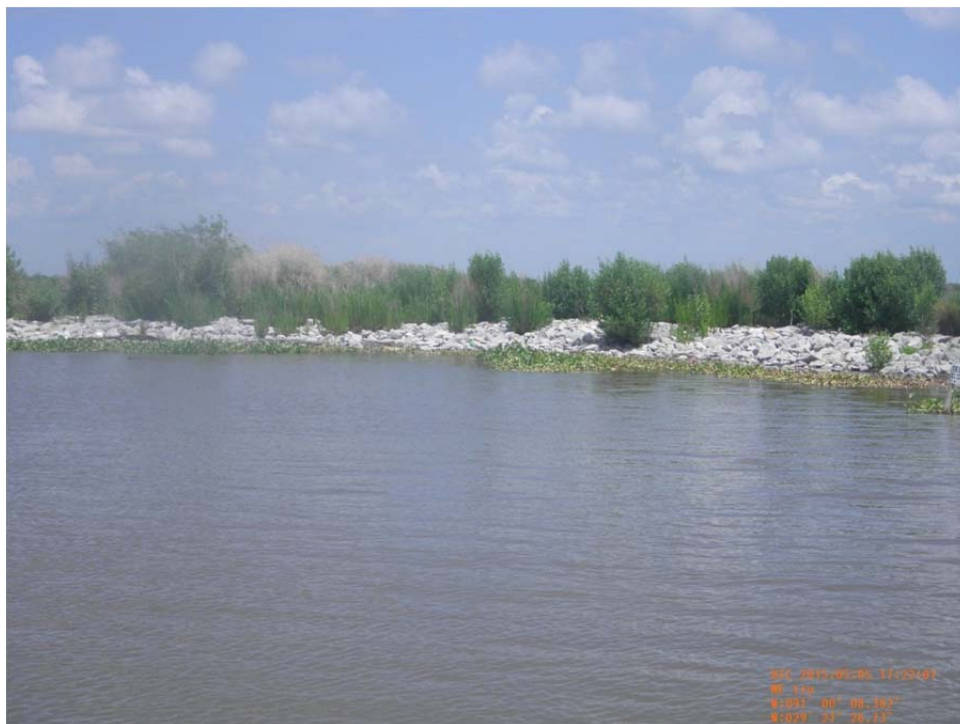
Photo 16: View of rock shoreline revetment on the north bank of Bayou Decade northeast of Structure No.4 along Reach 2 near Sta. 04+00.

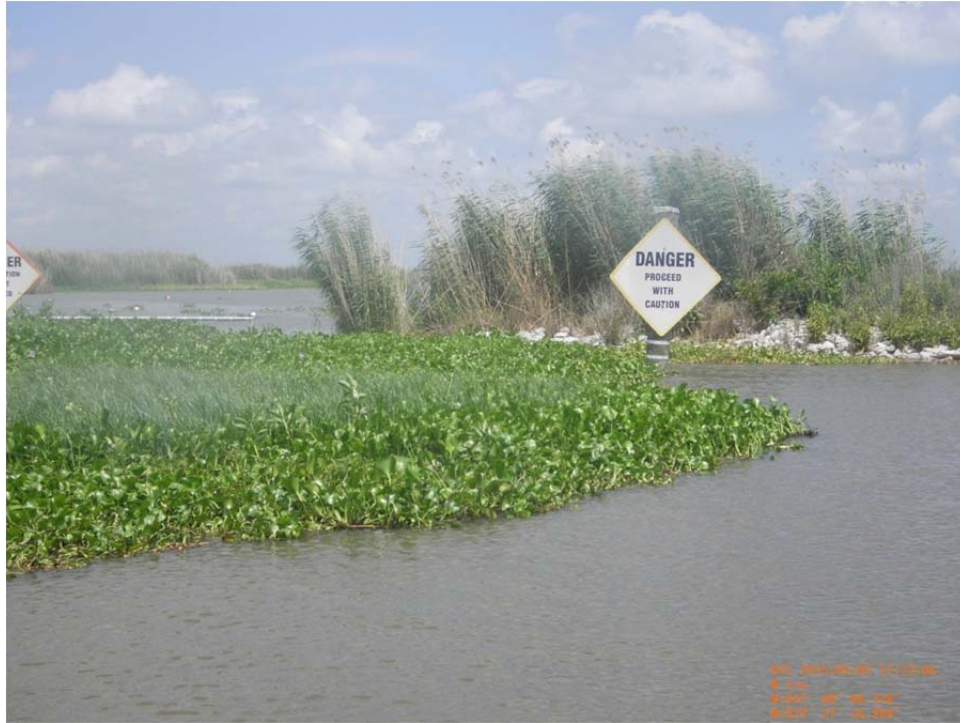
The first fixed crest weir with boat bay from Voss Canal along the north bank of Bayou Decade was inundated with water hyacinth and difficult to view or approach. The only visible portion of the structure was the pipe railing attached to the top whaler and the bank tie-ins. Although our view of the structure was limited, we do not expect any damage to the structure since the structure is relatively new and was constructed a couple of years ago. The bank tie-ins are armored and are in good condition. The signs and supports were also in good condition. We hope to get a better view of the structure during the 2016 annual inspection. (Appendix B, Photos 17 through 19)

Photo 17: View of rock weir, signage and rock revetment on the north side of Structure No.4 along the north bank of Bayou Decade.

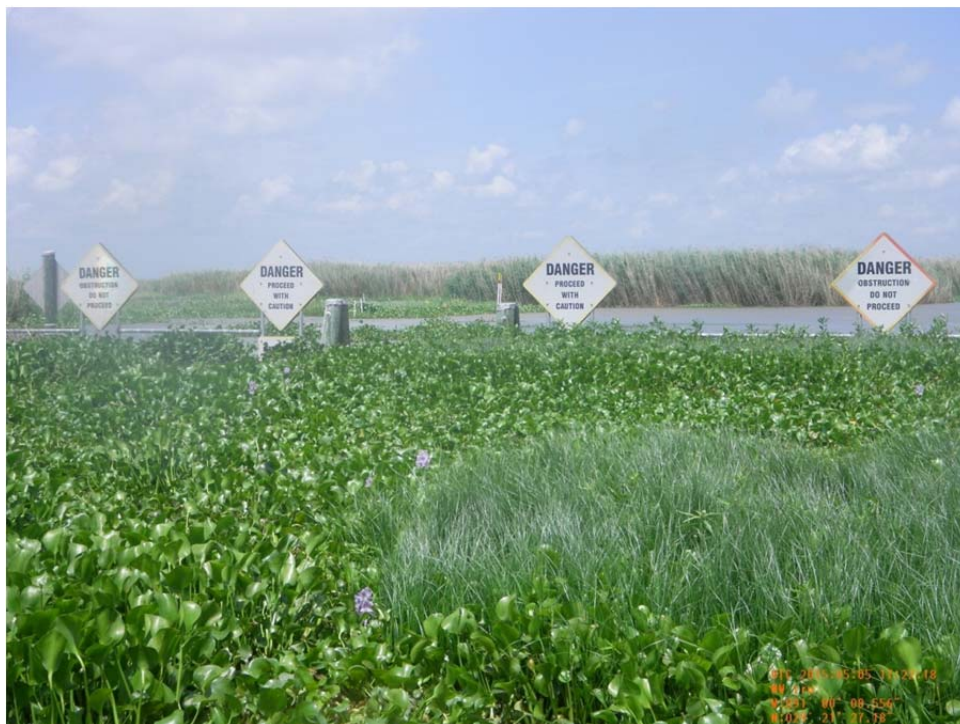
Photo 18: View of the water hyacinth along the face of the Structure No.4. The structure was not visible due to floating vegetation.

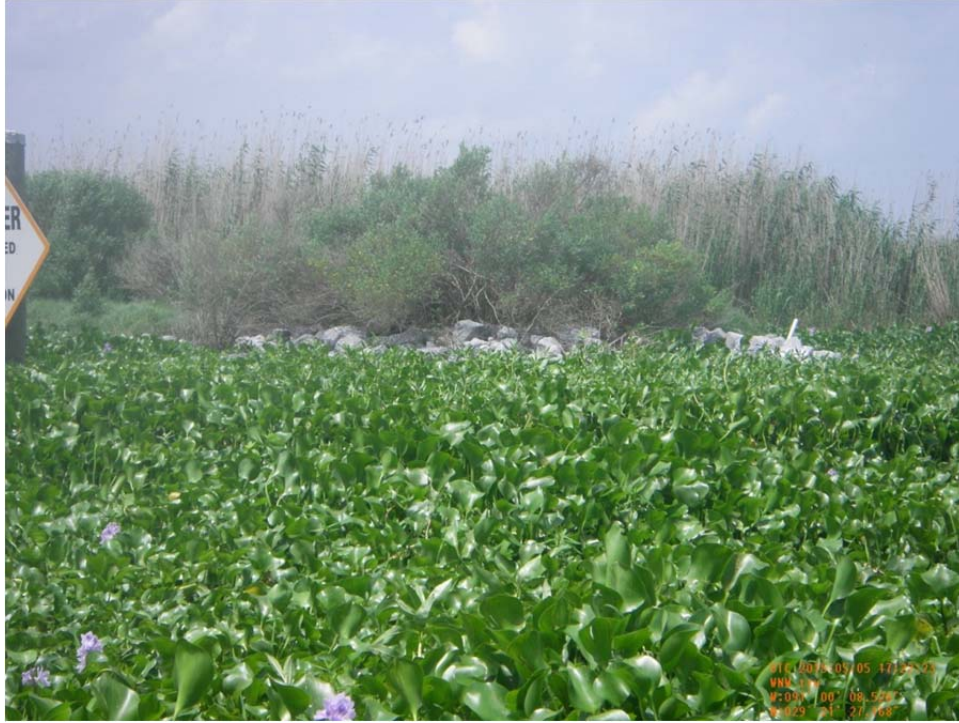
Photo 19: View of rock revetment tie-in on the south side of Structure No.4 along the north bank of Bayou Decade. Entire structure was not visible due to water hyacinth.

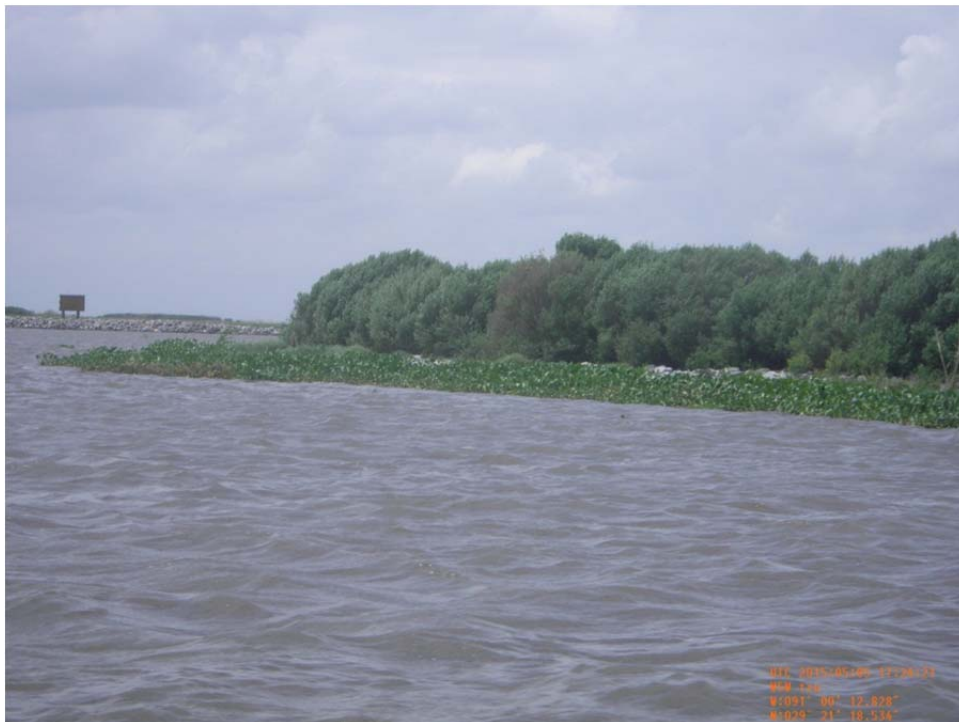
Photo 20: View of rock revetment along the north bank of Bayou Decade near Sta. 30+00 of Reach 2.

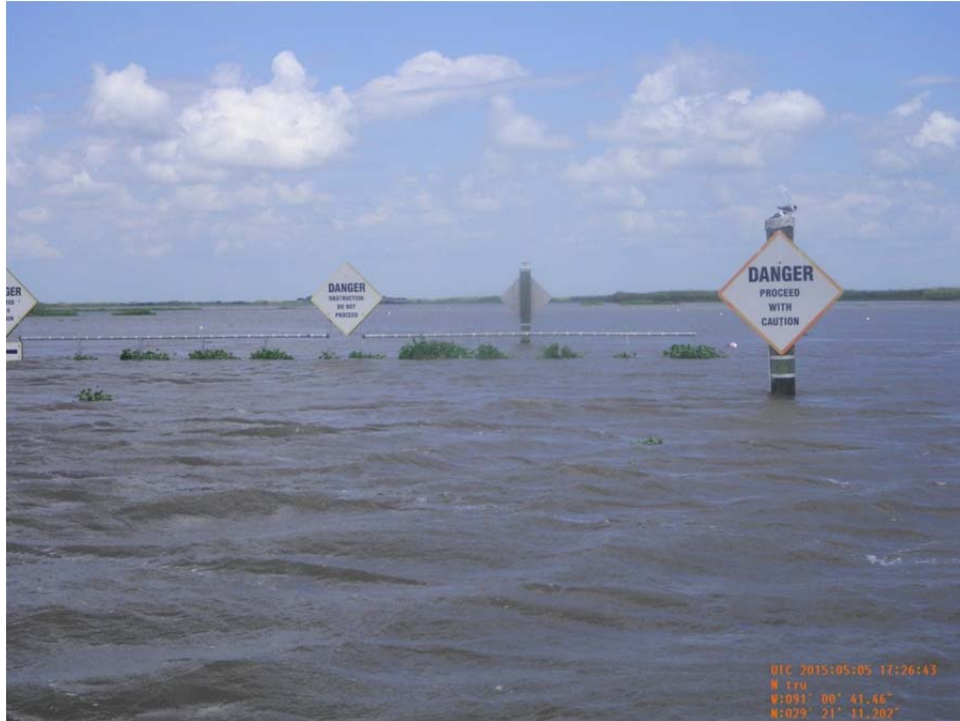
The fixed crest weir with boat bay closest to Lost Lake along the north bank of Bayou Decade was in good condition with no obvious damage. The steel sheet piling was below the water line at the time of the inspection, but we did not observe any defects. The bank tie-ins on both sides of the structure are armored and are in good condition. The signs and supports were in good condition as well. No maintenance will be required at this time. (Appendix B, Photos 21 and 22)

Photo 21: View of steel sheetpile weir and warnings signs at Structure No.5 along the north bank of Bayou Decade.

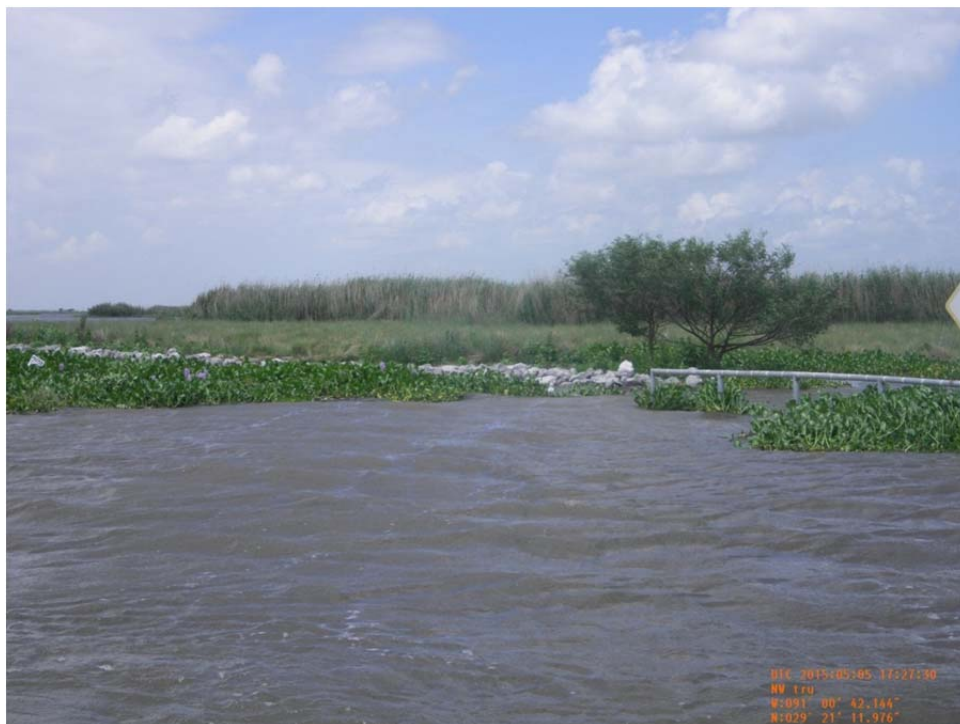
Photo 22: View of Structure No.5 tie-in to the rock revetment on the south side of the structure along Bayou Decade.

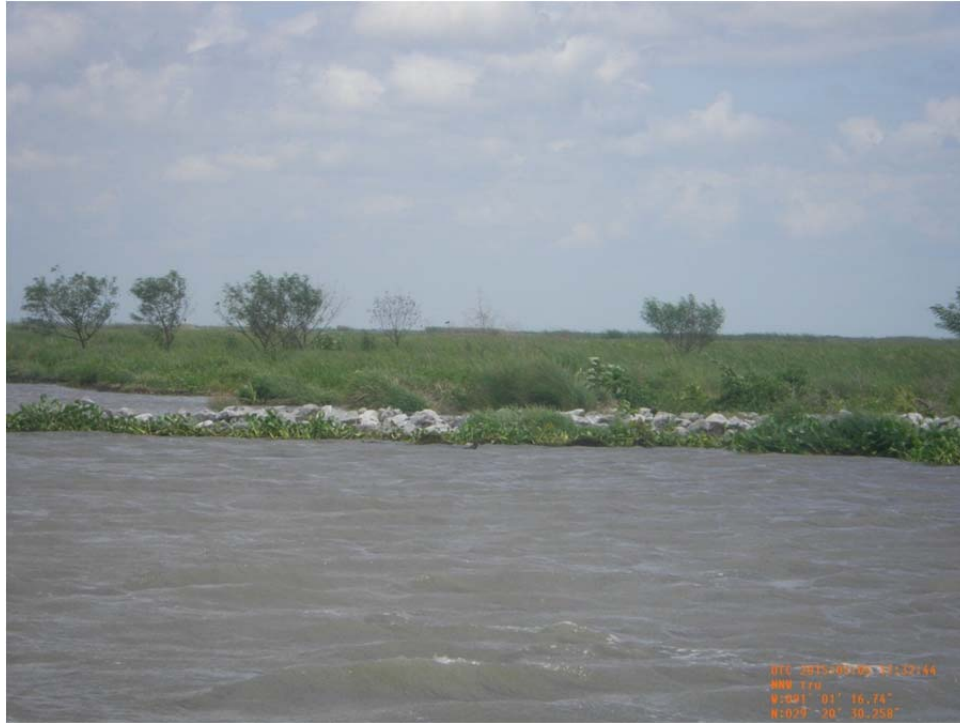
Photo 23: View of rock revetment at the far southern end of Reach No.1 near Lost Lake.

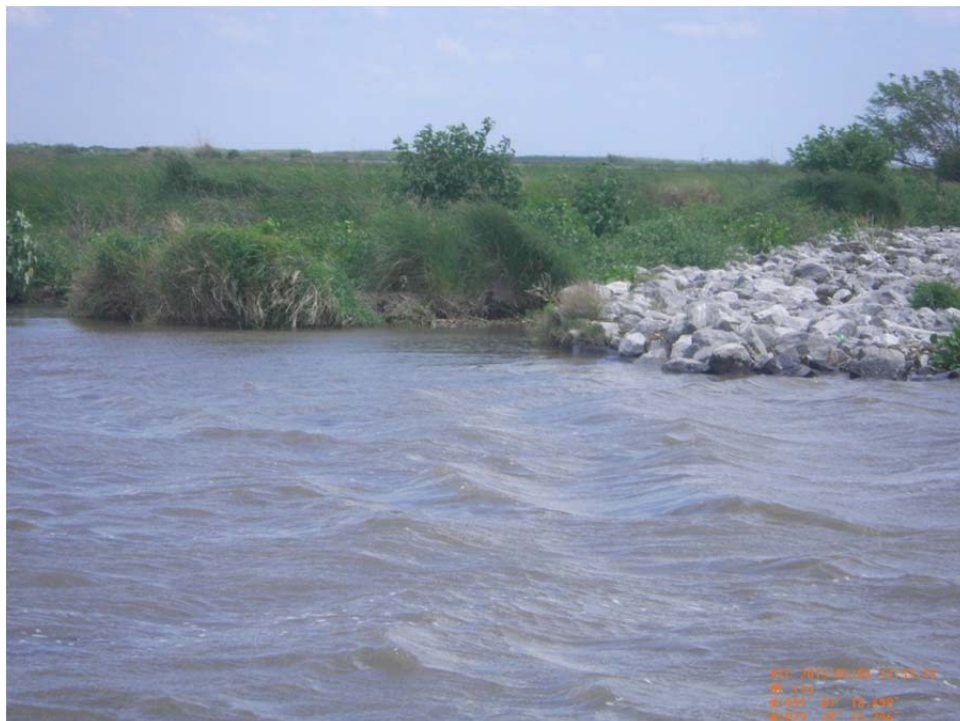
Photo 24: View of rock revetment at the far southern end of Reach No.1 near Lost Lake.
