**State of Louisiana
Coastal Protection and Restoration
Authority**

2017 Annual Inspection Report

**South Lake Decade Freshwater
Introduction Project (TE-39)**

State Project Number TE-39
Priority Project List 9

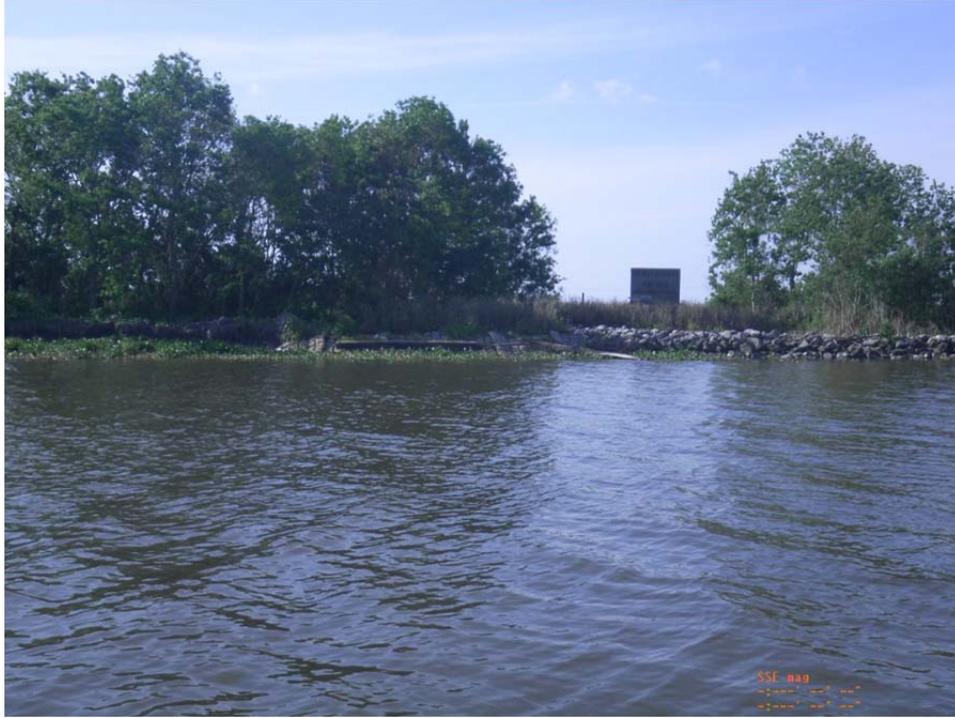
Photo 1 – view of the east end of the rock revetment along the south bank of Lake Decade near the Williams Pipeline at Sta. 86+00.

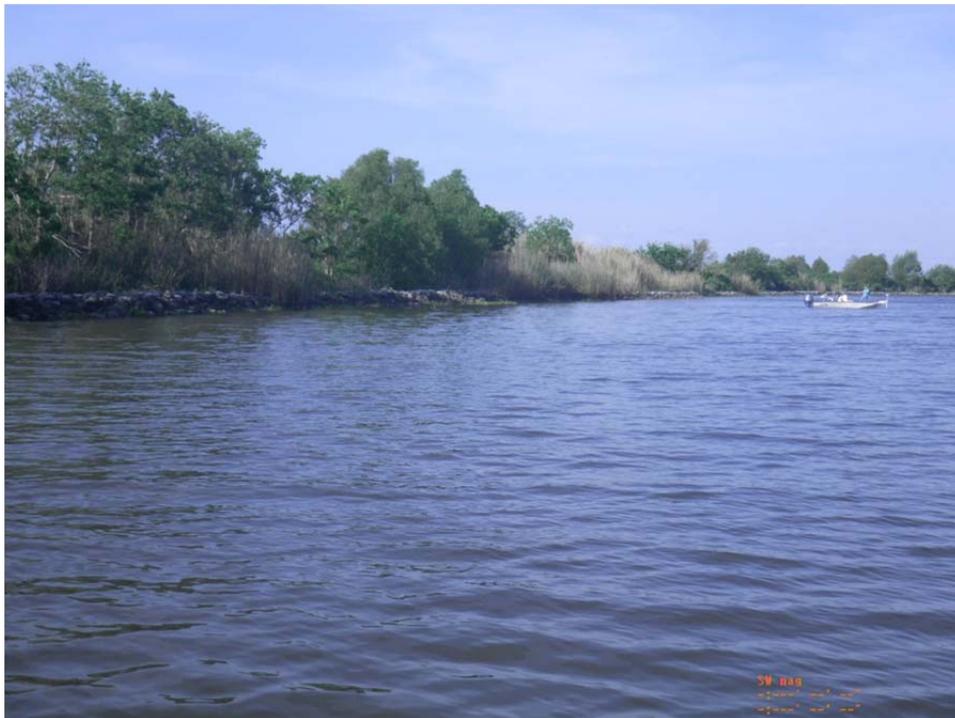
Photo 2 – view of the rock revetment along the south bank of Lake Decade from Sta. 86+00 looking in southwesterly direction.

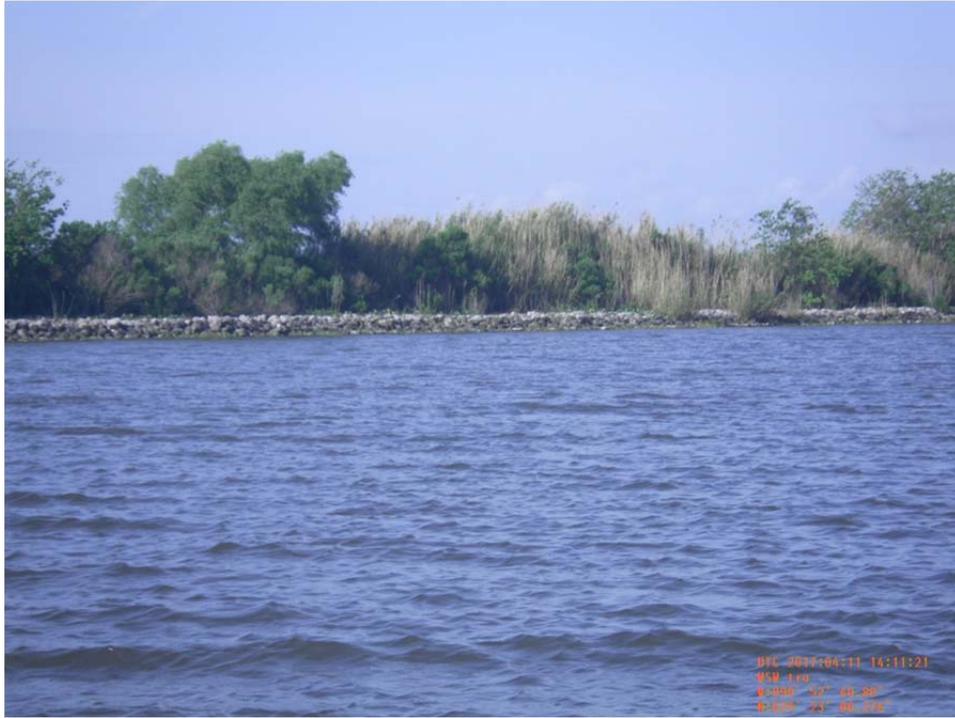
Photo 3 – view of the rock revetment along the south bank of Lake Decade.

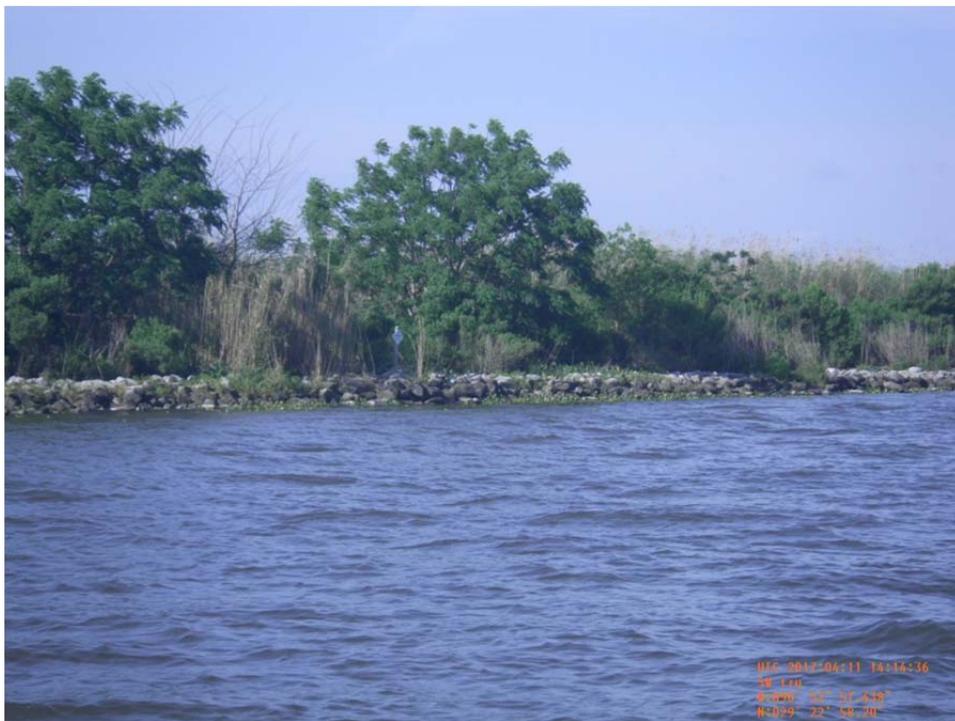
Photo 4 - view of the rock revetment along the south bank of Lake Decade.

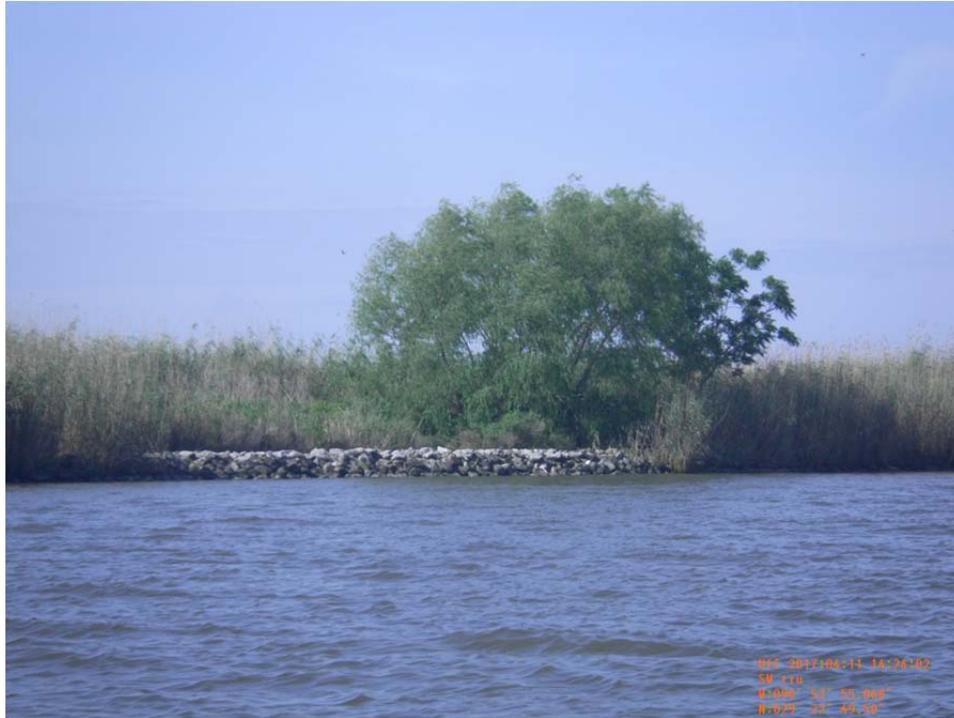
Photo 5 – view of rock revetment along south bank of Lake Decade near Sta. 0+18, beginning of project.

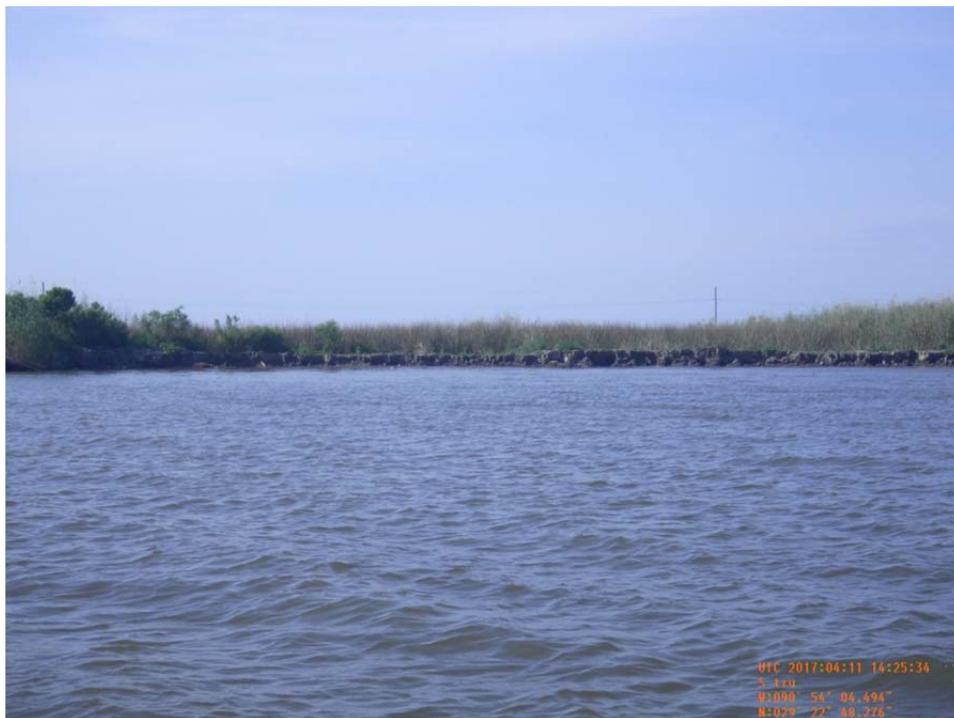
The rock revetment and earthen embankment appeared to be in very good condition with no obvious settlement or displacement of the rock riprap. The earthen embankment behind the rock revetment was in good shape and well vegetated. We did observe large cut banks in the embankment on both ends of the rock revetment; however, this is expected considering the wave action along the south bank of Lake Decade. Apache Minerals routinely refurbishes the earthen bankline along the lake on the east and west sides of the rock revetment to maintain the lake rim.

Photo 6 – view of cut banks between Sta. 0+18 of the rock revetment and the mouth of Bayou Decade.
