**State of Louisiana
Coastal Protection and Restoration
Authority**

2016 Annual Inspection Report

**South Lake Decade Freshwater
Introduction Project (TE-39)**

April 27, 2016
Terrebonne Parish

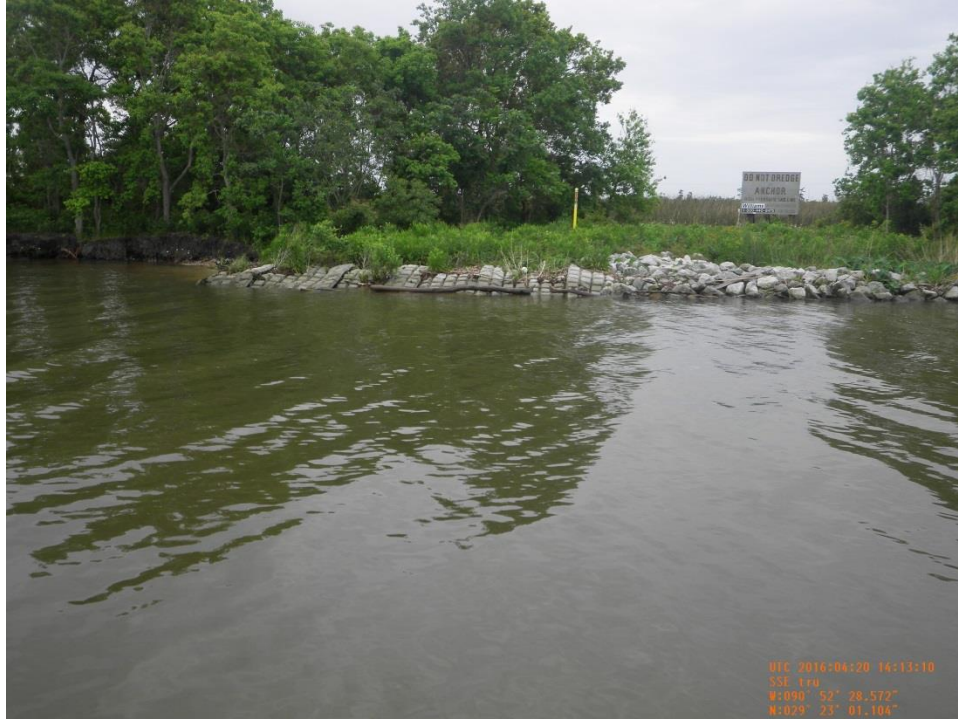
Photos 1: View of earthen embankment and rock revetment at east end of project along south bank of Bayou Decade near Sta. 86+00.

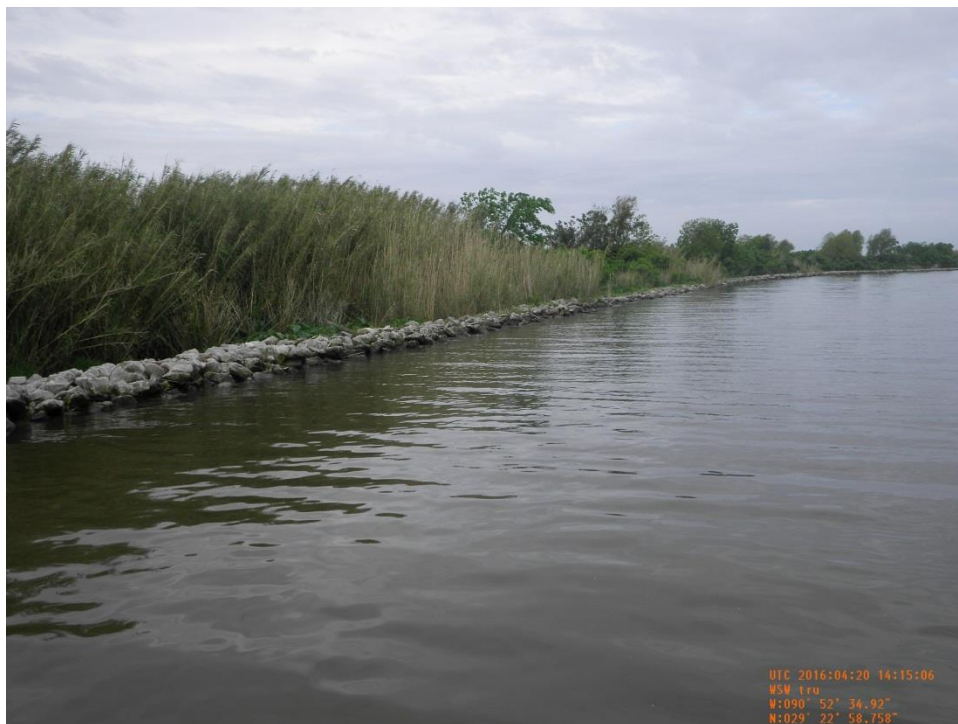
Photo 2: View of earthen embankment and rock revetment along south bank of Bayou Decade near Sta. 80+00 looking westward.

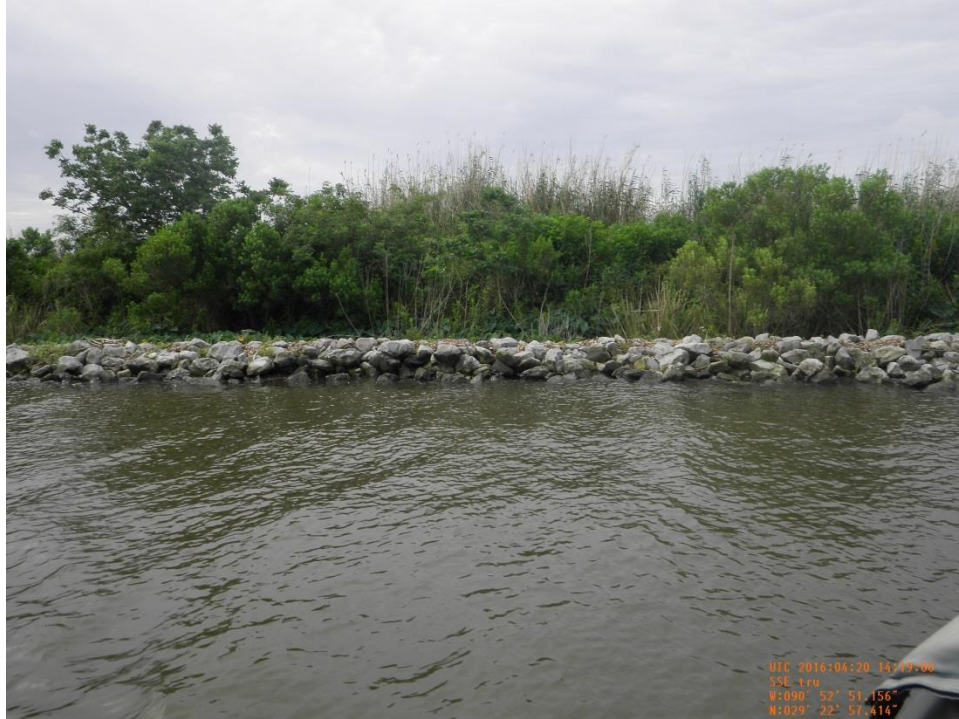
Photo 3: View of earthen embankment and rock revetment along south bank of Bayou Decade near Sta. 66+00.

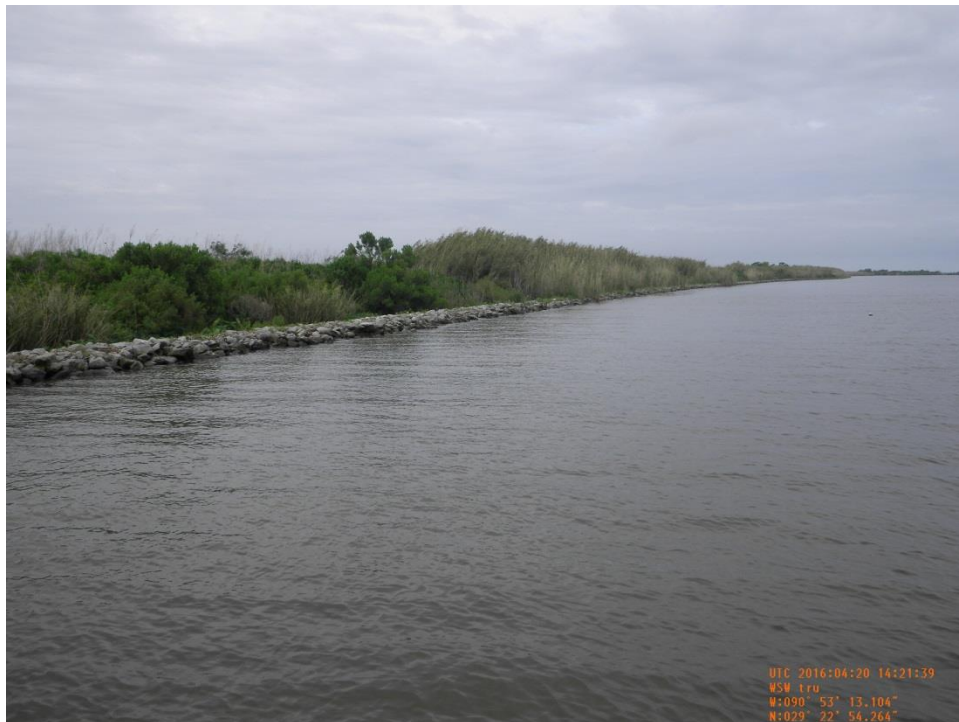
Photo 4: View of earthen embankment and rock revetment along the south bank of Bayou Decade near Sta. 46+00 looking westward.

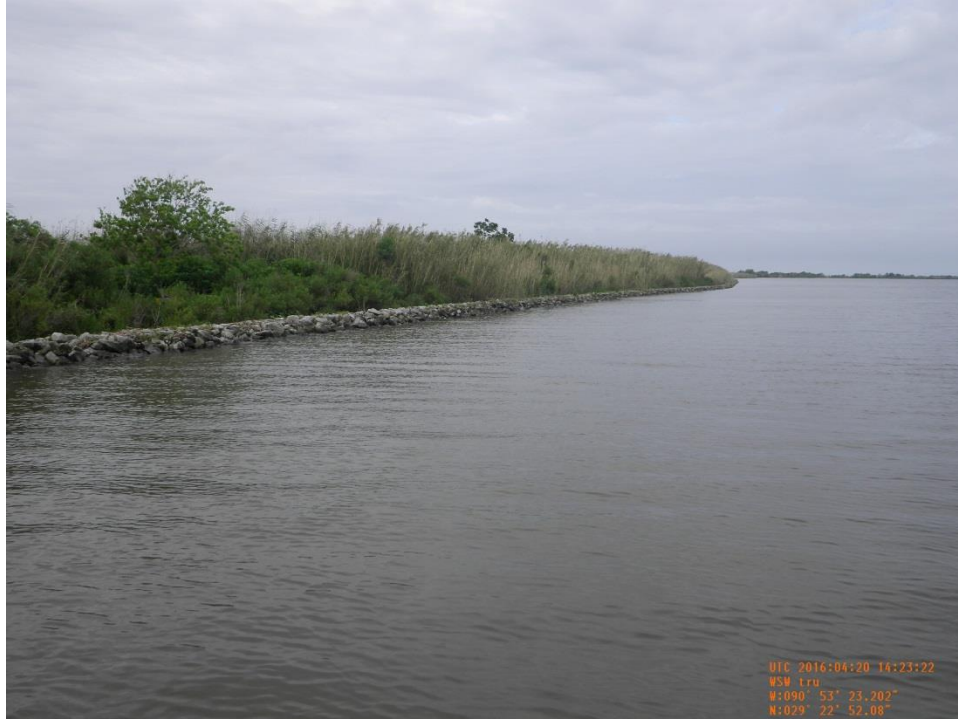
Photo 5: View of earthen embankment and rock revetment on the south bank of Lake Decade near Sta. 36+00 looking westward.

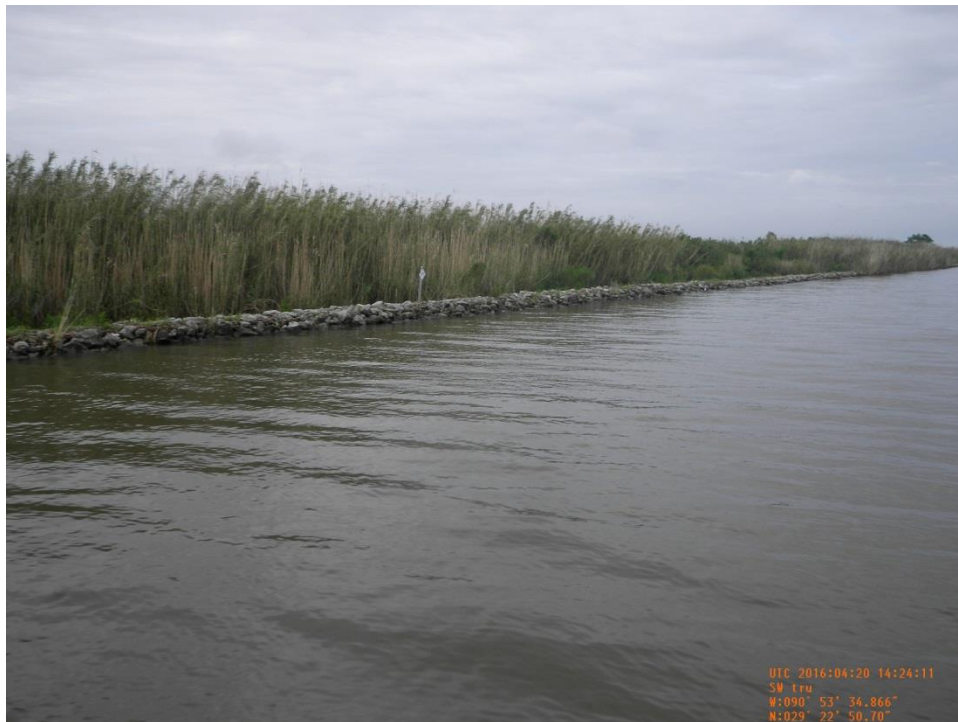
Photo 6: View of earthen embankment and rock revetment on the south bank of Lake Decade near Sta. 26+00 looking westward.

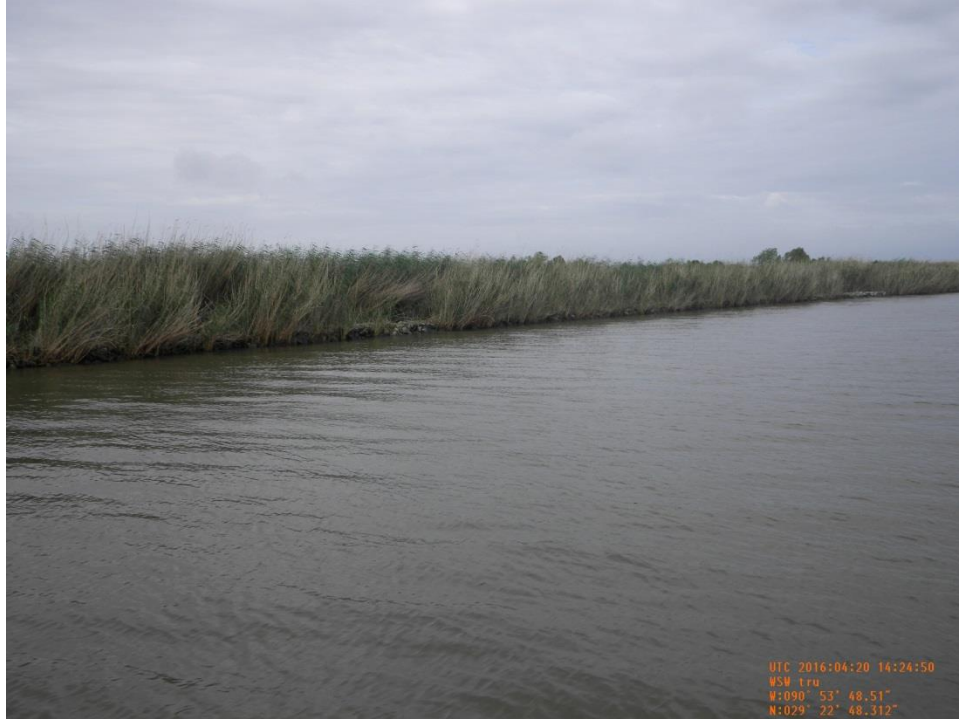
Photo 7: View of earthen embankment and rock revetment on the south bank of Lake Decade near Sta. 16+00.

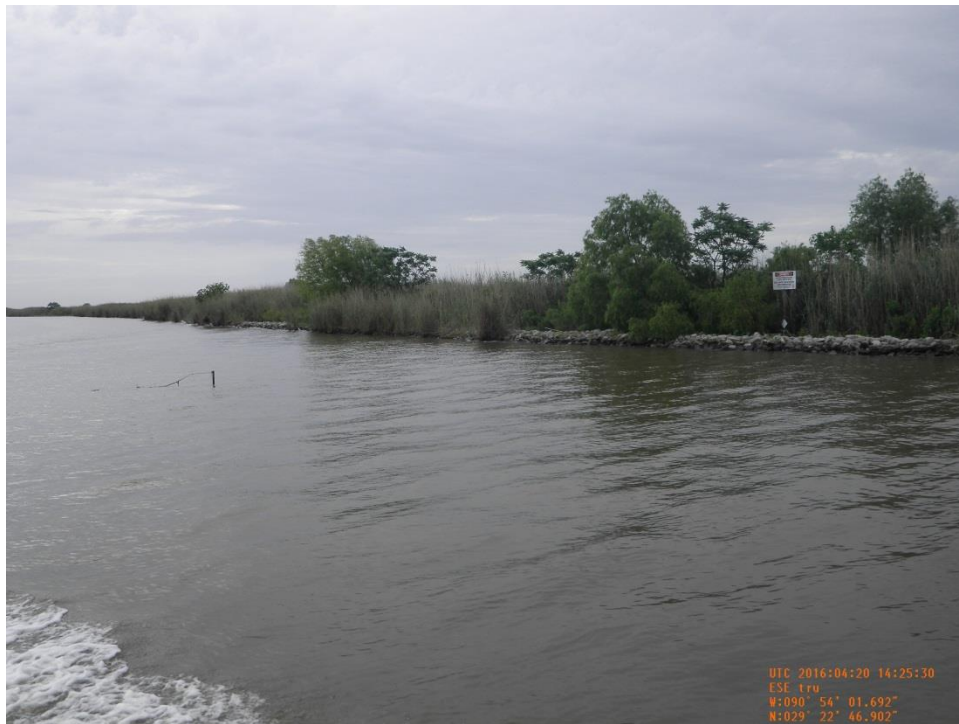
Photo 8: View of earthen embankment and rock revetment along south bank of Bayou Decade near Sta. 2+00 looking eastward

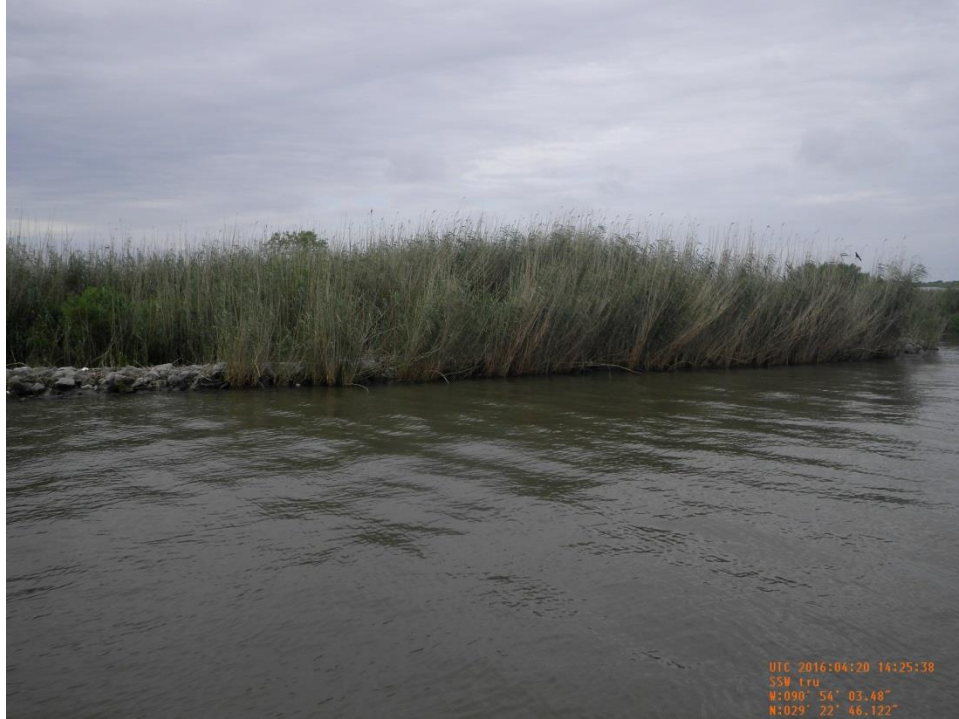
Photo 9: View of earthen embankment and rock revetment along the south bank of Bayou Decade near Sta. 1+00

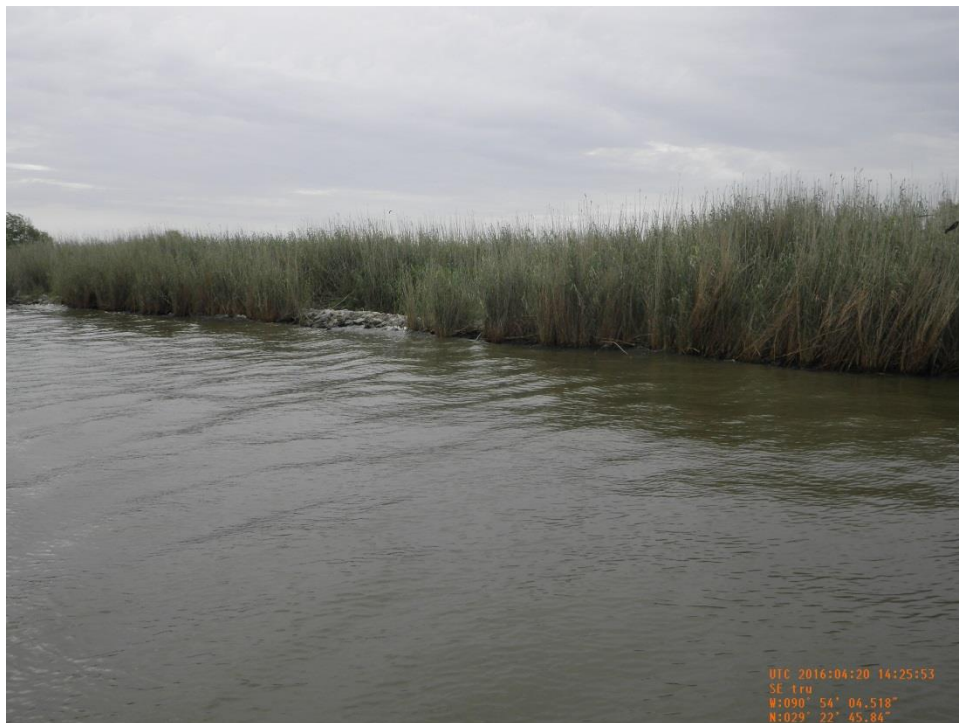
Photo 10: View of earthen embankment and rock revetment along the south bank of Bayou Decade near Sta. 0+50 looking eastward.

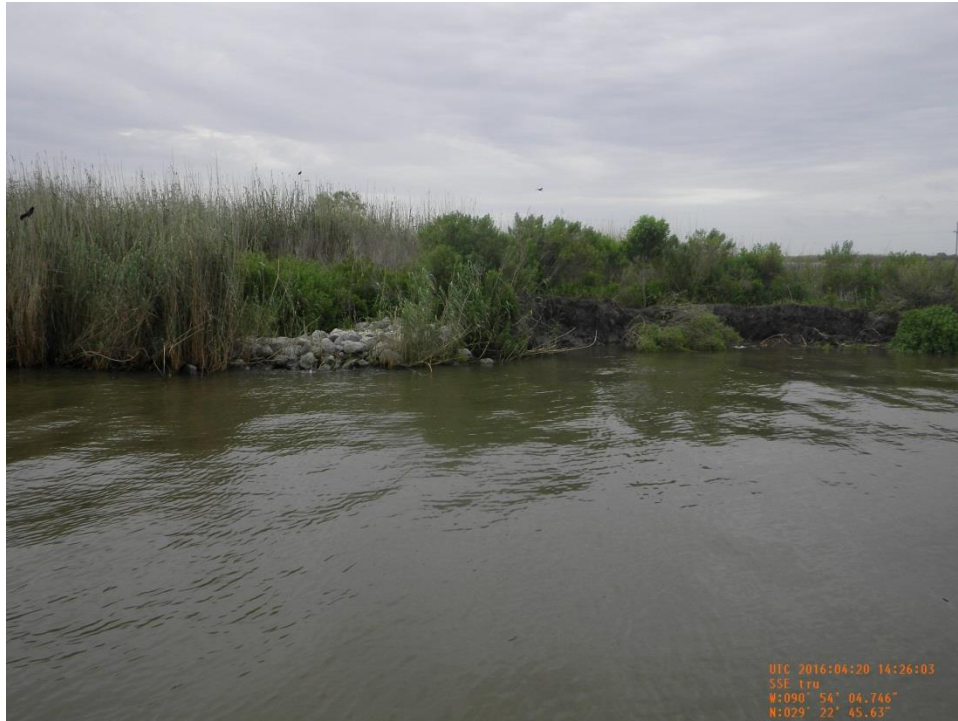
Photo 11: View of earthen embankment and rock revetment on the west end (Sta. 0+10) of the South Lake Decade.
