**State of Louisiana
Coastal Protection and Restoration
Authority**

2017 Annual Inspection Report

**GIWW Bank Restoration Project –
Segment 4 (TE-43)**

State Project Number TE-43
Priority Project List 10

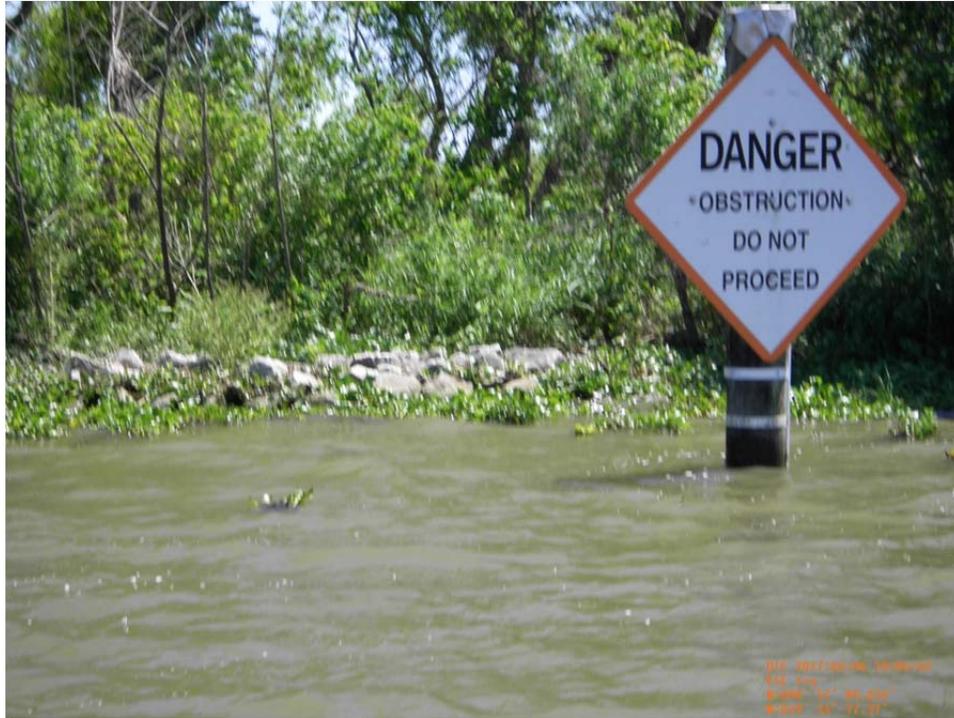
Photo No.1 – view of rock dike tie-in along an oil field location canal at Sta. 0+00.

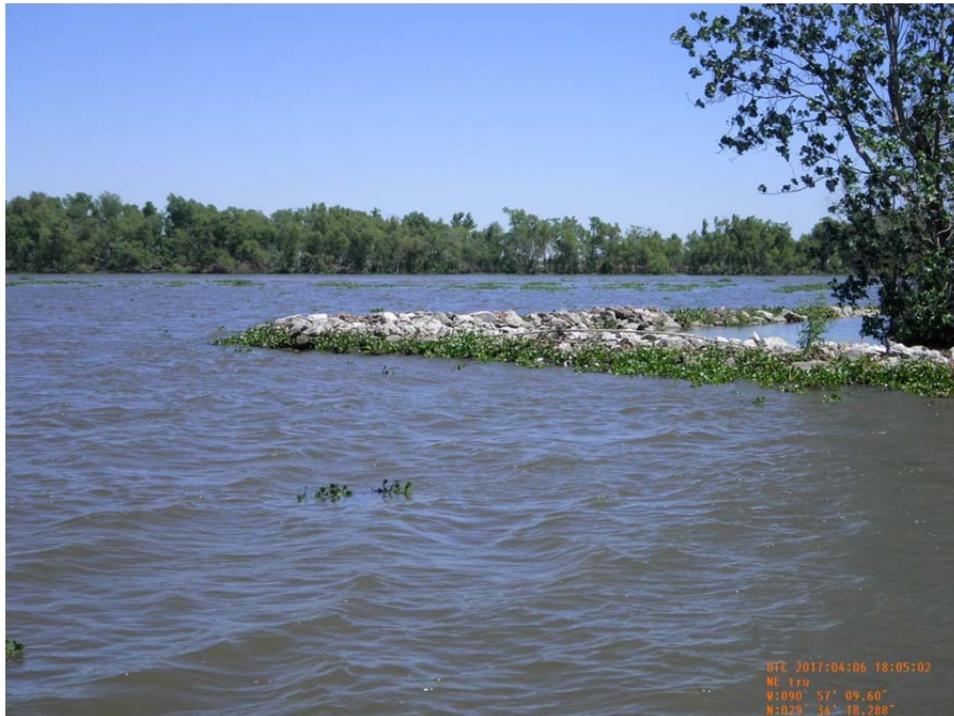
Photo No.2 – view of rock dike protection along the GIWW near Sta. 3+00.

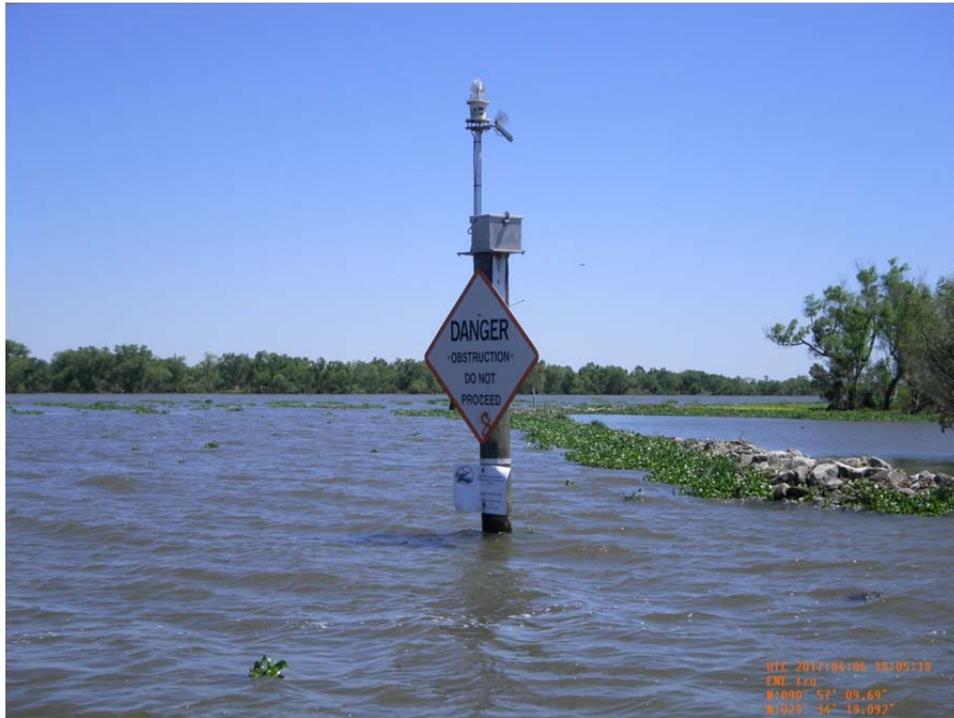
Photo No.3 – view of rock dike and navigational aid structure near Sta. 3+00 along the GIWW.

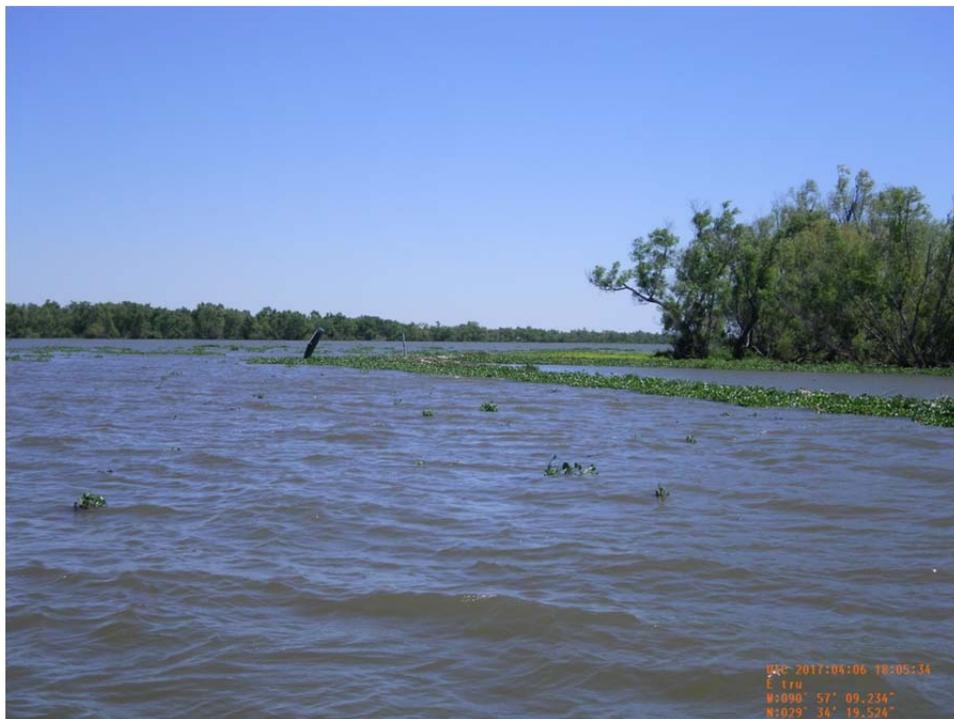
Photo No.4 – view of rock dike along the GIWW looking eastward.

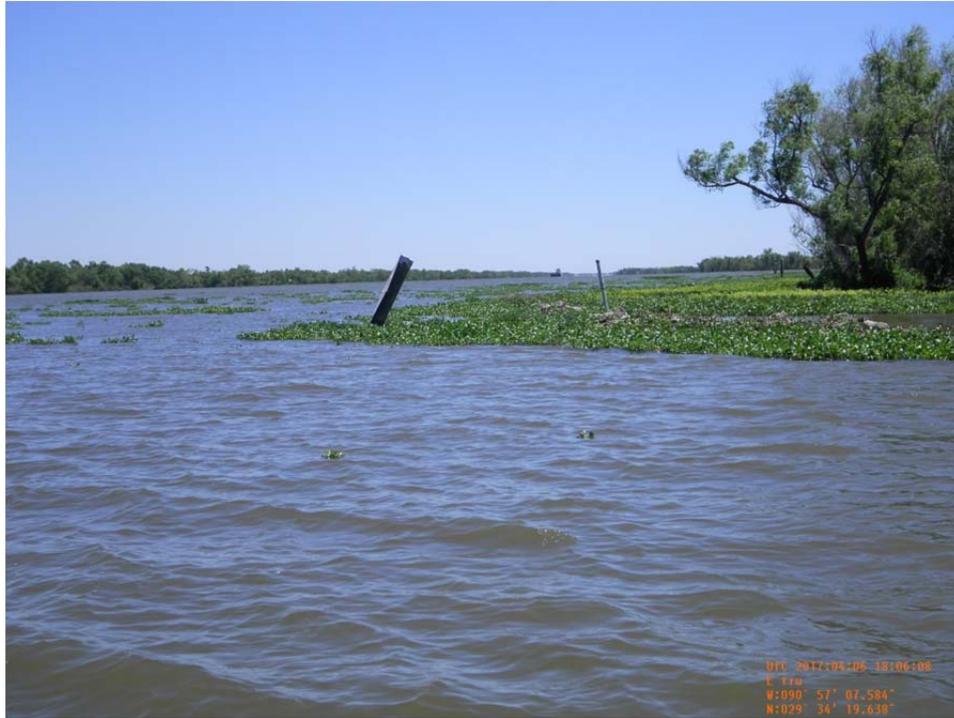
We did note that all of the warning signs along the length of the project were in good condition with the exception of two (2) signs on the western end of the project which had been pushed over or leaning partially into the water. These signs shall be replaced on the next maintenance cycle of the rock dike.

Photo No.5 – view of rock dike and warning sign leaning over near Sta. 05+00.

As for the warning signs and settlement plates, we recommend that the damaged timber pile and sign be replaced during the next maintenance event and additional segments of galvanized pipe be installed on settlement plates that have settled below an elevation that would make it difficult to access for future surveys.

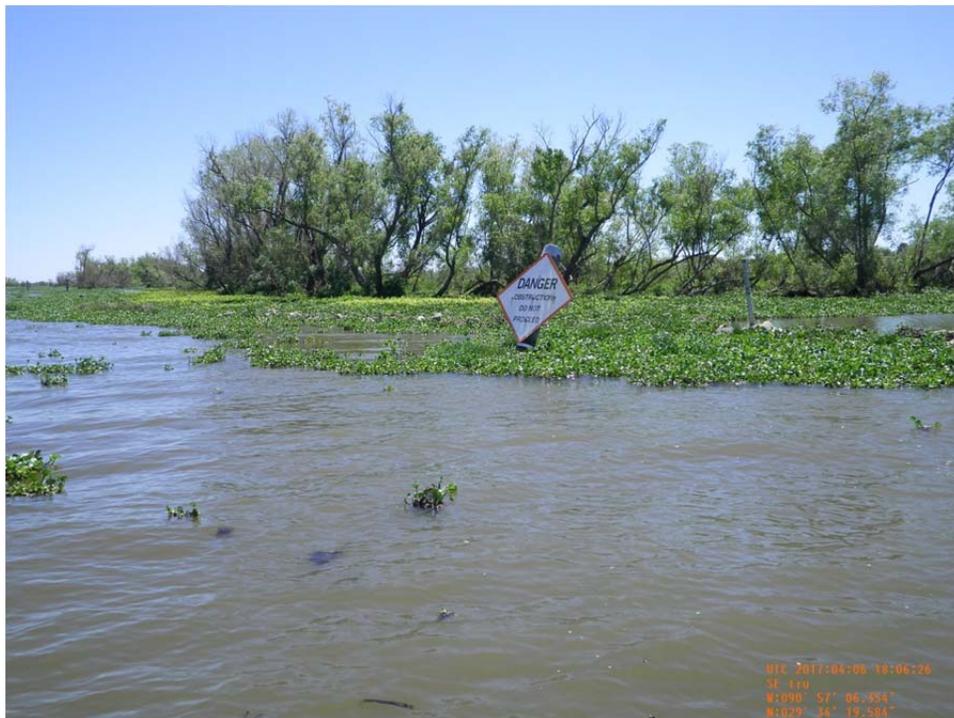
Photo No.6 – view of rock dike and warning sign leaning over near Sta. 05+00.

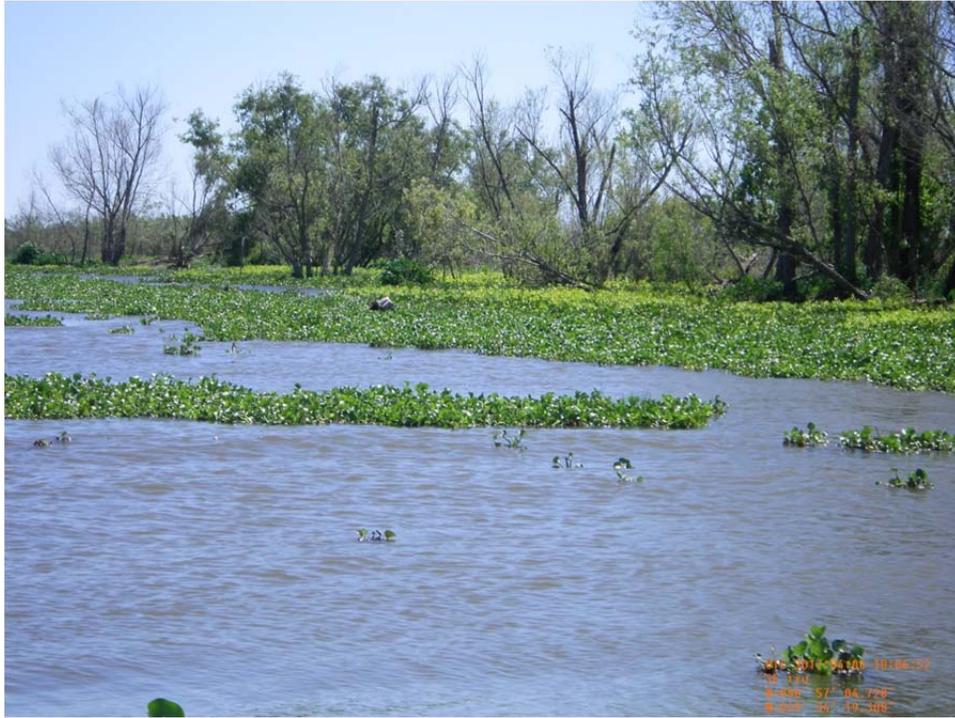
Photo No.7 – view of rock dike and downed warning sign over near Sta. 10+00.

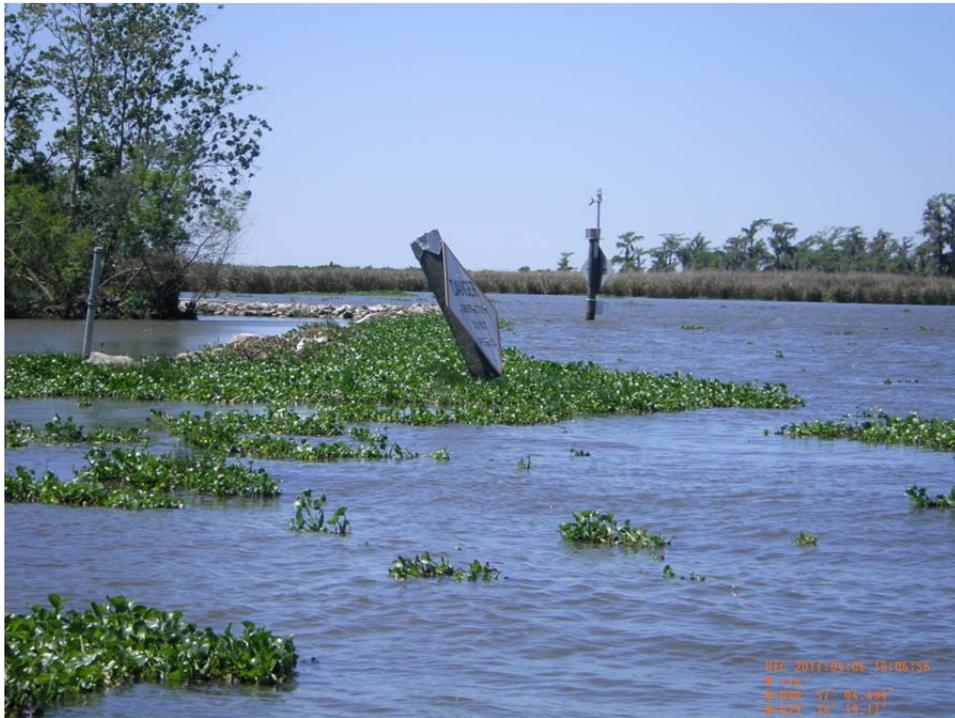
Photo No.8 – view of rock dike and warning sign leaning over near Sta. 05+00.

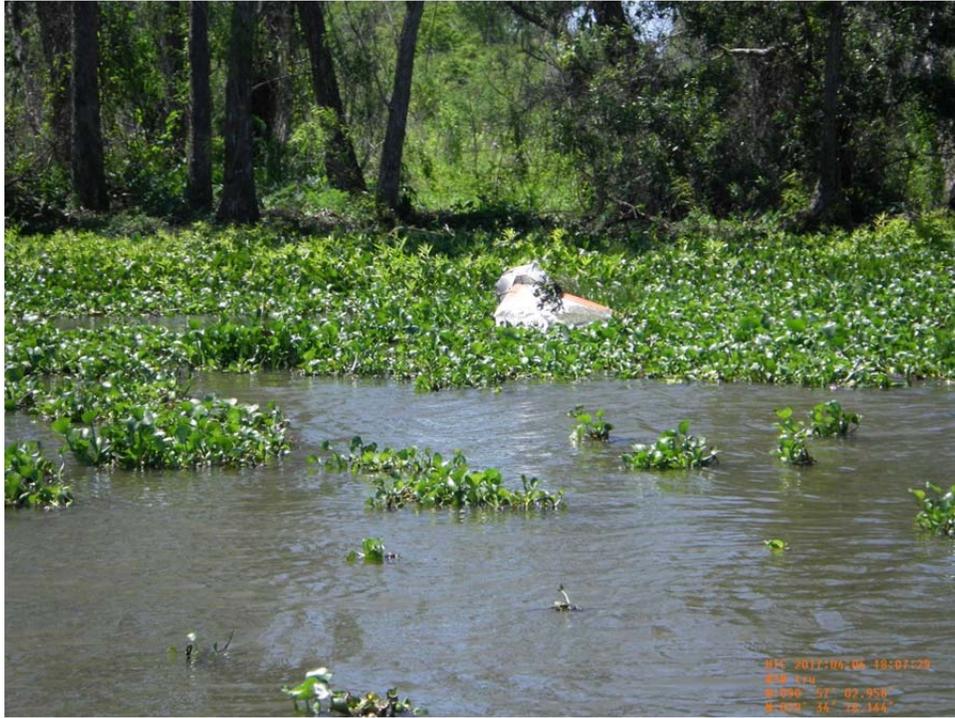
Photo No.9 – view of rock dike and downed warning sign over near Sta. 10+00.
