**State of Louisiana
Coastal Protection and Restoration
Authority**

2014 Annual Inspection Report

**North Lake Mechant Landbridge
Restoration Project (TE-44)**

June 11, 2014
Terrebonne Parish

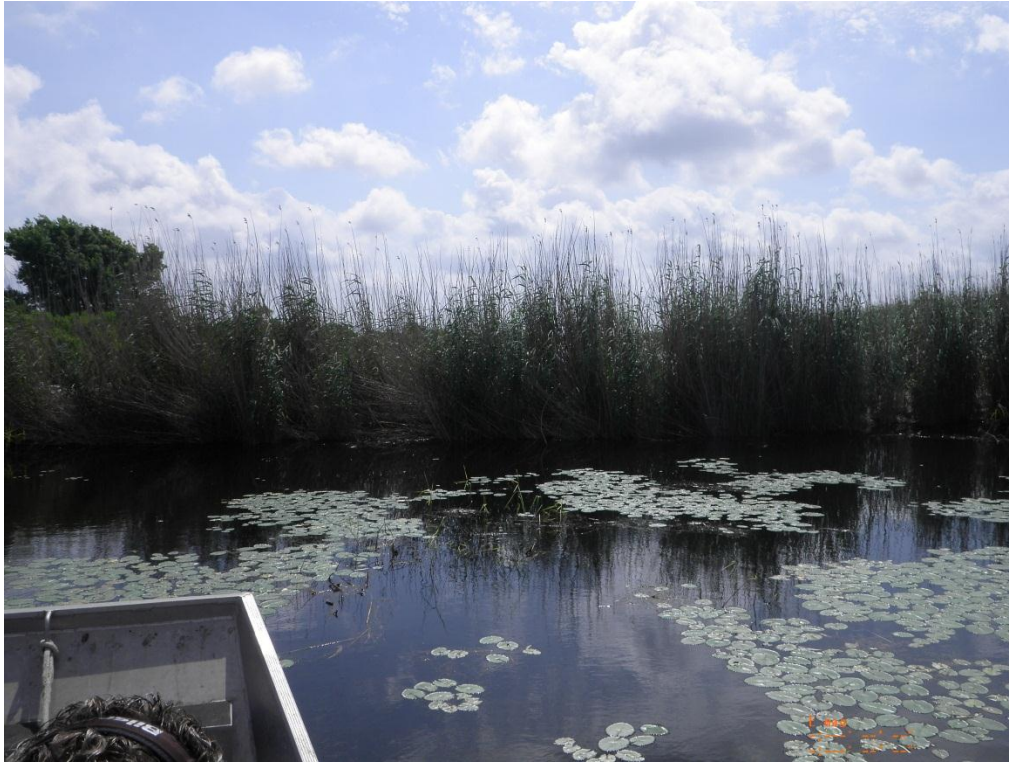
Rock plug 2 appears to be in good overall condition. During construction, the structure experienced some settlement of the rock riprap material and erosion causing a breach around its northern embankment tie-in. In order to repair this situation and prevent further breaching, extra rock riprap material was placed on this northern end of the structure raising its elevation. The as-built drawings indicate the north end was constructed to an elevation of approximately 5.5' NAVD with a gradual slope to the southern end at an elevation of approximately 3.0' NAVD. Our observations during the 2013 annual inspection are consistent with the as-built drawings, as the northern end is approximately 2.0'-3.0' higher in elevation than the southern end. The warning signs for the structure are up right and visible, but the southwest sign has been damaged by a shotgun. Overall this structure is in good condition.

Photo 1: Overall view of Rock Plug 2 from the oilfield canal, looking east

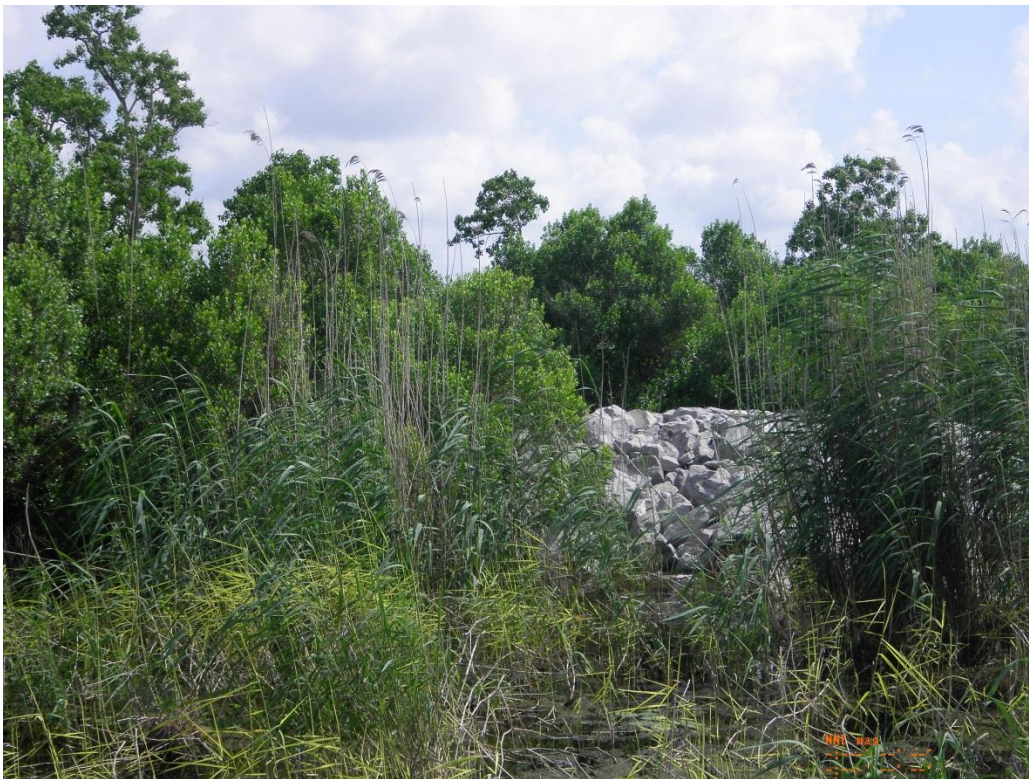
Photo 2: View of northern embankment on Rock Plug 2, facing northeast

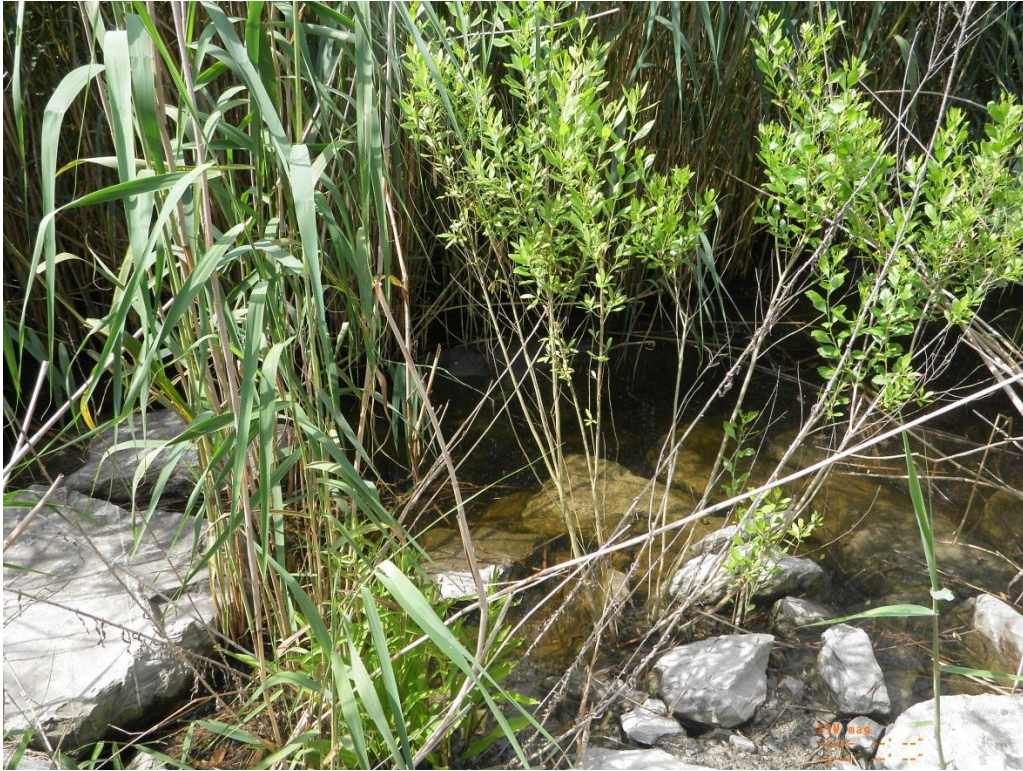
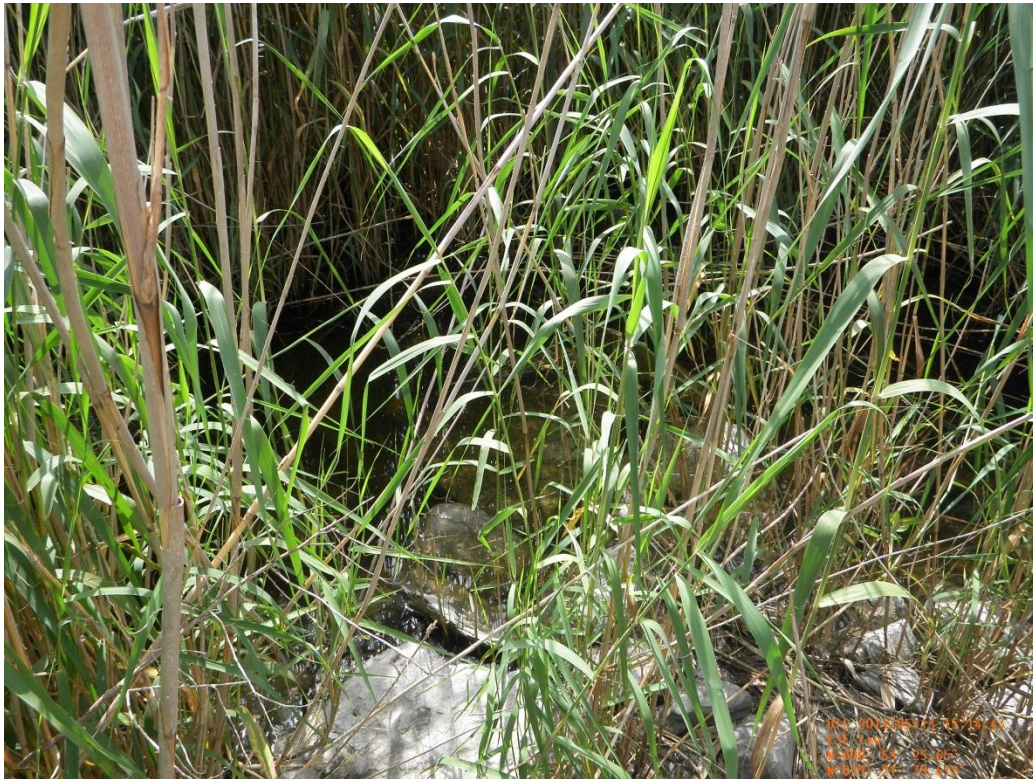
On the southern end of the structure, it appears the geofabric on which the rock riprap was placed was not properly trimmed to the edge of the structure. The excess of geofabric has prevented the native vegetation to grow around this end of the structure. With the lack of vegetation, standing water can be seen wrapping around the southern embankment tie-in. Although there was no flow of water around the structure observed during the inspection indicating a breach, this scenario would be plausible during an elevated tide or high water event. Due to the location of this structure and low volume of fill material, a repair of the embankment would be extremely expensive. Since this area does not pose an immediate threat, there are no recommendations for corrective action at this time, but CPRA will continue to monitor this location and would like to begin conversation with USFWS to discuss the feasibility of repairing this location.

Photo 3: View of standing water and untrimmed geo-fabric on the southern end of Rock Plug 2

Photo 4: View of standing water and untrimmed geo-fabric on the southern end of Rock Plug 2

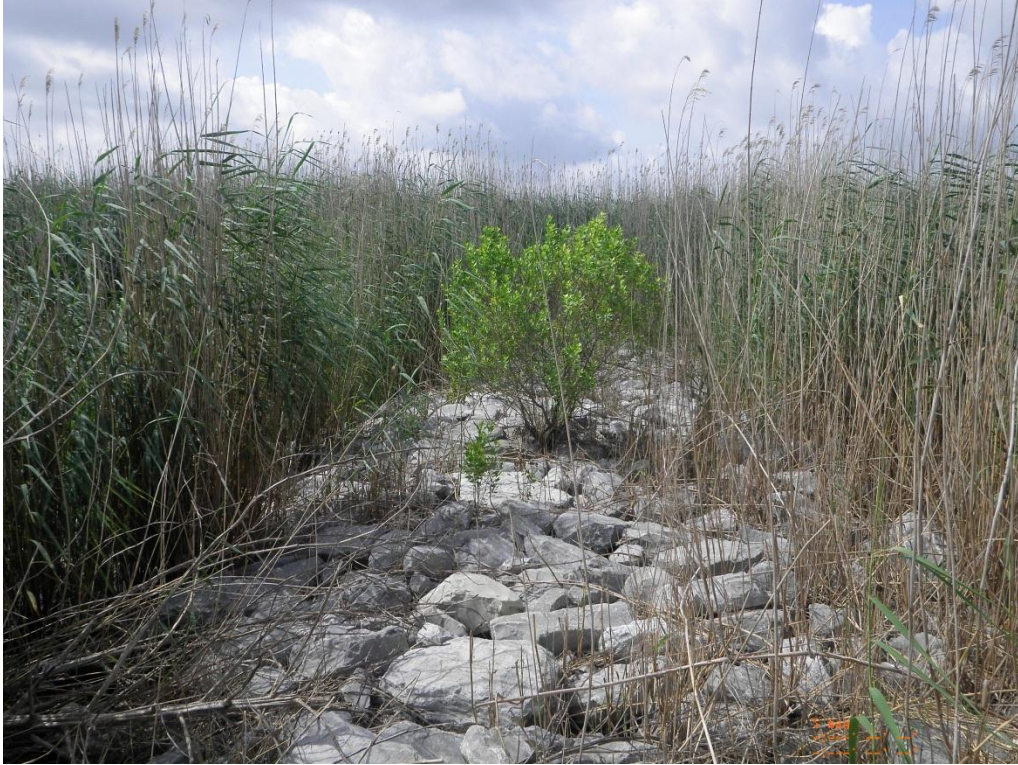
Photo 5: View of Rock Plug 2 from on top of the structure, looking north

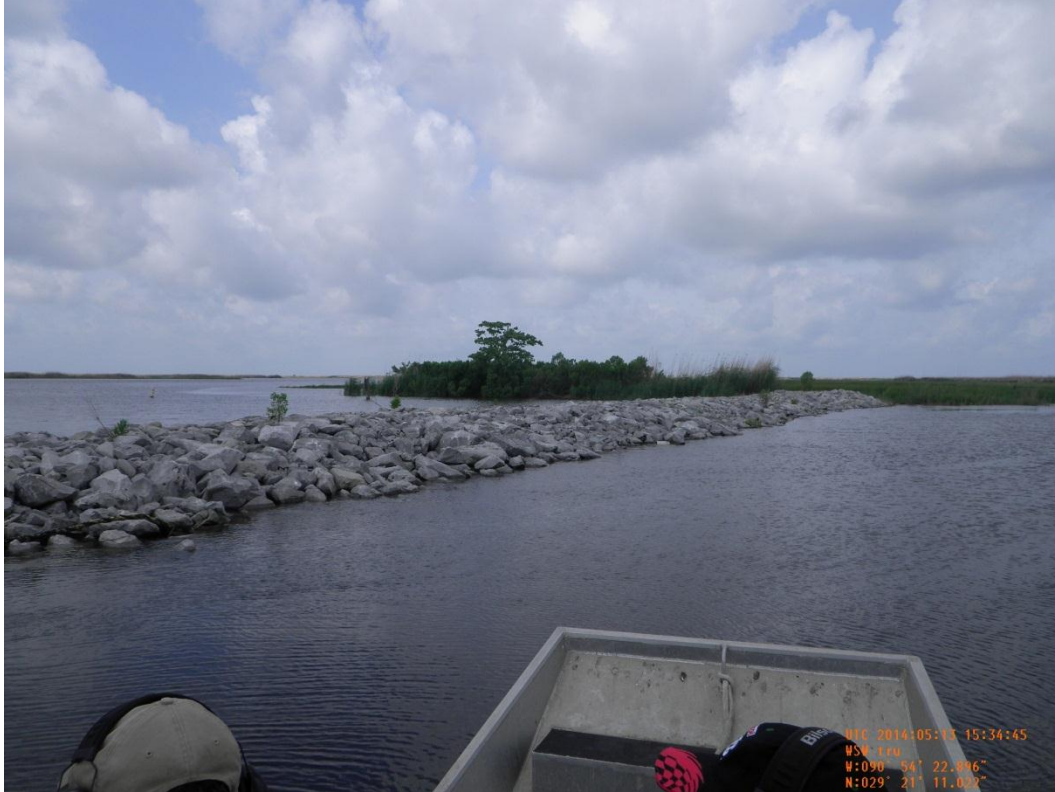
The Rock Plug 1 structure located along the south bank of Small Bayou LaPointe appeared to be in very good condition. There is no observable settlement since the end of construction and there is no evidence of erosion or washouts around the embankment tie-ins. The rock plug is still functioning as designed; therefore there are no recommendations for corrective action at this time.

Photo 6: Overall view of Rock Plug 1, looking southwest

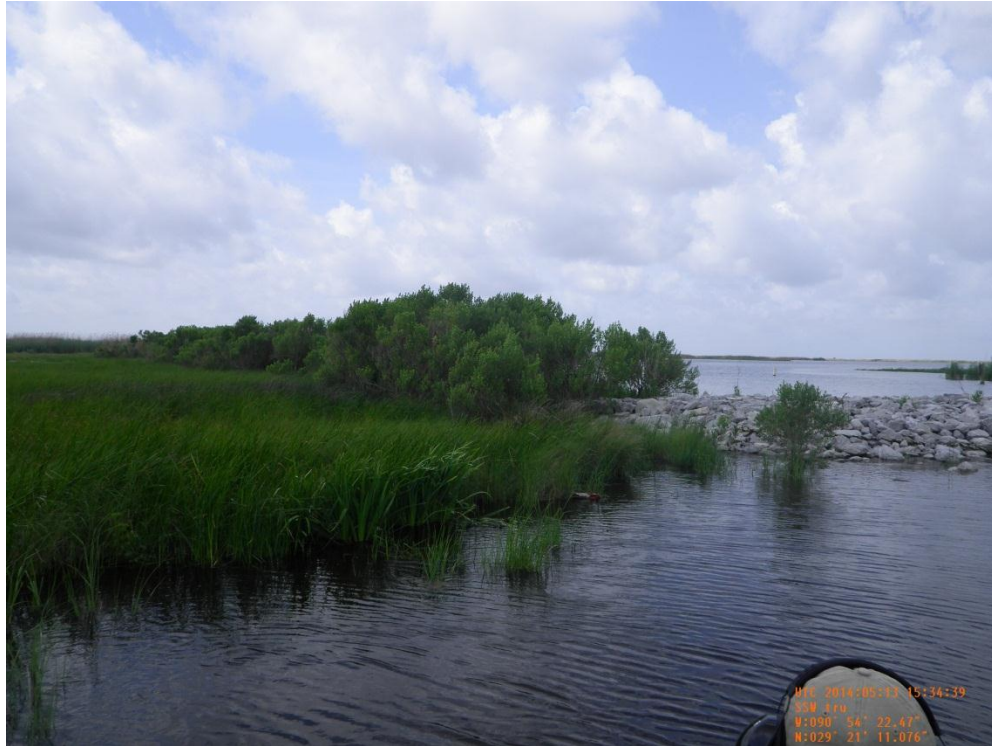
Photo 7: View of the eastern embankment tie-in of Rock Plug 1, looking south

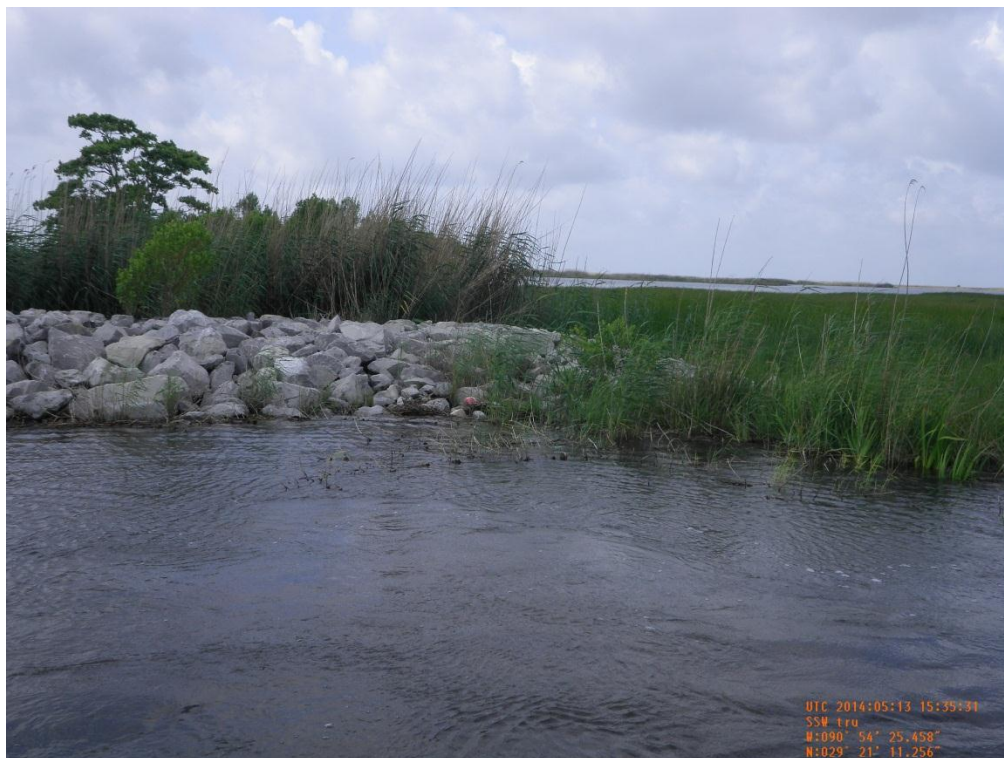
Photo 8: View of the western embankment tie-in of Rock Plug 1, looking south

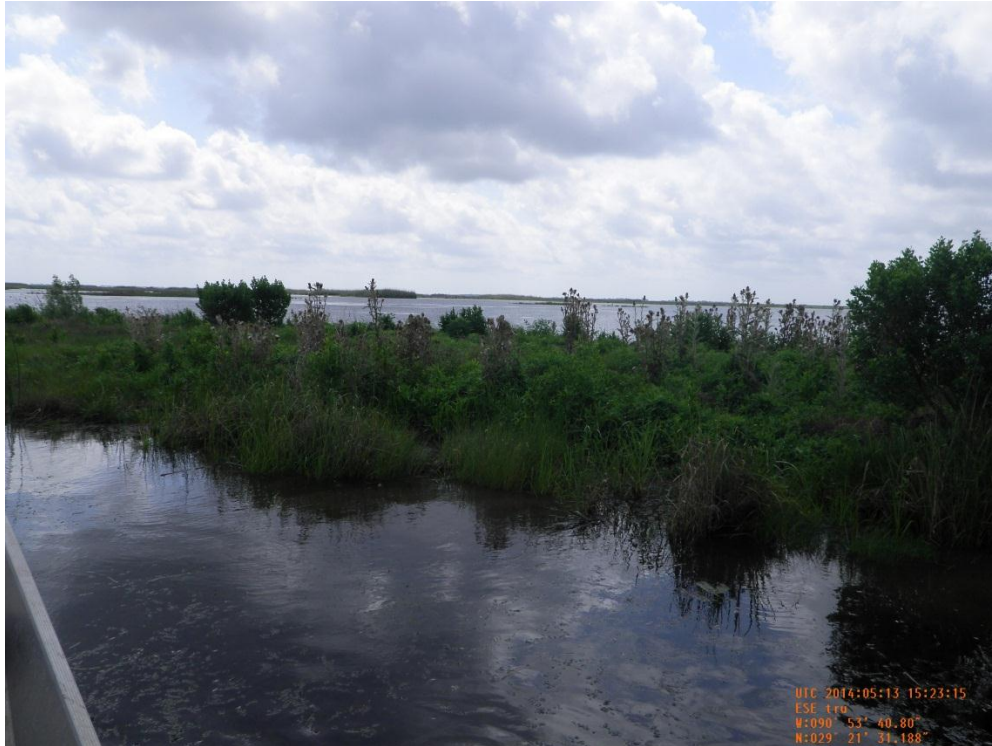
The Earthen Plug 2 structure located along the southern edge of Small Bayou LaPointe is difficult to access and difficult to locate now that the structure is fully vegetated. Besides the slightly higher elevation than the adjacent marsh, the structure doesn't have any identifying characteristics. This structure is in good overall condition with no observed settlement or erosion of the plug. Also, there is no evidence of washouts around the structures embankment tie-ins. There are no recommendations for maintenance at this time.

Photo 9: Overall view of Earthen Plug 2 from Small Bayou Lapointe, looking east

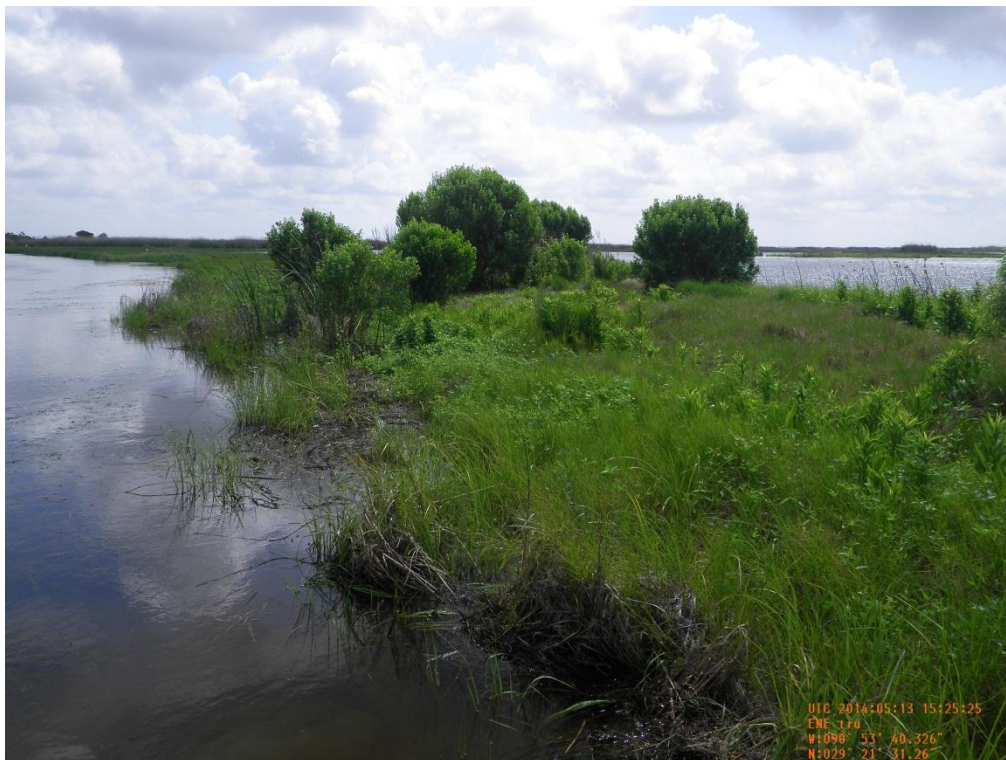
Photo 10: View of the eastern embankment tie-in of Earthen Plug 2, looking east

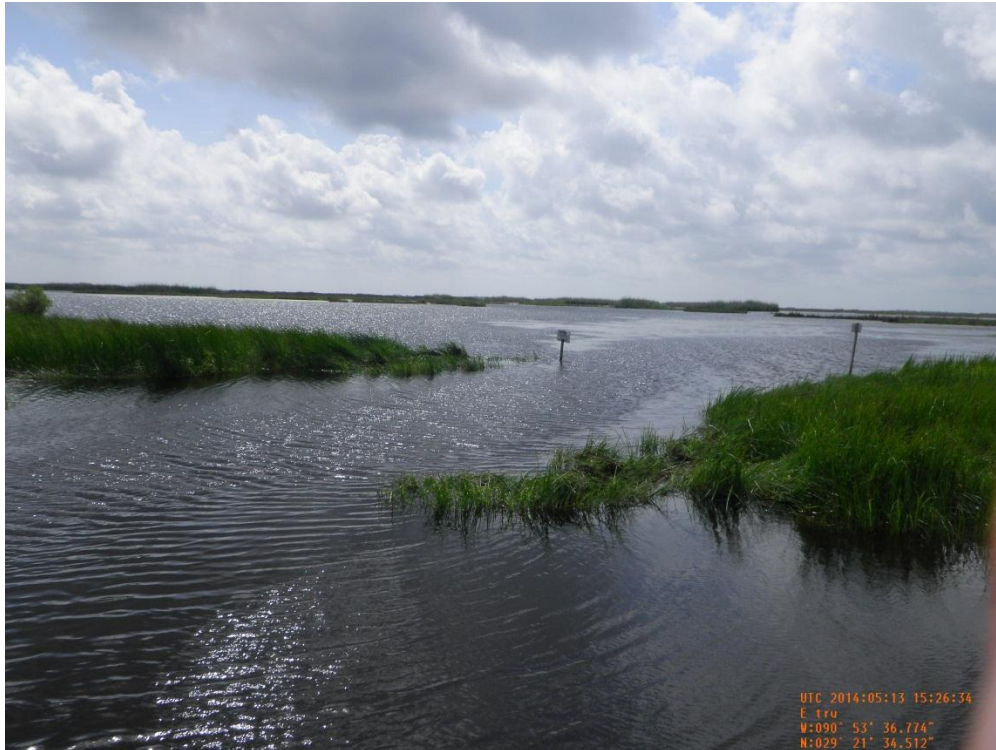
There was a breach identified during this year's annual inspection in the southern bank of Small Bayou LaPointe located approximately 400 feet north east of Earthen Plug 2. This is a new breach, and at the time of this report, it remains breached. Once repaired, this breach will be referred to as Earthen Plug 5.

Photo 11: View of a breach in the southern bank of Small Bayou Lapointe, looking east. It is located between Earthen Plug 2 and Rock Plug 2.

General Breach Repairs: Since the project was completed, we have noticed that the earthen embankments along the Small Bayou Lapointe Ridge are thin and endanger of breaching (very little marsh protecting the ridge). Below are estimated costs for refurbishing sections of the embankment. At this time, the specific areas have not been identified. For 2016/2017, we are assuming that approximately 500 linear feet of embankment will require refurbishment.

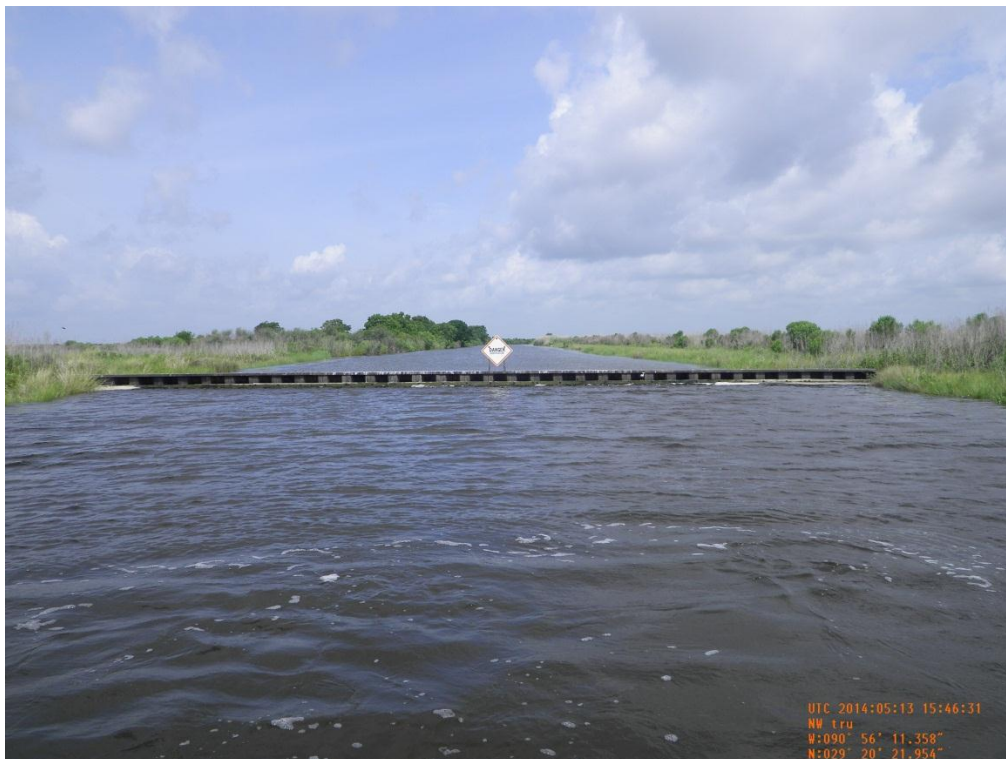
Sheet Pile Plug No. 3 appears to be in good overall condition. The sheet pile and top cap showed no signs of damage or excessive corrosion, and the embankment tie-ins had no signs of erosion or washouts. Photo comparison from previous annual inspections display the articulated concrete mat used to armor the embankment tie-ins are stable with no signs of settlement. In addition, the warning signs were intact and visible. There are no recommendations for corrective action at this time.

Photo 12: Overall view of Sheetpile Plug 3, looking northwest

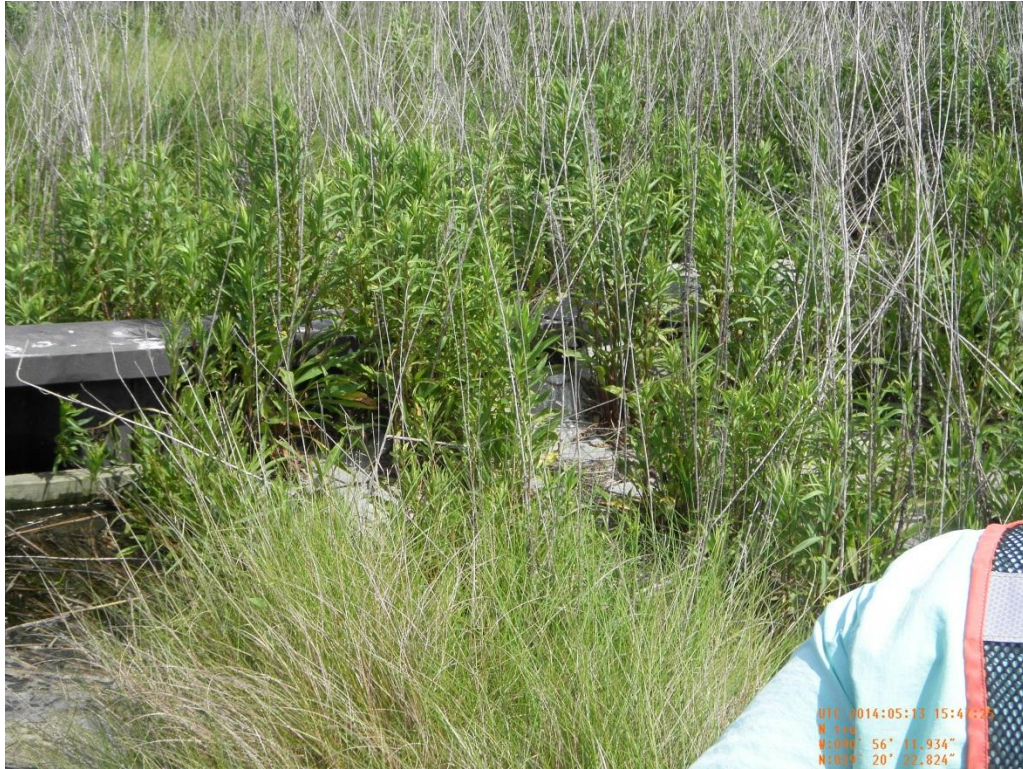
Photo 13: View of the articulated concrete mat on the northeastern embankment tie-in on Sheetpile Plug 3

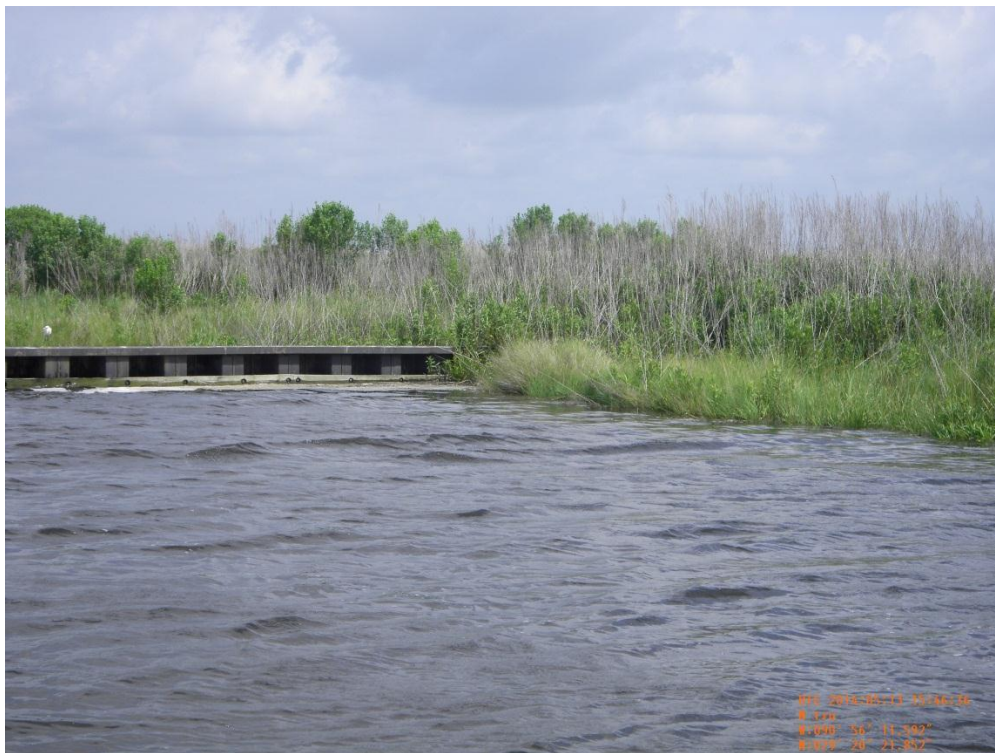
Photo 14: View of northeastern embankment tie-in on Sheetpile Plug 3, looking north.

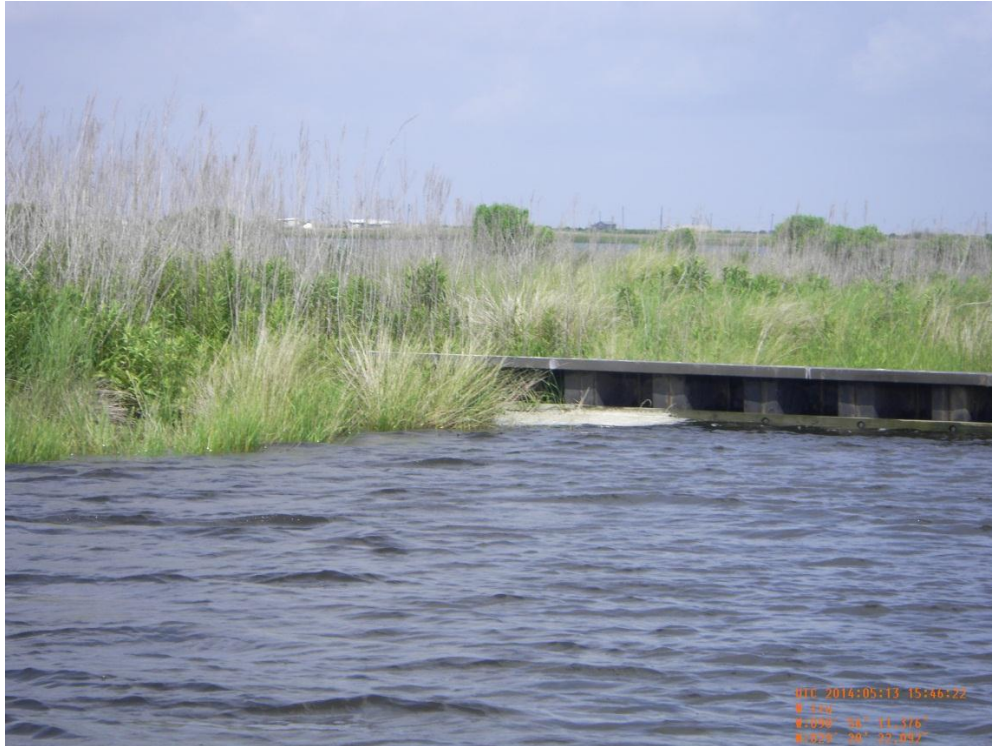
Photo 15: View of the southwestern embankment tie-in on Sheetpile Plug 3, looking west.

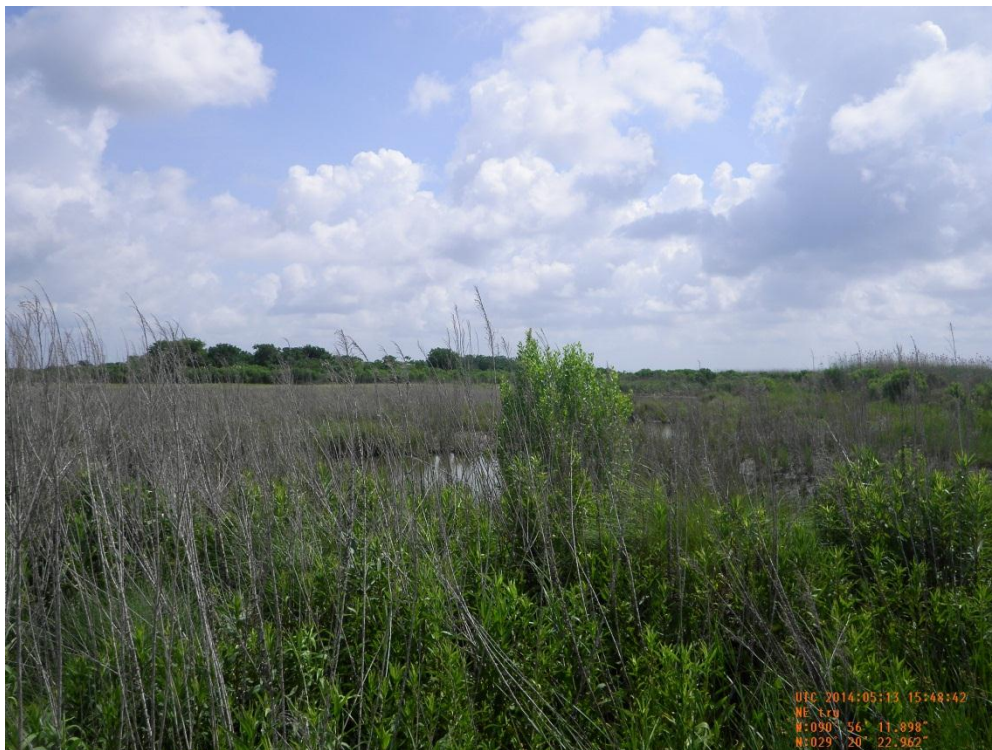
Photo 16: View of Fill Area 7 from Sheetpile Plug 3, looking northeast

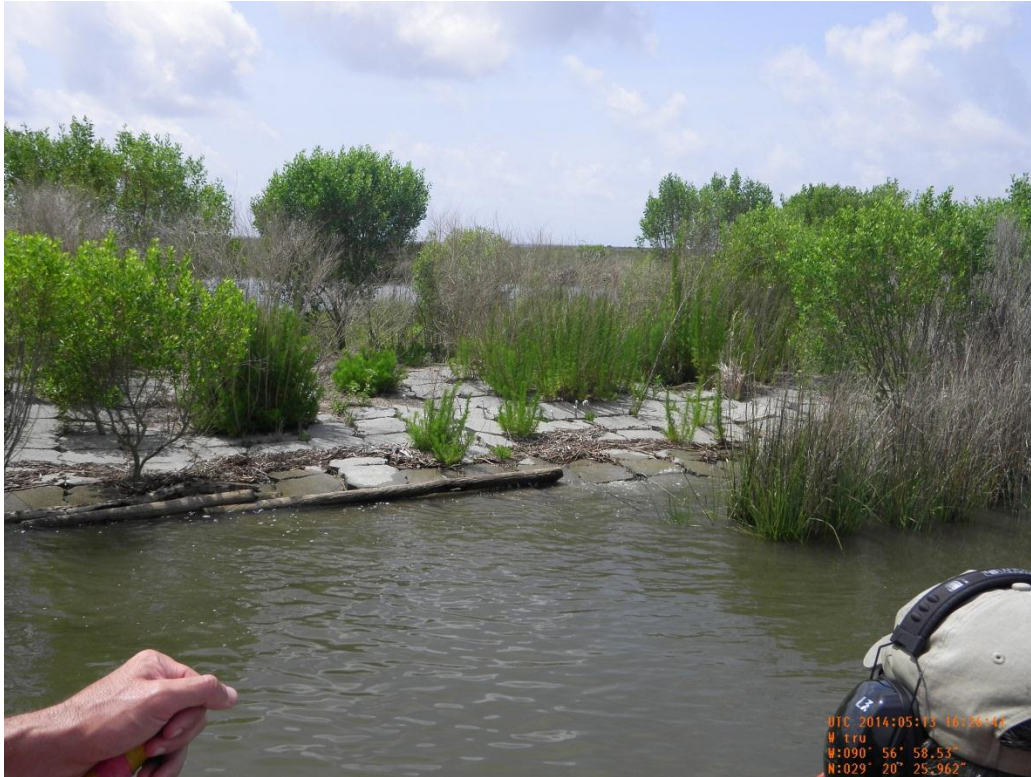
The Armored Earthen Dike on the west bank of Bayou Raccourci appears to be in good overall condition. The warning sign and its support timber show no signs of damage. The articulated concrete mats are still coupled by the copolymer rope with vegetation emerging through the seams and in front of the concrete mats. The woody vegetation that is growing through the mats raises some concern as the trees/shrubs continue to grow. This vegetation will be monitored in future inspections. As expected, there is some variation in height along the length of the armored earthen dike. This is believed to be caused by a difference in dredged material settling at different rates under the weight of the articulated concrete mats in addition to placement of the mats on earthen material that was not fully compacted. Although there are some slight variations in elevation, the armored earthen dike is still performing as designed; therefore, there are no recommendations for corrective actions at this time.

Photo 17: View of the articulated concrete mats along the southern end of Bayou Raccourci

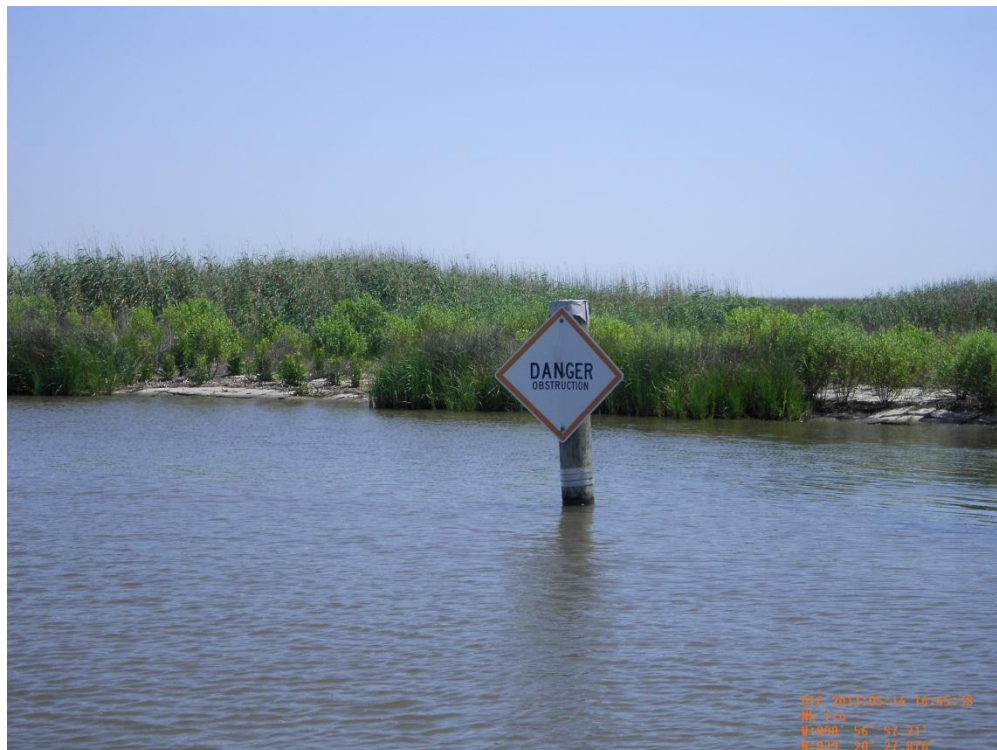
Photo 18: View of the warning signs in front of the articulated concrete mats along Bayou Raccourci

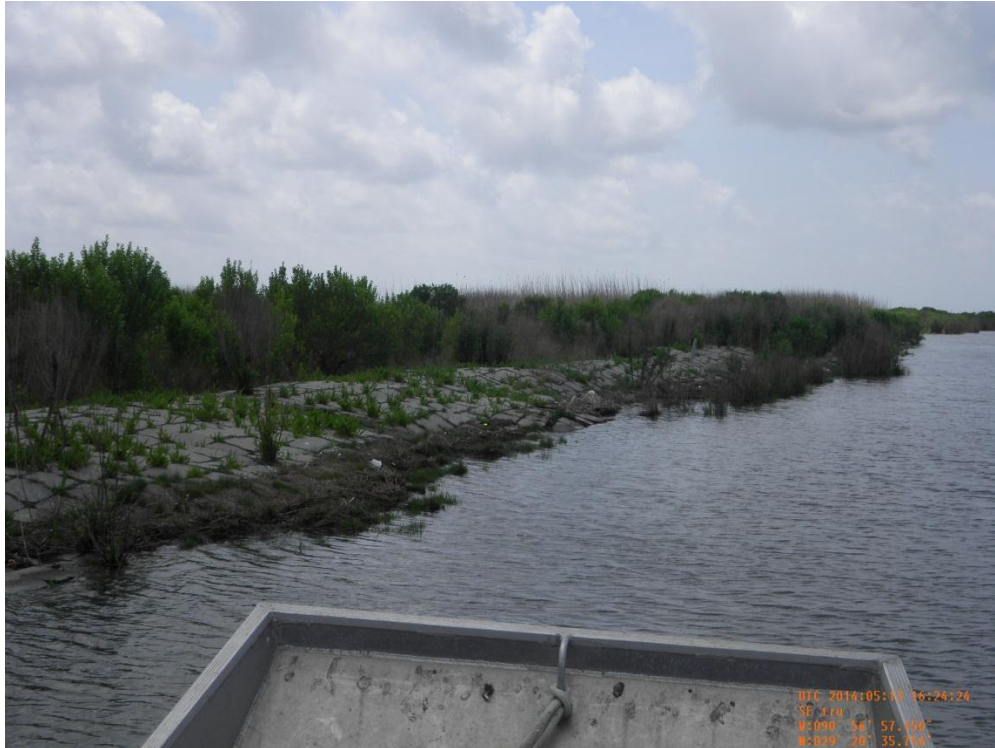
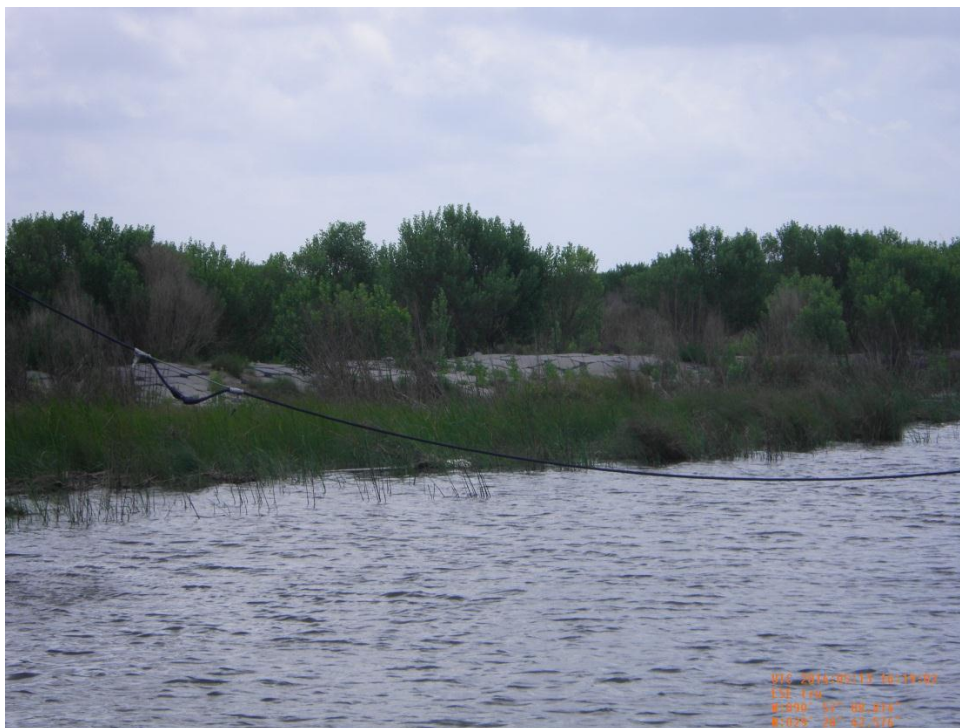
Photo 19: View of the articulated concrete mats along the eastern bank of Bayou Raccourci, looking southeast

Photo 20: View of the articulated concrete mats along the eastern bank of Bayou Raccourci, looking southeast

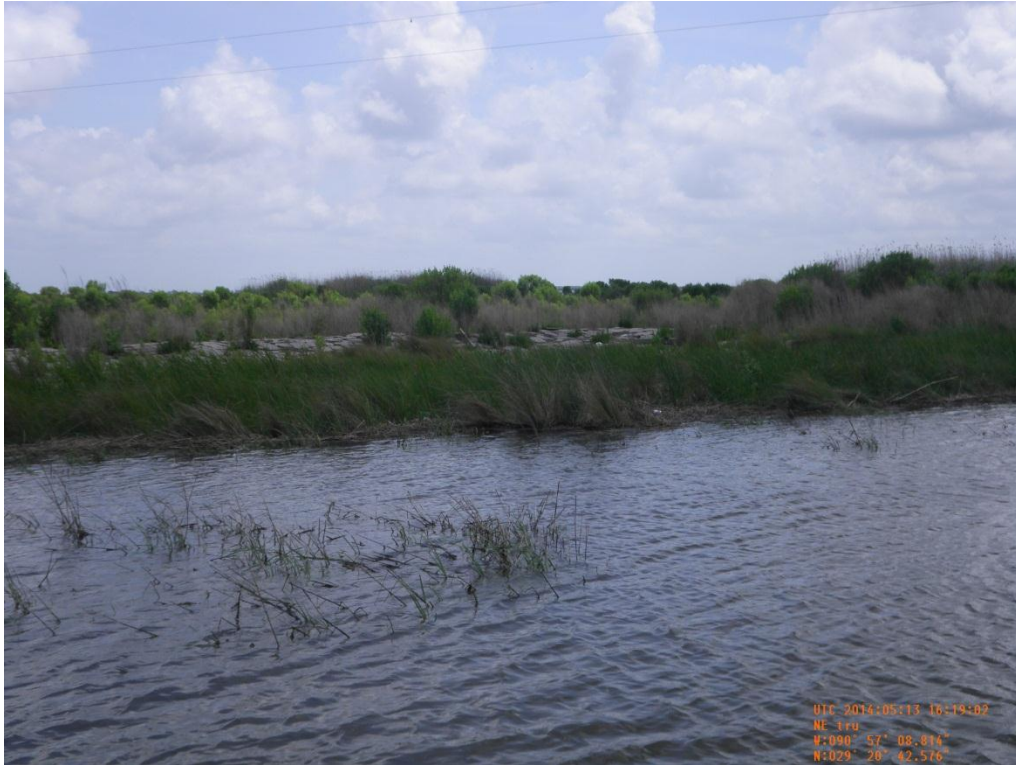
Photo 21: View of the articulated concrete mats along the northern end of Bayou Raccourci

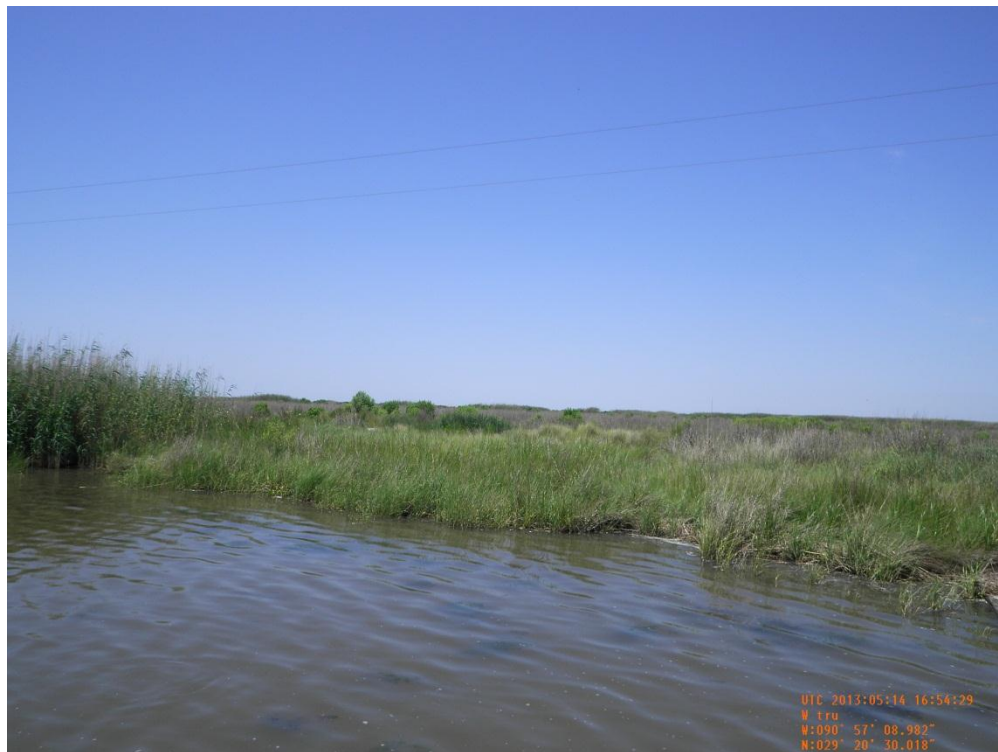
From our observations during the annual inspection, it appears the fill areas are promoting the growth of vegetation with the majority of the areas fully vegetated. All of the fill areas were visually inspected from the perimeter of the individual areas, but with the capabilities of the airboat, we were able to see the interior of Fill Areas 2A, 2-3, 4, and 5. There are no signs of extreme settlement of the fill material, as the elevation of the dredged material remains fairly consistent with the typical spikes in elevation where the dredge pipe was located during construction. Overall the fill areas appear to be in very good condition and there are no recommendations for corrective actions at this time.

Photo 22: View of Fill Area 5 from the western bank of Bayou Raccourci, looking west

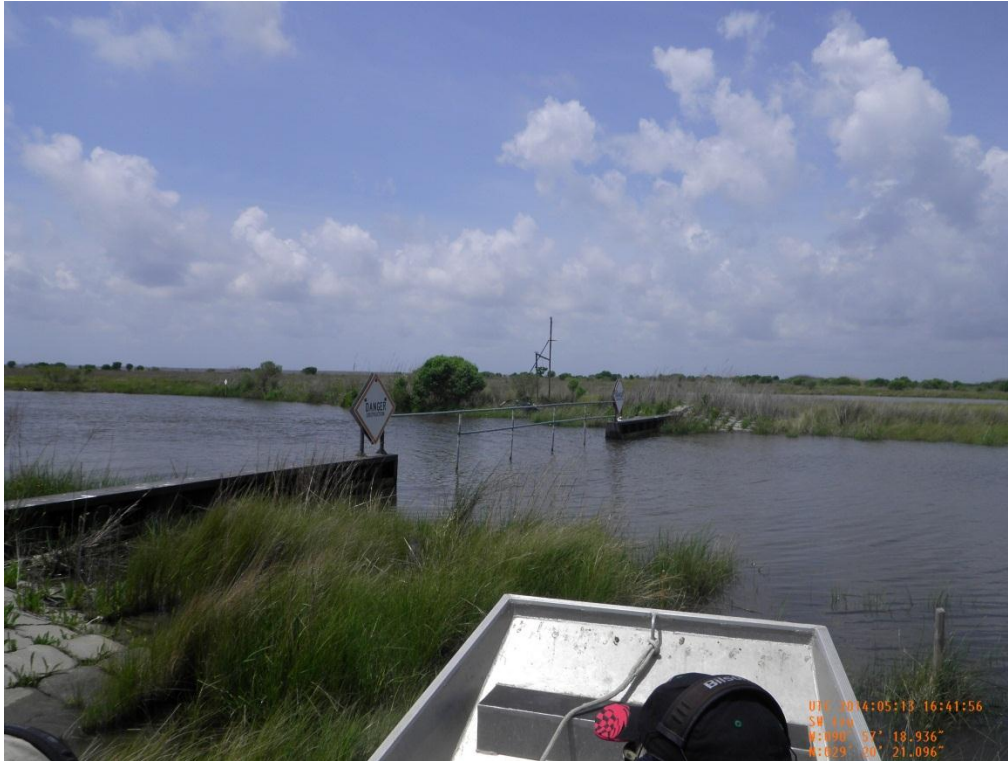
The Sheetpile Weir structure appears to be in good overall condition. There are no signs of excessive corrosion or damage to the sheet pile or top cap. There appears to be no erosion or washouts around the embankment tie-ins. Photo comparison from previous annual inspections display the articulated concrete mat used to armor the embankment tie-ins are stable with no signs of settlement. The warning signs and supports are also in good condition. There are no recommendations for corrective action at this time.

Photo 23: Overall view of the Sheetpile Weir replacement, looking southwest

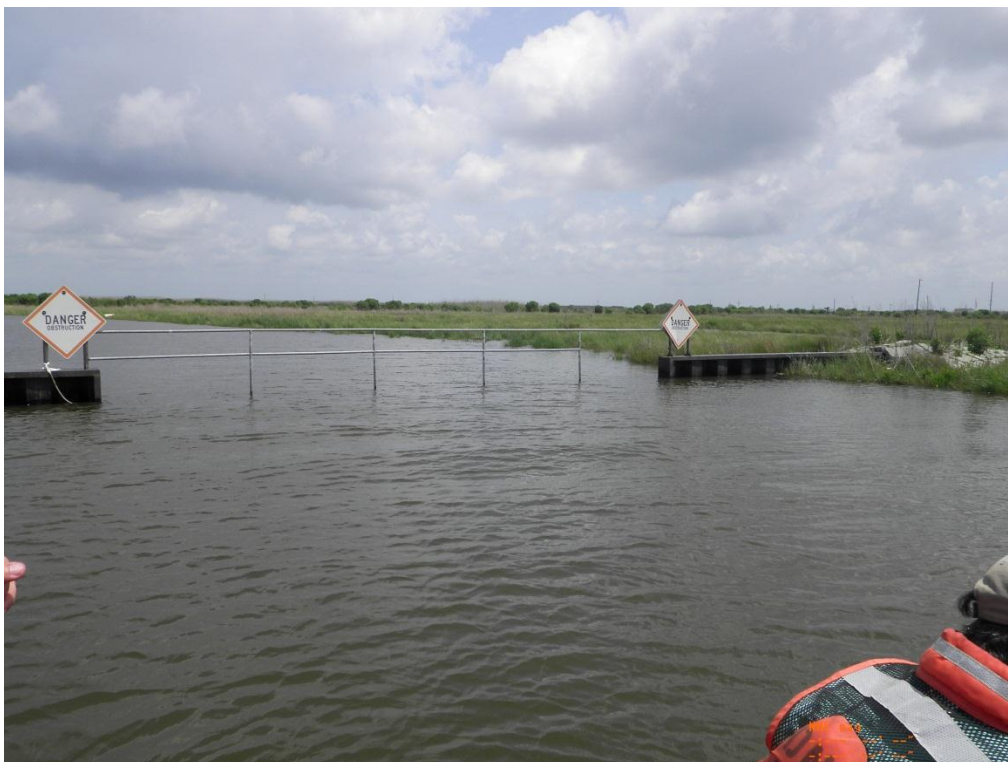
Photo 24: Close-up view of the warning signs on top of the Sheetpile Weir, looking north

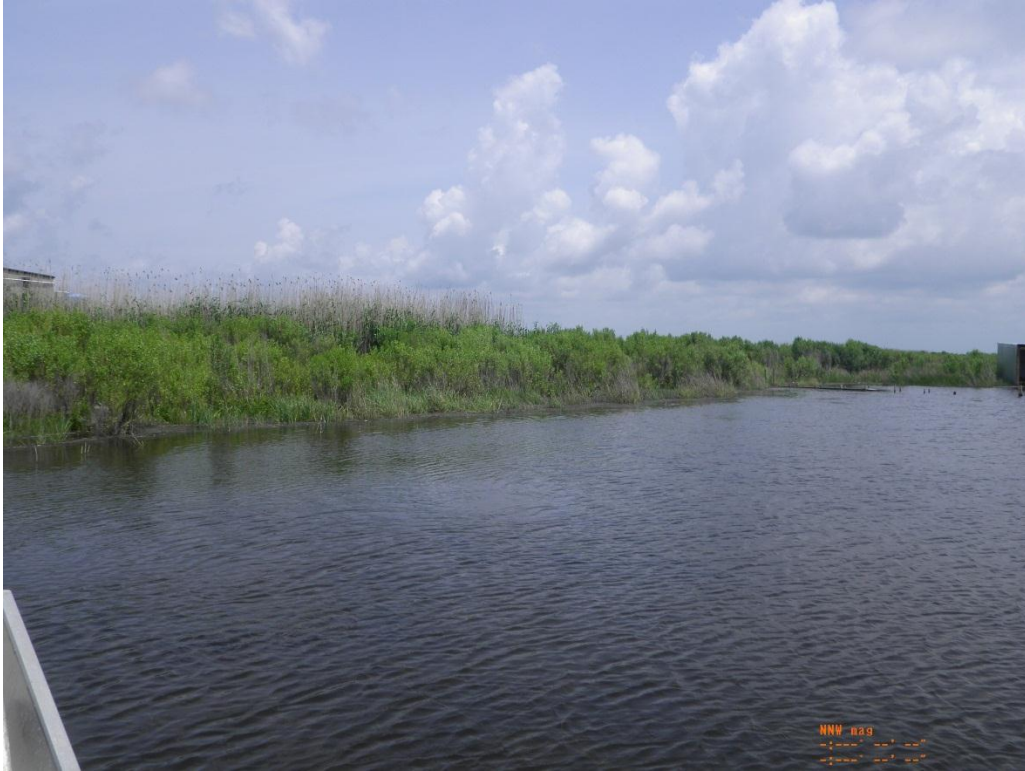
The Earthen Plug 1 structure located on the eastern edge of Lake Pagie appeared to be in good overall condition. The plug was viewed from the “Y” canal and from directly on top of the structure at the southern embankment tie-in. It appears to be densely vegetated with no signs of erosion or washout around the embankment tie-ins. Earthen Plug 1 is in good shape and there are no recommendations for corrective action at this time.

Photo 25: Overall view of Earthen Plug 1 from the Y canal, looking northwest

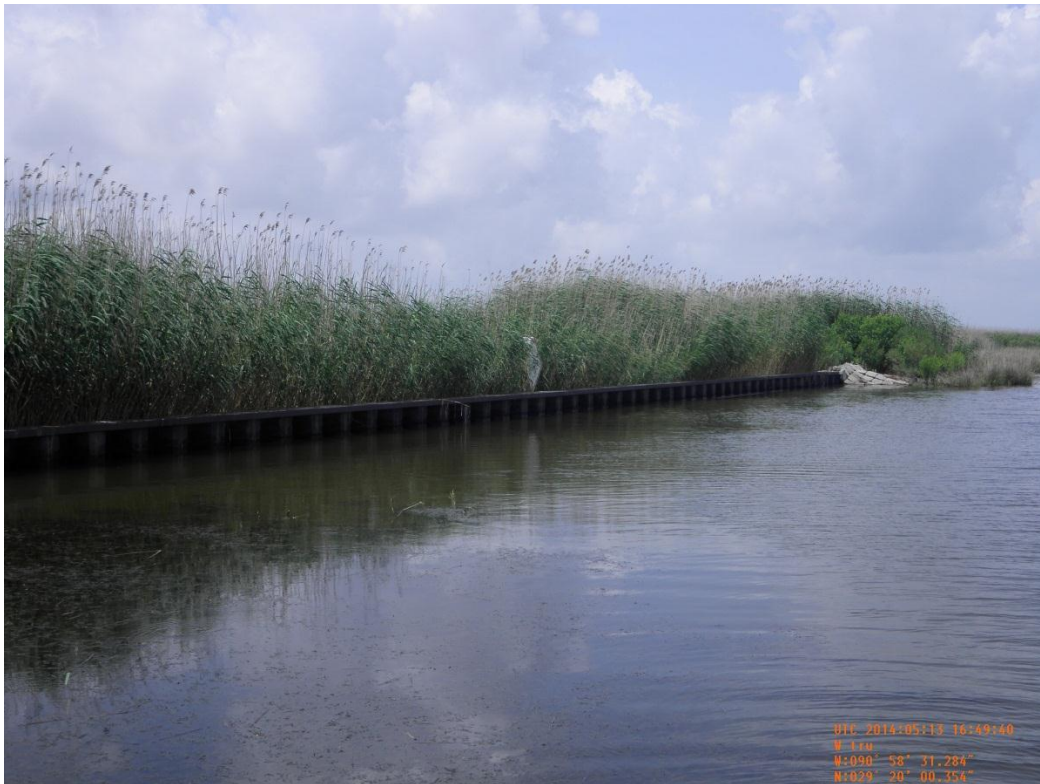
Sheet pile plug 1 is in good condition. There are no signs of settlement or excessive corrosion of the sheet pile, cap, warning signs and supports. The embankment tie-ins are armored with articulated concrete mats and also show no signs of settlement or erosion around its ends. The structure appears to be stable and functioning as intended. There are no recommendations for corrective actions at this time.

Photo 26: Overall view of Sheetpile Plug 1 from the Y canal. Looking west
