**State of Louisiana
Coastal Protection and Restoration
Authority**

2014 Annual Inspection Report

**North Lake Mechant Landbridge
Restoration Project (TE-44)**

June 11, 2014
Terrebonne Parish

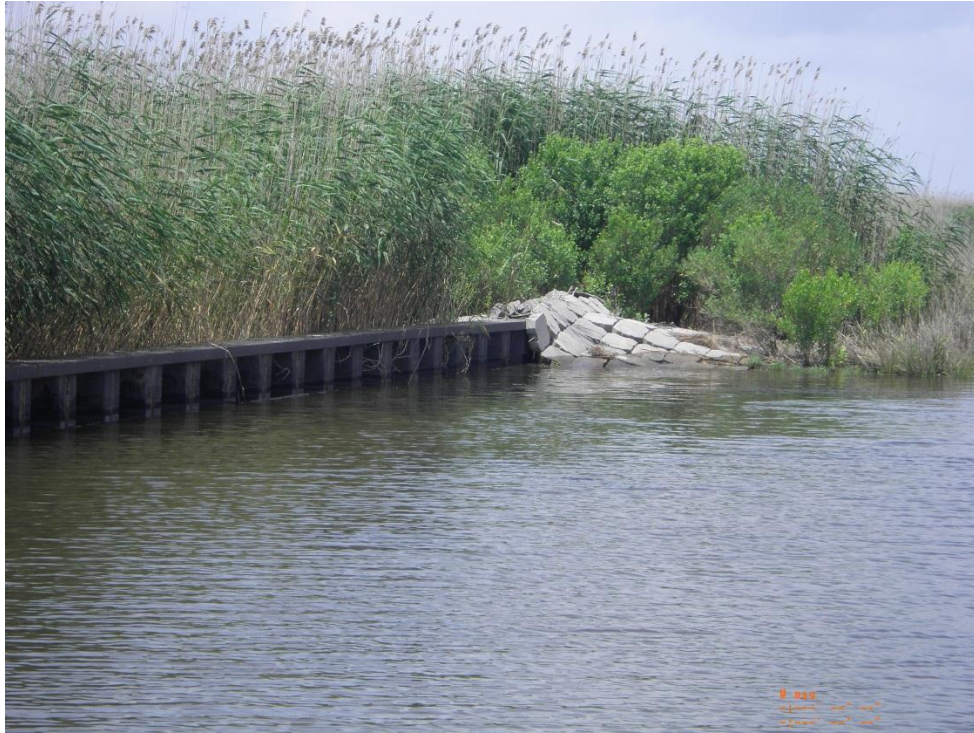
Photo 27: View of the articulated concrete mats used on the western embankment tie-in of Sheetpile Plug 1, looking south

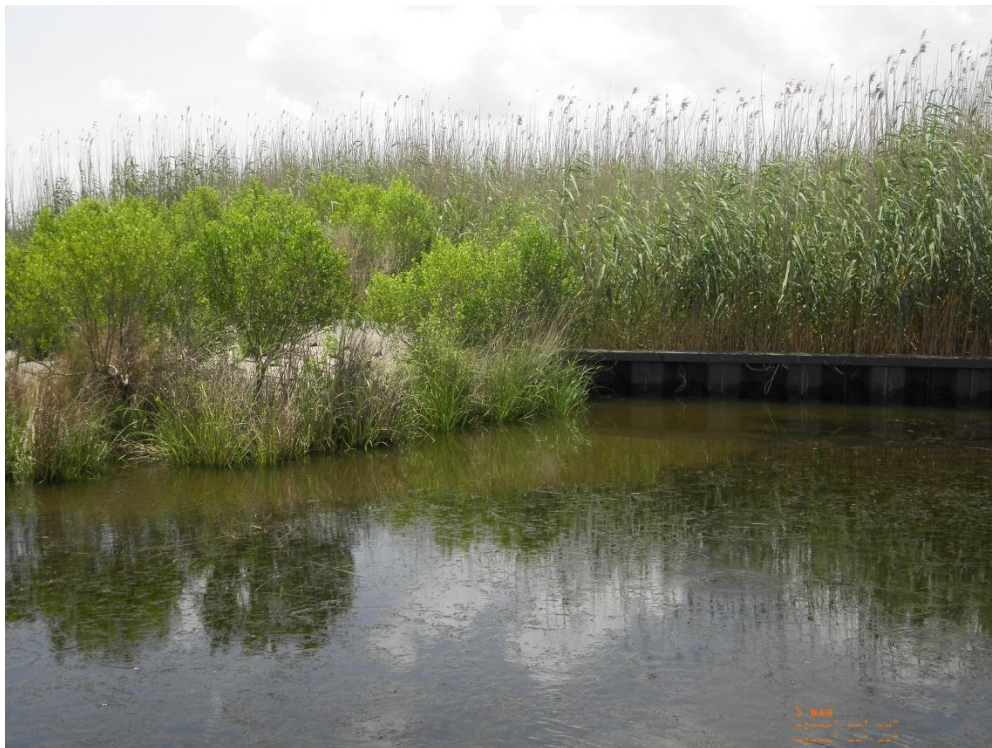
Photo 28: View of the articulated concrete mats used on the eastern embankment tie-in of Sheetpile Plug 1, looking south

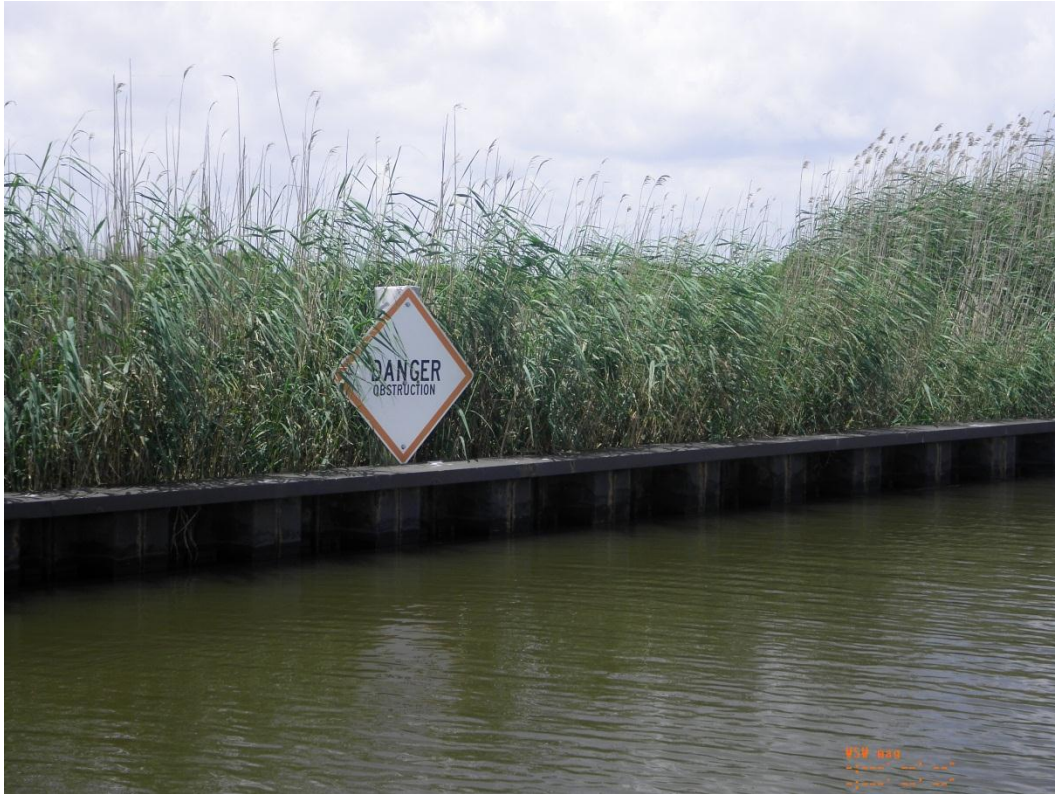
Photo 29: View of the warning sign installed on top of Sheetpile Plug 1, looking south

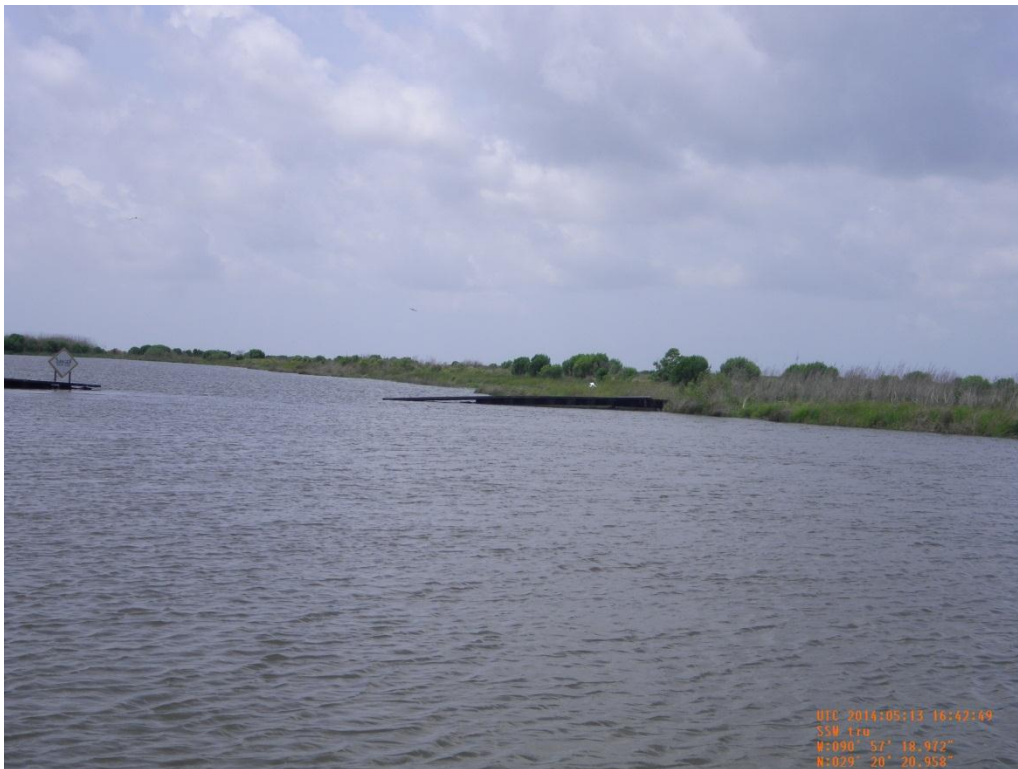
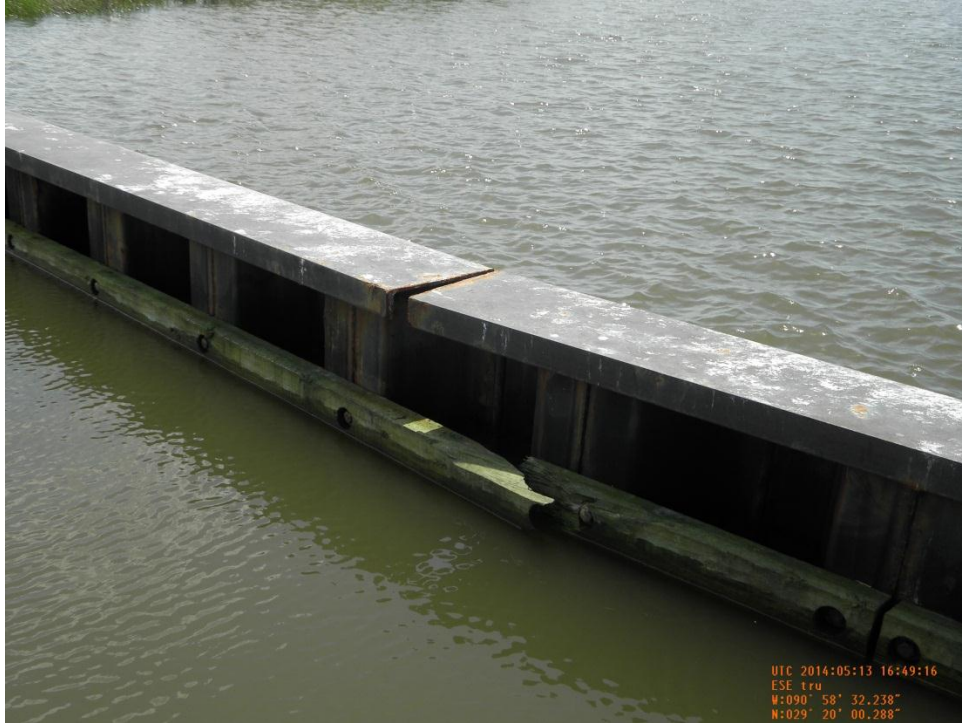
The Sheetpile Plug 2 suffered catastrophic structural damage due to Hurricane Isaac in August 2012. It appears a large water level differential during the storm caused the free standing structure to fail and fall over. A section of the top cap is missing and the sheet pile is bent below the water line allowing water to pass through/over the structure. Sheetpile Plug 2 is damaged in such a way that there are minimal options for repairing the structure, it must be removed and then replaced. CPRA has initiated a claim with the

Photo 30: View of structural damage to Sheetpile Plug 2 caused by Hurricane Isaac, looking south

Photo 33: View of structural damage to Sheetpile Plug 2 caused by Hurricane Isaac.

Federal Emergency Management Agency (FEMA) as the structure was damaged during a natural disaster. As of June 2014, CPRA has provided FEMA personnel with design plans, replacement estimates, supporting documentation, and site visits to help advance the claims procedure and are currently waiting a response from FEMA claims processing.

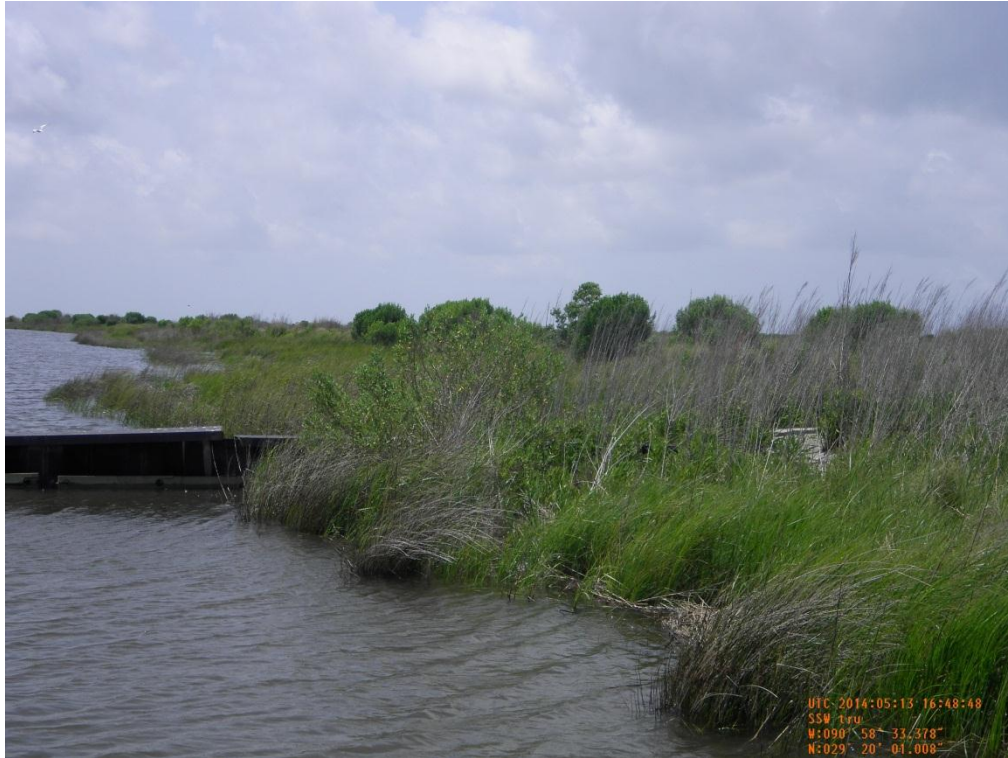
Photo 31: View of western embankment tie-in of Sheetpile Plug 2, looking west

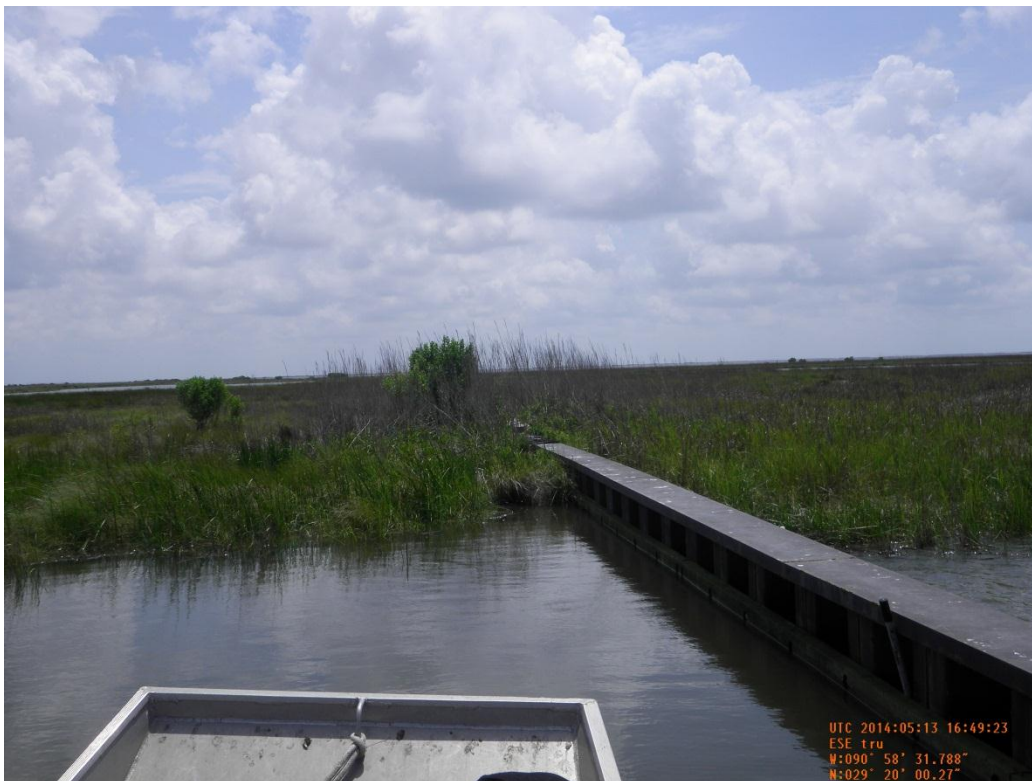
Photo 32: View of eastern embankment tie-in of Sheetpile Plug 2, looking east
