**State of Louisiana
Coastal Protection and Restoration
Authority**

2018 Annual Inspection Report

**North Lake Mechant Landbridge
Restoration Project (TE-44)**

August 8, 2018
Terrebonne Parish

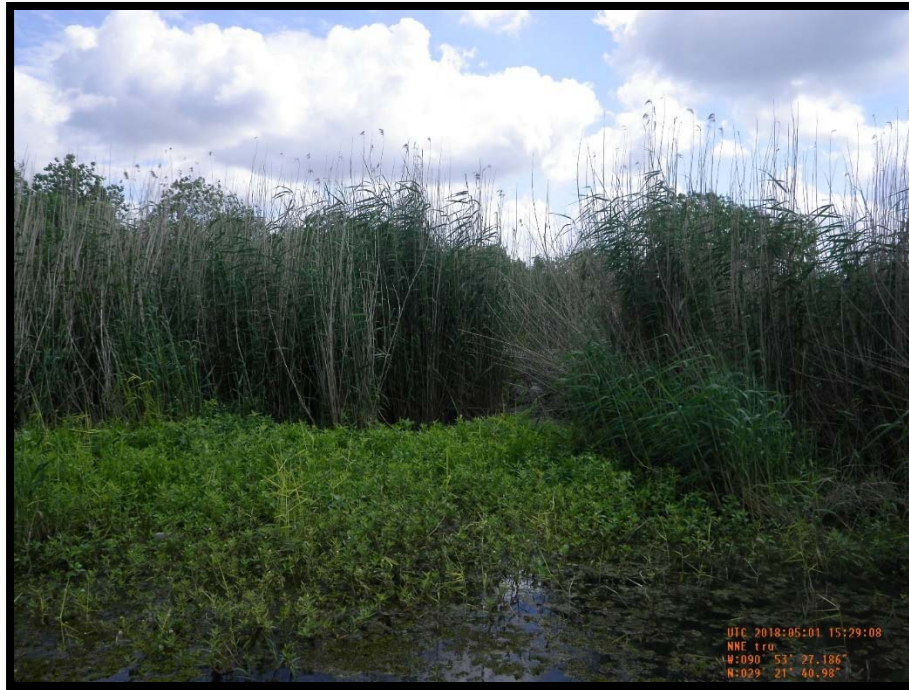
Rock plug 2 appears to be in fair condition. At the time of the inspection, the rock plug was over-grown with vegetation making it difficult to view the structure. We were unable to inspect the bank tie-ins due to limited access and the amount of vegetation covering the structure. We did not notice any signs of breaching on either end of the structure, or flow around the structure. The warning signs and floating buoys in front of the structure were in fair condition with only slight damage to the southwest sign that had been vandalized and damaged by a shotgun. (Appendix B, Photos 1 through 3)

Photo No.1 – View of Rock Plug No.2 located on the northeast edge of the project area looking east. Heavy vegetation on both sides of the structure.

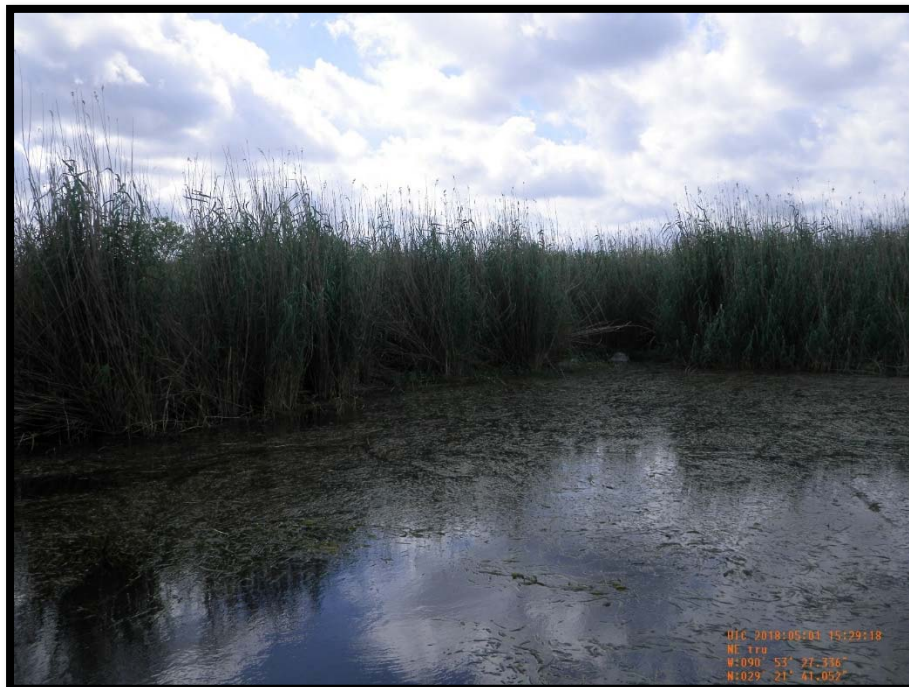
Photo No.2 – view of the southern bank tie-in of Rock Plug No.2 with heavy vegetation on both sides of the structure.

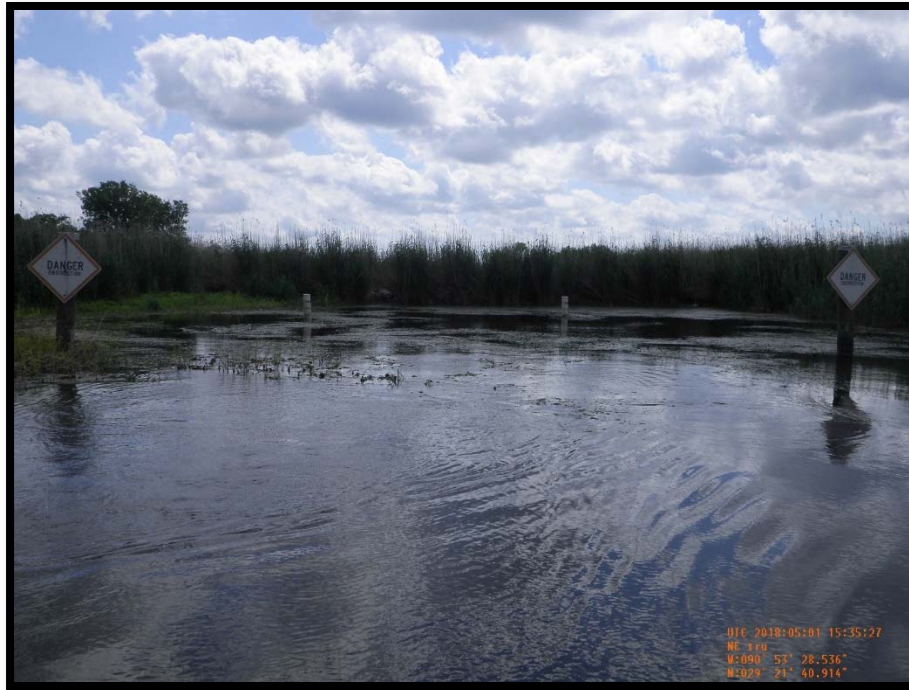
Photo No.3 – view of timber and floating warning signs on the west side of Rock Plug No.2.

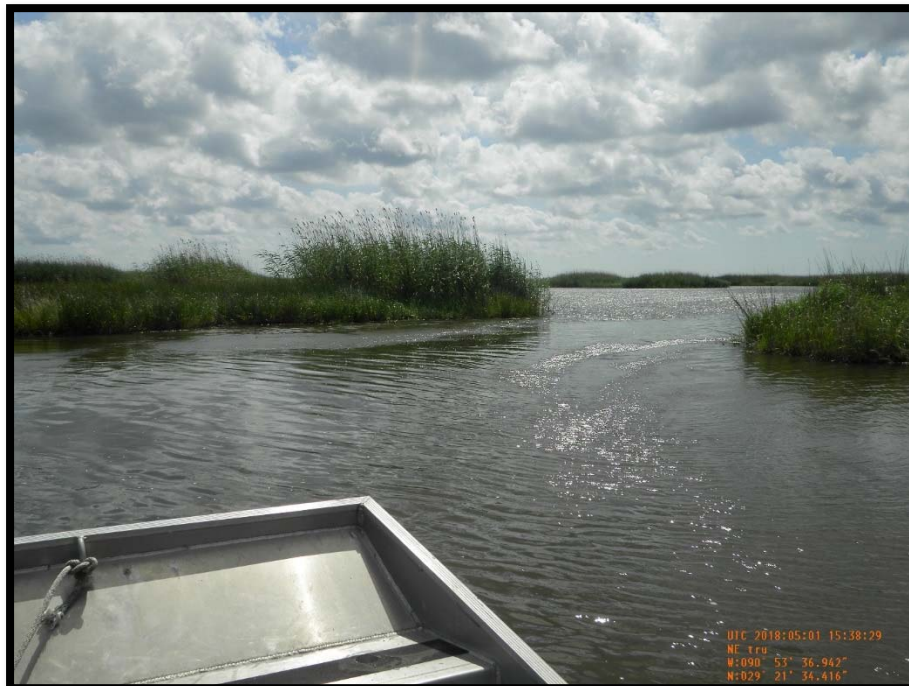
Photo No.4 – view of breach in Small Bayou LaPointe Ridge between Rock Plug No.2 and Earthen Plug No.1

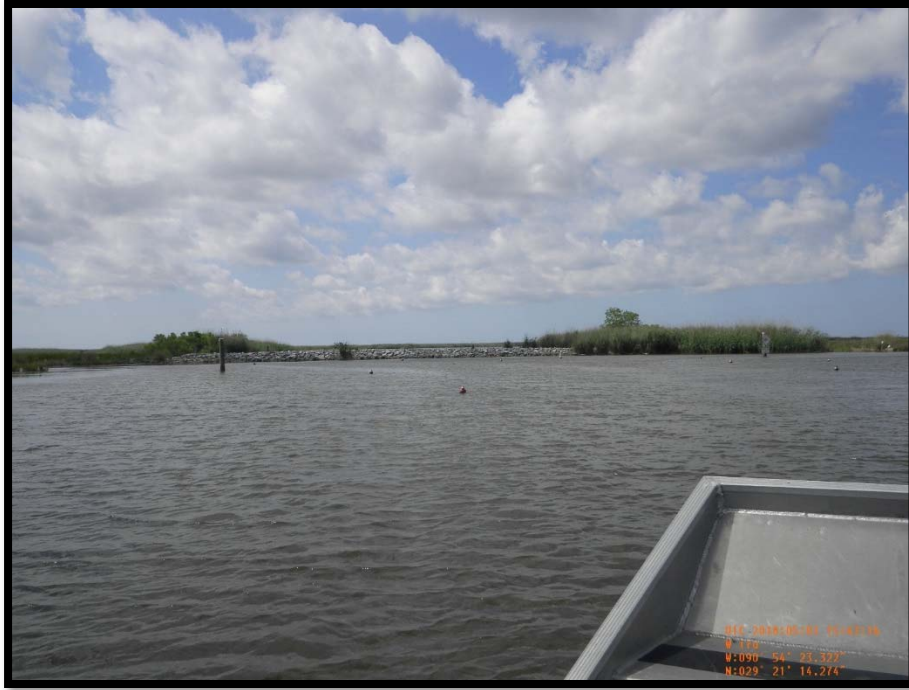
The Rock Plug 1 structure located along the south bank of Small Bayou LaPointe across the old Lil' Deuce Cut appears to be in good condition. There are no visible signs of settlement since construction or obvious erosion and washouts around the embankment tie-ins. There was a warning sign and floating buoy missing on the northeast side of the structure. The other signs and buoys appear to be in fair condition. It is recommended that the aluminum warning sign and floating buoy be replaced during the next maintenance event in the area. (Appendix B, Photos 5 through 7)

Photo No.5 – overall view of Rock Plug No.1 along Small Bayou LaPointe Ridge looking south.

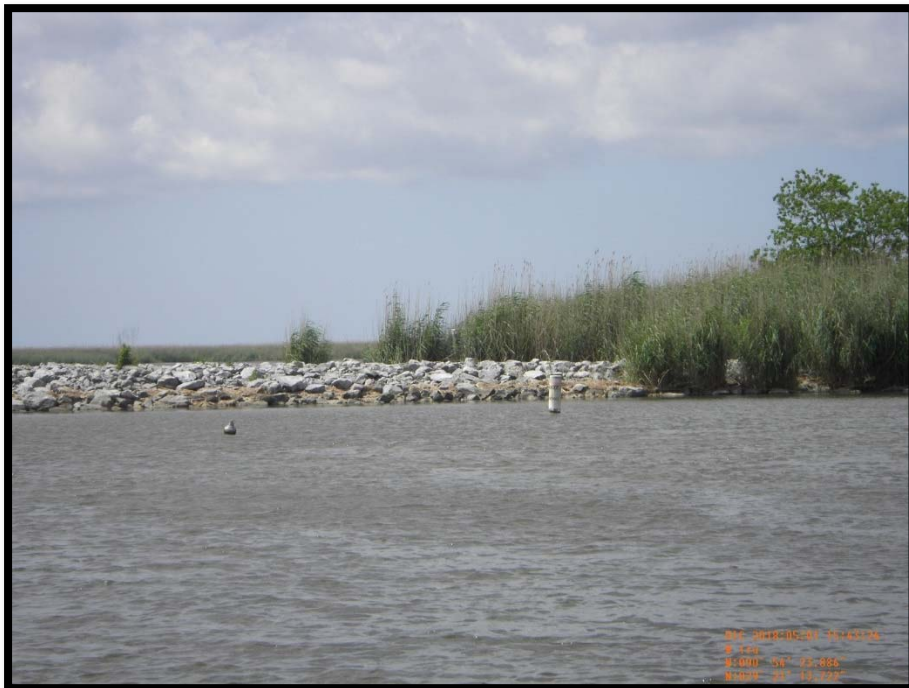
Photo No.6 – view of the west bank tie-in of Rock Plug No.1 along Small Bayou LaPointe Ridge.

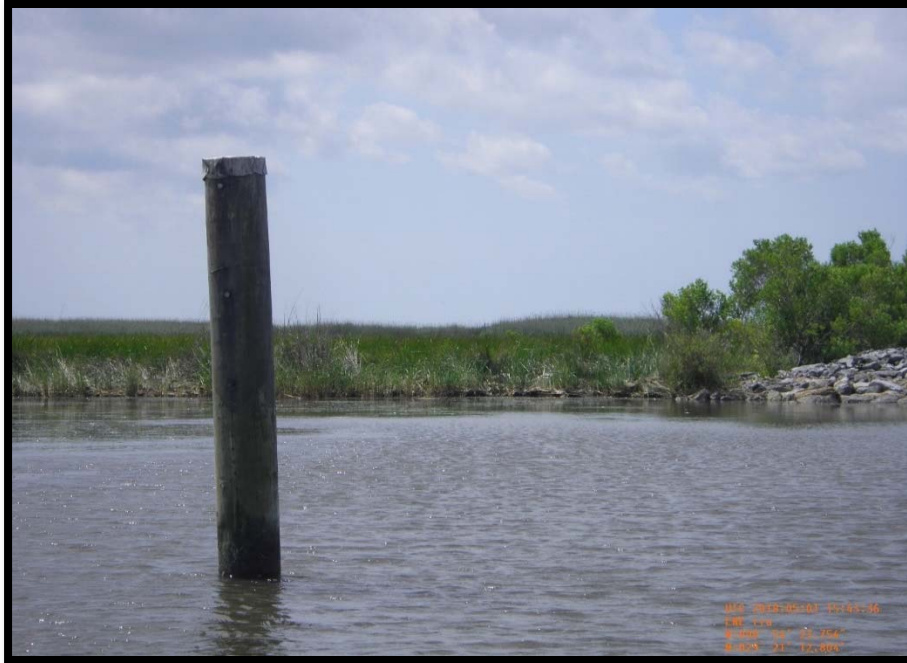
Photo No.7 - view of east bank tie-in and missing sign of Rock Plug No.1 along Small Bayou LaPointe Ridge.

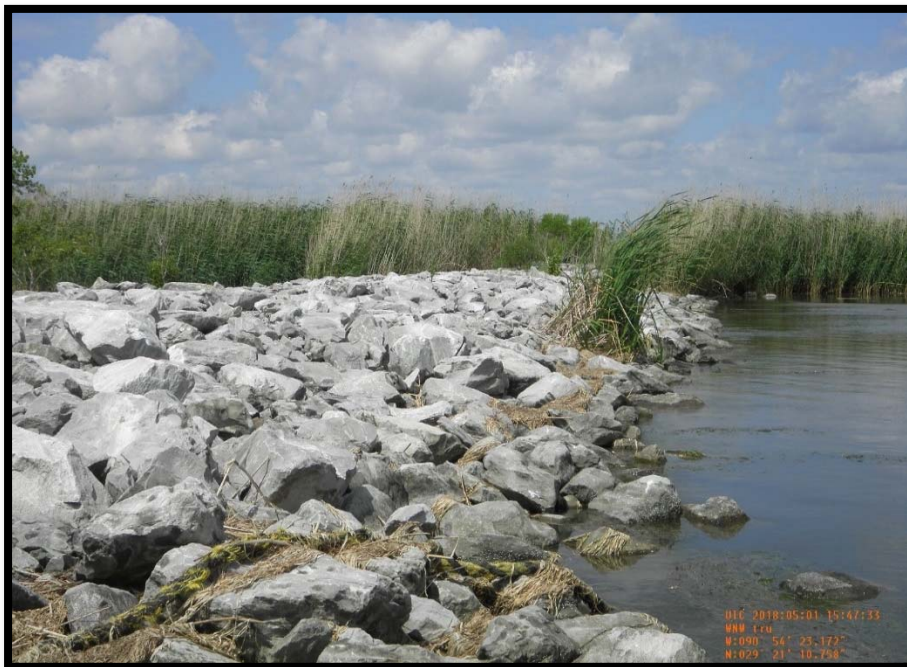
Photo No.8 – view along the crest of Rock Plug No.1 looking west along Small Bayou LaPointe Ridge.

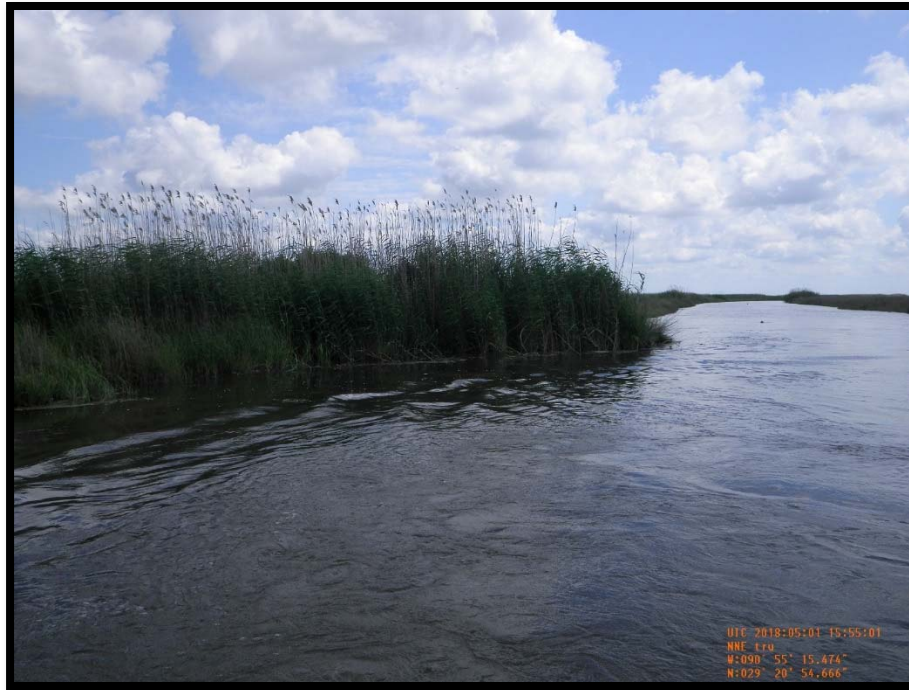
Earthen Plug No. 4 is located in Small Bayou LaPointe between Rock Plug 1 and Fill Area 8. At some point after construction, the earthen plug was breached by vandals and continues to erode. The breach has completely eroded away with a small portion of the earthen plug connecting the north bank. Due to the remote location of this structure, any corrective action would require a marsh excavator tracking long distances to make repairs. We will continue to work with the landowner and federal sponsor on identifying other areas of the ridge that may be breached or eroded and include these repairs in the first scheduled maintenance event. (Appendix B, Photo 9).

Photo No.9 – View of eroded earthen plug along Bayou LaPointe Ridge between Rock Plug No.1 and Earthen Plug No.3 that was vandalized several years back.

Small Bayou Lapointe Ridge Breach Repairs Below are estimated costs for refurbishing sections of the embankment.

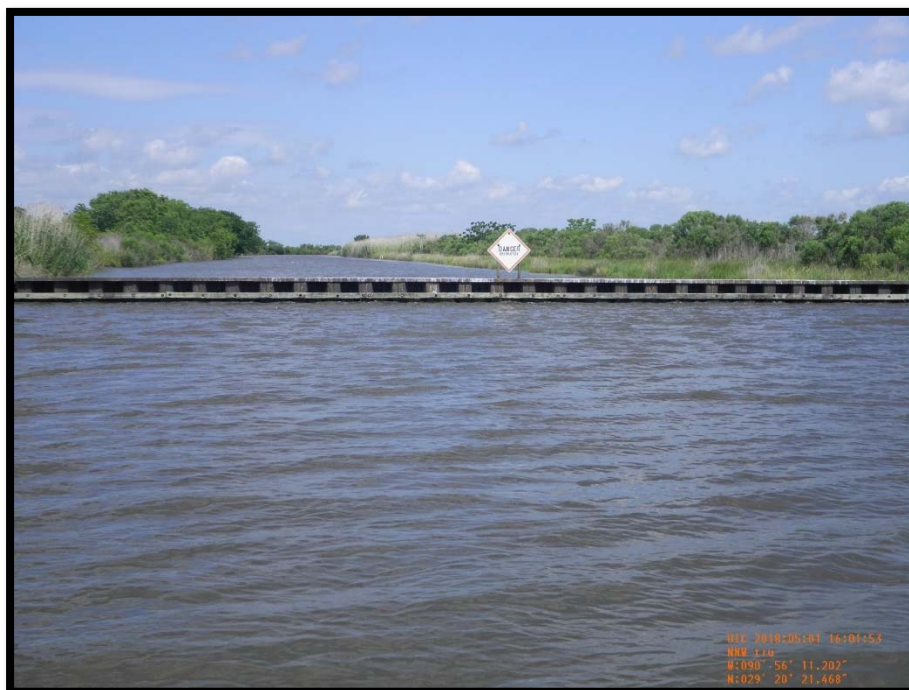
Overall, Sheetpile Plug No. 3 appeared to be in good condition with no damage or corrosion of the steel sheetpile or channel cap. The bank tie-ins and articulated erosion mats were also in good condition with no erosion or washouts present, and the warning signs on the structure were intact and visible. There are no recommendations for corrective action at this time. (Appendix B, Photos 10 through 12)

Photo No.10 – View of steel Sheetpile Plug No 3 located at the end of an existing channel along the south bank of Raccourci Bay.

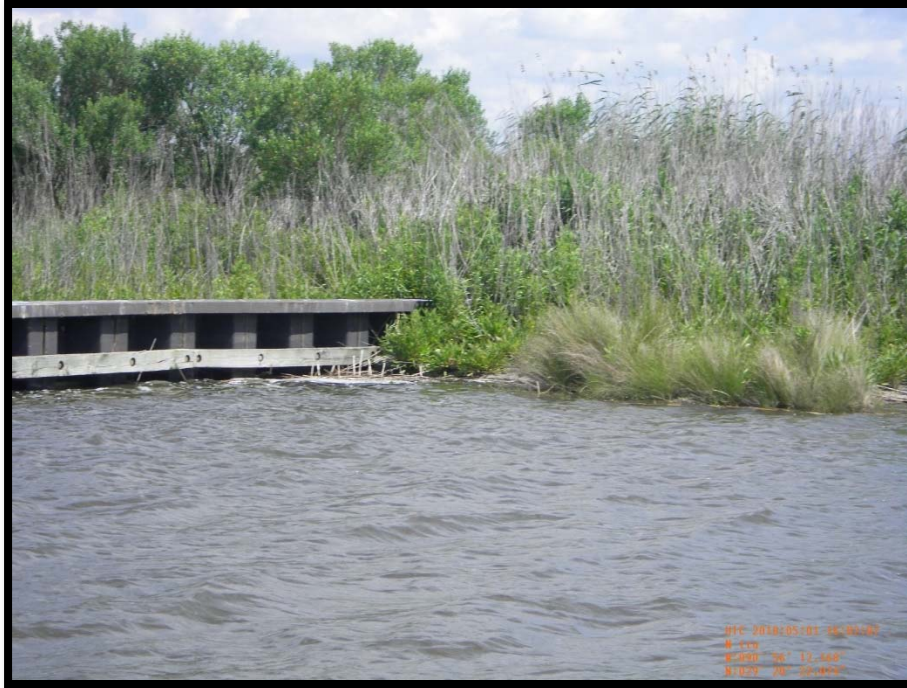
Photo No. 11 - View of the east bank tie-in and articulated mats of Steel Sheetpile Plug No.3

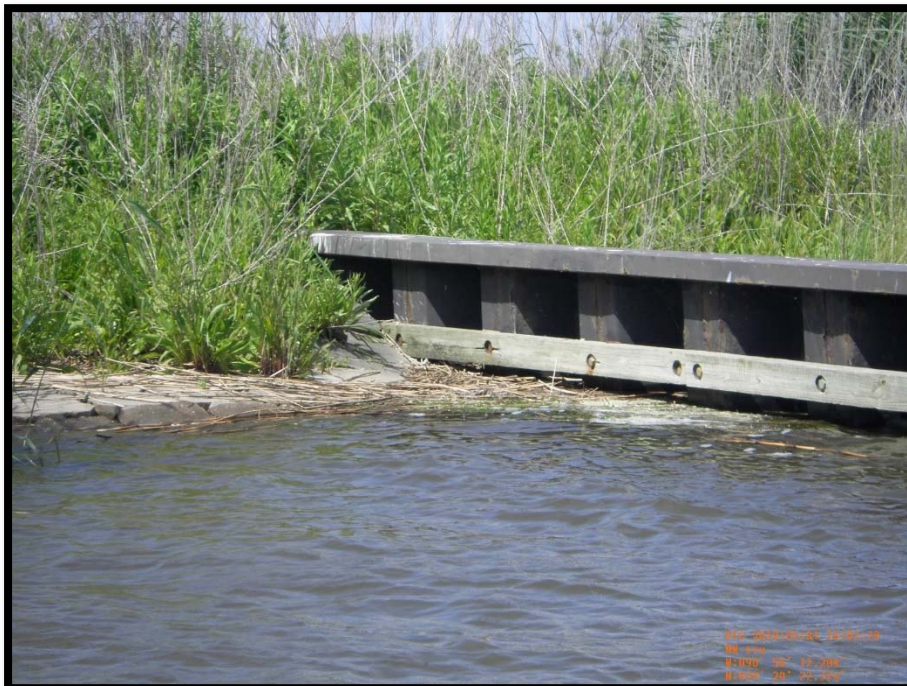
Photo No. 12 - View of the west bank tie-in and articulated mats of Steel Sheetpile Plug No.3

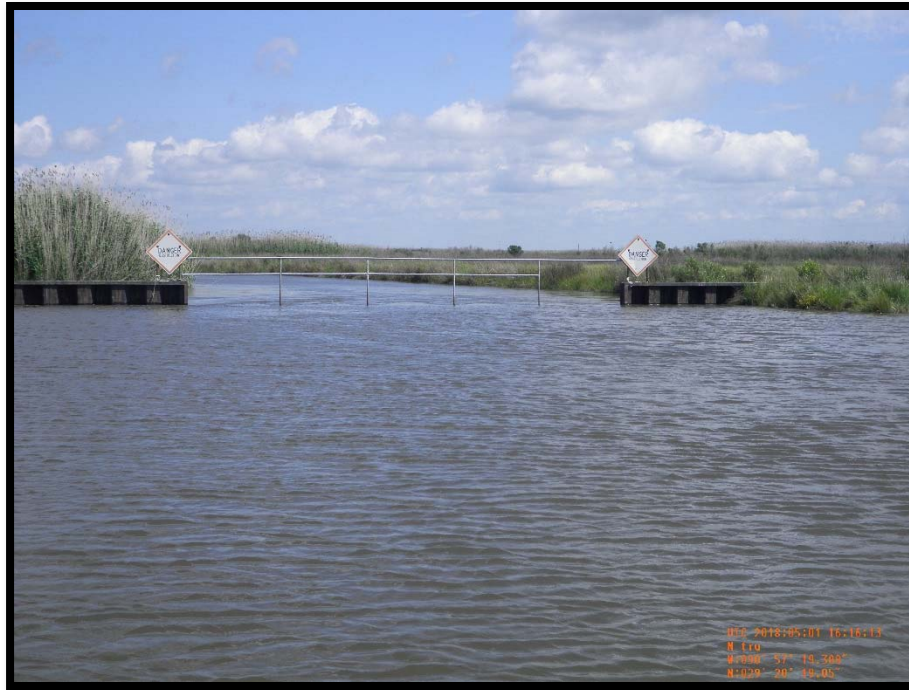
The steel sheetpile weir structure appears to be in good condition. There were no visual signs of corrosion or damage to the sheet pile or top channel cap. There doesn't appear to be any erosion or washouts around the embankment tie-ins as well. The warning signs and supports are also in good condition. There are no recommendations for corrective action at this time. (Appendix B, Photo 13)

Photo No.13 – View of Weir Removal and Replacement Structure along small channel along west bank of Bayou Raccourci.

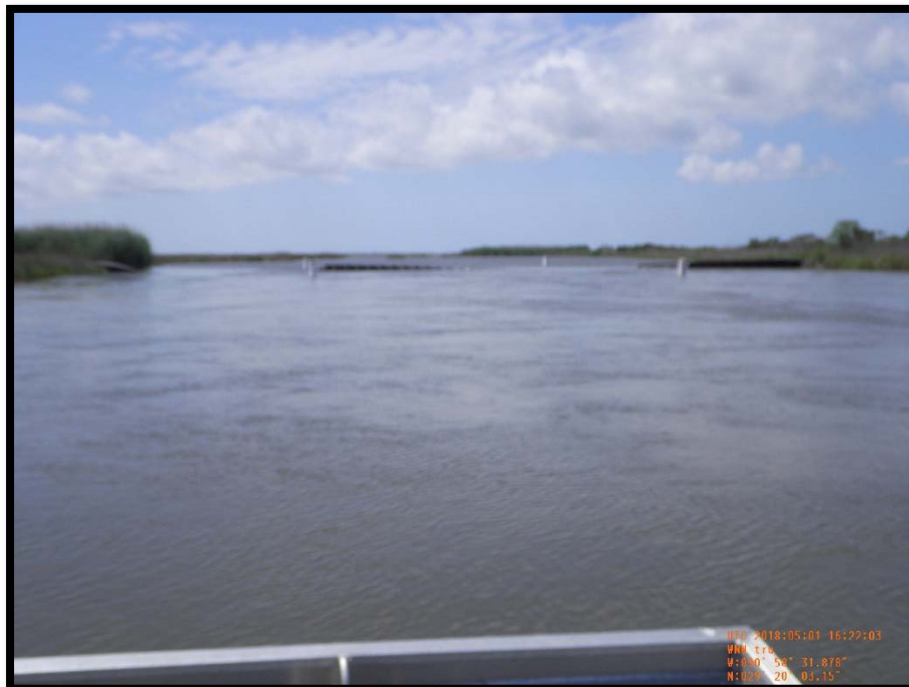
The Sheetpile Plug No.2 suffered catastrophic structural damage due to Hurricane Isaac in August 2012. A large portion of the center section of the sheet pile wall has collapsed over into the channel allowing water to pass through/over the structure. The structure is damaged in such a way that there are minimal options for repairing the structure, it must be removed and then replaced. CPRA has initiated a claim with the Federal Emergency Management Agency (FEMA) as the structure was damaged during a natural disaster. In

Photo No.14 – Overall view of Steel Sheetpile Plug No. 2 which was damaged during Hurricane Issac in 2012.

May 2015, FEMA had rejected CPRA's claim for funding the repair of the steel sheetpile structure. CPRA has appealed FEMA's decision and is currently awaiting a ruling on the appeal. Due to condition of the structure and the delays in CPRA's appeal to FEMA, CPRA has decided to proceed with the removal and replacement of the steel sheetpile plug using state funds. An engineering firm has been selected to prepare bid documents for this maintenance event. It is estimated that construction should be completed by late 2019. (Appendix B, Photos 14 through 19)

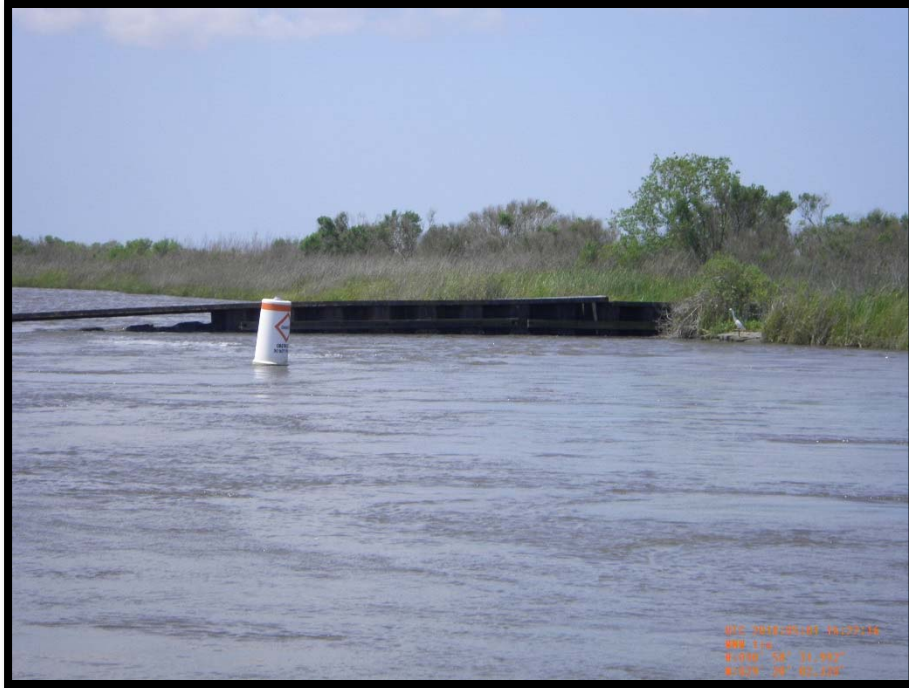
Photo No.15 – View of west bank tie-in and damaged sheet pile section and floating/lighted buoy of Steel Sheetpile Plug No. 2.

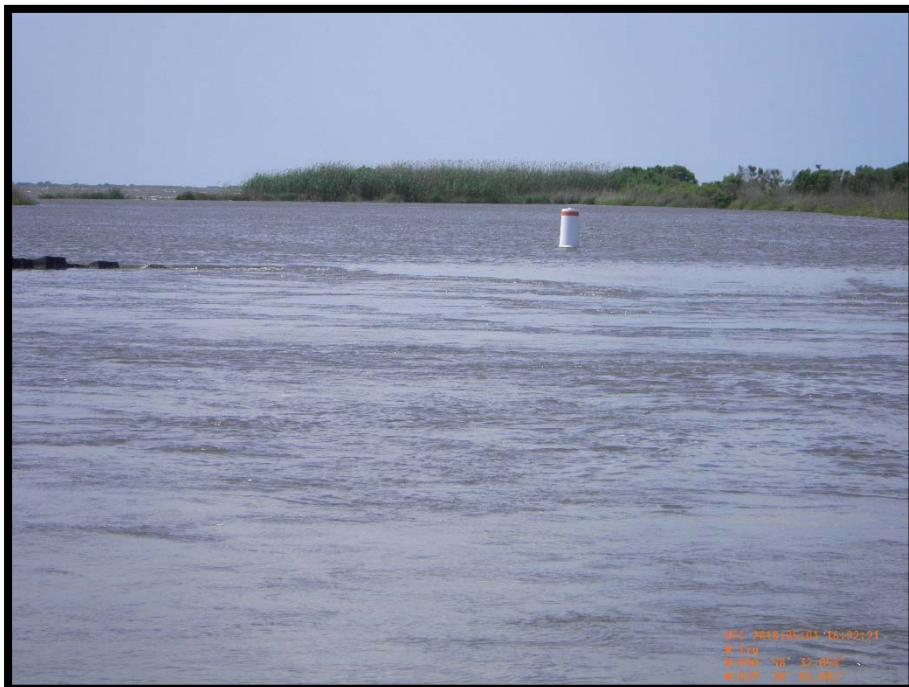
Photo No.16 – View of damaged center section of Steel Sheetpile Plug No. 2 and floating/lighted buoy.

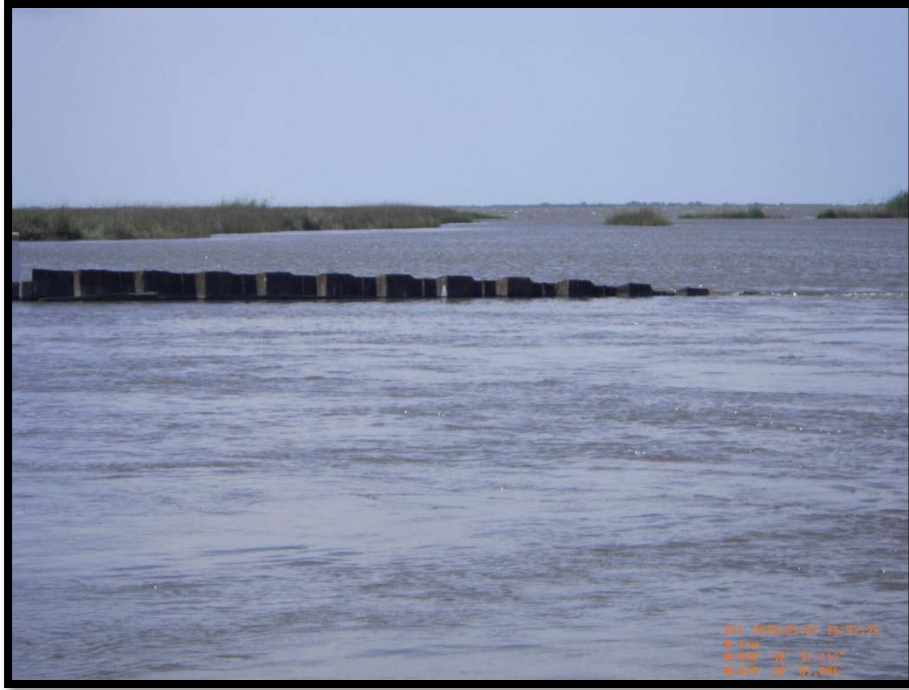
Photo No.17 – View of damaged center section of Steel Sheetpile Plug No. 2

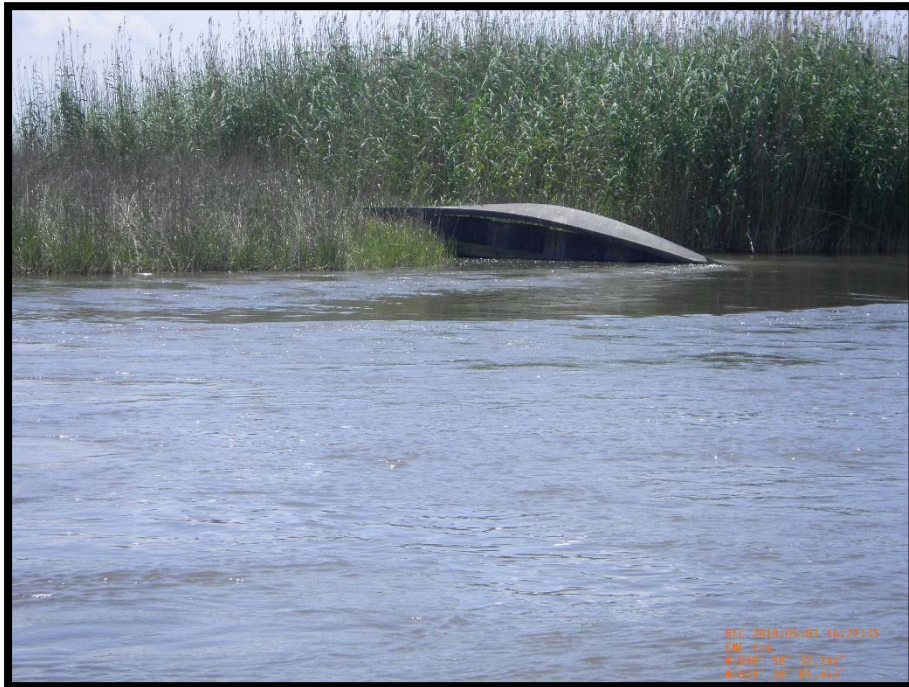
Photo No.18 – View of damaged steel sheetpile section and east bank tie-in of Sheetpile Plug No.2.

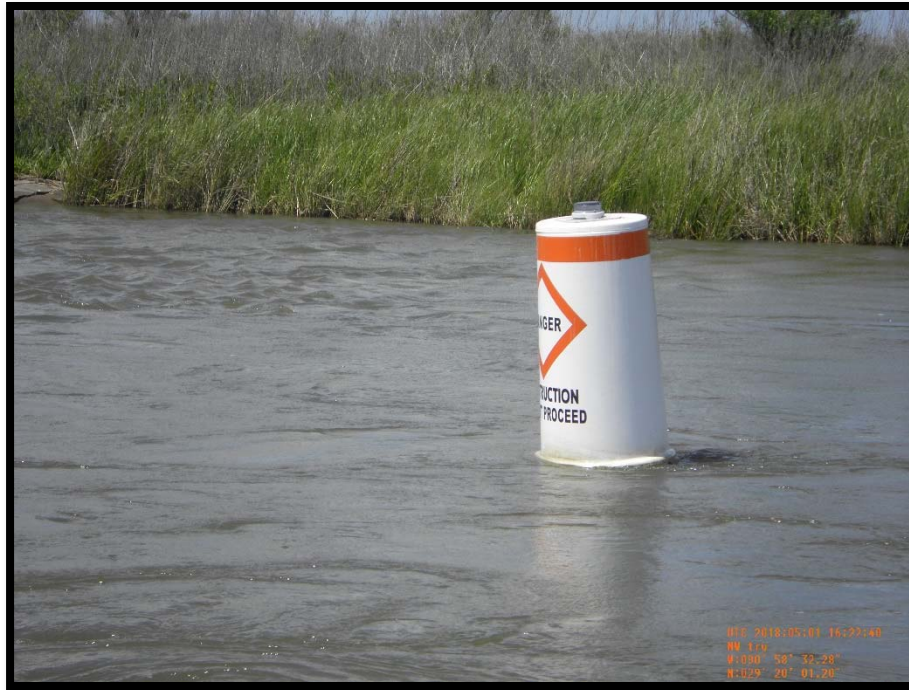
Photo No. 19 – View of floating/lighted buoy installed on both sides of damaged Sheetpile Plug No.2. Two (2) buoys were installed on both sides of the structure.

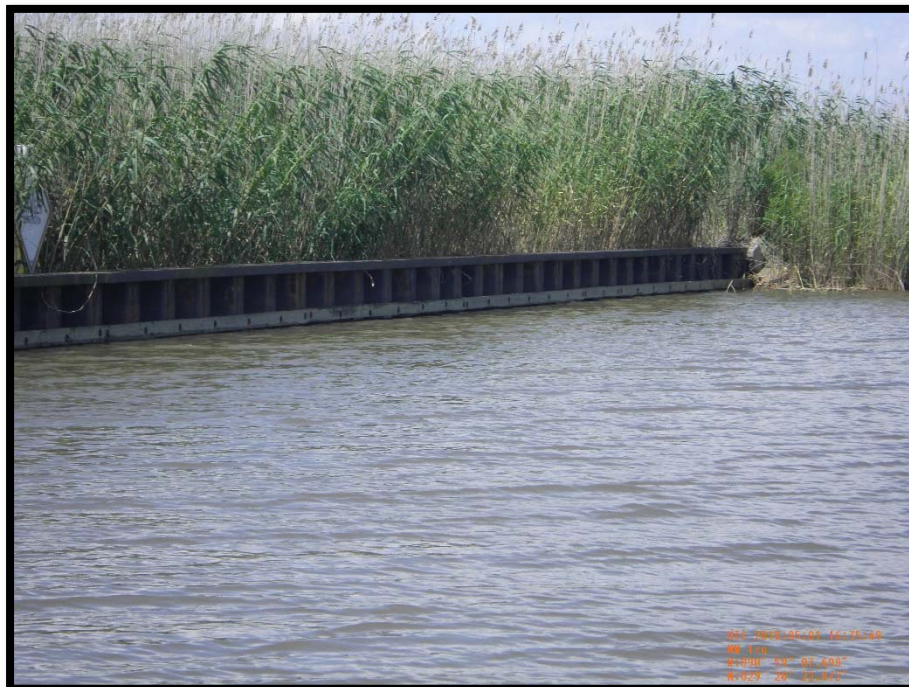
Sheetpile plug 1 is located along the south bank of the northwest reach of the "Y" Canal, just north of Lake Mechant. There are no signs of settlement or corrosion of the sheet pile, channel cap, warning signs or supports. The embankment tie-ins are armored with articulated concrete mats and also show no signs of settlement or erosion around structure. There are no recommendations for corrective actions at this time. (Appendix B, Photos 20 through 22)

Photo No.20 – View of Steel Sheetpile Plug No.1 and bank tie-in on west side of structure located along Y-Canal east of Lake Pagie.

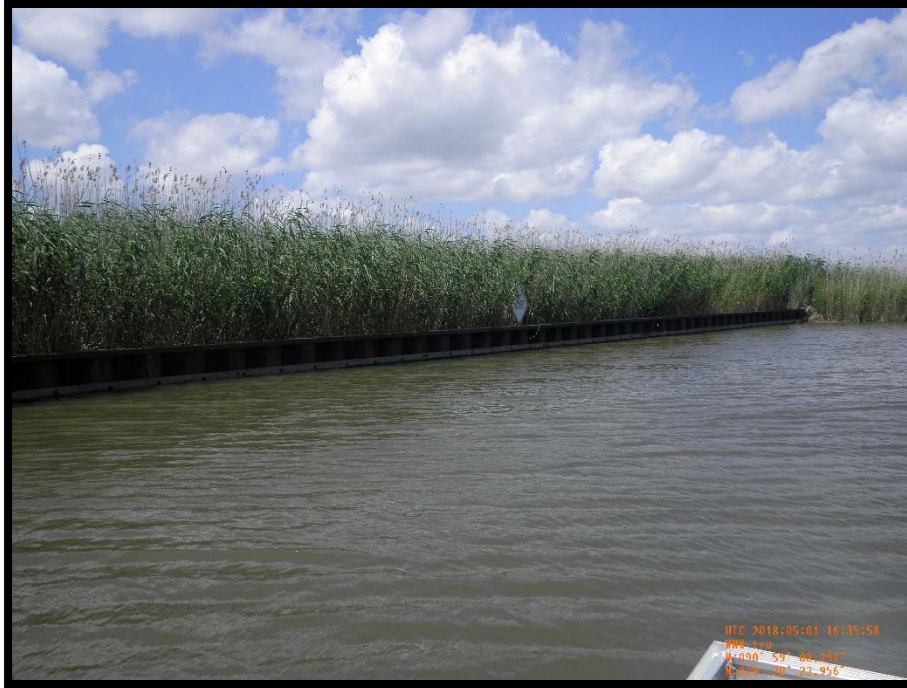
Photo No.21 – View of Steel Sheetpile Plug No.1 located along Y-Canal east of Lake Pagie.

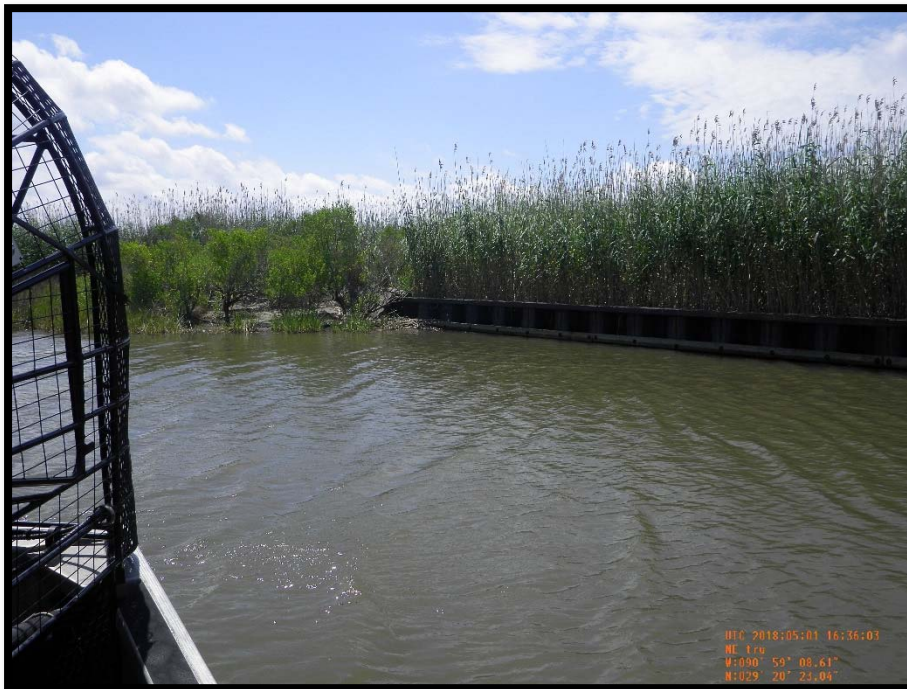
Photo No.22 – View of Steel Sheetpile Plug No.1 and bank tie-in on east side of structure located along Y-Canal east of Lake Pagie.

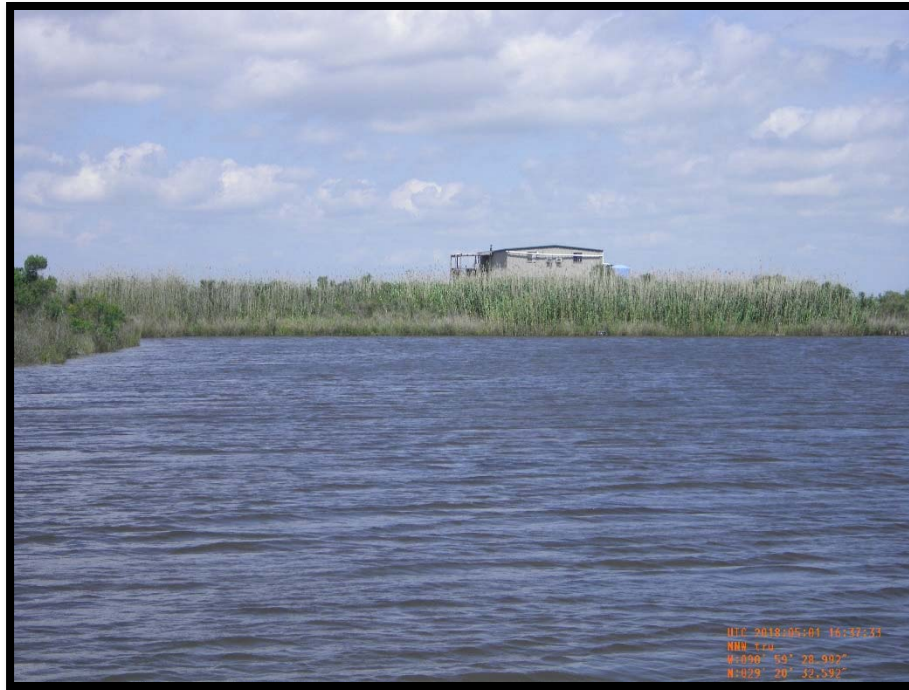
The Earthen Plug 1 structure located on the eastern edge of Lake Pagie appeared to be in good condition. The plug was viewed from the "Y" canal and was heavily vegetated with no signs of erosion or washouts of the bank tie-ins. There are no recommendations for corrective action at this time. (Appendix B, Photos 23)

Photo No.23 – View of earthen embankment plug located along the east bank of Lake Pagie at the head of the Y-Canal.

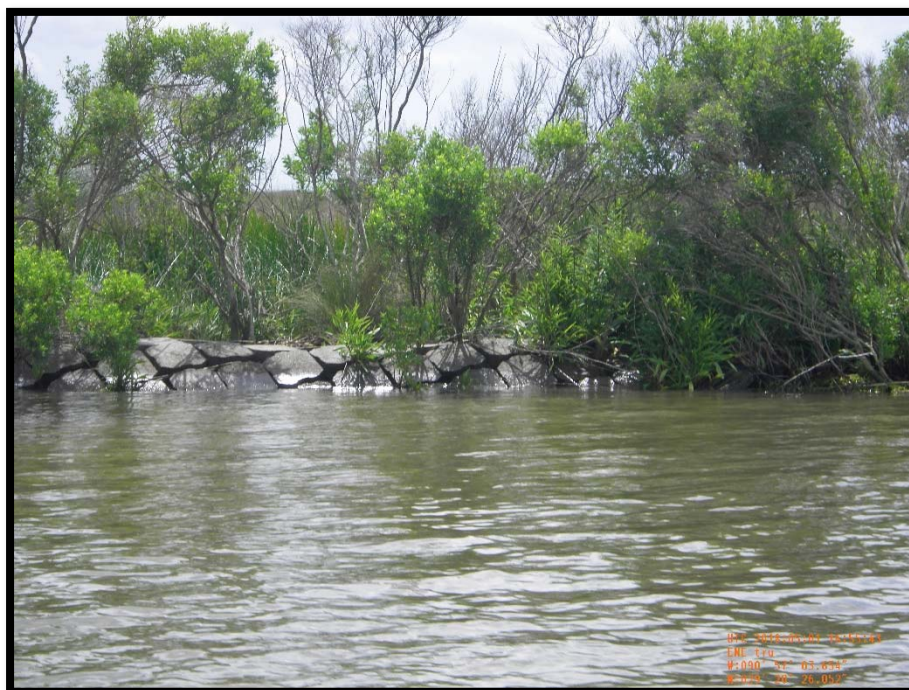
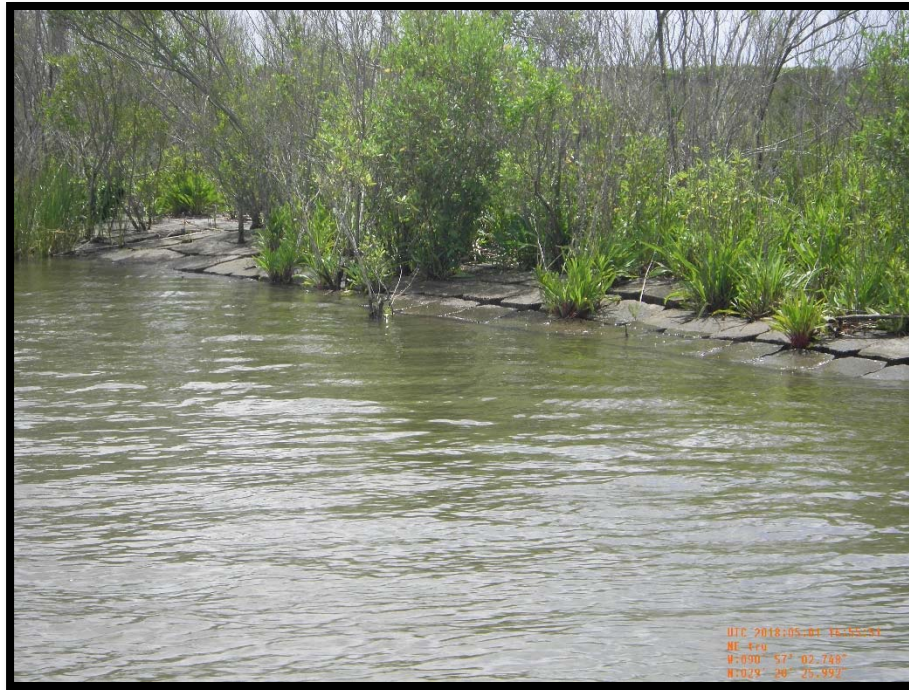
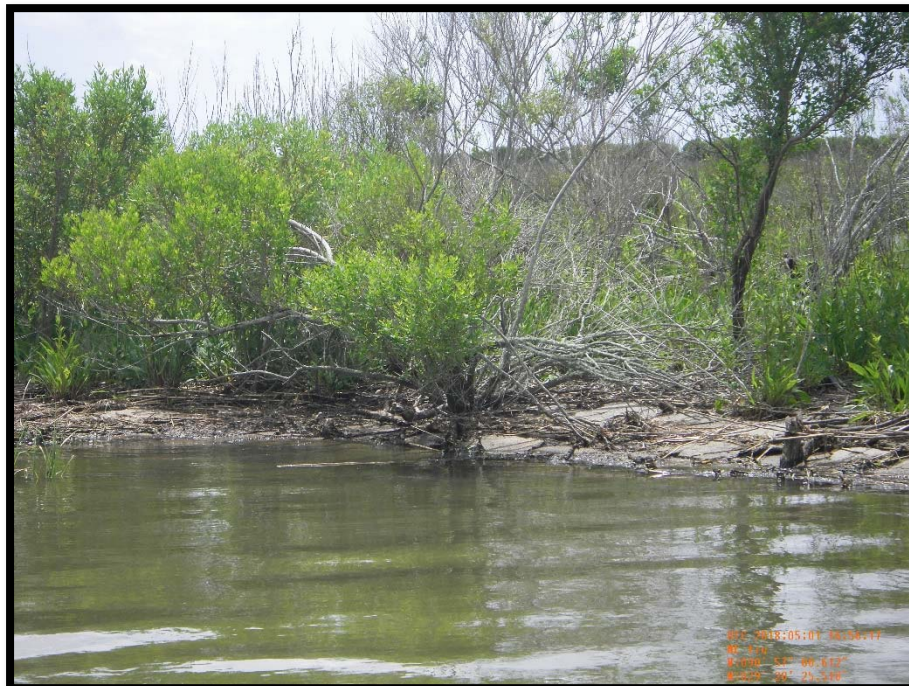
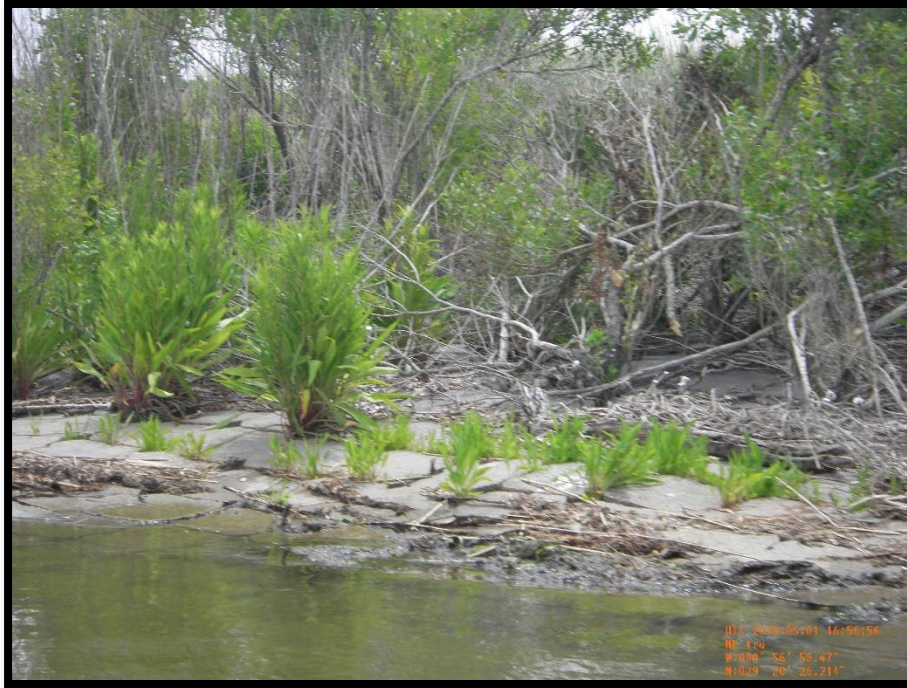
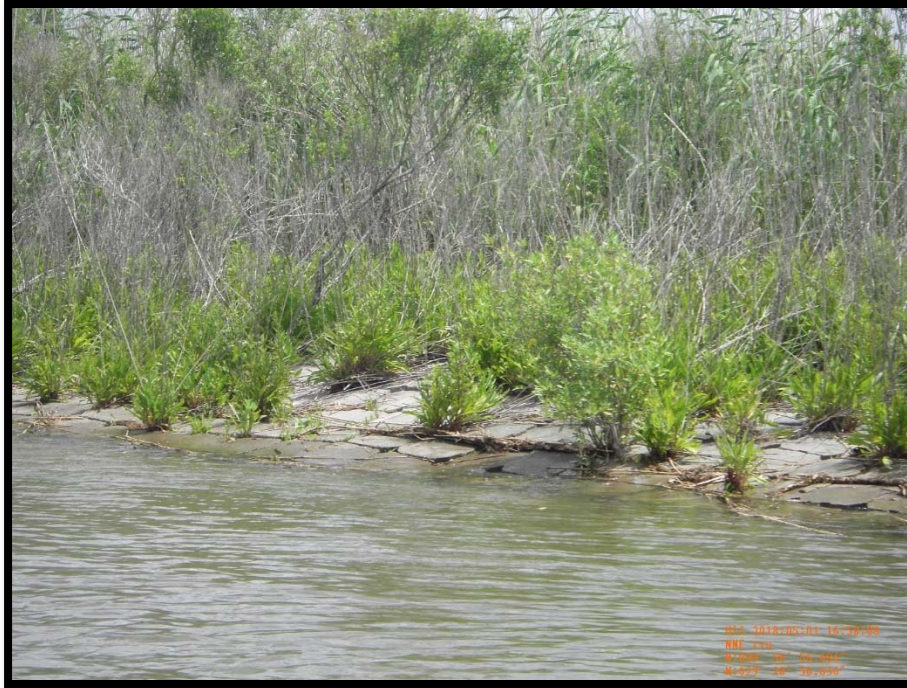
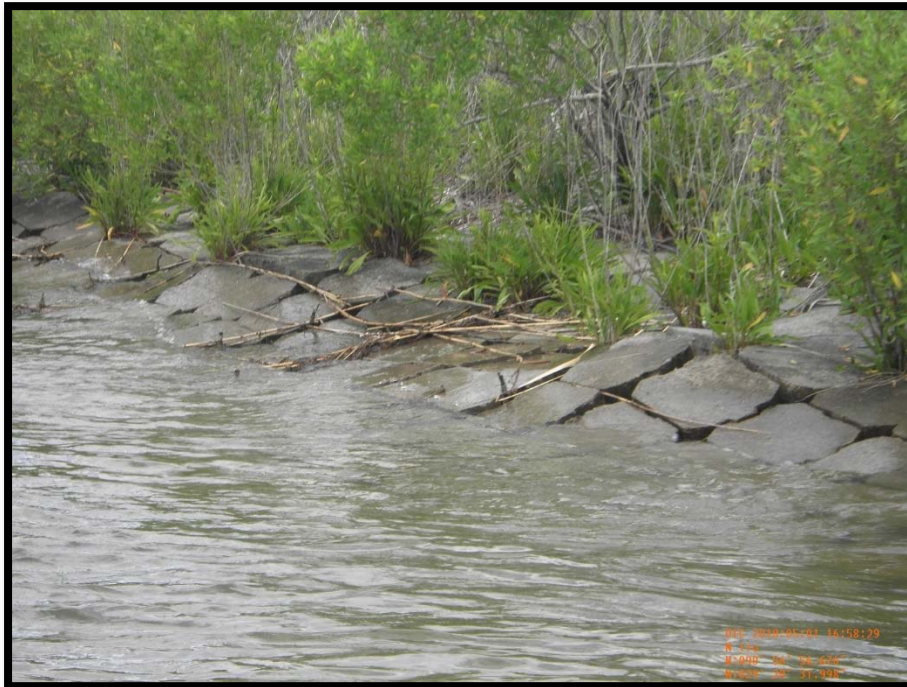
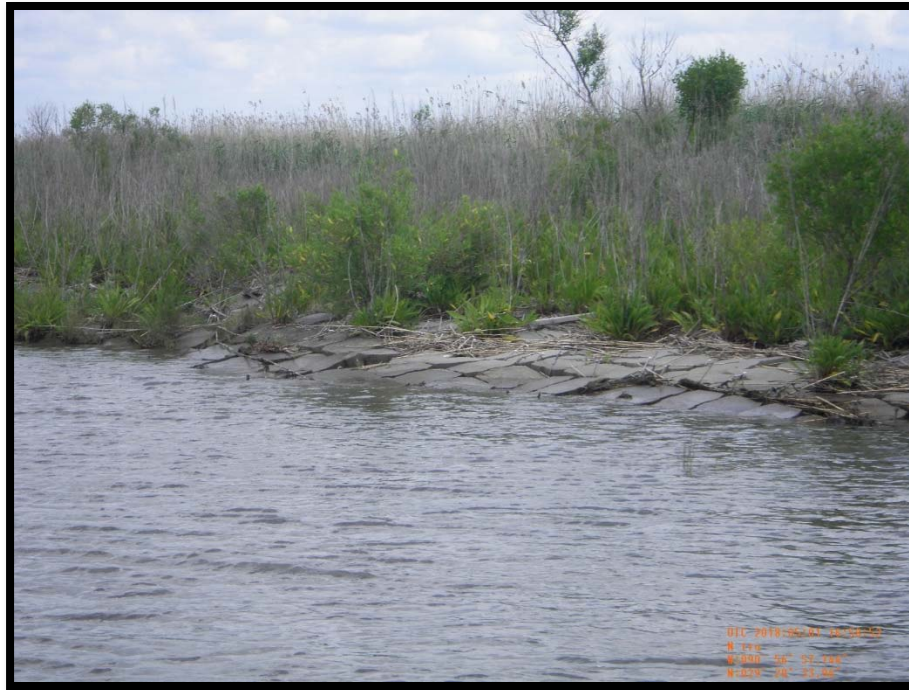
The Armored Earthen Dike on the west bank of Bayou Raccourci appears to be in fair condition. As reported on previous inspections, the articulated mats were inundated with woody vegetation emerging through the seams and in front of the concrete mats. The woody vegetation that is growing through the mats raises some concerns regarding the stability of the rope as the trees/shrubs continue to grow. The vegetative growth will be monitored during future inspections. As previously reported, there were isolated sections of the mat that appeared to be sliding towards the channel creating a separation of the concrete blocks at several locations causing a strain on the copolymer rope. Also, there are some variations in height of the embankment along the length of the armored earthen dike. This is believed to be caused by differential settlement of the dredged material and the weight of the articulated mats. These areas of concern will be monitoring closely on future site visits to determine if corrective actions are needed. (Appendix B, Photos 24 through 31)

Photo No.24 – View of the articulated mats along the east bank of Bayou Raccourci.

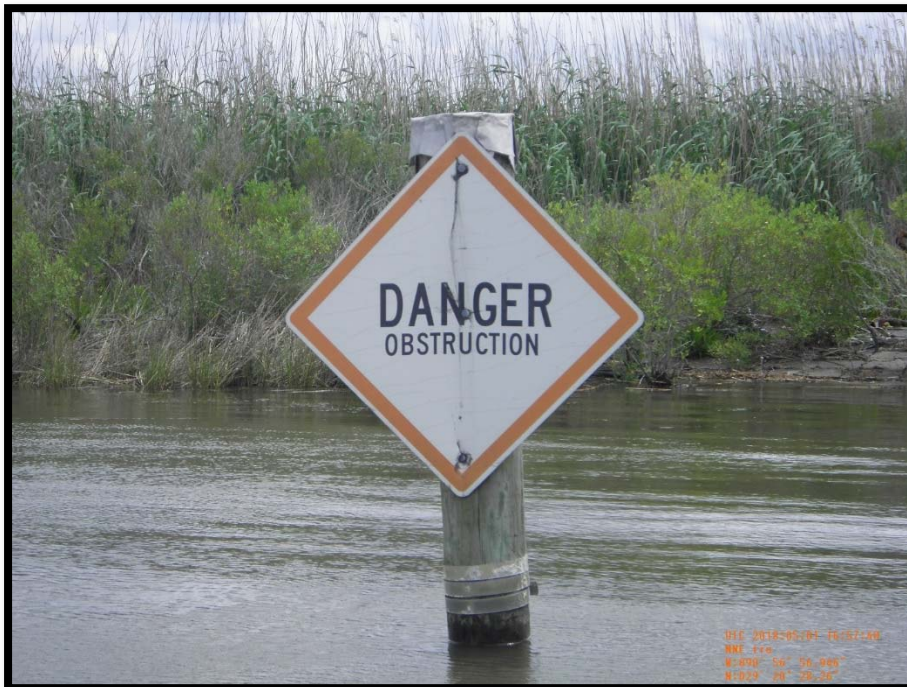
Photo No.28 – View of an existing warning sign along the east bank of Bayou Raccourci adjacent to the articulated concrete mats.
