**State of Louisiana
Coastal Protection and Restoration
Authority**

2015 Annual Inspection Report

**North Lake Mechant Landbridge
Restoration Project (TE-44)**

April 8, 2015
Terrebonne Parish

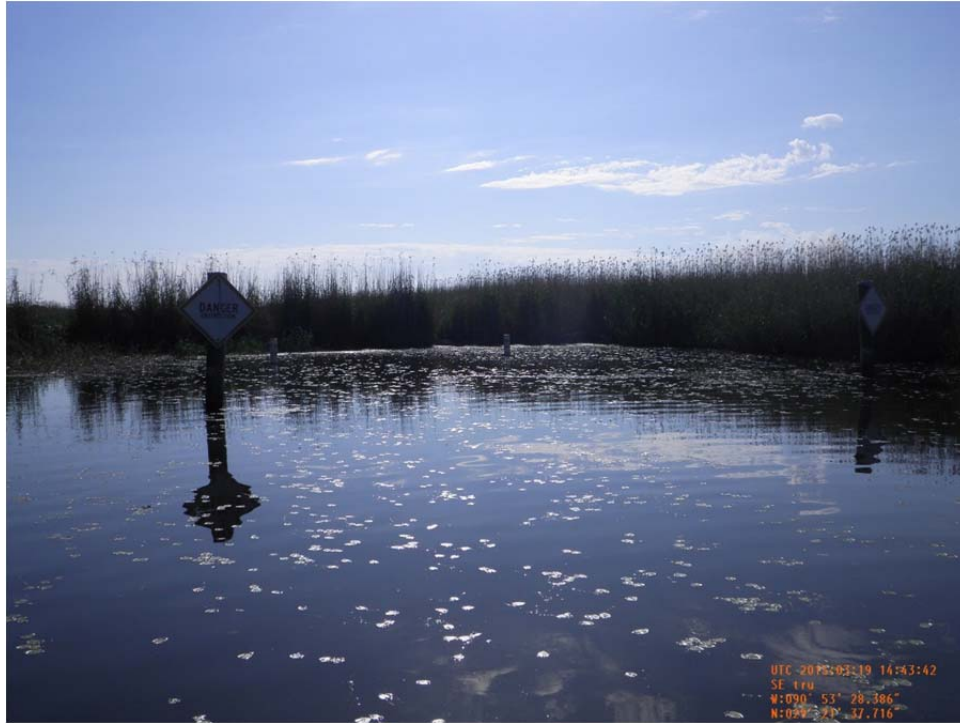
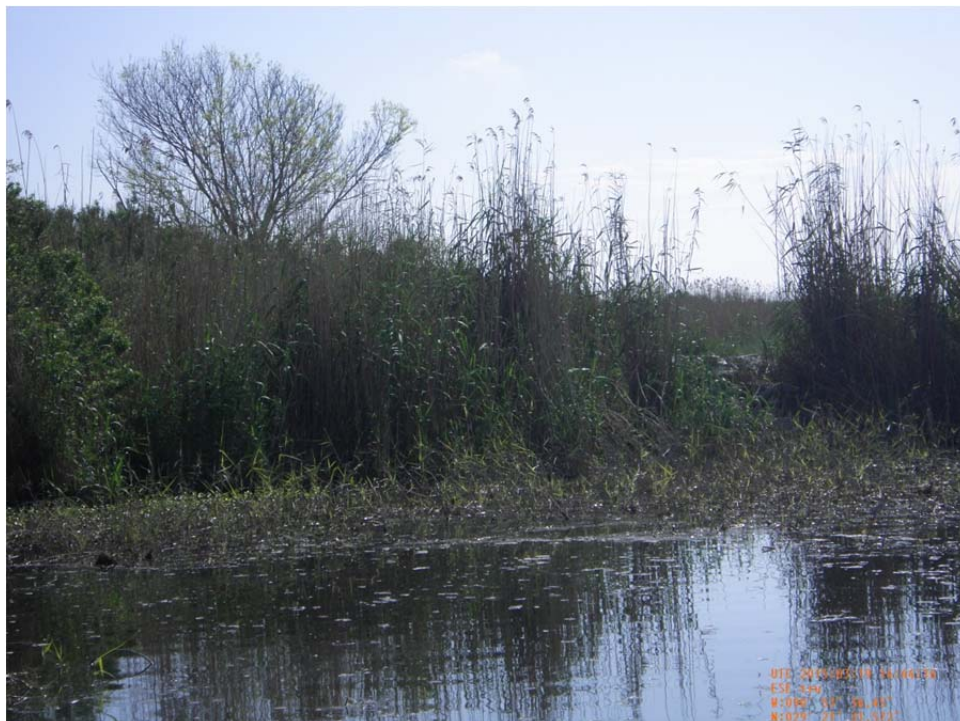
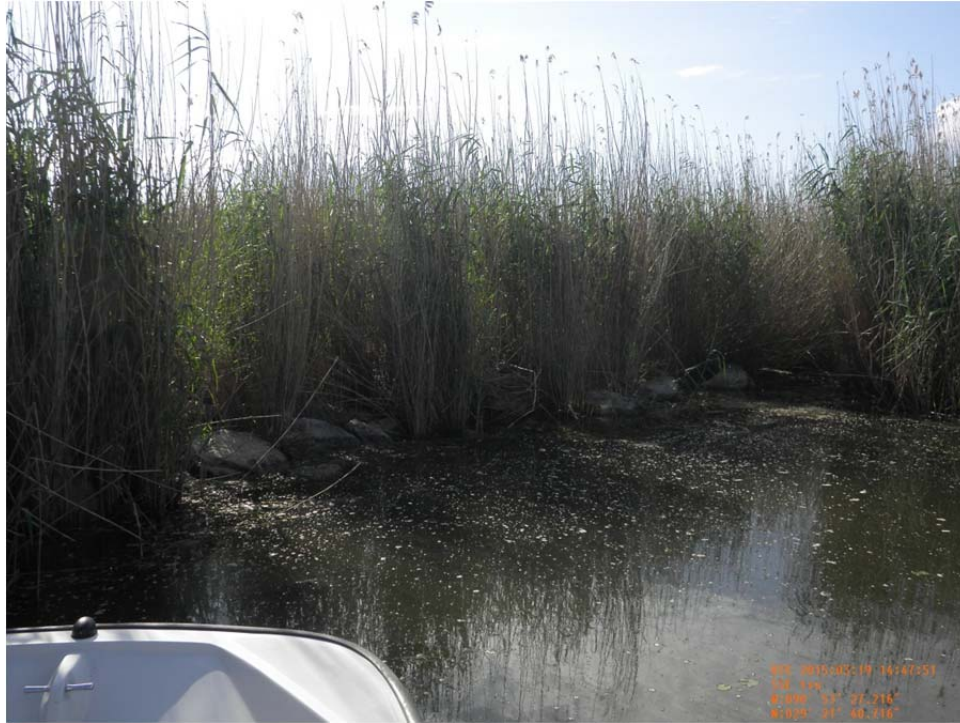
Rock plug 2 appears to be in good overall condition. During construction in 2009, the structure experienced some settlement after placement of the rock riprap material, causing erosion around its northern embankment tie-in. To mitigate erosion of the canal banks, additional rock rip rap was placed along the low areas, raising the crest elevation. The as-built drawings indicate the northern end of the structure was constructed to an elevation of 5.5' NAVD with a gradual slope to the southern end to an elevation of 3.0' NAVD. Observations during previous inspections revealed that the rock dike crest was consistent with the as-built drawings. The warning signs in front of the structure were in good condition with only slight damage to the southwest sign which has been vandalized and damaged by a shotgun.

Due to the excessive vegetative growth on and around the structure, it was difficult to visually determine if there was any settlement or the rock plug or water flow around the structure. It appears that the bank tie-ins are in good condition with no noticeable water bypassing the structure. CPRA will continue to monitor the earthen tie-ins for erosion and breaching on future site visits. (Appendix B, Photos 1 through 3)

Photo 1: Overall view of Rock Plug 2 from the oilfield canal, looking east

Photo 2: View of northern embankment on Rock Plug 2, facing northeast

Photo 3: View of southern embankment of Rock Plug No.2 looking southeast.

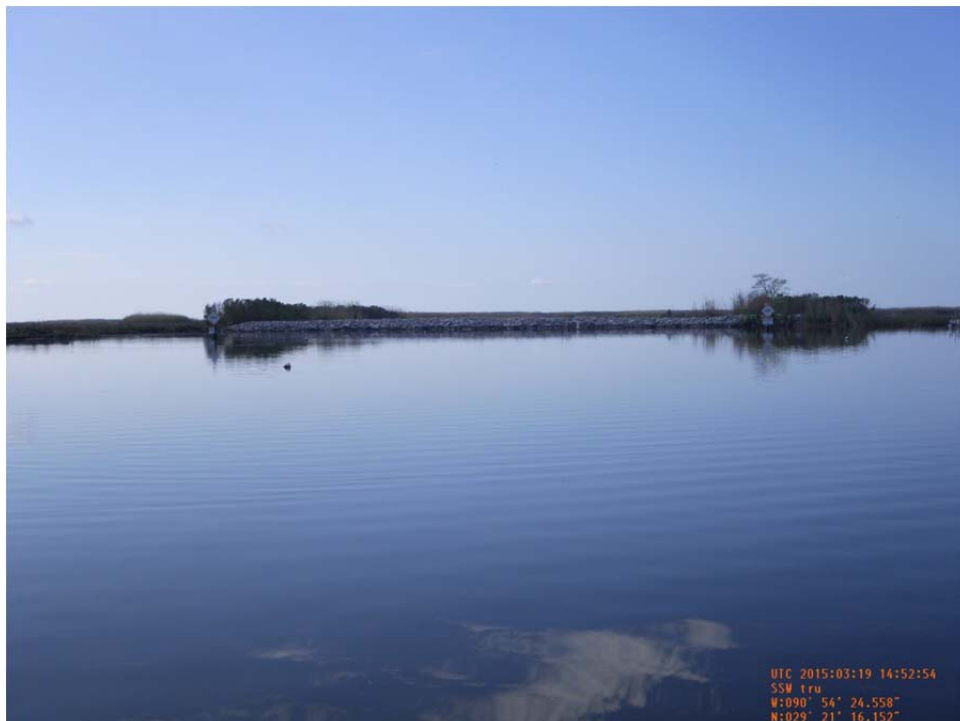
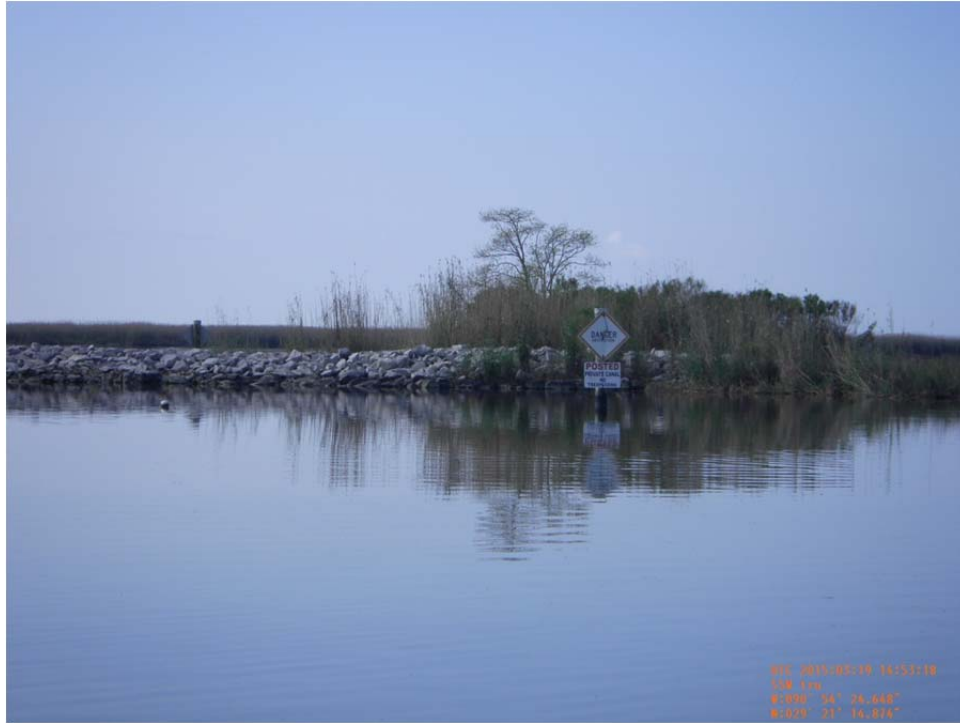
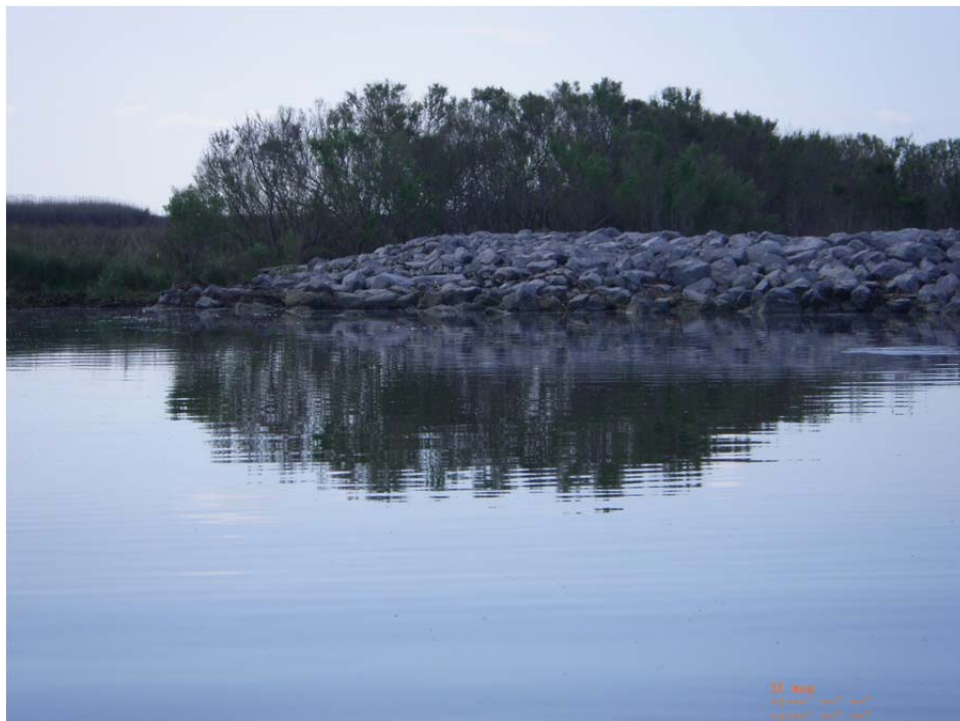
The Rock Plug 1 structure located along the south bank of Small Bayou LaPointe appears to be in very good condition. There are no visible signs of settlement since construction or evidence of erosion and washouts around the embankment tie-ins. There was also no visible damage to the warning signs on each end of the structure. There are no recommendations for corrective action at this time. (Appendix B, Photos 4 through 6)

Photo 4: Overall view of Rock Plug No.1, looking south.

Photo 5: View of western bank tie-in for Rock Plug No.1 looking southwest.

Photo 6: View of eastern bank tie-in of Rock Plug No.1, looking southeast.

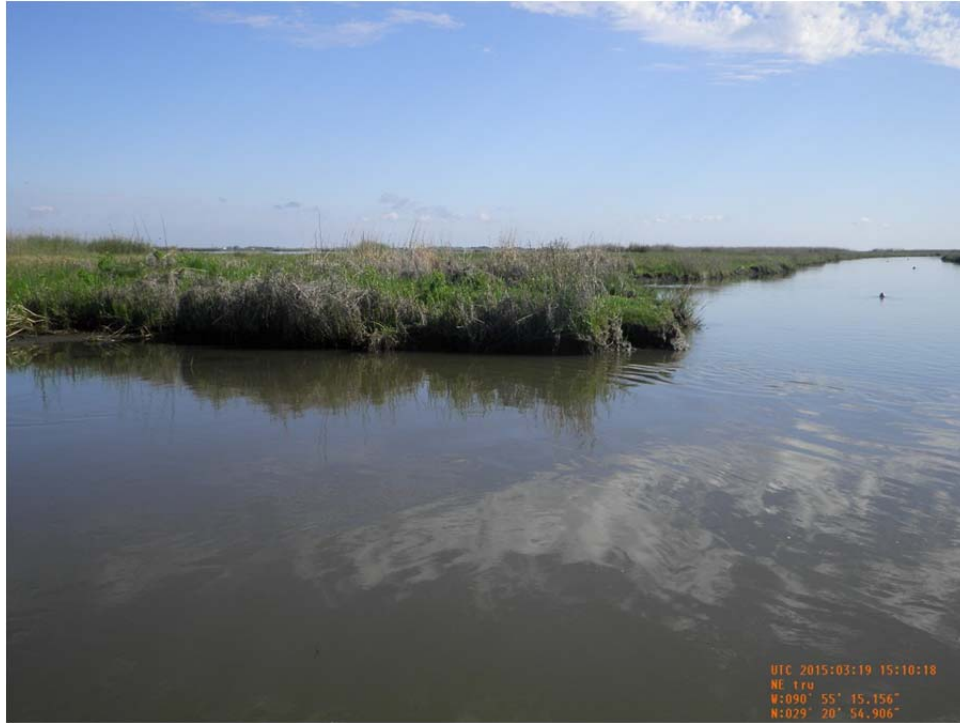
Earthen Plug No. 4 was not included in the original design of the project but was added to the proposed features during construction. It is located in Small Bayou LaPointe between Rock Plug 1 and Fill Area 8. At some point after construction, the earthen plug was vandalized by someone cutting a small breach in the earthen embankment. The breach has completely eroded away with a small portion of the earthen plug connecting the north bank. Due to the remote location of this structure, any corrective action would require a marsh excavator tracking long distances to make repairs. We will continue to work with the landowner and federal sponsor on identifying other areas of the ridge that may be breached or eroded and begin preparing a work plan for corrective actions. (Appendix B, Photo 7)

Photo 7: View of large breach in earthen plug along the Lapointe Ridge.

General Breach Repairs: Since the project was completed, we have noticed that the earthen embankments along the Small Bayou Lapointe Ridge are thin and endanger of breaching (very little marsh protecting the ridge). Below are estimated costs for refurbishing sections of the embankment. At this time, the specific areas have not been identified. For 2016/2017, we are assuming that approximately 500 linear feet of embankment will require refurbishment.

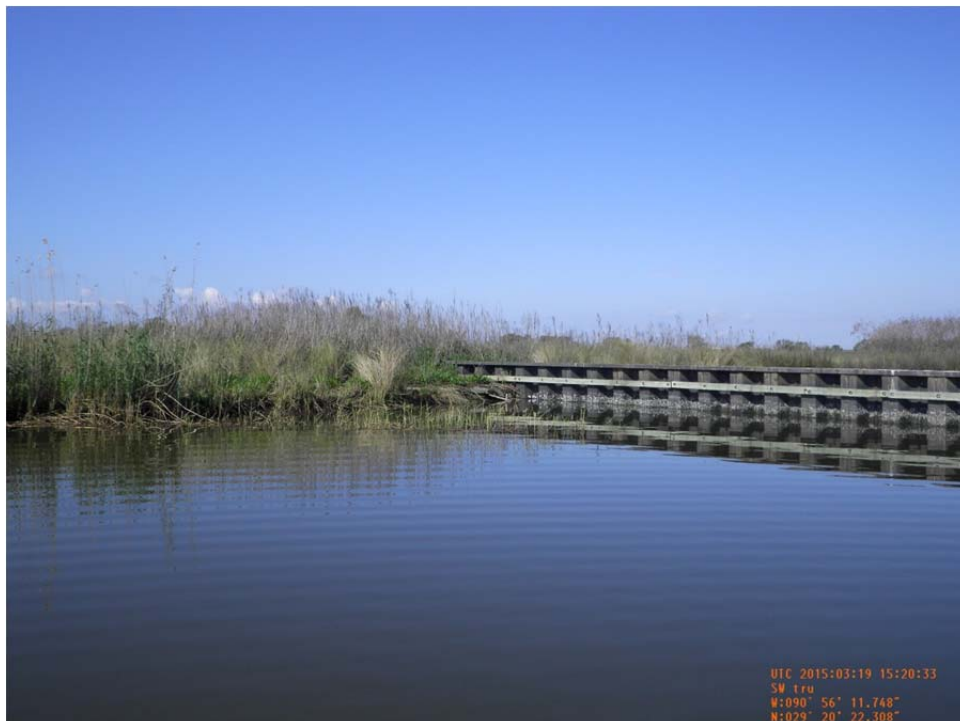
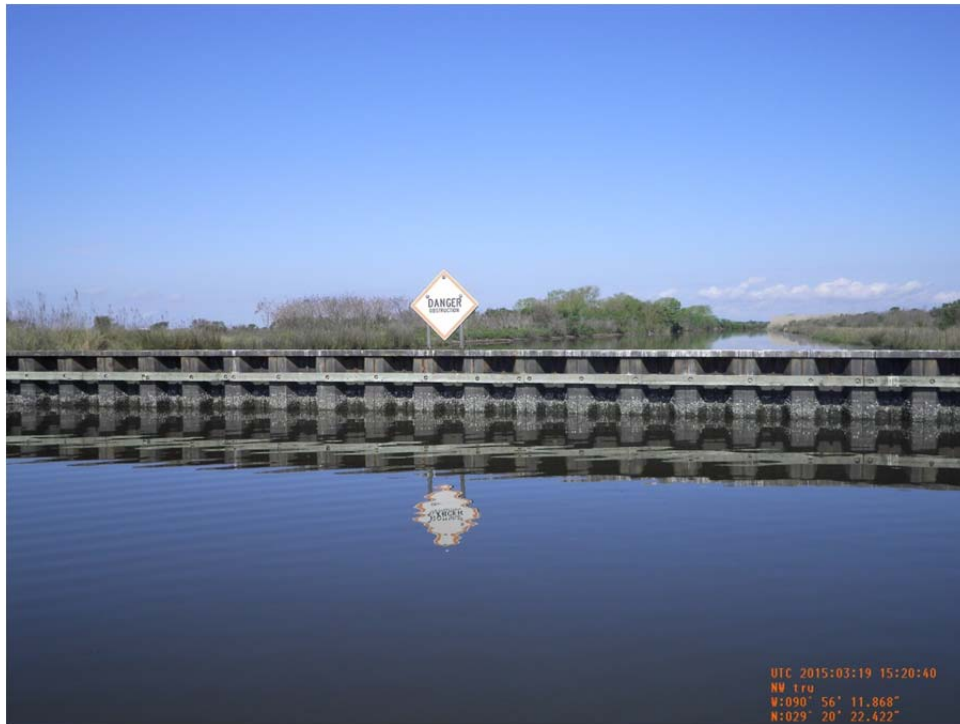
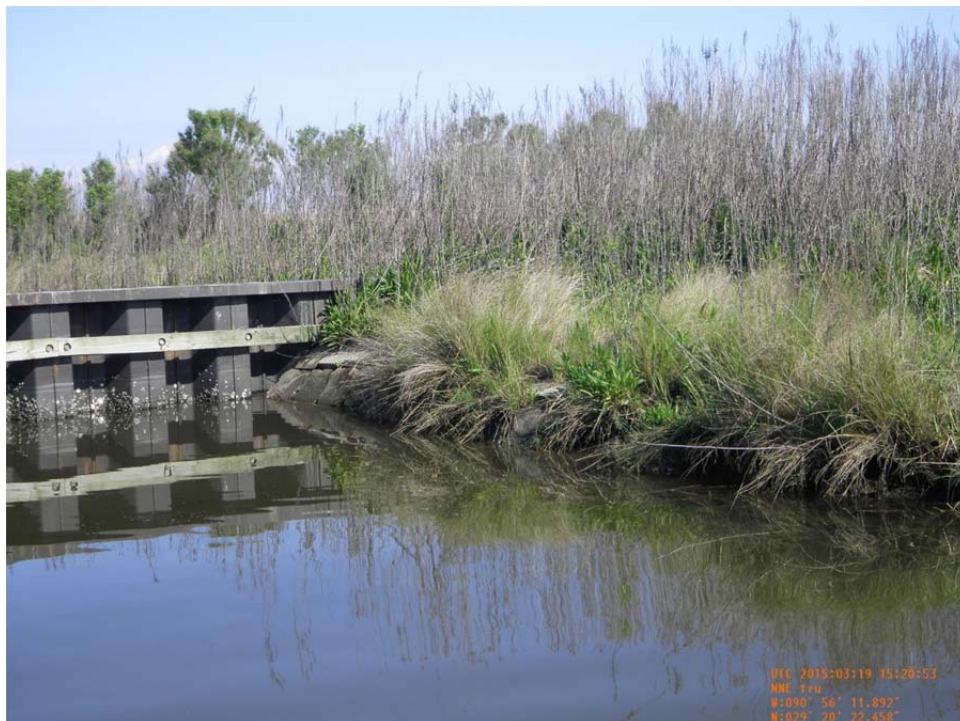
Overall, Sheet Pile Plug No. 3 appeared to be in good condition with no damage or corrosion of the steel sheetpile or channel cap. The bank tie-ins and articulated erosion mats were also in good condition with not erosion or washouts present, and the warning signs on the structure were intact and visible. There are no recommendations for corrective action at this time. (Appendix B, Photos 8 through 10)

Photo 8: View of southwest bank tie-in along Sheetpile Plug No.3, looking northwest.

Photo 9: Overall view of Sheetpile Plug No. 3 , looking northwest.

Photo 10: View of northeast bank tie-in along Sheetpile Plug No.3, looking north.

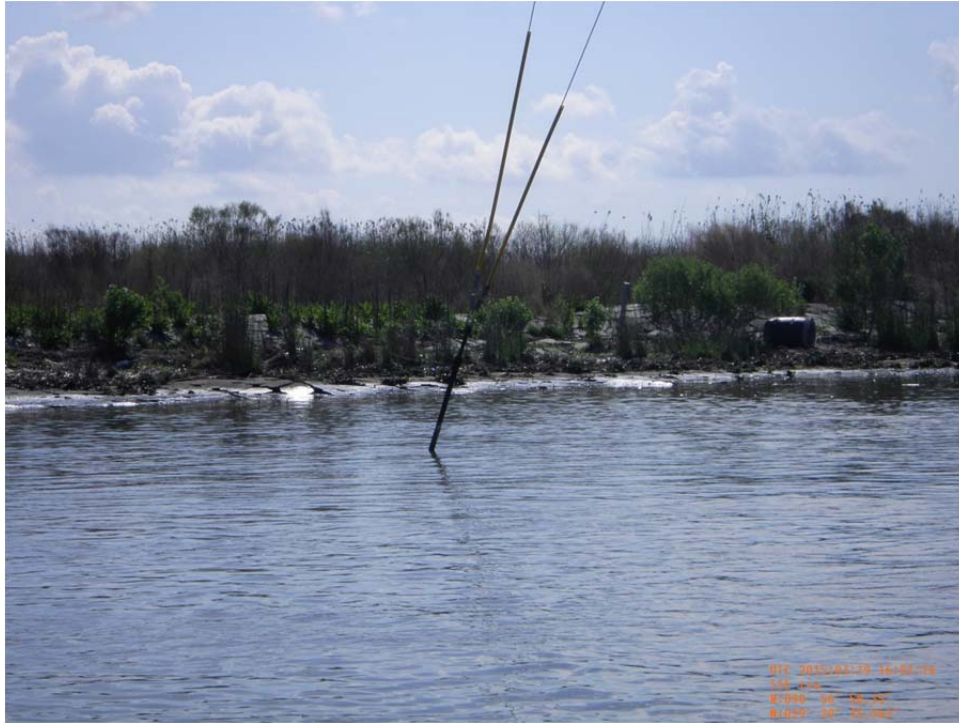
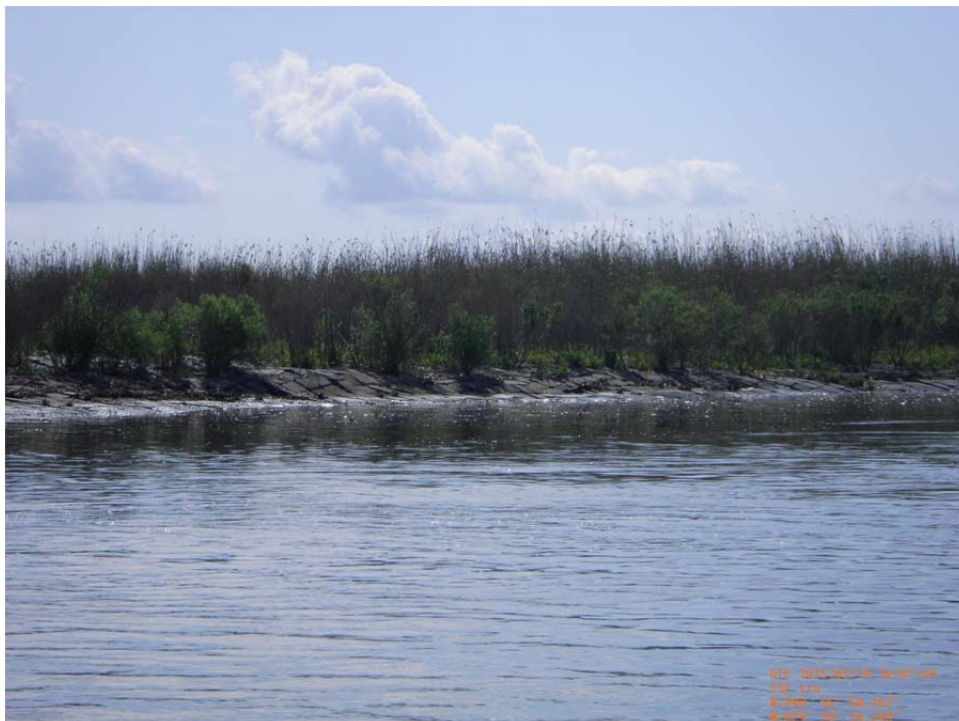
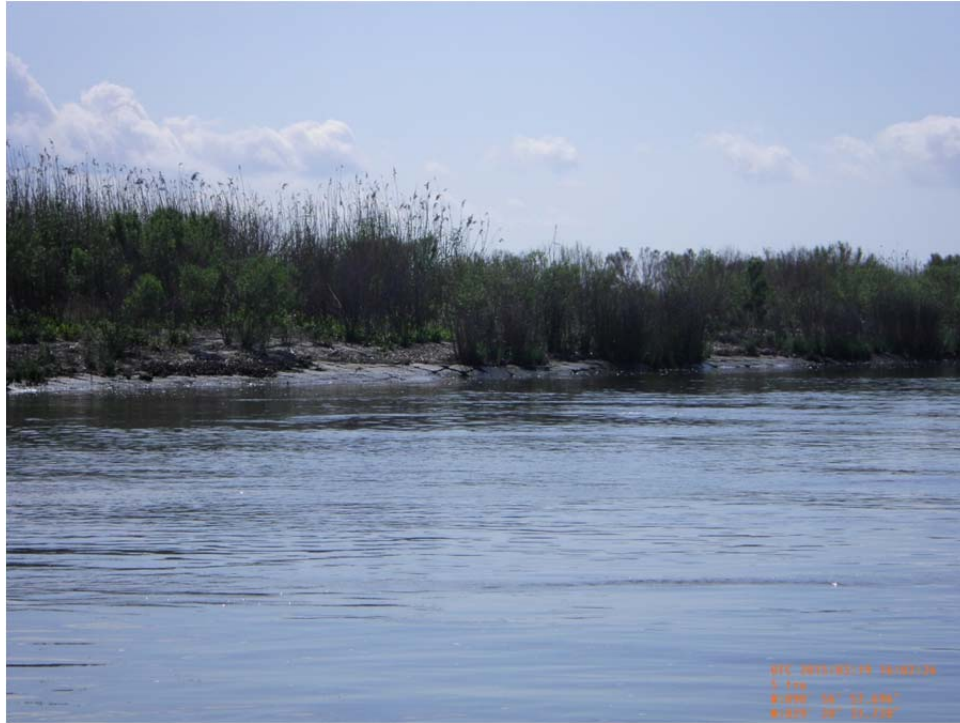
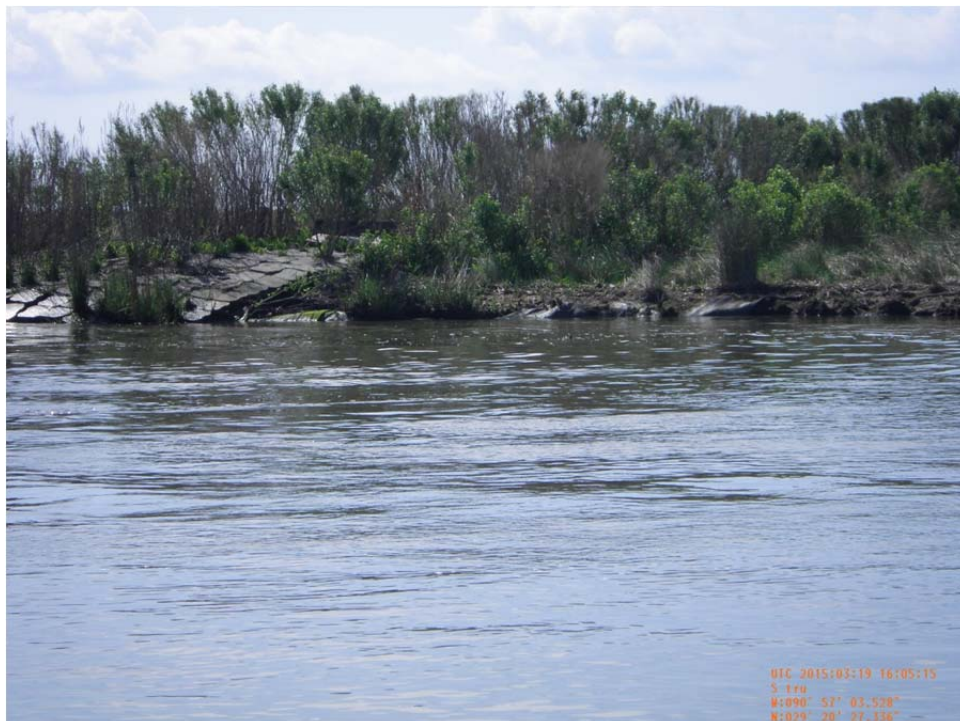
The Armored Earthen Dike on the west bank of Bayou Raccourci appears to be in good overall condition. The warning signs and its timber supports were not damaged or missing. The articulated concrete mats are still coupled by the copolymer rope with woody vegetation emerging through the seams and in front of the concrete mats. The woody vegetation that is growing through the mats raises some concern as the trees/shrubs continue to grow. The vegetative growth will be monitored during future inspections. As expected, there is some variation in height along the length of the armored earthen dike. This is believed to be caused by differential settlement of the dredged material and the weight of the articulated mats. Despite the variations in elevation, the armored earthen dike is still in good condition; therefore, there are no recommendations for corrective actions at this time. (Appendix B, Photos 11 through 14)

Photo 11: View of articulated concrete mats along the east bank of Bayou Raccourci.

Photo 12: View of articulated concrete mats along the east bank of Bayou Raccourci

Photo 13: View of articulated concrete mats along the east bank of Bayou Raccourci

Photo 14: View of southern end of articulated concrete mats along Bayou Raccourci.

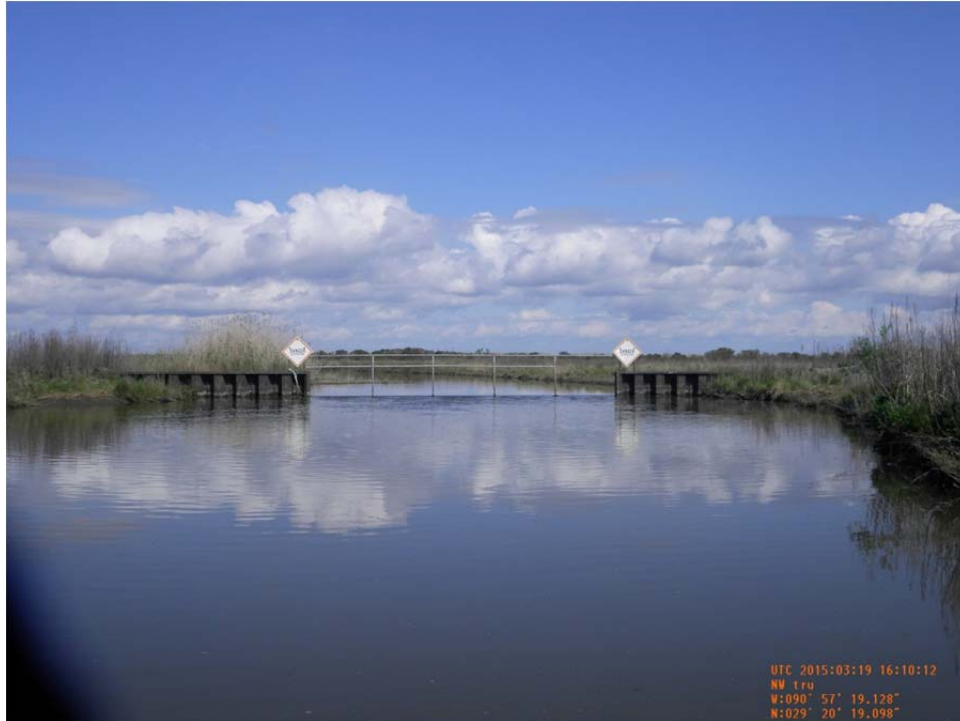
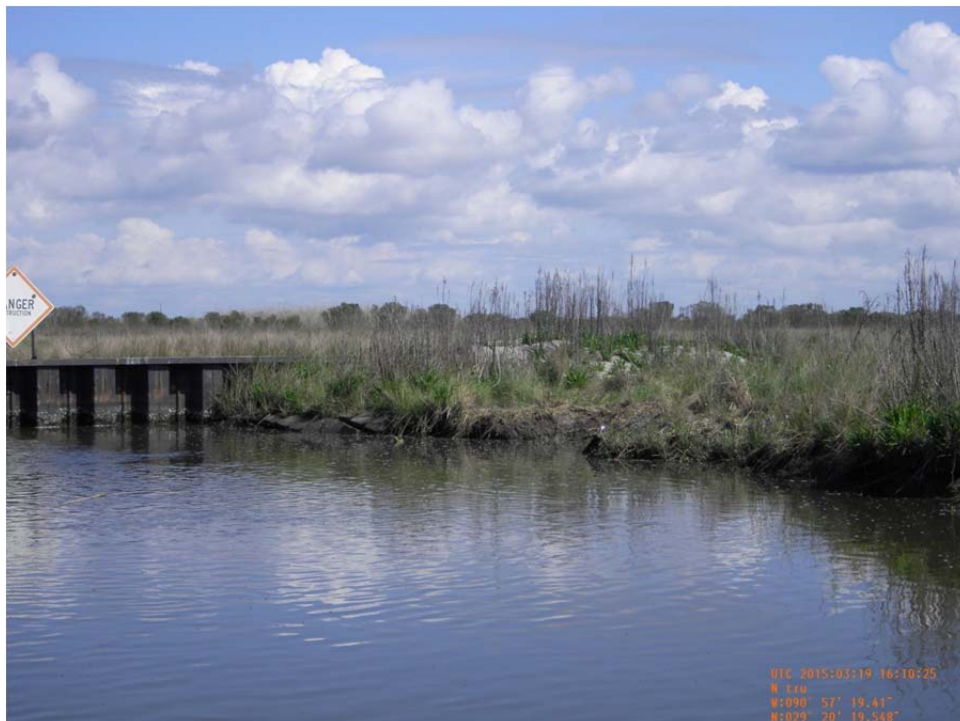
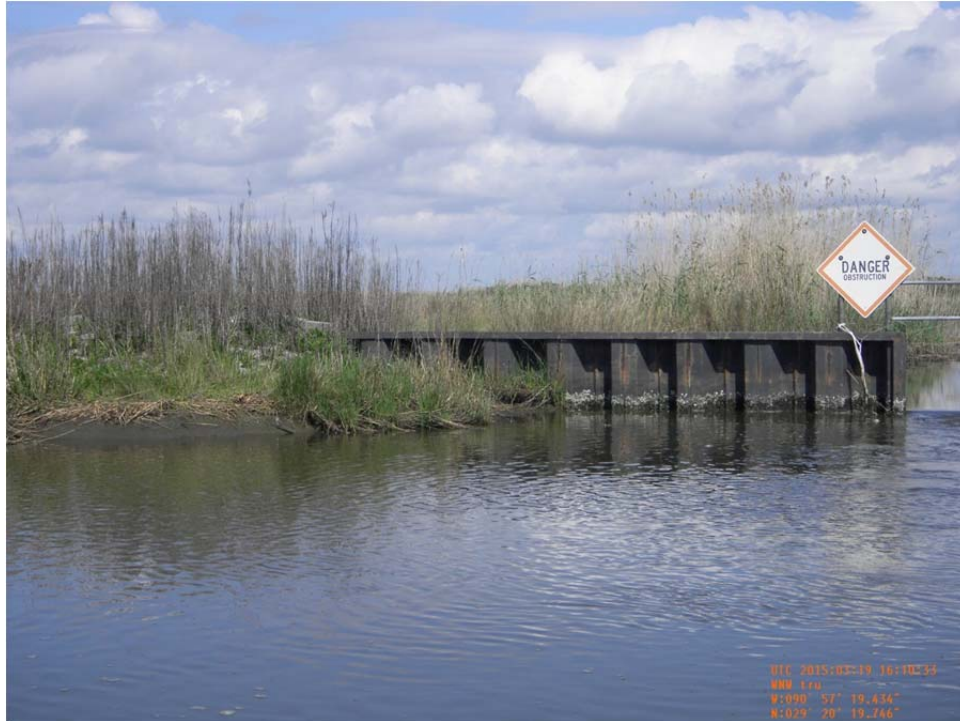
Overall, the sheetpile weir structure appears to be in good condition. There are no visual signs of corrosion or damage to the sheet pile or top channel cap. There doesn't appear to be any erosion or washouts around the embankment tie-ins, as well. The warning signs and supports are also in good condition. There are no recommendations for corrective action at this time. (Appendix B, Photos 15 through 17)

Photo 15: Overall view of weir replacement west of Bayou Raccourci.

Photo 16: view of east bank tie-in along the weir replacement structure west of Bayou Raccourci.

Photo 17: view of west bank tie-in along the weir replacement structure west of Bayou Raccourci.

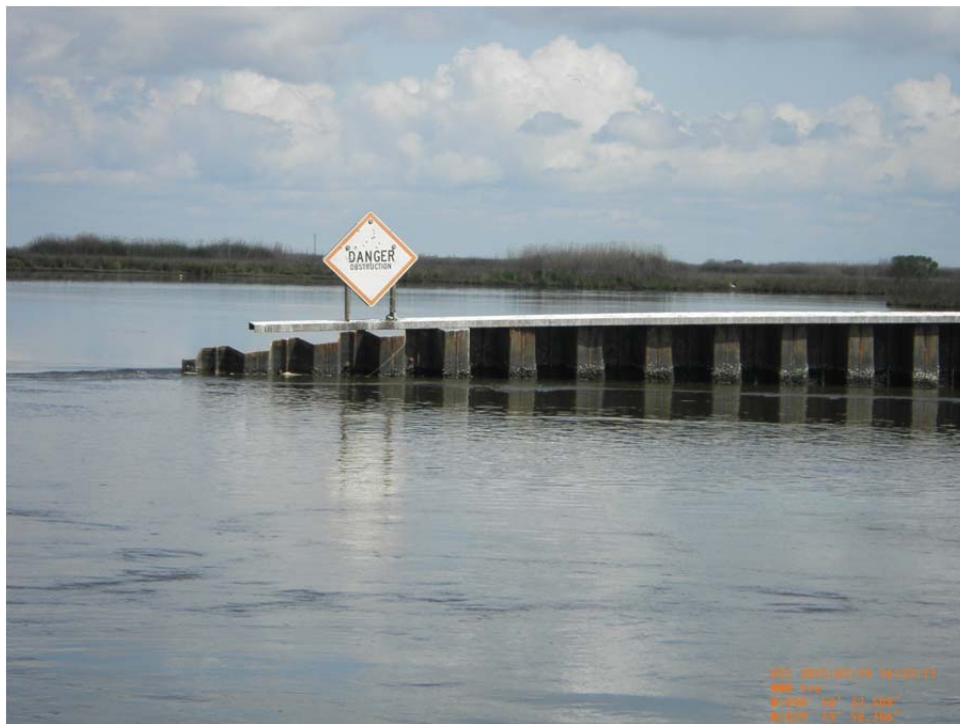
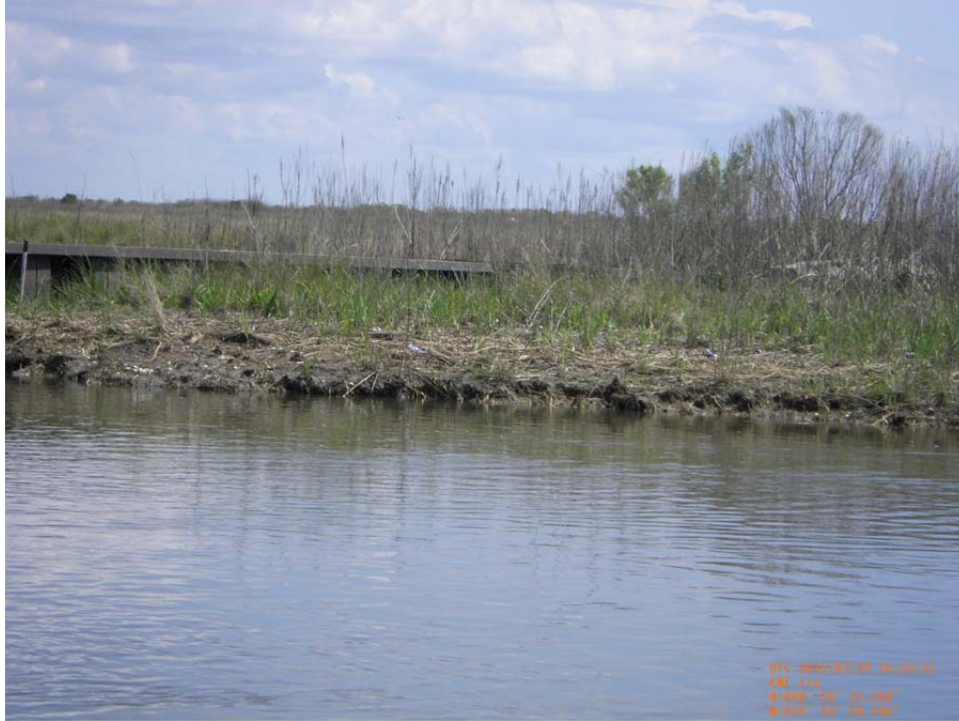
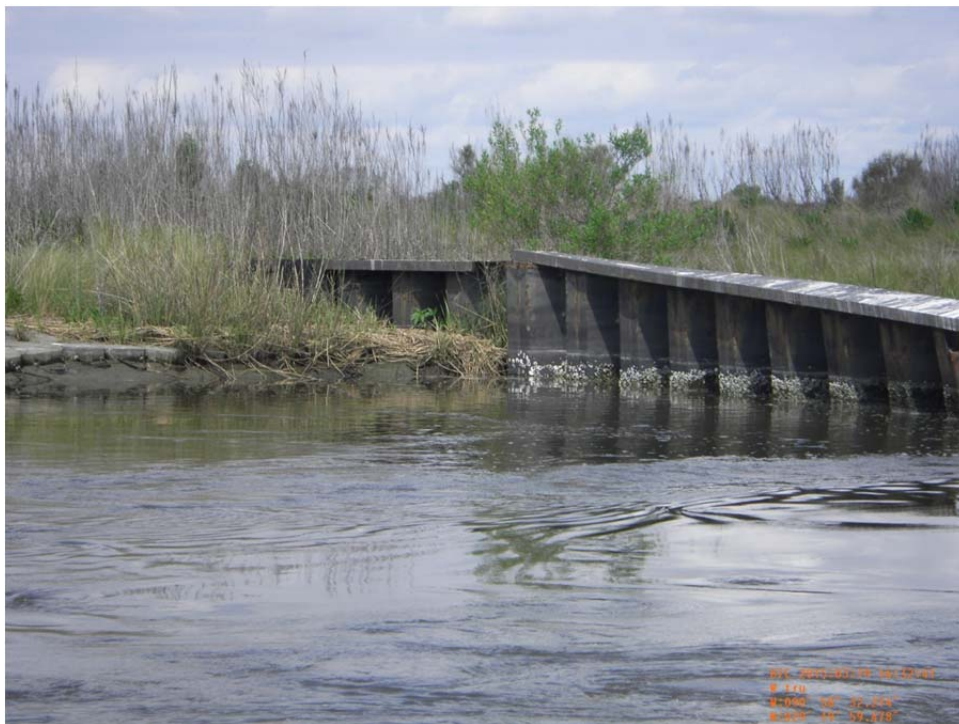
The Sheetpile Plug 2 suffered catastrophic structural damage due to Hurricane Isaac in August 2012. It appears that a large water level differential during the storm caused the bottom of the free standing wall to kick-out and the structure to fail. A section of the top cap is missing and the sheet pile is bent over below the water line, allowing water to pass through/over the structure. The structure is damaged in such a way that there are minimal options for repairing the structure, it must be removed and then replaced. CPRA has initiated a claim with the Federal Emergency Management Agency (FEMA) as the structure was damaged during a natural disaster. In May 2015, FEMA had rejected CPRA's claim for funding the repair of the steel sheetpile structure. CPRA has appealed

FEMA's decision and is currently awaiting a ruling on appeal. (Appendix B, Photos 18 through 20)

Photo 18: view of the center section of the damaged sheet pile along Sheetpile Plug No.2.

Photo 19: view of the east bank tie-in along Sheetpile No.2, looking northeast.

Photo 20: View of the west bank tie-in along Sheetpile No.2, looking northwest.
