2015 Annual Inspection Report

**Raccoon Island Shoreline Protection/
Marsh Creation Project**

State Project Number TE-48

**Raccoon Island Breakwater
Demonstration Project**

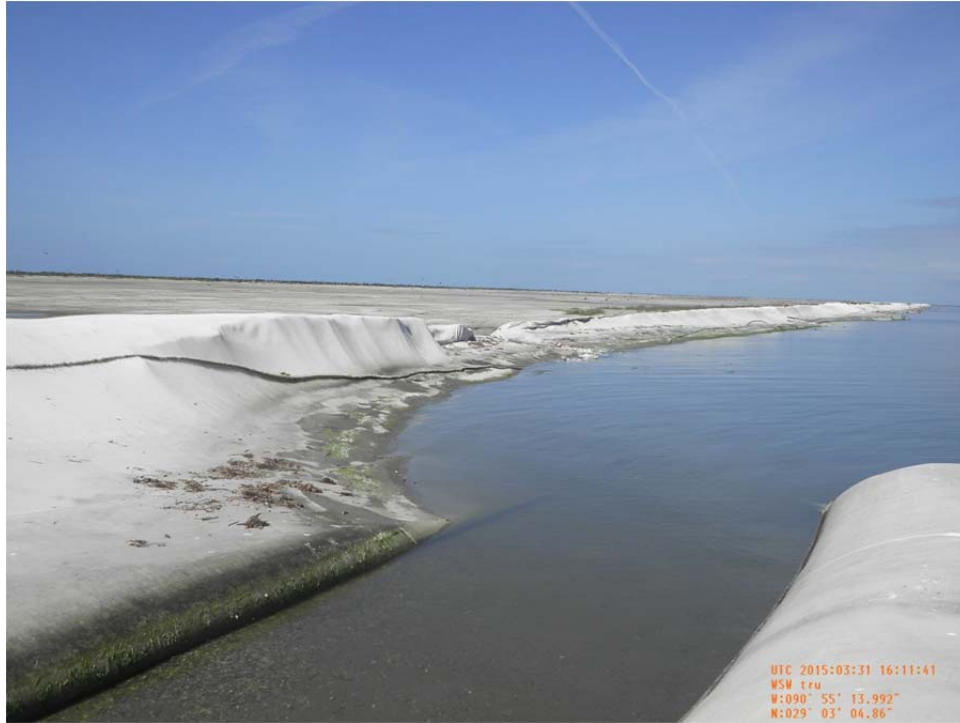
Photo 1: (1228) – View of geotextile fabric and geotubes along back containment dike near Sta. 5+00 looking west.

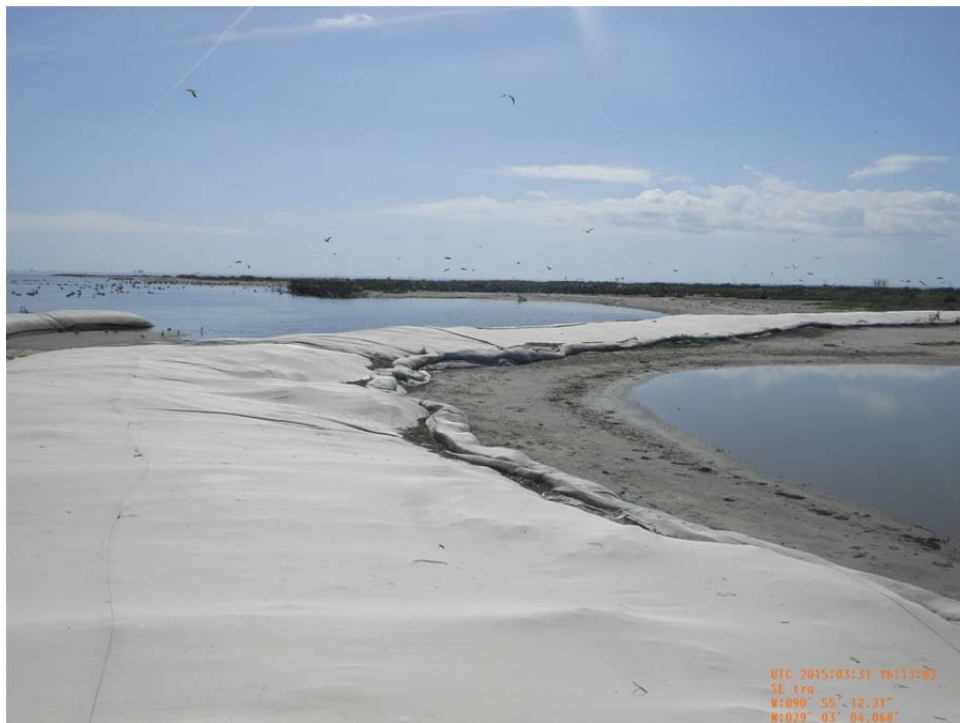
Photo 2: (1230) – View of geotextile fabric and geotube along back containment dike near Sta. 5+00 looking east.

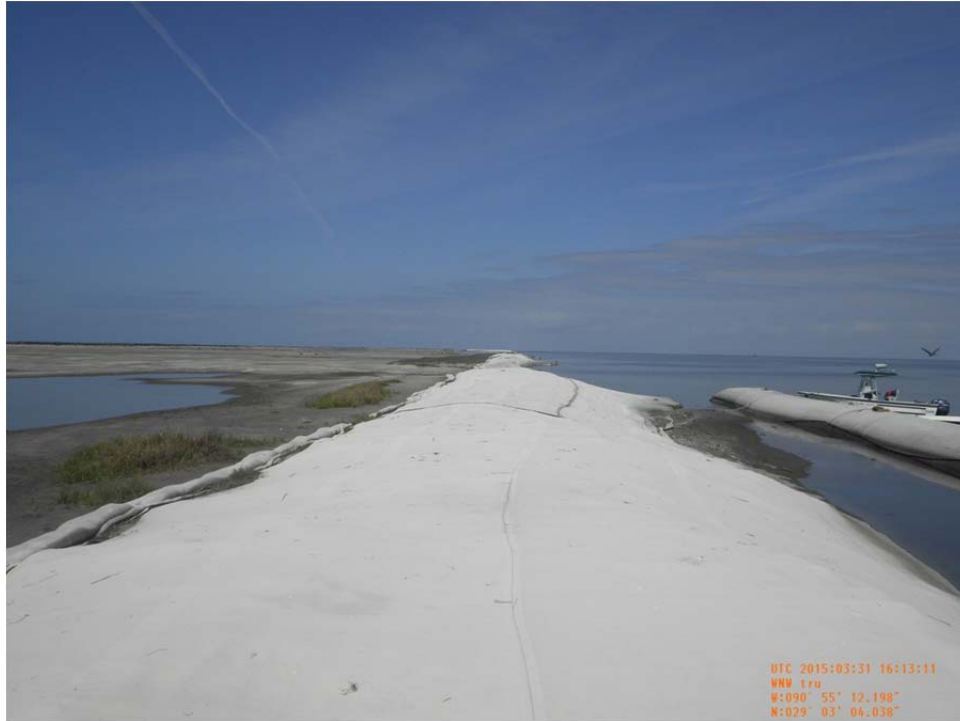
Photo 3: (1232) – View of geotextile fabric along back containment dike near Sta. 1+00 looking west.

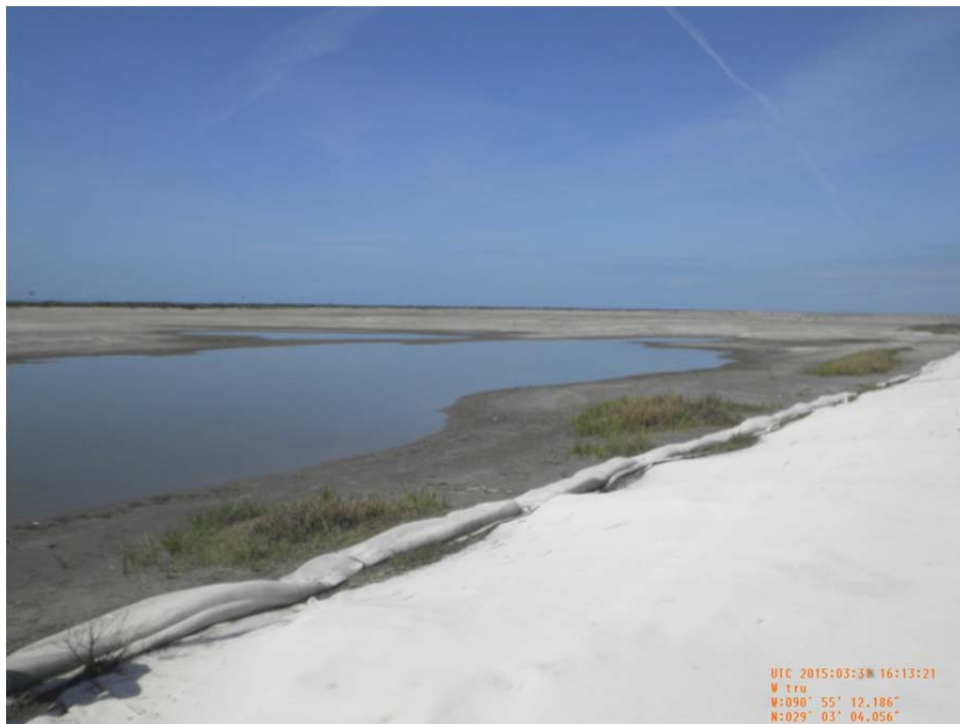
After viewing the marsh creation area, our first observation was that the presence of marsh plants were severely lacking. Considering the time that had passed since construction, we would expect more plants to have emerged. After discussing the lack of vegetation on the marsh platform with NRCS, we are planning to perform vegetative plantings event in year 2016 and 2018. We also noticed that the fabric material covering the earthen embankment and geotubes on the north side of the marsh fill area was severely degraded and splitting at the seams. The fabric and geotubes were placed during construction to protect the containment dike from wave action from the bay and had a projected life span of 2 years. The intention was to remove this material once the marsh platform had begun to vegetate. Due to the poor condition of the fabric material at this time, we are planning to remove the fabric material and geotubes under the first maintenance event. We will also be removing the spill box located on the western end of the containment dike. We plan on proceeding with the design of the first maintenance event in late fall of 2015. (Appendix B; Photos 1 through 28; 39 & 40)

Photo 4: (1234) – View of marsh fill area from back containment dike near Sta. 1+00.

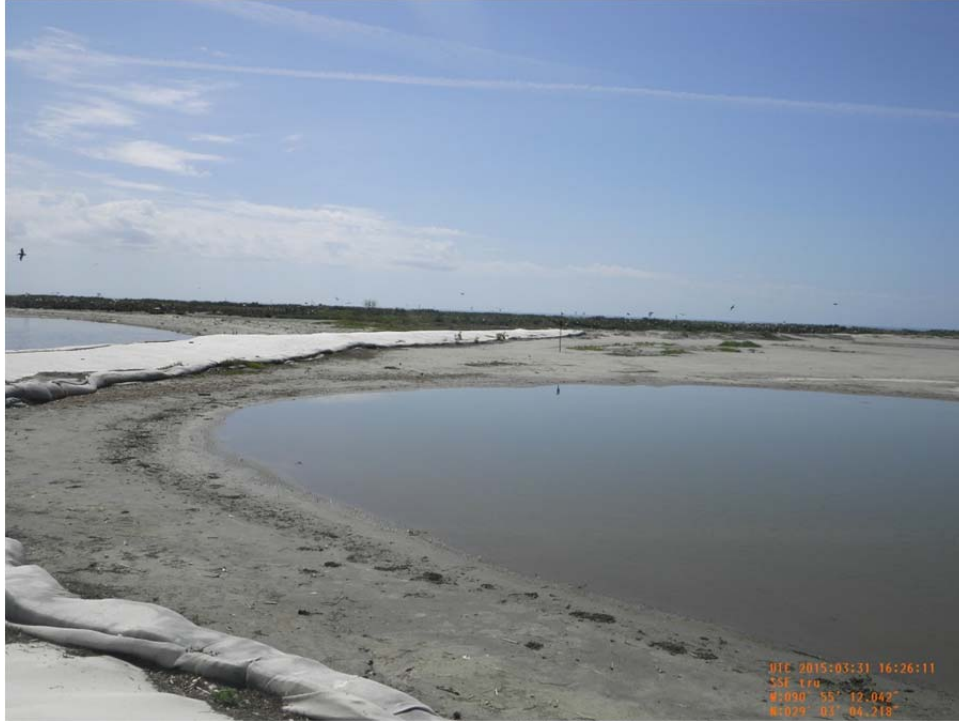
Photo 5: (1235) – View of marsh fill area and geotextile fabric containment from Sta. 1+00 looking south.

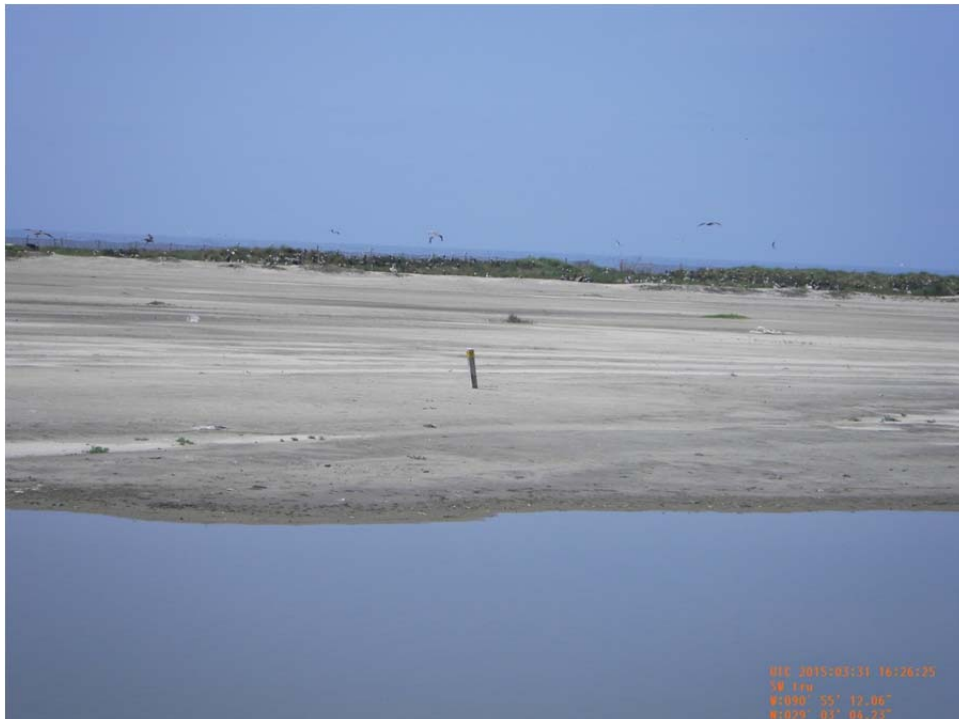
Photo 6: (1236) – View of marsh fill area from Sta. 1+00 looking south.

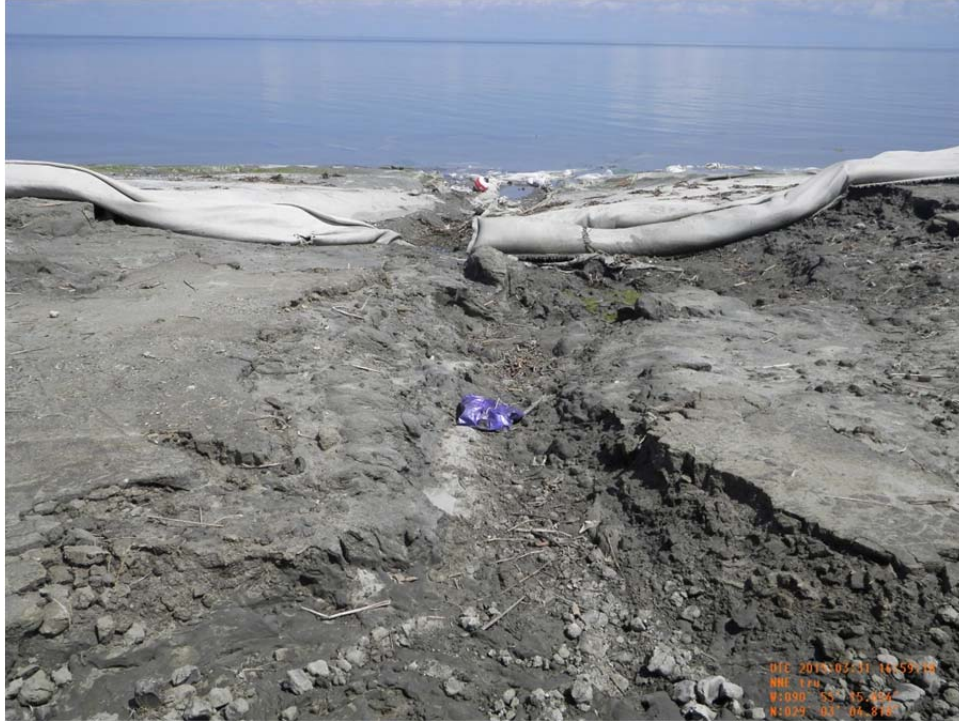
Photo 7: (1245) – View of erosion along the geotextile fabric along containment near Sta. 4+00.

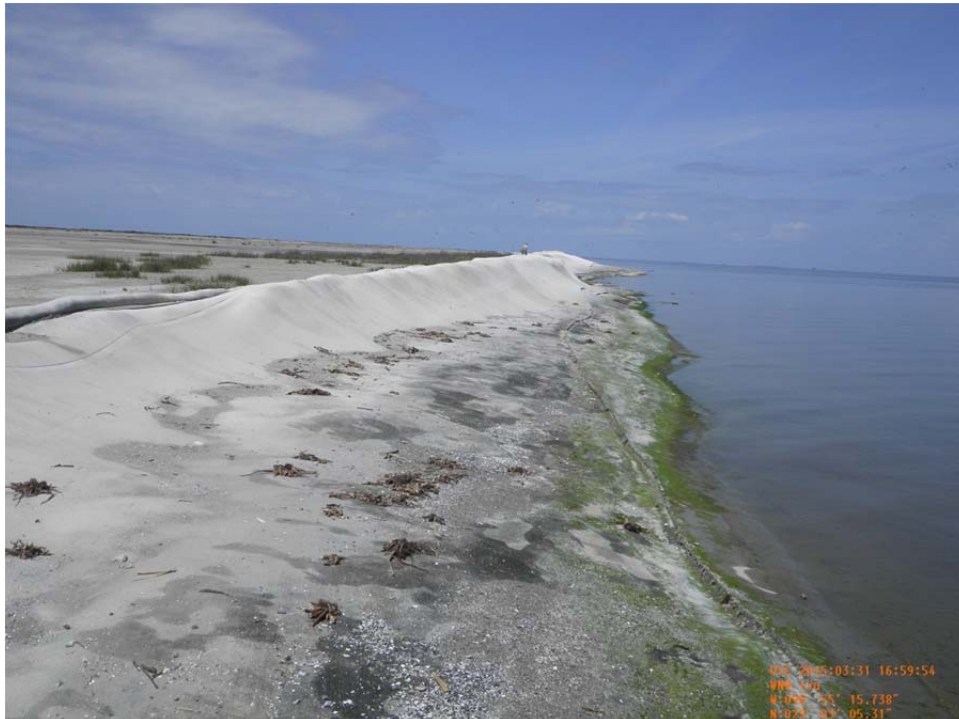
Photo 8: (1246) – View of geotextile fabric along containment near Sta. 4+00 looking west.

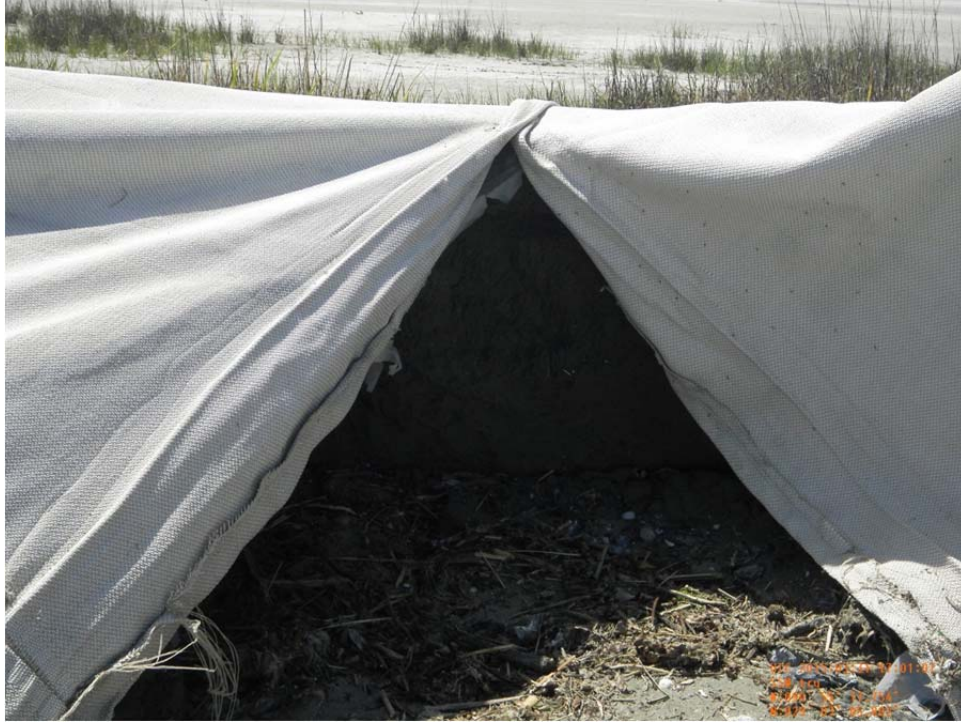
Photo 9: (1249) – Tear in geotextile fabric near Sta. 7+00

Removal of geotextile fabric protecting containment dike and recap existing breakwaters to original design elevation.

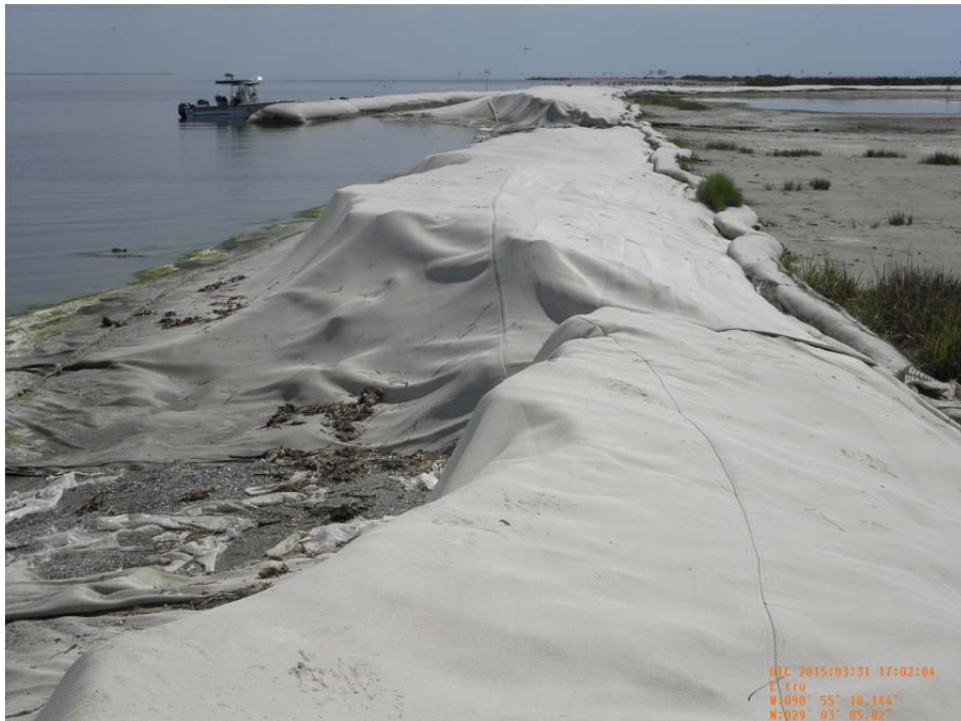
Photo 10: (1253) – View of geotextile fabric tear near Sta. 7+00 and erosion of containment.

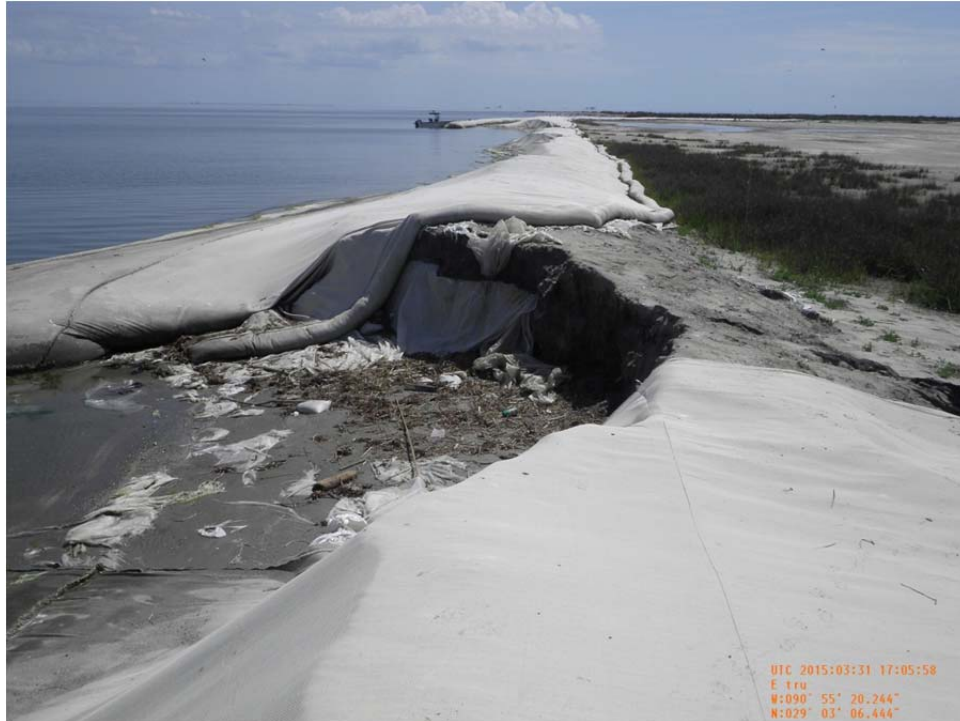
Photo 11: (1260) – View of torn geotextile fabric and erosion near Sta. 8+00.

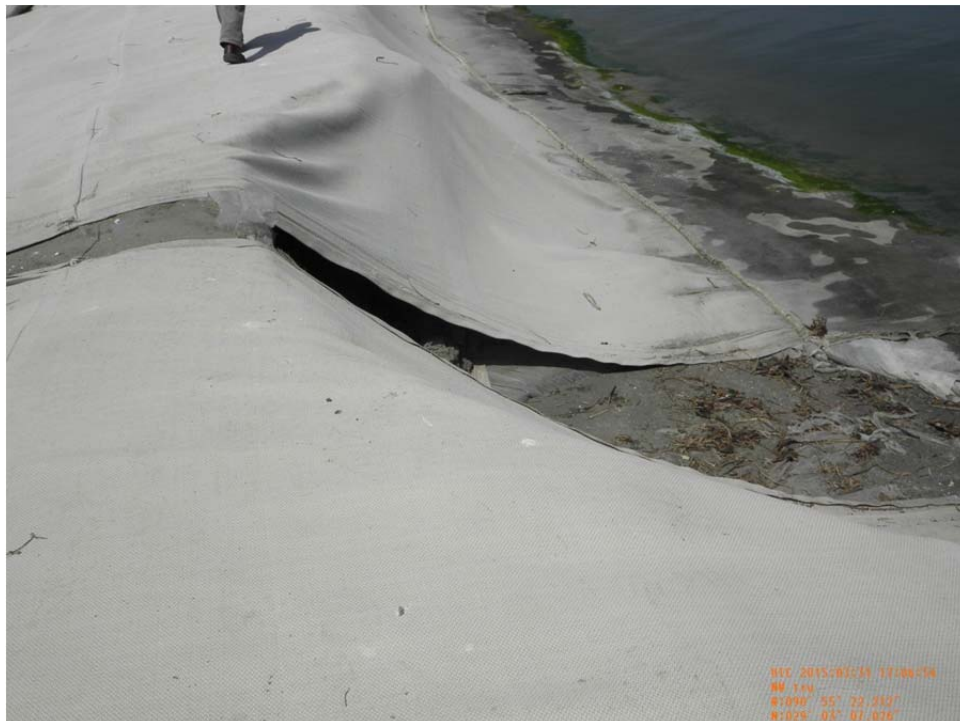
Photo 12: (1262) – View of torn geotextile fabric along back containment near Sta. 10+00

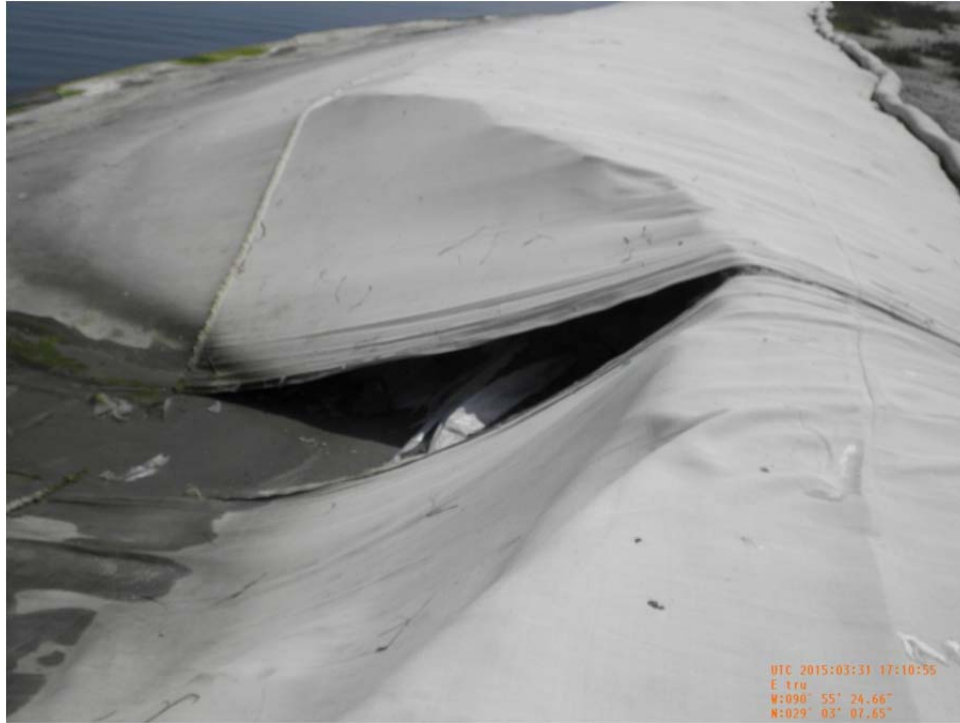
Photo 13: (1270) - View of torn geotextile fabric and erosion along back containment near Sta. 13+00.

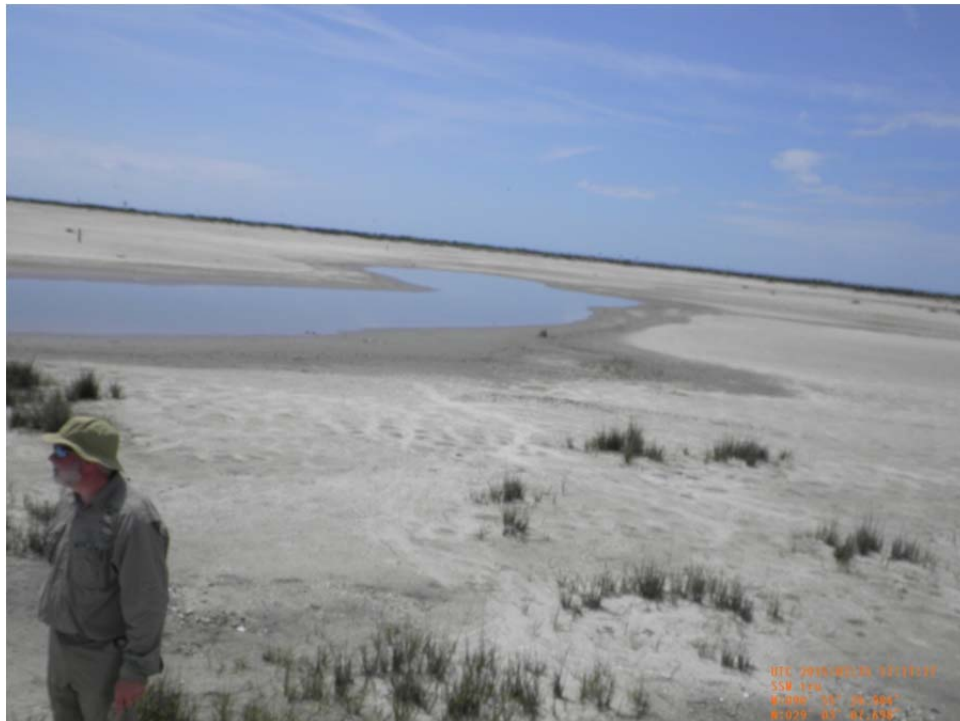
Photo 14: (1272) – View of fill area near Sta. 13+00 looking south.

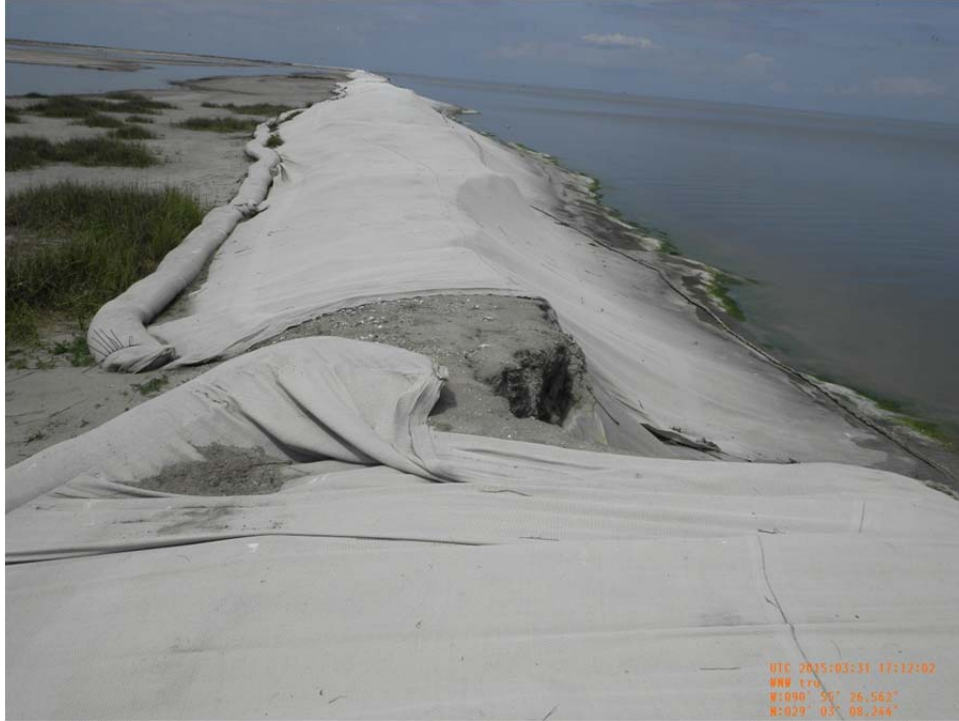
Photo 15: (1273) - View of tear in geotextile fabric along containment near Sta. 15+00.

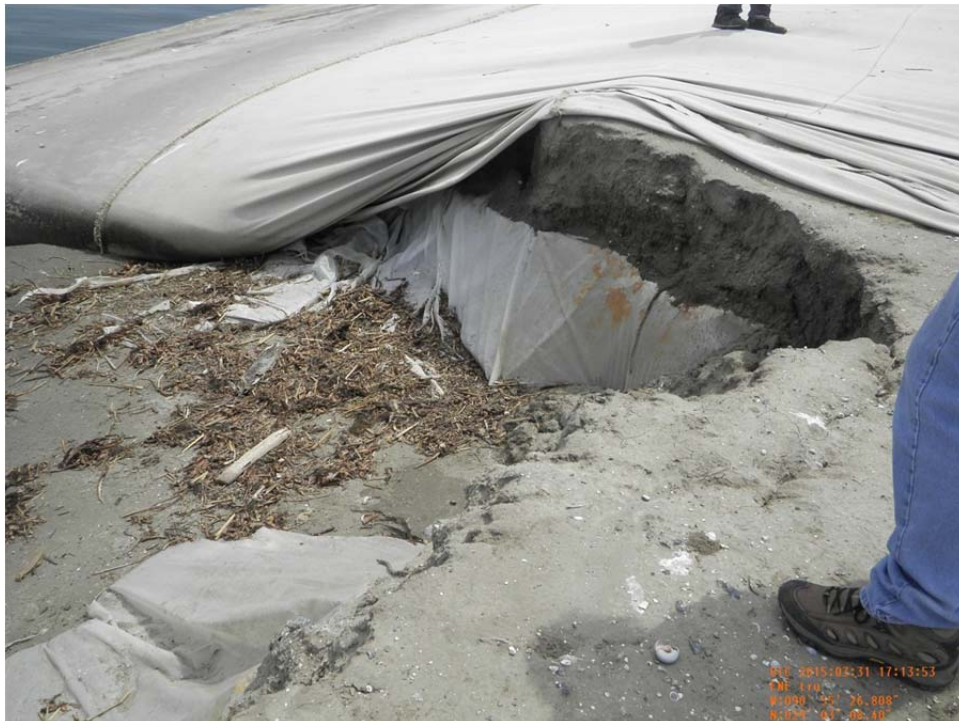
Photo 16: (1278) - View of tear in geotextile fabric along containment near Sta. 15+00.

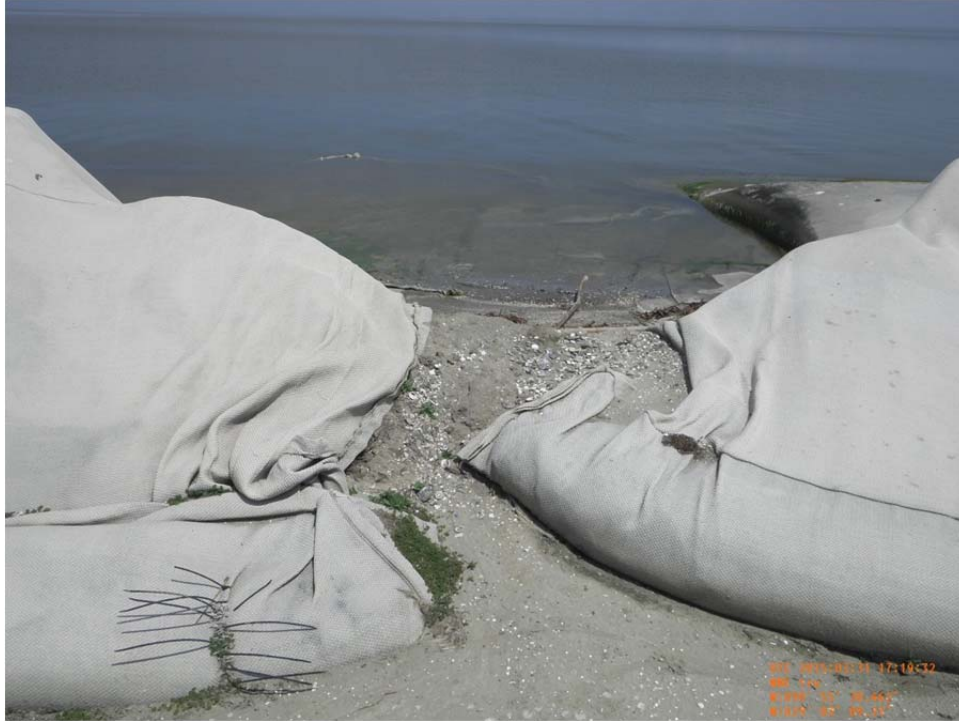
Photo 17: (1284) - View of tear in geotextile fabric and erosion of containment near Sta. 17+00.

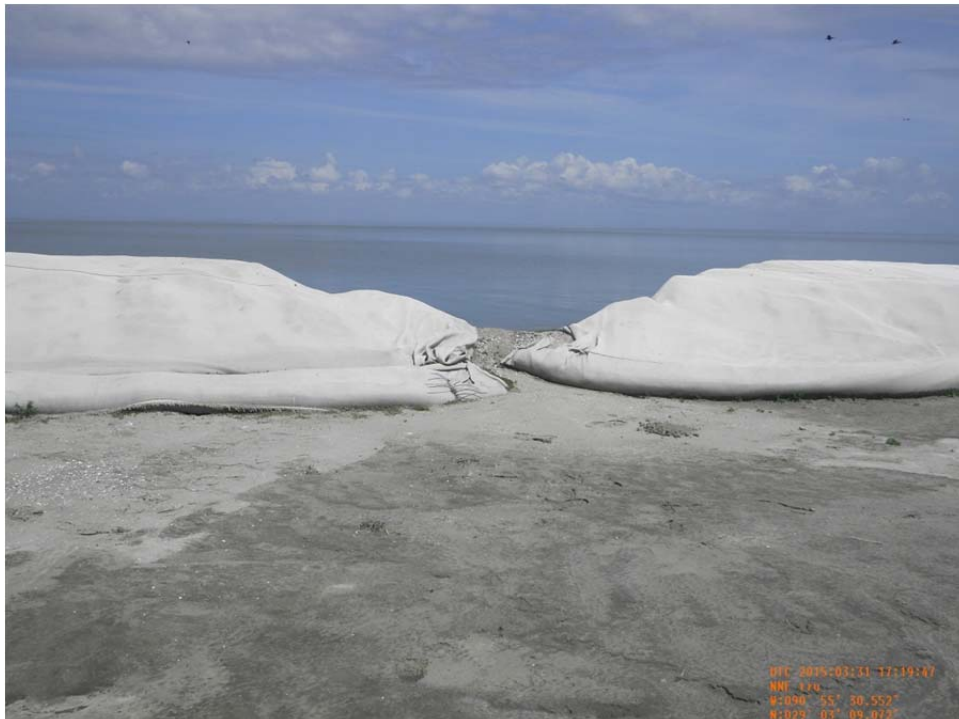
Photo 18: (1285) - View of tear in geotextile fabric and erosion of containment near Sta. 17+00.

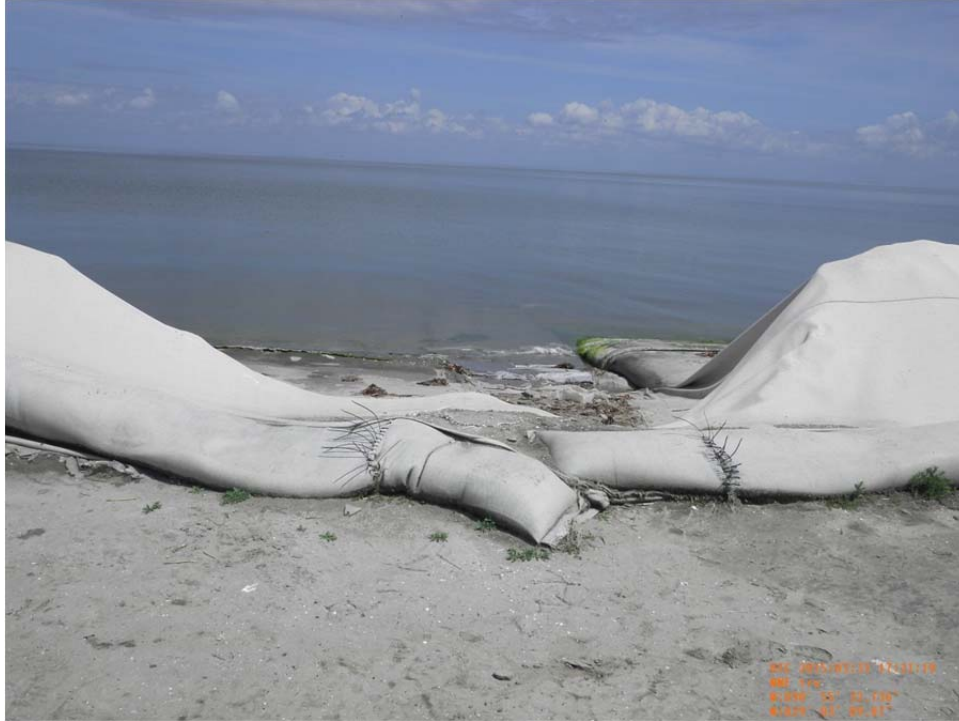
Photo 19: (1286) – View of large breach in containment near Sta. 20+00.

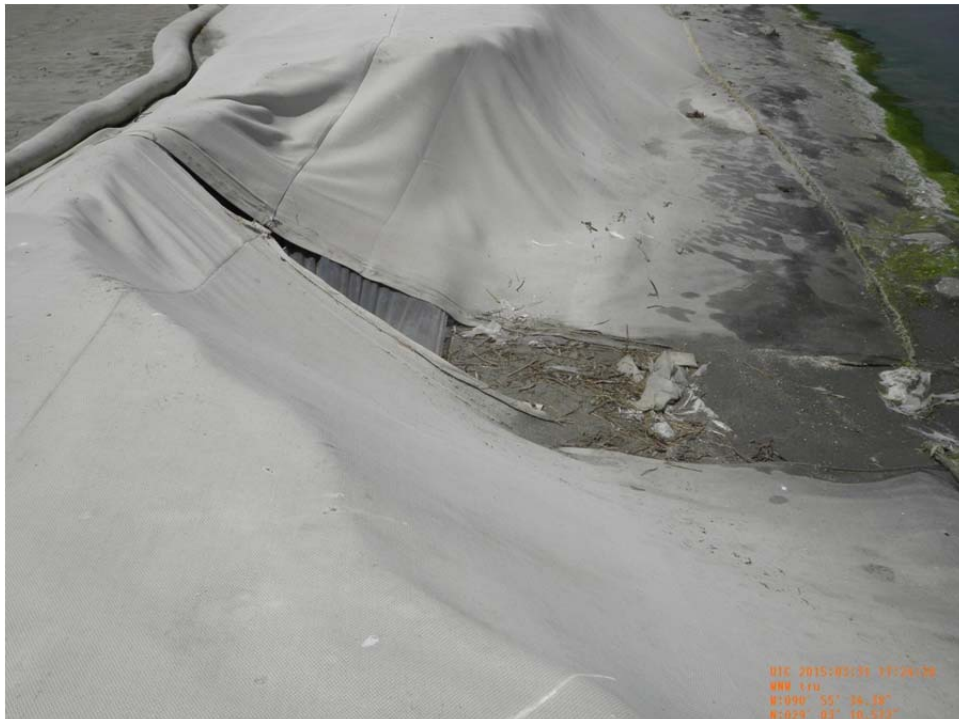
Photo 20: (1292) – View of tear in geotextile fabric along containment near Sta. 22+00.

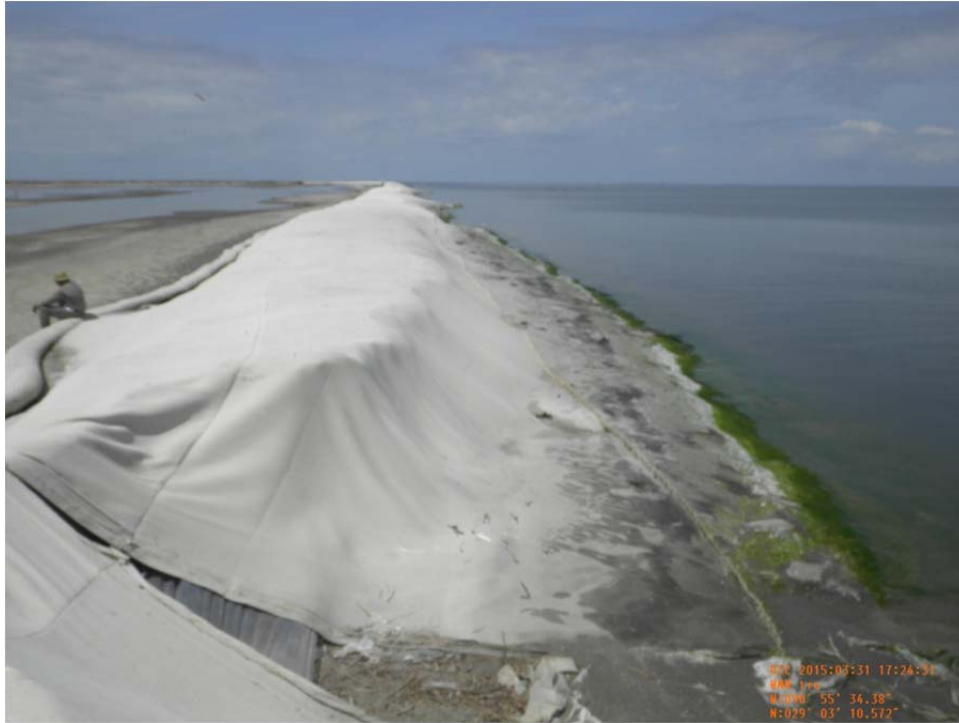
Photo 21: (1294) – View of geotextile fabric along containment near Sta. 22+00 looking west.

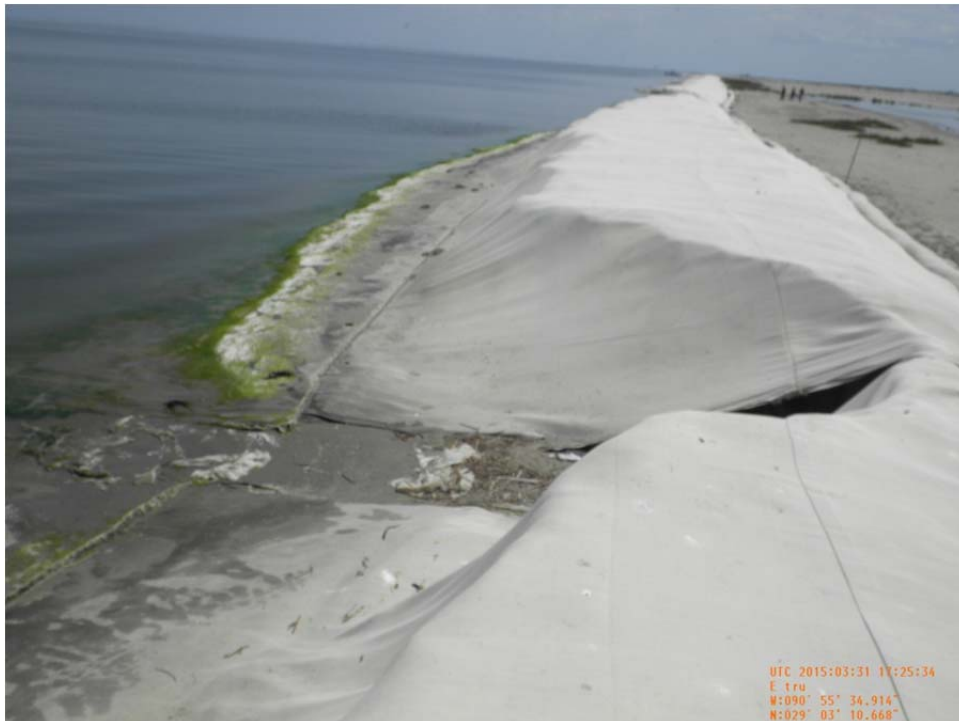
Photo 22: (1298) – View of geotextile fabric along containment near Sta. 22+00 looking east.

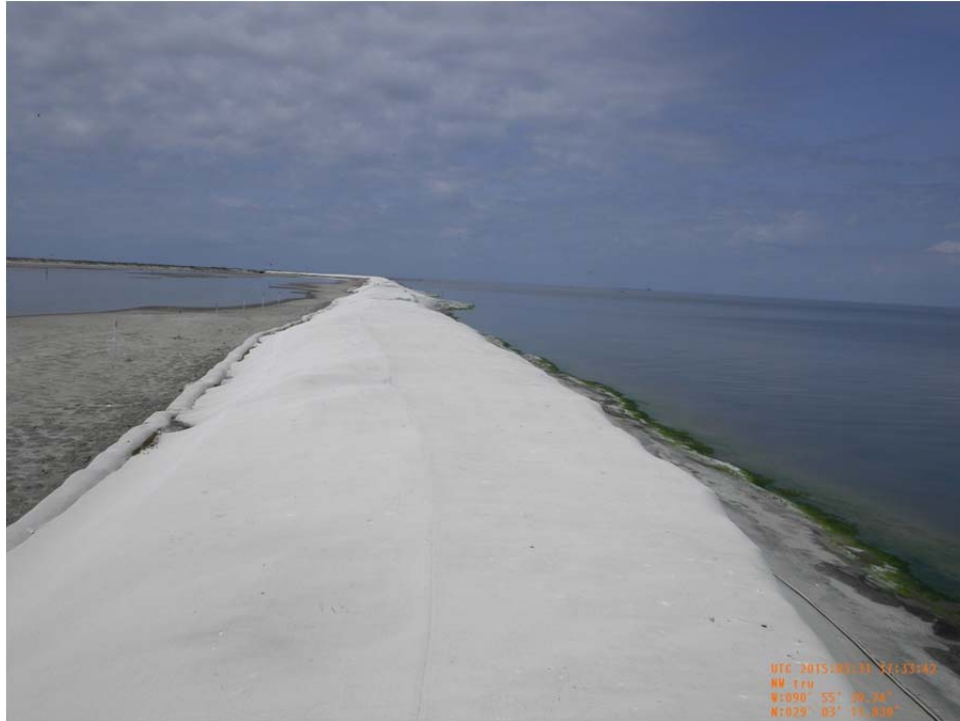
Photo 23: 1306 – view of containment dike near Sta. 26+00 looking west.

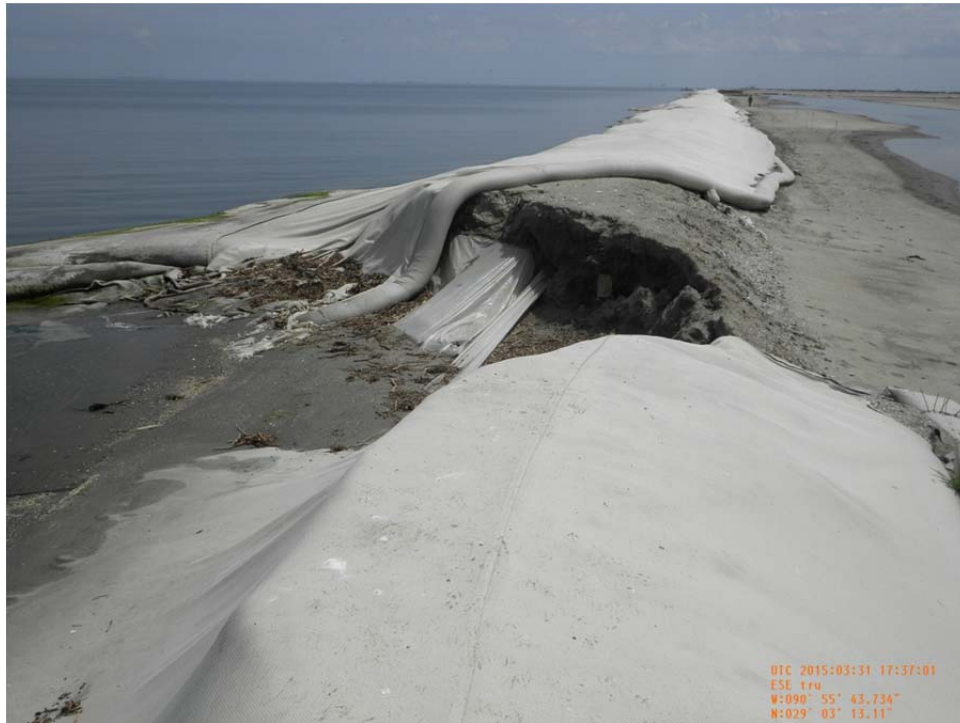
Photo 24: 1314 – View of containment dike near Sta. 30+00 looking east.

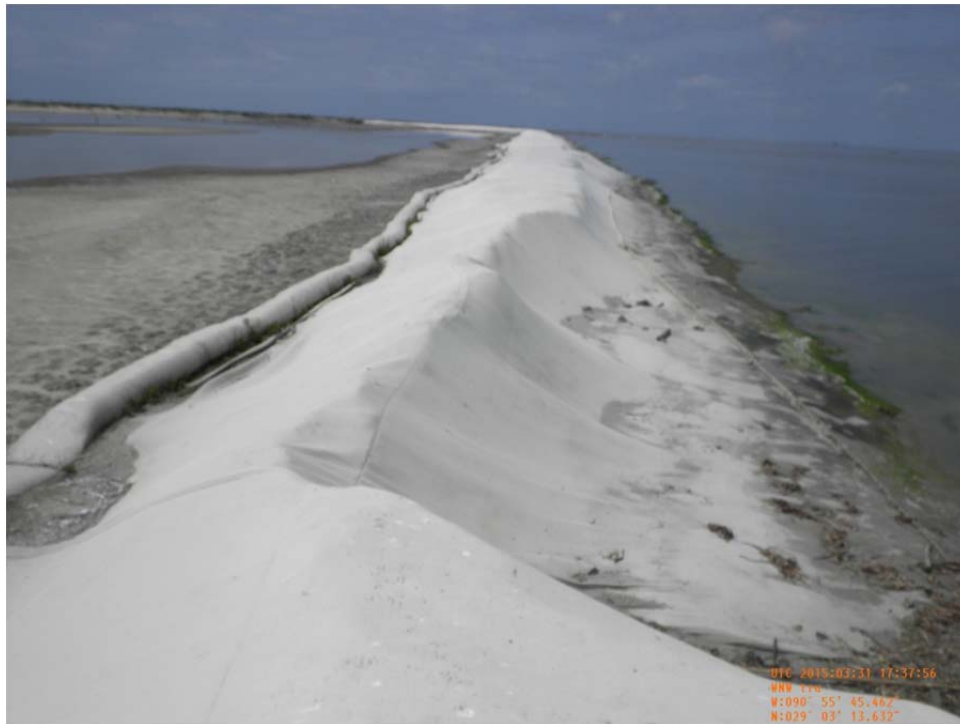
Photo 25: 1316 – View of containment dike near Sta. 22+50 looking west.

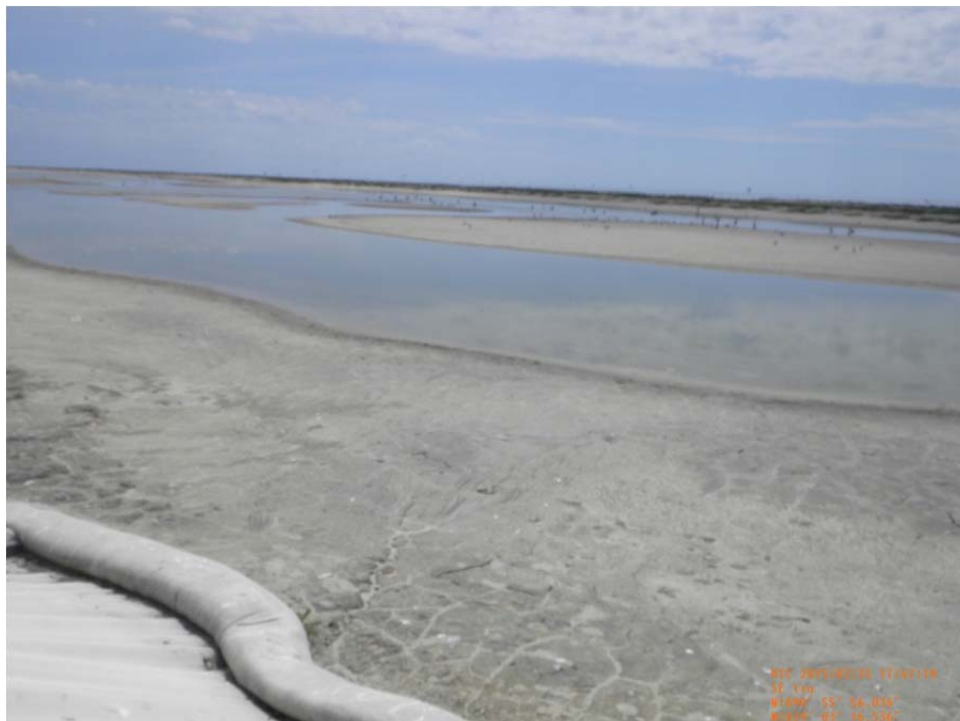
Photo 26: 1336 – View of marsh creation area from Sta. 42+00 looking southward.

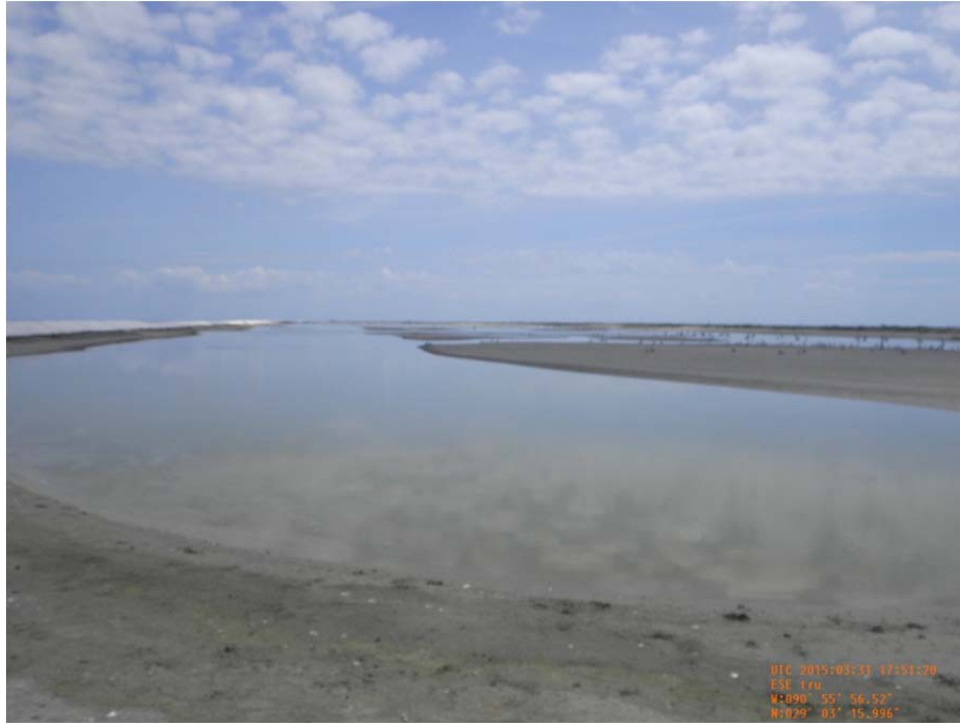
Photo 27: 1340 – View of the marsh creation area along containment dike near Sta. 43+00.

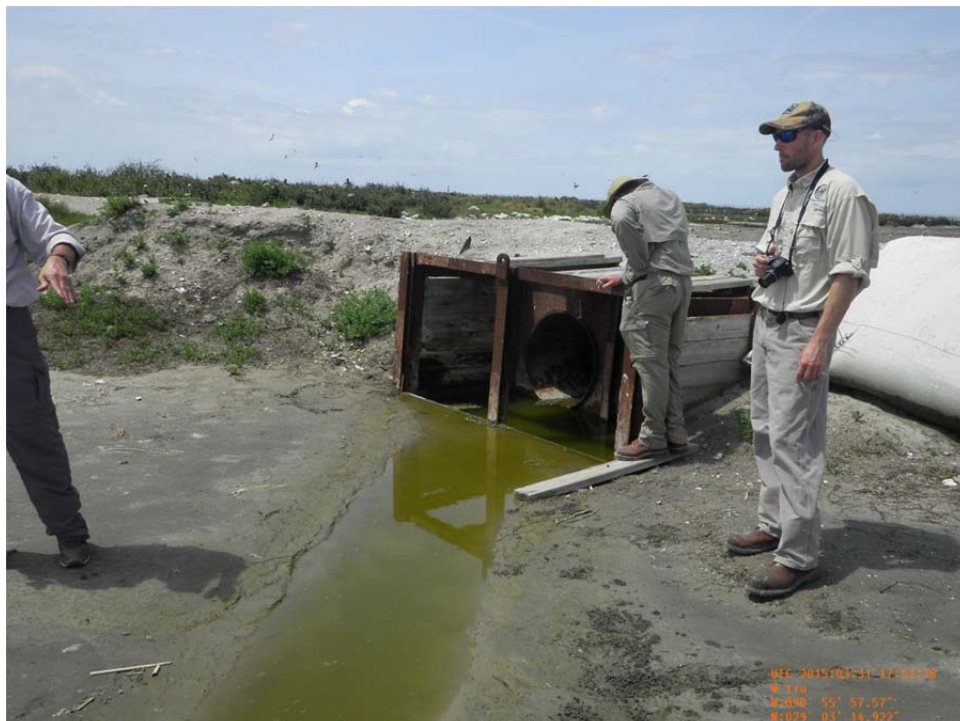
Photo 28: 1343 – View of spill box along containment dike near Sta. 44+00.

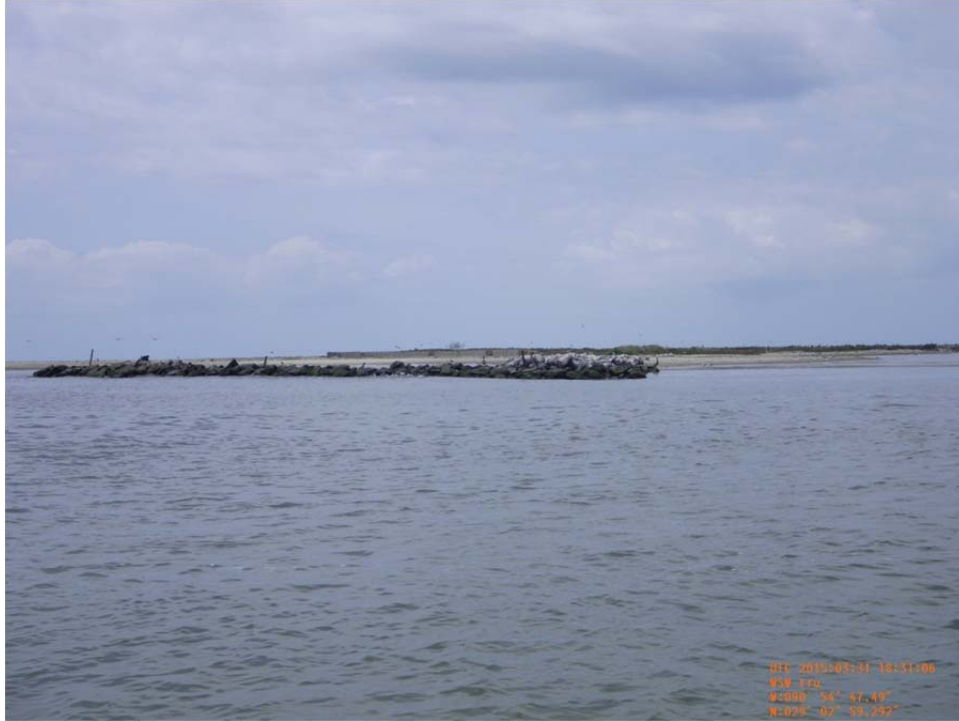
A visual inspection of the eight (8) segmented breakwaters constructed on the east end of the island revealed that the features were in fair condition. Several of the breakwaters appear to have settled since construction and the rock riprap was slightly displaced (Appendix B; Photos 29 through 38). A topographic survey was conducted in 2015 by T.Baker Smith of Houma, Louisiana to profile and cross section the breakwaters to determine the extent of settlement. The survey revealed that the breakwaters have settled at varying degrees with breakwaters 3 and 4 being the most severe with a total average settlement of -2.01', including the east groin which was constructed under the Raccoon Island Shoreline Protection and Marsh Creation (TE-48) project. Below are settlement averages of the breakwaters recorded during the 2015 survey:

Photo 29: View of segmented breakwater 0 and the eastern groin from breakwater to island.

Based on the settlement observed, we are recommending a rock riprap lift of all breakwaters to bring the crest to designed elevations. It is estimated that a total of 5,970 tons of riprap will be required to complete the capping of breakwaters 0 through 7. We anticipate that the design of the maintenance project can begin by November 2015.

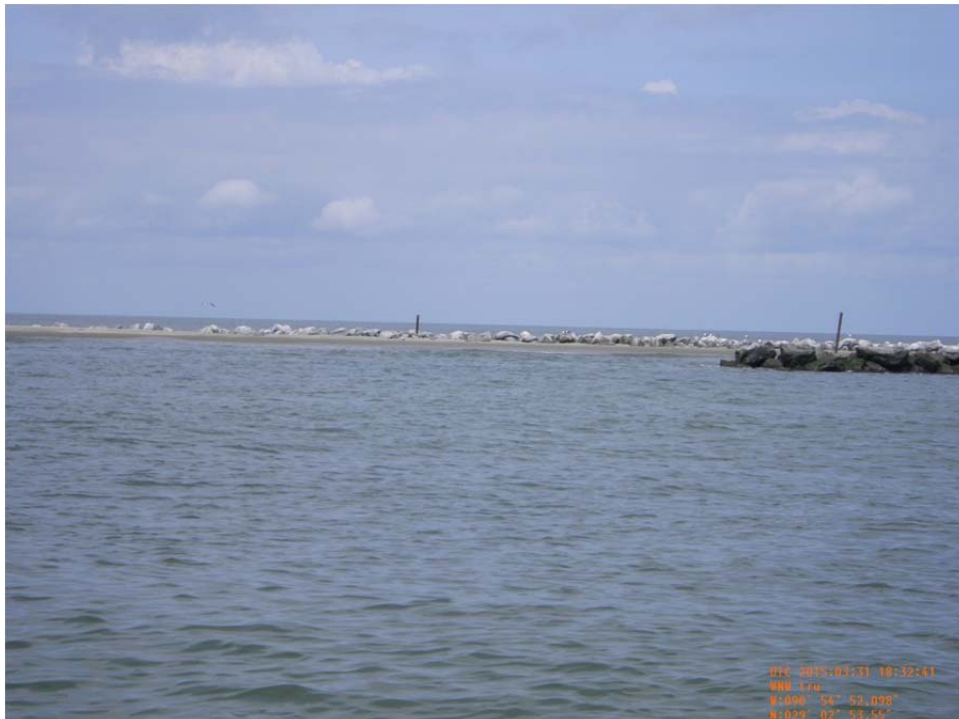
Photo 30: 1357 – View of segmented breakwater 0 and eastern groin looking north.

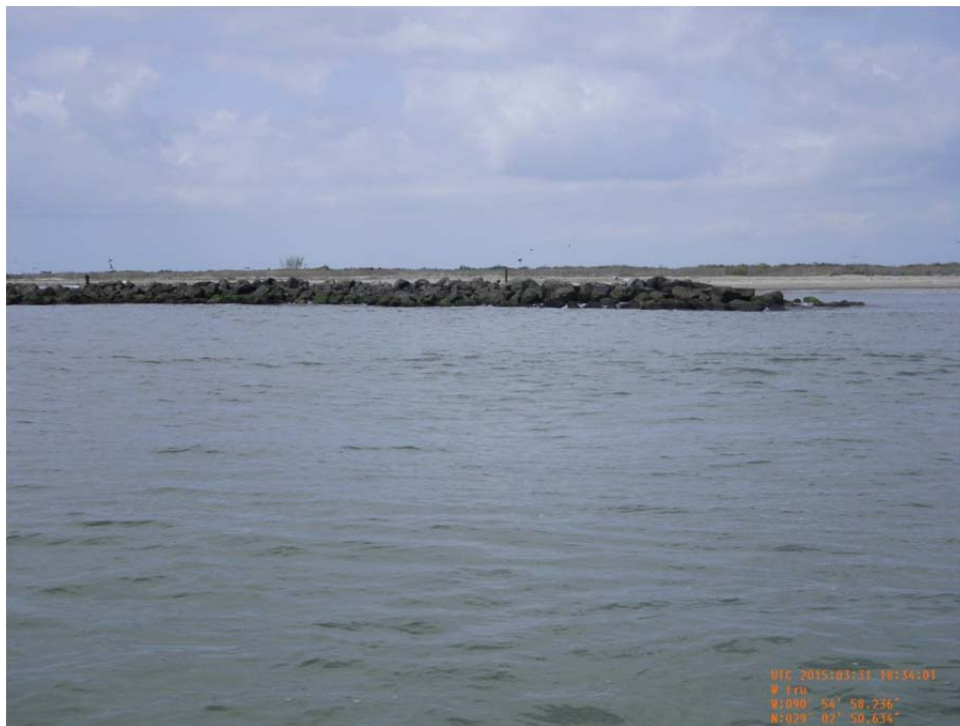
Photo 31: 1358 – View of segmented breakwater 2 looking northwest.
