2015 Annual Inspection Report

**Raccoon Island Shoreline Protection/
Marsh Creation Project**

State Project Number TE-48

**Raccoon Island Breakwater
Demonstration Project**

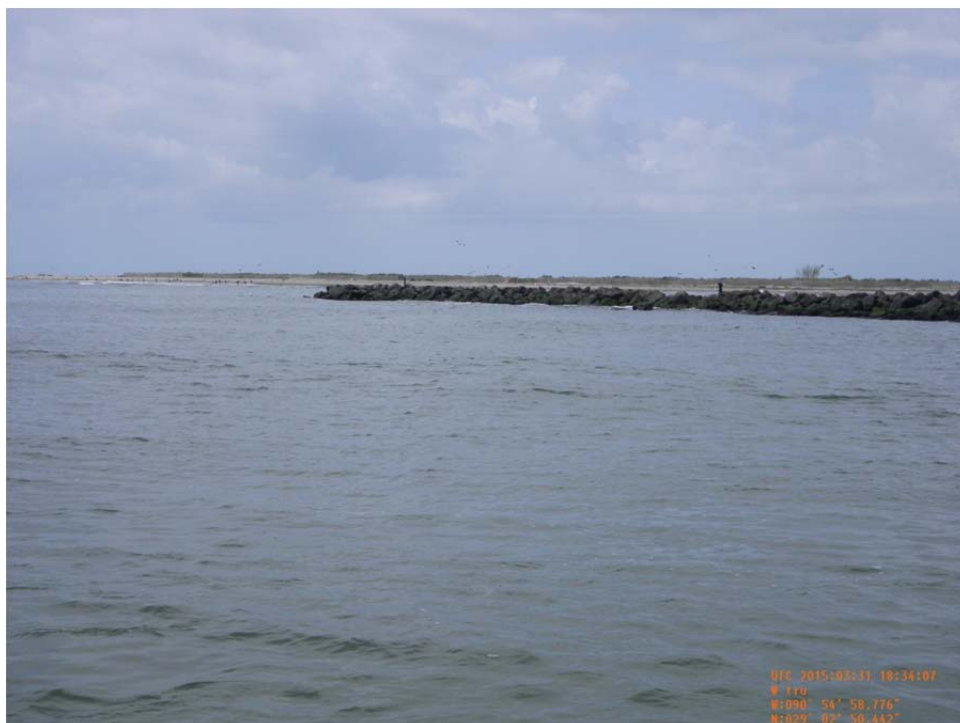
A visual inspection of the eight (8) segmented breakwaters constructed on the east end of the island revealed that the features were in fair condition. Several of the breakwaters appear to have settled since construction and the rock riprap was slightly displaced (Appendix B; Photos 29 through 38). A topographic survey was conducted in 2015 by T.Baker Smith of Houma, Louisiana to profile and cross section the breakwaters to determine the extent of settlement. The survey revealed that the breakwaters have settled at varying degrees with breakwaters 3 and 4 being the most severe with a total average settlement of -2.01', including the east groin which was constructed under the Raccoon Island Shoreline Protection and Marsh Creation (TE-48) project. Below are settlement averages of the breakwaters recorded during the 2015 survey:

Photo 32: 1359 – View of segmented breakwater 2 looking northwest.

Based on the settlement observed, we are recommending a rock riprap lift of all breakwaters to bring the crest to designed elevations. It is estimated that a total of 5,970 tons of riprap will be required to complete the capping of breakwaters 0 through 7. We anticipate that the design of the maintenance project can begin by November 2015.

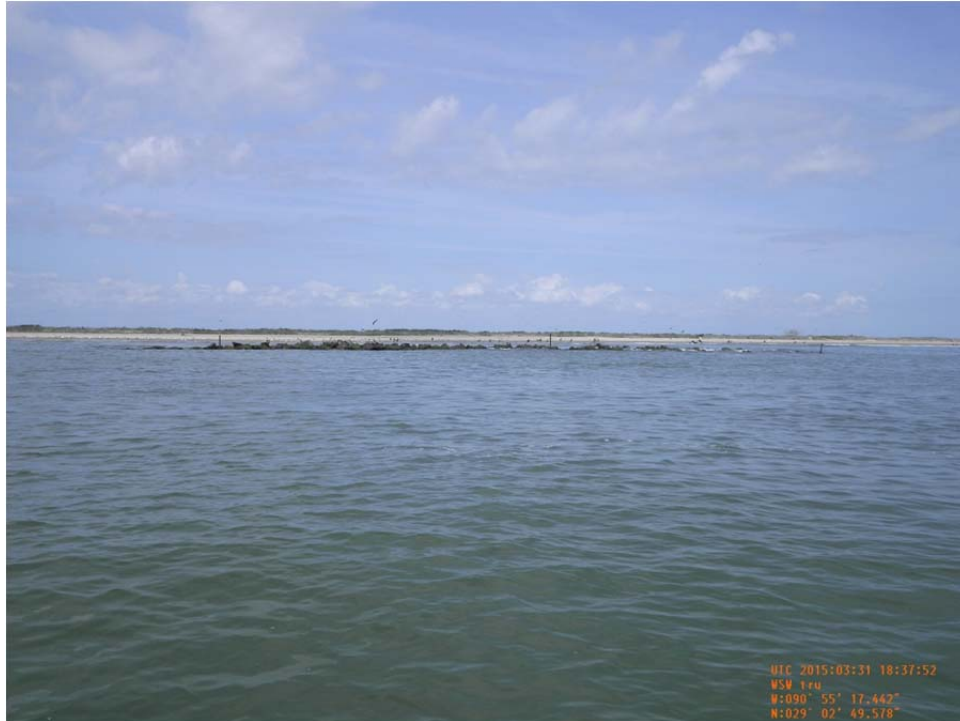
Photo 33: 1361 – View of segmented breakwater 4 looking north.

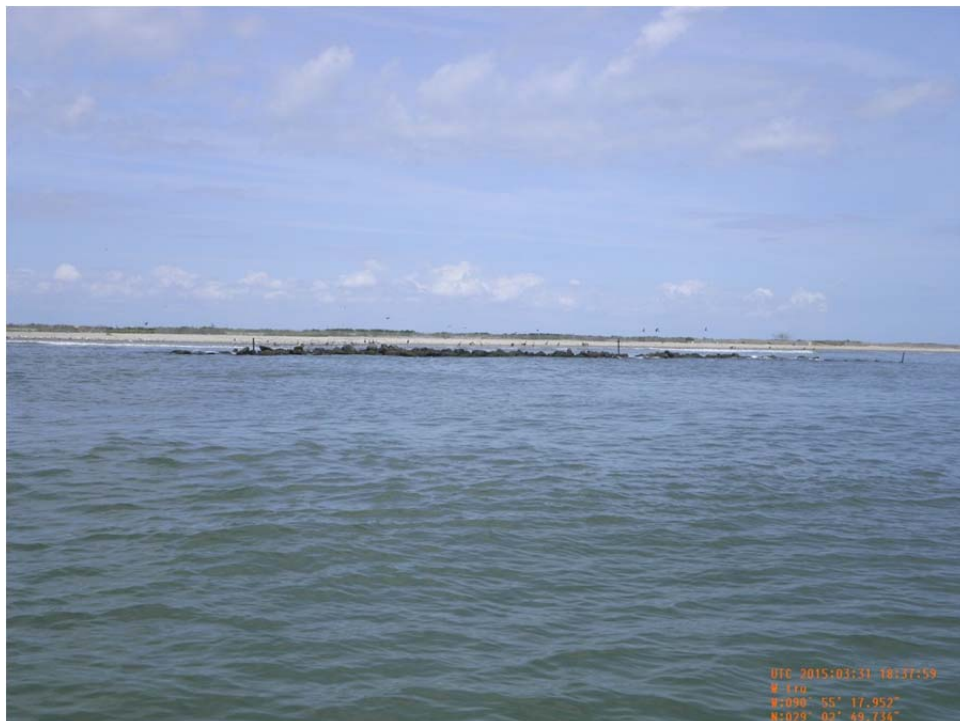
Photo 34: 1362 – View of segmented breakwater looking north.

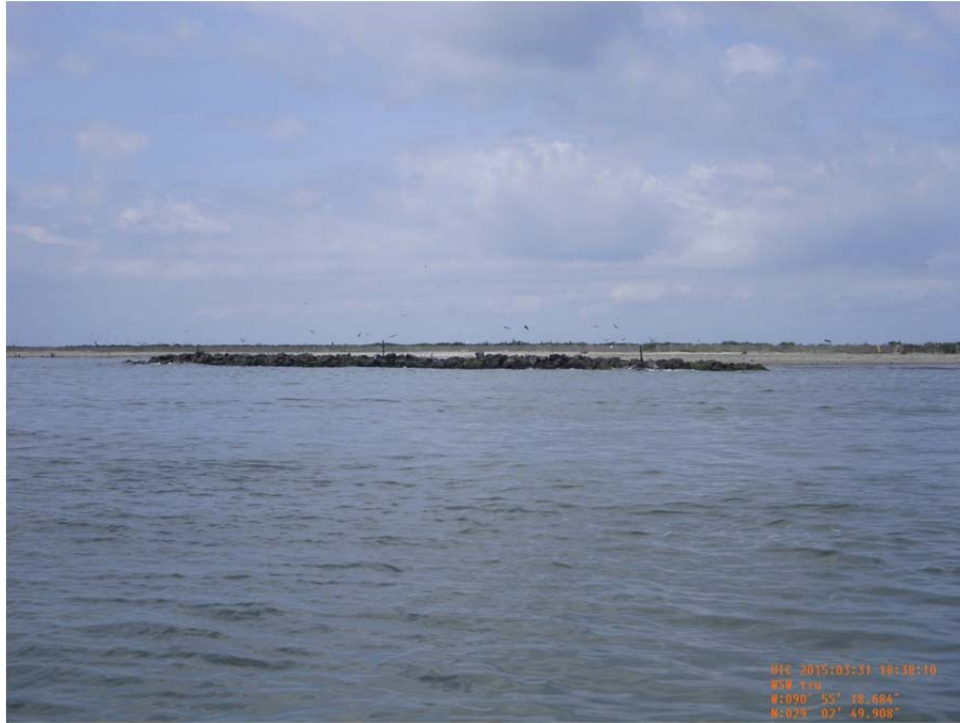
Photo 35: 1363 – View of segmented breakwater 5 looking northwest.

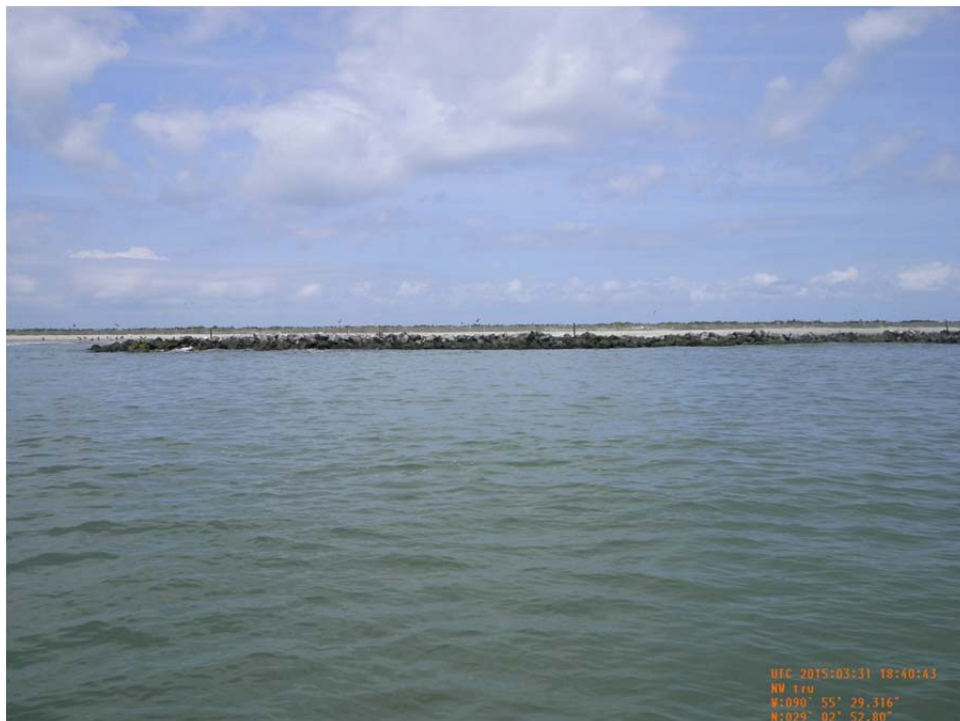
Photo 36: 1364 – View of segmented breakwater 6 looking north.

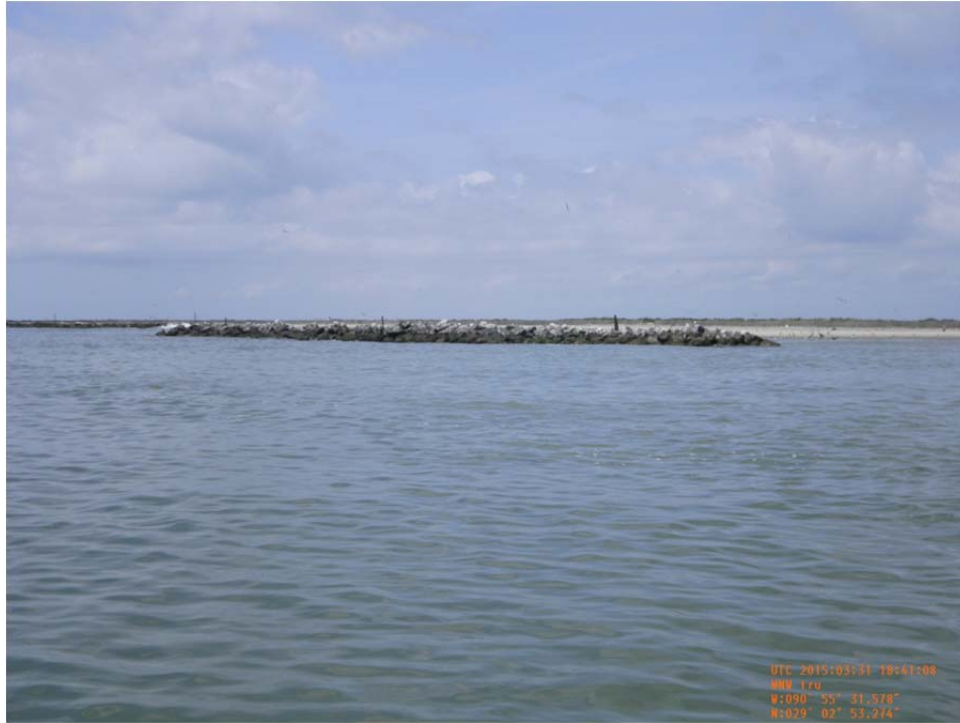
Photo 37: 1365 – View of segmented breakwater 7 looking northwest.

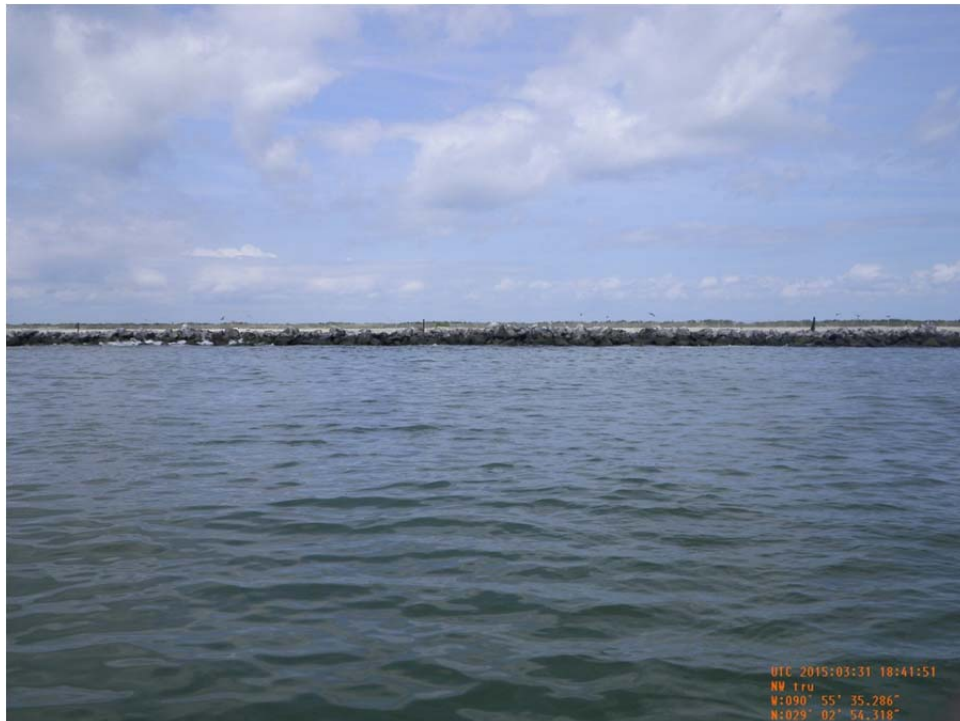
Photo 38: 1366 – View of segmented breakwater 7 looking north.

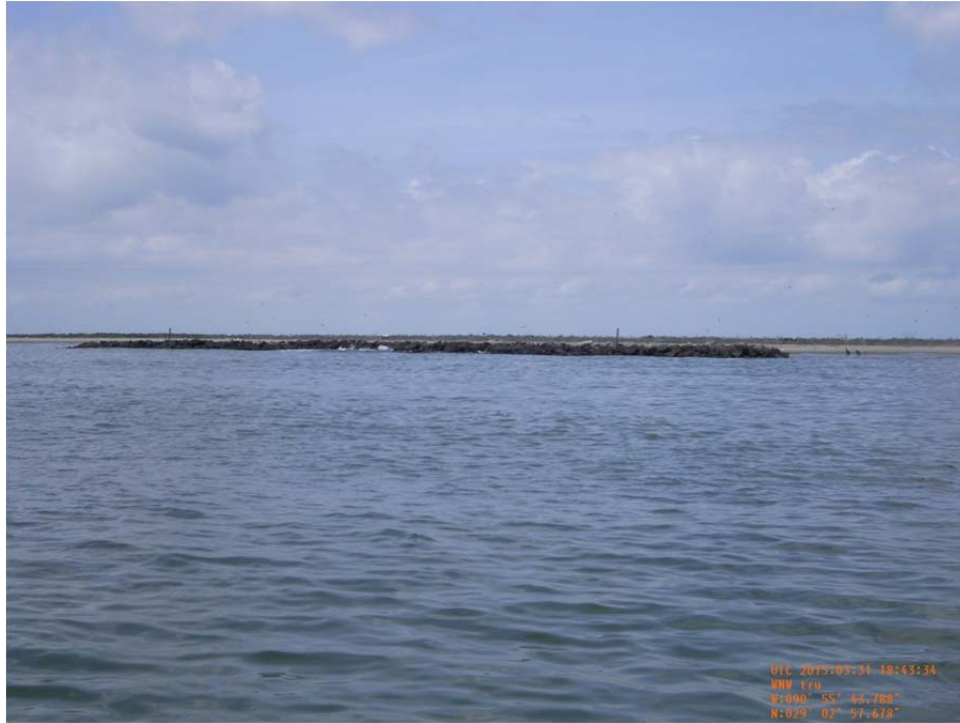
This project consists of eight (8) additional breakwaters (8 through 15), eastern groin, marsh creation and a protected containment dike on the north side of the island. The breakwaters appear to be in fair condition with no major settlement problems or rock displacement. While we are planning for a significant rock lift on the demonstration features, we will cap the low areas identified on breakwaters 8 through 15. Below are settlement averages of the breakwaters recorded during the 2015 survey.

Photo 39: 1367 – View of segmented breakwater 8 looking north.

Based on the settlement observed since construction, we are recommending that the rock breakwaters (8 through 15) be recapped at the same time at breakwaters 0 through 7, and the eastern groin. We estimated that a total of 7,771 tons of riprap will be required to raise the crest of the breakwaters to its design elevation.

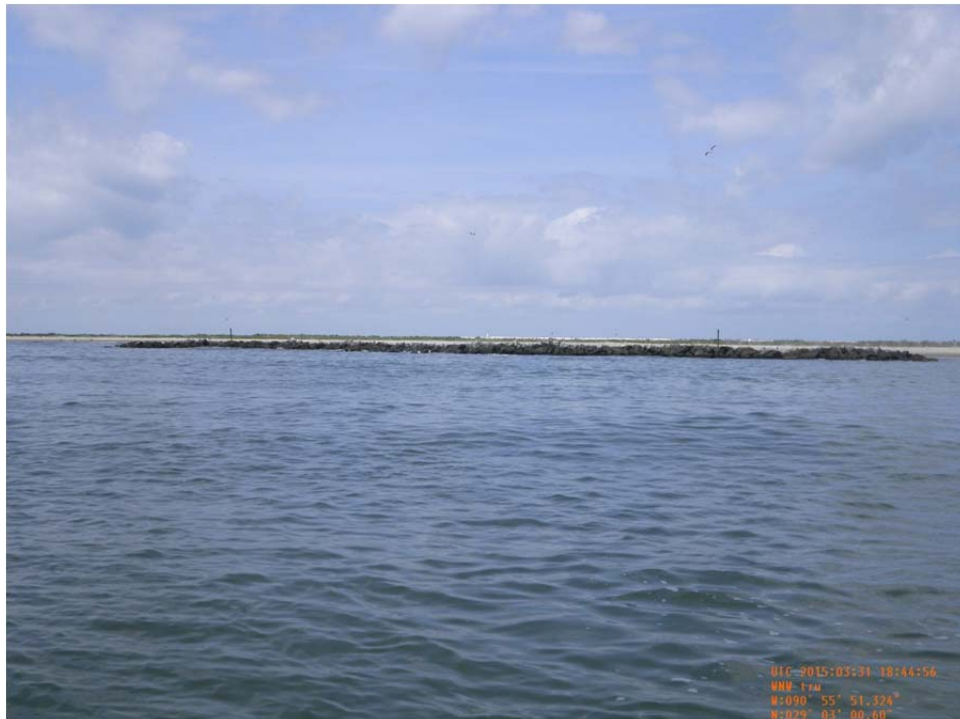
Photo 40: 1368 – View of segmented breakwater 10 looking northwest.
