2016 Annual Inspection Report

**Raccoon Island Shoreline Protection/
Marsh Creation Project**

State Project Number TE-48

**Raccoon Island Breakwater
Demonstration Project**

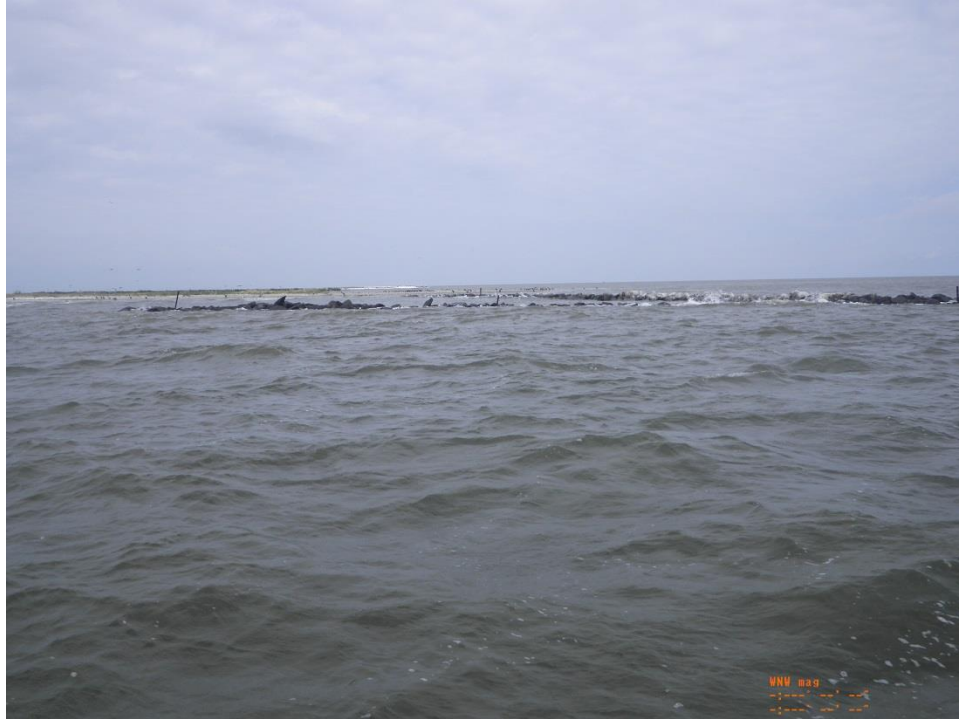
Photo 1 (0003) – View of segmented breakwater 0 and the eastern groin from breakwater to island

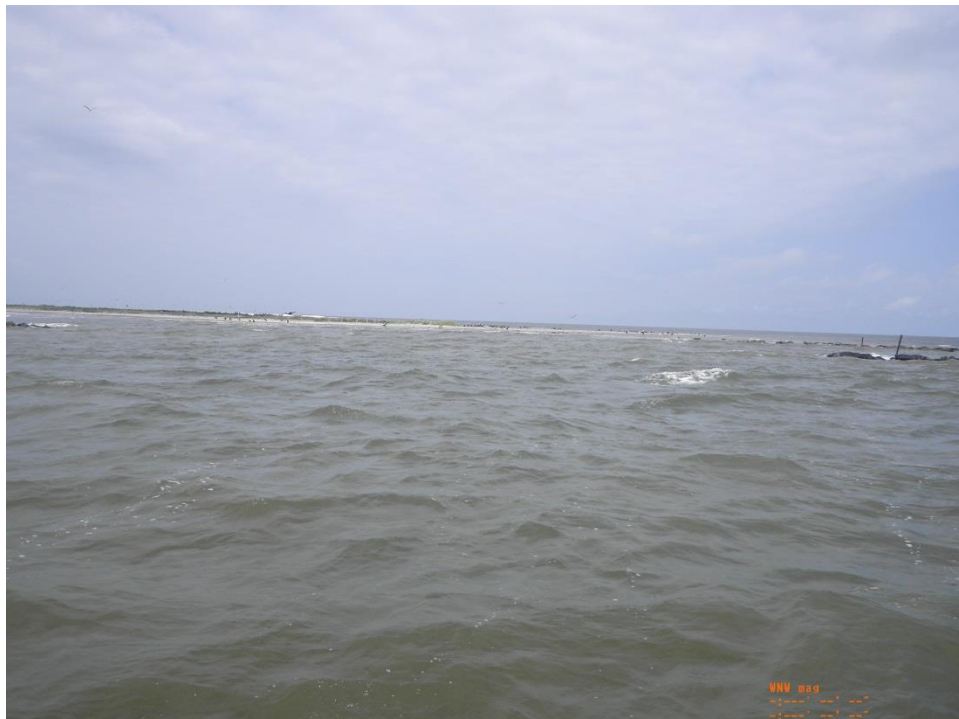
Photo 2 (0005) – View of segmented breakwater 0 and eastern groin looking north

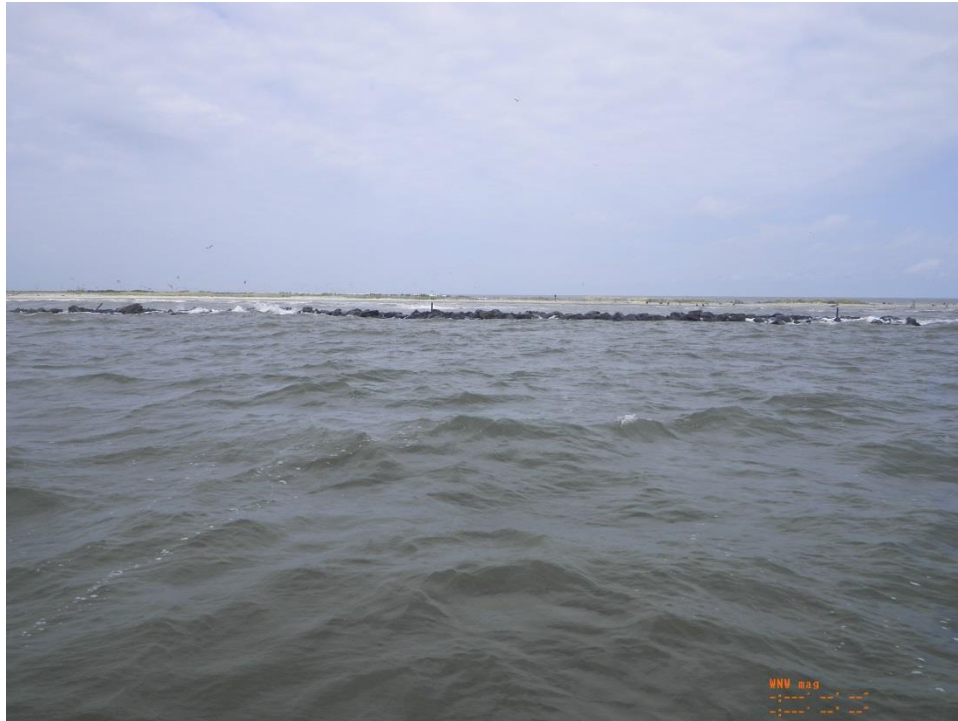
Photo 3 (0008) – View of segmented breakwater 1 west

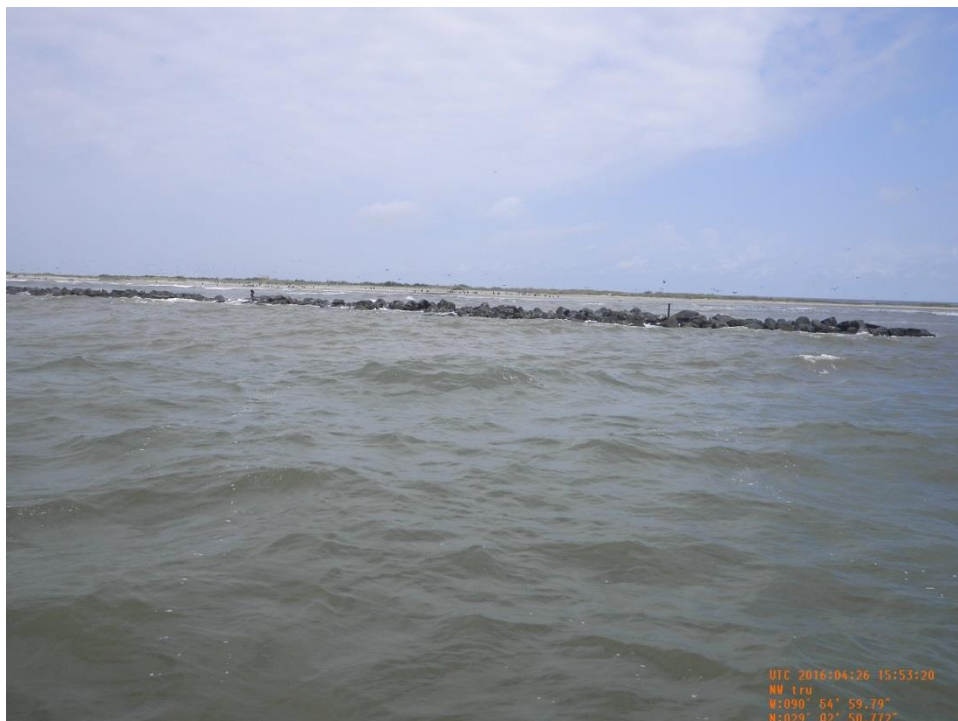
Photo 4 (0014) – View of segmented breakwater 2 north

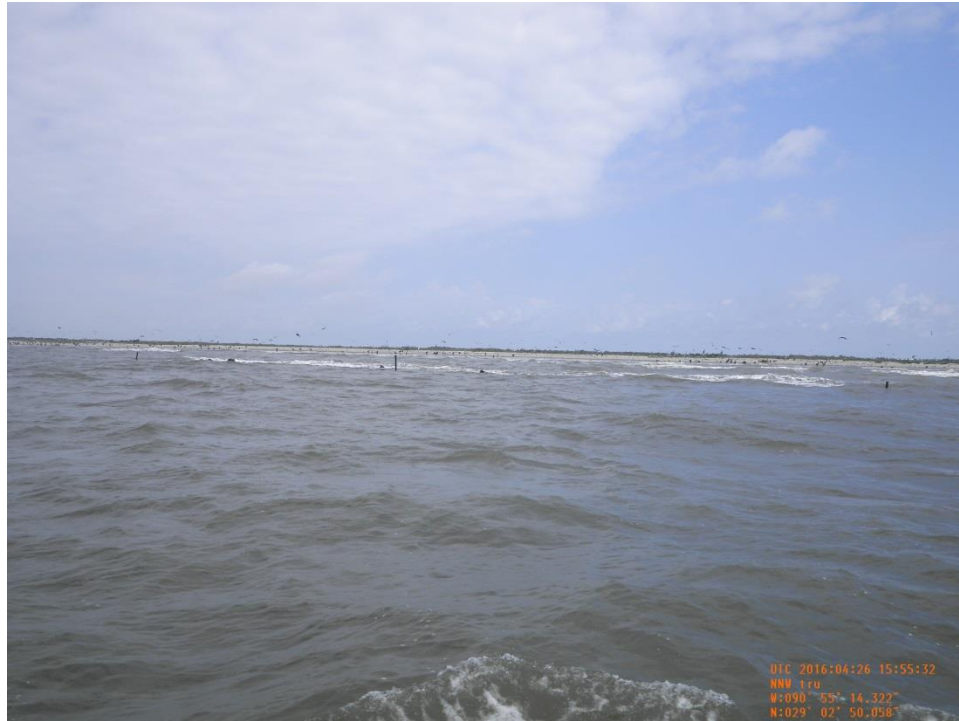
Photo 5 (0020) – View of segmented breakwater 4 north

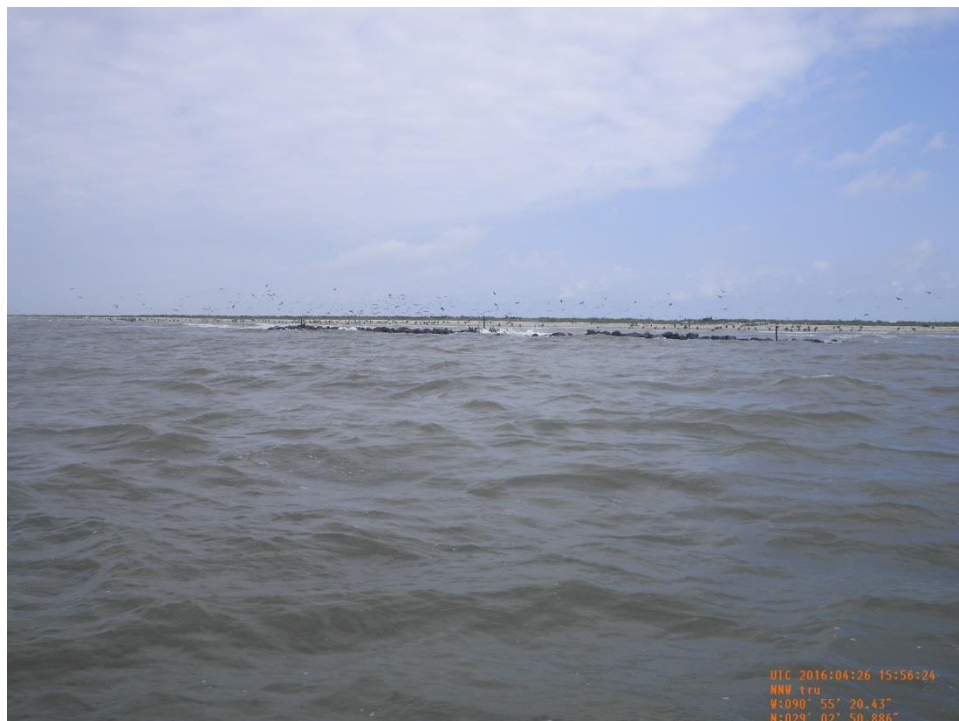
Photo 7 (0023) – View of segmented breakwater 5 looking north

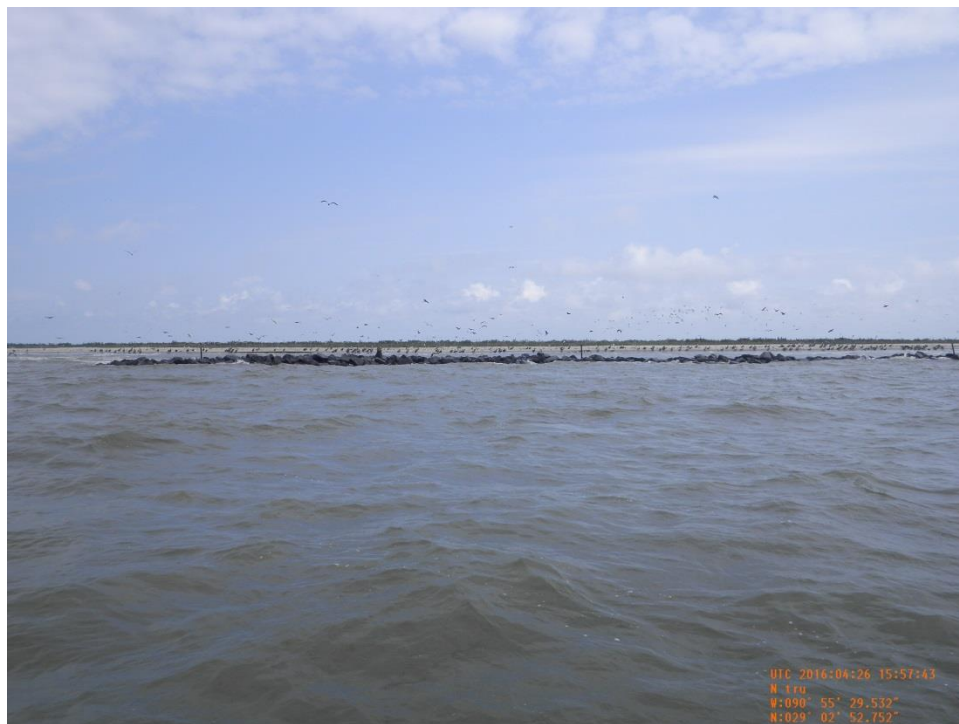
Photo 8 (0031) – View of segmented breakwater 6 looking north

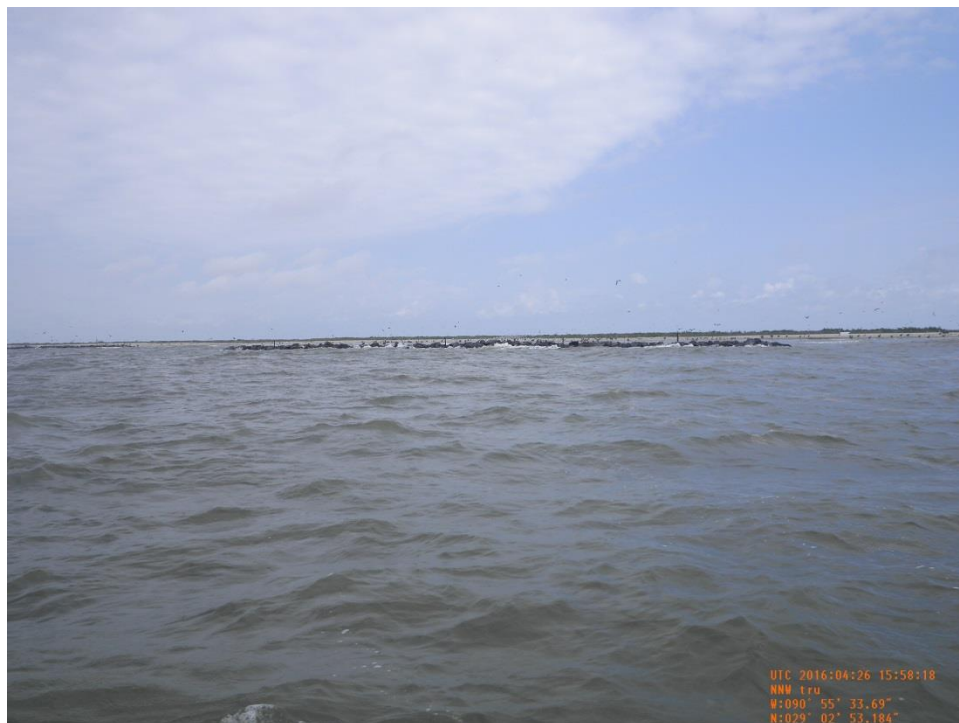
Photo 9 (0034) – View of segmented breakwater 7 looking north

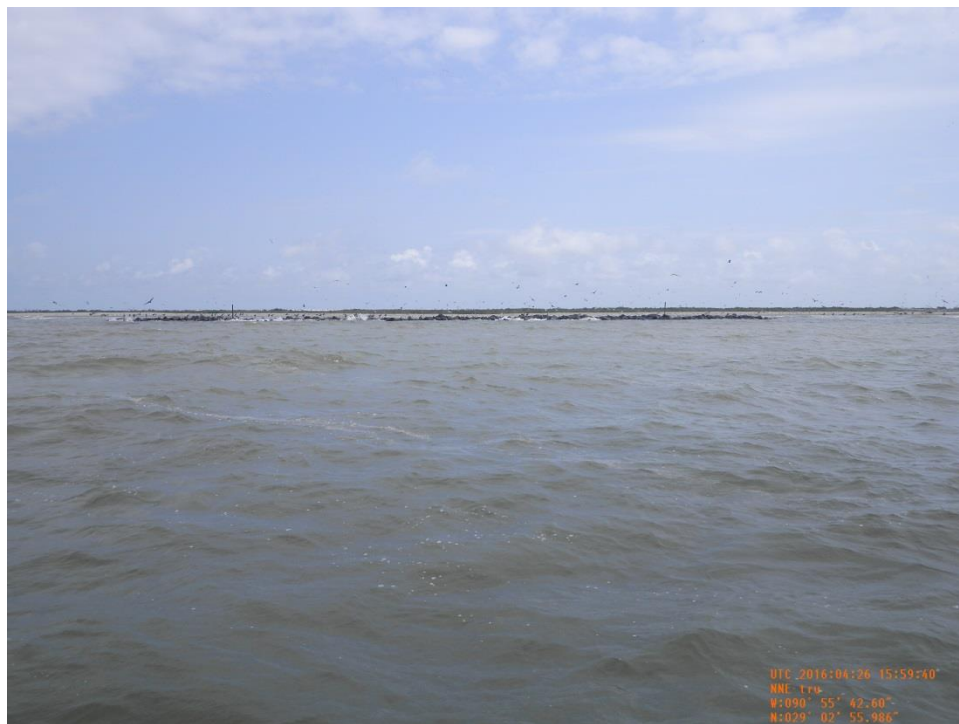
Photo 10 (0038) – View of segmented breakwater 8 looking north east

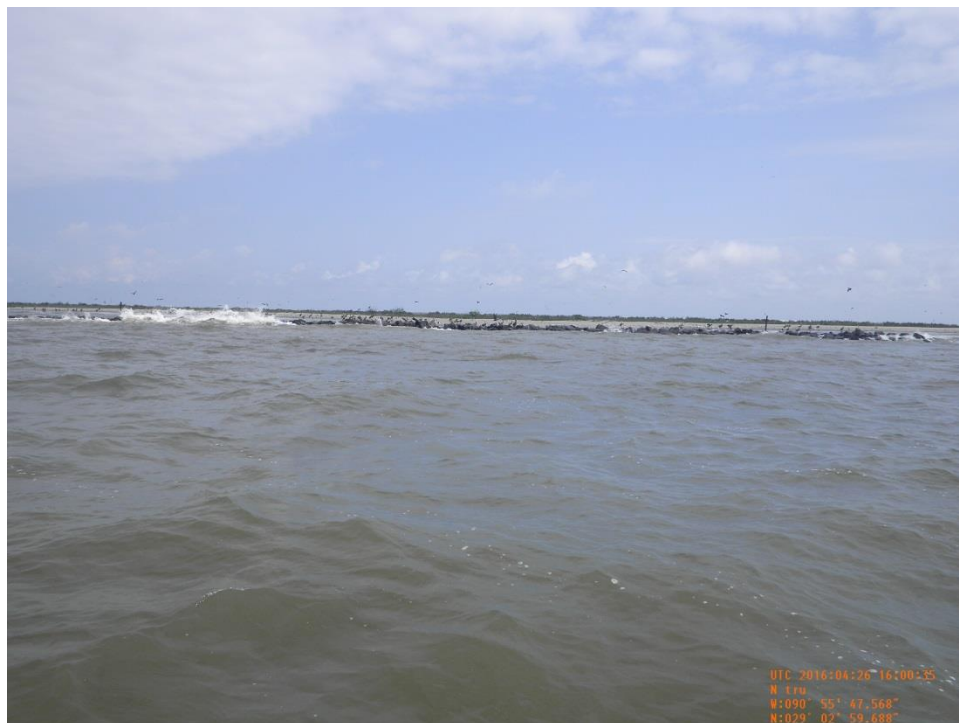
Photo 11 (0043) – View of segmented breakwater 9 looking north

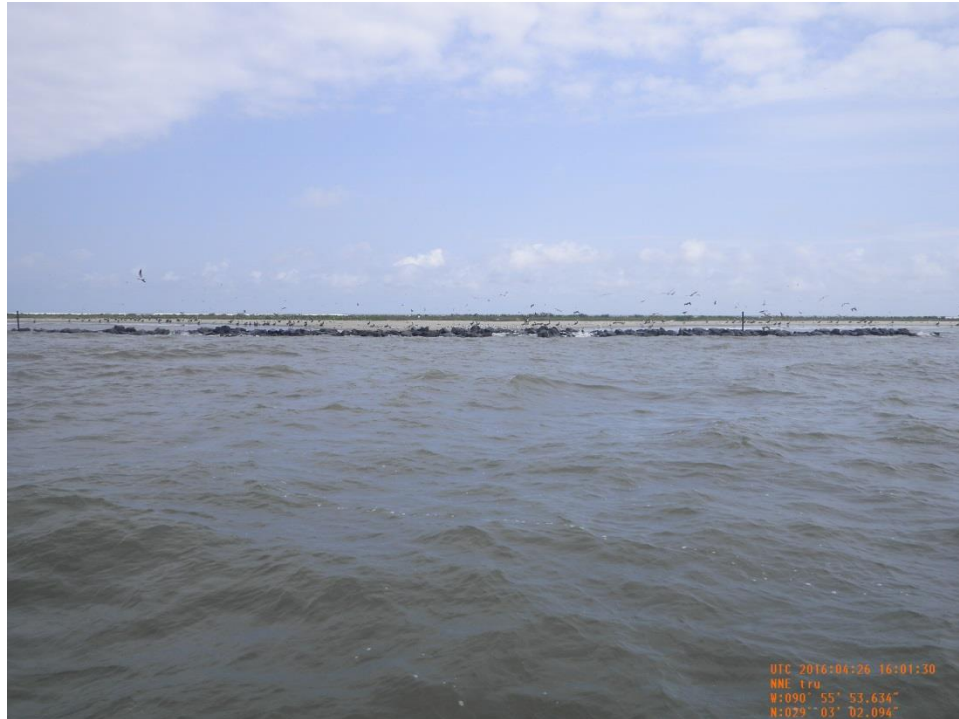
Photo 12 (0047) – View of segmented breakwater 10 looking north

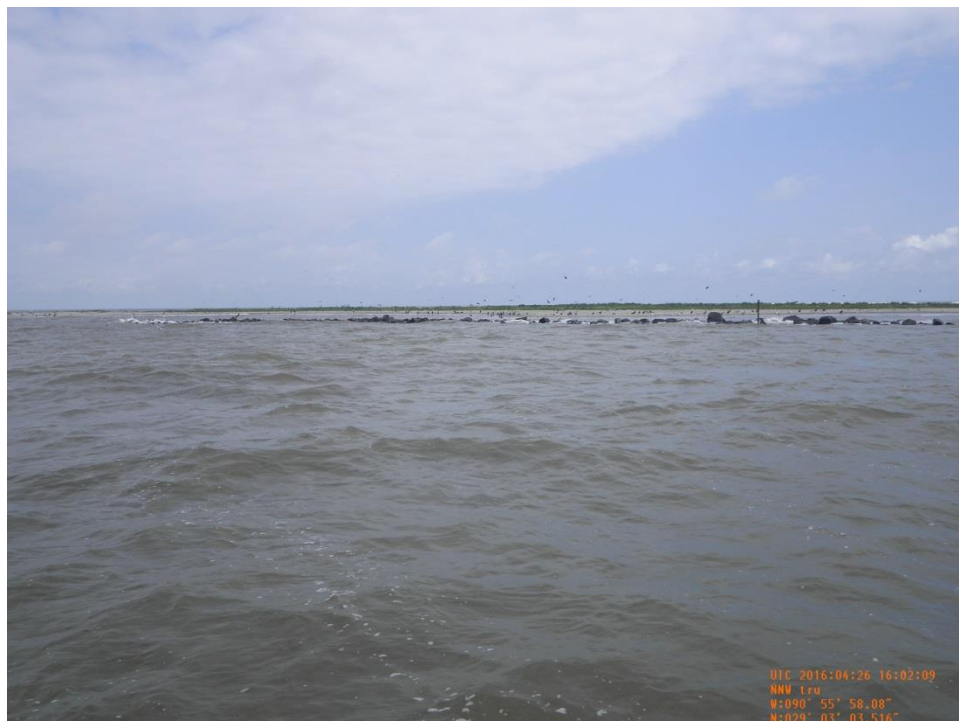
Photo 13 (0050) – View of segmented breakwater 11 looking north

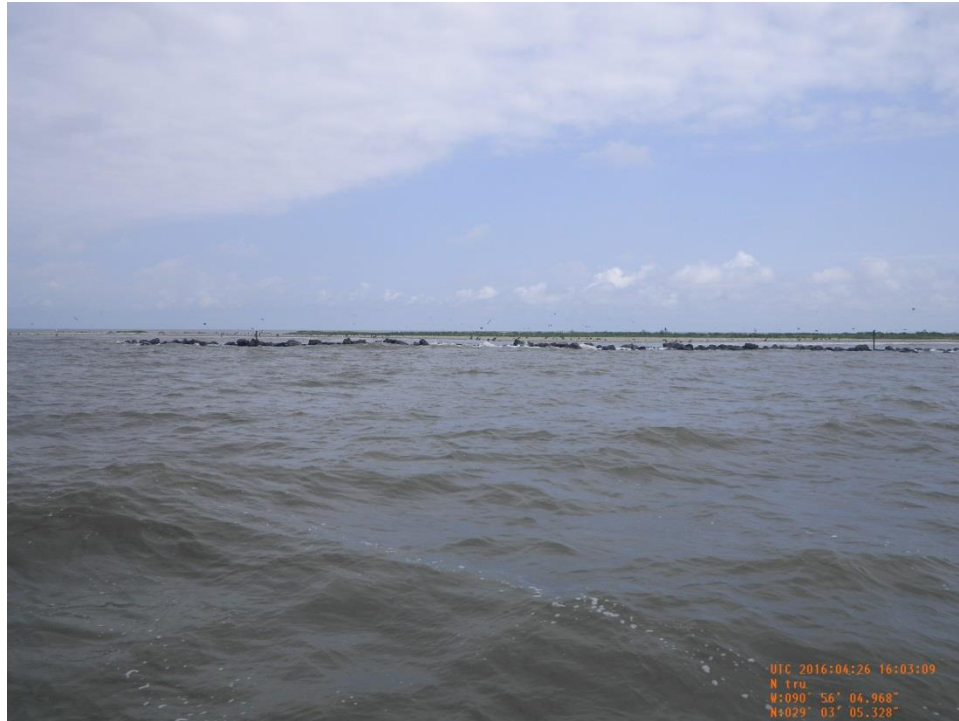
Photo 14 (0055) – View of segmented breakwater 12 looking north

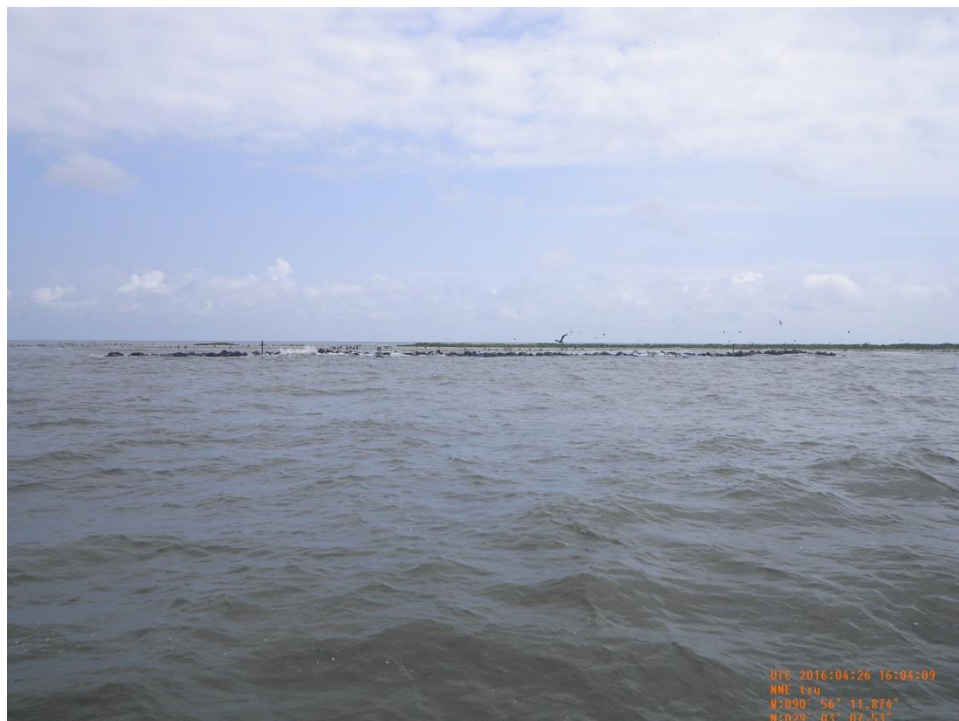
Photo 15 (0060) – View of segmented breakwater 13 looking north

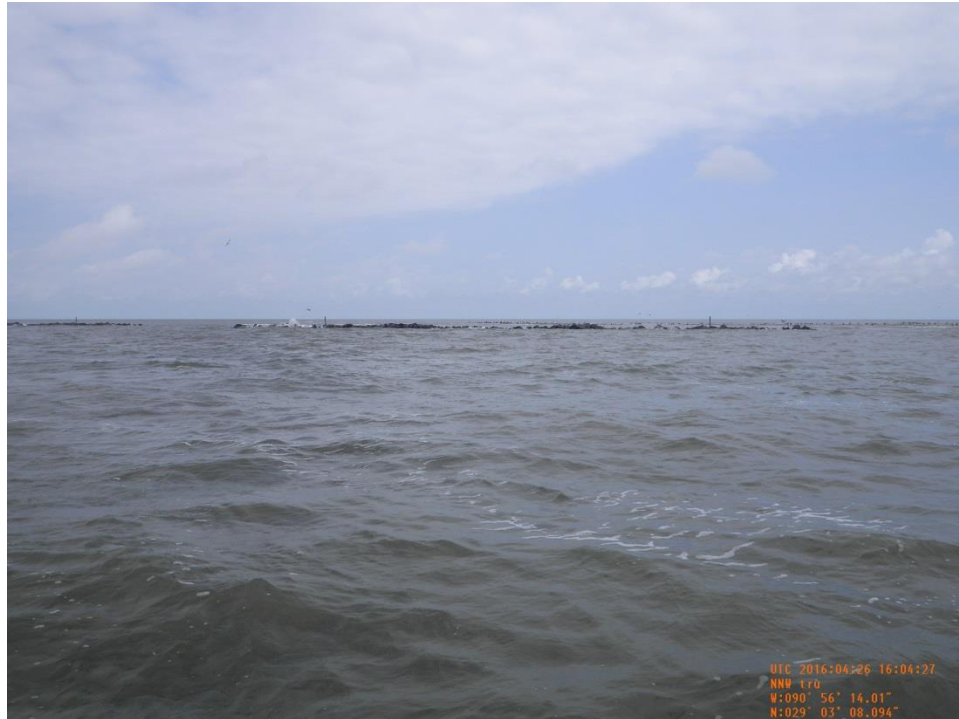
Photo 16 (0063) – View of segmented breakwater 14 looking north

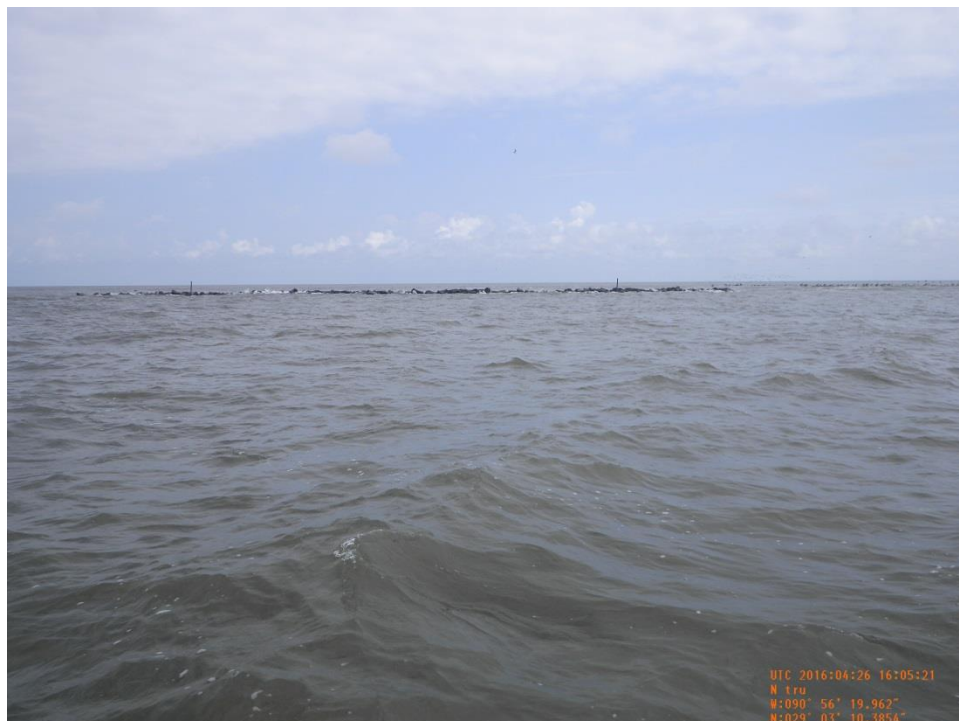
Photo 17 (0067) – View of segmented breakwater 15 looking north.

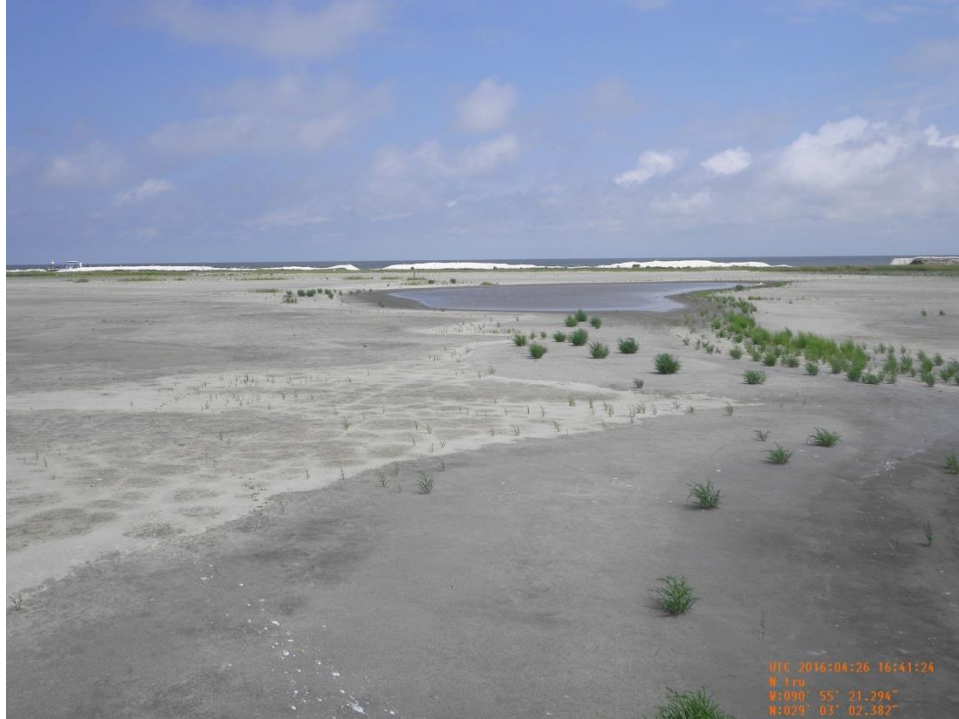
Photo 26 (0145) – View of marsh fill area and failures along containment dike at Sta. 10+00 looking north

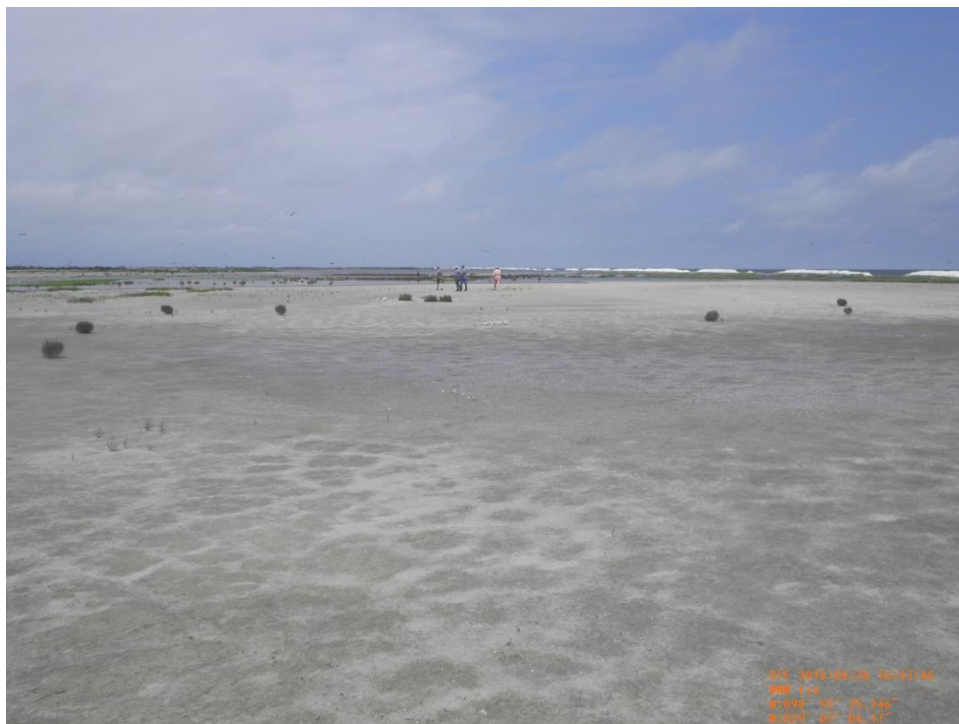
Photo 27 (0152) – View of marsh fill area and failures along containment dike at Sta. 13+00 looking north west

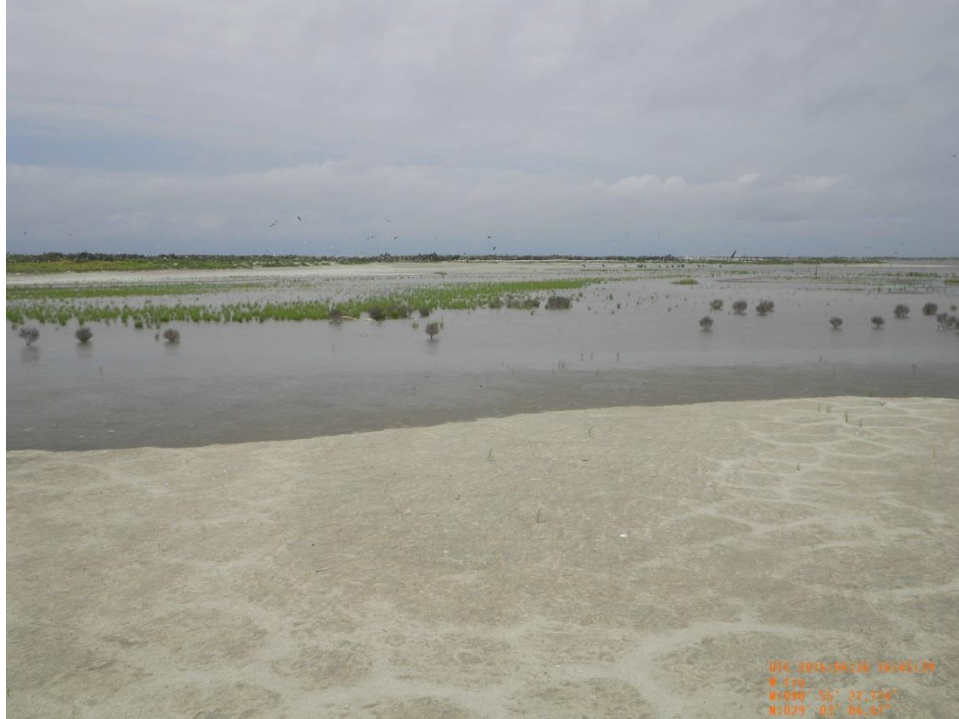
Photo 28 (0160) – View of marsh fill area and failures along containment dike at Sta. 16+00 looking west

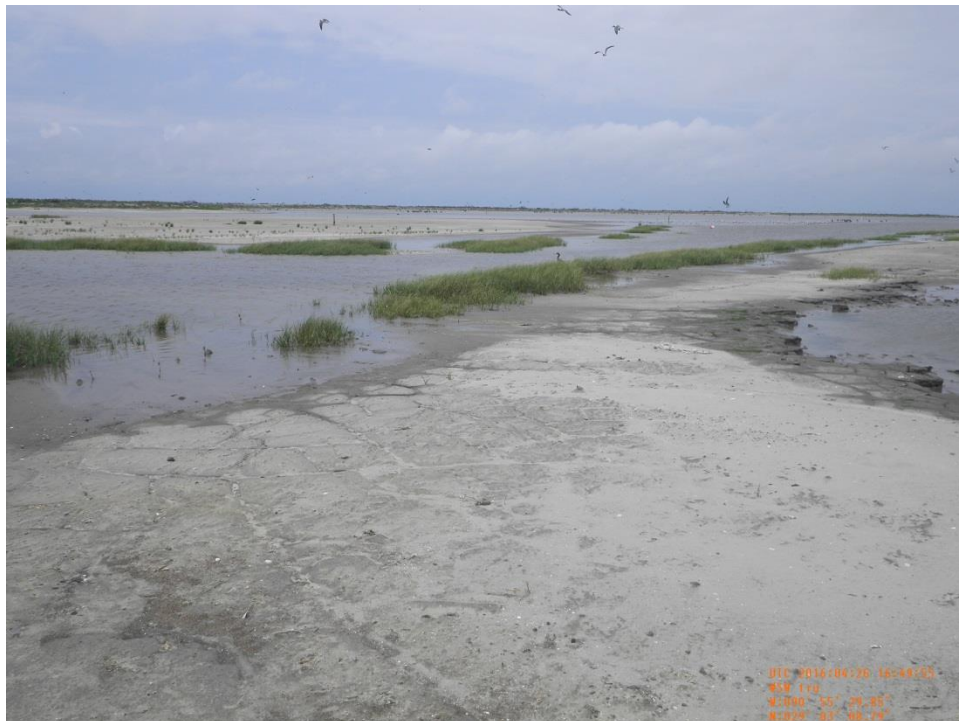
Photo 29 (0165) – View of marsh fill area and failures along containment dike at Sta. 19+00 looking west south west

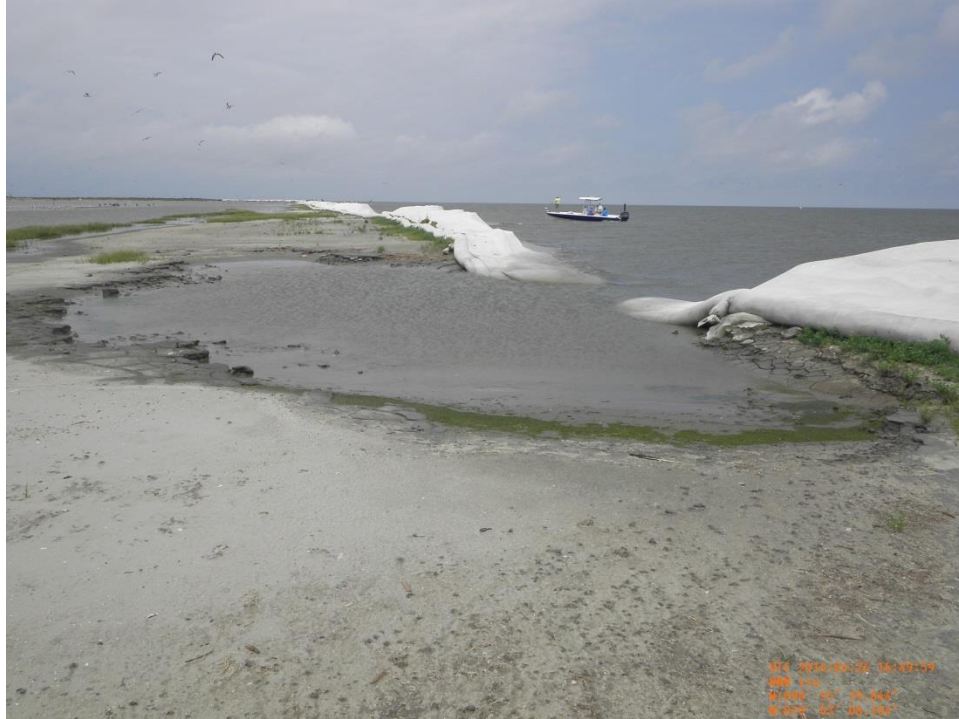
Photo 30 (0166) Breach through geotextile fabric near Sta. 20+00

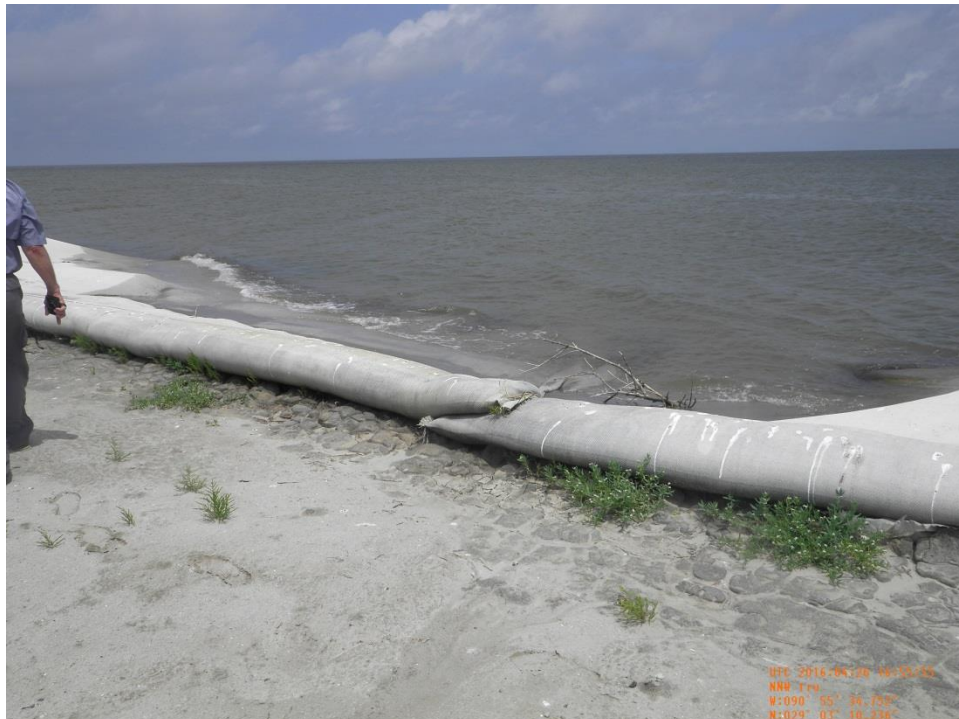
Photo 31 (0173) – View of geotextile fabric tear near Sta. 23+00 and erosion of containment.

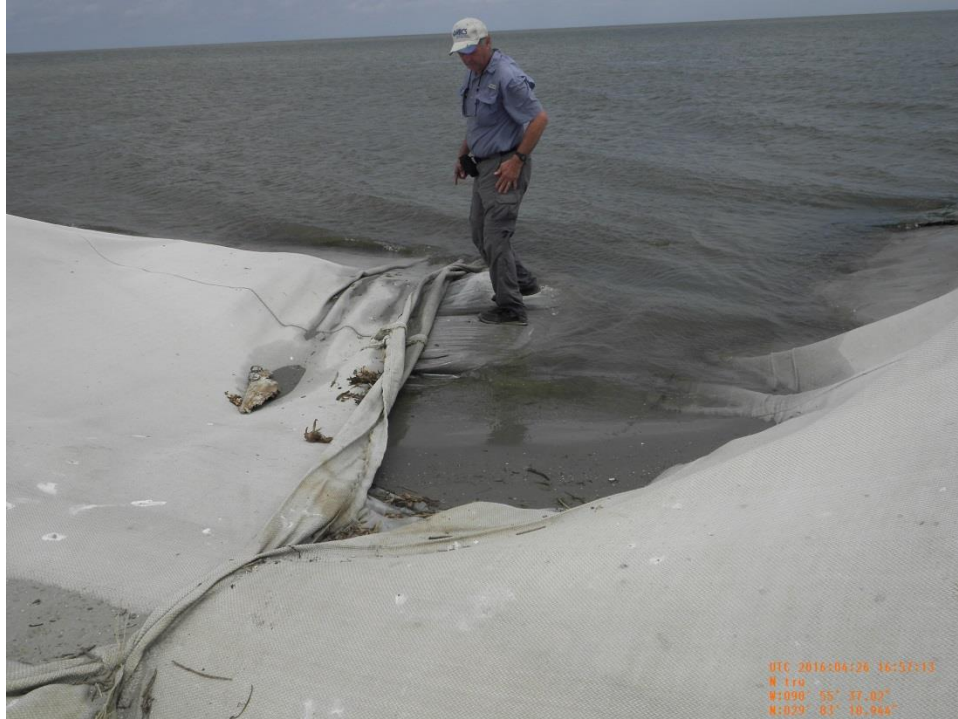
Photo 32 (0177) – View of a new tear in geotextile fabric and erosion near Sta. 25+00.

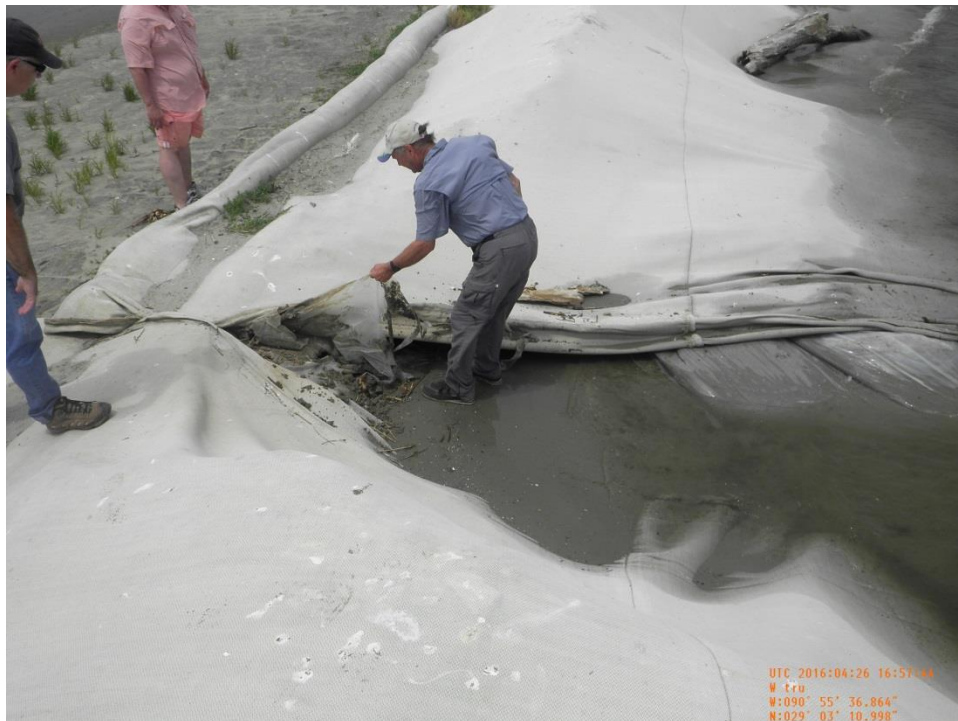
Photo 33 (0180) – View of a new tear in geotextile fabric and erosion near Sta. 25+00

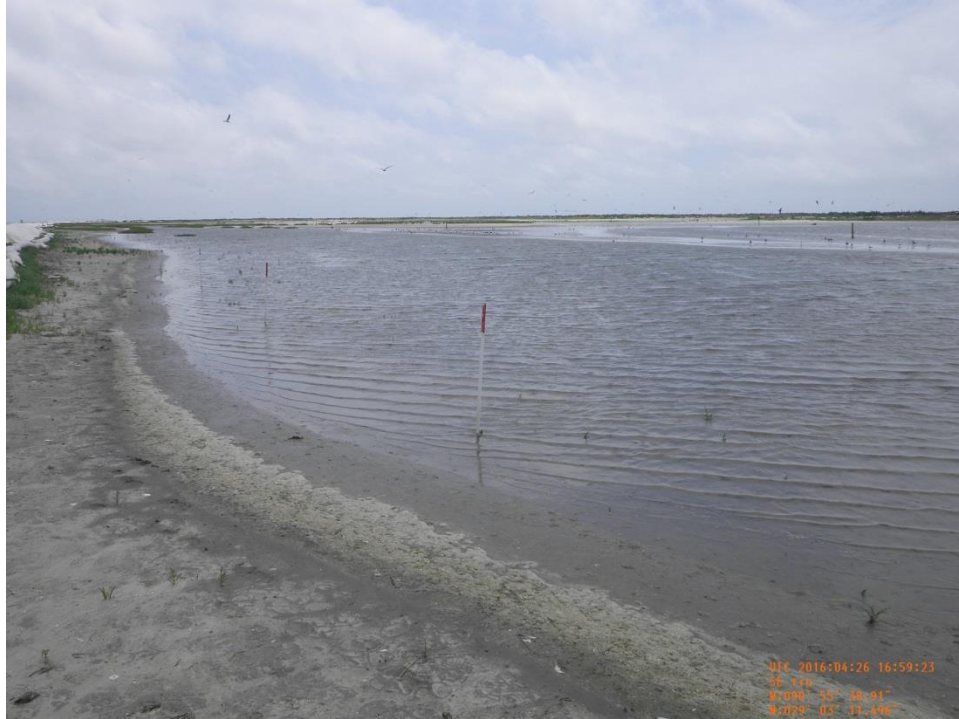
Photo 34 (0184) View of marsh fill area and failures along containment dike at Sta. 27+00 looking south east

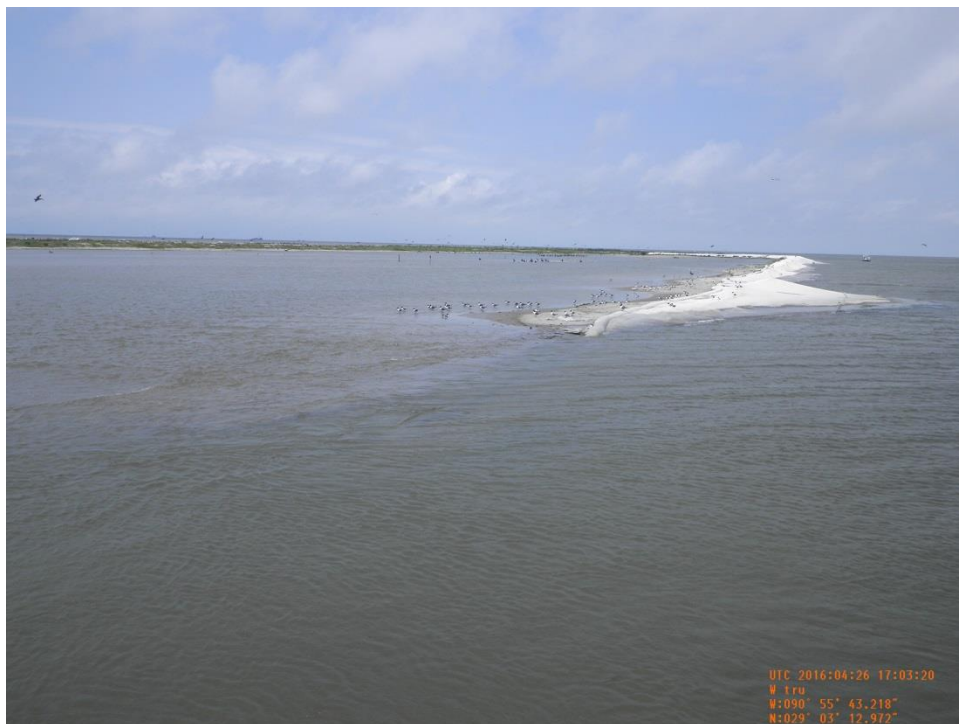
Photo 35 (0198) View of marsh fill area and large breach near Sta. 31+00 looking west

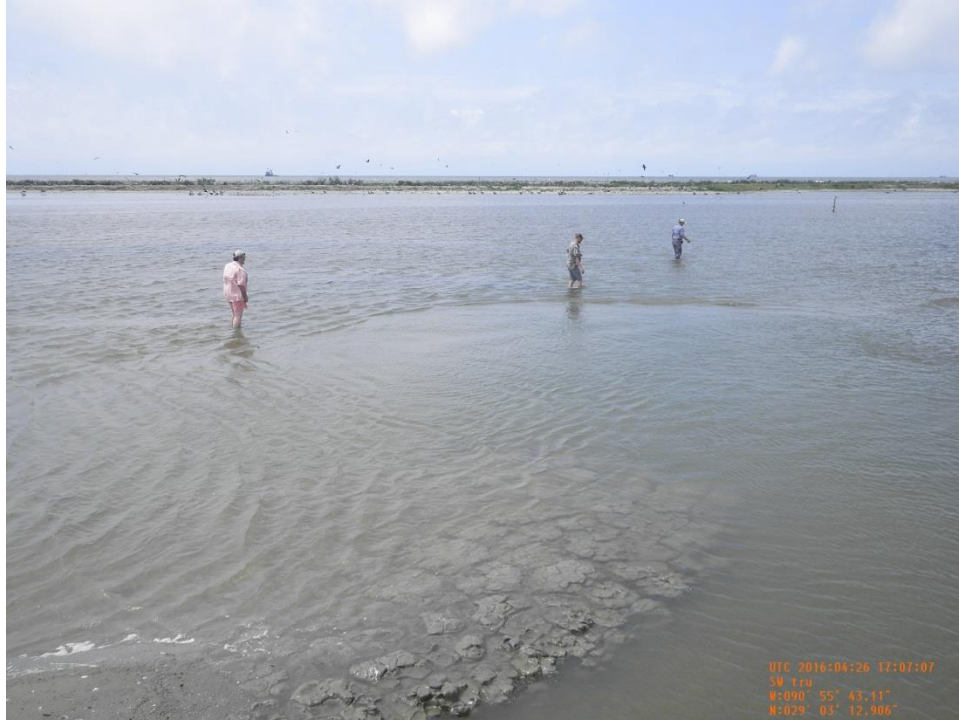
Photo 36 (0206) View of marsh fill area and large breach near Sta. 31+00 looking south west
