**State of Louisiana
Coastal Protection and Restoration
Authority**

2014 Annual Inspection Report

**WEST BELLE PASS BARRIER
HEADLAND RESTORATION
PROJECT (TE-52)**

June 4, 2014
Terrebonne Parish

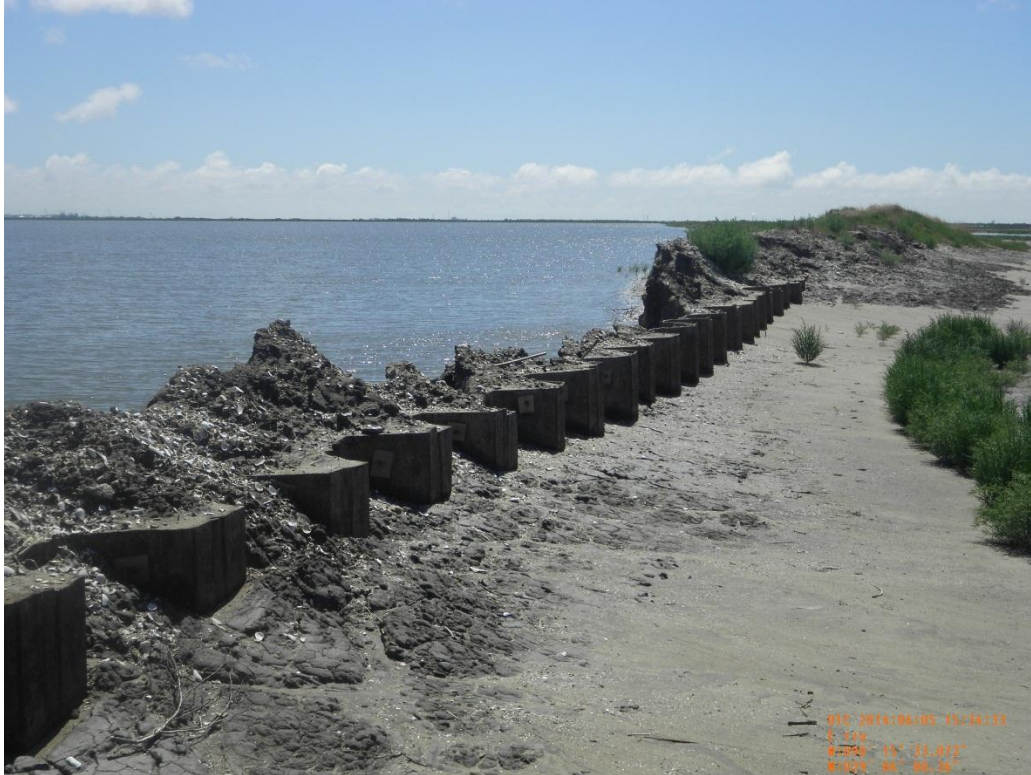
Photo 1: View of sheetpile plug in northern containment dike

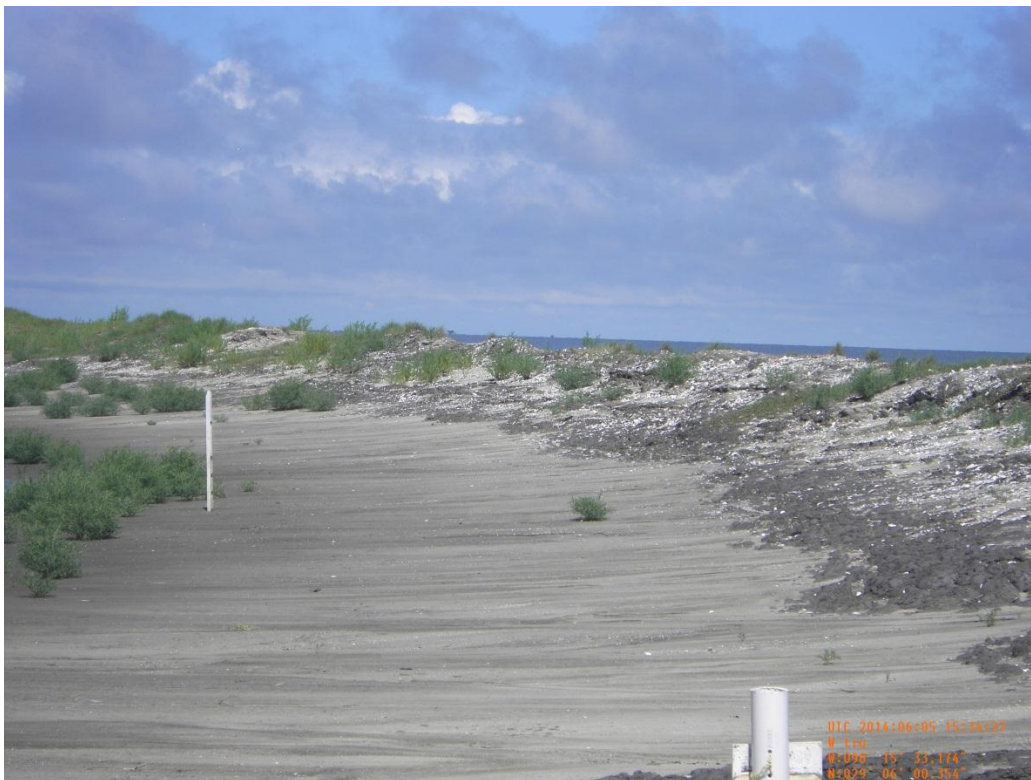
Photo 2: View of northern containment dike, looking west

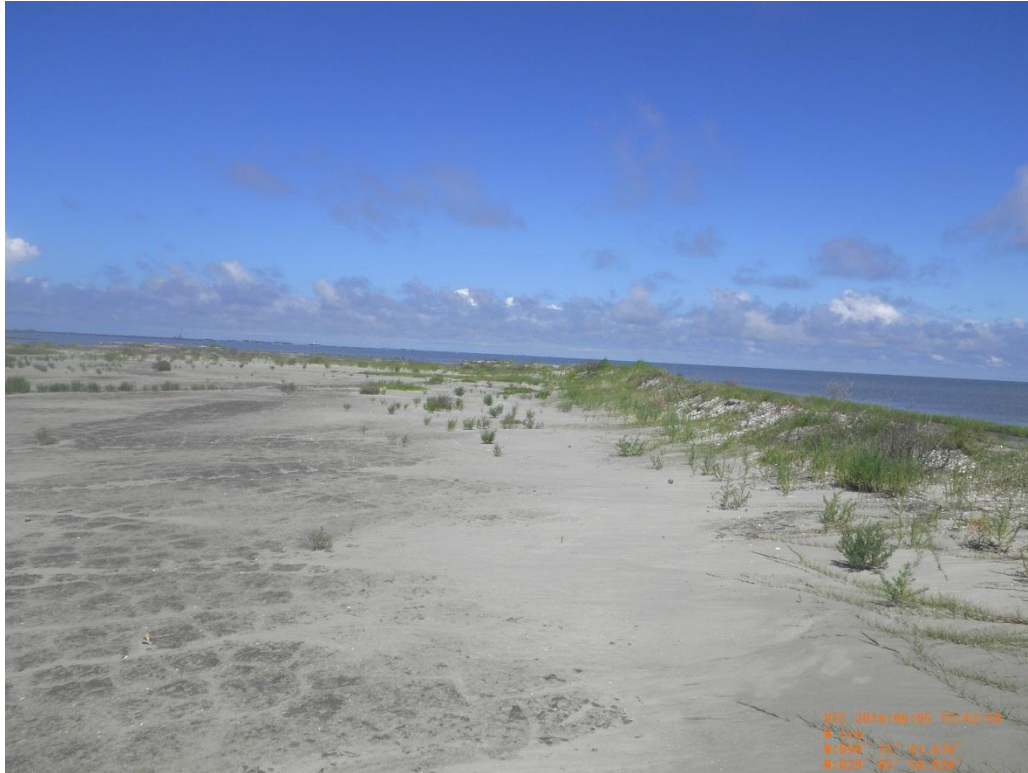
Photo 3: View of marsh fill and containment dike in northwest corner of fill area

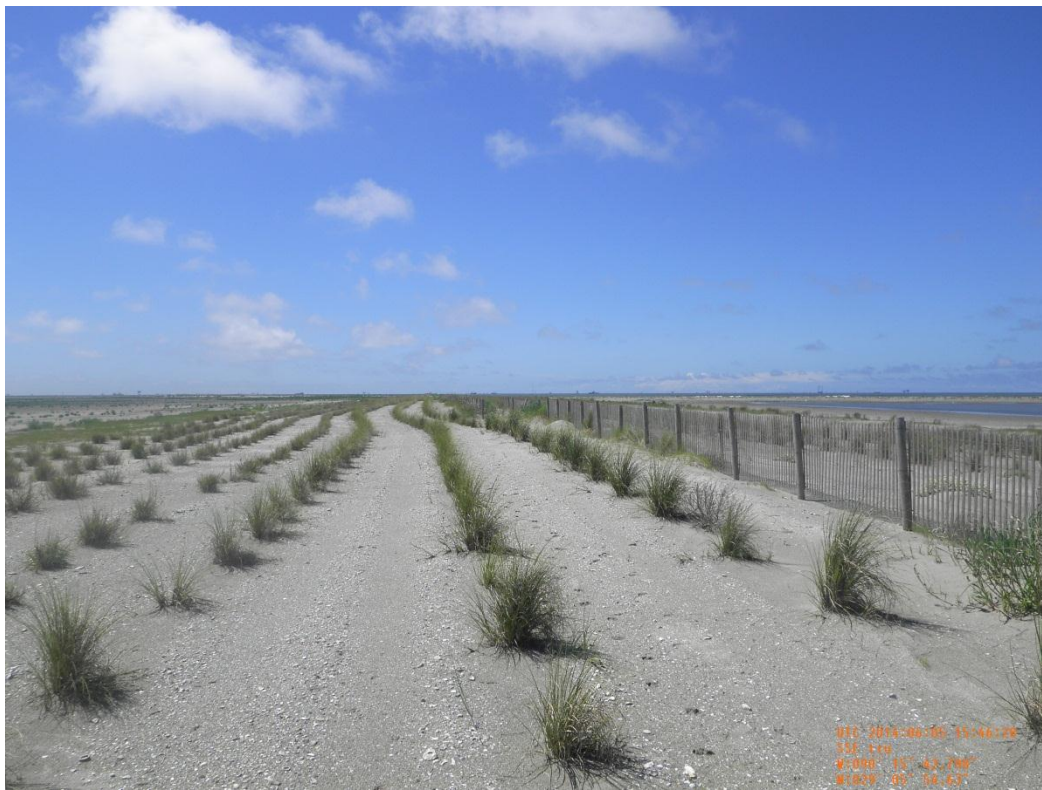
Photo 4: View of vegetative plantings and sand fence on western dune, looking southeast

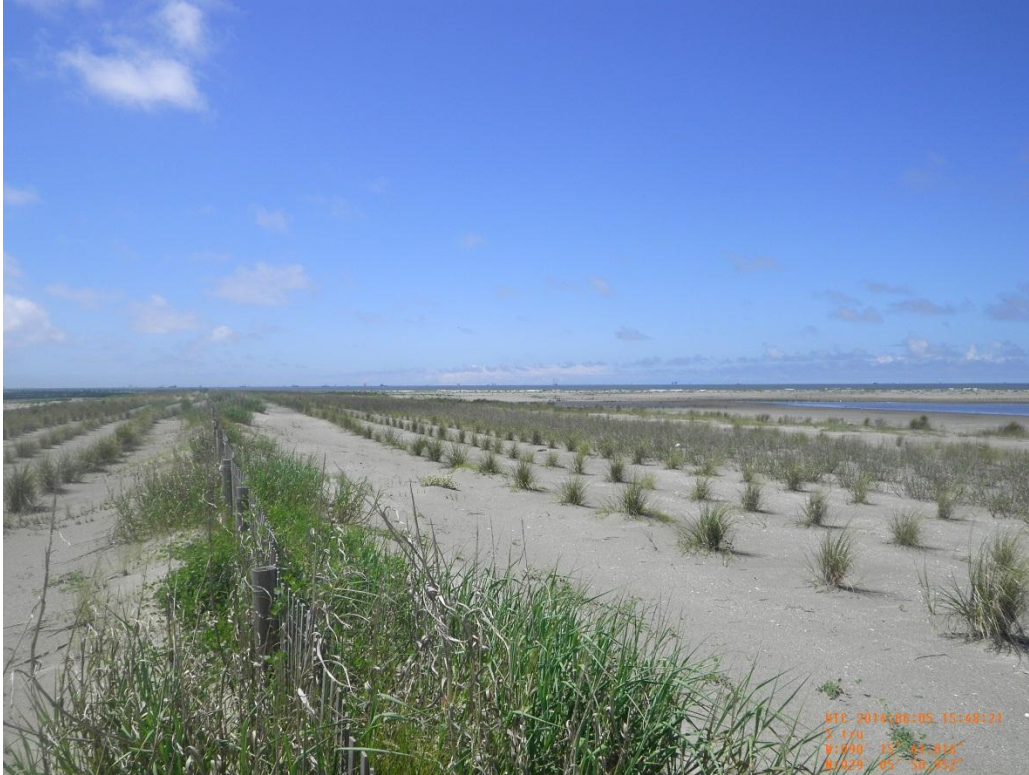
Photo 4: View of vegetative plantings and sand fence on western dune, looking south

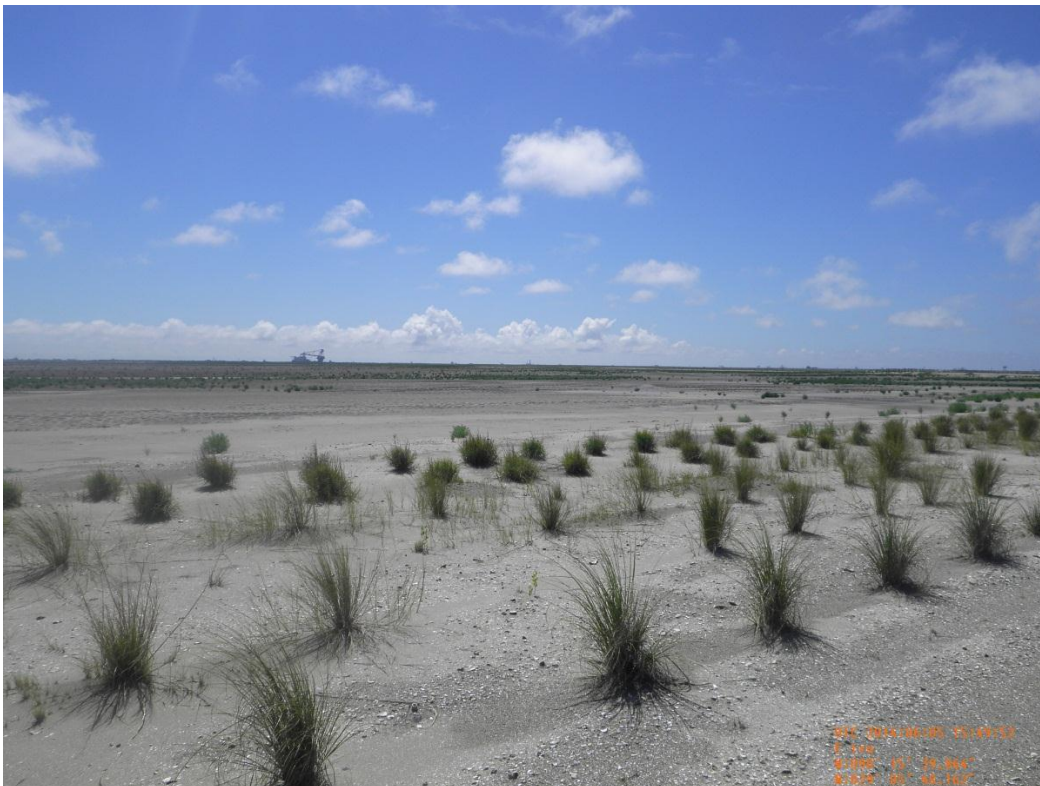
Photo 6: View of vegetative plantings and marsh fill area, looking east

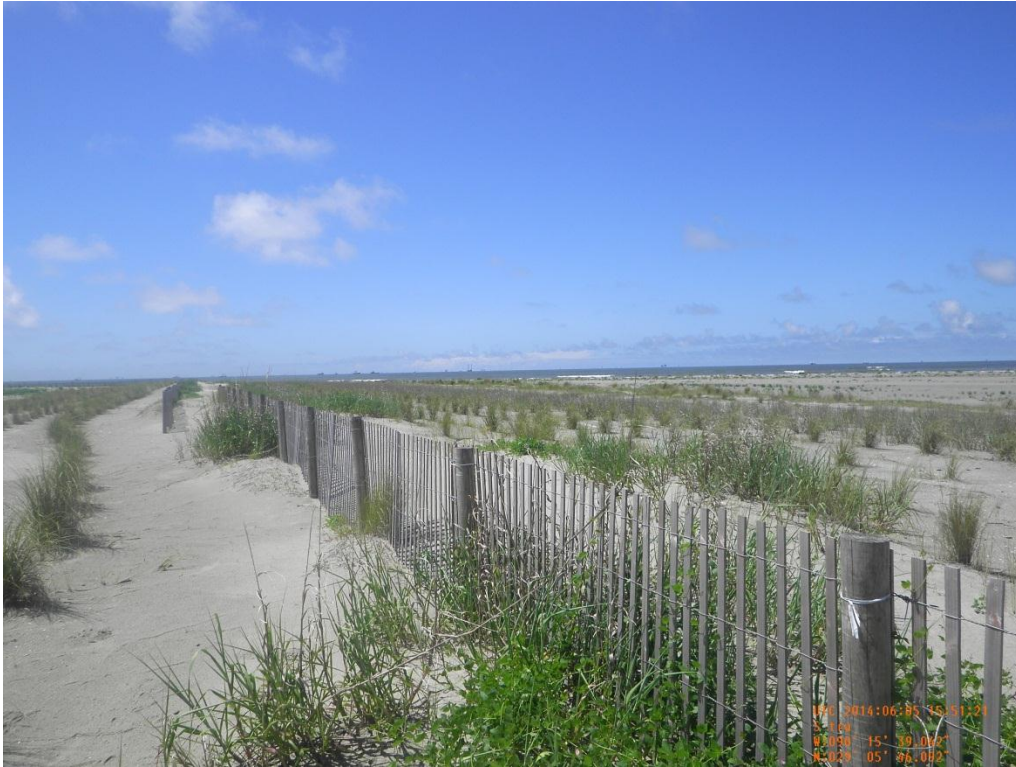
Overall, the beach fill appears to be in good condition. The beach profile is making changes to adapt to the environmental conditions, as expected. A scarp of the beach dune has formed near Sta. 105 and progressively worsens towards Belle Pass. A large sand spit has formed to the west of the beach template and extends towards East Timbalier Island. There are no signs of immediate breaching of the beach dune. There are no recommendations for maintenance at this time.

Photo 7: View of the western dune and sand fence with sand spit in background, looking south

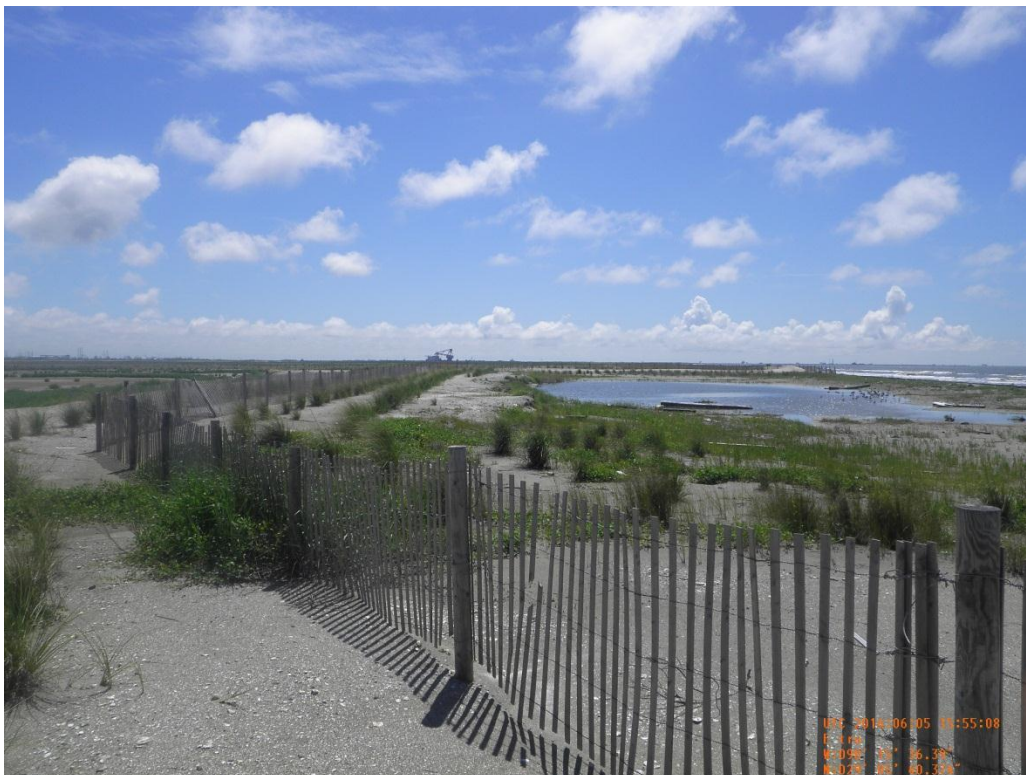
Photo 8: View of the relocated dune on western end of beach face, looking east.

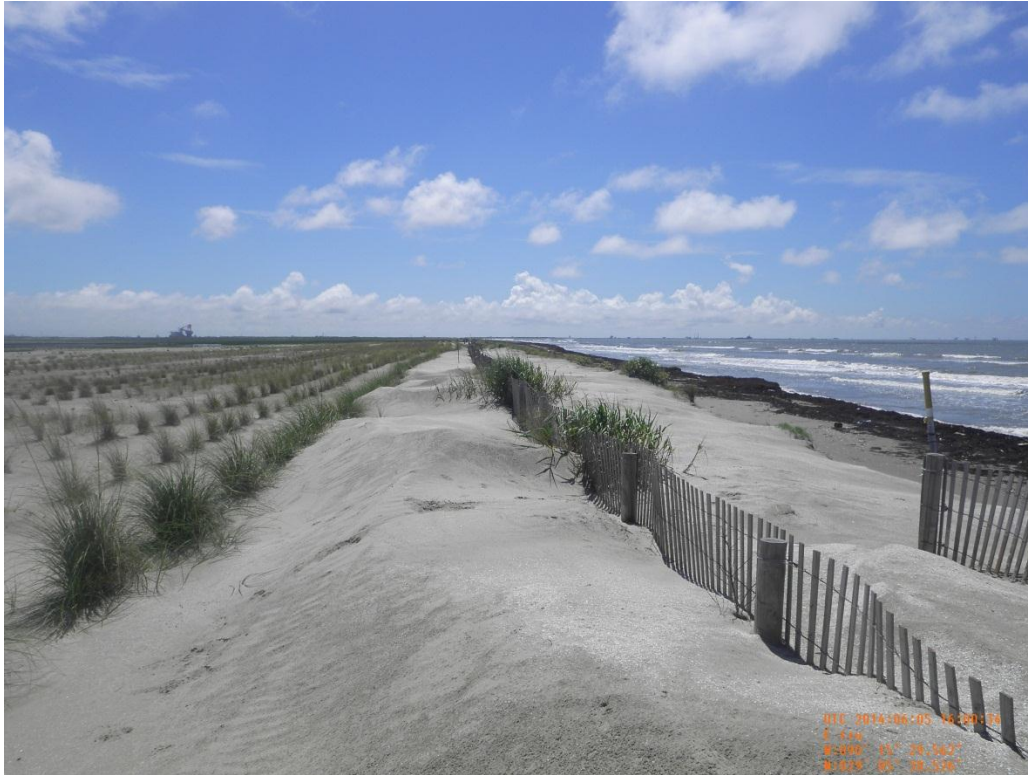
Photo 9: View of beach, dune, sand fencing and vegetative plantings, looking east

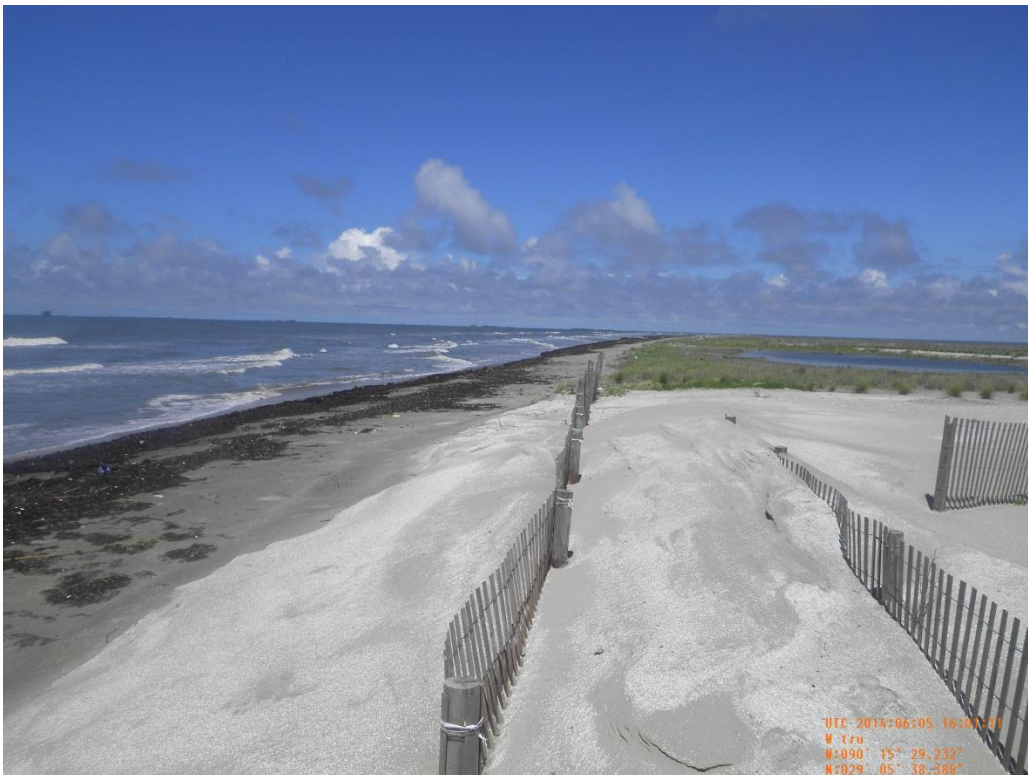
Photo 10: View of the western sand spit from southwest corner of fill, looking west

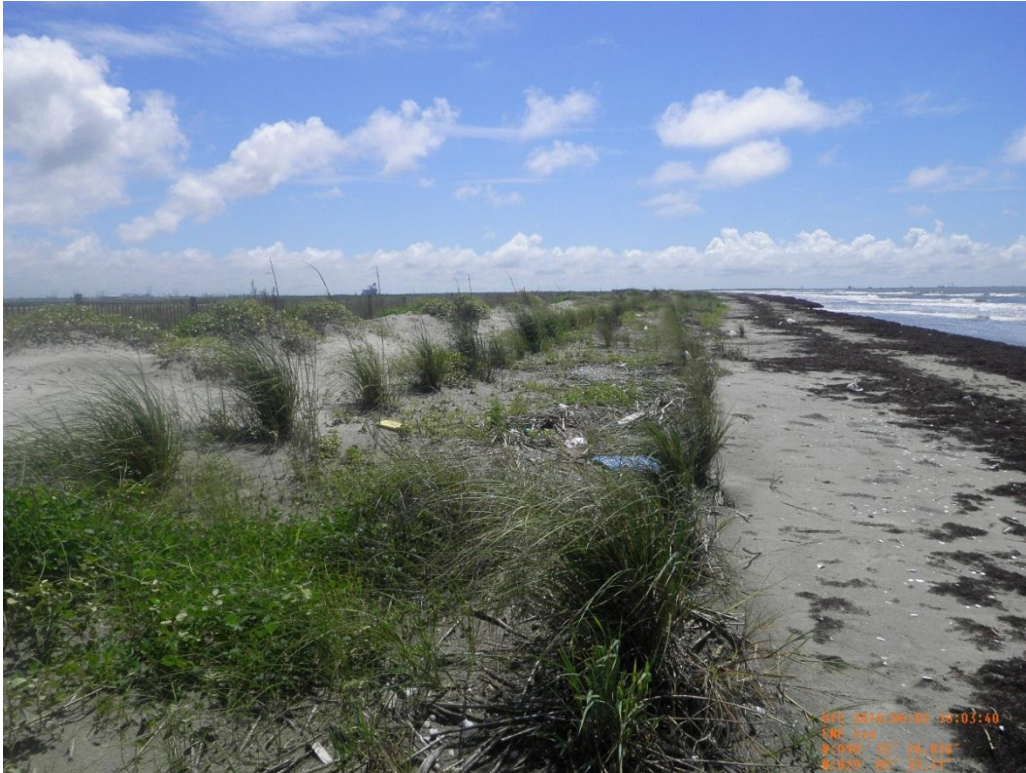
Photo 11: View of a beach, dune, and vegetative plantings, looking northeast

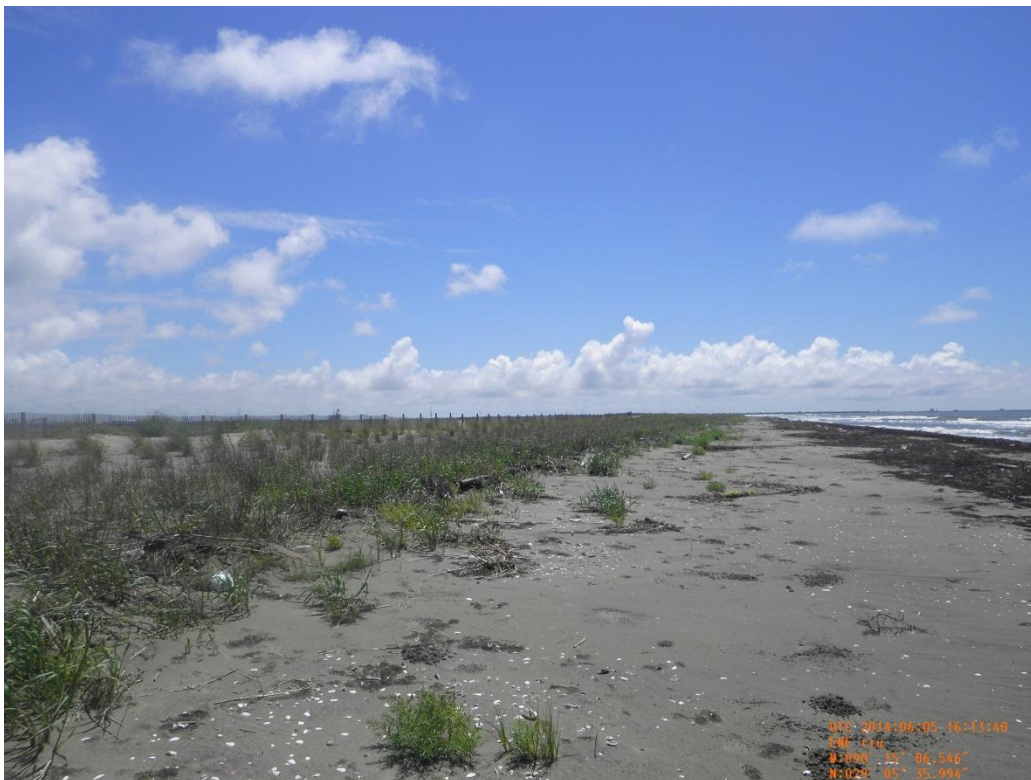
Photo 12: View of the beach and vegetative plantings, looking northeast

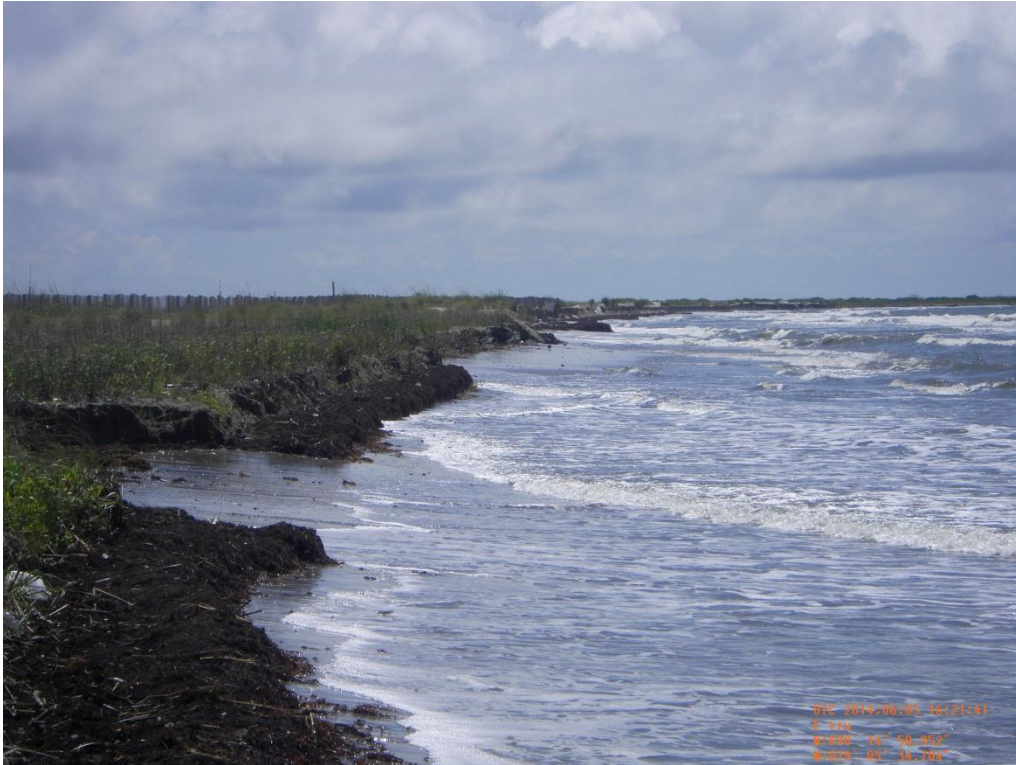
The beach fill and marsh fill appear to be functioning as designed. Some scarping of the beach dune has begun to occur on the eastern portion of the project as a result of erosional shadowing from the Belle Pass jetty. This scarping has caused extensive damage to the sand fencing that was placed along this stretch of dune. The sand fencing will need to be replaced in the future after the beach and dune has stabilized into its natural position. A large spit of sand has formed on the western end of the headland as a result of longshore sediment transport. The formation of this spit was expected and provides excellent habitat for shorebirds and other marine species. The marsh fill appears to be in good condition and is not experiencing any excessive settlement. The northern containment dike is beginning to breach, which will help to provide a hydrologic connection to the interior portions of the marsh. If this breach does not occur, measures should be taken to breach the dike in strategic locations in the future. This should be noted during future inspections. There are no recommendations of maintenance to the beach fill, marsh fill, or sand fencing at this time.

Photo 13: View of the western extent of the beach scarp that has formed, looking east.

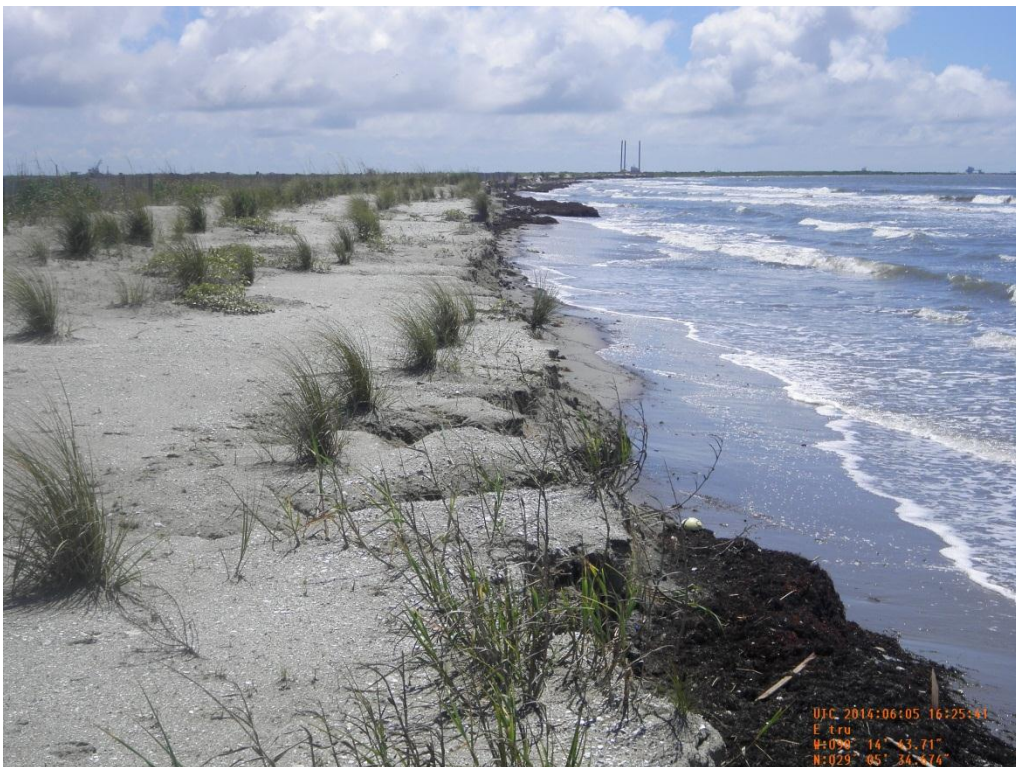
Photo 14: View of beach/dune scarp destroying vegetative planting, looking east

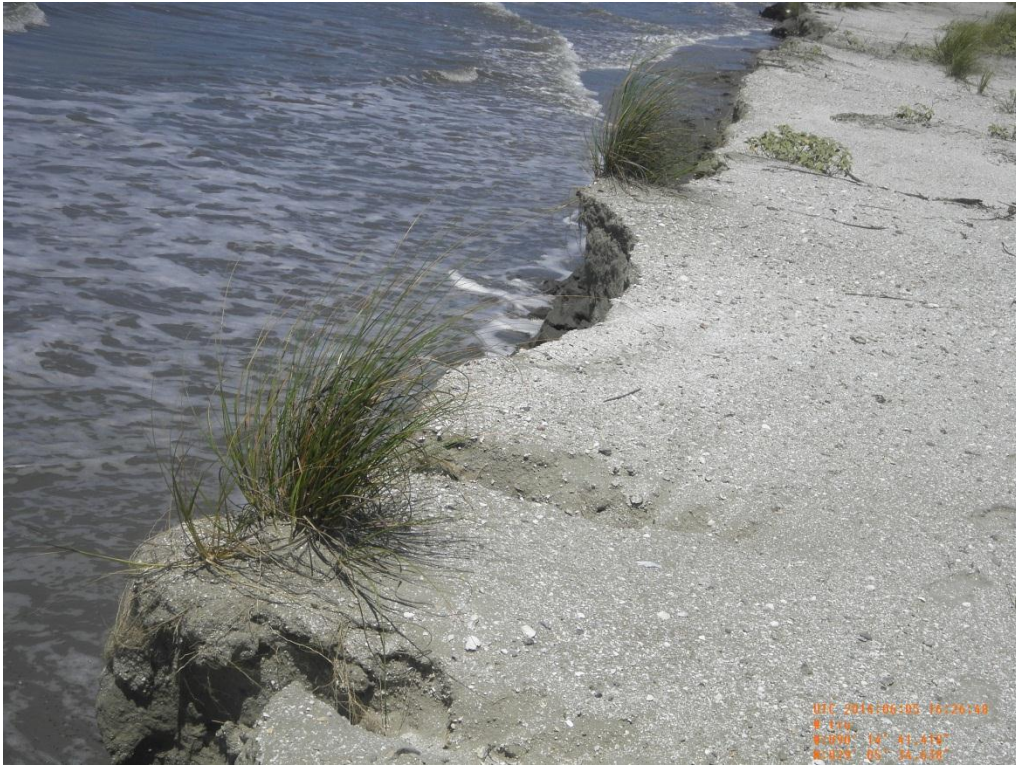
Photo 15: Close up of beach scarp destroying vegetative plantings.

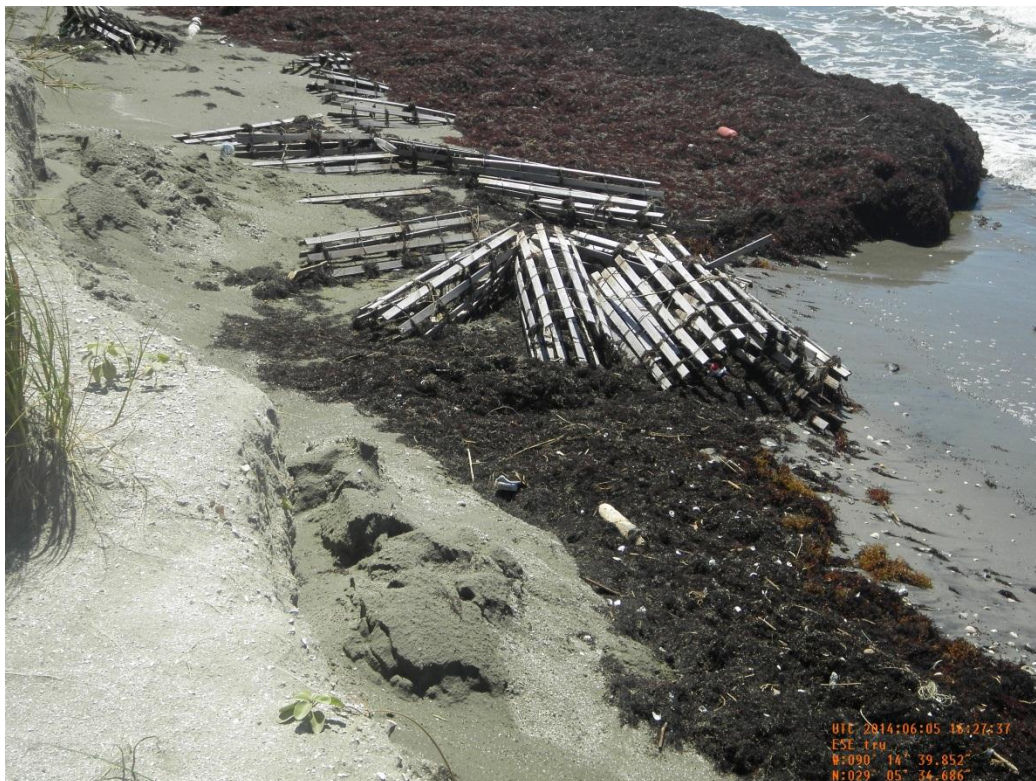
The sand fencing from Sta. 45+00 to Sta. 105+00 appears to be in good condition. The fence is catching sand as designed and the vegetation is growing around it. The sand fencing from Sta. 105+00 to the eastern extend is badly damaged or non-existent. The scarp in the dune has reached the sand fencing and destroyed it. The fencing in this area will need to be replaced after the beach has stabilized to its natural position. There are no recommendations for maintenance at this time.

Photo 16: Destroyed sand fencing due to the erosion of the beach dune

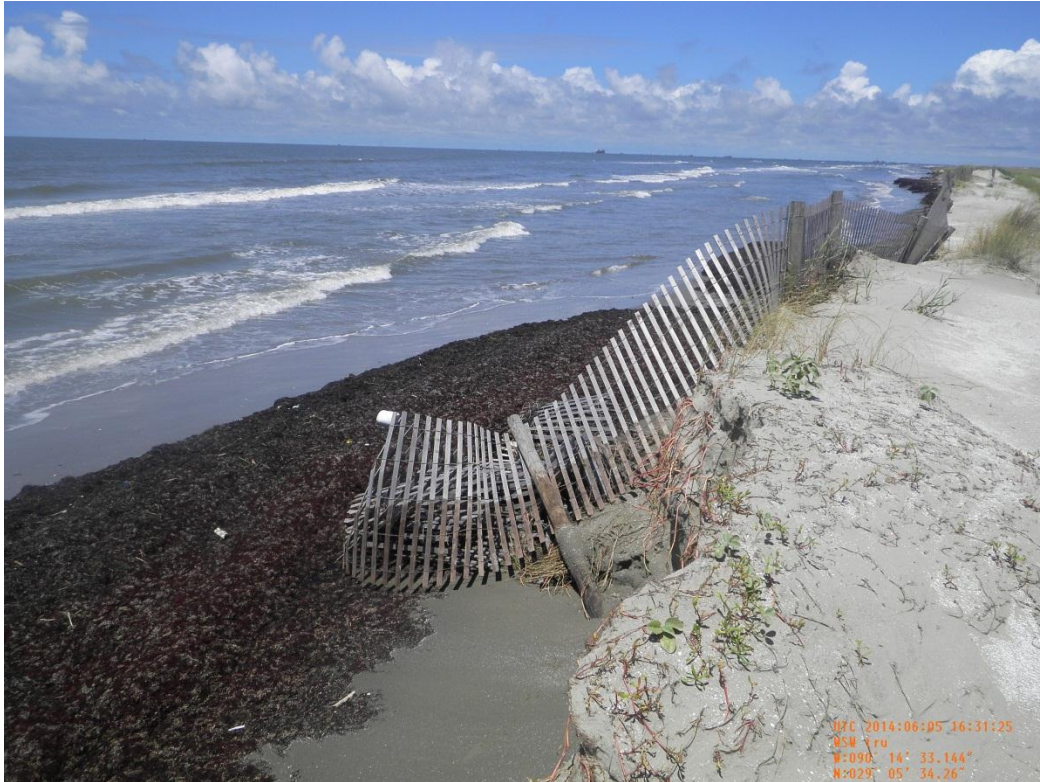
Photo 17: View of the damaged sand fence along the beach dune, looking southwest

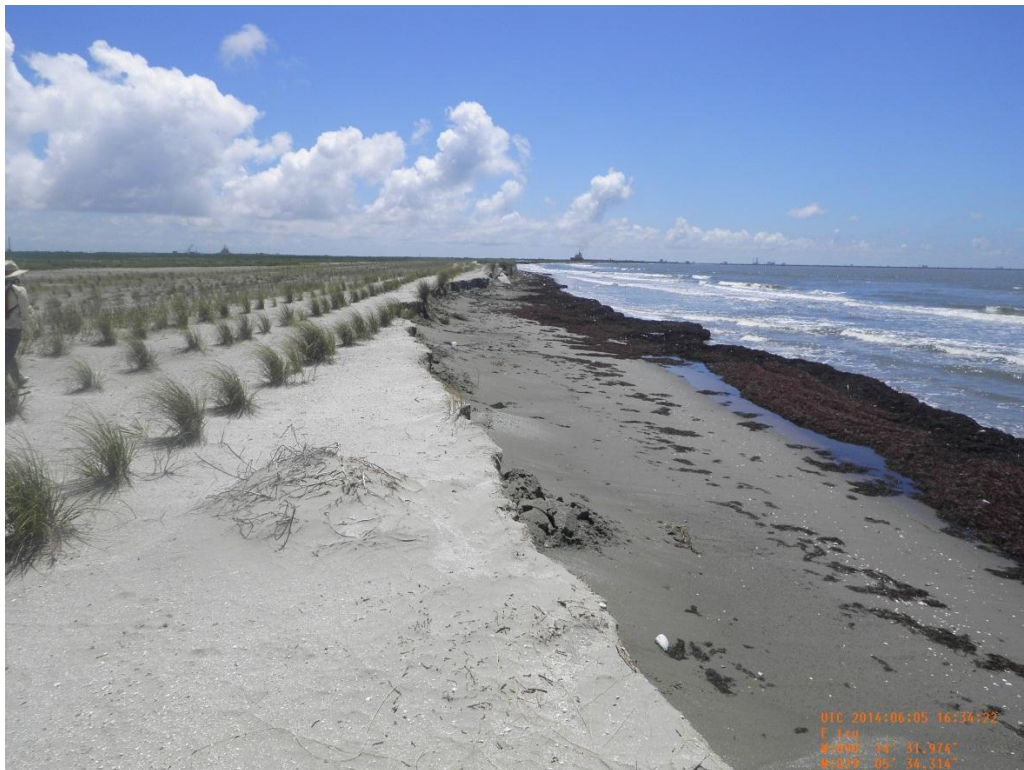
Photo 18: View of the scarping on the beach dune approaching more vegetative plantings

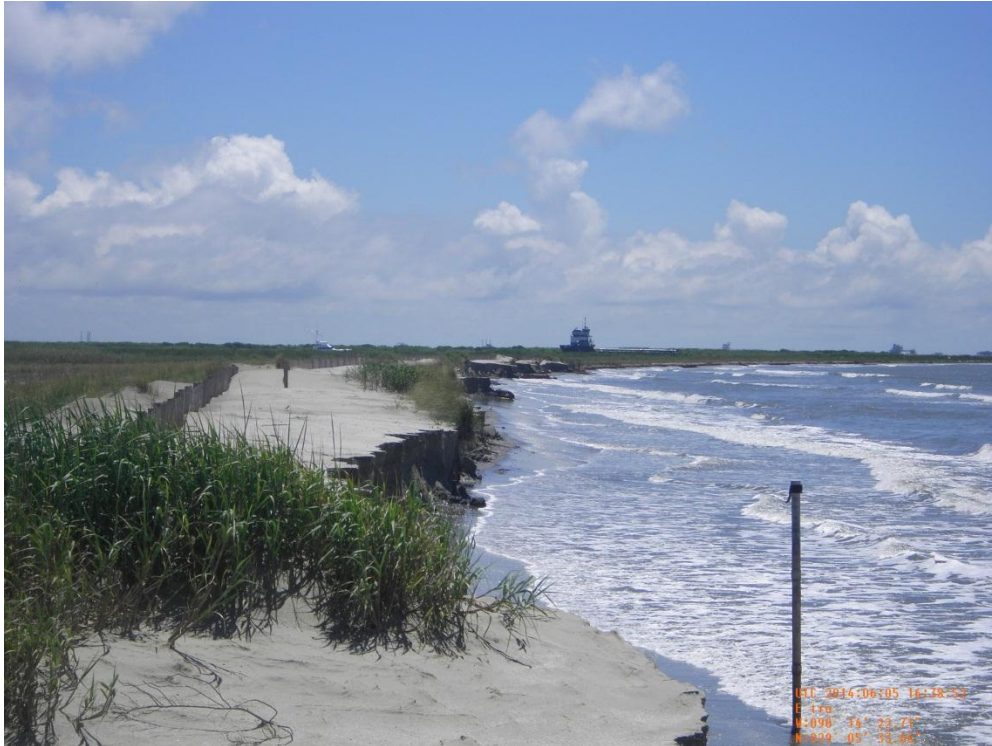
Photo 19: View of the eroding beach dune, looking east

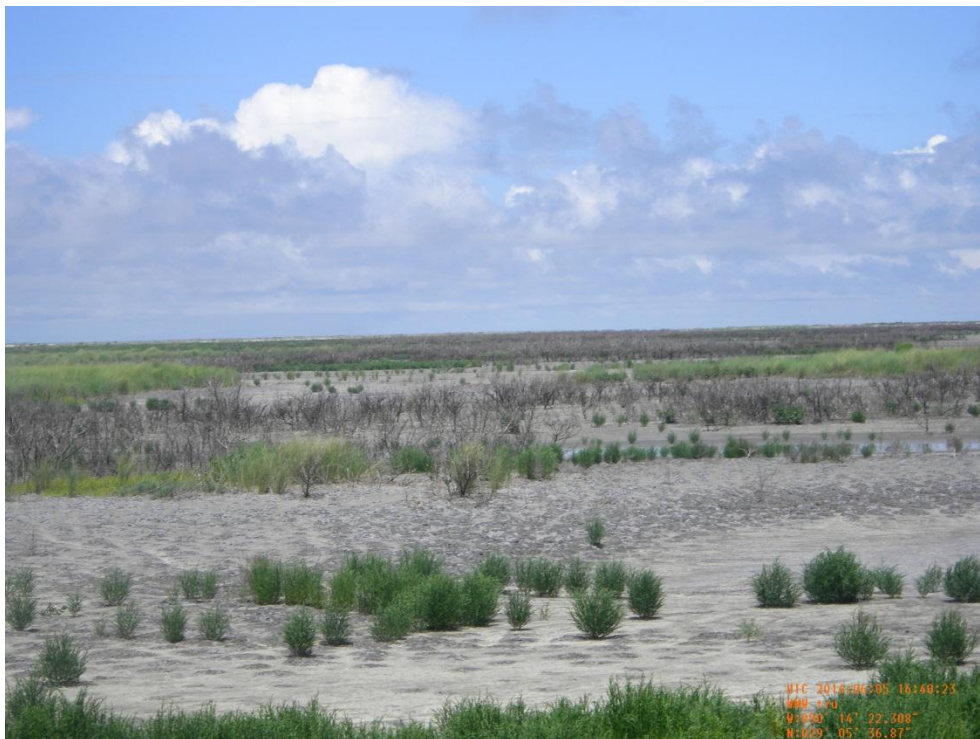
Photo 20: View of the newly created marsh platform, looking northwest

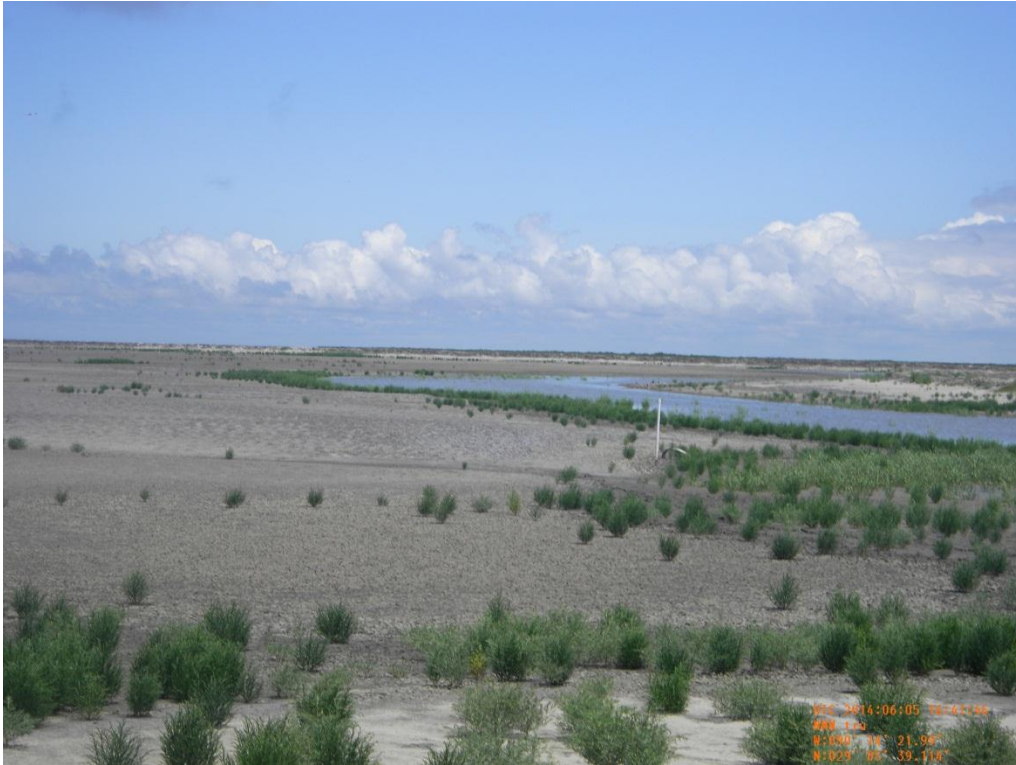
Photo 21: View of a tidal creek that has formed within the marsh fill area, looking northwest

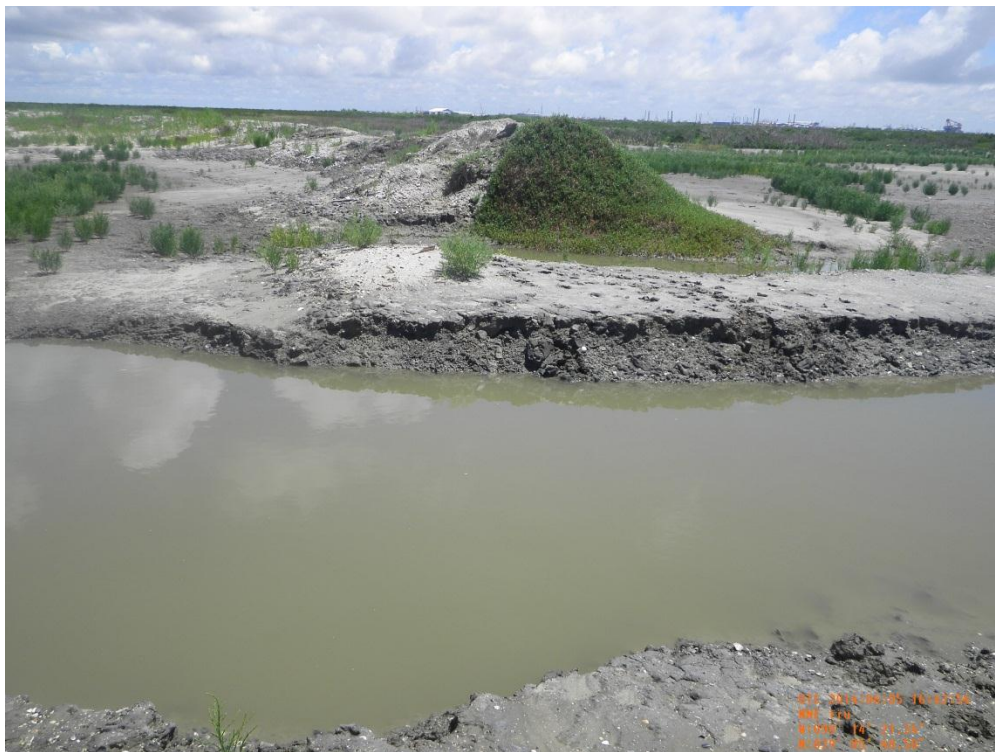
Overall, the marsh fill appears to be in good condition. There are no signs of extensive settlement and vegetation is beginning to appear. All containment dikes are fully intact, with the exception of the outfall area near the eastern adjacent marsh. This gap in the containment dike is providing a hydrologic connection to the channel that has formed as a result of the containment dike borrow area. The northern containment dike will likely form some gaps over the next year and will provide additional connectivity to the interior marsh. The formation of these gaps should be monitored in the future. There are no recommendations for maintenance at this time.

Photo 22: View of a tidal creek passing through the eastern containment dike near the outfall area, looking north

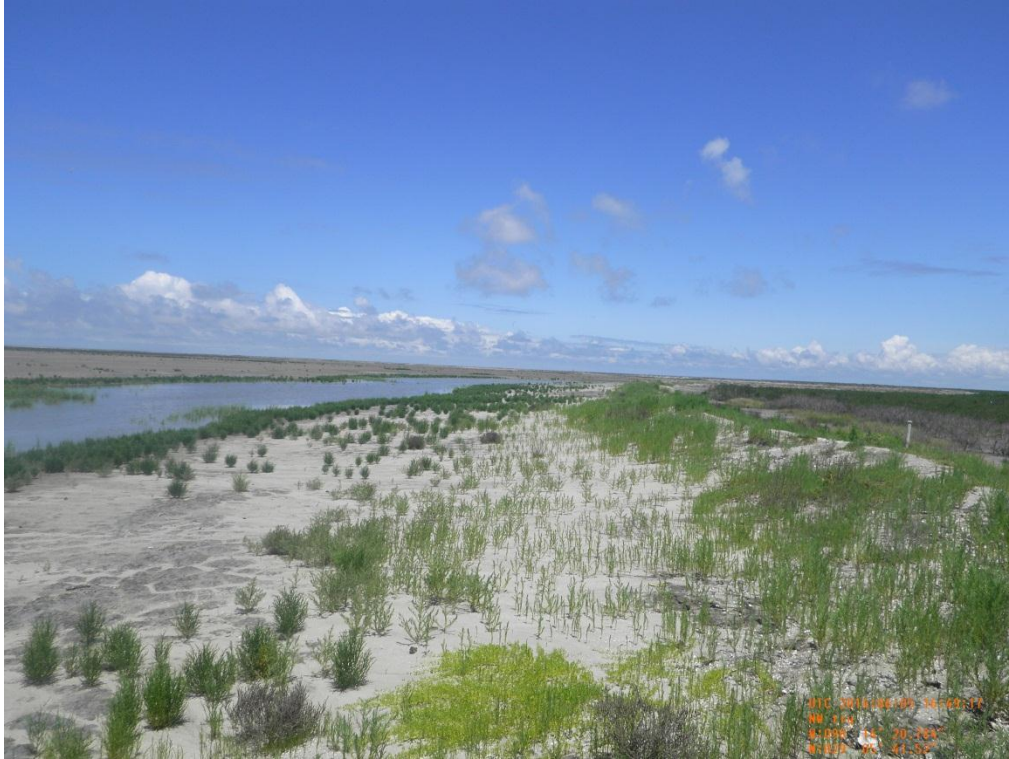
Photo 23: View of eastern containment dike and adjacent borrow area, looking northwest

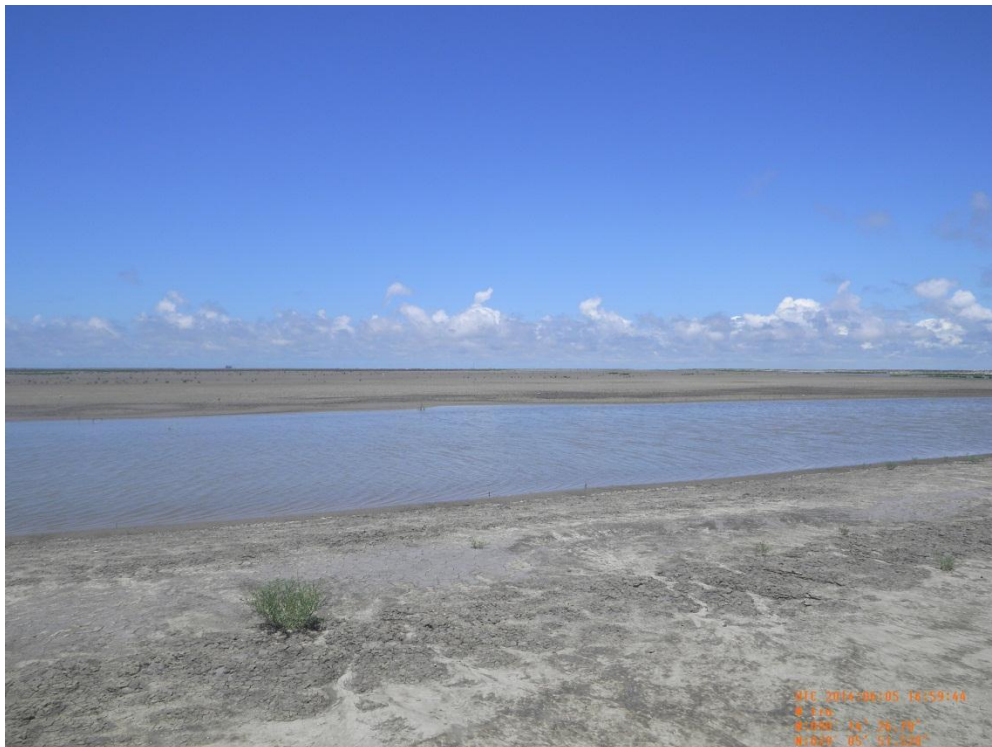
Photo 24: View of the containment dike borrow channel and marsh fill area near the northeastern corner of the fill area, looking west

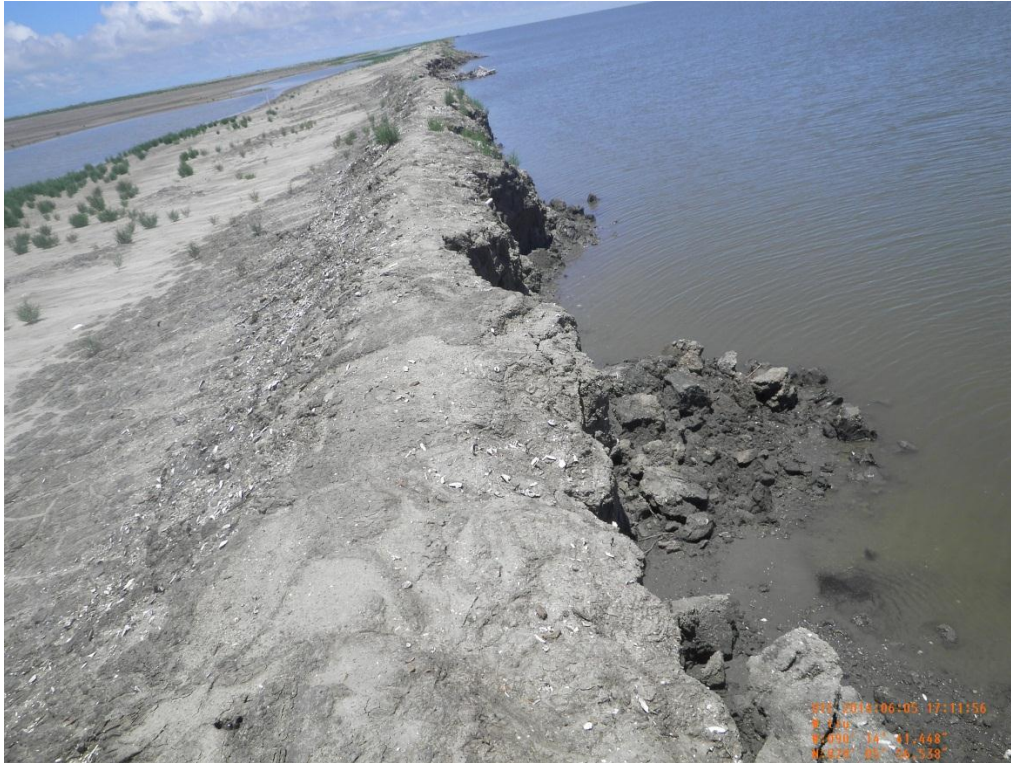
Photo 25: Close up of the erosion found on the northern containment dike

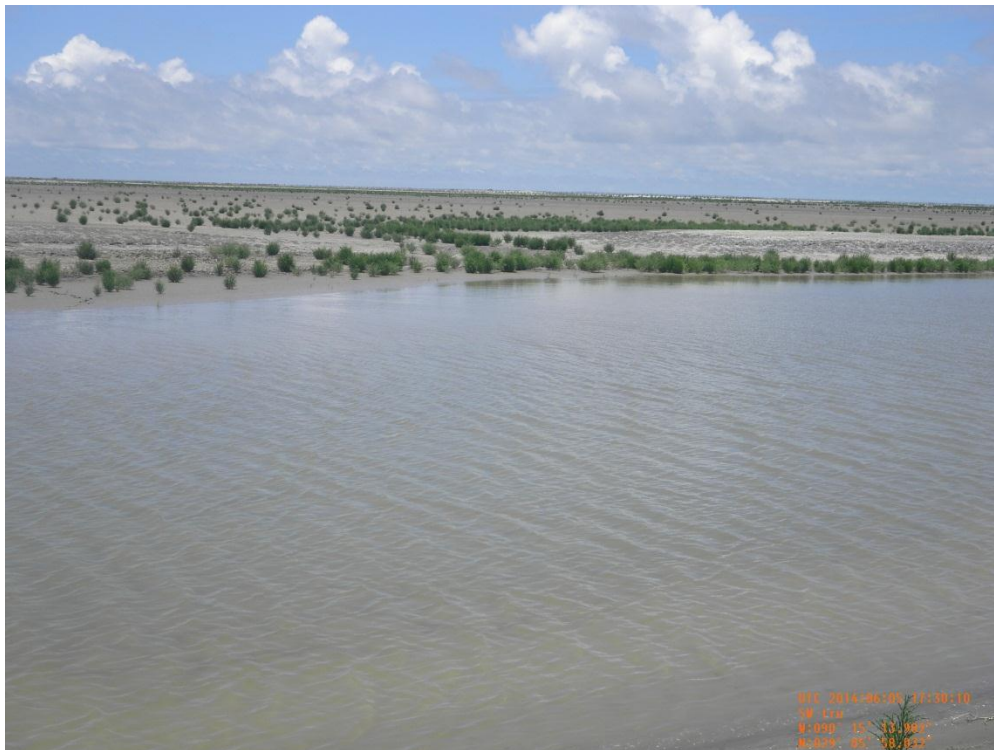
Photo 26: Overall view of the marsh fill area with scattered vegetation beginning to grow, looking southwest

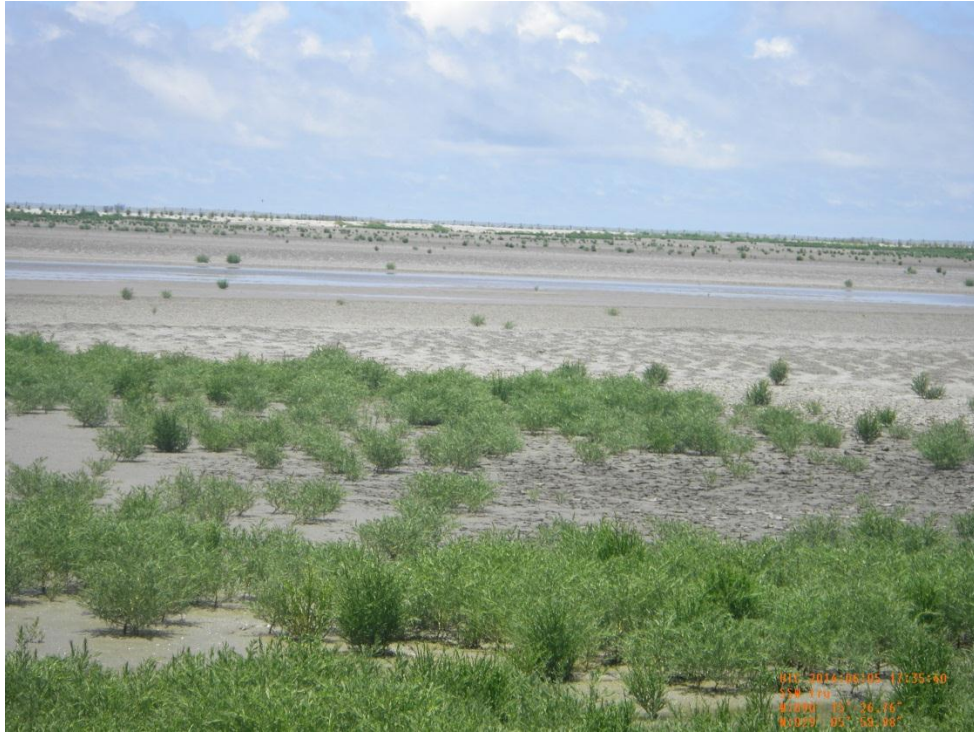
Photo 27: View of the marsh fill area with some internal ponding, looking southwest
