**2018 Annual Inspection Report**

**WEST BELLE PASS BARRIER  
HEADLAND RESTORATION  
PROJECT (TE-52)**

State Project Number TE-52  
Priority Project List 16

November 19, 2018  
Lafourche Parish

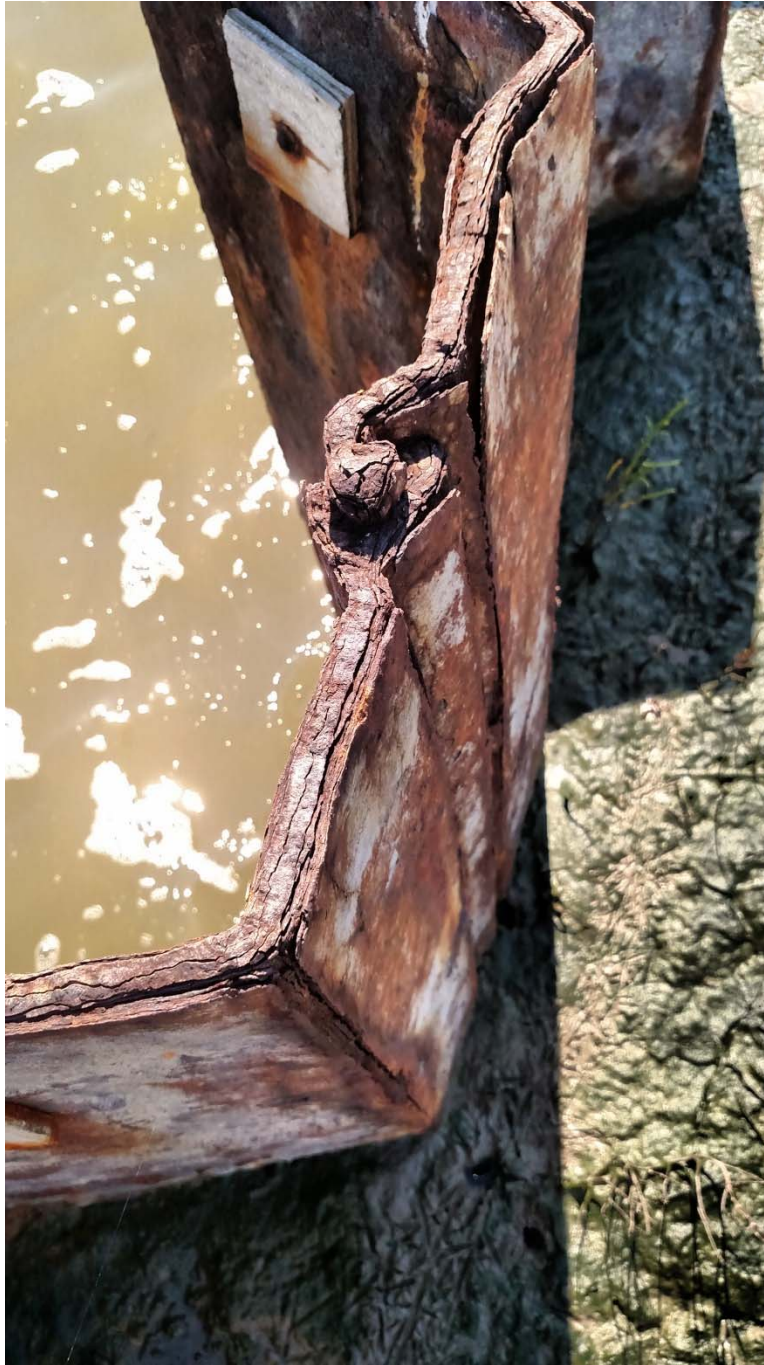
Photo 1: Close-up view of sheet pile condition

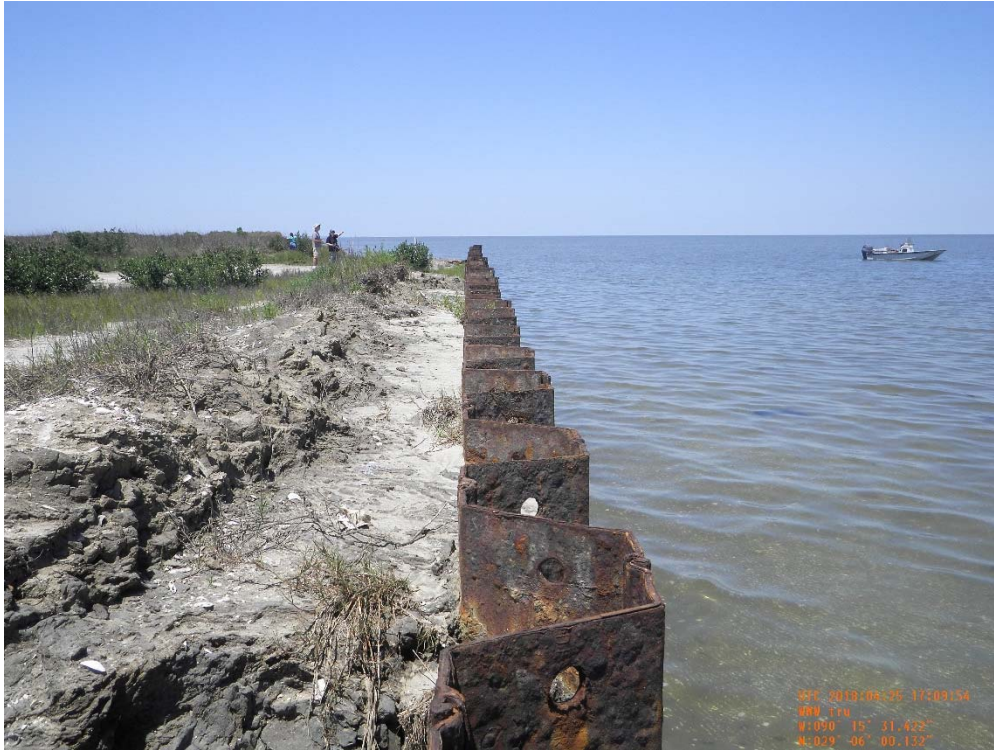
Photo 2: View of sheet pile plug in northern containment dike, looking west.

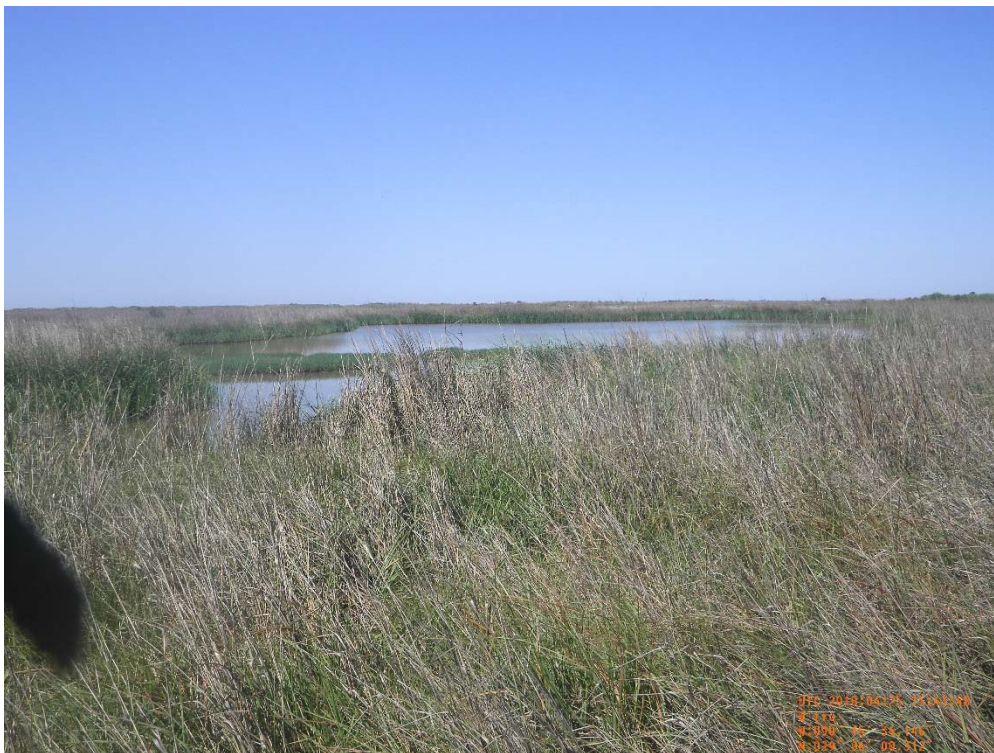
Photo 3: View of small impounded area with freshwater vegetation just southeast of sheet pile wall.

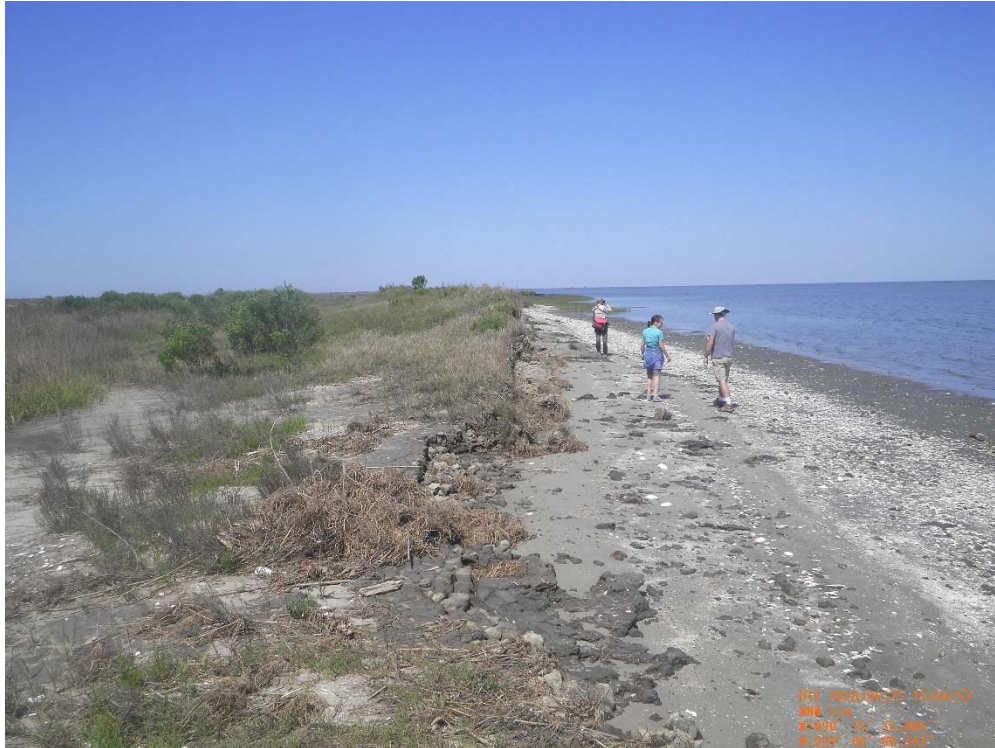
The marsh fill area appear to be in good condition. There are no signs of widespread settlement and vegetation is emerging near tidal water sources. All containment dikes are fully intact, with the exception of the outfall area near the eastern adjacent marsh left when the weir box was removed and the newly gapped areas constructed under the 2018 Maintenance Project that were completed in May 2018. The gaps in the containment dike

Photo 4: View of northern primary containment dike west of sheet pile wall.

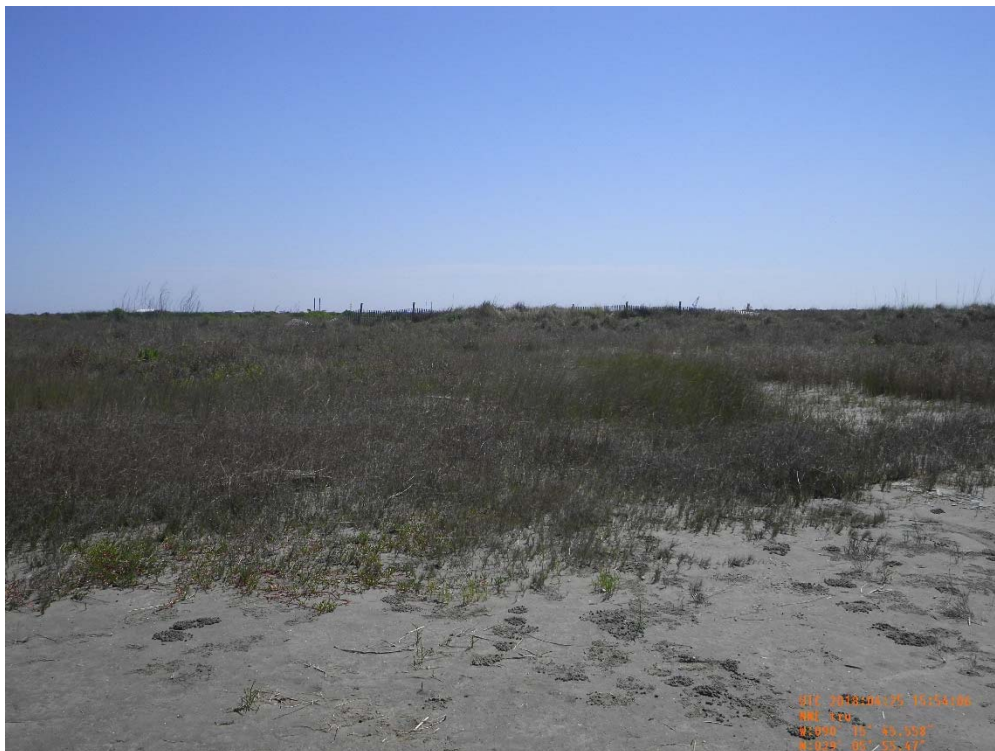
Along the dune, shoreline erosion noted in the beach fill section above has undercut the foundation and the fencing is completely destroyed. Only the reach from Sta. 45+00 to Sta. 55+00 has any sand fence remaining and it is not in good condition. Approximately 100' of fencing near Sta. 55+00 headed northwest has been damaged and is lying on the ground. Sand fencing from Sta. 105+00 to the eastern project extent is badly damaged or nonexistent. Without placement of additional sand, new sand fencing is not needed. There are no recommendations for maintenance at this time.

Photo 5: View of overgrown sand fencing looking east from internal jetty edge.

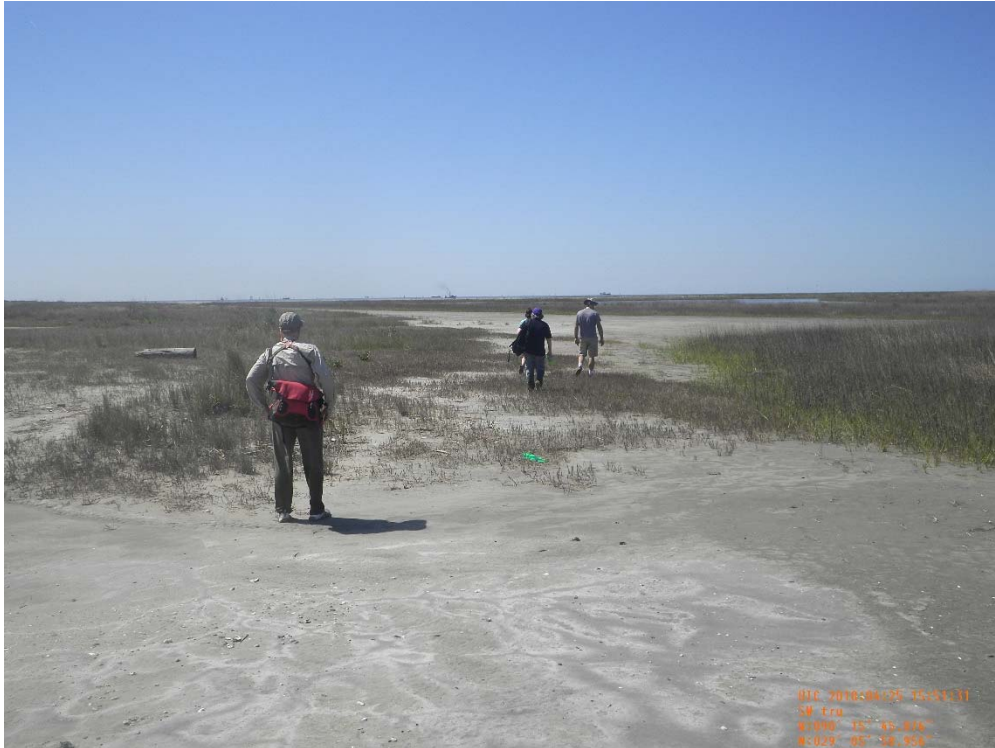
Photo 6: View of northern part of jetty looking south from the center of western marsh fill edge.

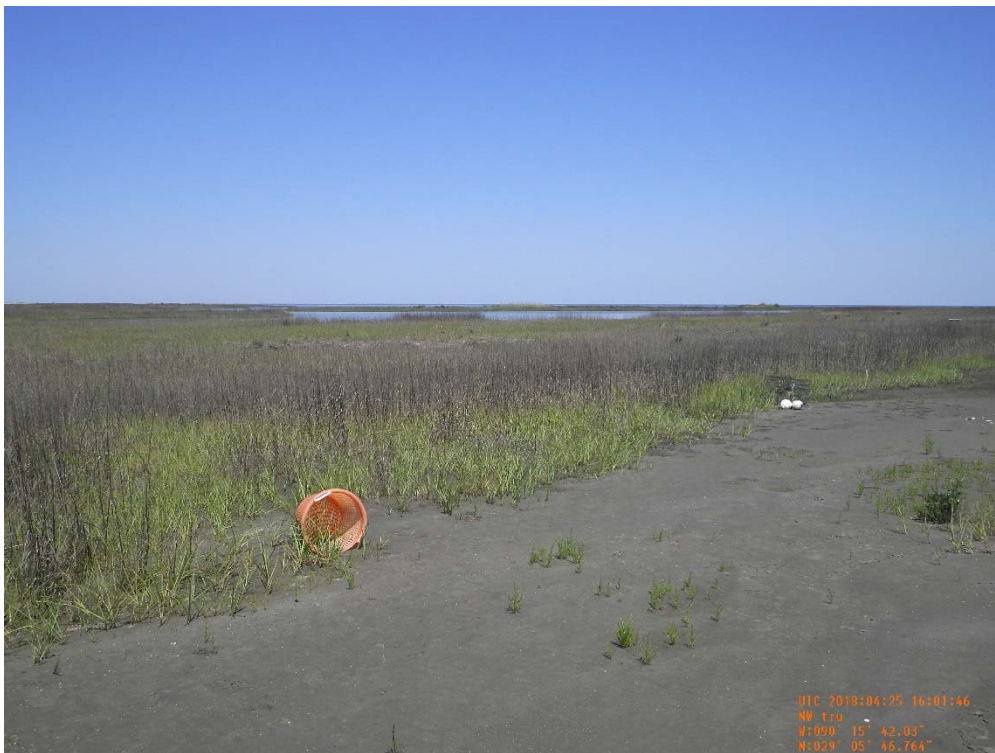
Photo 7: View of jetty from sand fencing on western marsh fill edge. Interior access route for contractors to perform upcoming maintenance event can be seen.

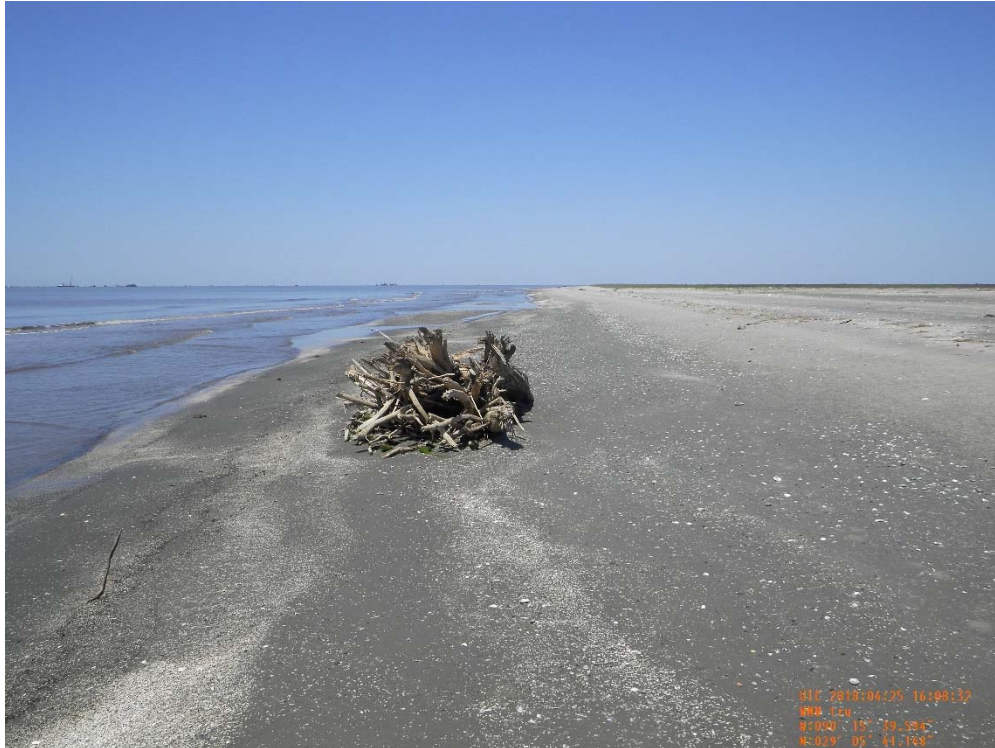
Photo 8: View of jetty beach face, looking west from southern tip of sand fence.

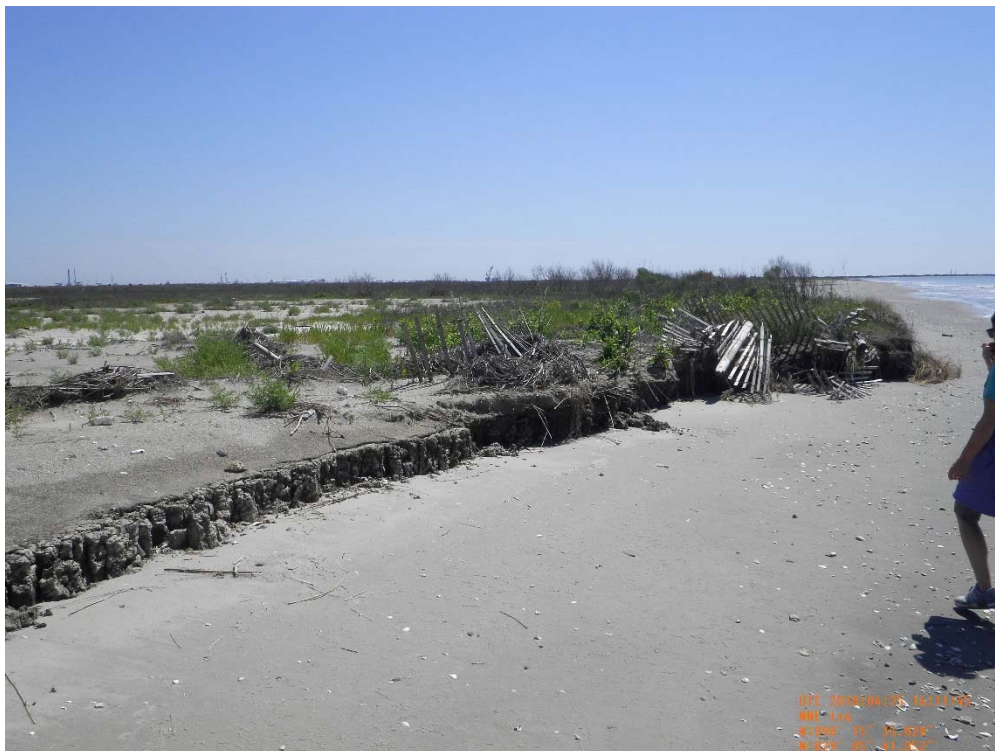
Photo 9: View of beach dune and sand fencing looking east.

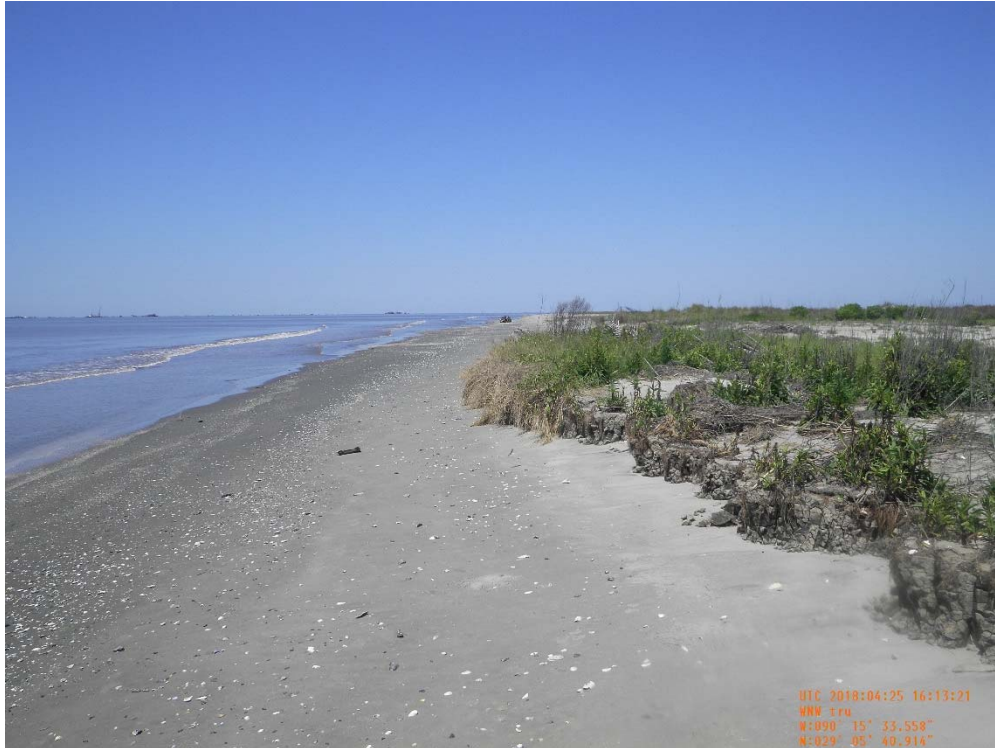
Photo 10: View of beach dune and sand fencing looking west.

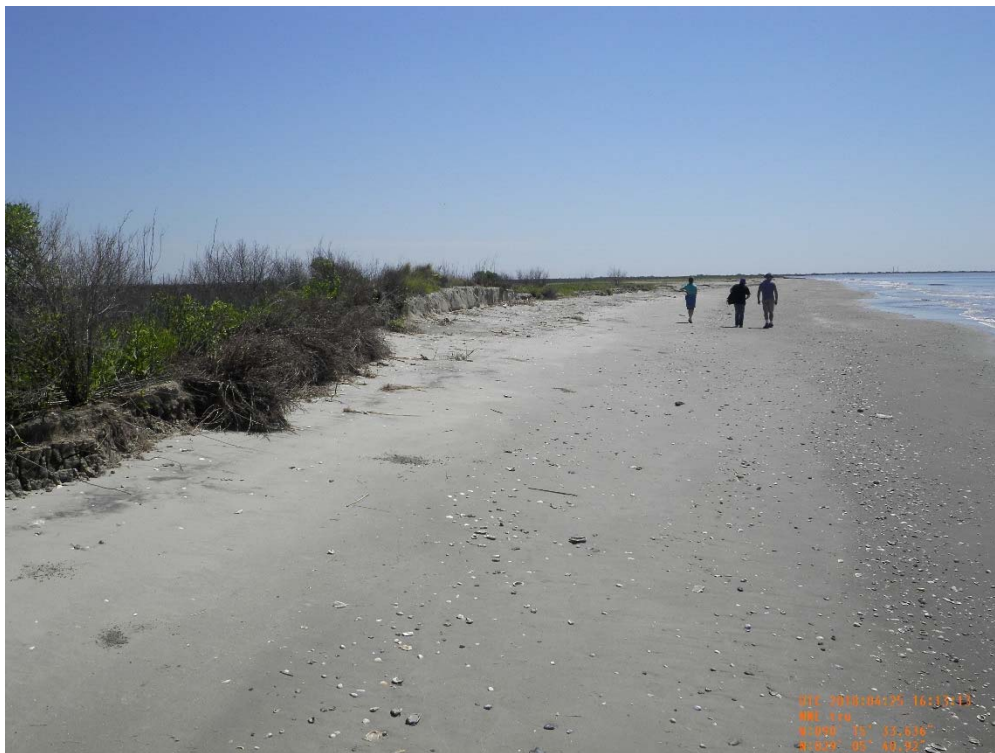
Overall, as the beach profile is continuing to adapt to the environmental conditions, the beach fill has completely eroded, with only a fragment left on the southwestern most tip. Longshore transport has eroded sand along the length of the beach face, depositing material westward and fueling the growth of a large spit, which has added sand volume and elongated the shoreline by 80 percent. The scarping is continuing to increase and there are signs that water from storm activity regularly accesses the interior marsh from the southeast. As noted in the 2017 inspection report, shoreline retreat measurements were recorded at several locations along the beach dune, with the highest rates of erosion occurring on the eastern side. Settlement plates that were once in the center of the dune are now missing or in open water. There are no recommendations for maintenance at this time; however, addition of sand fill along the shoreline is being considered under other efforts currently in design.

Photo 11: View of beach erosion, looking east.

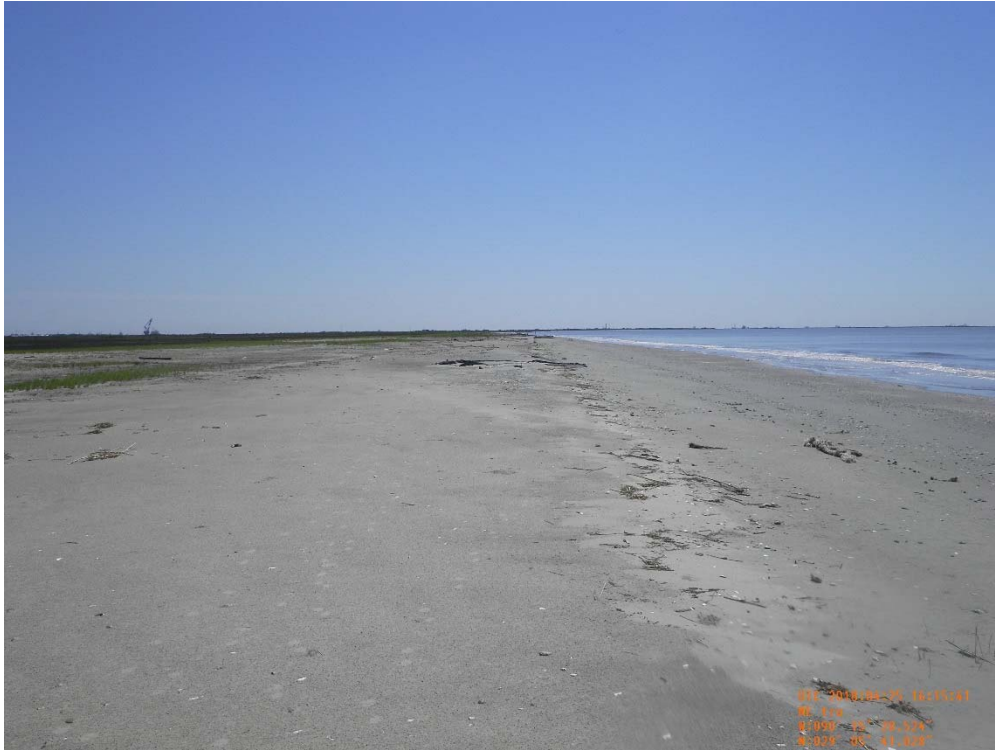
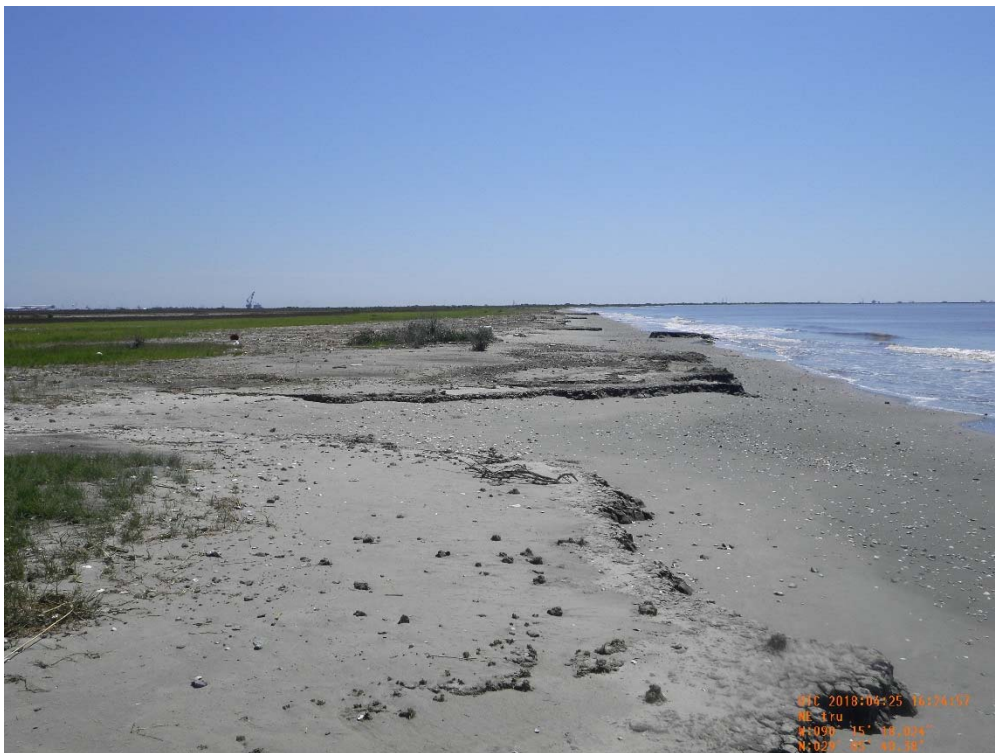
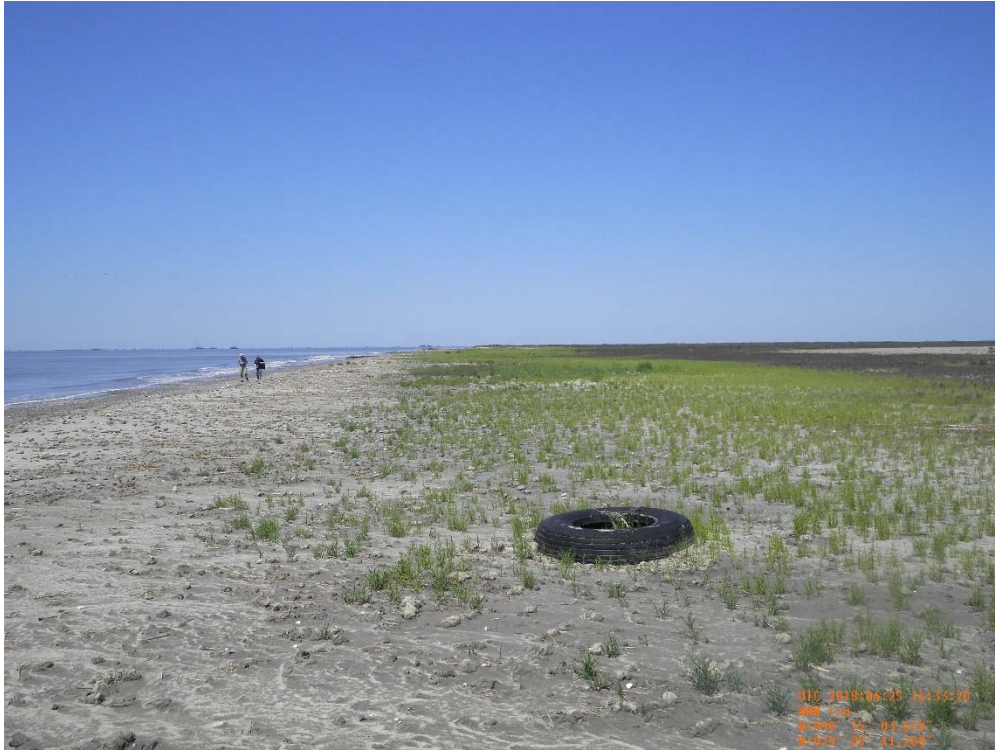
Photo 12: View of eroded beach and marsh platform from southern border of marsh creation area.

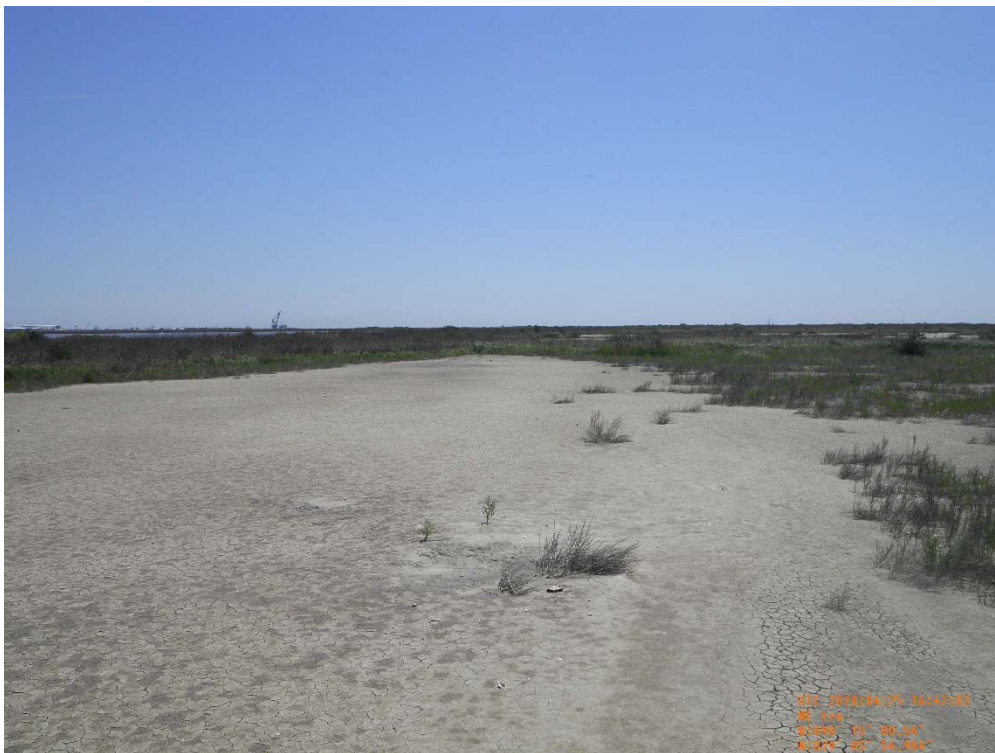
Photo 15: View of high areas just south of northern primary containment dike looking east.

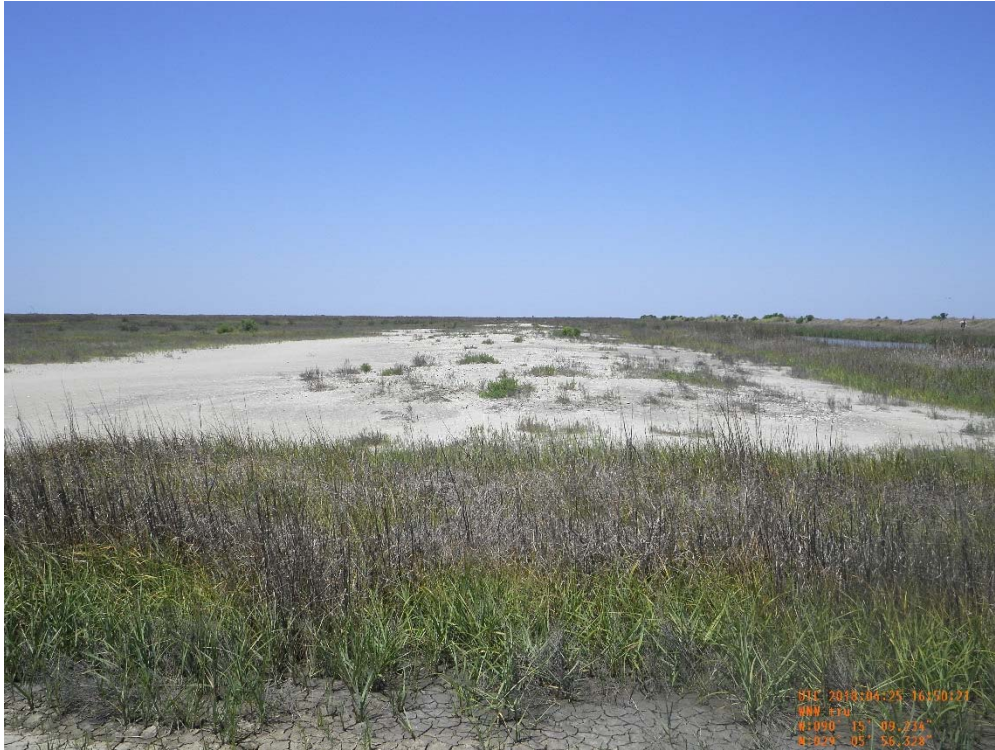
Photo 16: View of high areas just south of northern primary containment dike looking west.

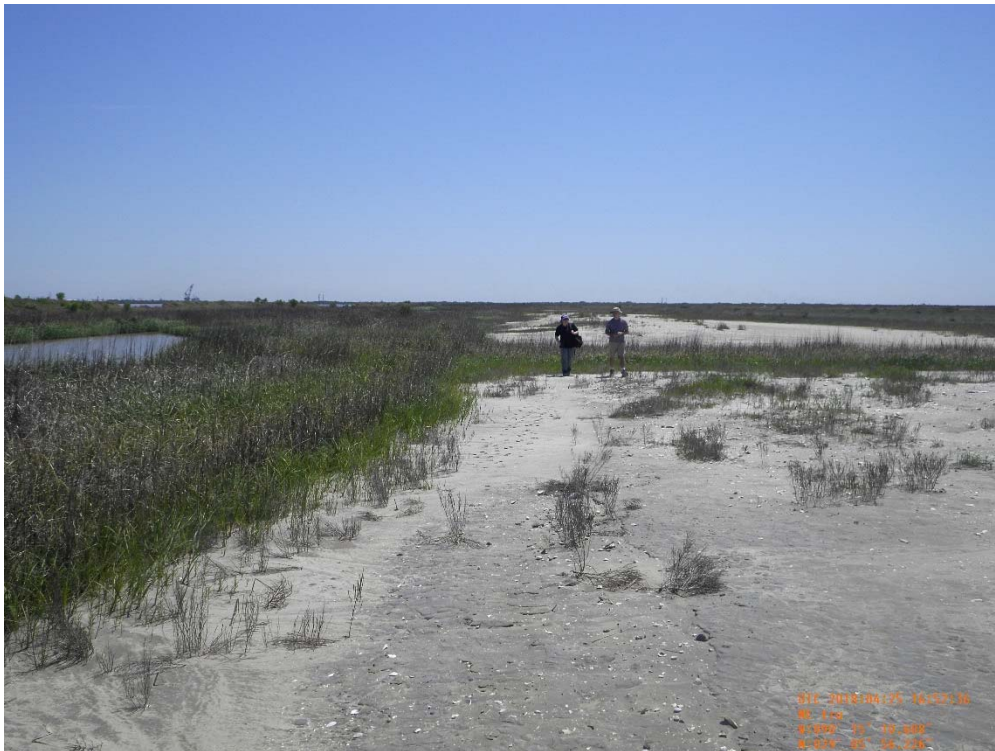
Photo 17: View of high areas just south of northern primary containment dike looking east.

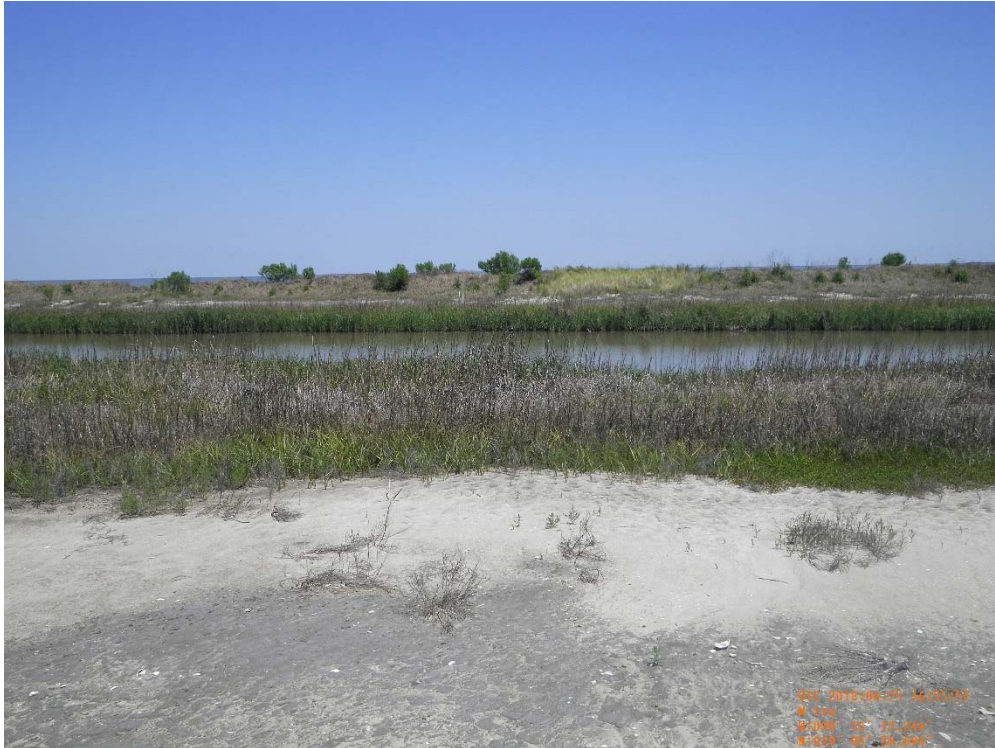
Photo 18: View of northern primary containment dike, adjacent ditch, & vegetation.

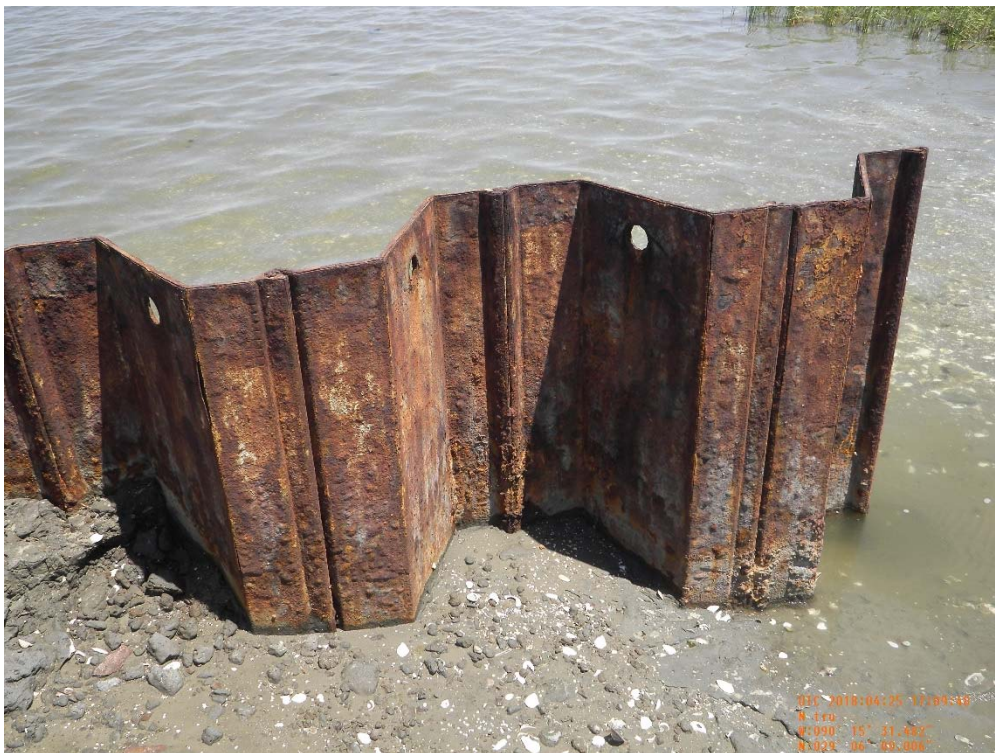
Photo 19: View of eastern edge of sheet-pile wall.

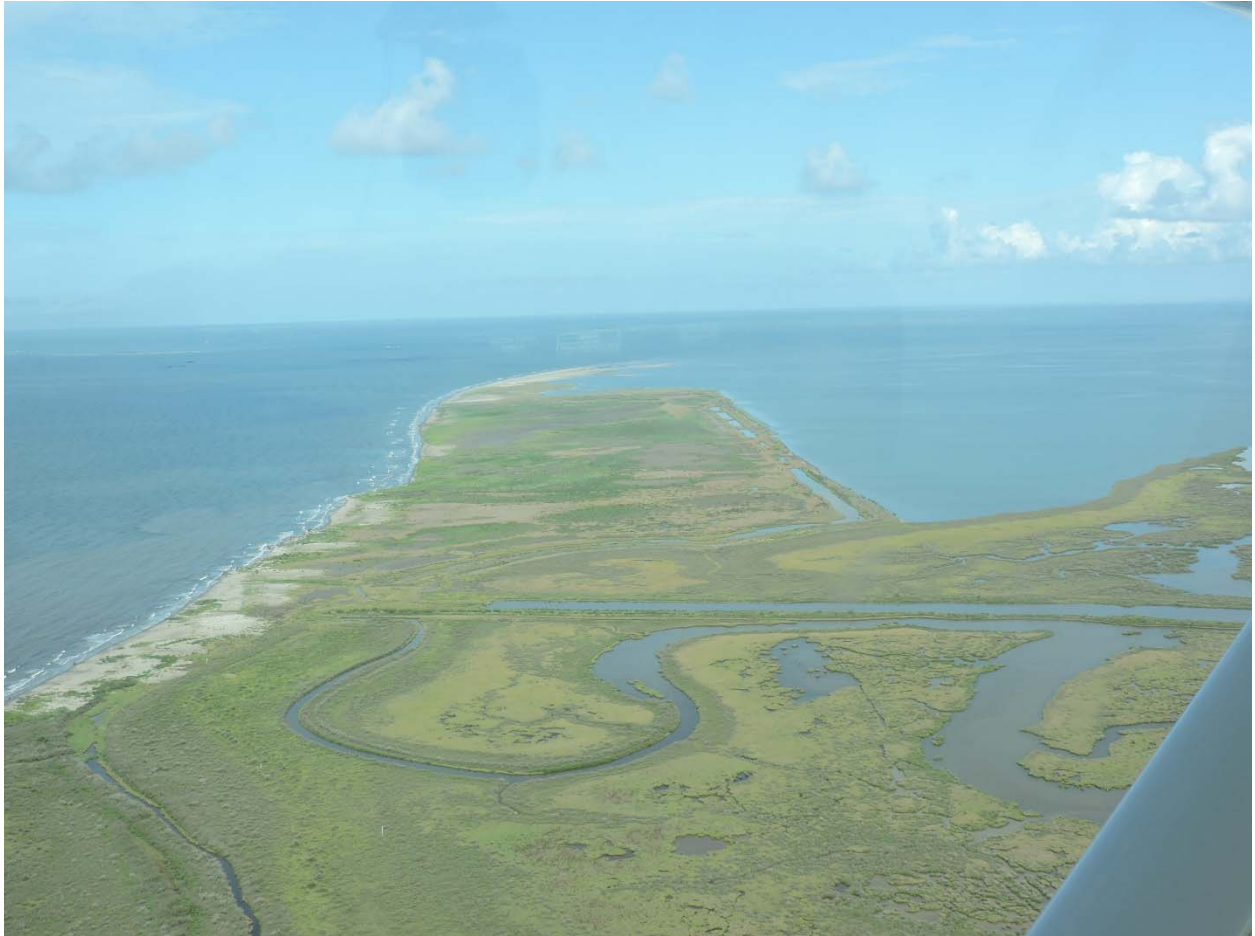
Photo 20: Ariel veiew of entire project area looking west.
