**State of Louisiana
Coastal Protection and Restoration
Authority**

2017 Annual Inspection Report

**WEST BELLE PASS BARRIER
HEADLAND RESTORATION
PROJECT (TE-52)**

State Project Number TE-52
Priority Project List 16

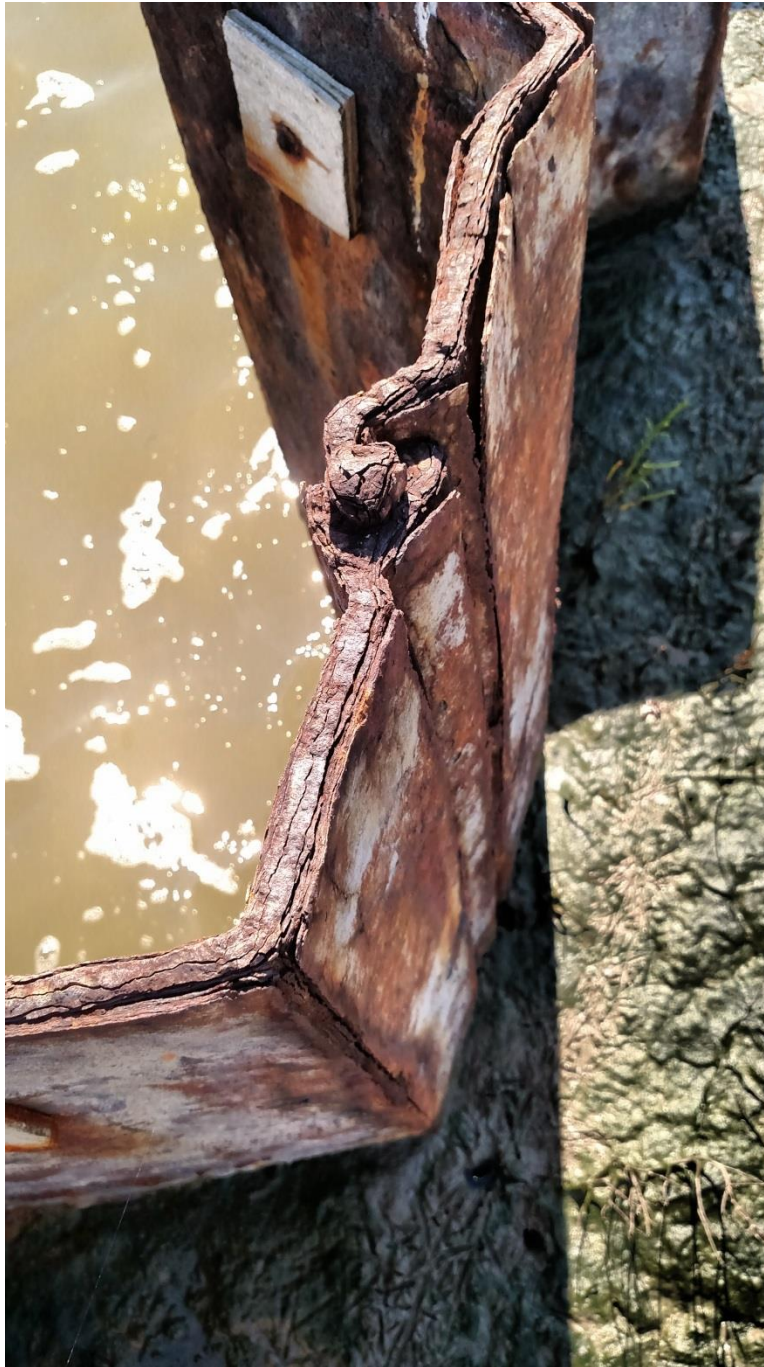
Minor erosion has occurred around the edges of the sheet pile wall; the western tip extends into open water with the shoreline 10 feet back towards the south and east. The marsh fill appears to be in good condition. There are no signs of extensive settlement and vegetation is continuing to emerge near tidal water sources. All containment dikes are fully intact, with the exception of the outfall area near the eastern adjacent marsh left when the weir box was removed. This gap in the containment dike is providing a hydrologic connection to the channel that was formed as a result of the containment dike borrow area. The northern containment dike has a few low areas which may soon form gaps, providing additional connectivity to the interior marsh. To speed this up, the Thibodaux Regional Office of CPRA has put together a scope of work to create three 50.0' gaps in the northern containment dike plus remove the existing 200' steel sheet pile wall.

Photo 1: Close-up view of sheet pile condition

Maintenance Event No.1 – remove existing steel sheet pile from back dike and degrade back dike to marsh elevation.

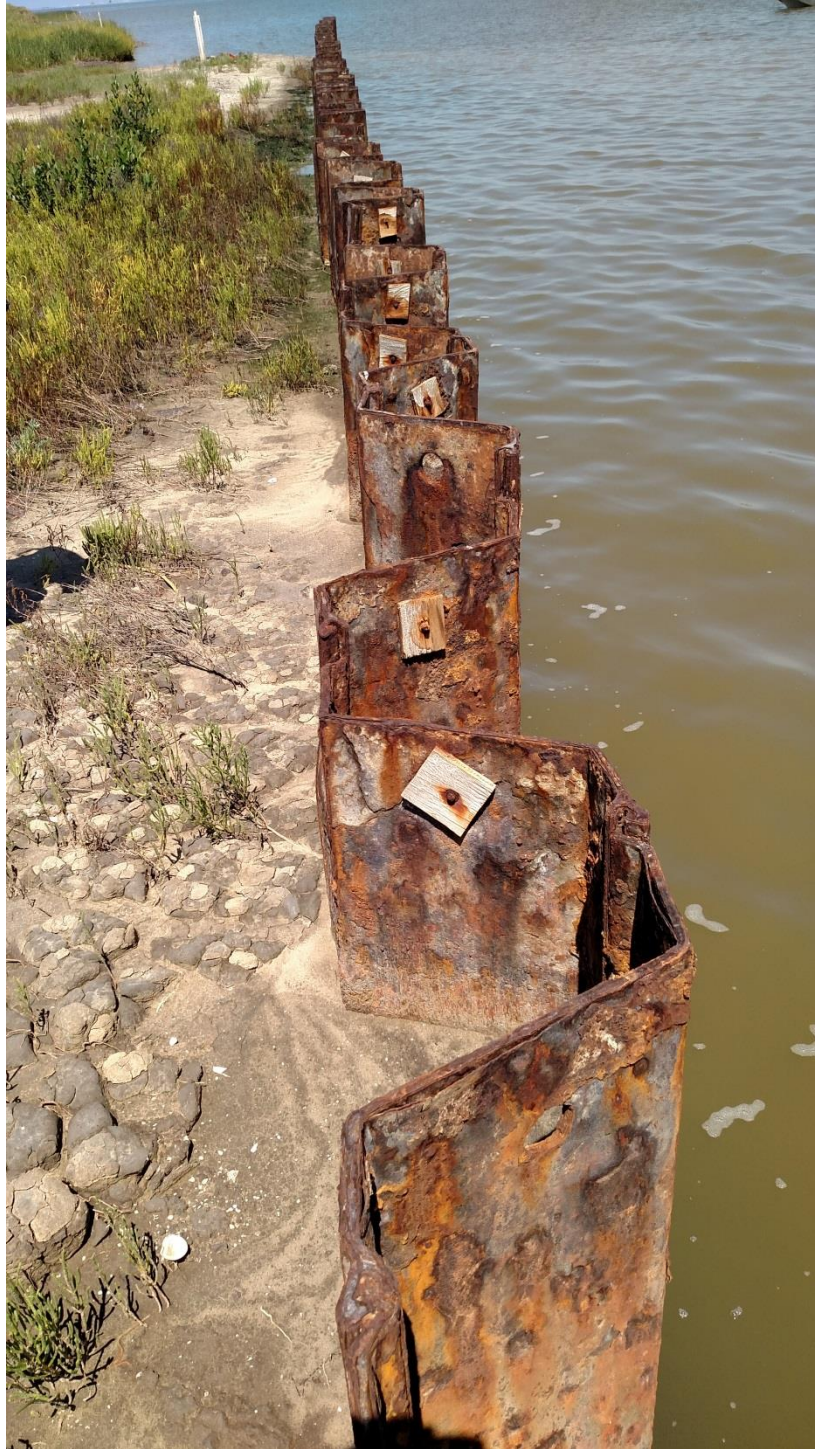
Photo 2: View of sheet pile plug in northern containment dike, looking west.

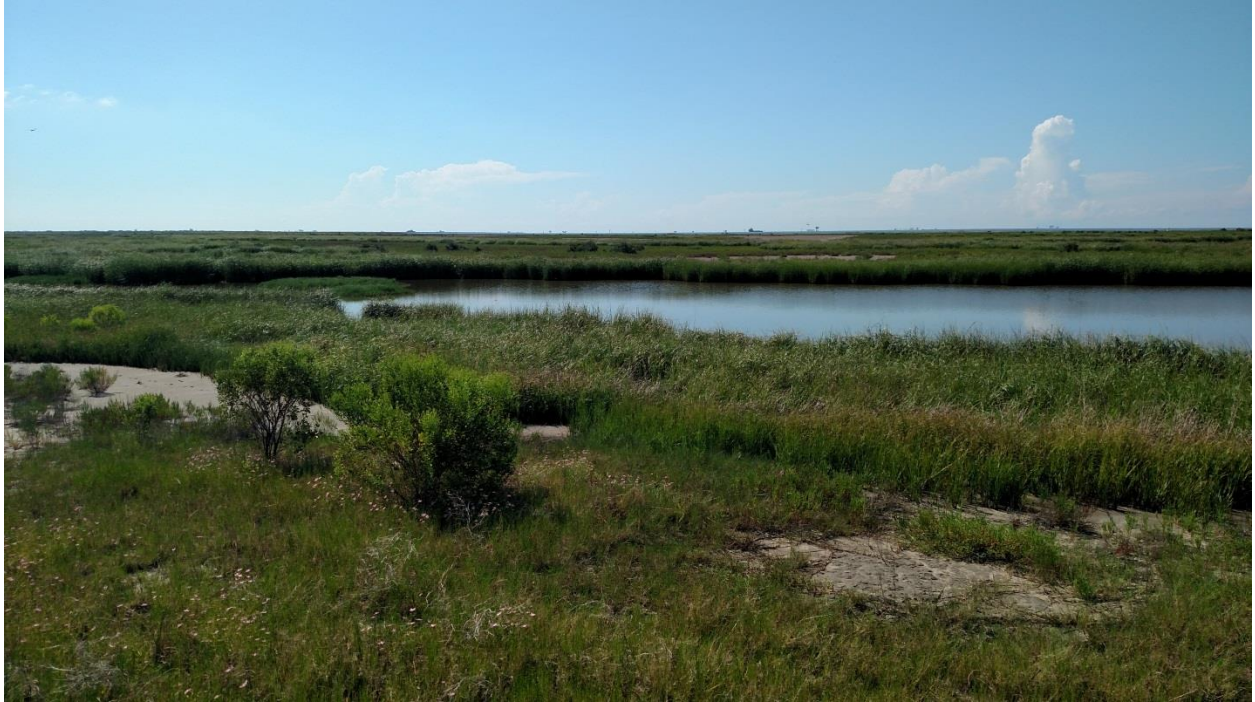
Photo 3: View of small impounded area with freshwater vegetation just southeast of sheet pile wall.

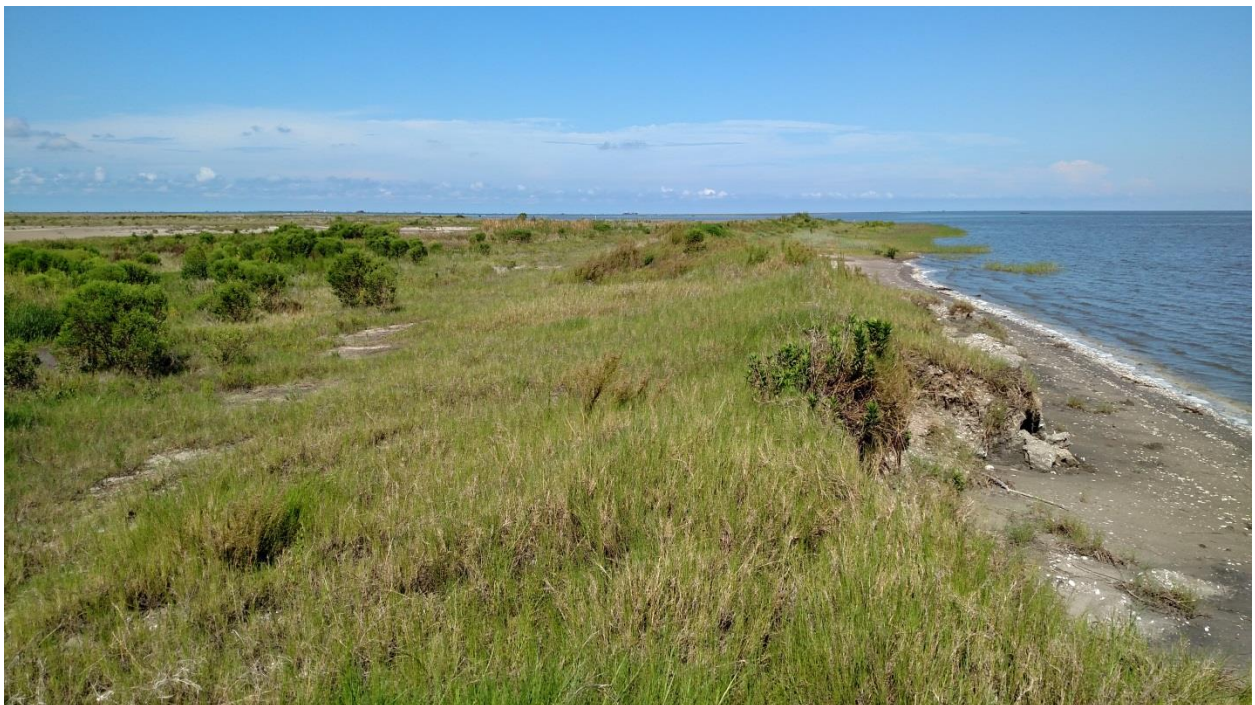
Photo 4: View of northern primary containment dike west of sheet pile wall.

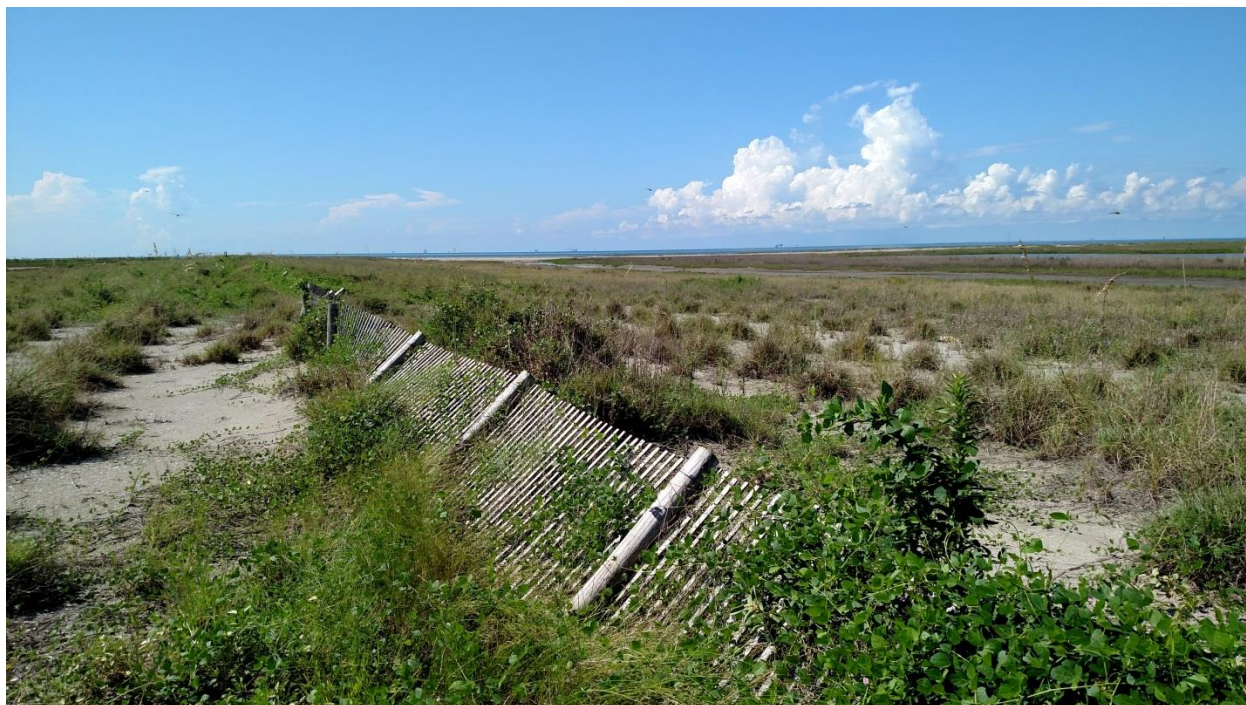
The 20,000 plugs of smooth cordgrass planted along the northern edge of the marsh fill have vegetated well. The annual inspection was held approximately 2 months after installation and the planted vegetation is indistinguishable from naturally vegetated sections. Thick vegetation prevented the inspection from continuing into the marsh platform.

Photo 5: View of successful vegetative planting & sand fence, looking south.

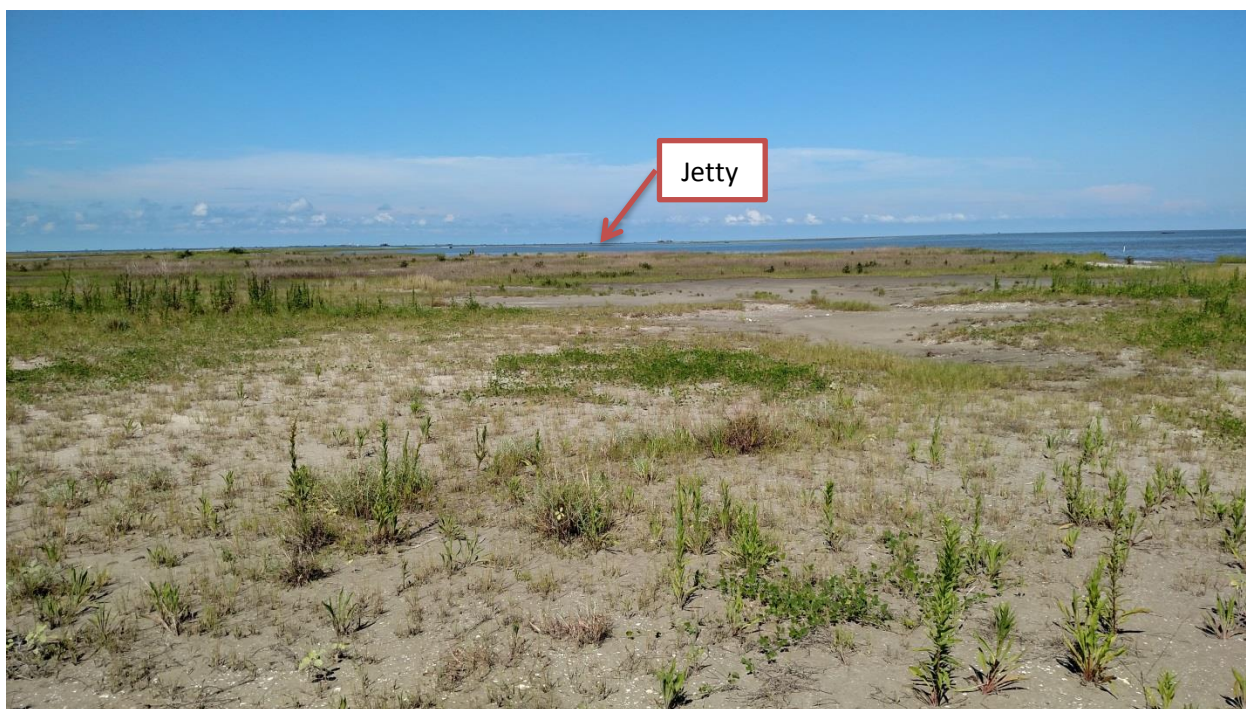
Photo 6: View of northern part of jetty from the center of western marsh fill edge.

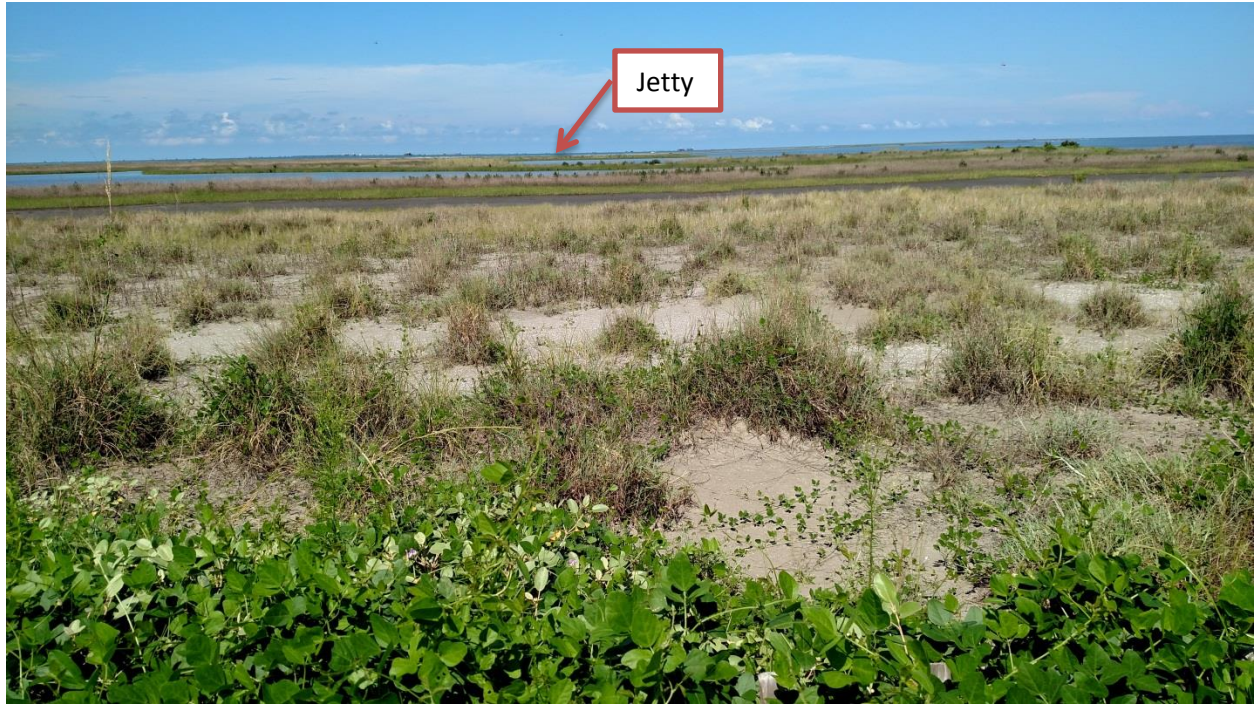
Photo 7: View of jetty from sand fencing on western marsh fill edge. Interior access route for contractors to perform upcoming maintenance event can be seen.

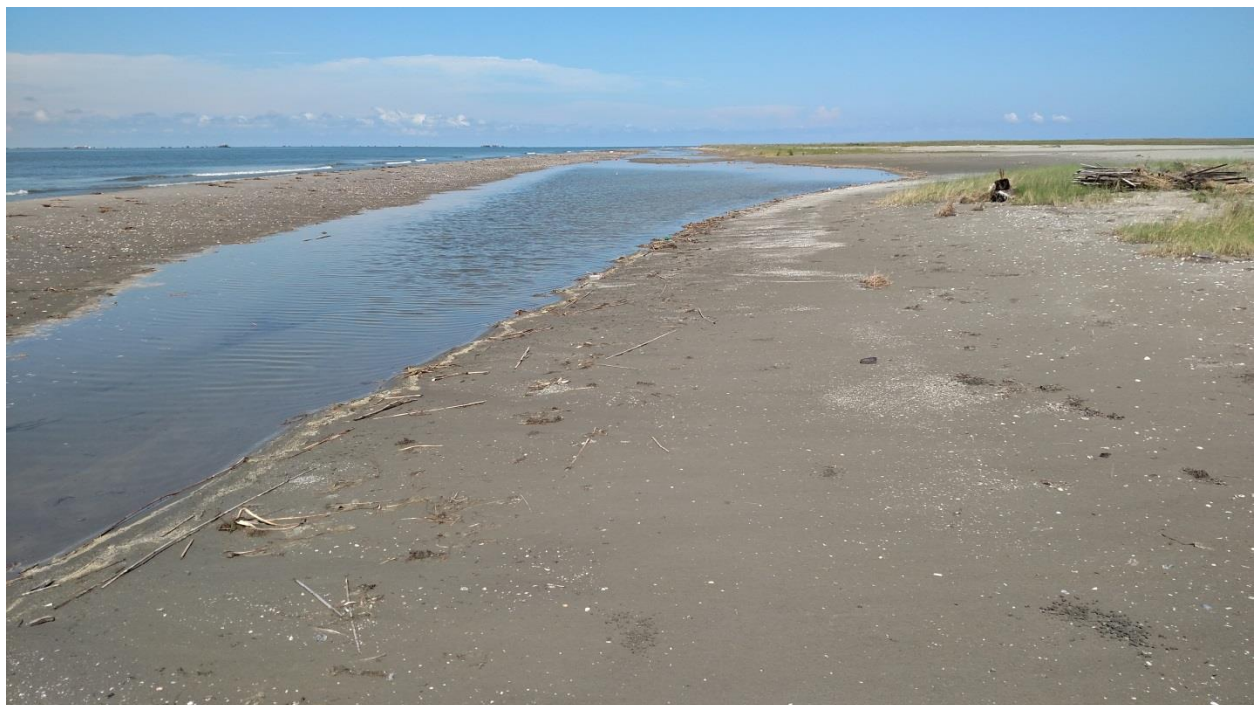
Photo 8: View of jetty beach face, looking west from southern tip of sand fence.

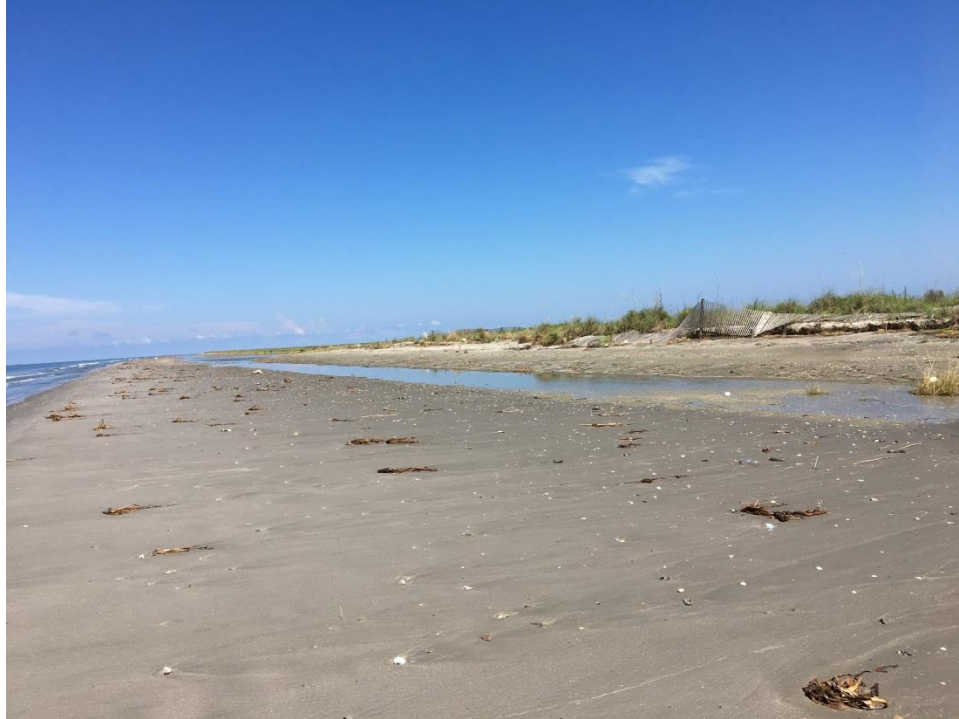
Photo 9: View of beach dune and sand fencing looking west.

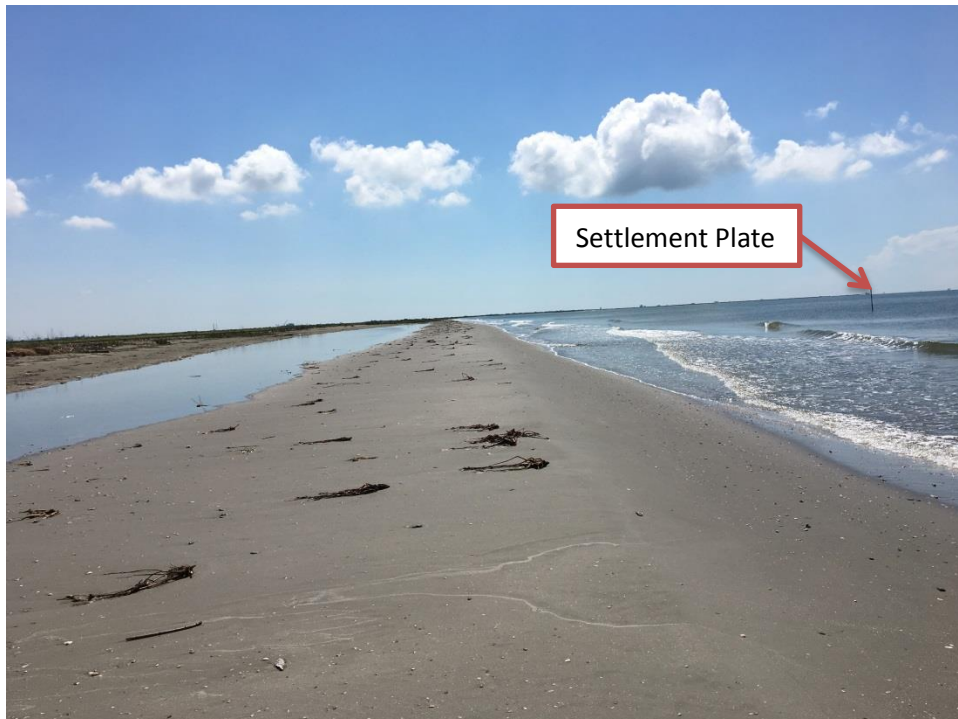
Overall, as the beach profile is continuing to adapt to the environmental conditions, the beach fill has completely eroded, with only a fragment left on the southwesternmost tip. Longshore transport has eroded sand along the length of the beach face, depositing material immediately west and fueling the growth of a large spit. The dune scarping from Belle Pass to near Sta. 105 is continuing to increase and there are signs that water from storm activity regularly accesses the interior from the southeast. Shoreline retreat has been measured at four locations along the beach dune, with the highest erosion occurring on the eastern side. Their location and measured retreat are as follows: Sta. 120+00, 271.00'; Sta. 100+00, 251.00'; Sta. 85+00, 119.00'; and Sta. 60+00, 97.00'. Settlement plates that were once in the center of the dune are now missing or in open water. There are no recommendations for maintenance at this time.

Photo 10: View of beach erosion, looking east. Note: settlement plate installed on the center of the dune is currently in the Gulf.

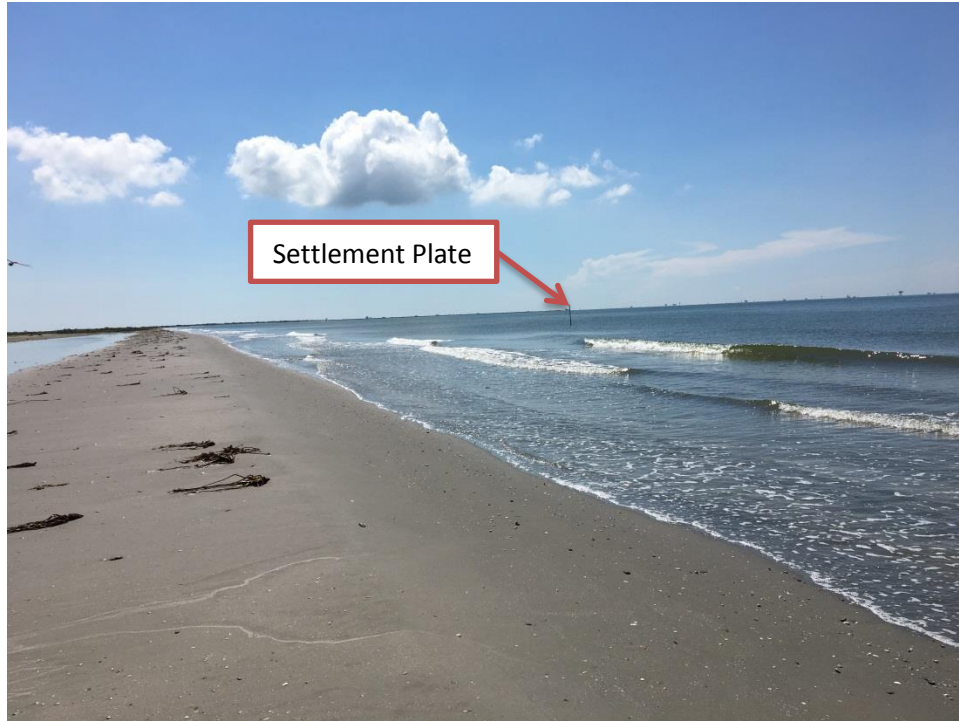
Photo 11: View of settlement plate, which used to be in the center of the dune.

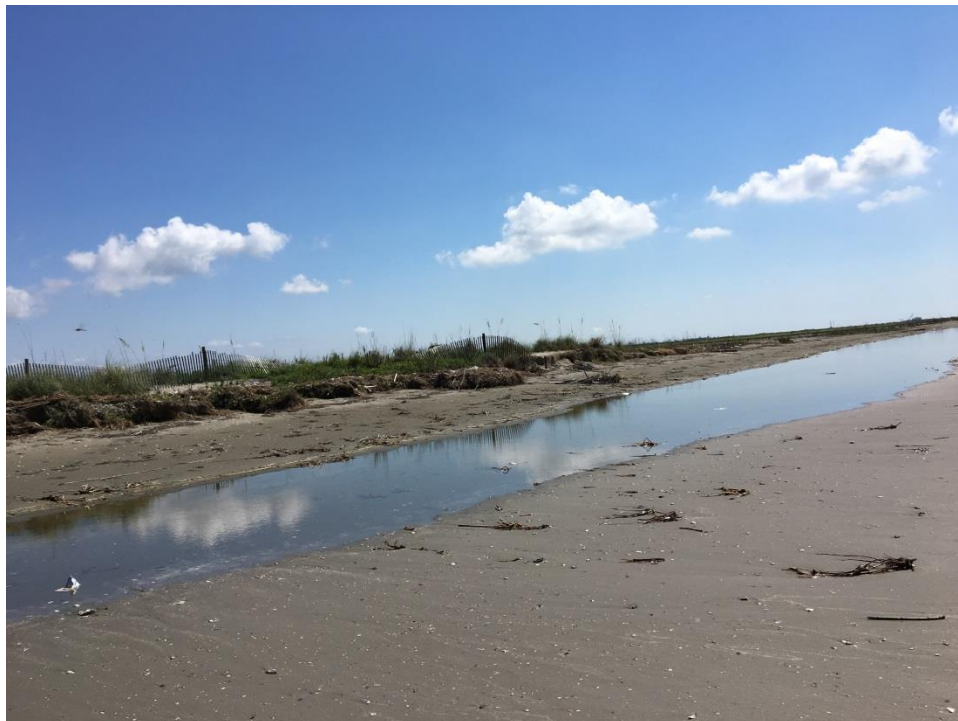
Along the dune, scarping has undercut the foundation and the fencing is completely destroyed. Only the reach from Sta. 45+00 to Sta. 55+00 has any sand fence remaining and it is not in good condition. Approximately 100' of fencing near Sta. 55+00 headed northwest has been damaged and is lying on the ground. Sand fencing from Sta. 105+00 to the eastern project extent is badly damaged or nonexistent. Without placement of additional sand, new sand fencing is not needed. There are no recommendations for maintenance at this time.

Photo 12: View of dune erosion and damaged sand fencing.

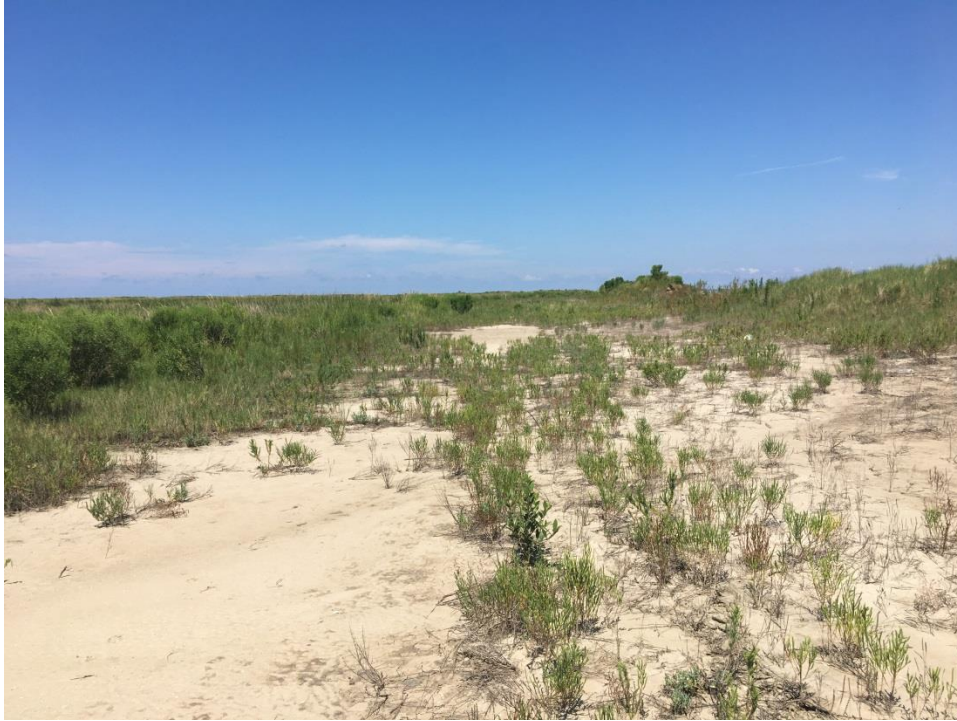
Photo 13: View of area behind primary containment dike

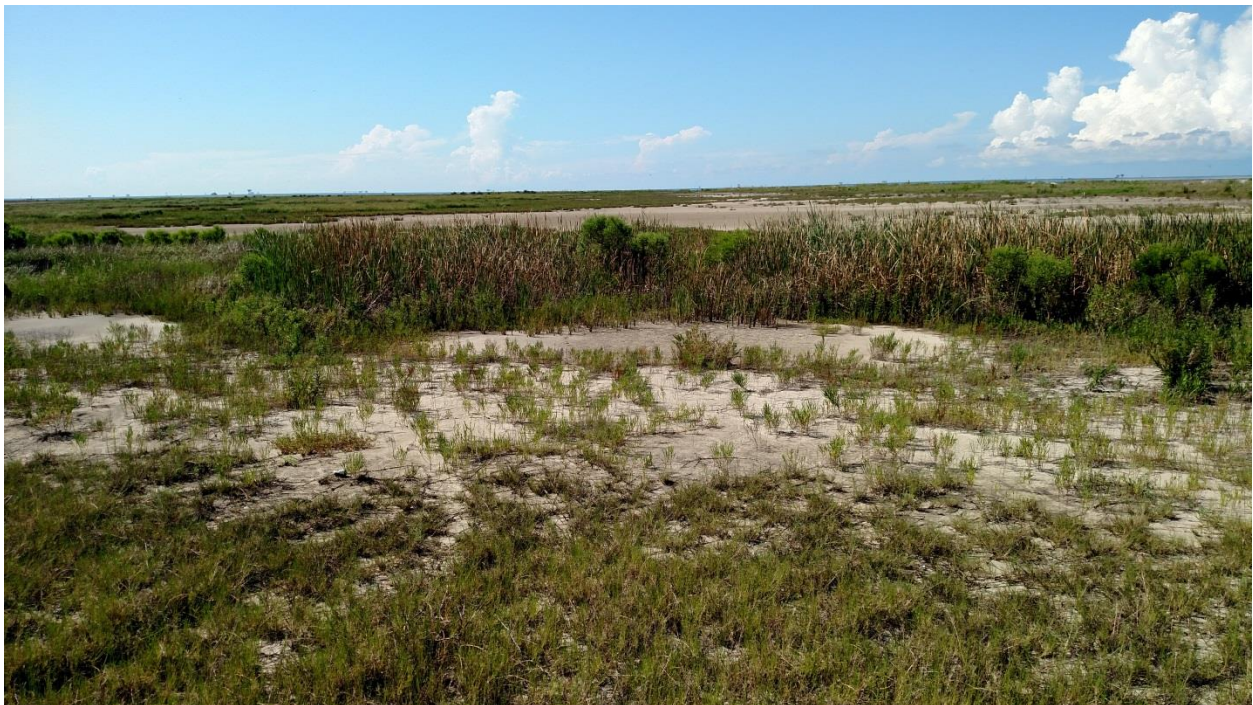
Photo 14: View of last non-vegetated section located in the center of the marsh platform, on the western edge of project.

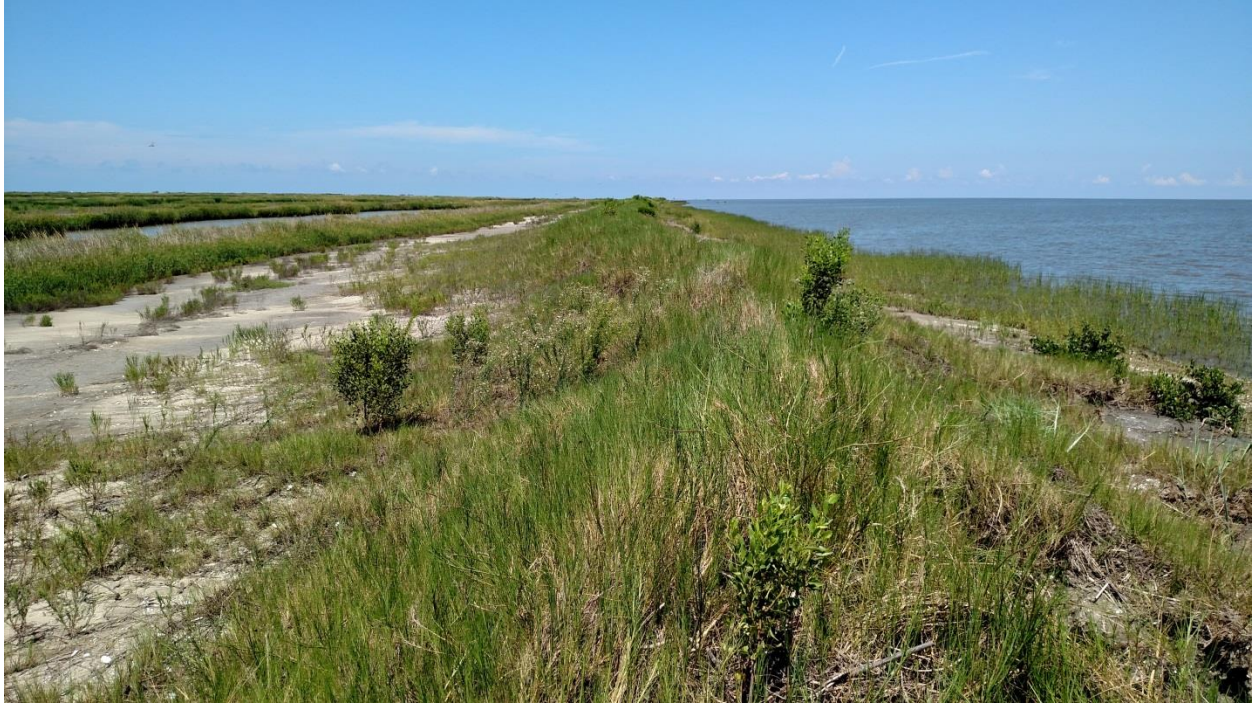
Photo 15: View along containment dike and access canal near southeastern corner of marsh fill.
